**DRAFT REPORT NUMBER: SINCAP-TRC-18-005**

**NEW CAR ASSESSMENT PROGRAM (NCAP)  
MOVING DEFORMABLE BARRIER SIDE IMPACT TEST**

**VOLSKWAGEN DE MEXICO S.A. DE C.V. MEXICO  
2018 Volkswagen Tiguan  
NHTSA NUMBER: M20185805**

**PREPARED BY:  
Transportation Research Center Inc.  
10820 State Route 347  
P. O. Box B-67  
East Liberty, OH 43319**

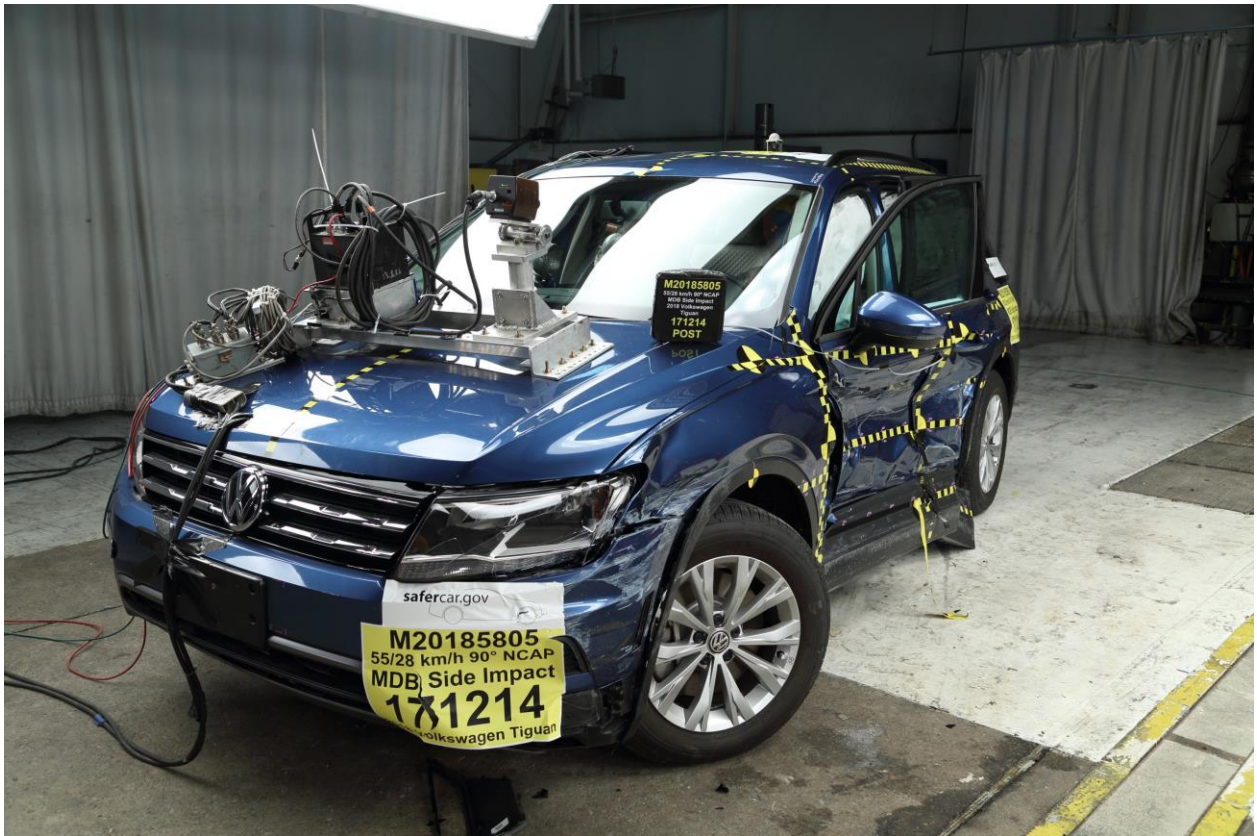
**006** Post-Test Left Front  $\frac{3}{4}$  View of Test Vehicle

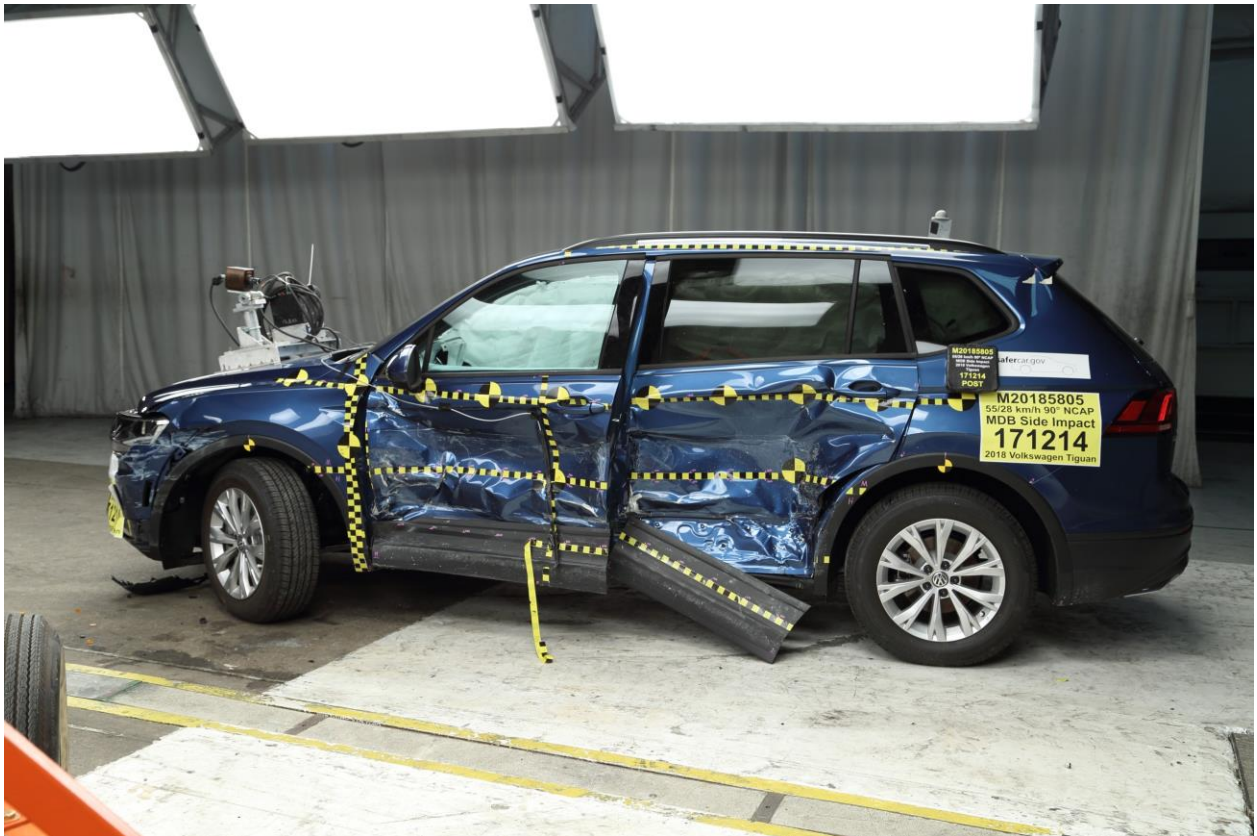
**008** Post-Test Left Side View of Test Vehicle

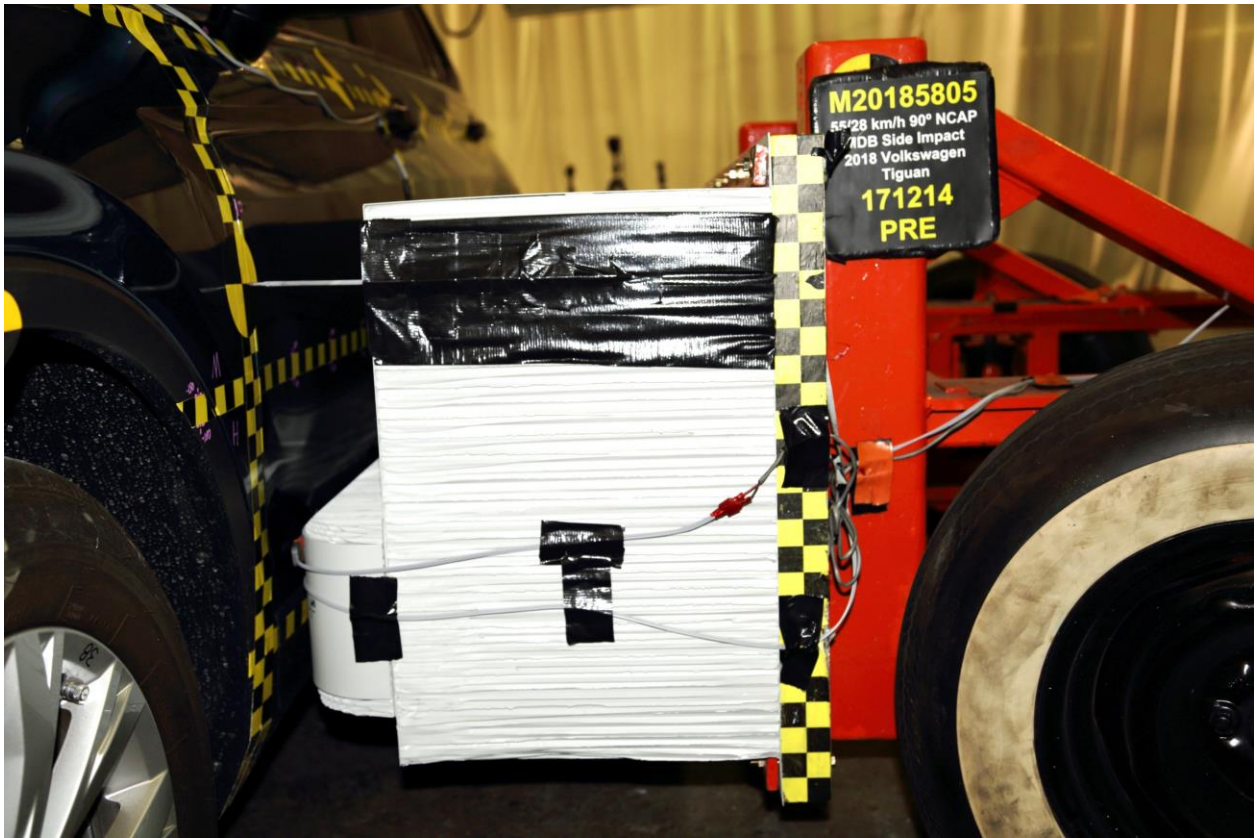
**017** Pre-Test Left Side View of MDB Positioned Against Side of Test Vehicle

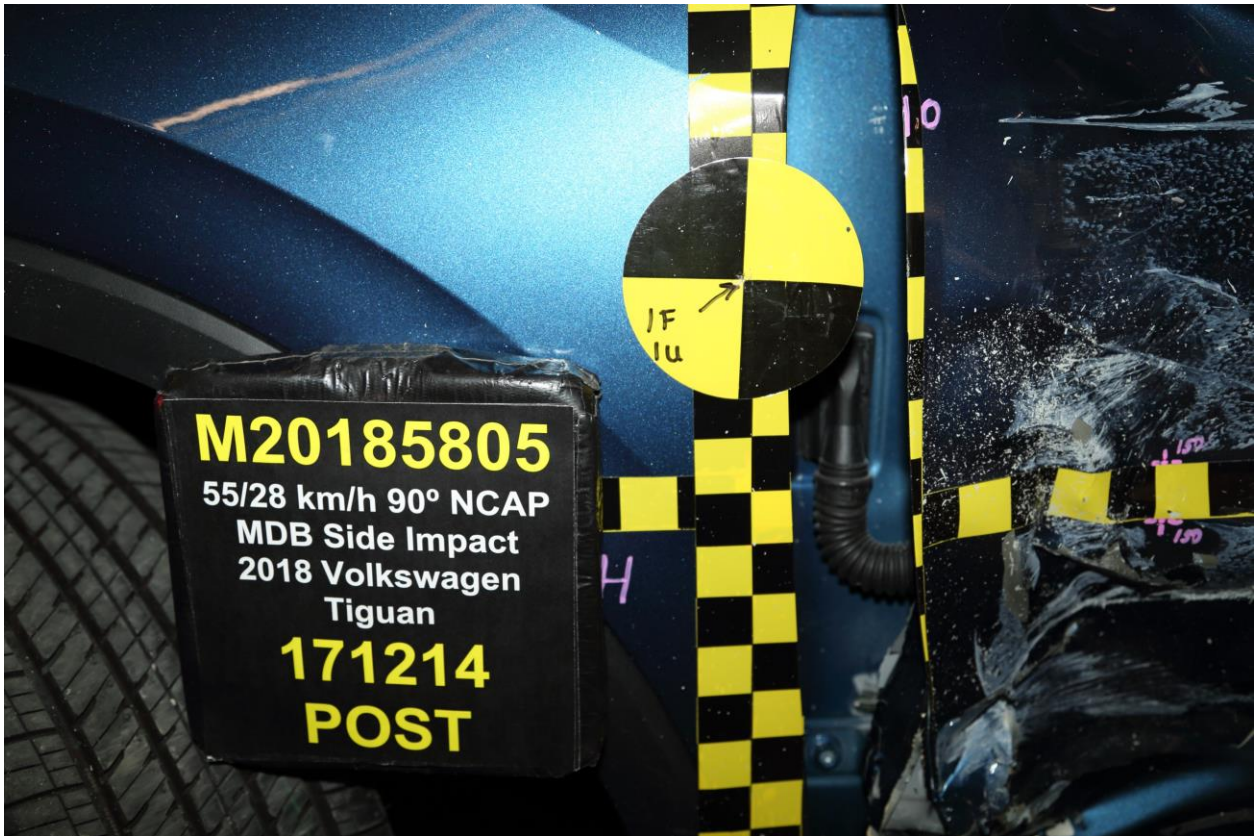
020 Post-Test Close-Up View of Impact Point Target

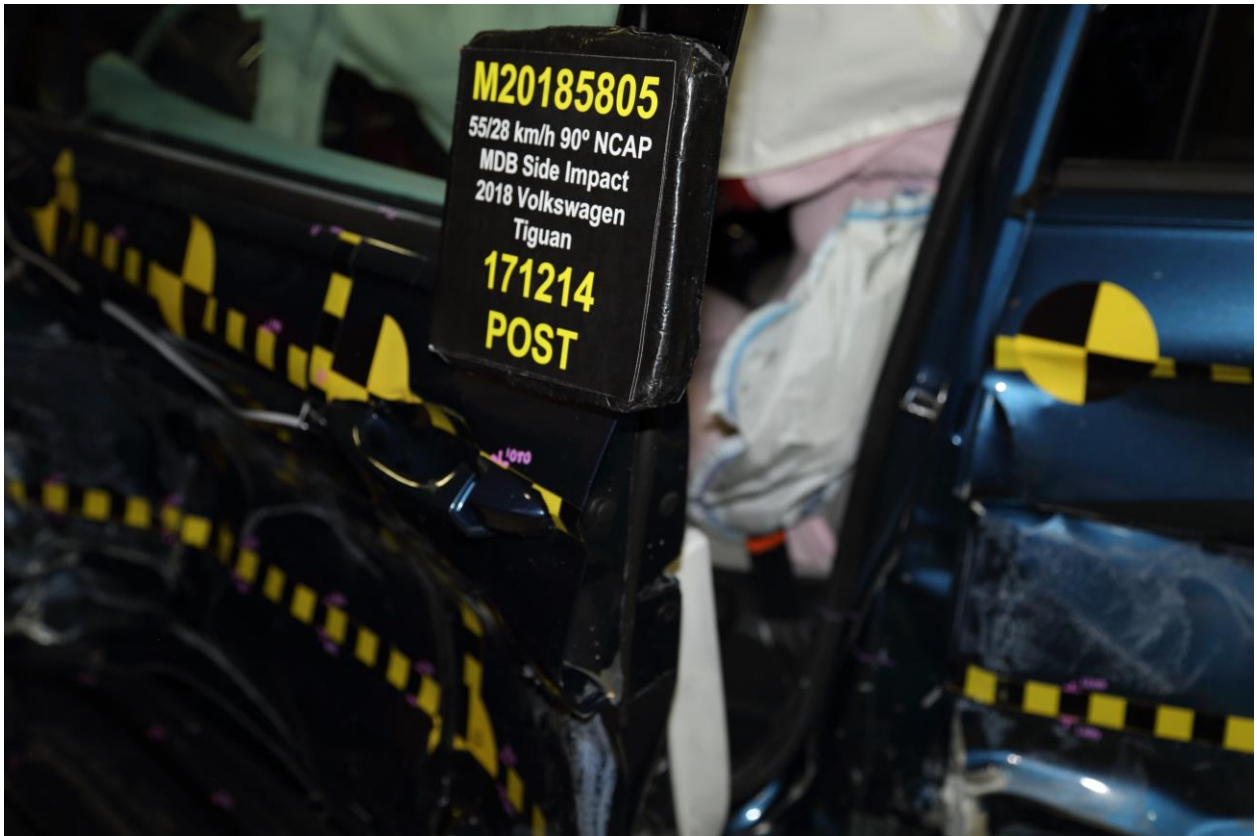
**022** Post-Test Left Front Door Latch Close-Up

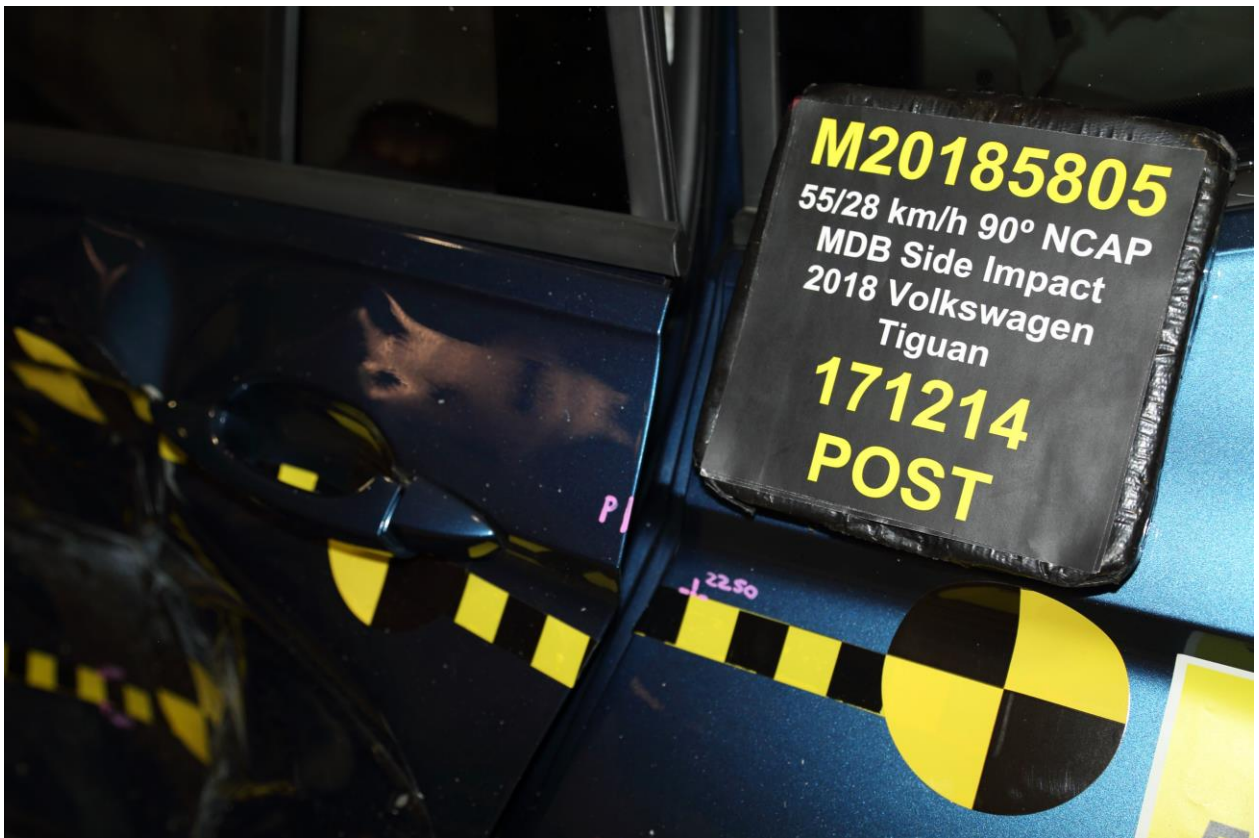
024 Post-Test Left Rear Door Latch Close-Up

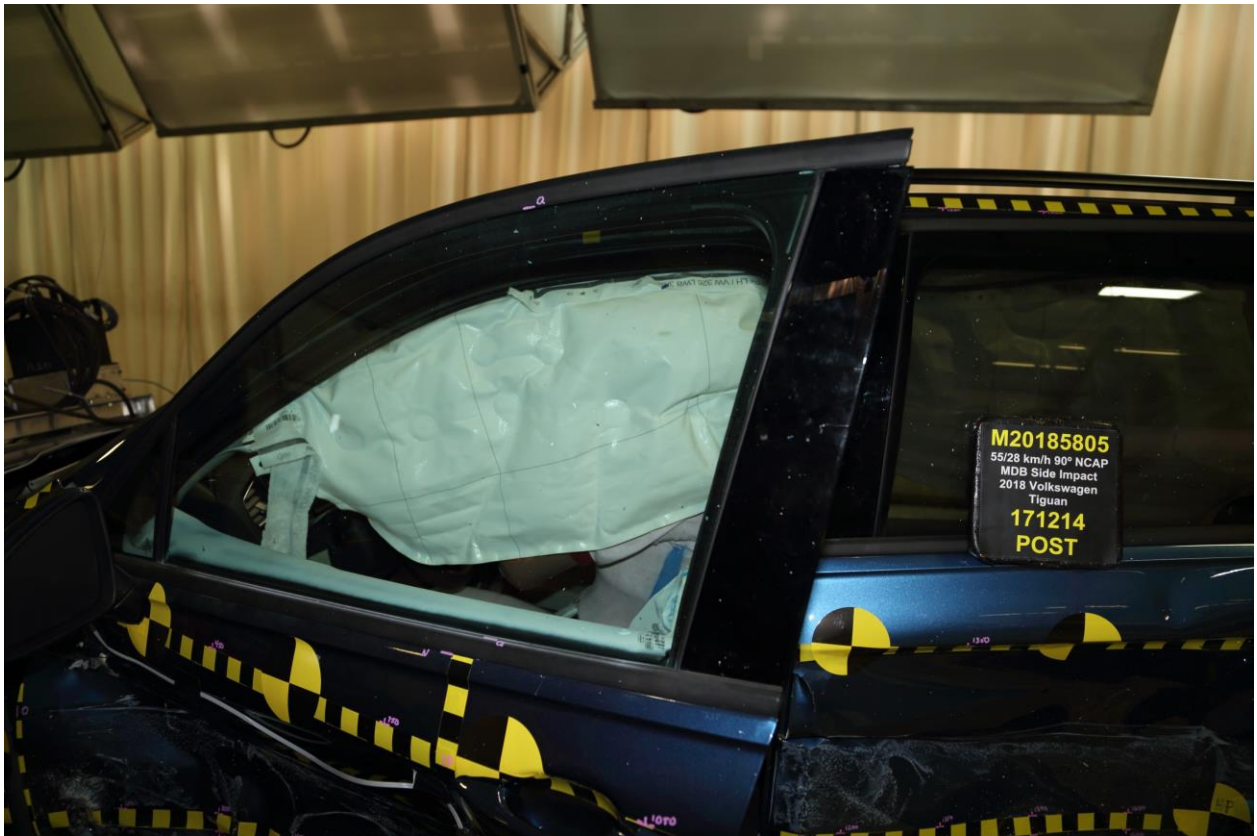
**029** Post-Test Left Side View of Driver Dummy Shoulder and Door Top

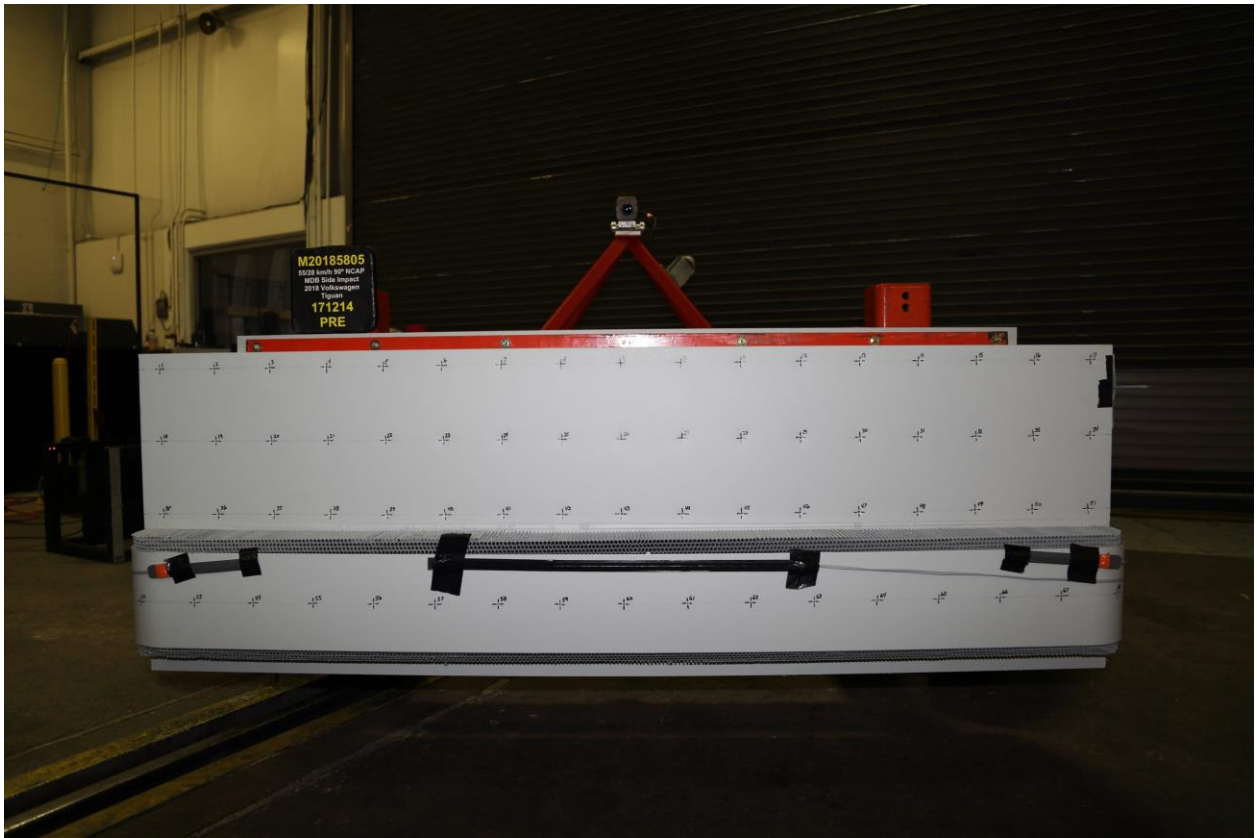
**084** Pre-Test Front View of MDB Impactor Face

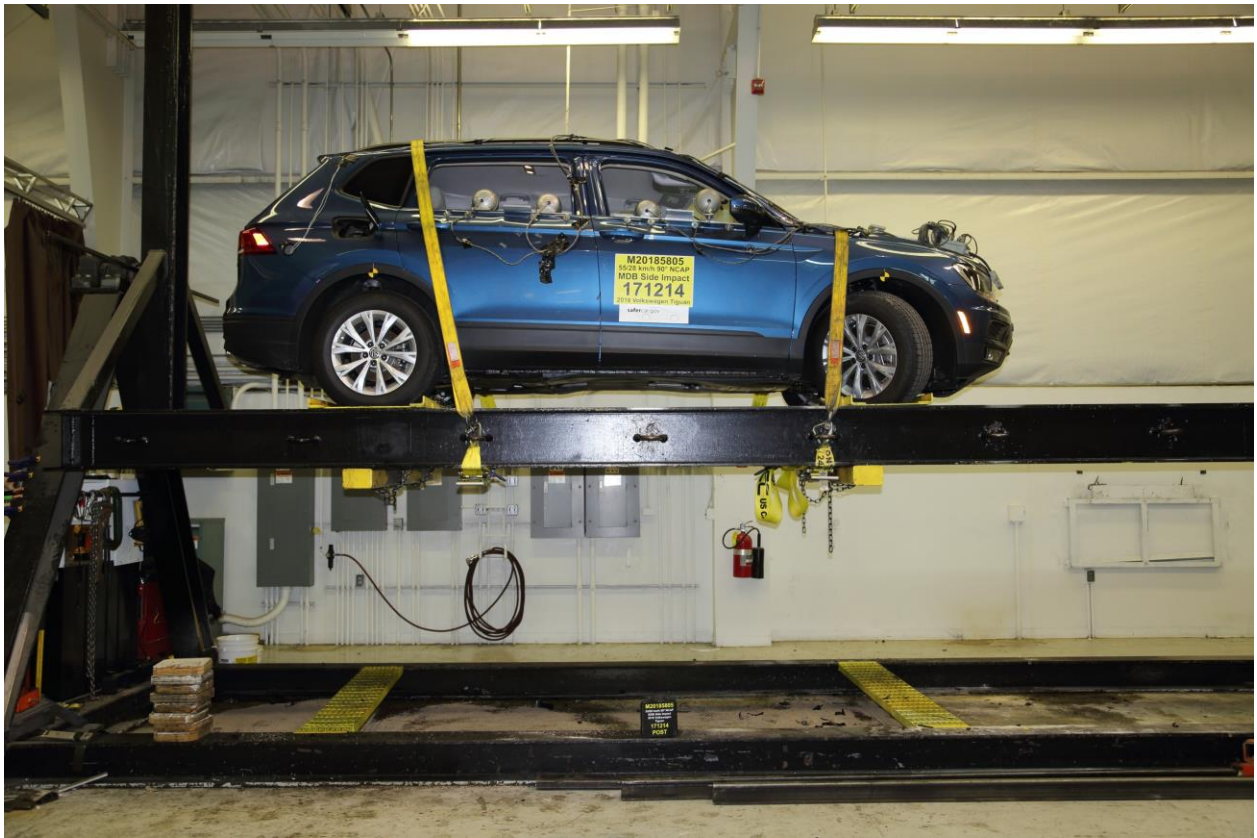
**096** FMVSS No. 301 Static Rollover 0 Degrees

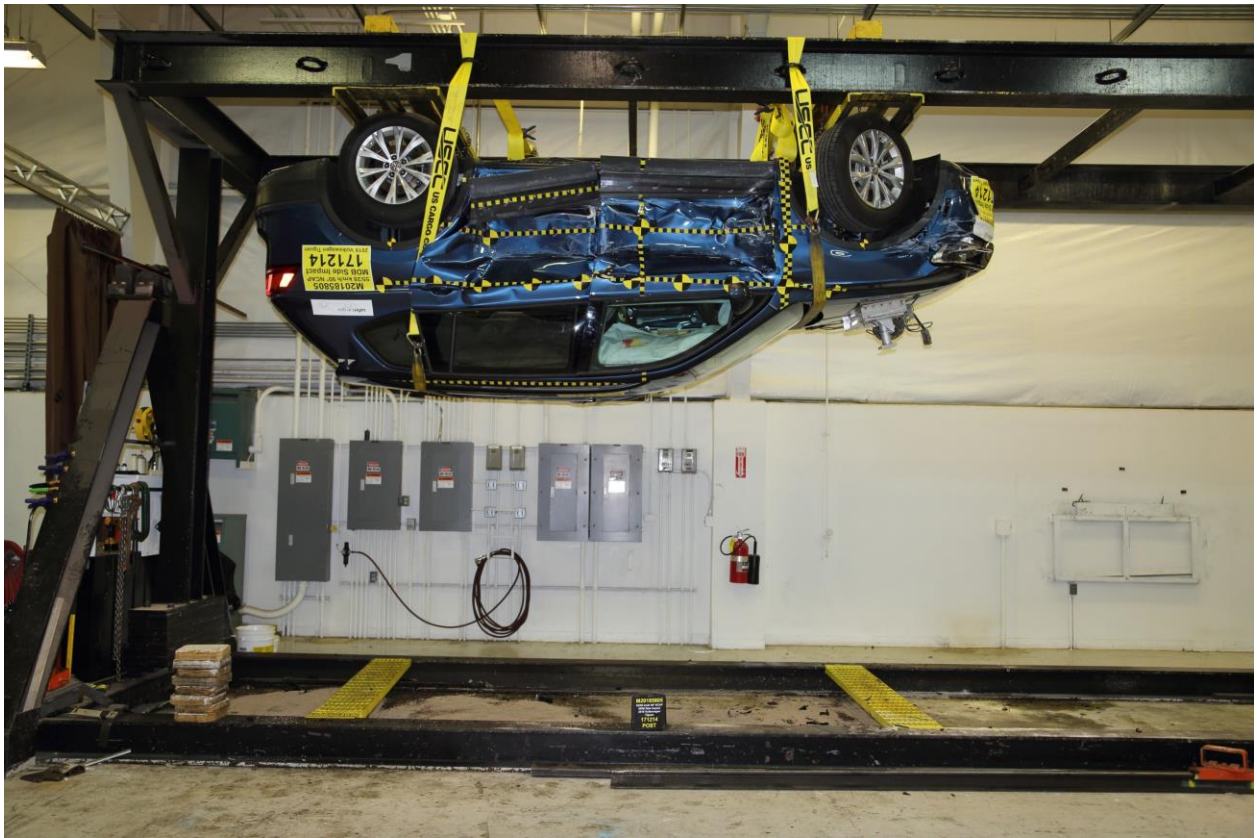
**098** FMVSS No. 301 Static Rollover 180 Degrees

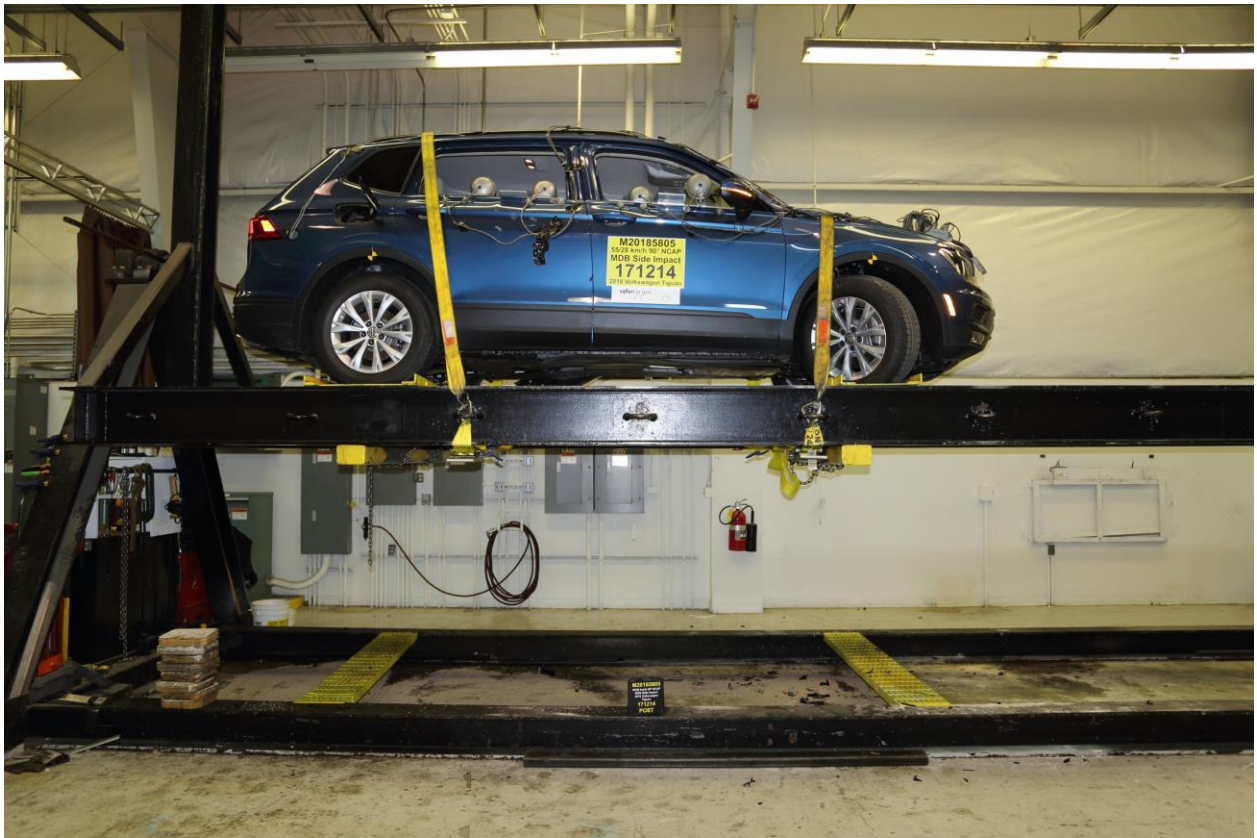
100 FMVSS No. 301 Static Rollover 360 Degrees
