**FINAL REPORT NUMBER: SPNCAP-TRC-18-005**

**NEW CAR ASSESSMENT PROGRAM (NCAP)  
SIDE IMPACT POLE TEST**

**VOLSKWAGEN DE MEXICO S.A. DE C.V. MEXICO  
2018 Volkswagen Tiguan  
NHTSA NUMBER: M20185804**

**PREPARED BY:  
Transportation Research Center Inc.  
10820 State Route 347  
P. O. Box B-67  
East Liberty, OH 43319**

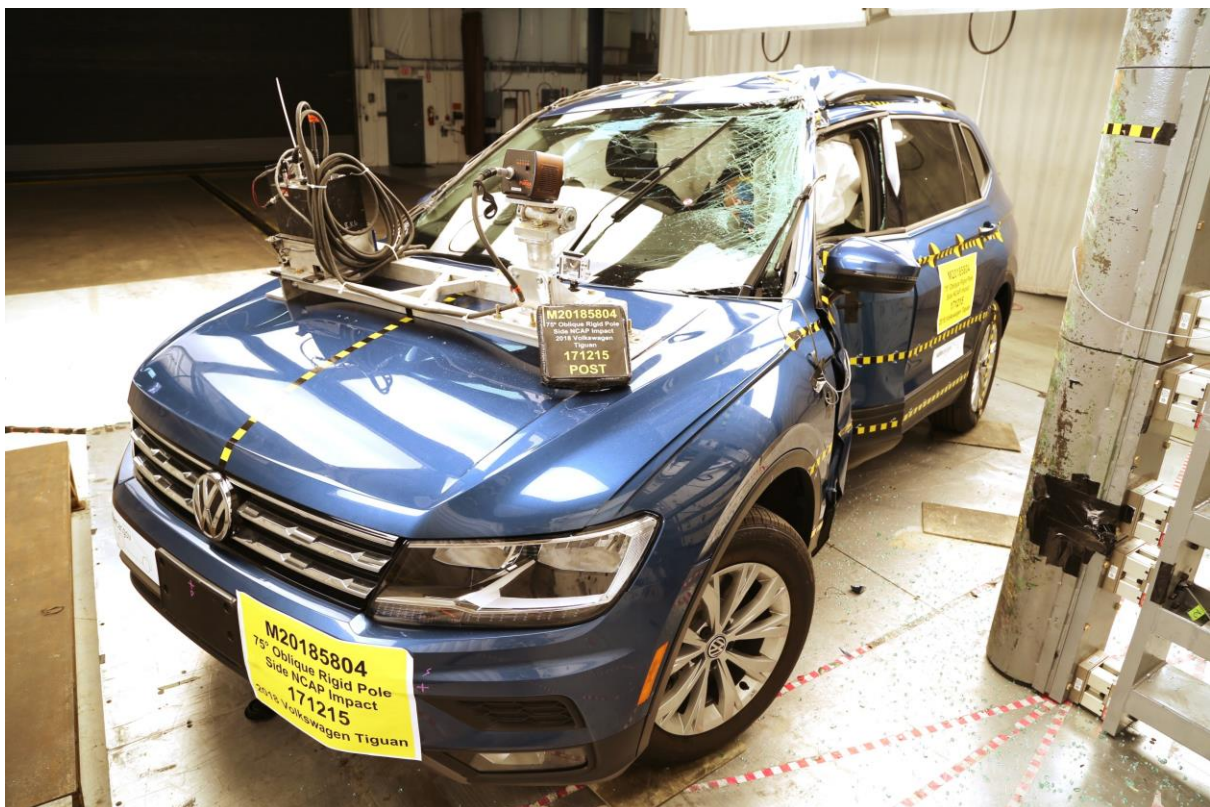
**No. 006 Post-Test Left Front  $\frac{3}{4}$  View of Test Vehicle**

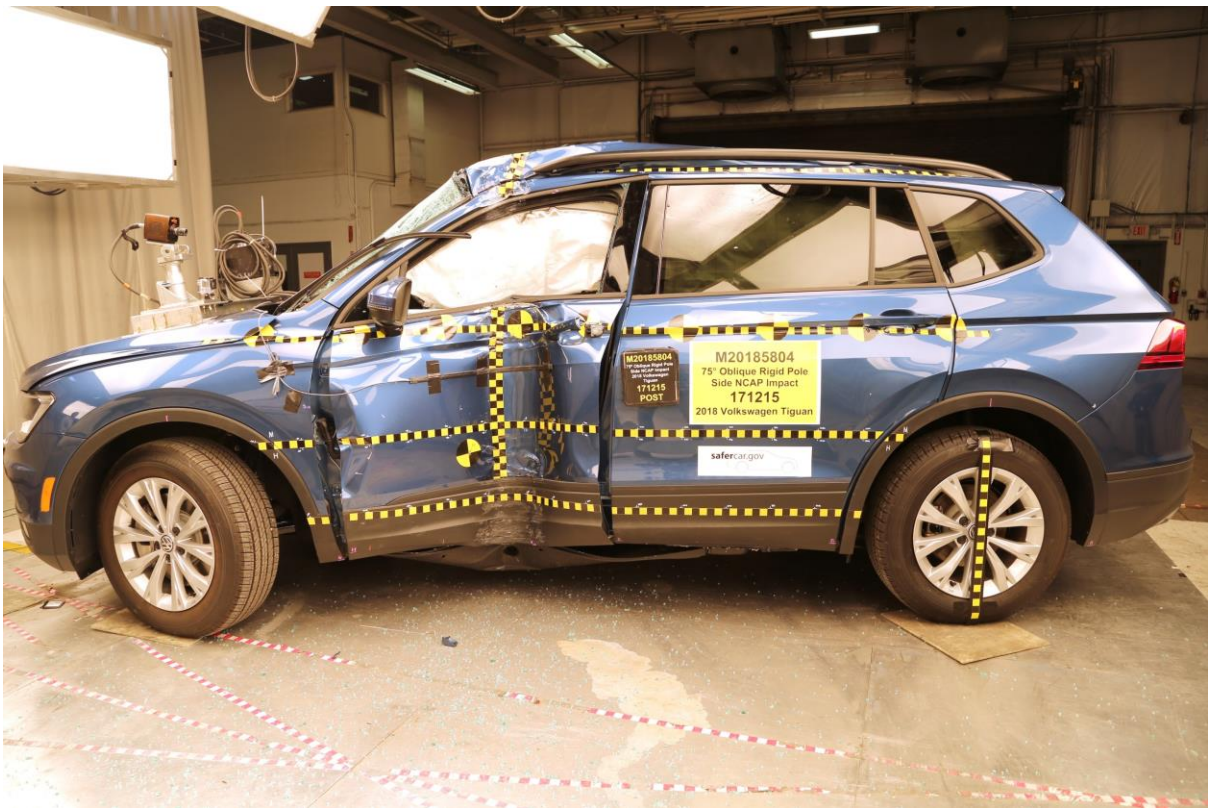
**No. 008 Post-Test Left Side View of Test Vehicle**

| Critical Areas of Performance | Observations and Conclusions |
|---|---|
| Windshield Damage | Major damage along driver A pillar |
| Side Window Damage | Driver side window broken out |

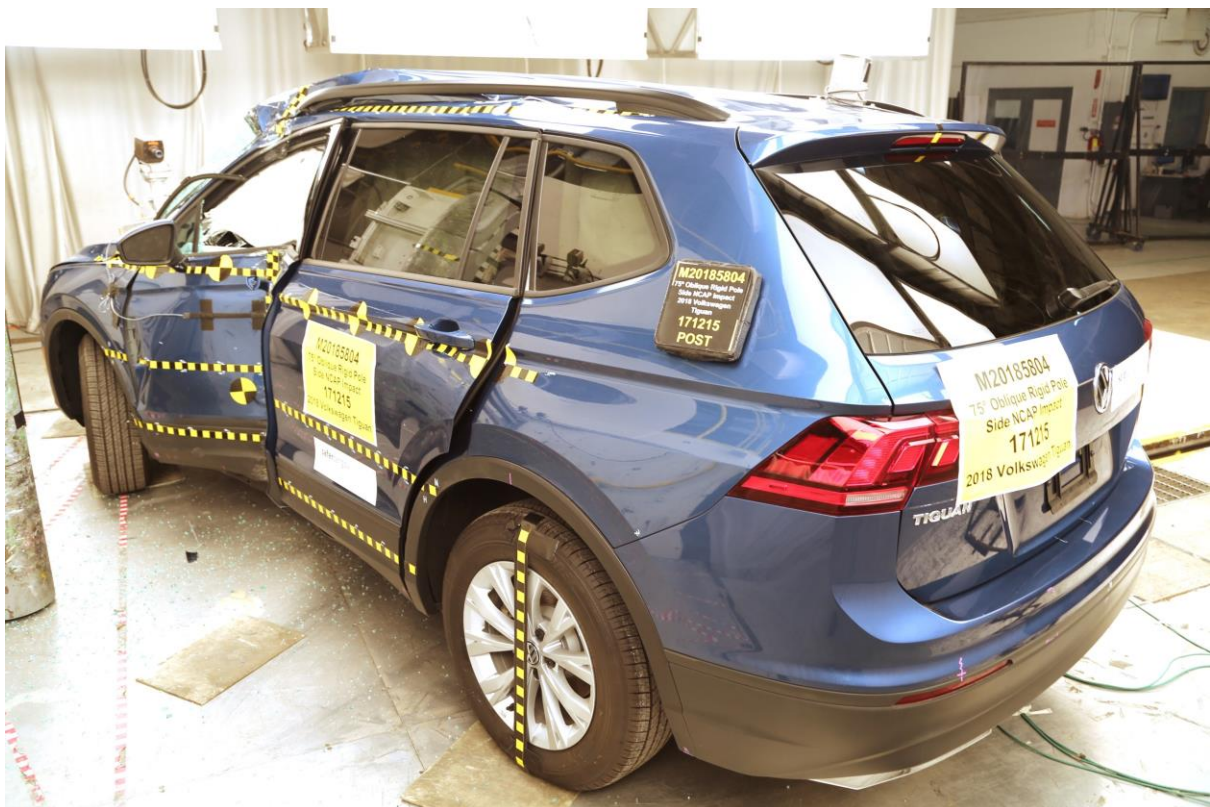
**No. 010 Post-Test Left Rear  $\frac{3}{4}$  View of Test Vehicle**

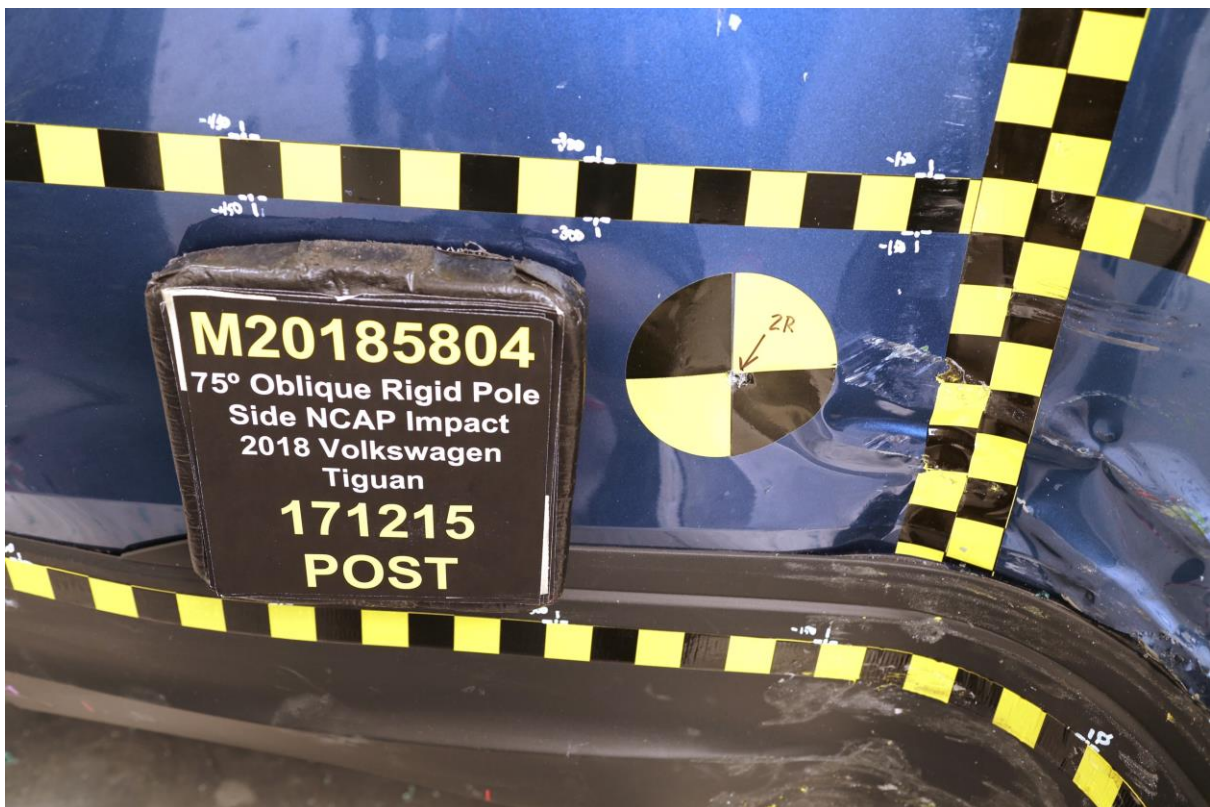
No. 020 Post-Test Close-Up View of Impact Point Target Showing Impact Location

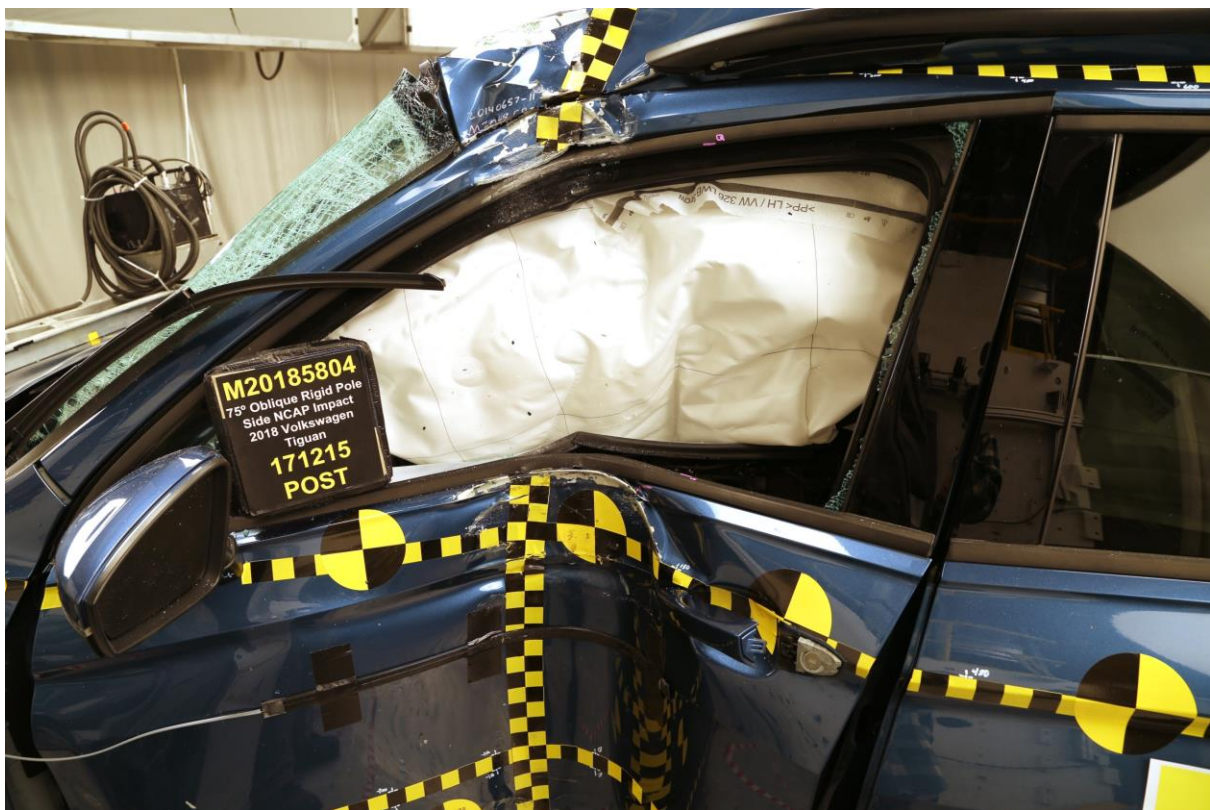
**No. 025 Post-Test Left Side View of Dummy Shoulder and Door Top View**

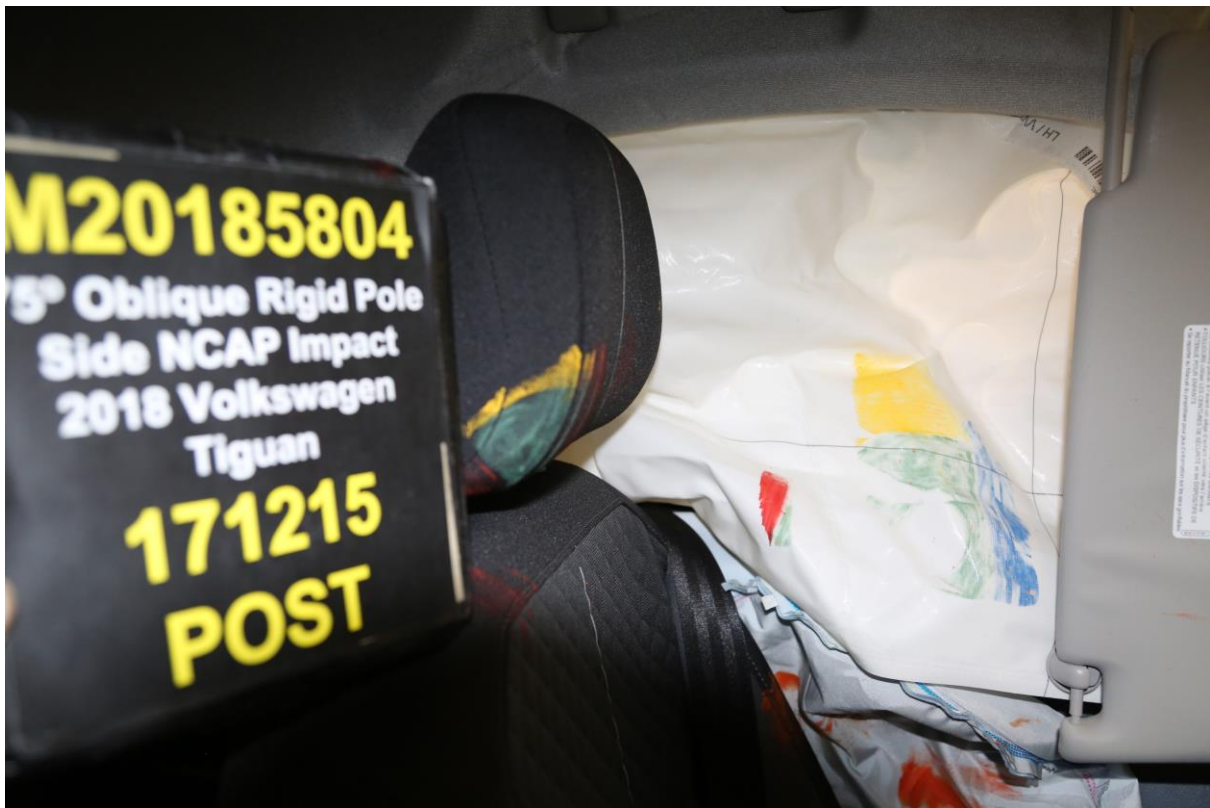
No. 046 Post-Test Dummy Close-Up Head Contact with Vehicle Interior View

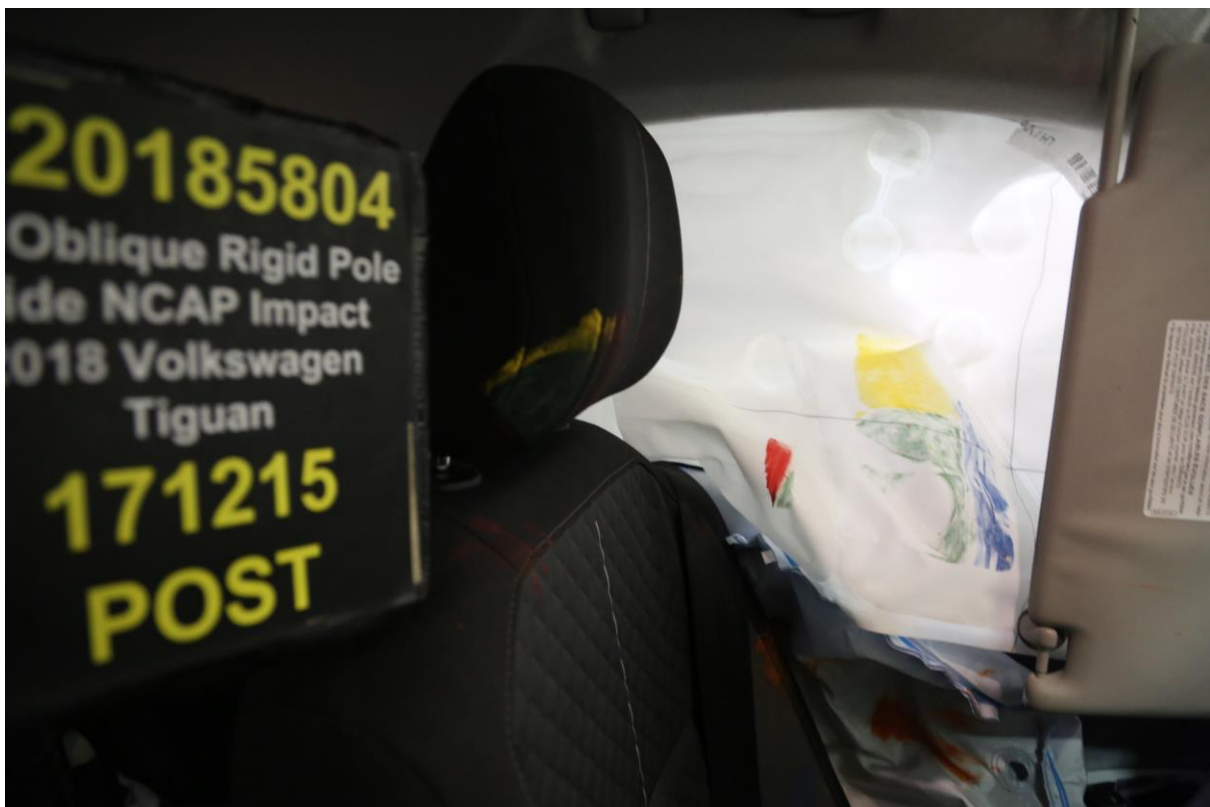
No. 047 Post-Test Dummy Close-Up Head Contact with Side Airbag View

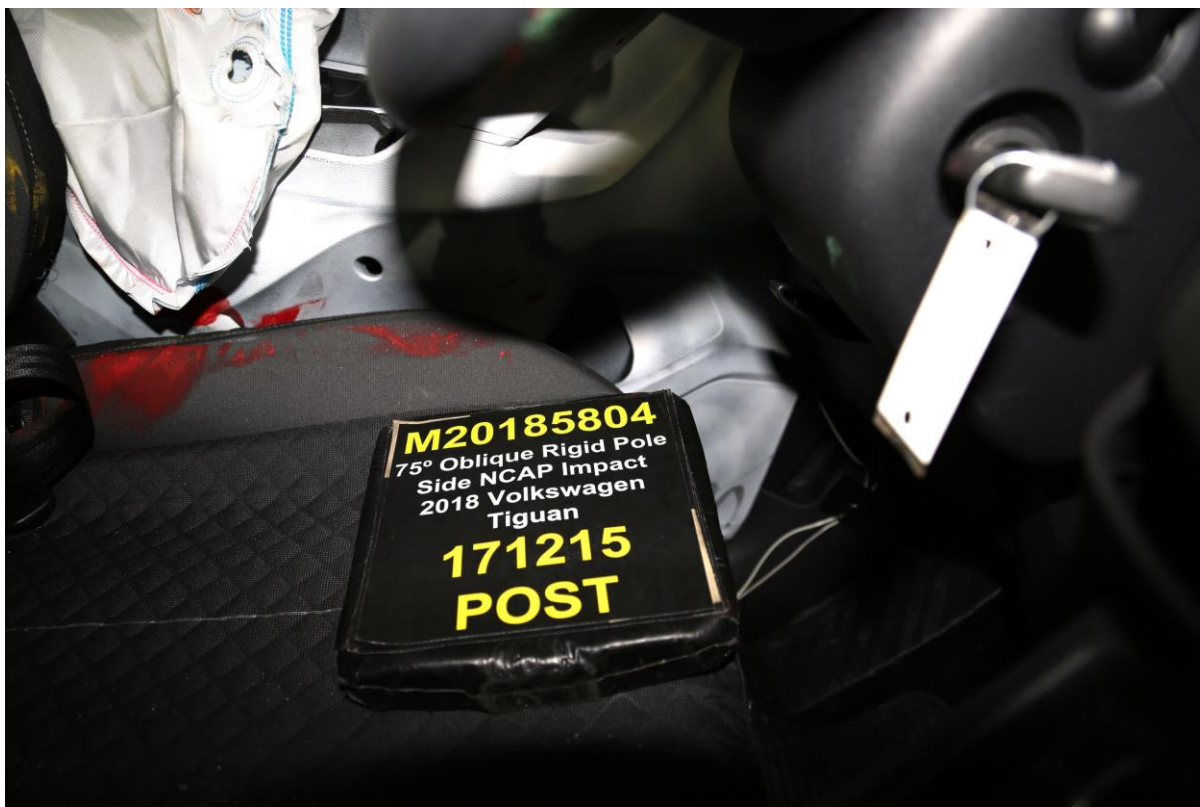
**No. 050 Post-Test Dummy Close-Up Pelvis Contact with Vehicle Interior View**
