**REPORT NUMBER: NCAP-KAR-18-012**

**NEW CAR ASSESSMENT PROGRAM (NCAP)  
FRONTAL BARRIER IMPACT TEST**

**FORD MOTOR CO.  
2018 FORD MUSTANG 2-DOOR COUPE**

**FINAL REPORT**

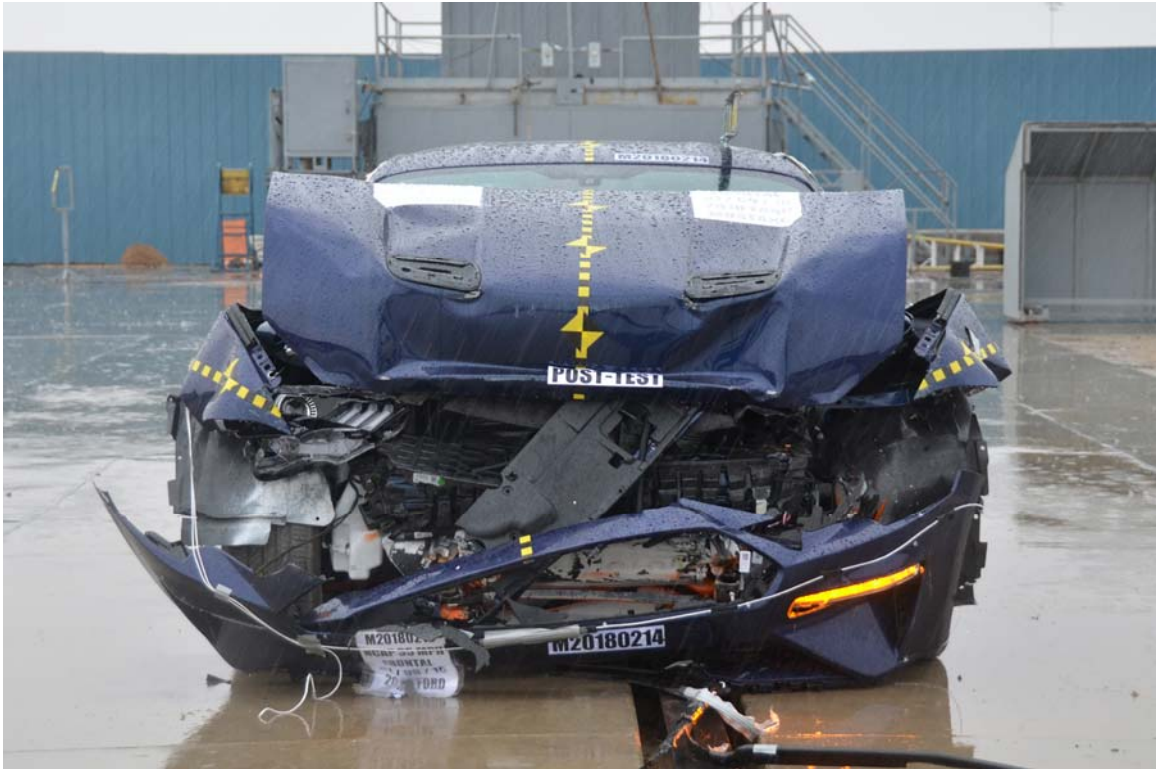
FIGURE 9. Post-Test Front View of Test Vehicle

The maximum static crush was 360 mm at the vehicle's centerline. Both the driver and passenger side doors remained closed during the impact event and were operable after the impact.
