**REPORT NUMBER: NCAP-KAR-18-013**

**NEW CAR ASSESSMENT PROGRAM (NCAP)  
FRONTAL BARRIER IMPACT TEST**

**2018 JEEP GRAND CHEROKEE LAREDO 4X4 5-DOOR MPV**

**FINAL REPORT**

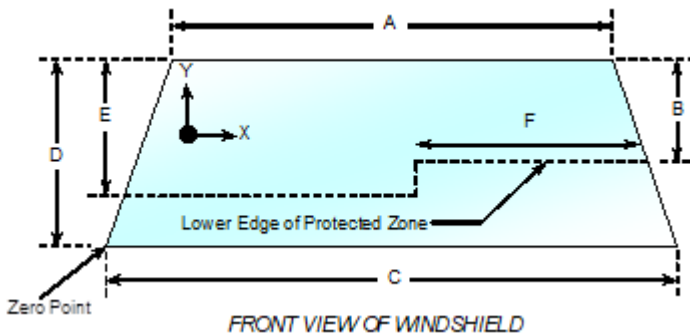
**WINDSHIELD PERIPHERY MEASUREMENTS**

Measurement	Pre-Test (mm)	Post-Test (mm)	% Retention
Left Side	2271	2271	100.0%
Right Side	2271	2271	100.0%
Total	4542	4542	100.0%

Item	Units	Value
A	mm	1322
B	mm	330
C	mm	1510
D	mm	855
E	mm	485
F	mm	530

There was 100% windshield retention and no intrusion into the protected zone of the windshield during the event.

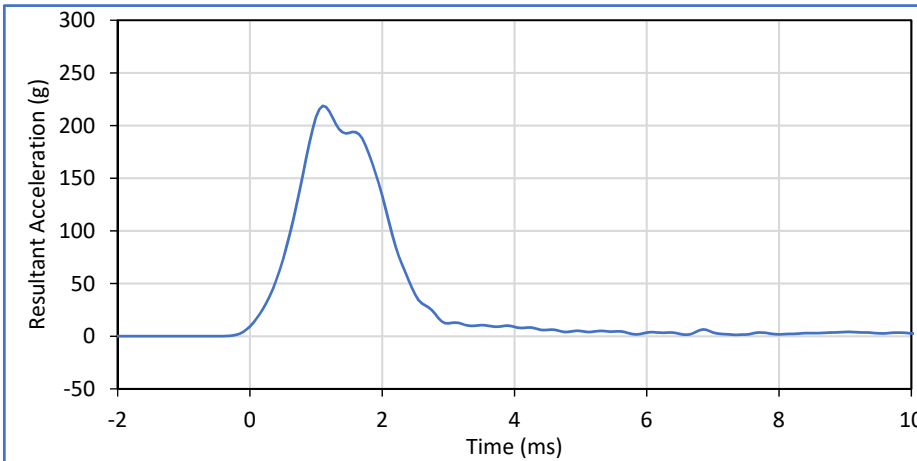
Tested Parameter	Units	Spec. Low	Spec. High	Result	Pass/Fail
Laboratory Temperature	°C	18.9	25.6	21.7	Pass
Laboratory Humidity	%	10	70	35	Pass
Peak Resultant Acceleration	g	225.0	275.0	218.7	Fail
Peak Lateral Acceleration	g	-15.0	15.0	-4.8	Pass
Oscillations After Main Pulse	%	0.0	10.0	2.9	Pass
Is Acceleration Unimodal?	Yes/No	Yes		Yes	Pass
<b>Overall Test Results</b>					<b>Fail</b>

**Head Acceleration Resultant**  
 Max:218.7@1.1 / Min:1.3@7.4  
 SAE Class 1000

2.) Failing head drop due to skull apparently seperating at casting seam or possible lead weight delamination

Replacement of skull with the same skin resolves the issue
