REPORT NUMBER: SINCAP-MGA-2018-027

**NEW CAR ASSESSMENT PROGRAM (NCAP)
Moving Deformable Barrier Side Impact Test**

**GENERAL MOTORS LLC
2018 Chevrolet Bolt EV LT 5-Door Hatchback
NHTSA No.: M20180102**

**MGA RESEARCH CORPORATION
5000 Warren Road
Burlington, WI 53105**

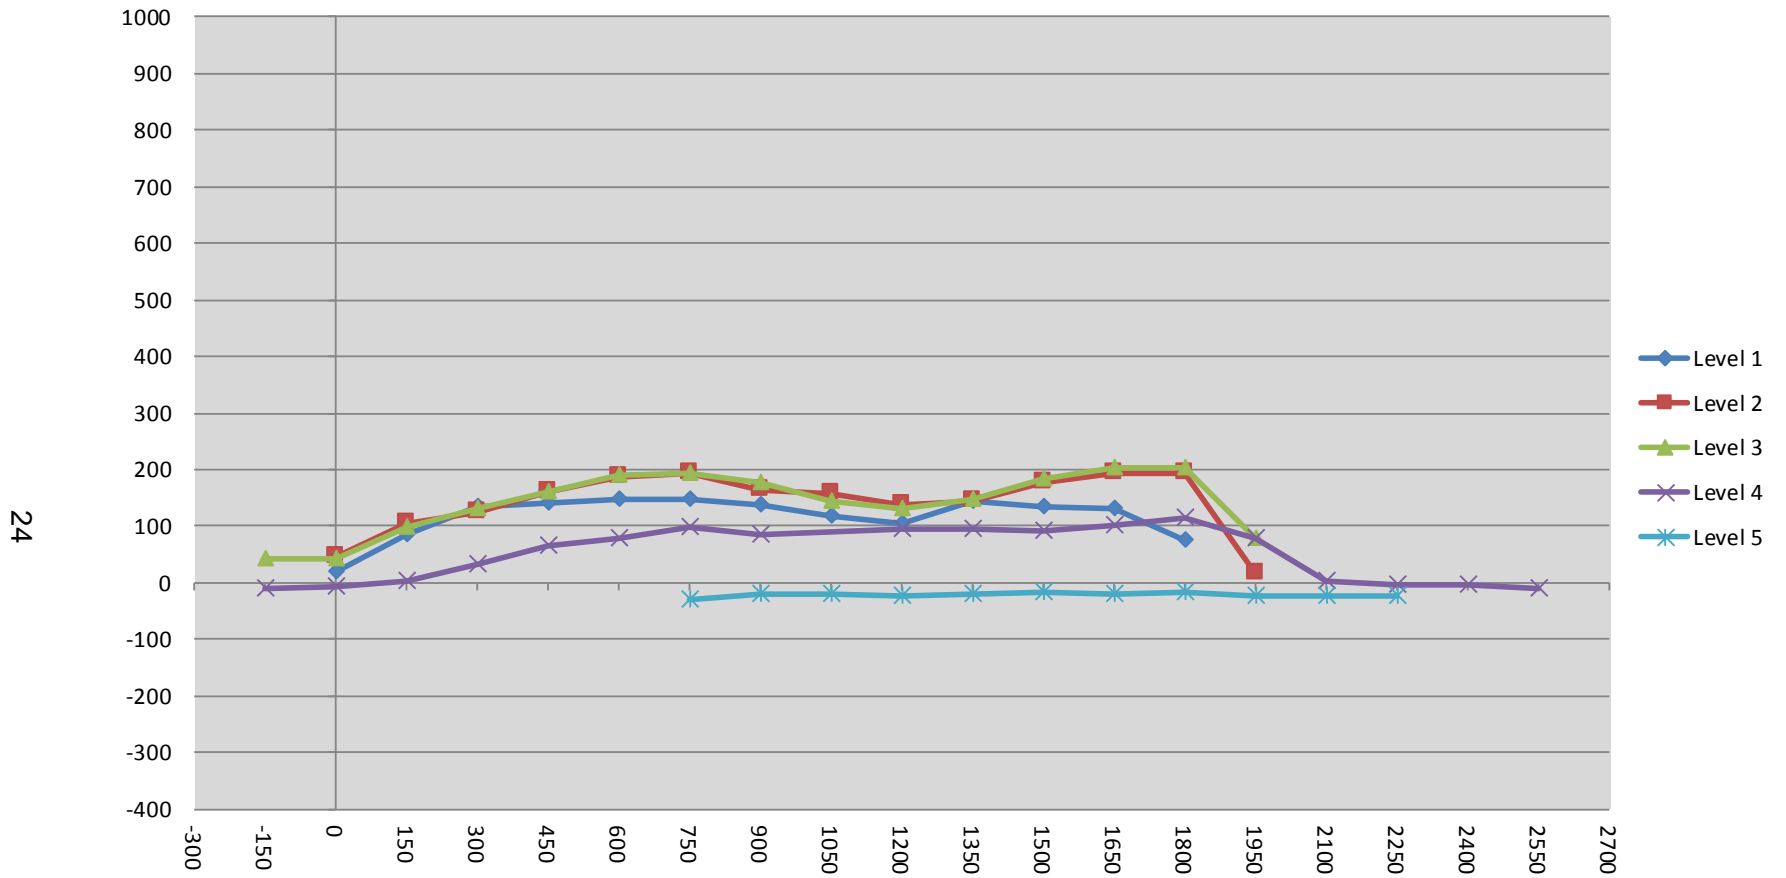
NOTE: Pre-test measurements are taken when the vehicle is in the "As Tested" weight condition. Vehicle measurements forward of the vertical impact reference line are negative. The crush profile grid is established prior to the test based on an estimated impact point.

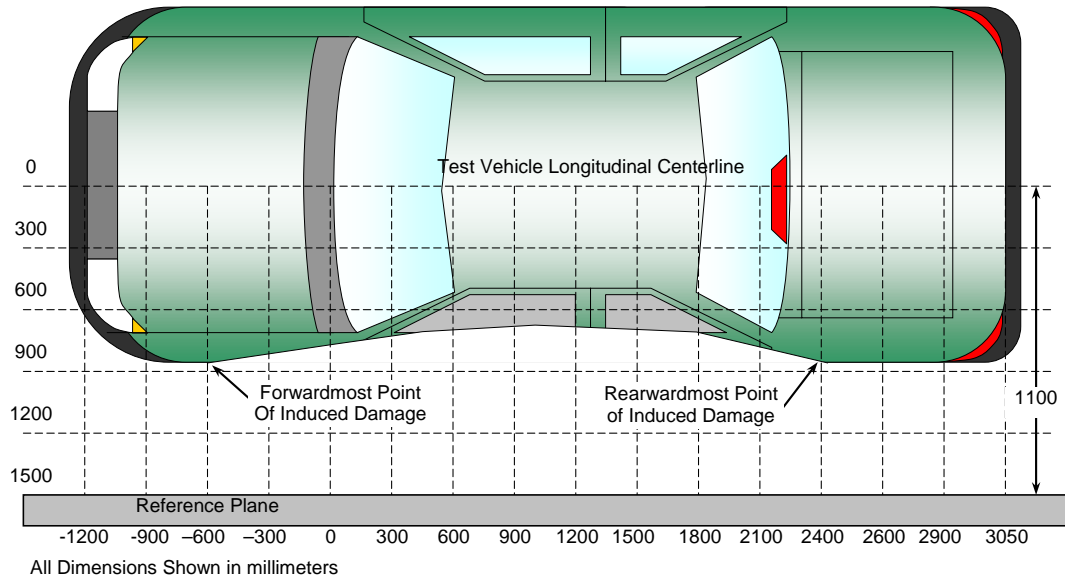
**DATA SHEET NO. 13
VEHICLE AND MDB DAMAGE PROFILE DISTANCES**

TOP VIEW

VEHICLE DAMAGE PROFILE DISTANCES

MDB DAMAGE PROFILE DISTANCES

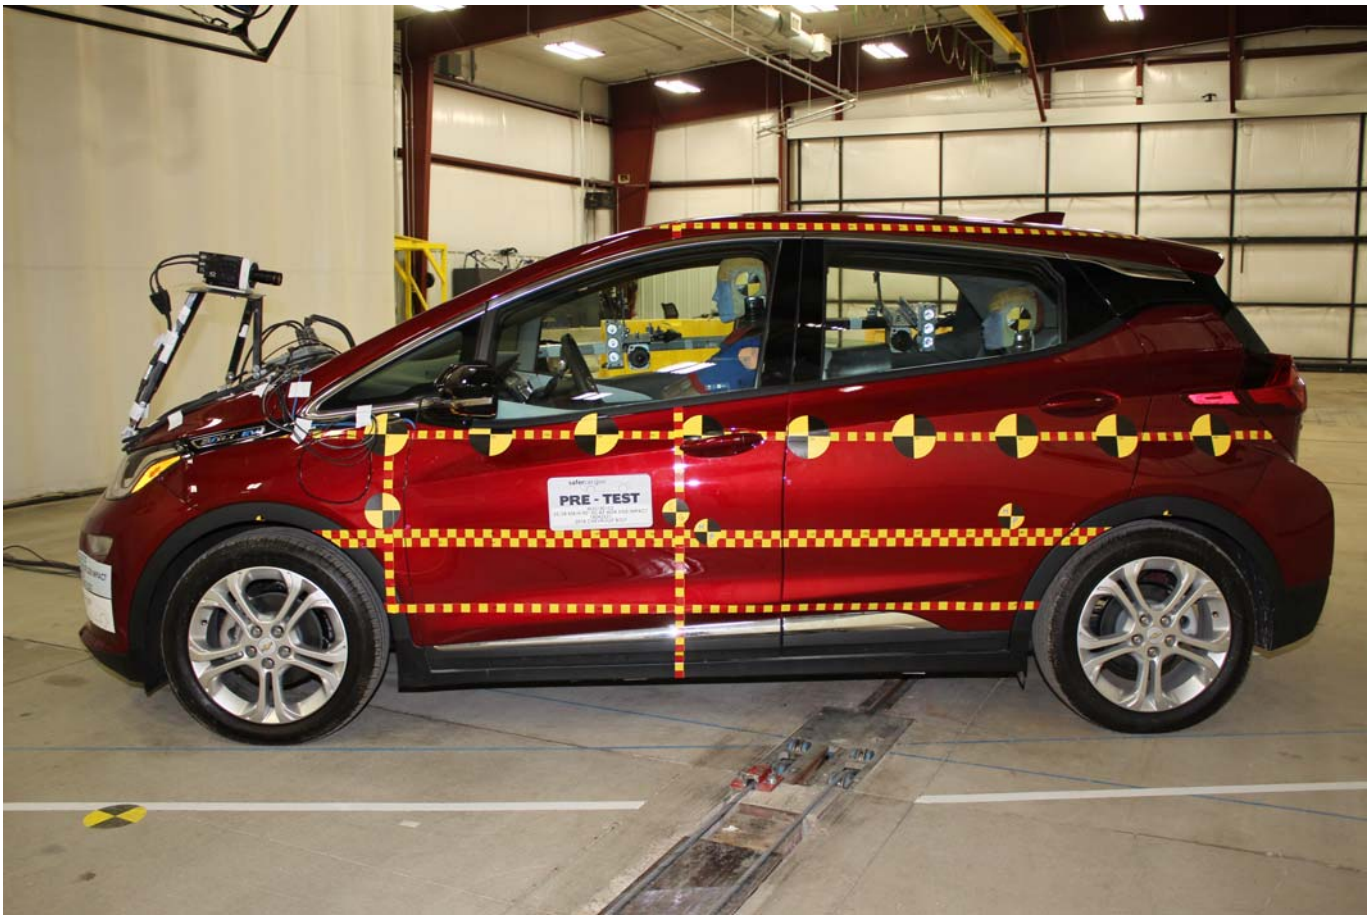
Photo No. 008 - Post-Test Left Side View of Test Vehicle

Critical Areas of Performance	Observations and Conclusions
Pillar Performance	No Separation
Sill Separation	None
Windshield Damage	None
Side Window Damage	LF Window Cracked
Other Notable Effects	None

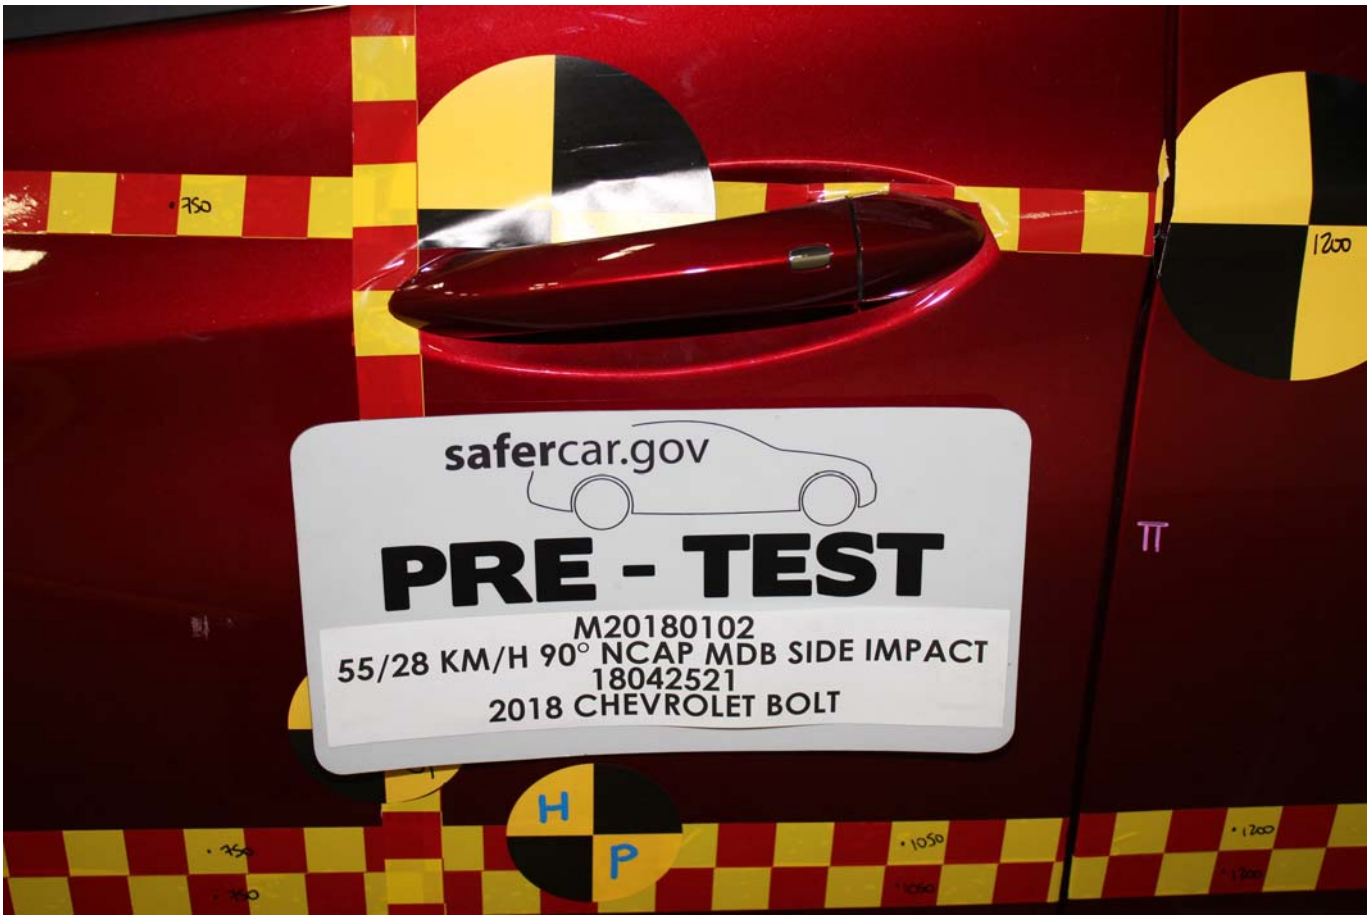
Photo No. 021 - Pre-Test Left Front Door Latch Close-Up

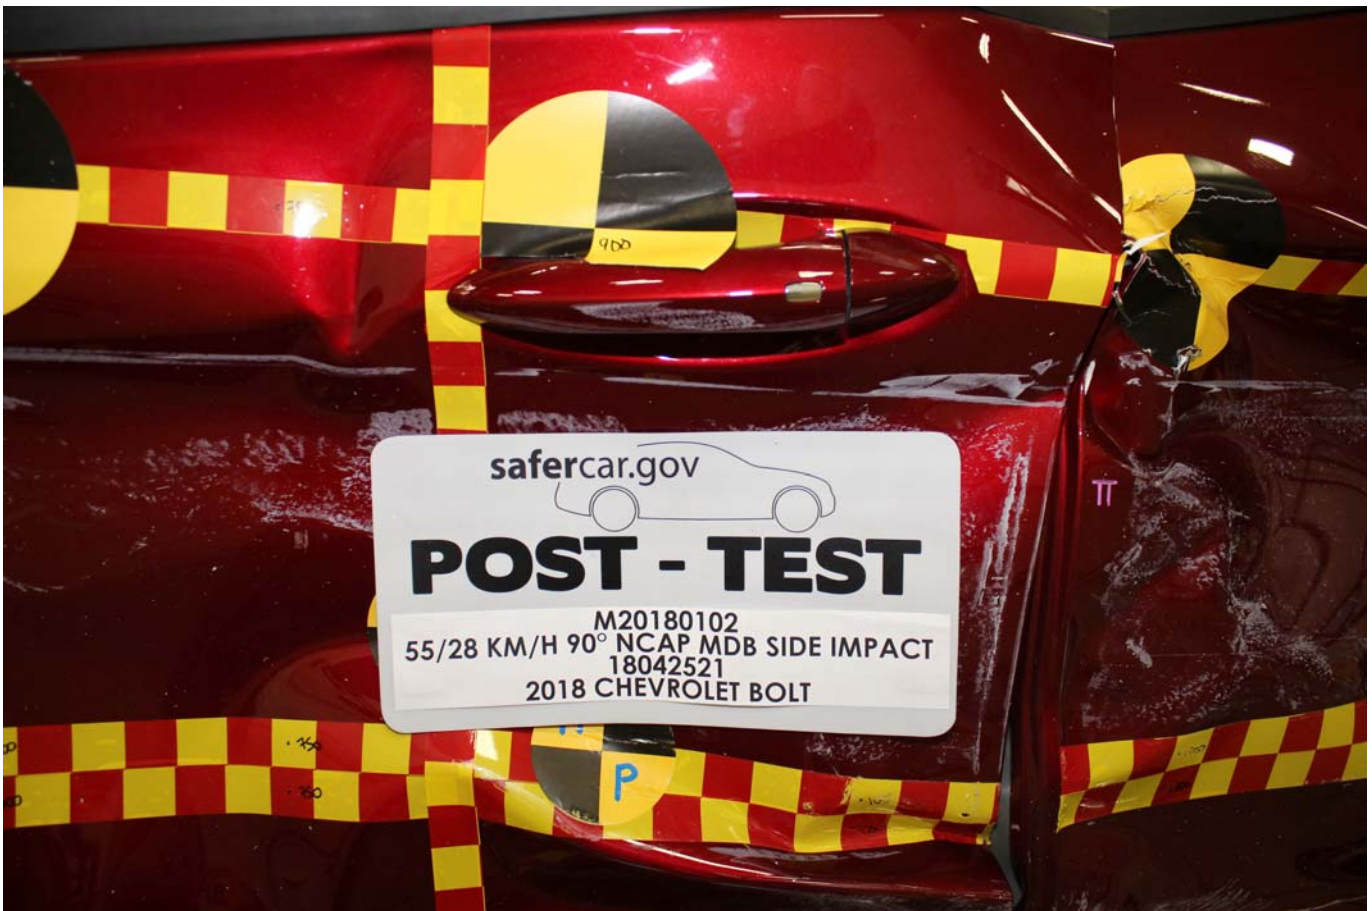
Photo No. 022 - Post-Test Left Front Door Latch Close-Up

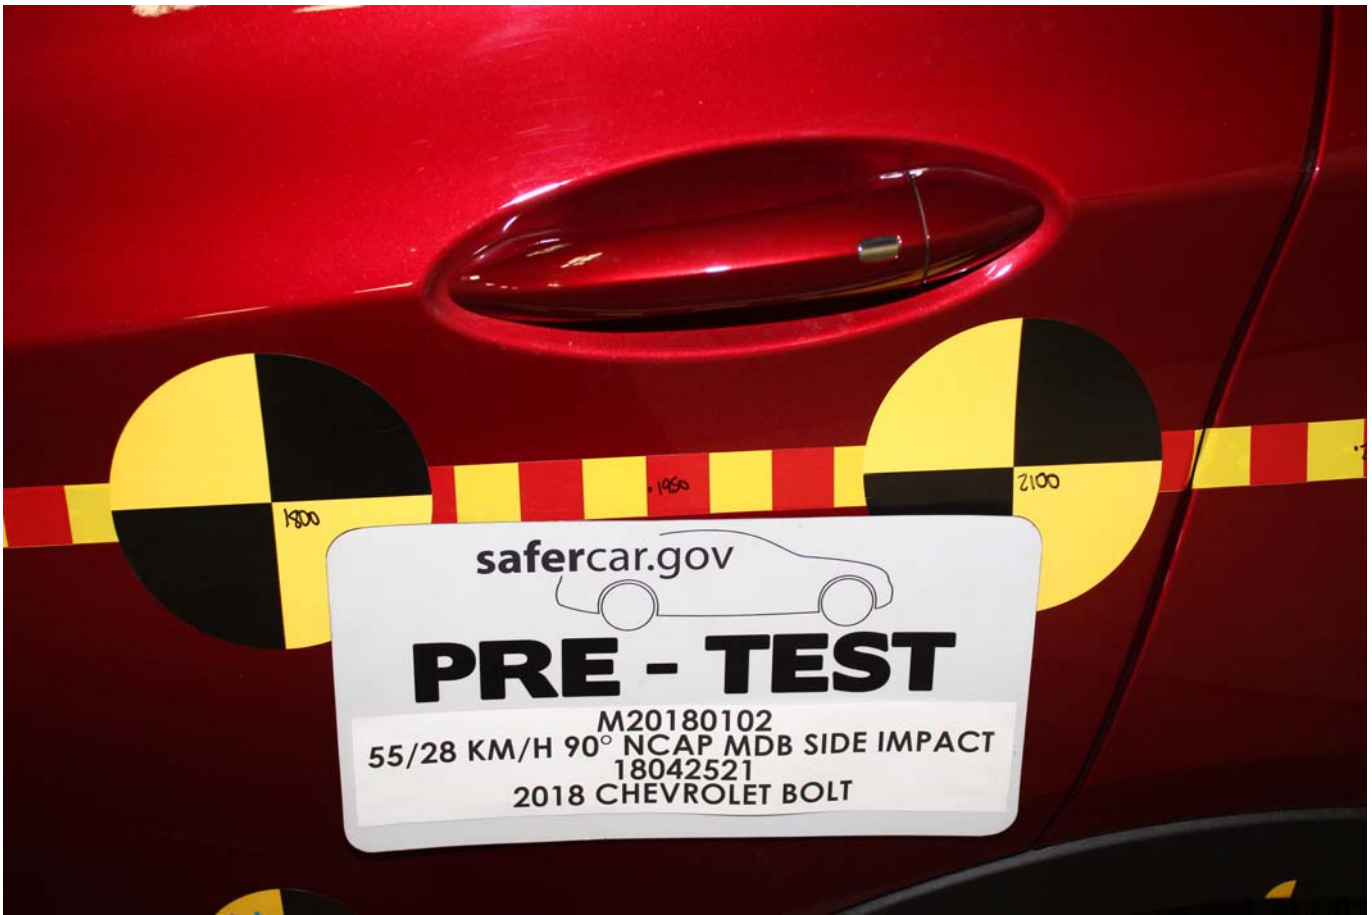
Photo No. 023 - Pre-Test Left Rear Door Latch Close-Up

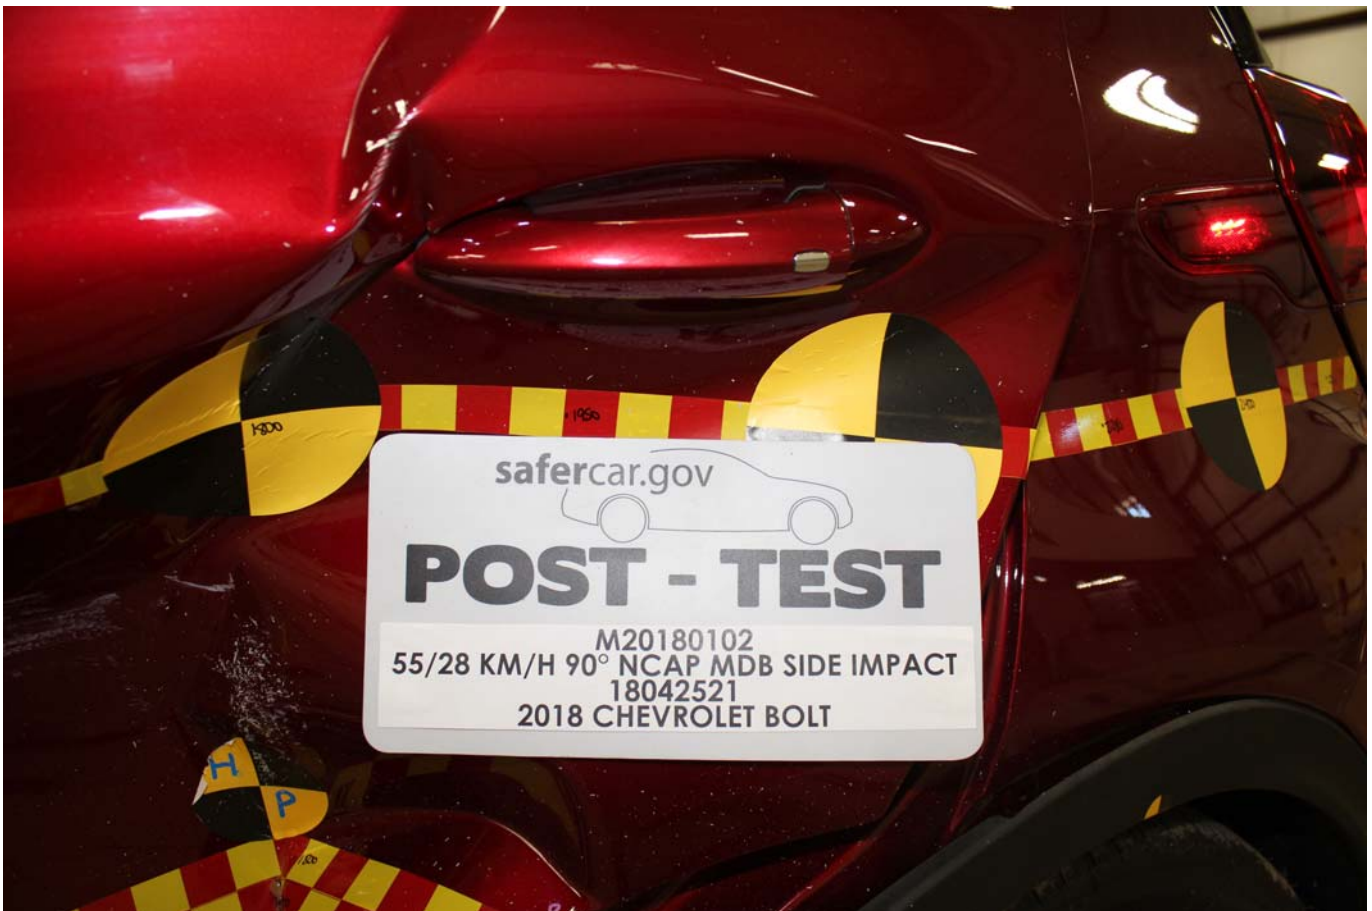
Photo No. 024 - Post-Test Left Rear Door Latch Close-Up

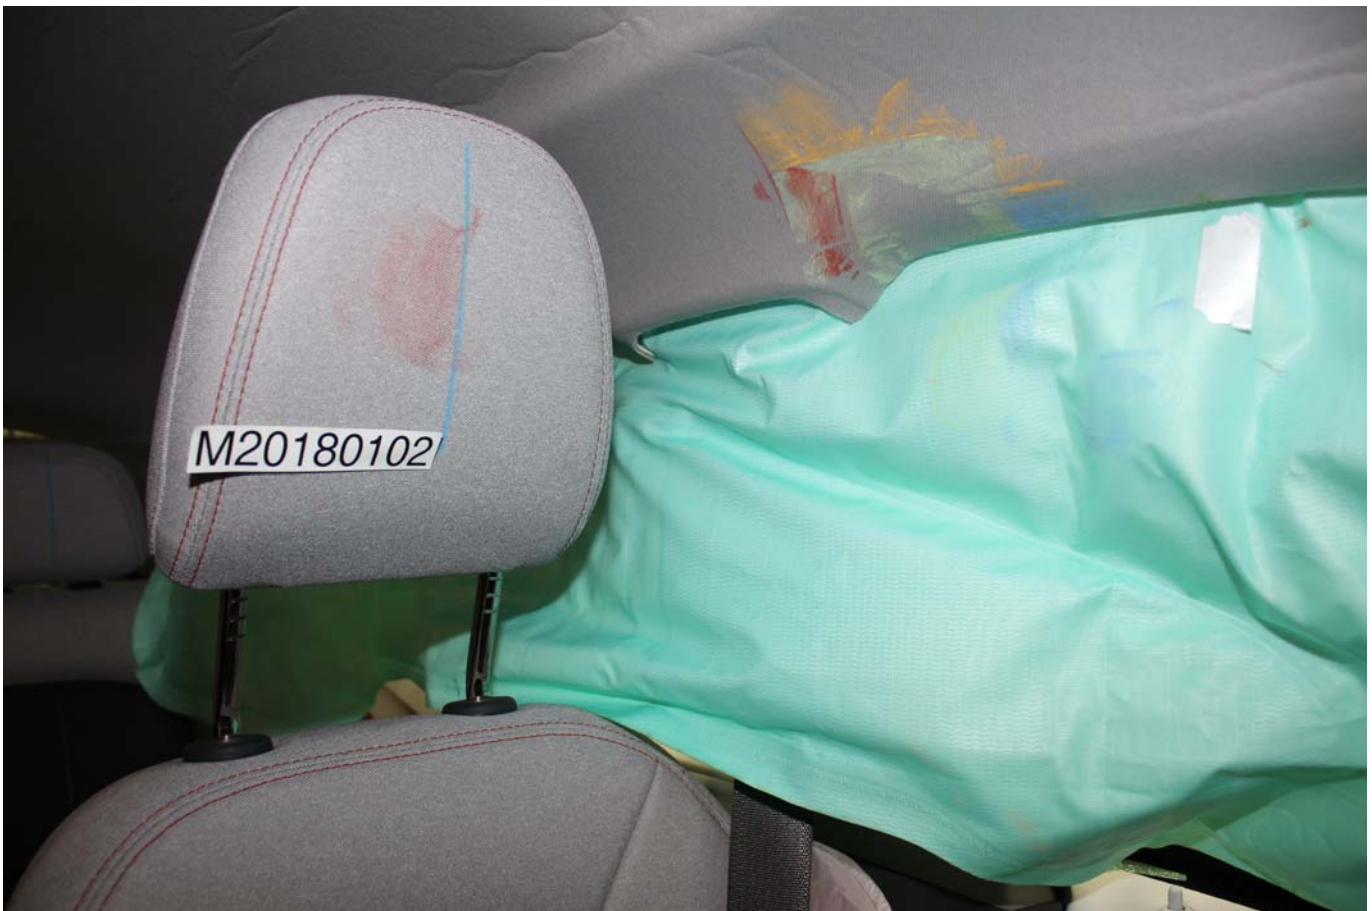
Photo No. 048 - Post-Test Driver Dummy Close-up Head Contact with Vehicle Interior View

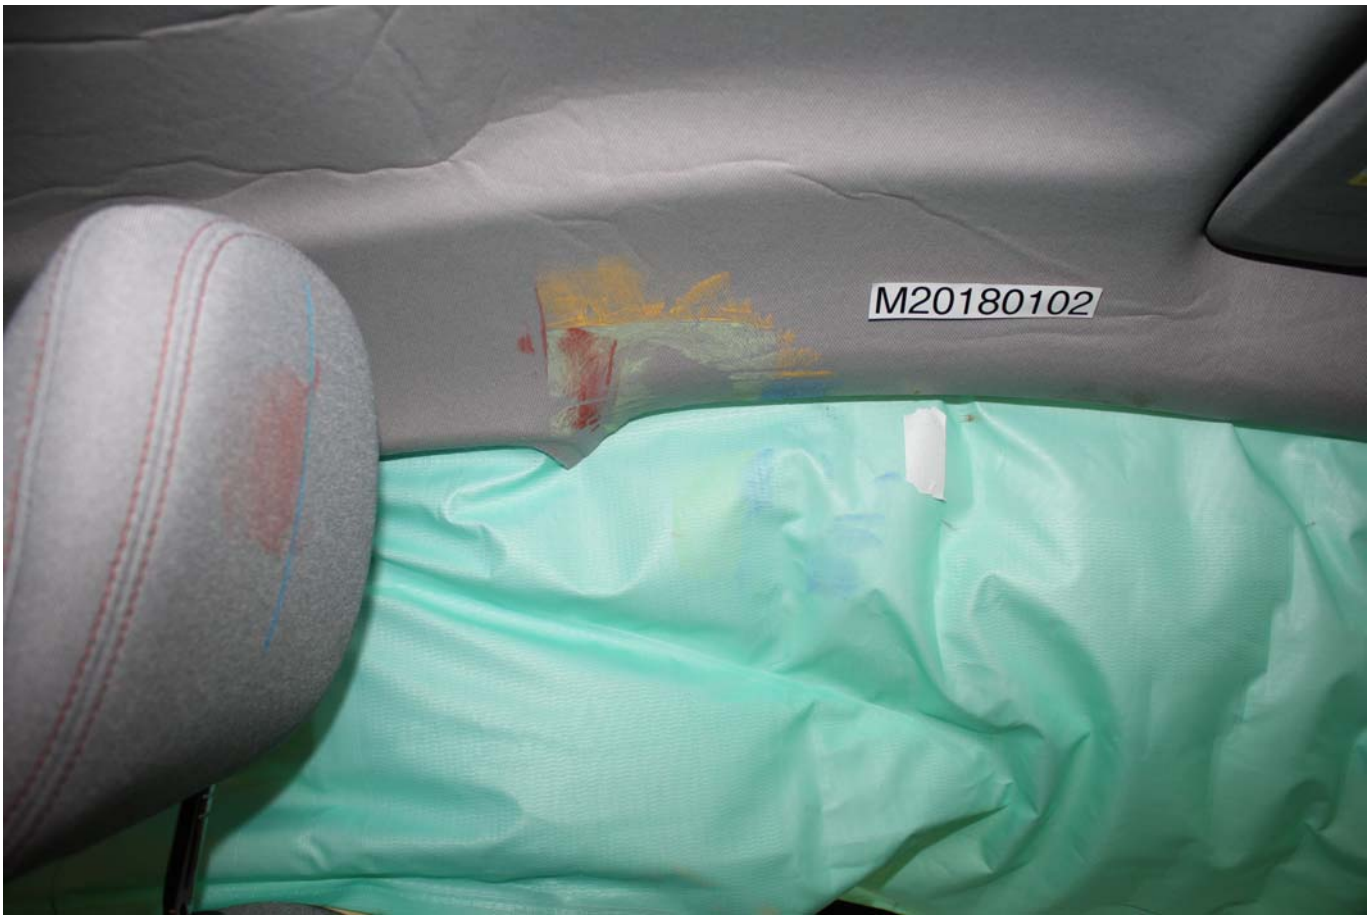
Photo No. 049 - Post-Test Driver Dummy Close-up Head Contact with Side Airbag View

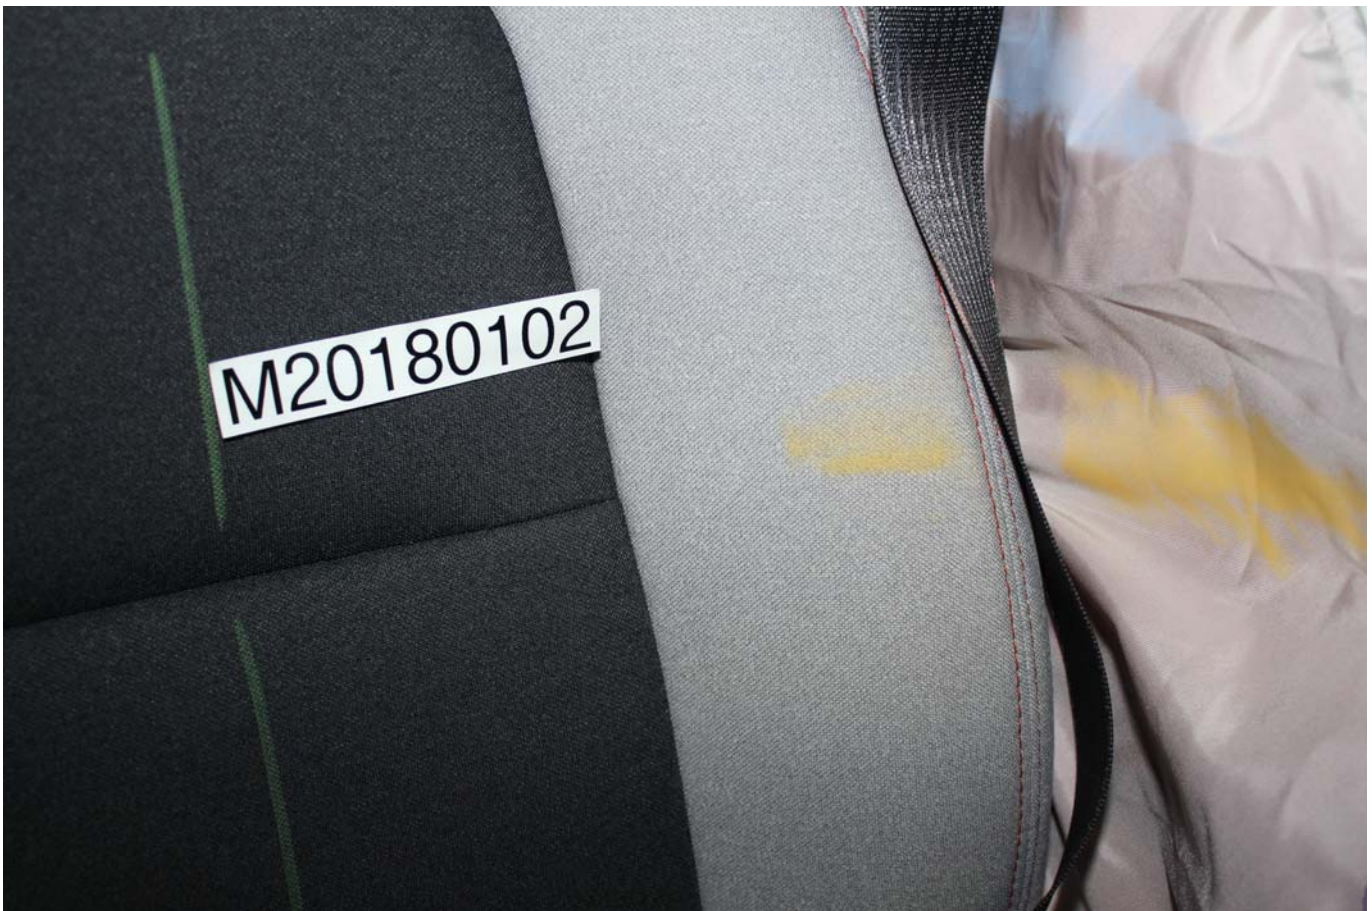
Photo No. 050 - Post-Test Driver Dummy Close-up Torso Contact with Vehicle Interior View

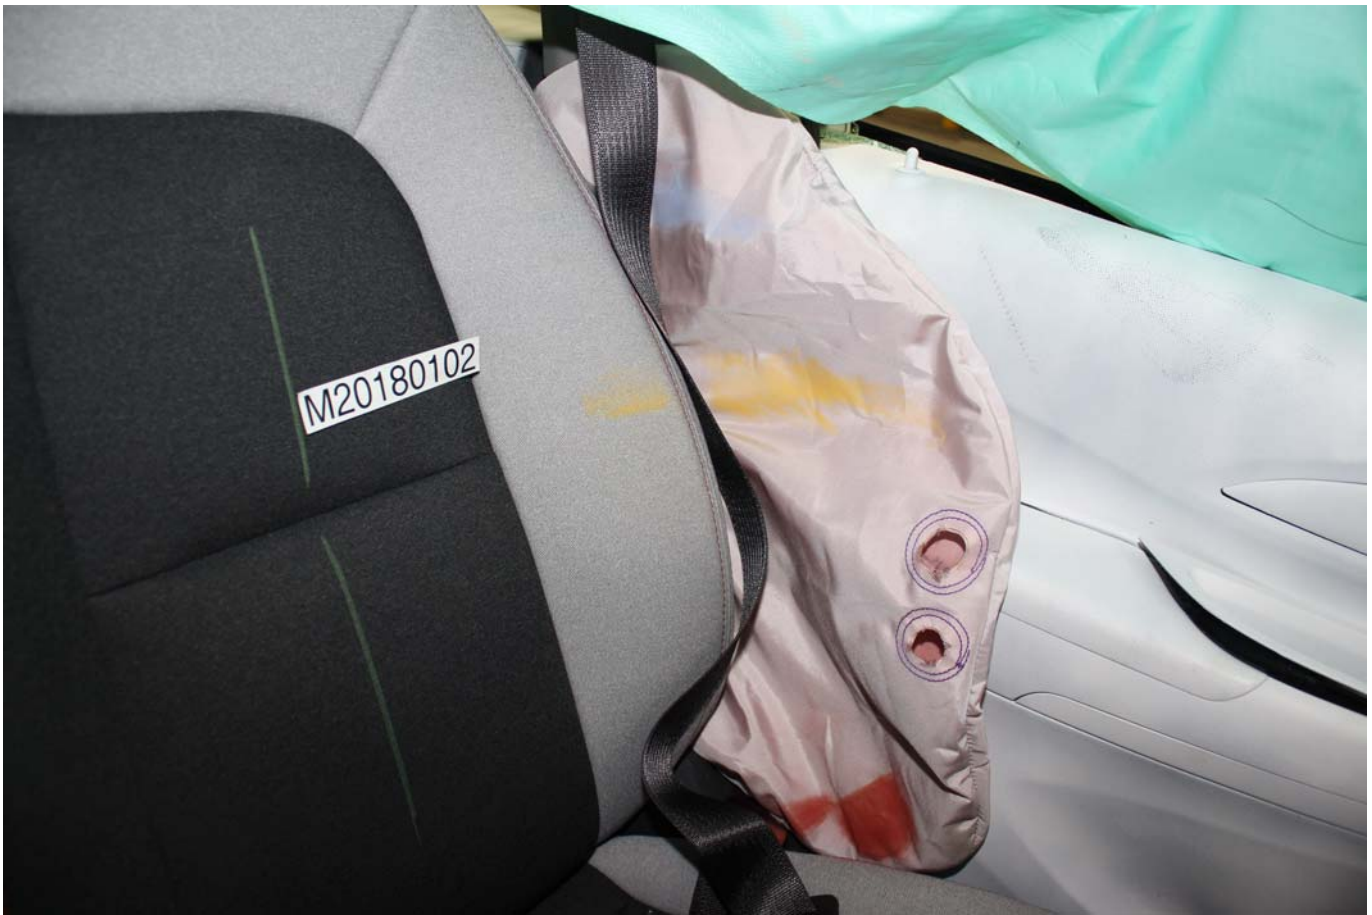
Photo No. 051 - Post-Test Driver Dummy Close-up Torso Contact with Side Airbag View

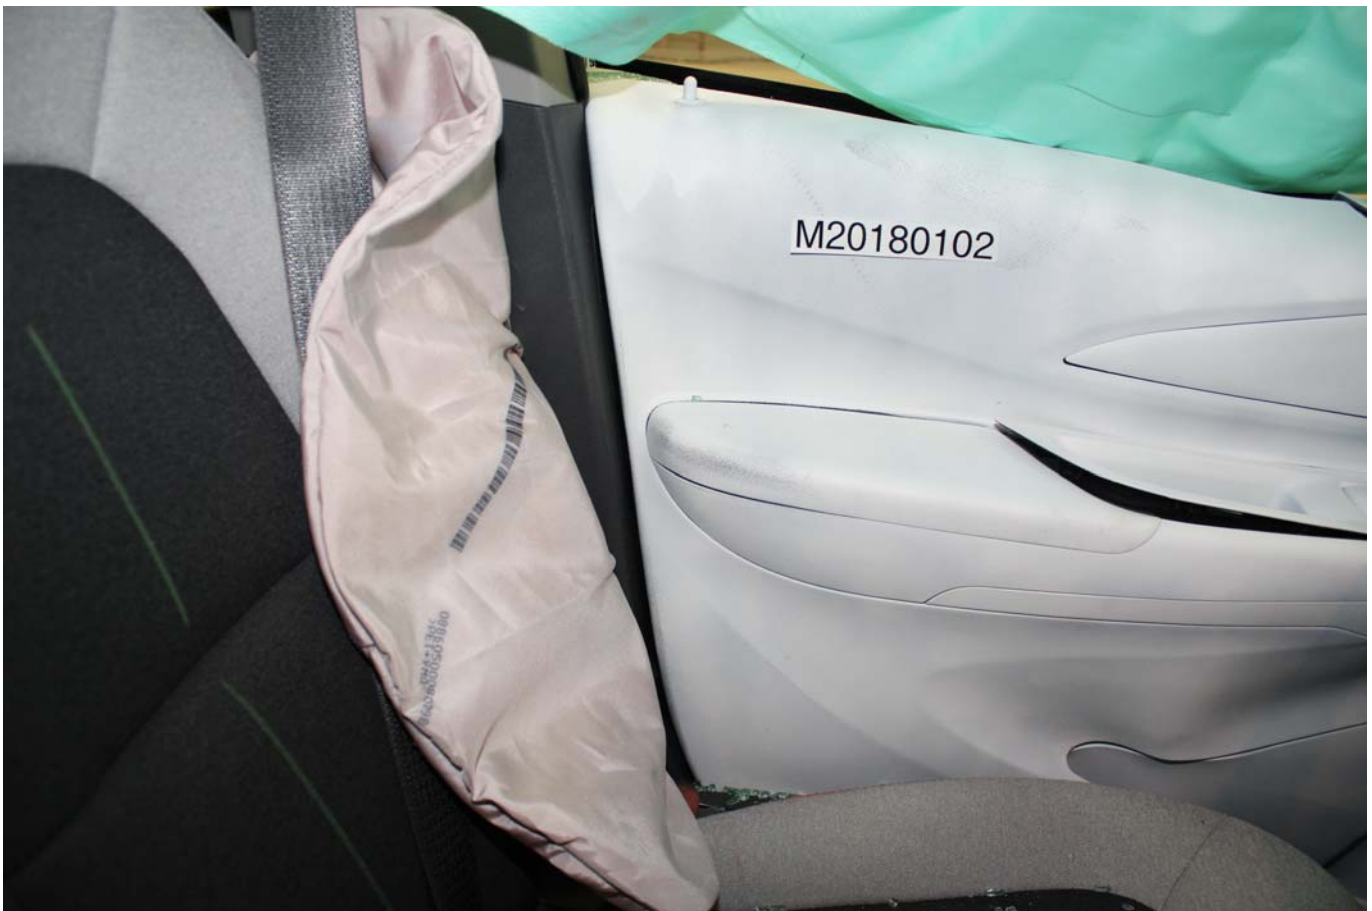
Photo No. 052 - Post-Test Driver Dummy Close-up Pelvis Contact with Vehicle Interior View

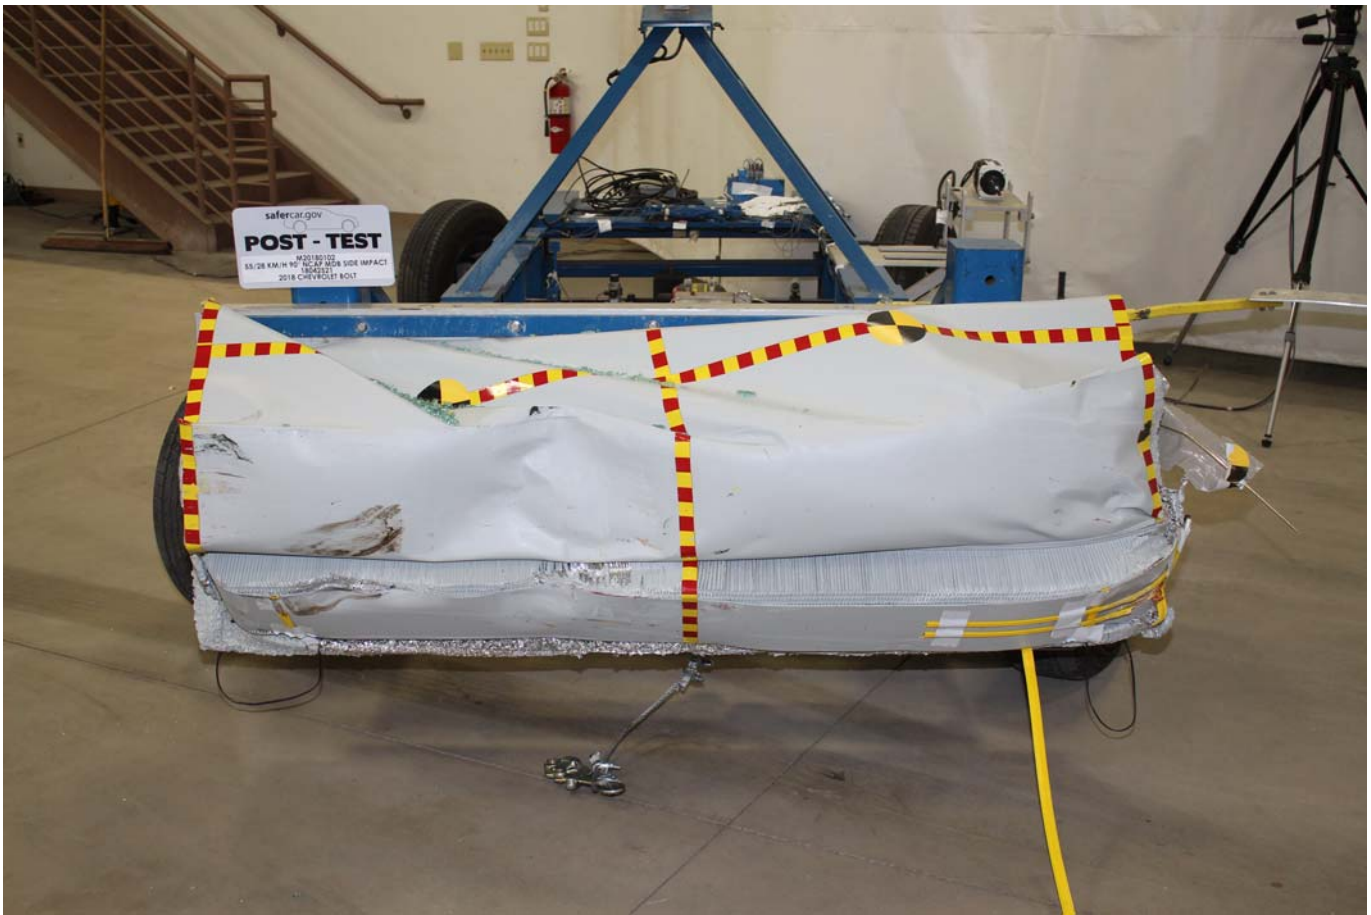
Photo No. 085 - Post-Test Front View of MDB Impactor Face

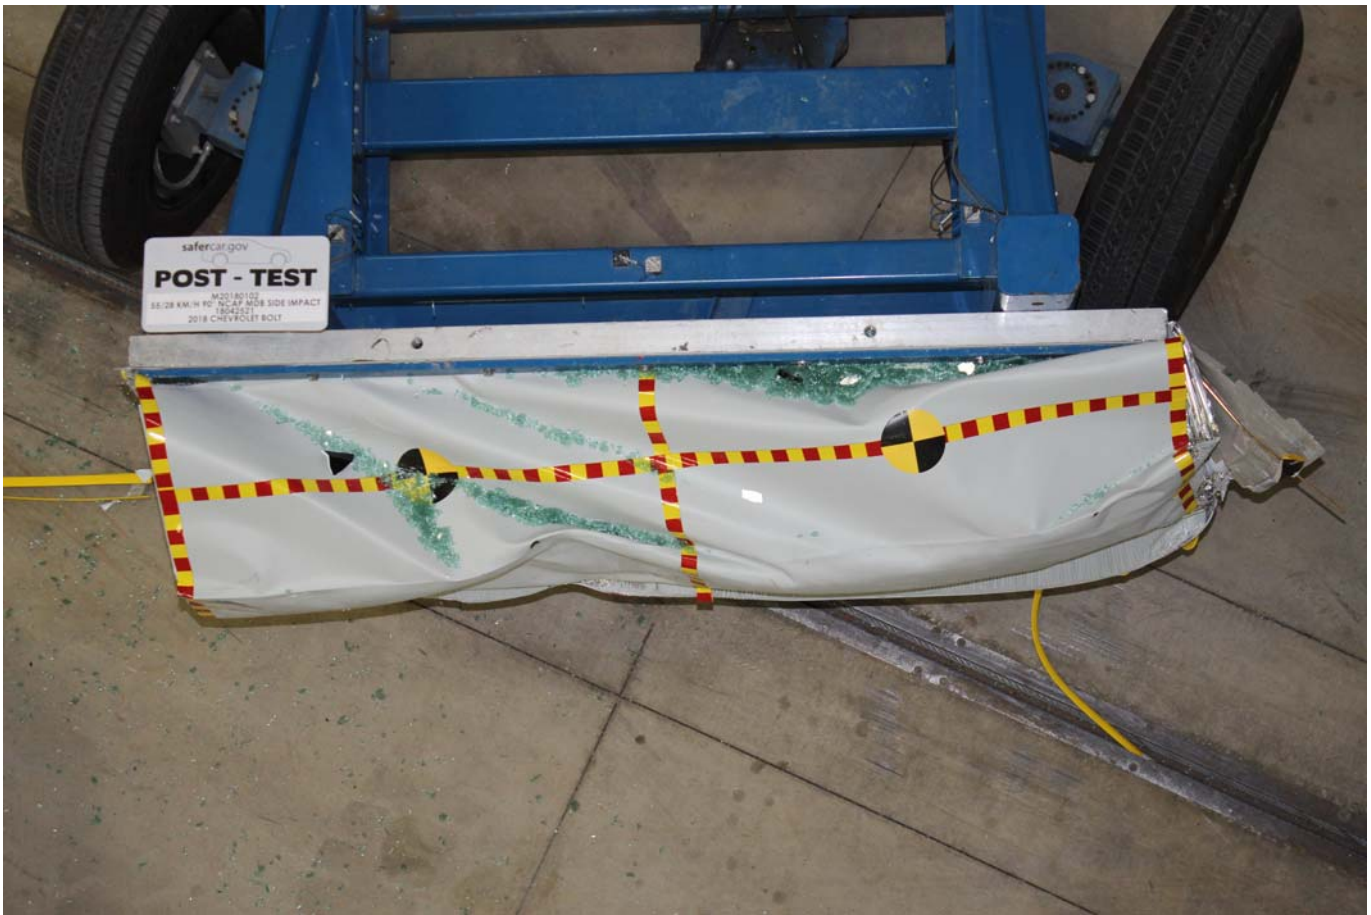
Photo No. 087 - Post-Test Top View of MDB Impactor Face

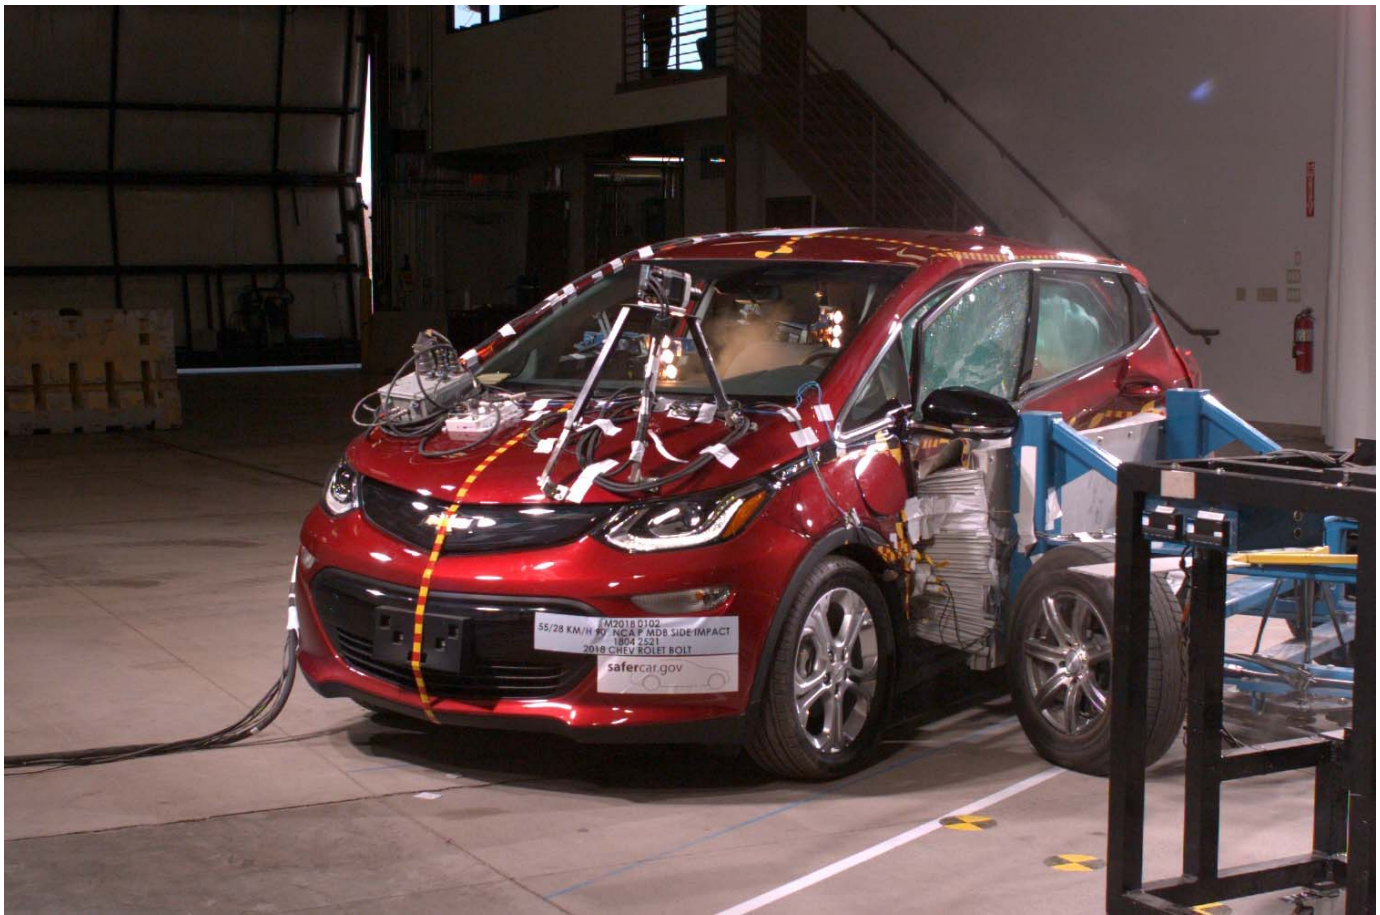
Photo No. 101 - Impact Event
