REPORT NUMBER: NCAP305I-MGA-2018-002

**NEW CAR ASSESSMENT PROGRAM (NCAP)
FMVSS No. 305 Indicant Test**

**GENERAL MOTORS LLC
2018 Chevrolet Bolt EV LT 5-Door Hatchback
NHTSA NUMBER: M20180102**

**MGA RESEARCH CORPORATION
5000 Warren Road
Burlington, WI 53105**

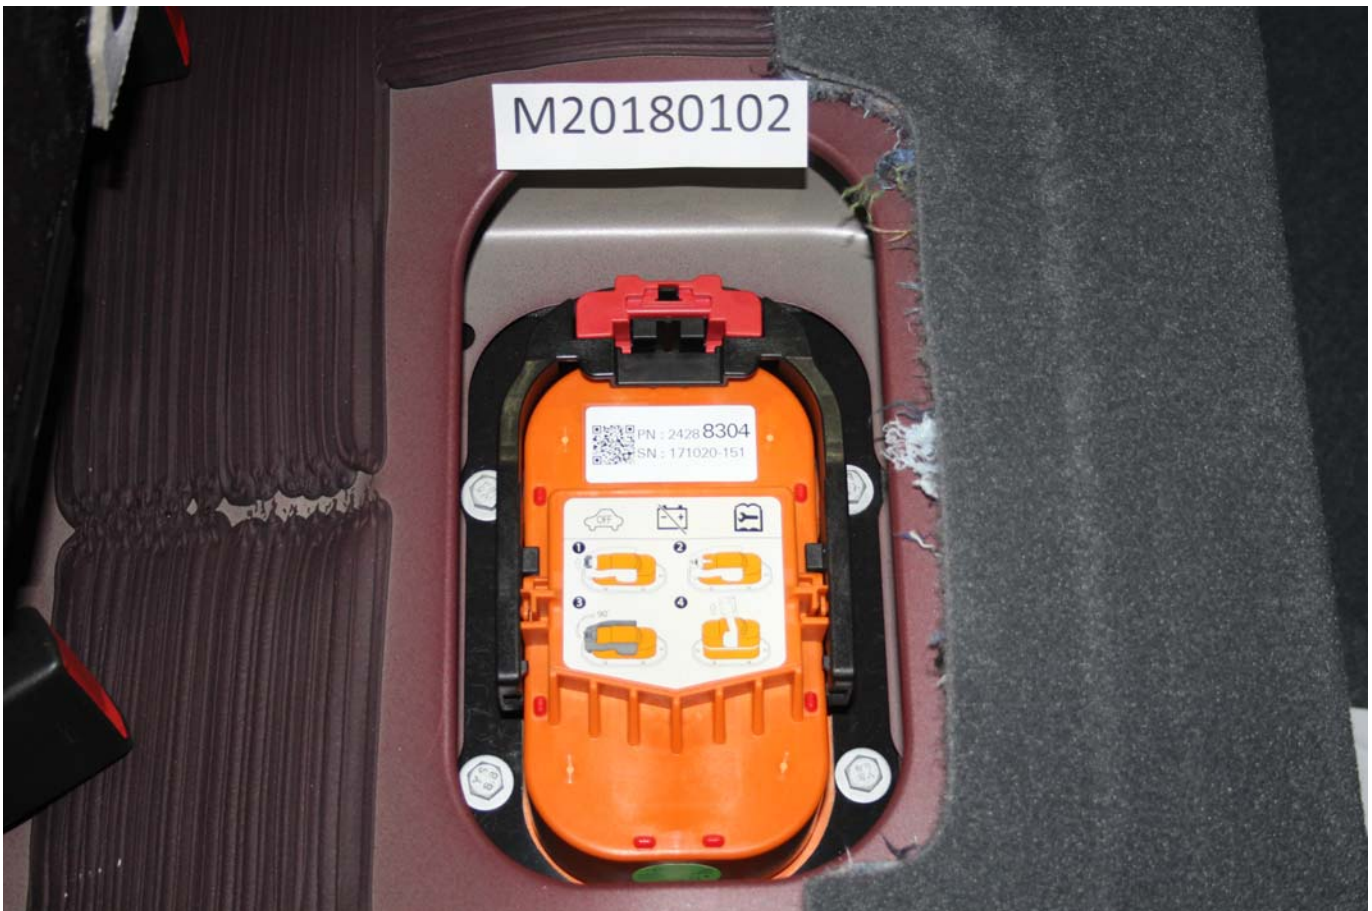
Photo No. 006 - Manual High Voltage Service Disconnect in Place

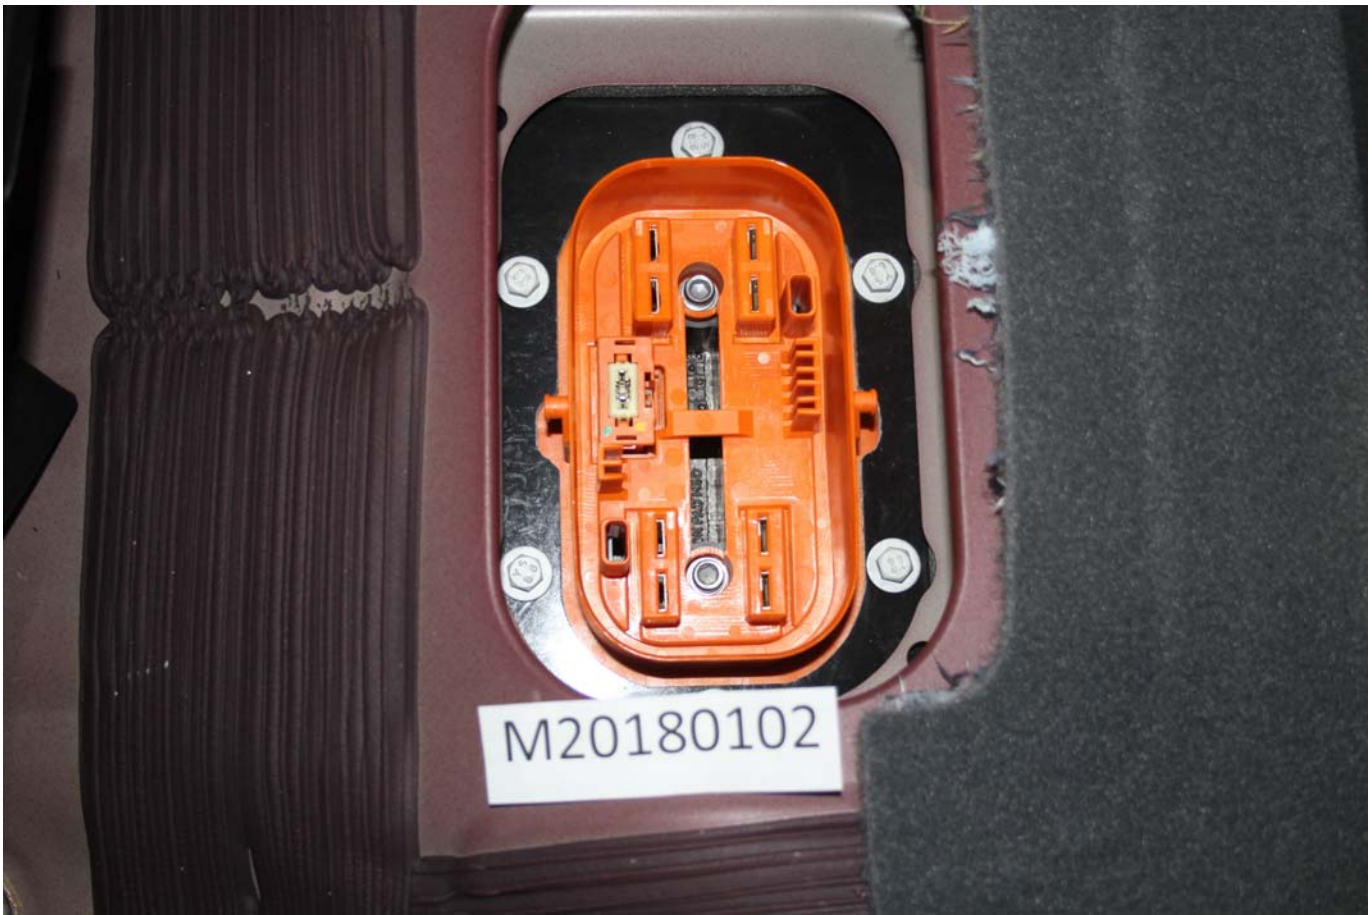
Photo No. 007 - Manual High Voltage Service Disconnect Removed

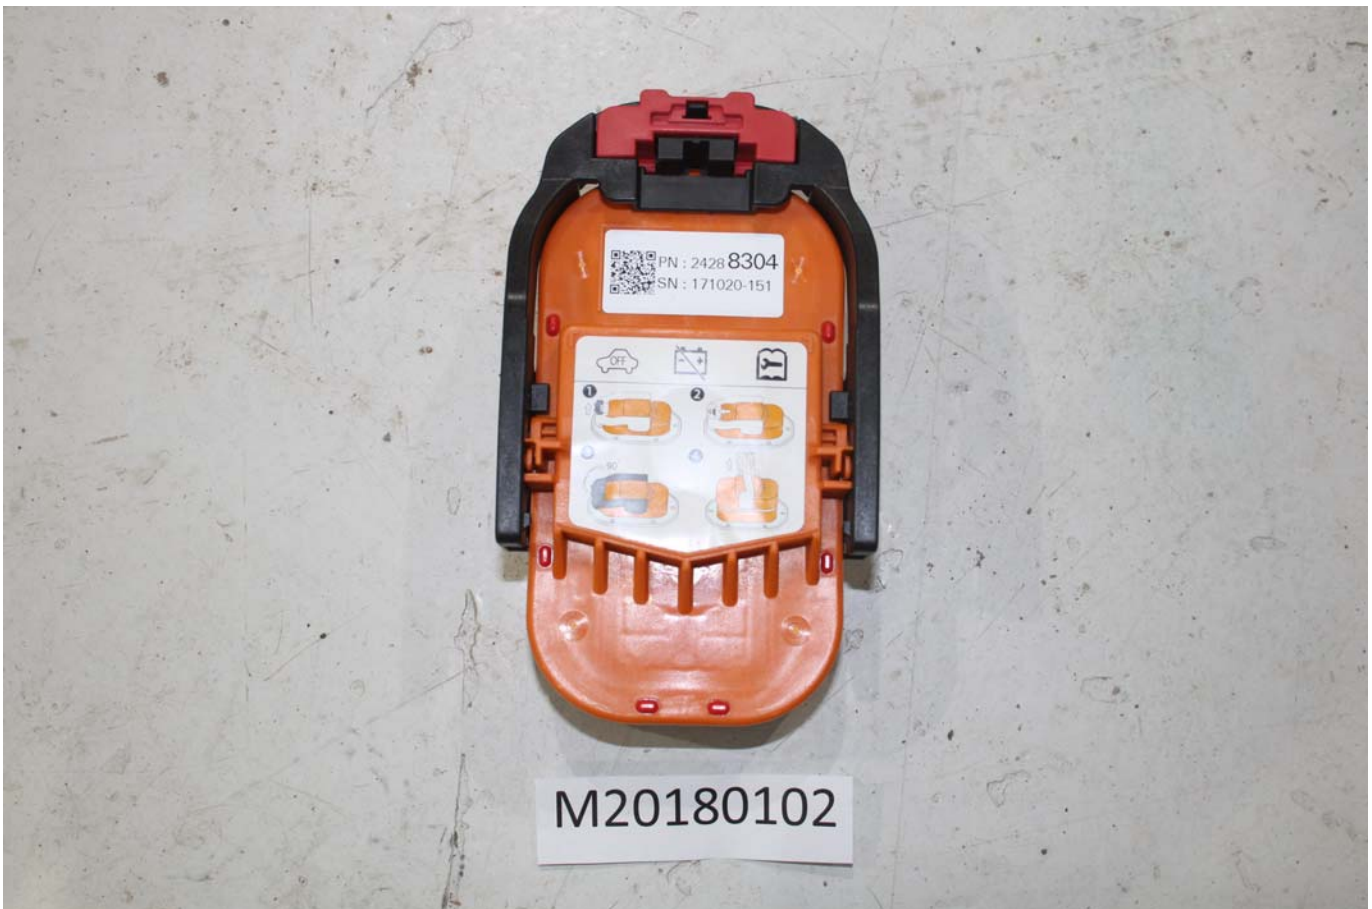
Photo No. 007a - Manual High Voltage Service Disconnect Removed

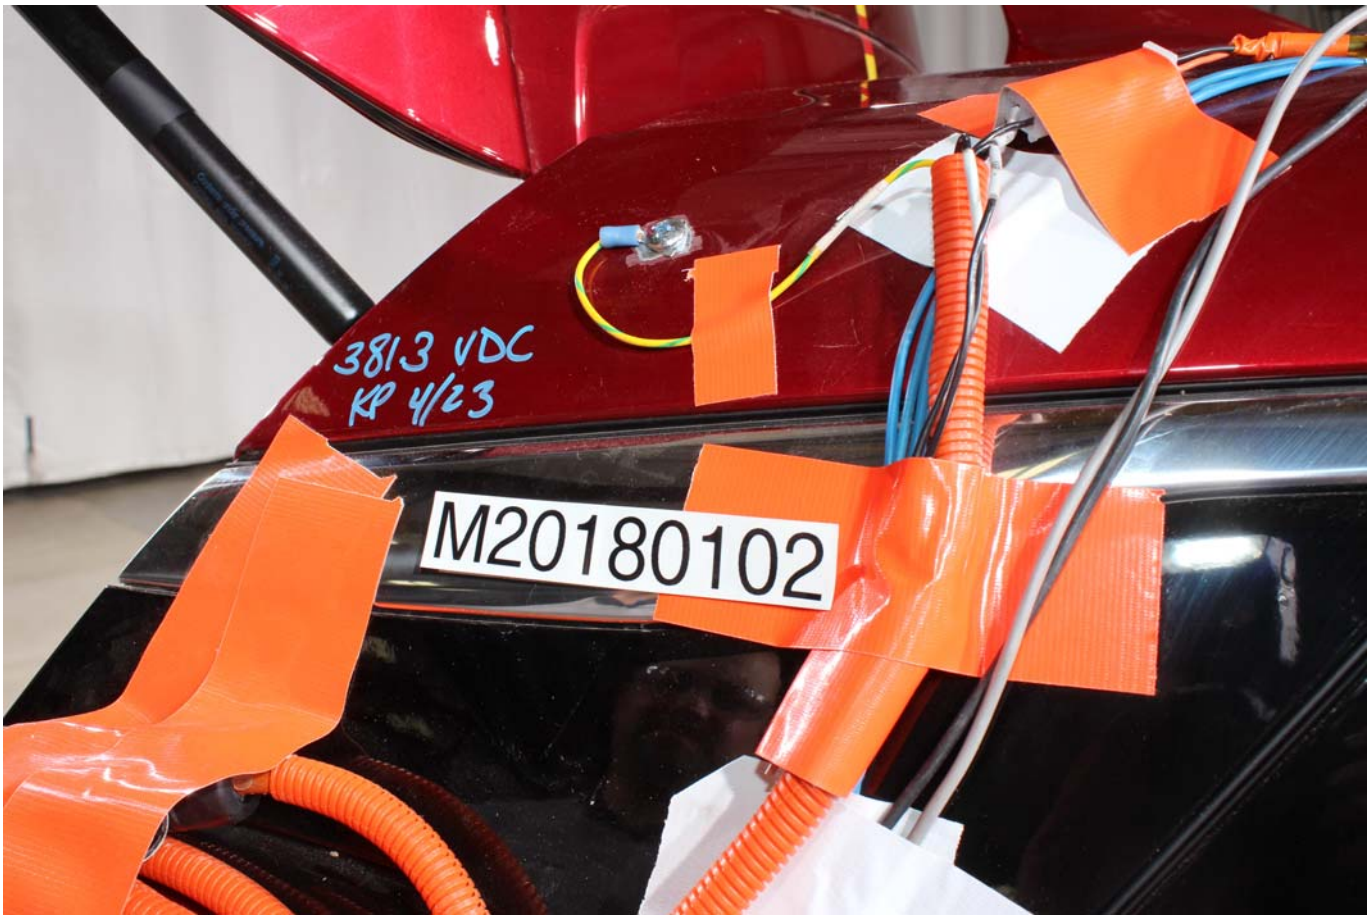
Details of Vehicle Chassis Ground Point(s) & Location(s)	Right rear corner of vehicle roof (paint removed)
--	---

Photo No. 020 - Pre-Impact View of Ground Lead Attached

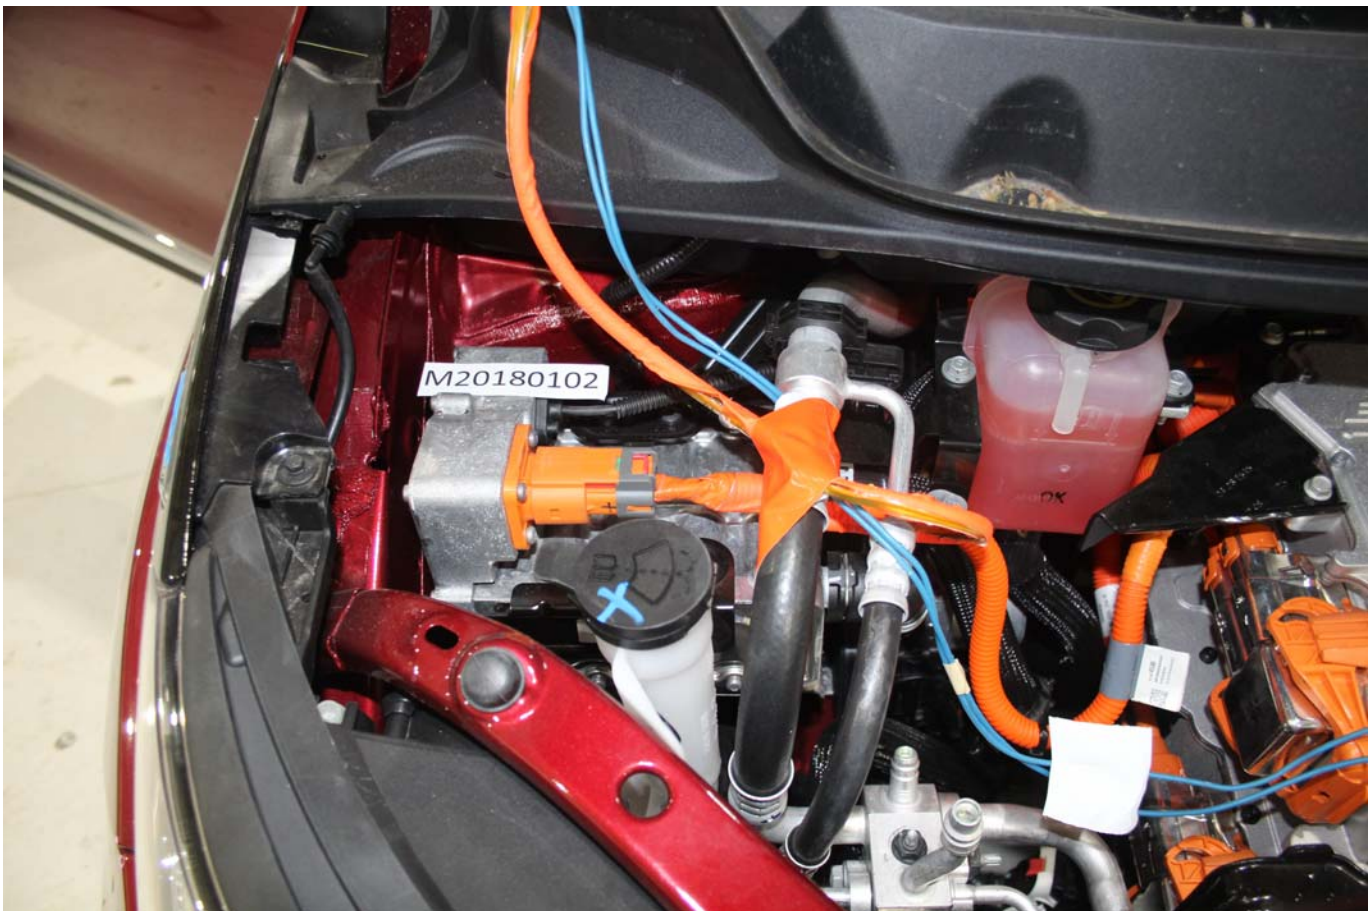
Details of Electric Energy Storage/Conversion System Test Points:	Connected at cabin heater control module (CHCM) connector, located in vehicle engine bay using manufacturer supplied harness
---	--

Photo No. 021 - Pre-Impact View of High Voltage Leads Attached

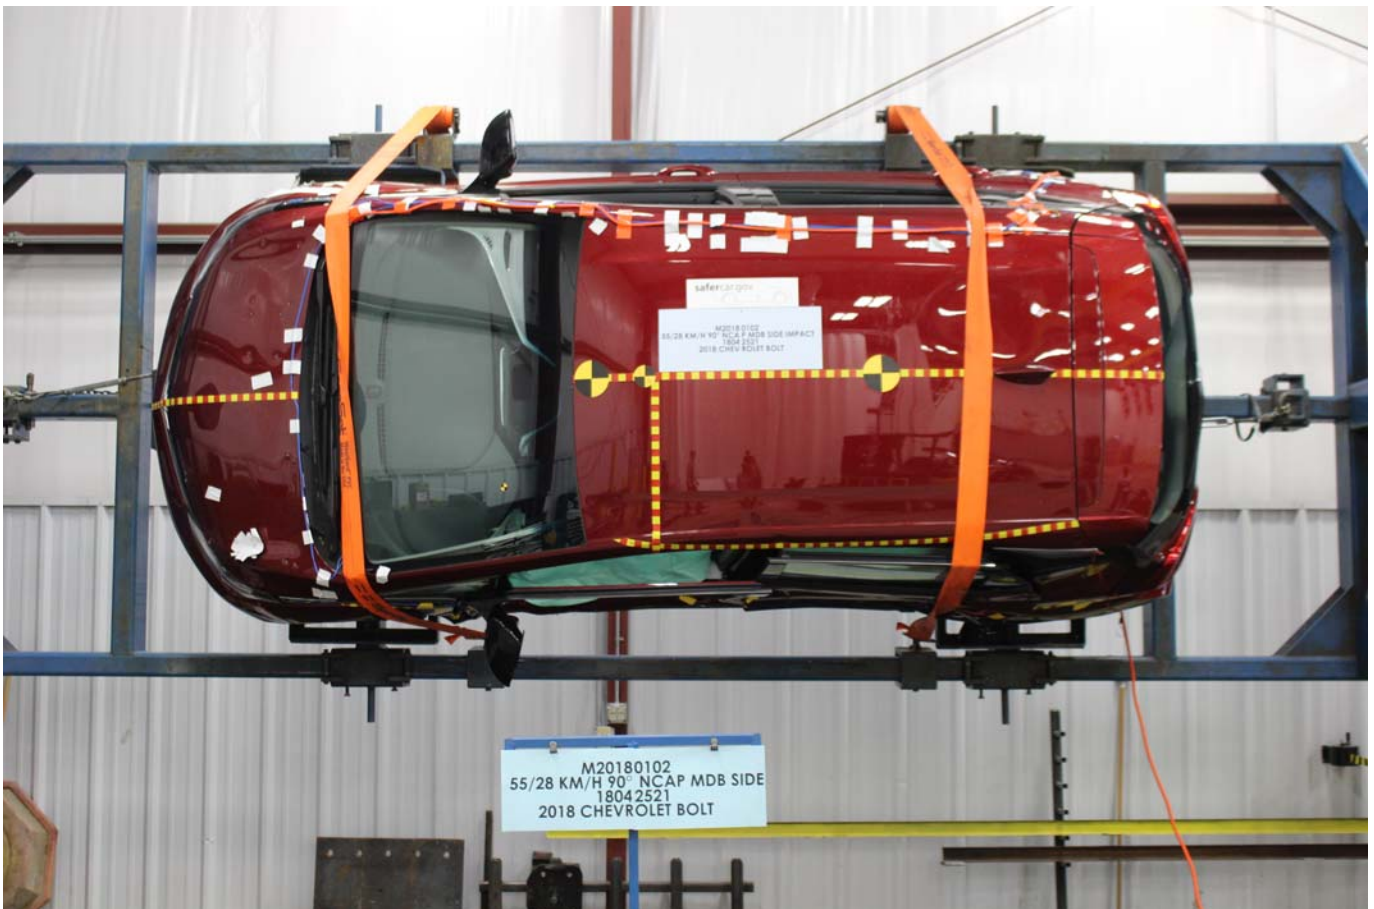
Rollover Stage	Electric Energy Storage/Conversion Device Electrolyte Spillage (L)	Spillage Location
0° to 90°	0	Not Applicable
90° to 180°	0	Not Applicable
180° to 270°	0	Not Applicable
270° to 360°	0	Not Applicable

Photo No. 027 - FMVSS No. 305 Static Rollover at 90°

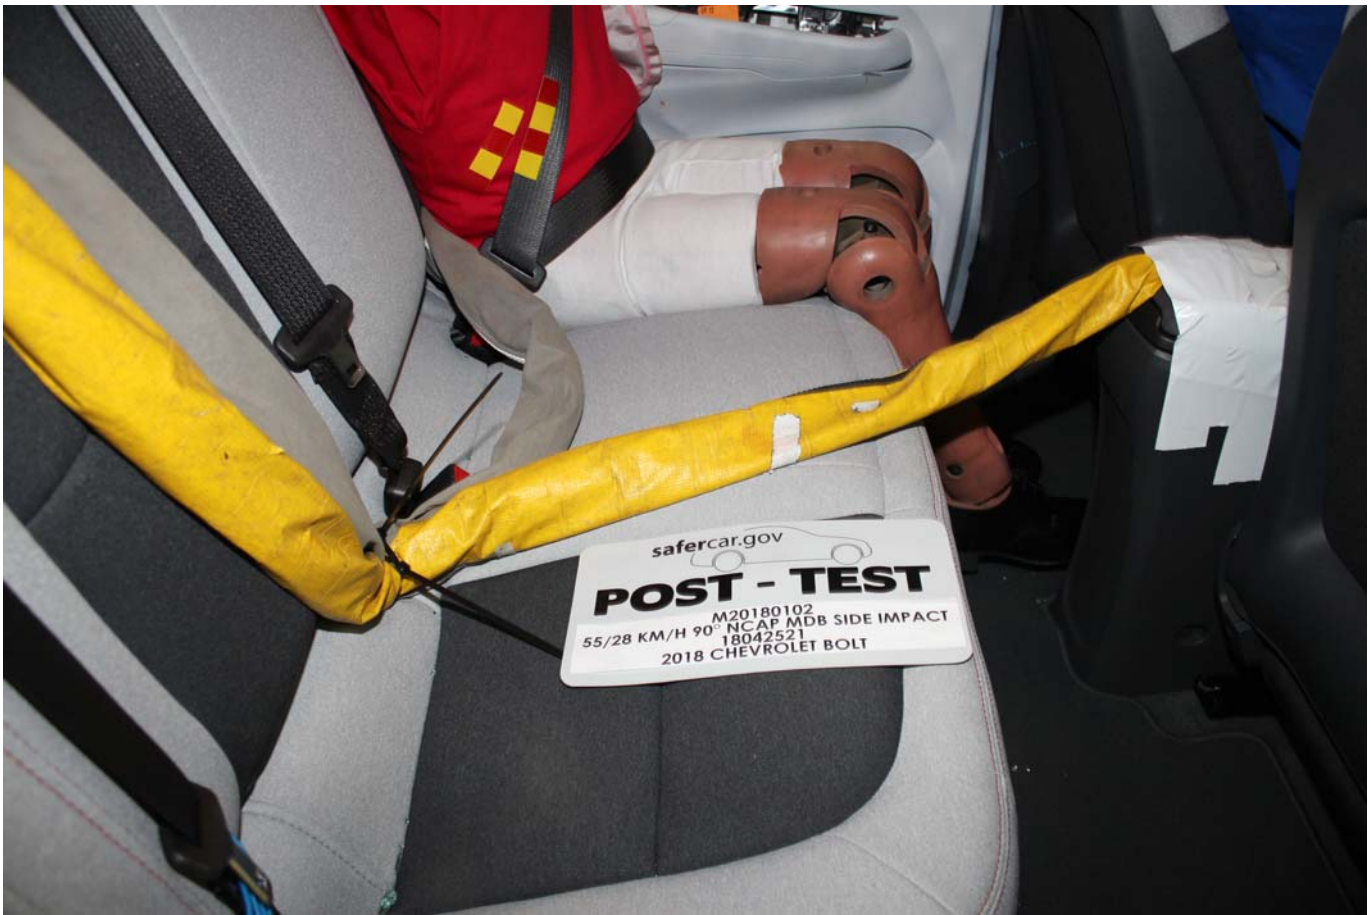
Yes, Fail	No, Pass
Is Electric Energy Storage/Conversion Device electrolyte spillage visible in the passenger compartment?		X

Photo No. 032 - Post-Impact View of the Vehicle Passenger Compartment Adjacent to Propulsion Battery

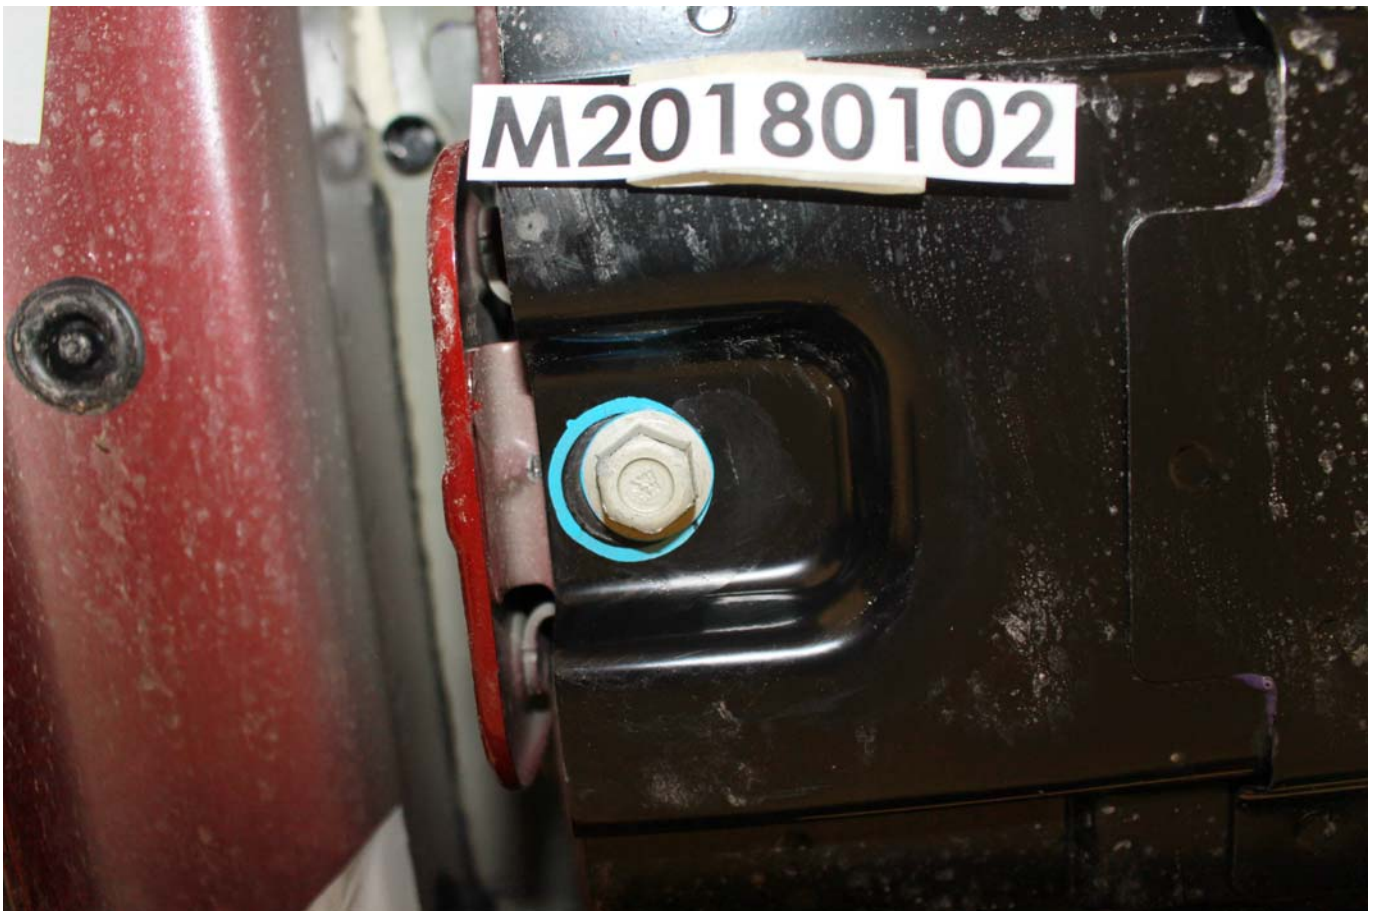
Yes, Pass	No, Fail
All Components of Electrical Energy Storage/Conversion Device remained attached to the vehicle with at least one mounting location.	X

Photo No. 035 - Post-Impact View of Battery Module Movement or Retention Loss
