FINAL REPORT NUMBER: SINCAP-TRC-18-006

**NEW CAR ASSESSMENT PROGRAM (NCAP)
MOVING DEFORMABLE BARRIER SIDE IMPACT TEST**

**FCA US LLC
2018 Dodge Durango SUV
NHTSA NUMBER: M20180301**

**PREPARED BY:
Transportation Research Center Inc.
10820 State Route 347
P. O. Box B-67
East Liberty, OH 43319**

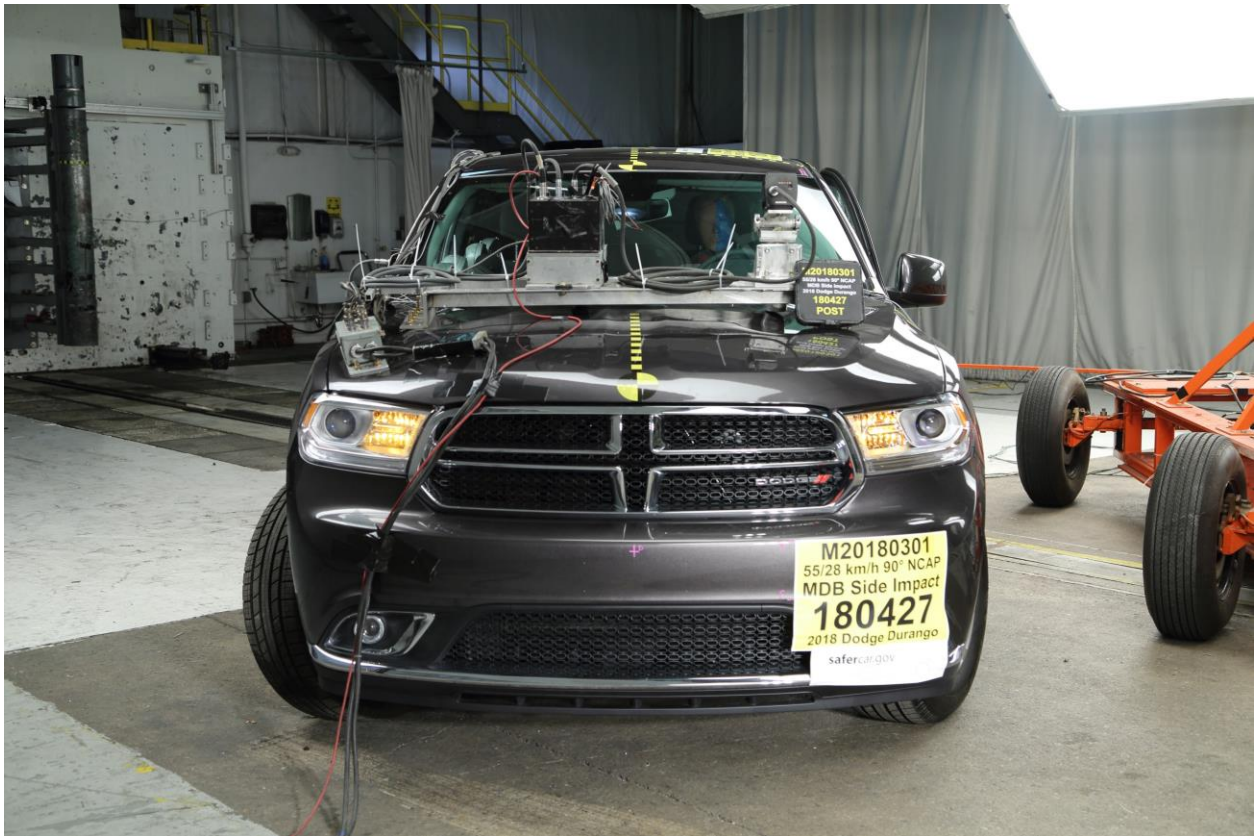
004 Post-Test Frontal View of Test Vehicle

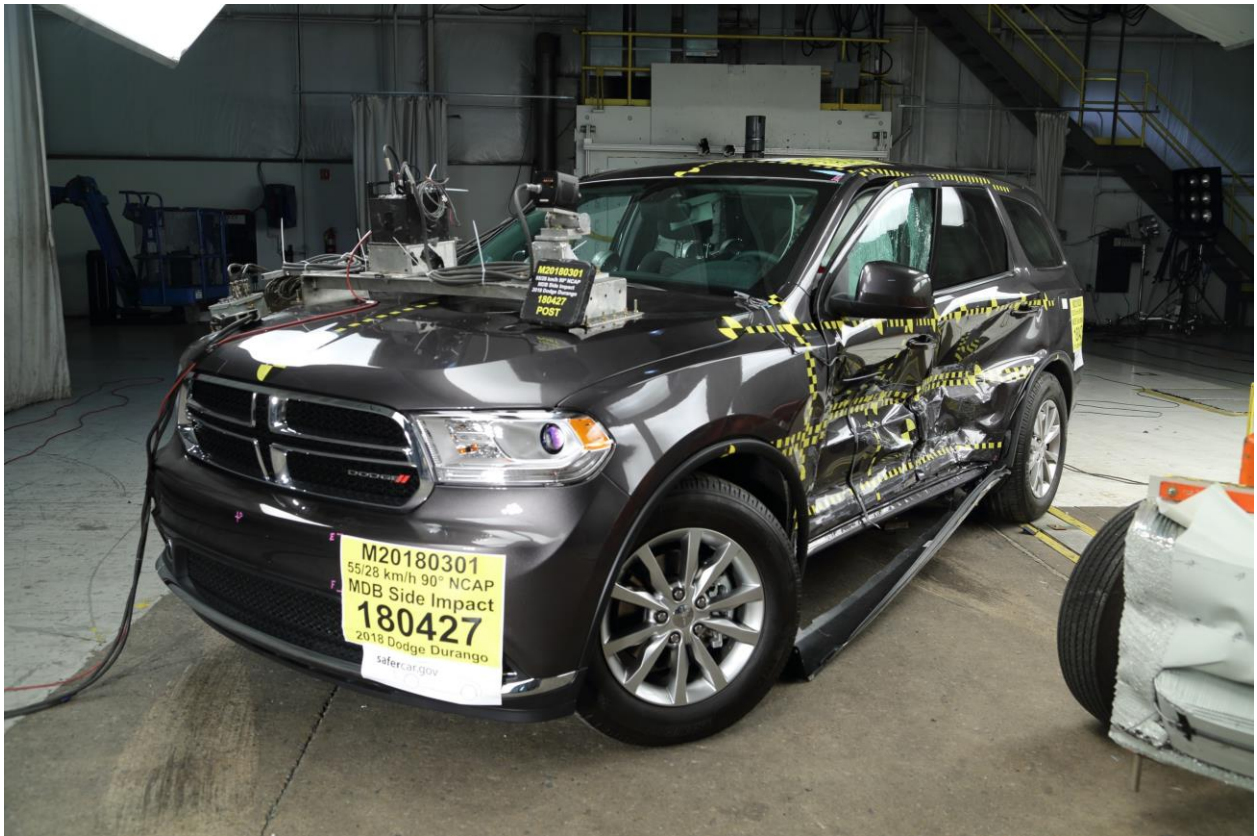
006 Post-Test Left Front $\frac{3}{4}$ View of Test Vehicle

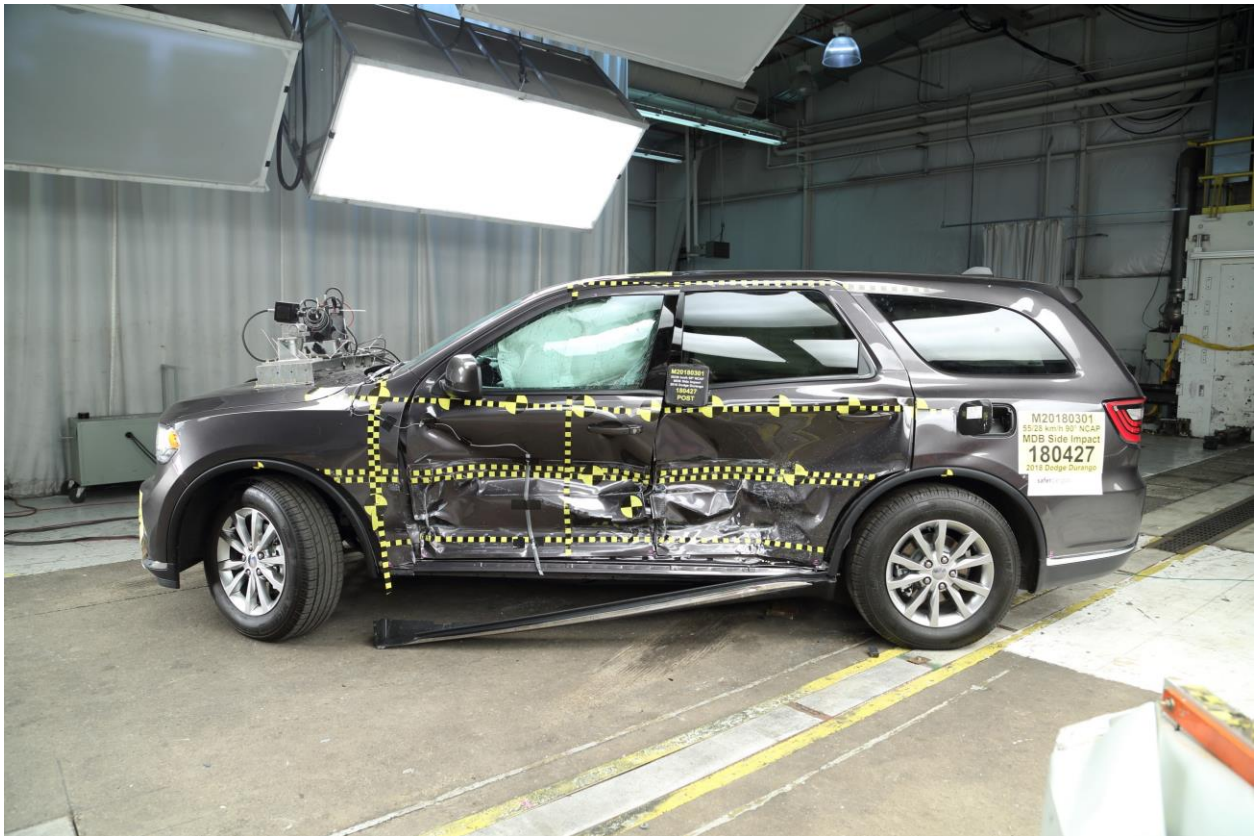
008 Post-Test Left Side View of Test Vehicle

Critical Areas of Performance	Observations and Conclusions
Pillar Performance	Good
Sill Separation	None
Windshield Damage	None
Side Window Damage	Driver's side window broken
Other Notable Effects	None

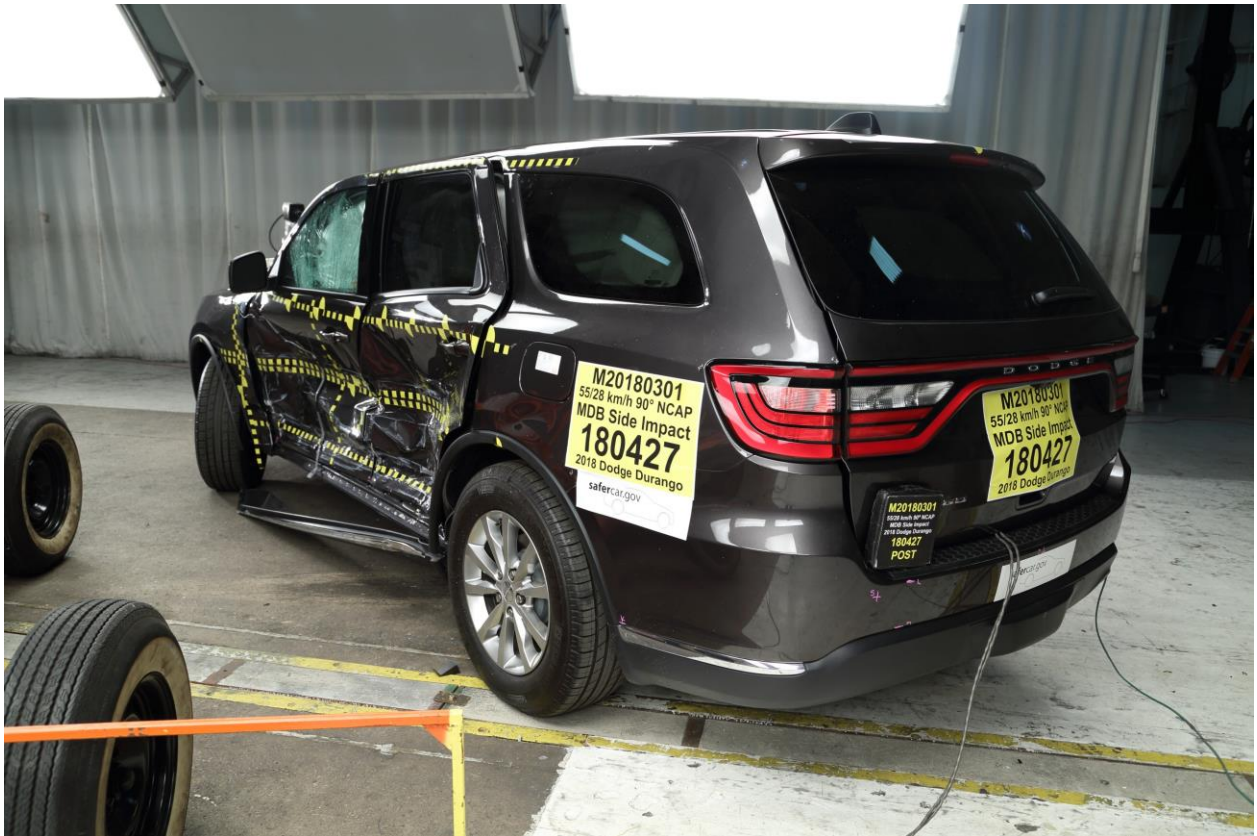
010 Post-Test Left Rear ¾ View of Test Vehicle

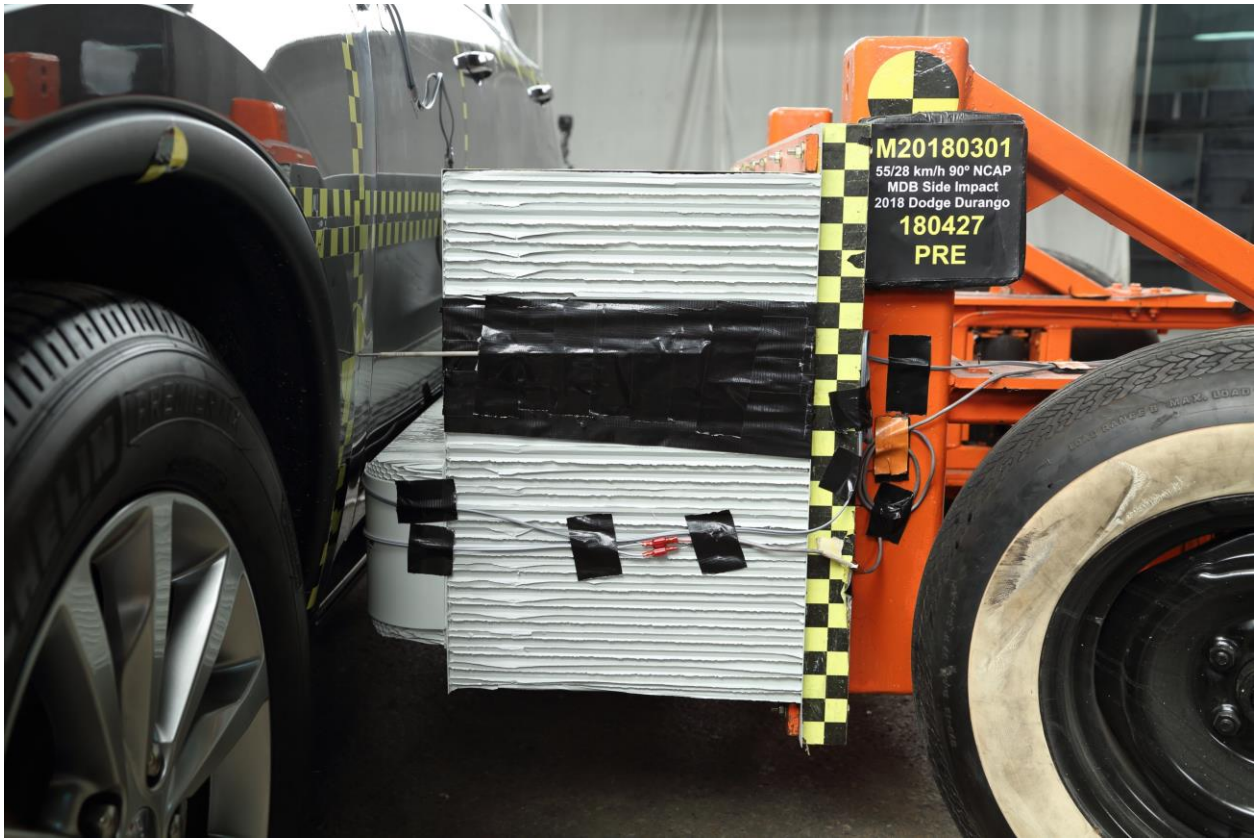
017 Pre-Test Left Side View of MDB Positioned Against Side of Test Vehicle

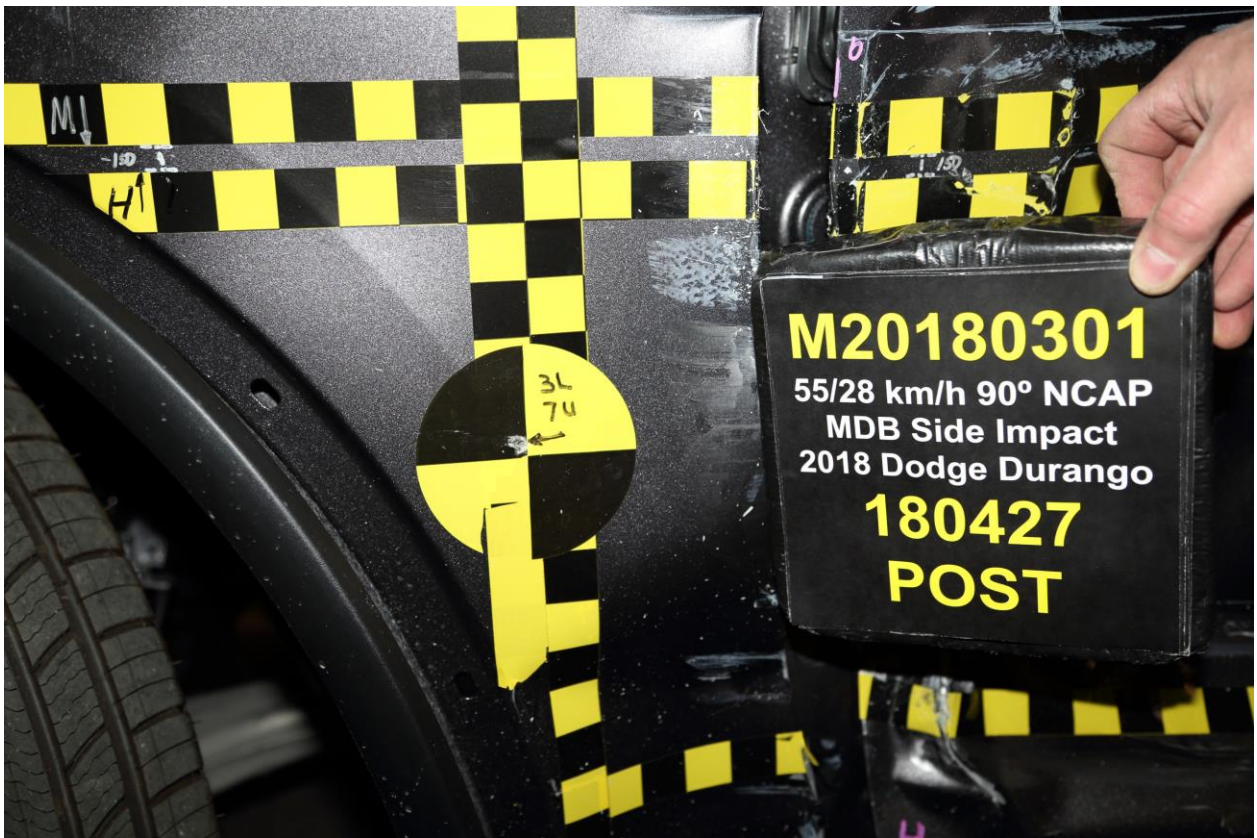
020 Post-Test Close-Up View of Impact Point Target

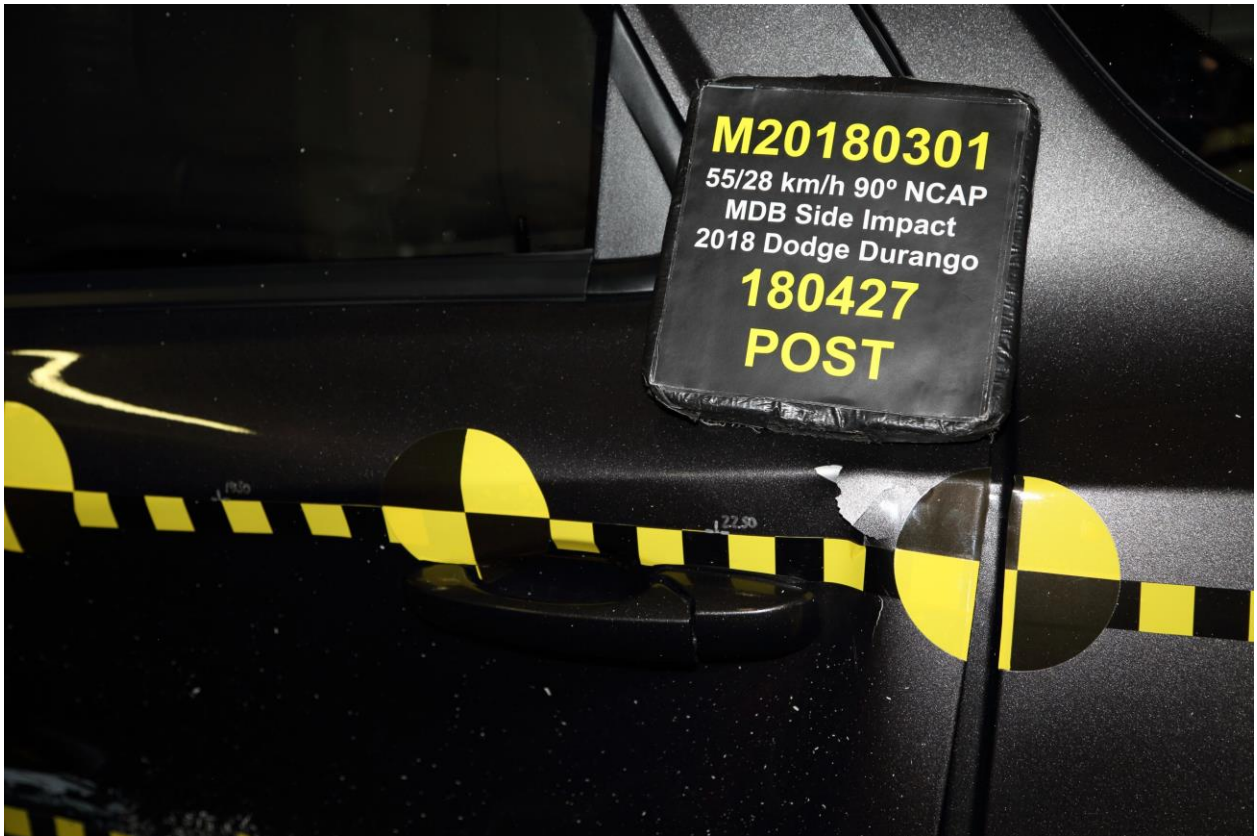
024 Post-Test Left Rear Door Latch Close-Up

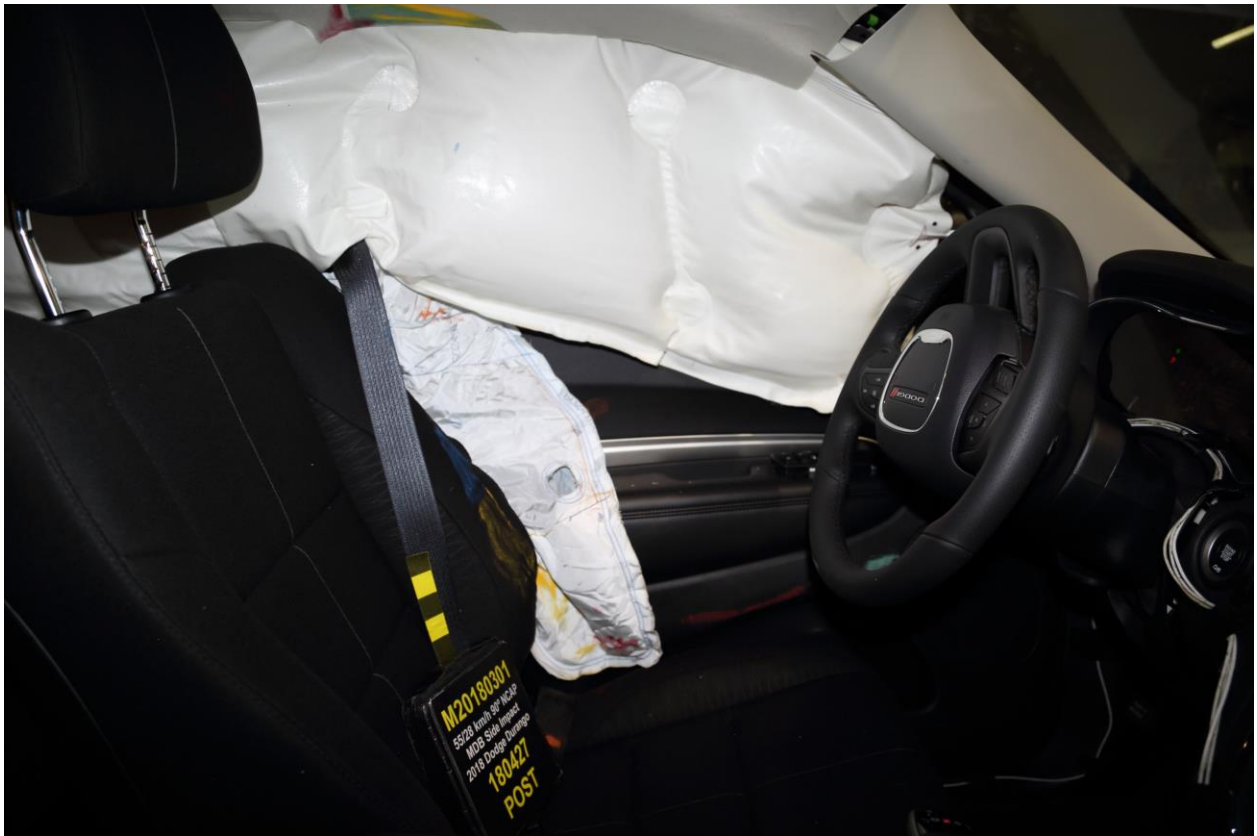
047 Post-Test Driver Inner Door Panel View Showing Driver Dummy Contact Locations

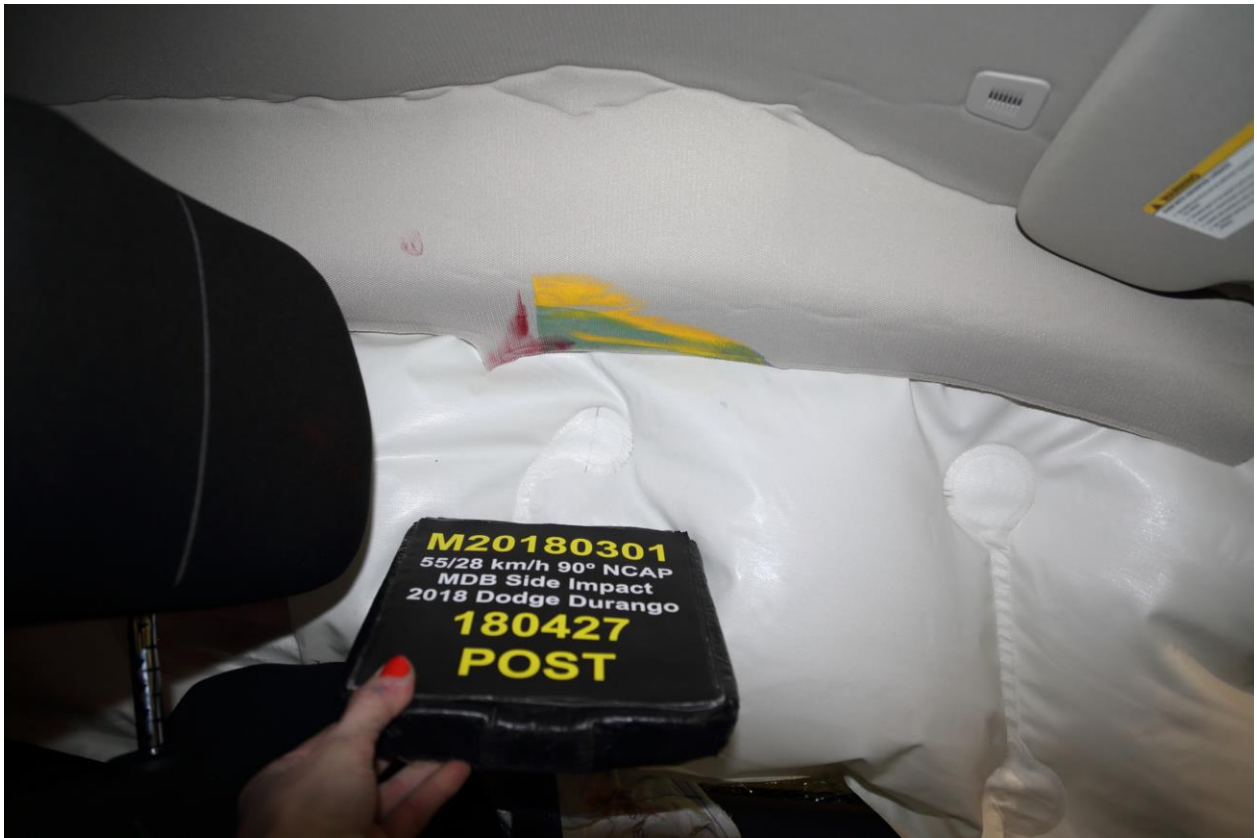
048 Post-Test Driver Dummy Close-Up Head Contact with Vehicle View

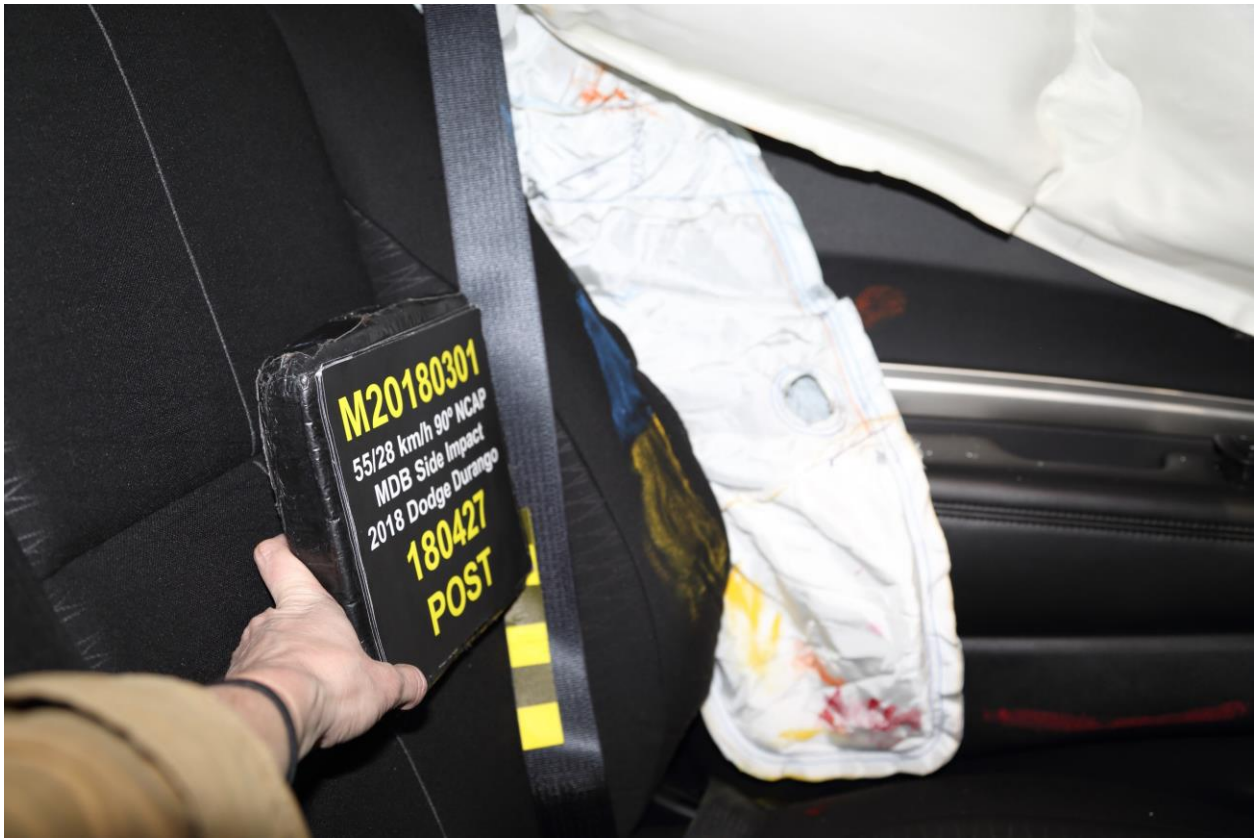
050 Post-Test Driver Dummy Close-Up Torso Contact with Vehicle Interior View

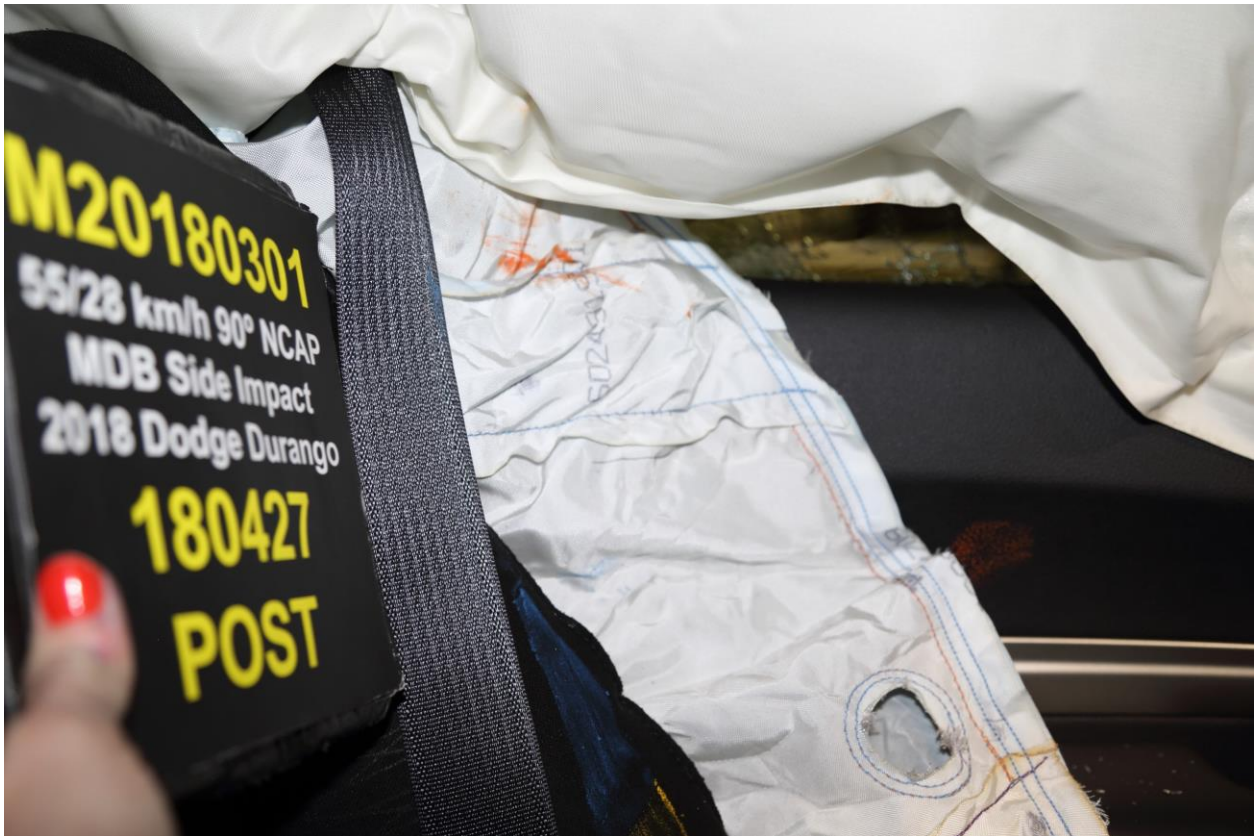
051 Post-Test Driver Dummy Close-Up Torso Contact with Side Airbag View

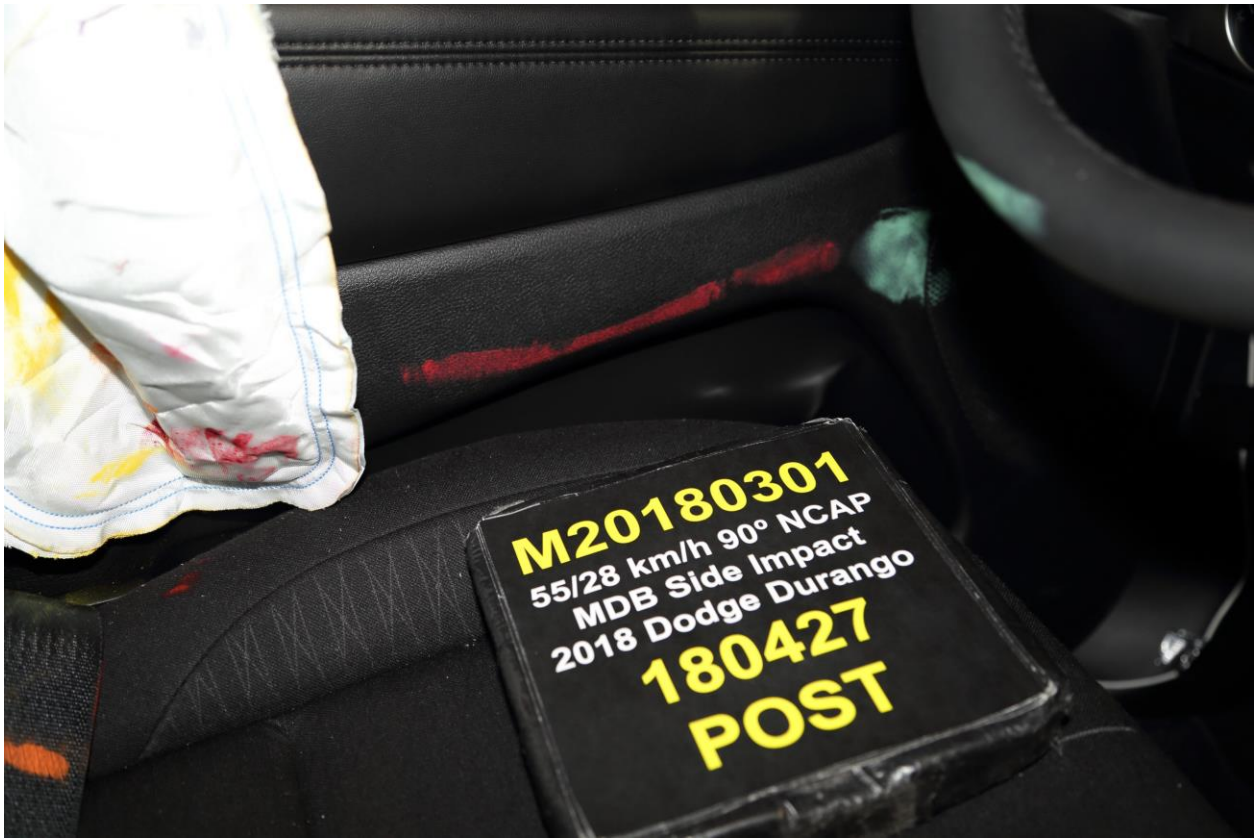
054 Post-Test Driver Dummy Close-Up Knee Contact View

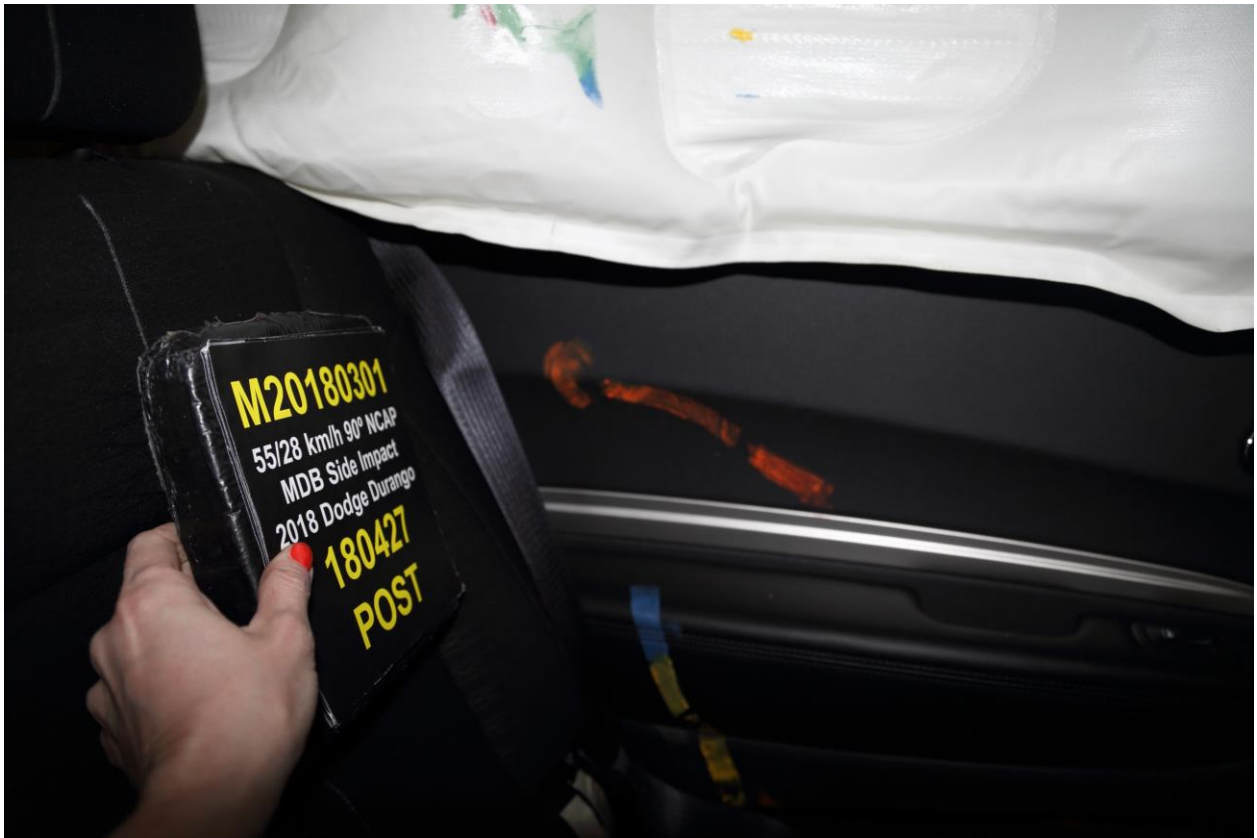
077 Post-Test Rear Passenger Dummy Close-Up Torso Contact with Vehicle Interior View

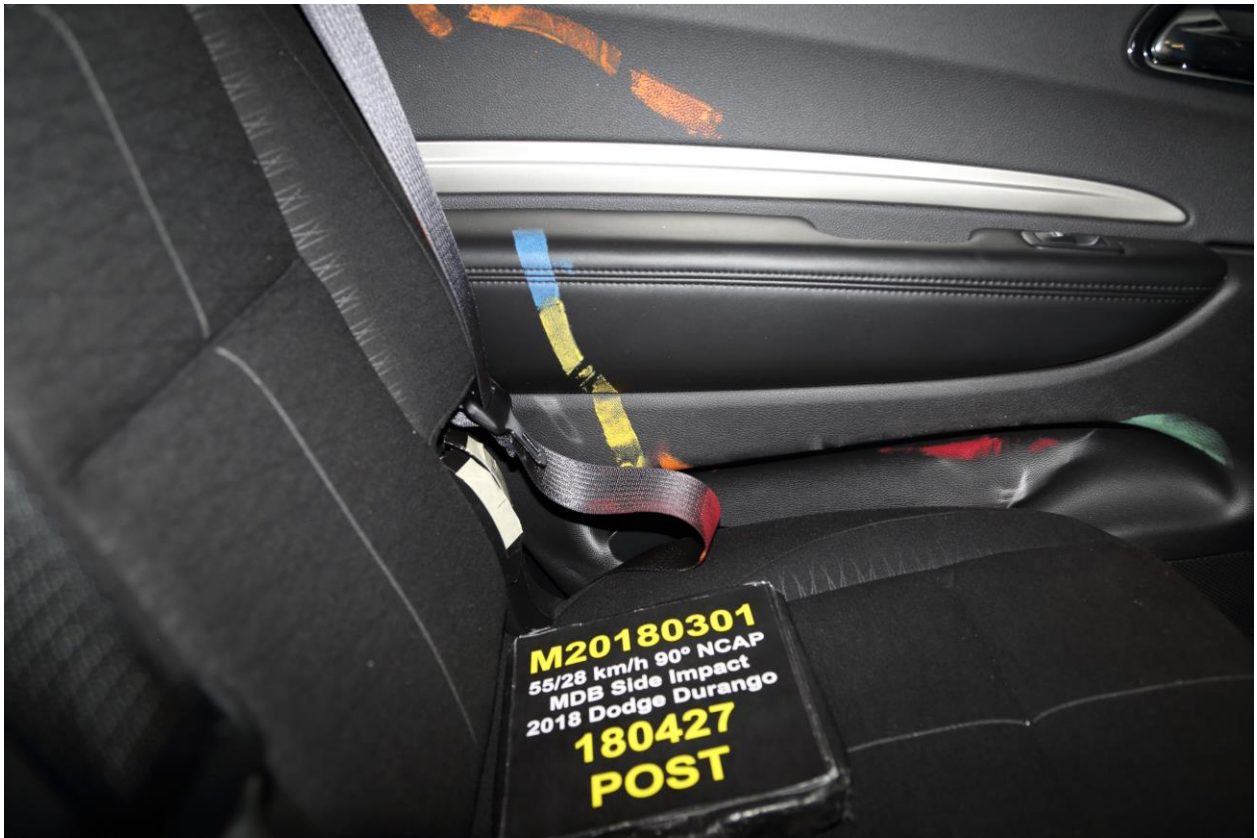
079 Post-Test Rear Passenger Dummy Close-Up Pelvis Contact View

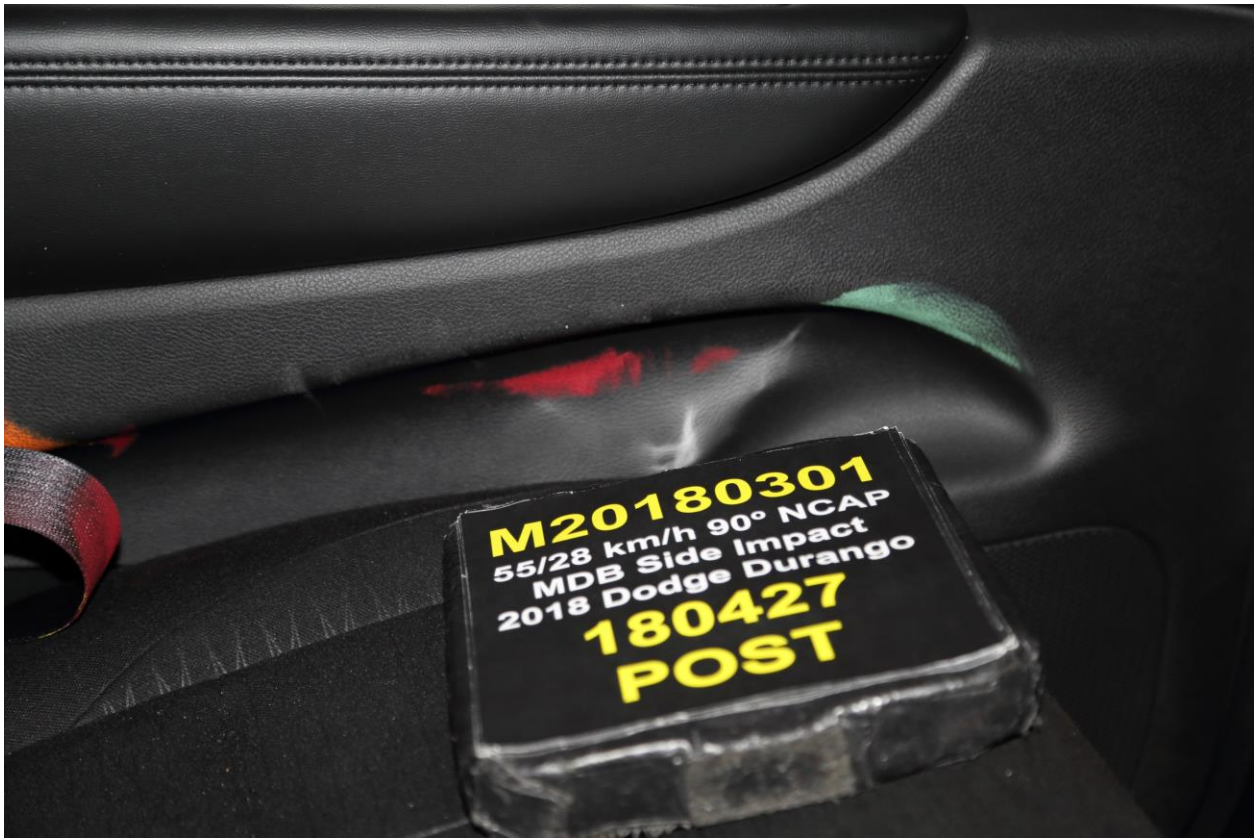
081 Post-Test Rear Passenger Dummy Close-Up Knee Contact View
