**REPORT NUMBER: NCAP-MGA-2018-028**

**NEW CAR ASSESSMENT PROGRAM (NCAP)  
Frontal Barrier Impact Test**

**GENERAL MOTORS LLC  
2018 Chevrolet Bolt EV LT 5-Door Hatchback  
NHTSA No.: M20180100**

**MGA RESEARCH CORPORATION  
5000 Warren Road  
Burlington, WI 53105**

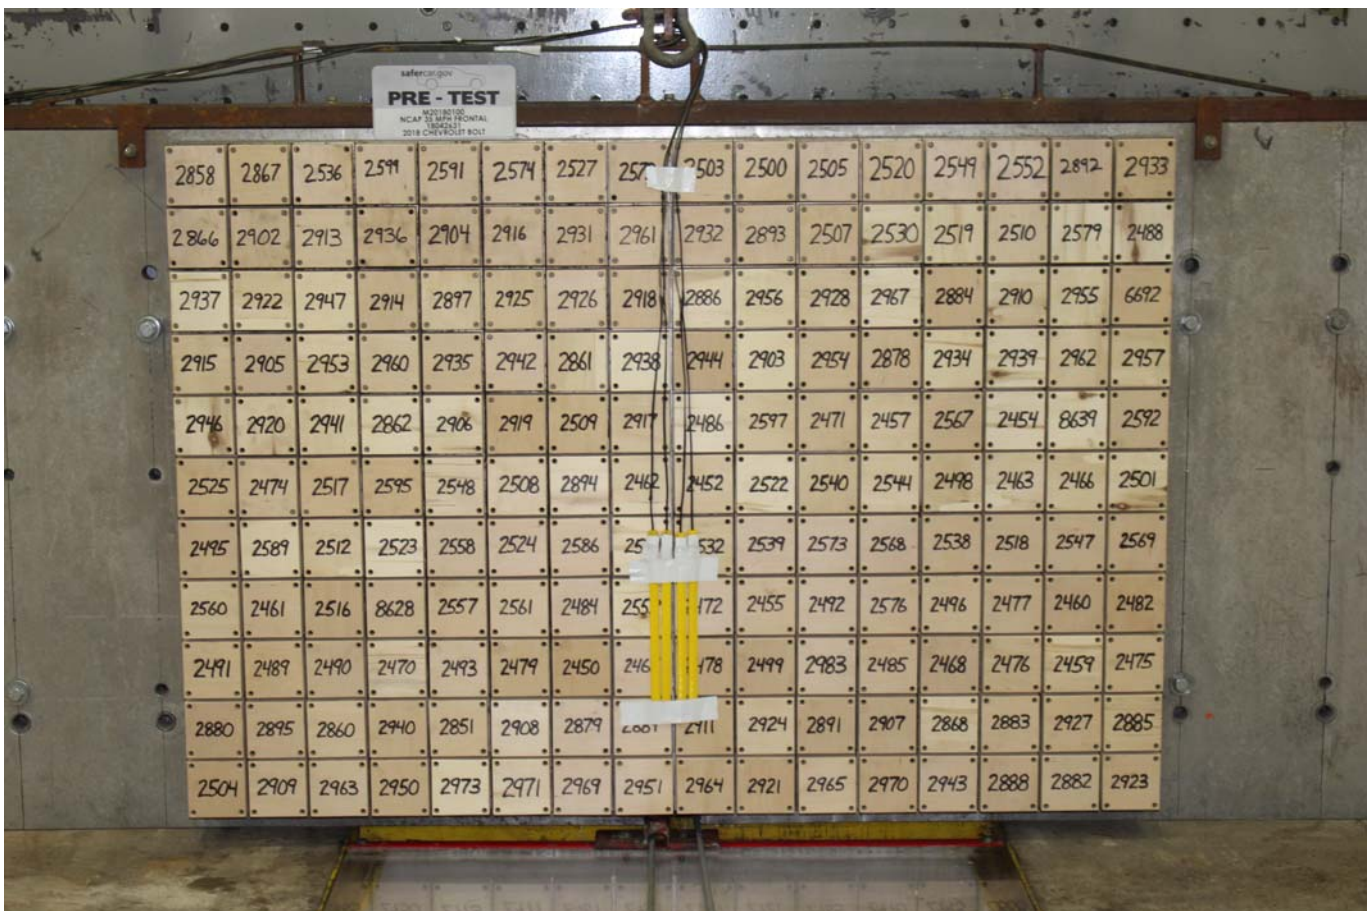
Photo No. 002 - Pre-Test Load Cell Wall

A load cell barrier consisting of 176 load cells was impacted by a 2018 Chevrolet Bolt EV LT 5-Door Hatchback at a velocity of 56.77 km/h. The test was performed at MGA Research Corporation on April 26, 2018. Pre-test and post-test photographs of the vehicle and dummies can be found in Appendix A.

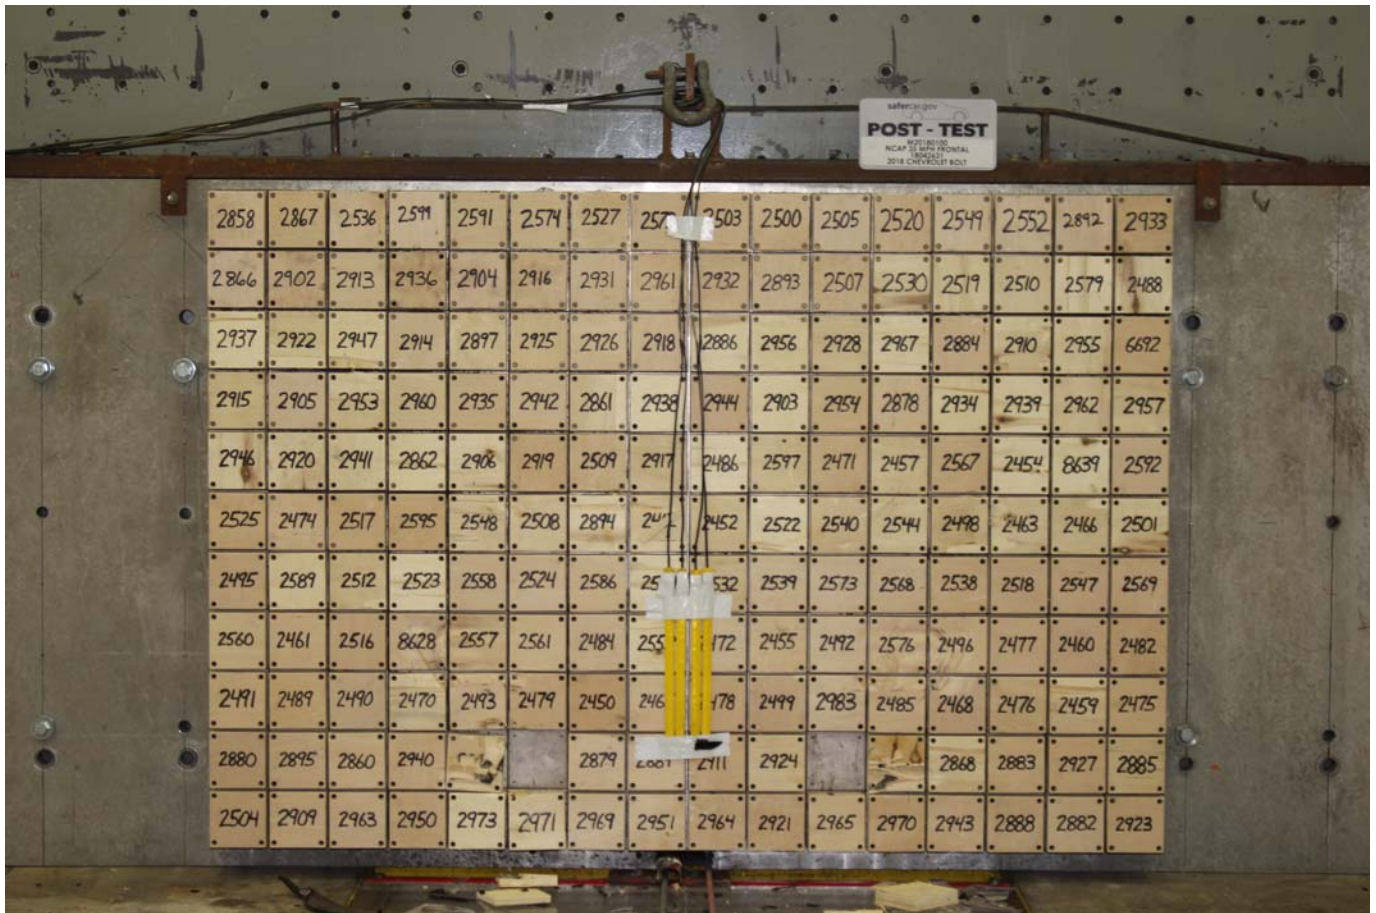
Photo No. 003 - Post-Test Load Cell Wall

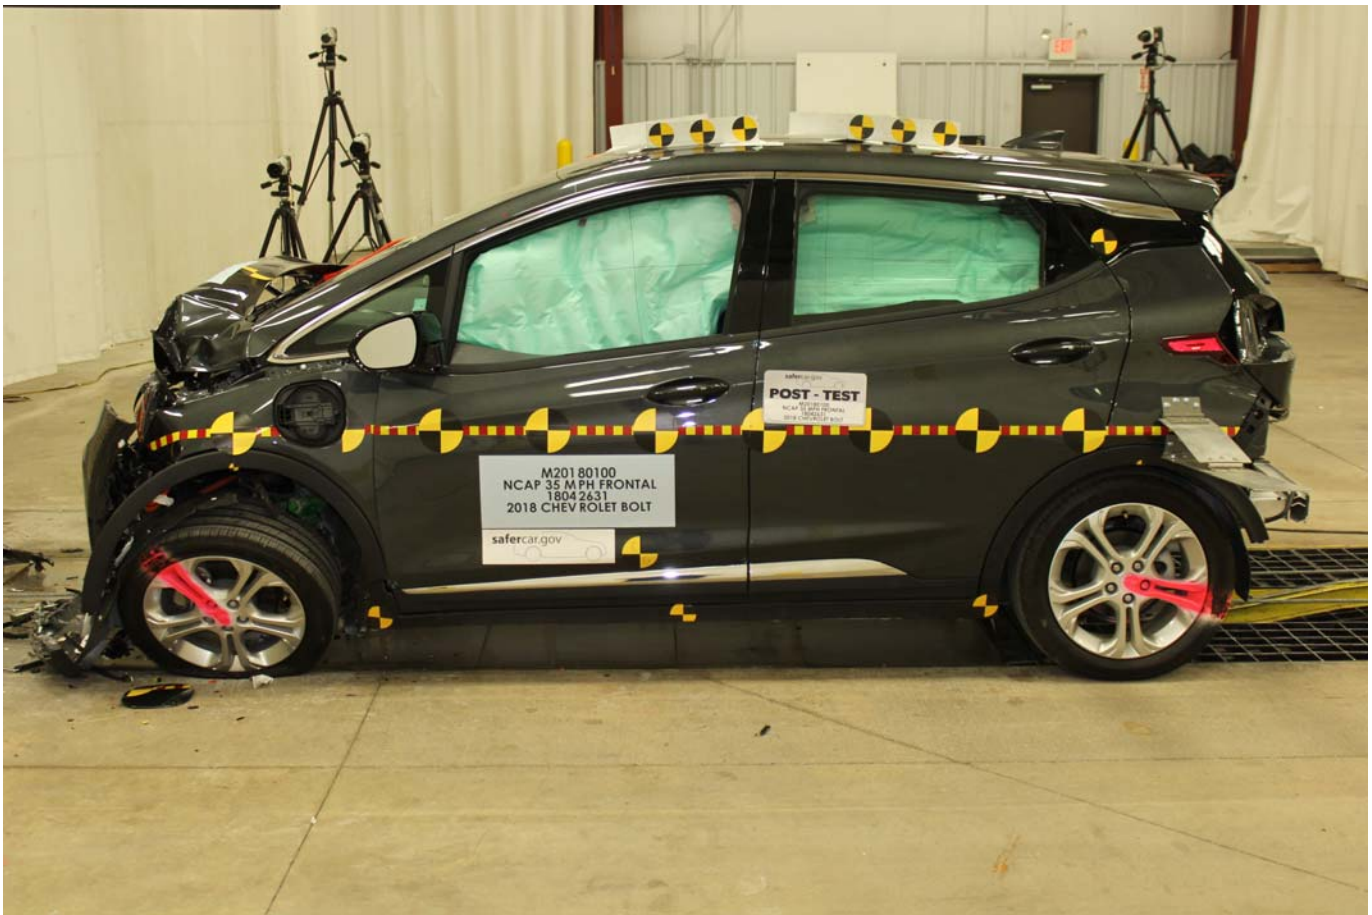
Photo No. 011 - Post-Test Left View of Test Vehicle

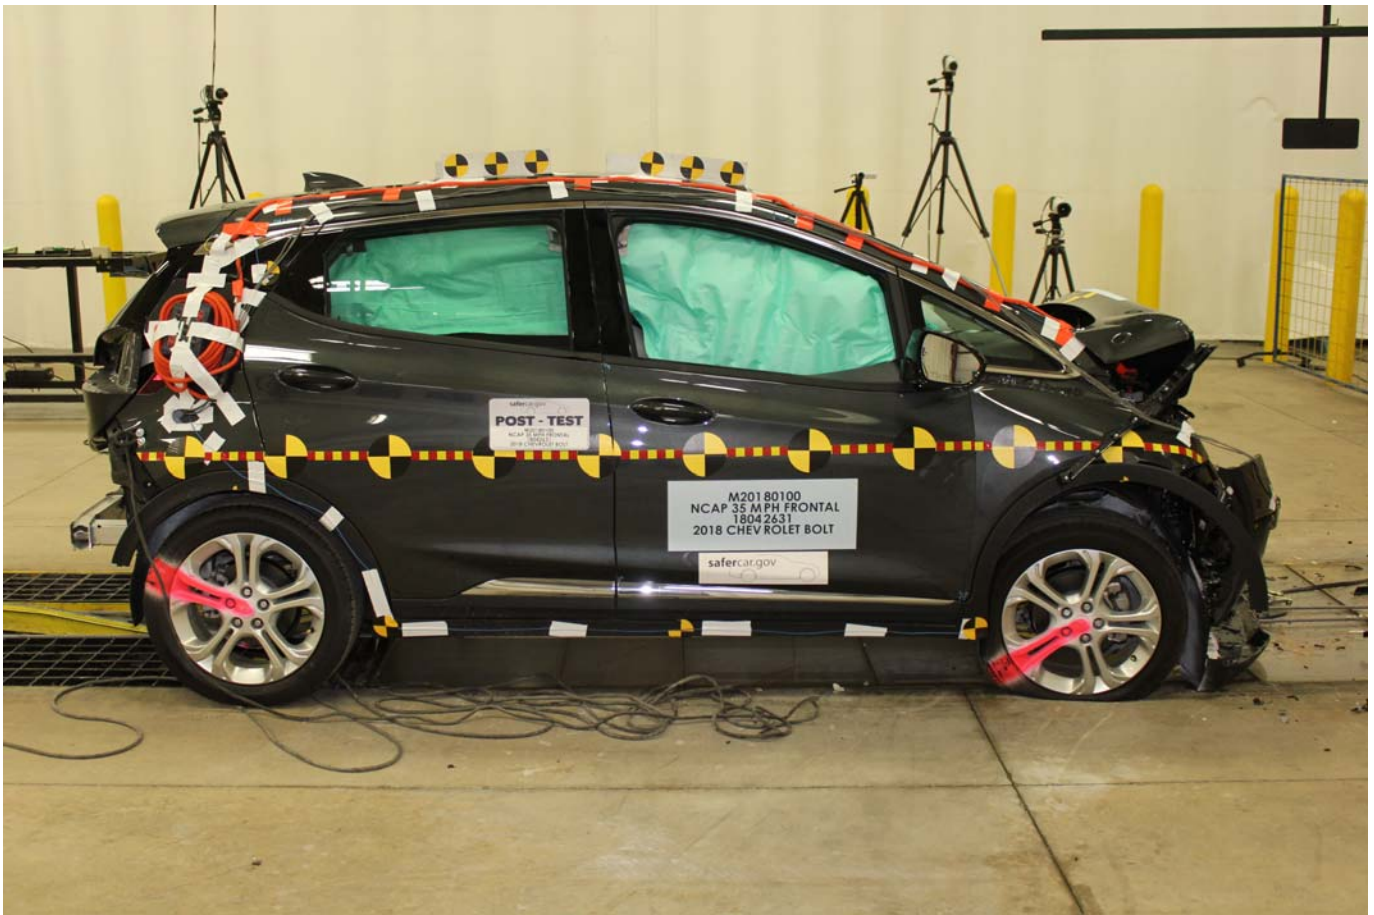
Photo No. 013 - Post-Test Right View of Test Vehicle

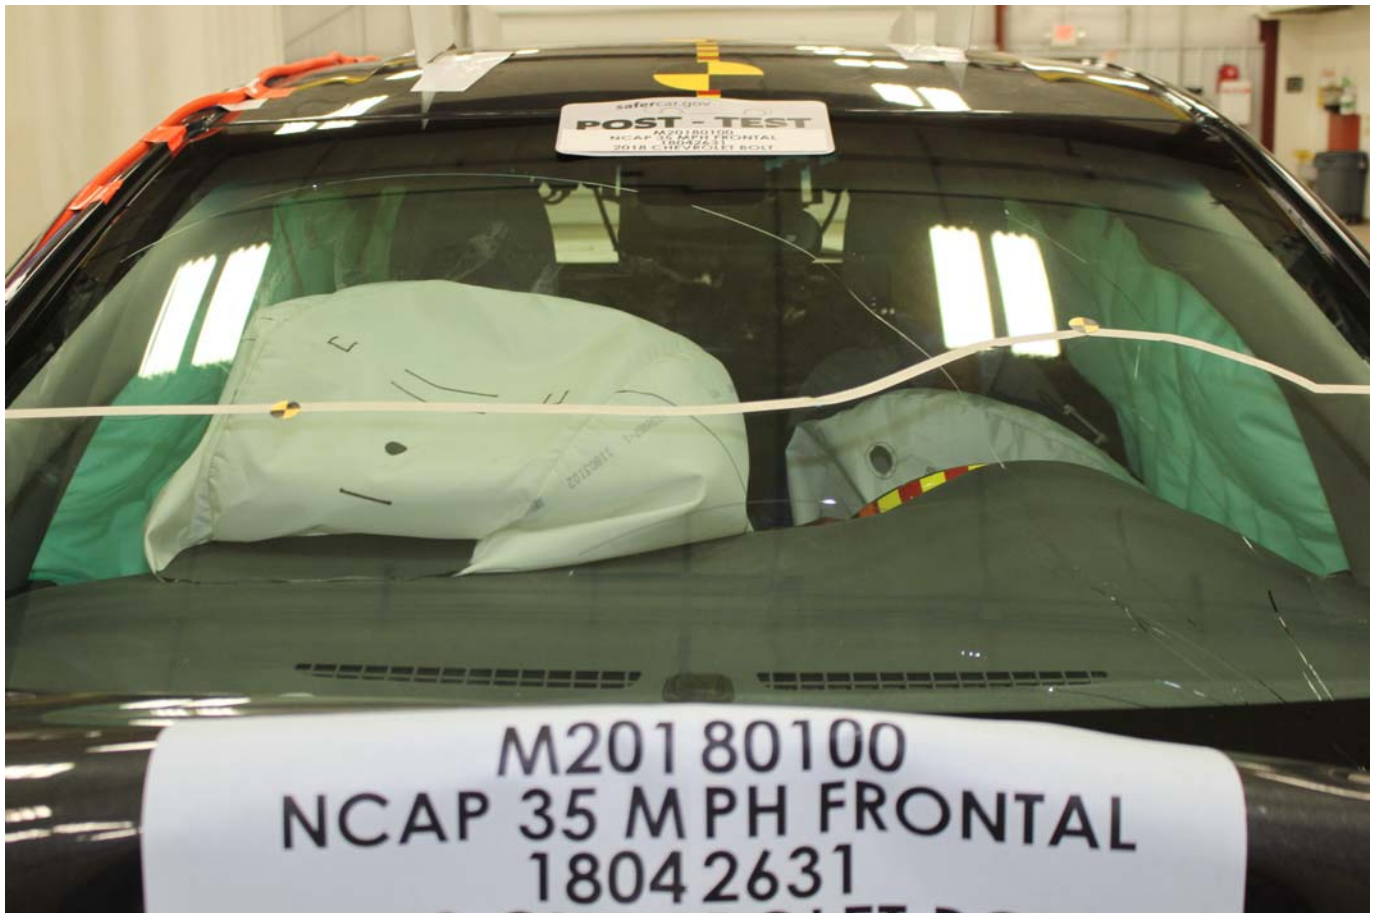
Photo No. 019 - Post-Test Windshield View

There was 100 percent windshield retention and no intrusion into the protected zone of the windshield during the event. There was no Stoddard Solvent leakage after the event or during any phase of the static rollover.

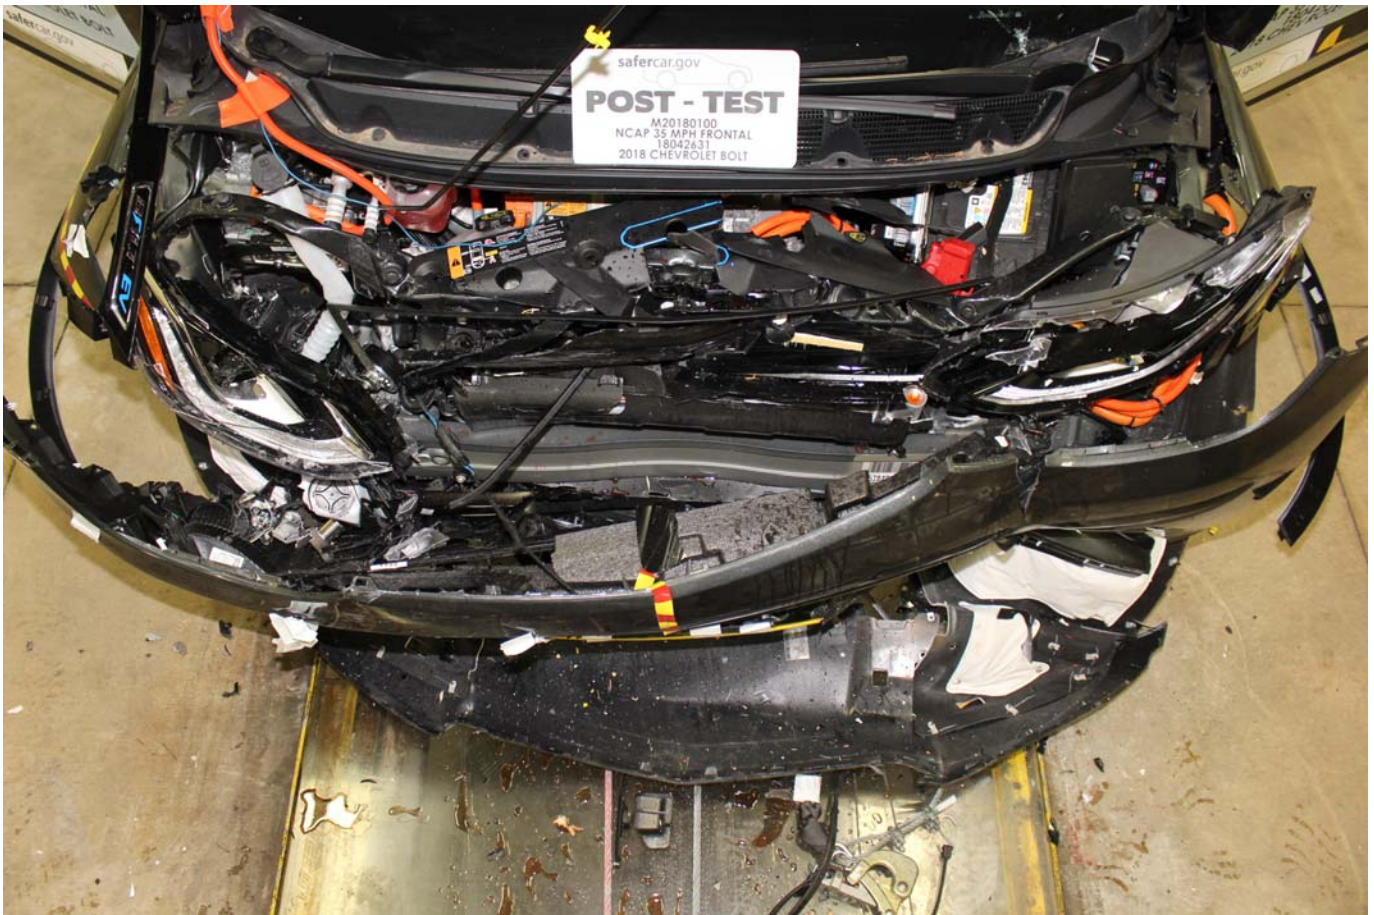
Photo No. 021 - Post-Test Engine Compartment View

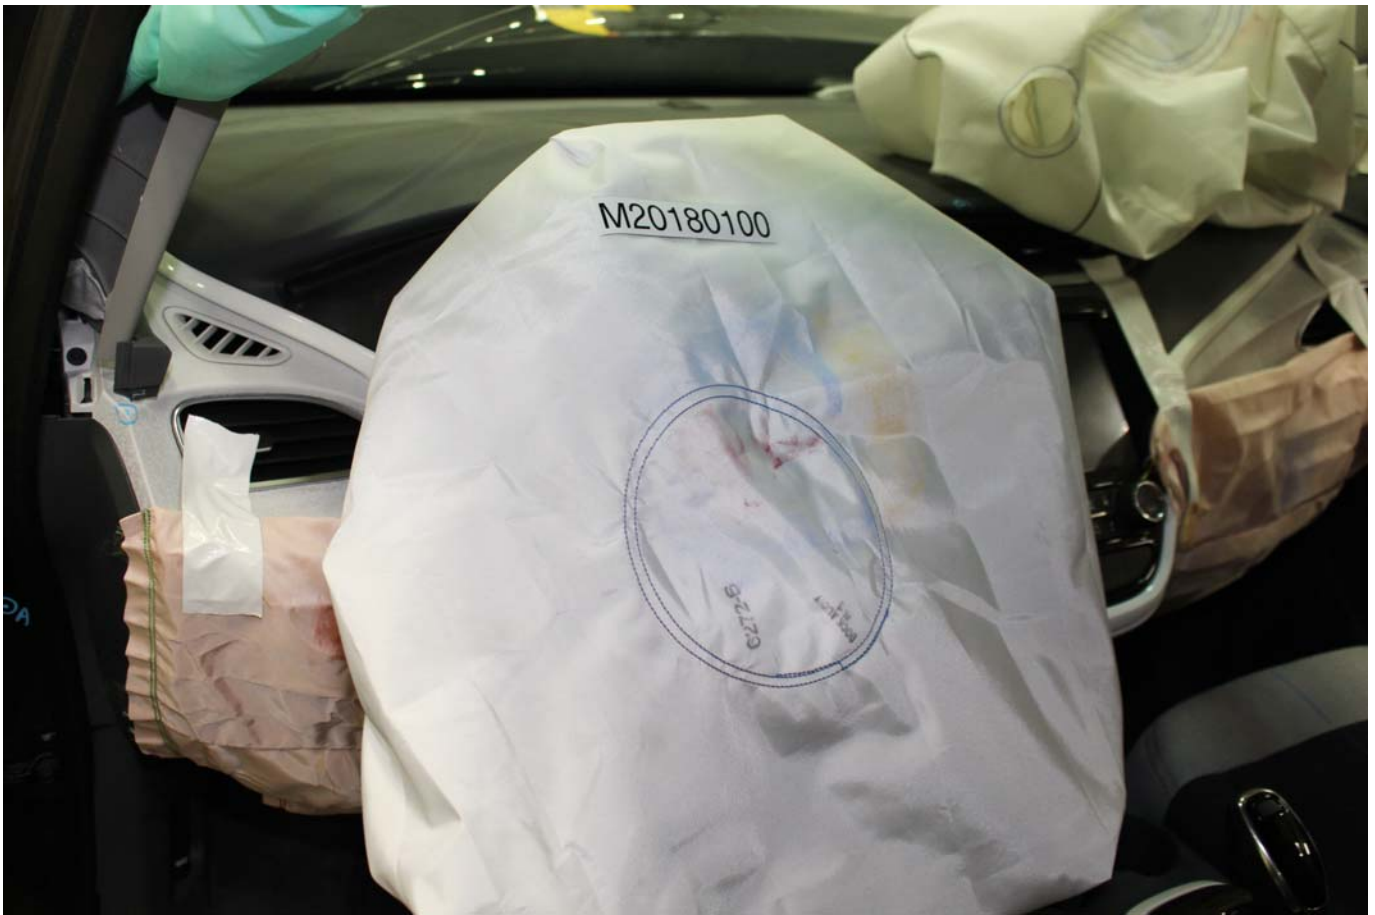
Photo No. 047 - Post-Test Driver Dummy Contact with Airbag

The driver's visible contact points were as follows: The driver's head contacted the airbag. The driver's head also contacted the headrest. The driver's knees contacted the knee airbag. The passenger's visible contact points were as follows: The passenger's head contacted the airbag. The passenger's head also contacted the headrest. The passenger's knees contacted the knee airbag.

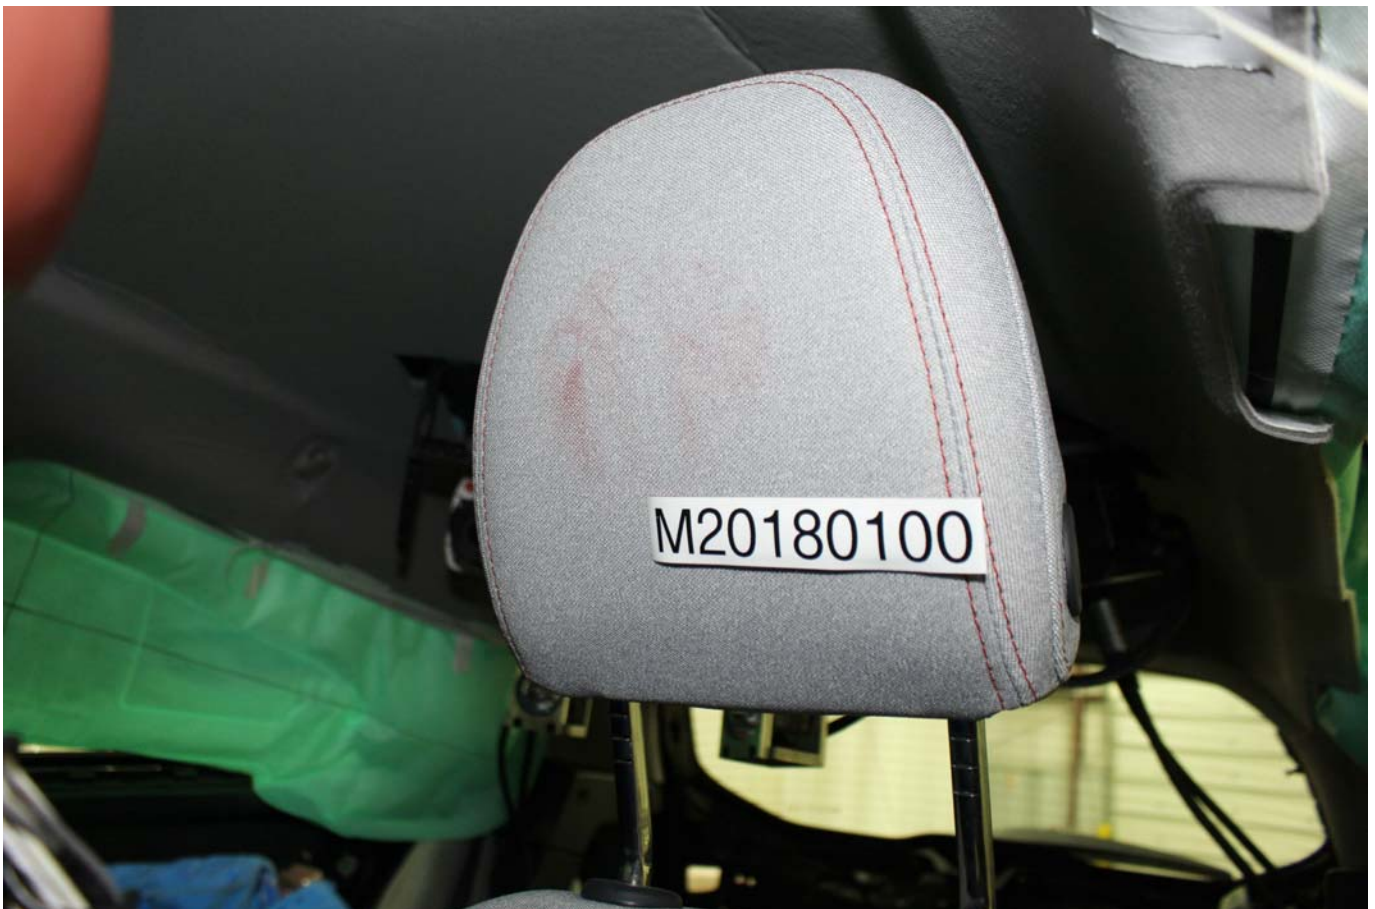
Photo No. 048 - Post-Test Driver Dummy Contact with Headrest

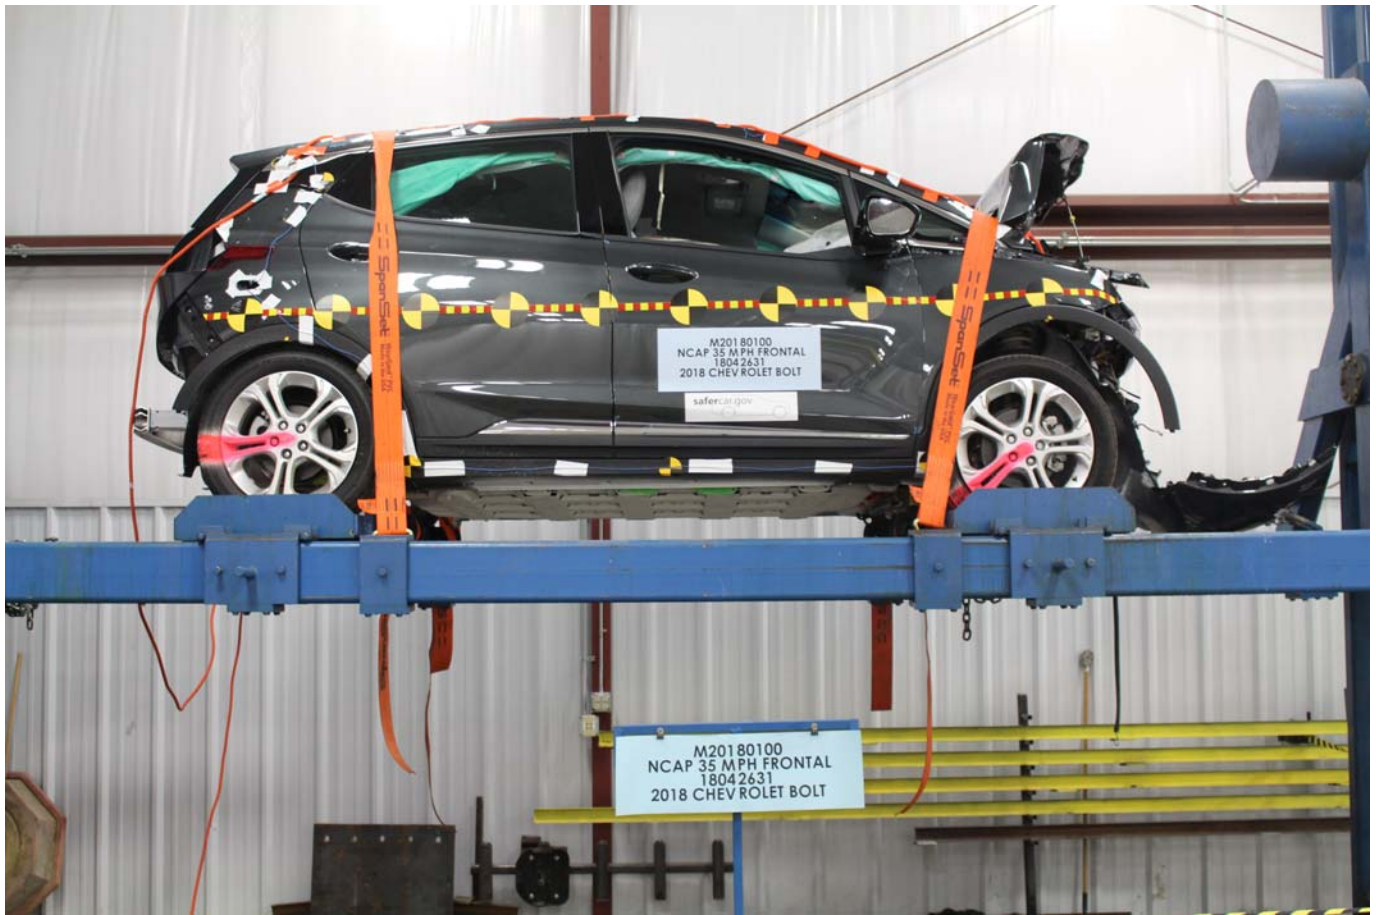
Photo No. 073 - Vehicle at 0 Degree on Static Rollover Device

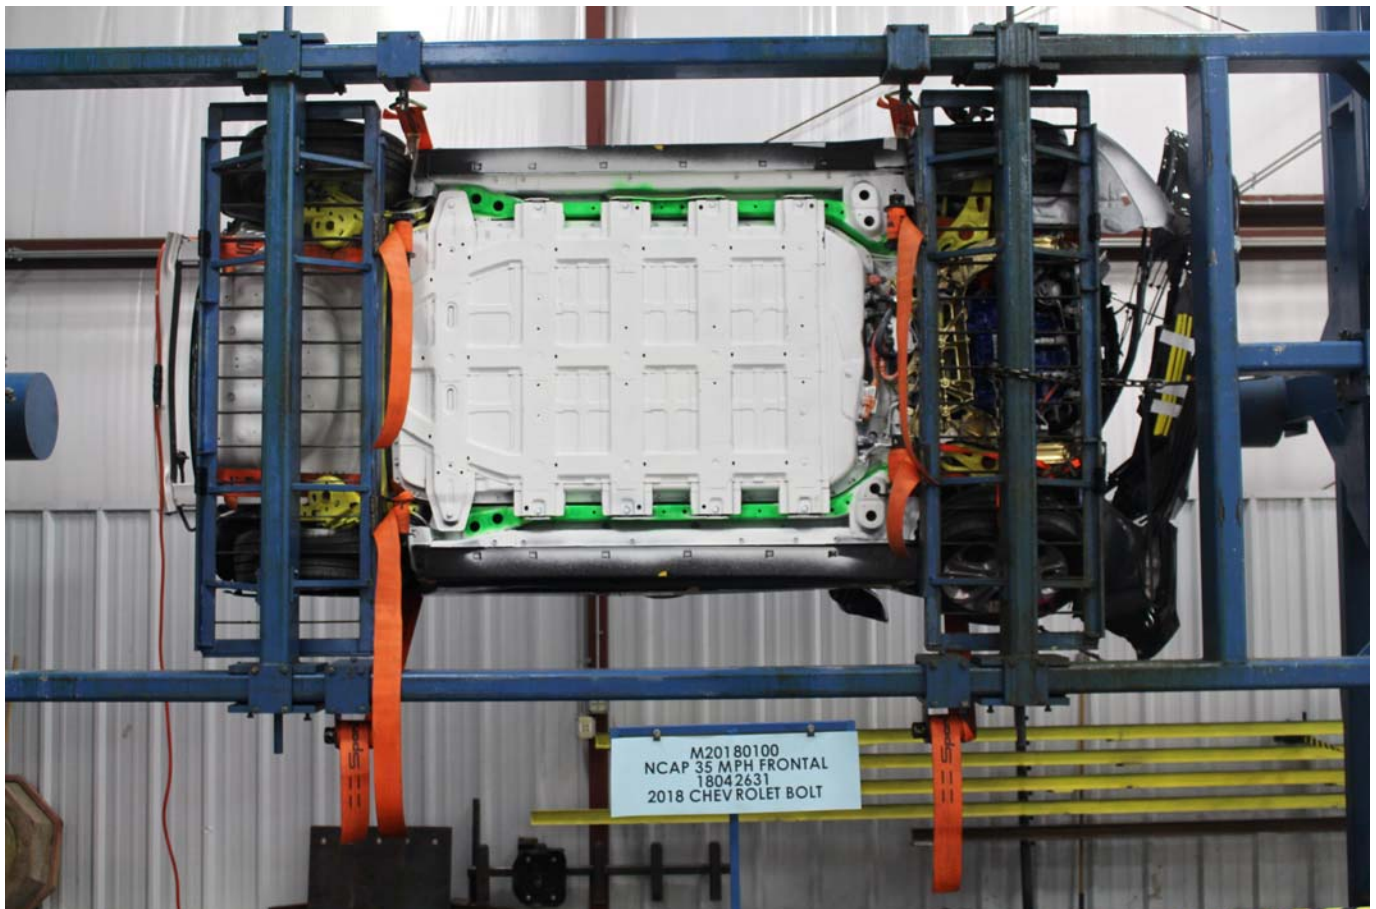
Photo No. 074 - Vehicle at 90 Degrees on Static Rollover Device

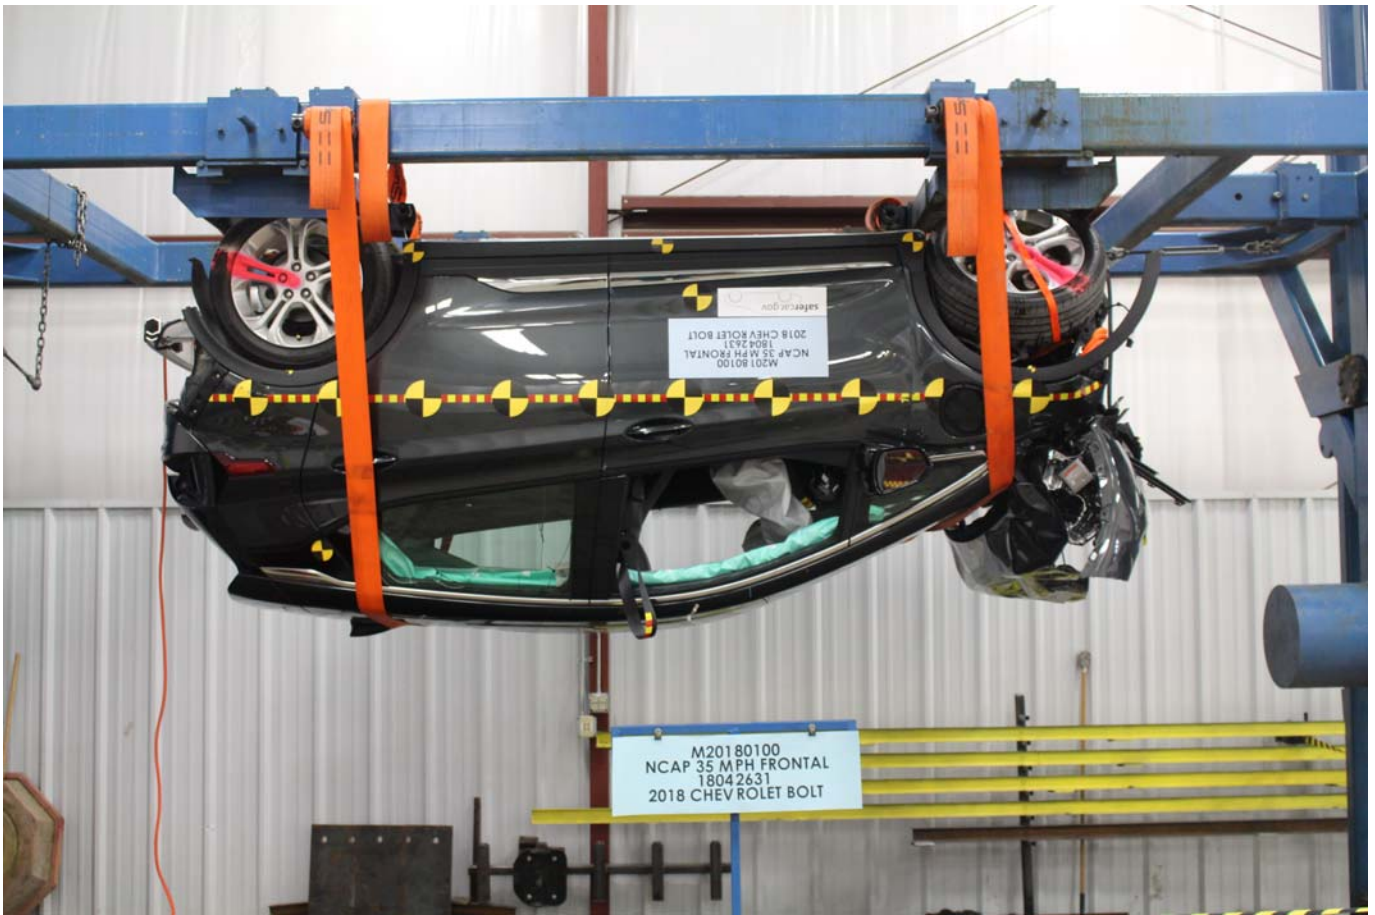
Photo No. 075 - Vehicle at 180 Degrees on Static Rollover Device

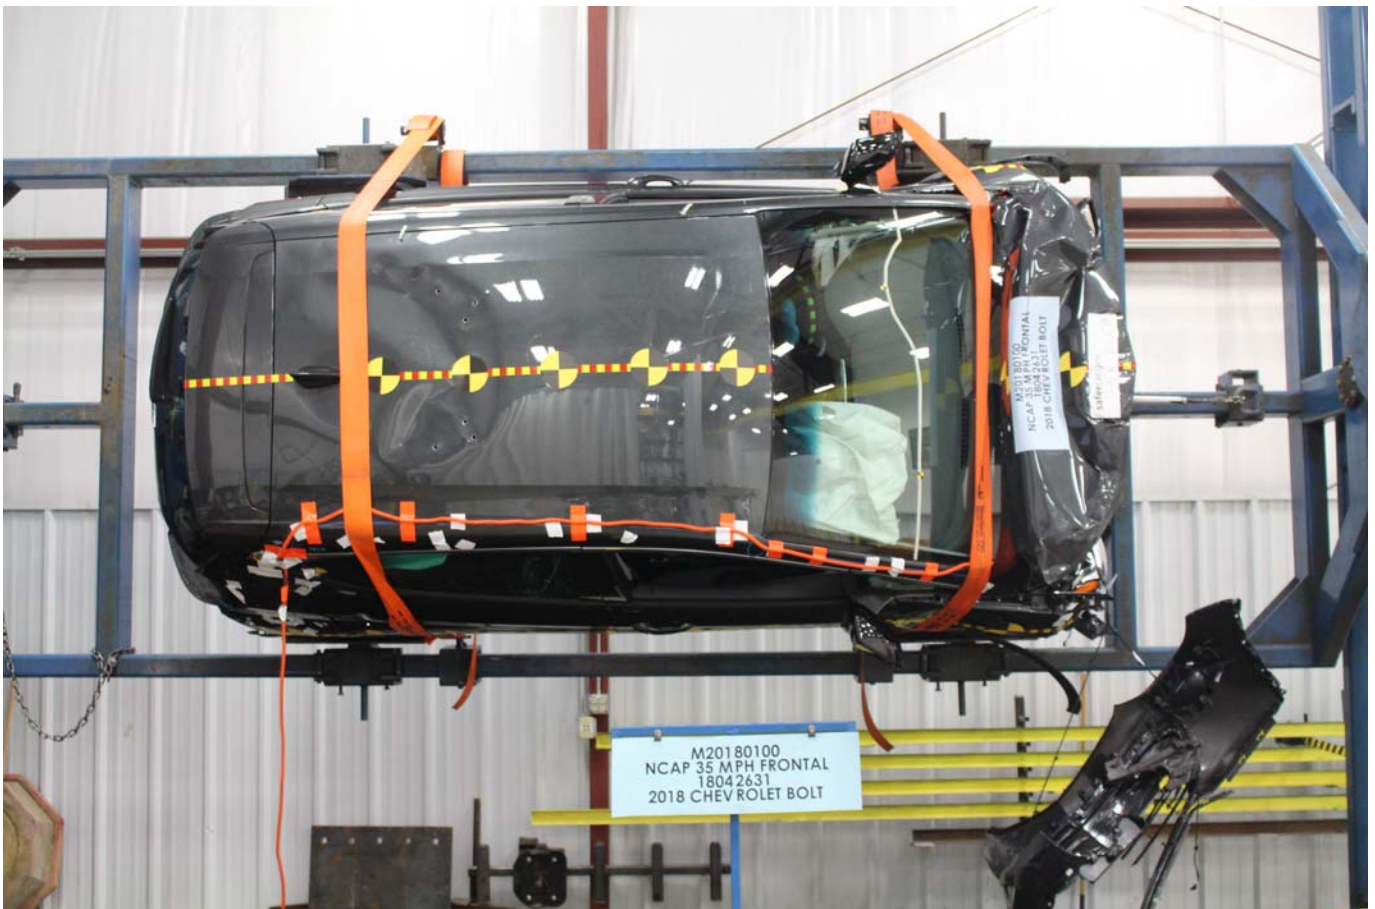
Photo No. 076 - Vehicle at 270 Degrees on Static Rollover Device
