REPORT NUMBER: NCAP-KAR-18-015

**NEW CAR ASSESSMENT PROGRAM (NCAP)
FRONTAL BARRIER IMPACT TEST**

**SUBARU CORPORATION
2018 SUBARU IMPREZA 2.0I/JLB 5-DOOR STATION WAGON**

FINAL REPORT

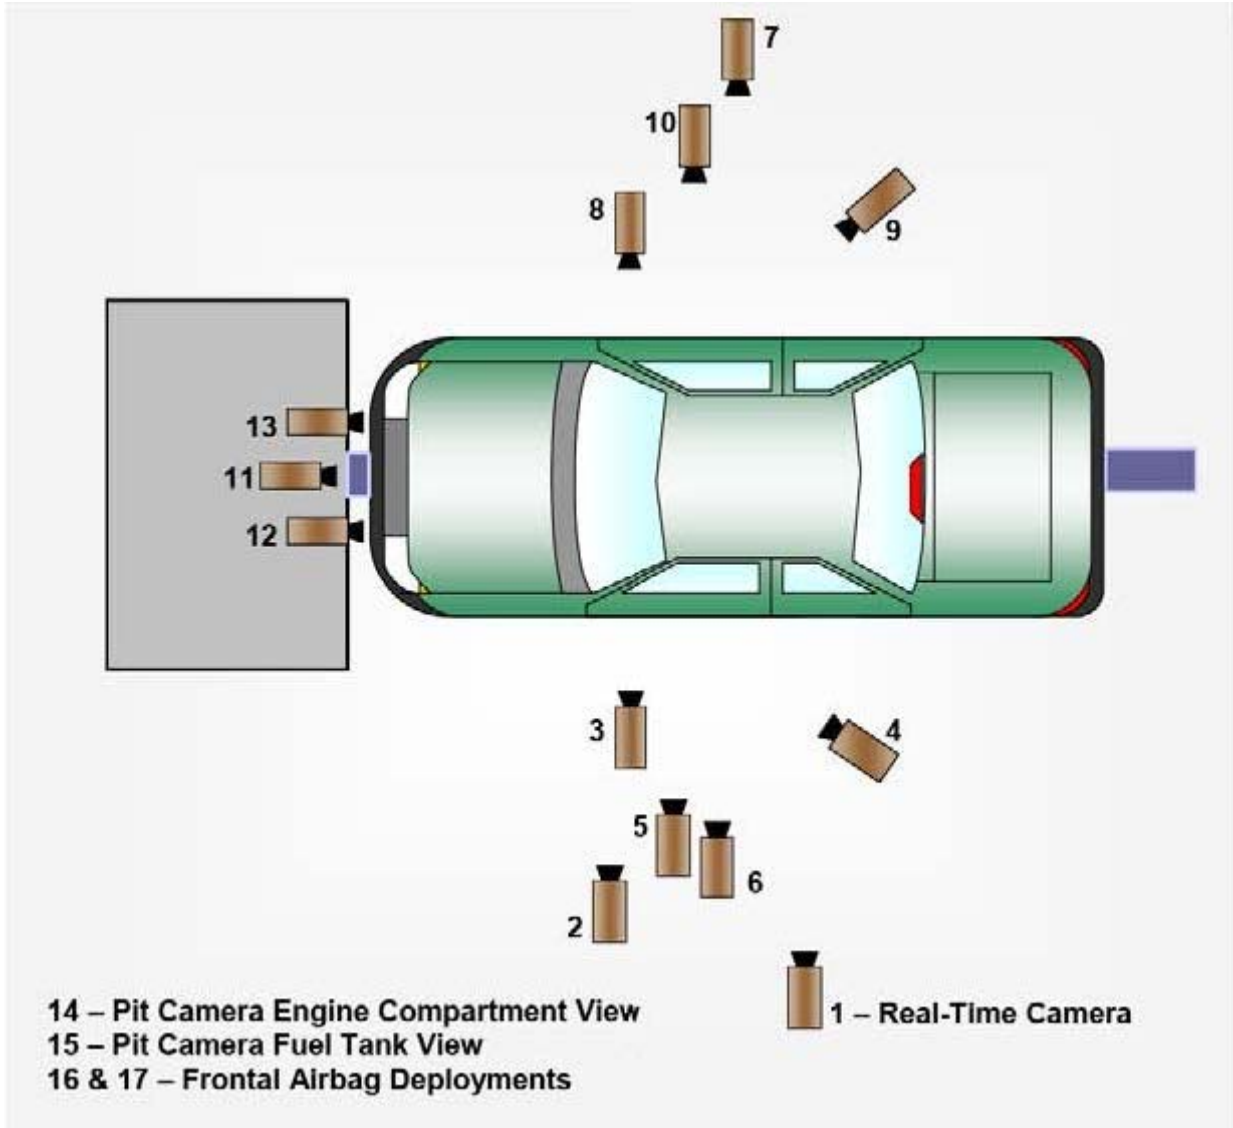
CAMERA POSITIONS FOR FRONTAL IMPACTS

Three (3) real-time cameras and sixteen (16) high-speed cameras were used to document the frontal barrier impact event. Camera locations and other pertinent camera information can be found in Data Sheet 6 of this report.

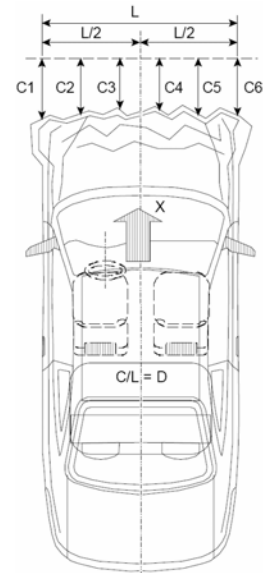
CRUSH PROFILE

Collision Deformation Classification: 12FDEW2
 Midpoint of Damage: Vehicle Centerline
 Damage Region Length (mm): 1405
 Impact Mode: Full Frontal

No.	Measurement Description	Units	Pre-Test	Post-Test	Difference
C1	Crush Zone 1 at Left Side	mm	175	370	195
C2	Crush Zone 2 at Left Side	mm	21	305	284
C3	Crush Zone 3 at Left Side	mm	14	308	294
C4	Crush Zone 4 at Right Side	mm	15	315	300
C5	Crush Zone 5 at Right Side	mm	26	350	324
C6	Crush Zone 6 at Right Side	mm	197	358	161
L	C1 to C6	mm	1405

The maximum static crush was 324 mm at DPD5 to the right of the vehicle's centerline. Both the driver and passenger side doors remained closed during the impact event and were operable after the impact.

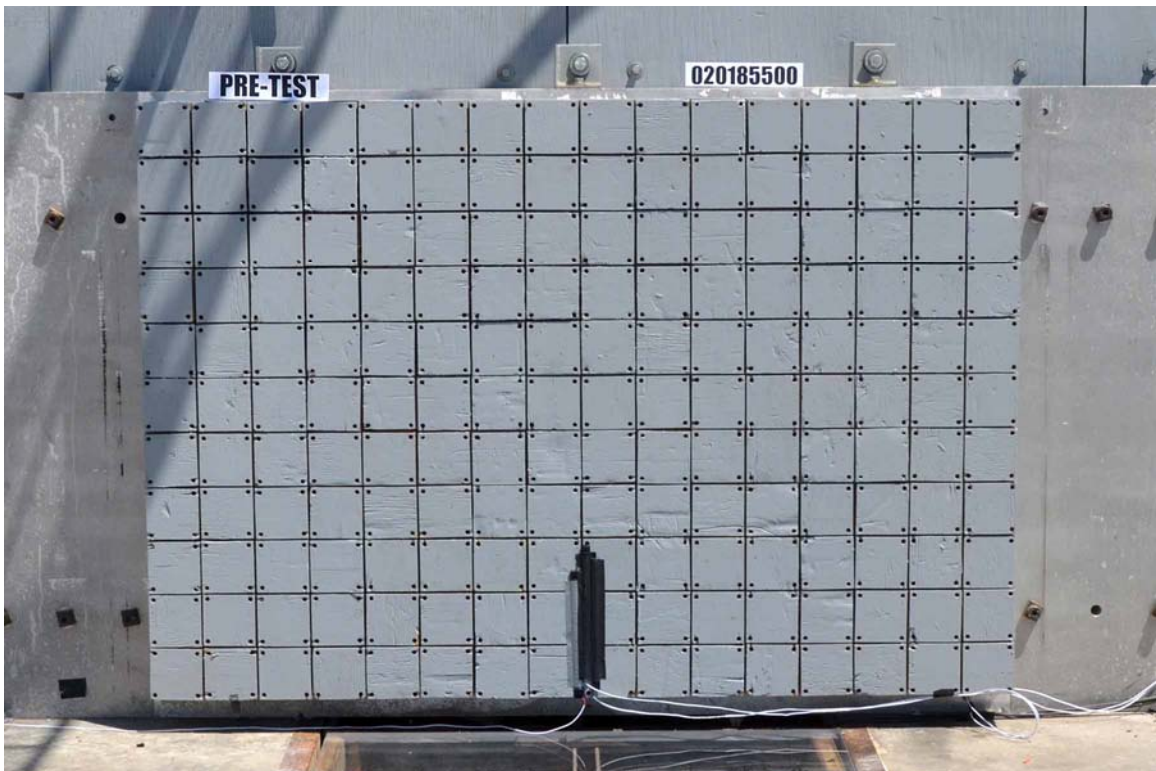
FIGURE 1. Load Cell Location

A load cell barrier consisting of 176 load cells was impacted by a 2018 Subaru Impreza 2.0i/JLB 5-door Station Wagon at a velocity of 56.12 km/h. The test was performed at KARCO Engineering, LLC. on April 25, 2018. Pre- and post-test photographs of the vehicle and dummies can be found in Appendix A of this report.

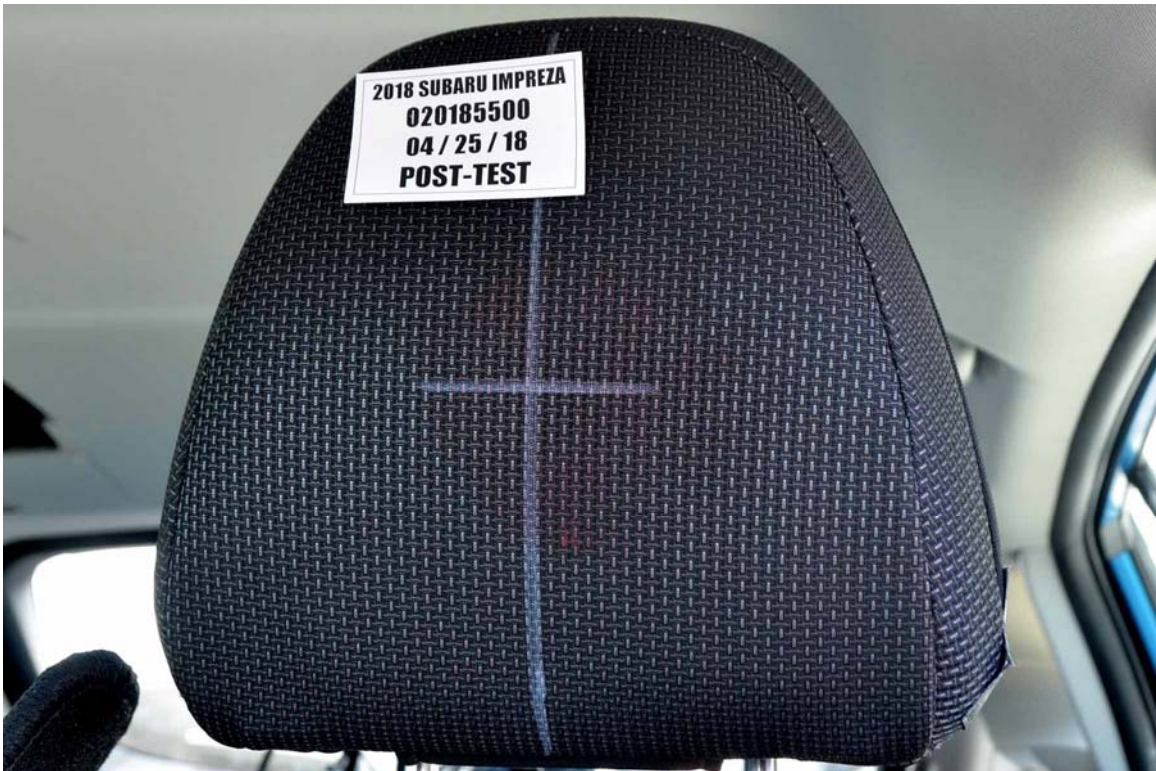
FIGURE 47. Post-Test Driver Dummy Contact with Airbag

The driver's visible contact points were as follows: The driver ATD's head contacted the frontal airbag and headrest. The upper torso contacted the frontal airbag. Both the left and right knees contacted the knee airbag.
