**REPORT NUMBER: SPNCAP-MGA-2018-029**

**NEW CAR ASSESSMENT PROGRAM (NCAP)  
Side Impact Pole Test**

**GENERAL MOTORS LLC  
2018 Chevrolet Bolt EV LT 5-Door Hatchback  
NHTSA No.: M20180101**

**MGA RESEARCH CORPORATION  
5000 Warren Road  
Burlington, WI 53105**

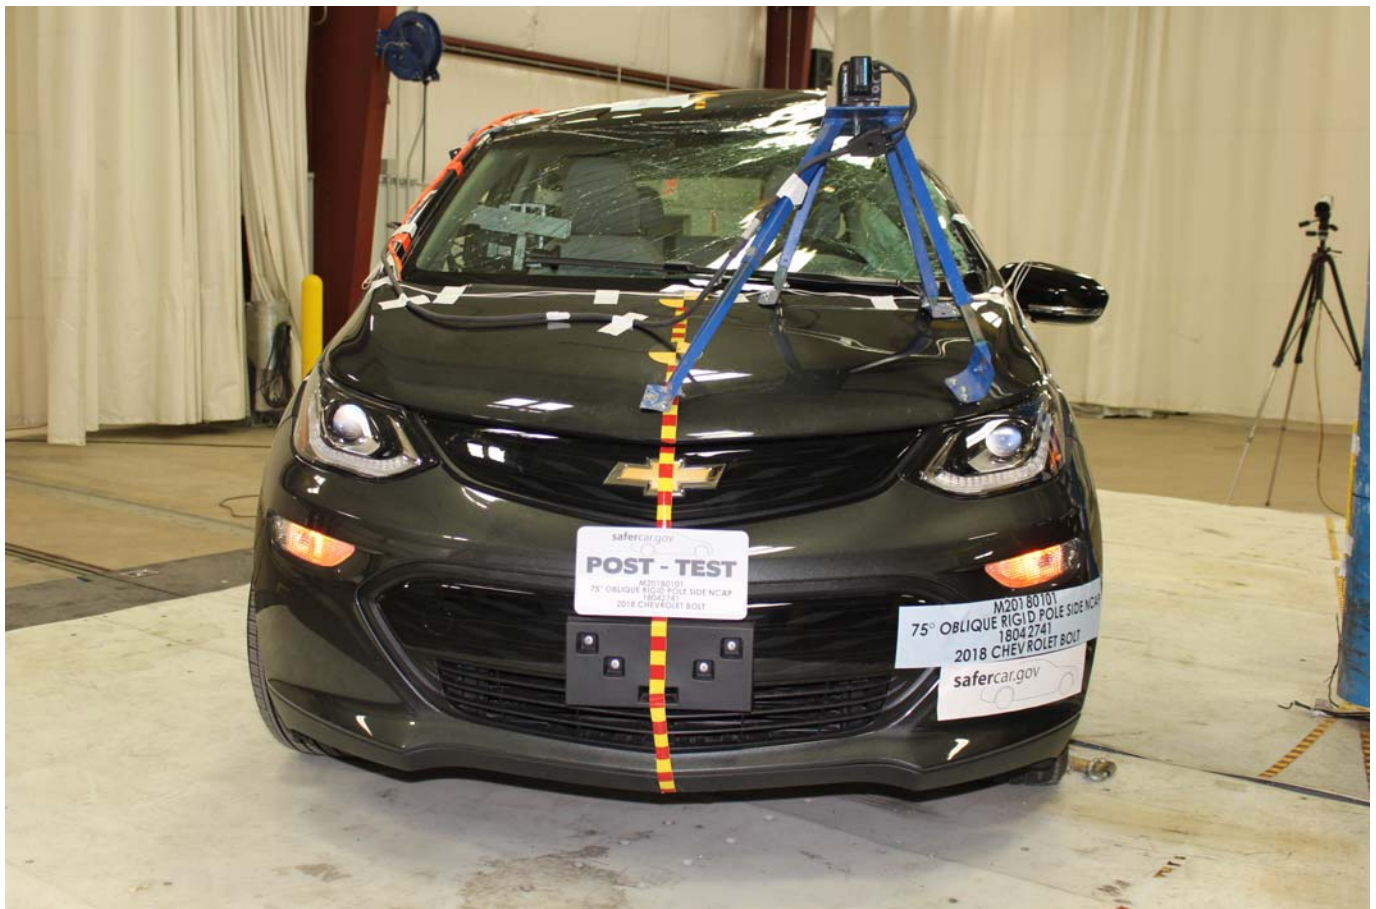
Photo No. 004 - Post-Test Frontal View of Test Vehicle

| Critical Areas of Performance | Observations and Conclusions |
|---|---|
| Windshield Damage | Cracked |

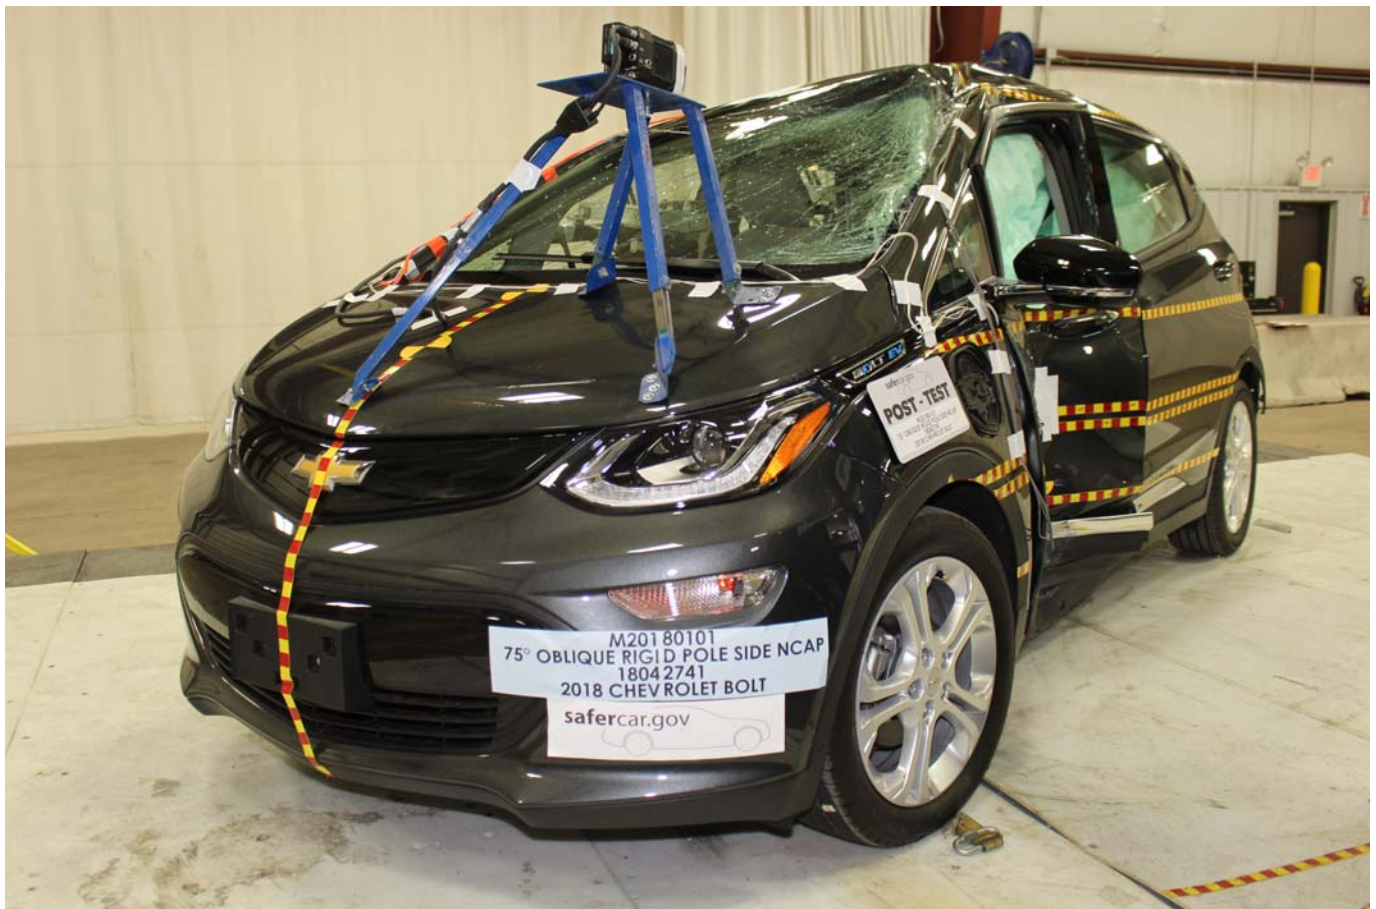
Photo No. 006 - Post-Test Left Front Three-Quarter View of Test Vehicle

| Critical Areas of Performance | Observations and Conclusions |
|---|---|
| Side Window Damage | Left Front Window Broken |

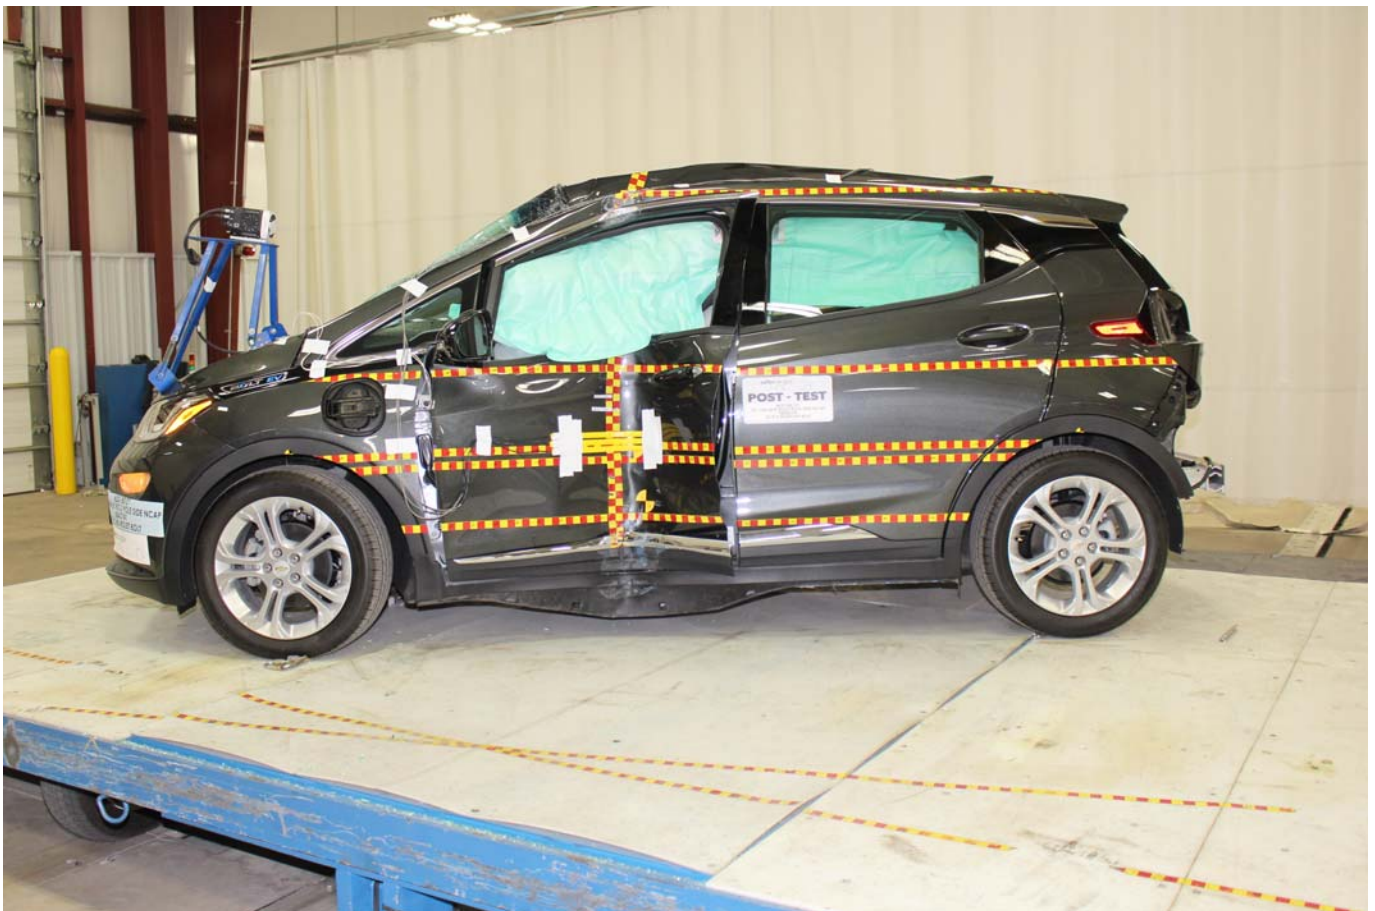
Photo No. 008 - Post-Test Left Side View of Test Vehicle

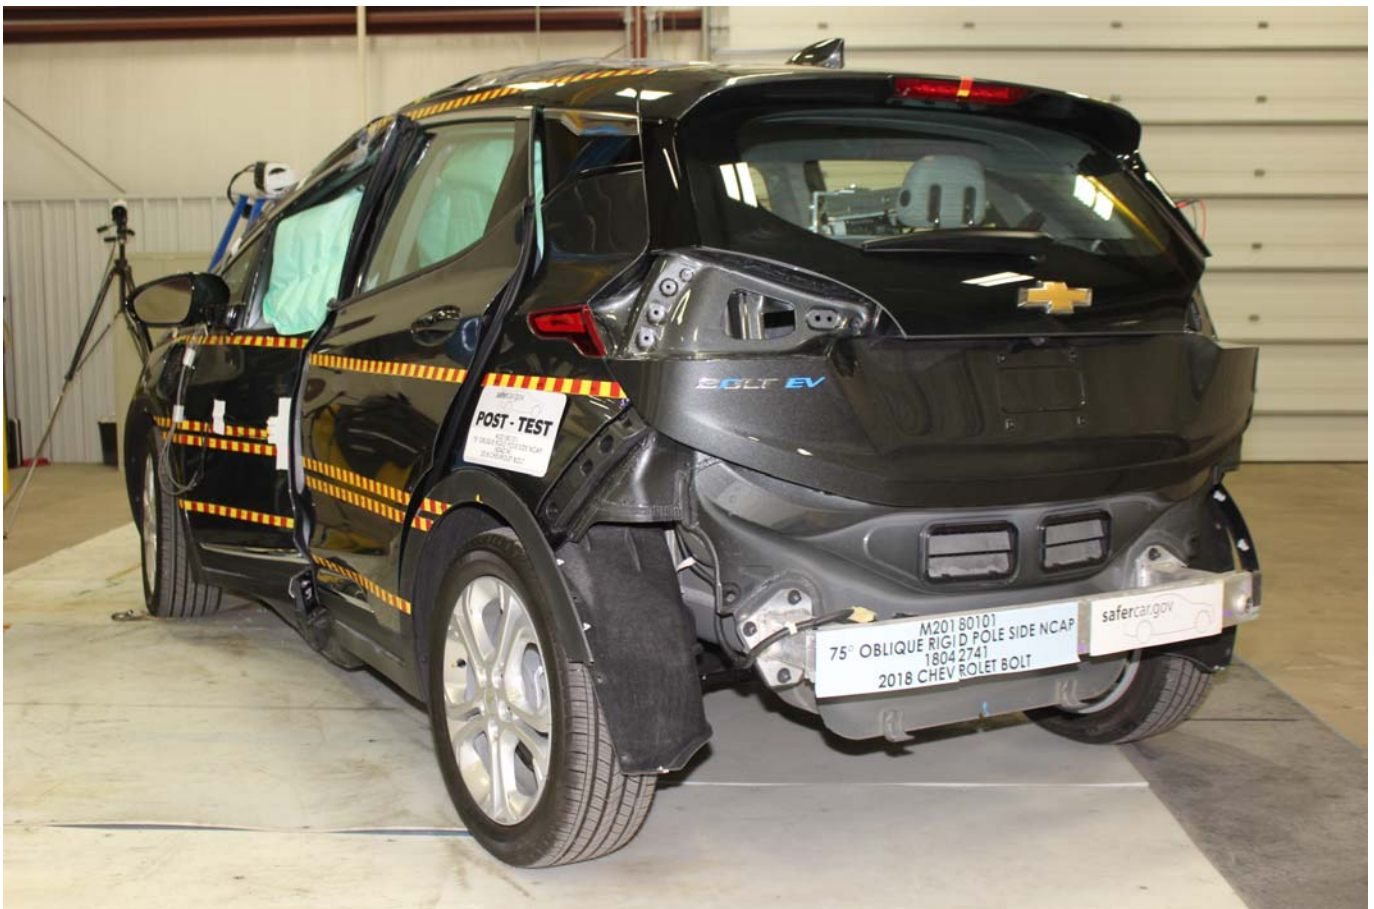
Photo No. 010 - Post-Test Left Rear Three-Quarter View of Test Vehicle

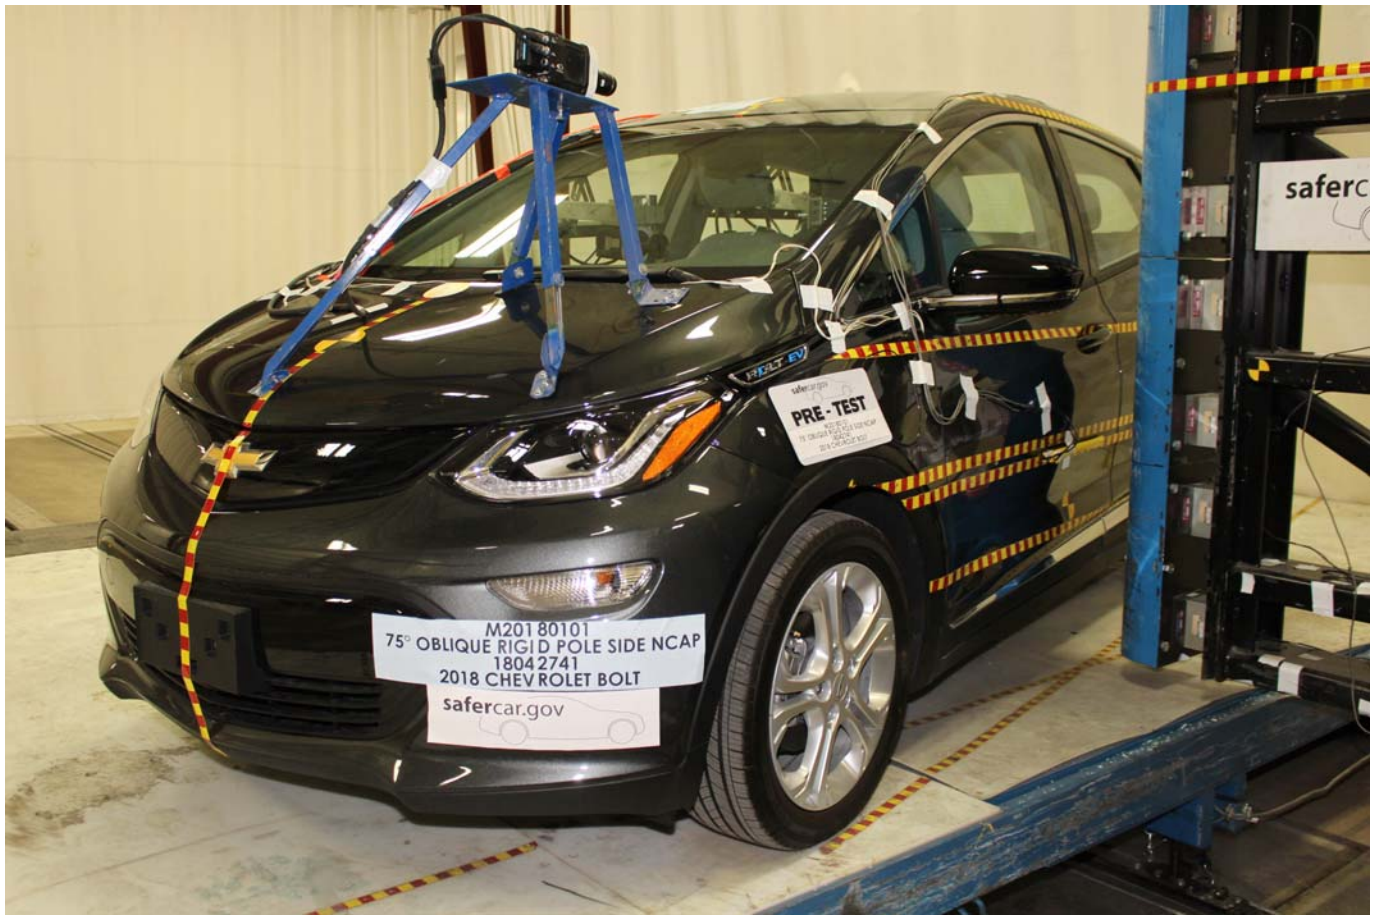
Photo No. 017 - Pre-Test Left Side View of Pole Positioned Against Side of Vehicle

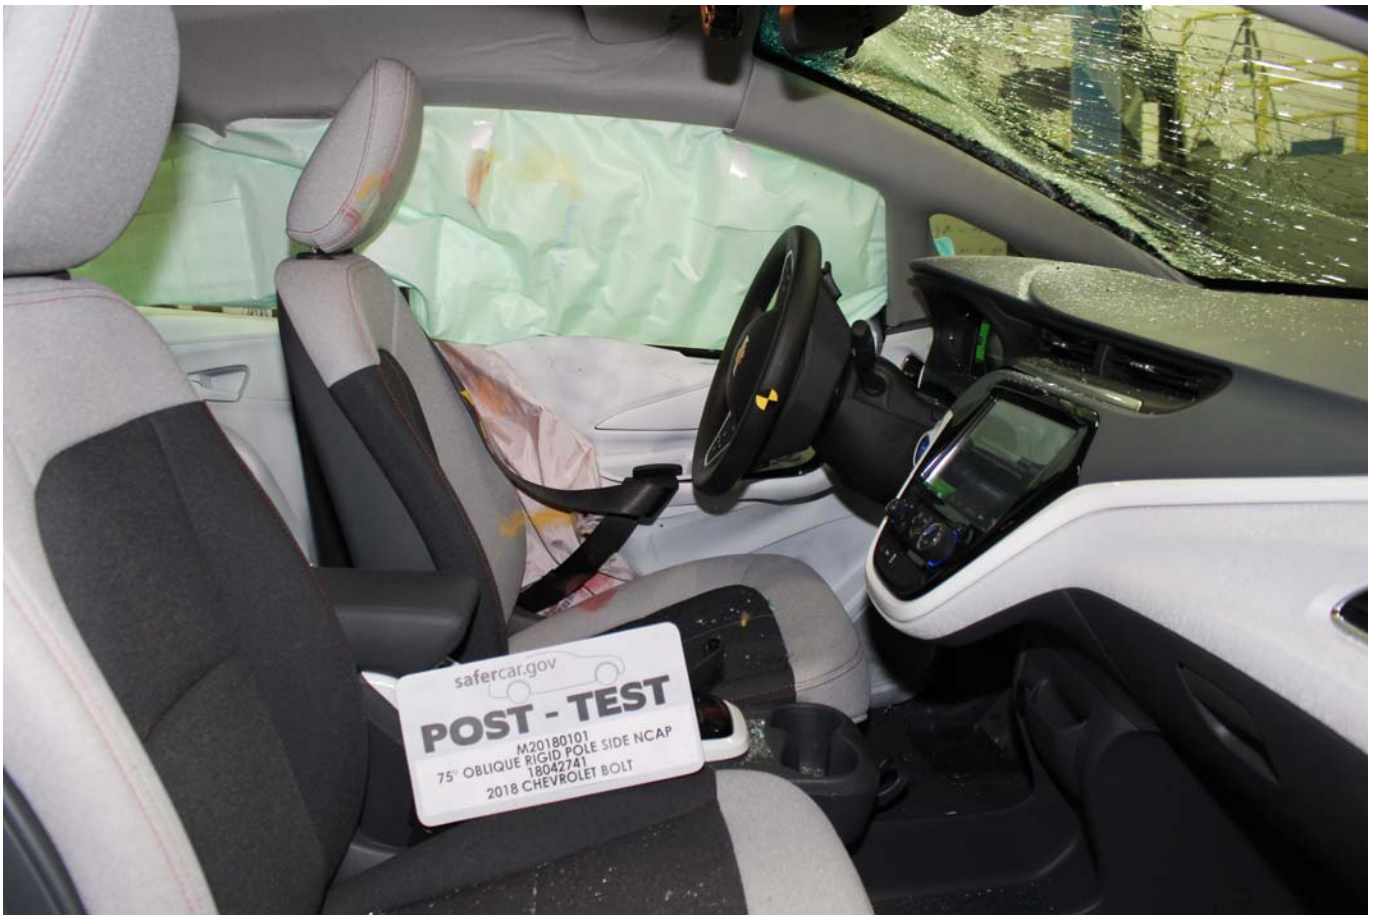
Photo No. 045 - Post-Test Inner Door Panel View Showing Dummy Contact Location

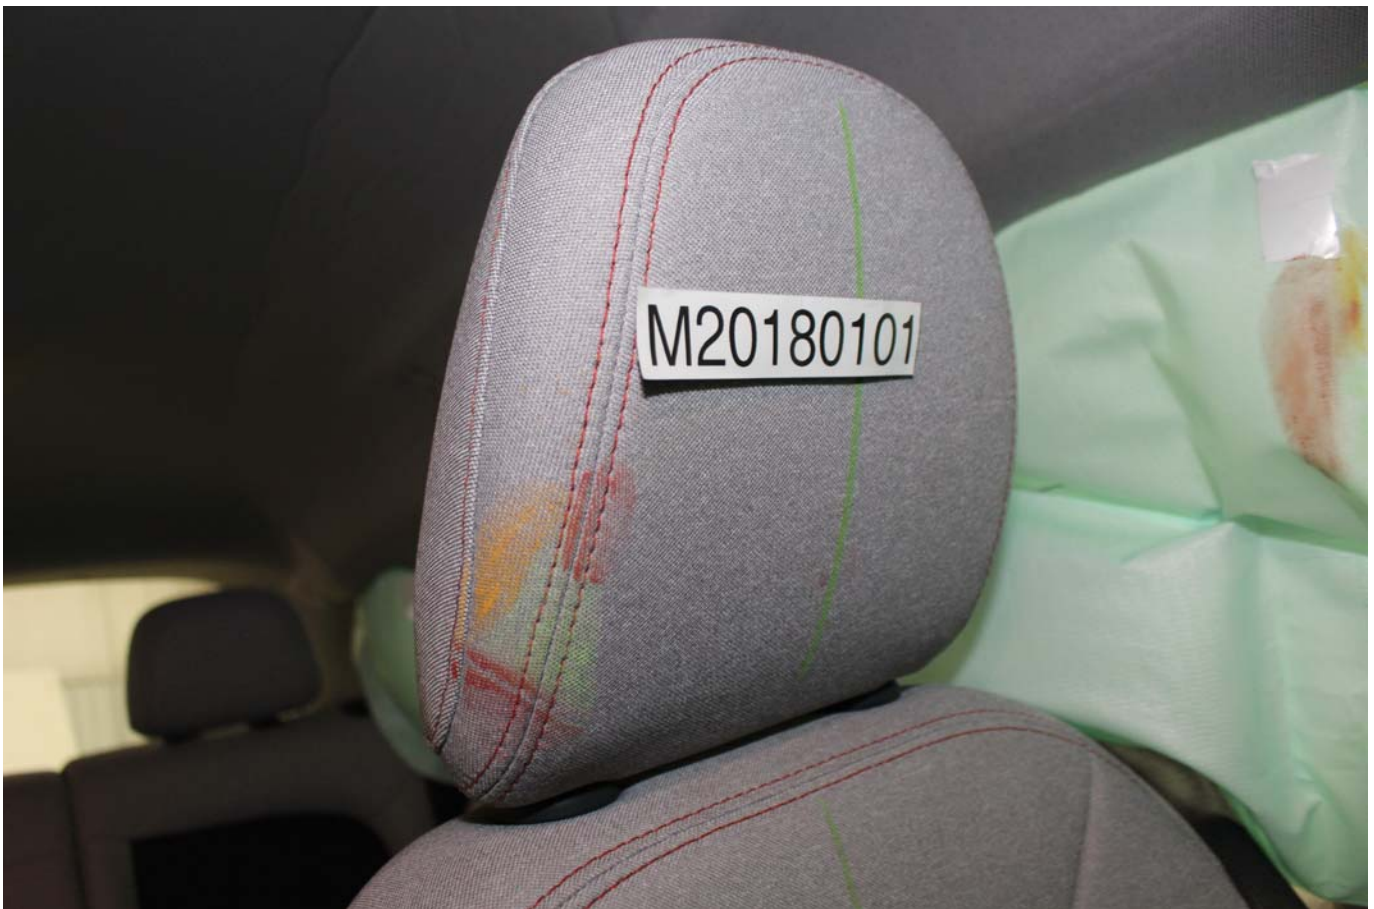
Photo No. 046 - Post-Test Dummy Close-Up Head Contact with Vehicle Interior View

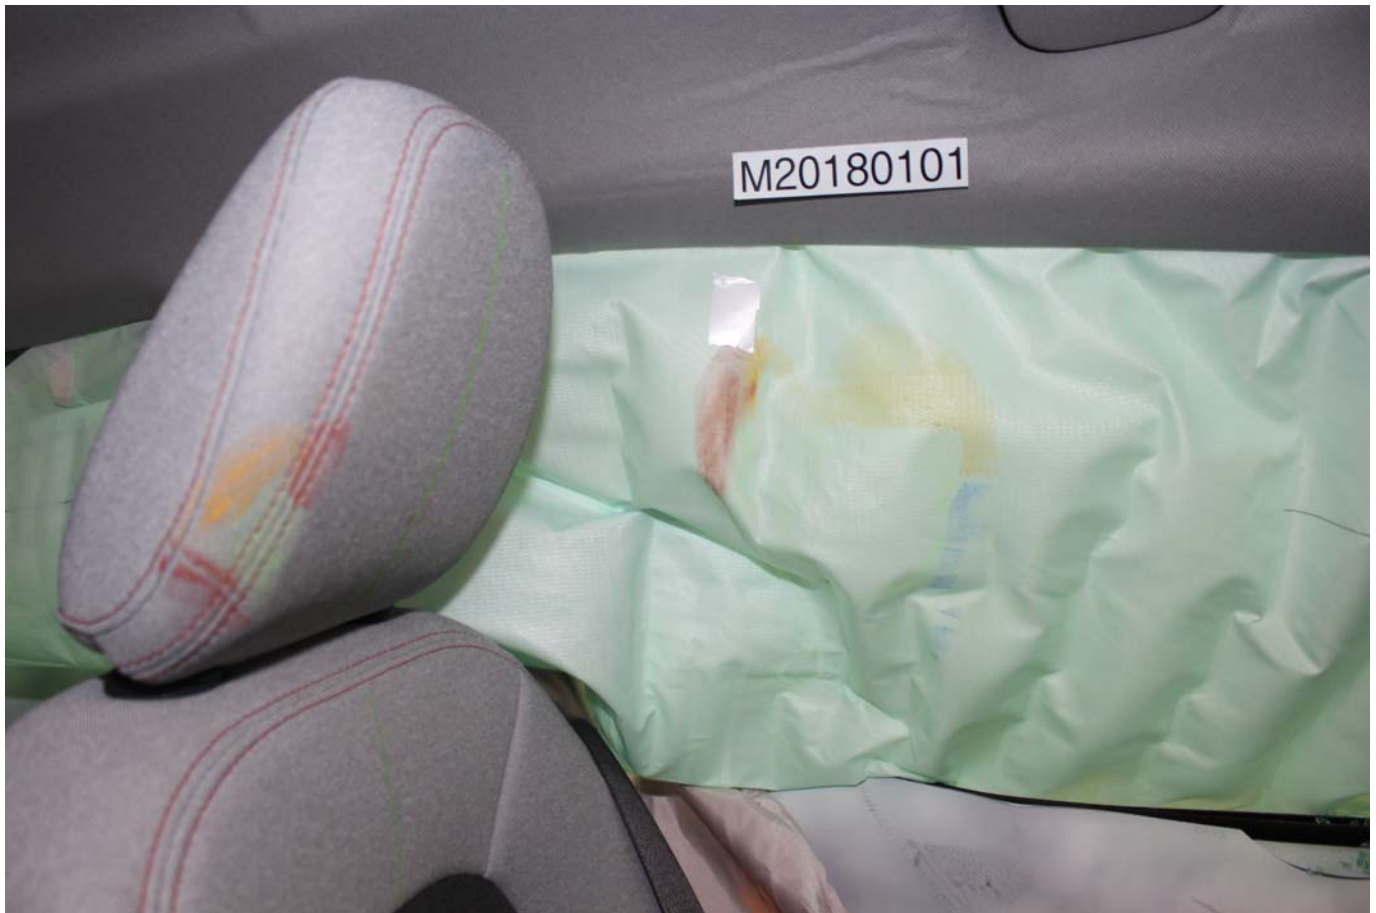
Photo No. 047 - Post-Test Dummy Close-Up Head Contact with Side Air Bag View

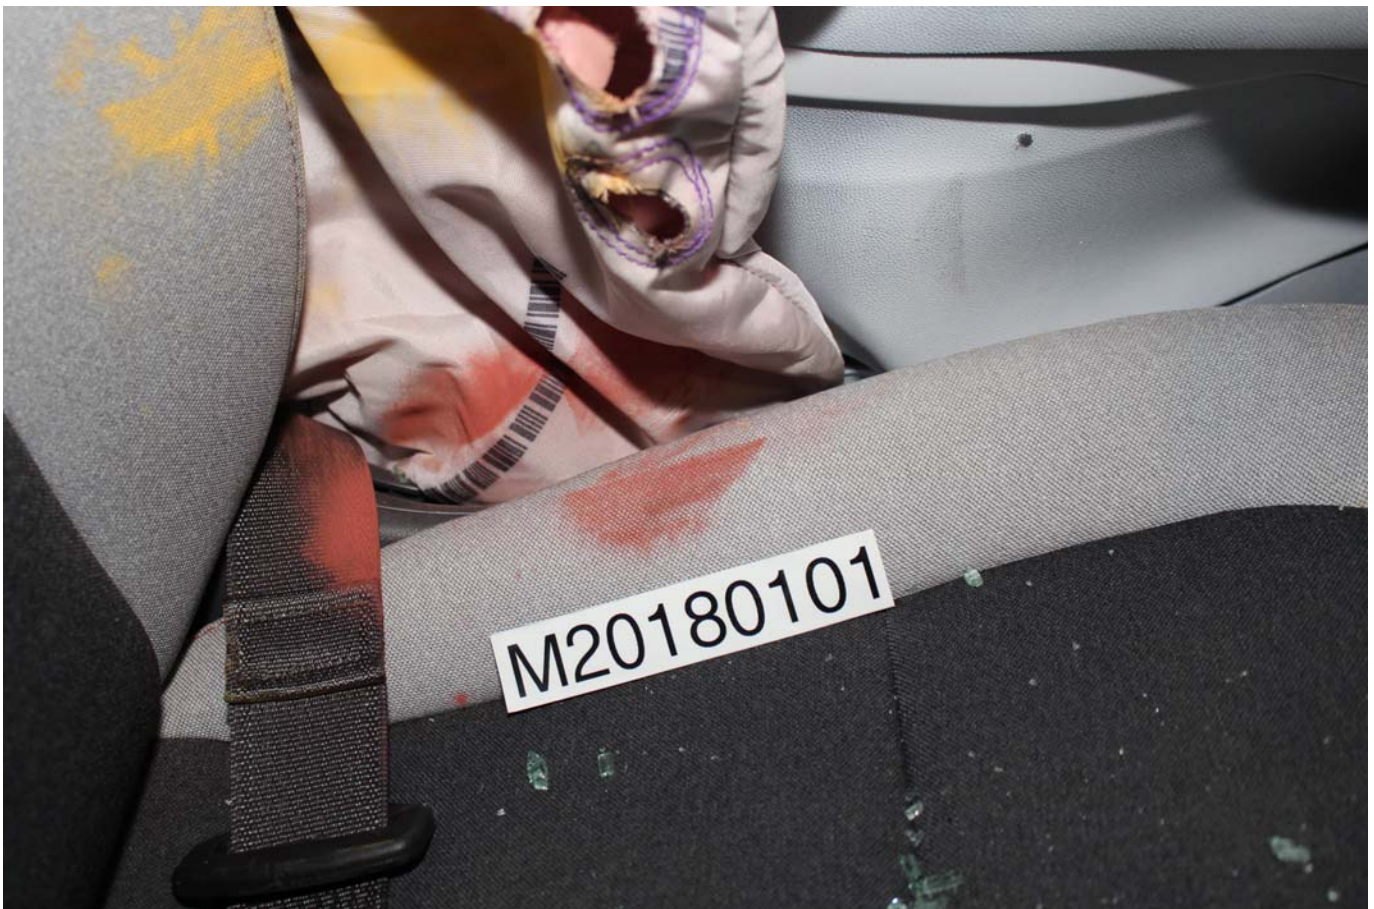
Photo No. 050 - Post-Test Dummy Close-Up Pelvis Contact with Vehicle Interior View

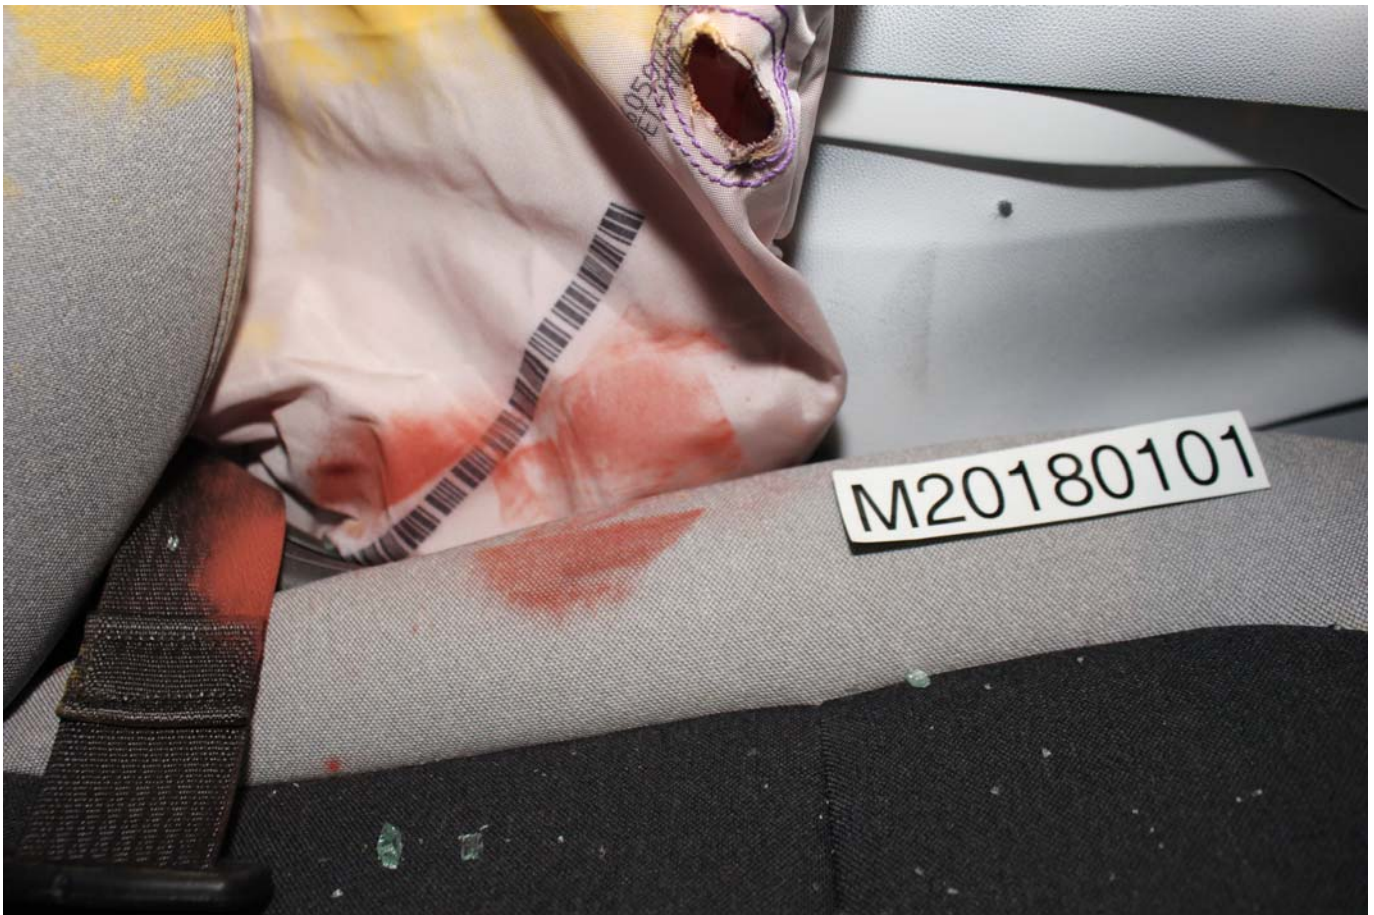
Photo No. 051 - Post-Test Dummy Close-Up Pelvis Contact with Side Air Bag View

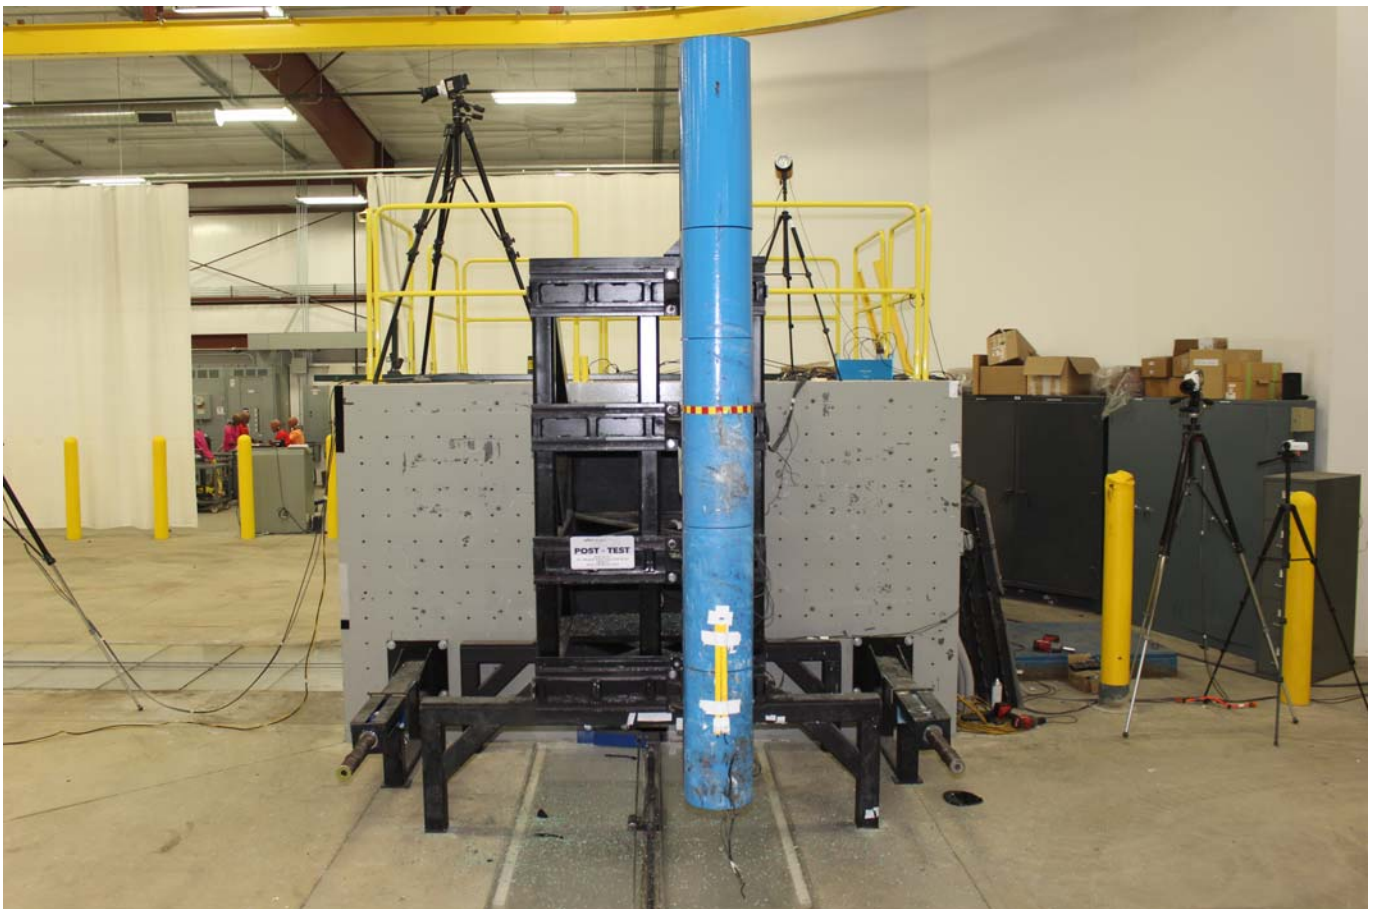
Photo No. 058 - Post-Test Pole Barrier Front View

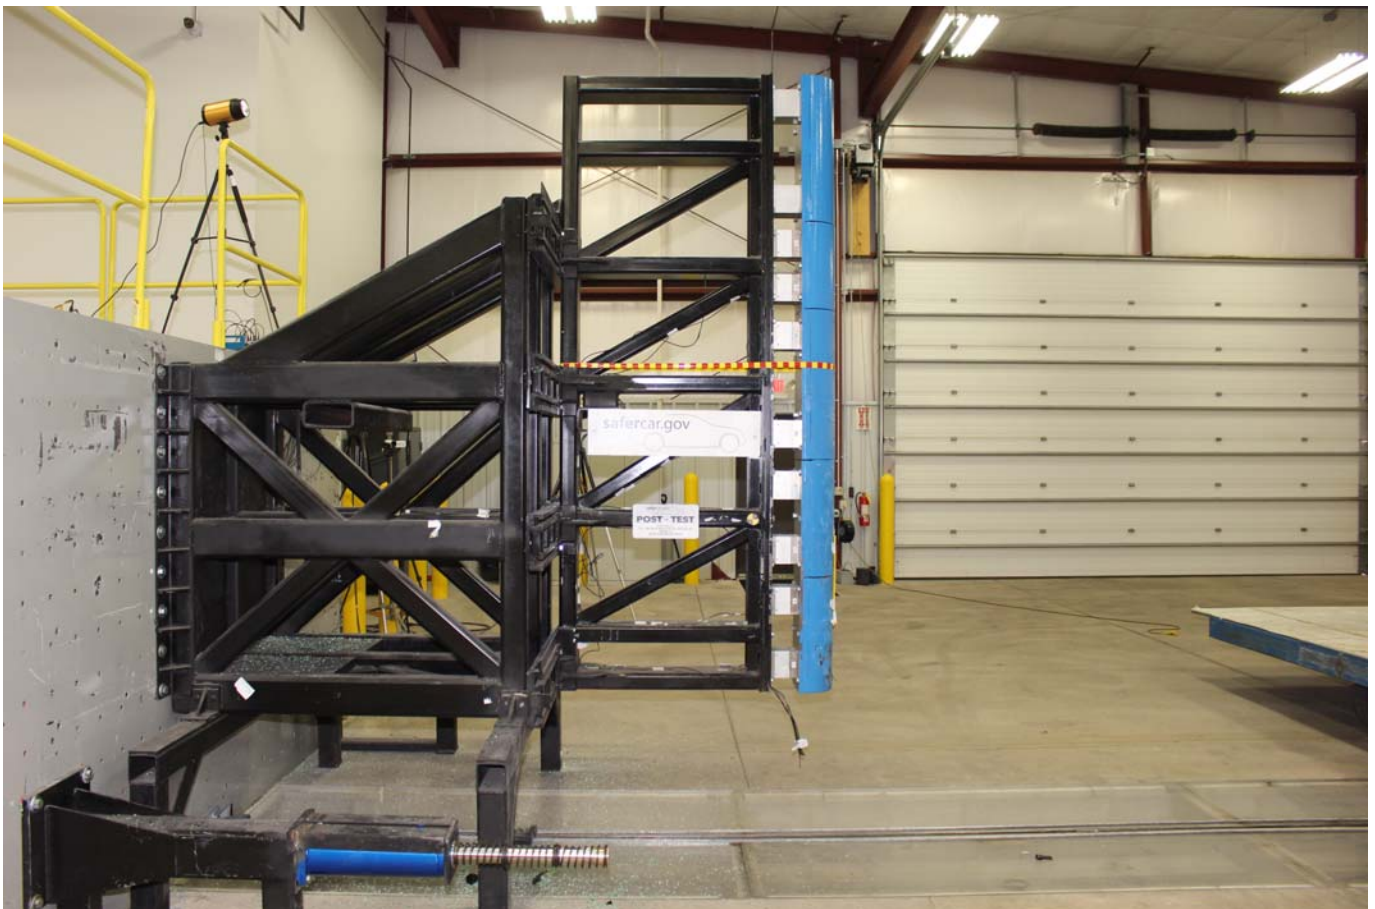
Photo No. 060 - Post-Test Pole Barrier Side View

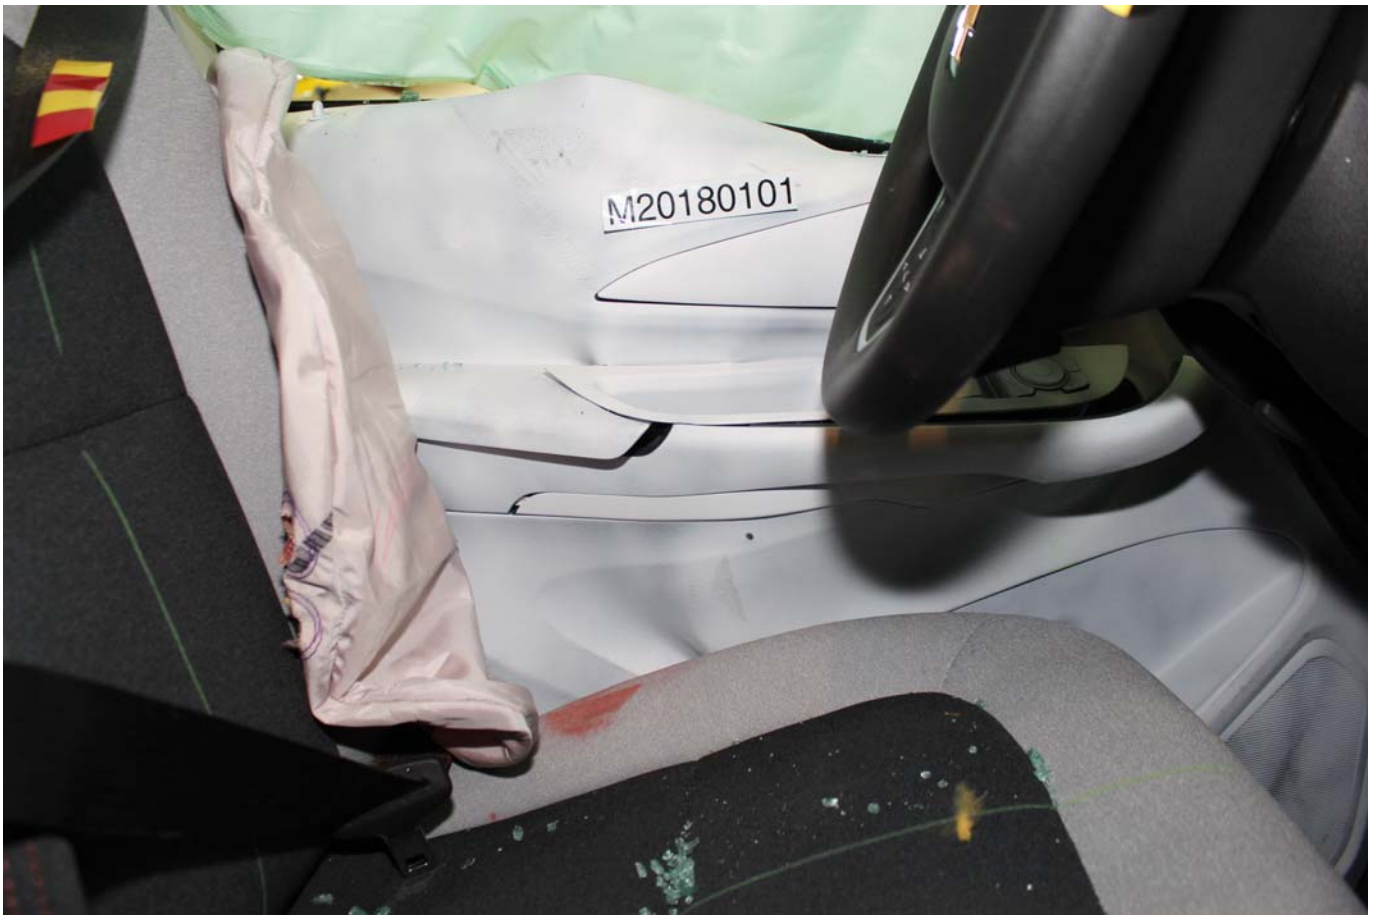
Photo No. 071 - Post-Test View of Shattered Vehicle Inner Door Panel
