**REPORT NUMBER: SINCAP-MGA-2018-030**

**NEW CAR ASSESSMENT PROGRAM (NCAP)  
Moving Deformable Barrier Side Impact Test**

**GENERAL MOTORS LLC  
2018 Chevrolet Equinox LT 5-Door SUV  
NHTSA No.: O20180100**

**MGA RESEARCH CORPORATION  
5000 Warren Road  
Burlington, WI 53105**

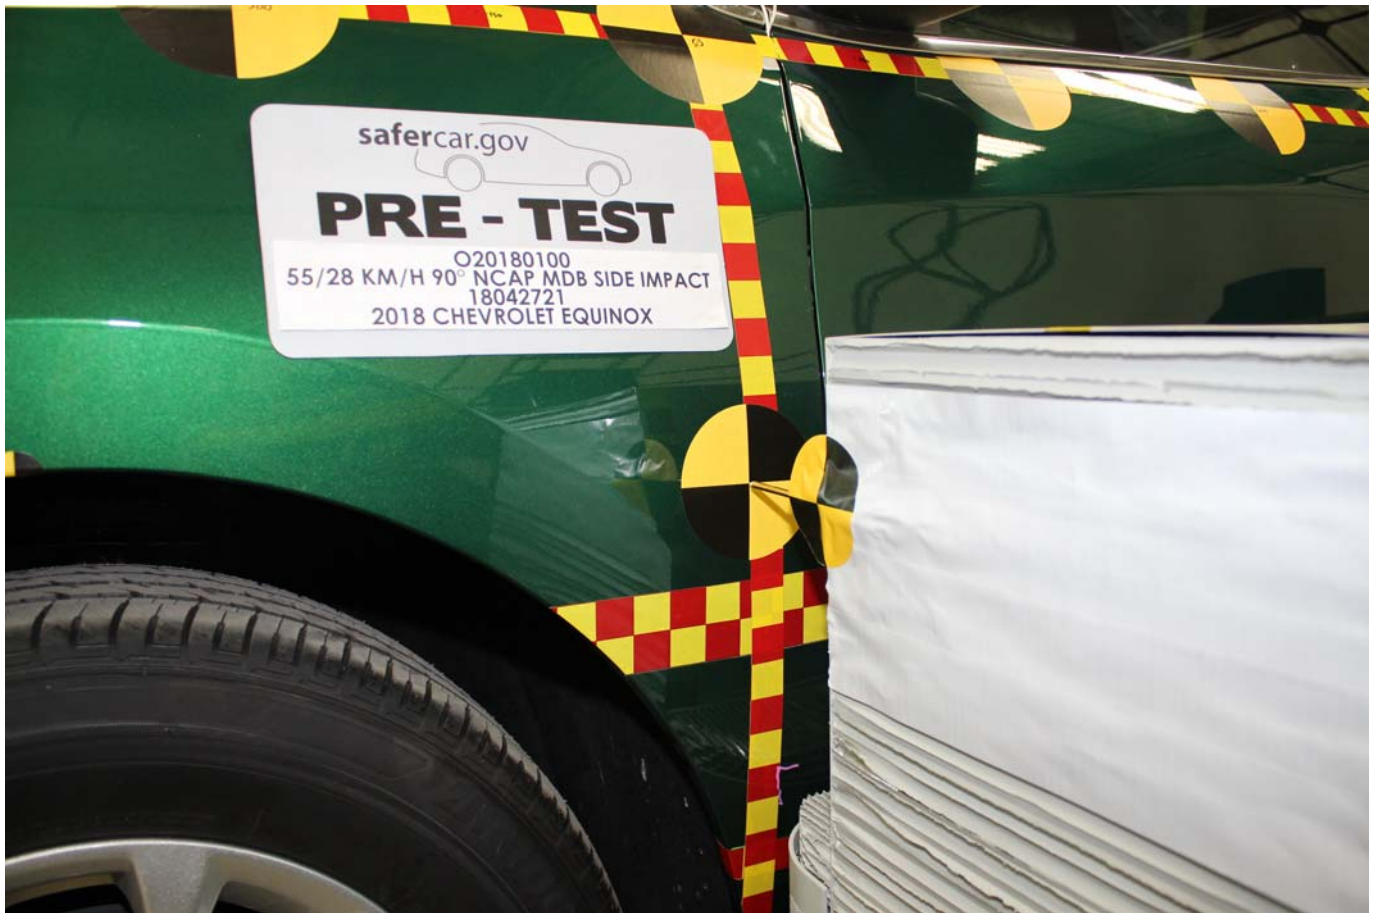
Photo No. 019 - Pre-Test Close-Up View of Impact Point Target

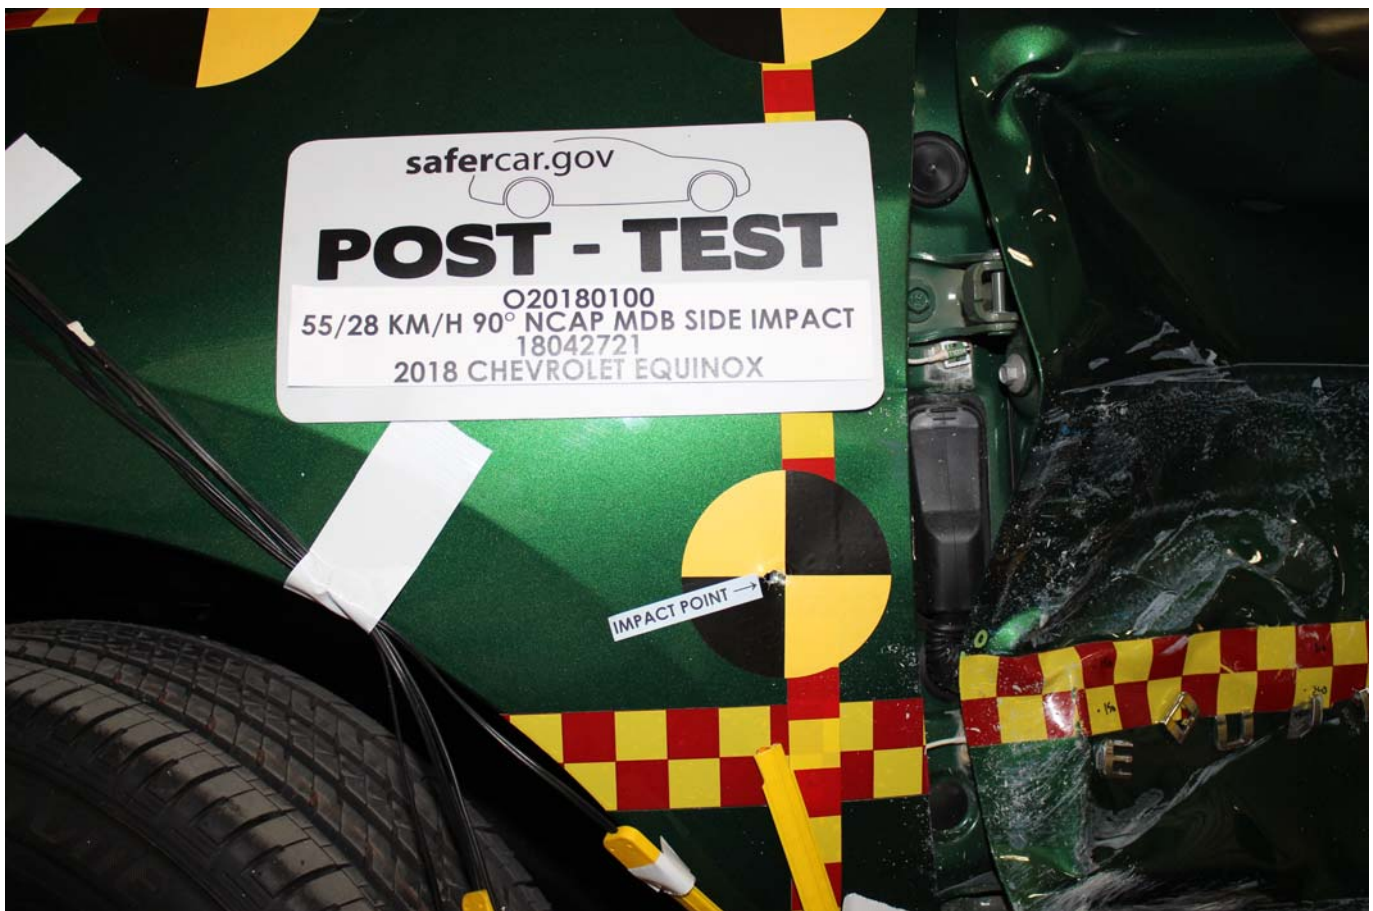
Photo No. 020 - Post-Test Close-Up View of Impact Point Target

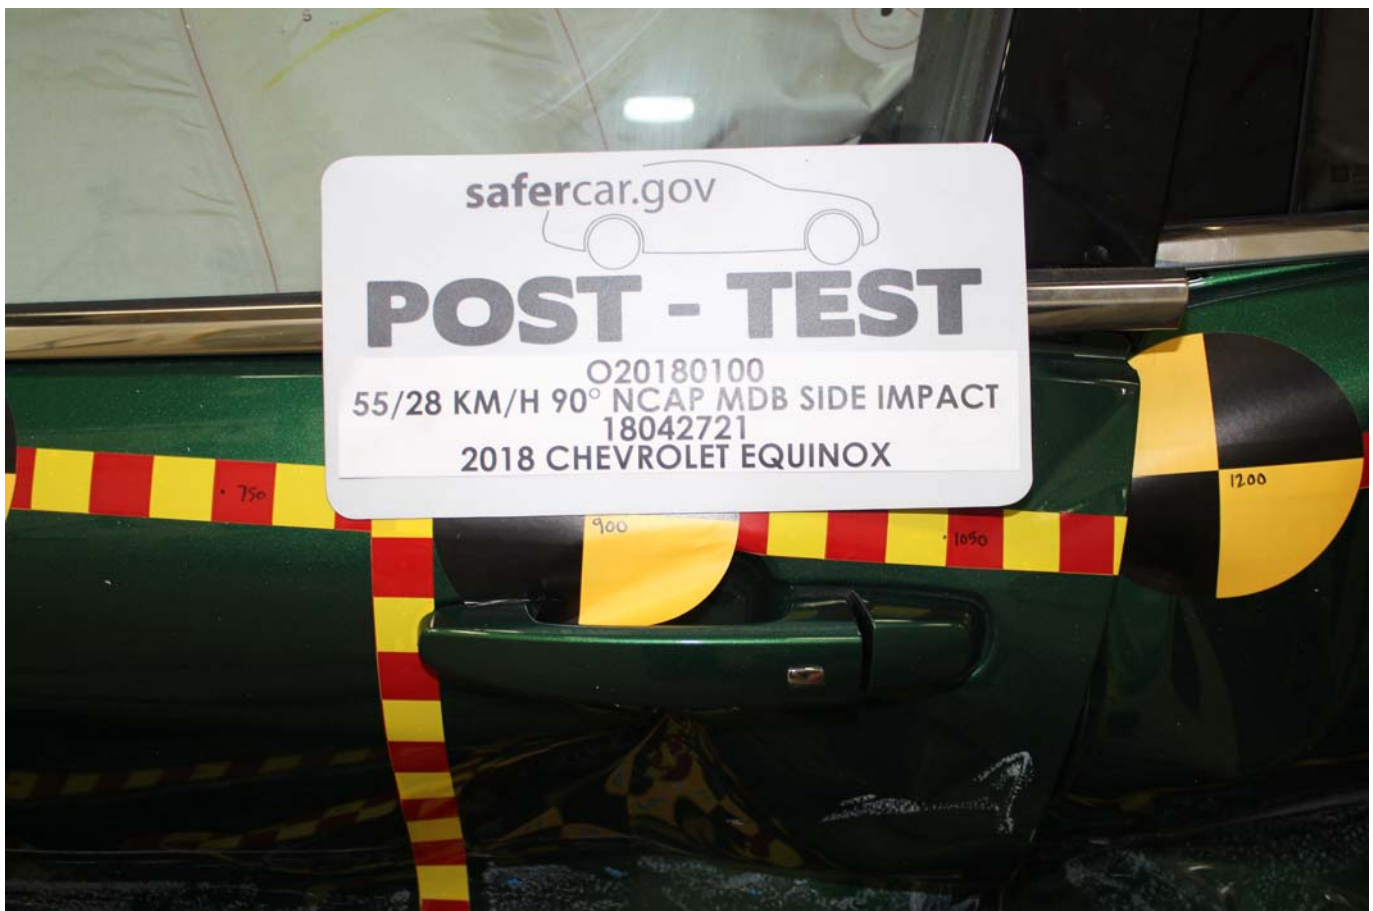
Photo No. 022 - Post-Test Left Front Door Latch Close-Up

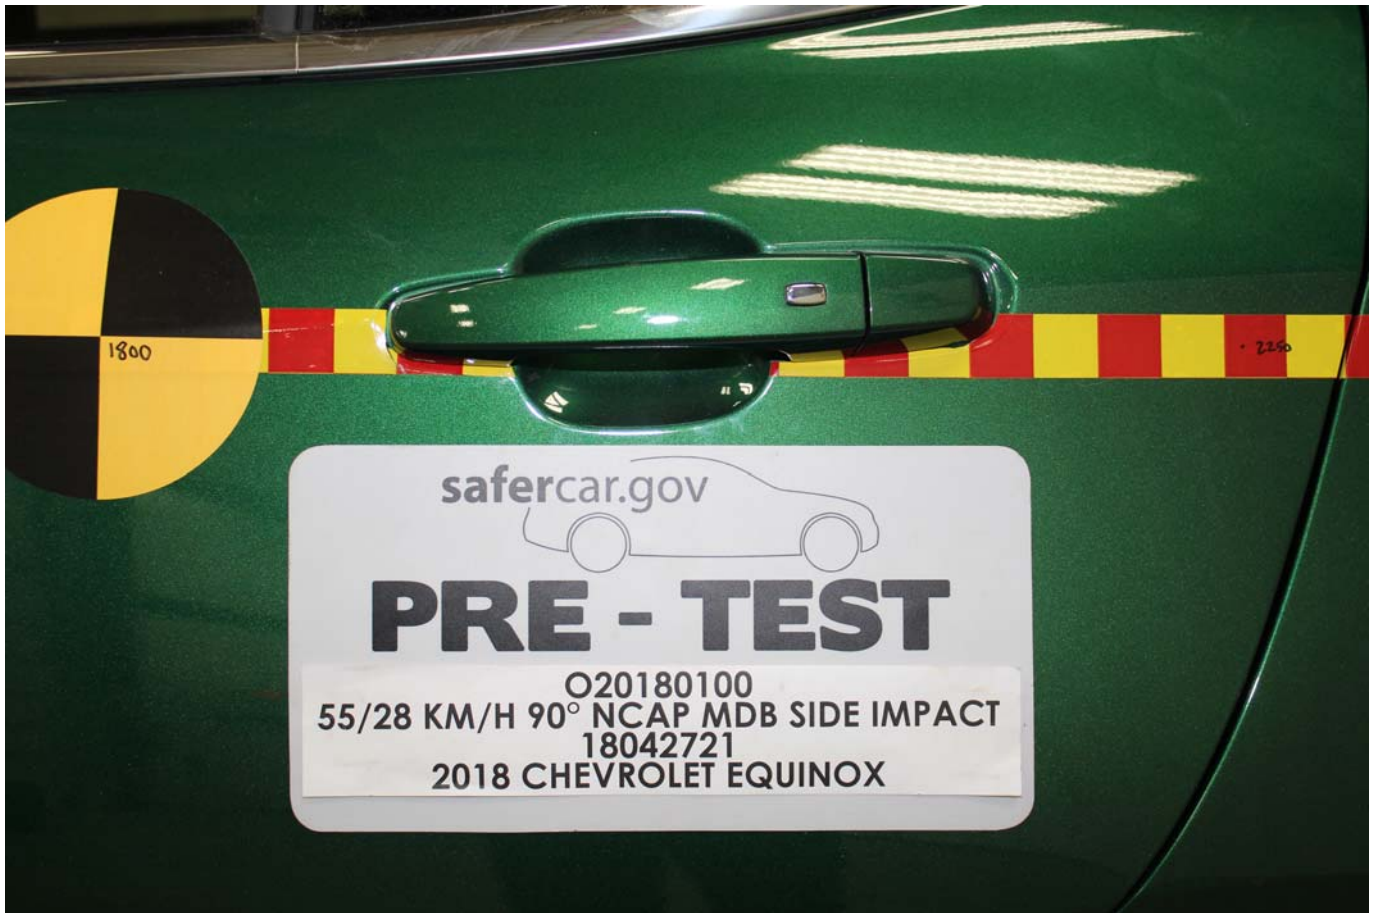
Photo No. 023 - Pre-Test Left Rear Door Latch Close-Up

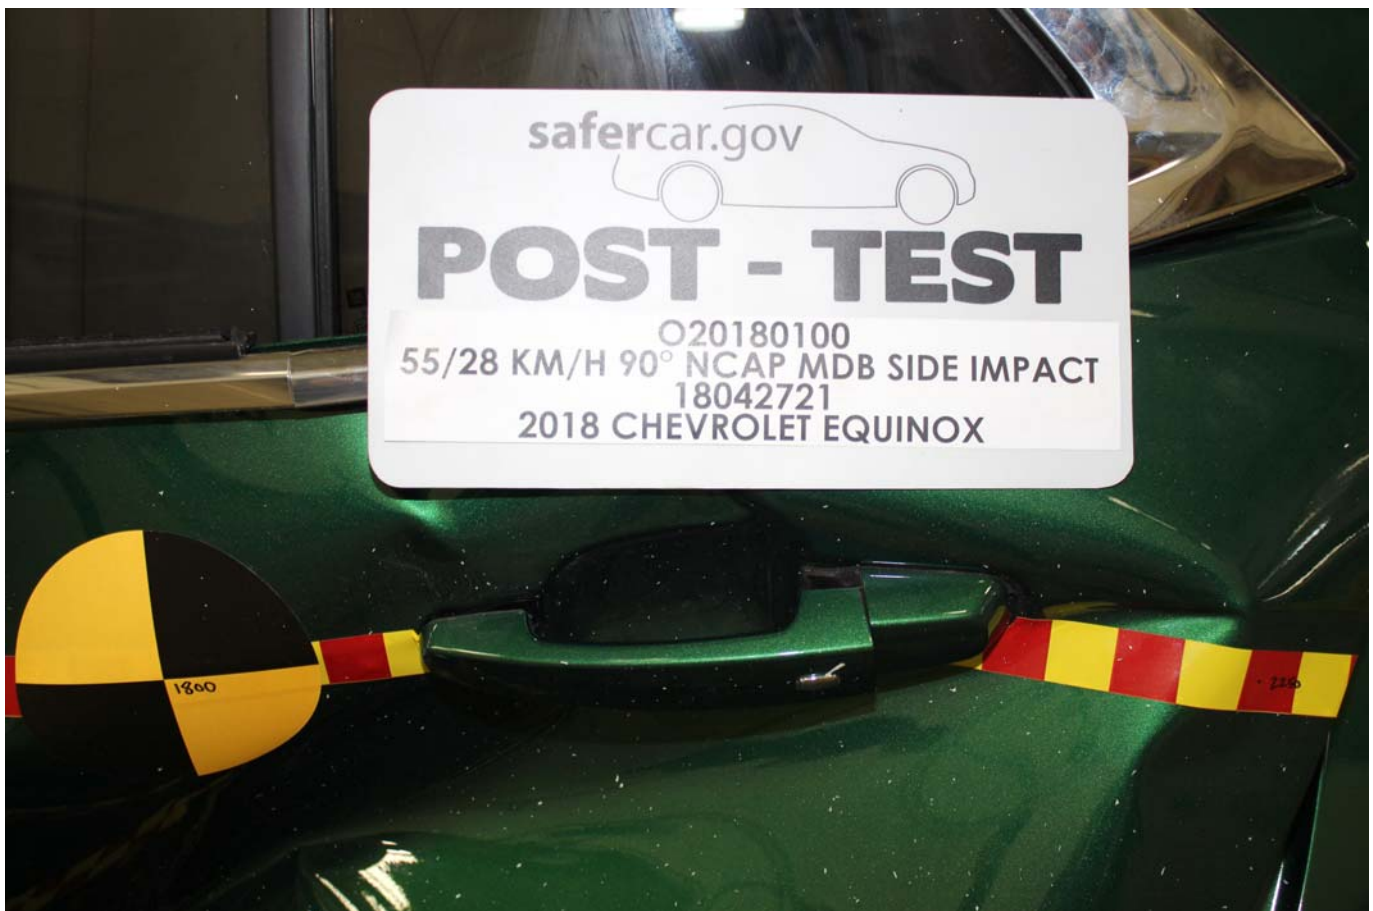
Photo No. 024 - Post-Test Left Rear Door Latch Close-Up

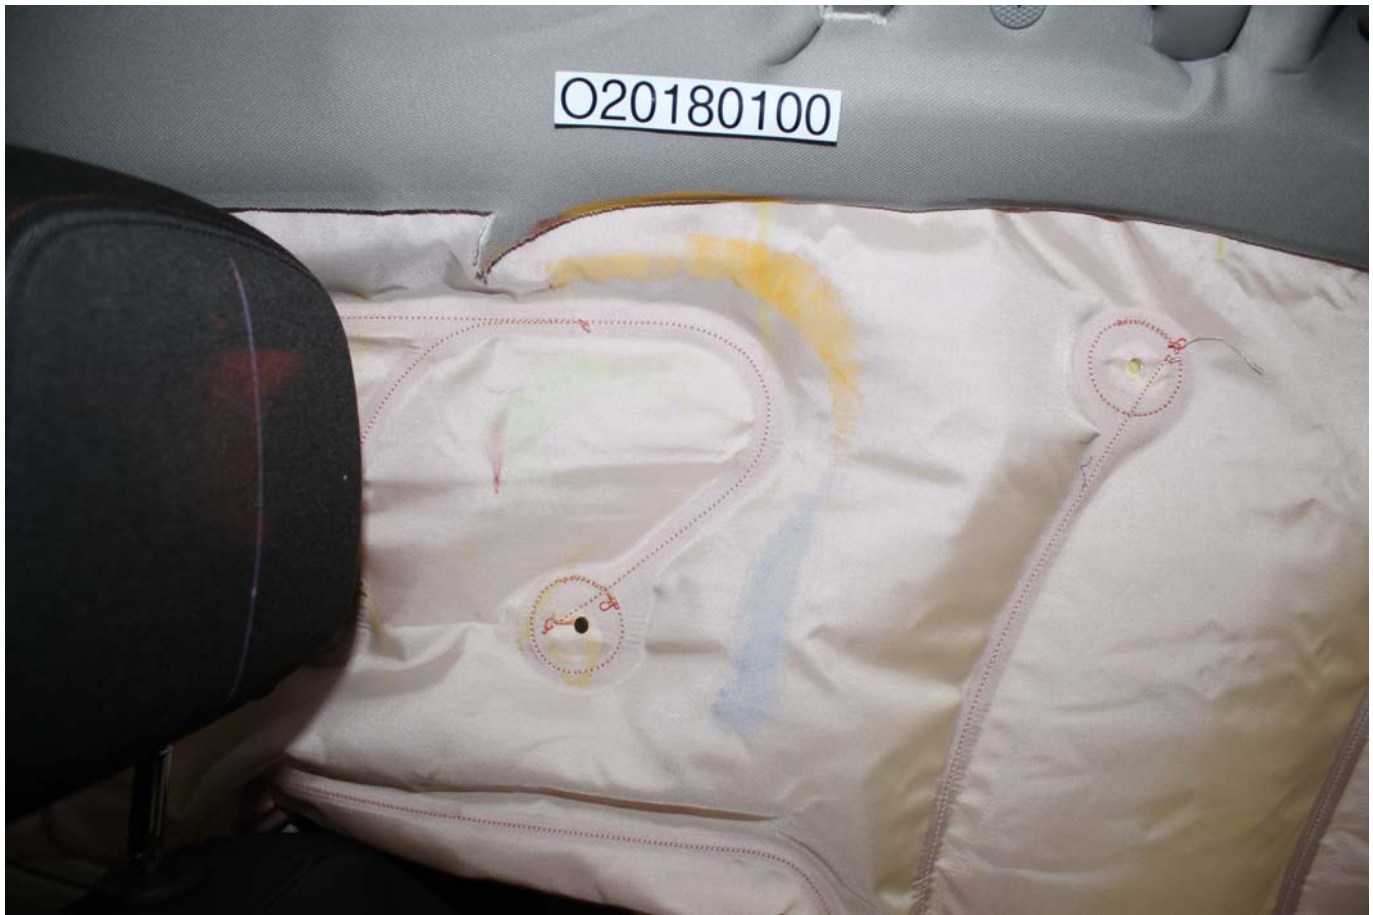
Photo No. 049 - Post-Test Driver Dummy Close-up Head Contact with Side Airbag View

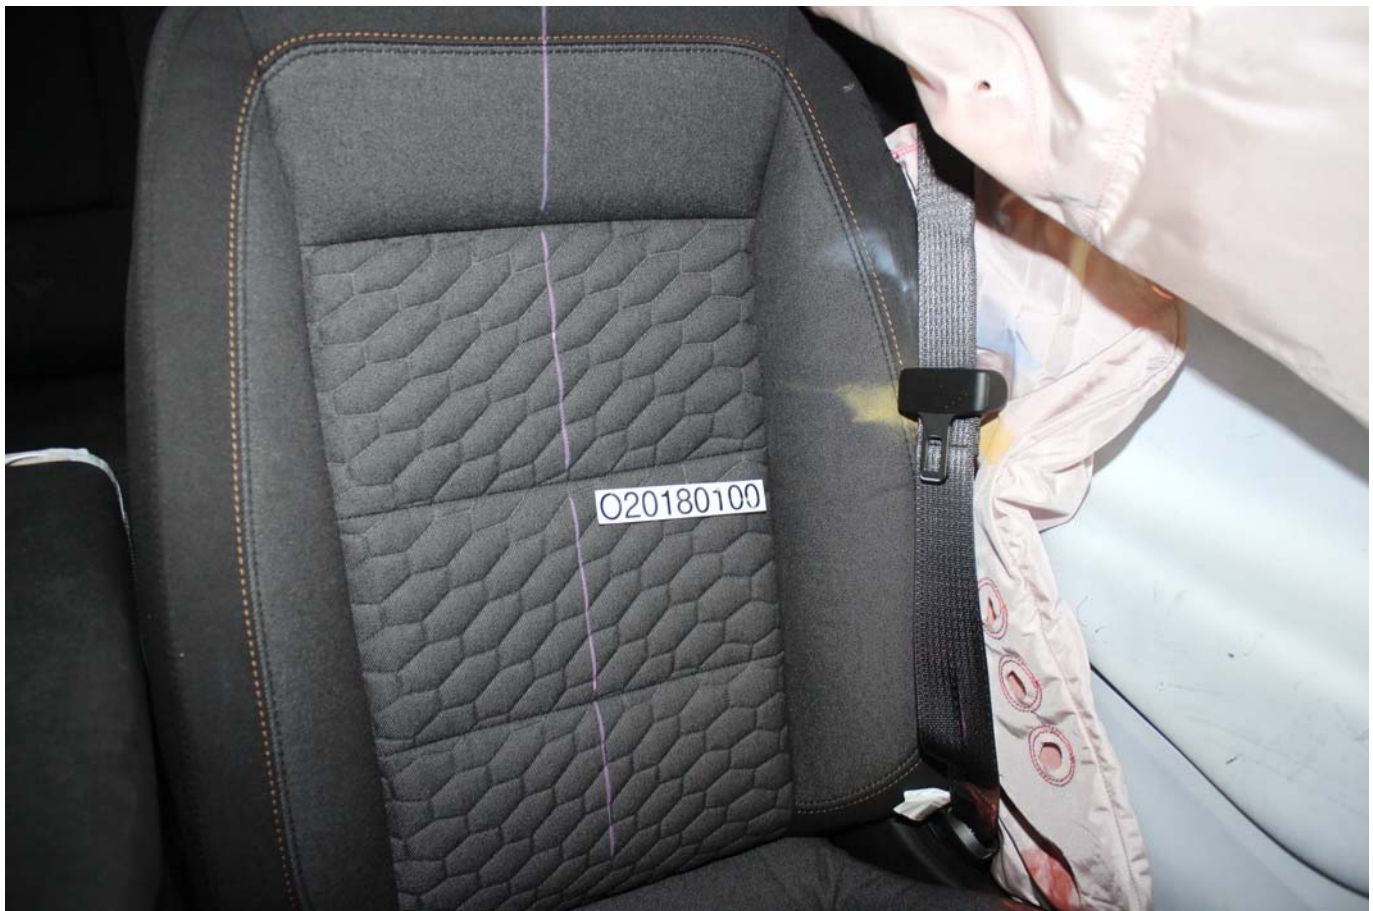
Photo No. 050 - Post-Test Driver Dummy Close-up Torso Contact with Vehicle Interior View

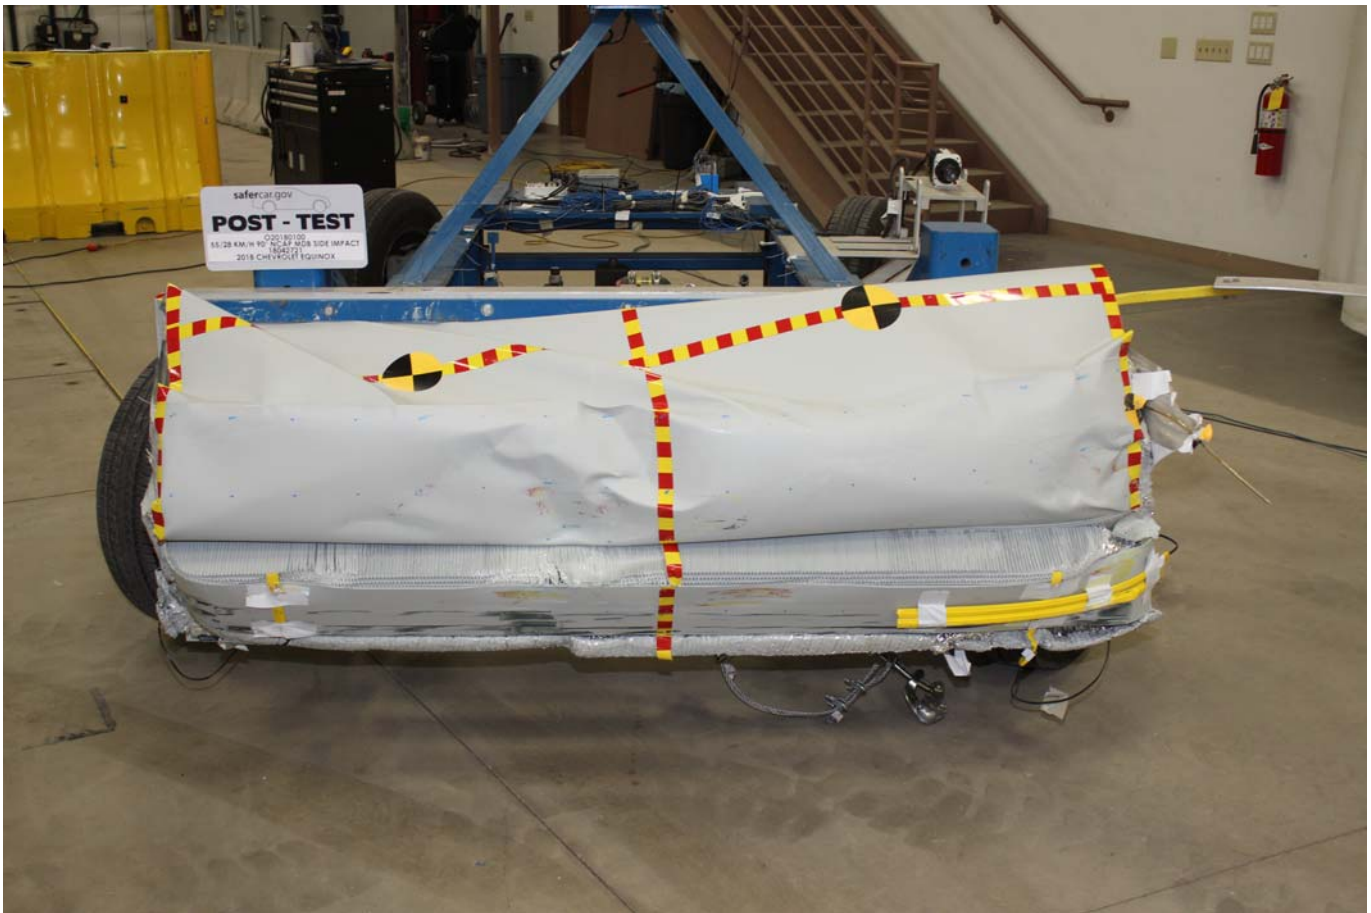
Photo No. 085 - Post-Test Front View of MDB Impactor Face

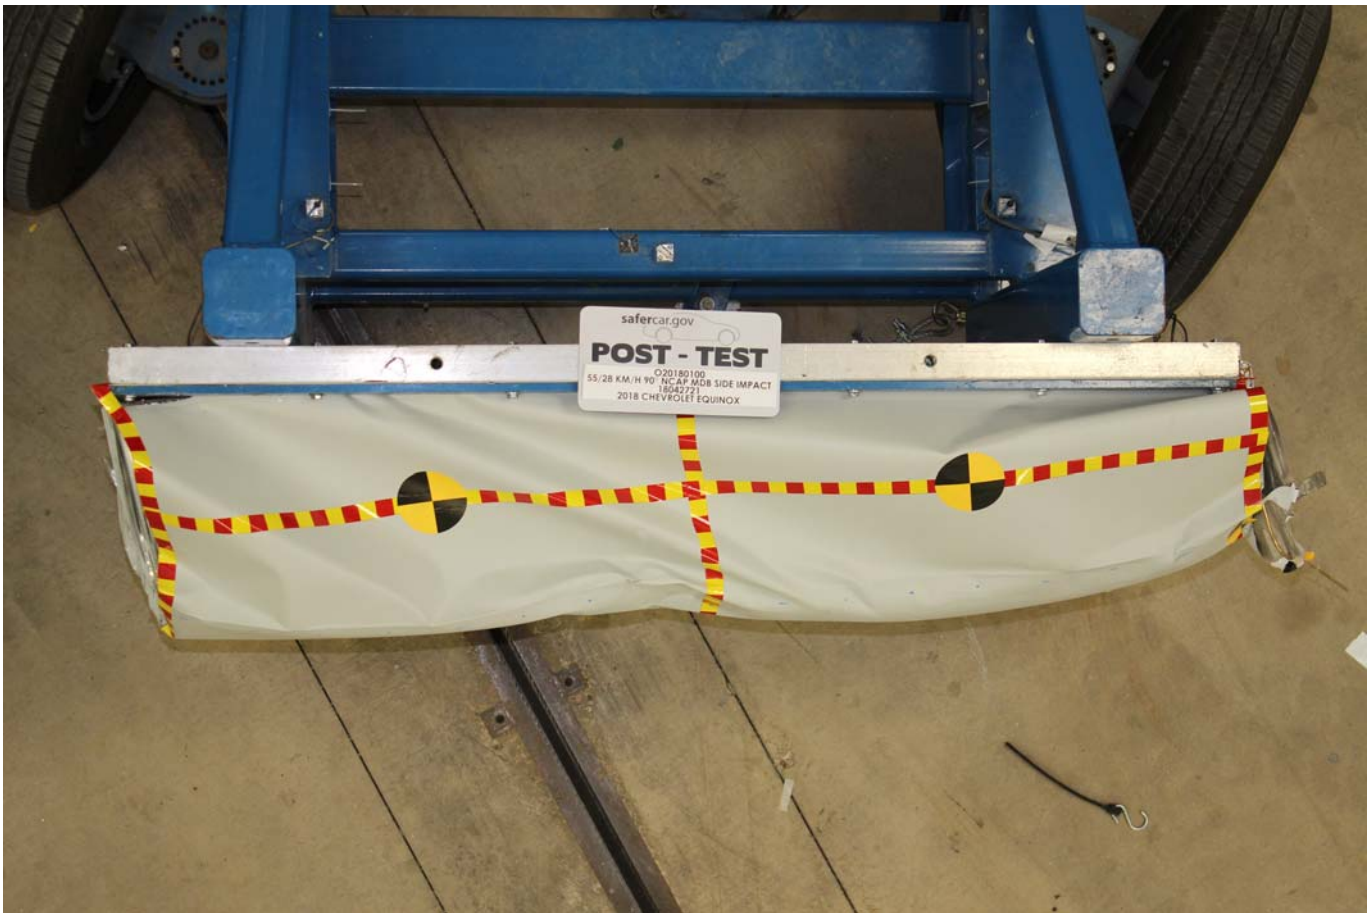
Photo No. 087 - Post-Test Top View of MDB Impactor Face

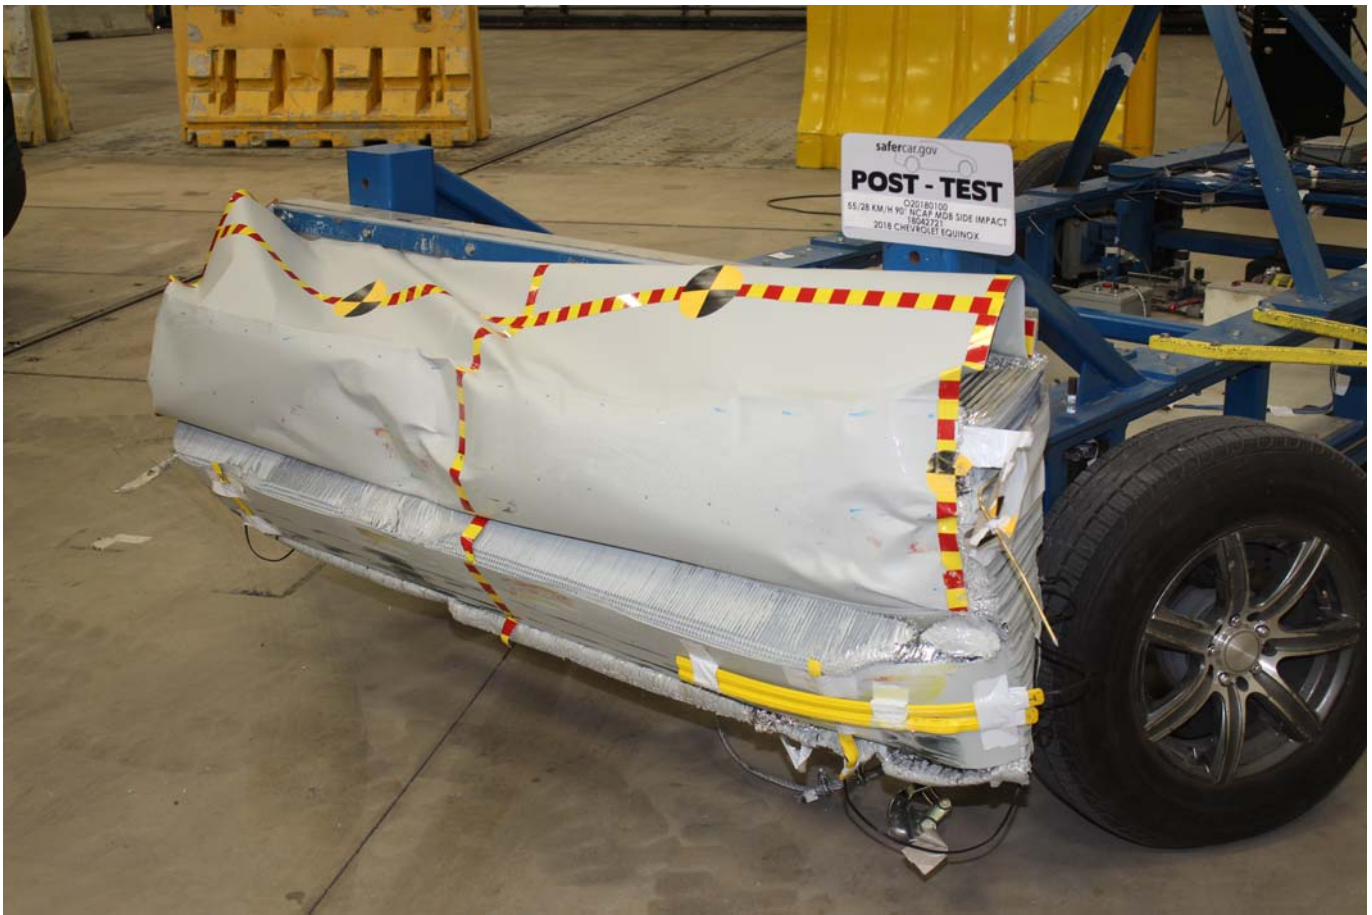
Photo No. 089 - Post-Test Left Side View of MDB Impactor Face

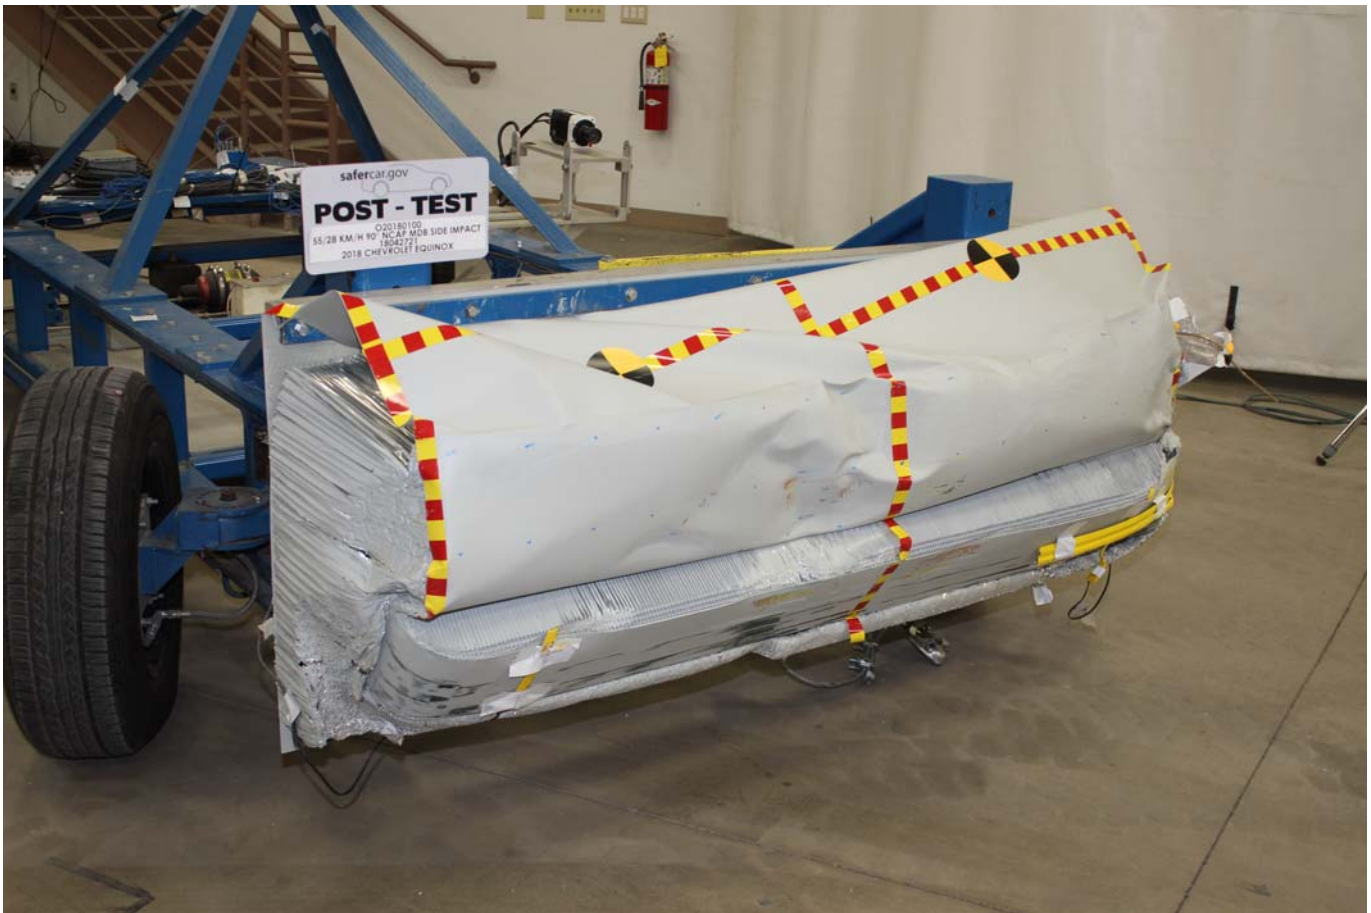
Photo No. 091 - Post-Test Right Side View of MDB Impactor Face

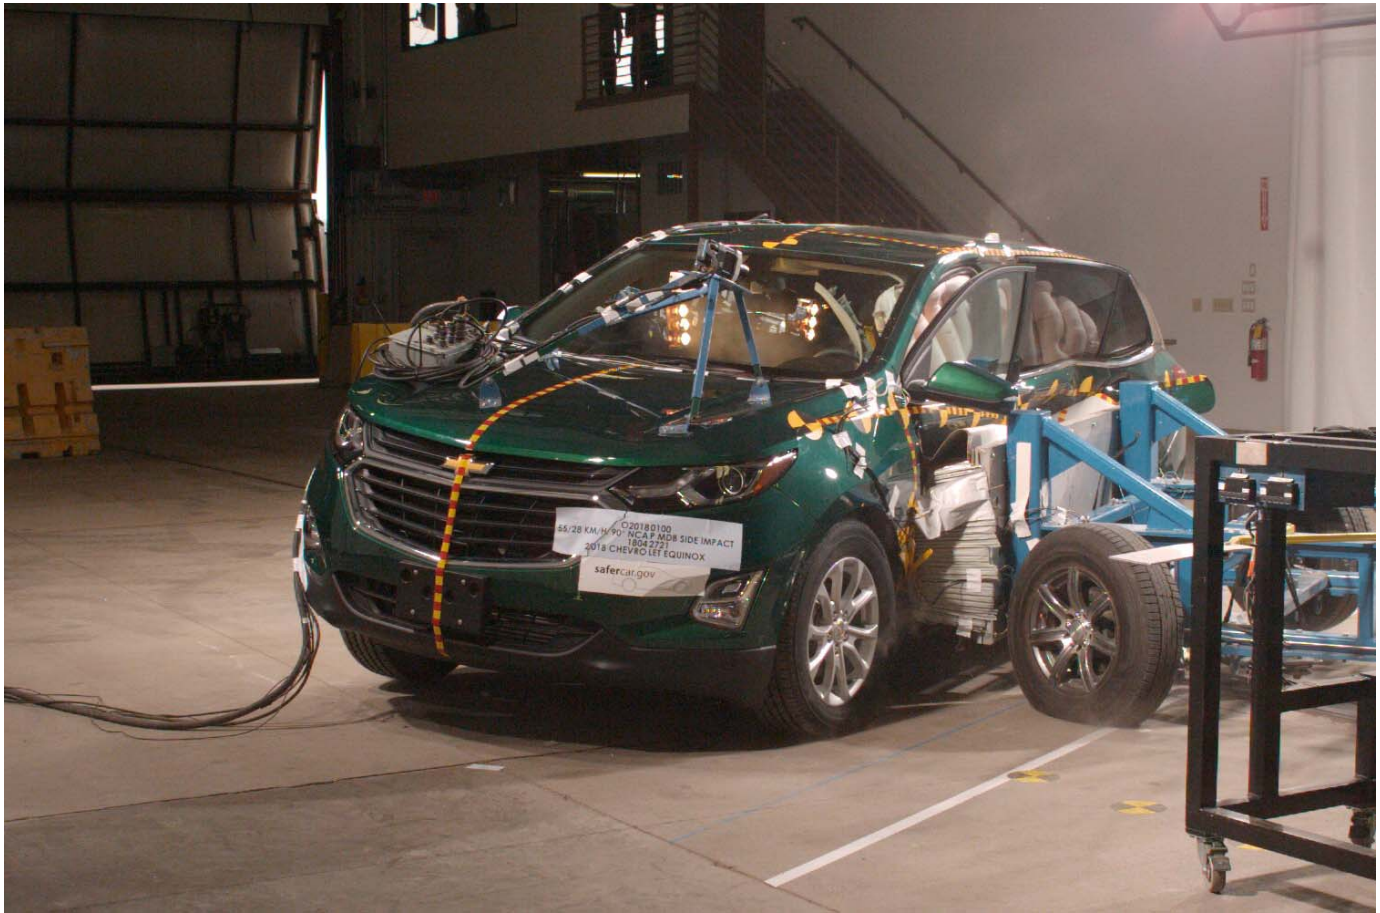
Photo No. 101 - Impact Event
