**FINAL REPORT NUMBER: SPNCAP-TRC-18-008**

**NEW CAR ASSESSMENT PROGRAM (NCAP)  
SIDE IMPACT POLE TEST**

**TOYOTA MOTOR MANUFACTURING, INDIANA, INC.  
2018 Toyota Sienna Van  
NHTSA NUMBER: M20185108**

**PREPARED BY:  
Transportation Research Center Inc.  
10820 State Route 347  
P. O. Box B-67  
East Liberty, OH 43319**

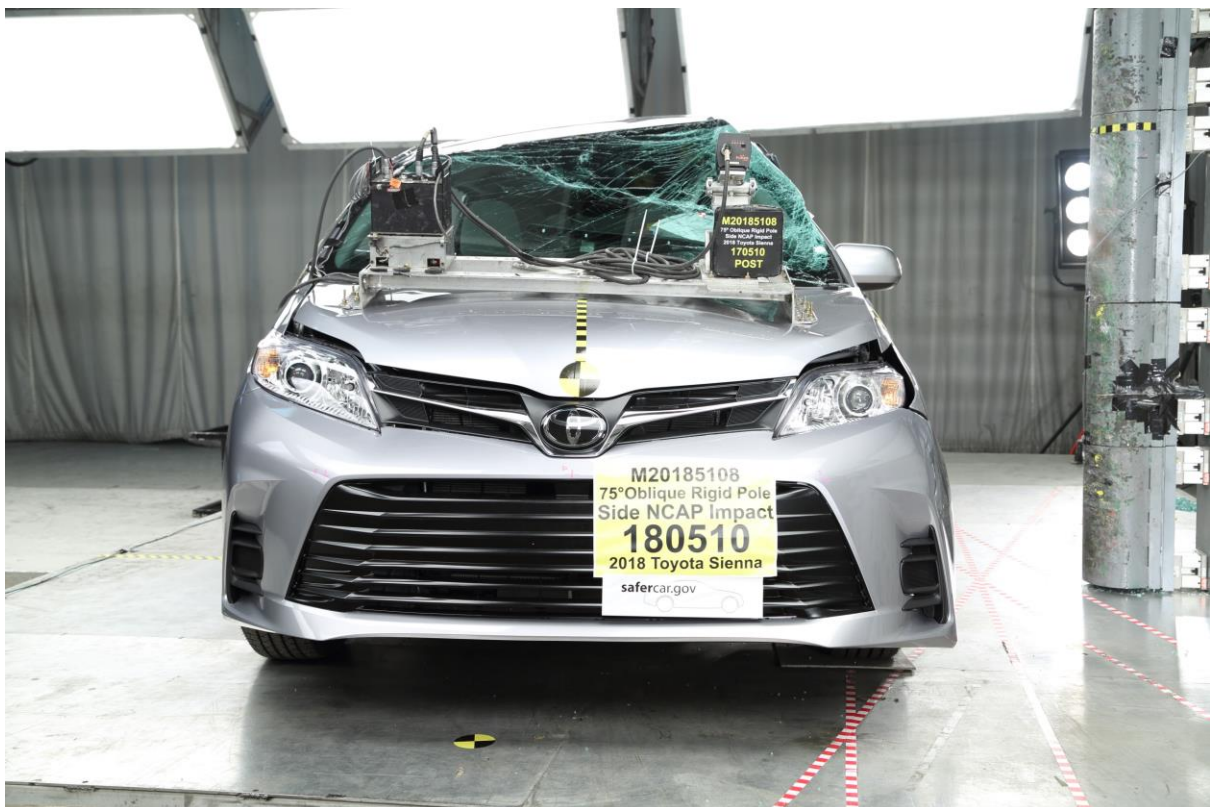
**No. 004 Post-Test Frontal View of Test Vehicle**

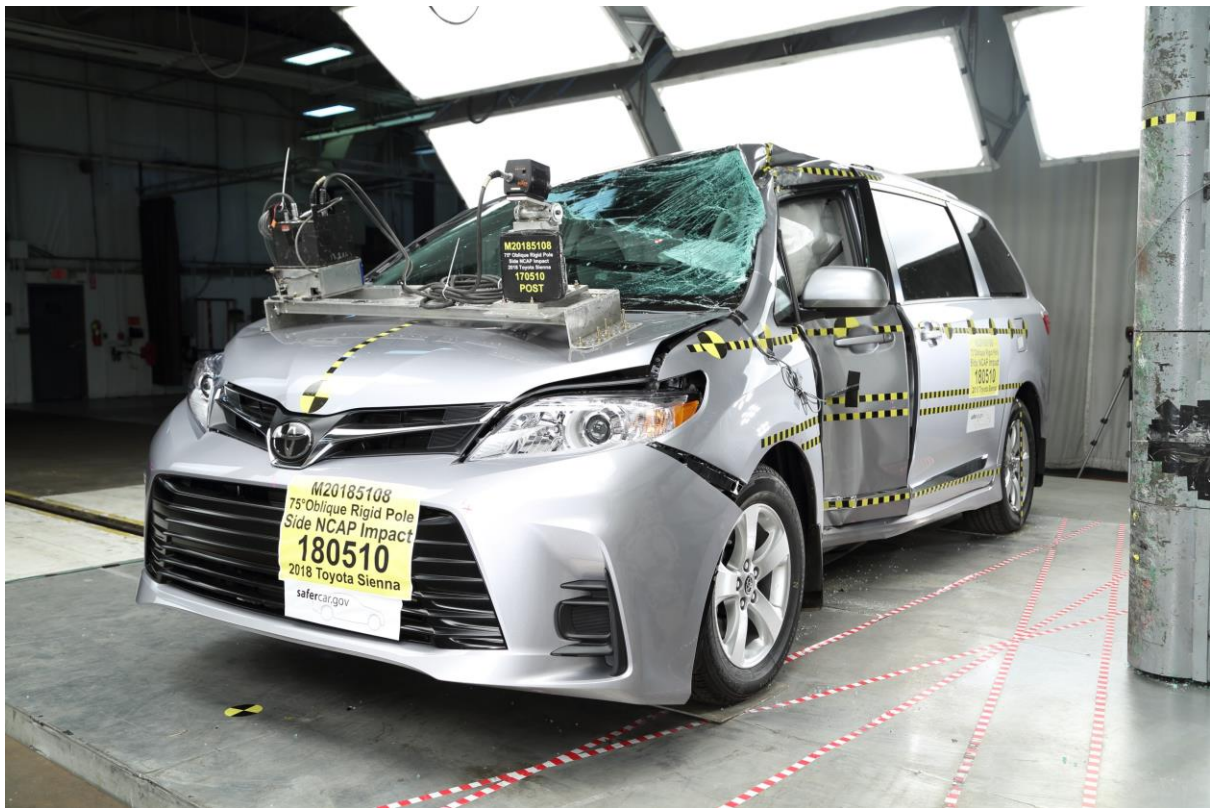
**No. 006 Post-Test Left Front  $\frac{3}{4}$  View of Test Vehicle**

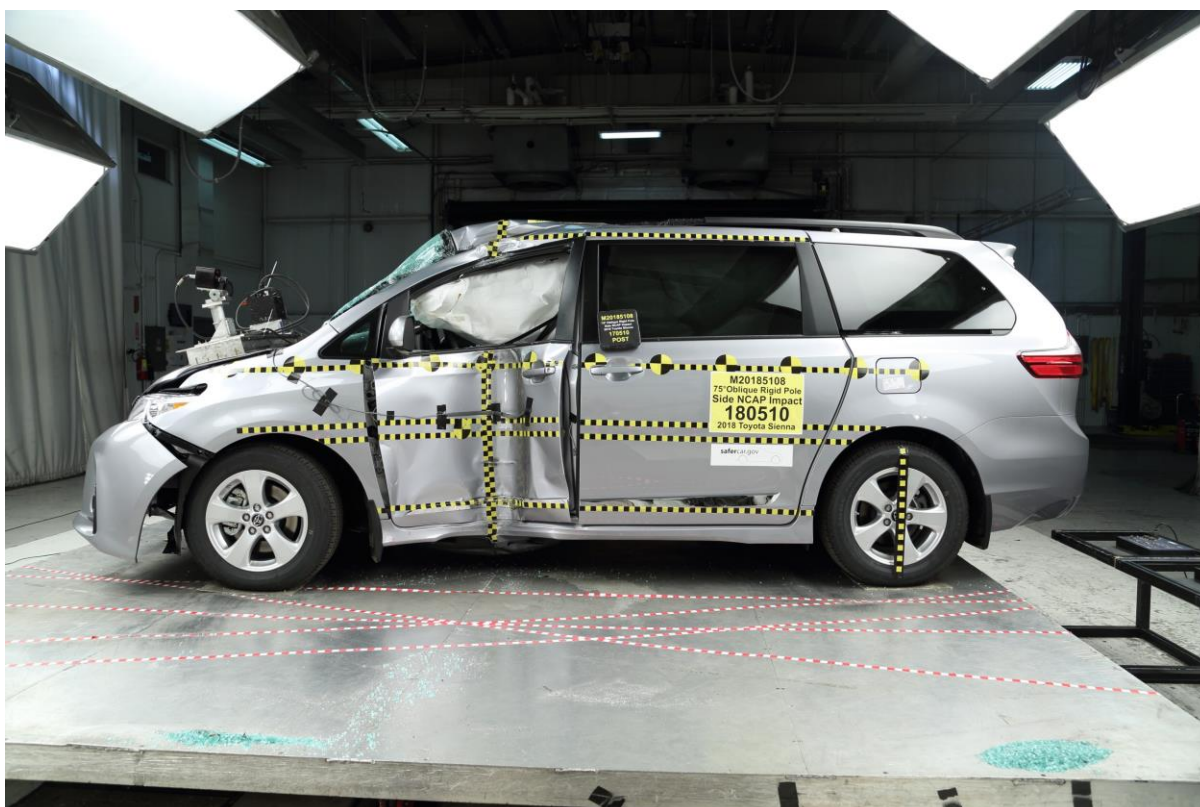
**No. 008 Post-Test Left Side View of Test Vehicle**

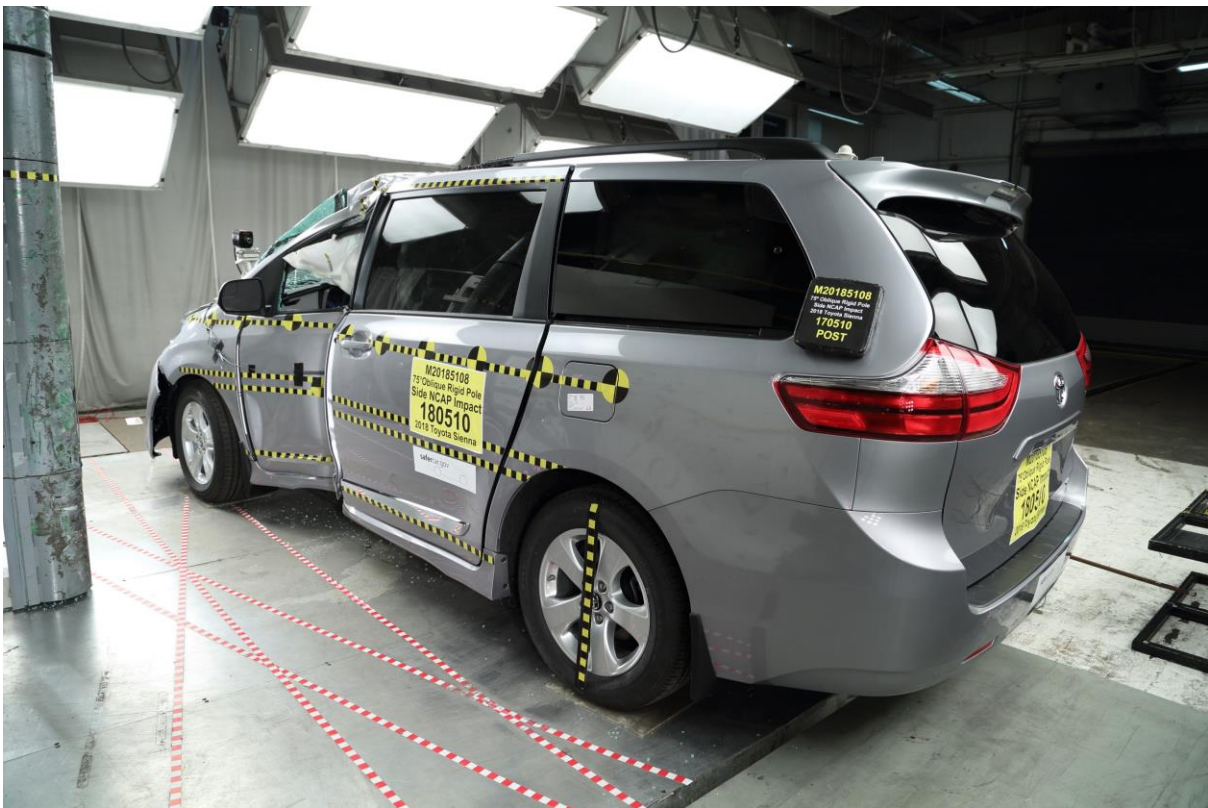
**No. 010 Post-Test Left Rear  $\frac{3}{4}$  View of Test Vehicle**

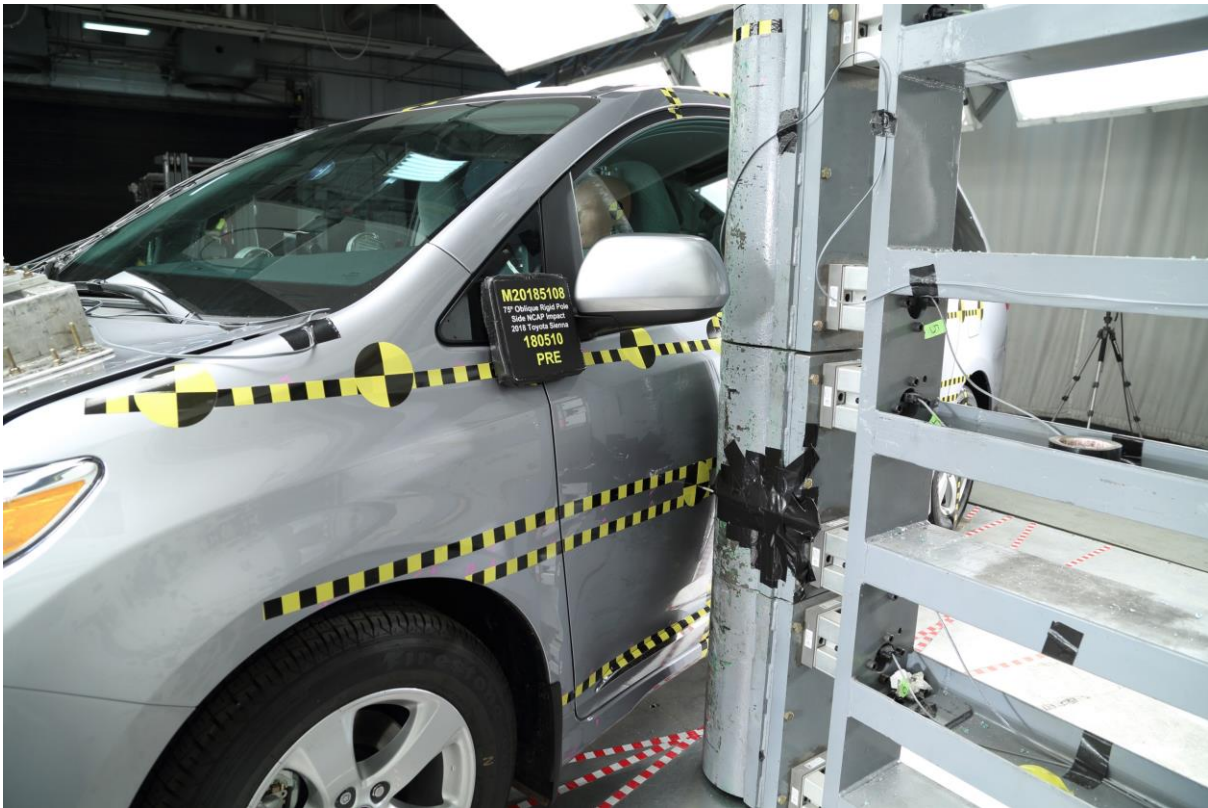
**No. 017 Pre-Test Left Side View of Pole Positioned Against Side of Vehicle**

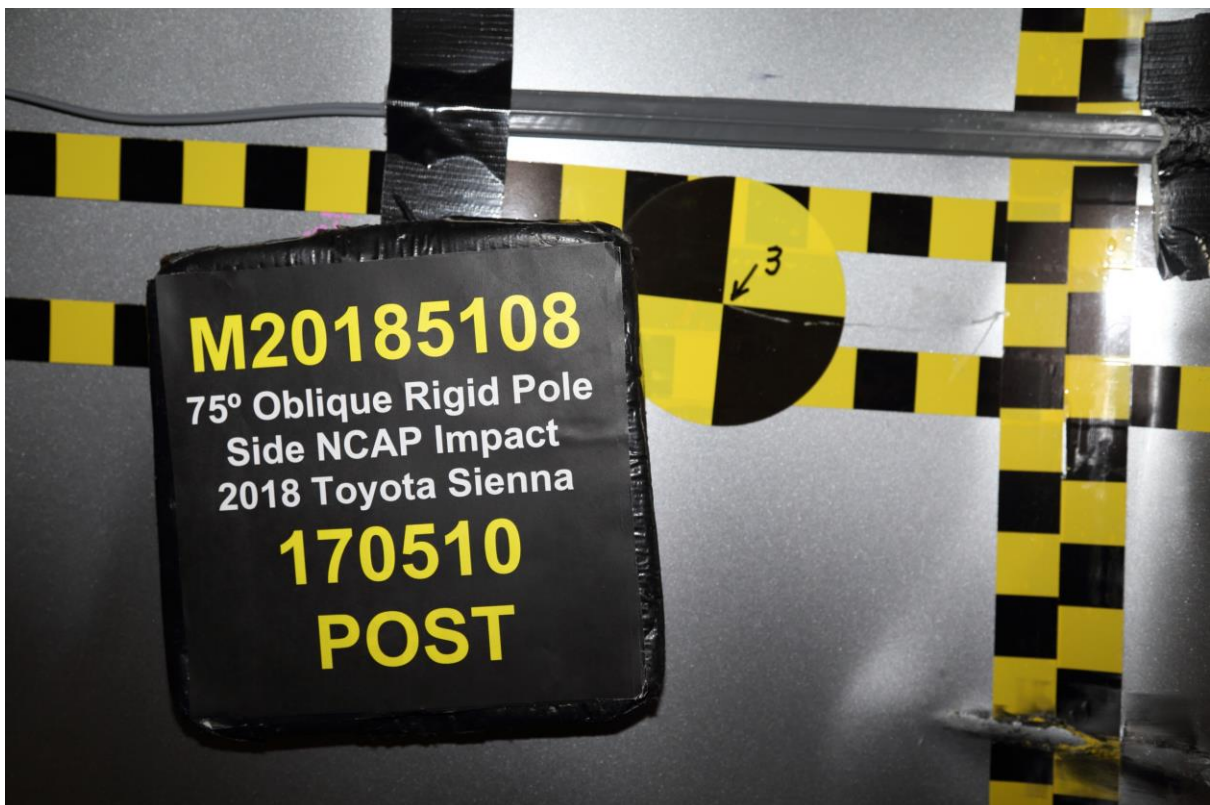
No. 020 Post-Test Close-Up View of Impact Point Target Showing Impact Location

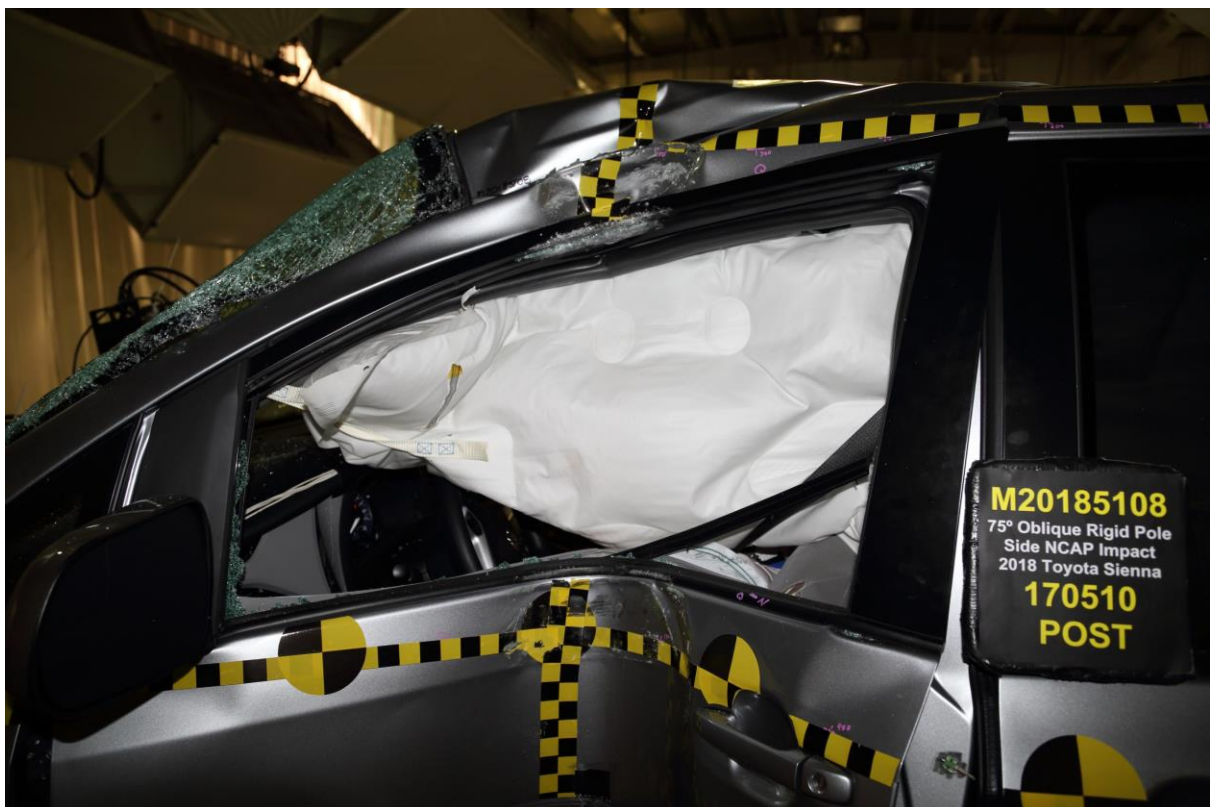
No. 025 Post-Test Left Side View of Dummy Shoulder and Door Top View

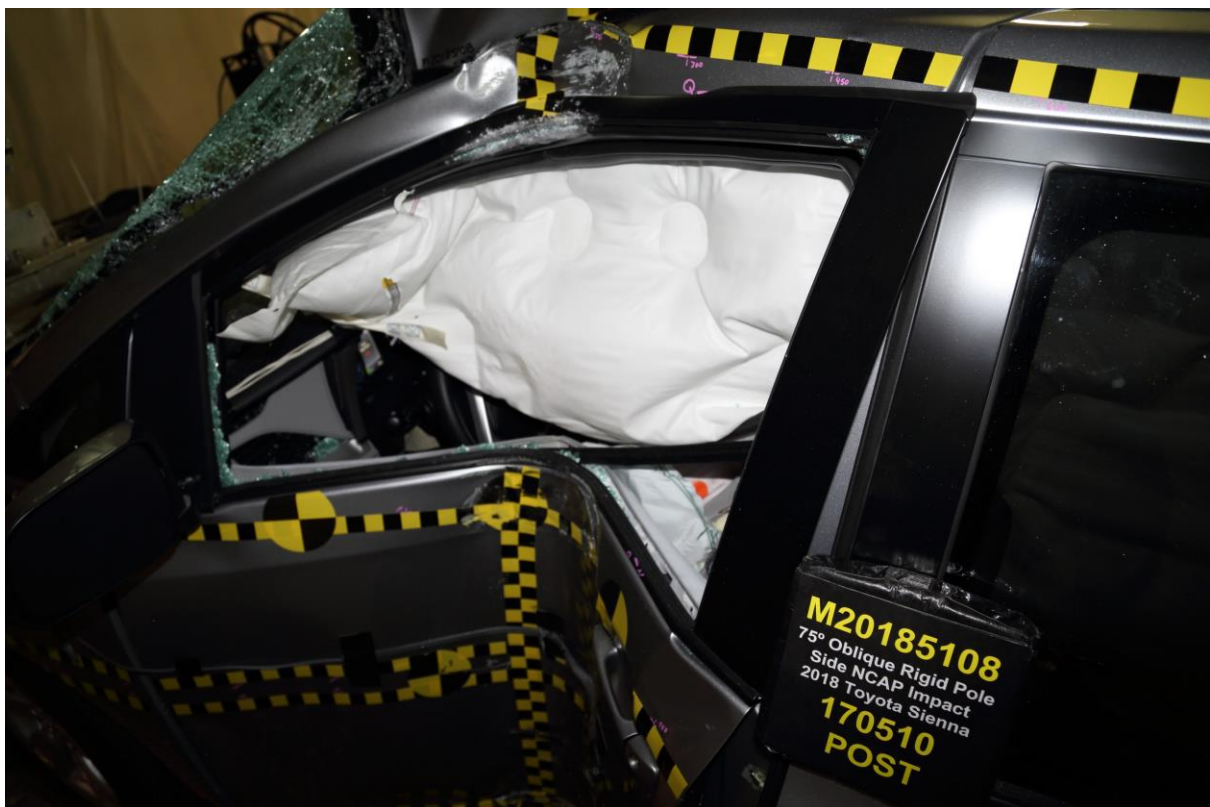
No. 041 Post-Test Dummy and Door Clearance View

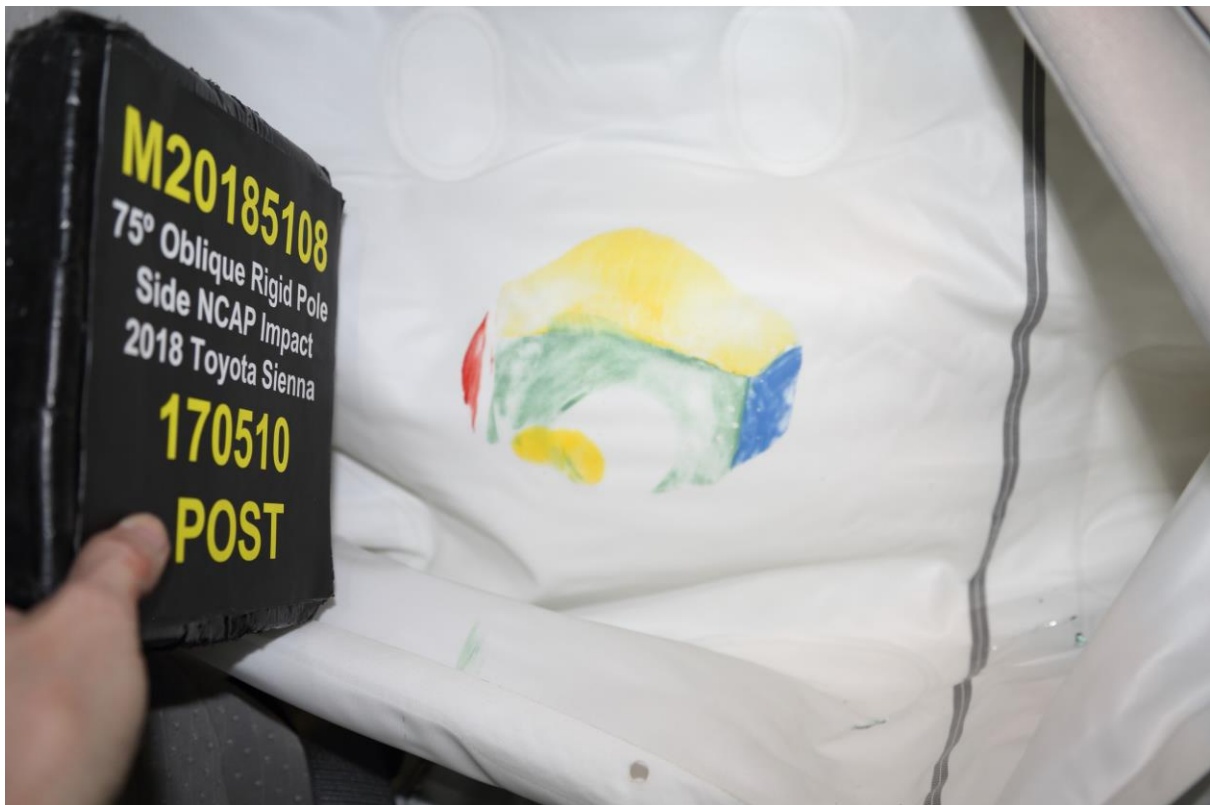
**No. 047 Post-Test Dummy Close-Up Head Contact with Side Airbag View**

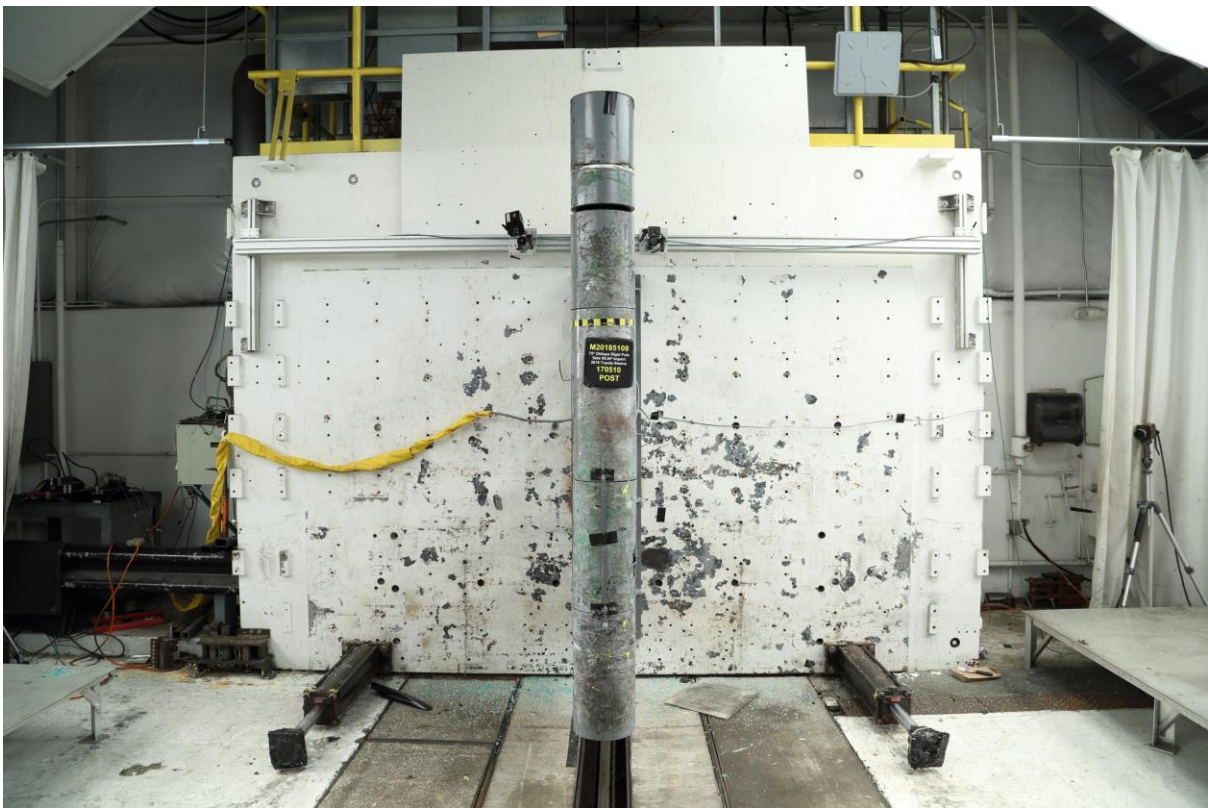
**No. 058 Post-Test Pole Barrier Front View**

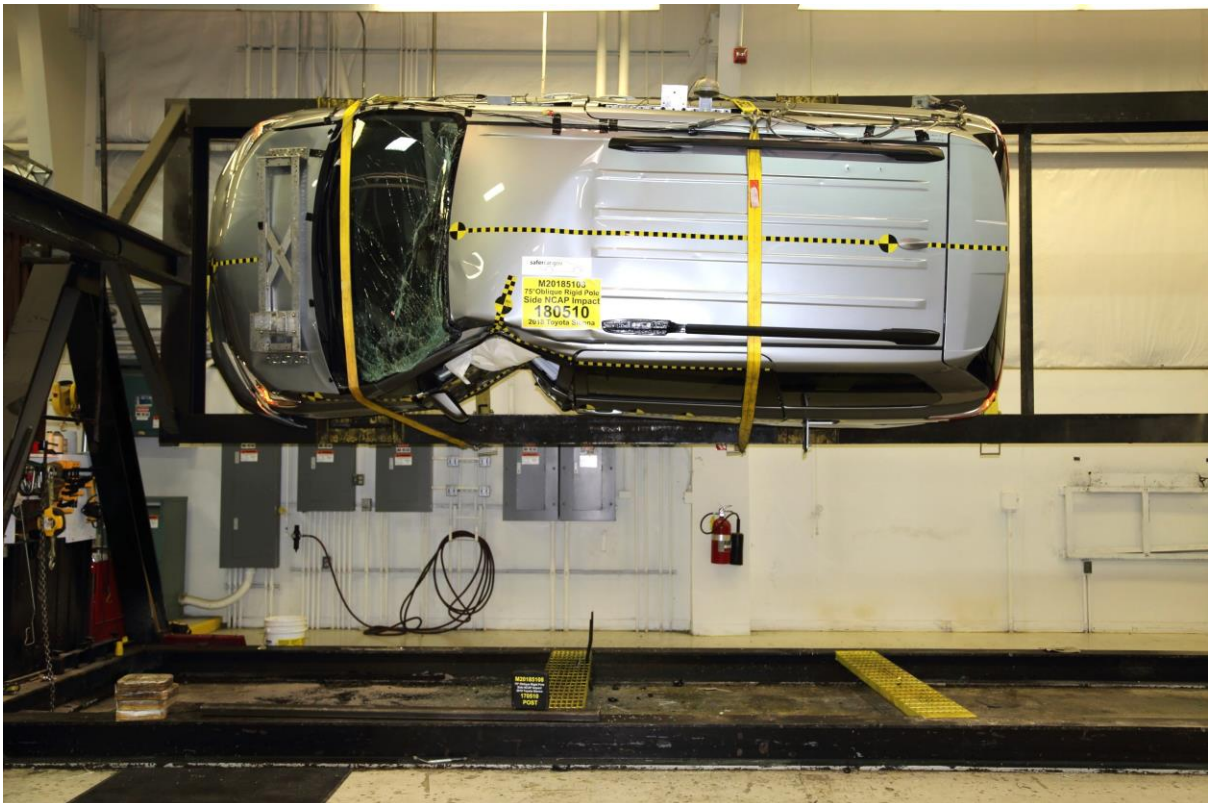
**No. 064 FMVSS No. 301 Static Rollover 90 Degrees**

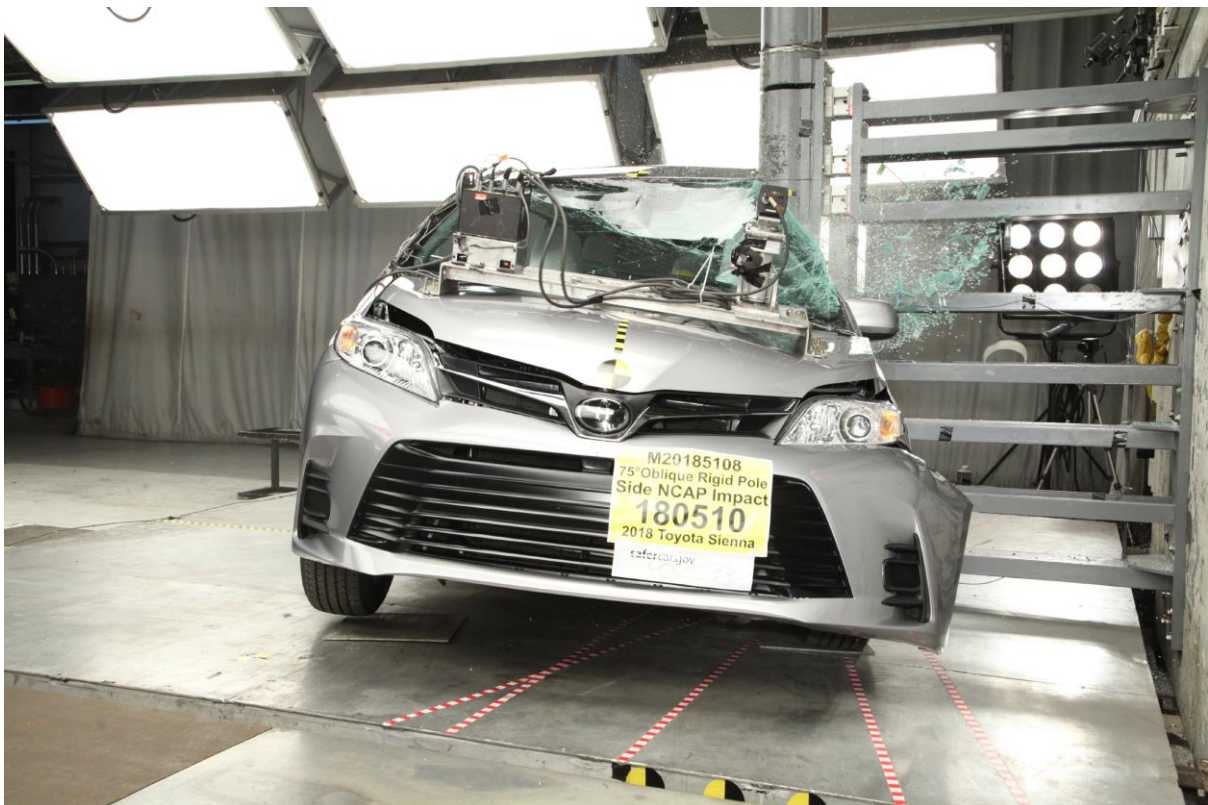
**No. 068 Impact Event**

A rigid pole side impact test was conducted on a model year 2018 Toyota Sienna Van. The subject vehicle was towed into the rigid pole at an angle of 75° and a velocity of 32.20 km/h. The side impact test was conducted by Transportation Research Center Inc. in East Liberty, OH, on May 10, 2018. Pre-test and post-test photographs of the test vehicle and the side impact dummy (SID-IIs) are included in Appendix A of this report.
