REPORT NUMBER: SINCAP-CAL-18-006

**NEW CAR ASSESSMENT PROGRAM (NCAP)
MOVING DEFORMABLE BARRIER SIDE IMPACT TEST**

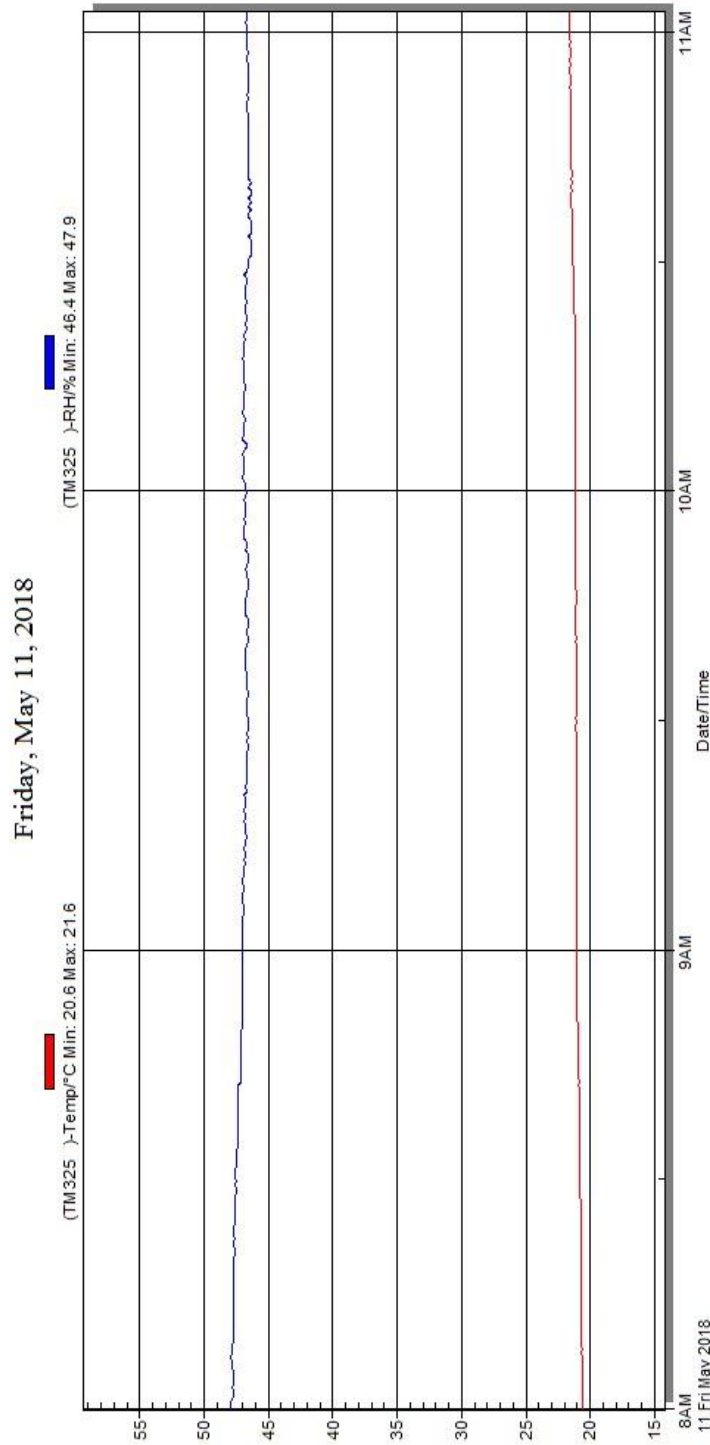
Temperature and Humidity Stabilization Chart/Data for Dummies and Test Vehicle
