**REPORT NUMBER: NCAP-KAR-18-017**

**NEW CAR ASSESSMENT PROGRAM (NCAP)  
FRONTAL BARRIER IMPACT TEST**

**FORD MOTOR CO.  
2018 FORD ECOSPORT S 4WD 5-DOOR MPV**

**FINAL REPORT**

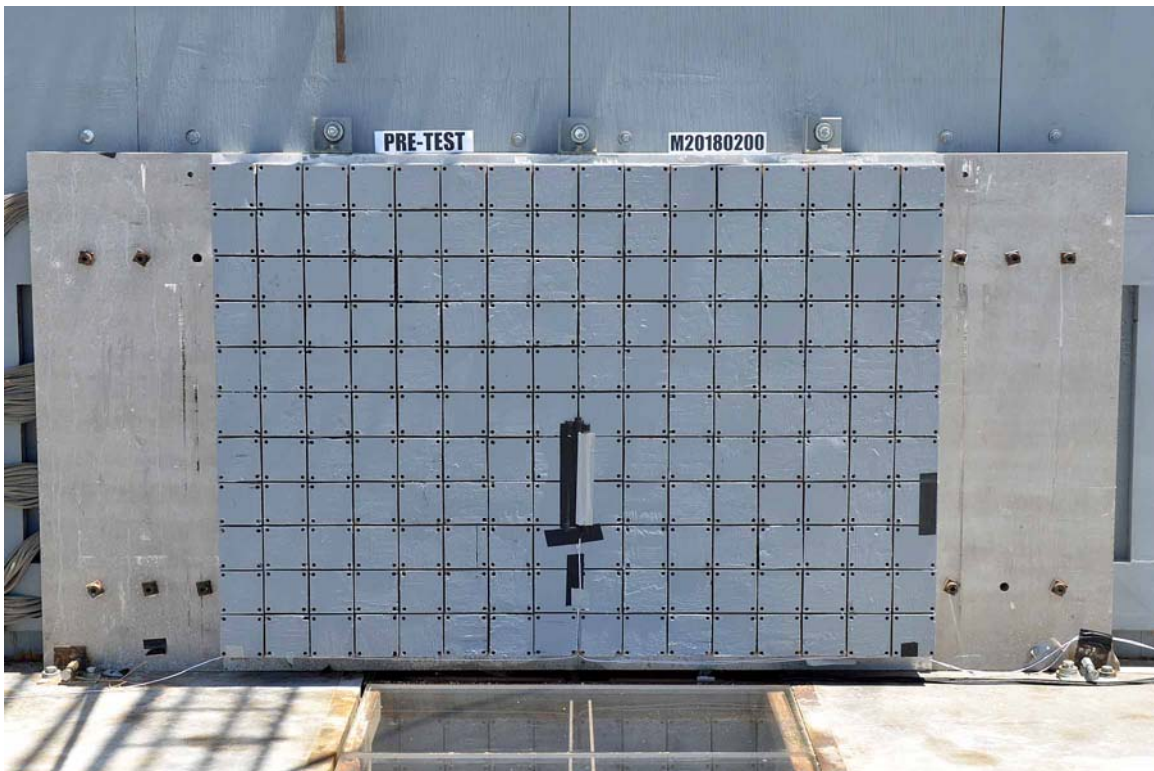
FIGURE 2. Pre-Test Load Cell Wall

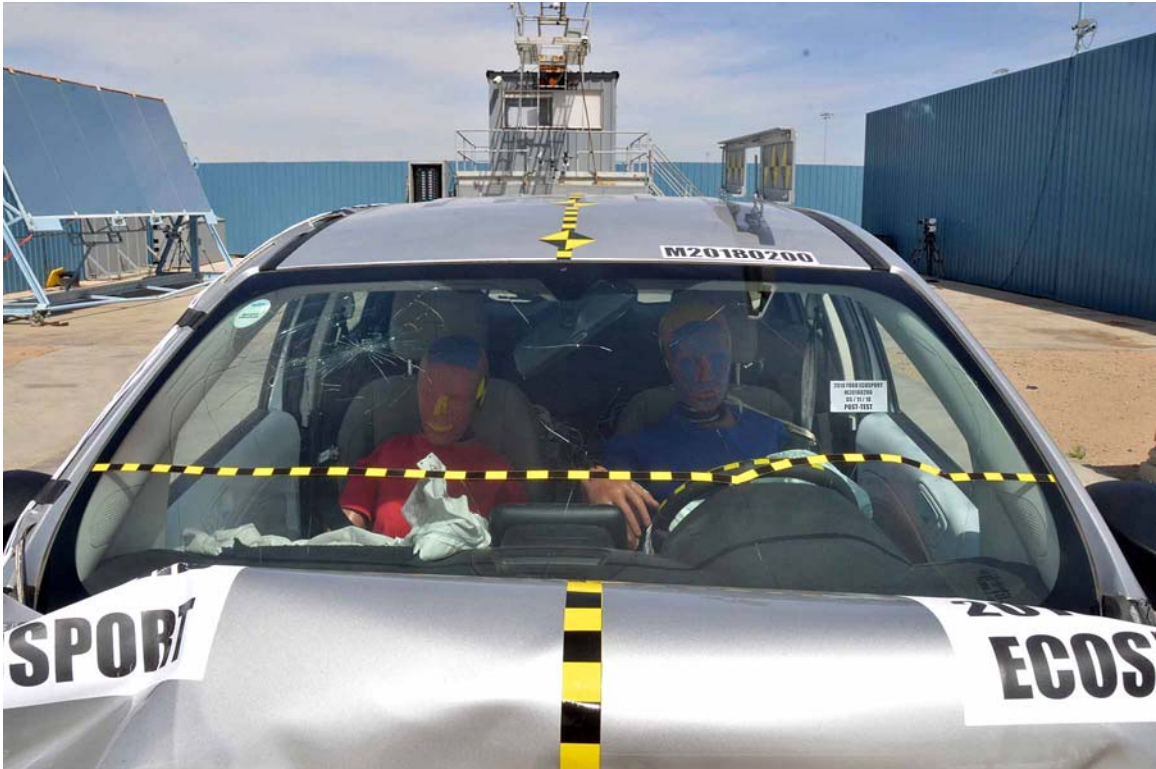
FIGURE 19. Post-Test Windshield View

There was 100% windshield retention and no intrusion into the protected zone of the windshield during the event.

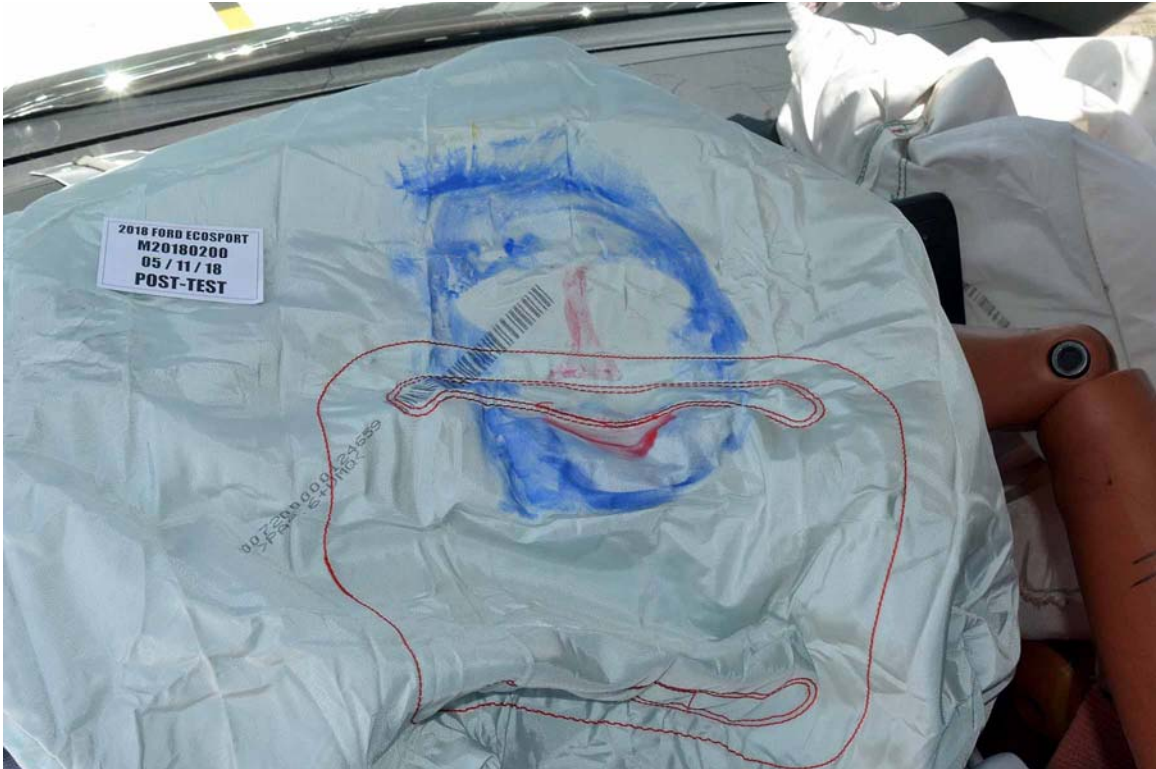
FIGURE 47. Post-Test Driver Dummy Contact with Airbag

The driver's visible contact points were as follows: The driver ATD's head contacted the frontal airbag and headrest. The upper torso contacted the frontal airbag. Both the left and right knees contacted the knee airbag.

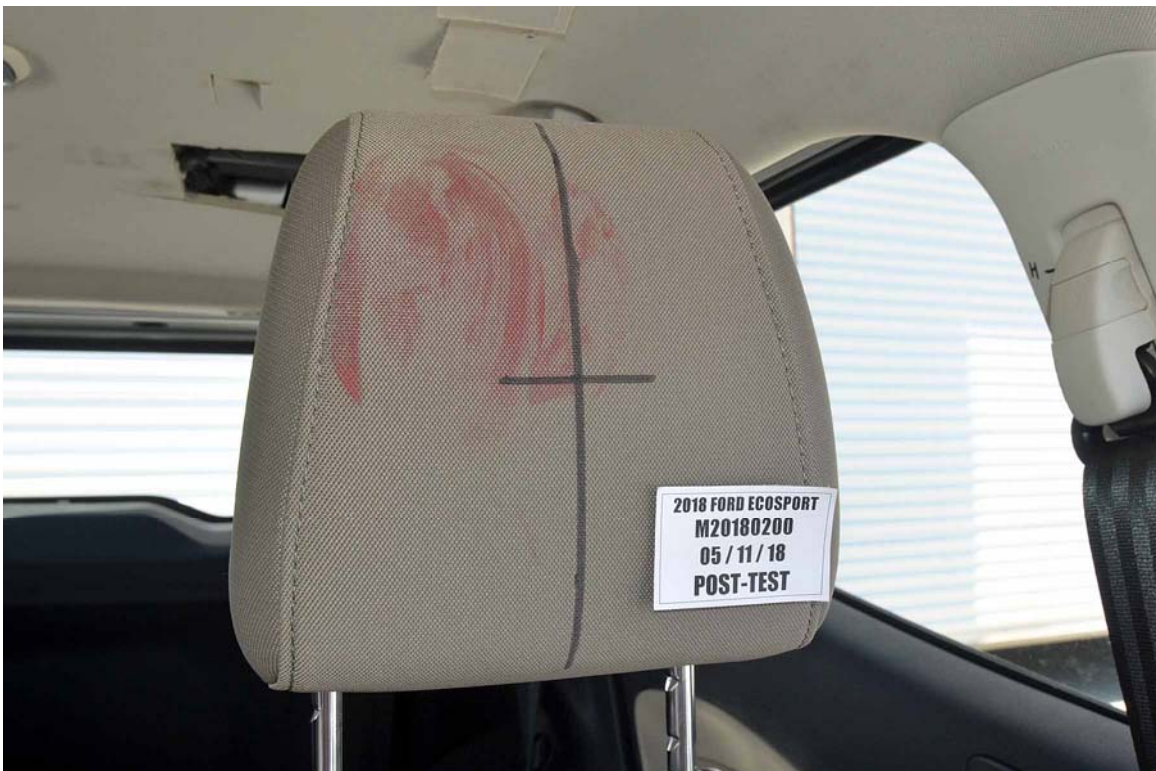
FIGURE 48. Post-Test Driver Dummy Contact with Headrest

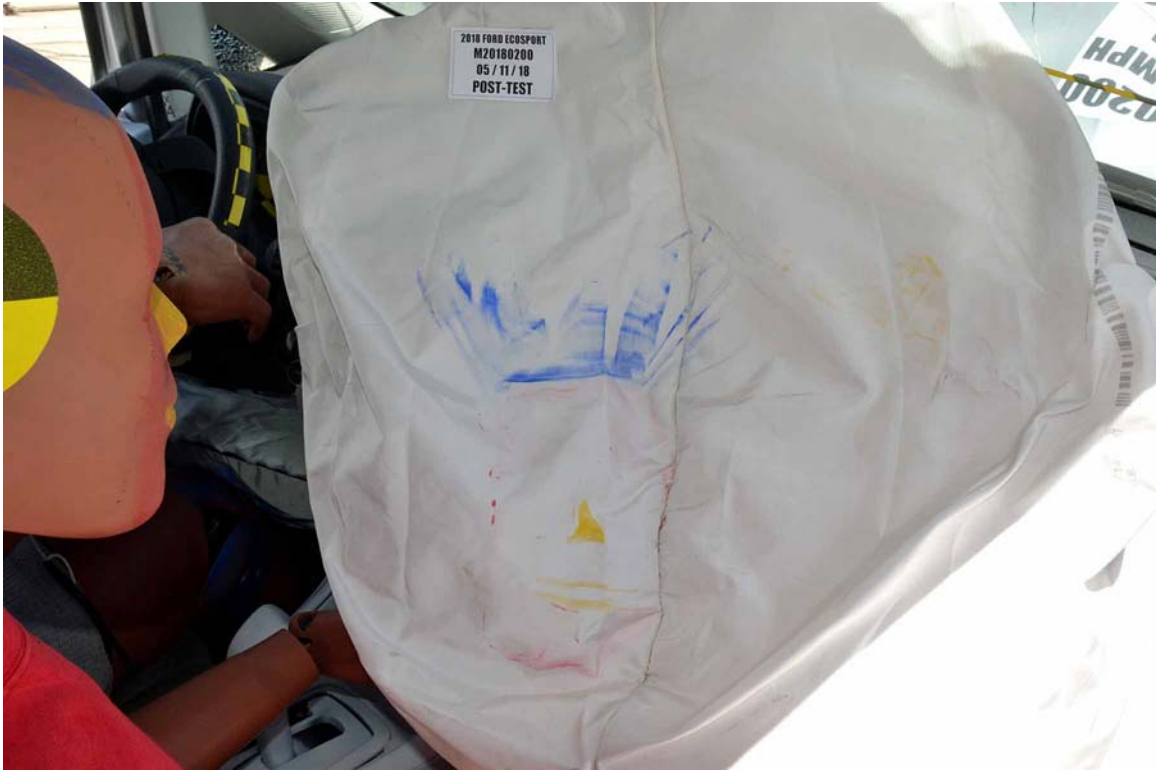
FIGURE 68. Post-Test Passenger Dummy Contact with Airbag

The passenger's visible contact points were as follows: The passenger ATD's head contacted the frontal airbag and headrest. The upper torso contacted the frontal airbag. Both left and right knees contacted the knee airbag.

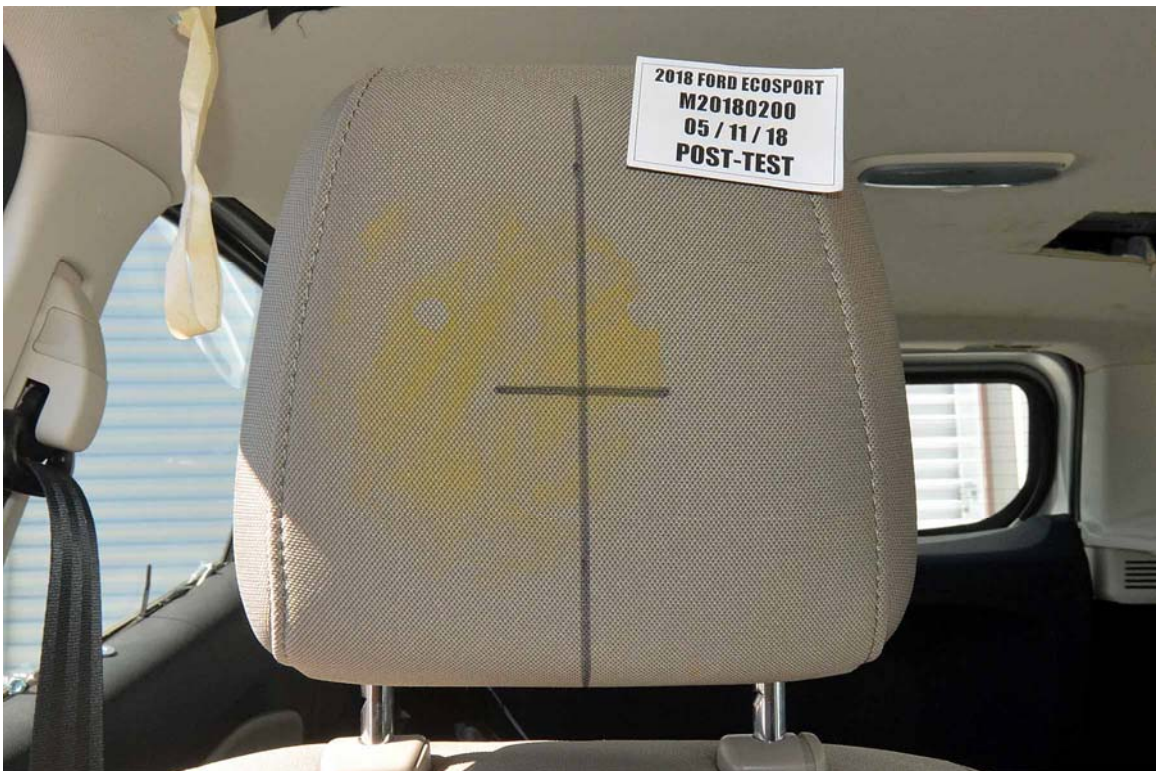
FIGURE 69. Post-Test Passenger Dummy Contact with Headrest

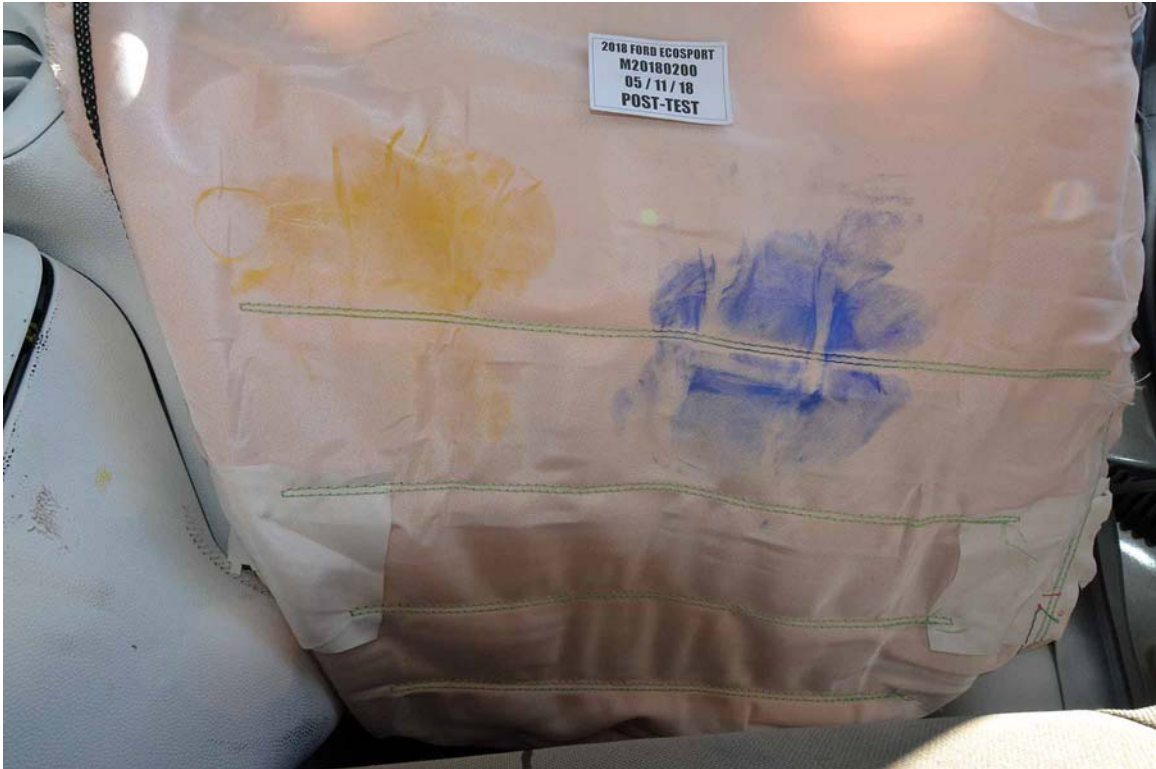
FIGURE 69a. Post-Test Passenger Dummy Contact with Knee Airbag
