**REPORT NUMBER: NCAP-MGA-2018-031**

**NEW CAR ASSESSMENT PROGRAM (NCAP)  
Frontal Barrier Impact Test**

**MAZDA MOTOR CORPORATION  
2018 Mazda CX-9 Sport AWD 5-Door SUV  
NHTSA No.: O20185401**

**MGA RESEARCH CORPORATION  
5000 Warren Road  
Burlington, WI 53105**

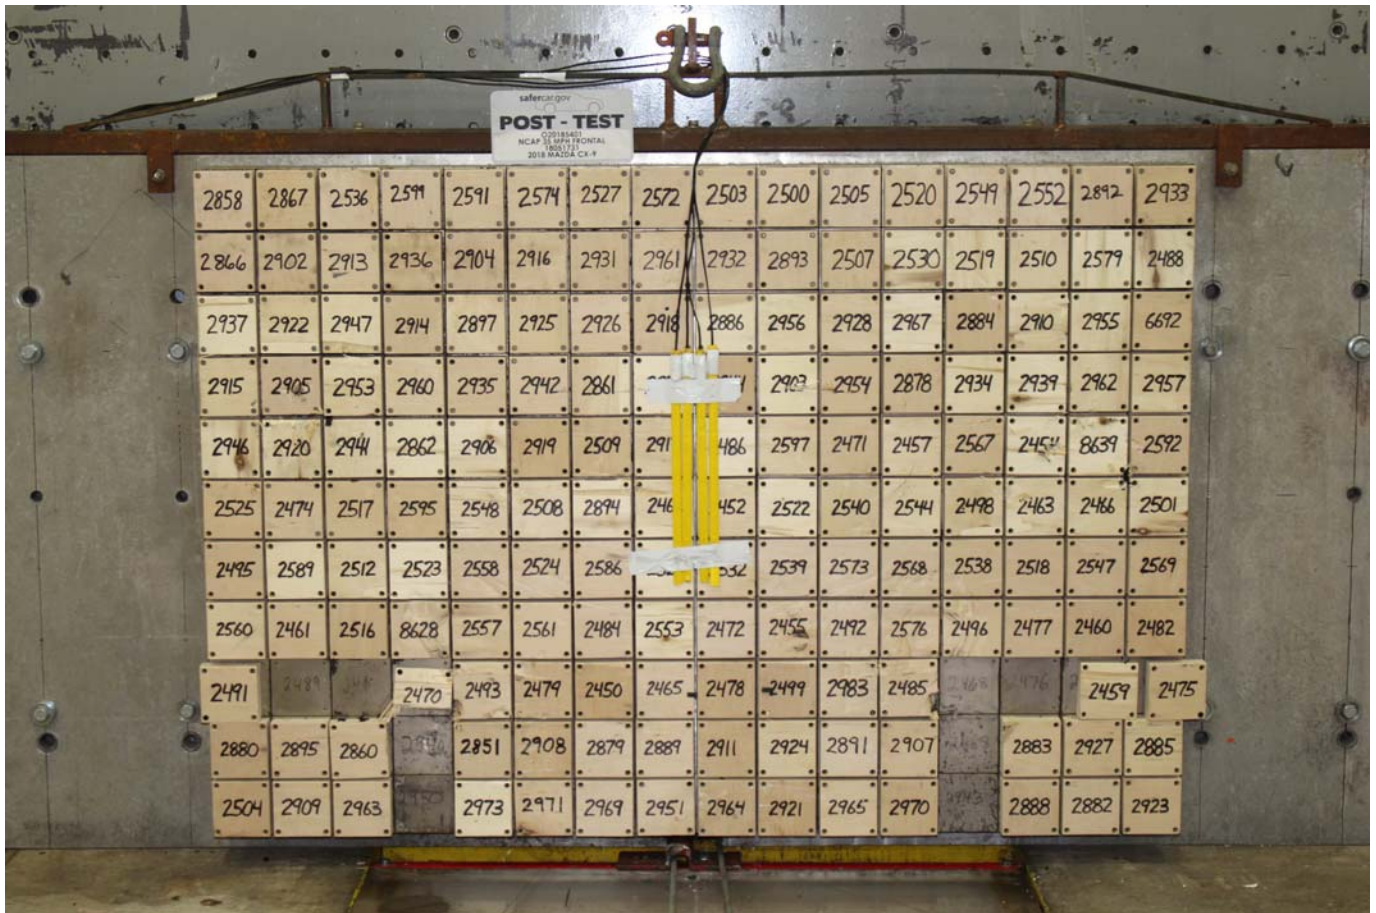
Photo No. 003 - Post-Test Load Cell Wall

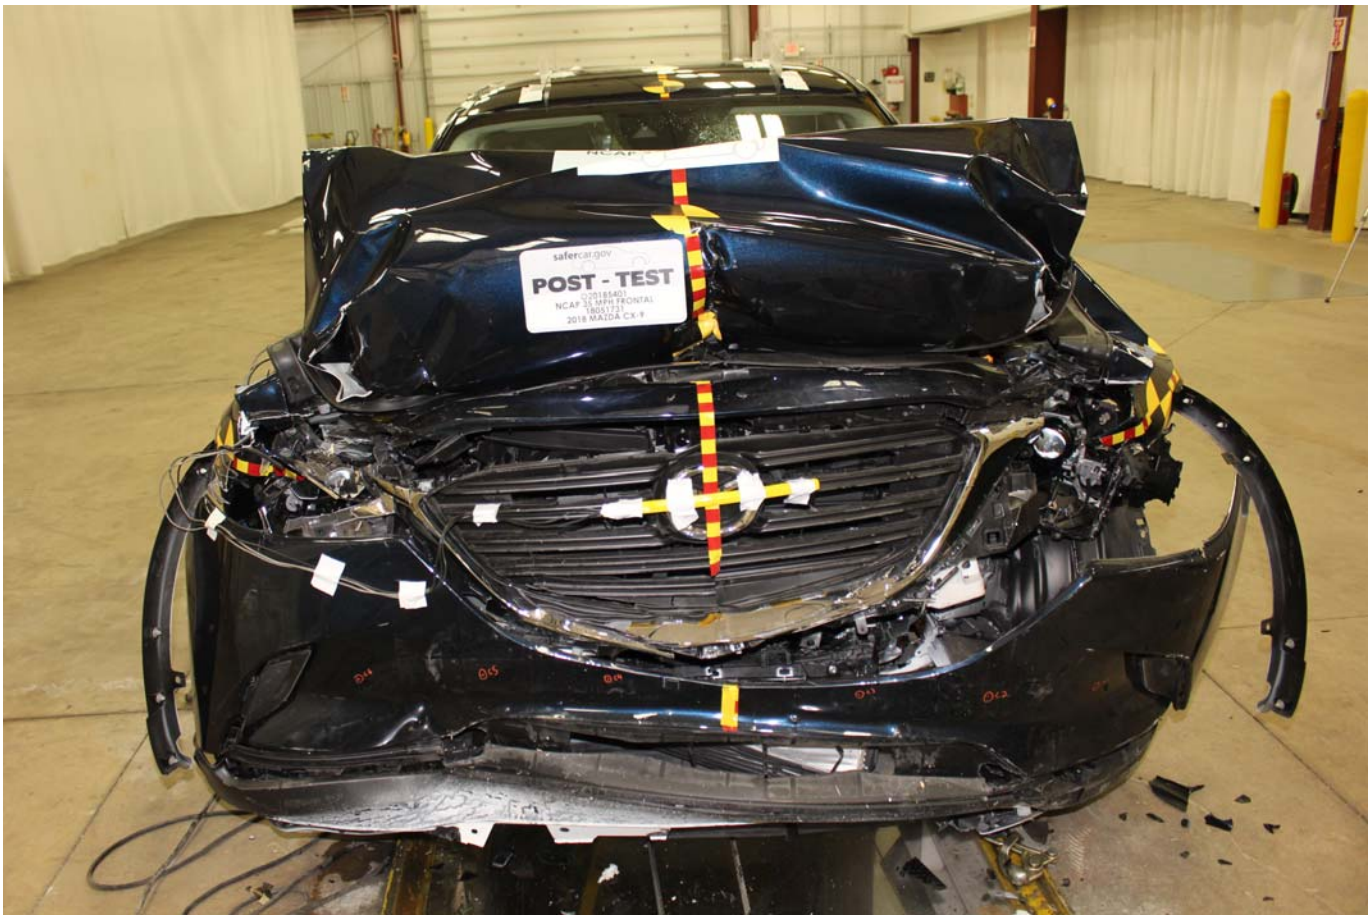
The maximum static crush of the vehicle was 701mm at the vehicle centerline and both the driver and passenger side doors remained closed during the impact event and were operable after the impact.

Photo No. 009 - Post-Test Front View of Test Vehicle

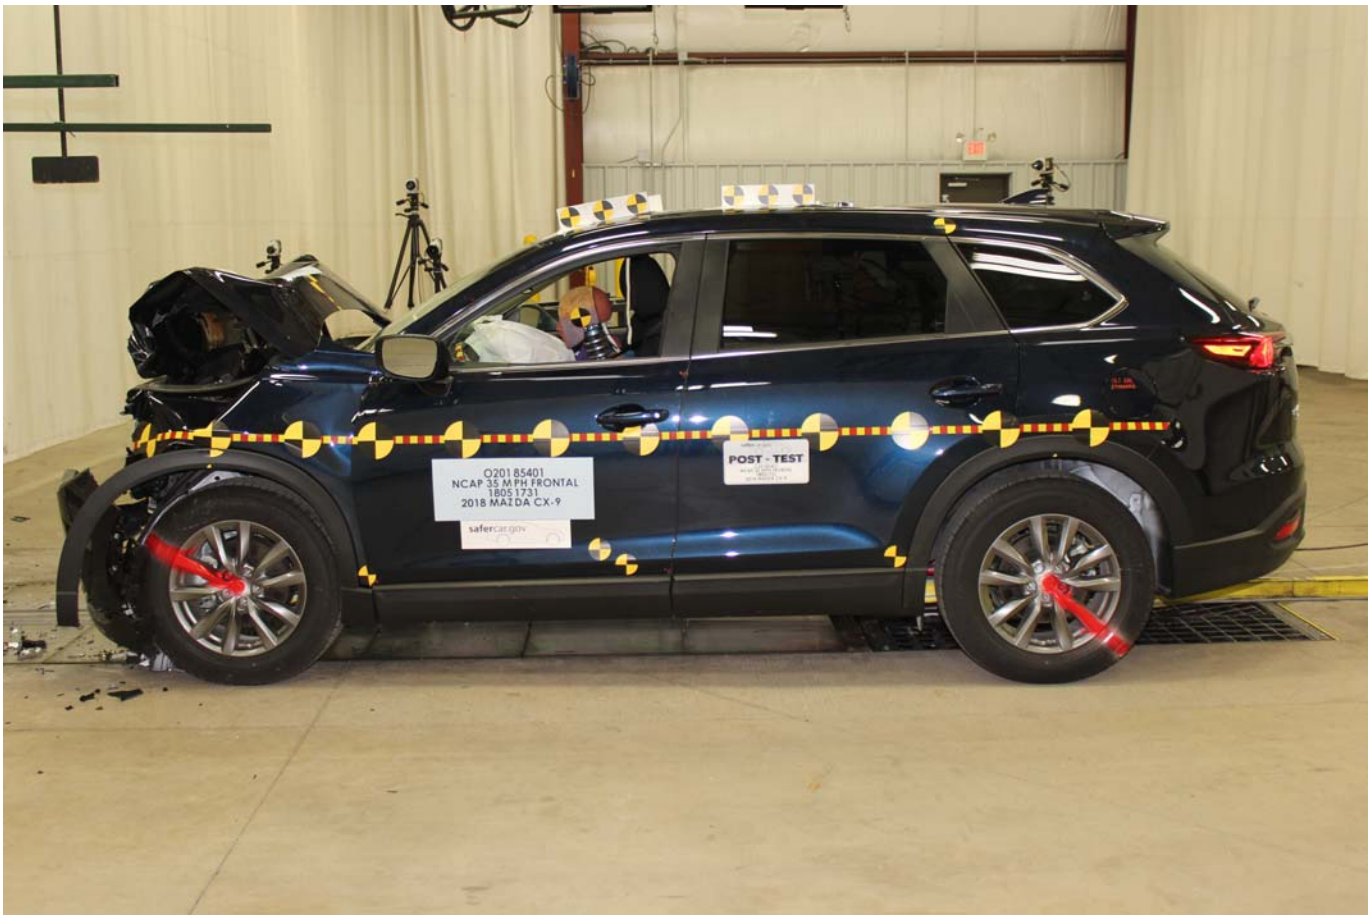
Photo No. 011 - Post-Test Left View of Test Vehicle

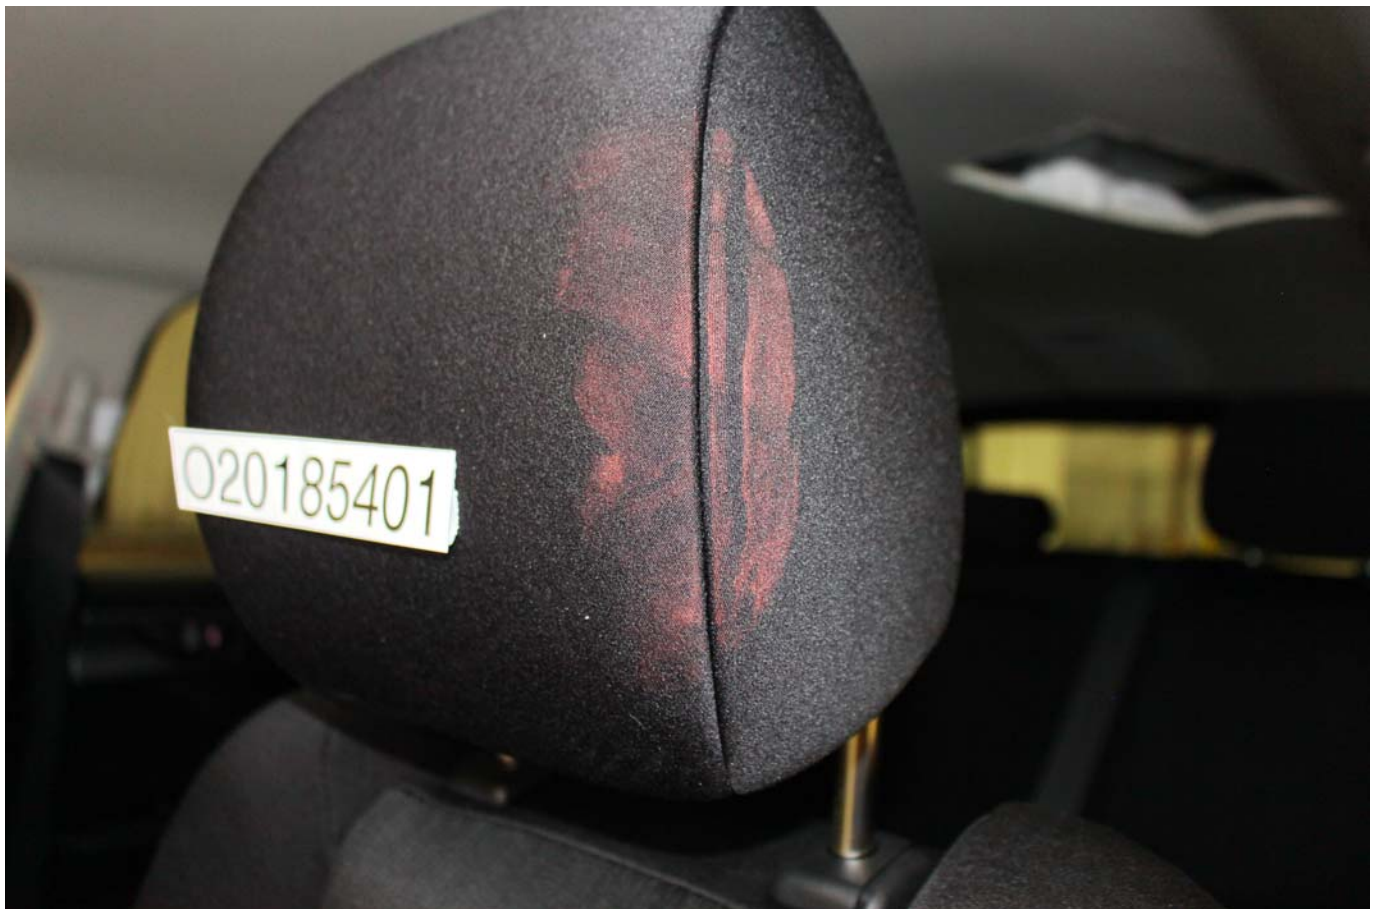
The driver's visible contact points were as follows: The driver's head contacted the airbag. The driver's head also contacted the headrest. The driver's knees contacted the knee bolster. The passenger's visible contact points were as follows: The passenger's head contacted the airbag. The passenger's head also contacted the headrest. The passenger's knees contacted the glove box.

Photo No. 047 - Post-Test Driver Dummy Contact with Airbag

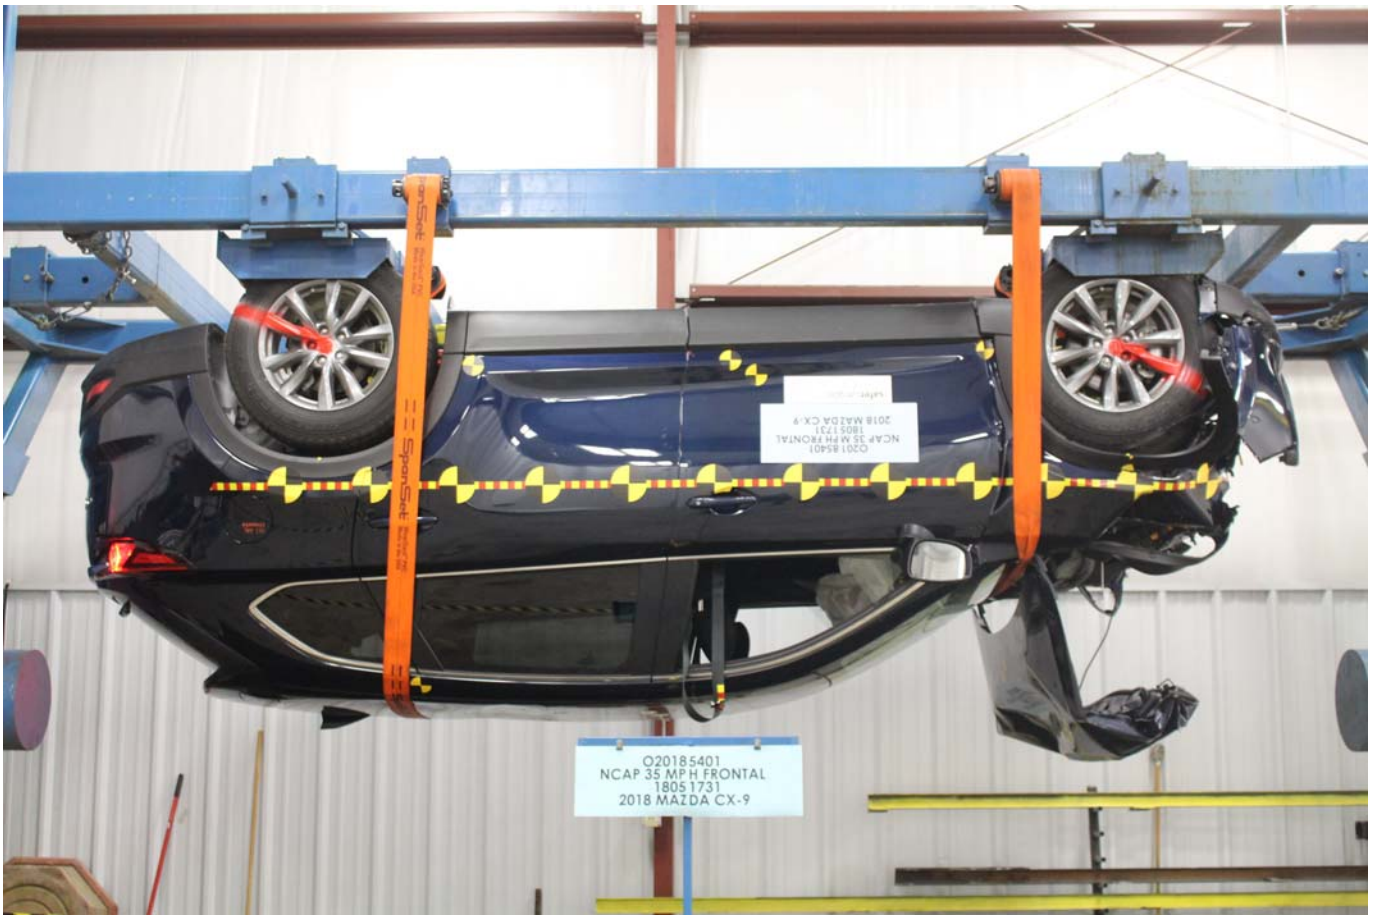
Photo No. 075 - Vehicle at 180 Degrees on Static Rollover Device

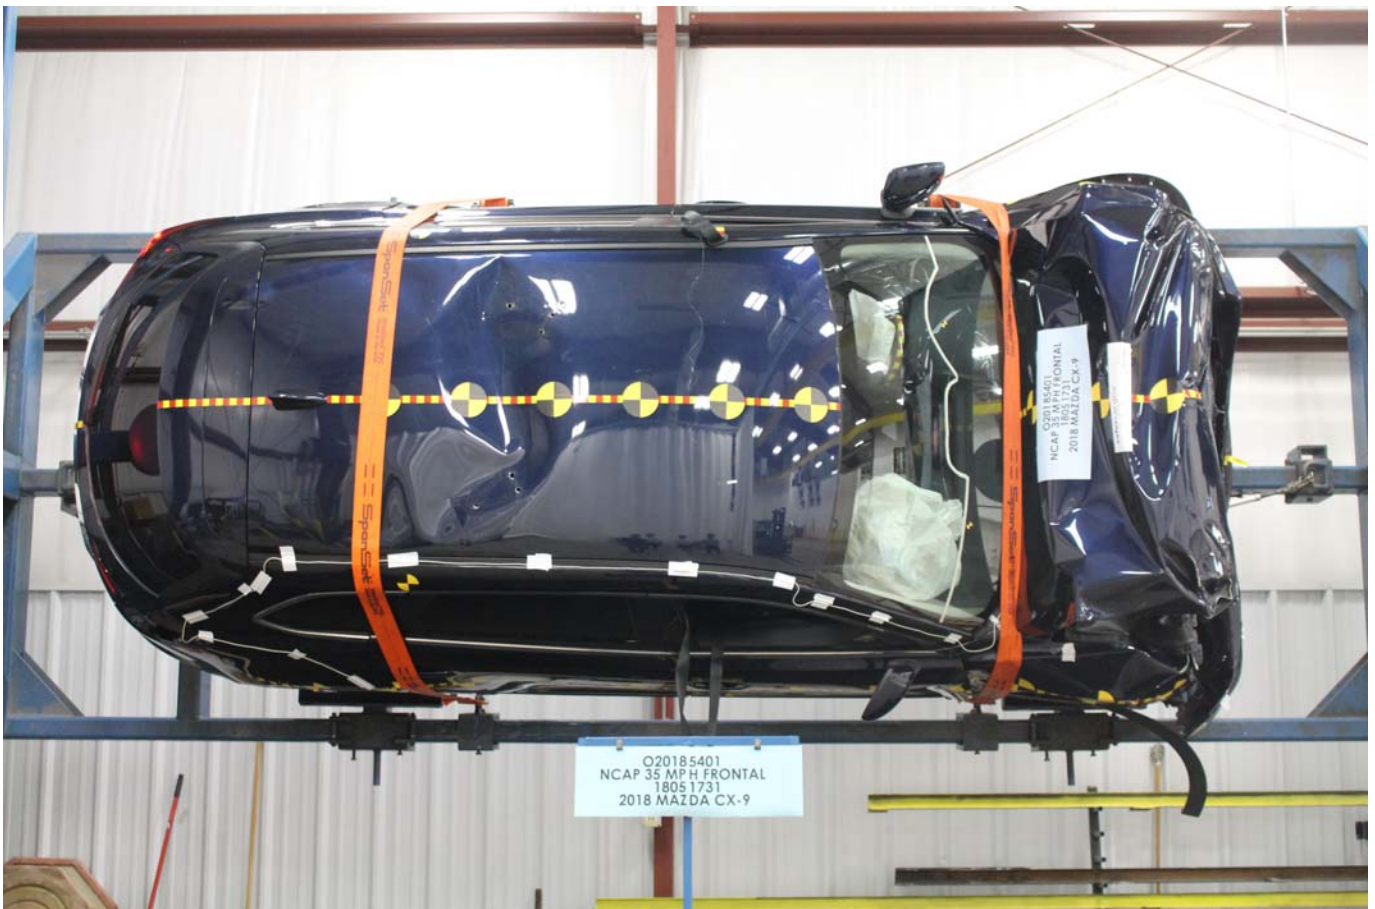
Photo No. 076 - Vehicle at 270 Degrees on Static Rollover Device

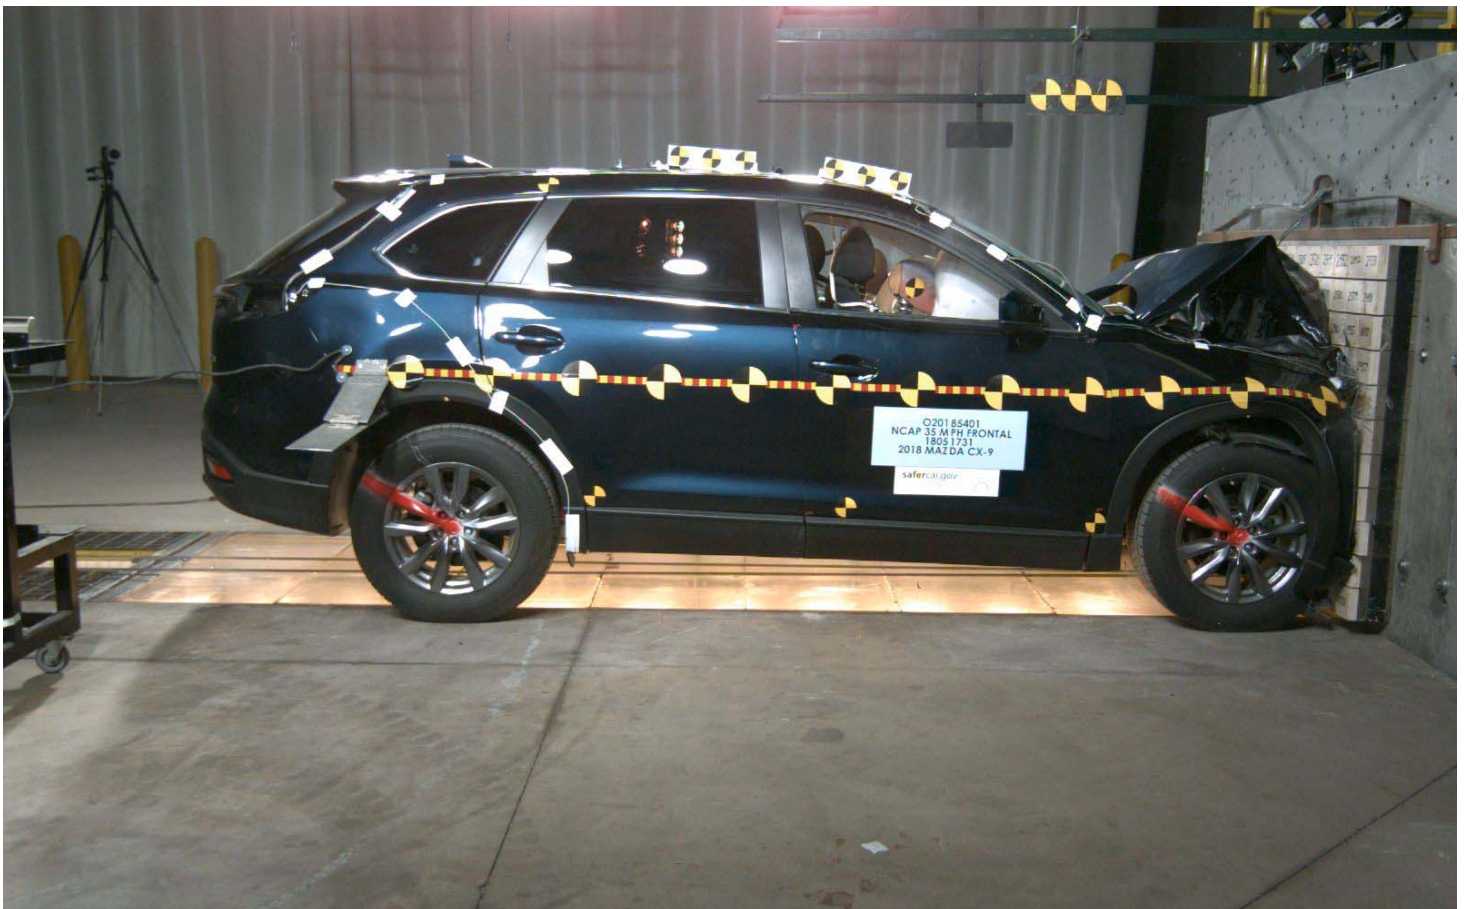
Photo No. 078 - 2018 Mazda CX-9 Sport AWD 5-Door SUV 5-Door SUV Frontal Impact Event
