**REPORT NUMBER: SPNCAP-CAL-18-006**

**NEW CAR ASSESSMENT PROGRAM (NCAP)  
SIDE IMPACT POLE TEST**

**Ford Motor Co.  
2018 Ford Expedition  
SUV**

**PREPARED BY:  
CALSPAN CORPORATION  
P.O. BOX 400  
BUFFALO, NEW YORK 14225**

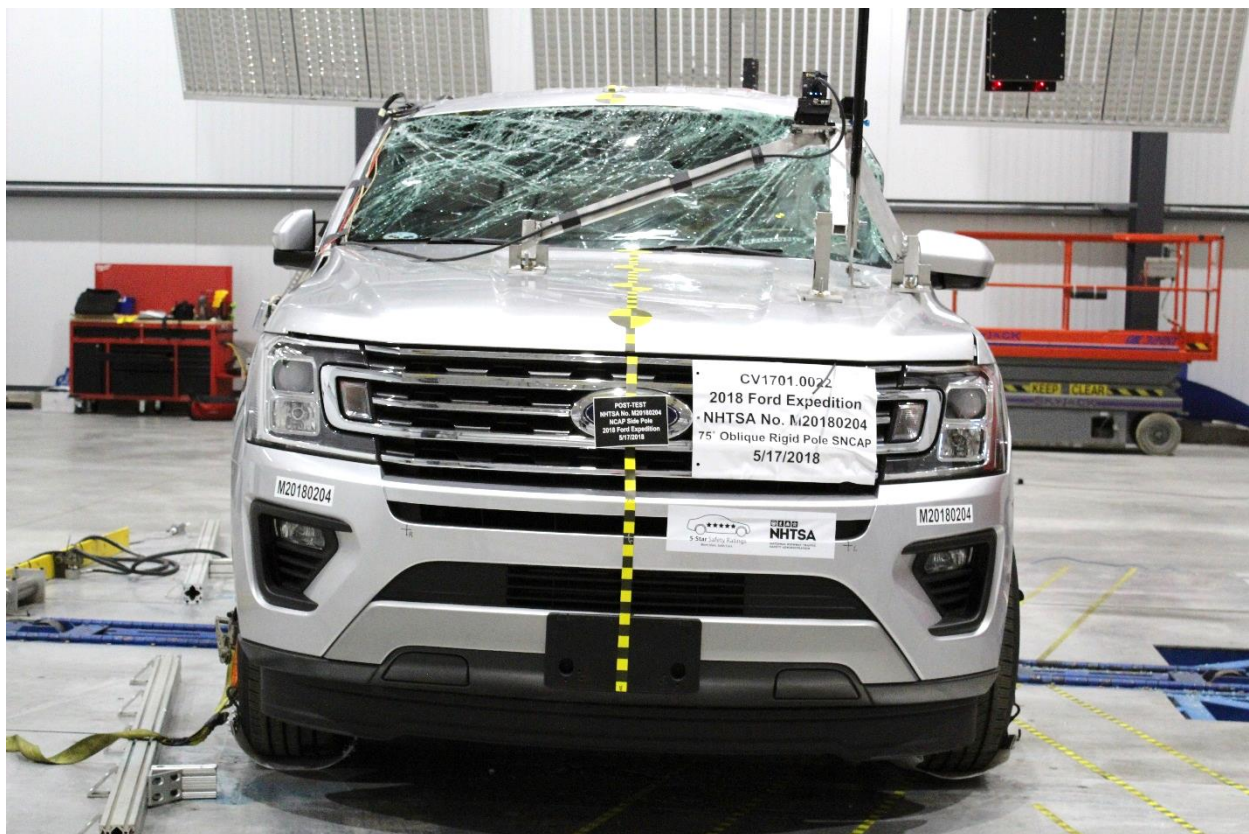
**Figure A-4: Post-Test Frontal View of Test Vehicle**

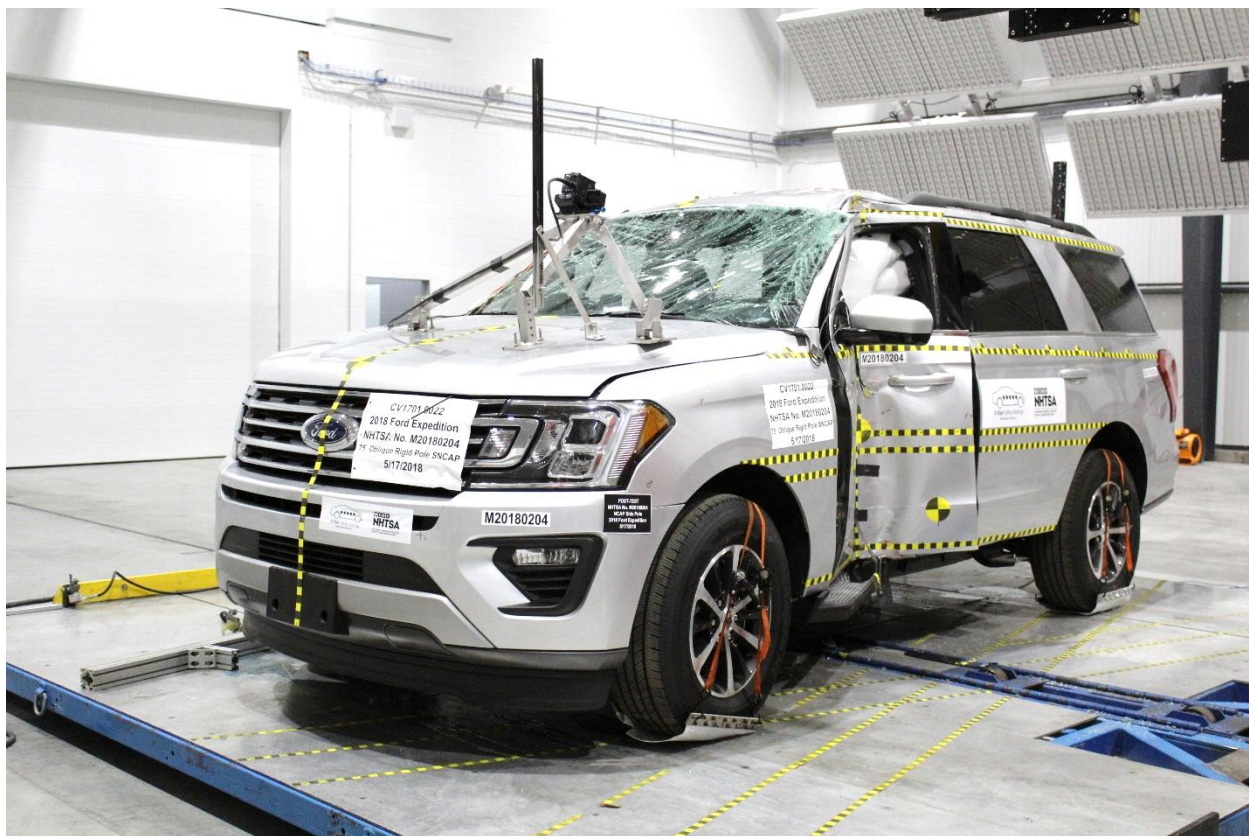
**Figure A-6: Post-Test Left Front  $\frac{3}{4}$  View of Test Vehicle**

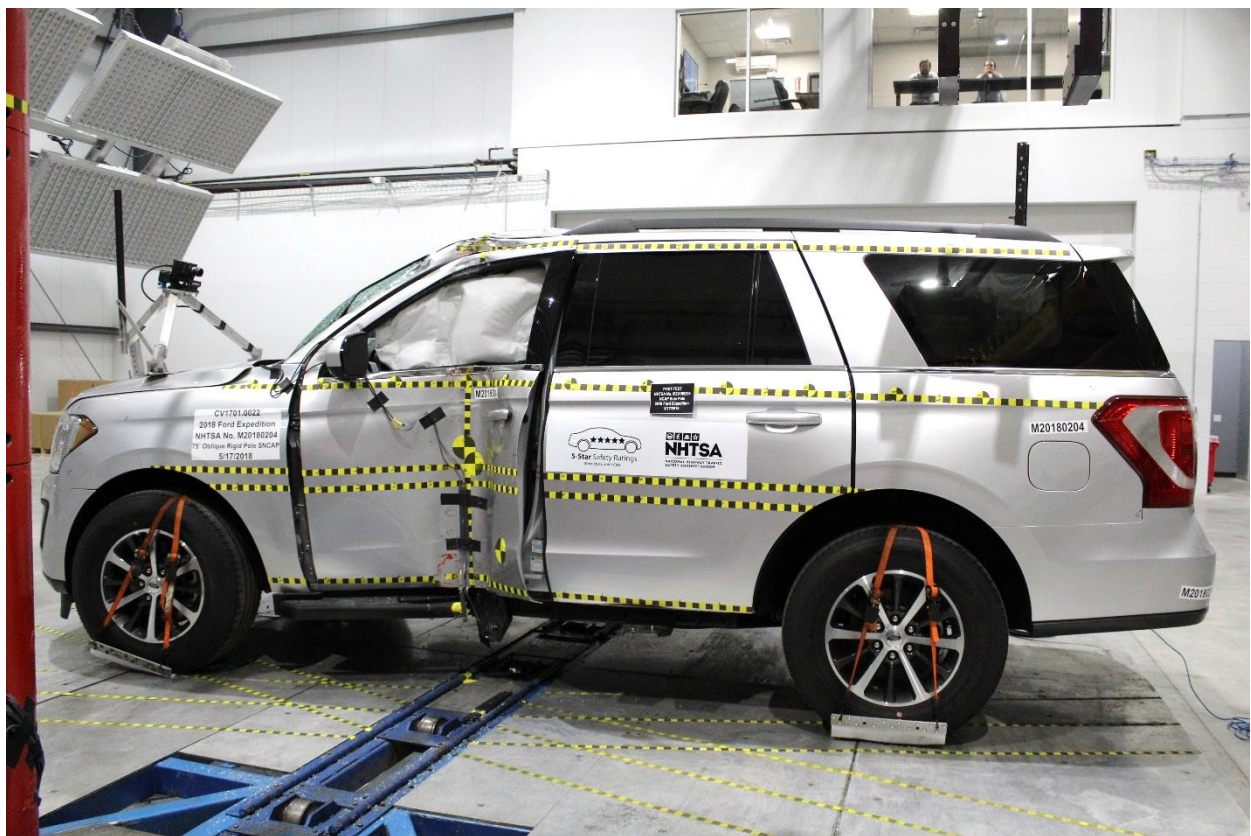
**Figure A-8: Post-Test Left Side View of Test Vehicle**

| Critical Areas of Performance | Observations and Conclusions |
|---|---|
| Windshield Damage | Cracks throughout with separation along driver A-Pillar |
| Side Window Damage | Driver Window Shattered |

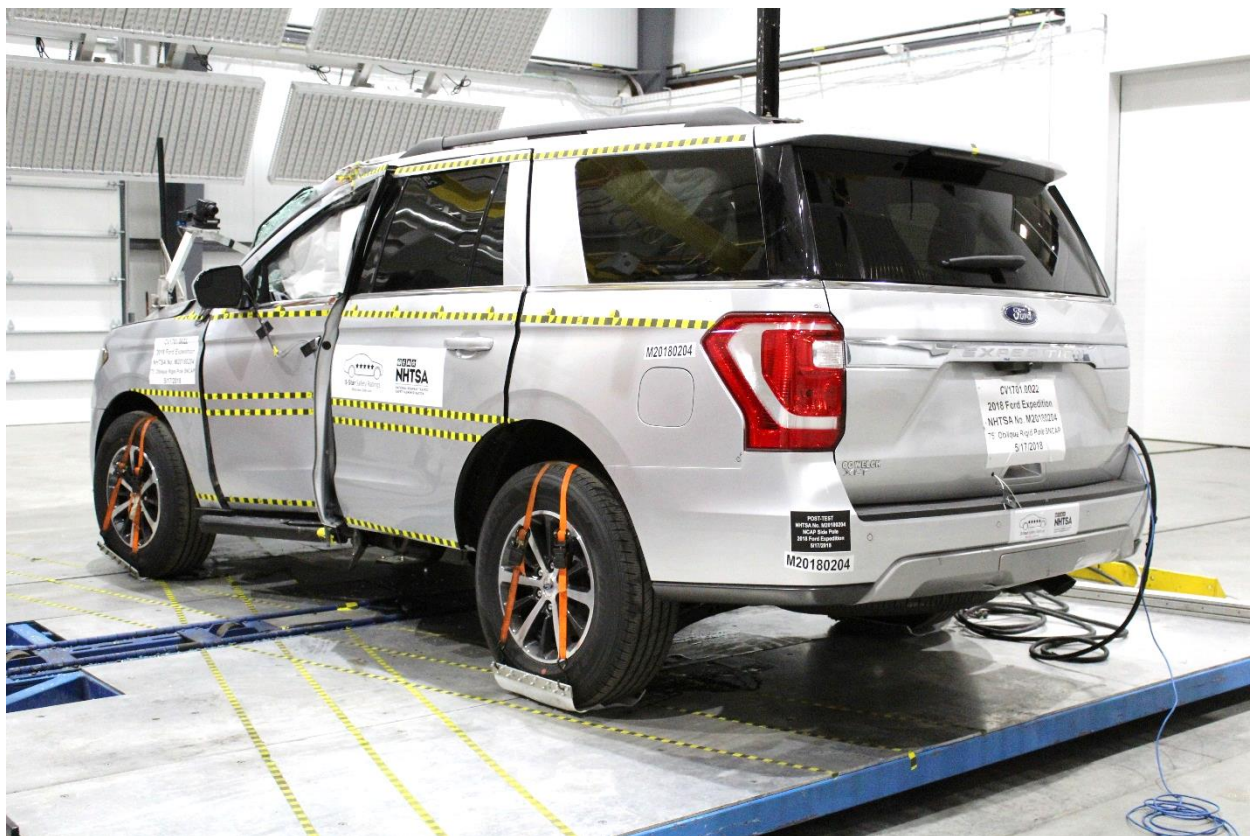
**Figure A-10: Post-Test Left Rear  $\frac{3}{4}$  View of Test Vehicle**

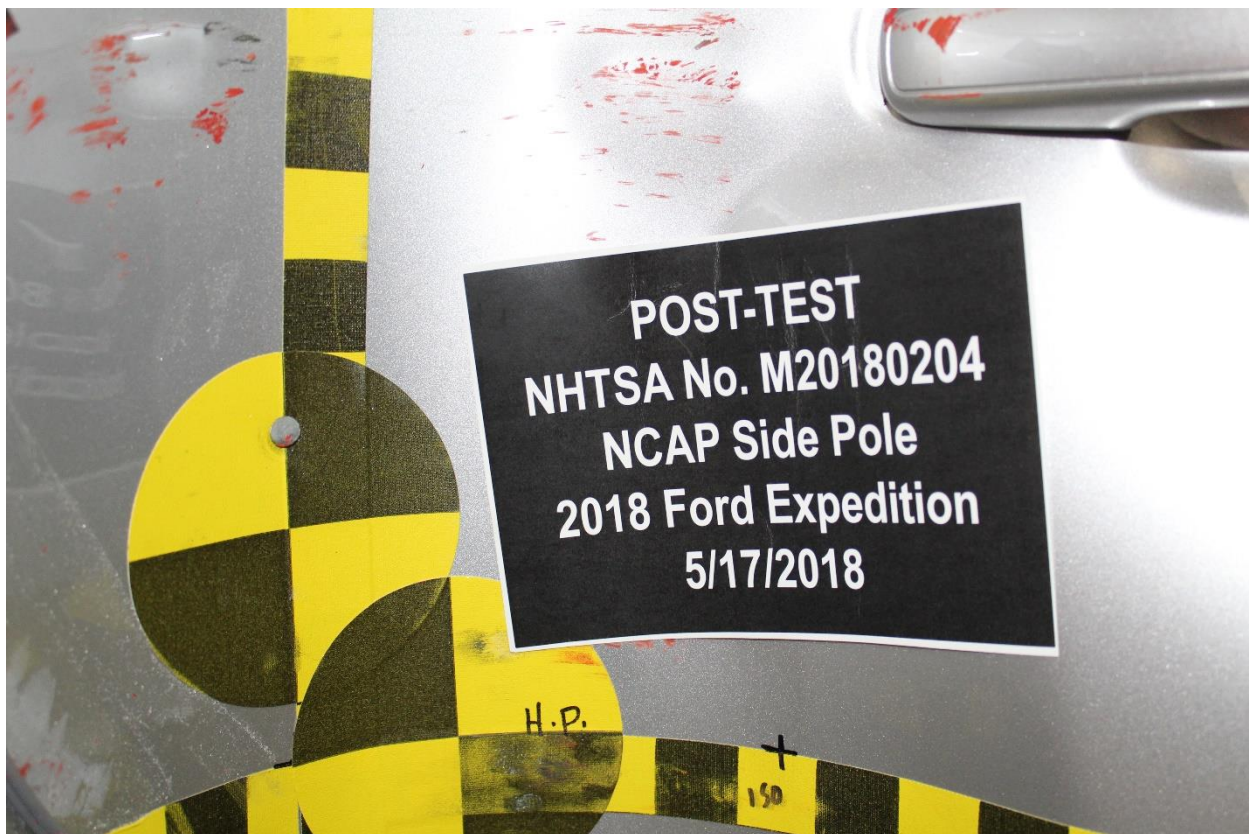
Figure A-20: Post-Test Close-Up View of Impact Point Target Showing Impact Location

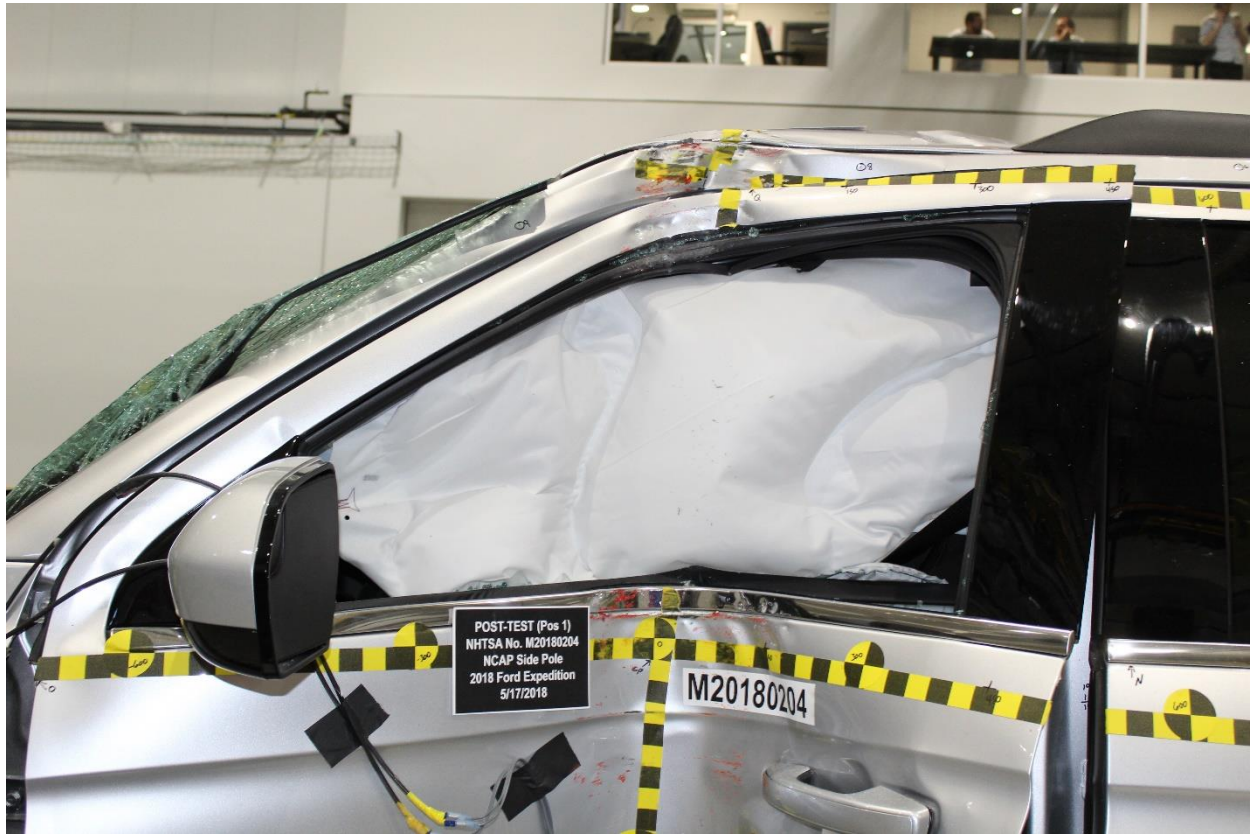
**Figure A-25: Post-Test Left Side View of Dummy Shoulder and Door Top View**

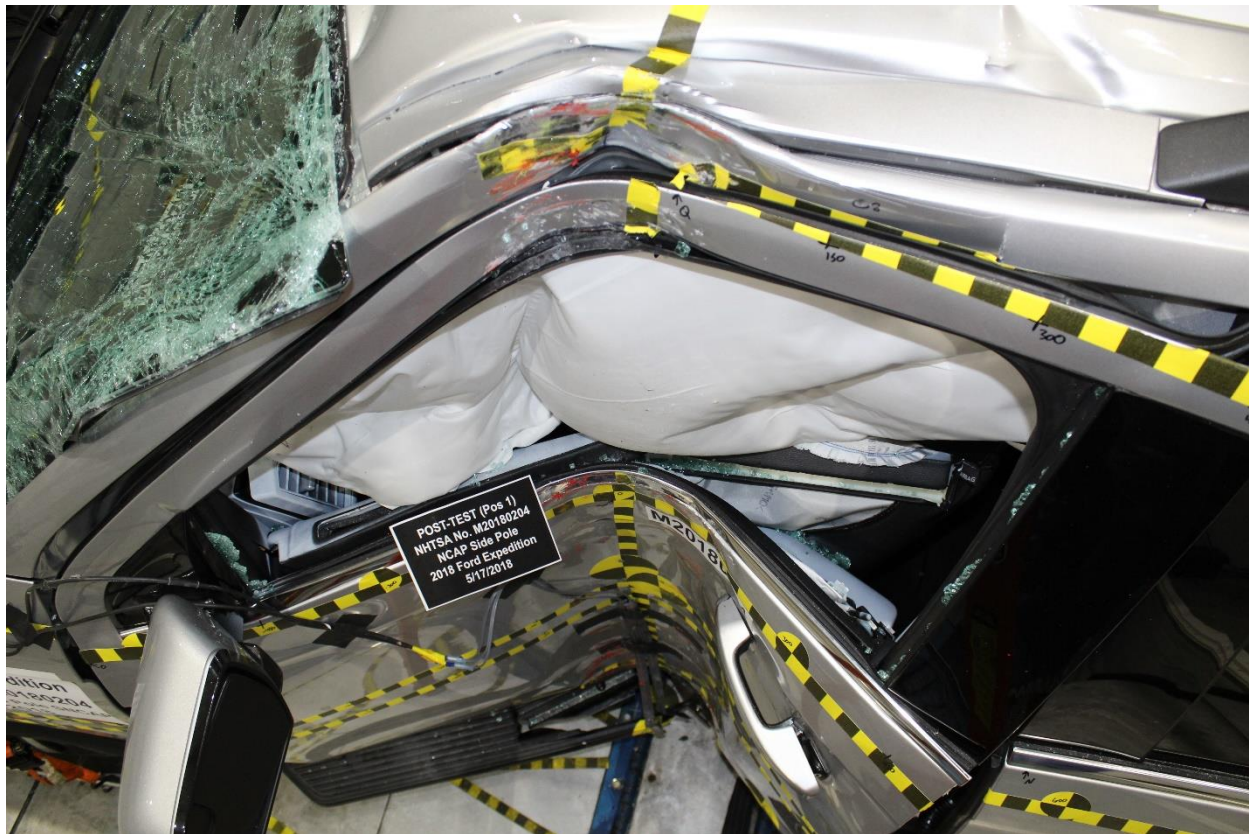
**Figure A-41: Post-Test Dummy and Door Clearance View**

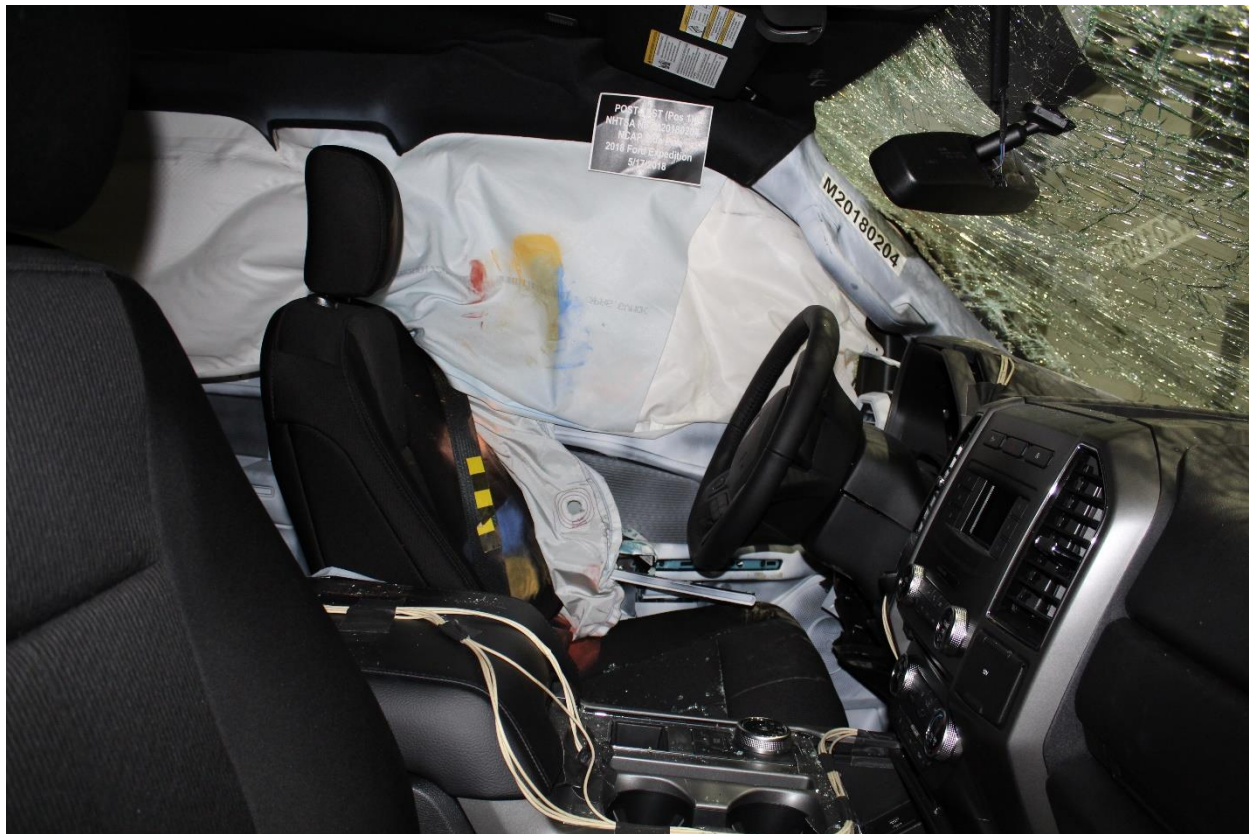
**Figure A-45: Post-Test Inner Door Panel View Showing Dummy Contact Location**

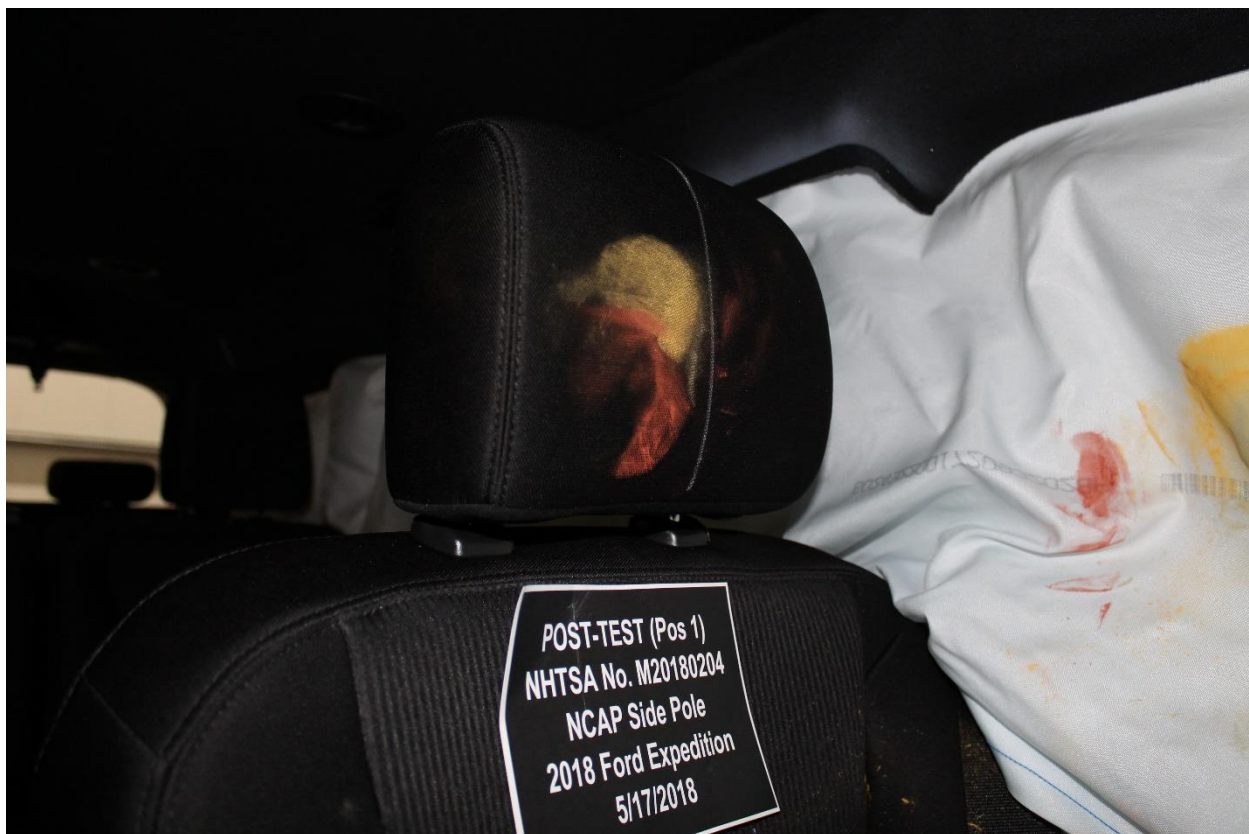
**Figure A-46: Post-Test Dummy Close-Up Head Contact with Vehicle Interior View**

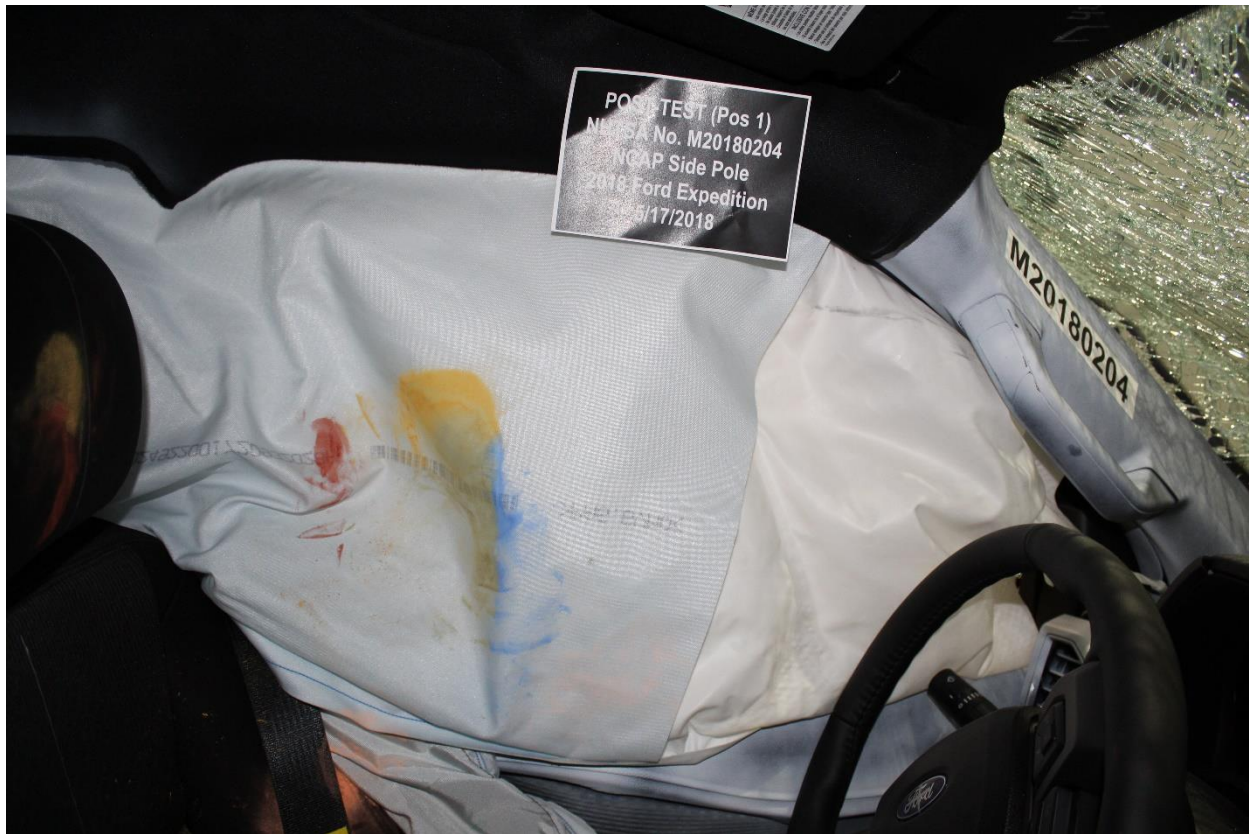
**Figure A-47: Post-Test Dummy Close-Up Head Contact with Side Airbag View**

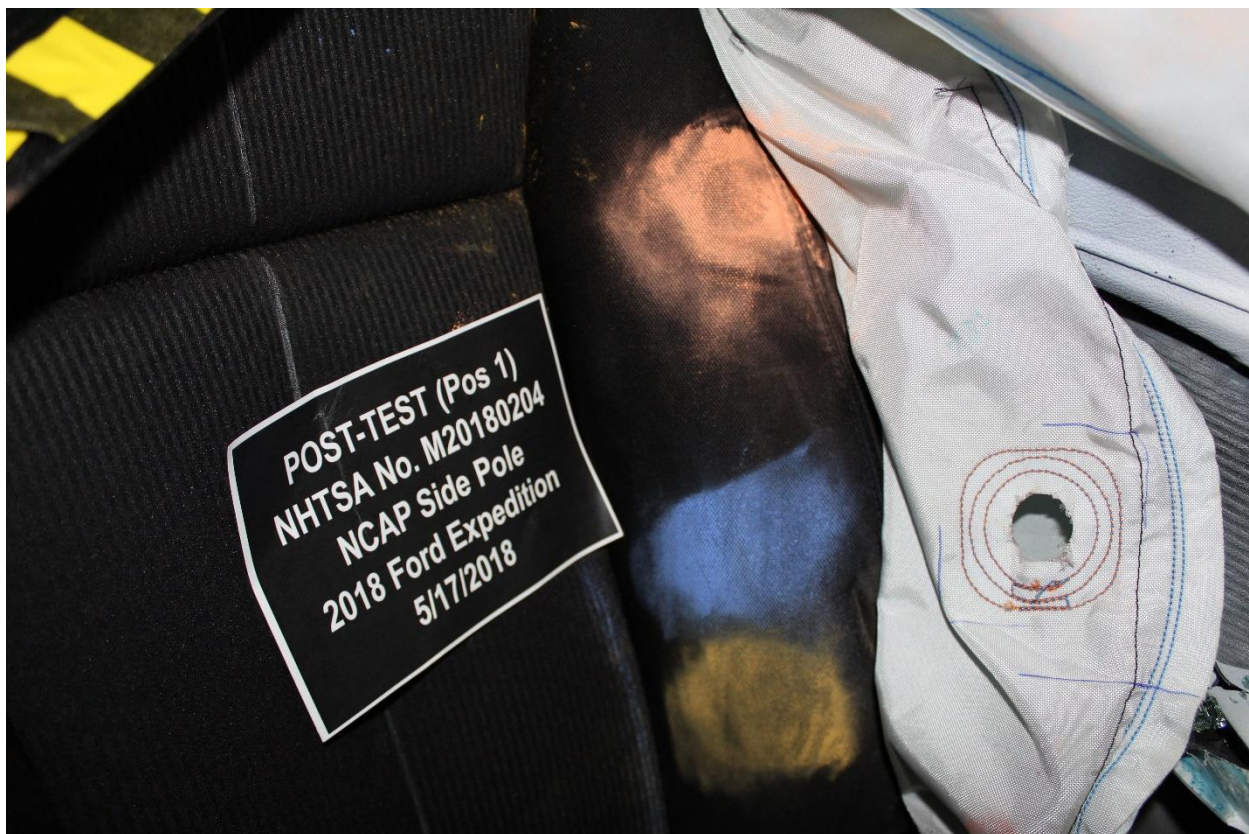
**Figure A-48: Post-Test Dummy Close-Up Torso Contact with Vehicle Interior View**

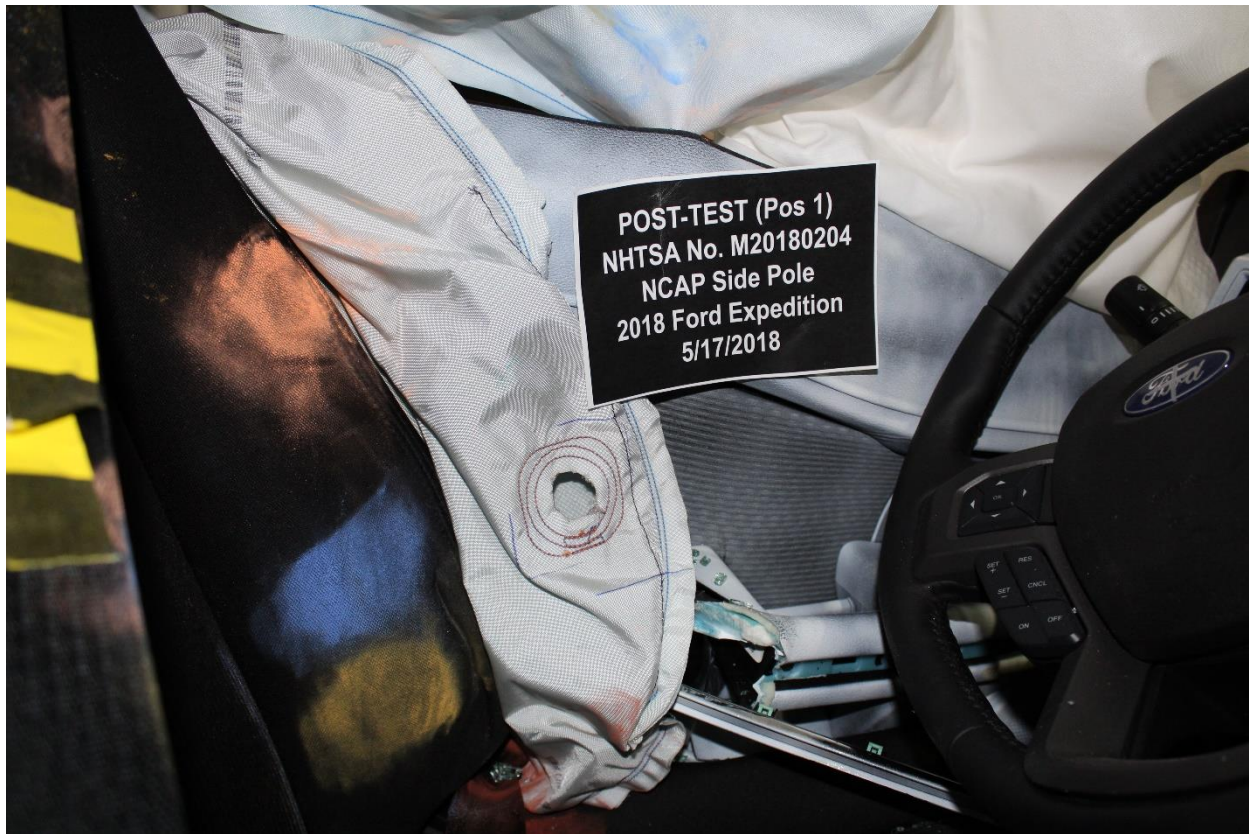
**Figure A-49: Post-Test Dummy Close-Up Torso Contact with Side Airbag View**

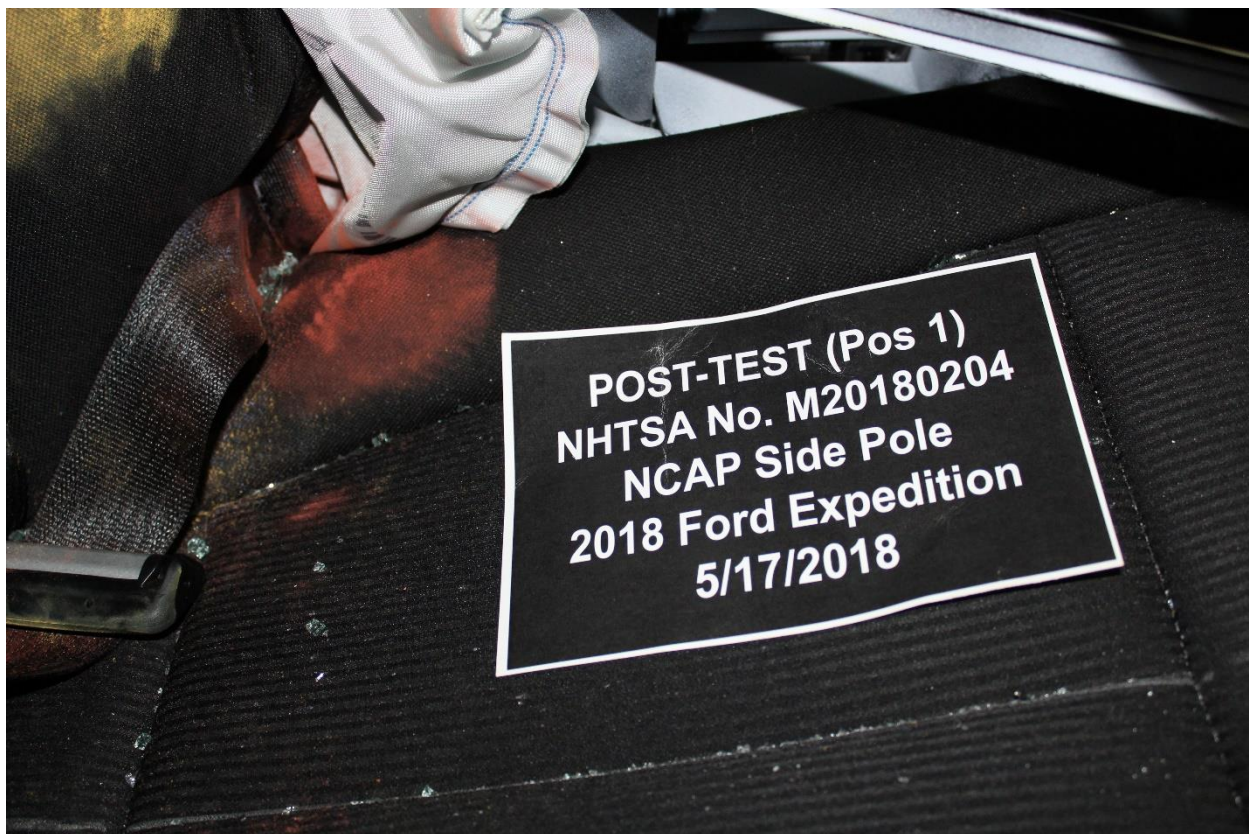
**Figure A-50: Post-Test Dummy Close-Up Pelvis Contact with Vehicle Interior View**

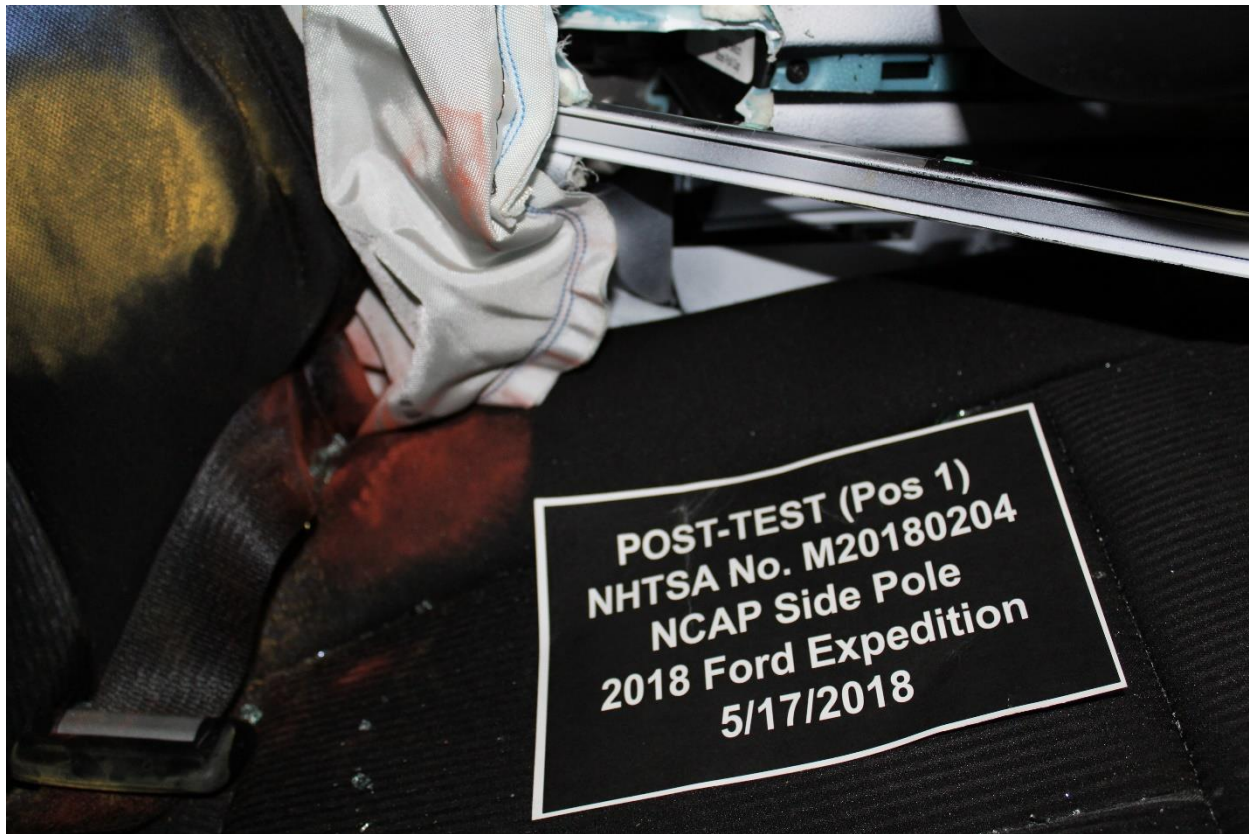
**Figure A-51: Post-Test Dummy Close-Up Pelvis Contact with Side Airbag View**

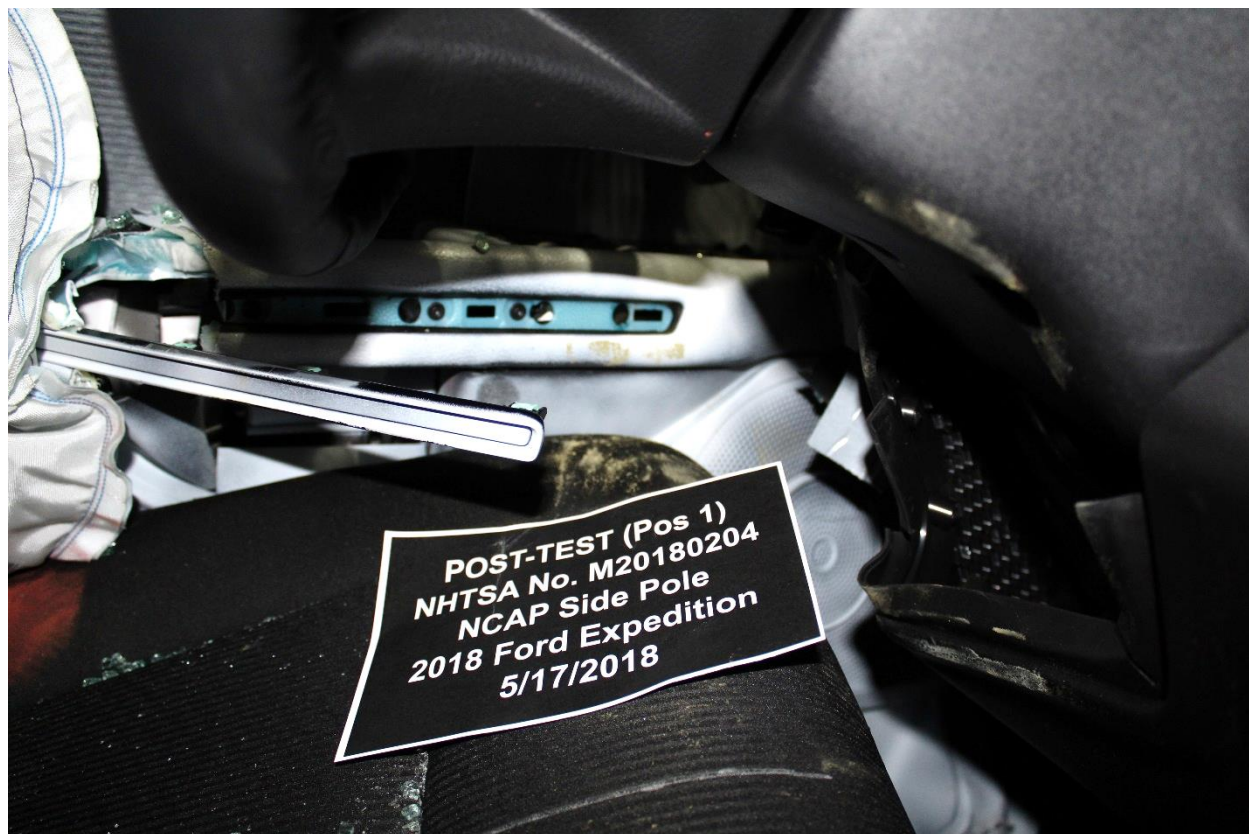
**Figure A-52: Post-Test Dummy Close-Up Knee Contact with Vehicle Interior View**

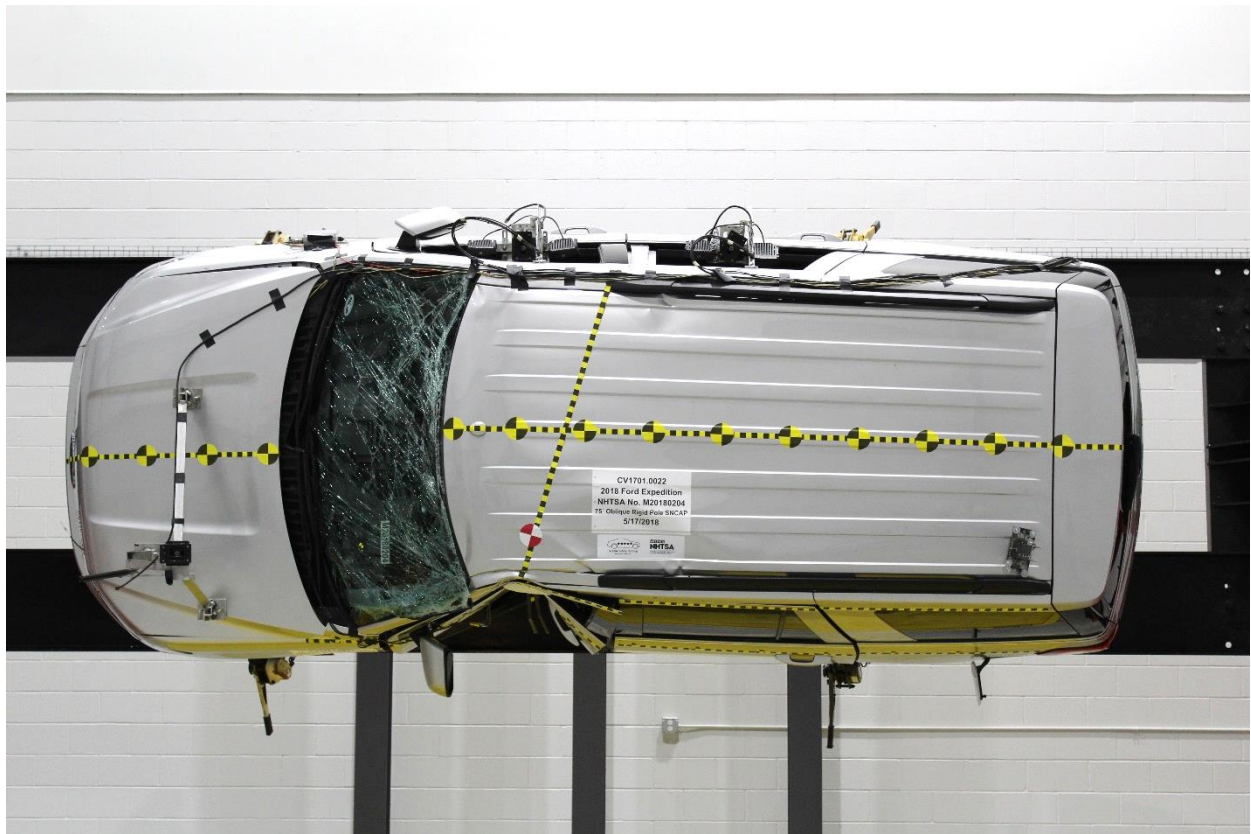
**Figure A-64: FMVSS No. 301 Static Rollover 90 Degrees**

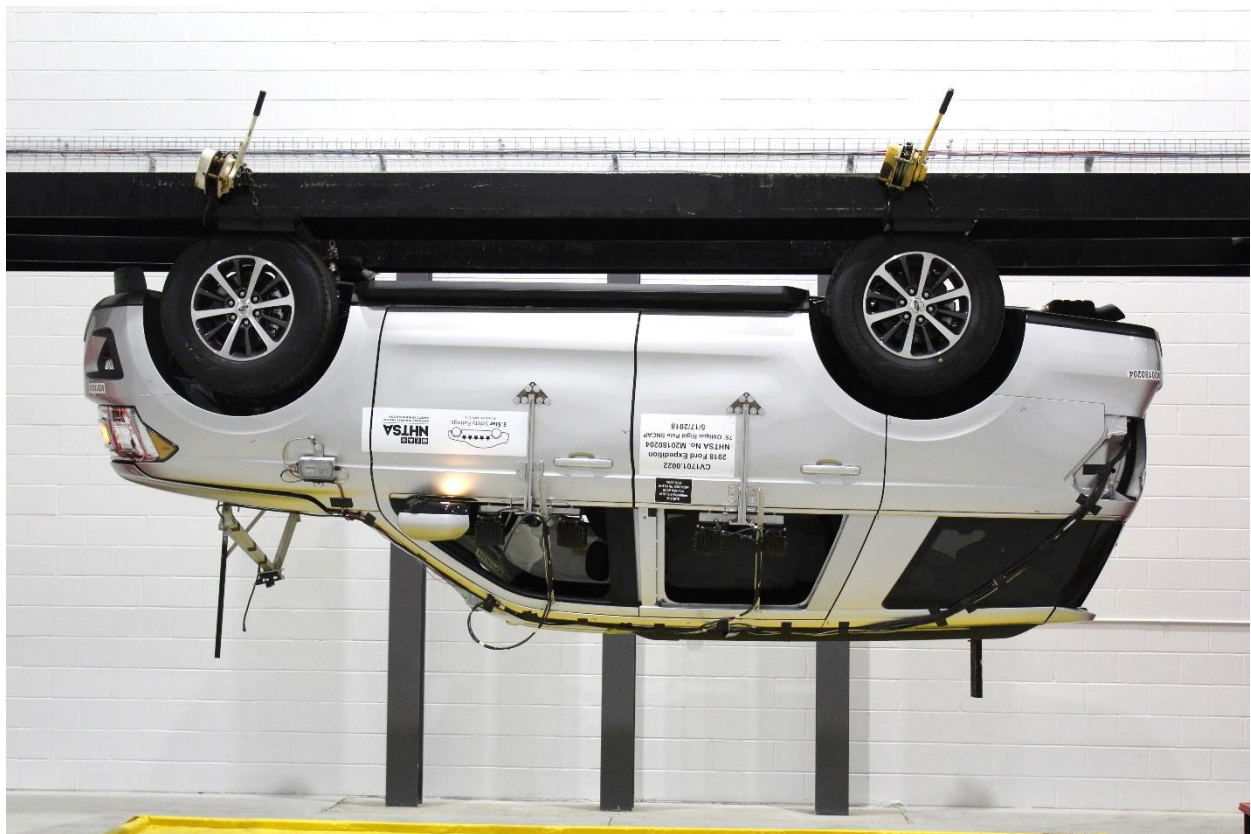
**Figure A-65: FMVSS No. 301 Static Rollover 180 Degrees**

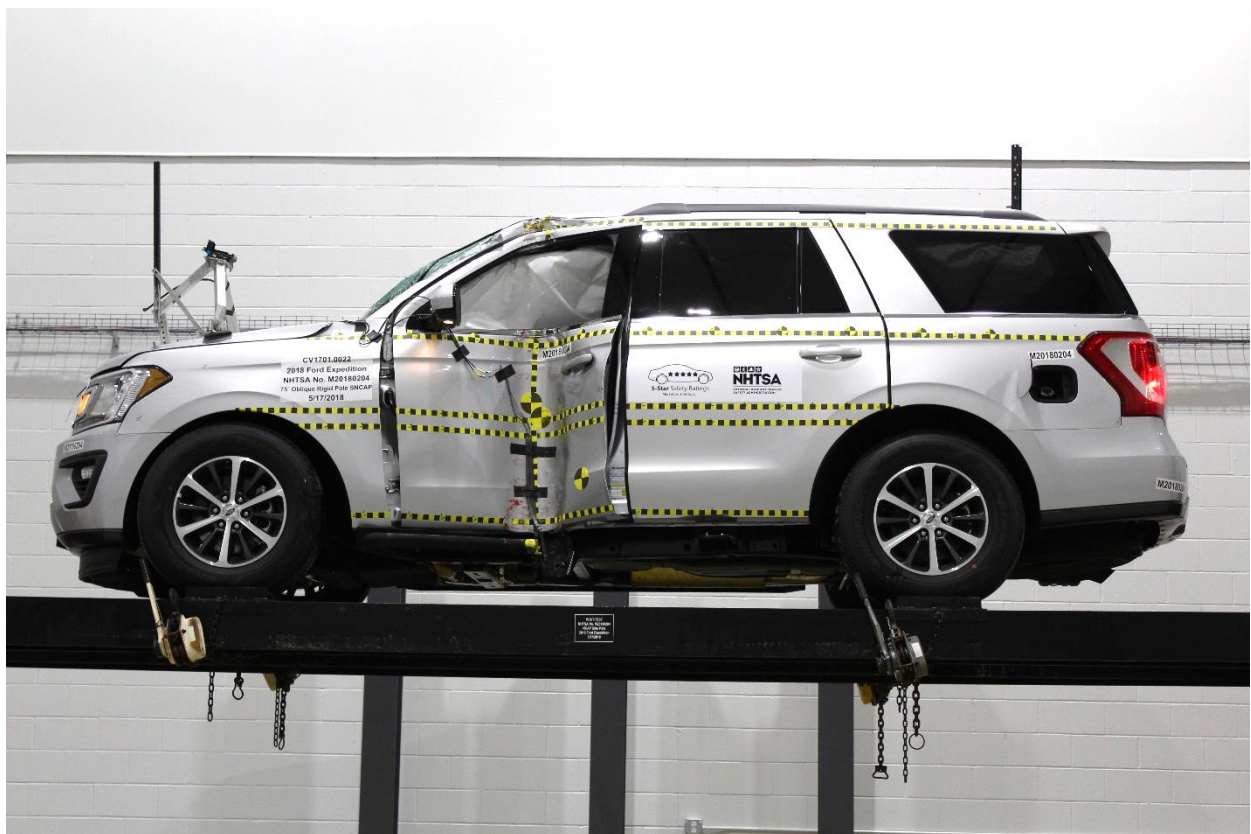
**Figure A-67: FMVSS No. 301 Static Rollover 360 Degrees**

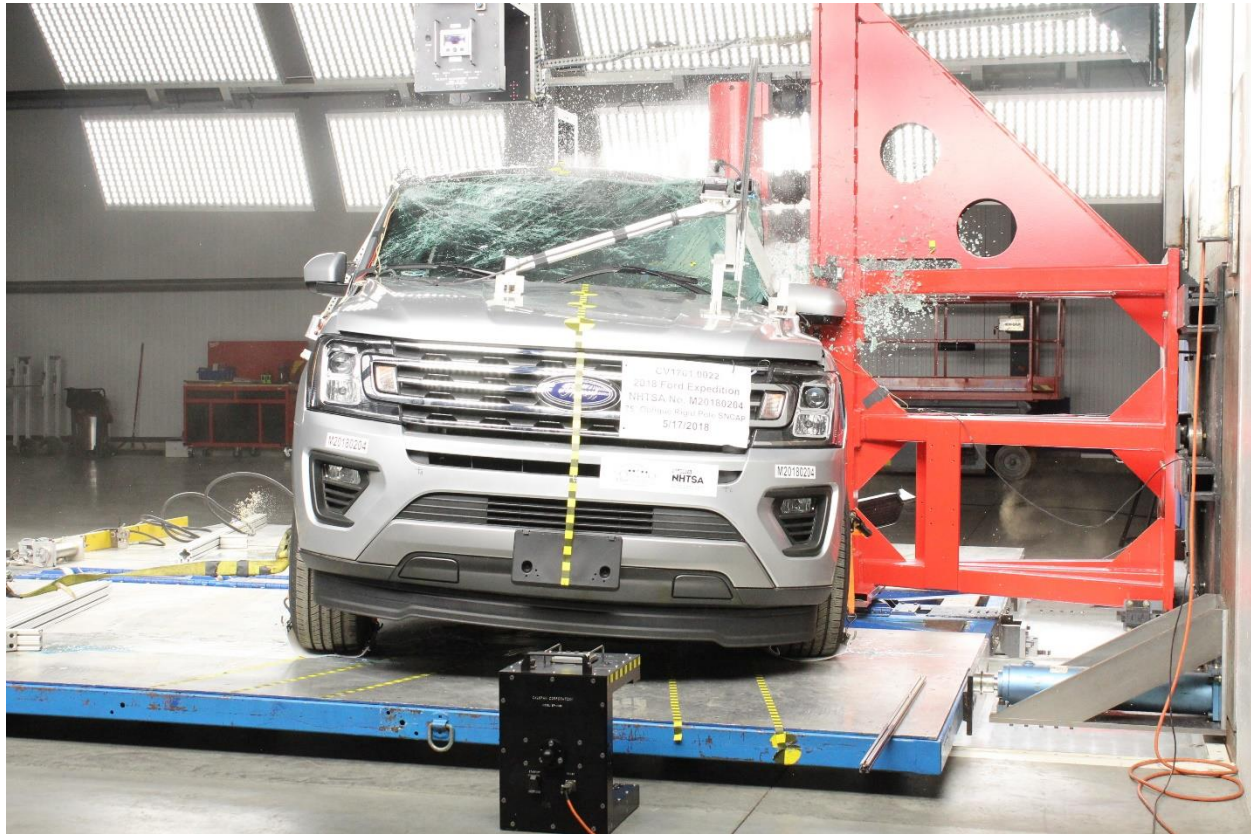
Figure A-68: Impact Event
