**REPORT NUMBER: NCAP-KAR-18-019**

**NEW CAR ASSESSMENT PROGRAM (NCAP)  
FRONTAL BARRIER IMPACT TEST**

**NISSAN MOTOR CO.  
2018 NISSAN MAXIMA S 4-DOOR SEDAN**

**FINAL REPORT**

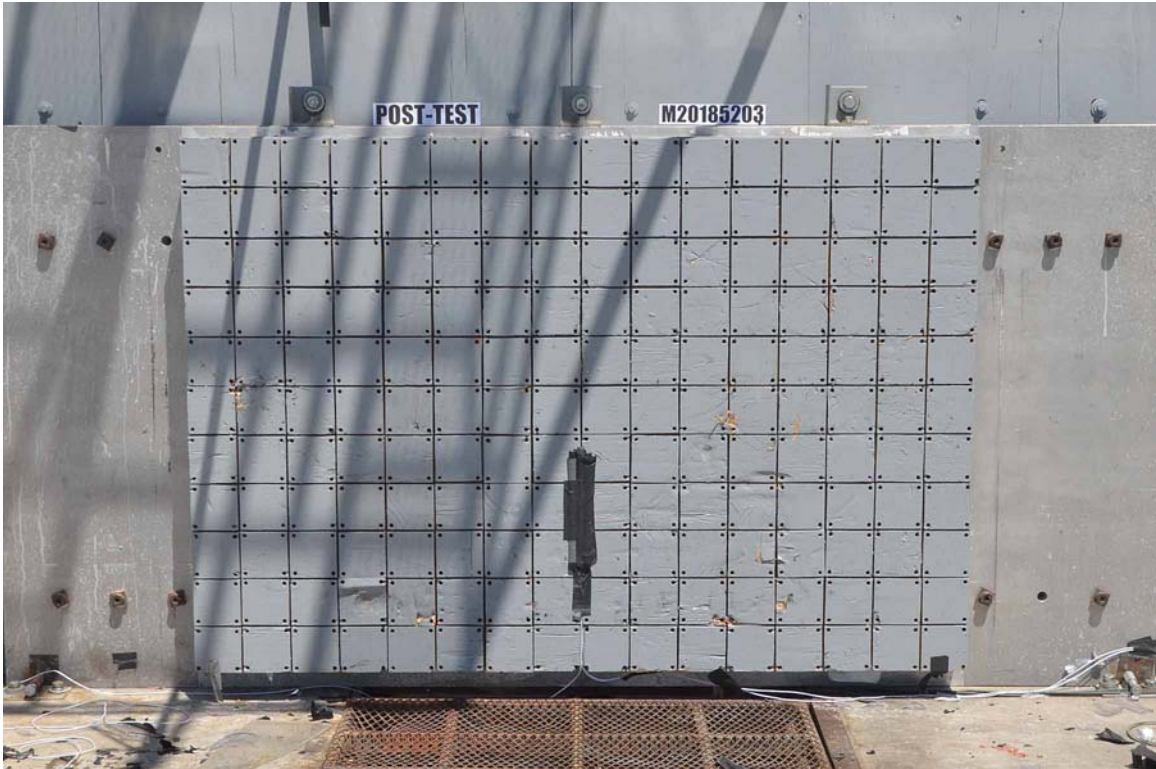
FIGURE 2. Pre-Test Load Cell Wall

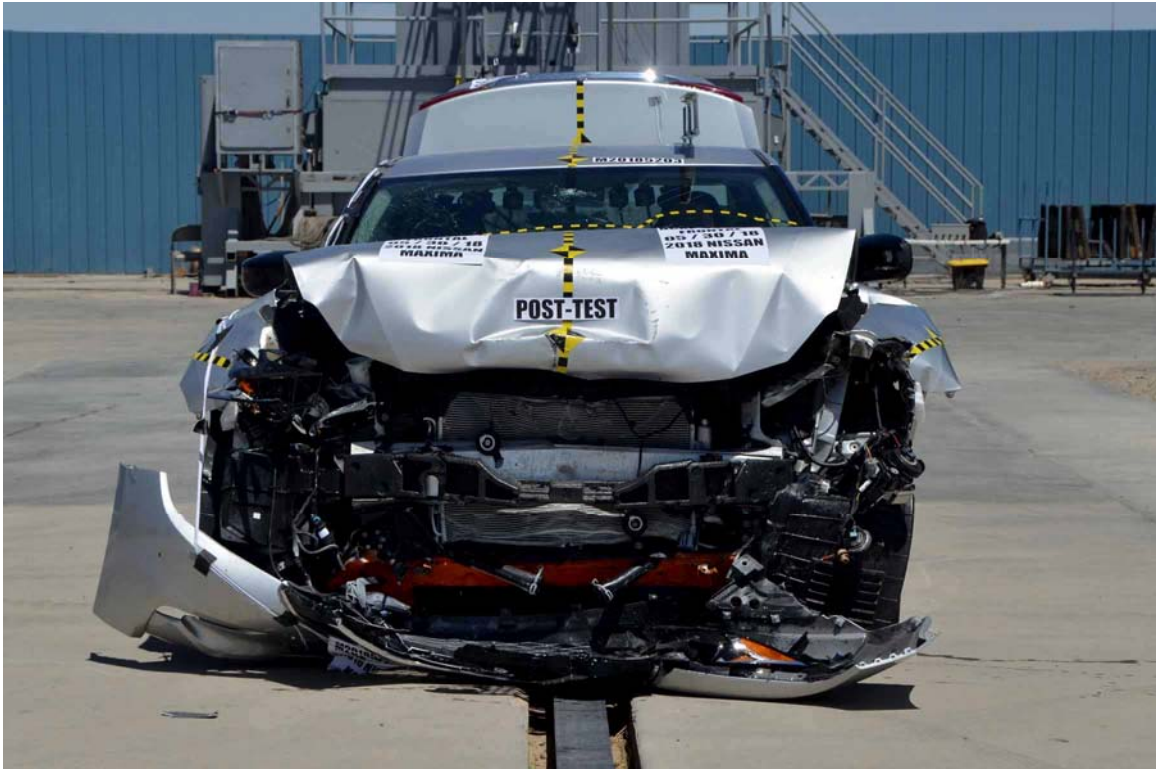
FIGURE 9. Post-Test Front View of Test Vehicle

The maximum static crush was 349 mm at DPD3 to the left of the vehicle's centerline. Both the driver and passenger side doors remained closed during the impact event and were operable after the impact.

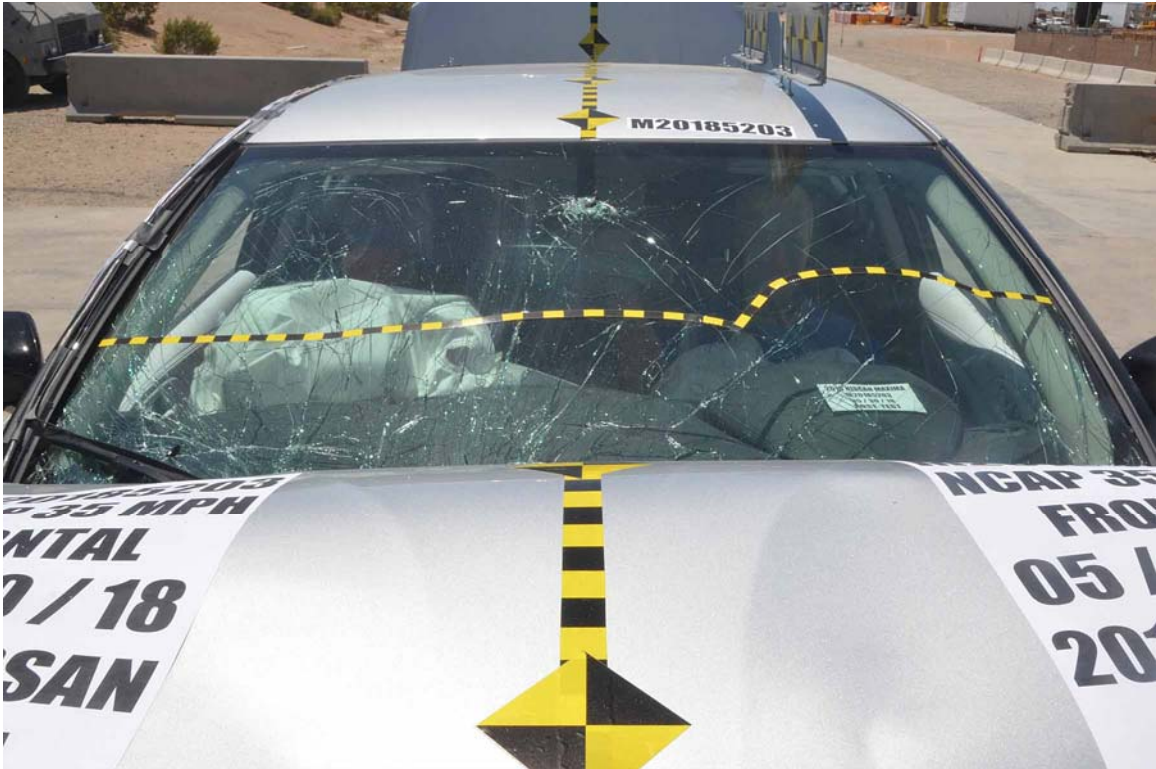
FIGURE 19. Post-Test Windshield View

There was 100% windshield retention and no intrusion into the protected zone of the windshield during the event.

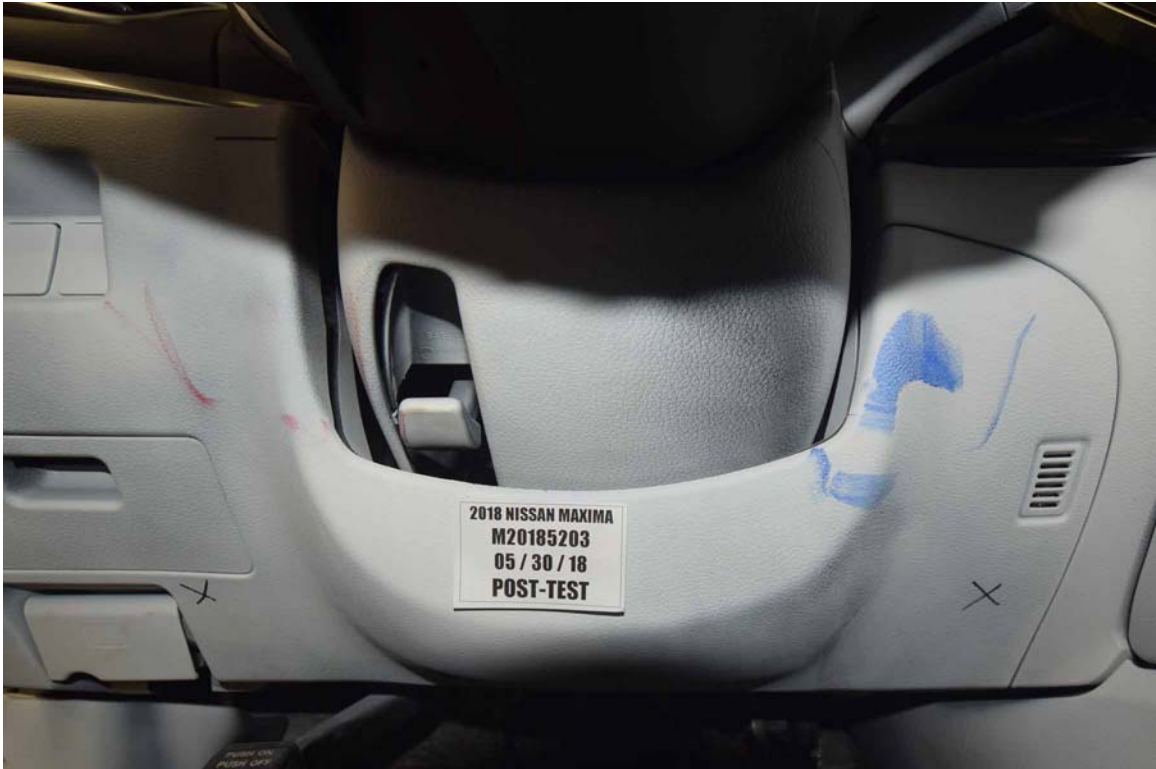
FIGURE 48a. Post-Test Driver Dummy Contact with Knee Bolster

The driver's visible contact points were as follows: The driver ATD's head contacted the frontal airbag and headrest. The upper torso contacted the frontal airbag. The left knee contacted the knee bolster and the steering column. The right knee contacted the knee bolster.

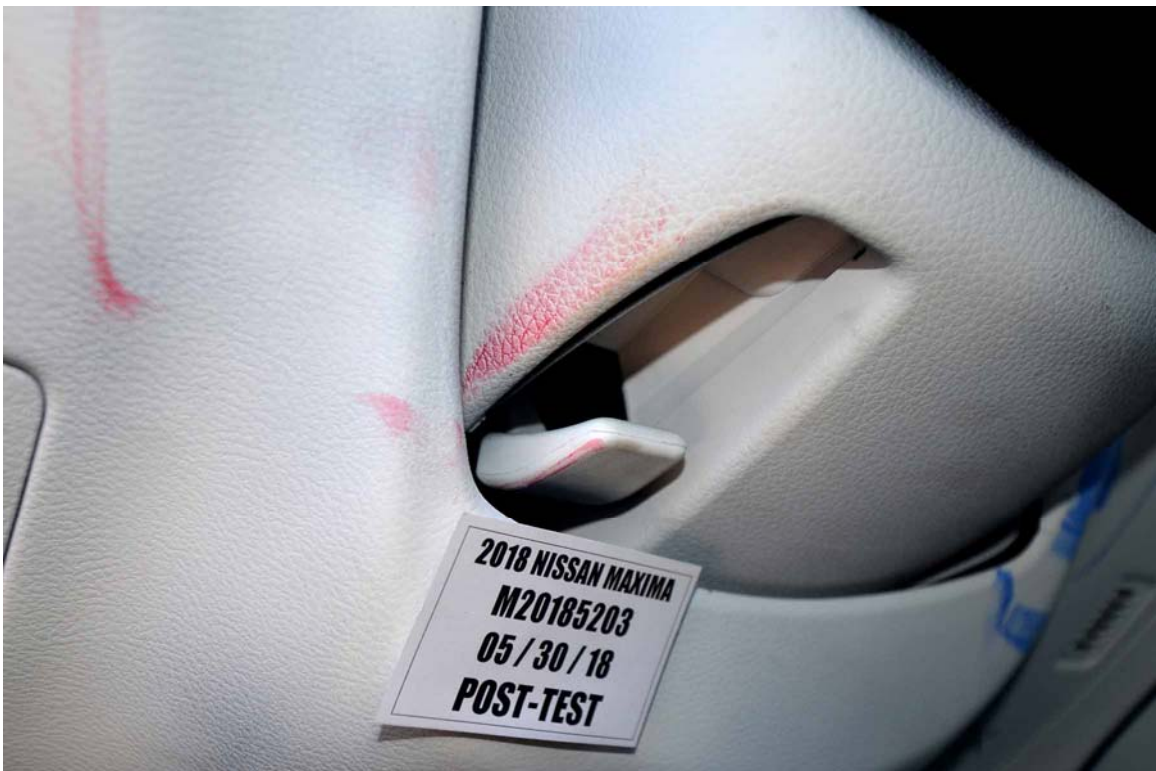
FIGURE 48b. Post-Test Driver Dummy Contact with Steering Column
