**REPORT NUMBER: SINCAP-CAL-18-008**

**NEW CAR ASSESSMENT PROGRAM (NCAP)  
MOVING DEFORMABLE BARRIER SIDE IMPACT TEST**

**Ford Motor Co.  
2018 Ford EcoSport  
SUV**

**NHTSA No: M20180202**

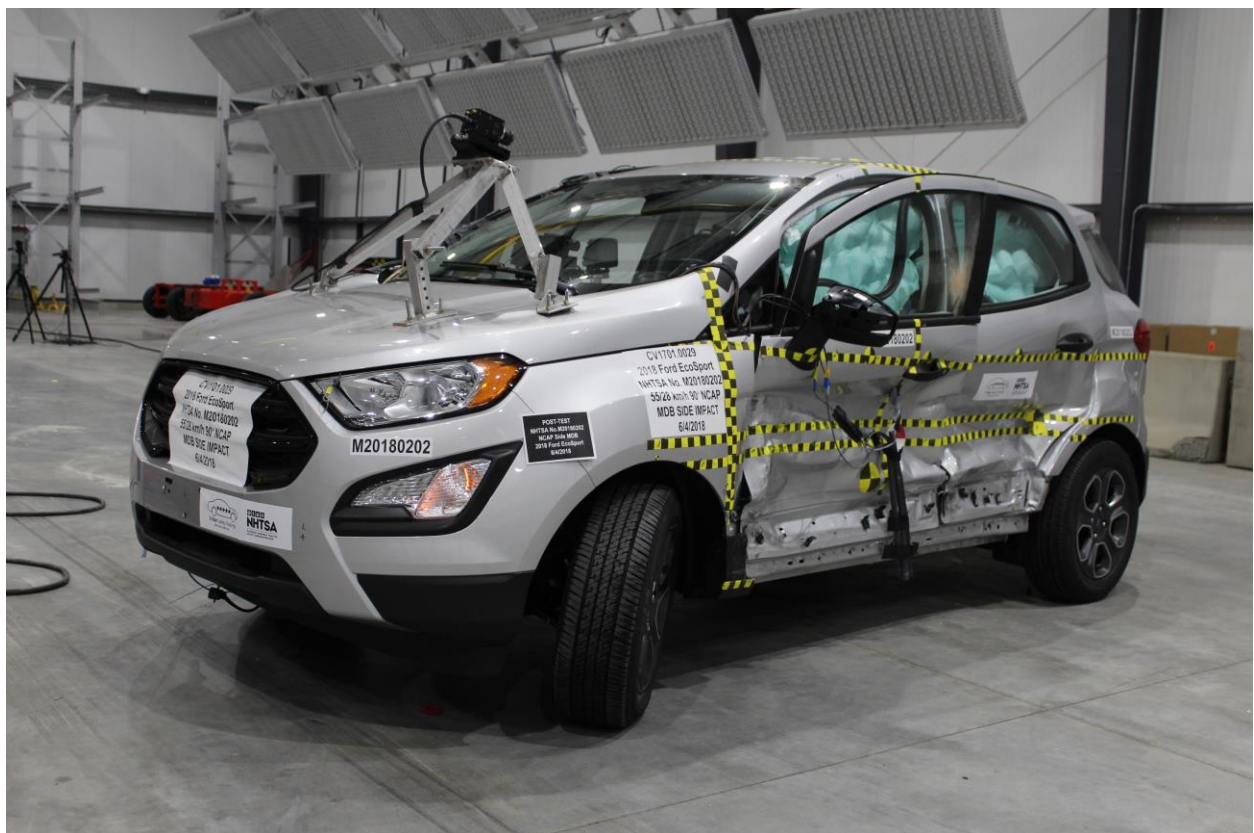
**Figure A-6: Post-Test Left Front  $\frac{3}{4}$  View of Test Vehicle**

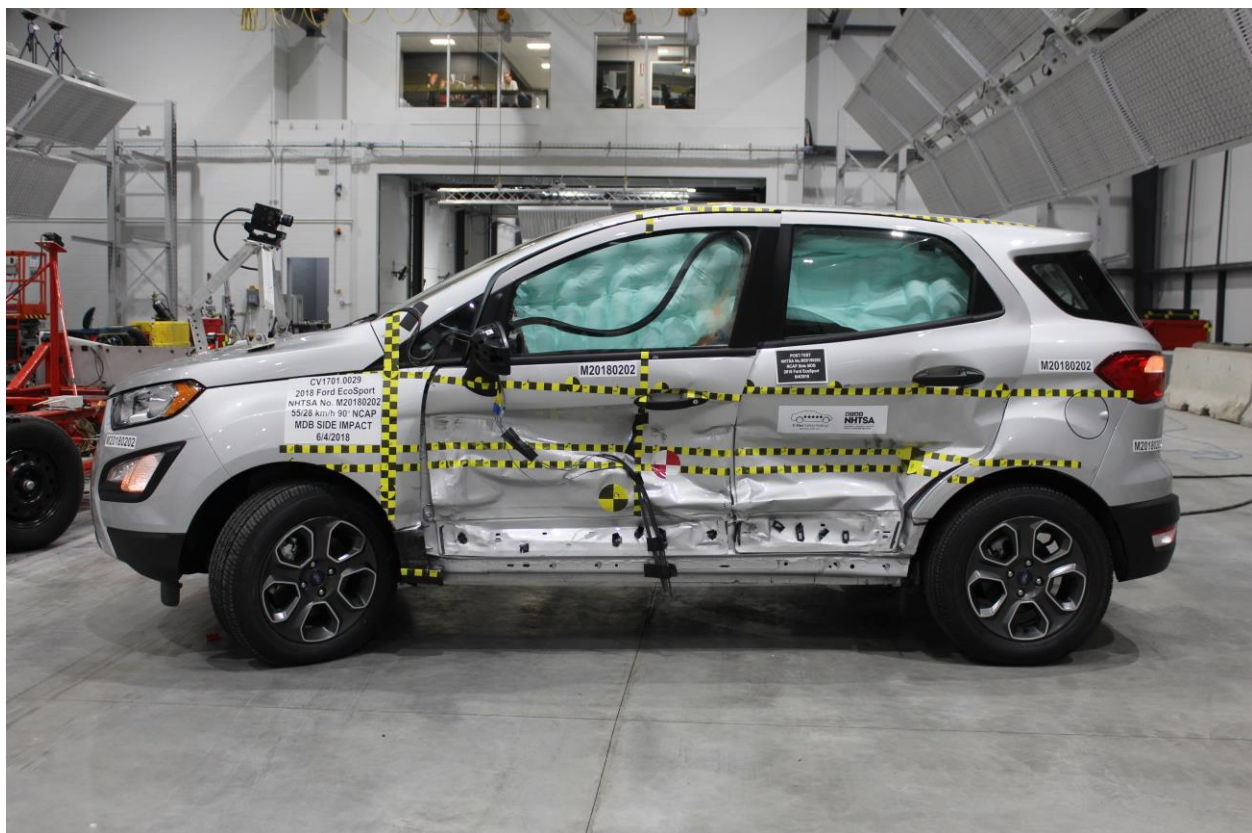
**Figure A-8: Post-Test Left Side View of Test Vehicle**

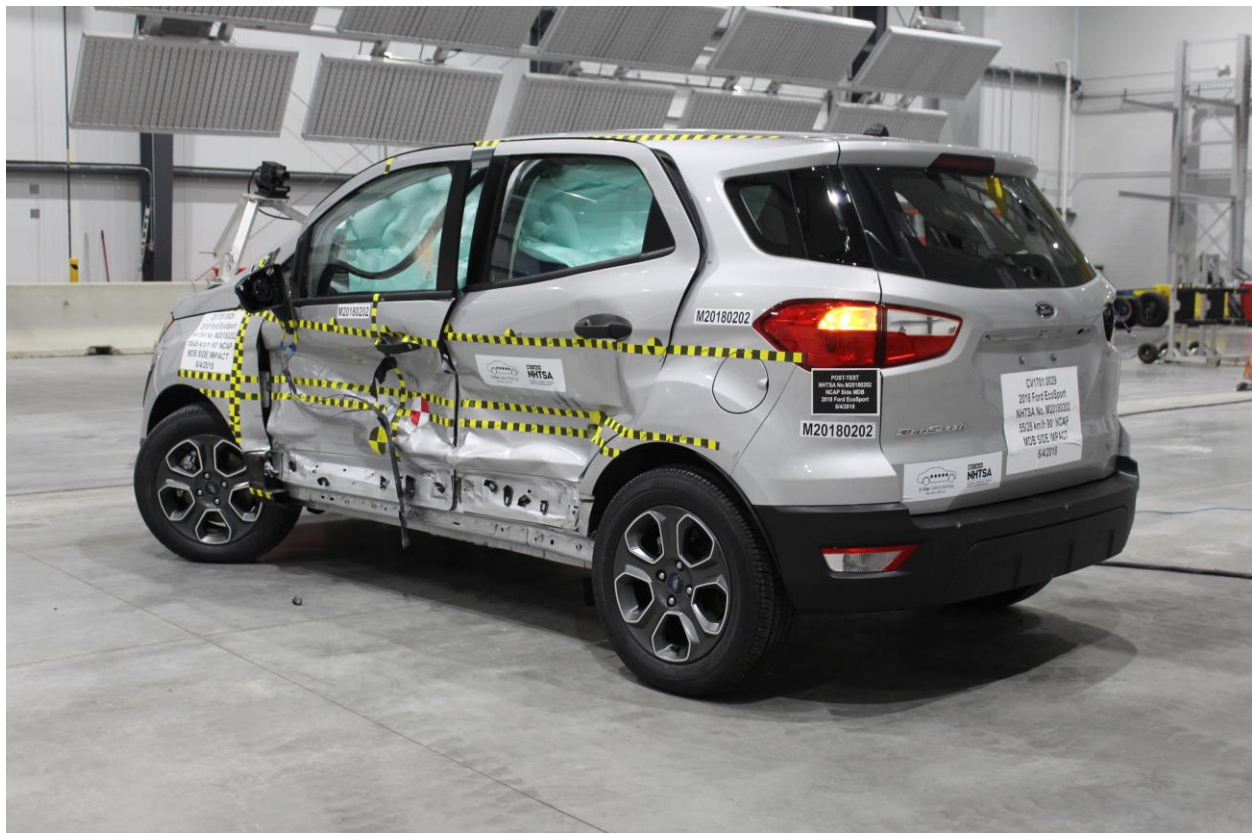
**Figure A-10: Post-Test Left Rear  $\frac{3}{4}$  View of Test Vehicle**

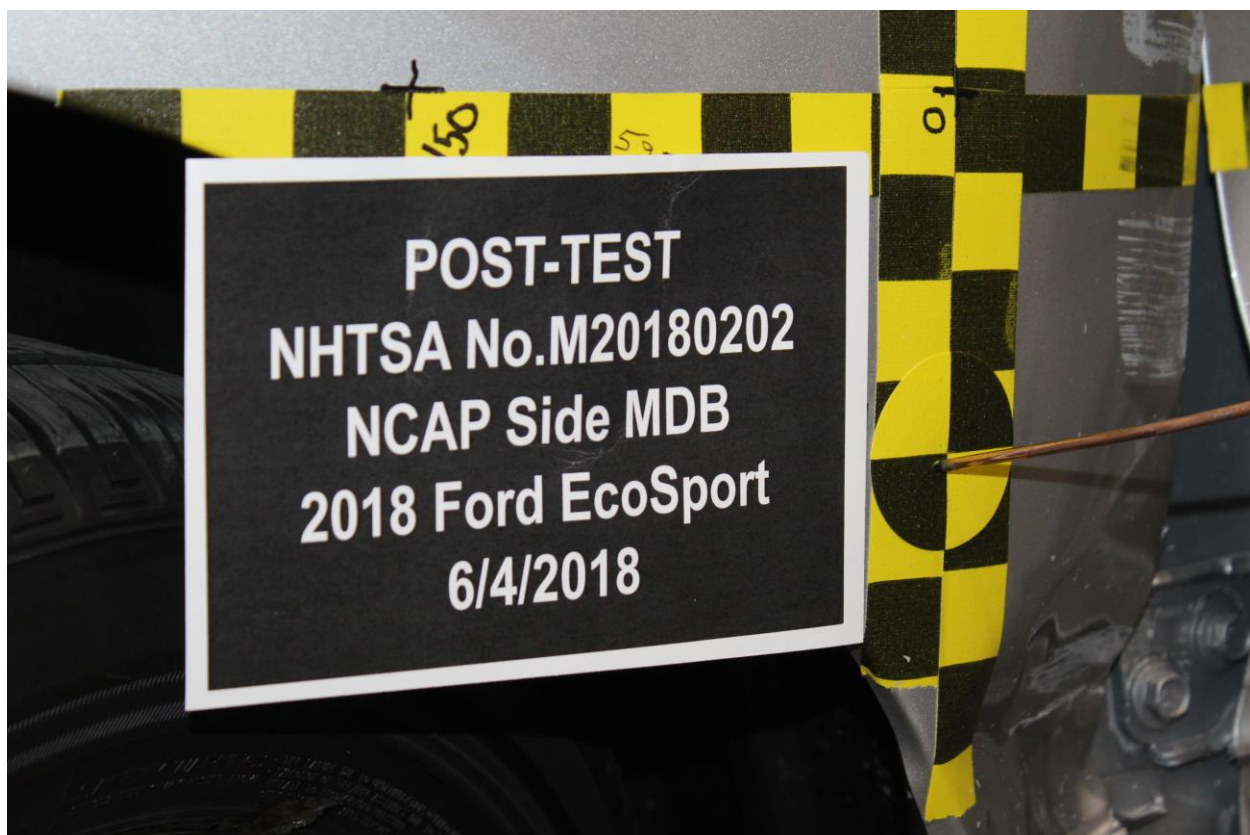
Figure A-20: Post-Test Close-up View of Impact Point Target

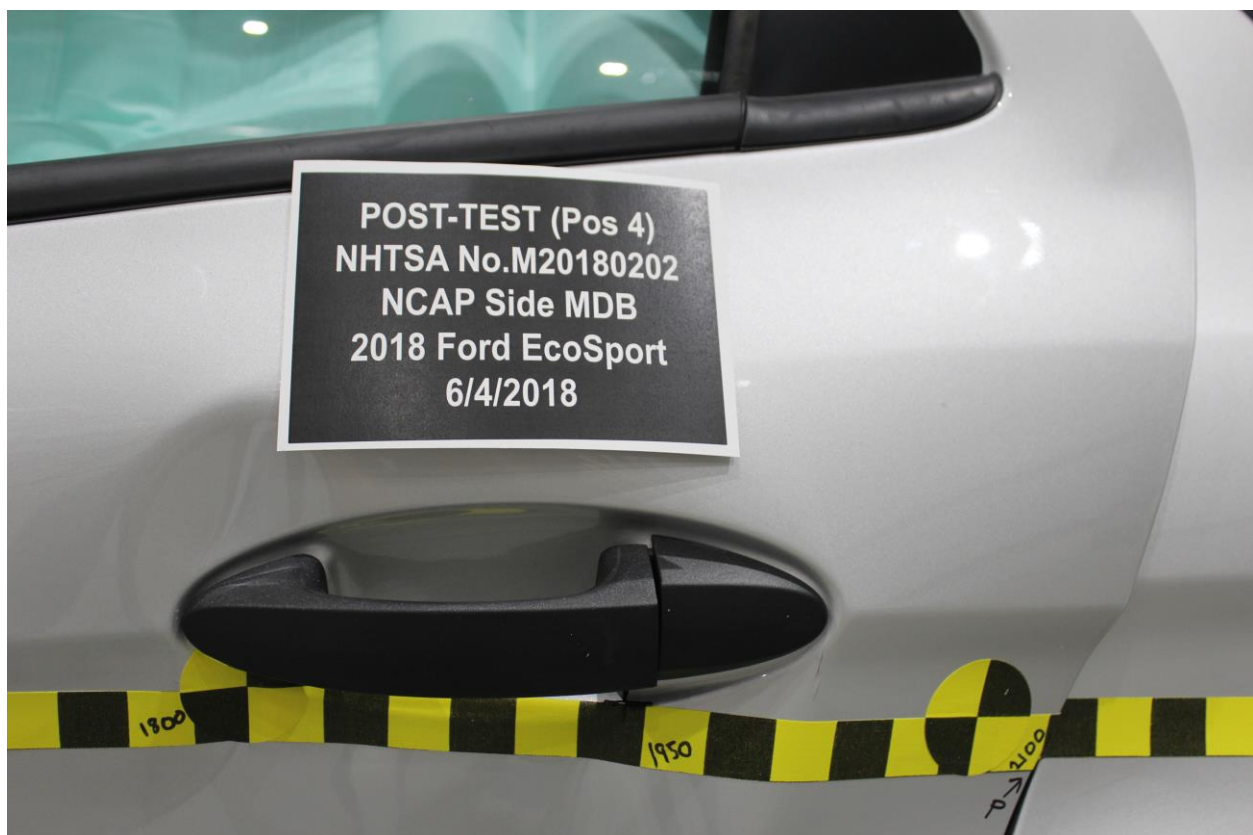
Figure A-24: Post-Test Left Rear Door Latch Close-Up

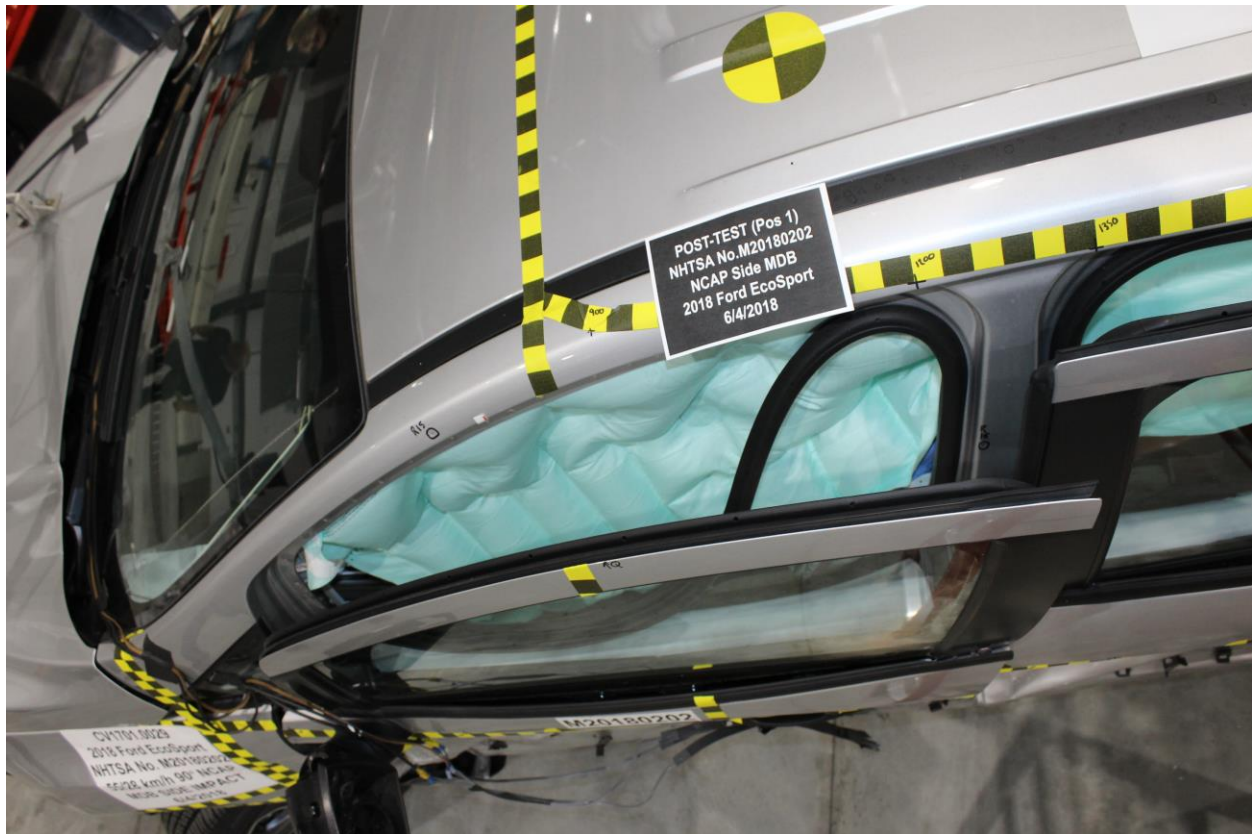
**Figure A-43: Post-Test Driver Dummy and Door Clearance View**

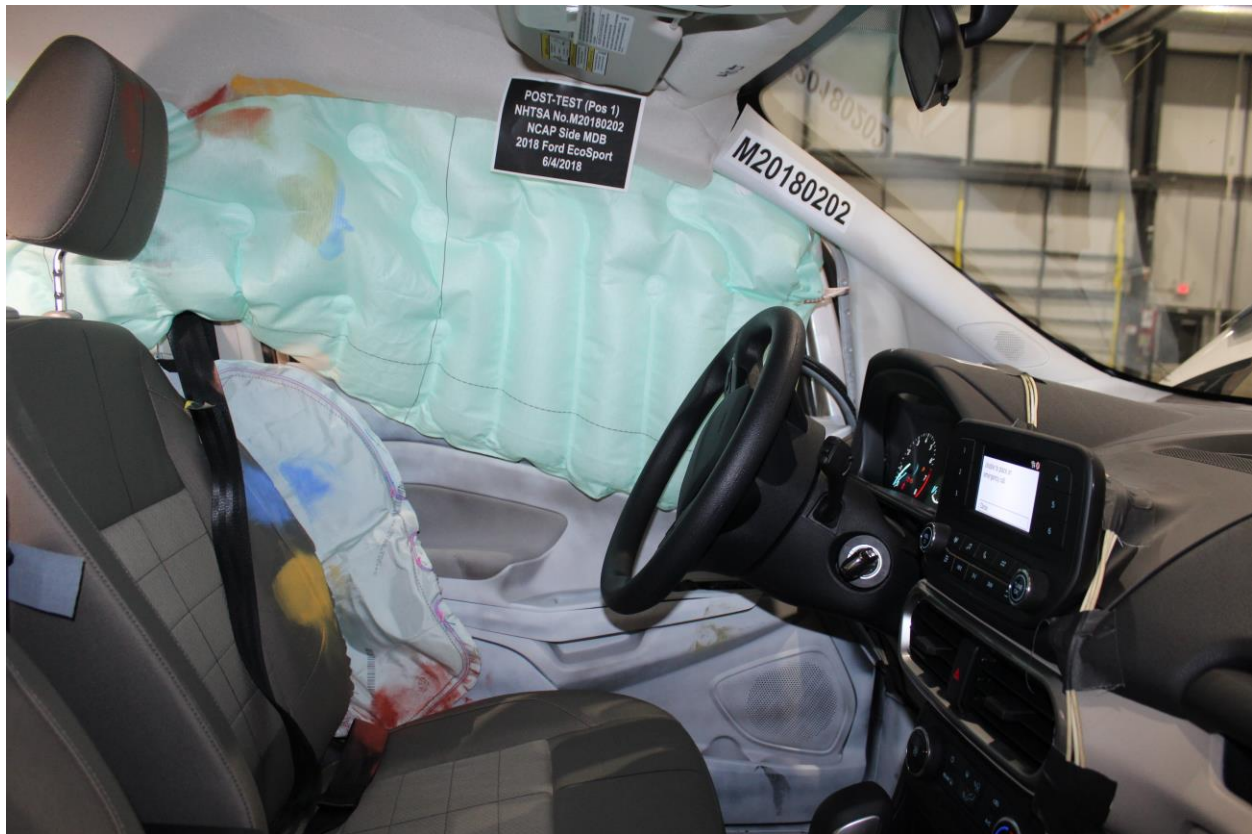
**Figure A-47: Post-Test Driver Inner Door Panel View**

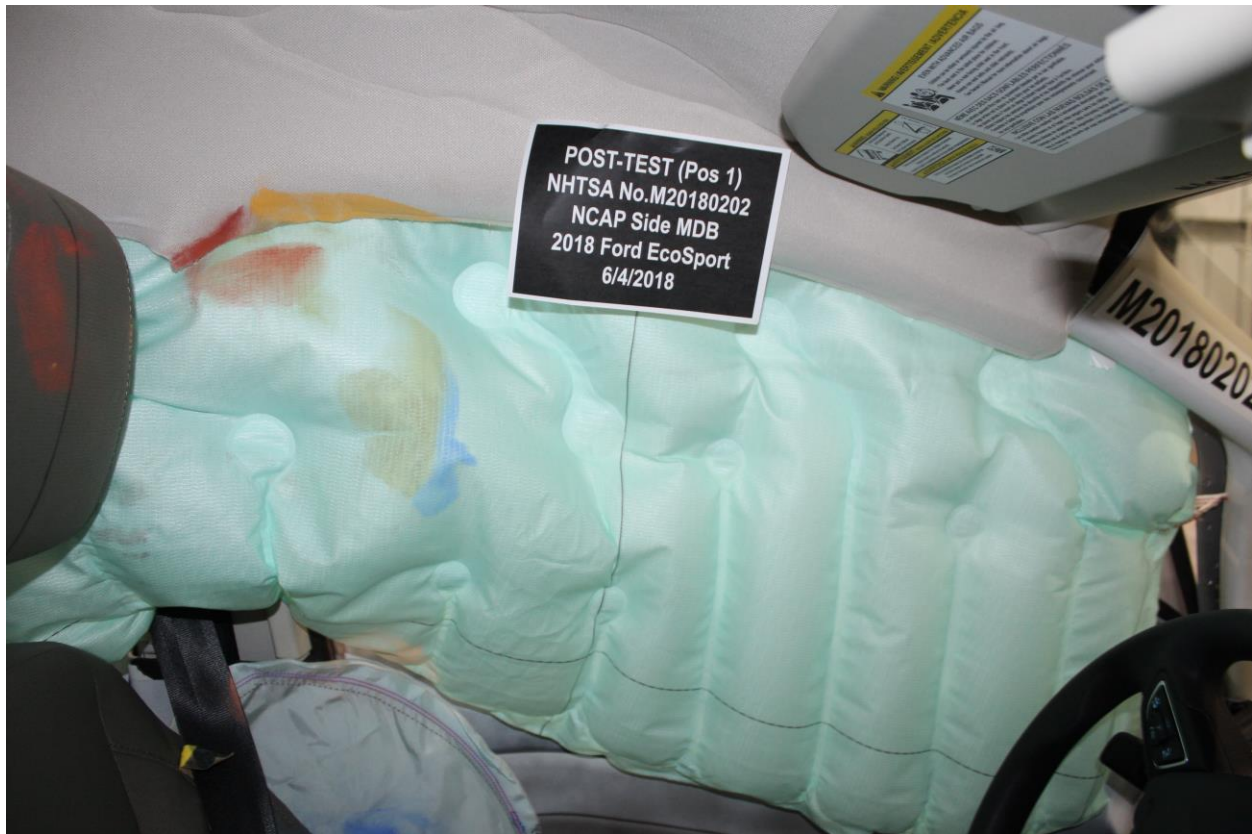
**Figure A-49: Post-Test Driver Dummy Close-Up Head Contact with Side Airbag View**

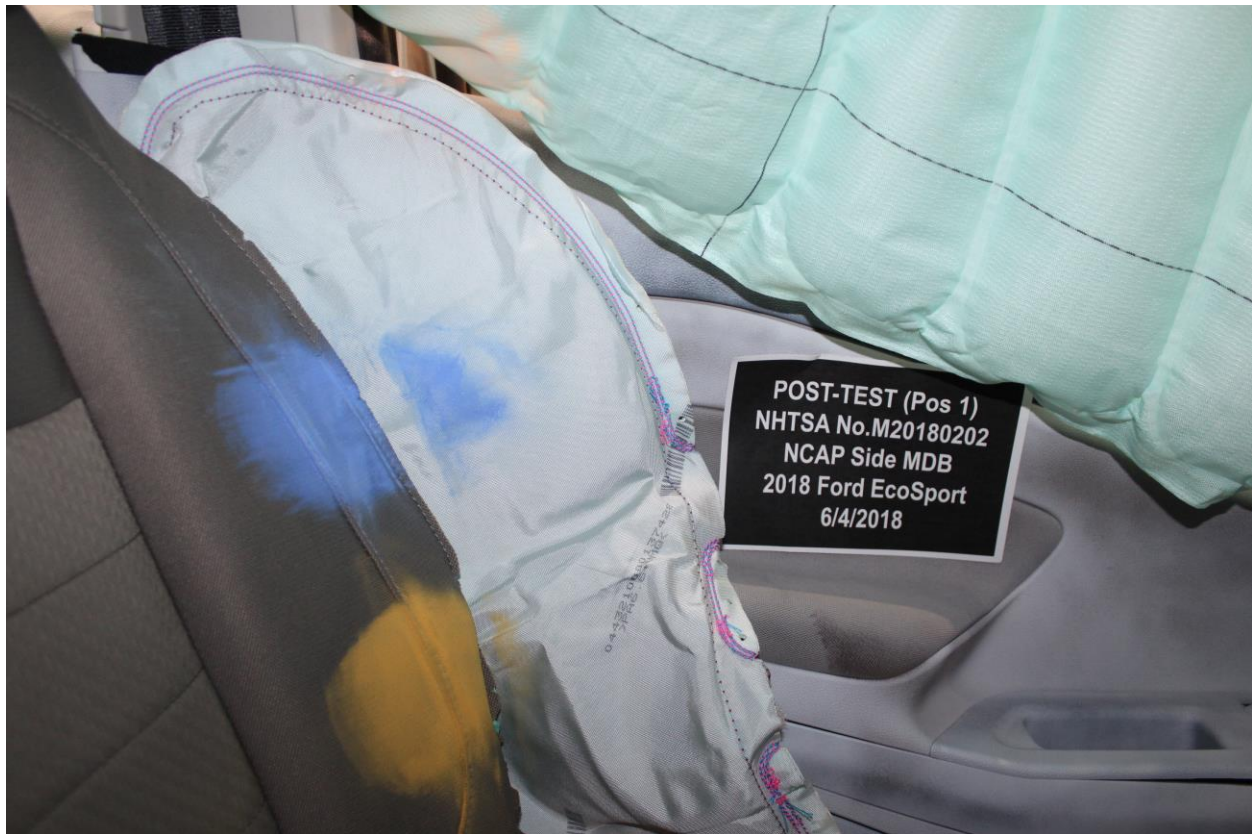
**Figure A-51: Post-Test Driver Dummy Close-Up Torso Contact with Side Airbag View**

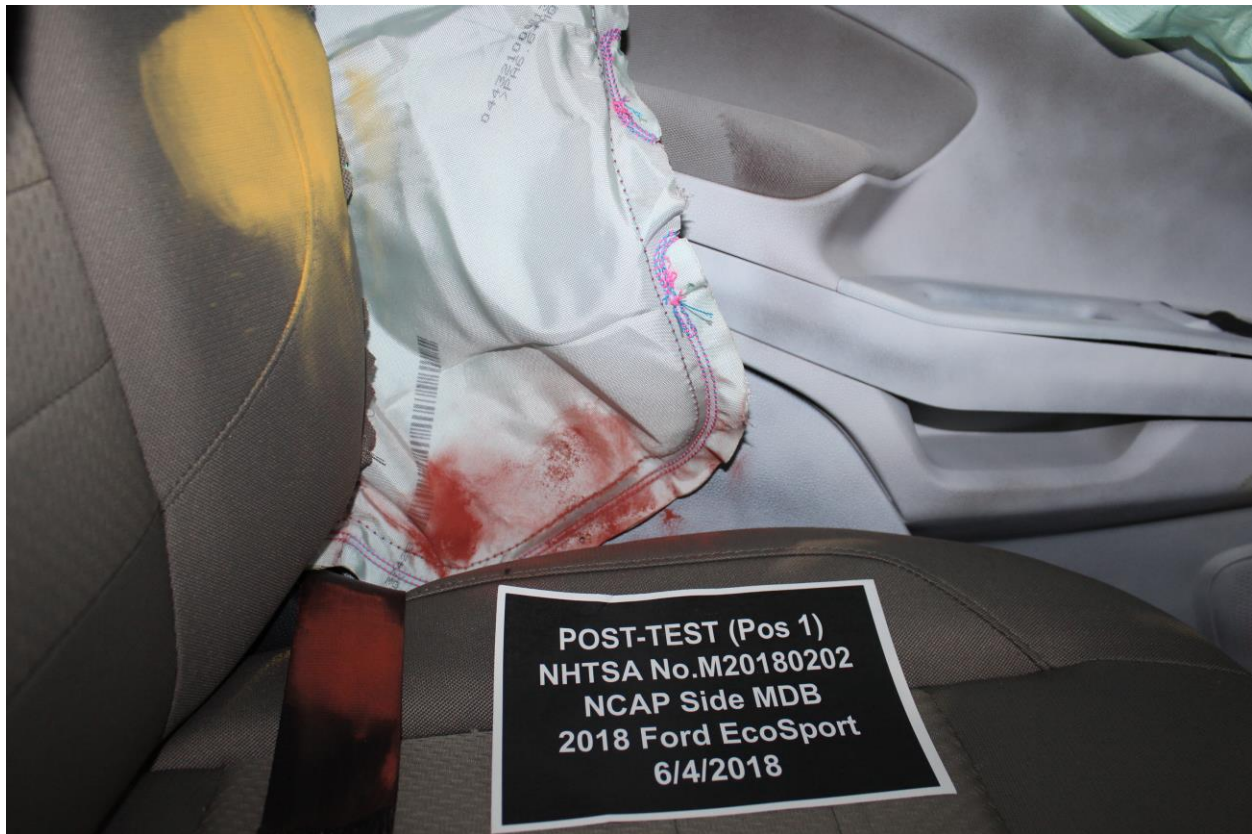
**Figure A-53: Post-Test Driver Dummy Close-Up Pelvis Contact with Side Airbag View**

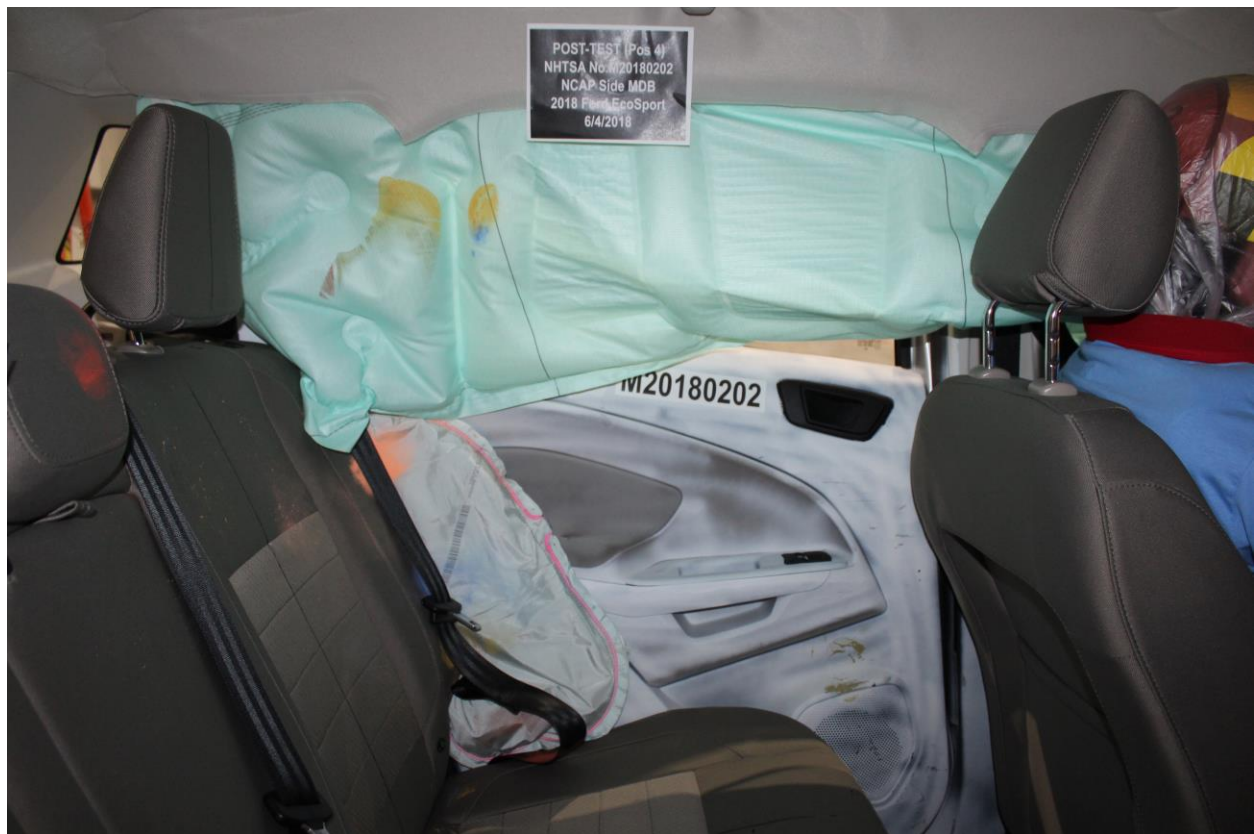
**Figure A-74: Post-Test Passenger Inner Door Panel View**

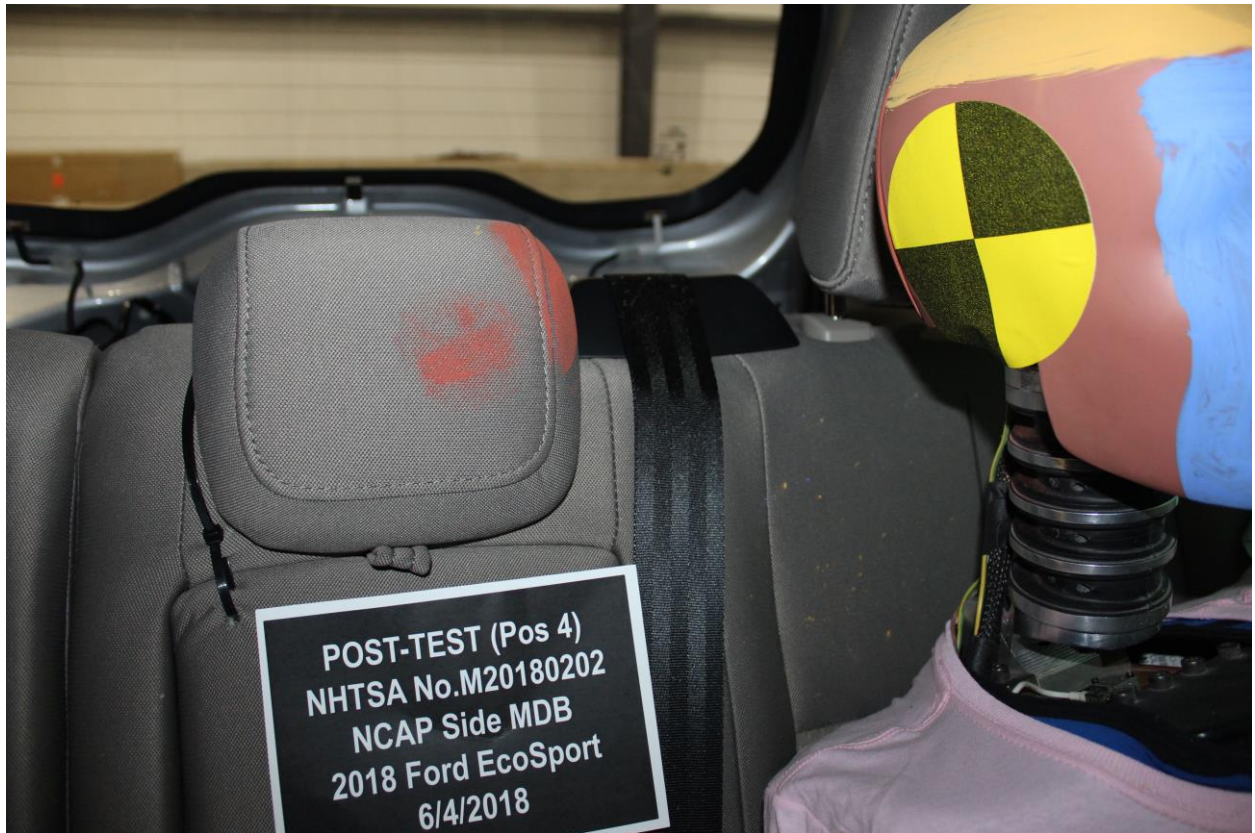
**Figure A-75: Post-Test Rear Passenger Dummy Close-Up Head Contact with Vehicle View**

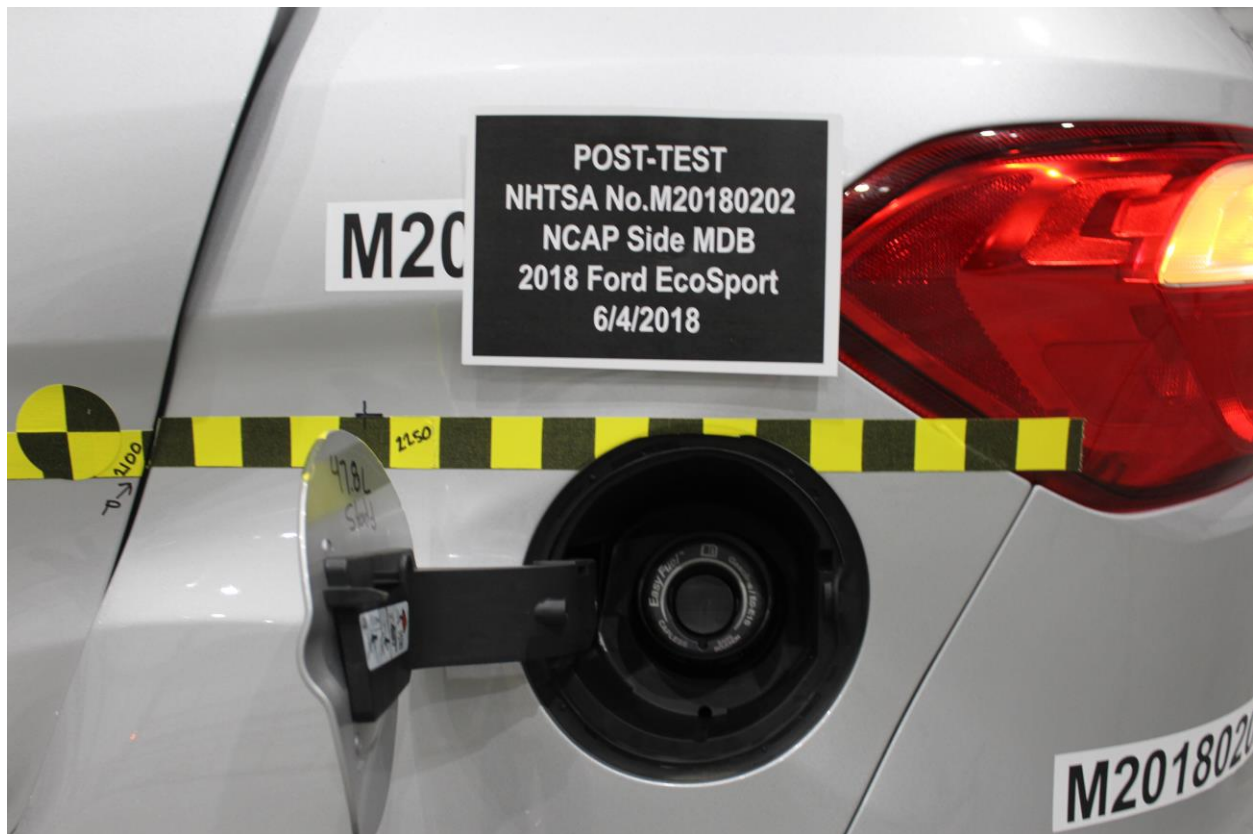
**Figure A-83: Post-Test View of Fuel Filler Cap or Fuel Filler Neck**

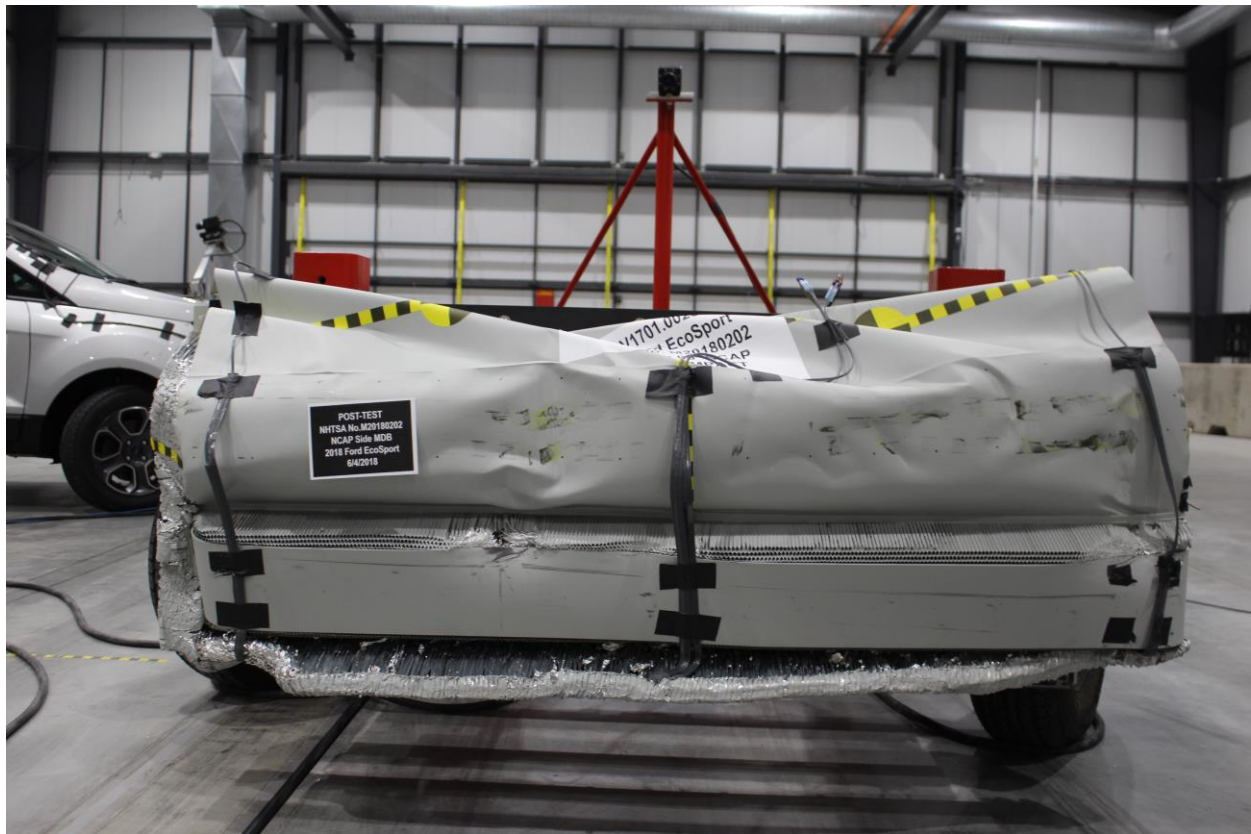
**Figure A-85: Post-Test Front View of MDB Impactor Face**

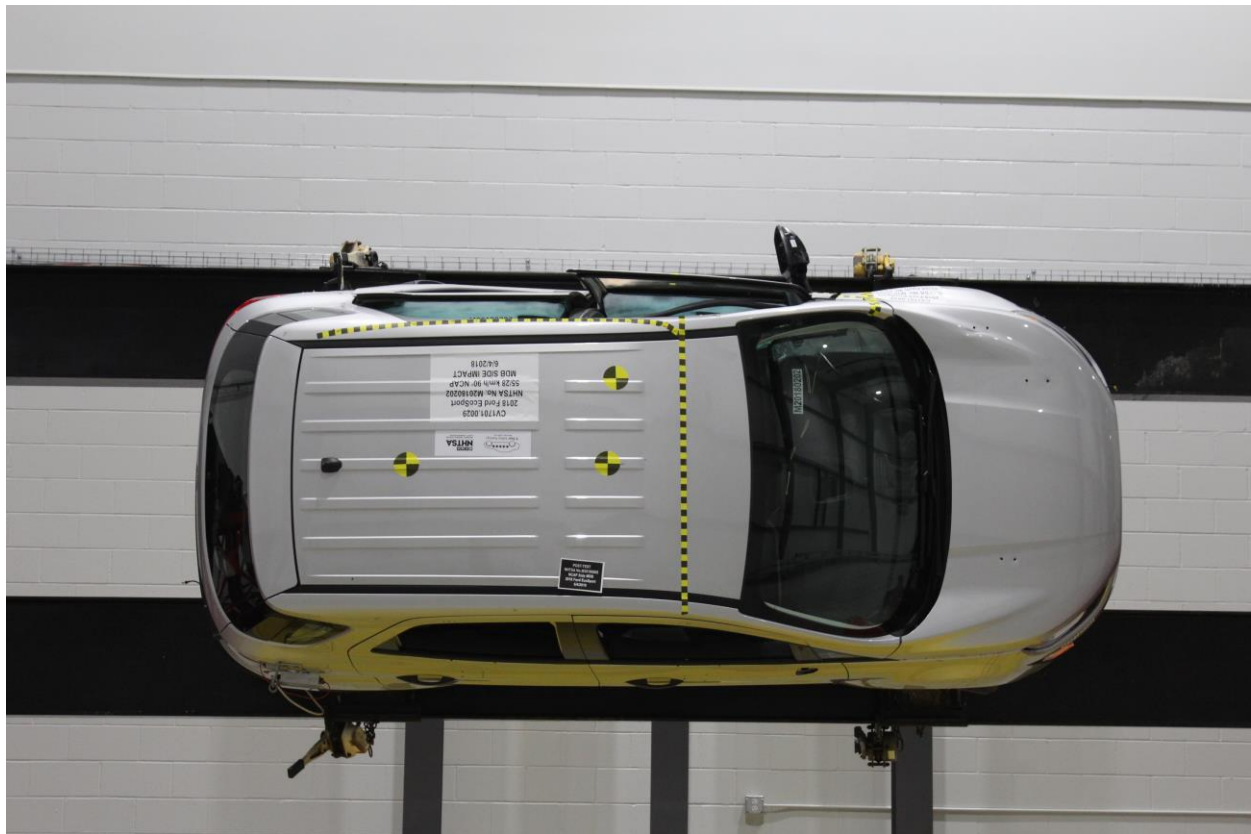
**Figure A-99: FMVSS No. 301 Static Rollover 270 Degrees**
