**REPORT NUMBER: SPNCAP-CAL-18-008**

**NEW CAR ASSESSMENT PROGRAM (NCAP)  
SIDE IMPACT POLE TEST**

**Ford Motor Co., LTD.  
2018 Ford Fiesta  
Four Door Sedan**

**FINAL REPORT**

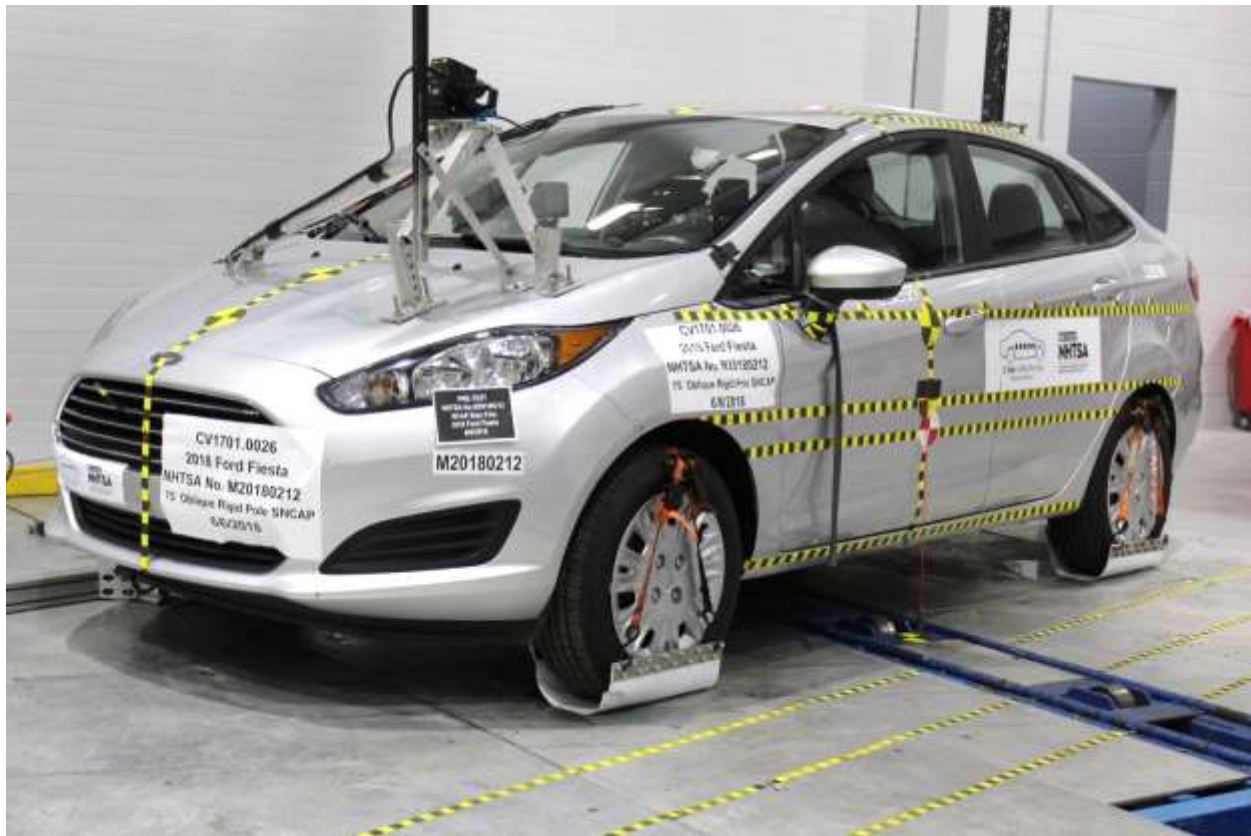
**Figure A-4: Post-Test Frontal View of Test Vehicle**

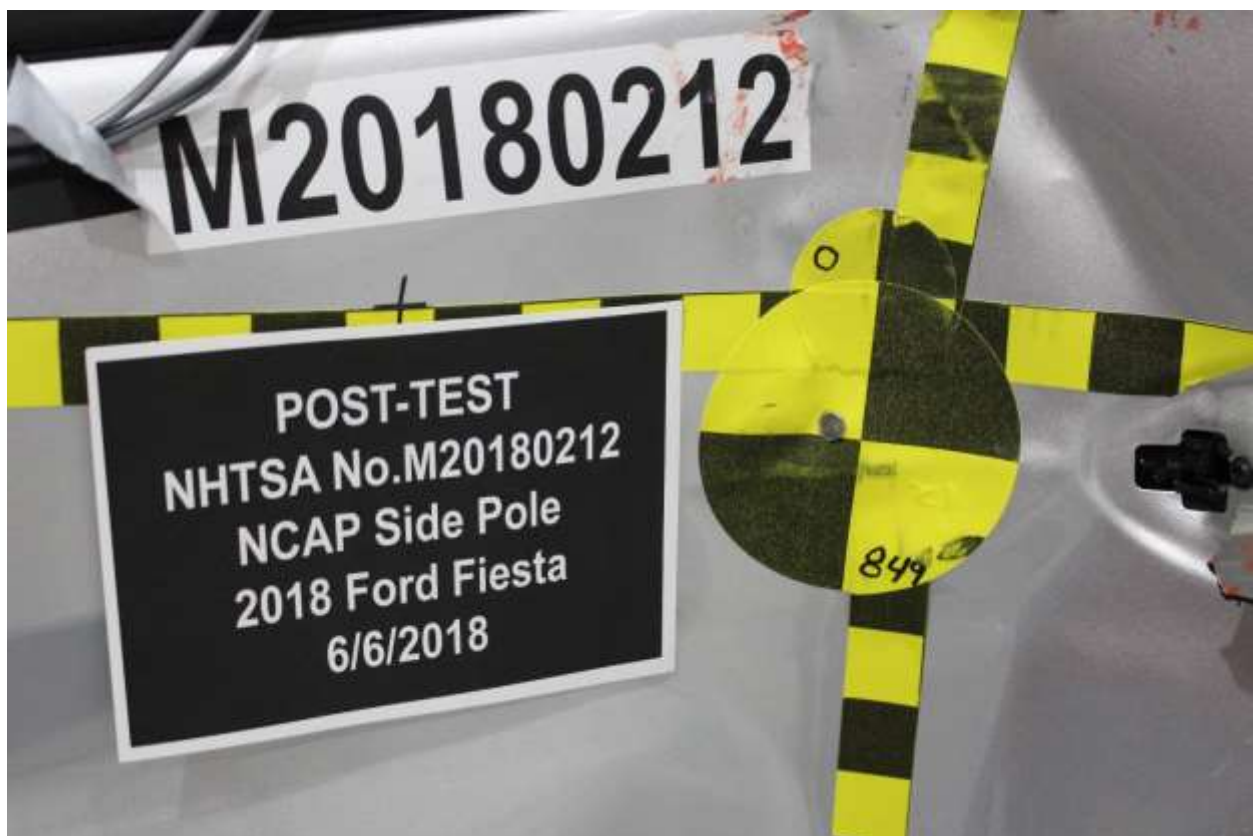
Figure A-20: Post-Test Close-Up View of Impact Point Target Showing Impact Location

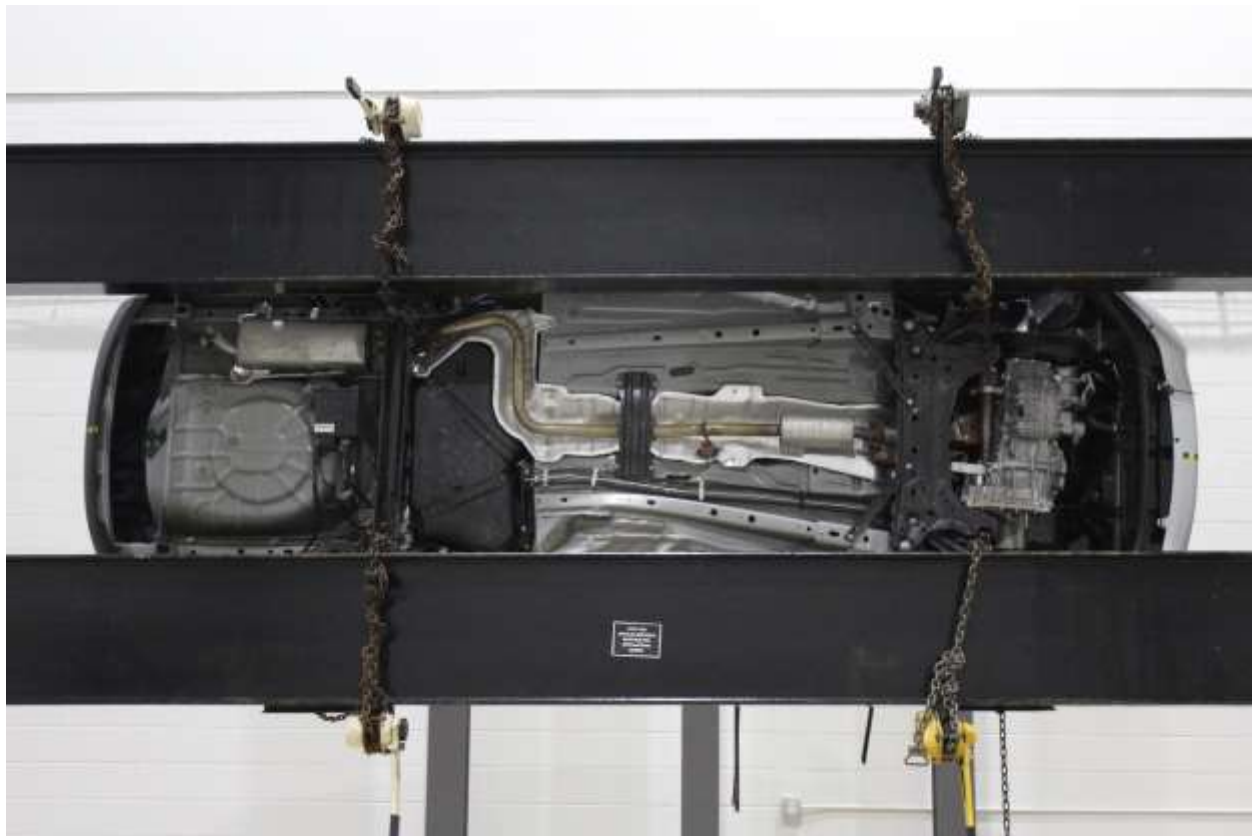
**Figure A-63: FMVSS No. 301 Static Rollover 0 Degrees**
