**REPORT NUMBER: SINCAP-CAL-18-011**

**NEW CAR ASSESSMENT PROGRAM (NCAP)  
MOVING DEFORMABLE BARRIER SIDE IMPACT TEST**

**Mazda Motor Corporation  
2018 Mazda CX-5  
Four Door SUV**

**NHTSA No: O20185400**

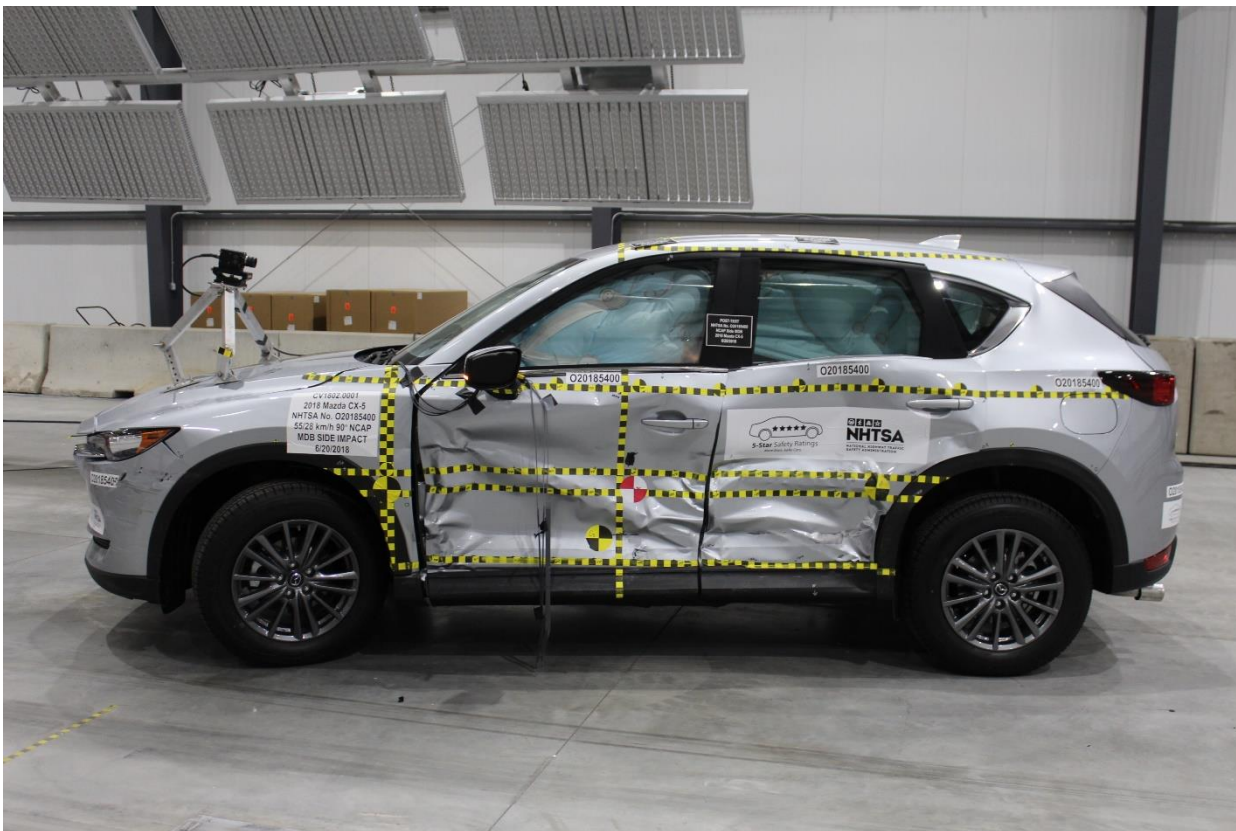
**Figure A-8: Post-Test Left Side View of Test Vehicle**

Critical Areas of Performance	Observations and Conclusions
Pillar Performance	B-Pillar Buckled
Sill Separation	None
Windshield Damage	None
Side Window Damage	Driver Window has some cracks from Driver's Shoulder
Other Notable Effects	None

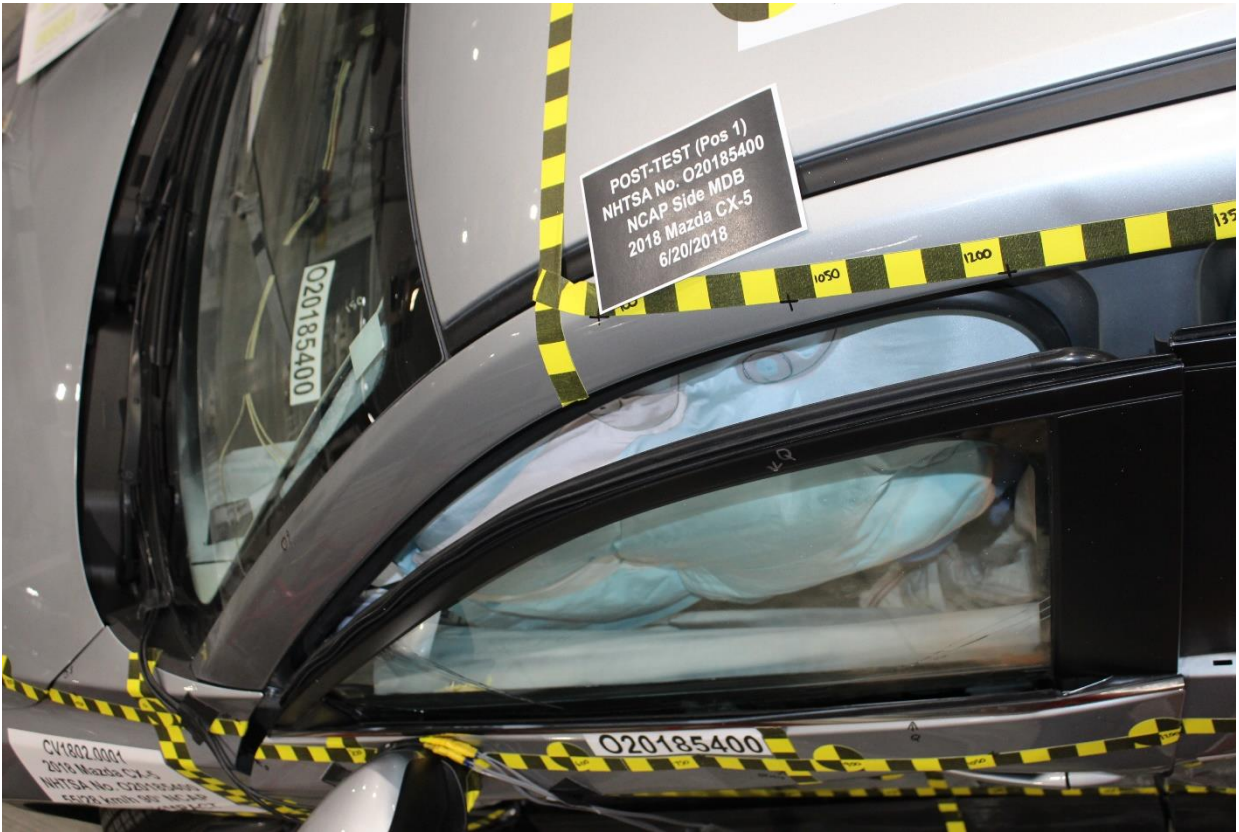
**Figure A-43: Post-Test Driver Dummy and Door Clearance View**

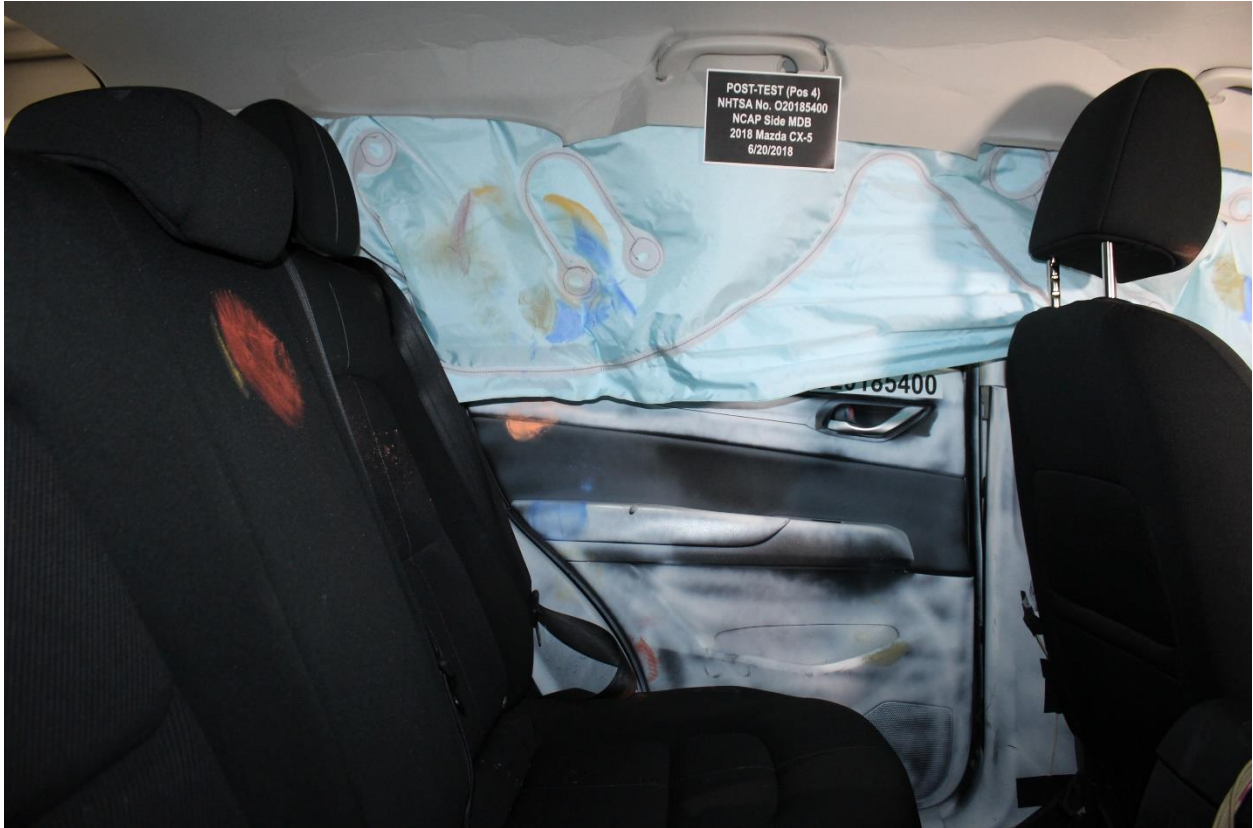
**Figure A-74: Post-Test Rear Passenger Inner Door Panel View Showing Rear Passenger Contact Locations**

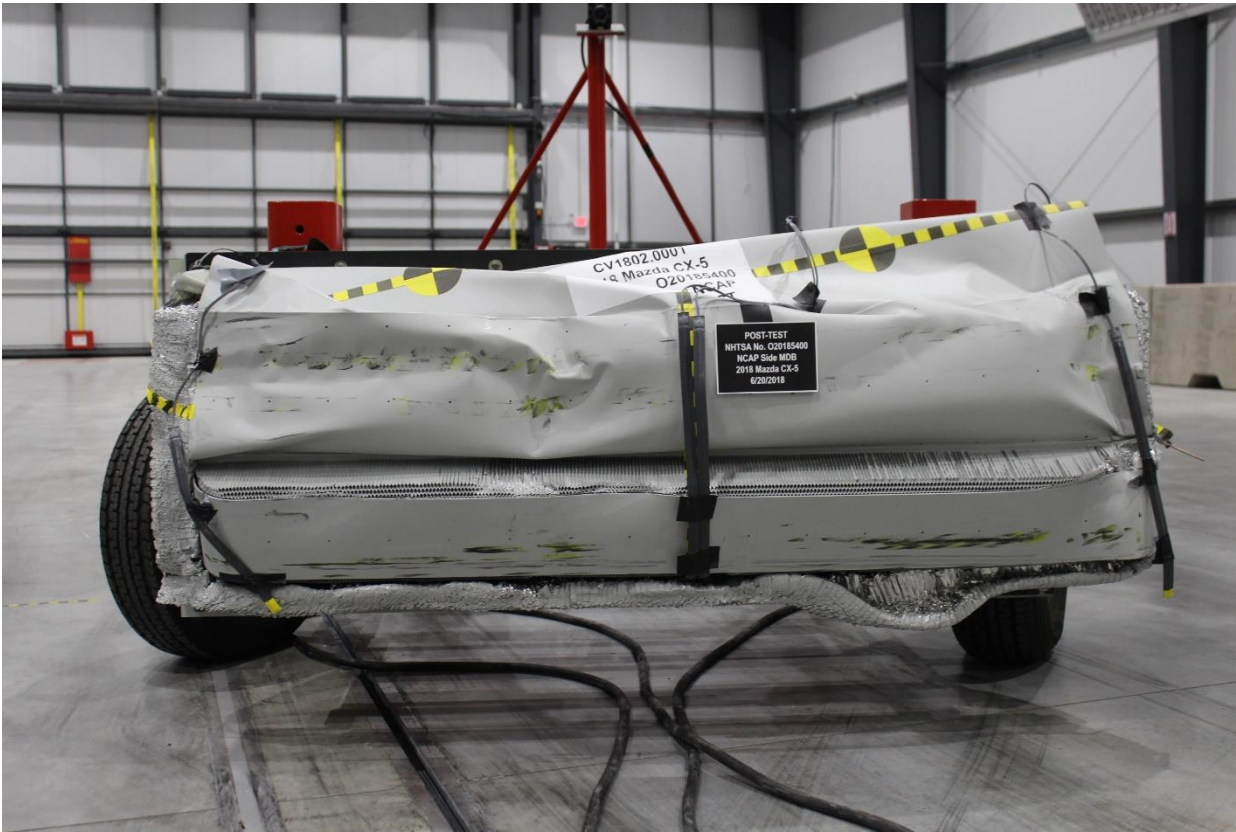
**Figure A-85: Post-Test Front View of MDB Impactor Face**

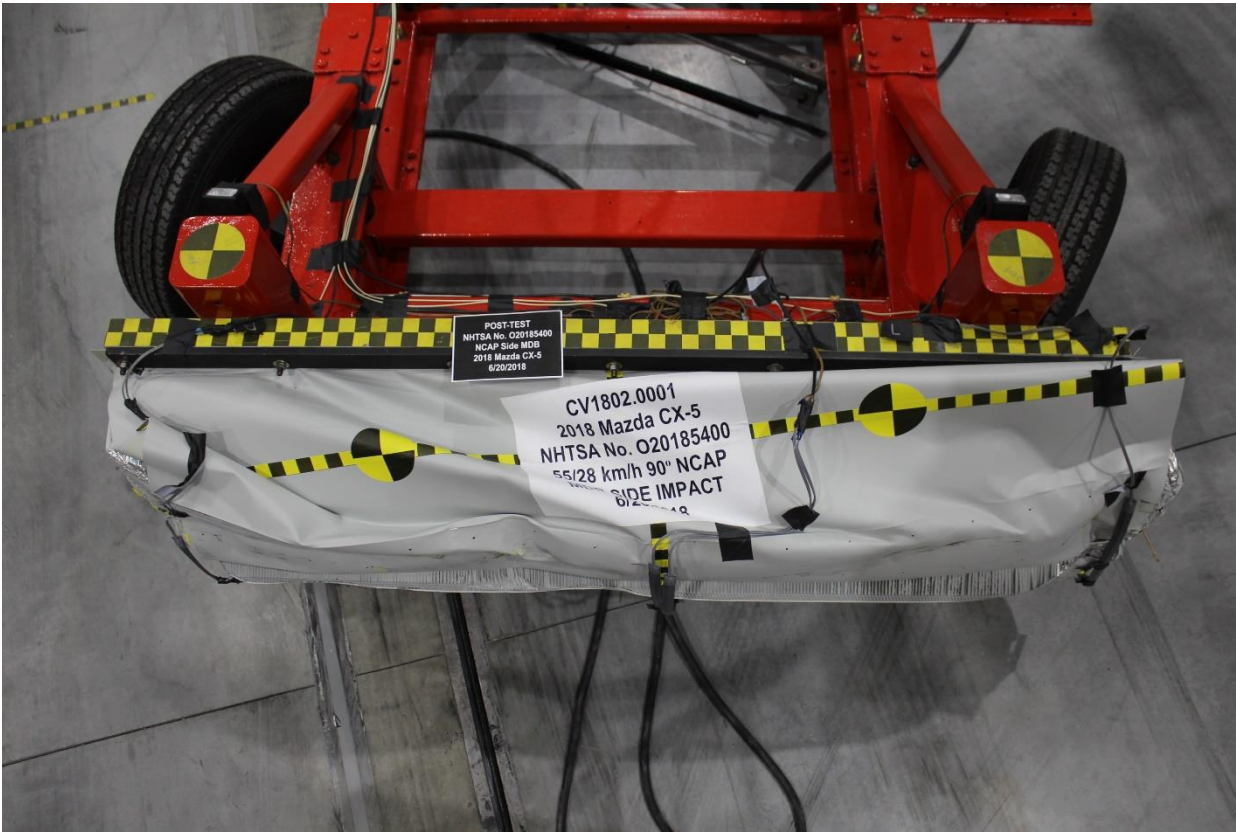
**Figure A-87: Post-Test Top View of MDB Impactor Face**
