**REPORT NUMBER: SPNCAP-CAL-18-009**

**NEW CAR ASSESSMENT PROGRAM (NCAP)  
SIDE IMPACT POLE TEST**

**Nissan Motor Co., LTD.  
2018 Nissan Rogue Sport  
SUV**

**FINAL REPORT**

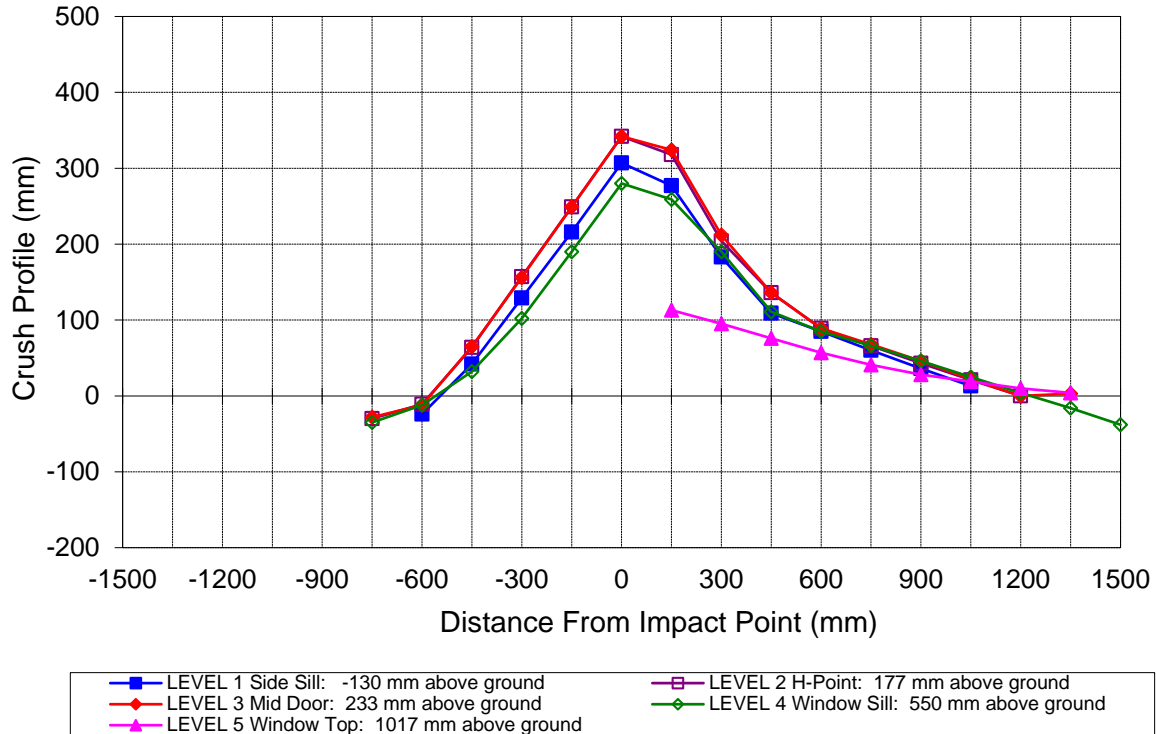
**Vehicle Exterior Crush Measurements - Visual Representation**

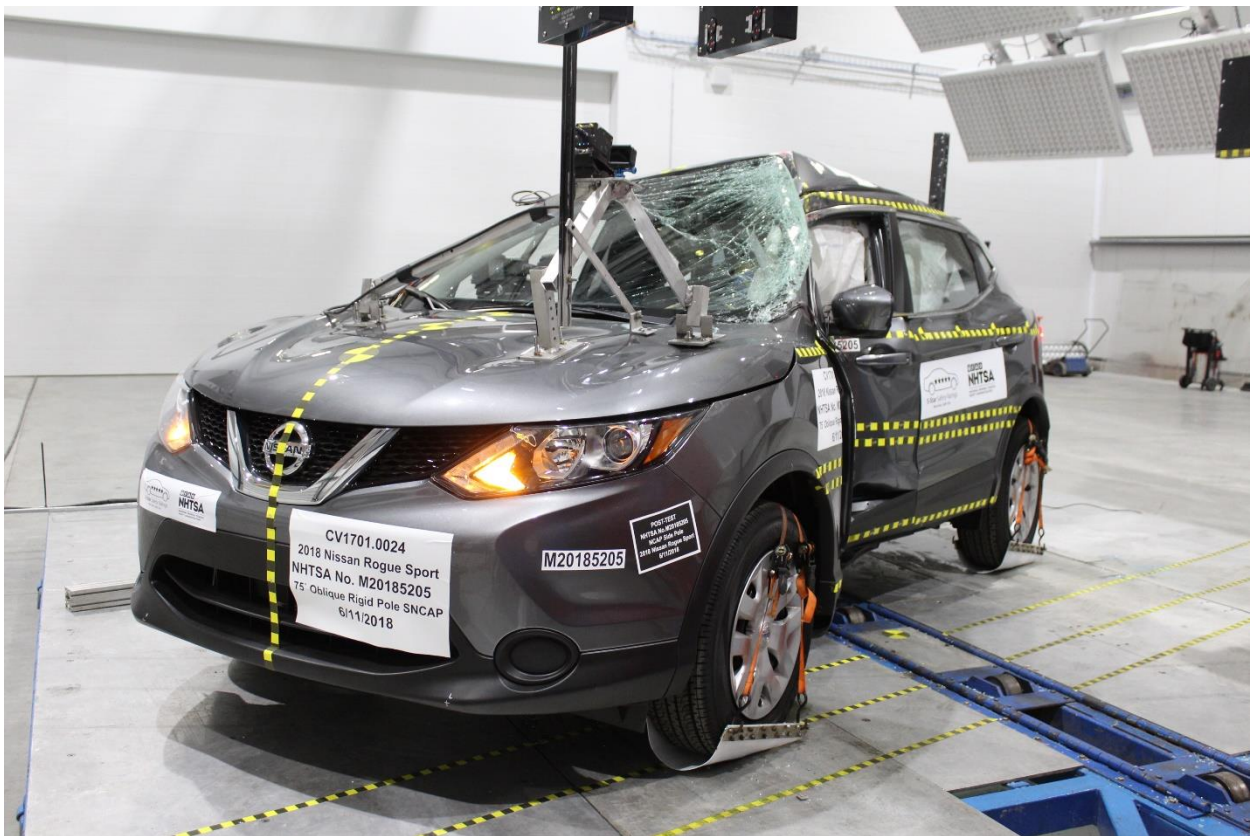
**Figure A-6: Post-Test Left Front ¾ View of Test Vehicle**

Critical Areas of Performance	Observations and Conclusions
Pillar Performance	A Pillar Buckled
Sill Separation	None
Windshield Damage	Cracks Throughout
Side Window Damage	Driver Window Shattered
Other Notable Effects	None

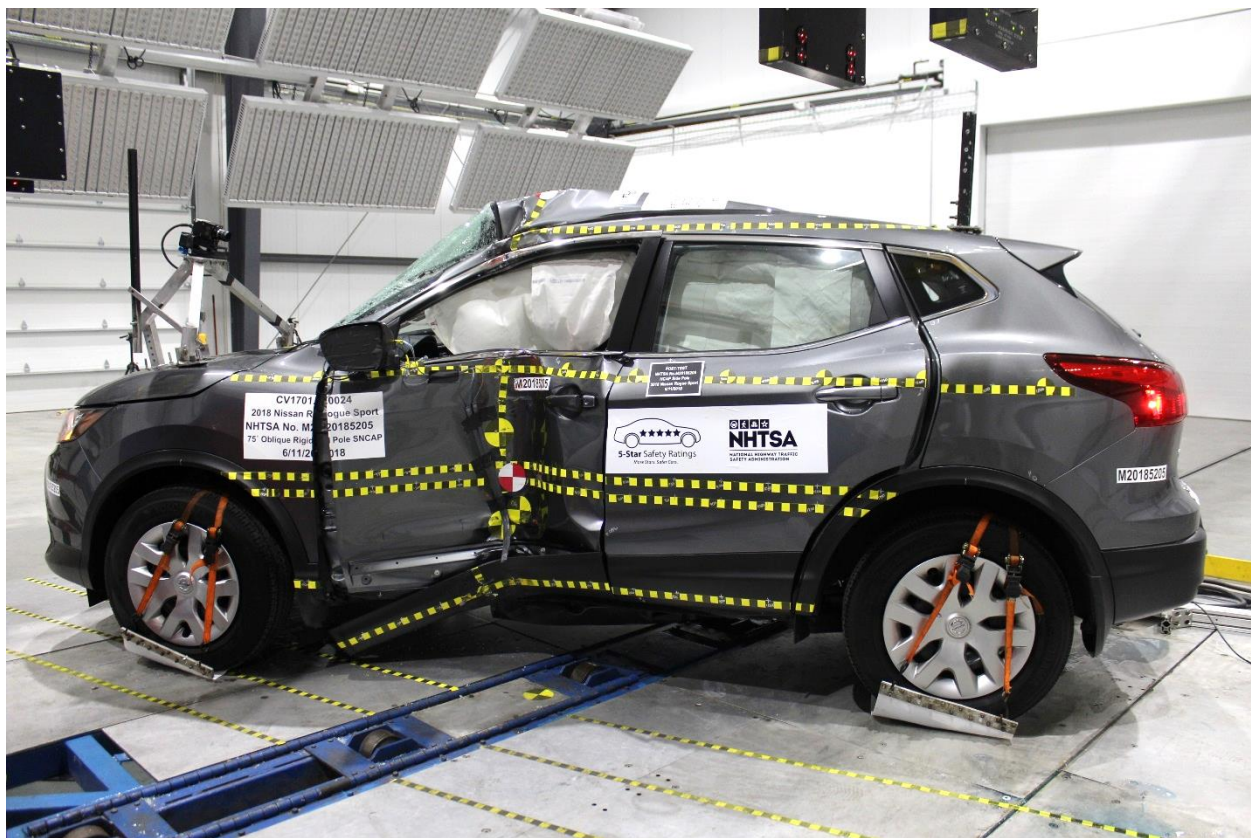
**Figure A-8: Post-Test Left Side View of Test Vehicle**

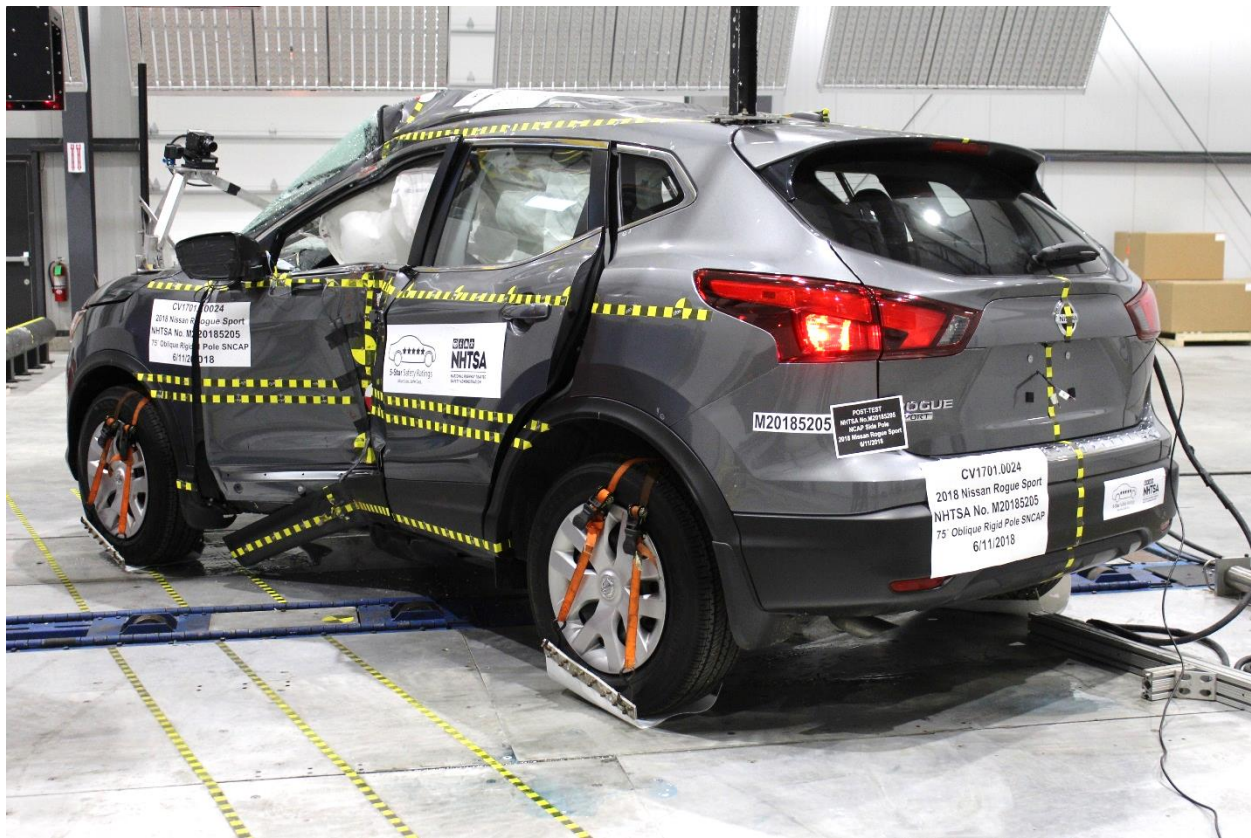
Figure A-10: Post-Test Left Rear ¾ View of Test Vehicle

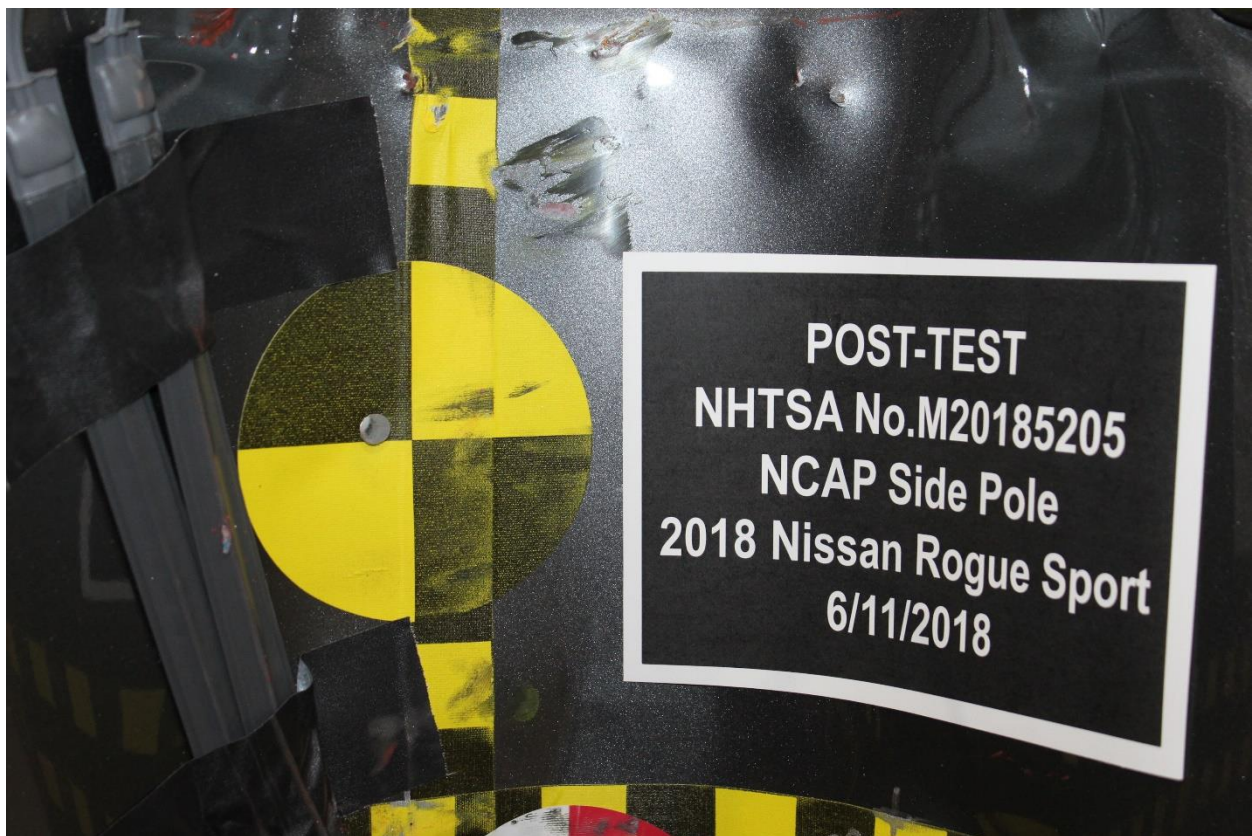
**Figure A-20: Post-Test Close-Up View of Impact Point Target Showing Impact Location**

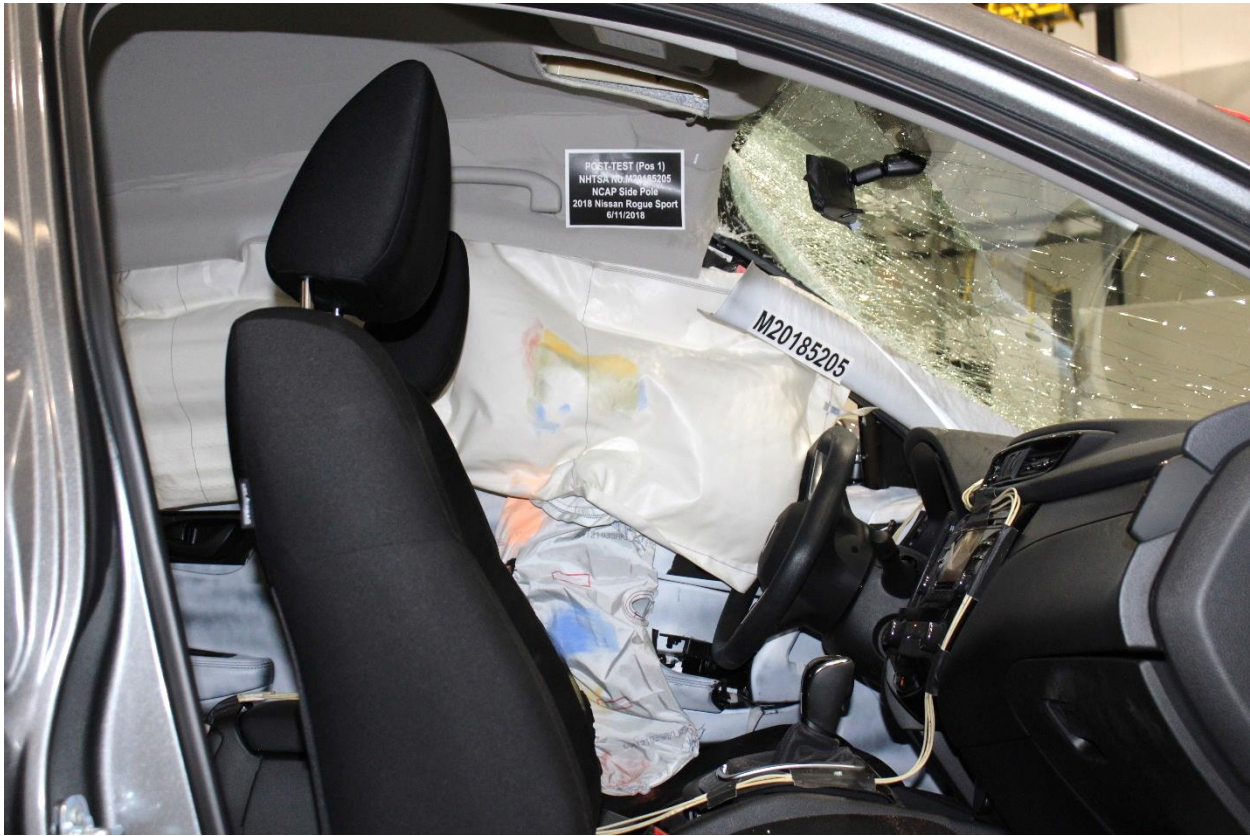
**Figure A-45: Post-Test Inner Door Panel View Showing Dummy Contact Location**

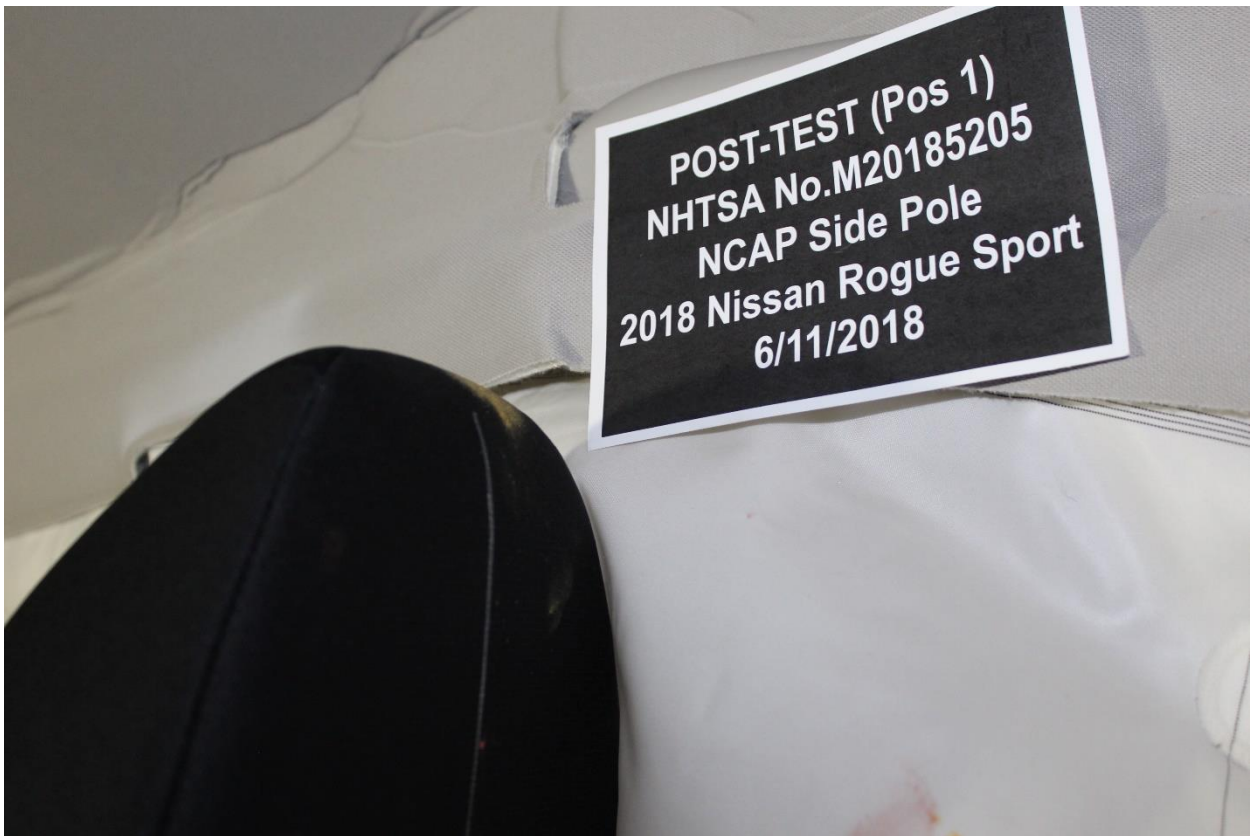
**Figure A-46: Post-Test Dummy Close-Up Head Contact with Vehicle Interior View**

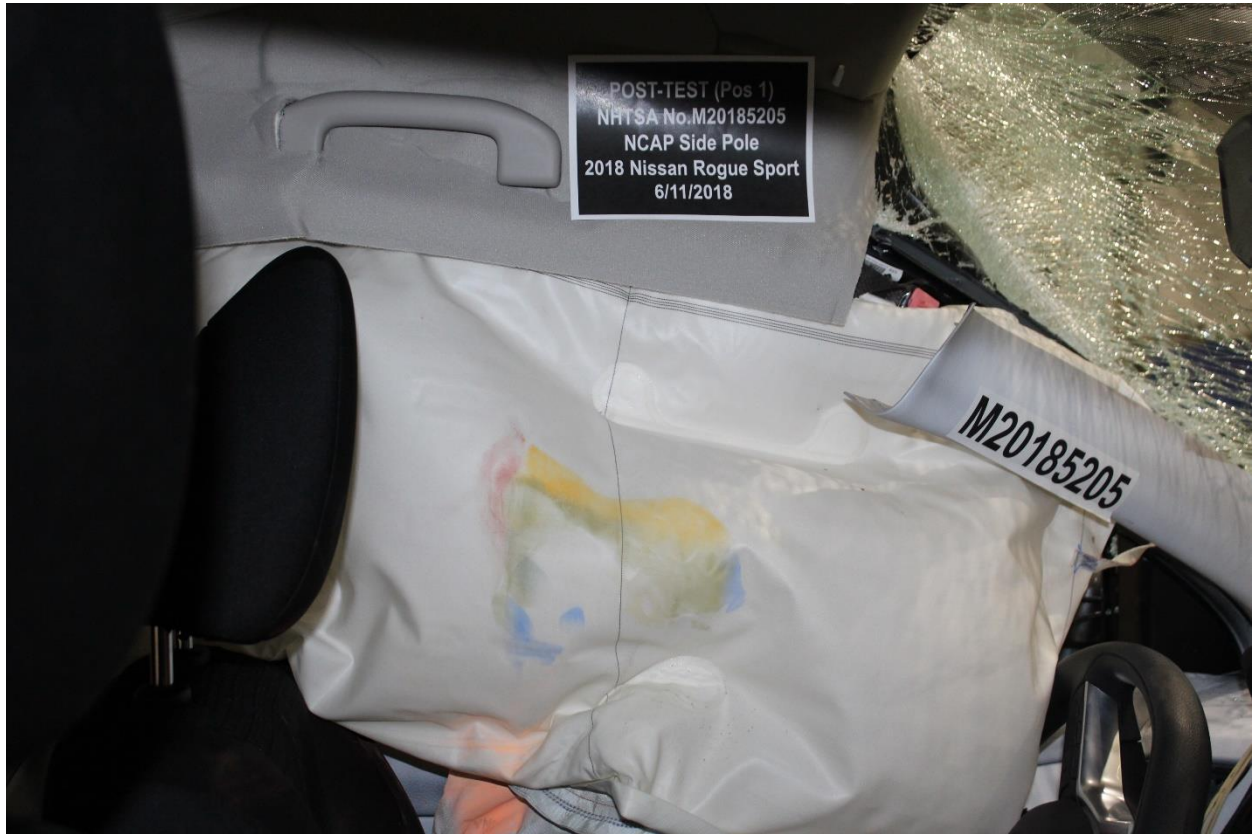
**Figure A-47: Post-Test Dummy Close-Up Head Contact with Side Airbag View**

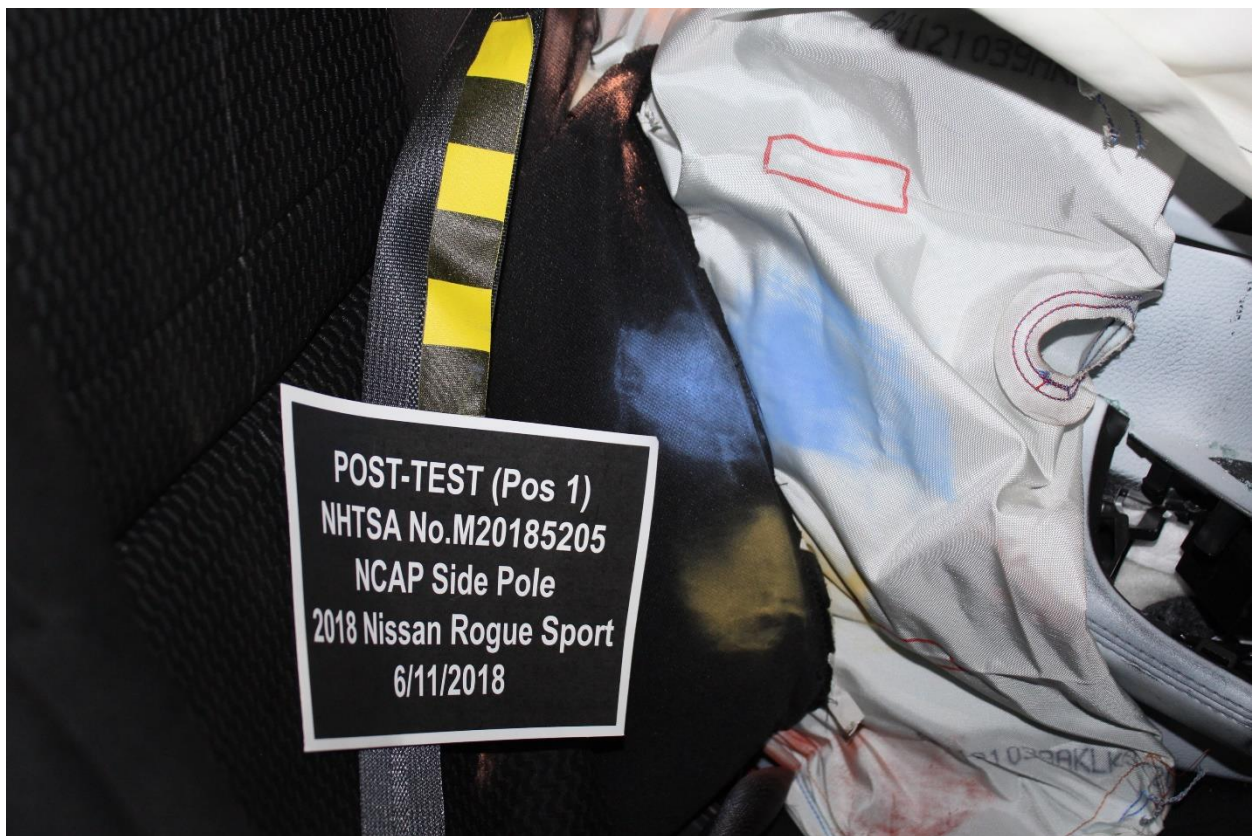
**Figure A-48: Post-Test Dummy Close-Up Torso Contact with Vehicle Interior View**

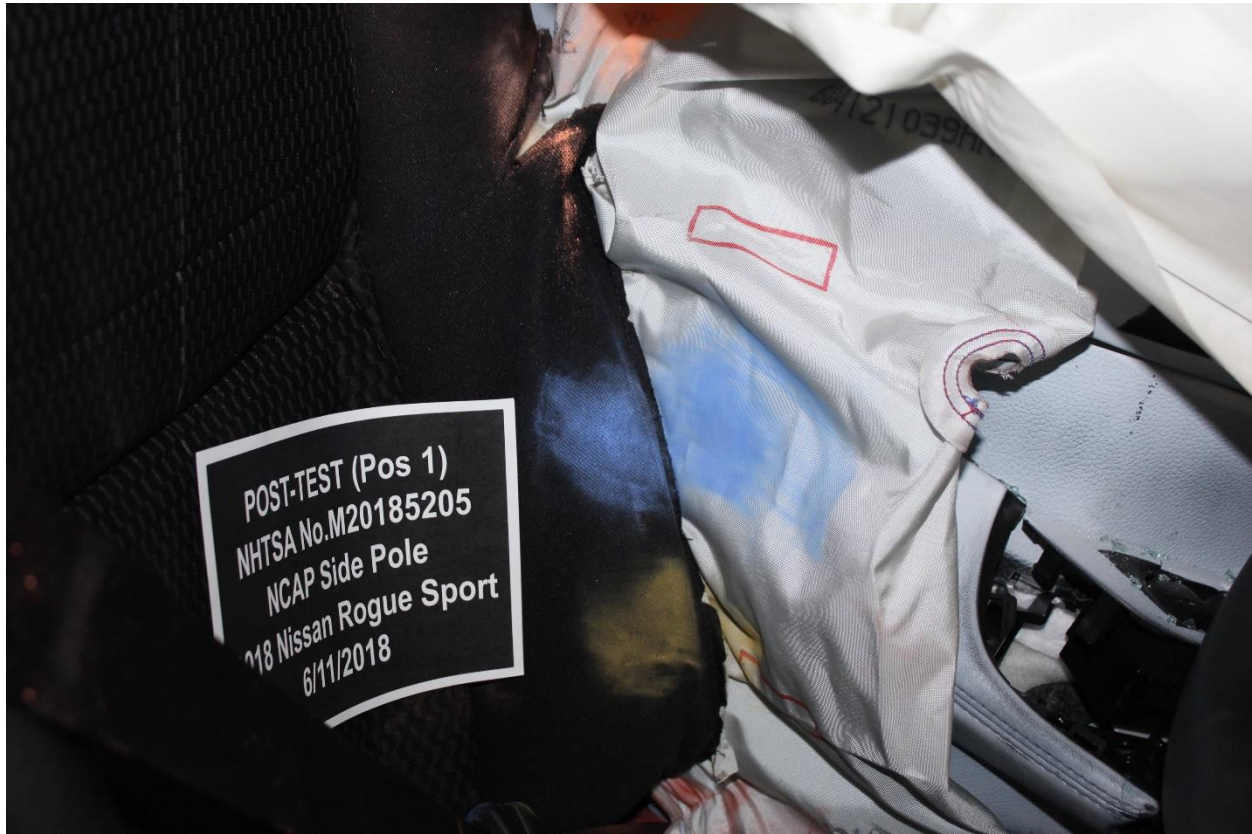
**Figure A-49: Post-Test Dummy Close-Up Torso Contact with Side Airbag View**

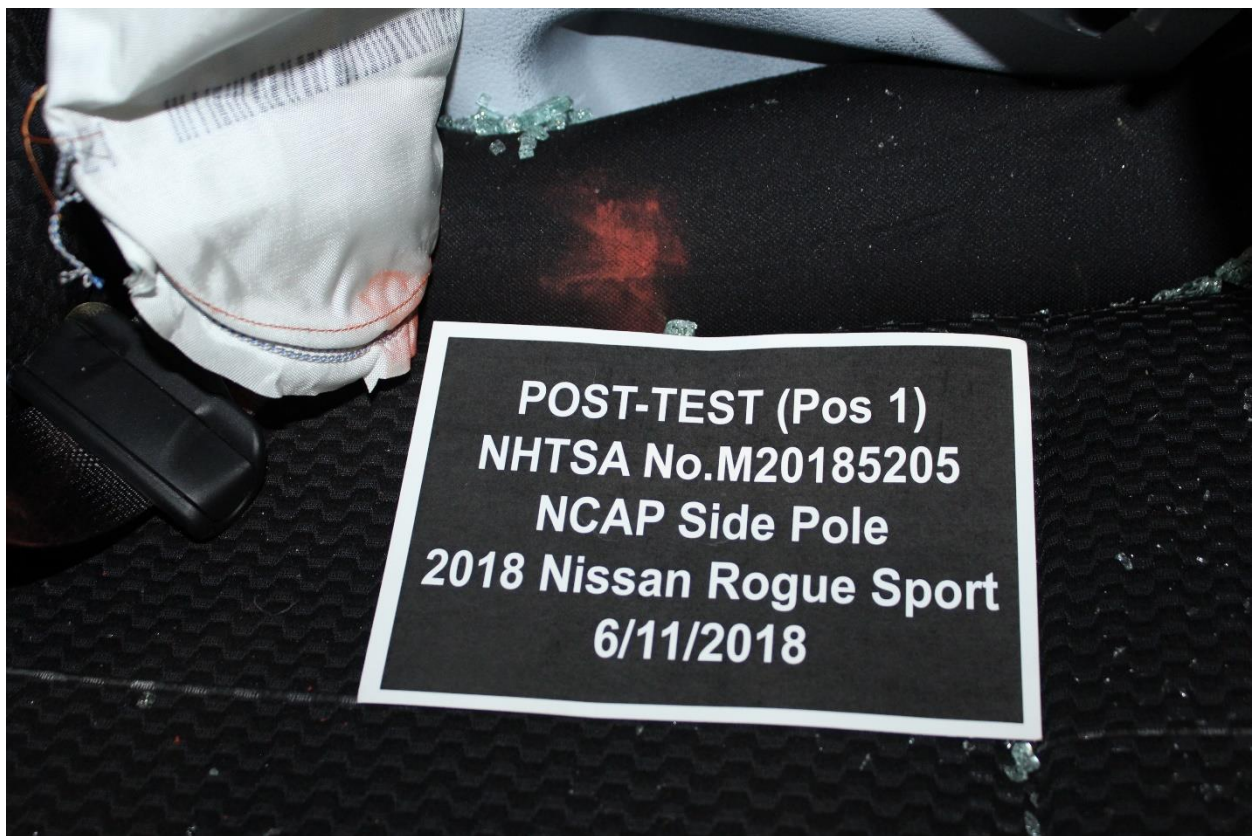
**Figure A-50: Post-Test Dummy Close-Up Pelvis Contact with Vehicle Interior View**

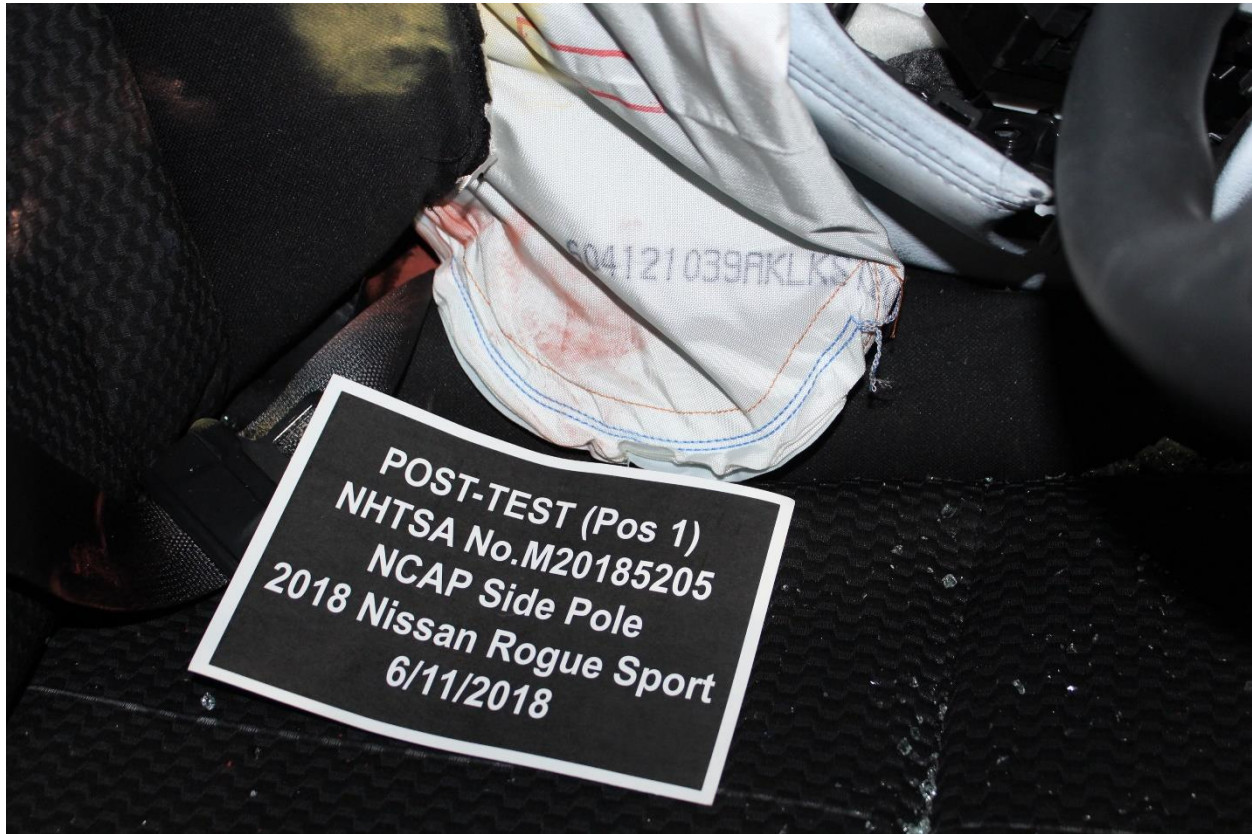
**Figure A-51: Post-Test Dummy Close-Up Pelvis Contact with Side Airbag View**

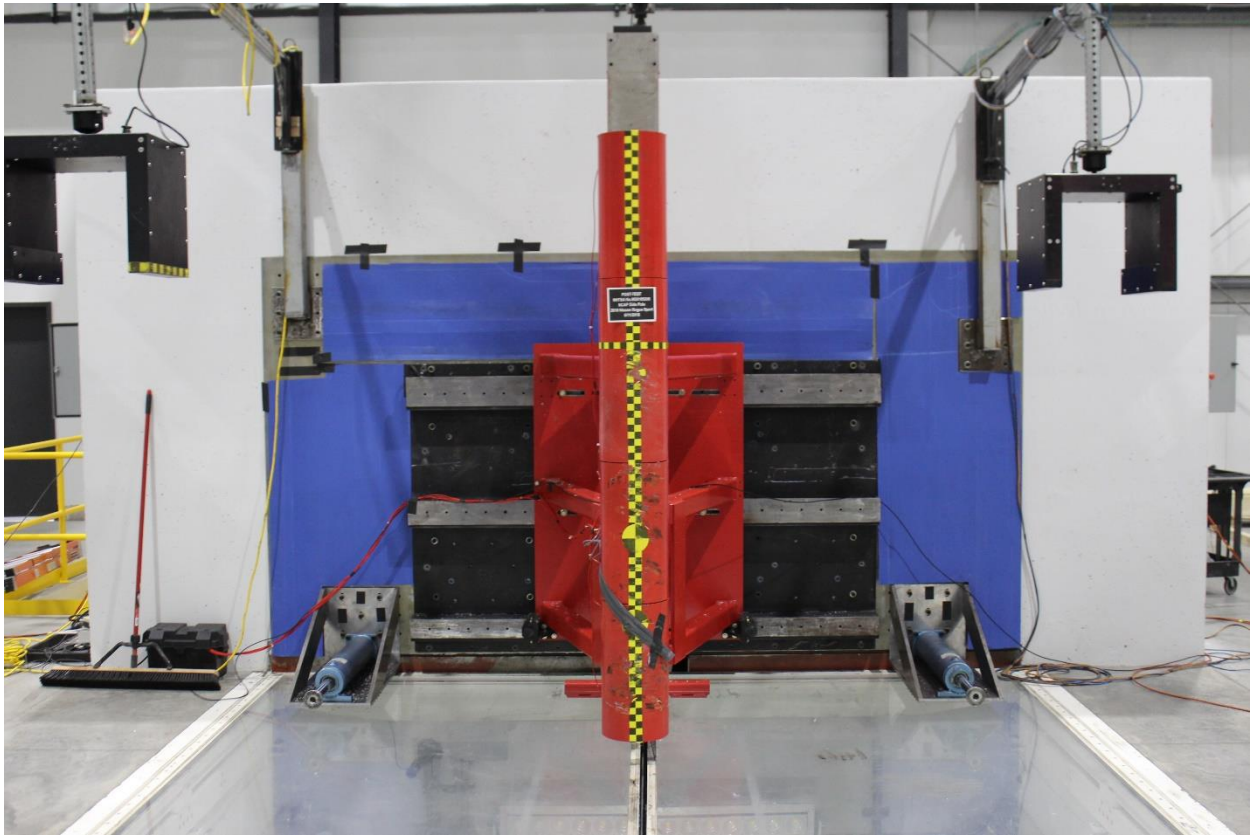
**Figure A-58: Post-Test Pole Barrier Front View**

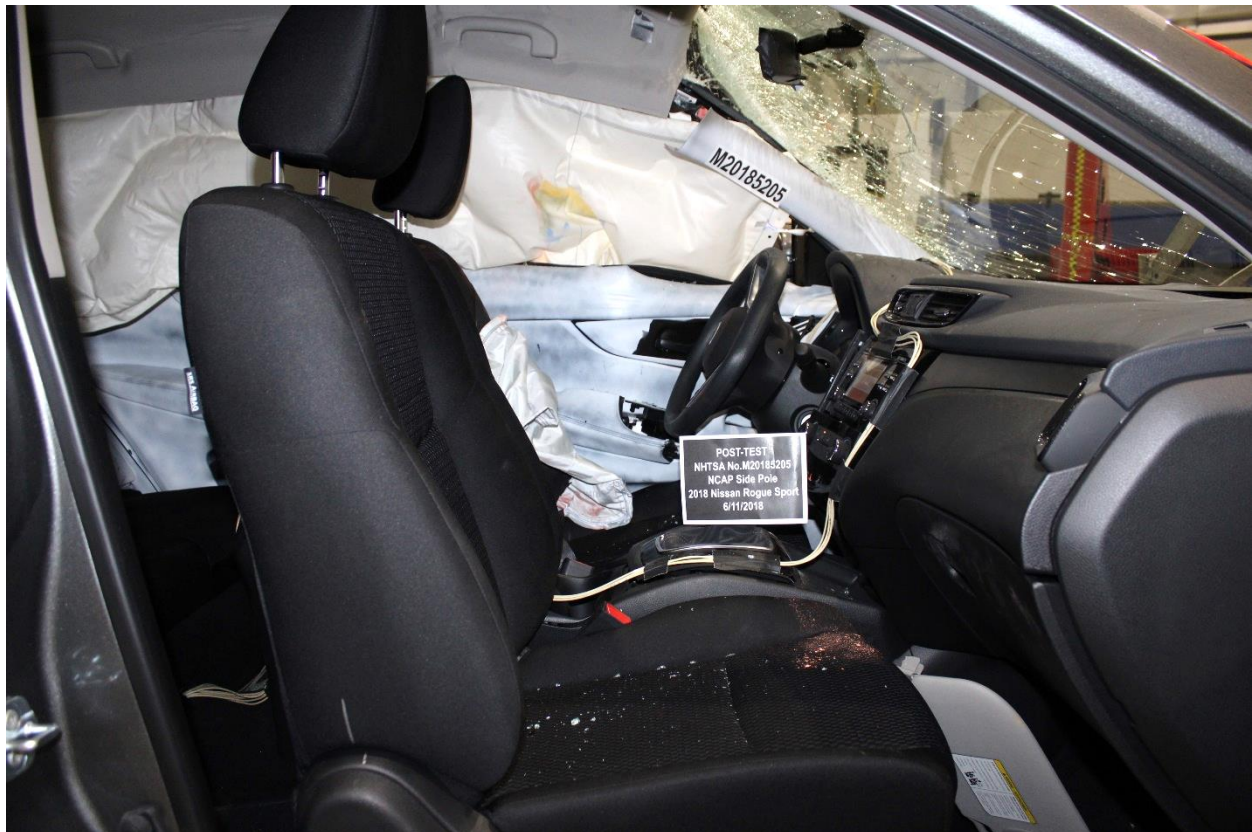
**Figure A-71: Post-Test View of Shattered Vehicle Inner Door Panel (if applicable)**

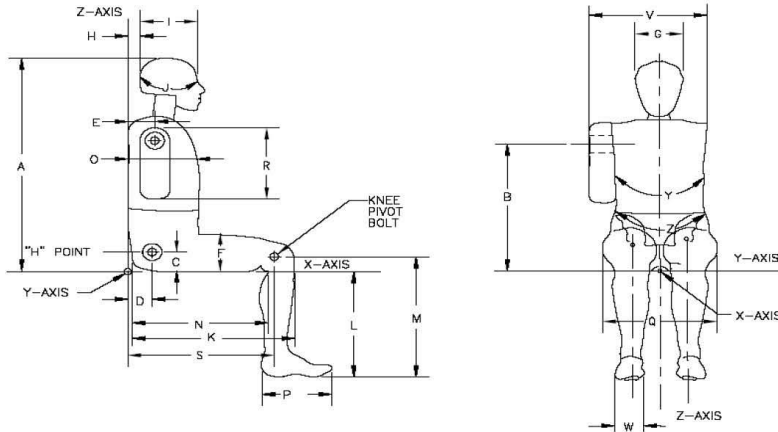
Symbol	Description	Specification (mm)		Result (mm)	Pass/Fail
A	Sitting Height	772	788	782	Pass
B	Shoulder Pivot Height	437	453	445	Pass
C	H-point Height	79	89	85	Pass
D	H-point from seatback	141	151	147	Pass
E	Shoulder Pivot from Backline	97	107	103	Pass
F	Thigh Clearance	119	135	129	Pass
G	Head Breadth	140	148	143	Pass
H	Head Back from Backline	40	46	44	Pass
I	Head Depth	178	188	183	Pass
J	Head Circumference	541	551	545	Pass
K	Buttock to Knee Length	514	540	531	Pass
L	Popliteal Height	343	369	354	Pass
M	Knee Pivot to floor height	392	409	400	Pass
N	Buttock Popliteal Length	416	442	429	Pass
O	Chest Depth w/o jacket	195	211	207	Pass
P	Foot Length	216	232	221	Pass
Q	Hip Breadth (w/pelvic plugs)	313	323	317	Pass
R	Arm Length	249	259	254	Pass
S	Knee Joint to seatback	477	493	485	Pass
V	Shoulder Width	341	357	345	Pass
W	Foot Width	78	94	85	Pass
Y	Chest Circumference w/jacket	851	881	865	Pass
Z	Waist Circumference	761	791	770	Pass
