REPORT NUMBER: SINCAP-MGA-2019-001

**NEW CAR ASSESSMENT PROGRAM (NCAP)
Moving Deformable Barrier Side Impact Test**

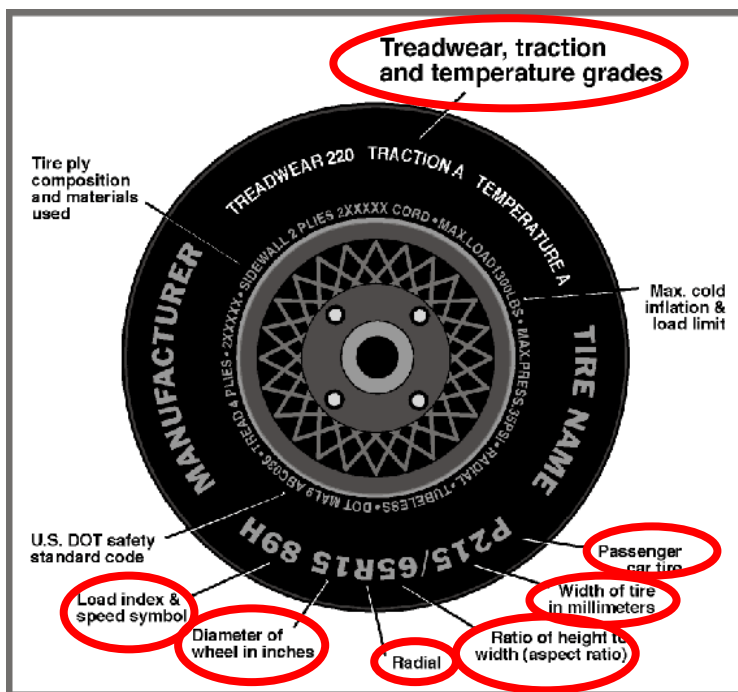
Measured Parameter	Front	Rear
Max. Tire Pressure (kPa)	350	350
Cold Pressure (kPa)	230	230
Recommended Tire Size	235/55R19	235/55R19
Tire Size on Vehicle	235/55R19	235/55R19
Tire Manufacturer	Continental	Continental
Tire Model	CrossContact	CrossContact
Treadwear	480	480
Traction	A	A
Temperature Grade	A	A
Tire Plies Sidewall	2 Polyester	2 Polyester
Tire Plies Body	2 Polyester, 2 Steel, 1 Polyamide	2 Polyester, 2 Steel, 1 Polyamide
Load Index/Speed Symbol	101H	101H
Tire Material	Rubber	Rubber
DOT Safety Code Left	HWE7 WC8K 5017	HWE7 WC8K 5017
DOT Safety Code Right	HWE7 WC8K 5017	HWE7 WC8K 5017

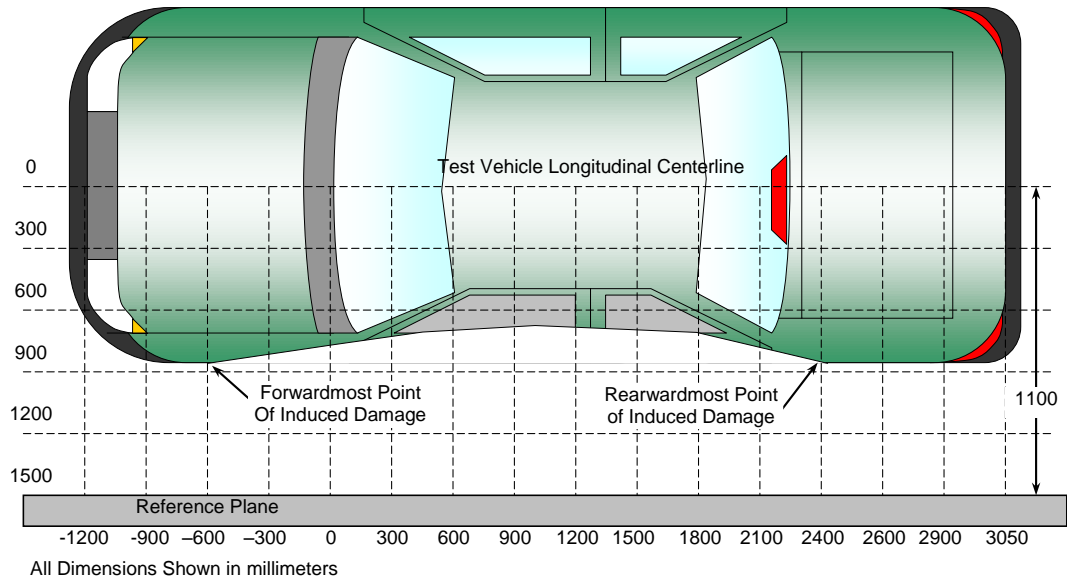
NHTSA No. O20195302
Test Date: 8/1/2018

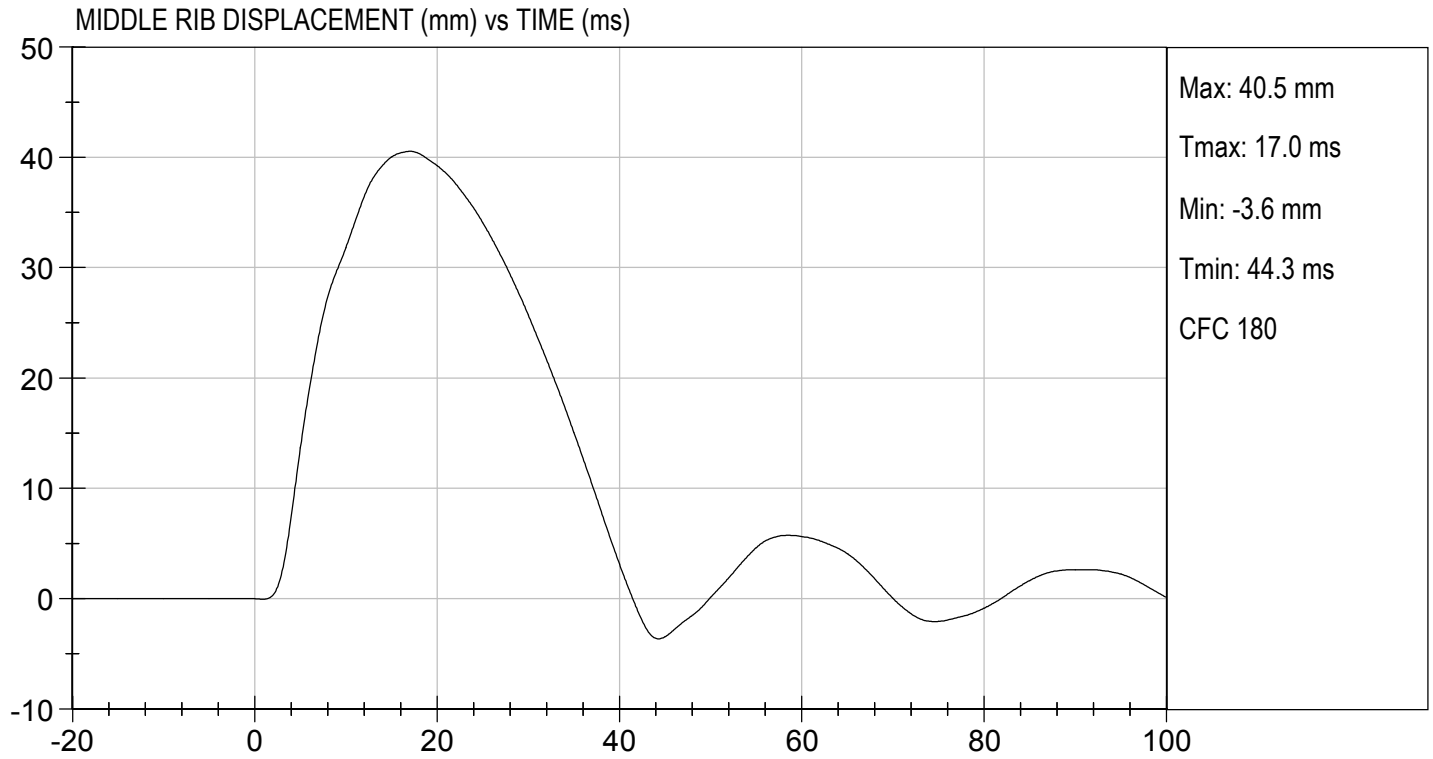
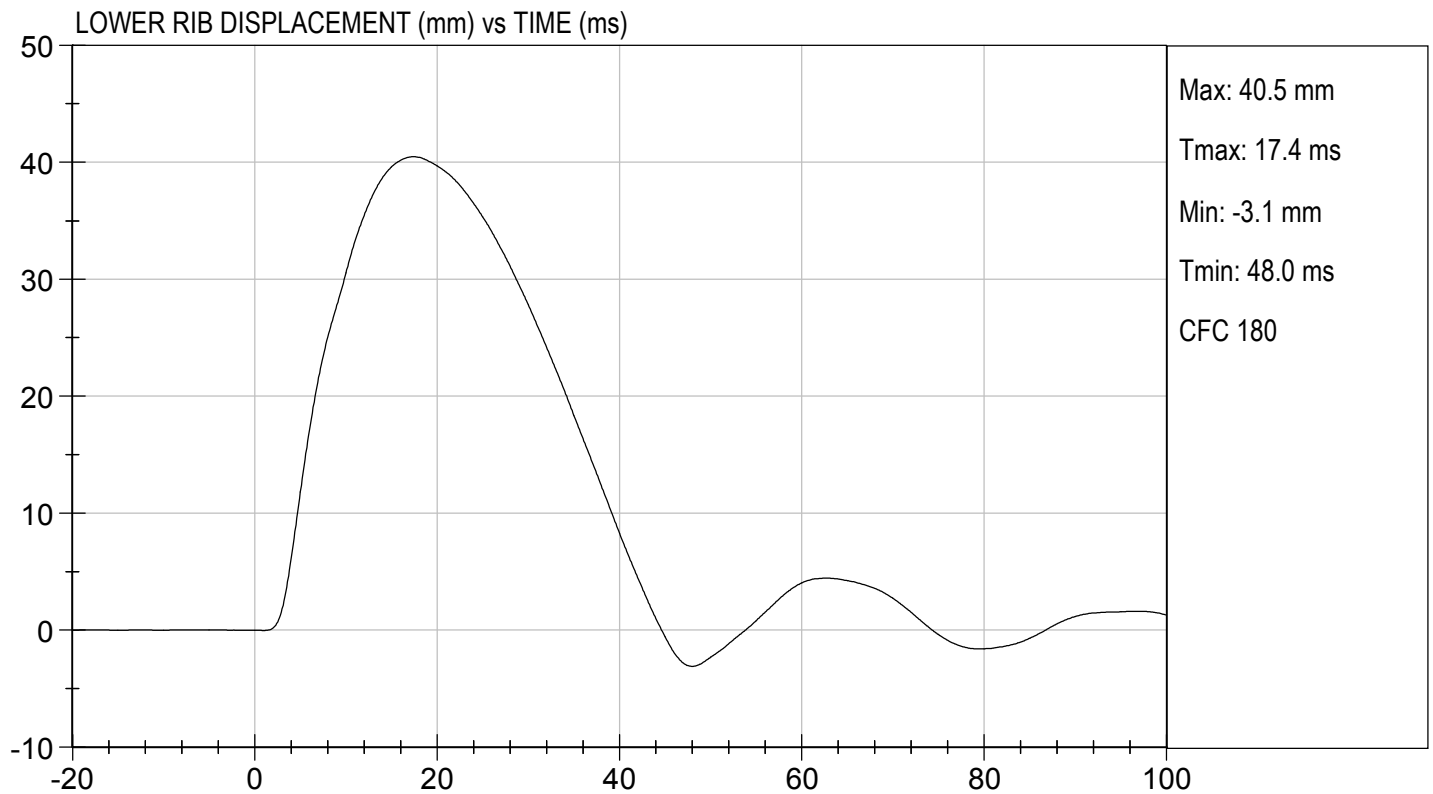
ES-2re External Measurements
SN: 032

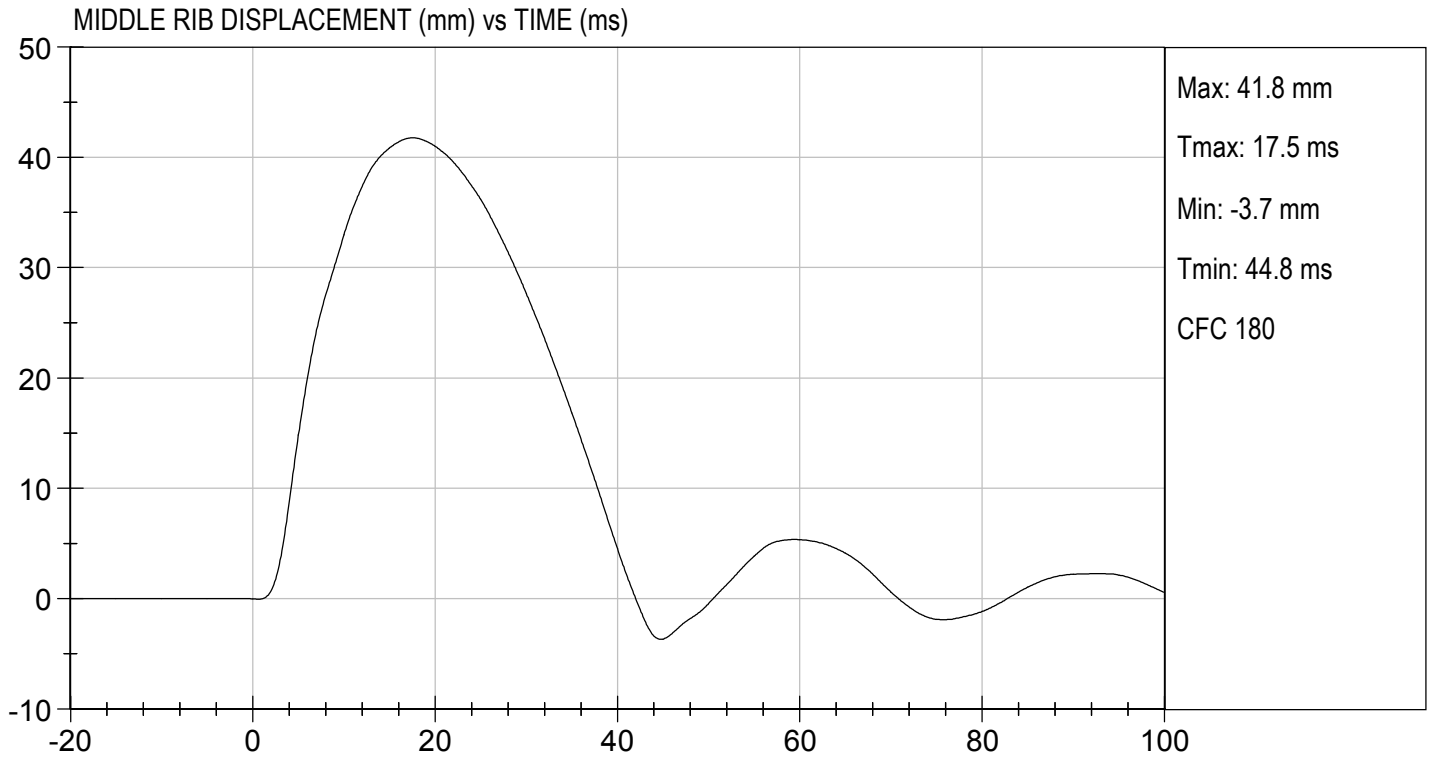
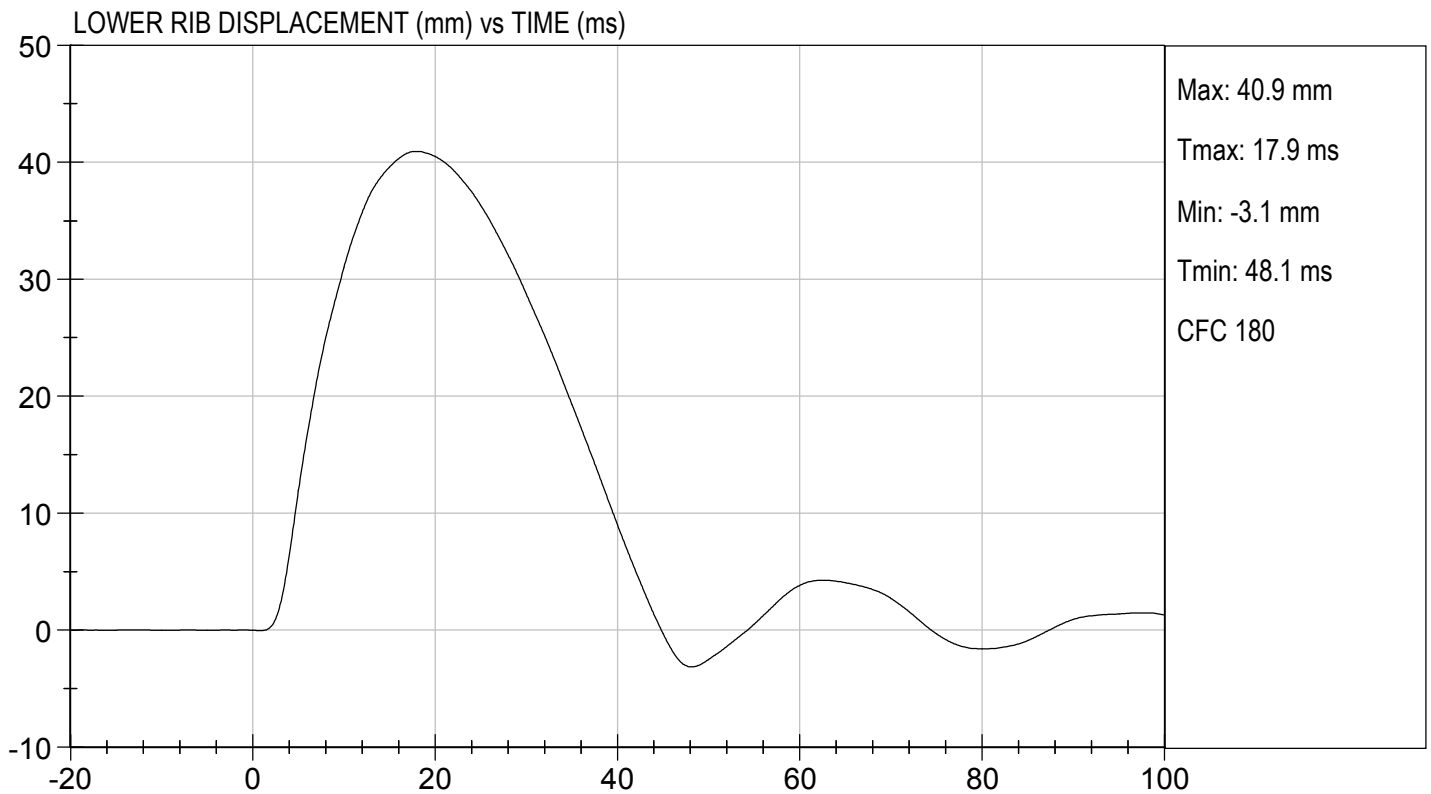
SID-IIsD External Measurements
SN: 306

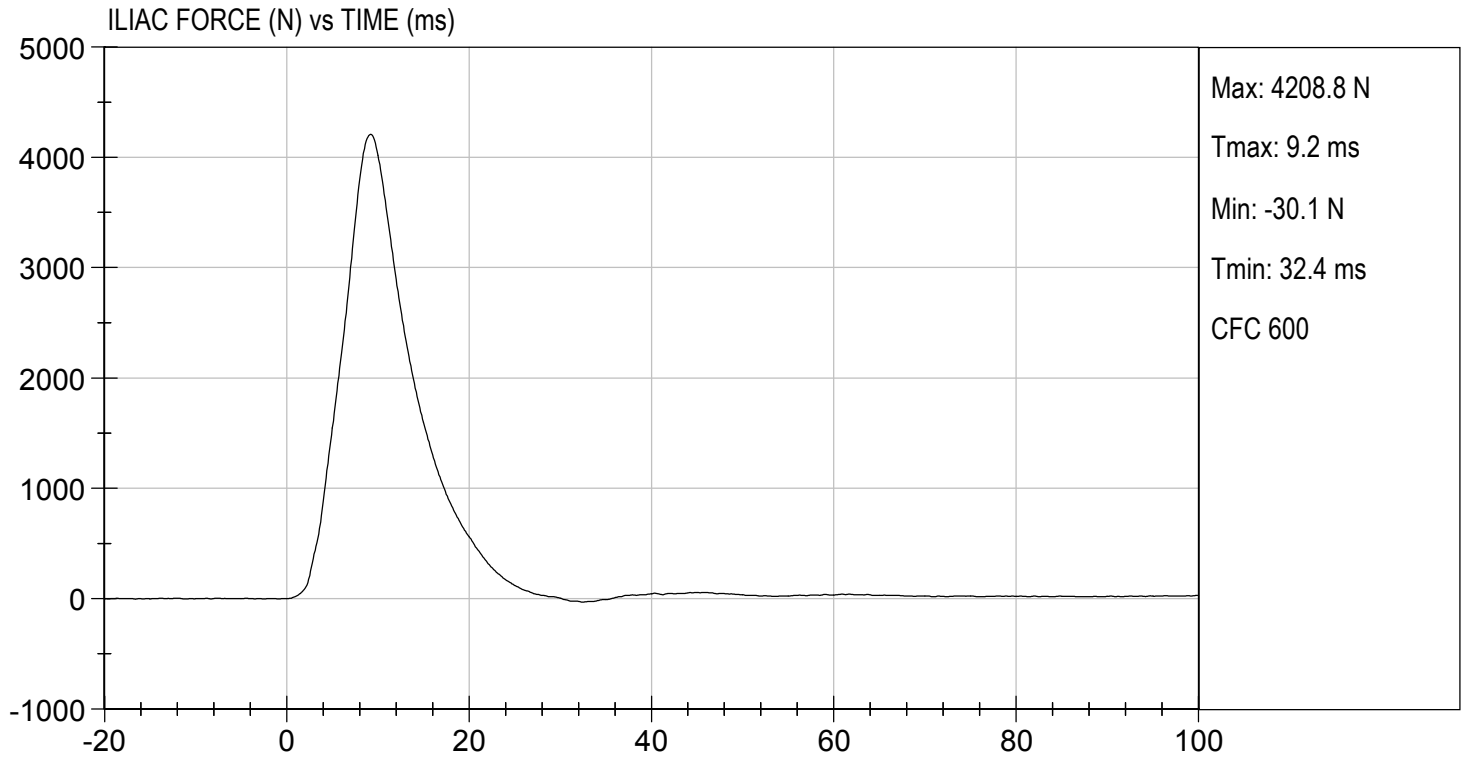
SID-IIsD External Measurements
SN: 306
