**REPORT NUMBER: TWG-KAR-18-001**

**SIDE AIRBAG OCCUPANT RISK PROGRAM  
OCCUPANT OUT-OF-POSITION TESTS**

**FCA US LLC  
2018 JEEP COMPASS SPORT 5-DOOR MPV**

**NHTSA NUMBER: M20180308TWG2**

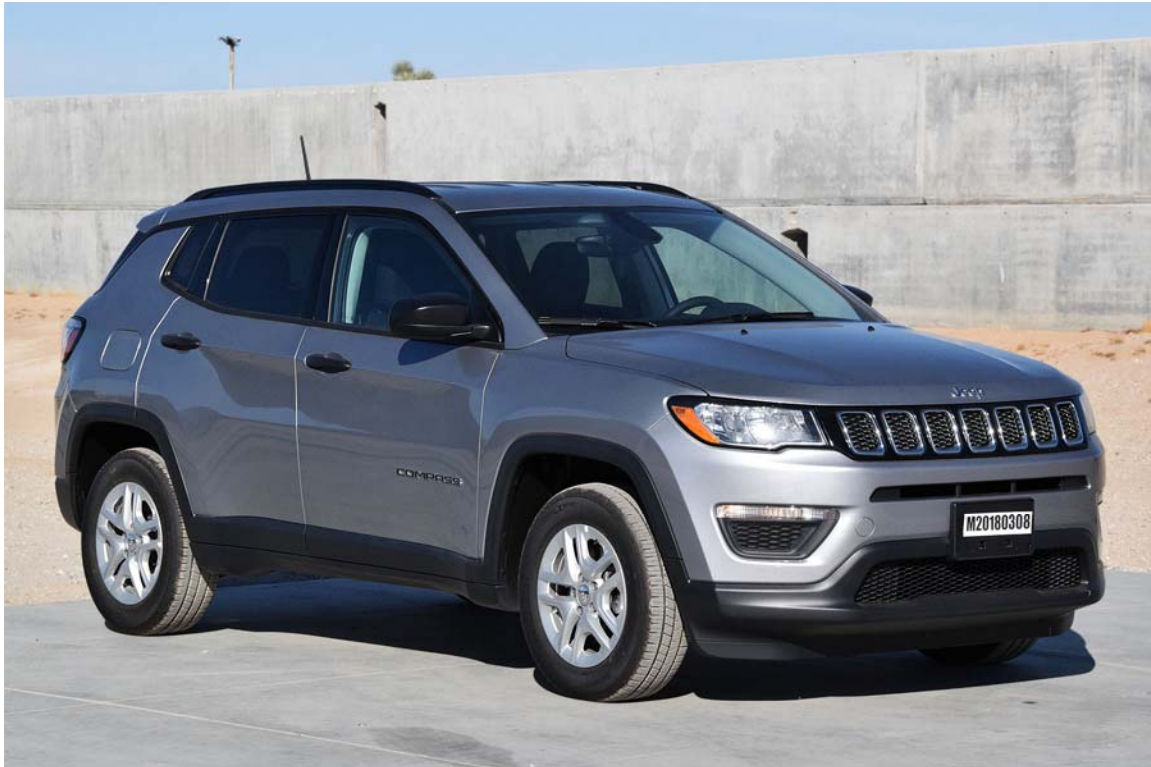
FIGURE 1. Right Front ¾ View, As Received

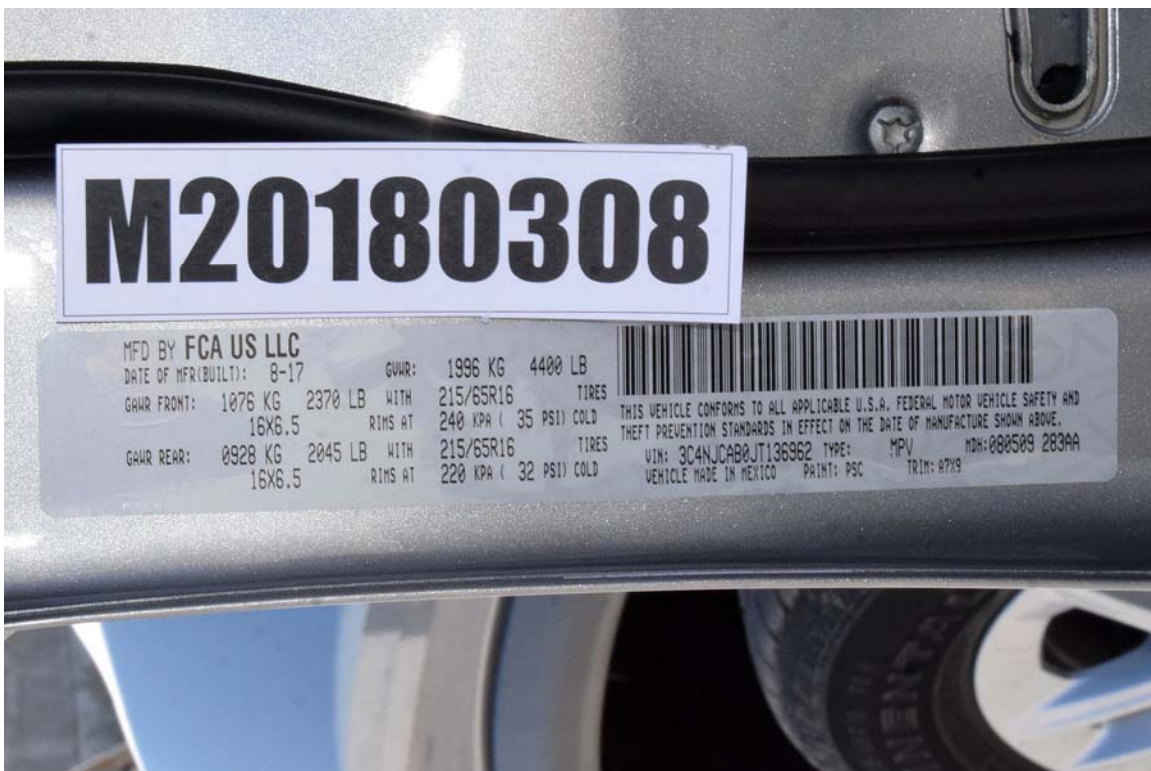
FIGURE 2. Vehicle Certification Label

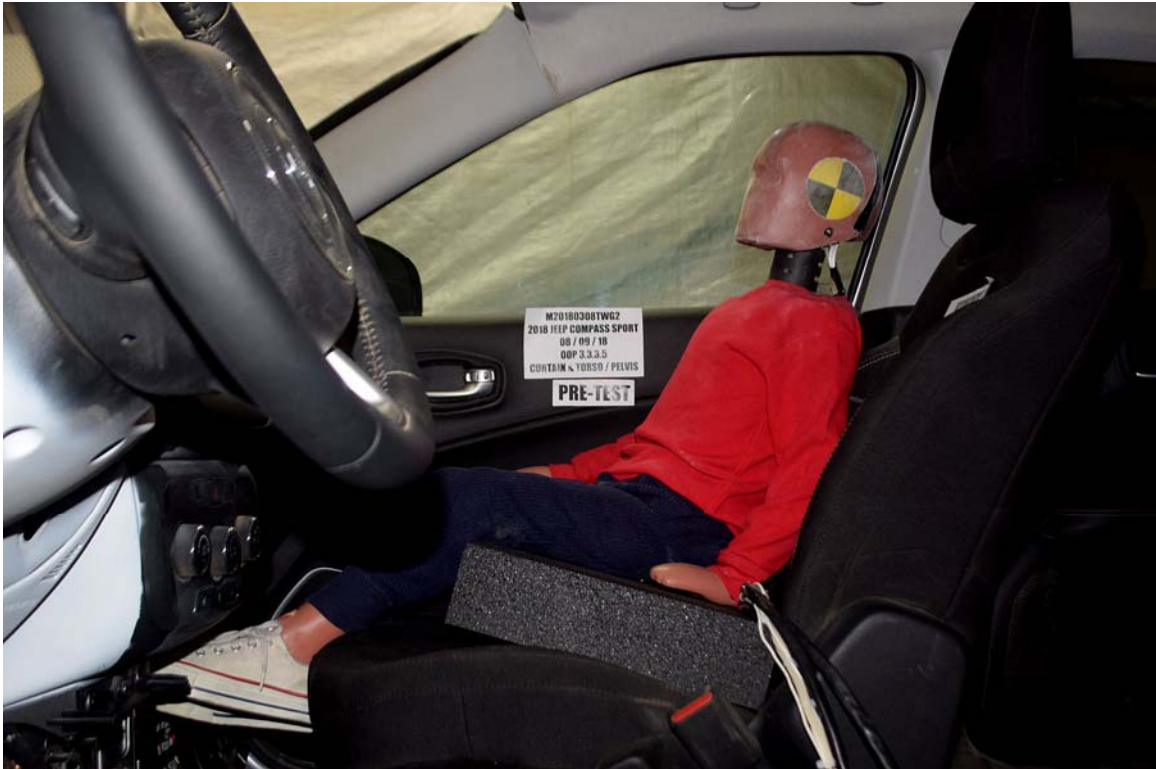
FIGURE 7. Pre-Test Dummy Position, Left View

Orientation of the 6-year old dummy was with the dummy facing forward. The seat is set at the 5<sup>th</sup> detent (60 mm) from the full forward position and adjusted vertically to its highest position. The seat was not tested in the lowest and rearmost position in order to maximize the interaction and contact between the dummy and airbag. The dummy is placed on the outboard edge of the foam block with the upper spine aligning with the deployment trajectory of the airbag. The dummy's head is placed between the seat bolster and pillar or side trim and the legs crossing the heel points. The pelvis is slid forward for spine alignment and outboard to contact the door panel. The outboard arm is placed on the armrest. This orientation complies with section 3.3.3.5 of the Technical Working Group (TWG) recommendation in the Recommended Procedures for Evaluating Occupant Injury Risk from Deploying Side Airbags.

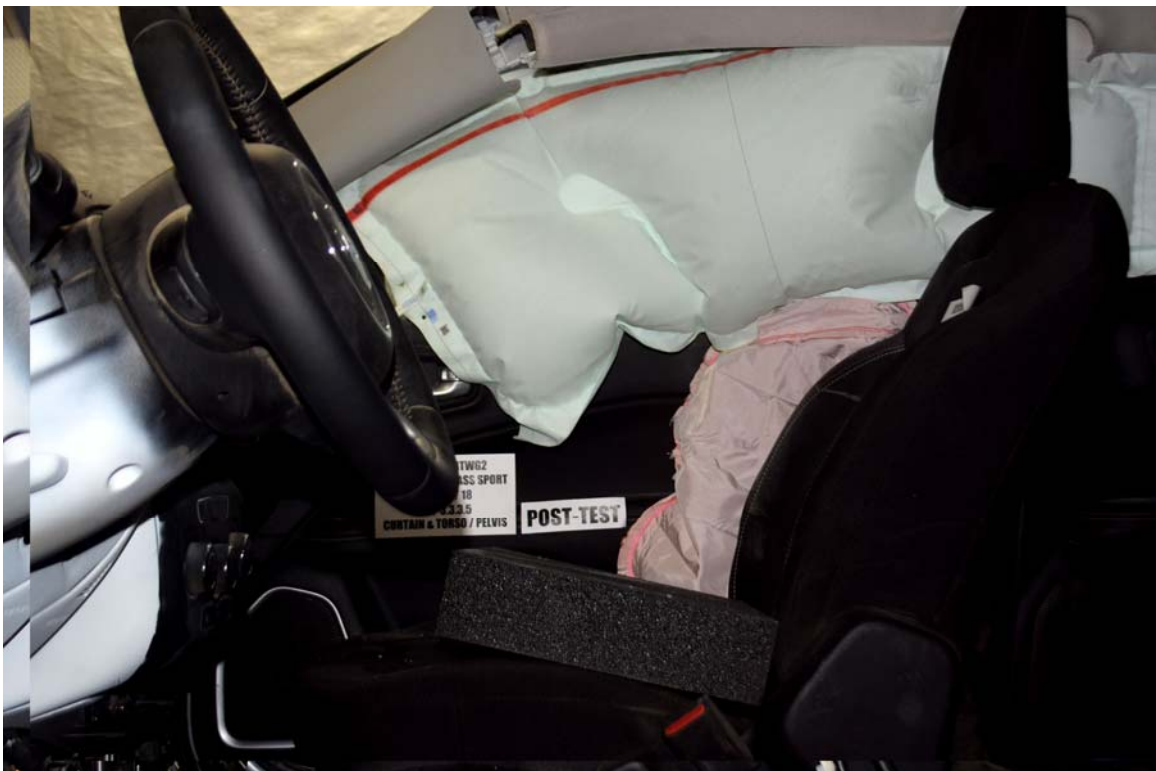
FIGURE 8. Post-Test Dummy Position, Left View

The 6-year old dummy's visible contact points were as follows: The ATD's head contacted the curtain airbag. The ATD's torso contacted the curtain and torso/pelvis airbags. The 6-year old dummy ended up on the floor pan of the driver's side of the vehicle as a result of the airbag deployment.

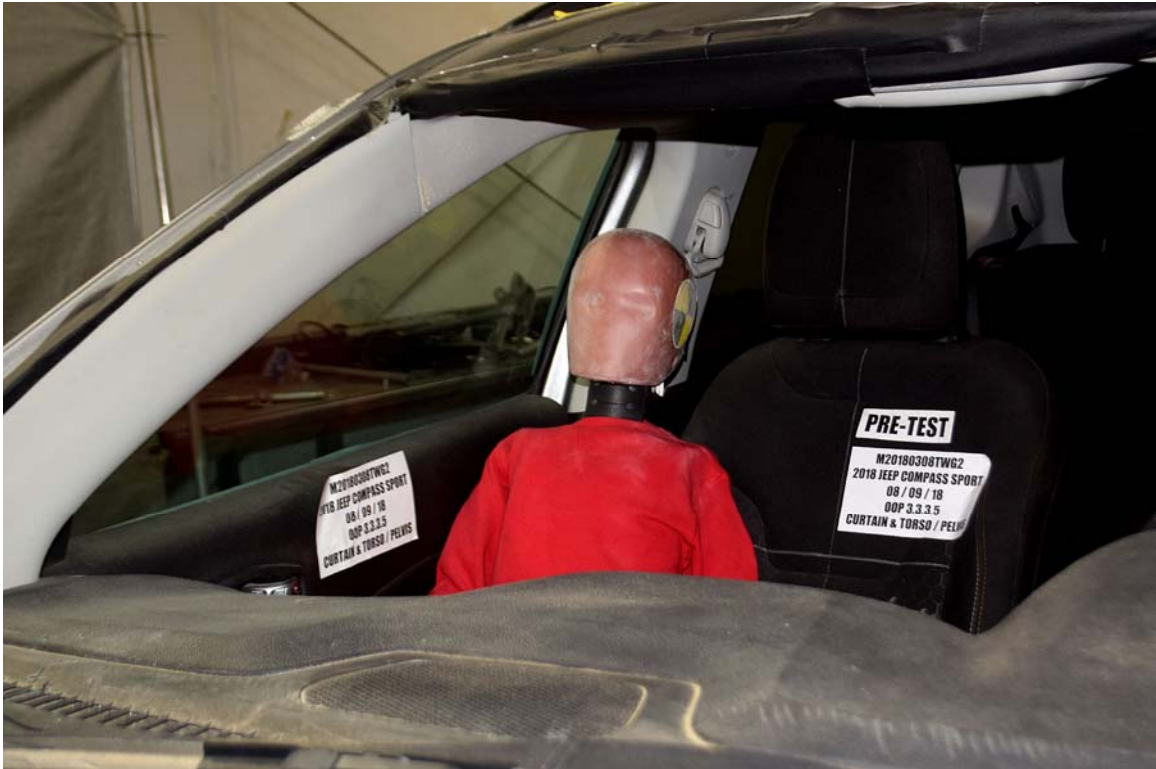
FIGURE 9. Pre-Test Dummy Position,  $\frac{3}{4}$  View

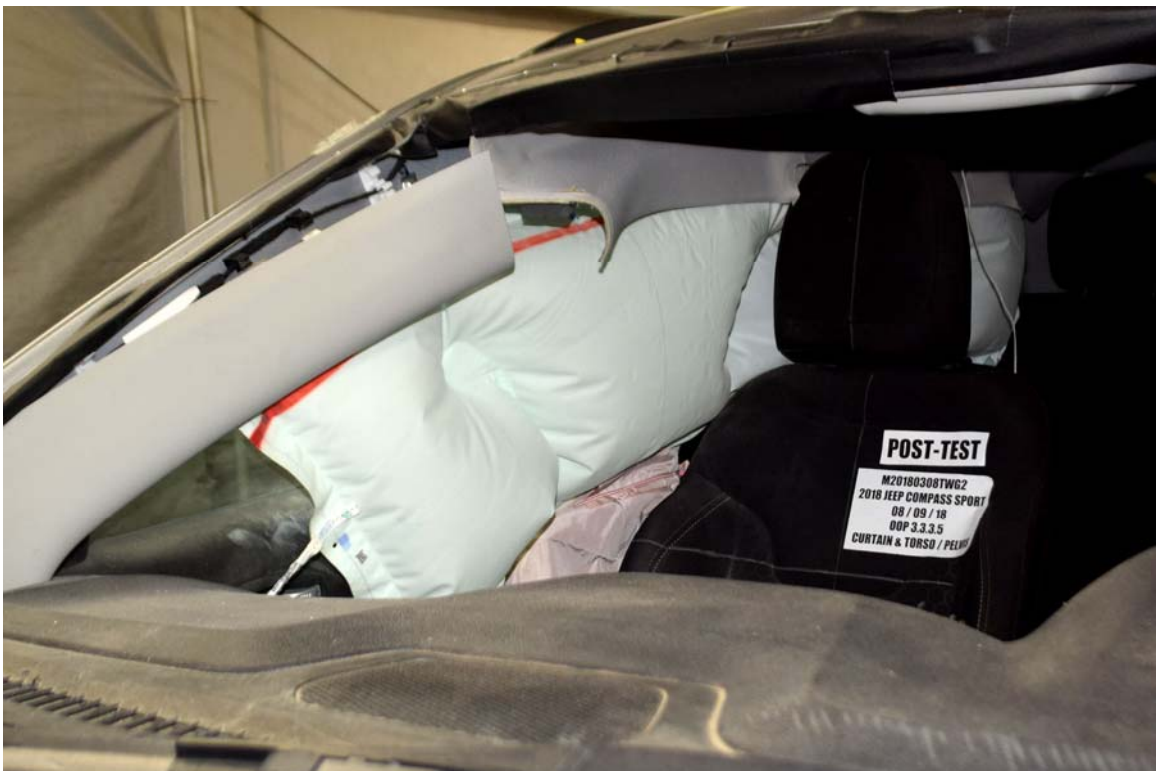
FIGURE 10. Post-Test Dummy Position,  $\frac{3}{4}$  View

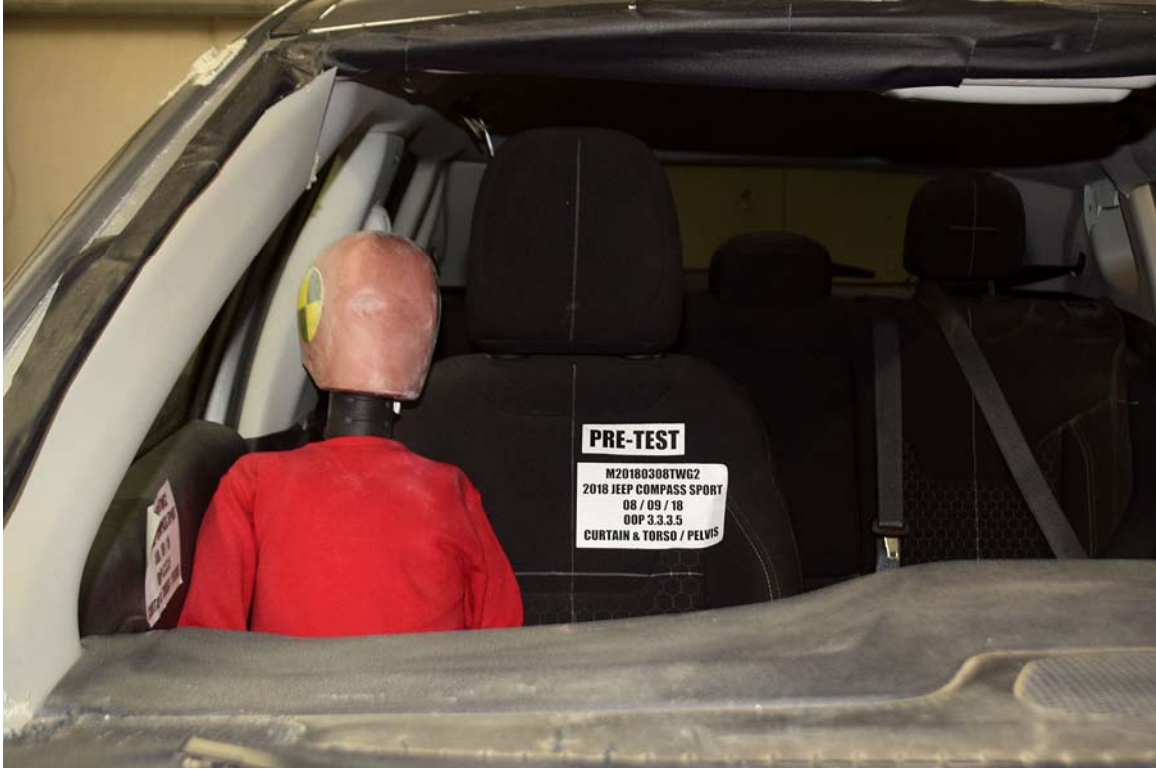
FIGURE 11. Pre-Test Dummy Position, Front View

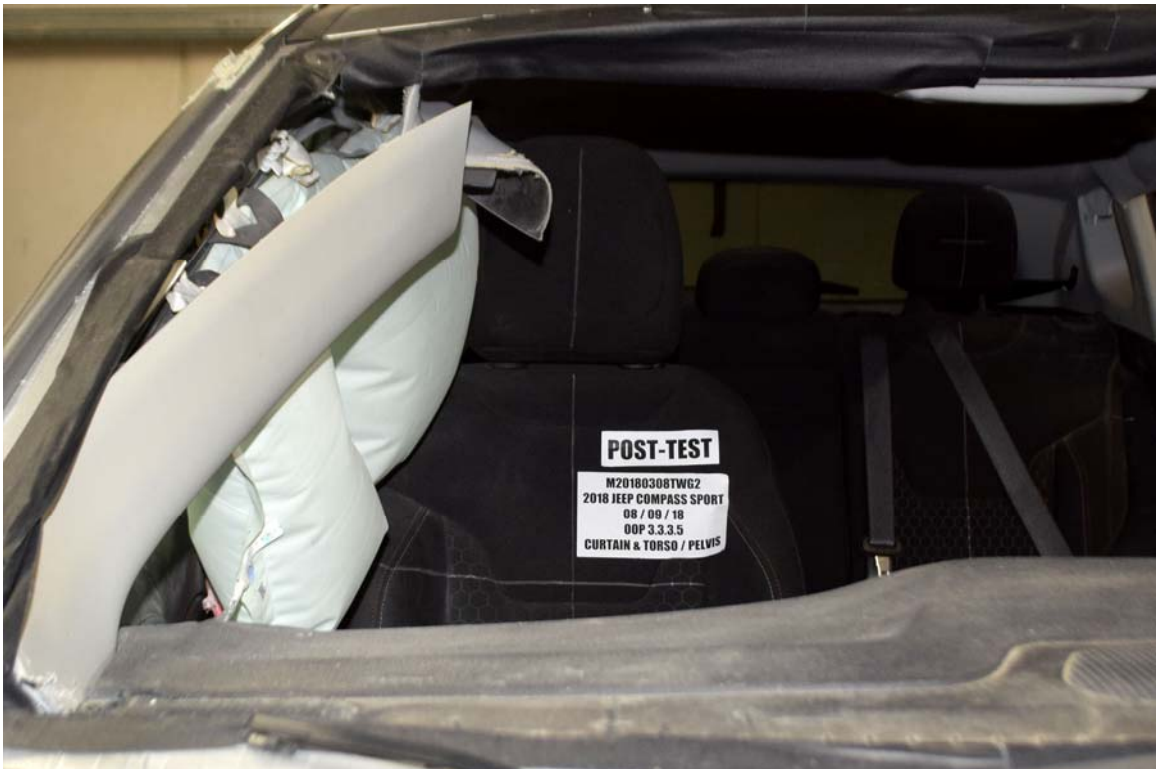
FIGURE 12. Post-Test Dummy Position, Front View

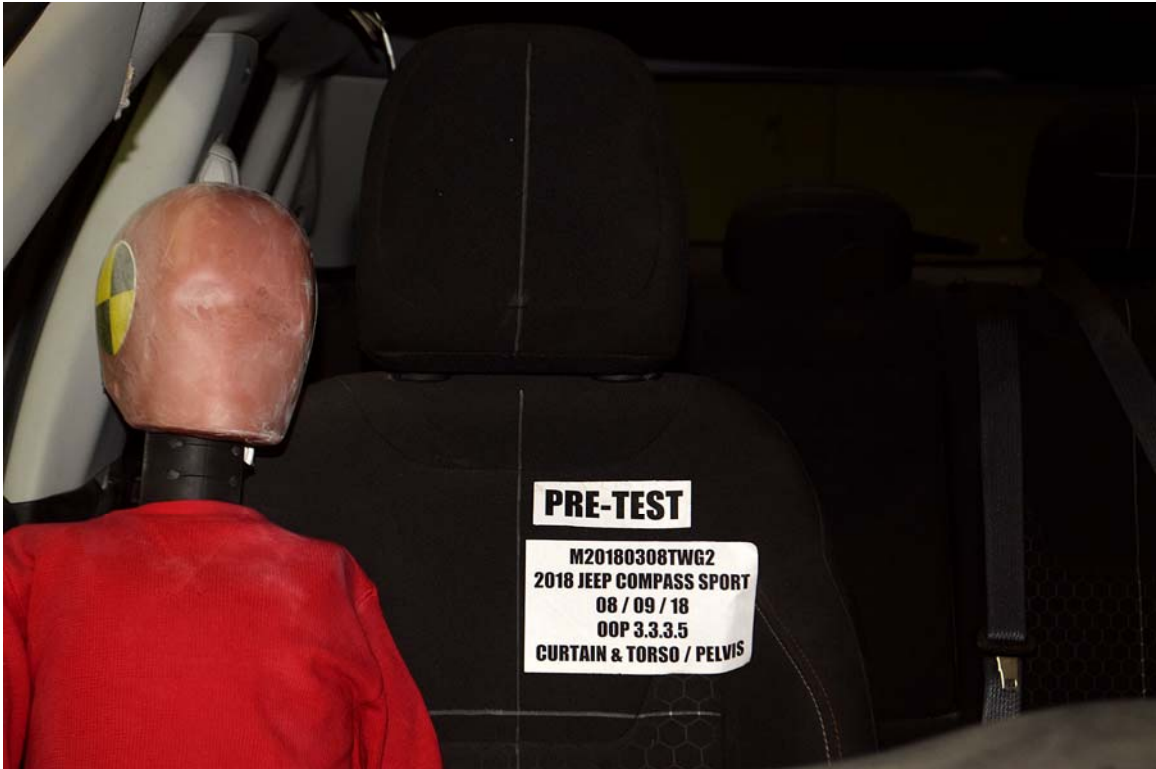
FIGURE 13. Pre-Test Dummy Position, Close-Up Front View

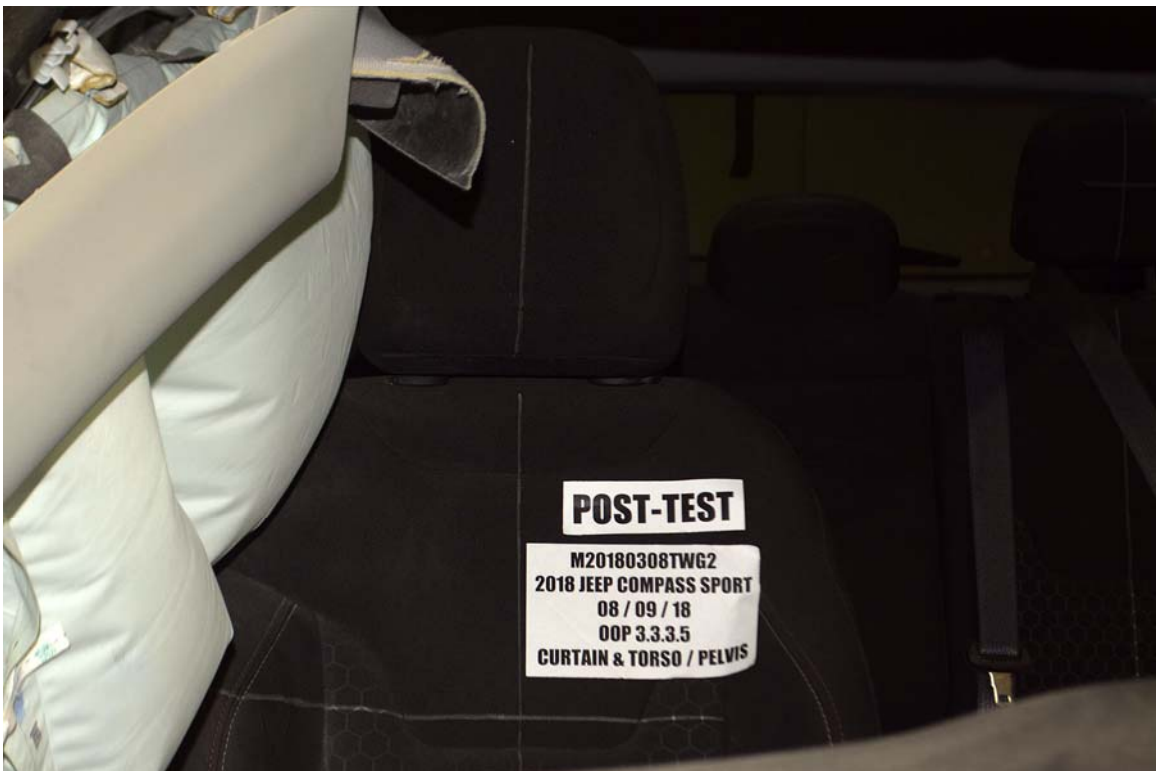
FIGURE 14. Post-Test Dummy Position, Close-Up Front View

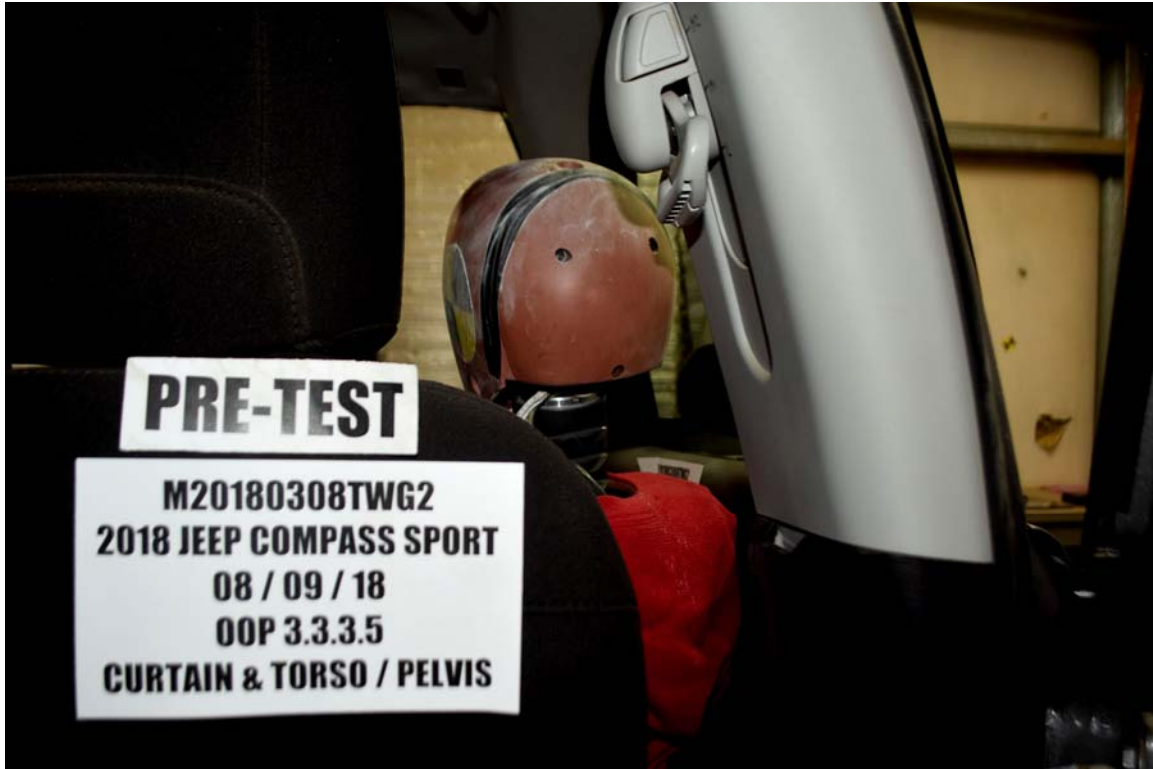
FIGURE 15. Pre-Test Dummy Position, Close-Up Rear View

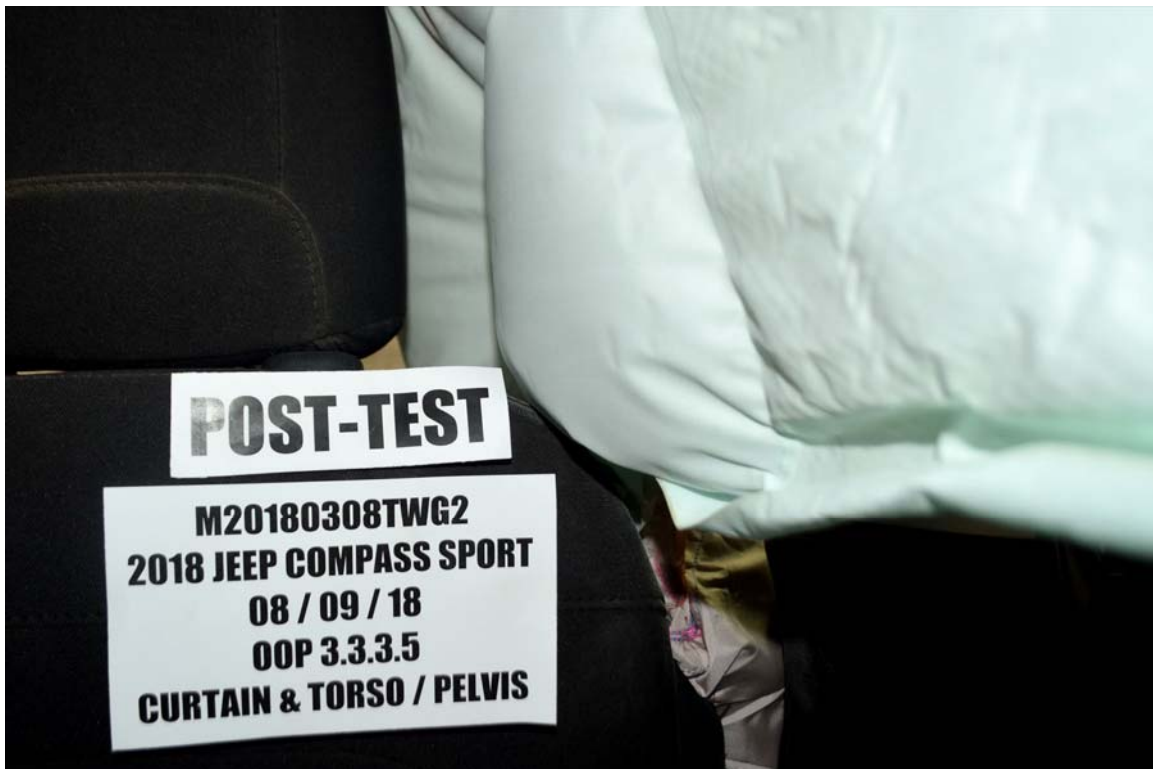
FIGURE 16. Post-Test Dummy Position, Close-Up Rear View

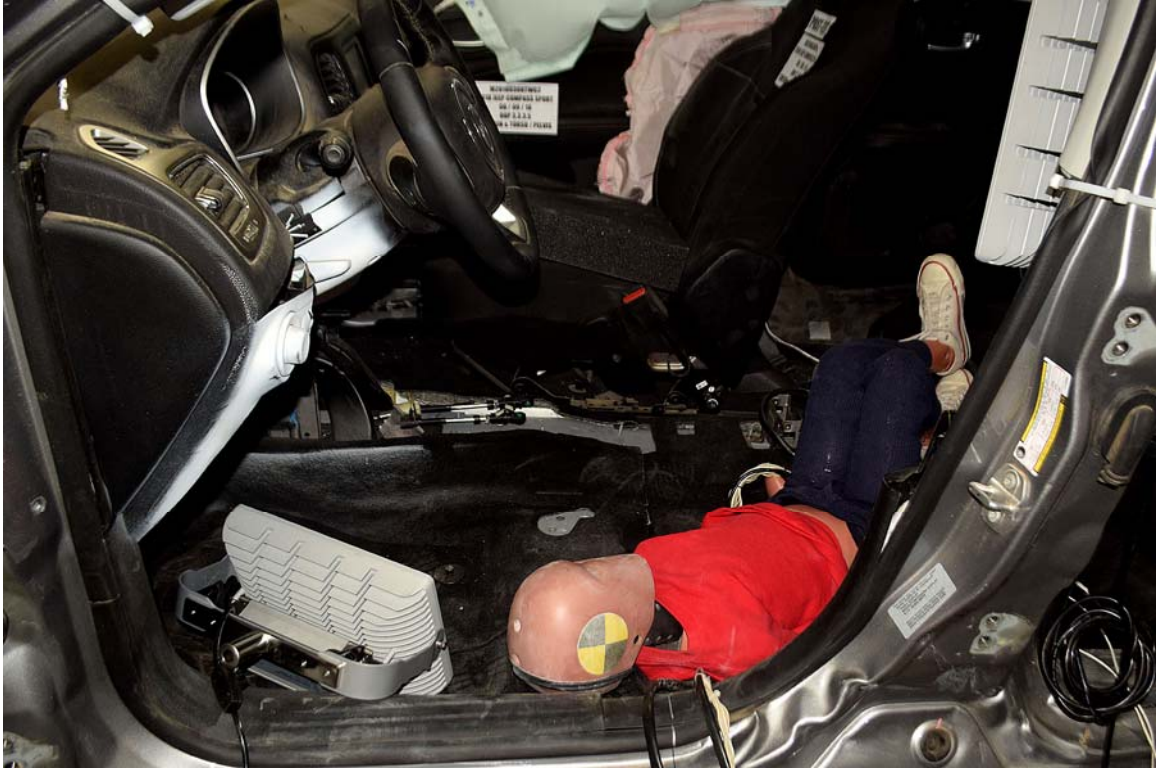
FIGURE 17. Post Test Dummy Position, Overall Side View

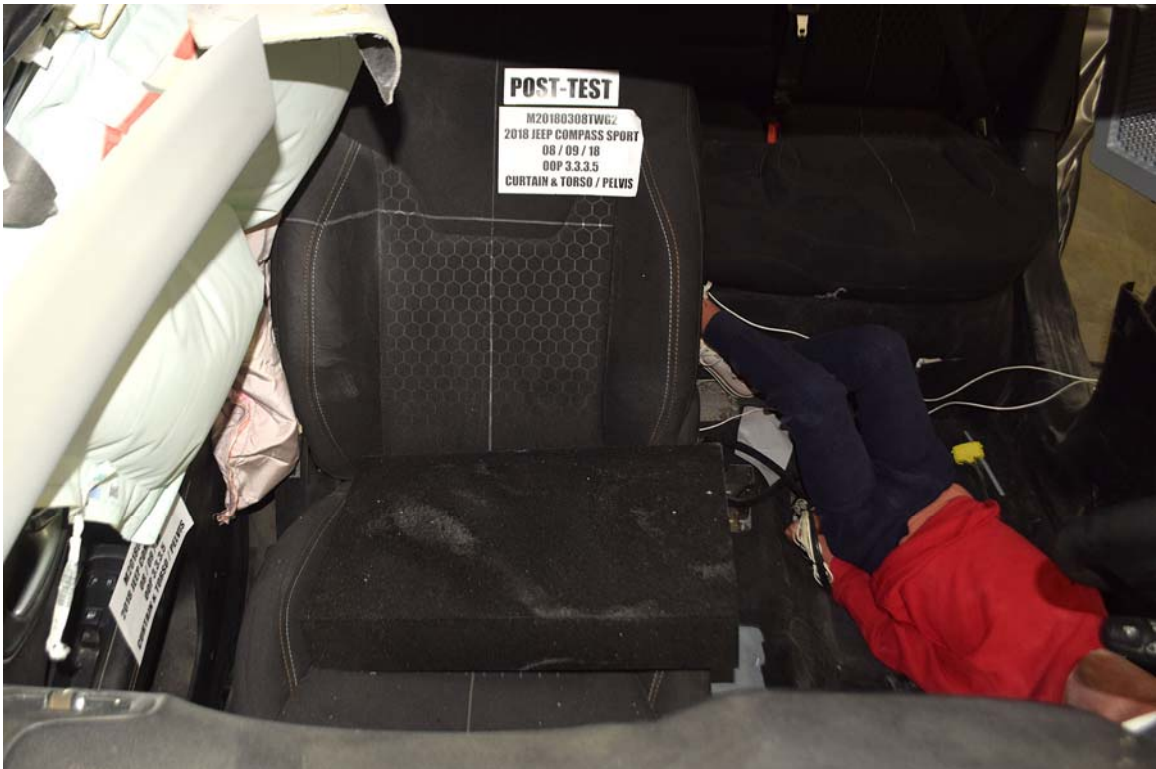
FIGURE 18. Post-Test Dummy Position, Overall Front View

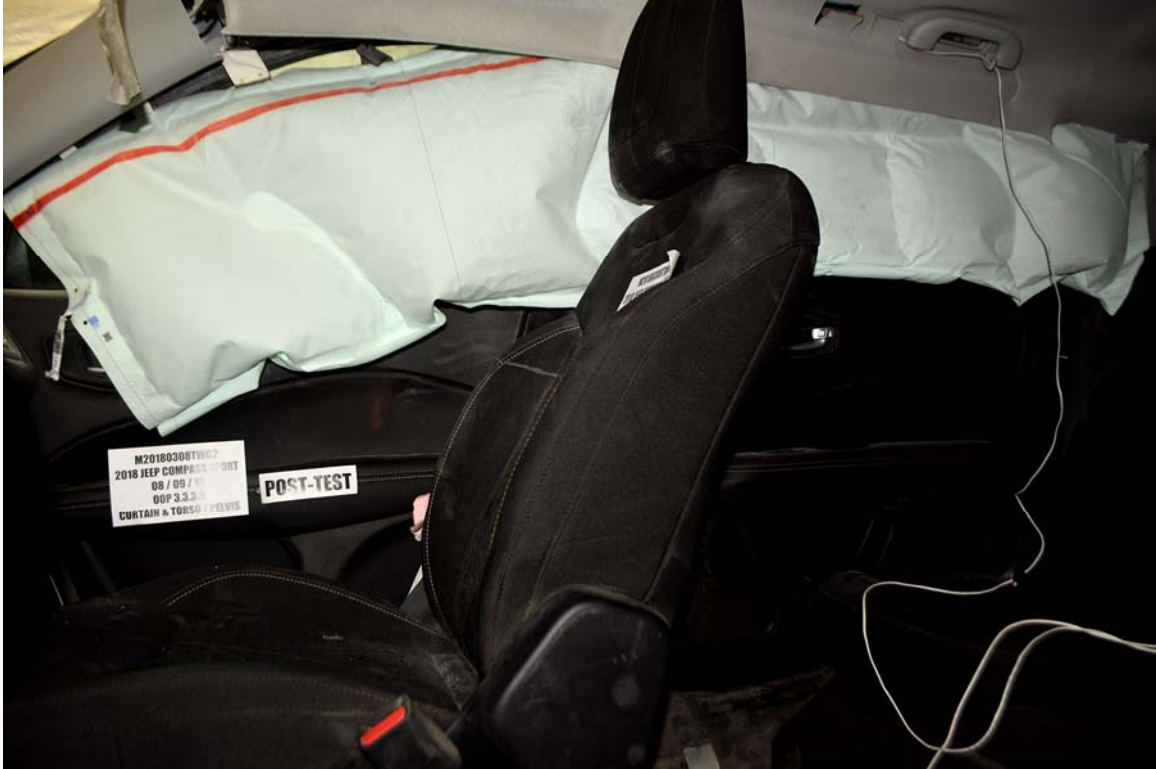
FIGURE 19. Post-Test Airbags, Left Side View

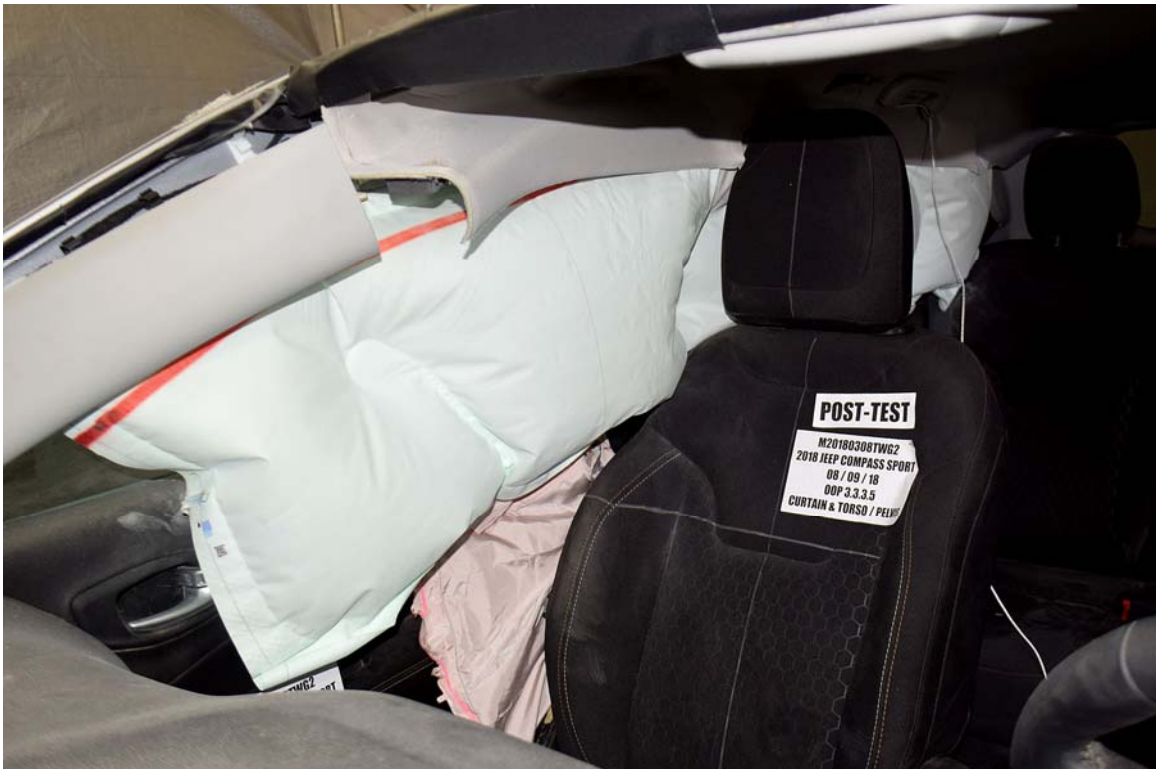
FIGURE 20. Post-Test Airbags, Left Front  $\frac{3}{4}$  View
