REPORT NUMBER: NCAP-KAR-18-020

**NEW CAR ASSESSMENT PROGRAM (NCAP)
FRONTAL BARRIER IMPACT TEST**

2018 TESLA MODEL 3 LONG RANGE RWD 4-DOOR SEDAN

FINAL REPORT

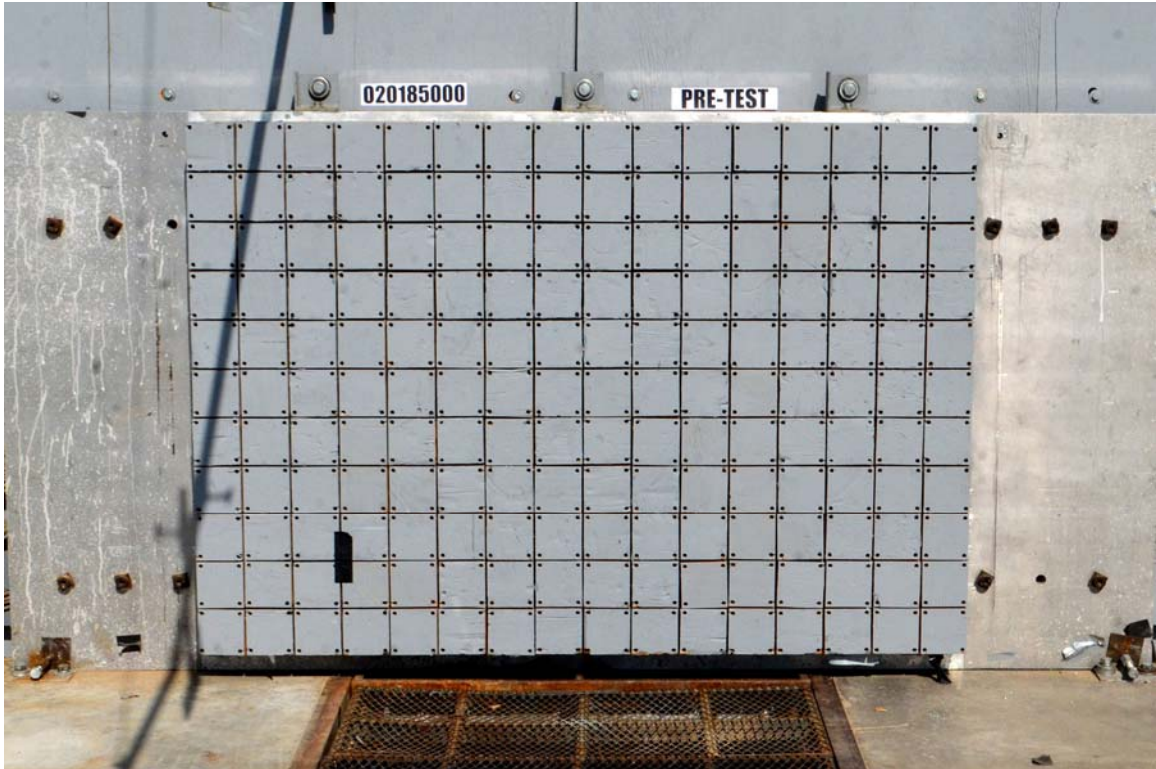
FIGURE 2. Pre-Test Load Cell Wall

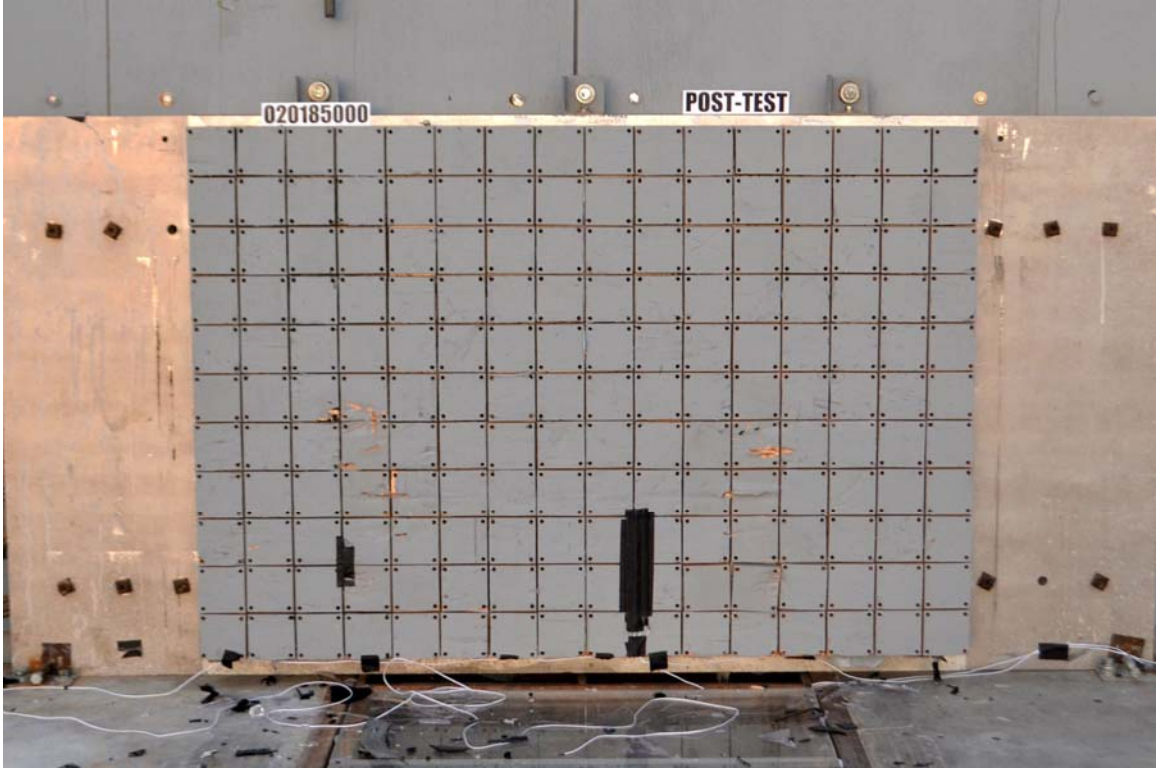
FIGURE 3. Post-Test Load Cell Wall

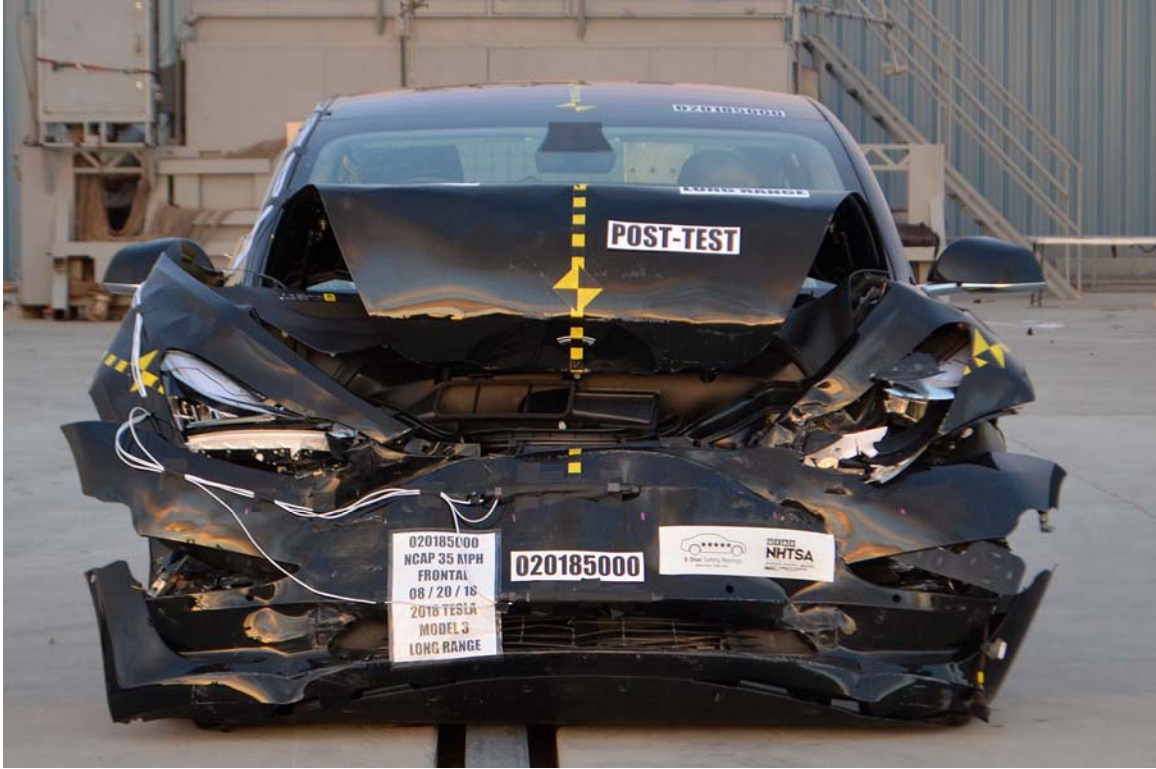
FIGURE 9. Post-Test Front View of Test Vehicle

The maximum static crush was 437 mm at DPD4 to the right of the vehicle's centerline. Both the driver and passenger side doors remained closed during the impact event and were operable after the impact.

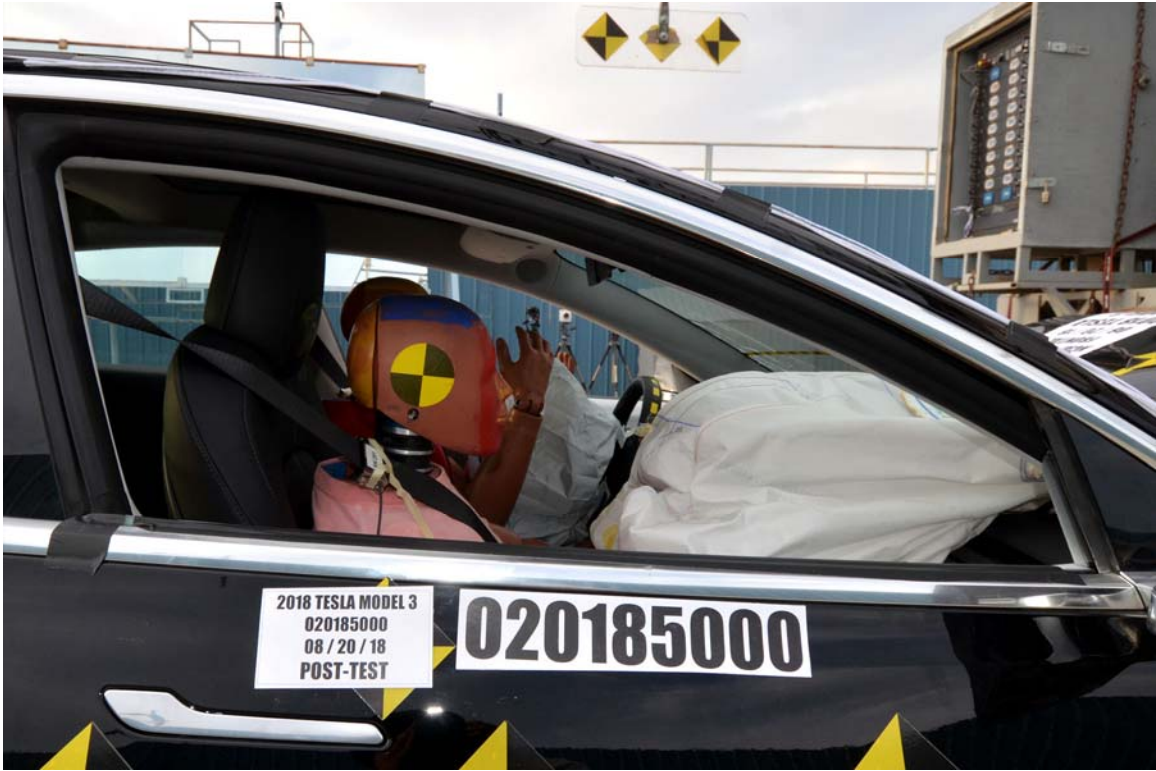
FIGURE 54. Post-Test Passenger Dummy Window View

The passenger's visible contact points were as follows: The passenger ATD's head contacted the frontal airbag, headrest, and seatback. The upper torso contacted the frontal airbag.
