**REPORT NUMBER: SINCAP-KAR-18-021**

**NEW CAR ASSESSMENT PROGRAM (NCAP)  
MOVING DEFORMABLE BARRIER SIDE IMPACT TEST**

**TESLA, INC.  
2018 TESLA MODEL 3 LONG RANGE RWD 4-DOOR SEDAN**

**NHTSA No: O20185002**

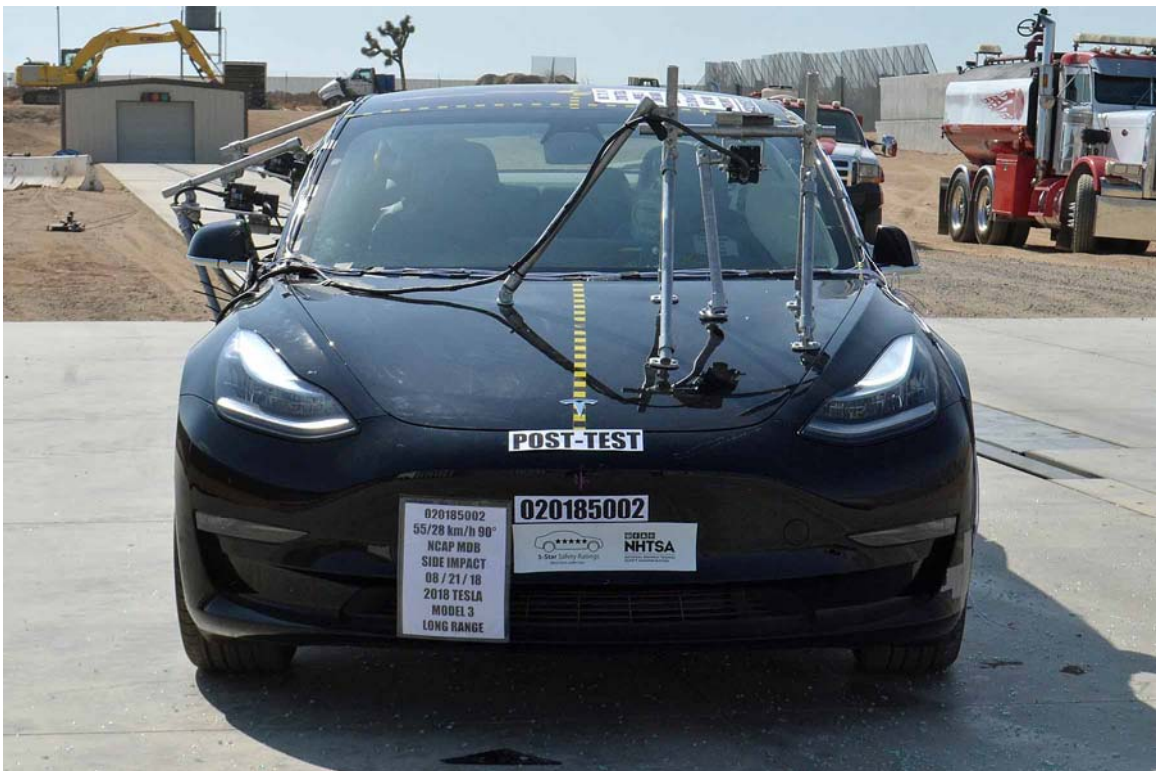
FIGURE 4. Post-Test Frontal View of Test Vehicle

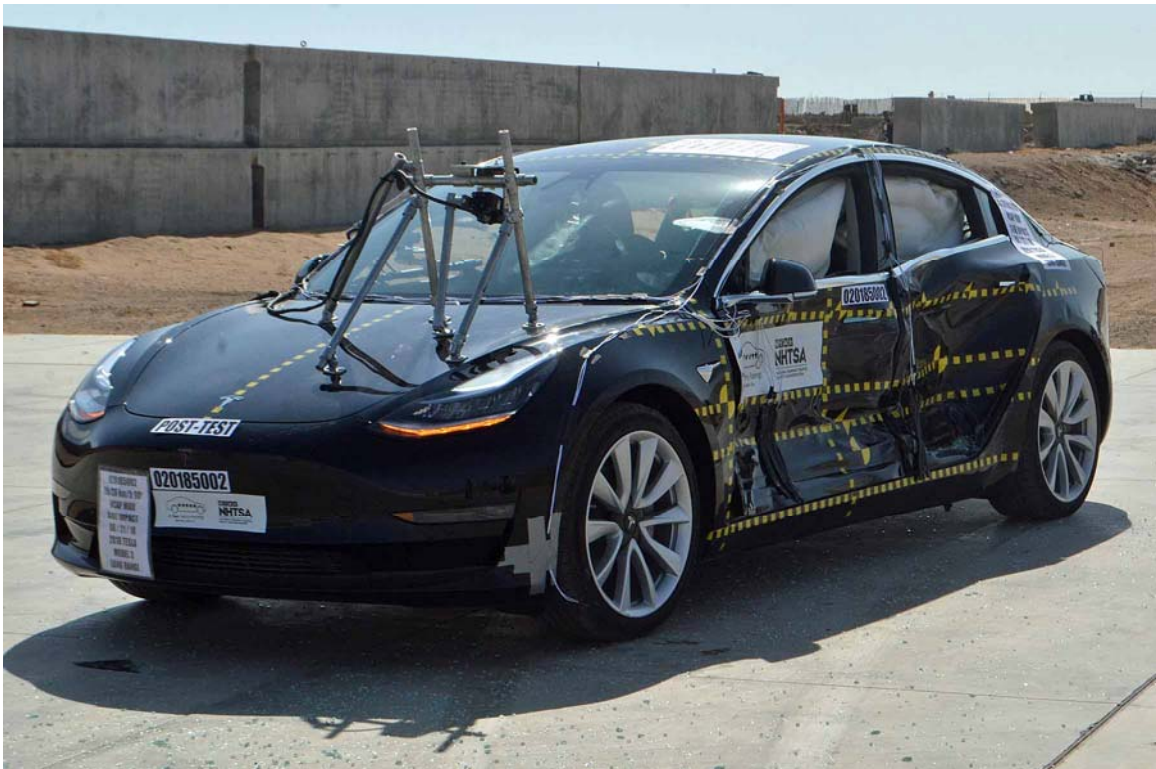
FIGURE 6. Post-Test Left Front  $\frac{3}{4}$  View of Test Vehicle

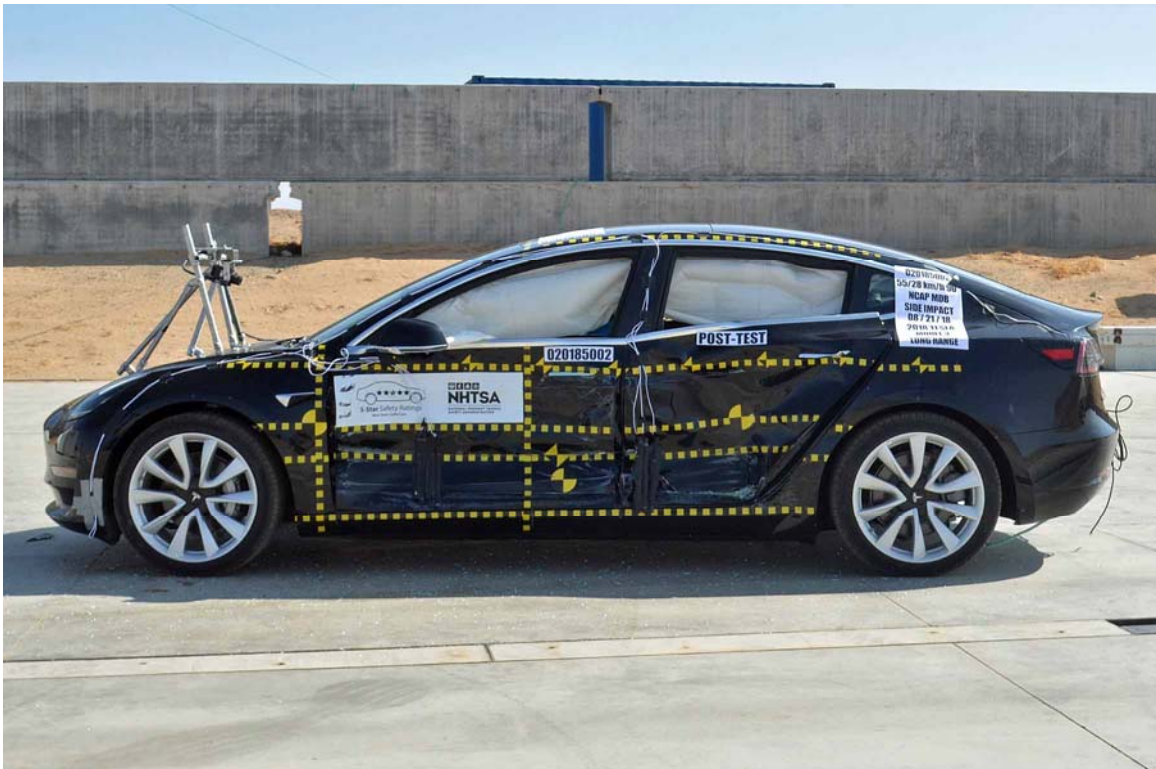
FIGURE 8. Post-Test Left Side View of Test Vehicle

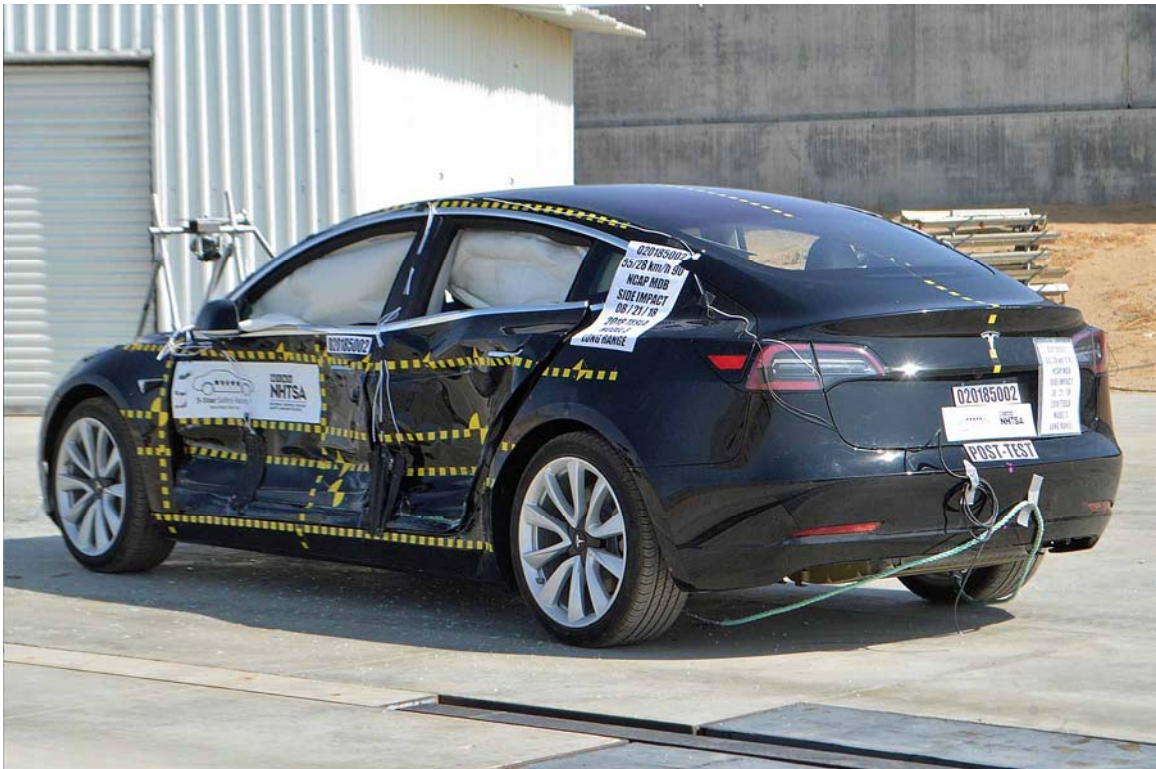
FIGURE 10. Post-Test Left Rear  $\frac{3}{4}$  View of Test Vehicle

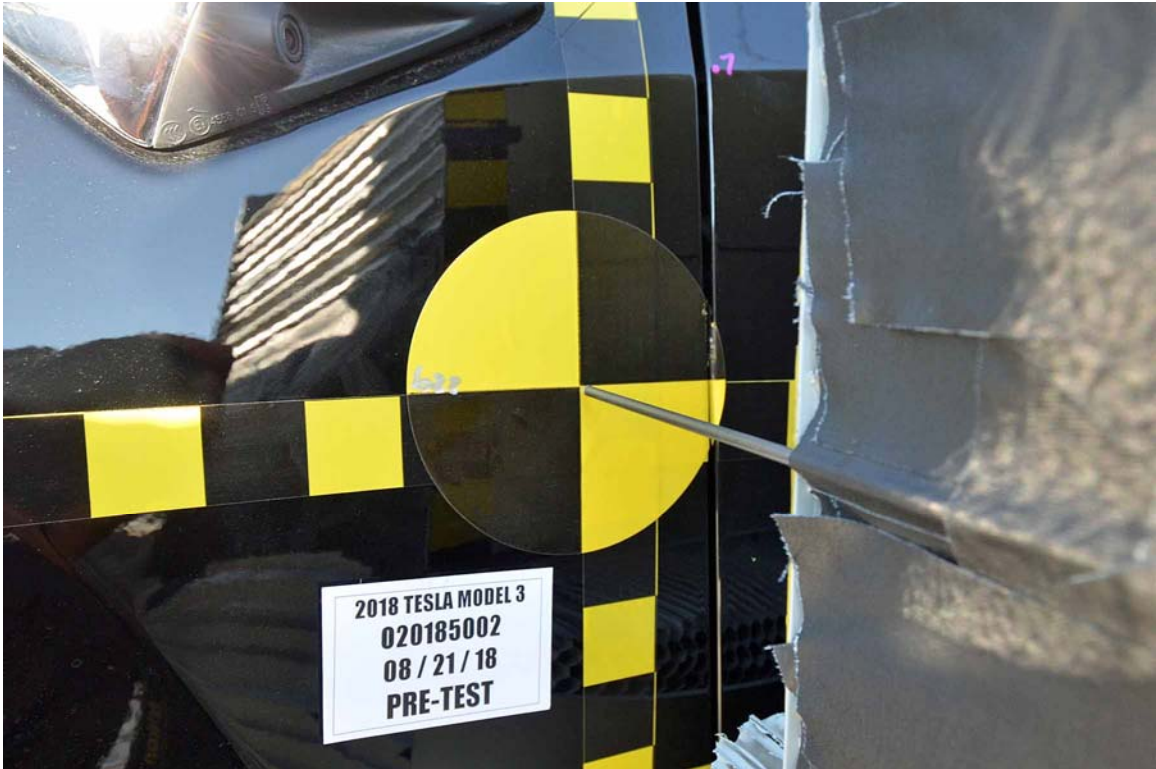
FIGURE 19. Pre-Test Close-Up View of Impact Point Target

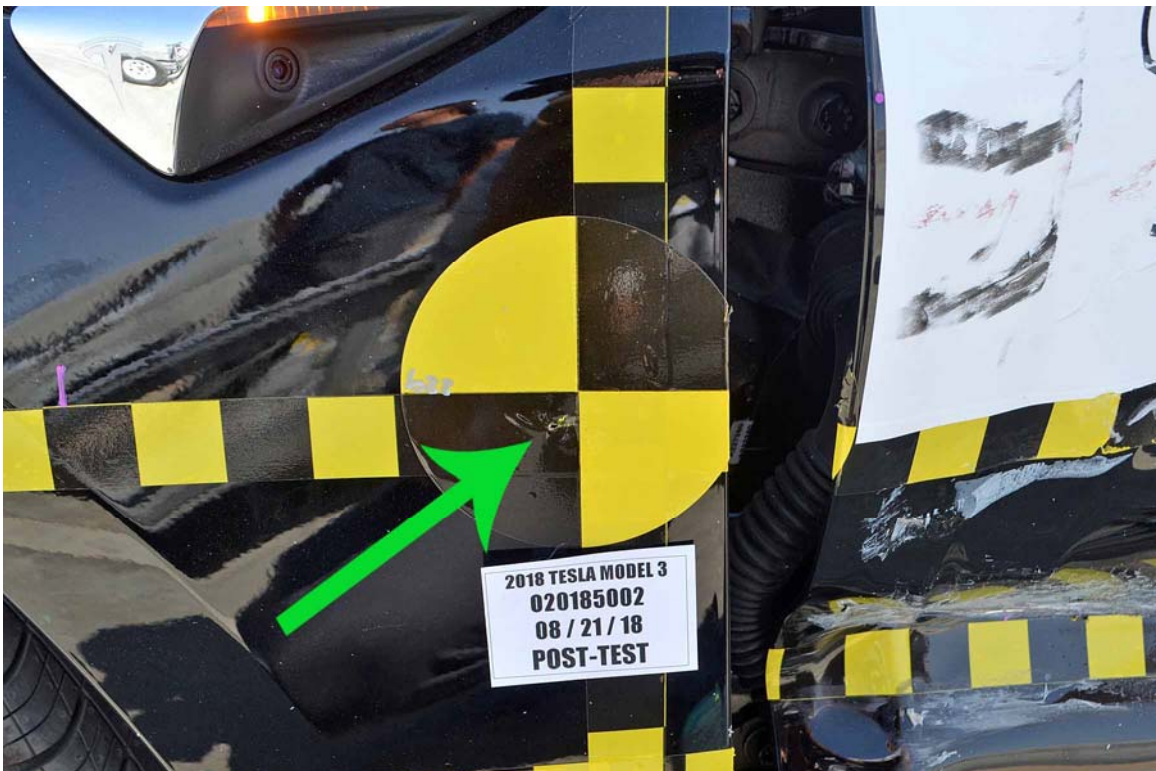
FIGURE 20. Post-Test Close-Up View of Impact Point Target

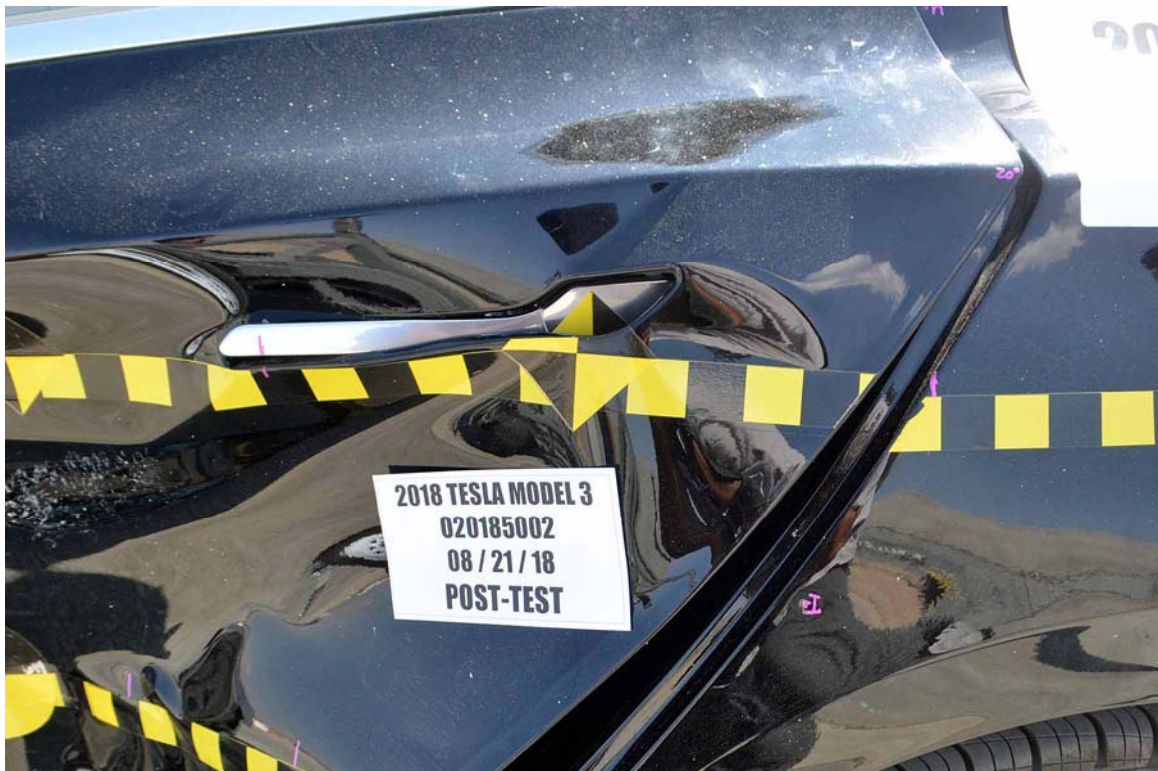
FIGURE 24. Post-Test Left Rear Door Latch Close-Up

The doors on the struck side of the vehicle did not separate from the body at the hinges or latches. The opposite side doors did not open during the side impact event.

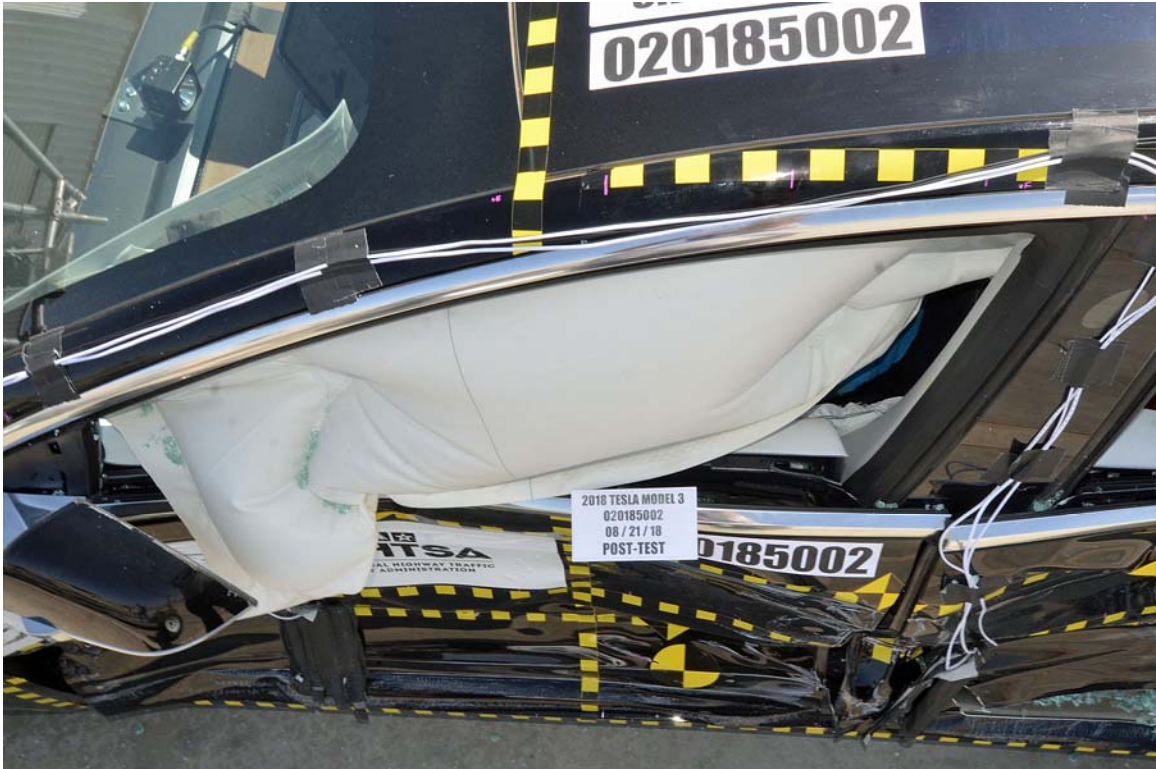
FIGURE 43. Post-Test Driver Dummy and Door Clearance View

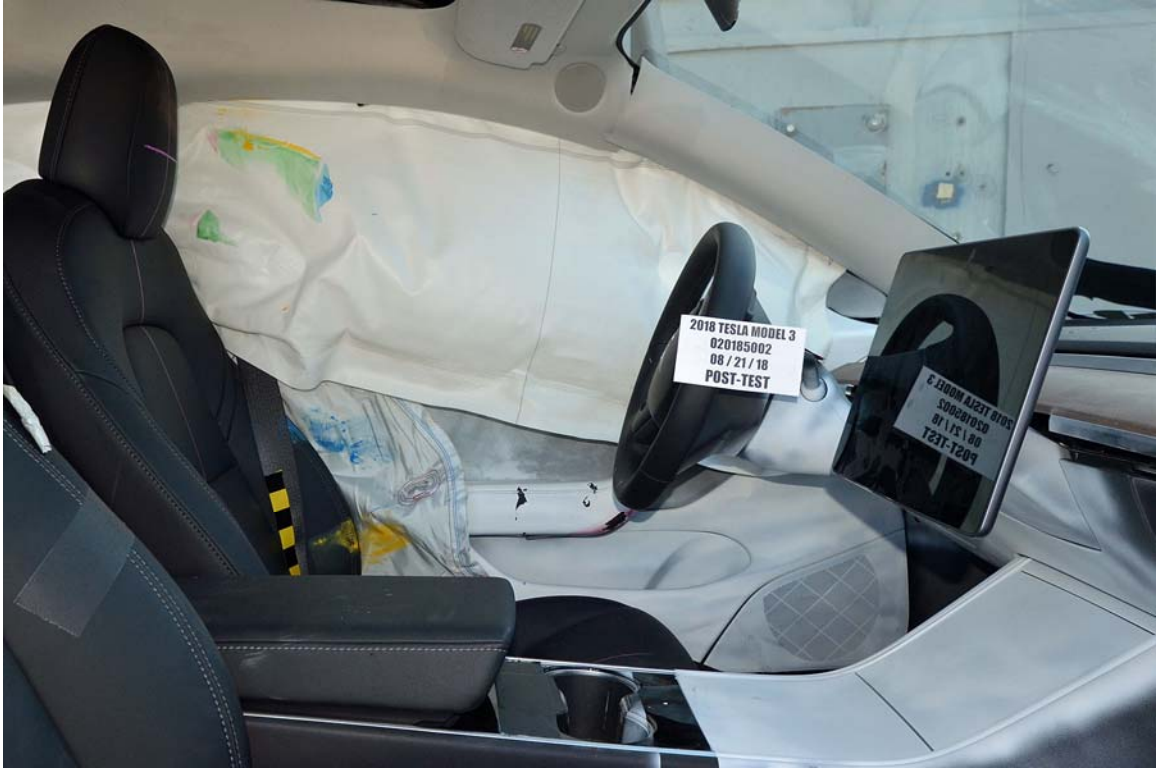
FIGURE 47. Post-Test Driver Inner Door Panel View  
Showing Driver Dummy Contact Locations

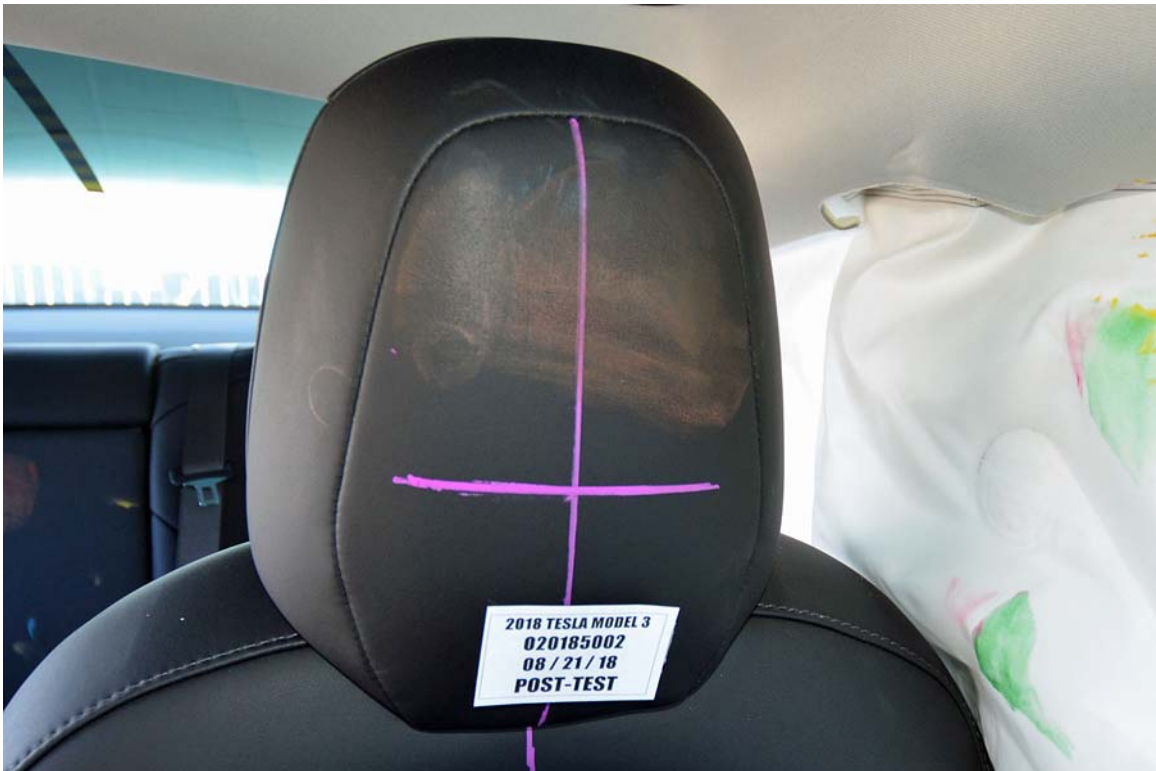
FIGURE 48. Post-Test Driver Dummy Close-Up Head Contact  
with Vehicle Interior View

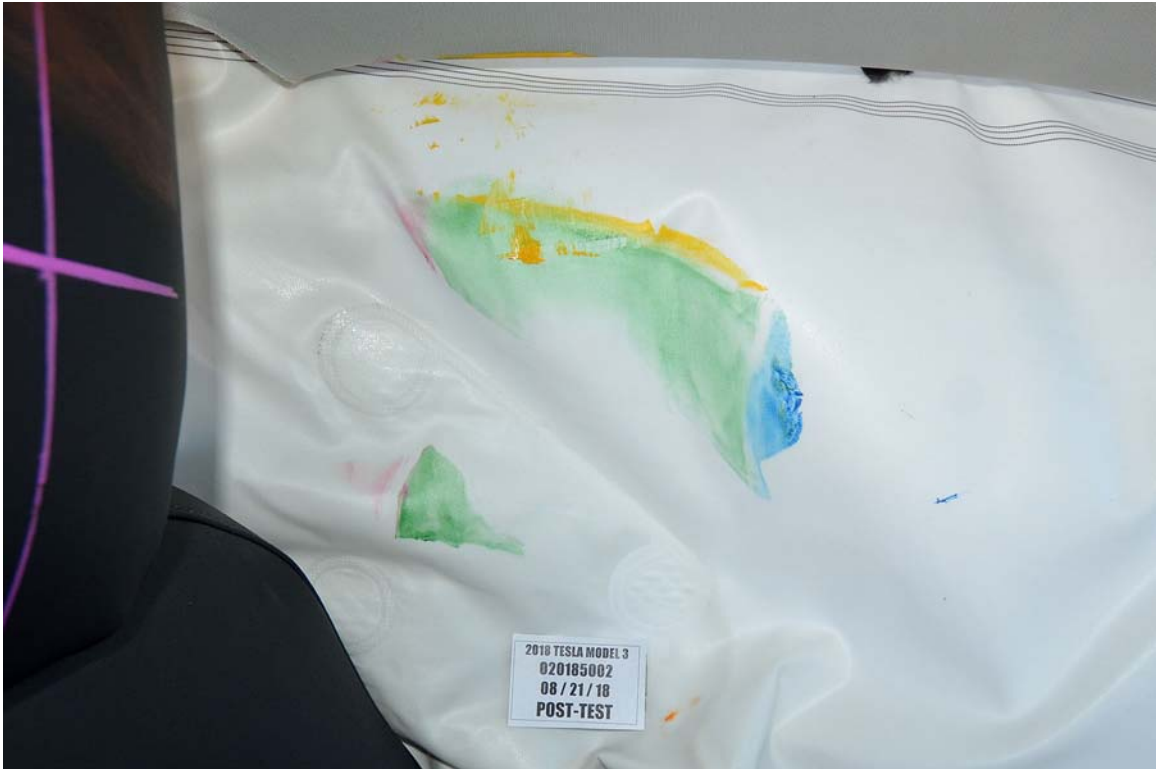
FIGURE 49. Post-Test Driver Dummy Close-Up Head Contact with Side Airbag View

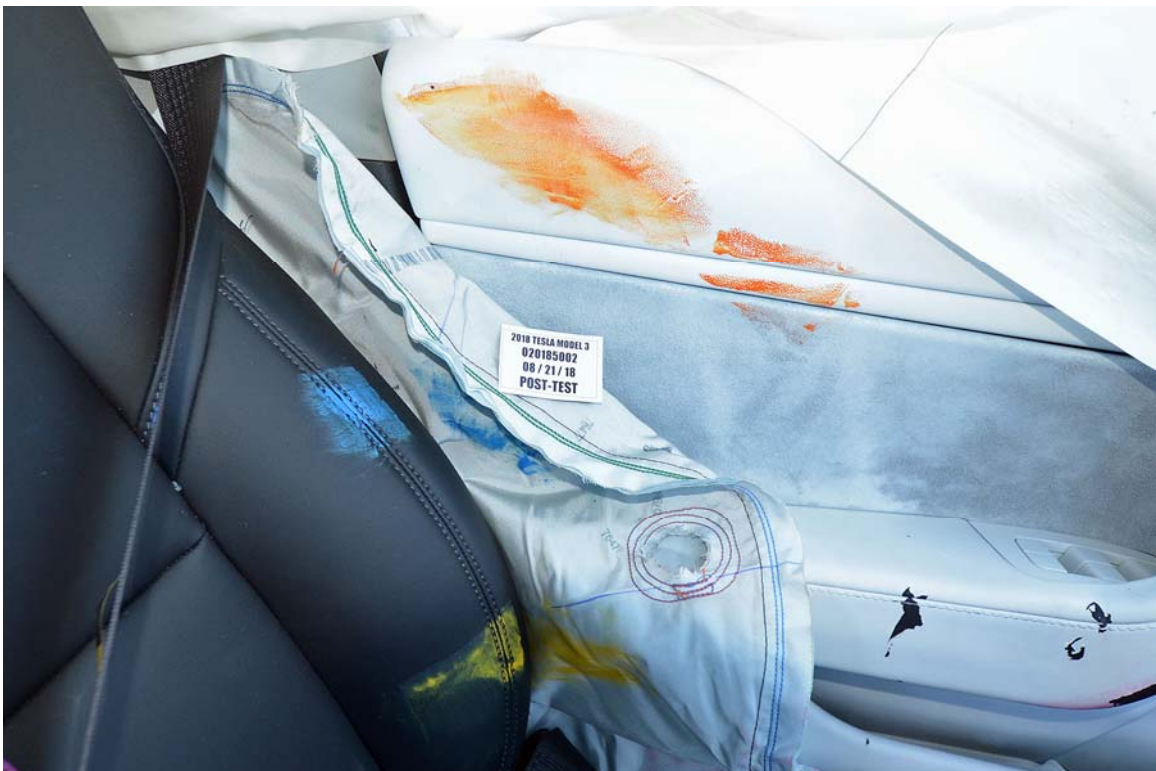
FIGURE 50. Post-Test Driver Dummy Close-Up Torso Contact with Vehicle Interior View

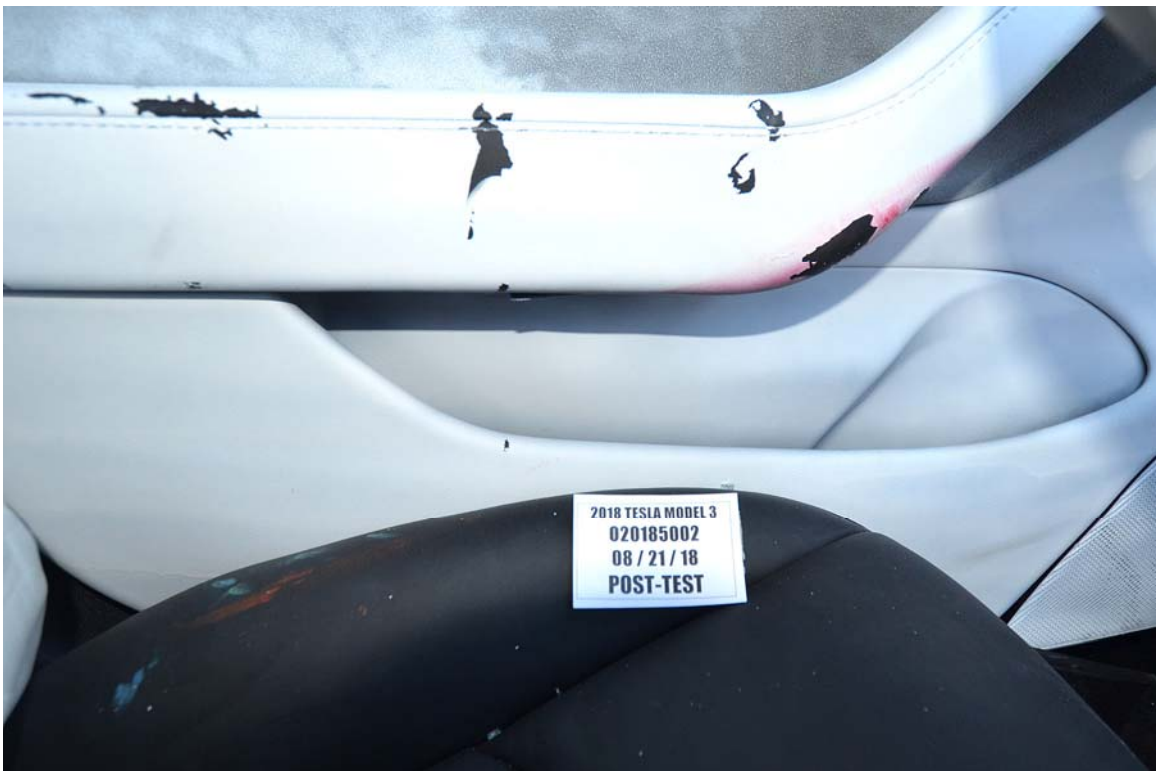
FIGURE 52. Post-Test Driver Dummy Close-Up Pelvis Contact  
with Vehicle Interior View

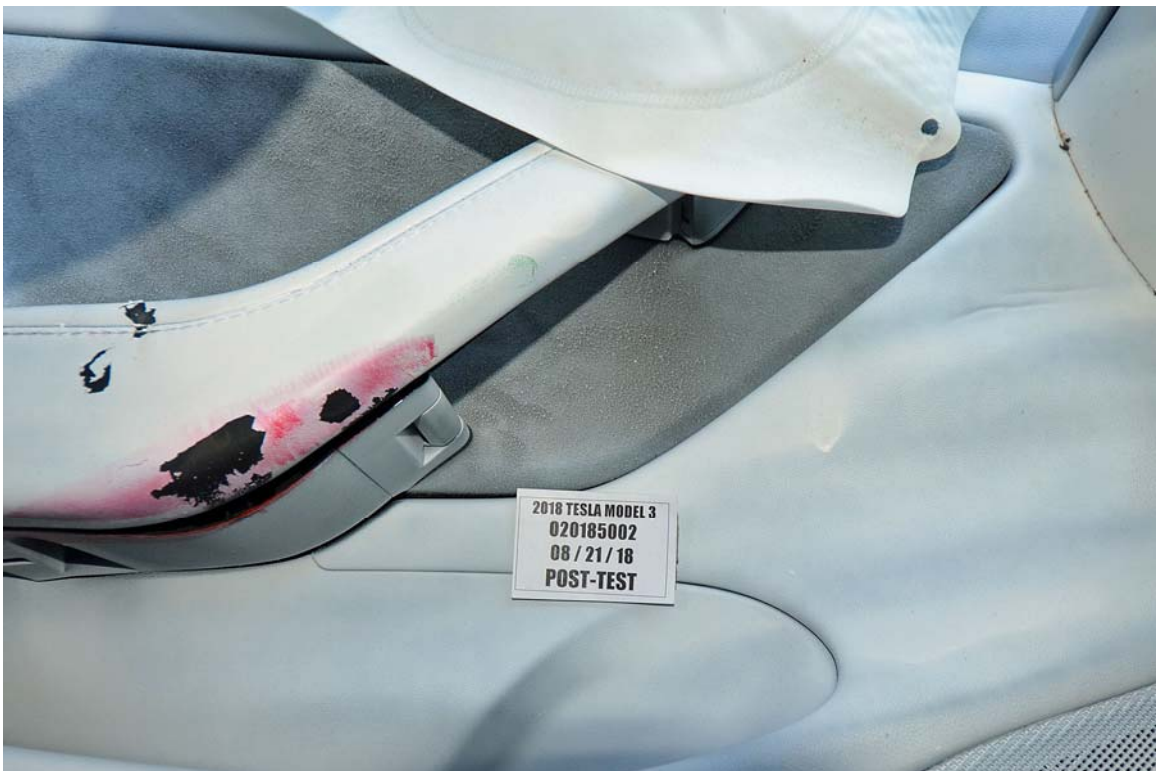
FIGURE 54. Post-Test Driver Dummy Close-Up Knee Contact View

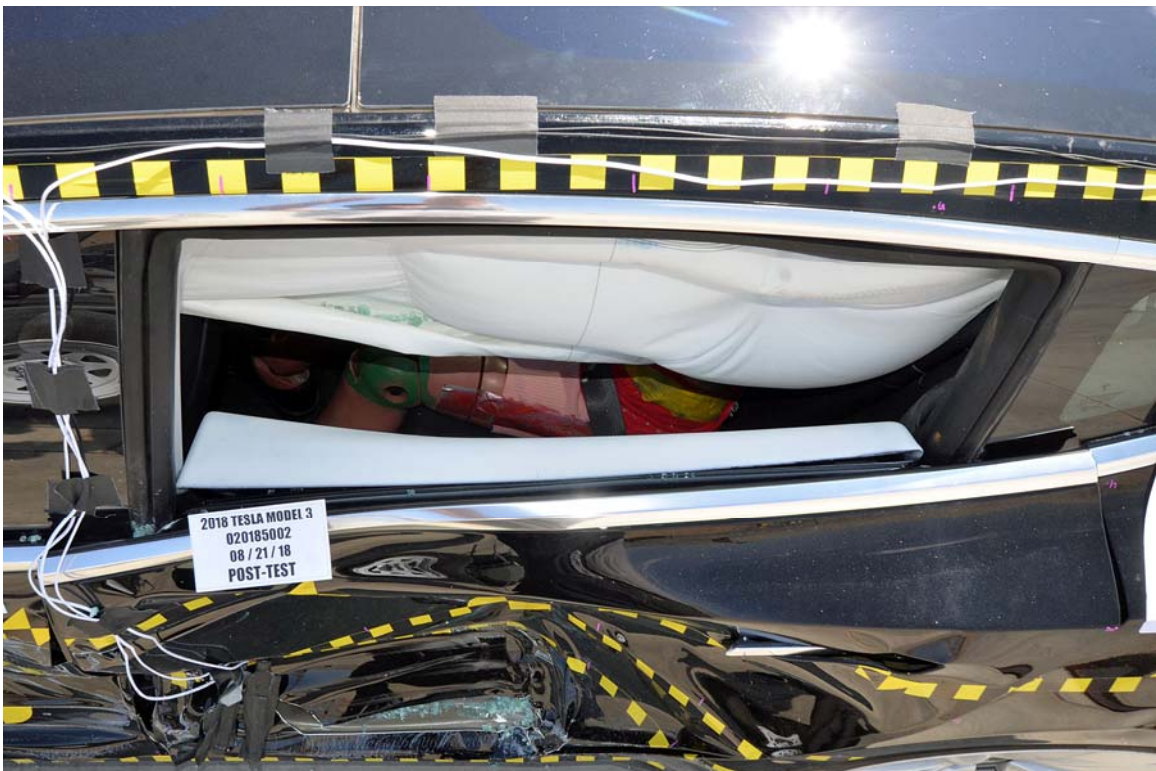
FIGURE 70. Post-Test Rear Passenger Dummy and Door Clearance View

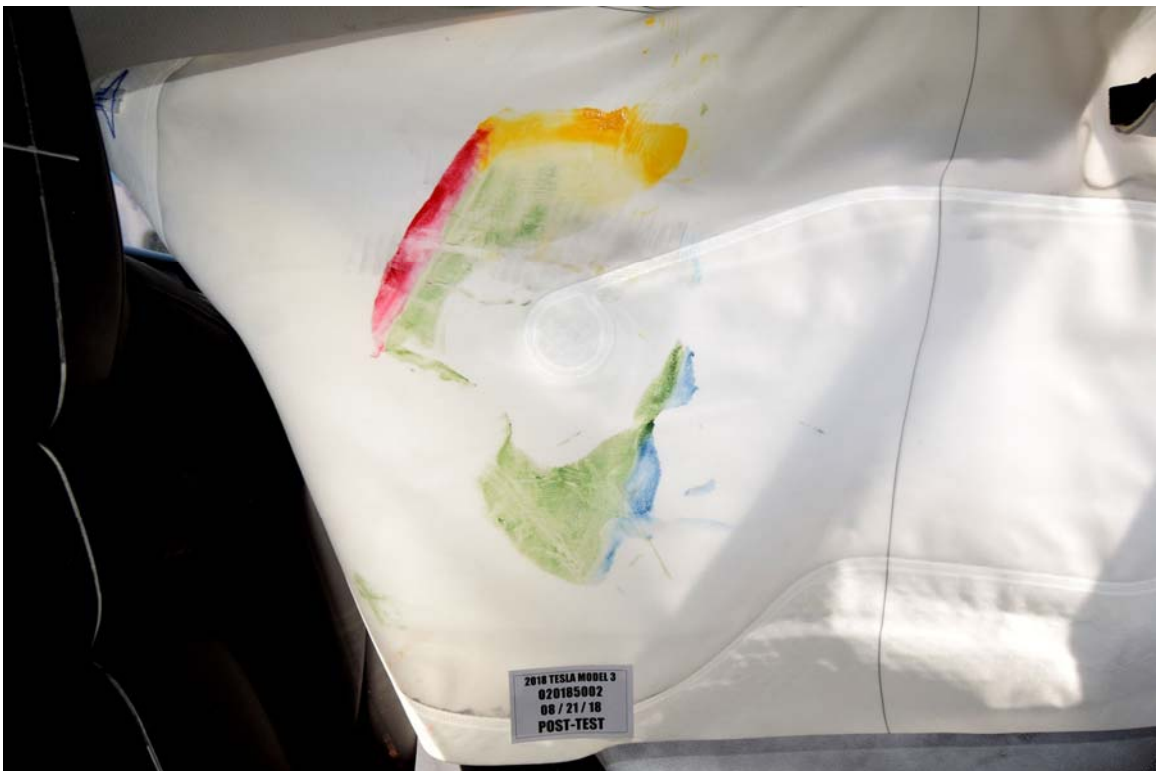
FIGURE 76. Post-Test Rear Passenger Dummy Close-Up  
Head Contact with Side Airbag View

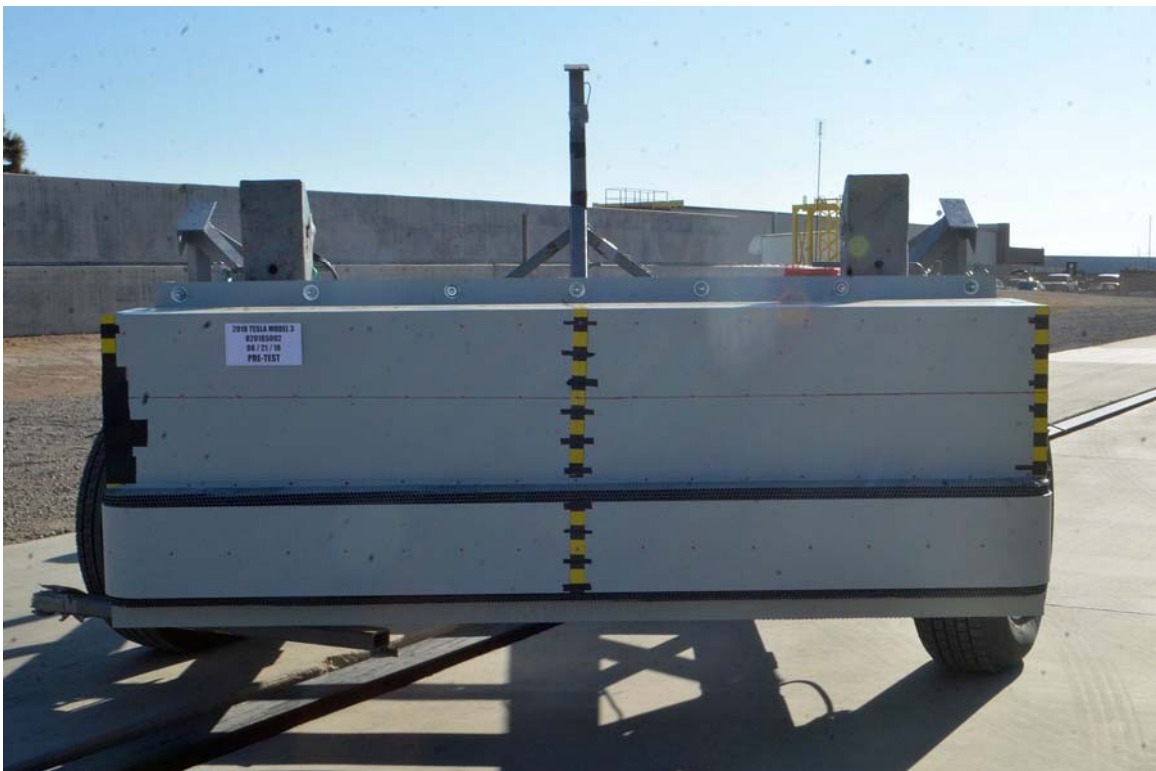
FIGURE 84. Pre-Test Front View of MDB Impactor Face

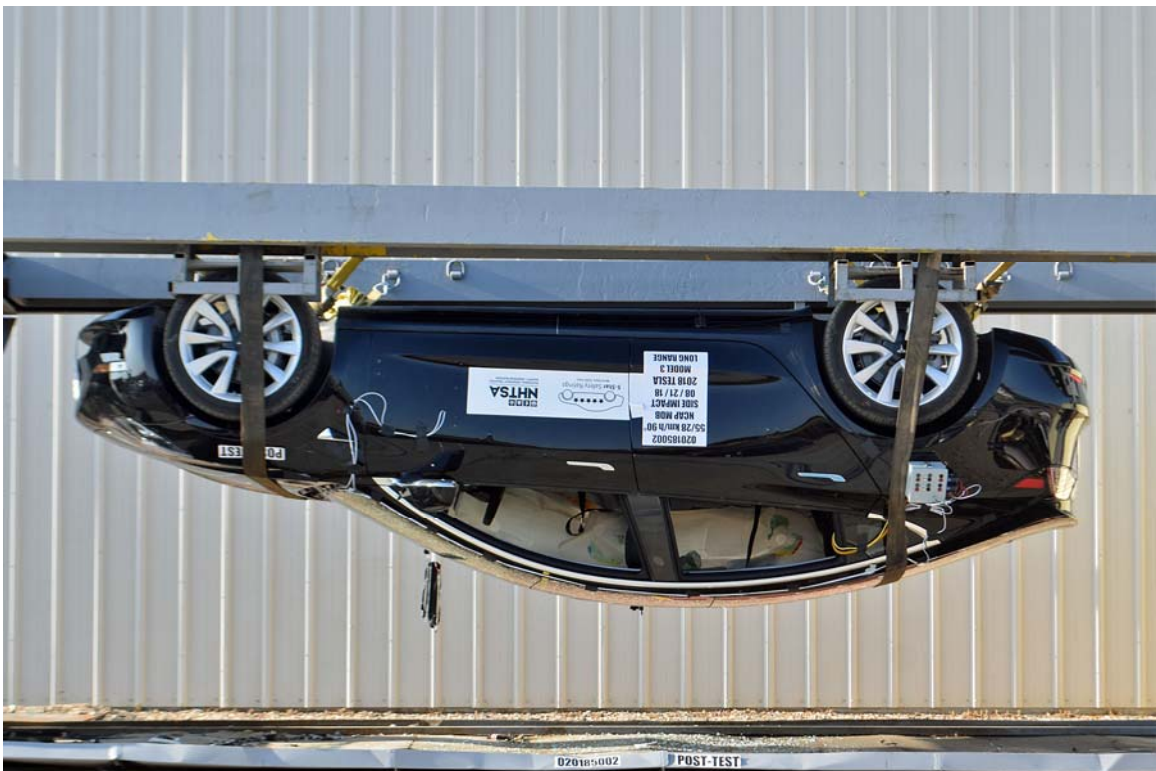
FIGURE 98. FMVSS No. 301 Static Rollover 180 Degrees
