**REPORT NUMBER: SPNCAP-KAR-18-022  
NEW CAR ASSESSMENT PROGRAM (NCAP)  
SIDE IMPACT POLE TEST**

**TESLA, INC.  
2018 TESLA MODEL 3 LONG RANGE RWD 4-DOOR SEDAN**

**NHTSA No: O20185001**

**FINAL REPORT**

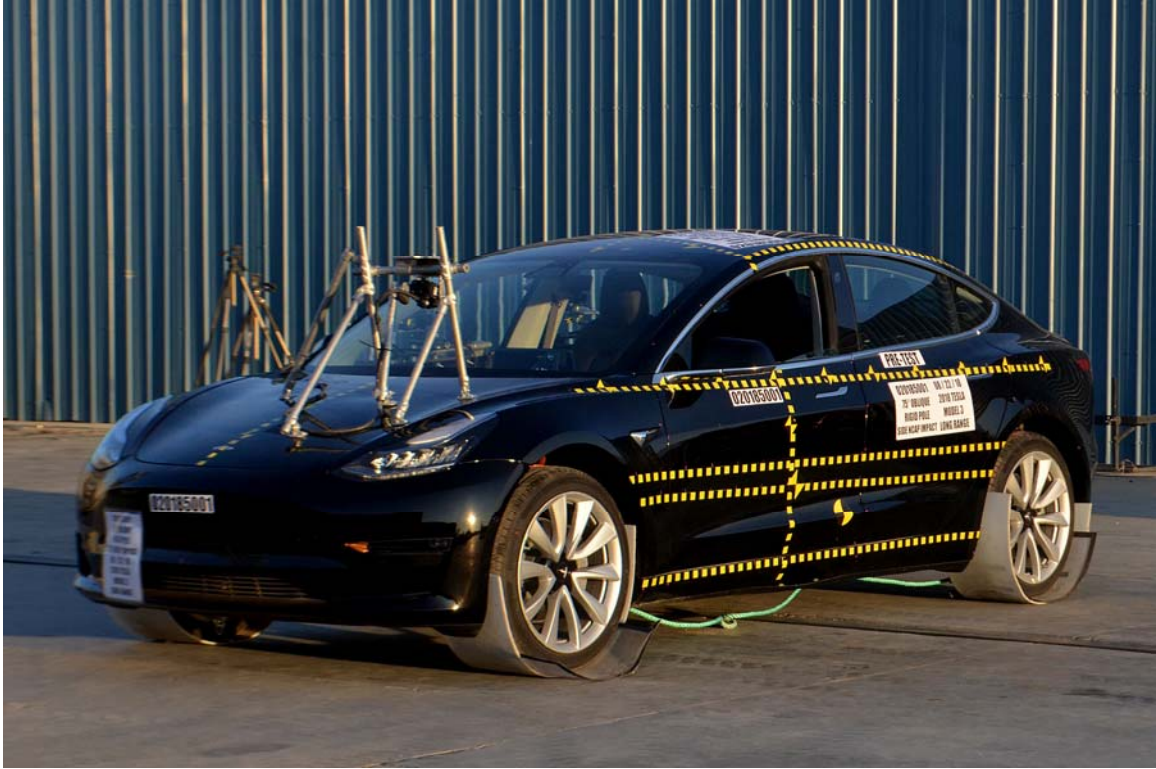
FIGURE 4. Post-Test Frontal View of Test Vehicle

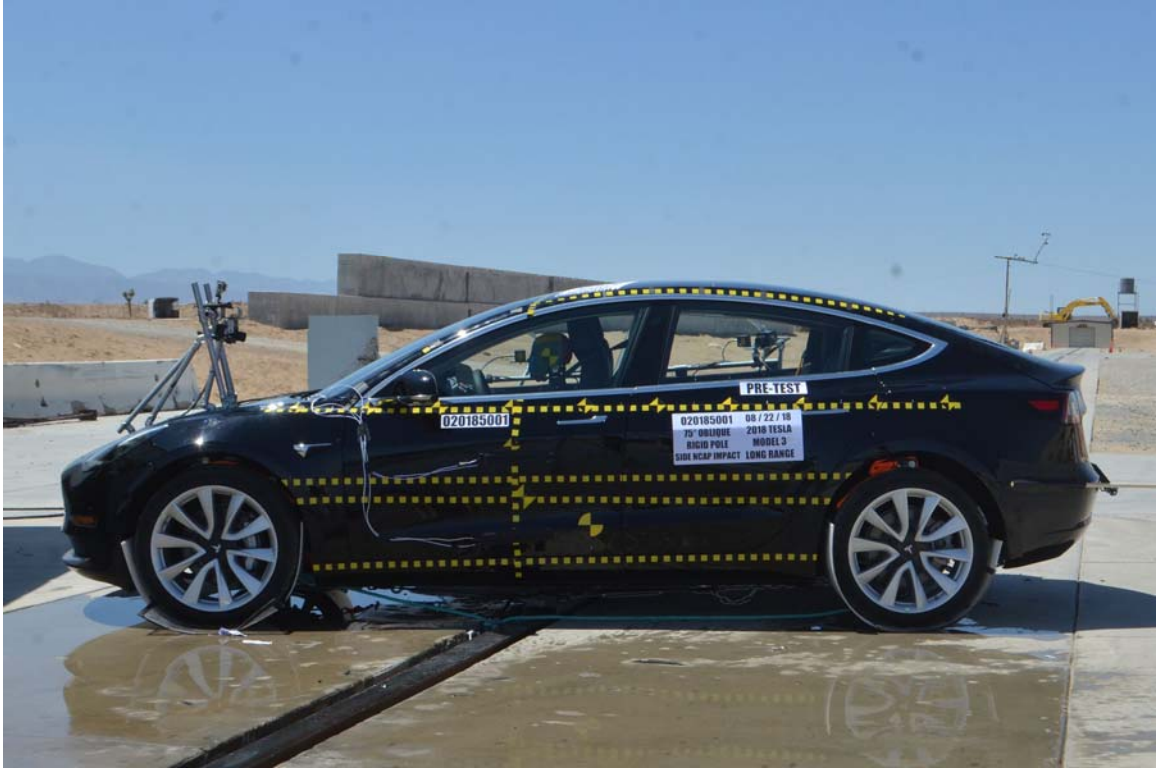
FIGURE 6. Post-Test Left Front  $\frac{3}{4}$  View of Test Vehicle

The front door on the struck side of the vehicle was jammed shut. There was no separation at the hinges or latches. The left rear, and non-struck side doors remained closed and latched. There were no ATD values that exceeded limits.

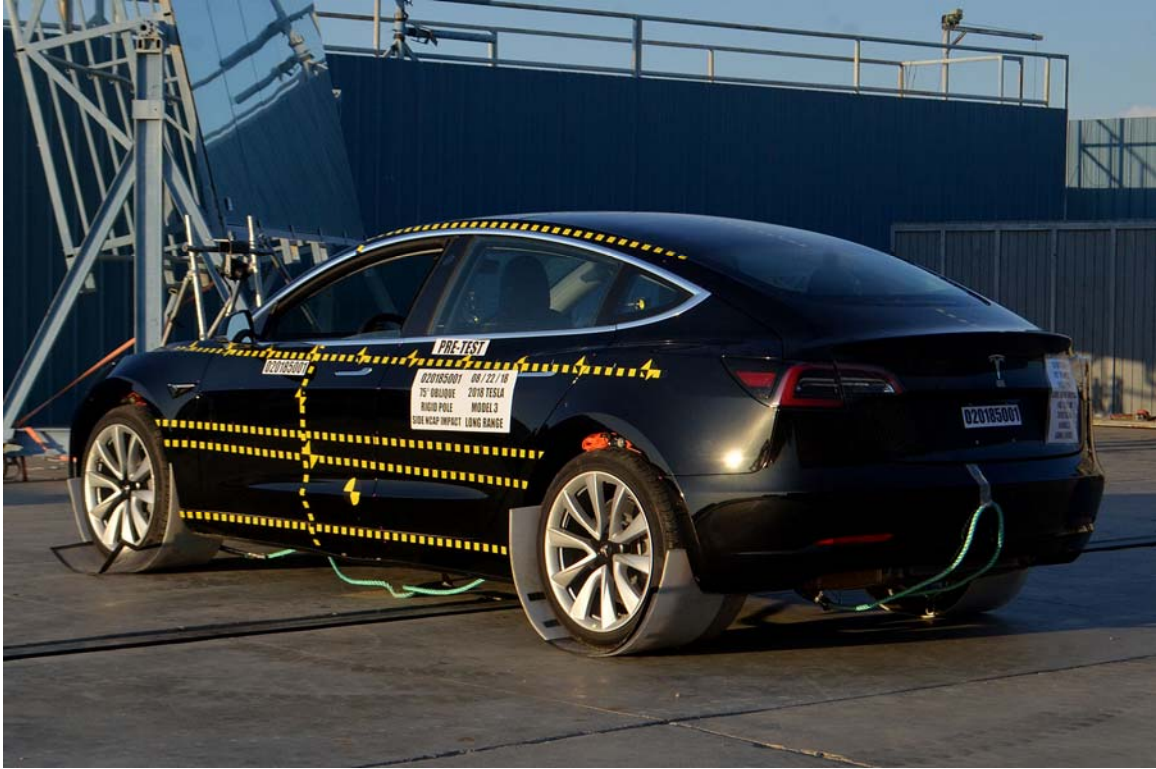
FIGURE 8. Post-Test Left Side View of Test Vehicle

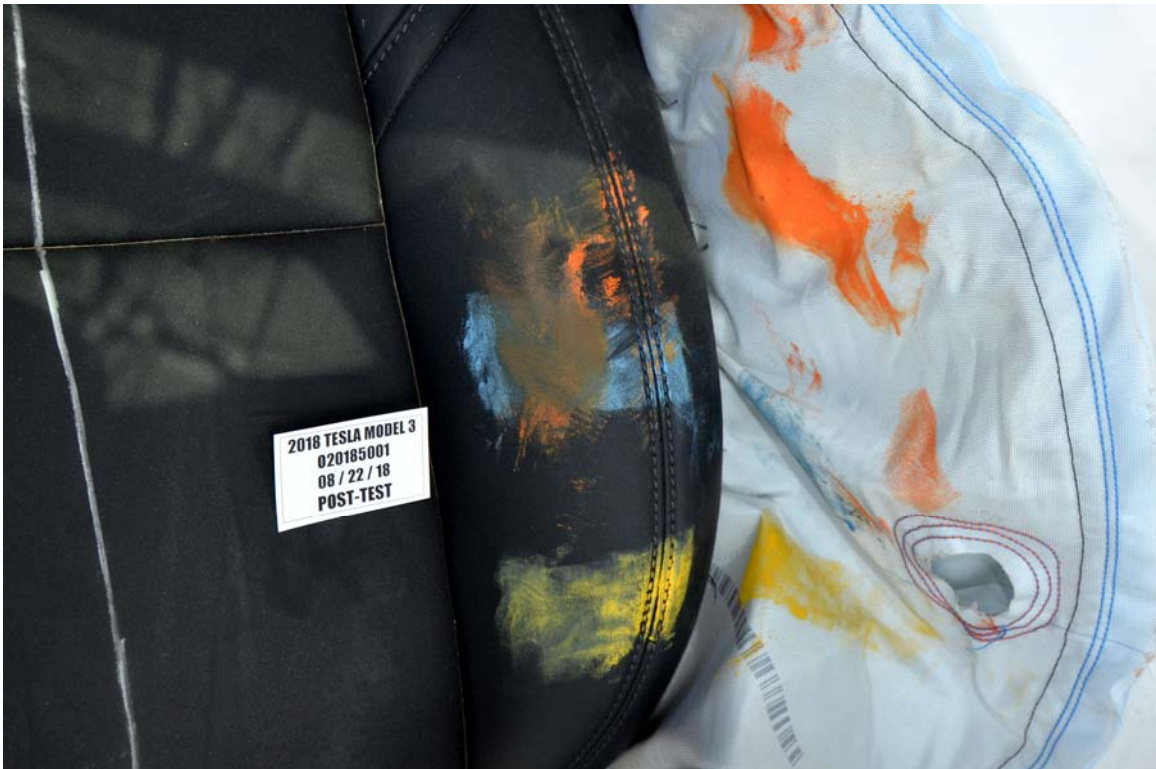
FIGURE 47. Post-Test Dummy Close-Up Head Contact With Side Airbag View
