**REPORT NUMBER: SPNCAP-MGA-2019-004**

**NEW CAR ASSESSMENT PROGRAM (NCAP)  
Side Impact Pole Test**

**HONDA MFG. OF INDIANA, LLC  
2019 Honda Insight LX 4-Door Sedan  
NHTSA No.: O20195304**

**FINAL REPORT**

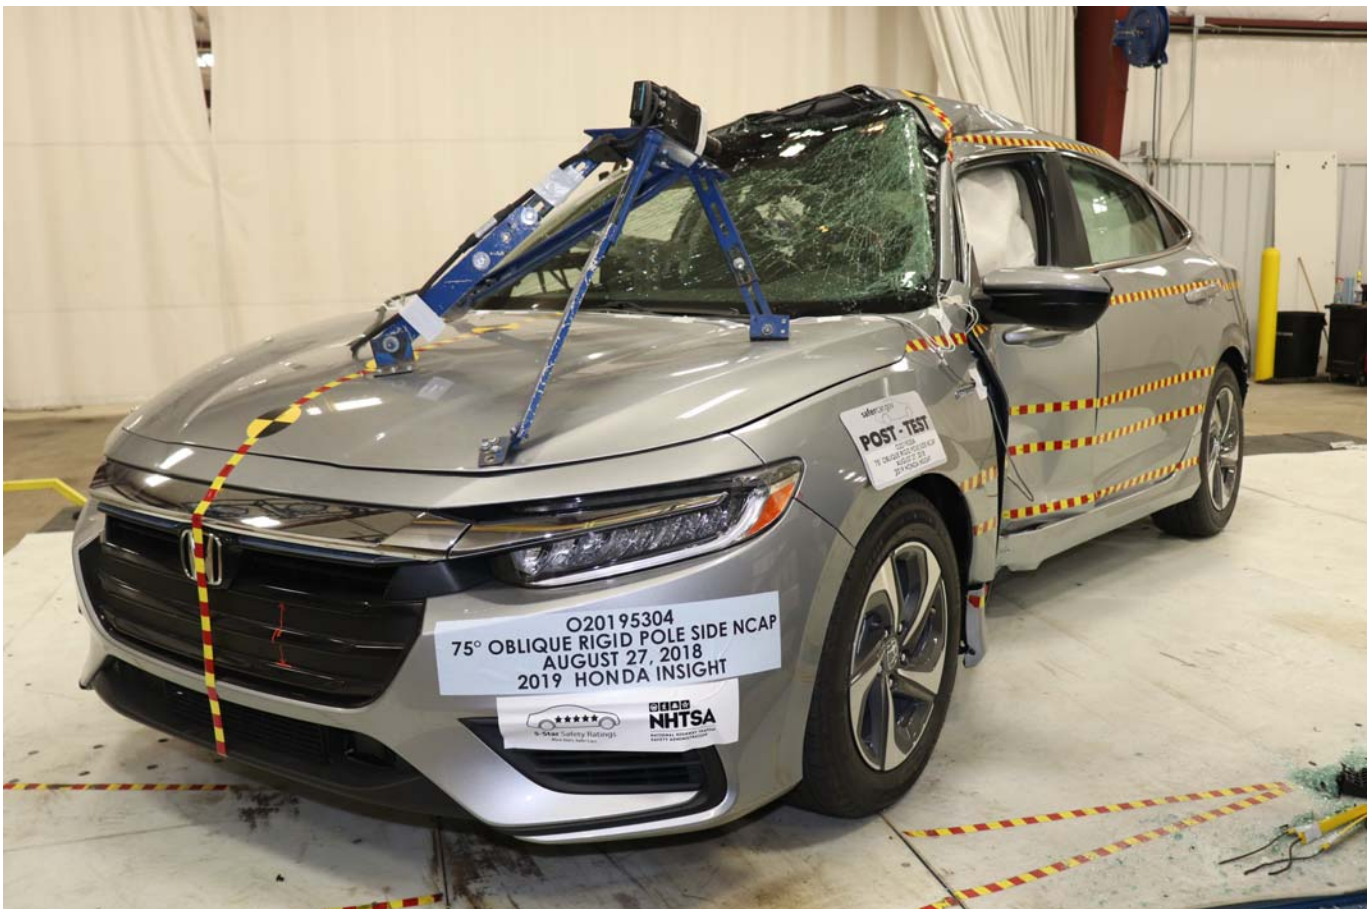
Photo No. 006 - Post-Test Left Front Three-Quarter View of Test Vehicle

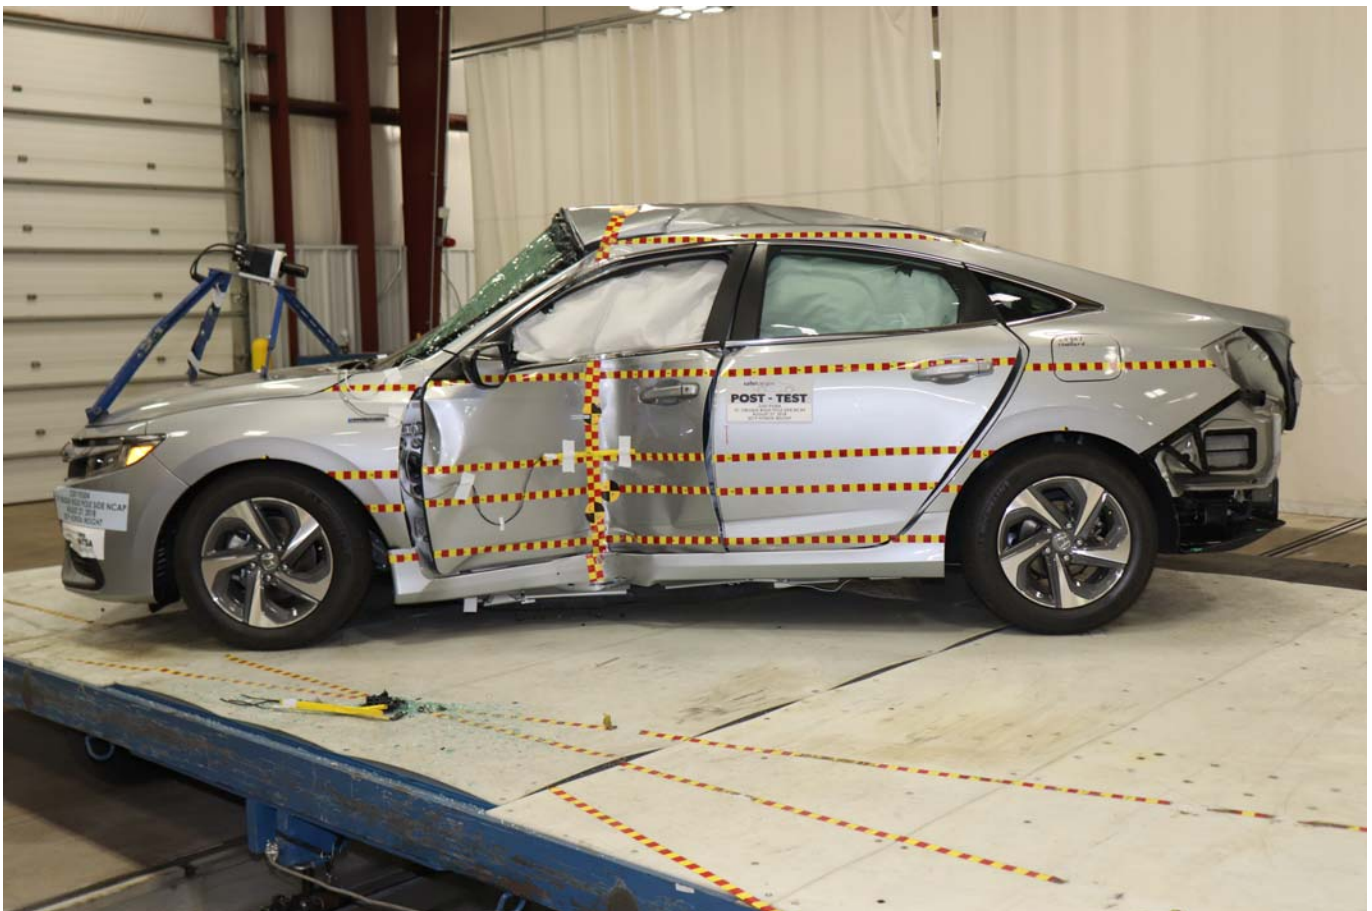
Photo No. 008 - Post-Test Left Side View of Test Vehicle

Critical Areas of Performance	Observations and Conclusions
Pillar Performance	No Separation
Sill Separation	None
Windshield Damage	Cracked
Side Window Damage	Left Front Window Broken
Other Notable Effects	None

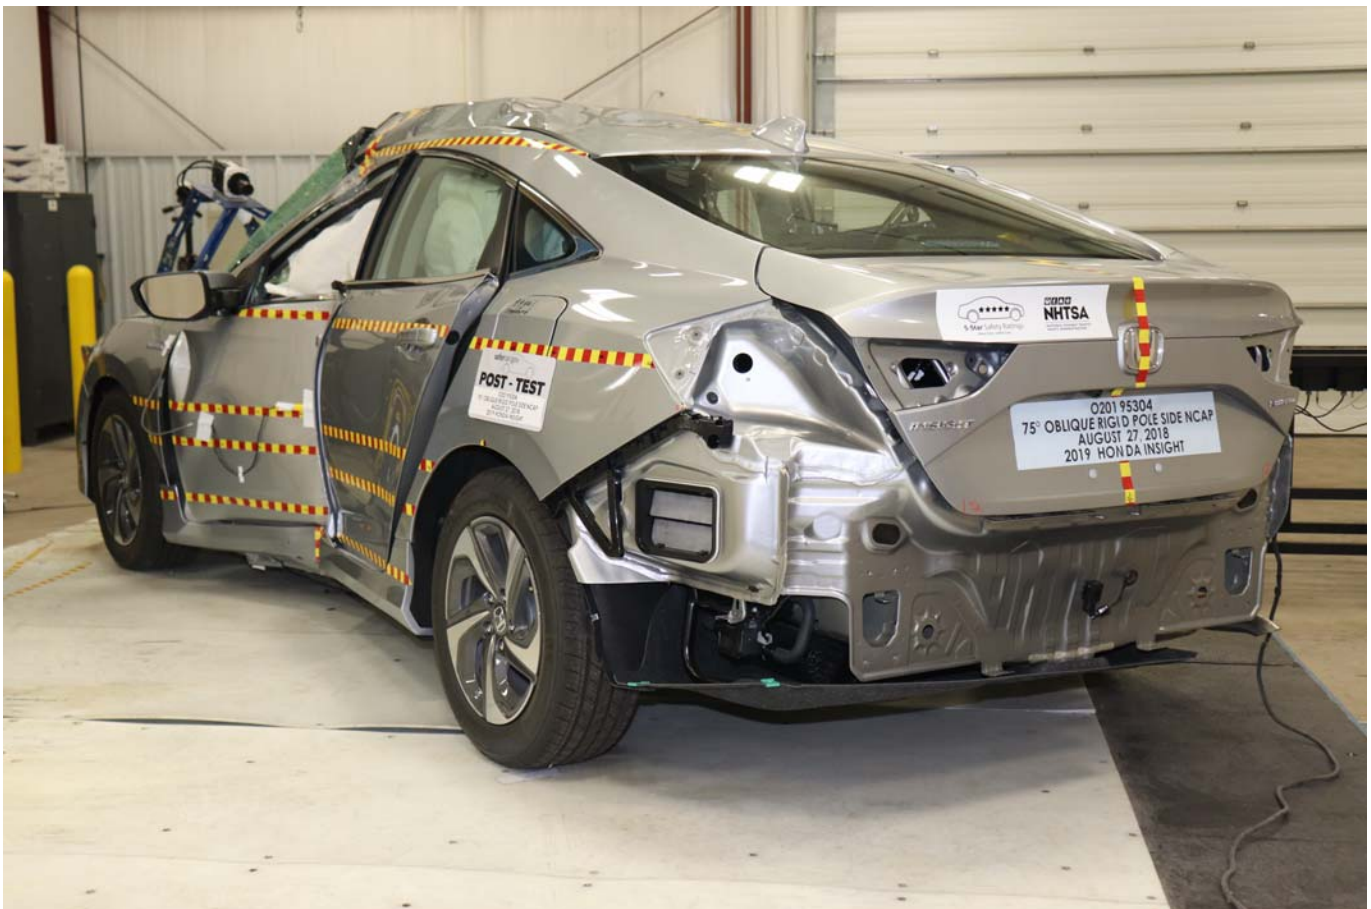
Photo No. 010 - Post-Test Left Rear Three-Quarter View of Test Vehicle

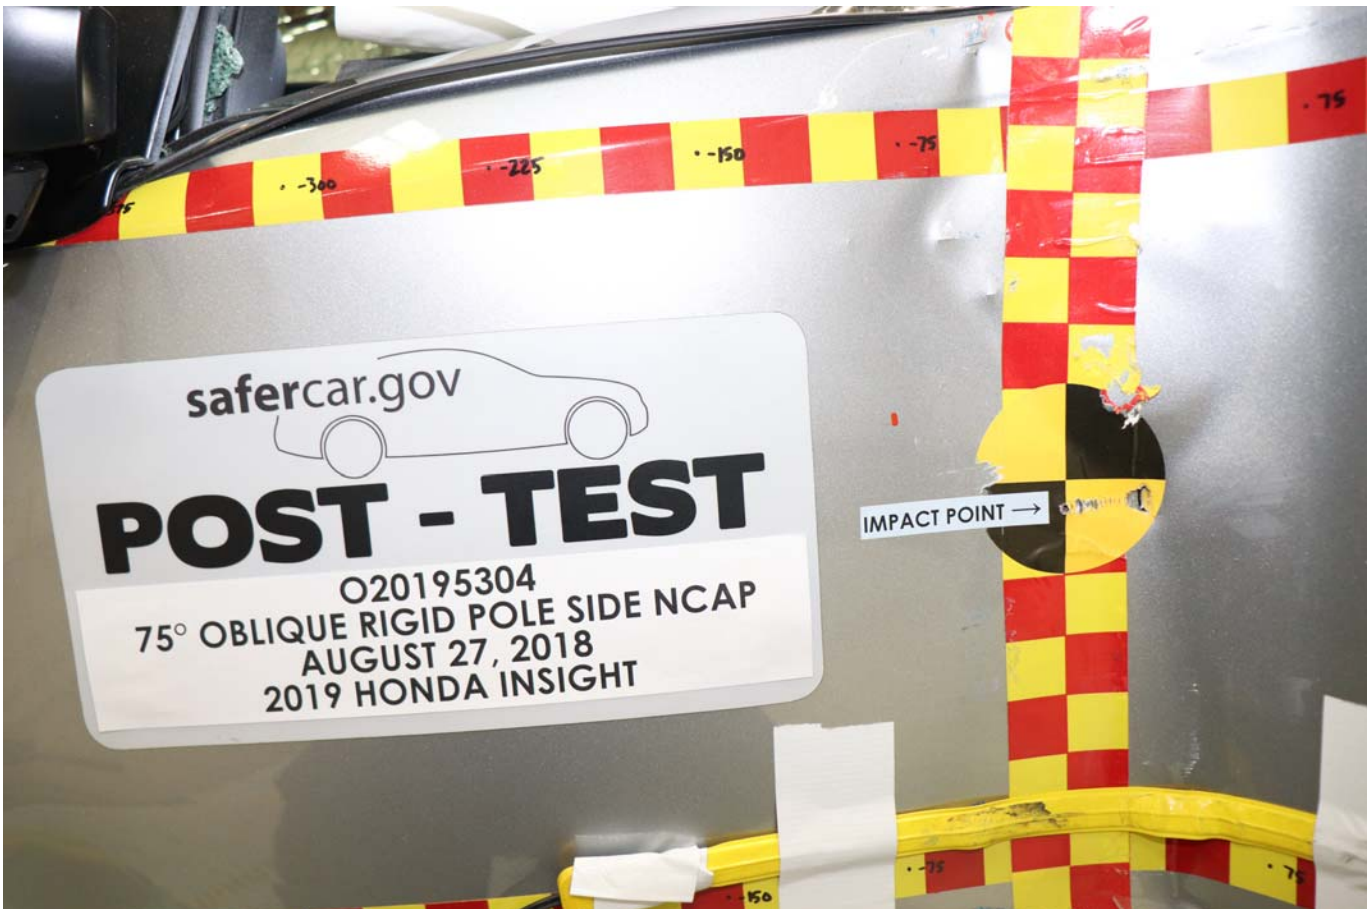
Photo No. 020 - Post-Test Close-Up View of Impact Point Target Showing Impact Location

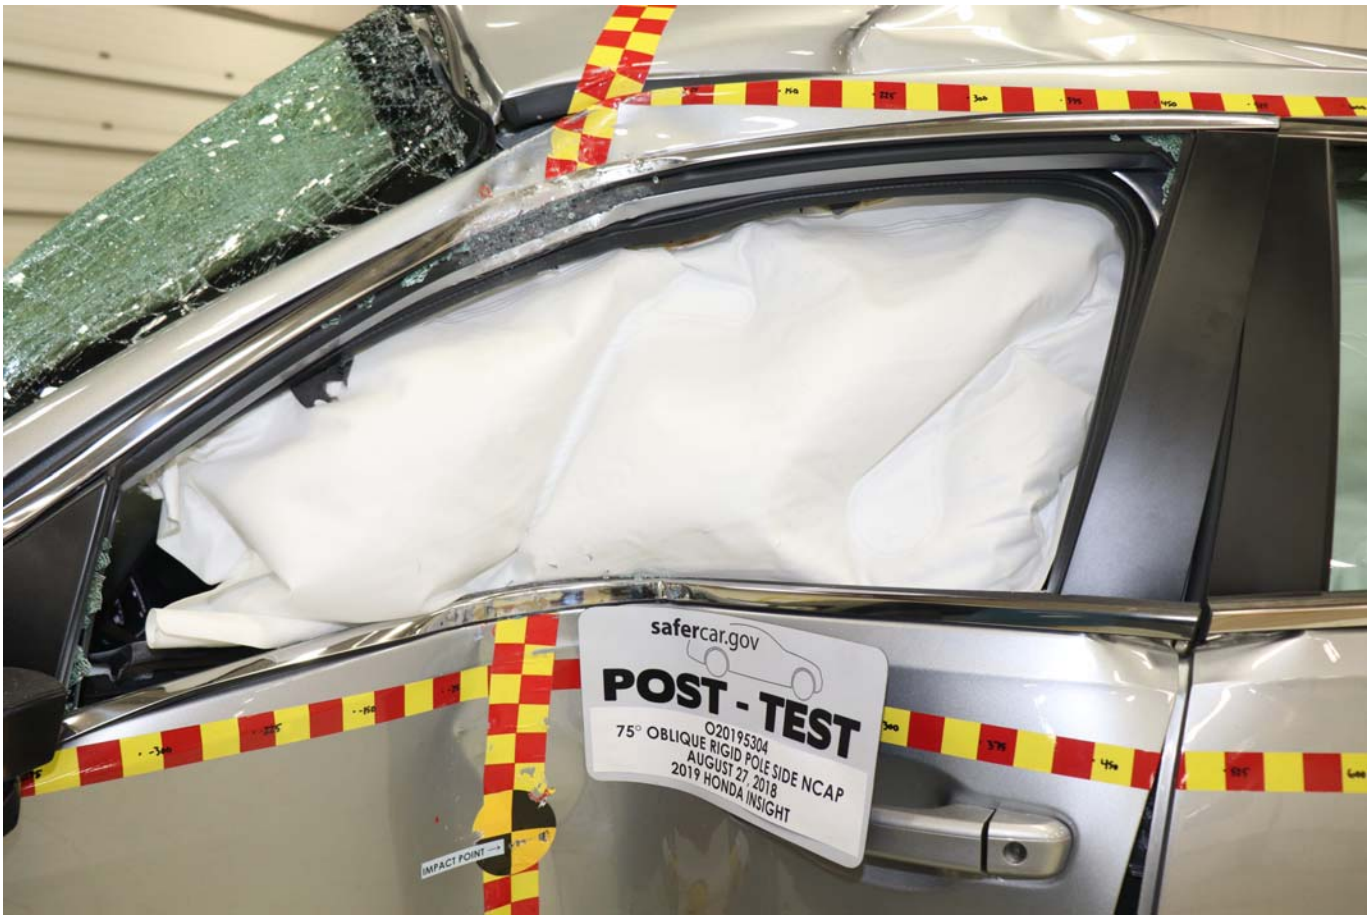
Photo No. 025 - Post-Test Left Side View of Dummy Shoulder and Door Top View

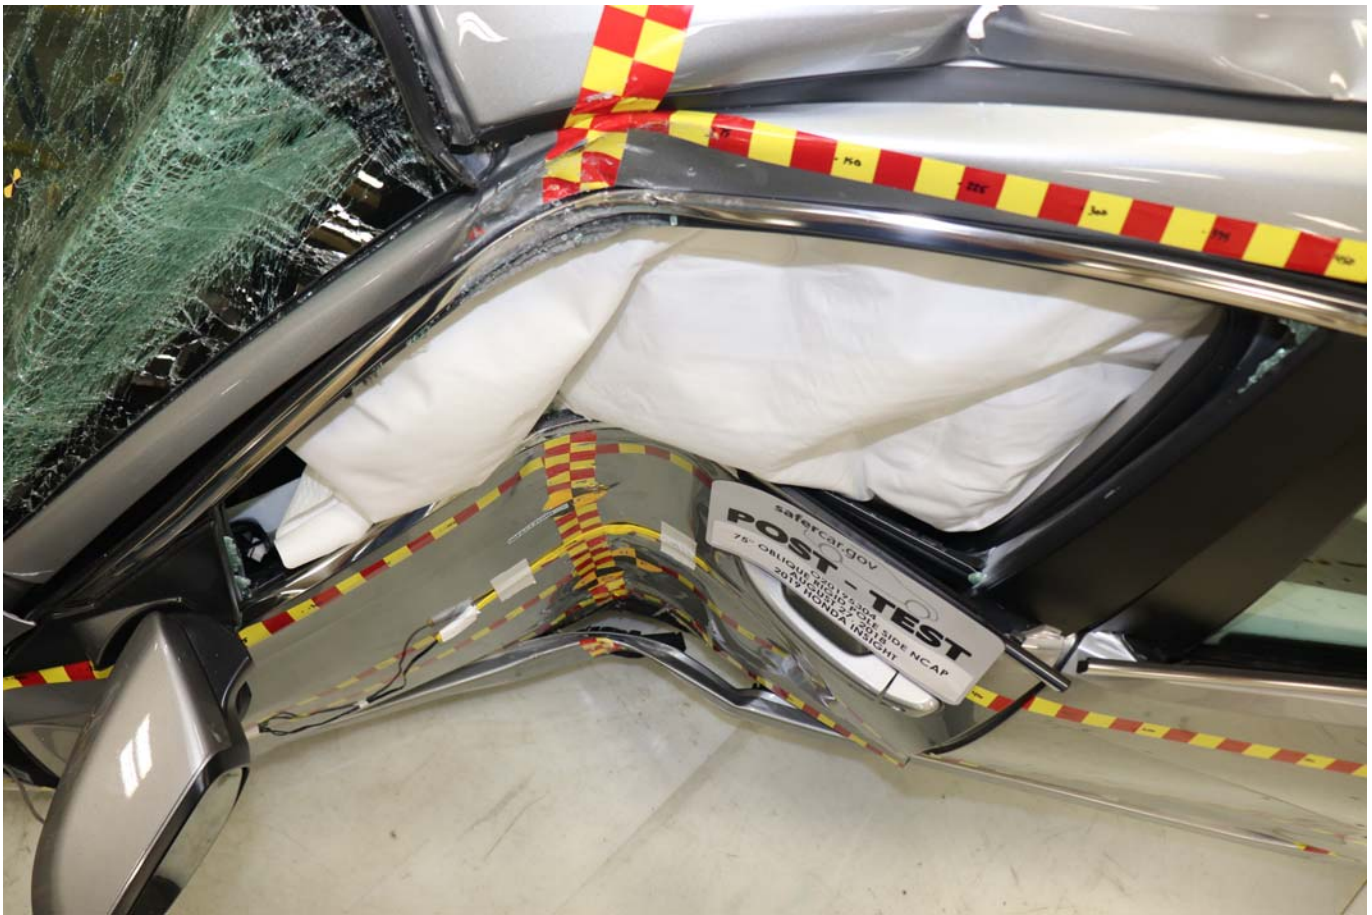
Photo No. 041 - Post-Test Dummy and Door Clearance View

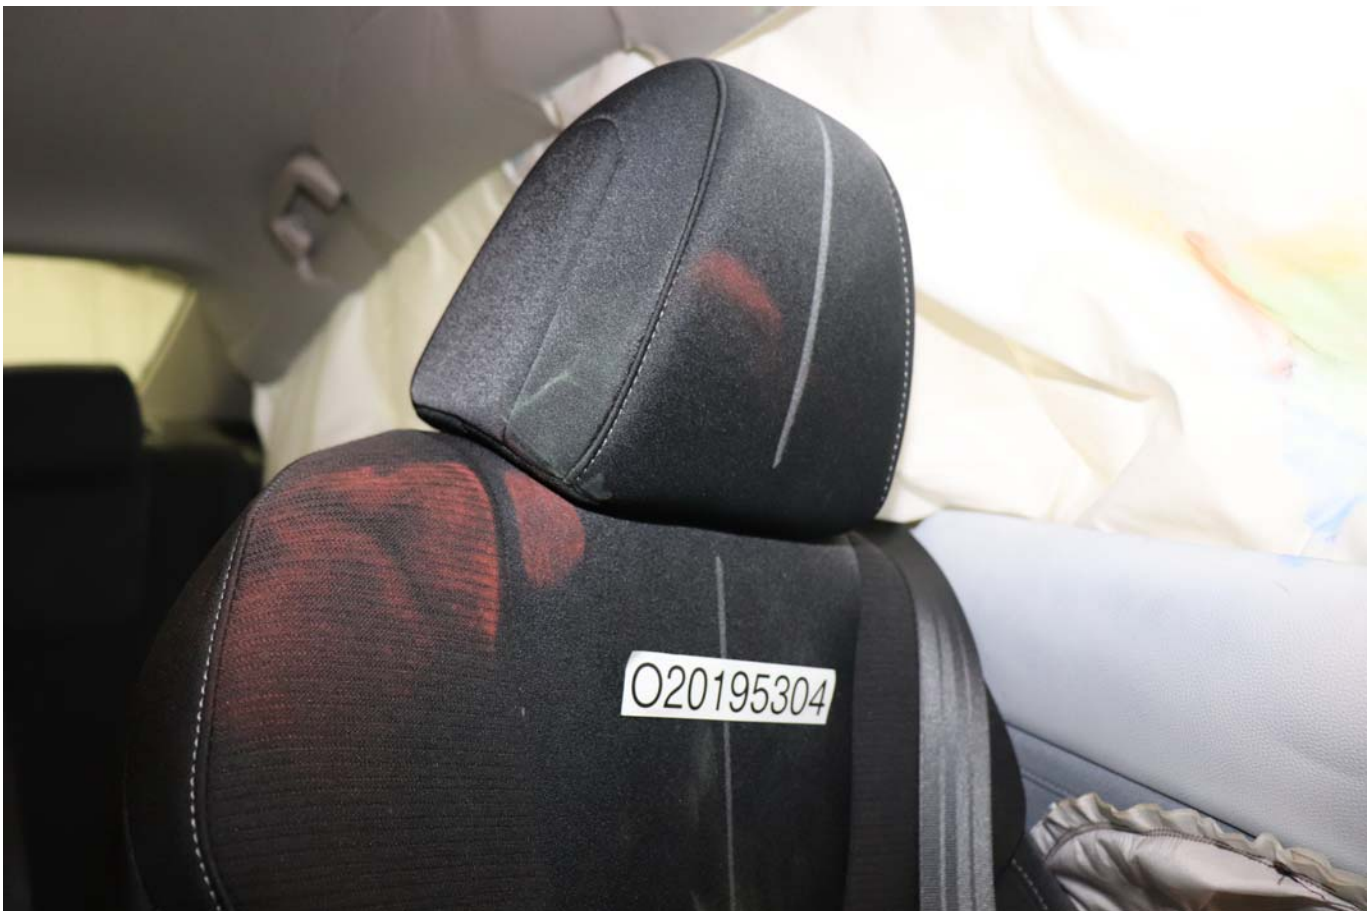
Photo No. 046 - Post-Test Dummy Close-Up Head Contact with Vehicle Interior View

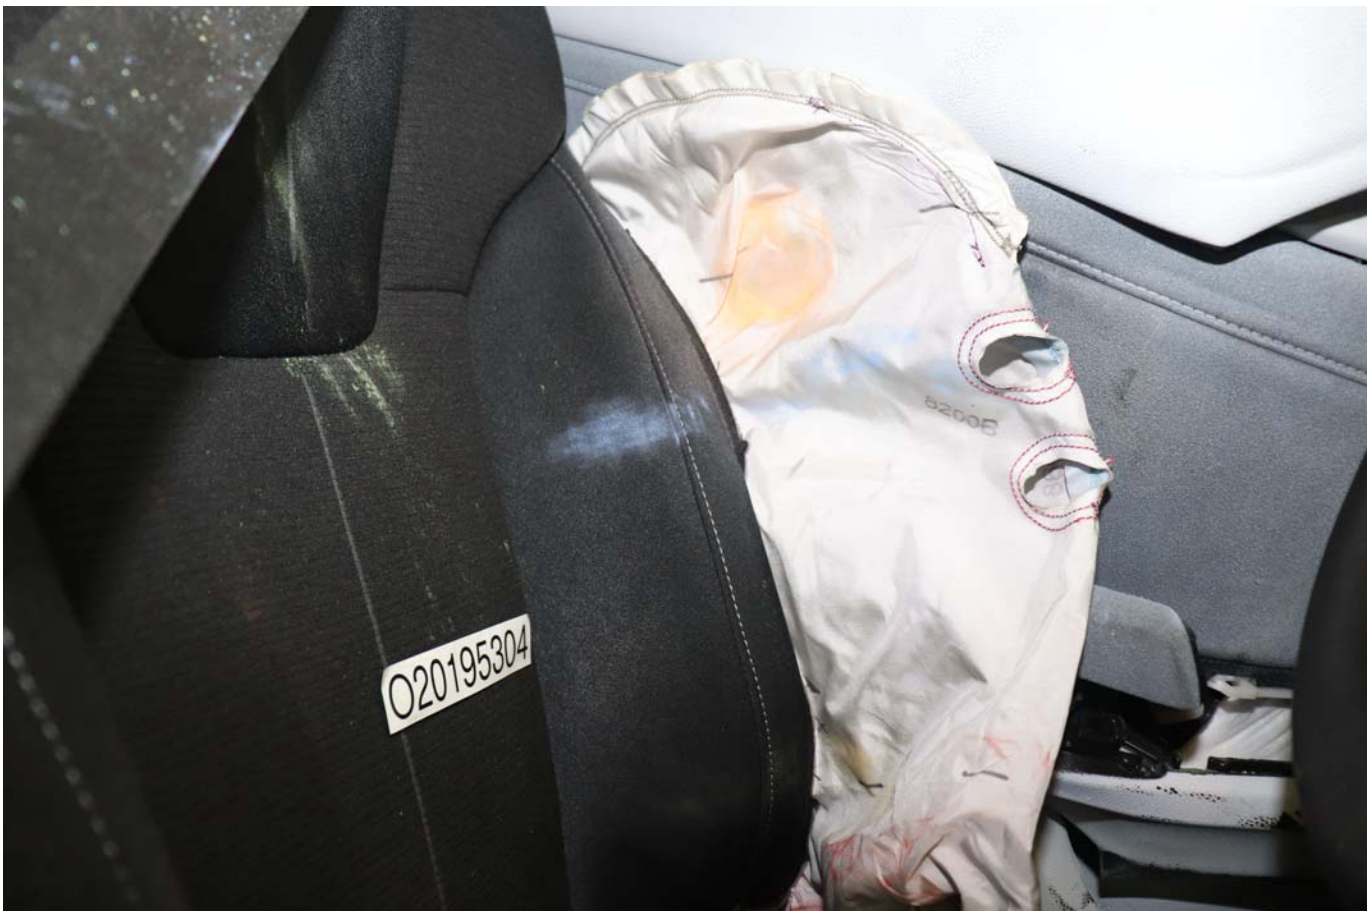
Photo No. 048 - Post-Test Dummy Close-Up Torso Contact with Vehicle Interior View

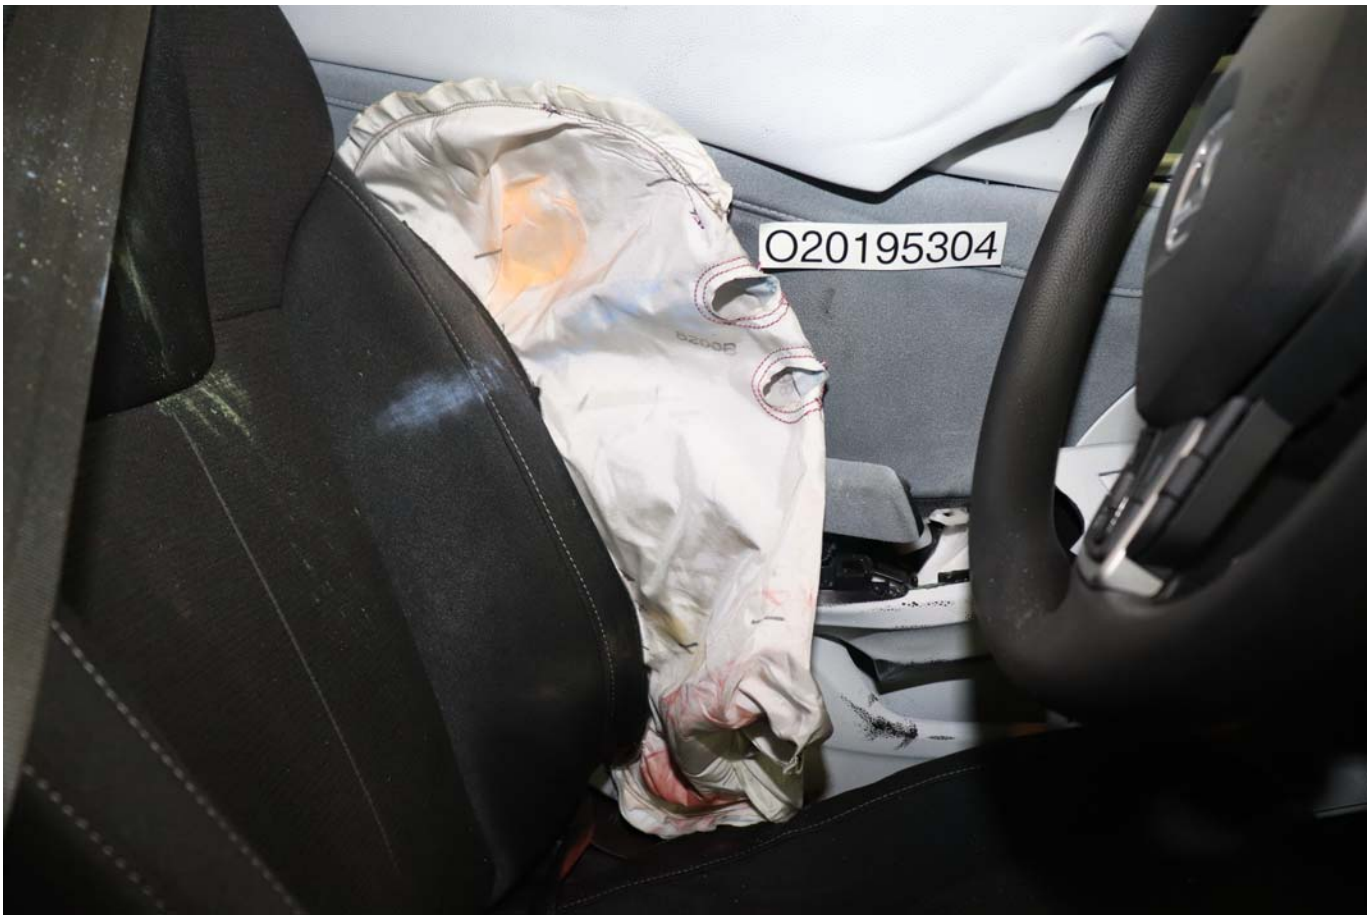
Photo No. 049 - Post-Test Dummy Close-Up Torso Contact with Side Air Bag View

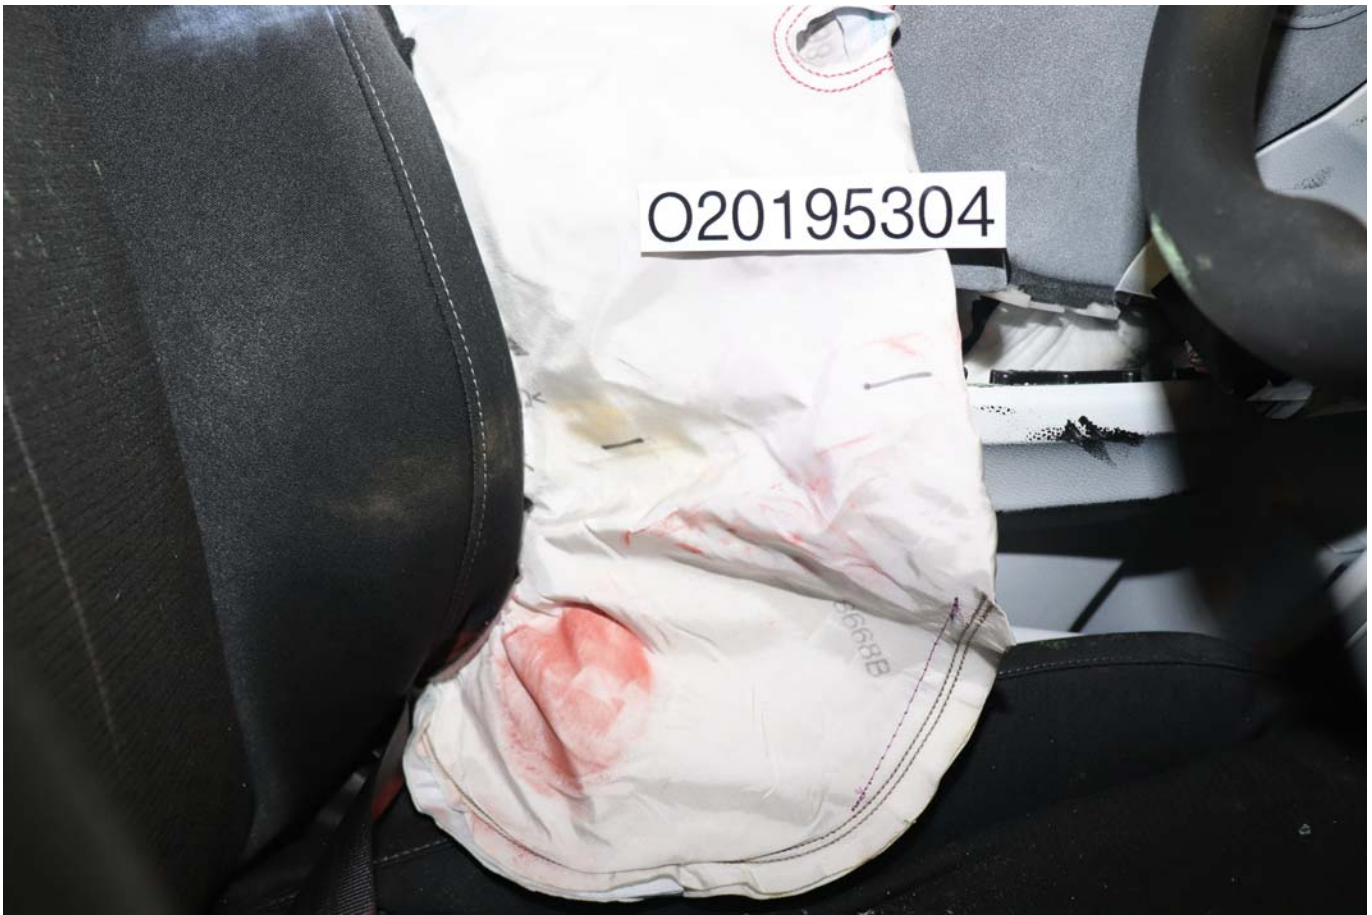
Photo No. 051 - Post-Test Dummy Close-Up Pelvis Contact with Side Air Bag View

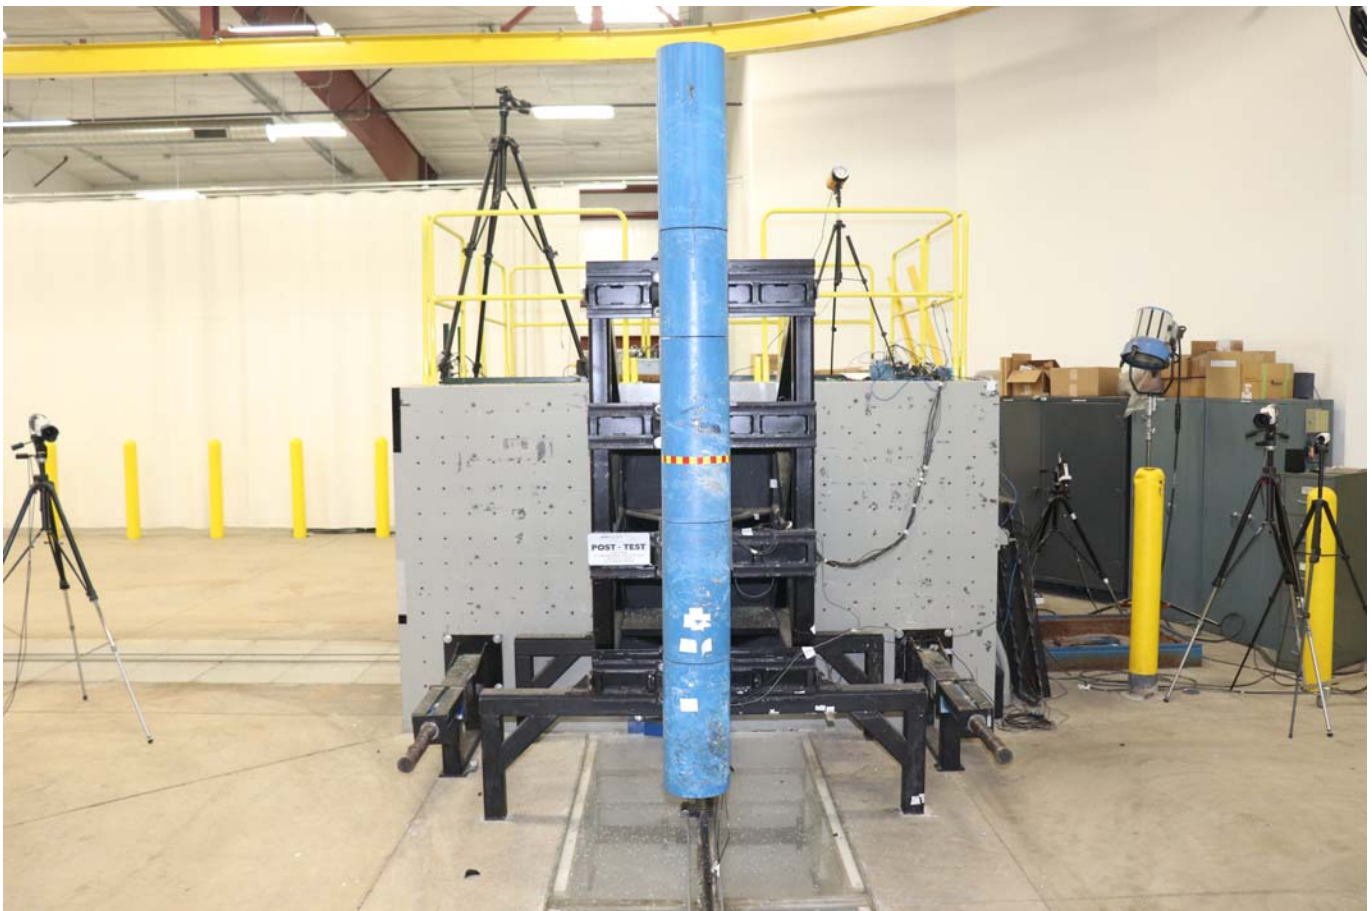
Photo No. 058 - Post-Test Pole Barrier Front View

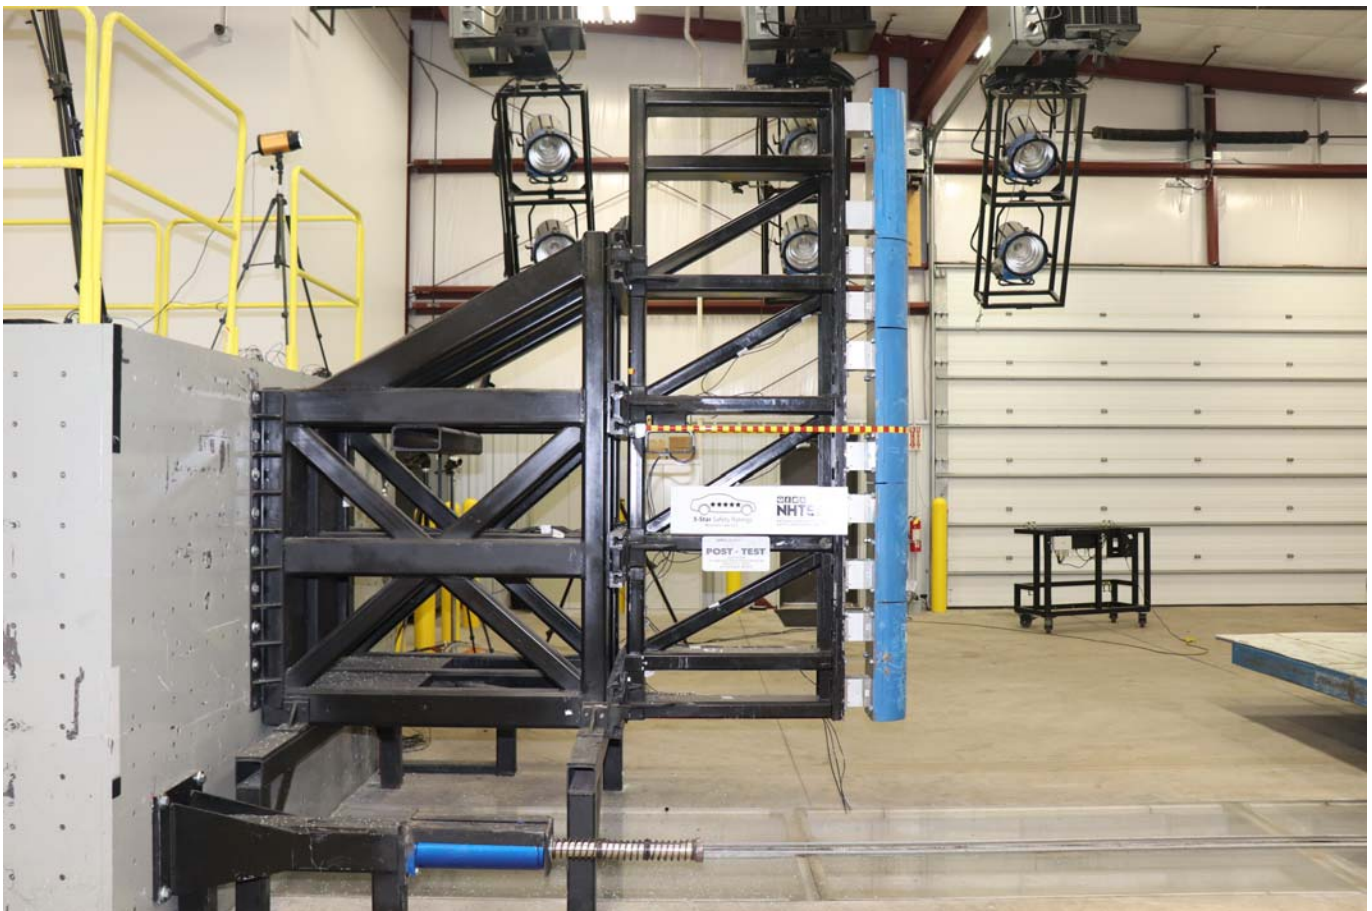
Photo No. 060 - Post-Test Pole Barrier Side View

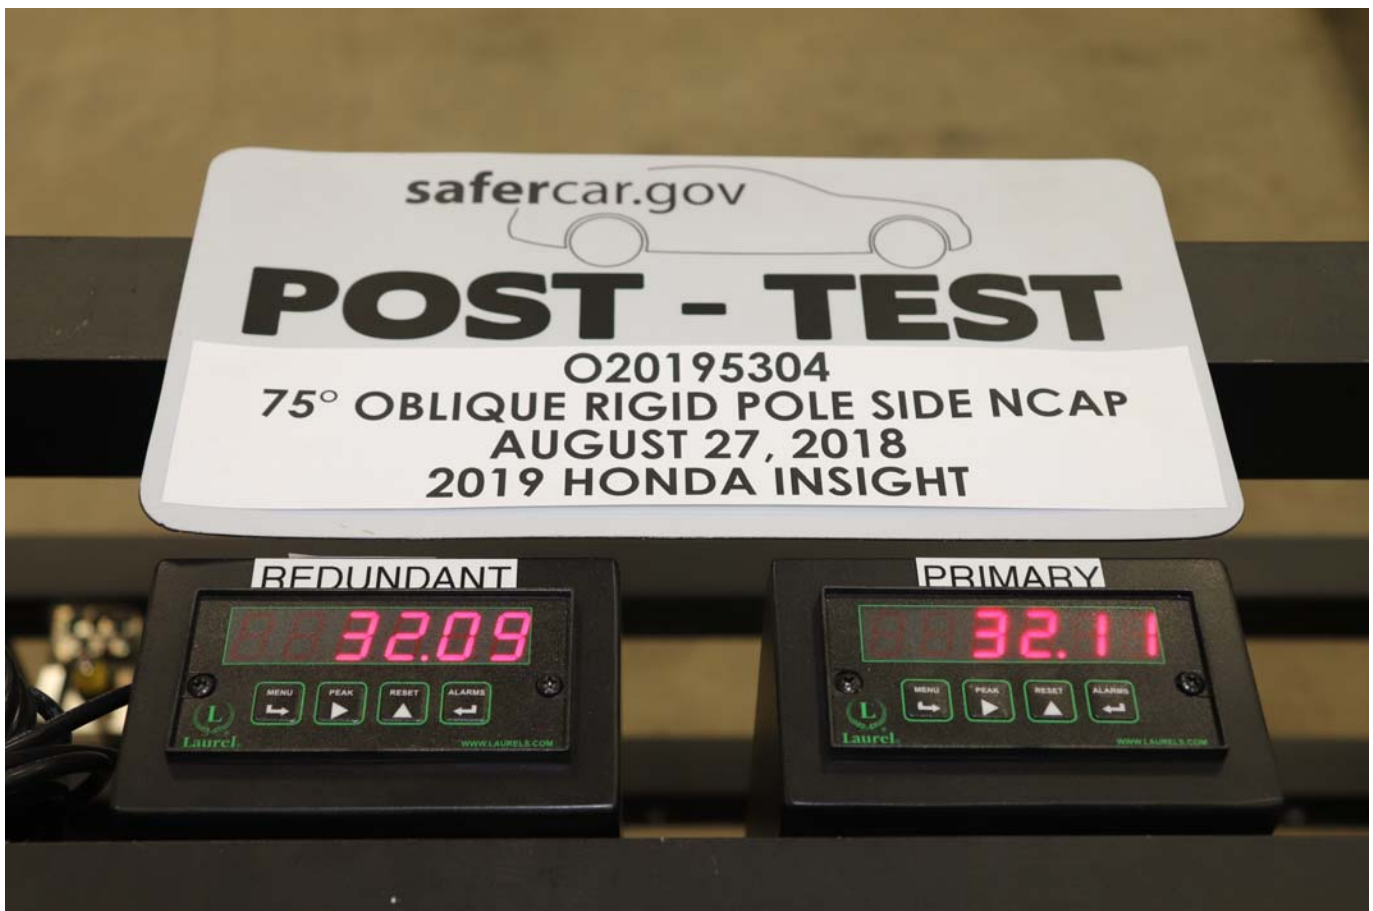
Photo No. 062 - Post-Test Primary and Redundant Speed Trap Read-Out

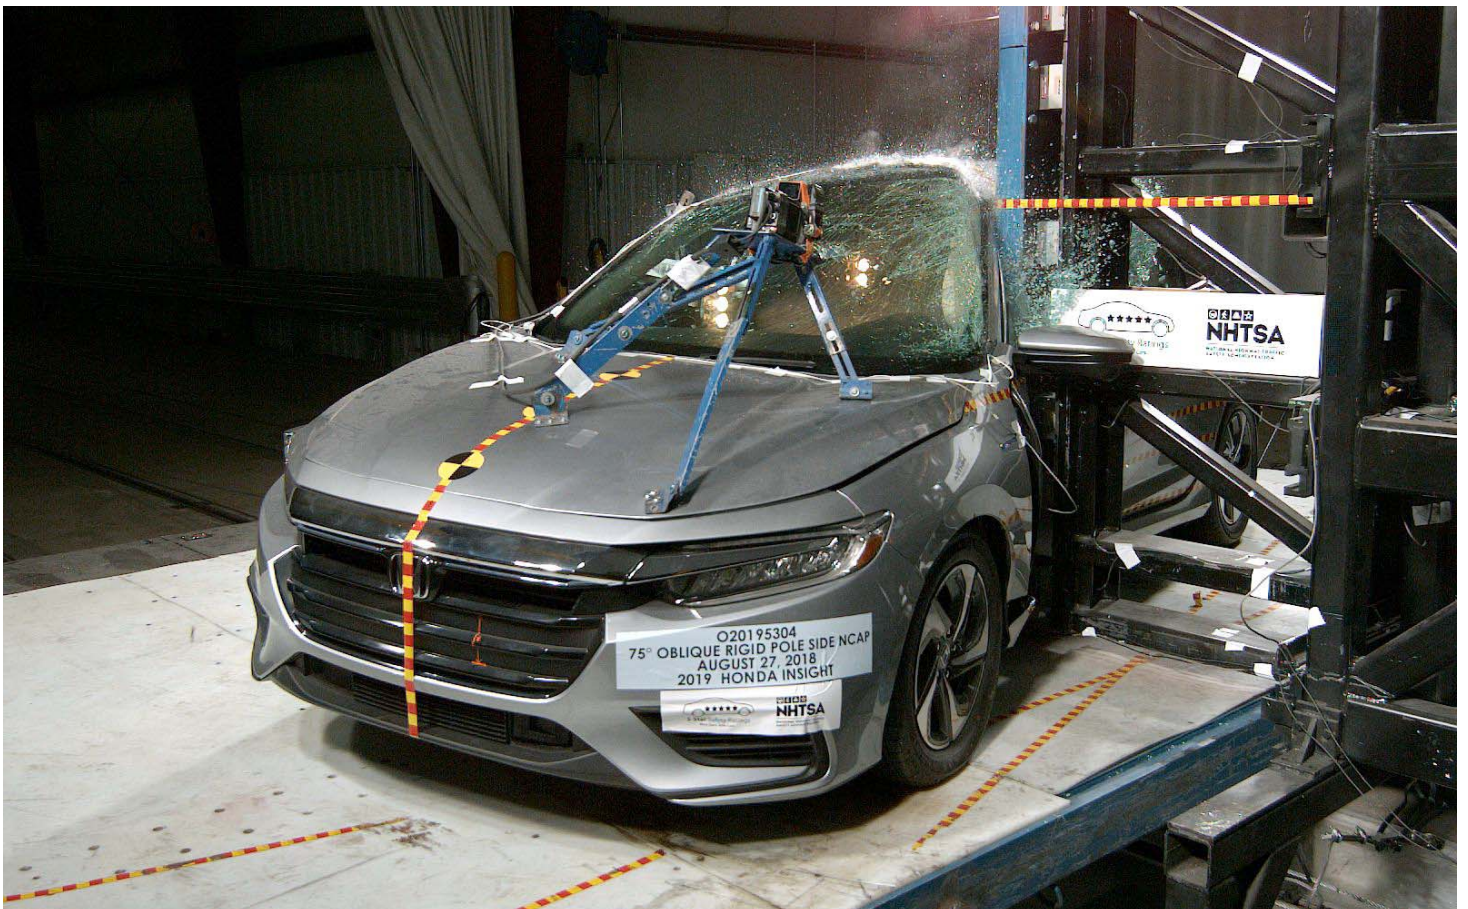
Photo No. 068 - Impact Event

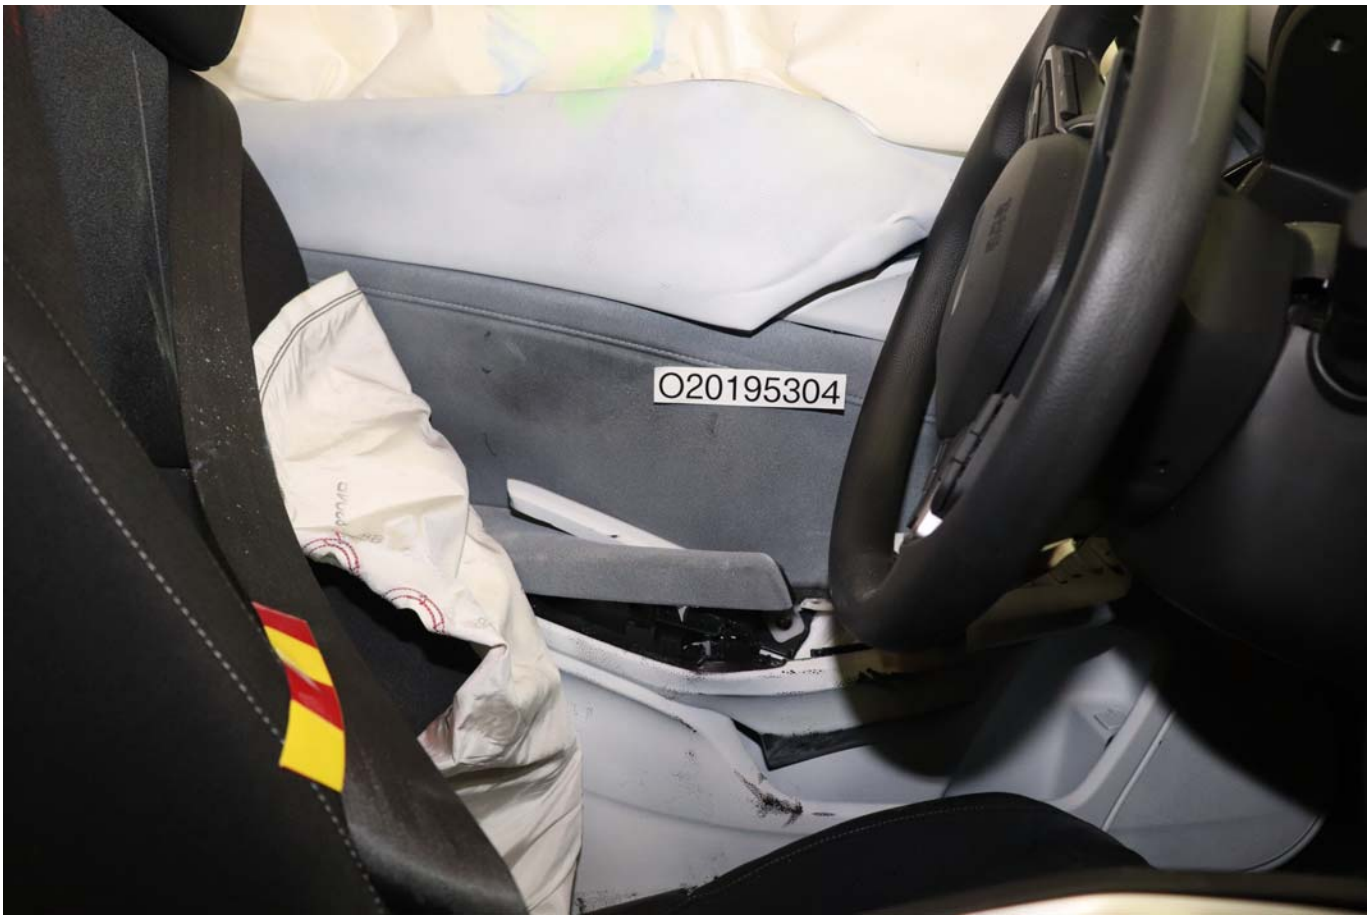
Photo No. 071 - Post-Test View of Shattered Vehicle Inner Door Panel
