**REPORT NUMBER: SINCAP-MGA-2019-006**

**NEW CAR ASSESSMENT PROGRAM (NCAP)  
Moving Deformable Barrier Side Impact Test**

**HONDA MFG. OF INDIANA, LLC  
2019 Honda Insight LX 4-Door Sedan  
NHTSA No.: O20195305**

**FINAL REPORT**

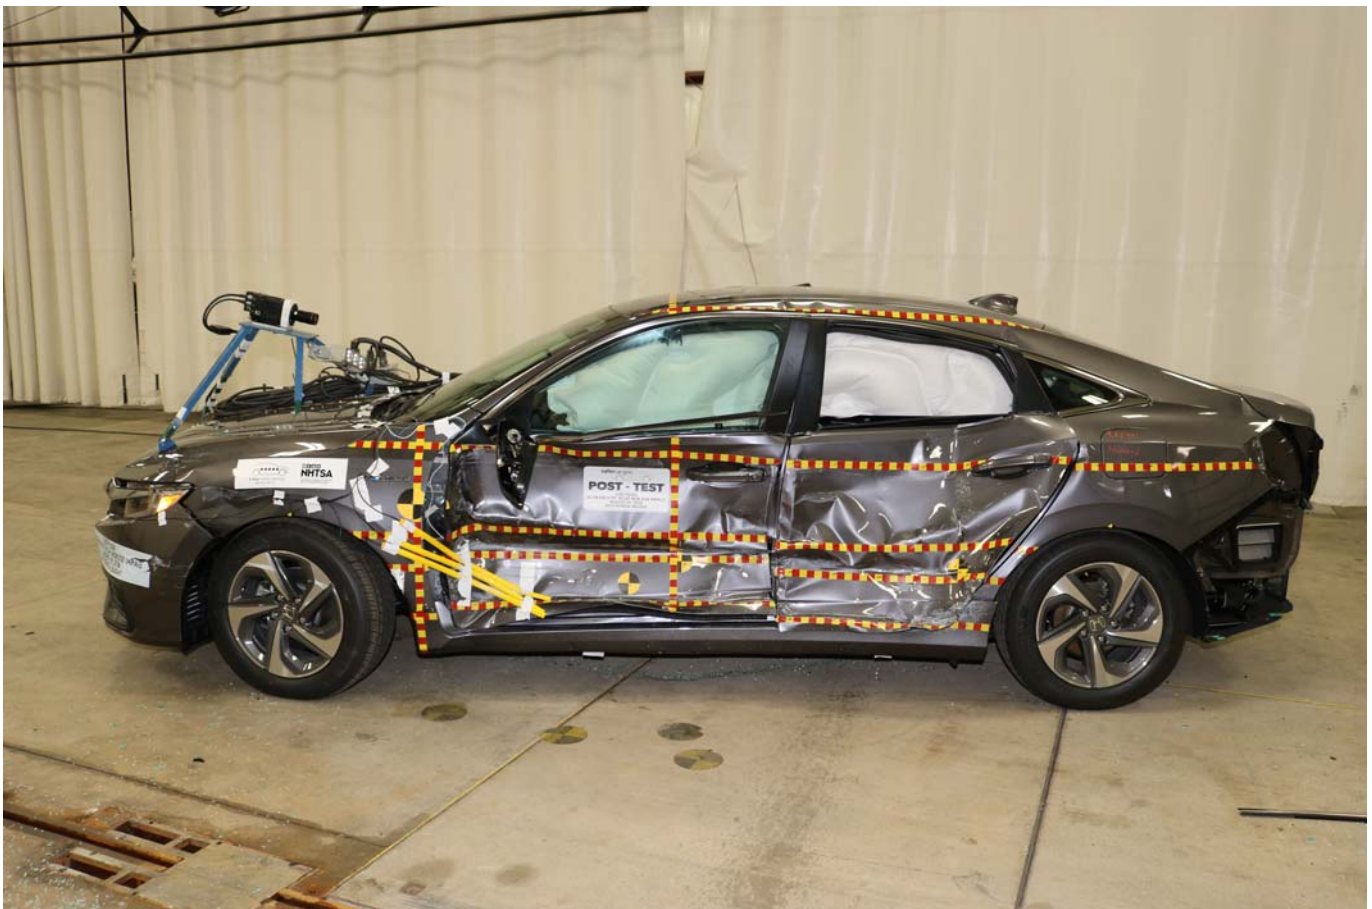
Photo No. 008 - Post-Test Left Side View of Test Vehicle

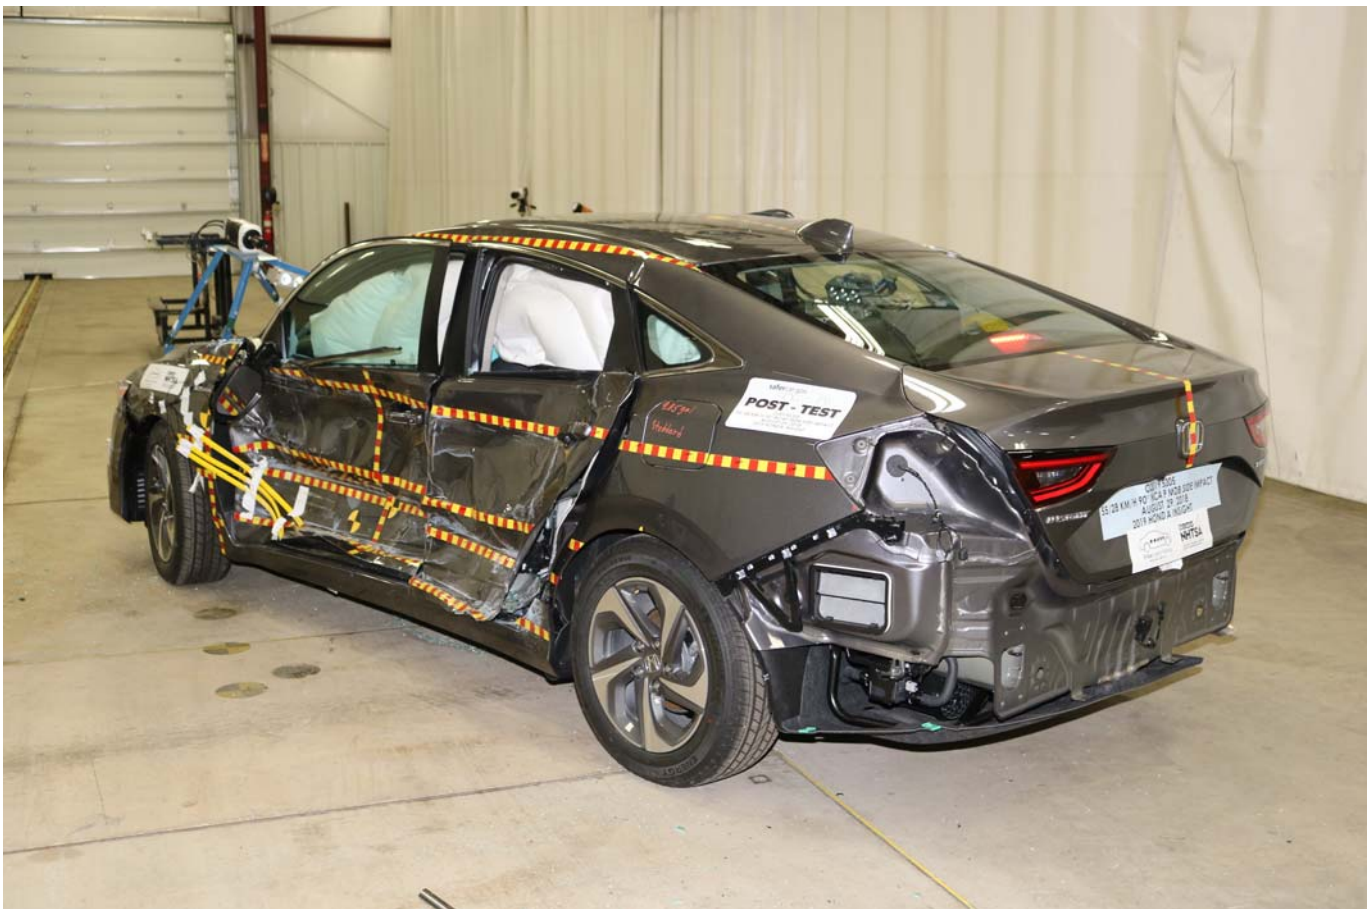
Photo No. 010 - Post-Test Left Three-Quarter Rear View of Test Vehicle

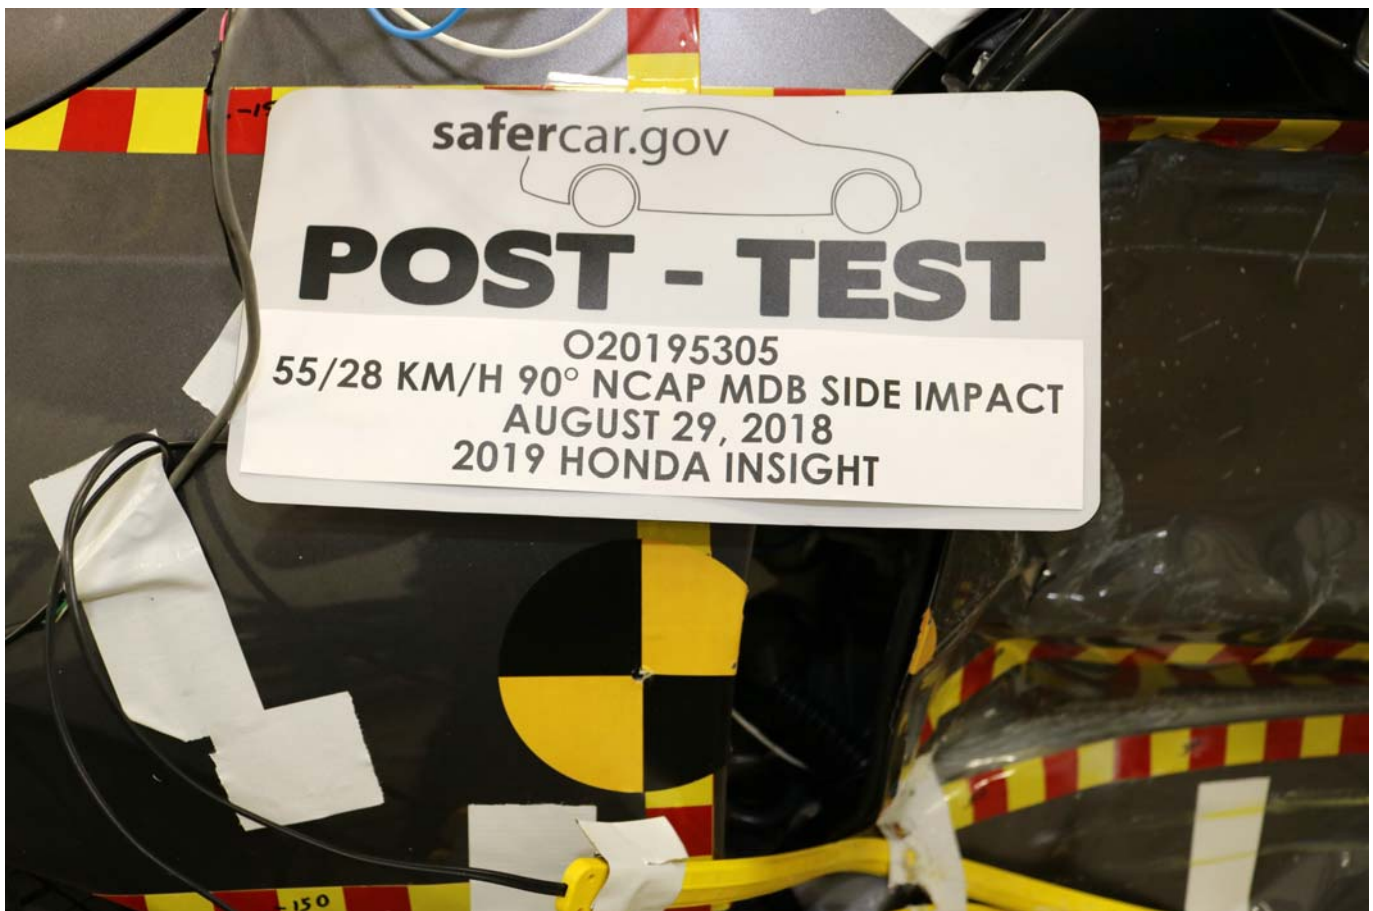
Photo No. 020 - Post-Test Close-Up View of Impact Point Target

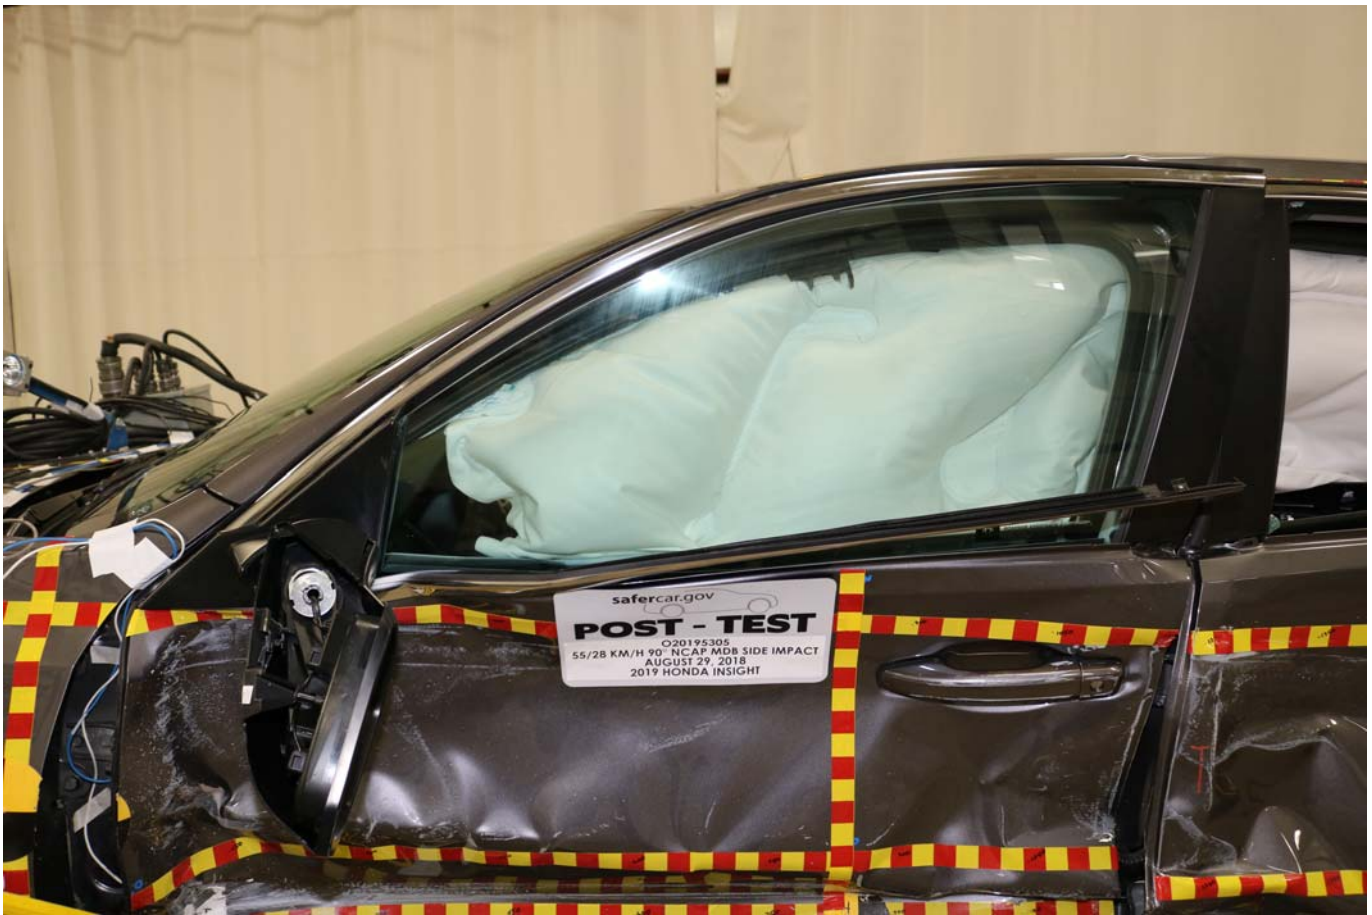
Photo No. 029 - Post-Test Left Side View of Driver Dummy Shoulder and Door Top View

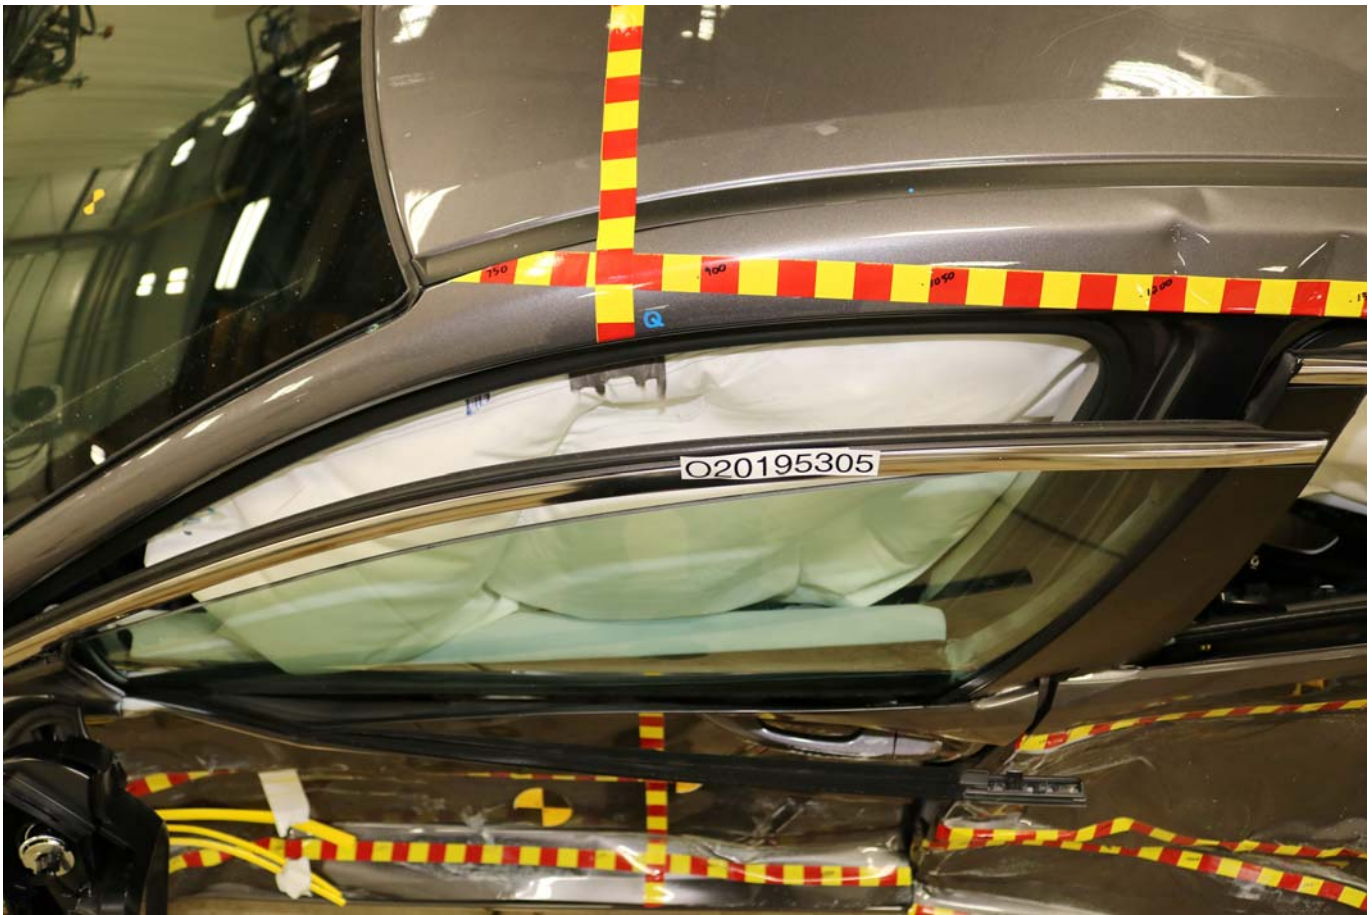
Photo No. 043 - Post-Test Driver Dummy and Door Clearance View

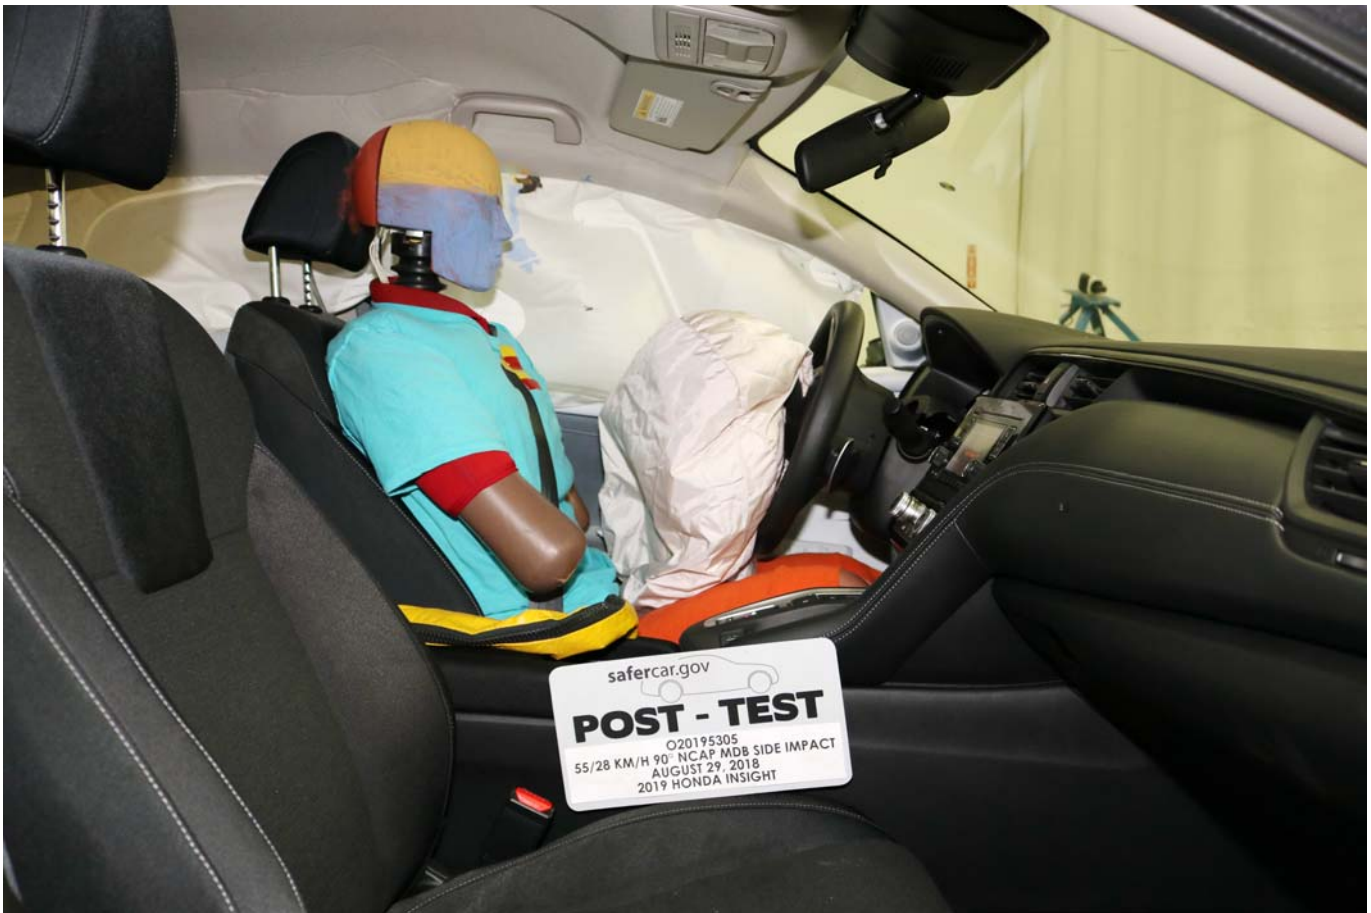
Photo No. 045 - Post-Test Right Side View of Driver Dummy and Front Seat of Occupant Compartment

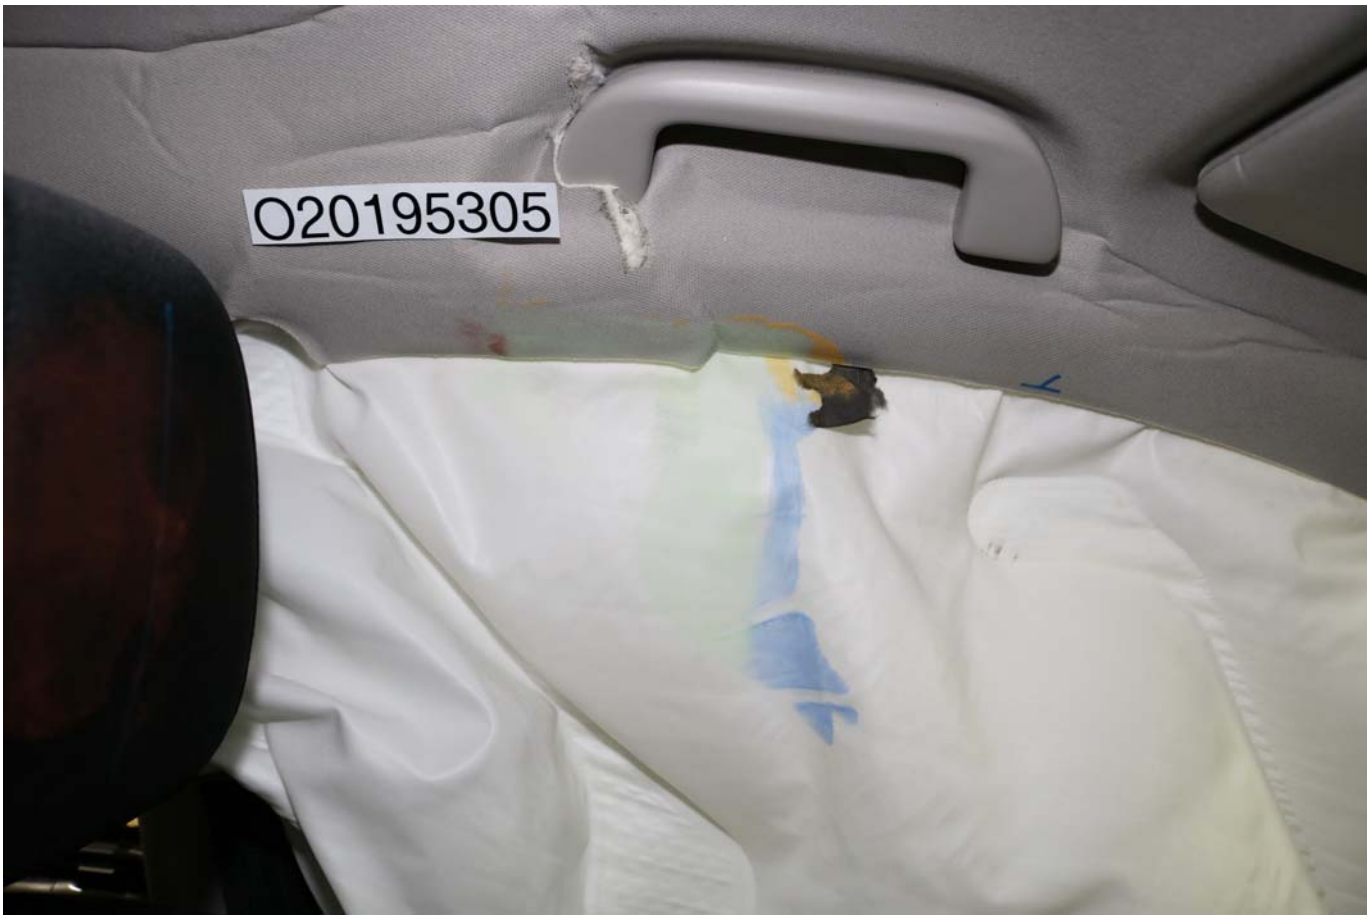
Photo No. 049 - Post-Test Driver Dummy Close-up Head Contact with Side Airbag View

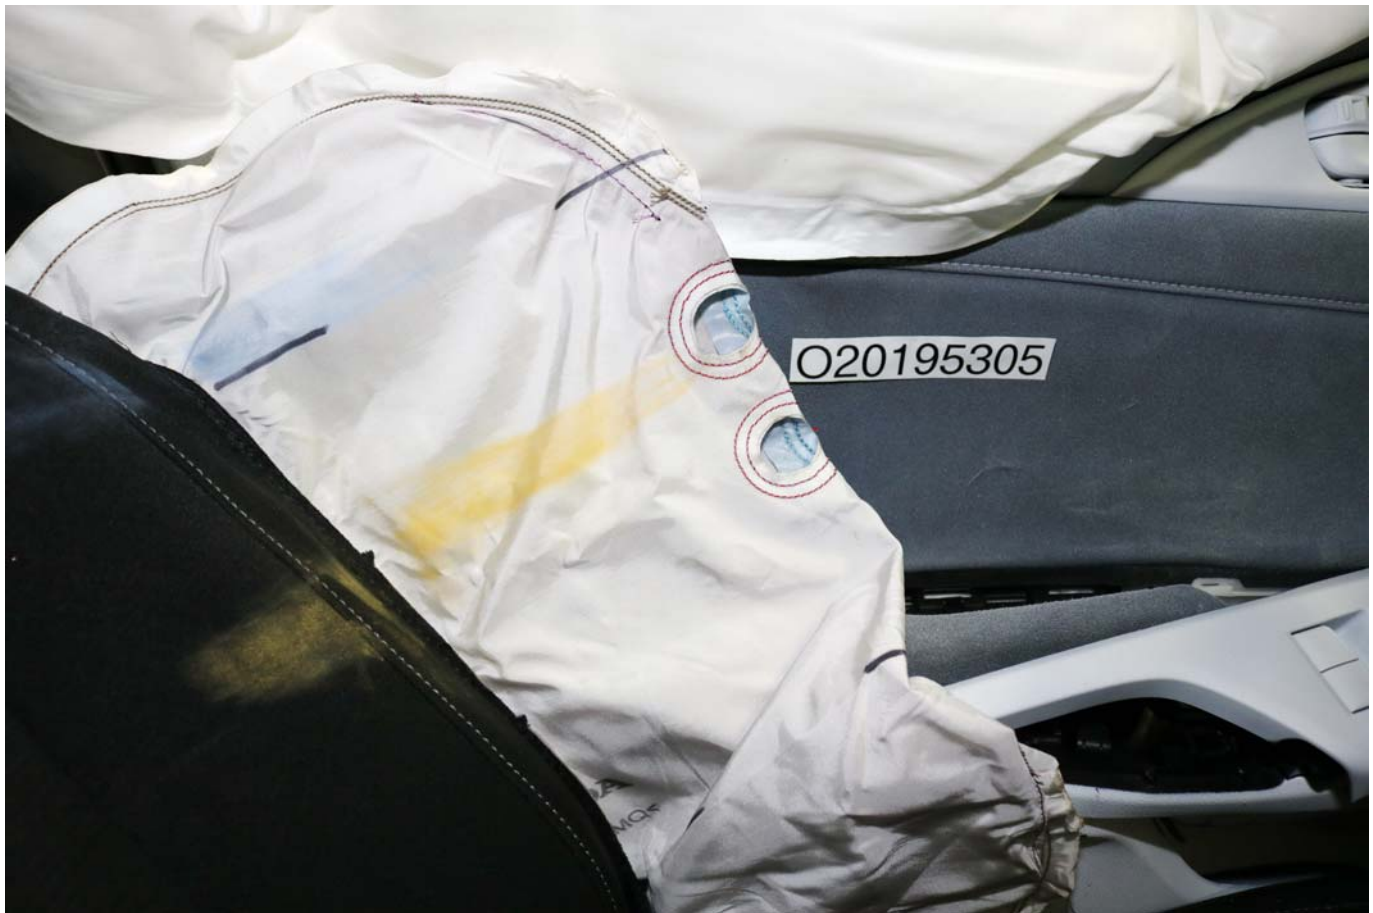
Photo No. 051 - Post-Test Driver Dummy Close-up Torso Contact with Side Airbag View

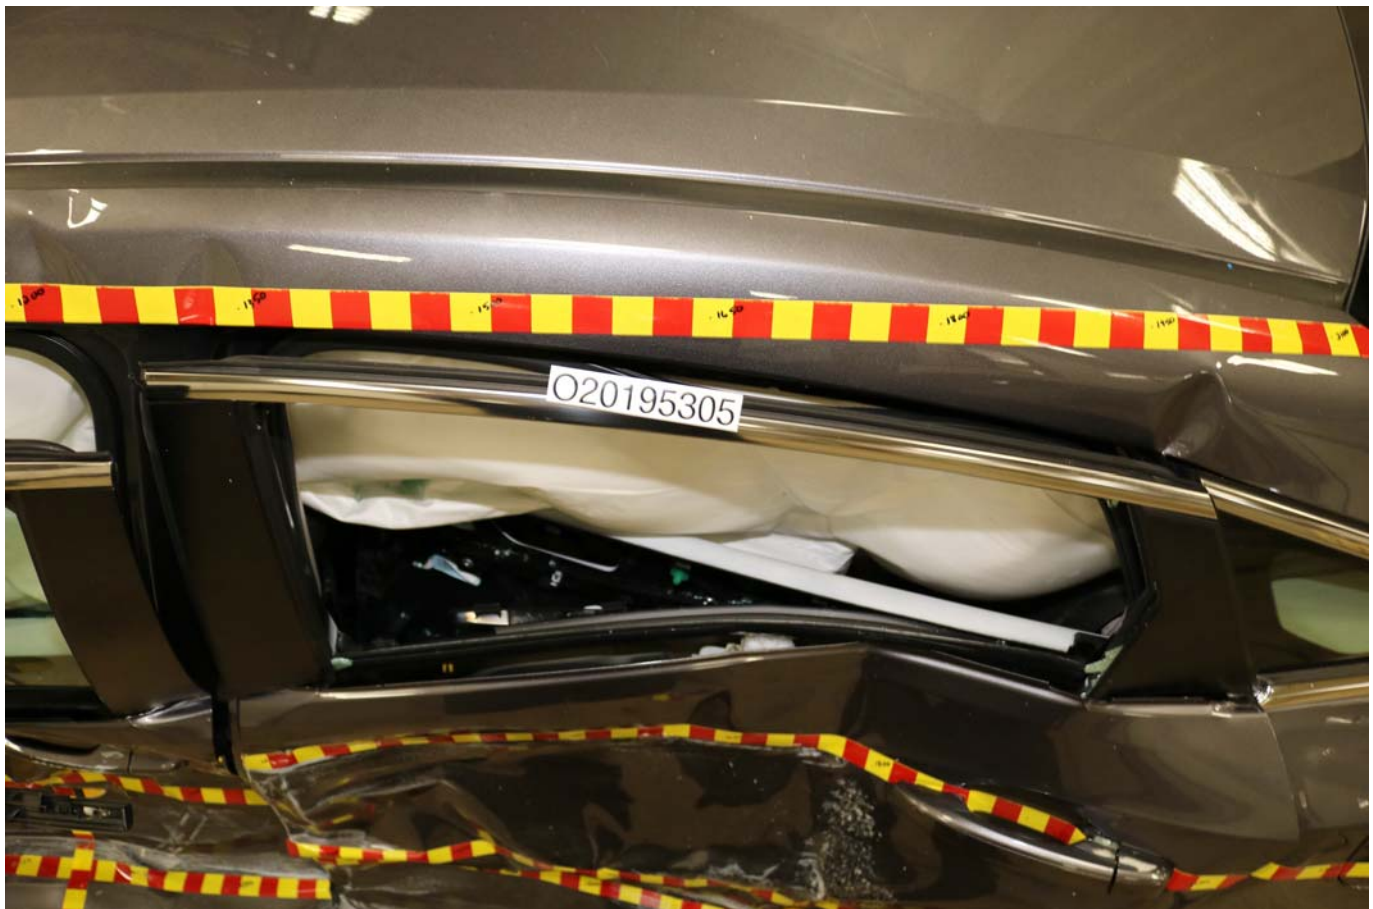
Photo No. 070 - Post-Test Rear Passenger Dummy and Door Clearance View

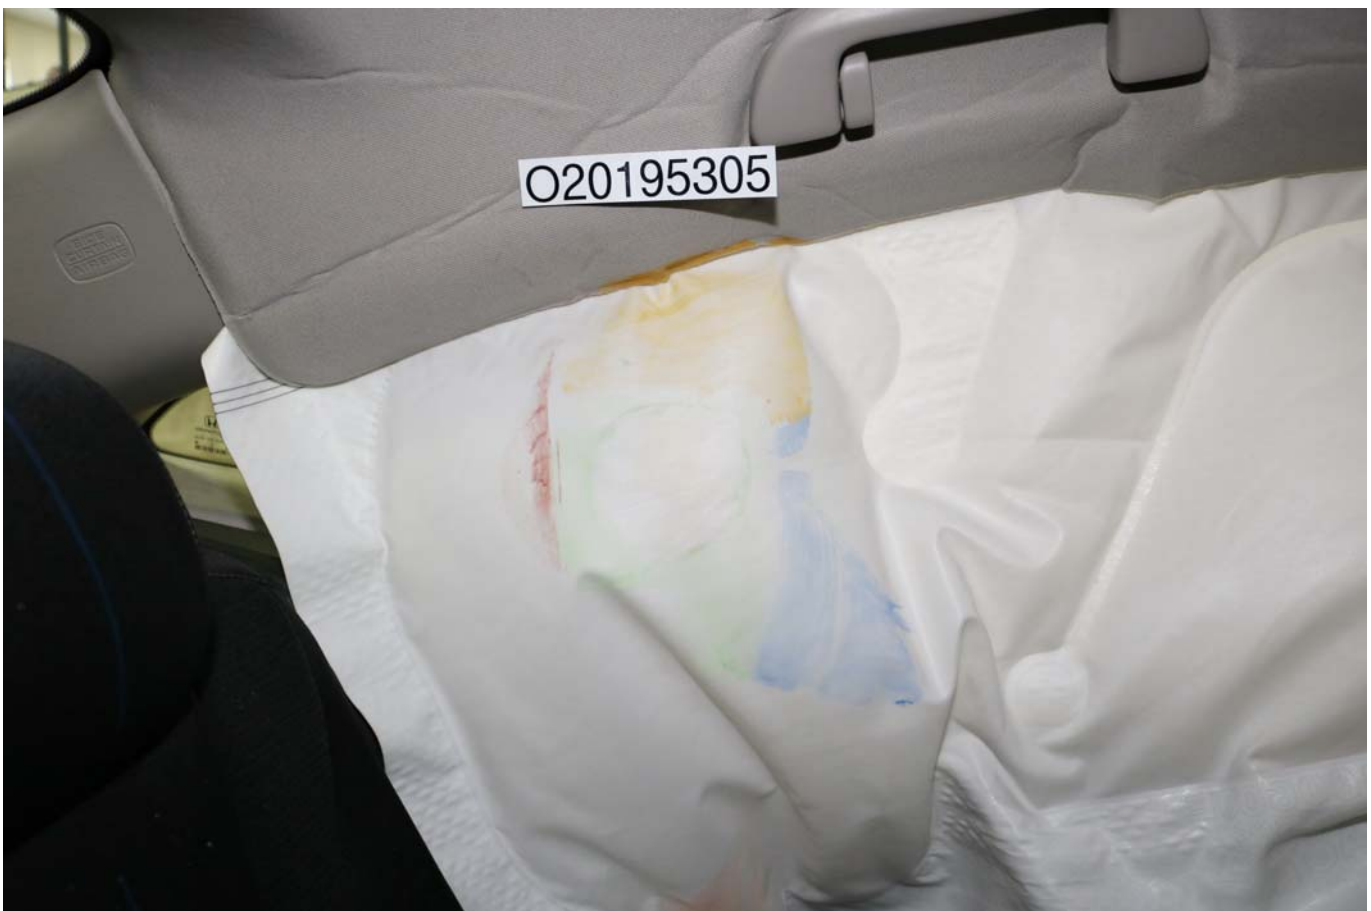
Photo No. 076 - Post-Test Rear Passenger Dummy Close-up Head Contact with Side Airbag View

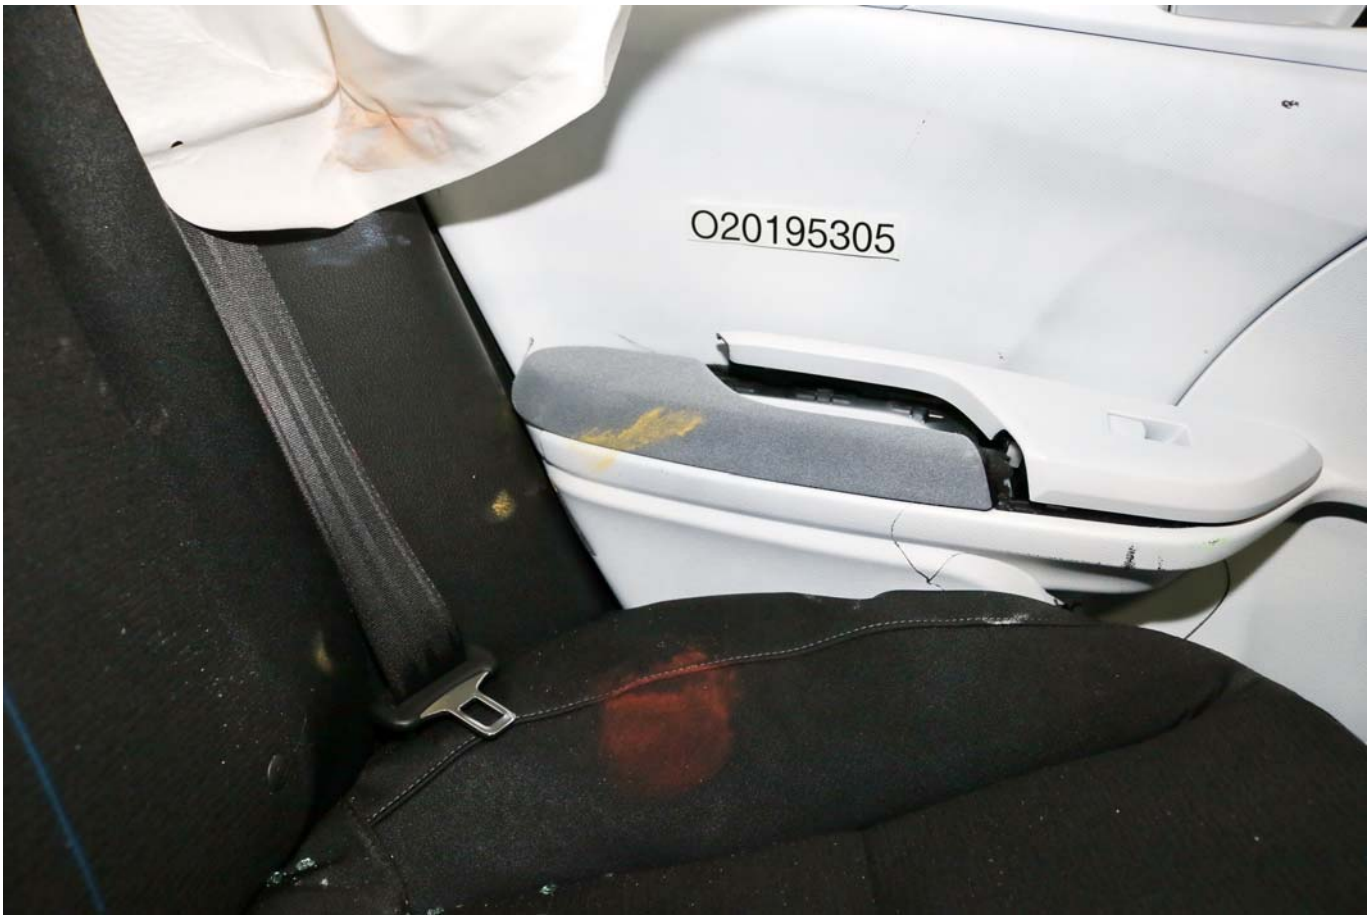
Photo No. 077 - Post-Test Rear Passenger Dummy Close-up Torso Contact with Vehicle Interior View

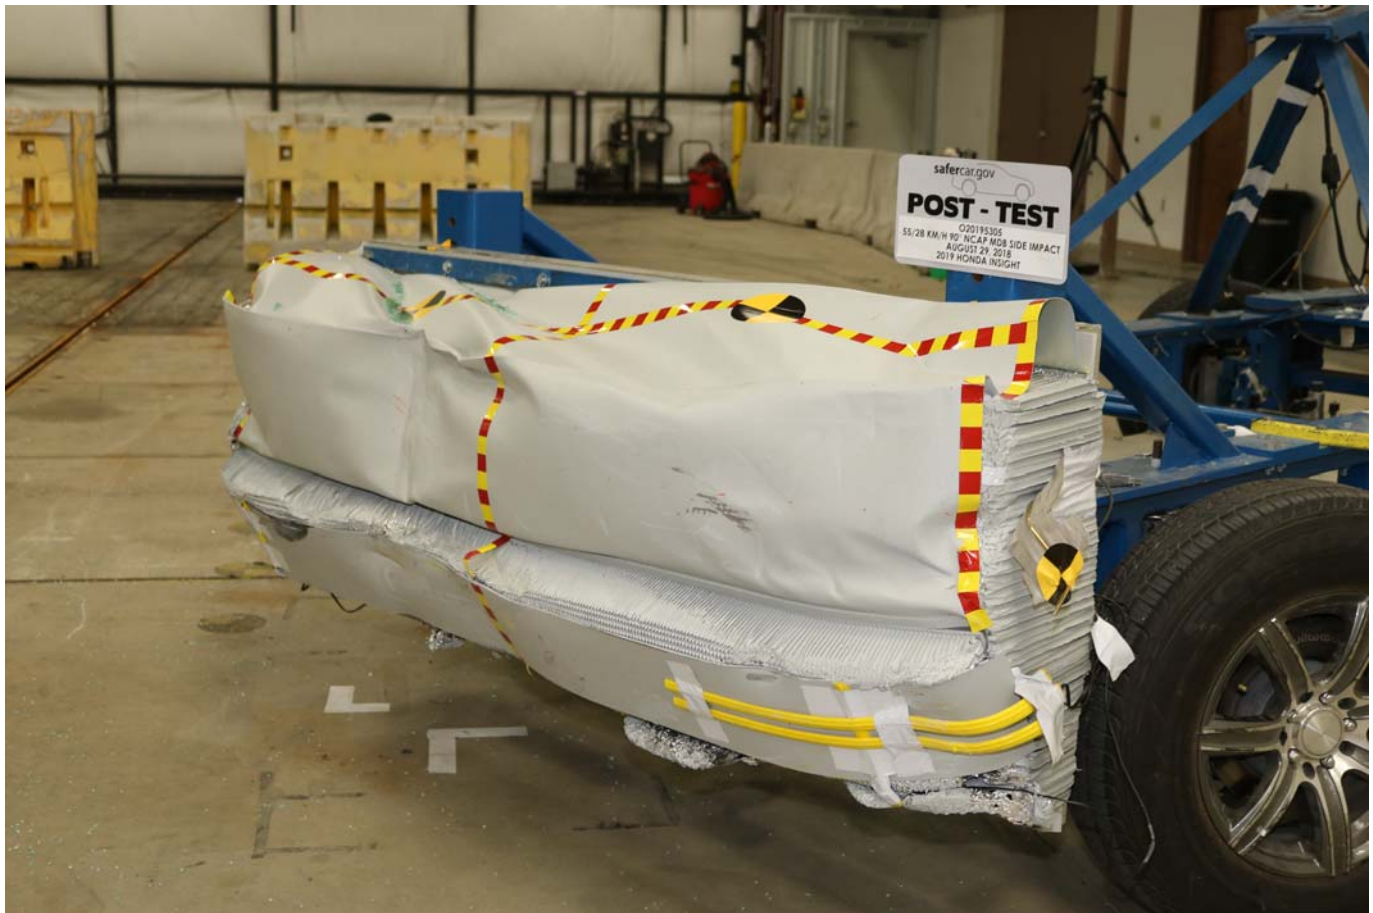
Photo No. 089 - Post-Test Left Side View of MDB Impactor Face

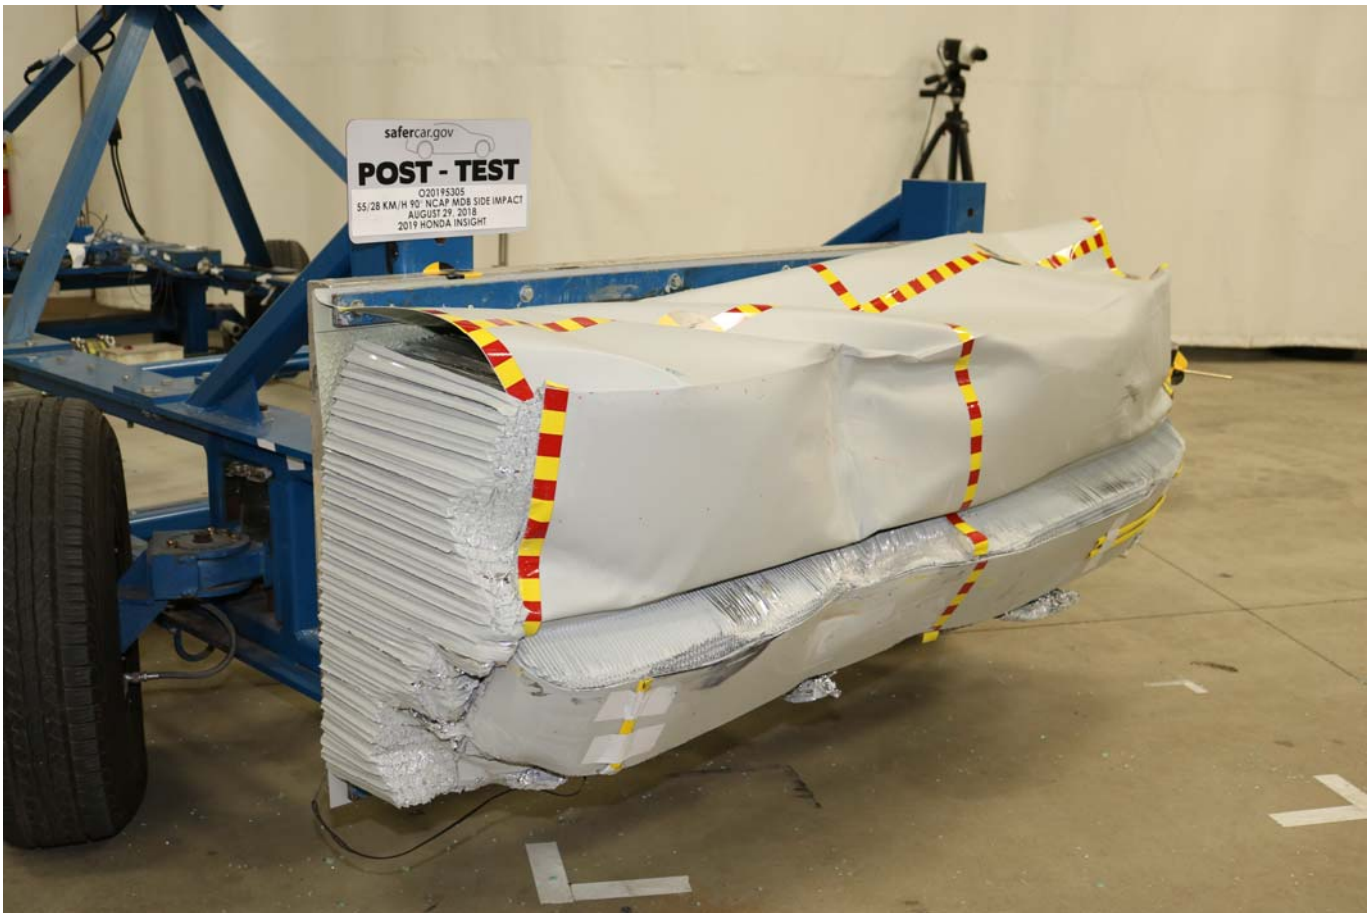
Photo No. 091 - Post-Test Right Side View of MDB Impactor Face

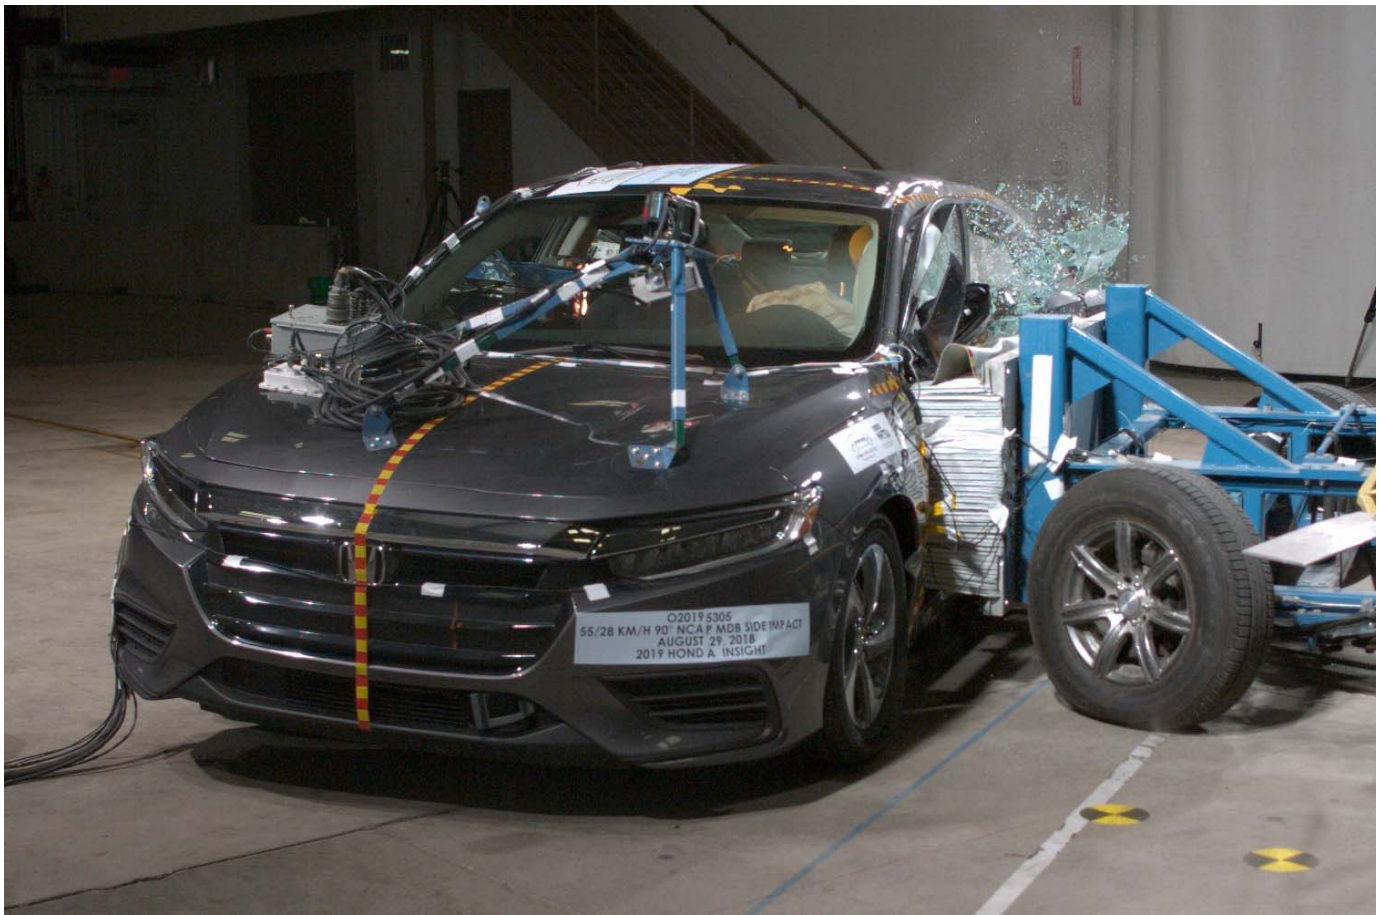
Photo No. 101 - Impact Event
