**REPORT NUMBER: SPNCAP-KAR-19-001  
NEW CAR ASSESSMENT PROGRAM (NCAP)  
SIDE IMPACT POLE TEST**

**SUBARU CORPORATION  
2019 SUBARU ASCENT 5-DOOR MPV**

**NHTSA No: O20195504**

**FINAL REPORT**

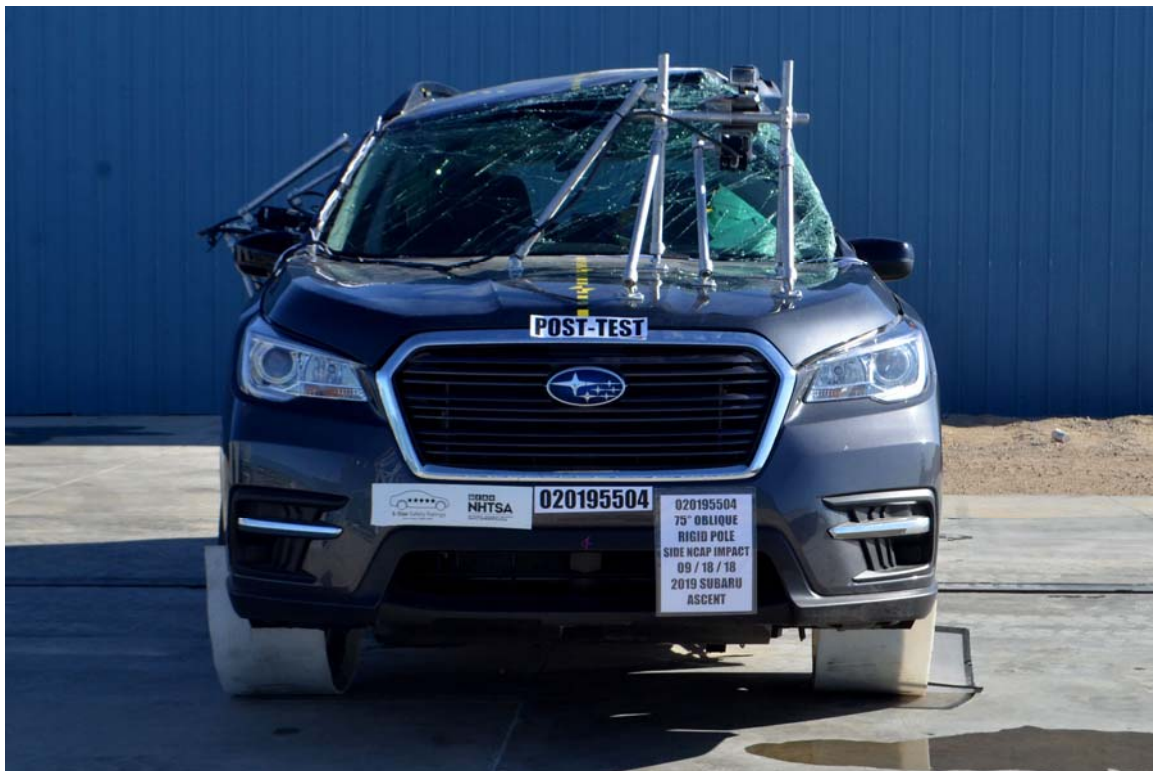
FIGURE 4. Post-Test Frontal View of Test Vehicle

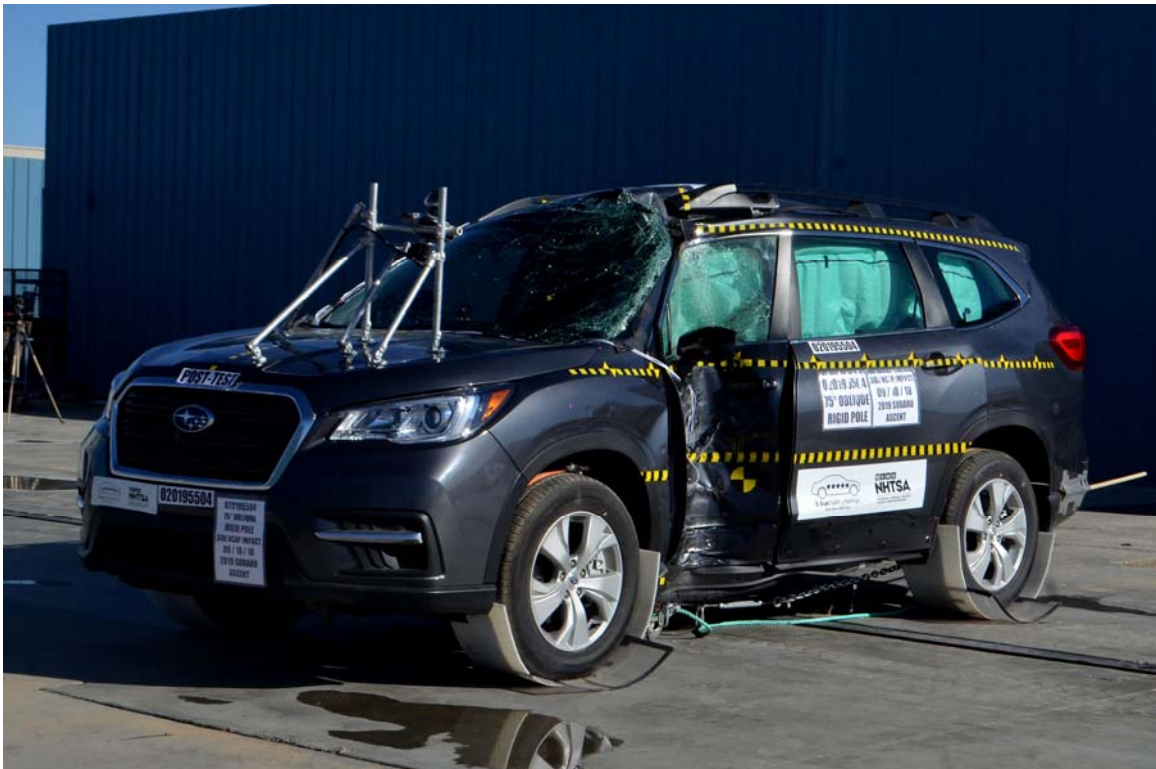
FIGURE 6. Post-Test Left Front  $\frac{3}{4}$  View of Test Vehicle

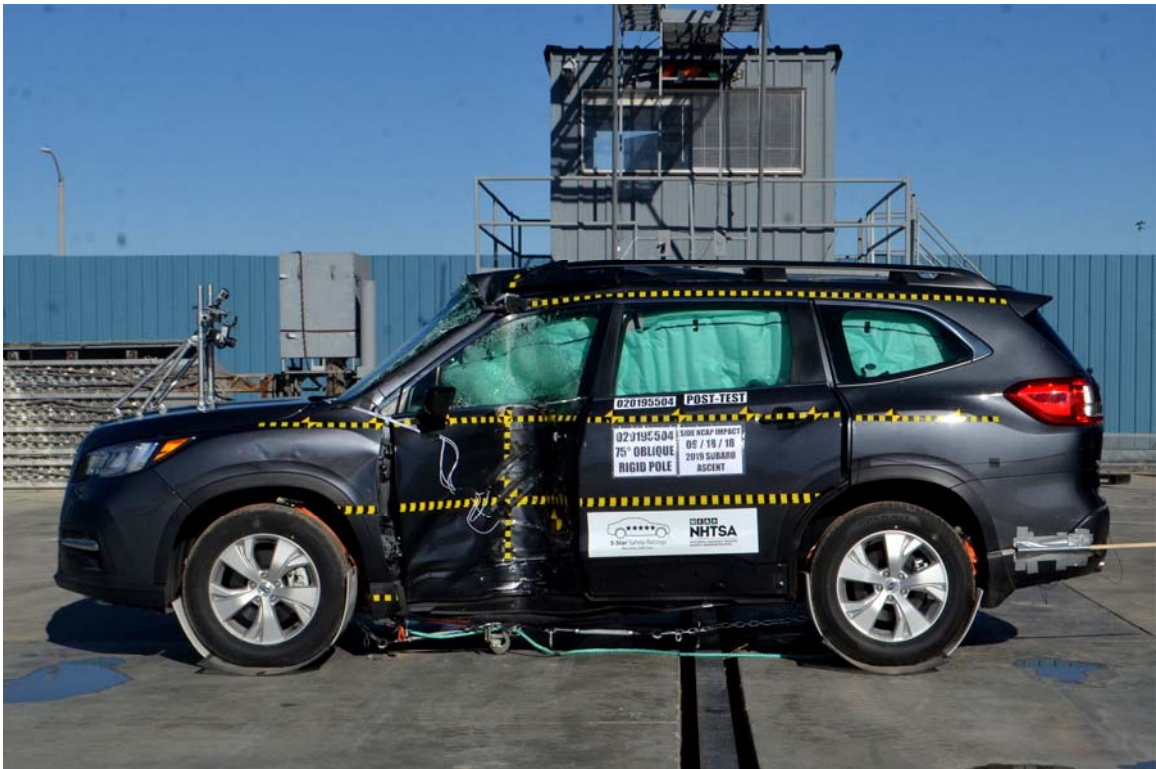
FIGURE 8. Post-Test Left Side View of Test Vehicle

The front door on the struck side of the vehicle was jammed shut. There was no separation at the hinges or latches. The left rear, and non-struck side doors remained closed and latched. There were no ATD values that exceeded limits. The Left Floor Sill Y channel failed.

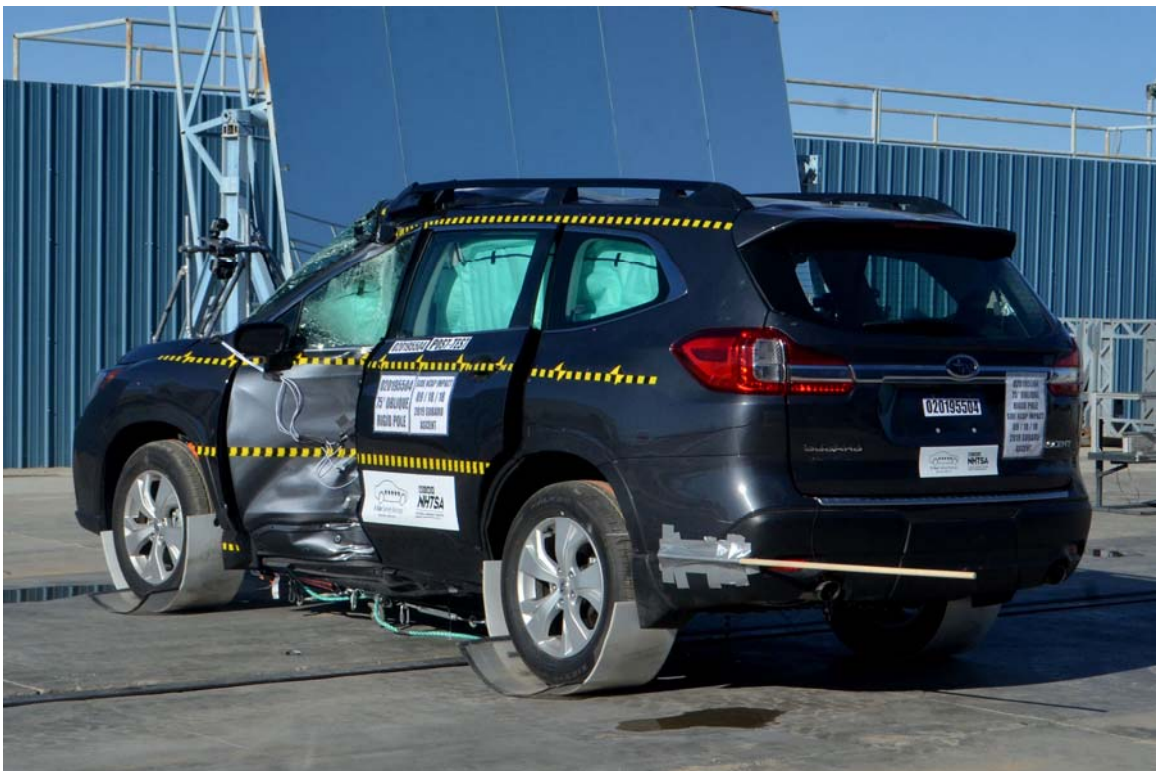
FIGURE 10. Post-Test Left Rear  $\frac{3}{4}$  View of Test Vehicle

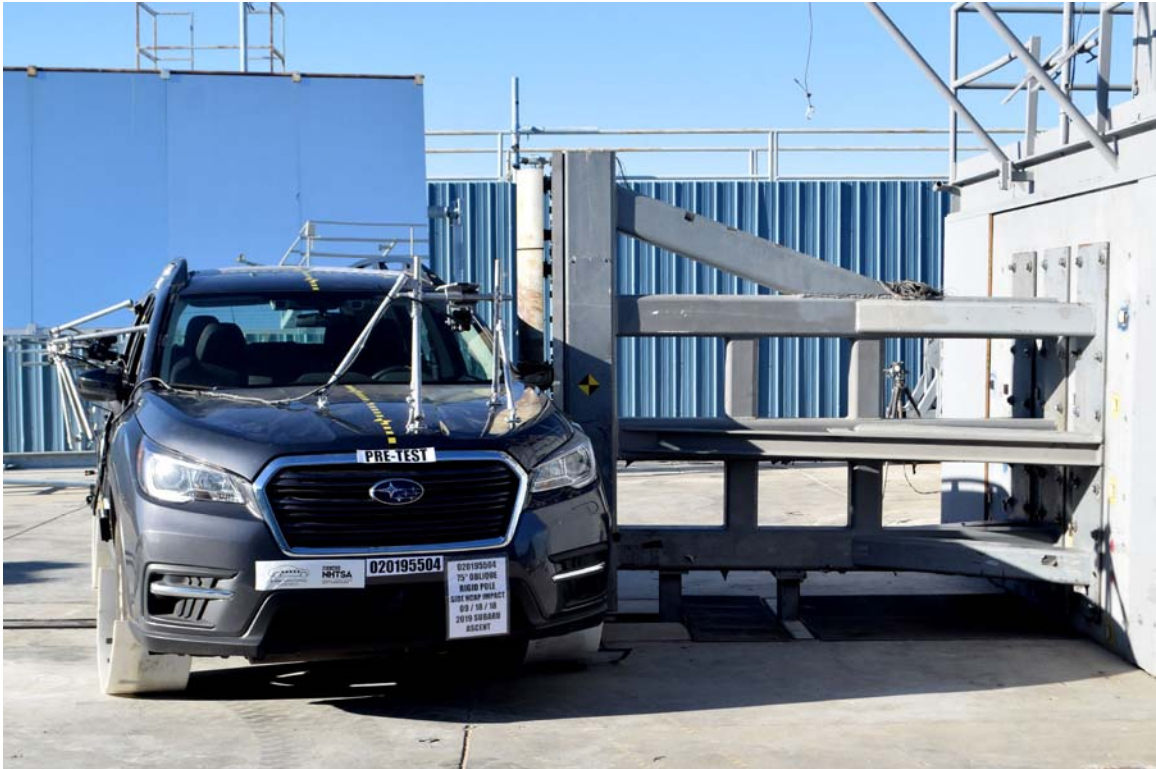
FIGURE 17. Pre-Test Left Side View of Pole Positioned Against Side of Vehicle

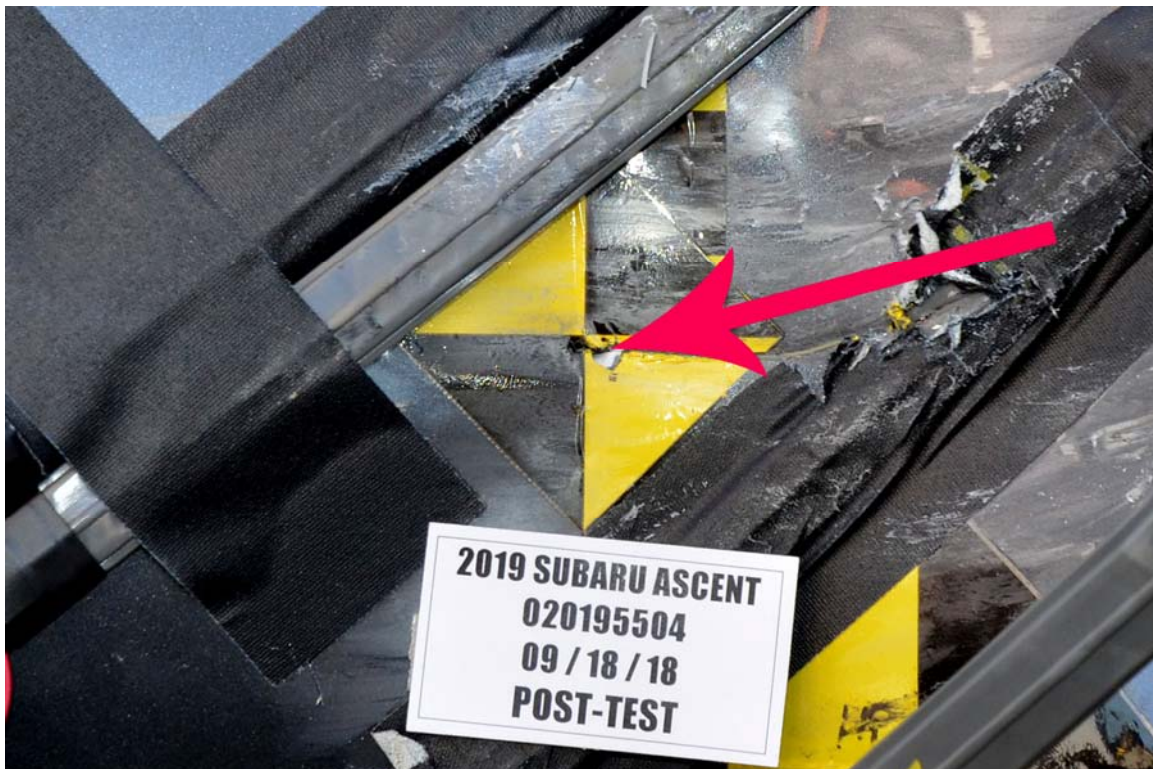
FIGURE 20. Post-Test Close-Up View of Impact Point Target Showing Impact Location

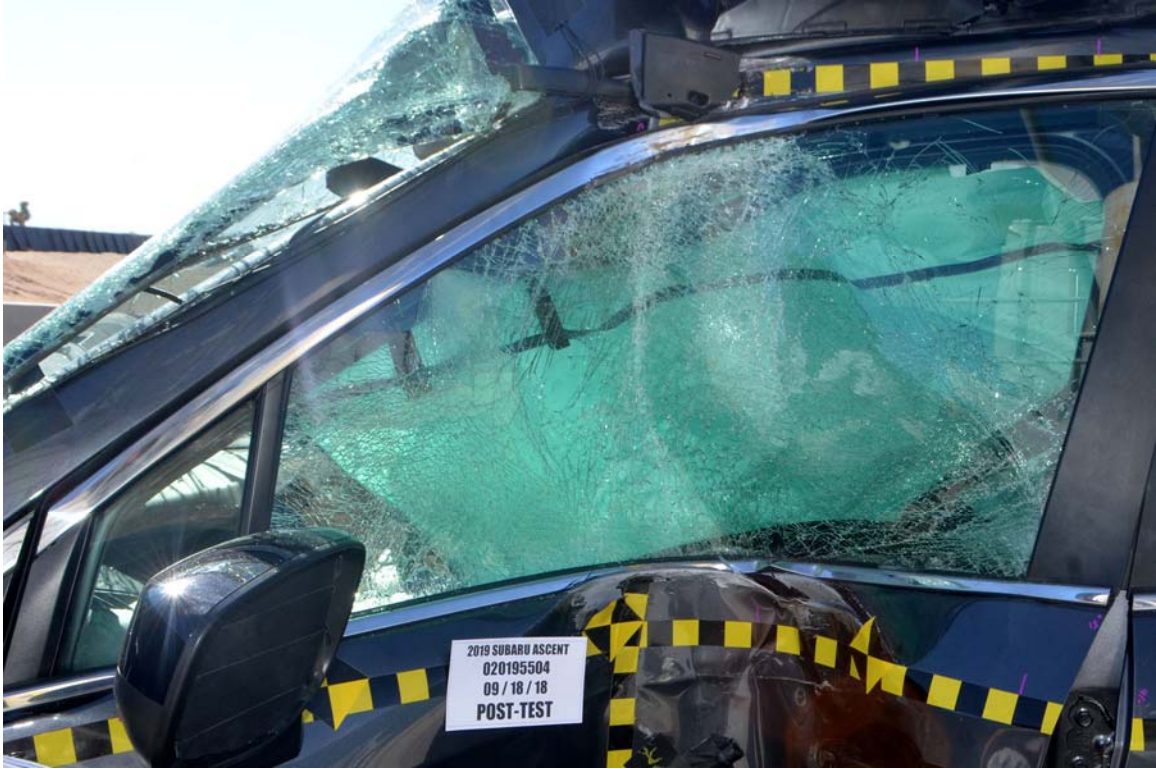
FIGURE 25. Post-Test Left Side View of Dummy Shoulder and Door Top View

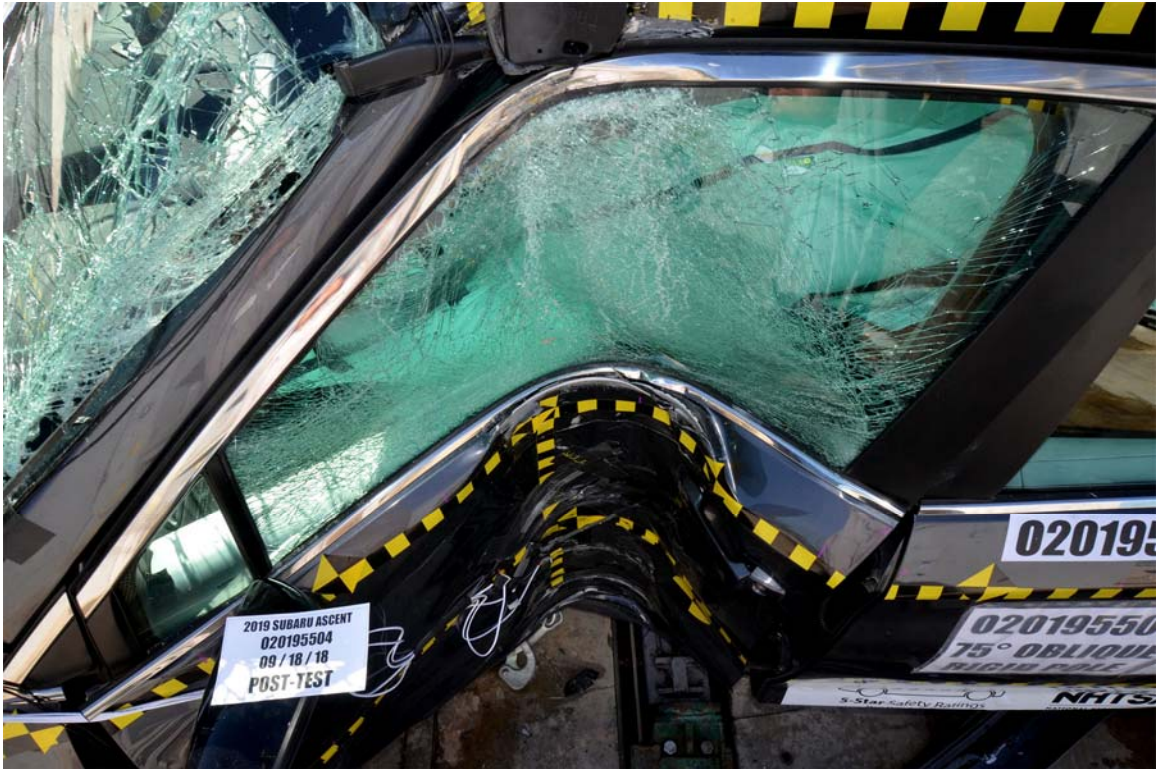
FIGURE 41. Post-Test Dummy and Door Clearance View

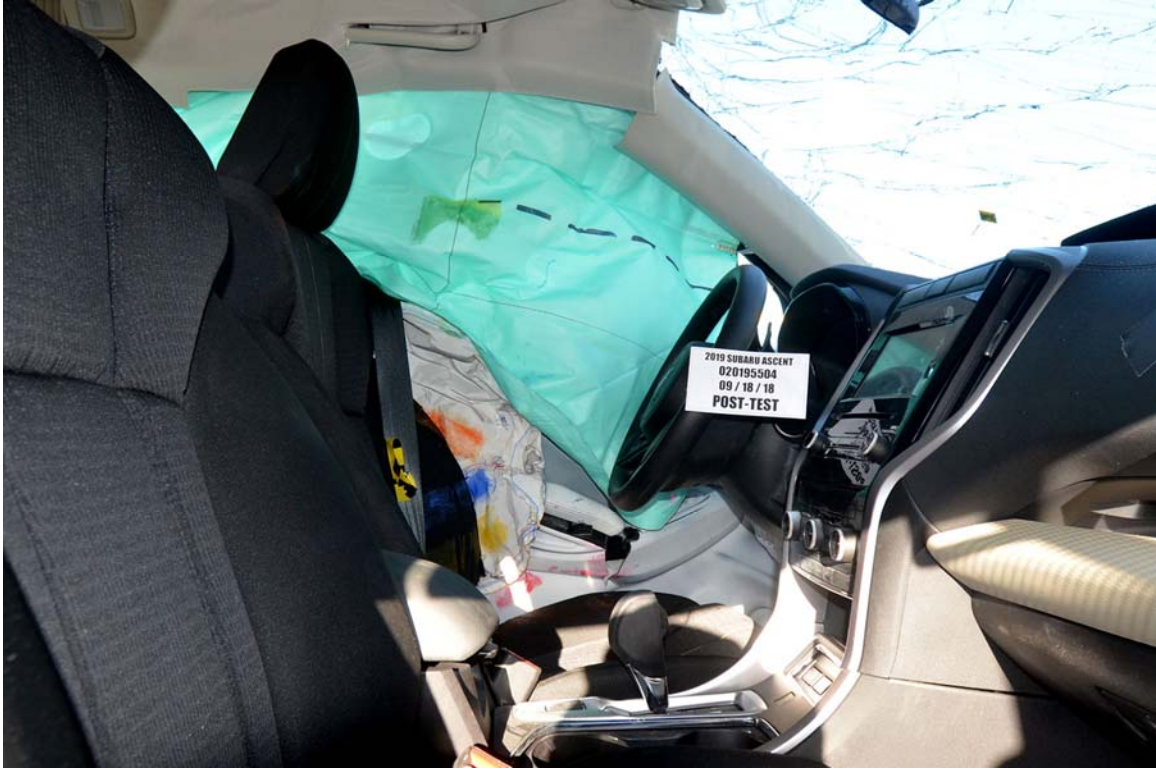
FIGURE 45. Post-Test Inner Door Panel View Showing Dummy Contact Locations

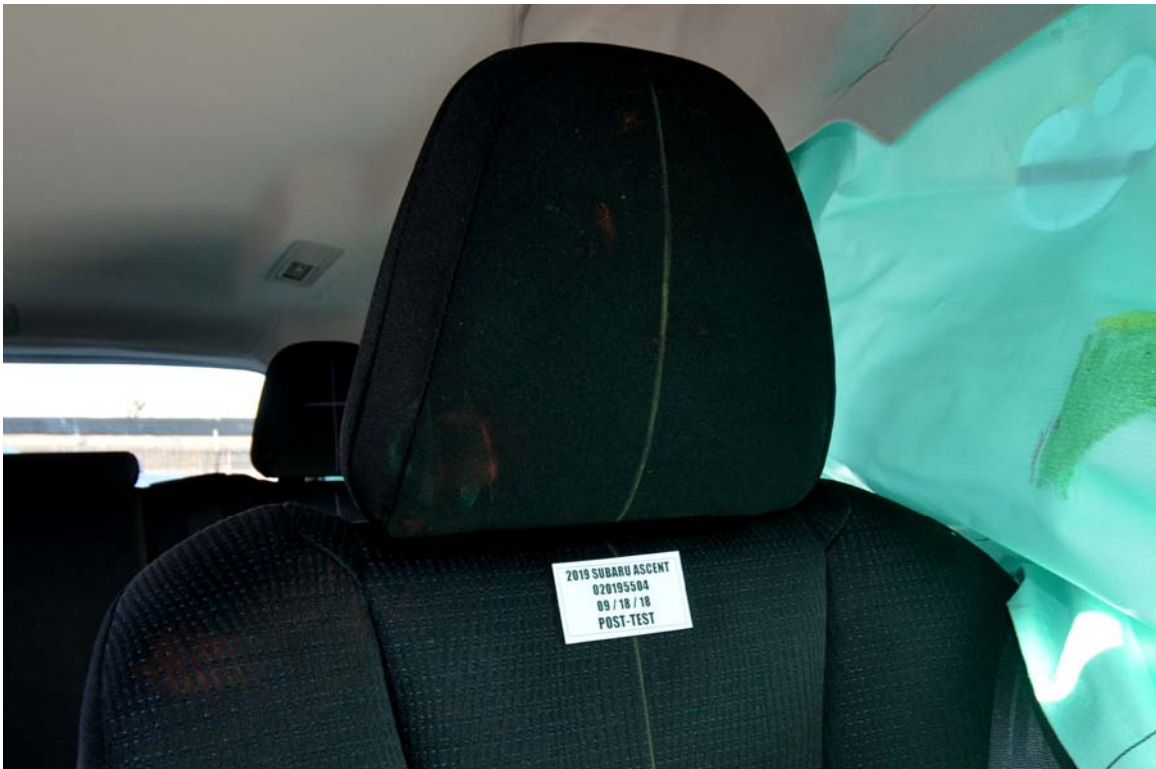
FIGURE 46. Post-Test Dummy Close-Up Head Contact with Vehicle Interior View

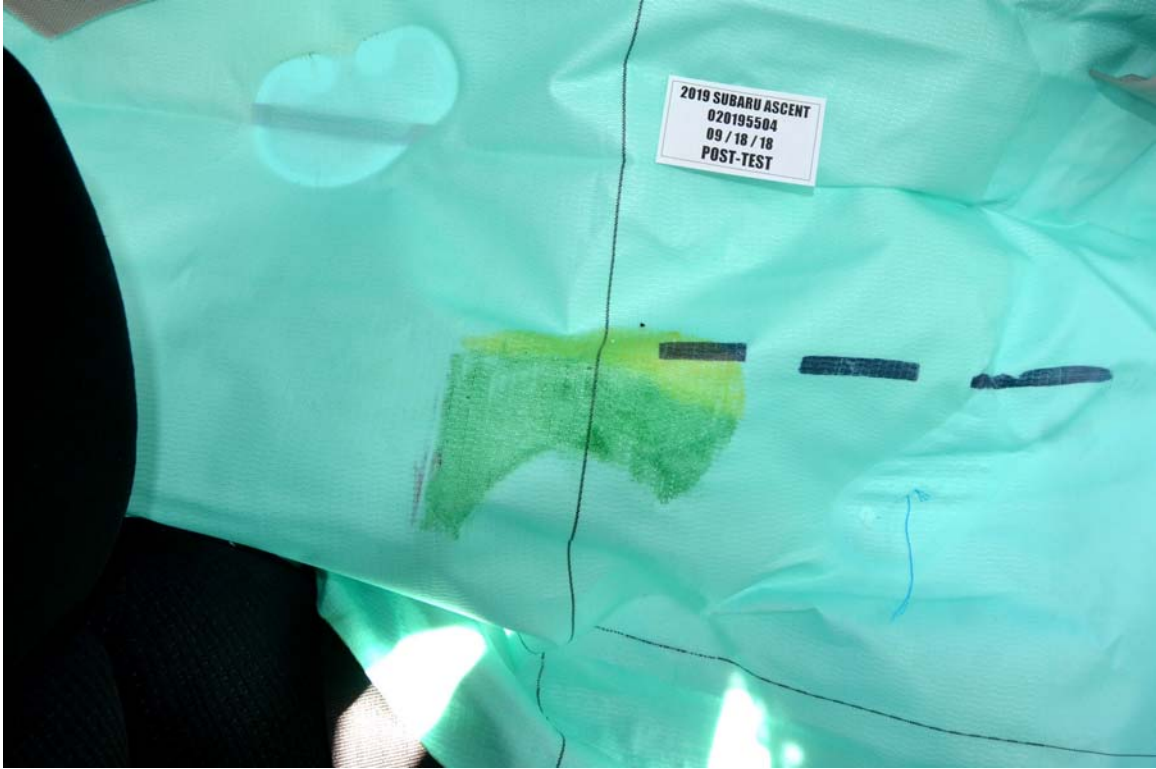
FIGURE 47. Post-Test Dummy Close-Up Head Contact With Side Airbag View

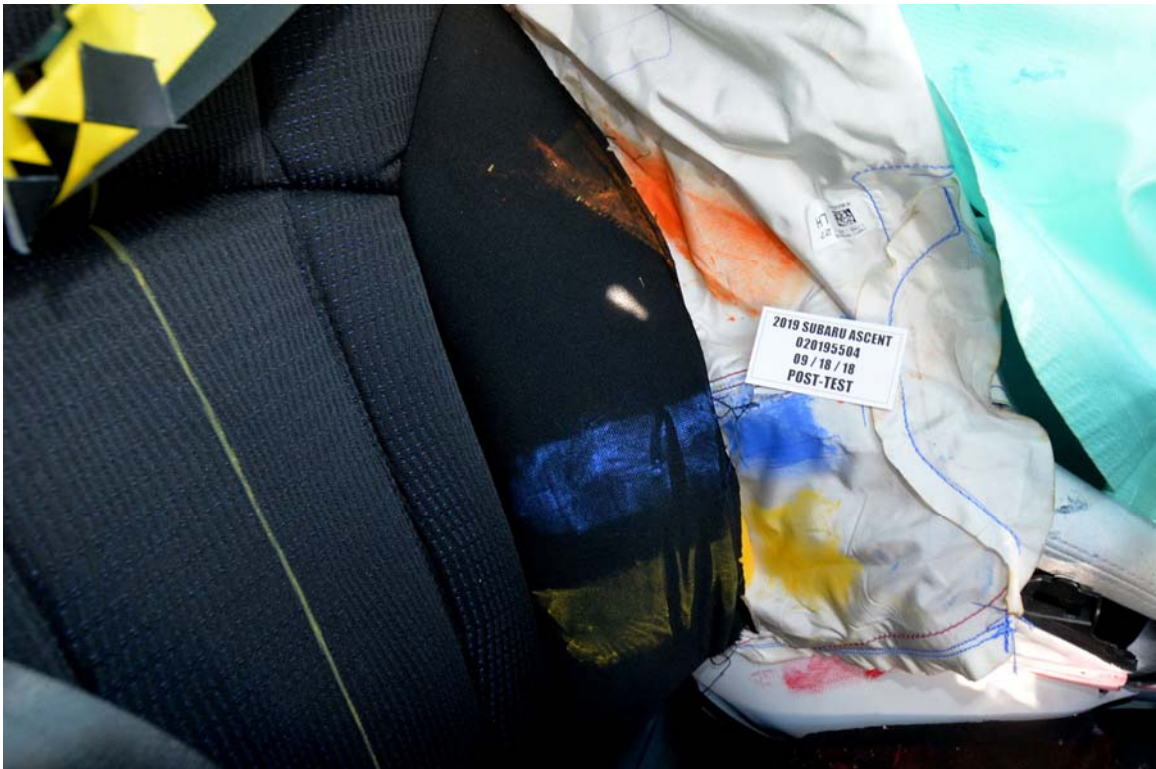
FIGURE 48. Post-Test Dummy Close-Up Torso Contact With Vehicle Interior View

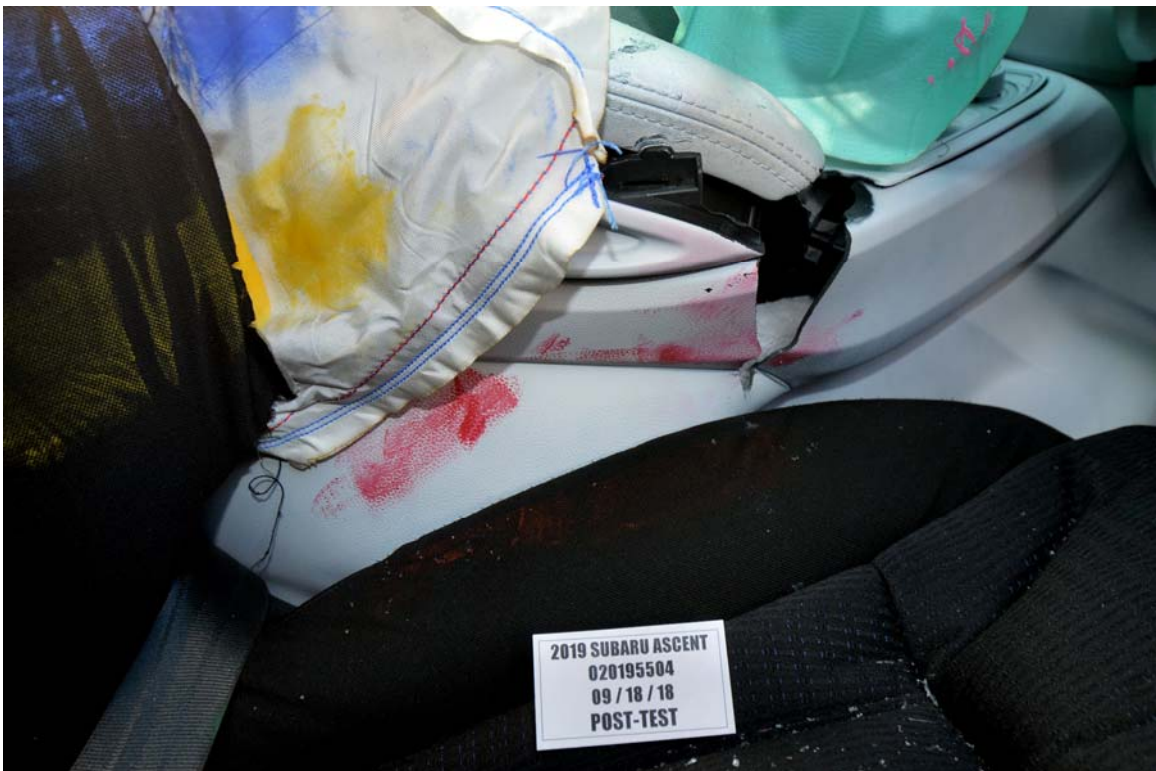
FIGURE 50. Post-Test Dummy Close-Up Pelvis Contact With Vehicle Interior View

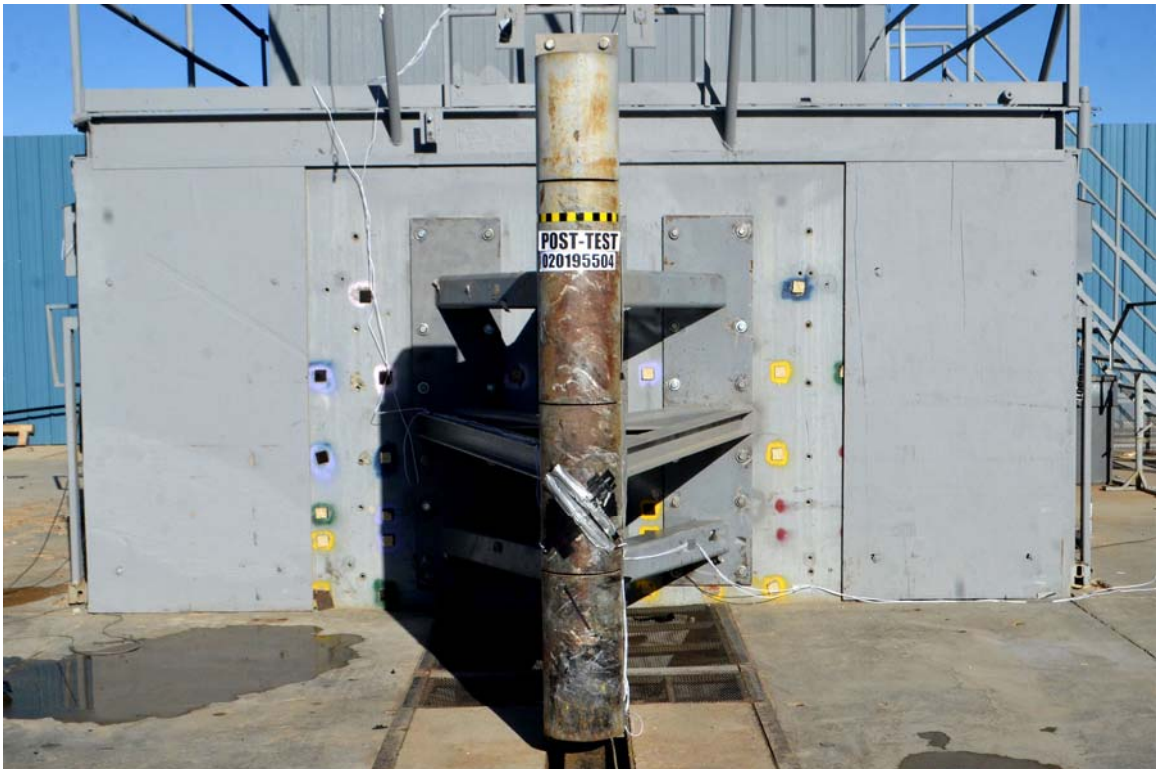
FIGURE 58. Post-Test Pole Barrier Front View

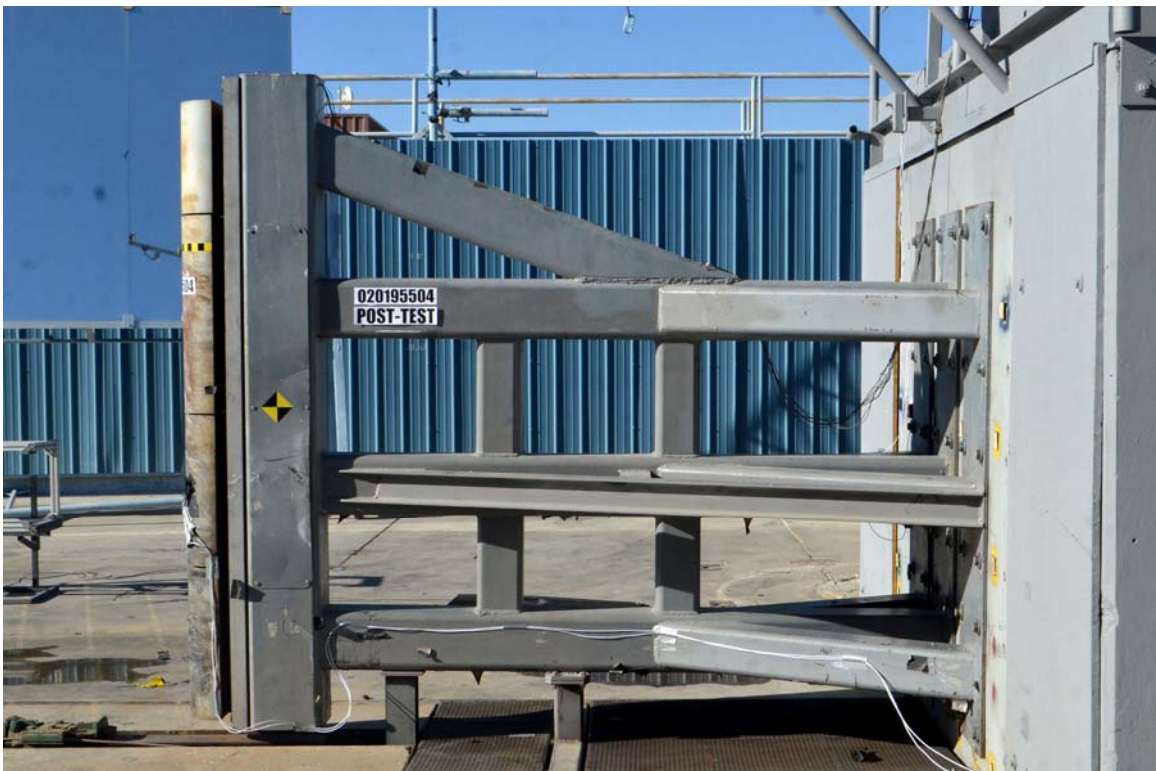
FIGURE 60. Post-Test Pole Barrier Side View

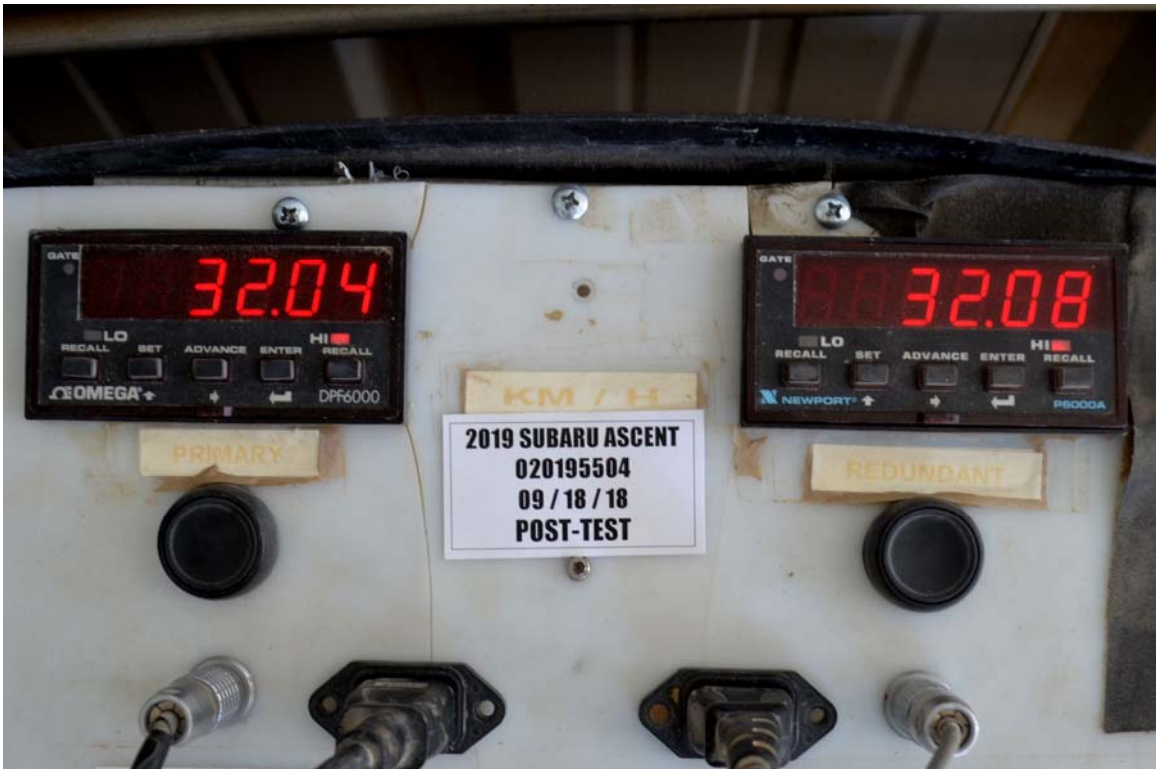
FIGURE 62. Post-Test Primary and Redundant Speed Trap Read-Out
