**REPORT NUMBER: NCAP-MGA-2018-034**

**NEW CAR ASSESSMENT PROGRAM (NCAP)  
Frontal Barrier Impact Test**

**NISSAN MOTOR CO., LTD.  
2018 Nissan Rogue S AWD 5-Door SUV  
NHTSA No.: O20185200**

**FINAL REPORT**

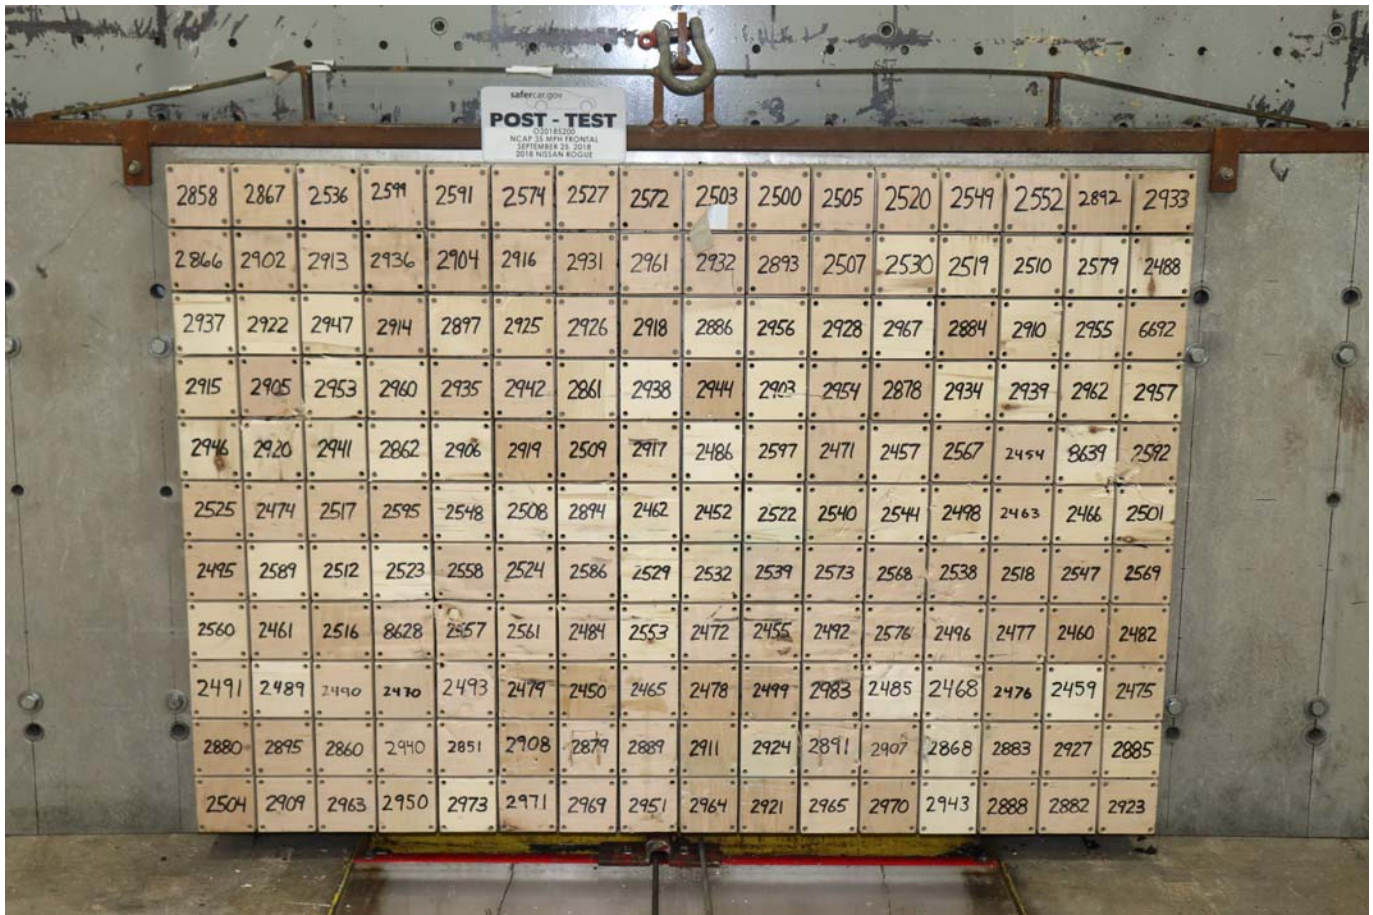
Photo No. 003 - Post-Test Load Cell Wall

A load cell barrier consisting of 176 load cells was impacted by a 2018 Nissan Rogue S AWD 5-Door SUV at a velocity of 57.04 km/h. The test was performed at MGA Research Corporation on September 25, 2018. Pre-test and post-test photographs of the vehicle and dummies can be found in Appendix A.

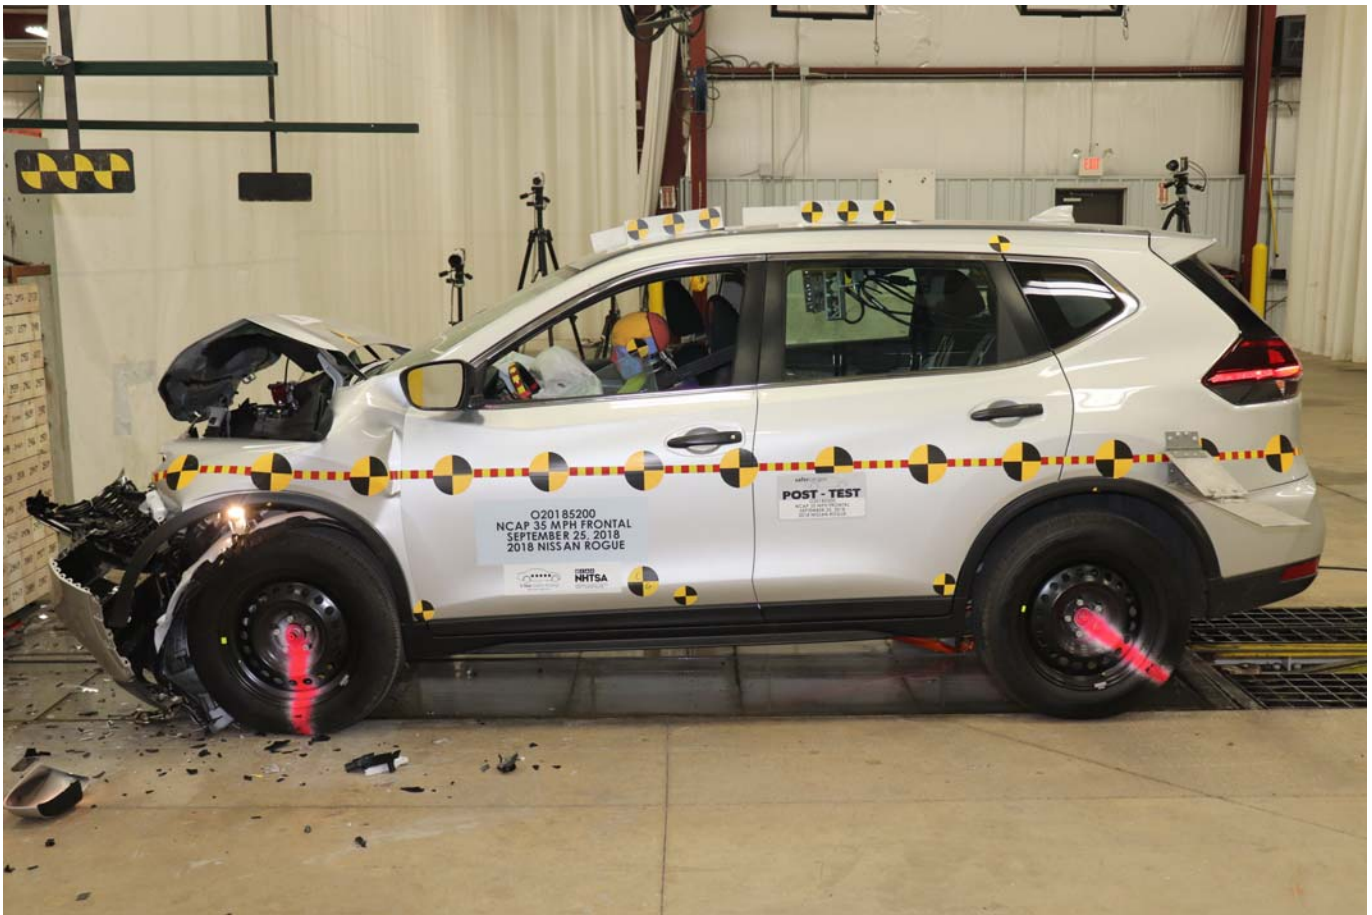
Photo No. 011 - Post-Test Left View of Test Vehicle

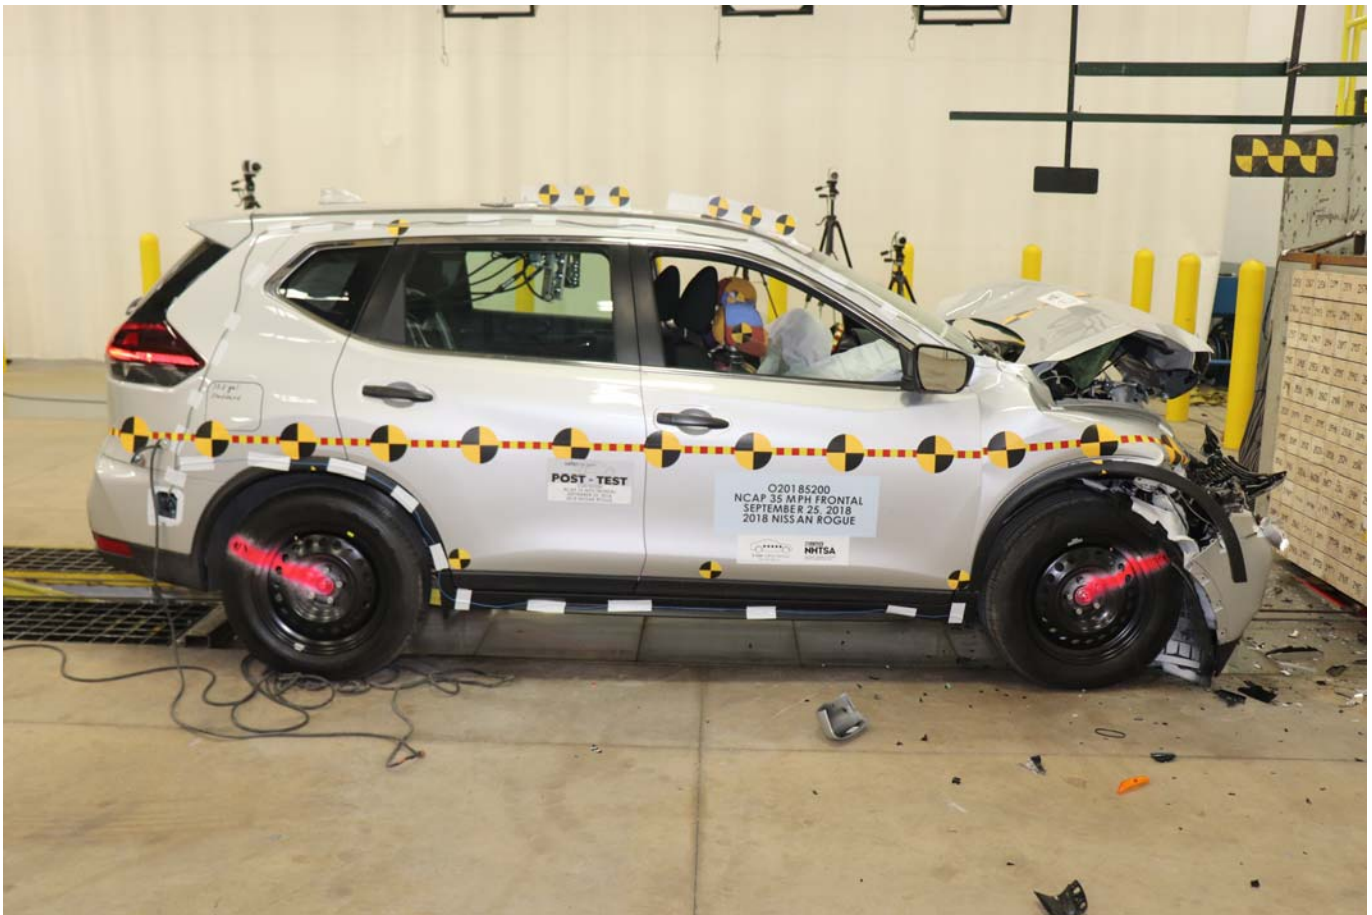
Photo No. 013 - Post-Test Right View of Test Vehicle

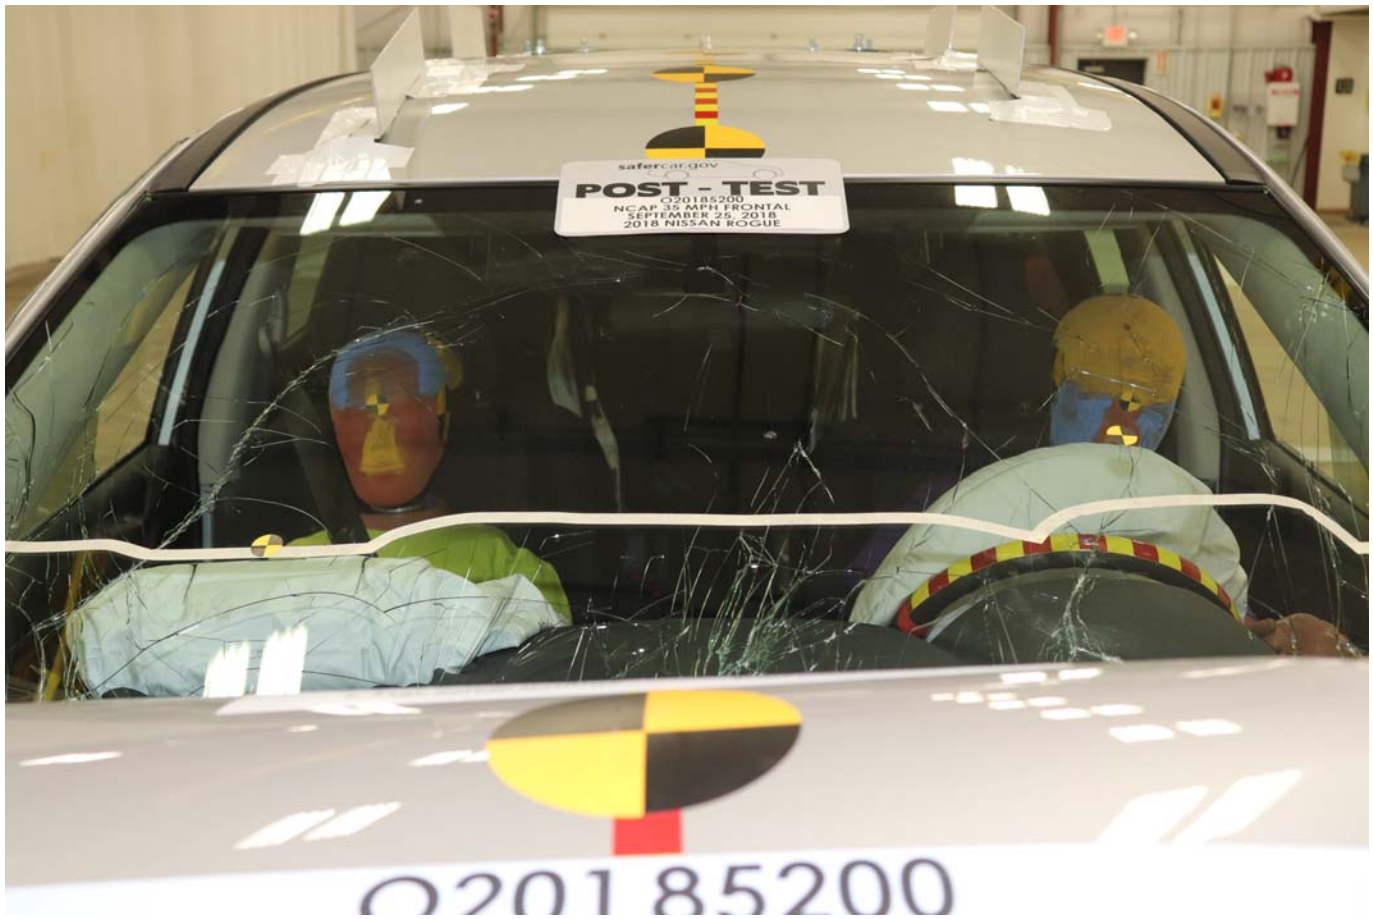
Photo No. 019 - Post-Test Windshield View

There was 100 percent windshield retention and no intrusion into the protected zone of the windshield during the event. There was no Stoddard Solvent leakage after the event or during any phase of the static rollover.

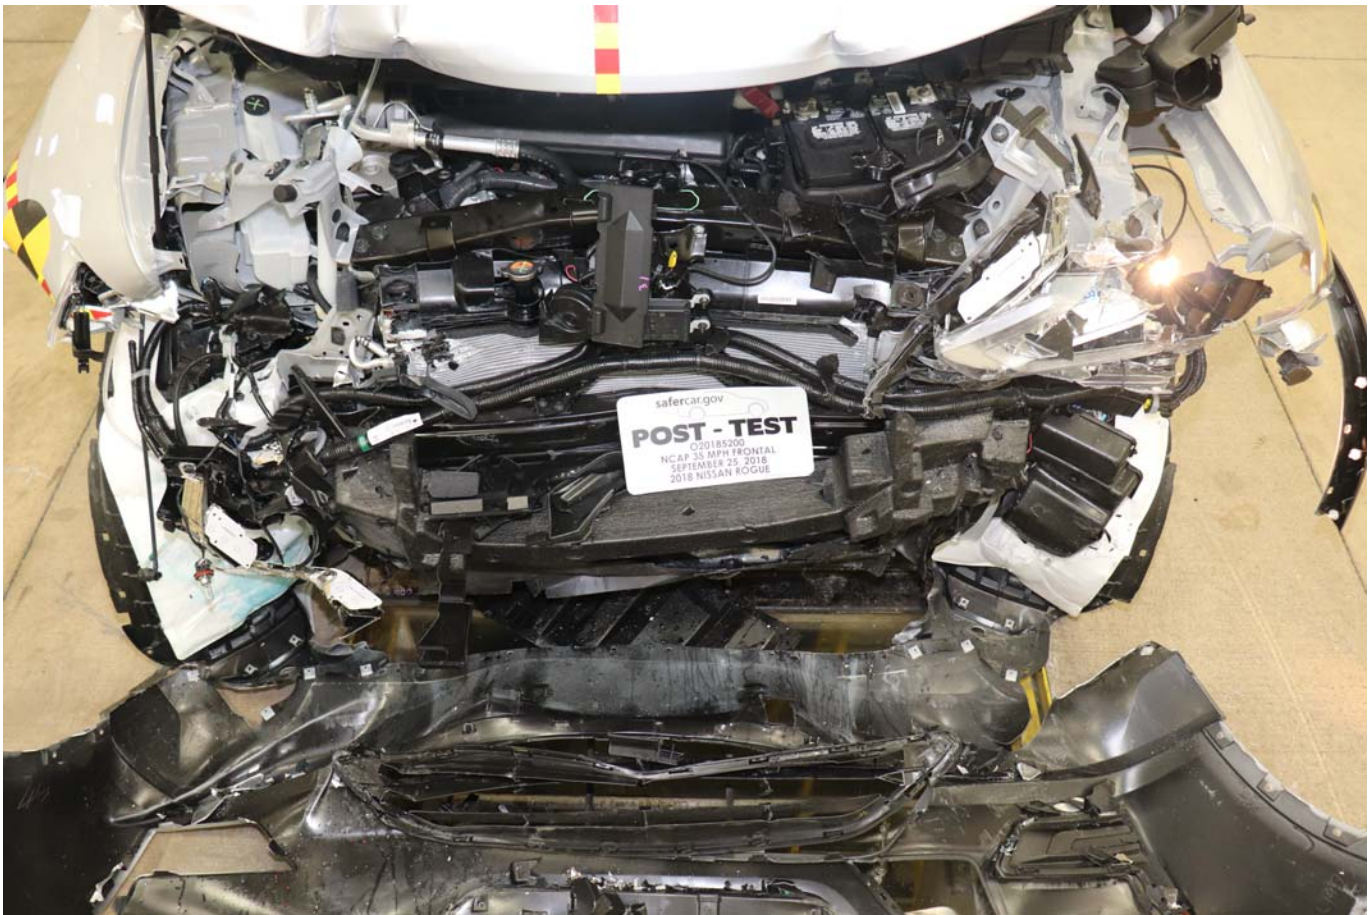
Photo No. 021 - Post-Test Engine Compartment View

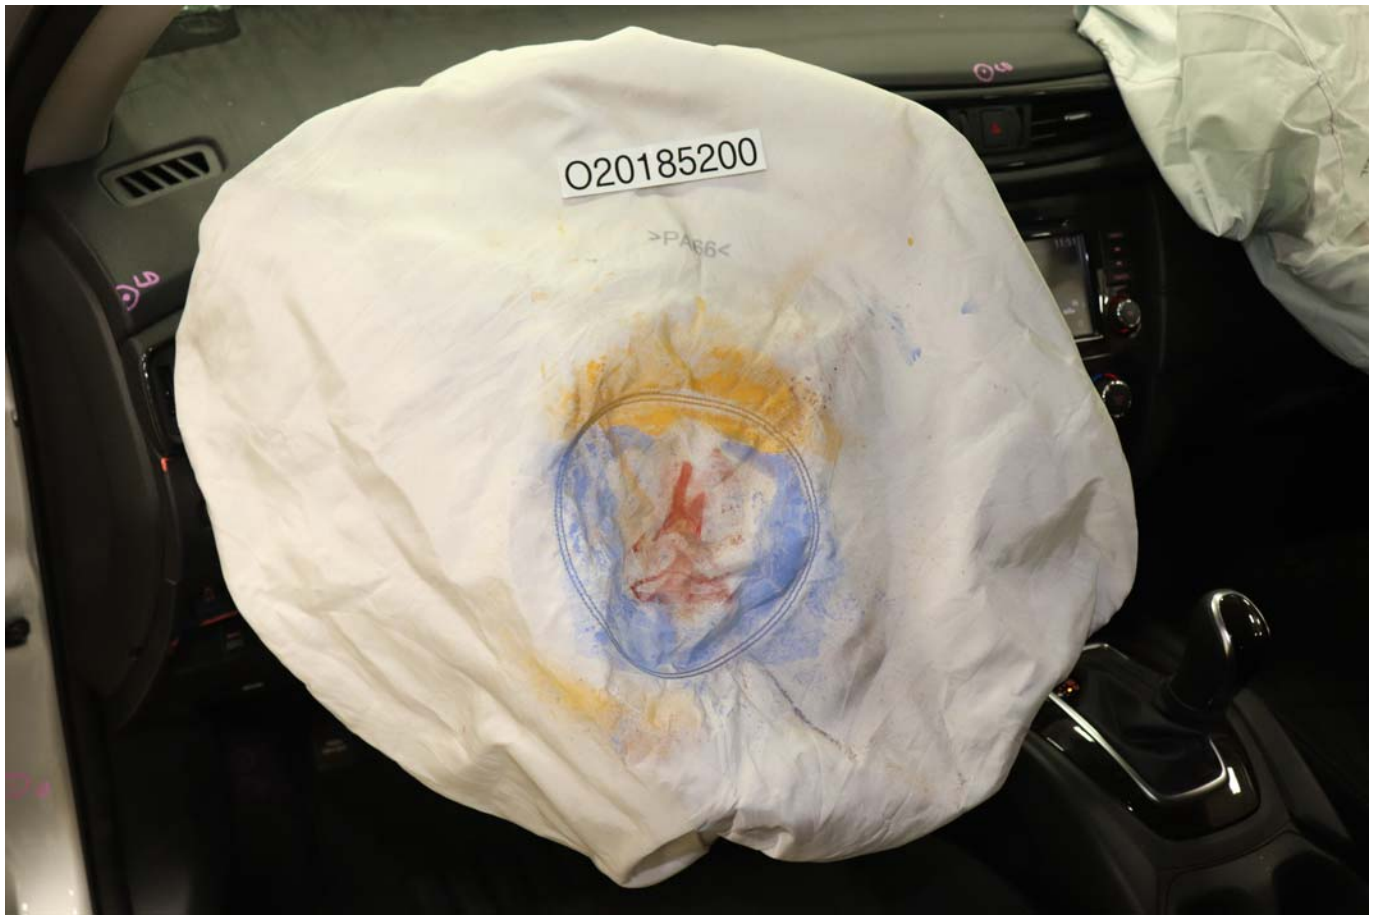
Photo No. 047 - Post-Test Driver Dummy Contact with Airbag

The driver's visible contact points were as follows: The driver's head contacted the airbag. The driver's head also contacted the headrest. The driver's knees contacted the knee bolster. The passenger's visible contact points were as follows: The passenger's head contacted the airbag. The passenger's head also contacted the headrest. The passenger's knees contacted the glove box.

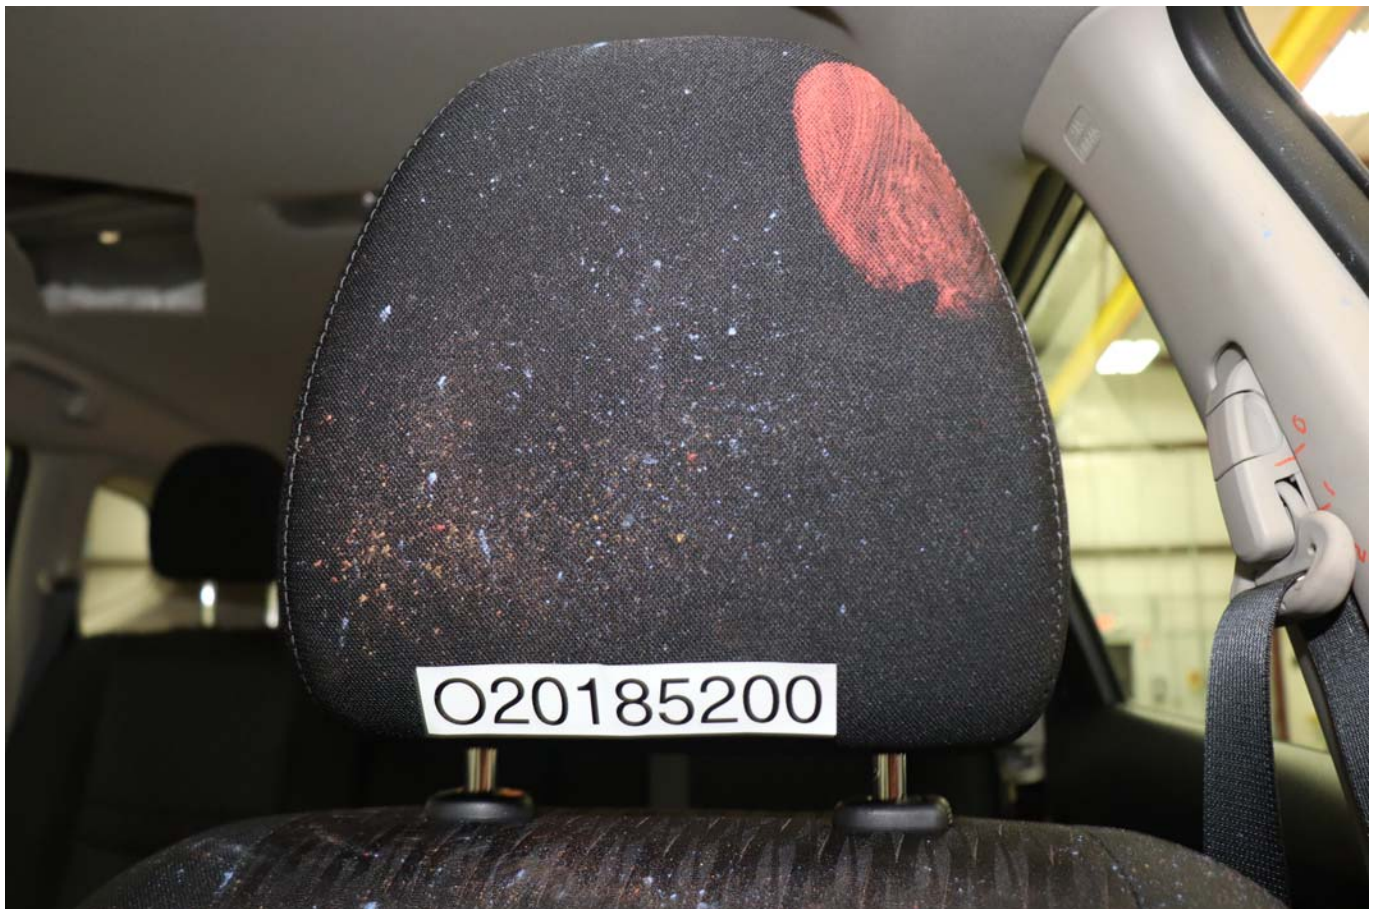
Photo No. 048 - Post-Test Driver Dummy Contact with Headrest

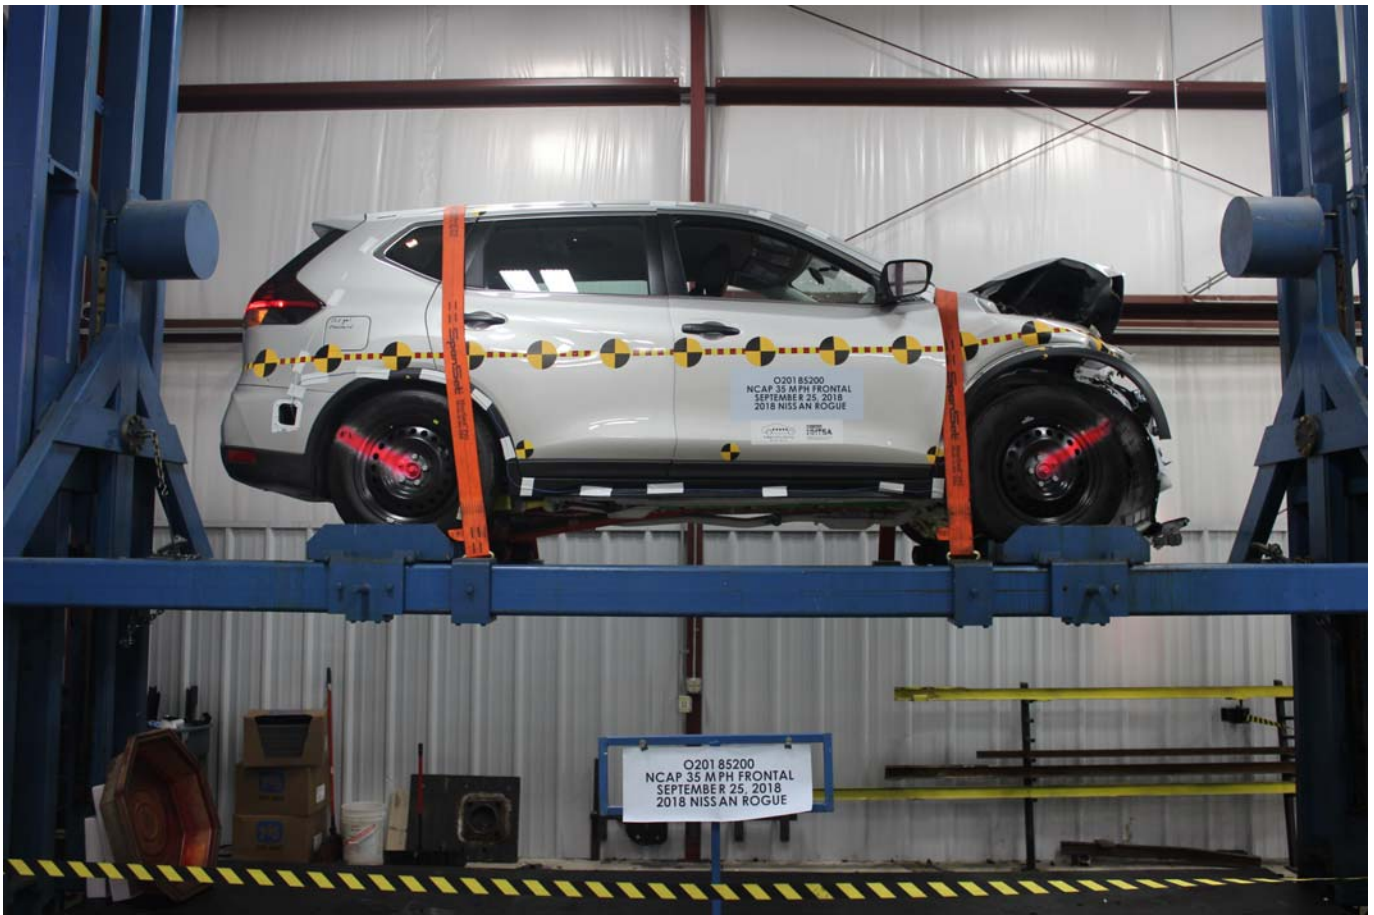
Photo No. 073 - Vehicle at 0 Degree on Static Rollover Device

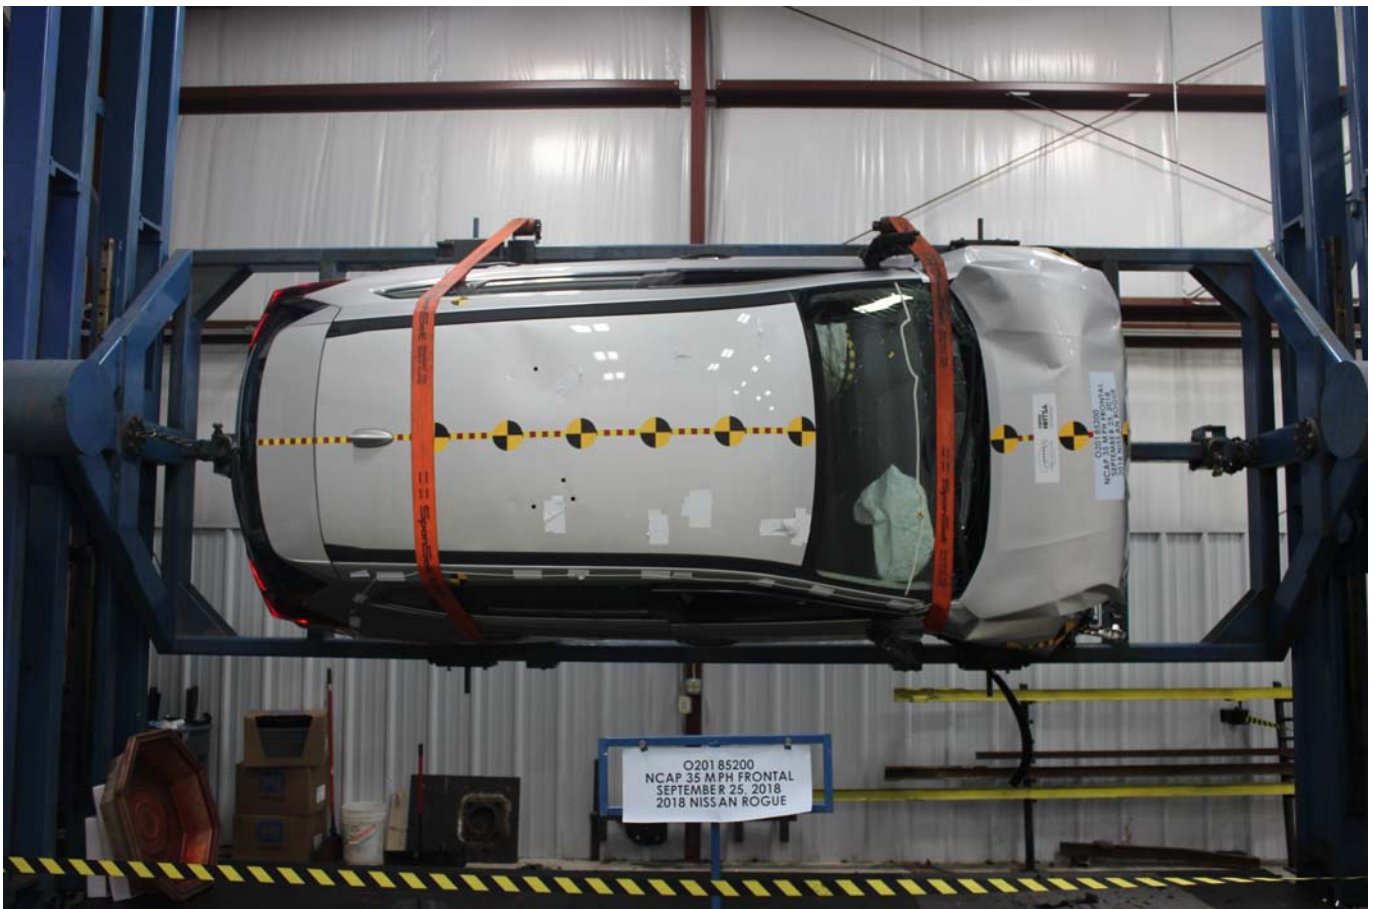
Photo No. 074 - Vehicle at 90 Degrees on Static Rollover Device

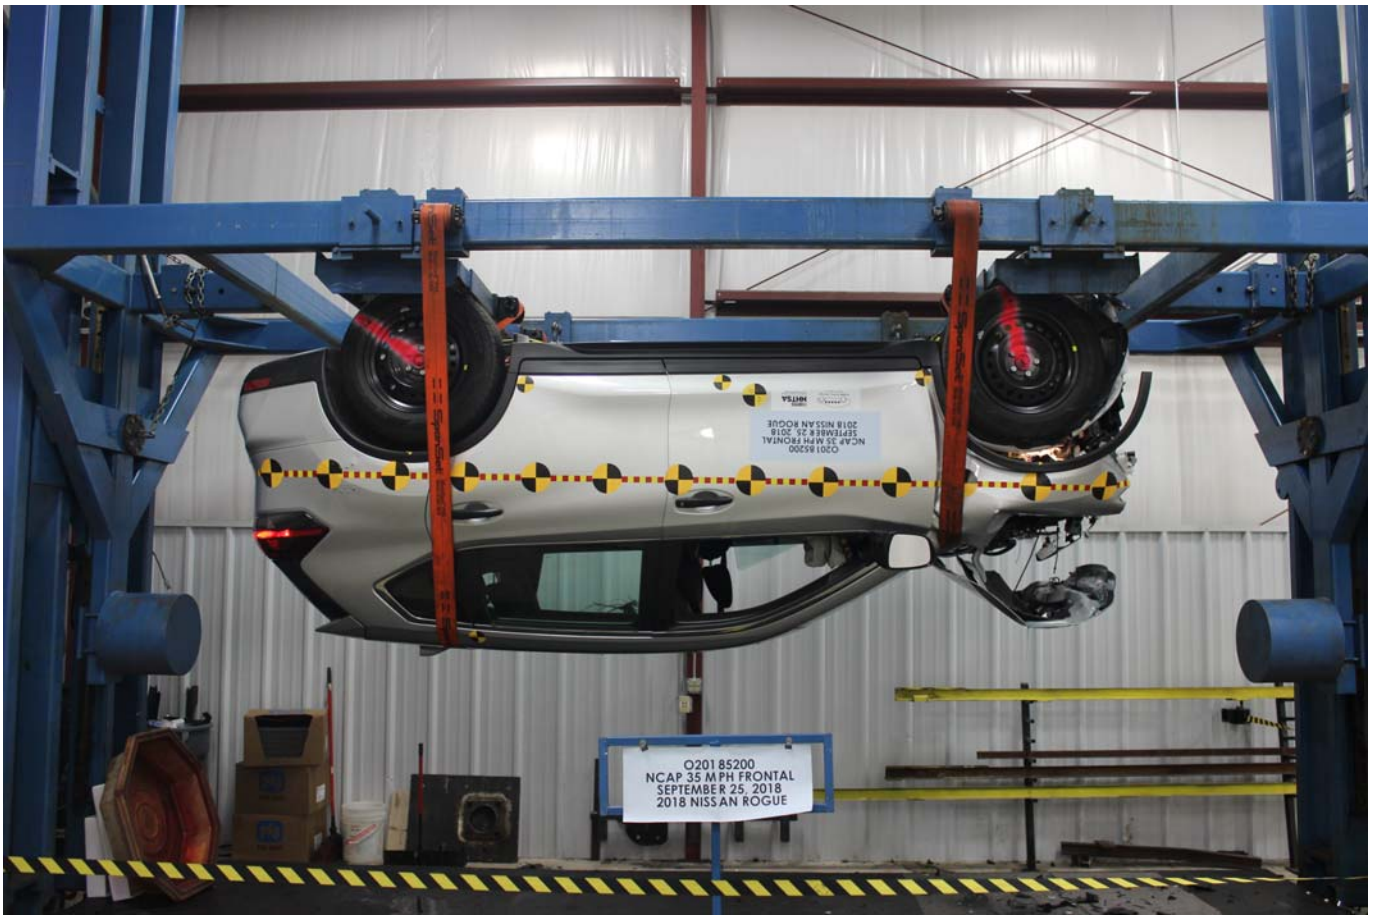
Photo No. 075 - Vehicle at 180 Degrees on Static Rollover Device

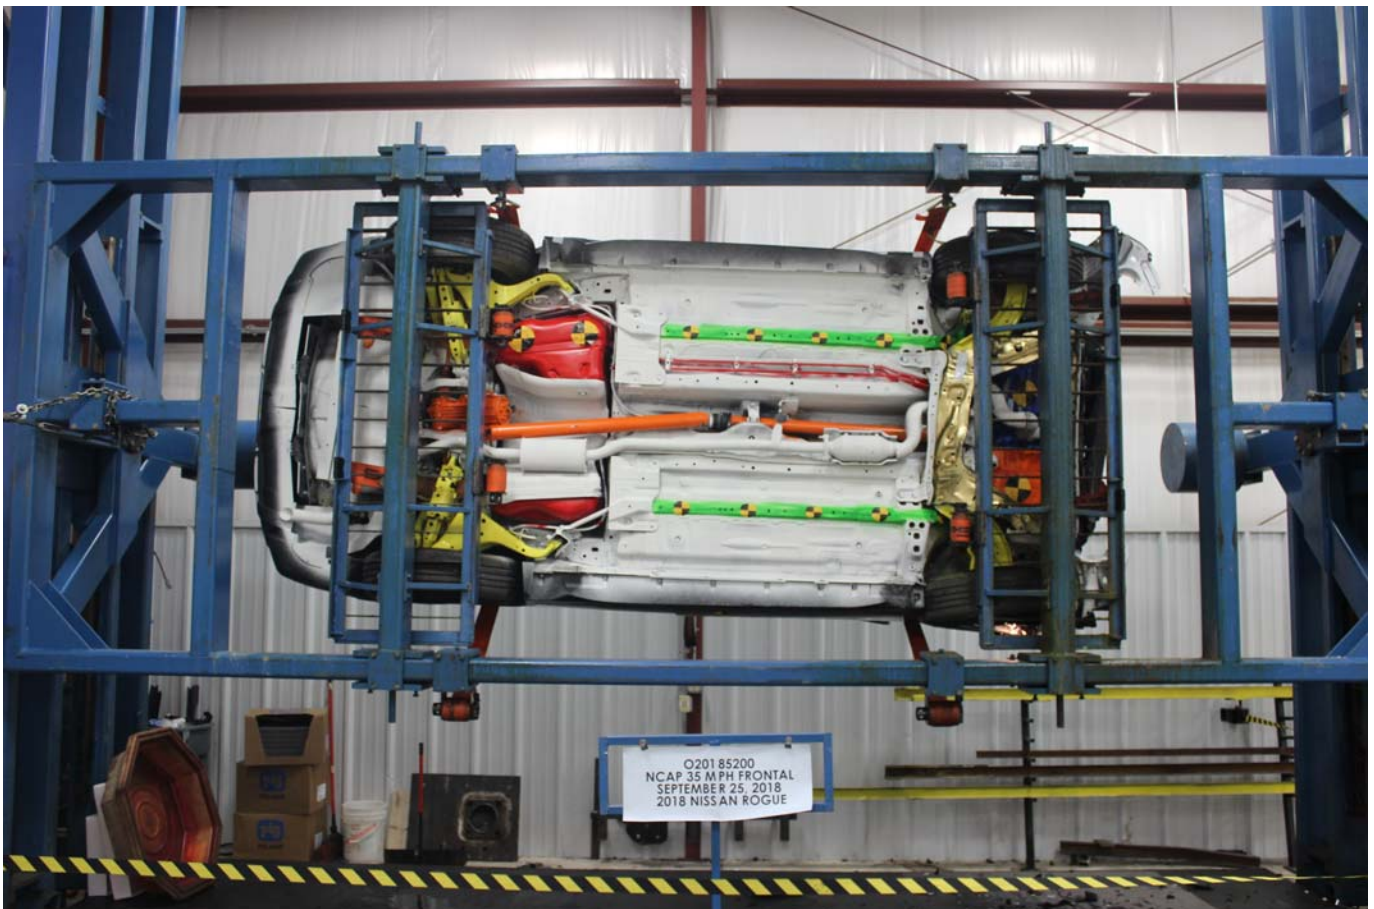
Photo No. 076 - Vehicle at 270 Degrees on Static Rollover Device

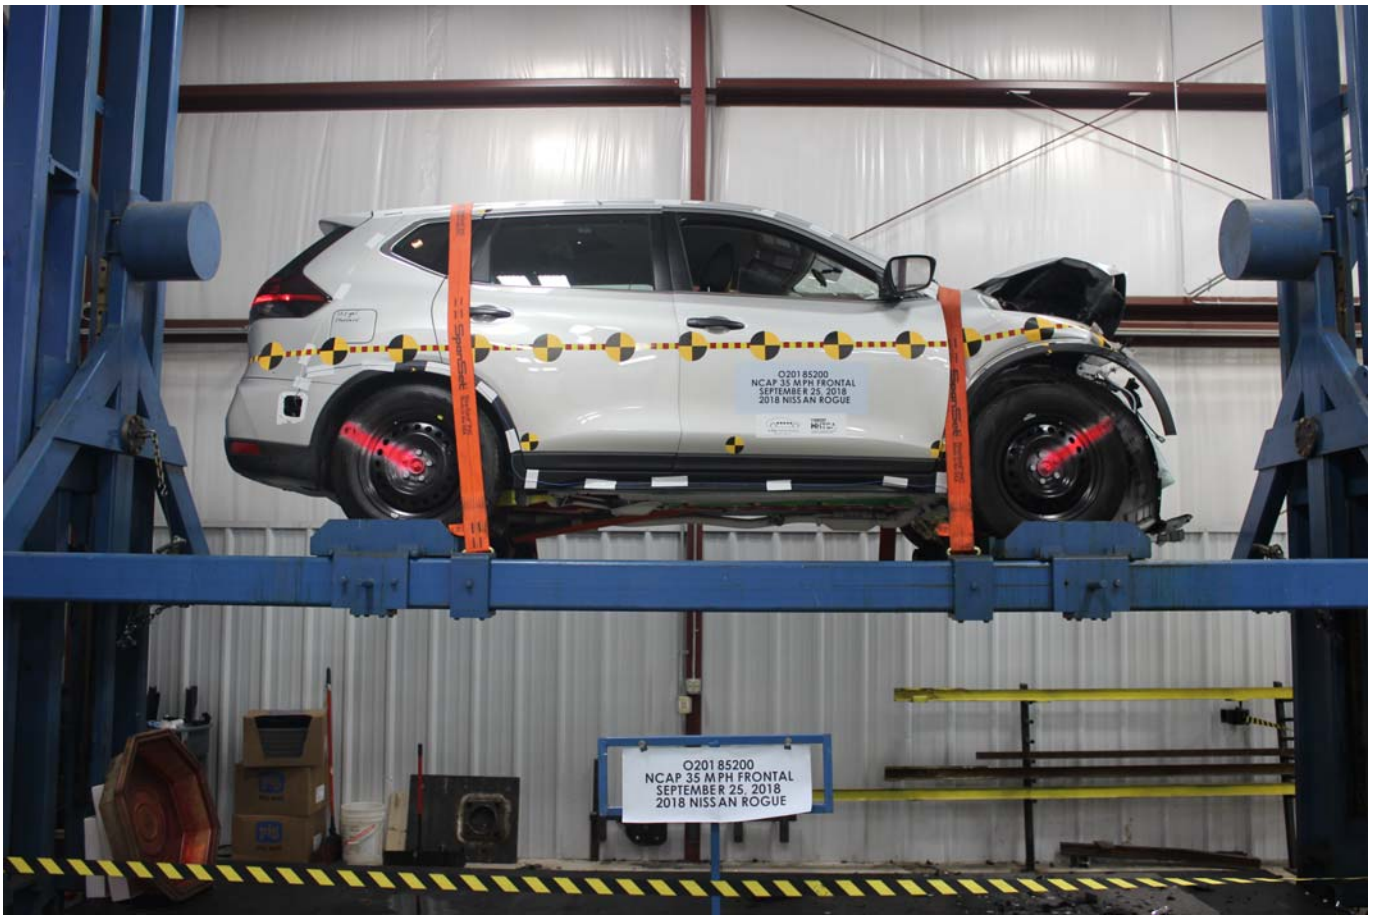
Photo No. 077 - Vehicle at 360 Degrees on Static Rollover Device

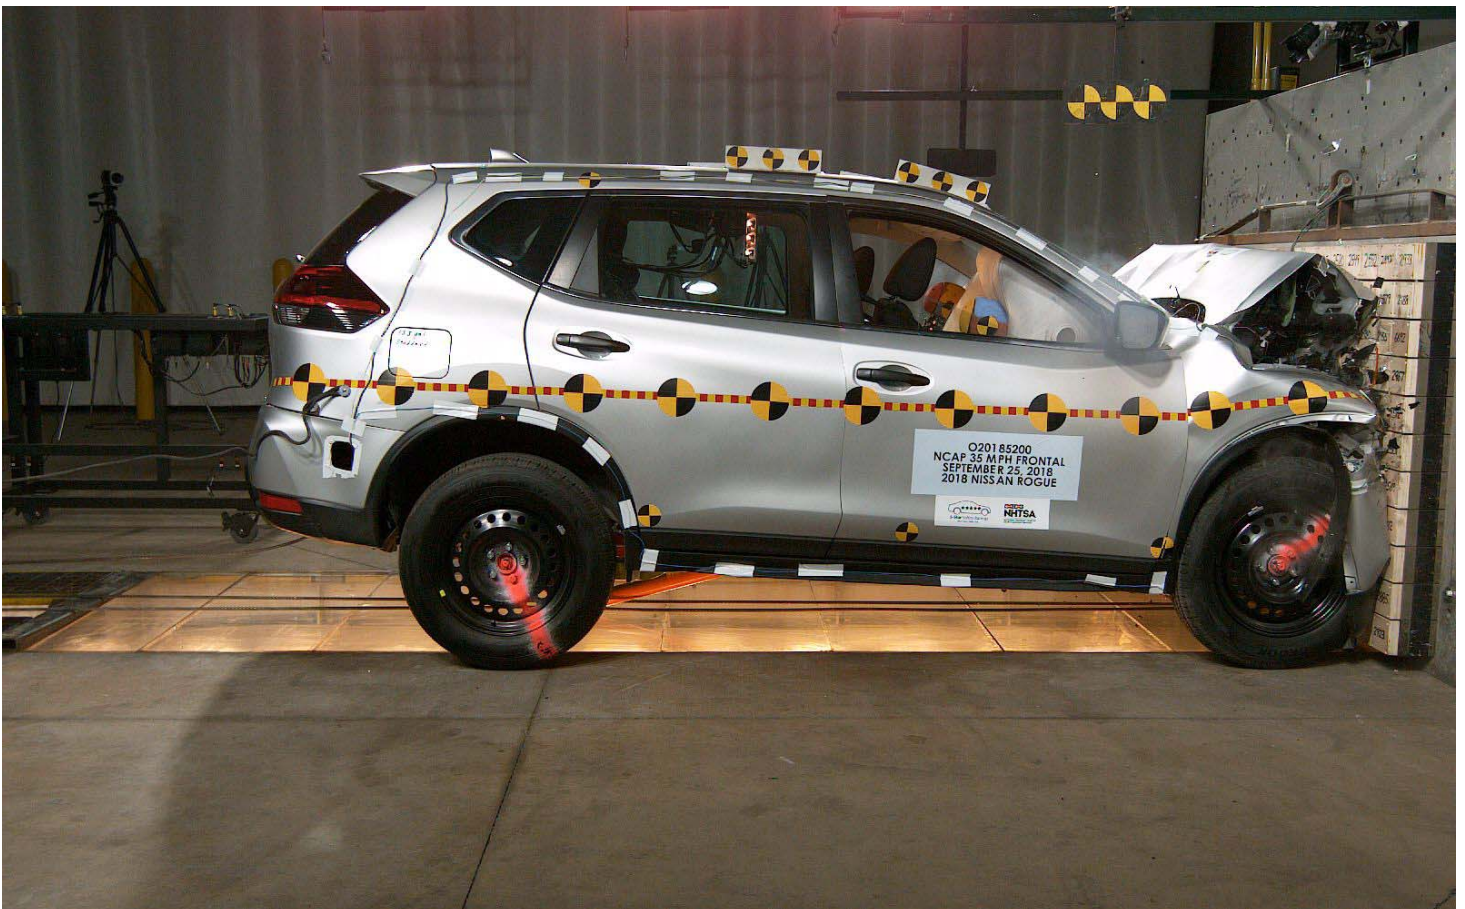
Photo No. 078 - 2018 Nissan Rogue S AWD 5-Door SUV Frontal Impact Event
