REPORT NUMBER: SPNCAP-MGA-2018-035

**NEW CAR ASSESSMENT PROGRAM (NCAP)
Side Impact Pole Test**

**MAZDA MOTOR CORPORATION
2018 Nissan Titan S Crew Cab Truck
NHTSA No.: O20185202**

**MGA RESEARCH CORPORATION
5000 Warren Road
Burlington, WI 53105**

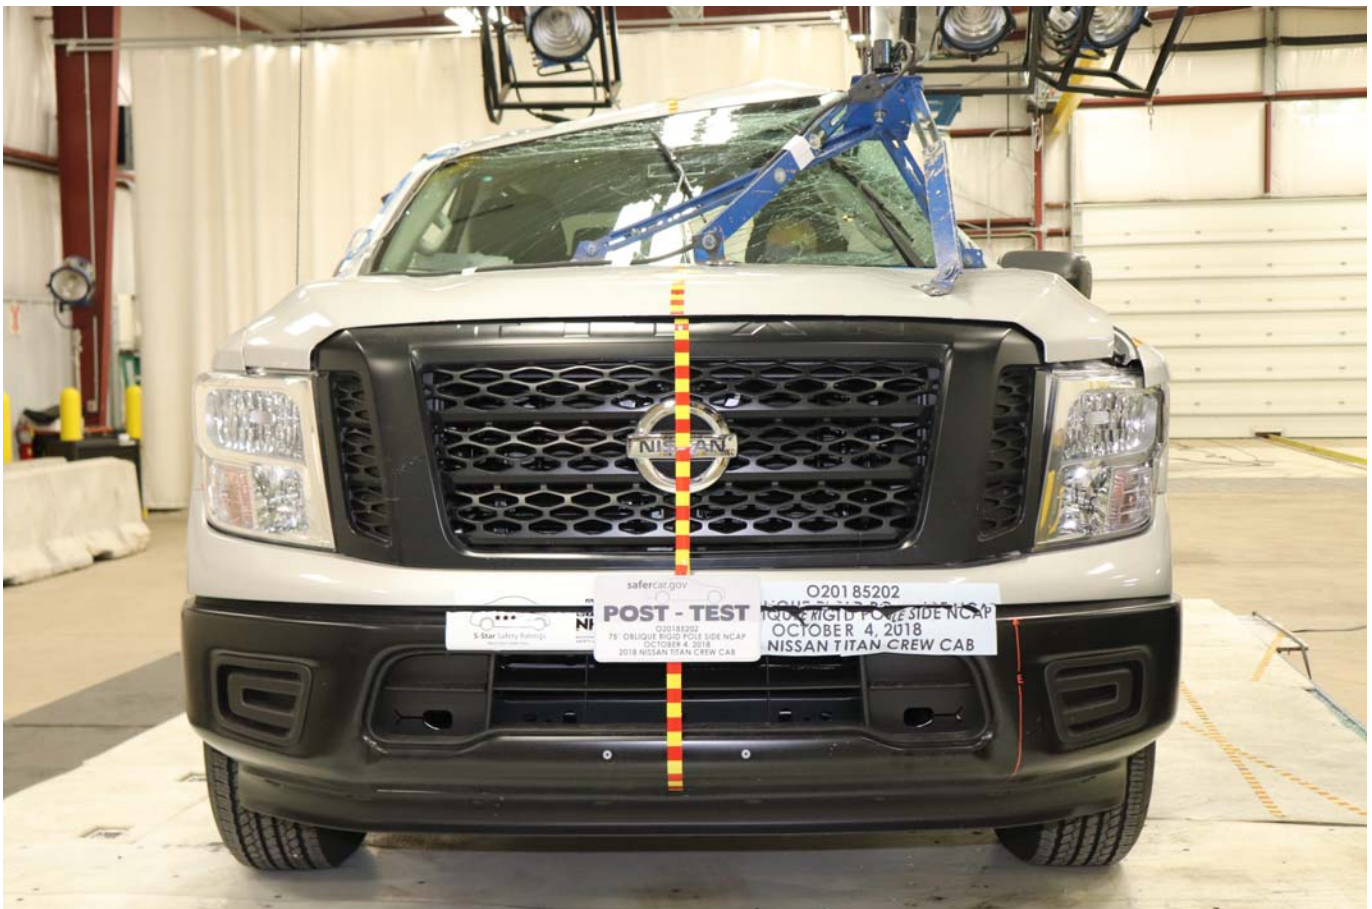
Photo No. 004 - Post-Test Frontal View of Test Vehicle

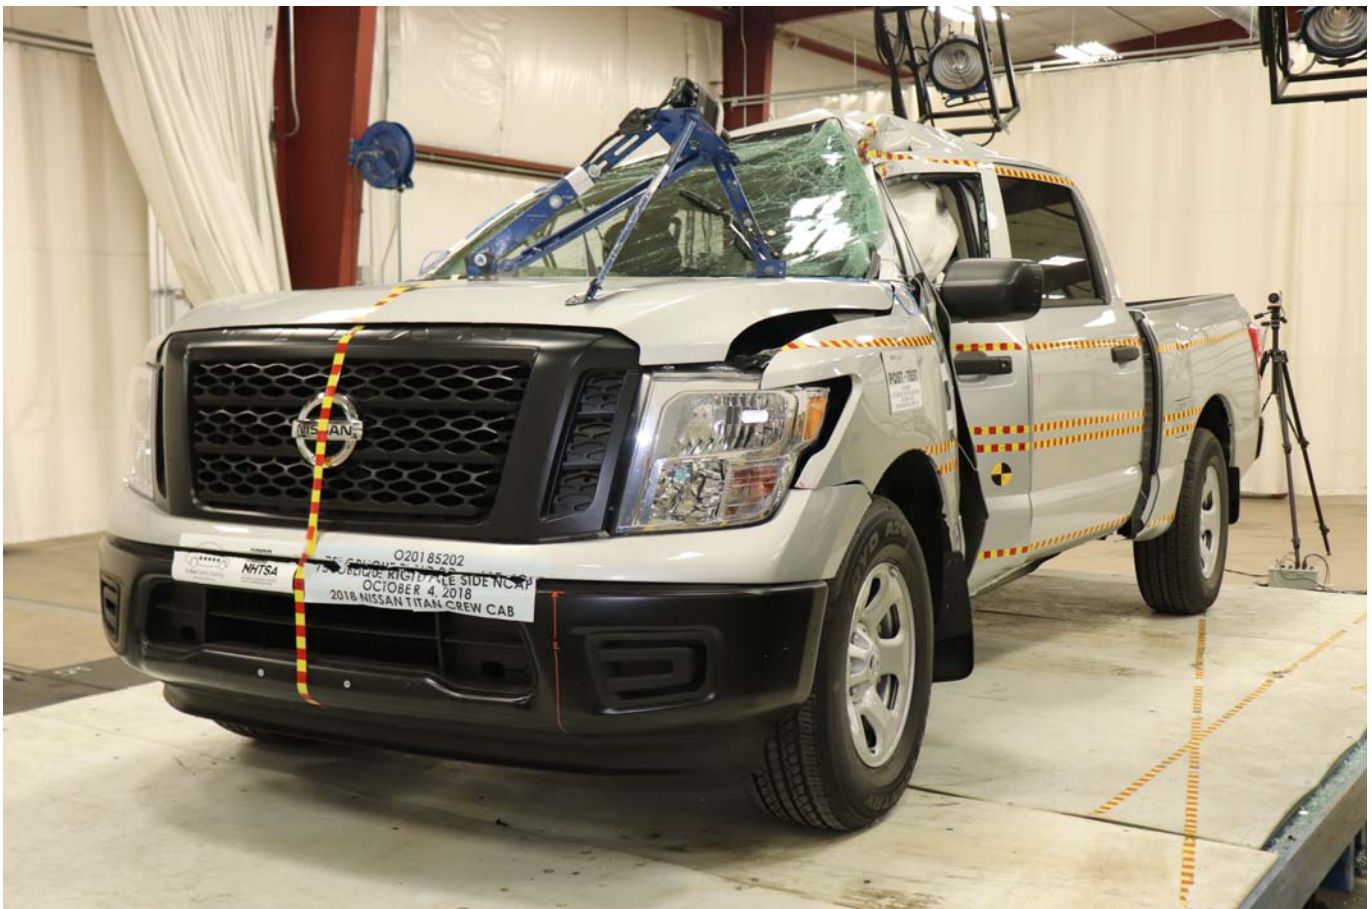
Photo No. 006 - Post-Test Left Front Three-Quarter View of Test Vehicle

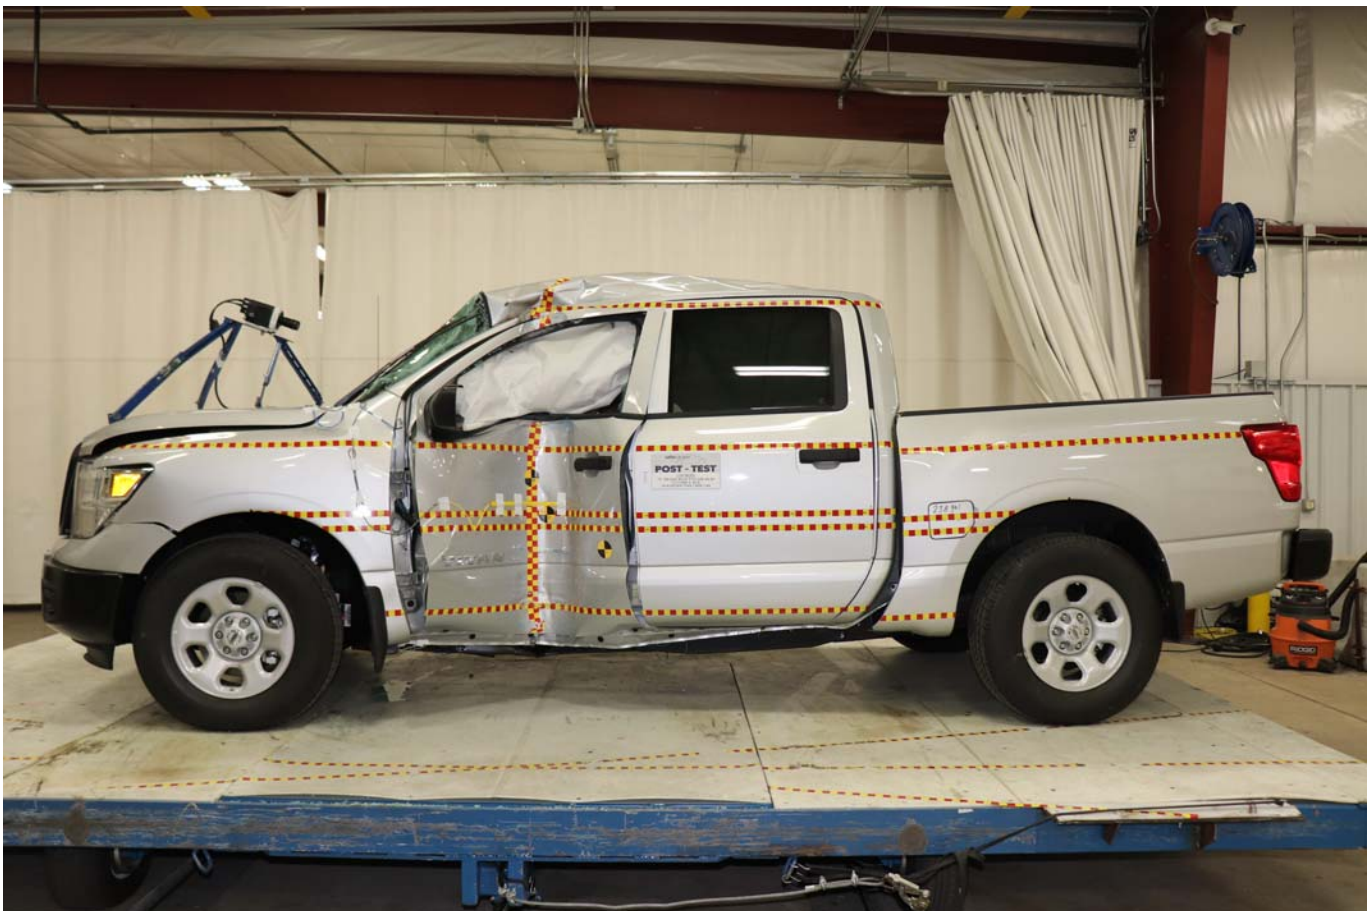
Photo No. 008 - Post-Test Left Side View of Test Vehicle

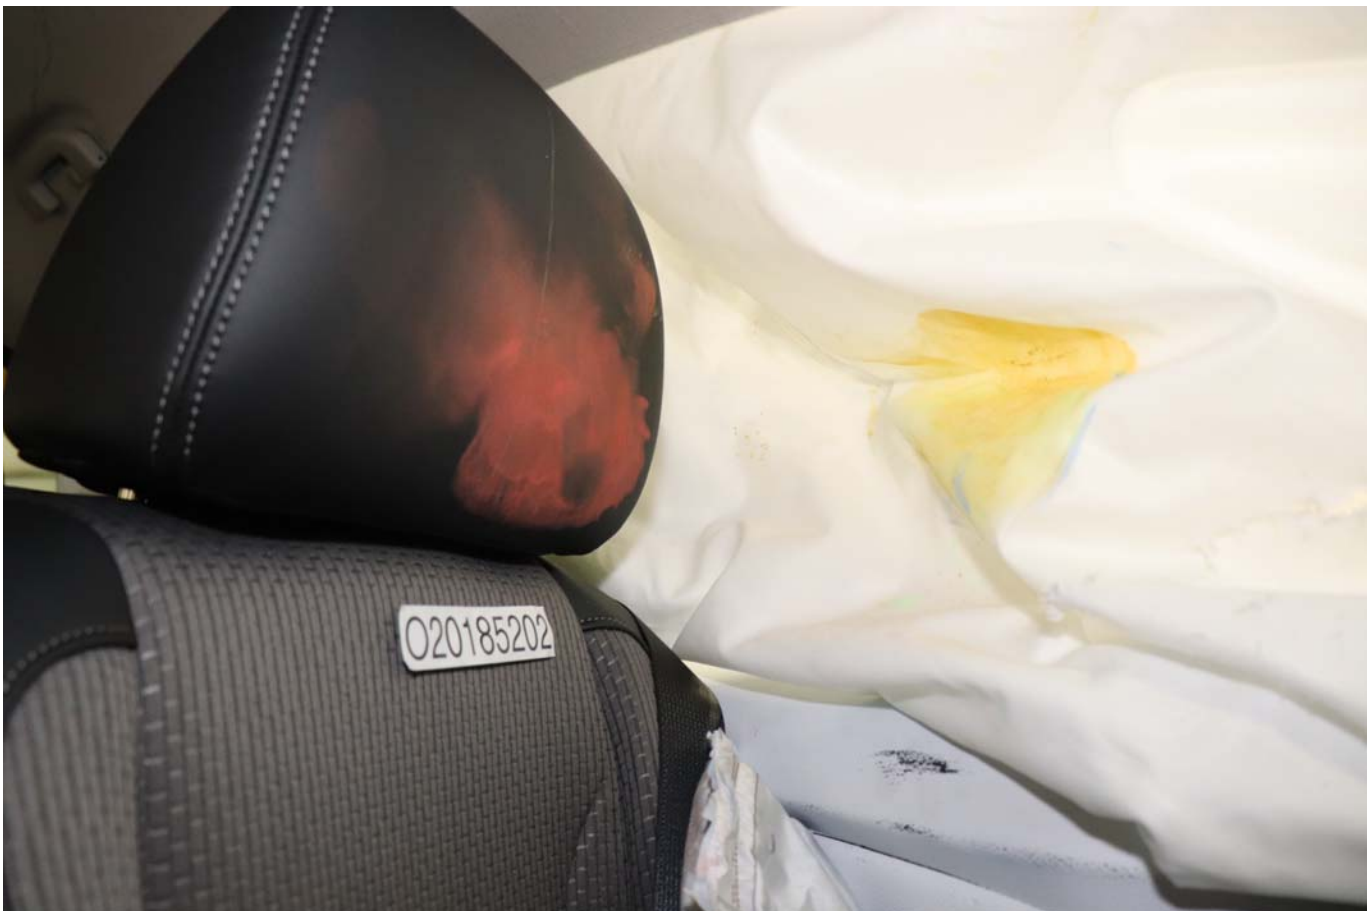
Photo No. 046 - Post-Test Dummy Close-Up Head Contact with Vehicle Interior View

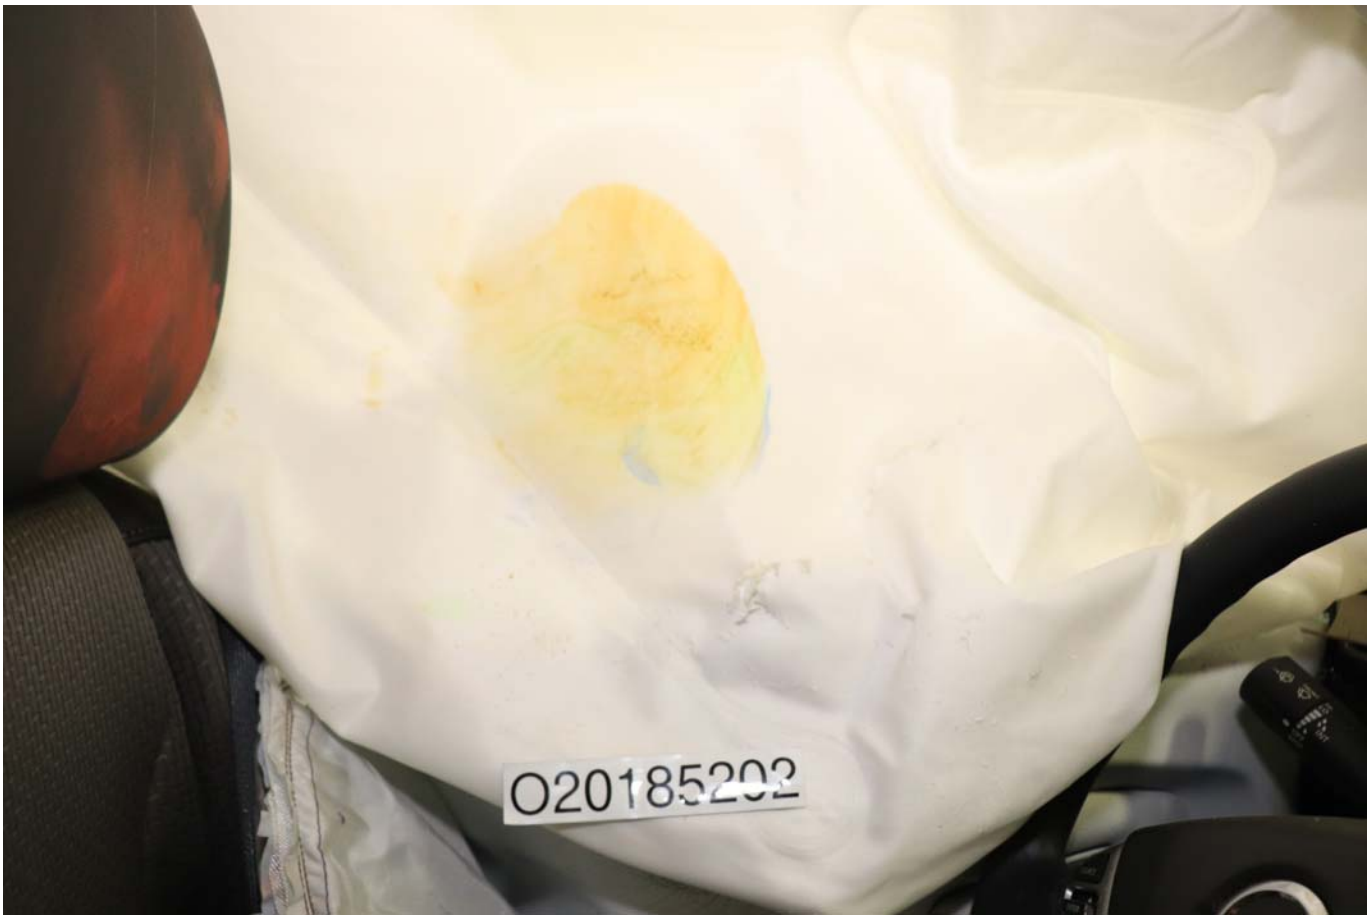
Photo No. 047 - Post-Test Dummy Close-Up Head Contact with Side Air Bag View

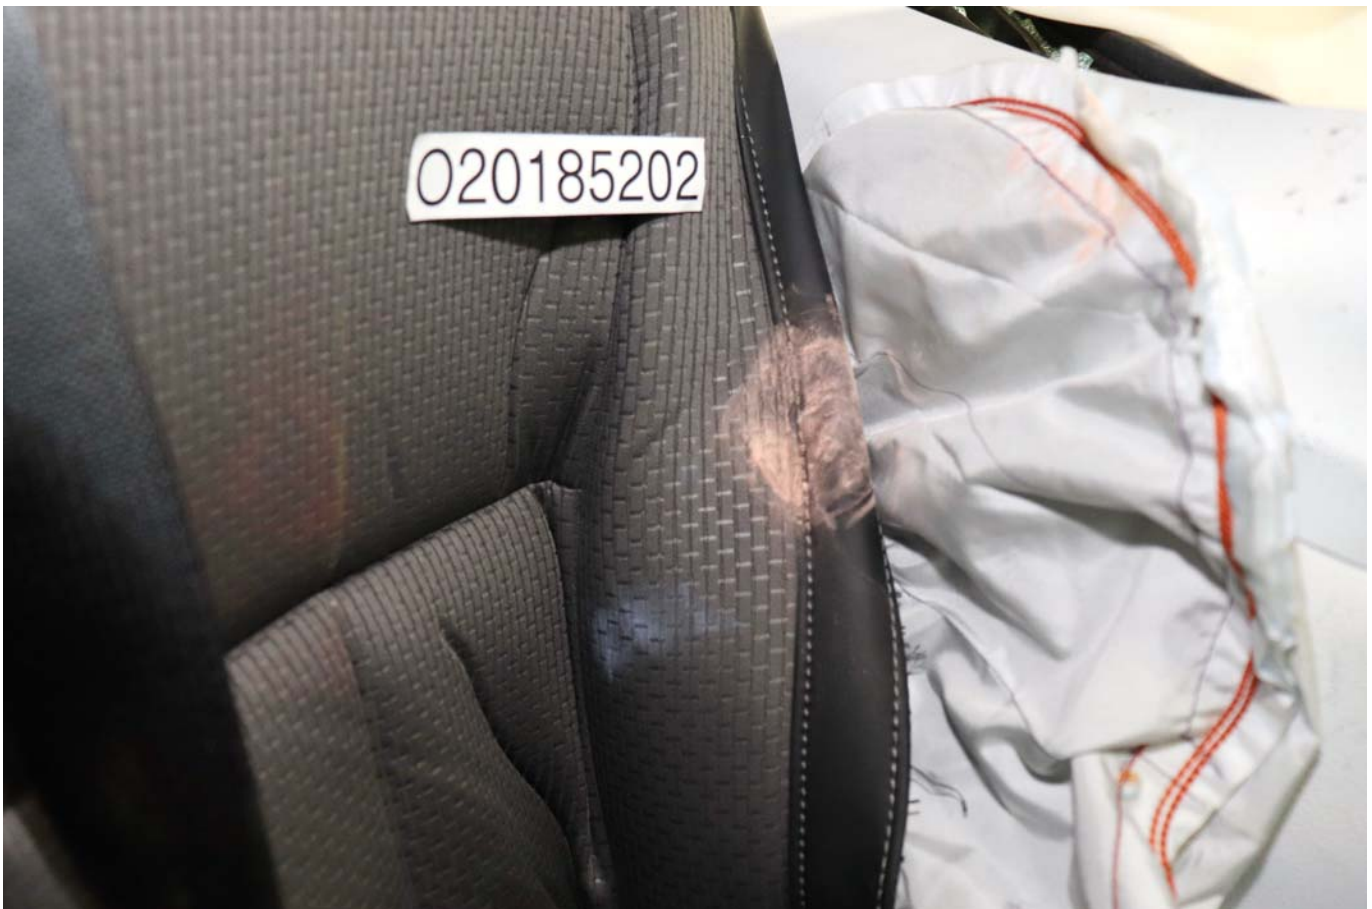
Photo No. 048 - Post-Test Dummy Close-Up Torso Contact with Vehicle Interior View

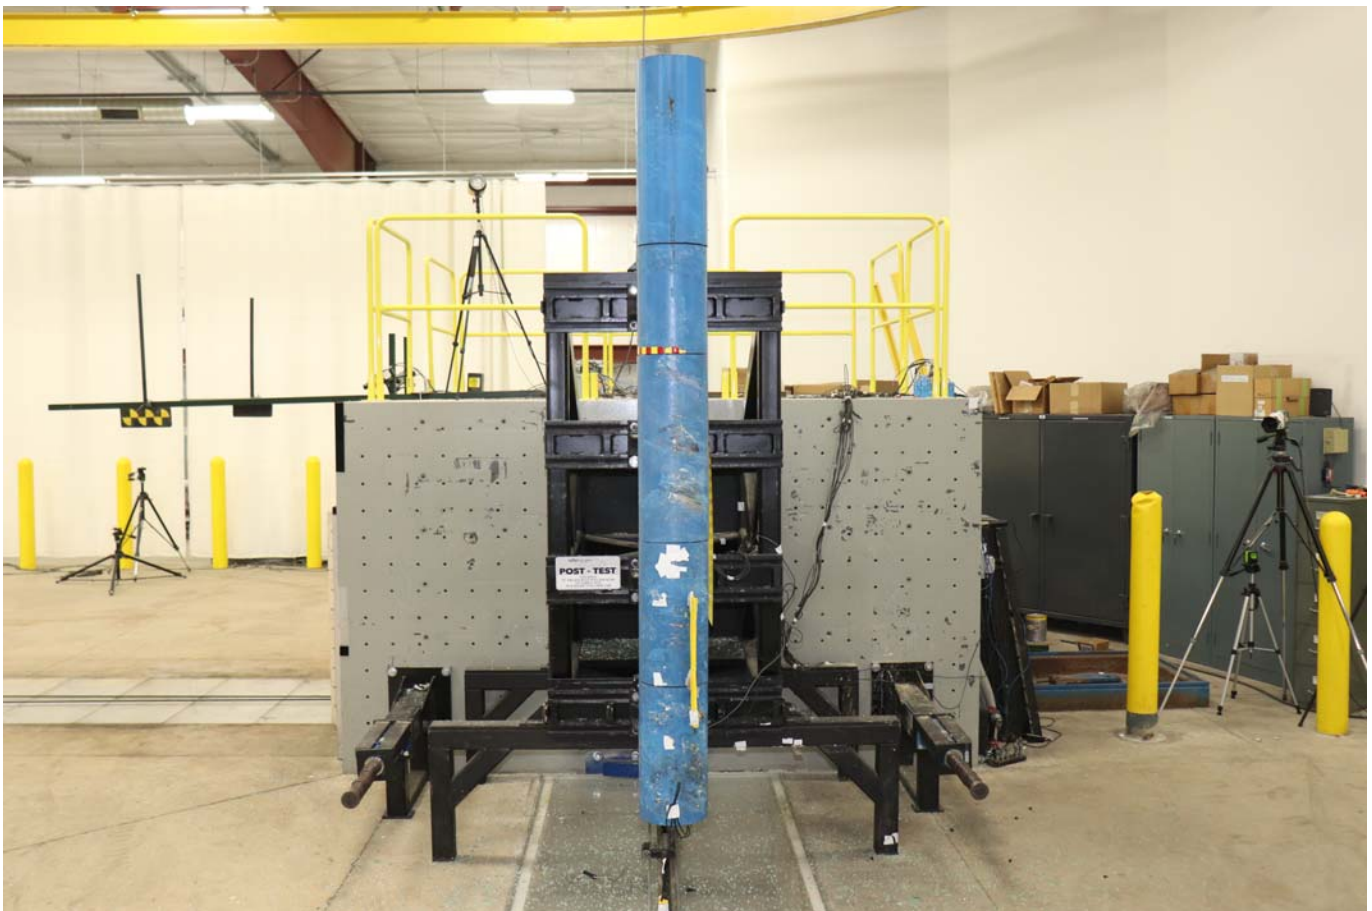
Photo No. 058 - Post-Test Pole Barrier Front View

Load Cell Pole #8 FY recorded no valid data.

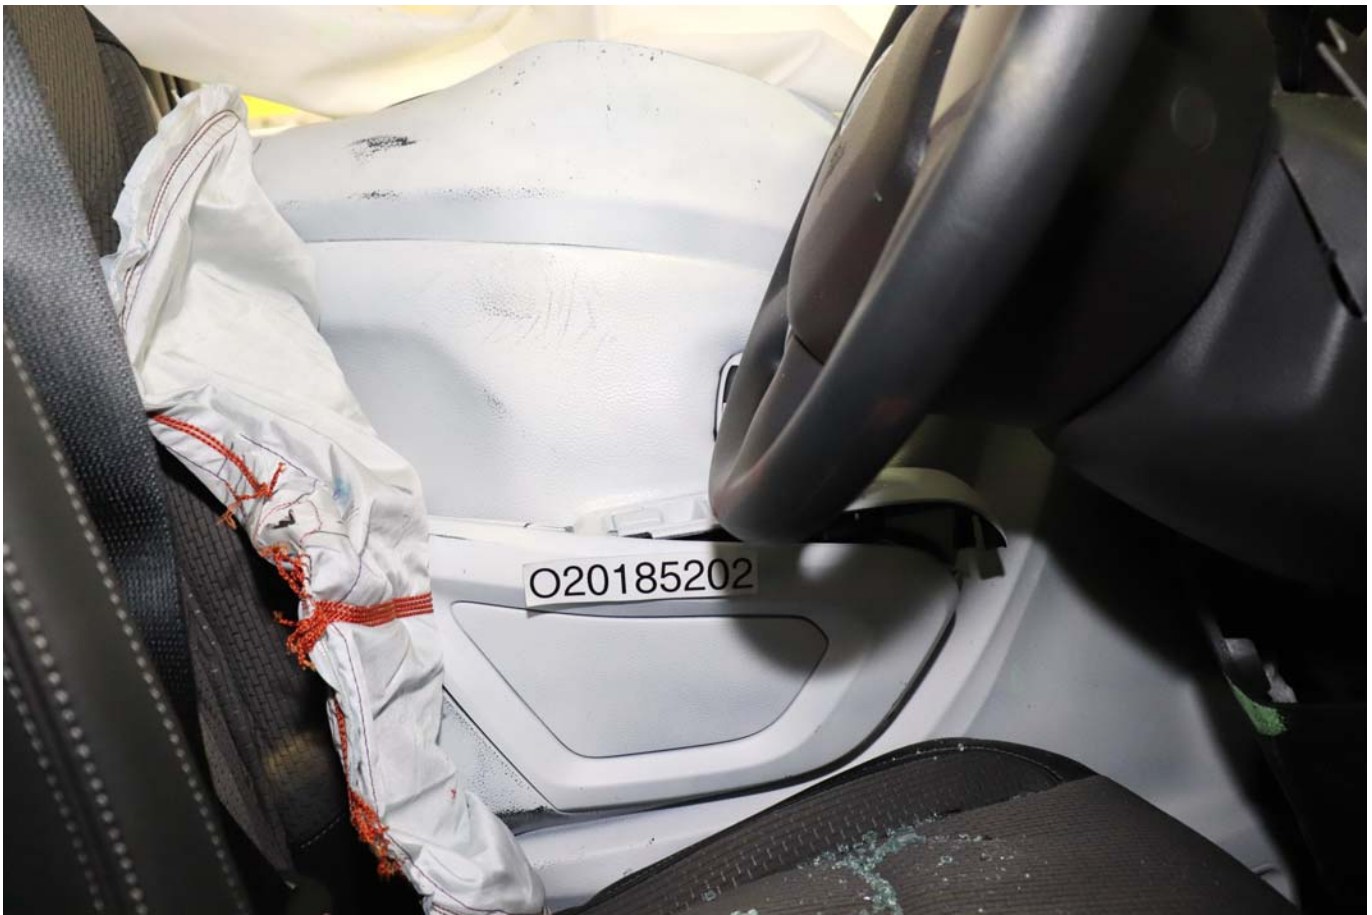
Photo No. 071 - Post-Test View of Shattered Vehicle Inner Door Panel
