**REPORT NUMBER: NCAP-MGA-2018-037**

**NEW CAR ASSESSMENT PROGRAM (NCAP)  
Frontal Barrier Impact Test**

**GENERAL MOTORS OF CANADA COMPANY  
2018 Nissan Titan S 4x4 Crew Cab Truck  
NHTSA No.: O20185201**

**FINAL REPORT**

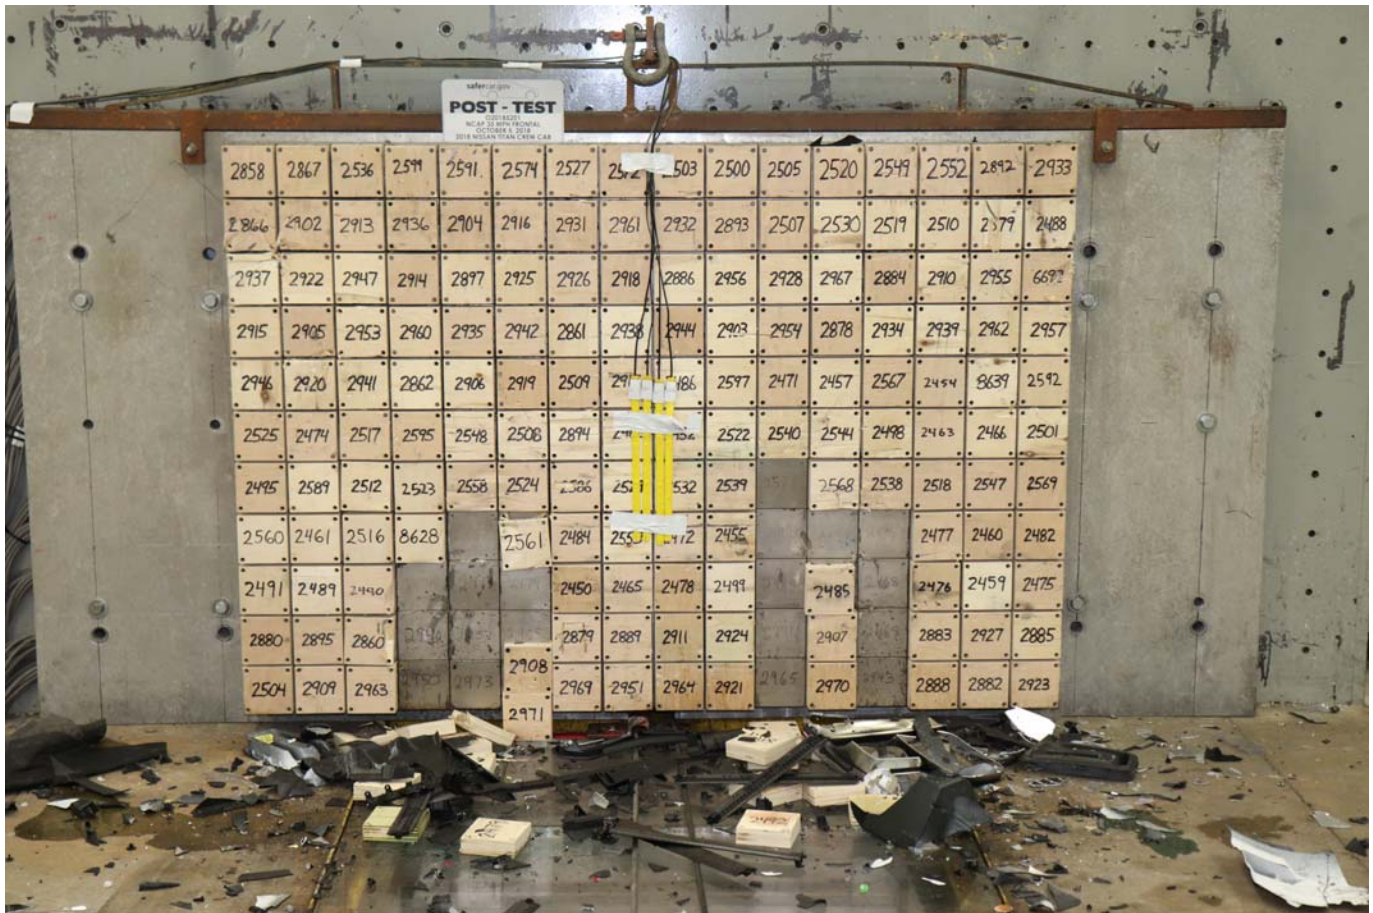
Photo No. 003 - Post-Test Load Cell Wall

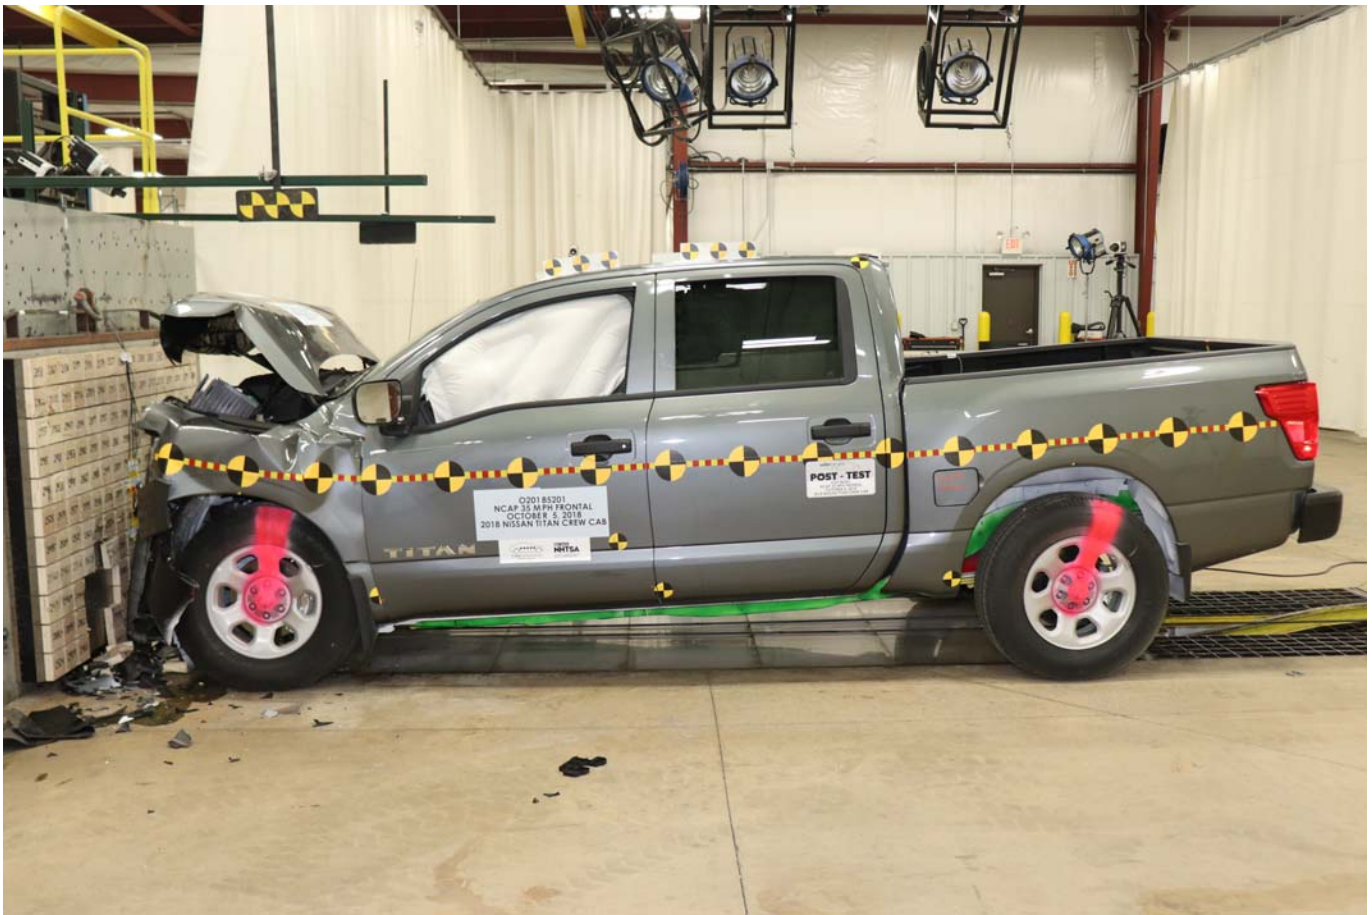
Photo No. 011 - Post-Test Left View of Test Vehicle

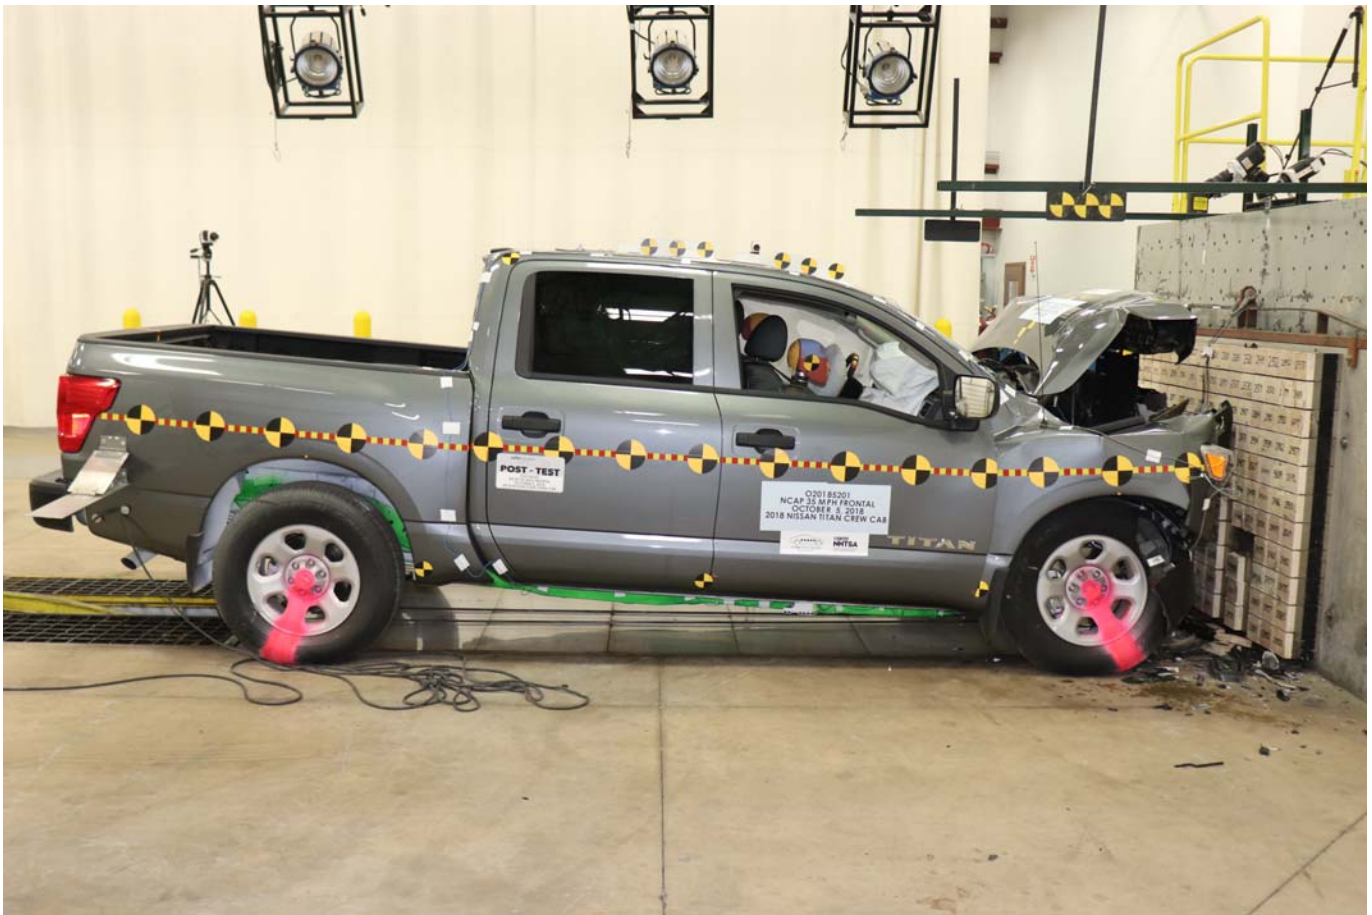
Photo No. 013 - Post-Test Right View of Test Vehicle

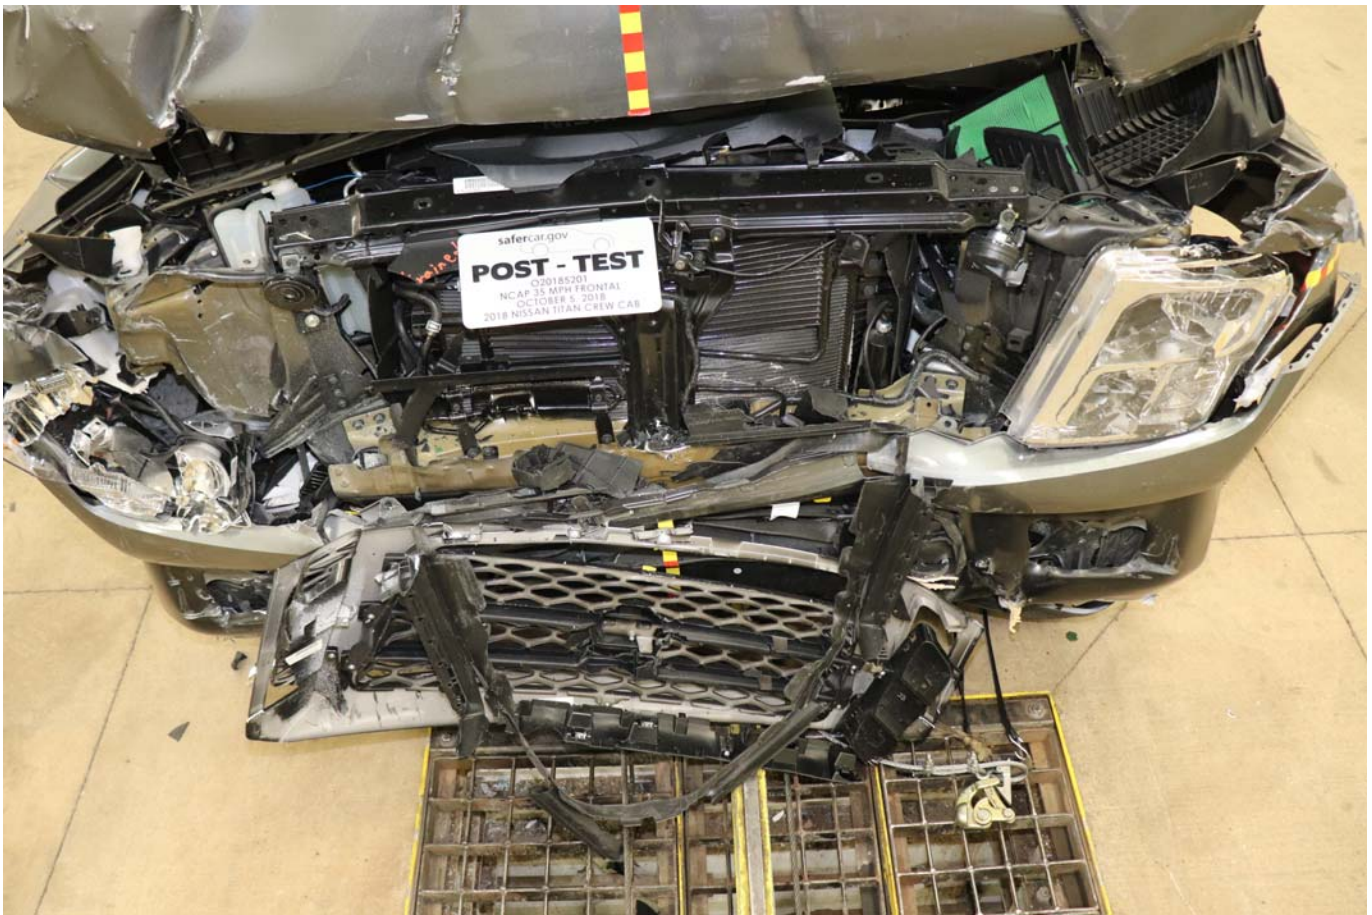
Photo No. 021 - Post-Test Engine Compartment View

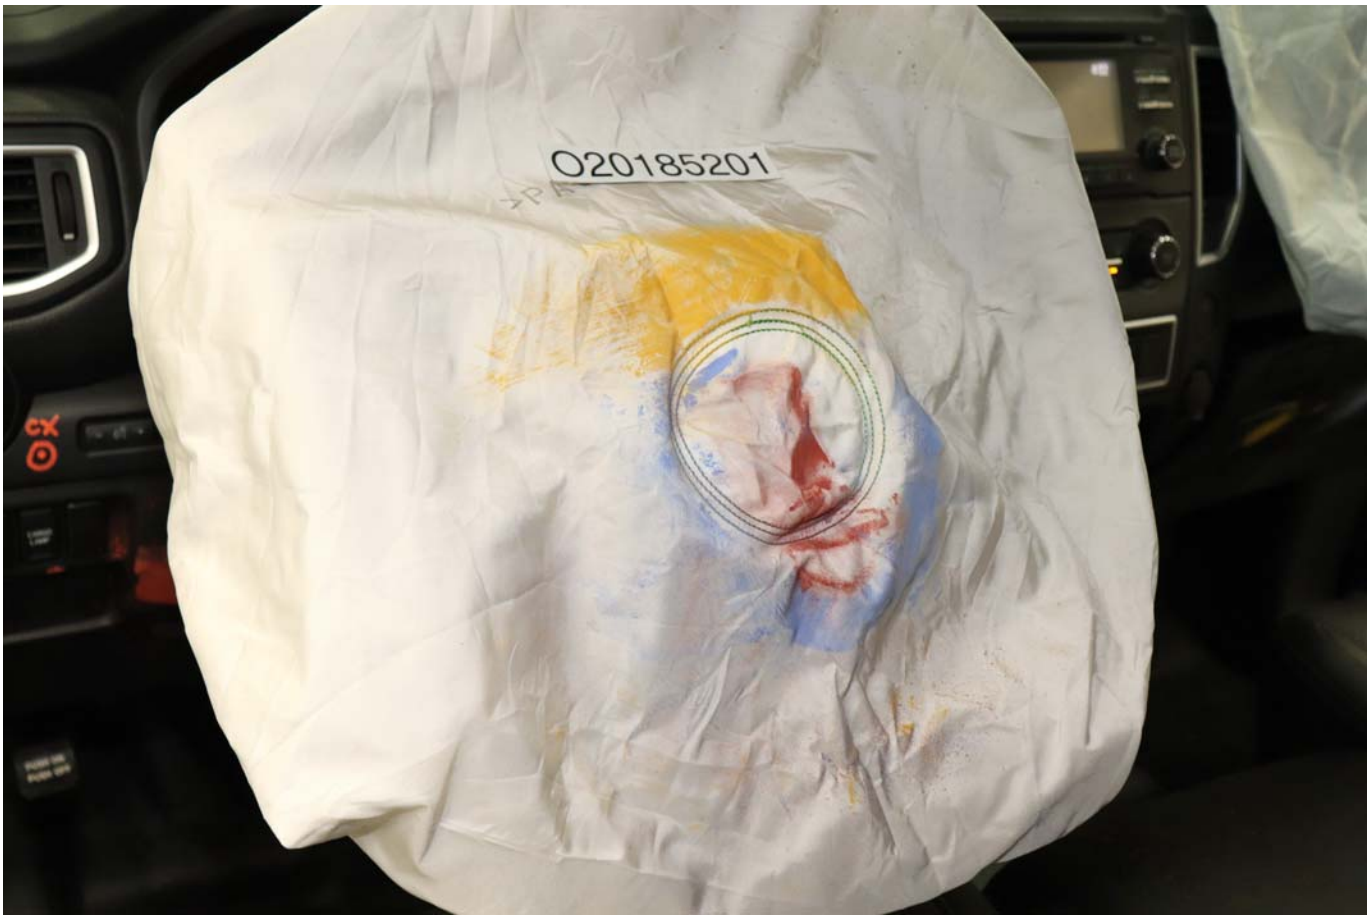
Photo No. 047 - Post-Test Driver Dummy Contact with Airbag

The driver's visible contact points were as follows: The driver's head contacted the airbag. The driver's head also contacted the headrest. The driver's knees contacted the knee bolster. The passenger's visible contact points were as follows: The passenger's head contacted the airbag. The passenger's head also contacted the headrest. The passenger's knees contacted the glove box.

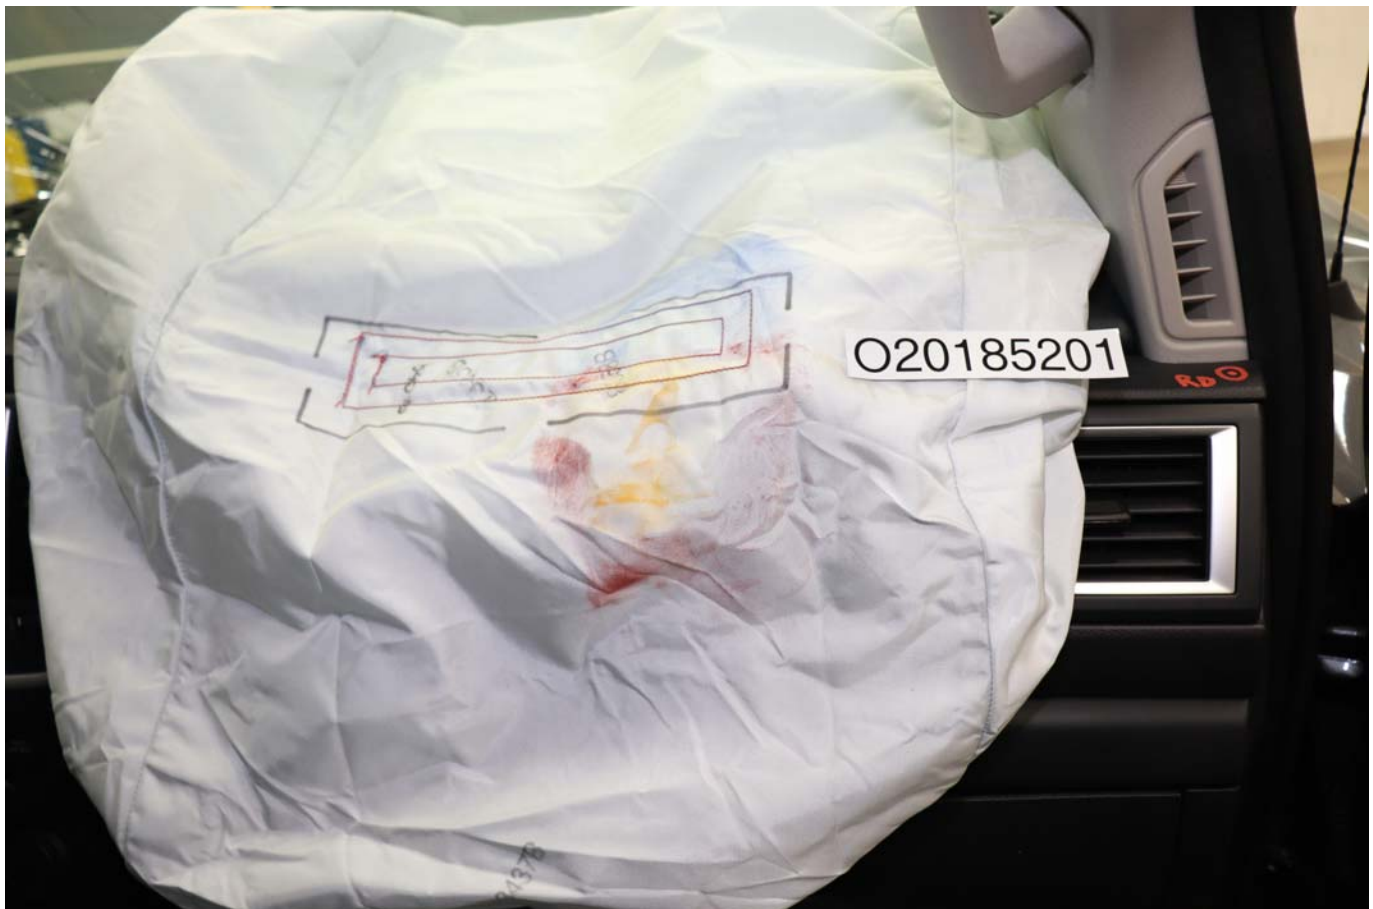
Photo No. 068 - Post-Test Passenger Dummy Contact with Airbag

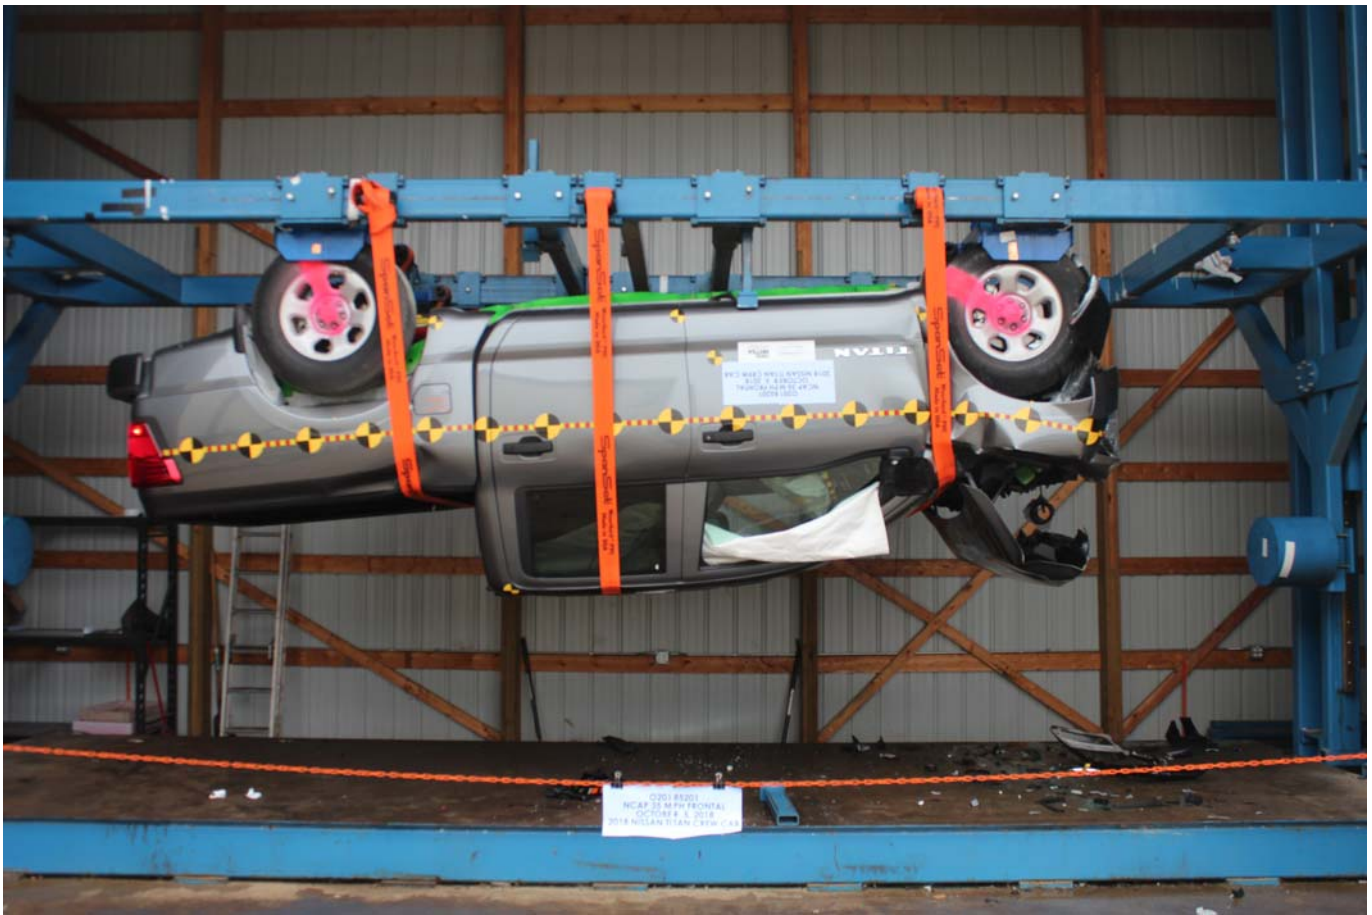
Photo No. 075 - Vehicle at 180 Degrees on Static Rollover Device

There was 100 percent windshield retention and no intrusion into the protected zone of the windshield during the event. There was no Stoddard Solvent leakage after the event or during any phase of the static rollover.

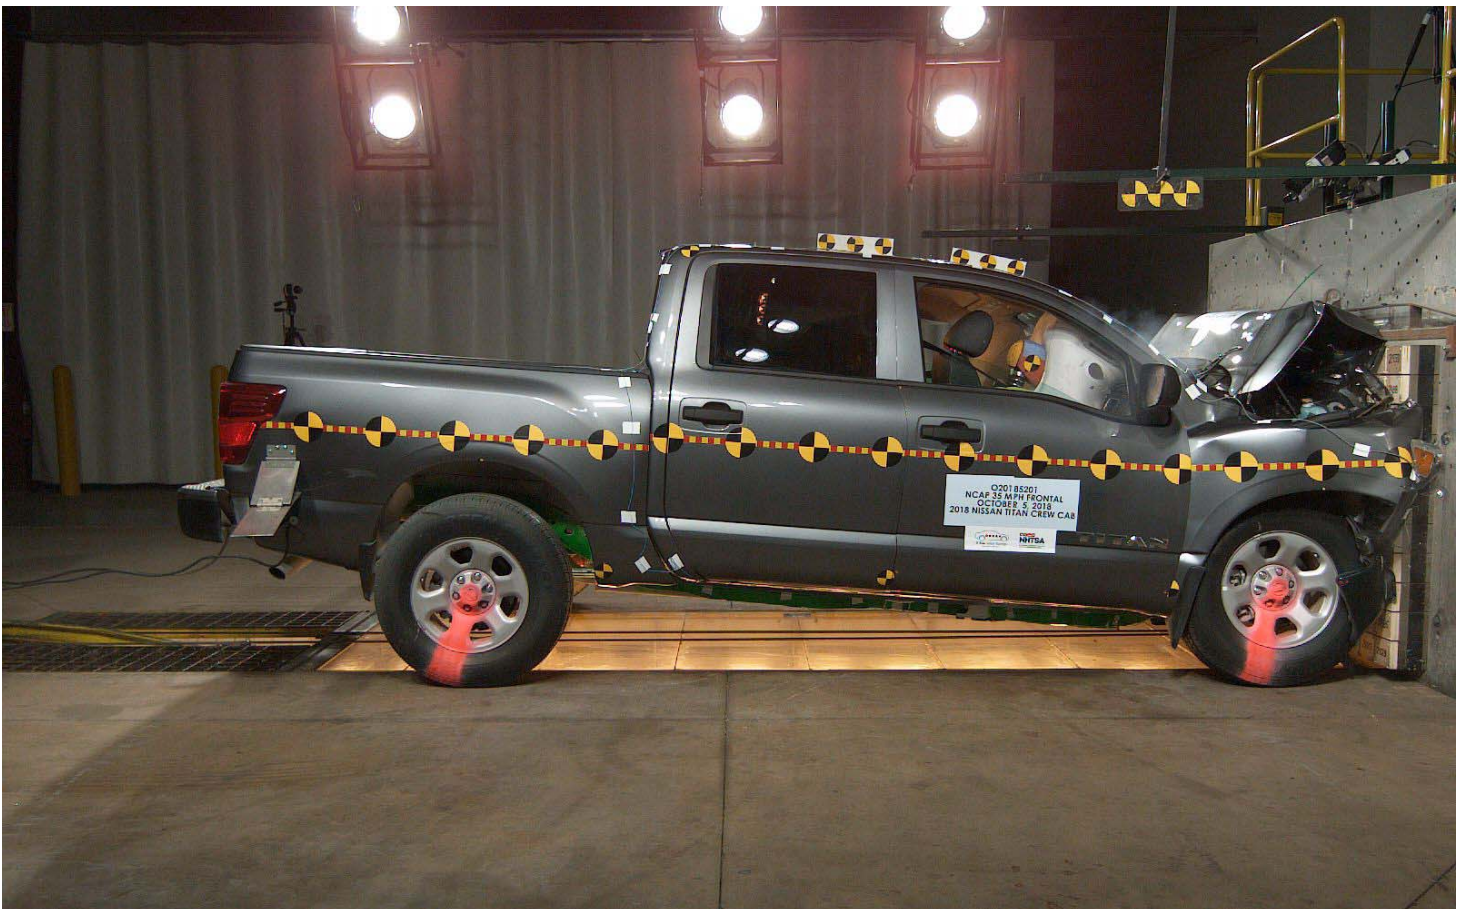
Photo No. 078 - 2018 Nissan Titan S 4x4 Crew Cab Truck Frontal Impact Event

A load cell barrier consisting of 176 load cells was impacted by a 2018 Nissan Titan S 4x4 Crew Cab Truck at a velocity of 56.97 km/h. The test was performed at MGA Research Corporation on October 5, 2018. Pre-test and post-test photographs of the vehicle and dummies can be found in Appendix A.
