**Final Report Number: NCAP-TRC-19-002**

**New Car Assessment Program (NCAP)  
Frontal Barrier Impact Test**

**NISSAN MOTOR CO., LTD.  
2019 Nissan Armada SUV  
NHTSA Number: M20195203**

**PREPARED BY:  
Transportation Research Center Inc.  
10820 State Route 347  
P. O. Box B-67  
East Liberty, OH 43319**

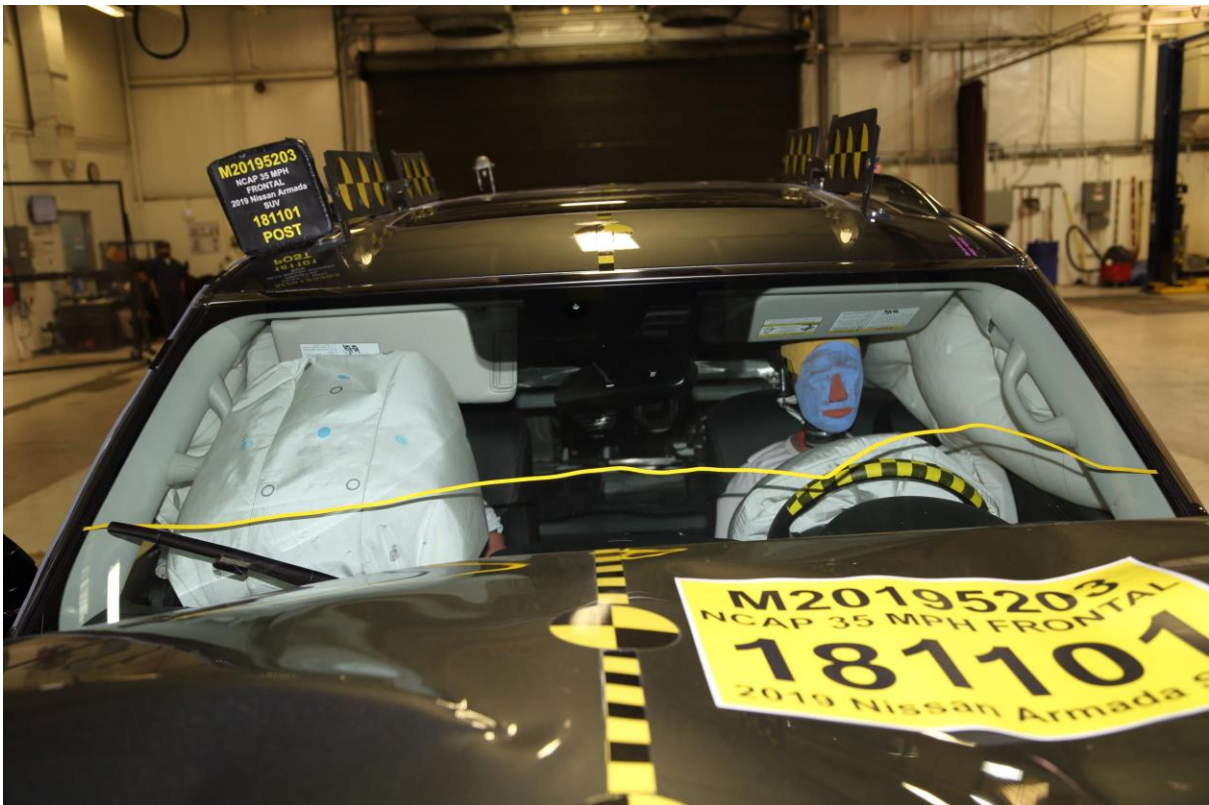
019 Post-Test Windshield View

There was 100.0 percent windshield retention and no intrusion into the protected zone of the windshield during the event. There was no Stoddard solvent leakage (or electrolyte spillage) after the event or during any phase of the static rollover.

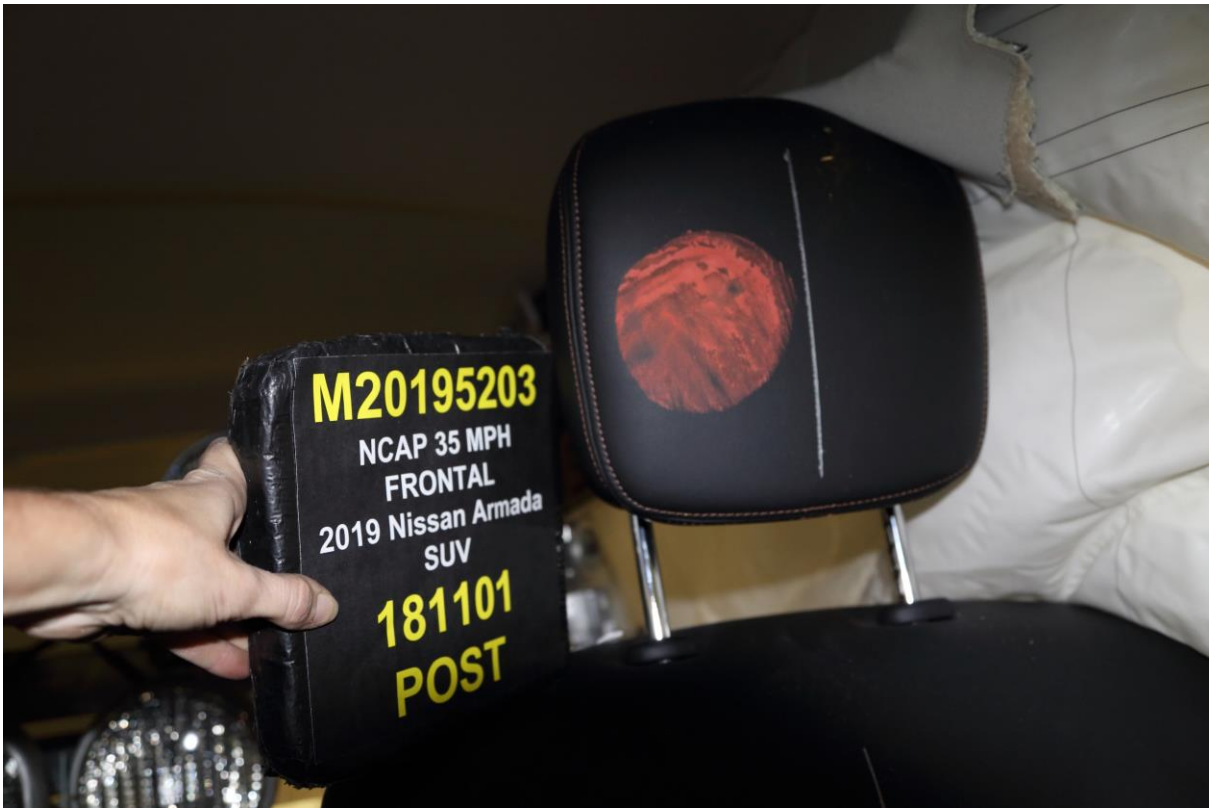
**050 Post-Test Driver Dummy Contact with Headrest**

The driver's visible contact points were as follows: front airbag, headrest, side airbag and knee bolster. The passenger's visible contact points were as follows: front airbag, sun visor, headrest, side airbag and glove box.

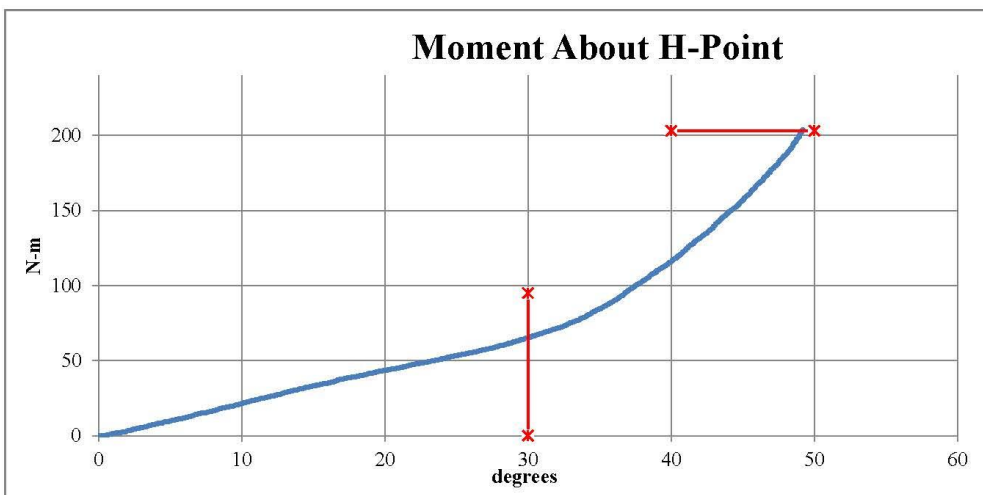
TEST PARAMETER	SPECIFICATION	TEST RESULTS
Temperature	18.9 - 25.6	20.9 °C Pass
Humidity	10 - 70	41 % Pass
Moment at 30°	0 ≤ 94.9	65.45 N-m Pass
Angle at 203 Nm	40 - 50	49.21 deg Pass
Average Velocity	5 - 10	7.11 deg/sec Pass

Max: 8.02 deg/sec      Min: 5.96 deg/sec

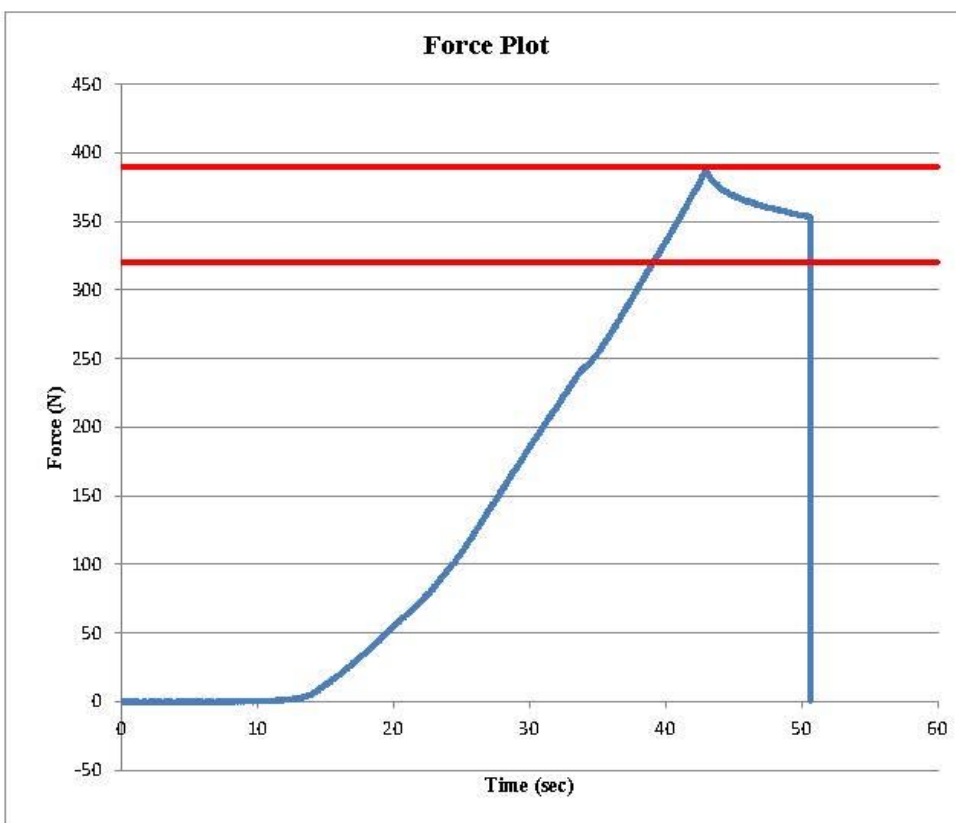
TEST PARAMETER	SPECIFICATION	TEST RESULTS
Temperature	18.9 - 25.6	21.8 °C Pass
Humidity	10 - 70	45 % Pass
Average Angular Velocity	0.5 - 1.5	0.94 deg/sec Pass
Initial Angle	0 - 20	17.58 deg Pass
Peak Force at 45.42°	320 - 390	386.26 N Pass
Final Angle	-8 - 8	4.5 deg Pass

Comments:  
 Abdomen S/N: 1047  
 Pelvis S/N: 885  
 Lumbar S/N: N/A
