**REPORT NUMBER: SINCAP-KAR-19-006**

**NEW CAR ASSESSMENT PROGRAM (NCAP)  
MOVING DEFORMABLE BARRIER SIDE IMPACT TEST**

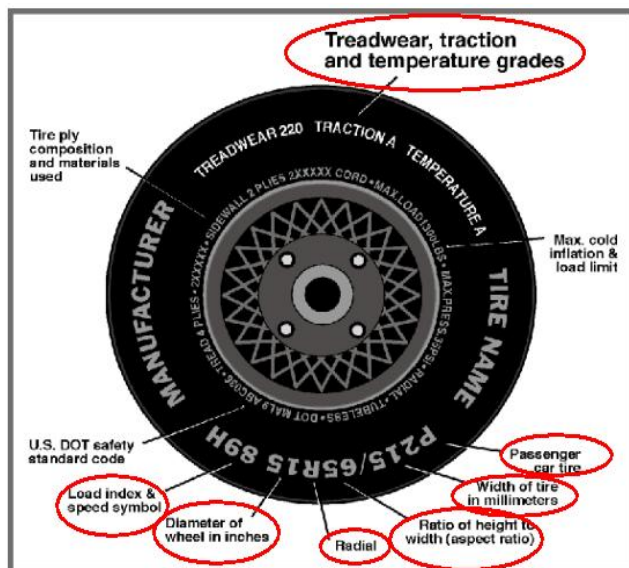
Measured Parameter	Front	Rear
Max. Tire Pressure (kpa)	350	350
Cold Pressure (kPa)	240	240
Recommended Tire Size	P265/70R16	P265/70R16
Tire Size on Vehicle	P265/70R16	P265/70R16
Tire Manufacturer	Hankook	Hankook
Tire Model	DynaPro HT	DynaPro HT
Treadware	700	700
Traction Grade	A	A
Temperature Grade	B	B
Tire Plies Sidewall	2 Polyester	2 Polyester
Tire Plies Body	2 Polyester, 2 Steel, 2 Nylon	2 Polyester, 2 Steel, 2 Nylon
Load Index/Speed Symbol	111T	111T
Tire Material	Polyester, Steel, Nylon	Polyester, Steel, Nylon
DOT Safety Code Left	T79M HUH 0618	T79M HUH 0618
DOT Safety Code Right	T79M HUH 0618	T79M HUH 0618

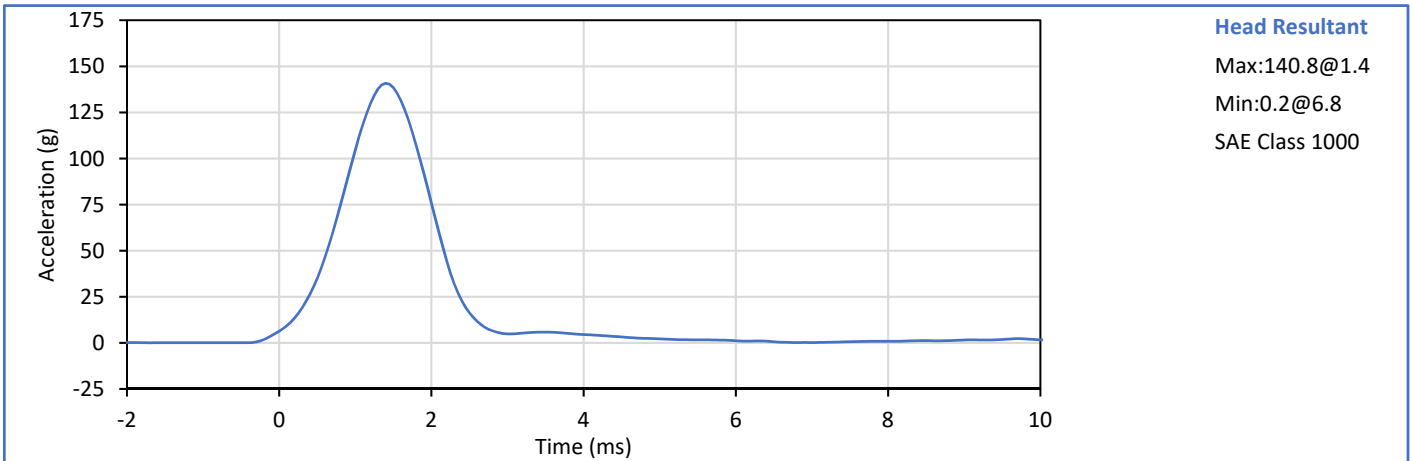
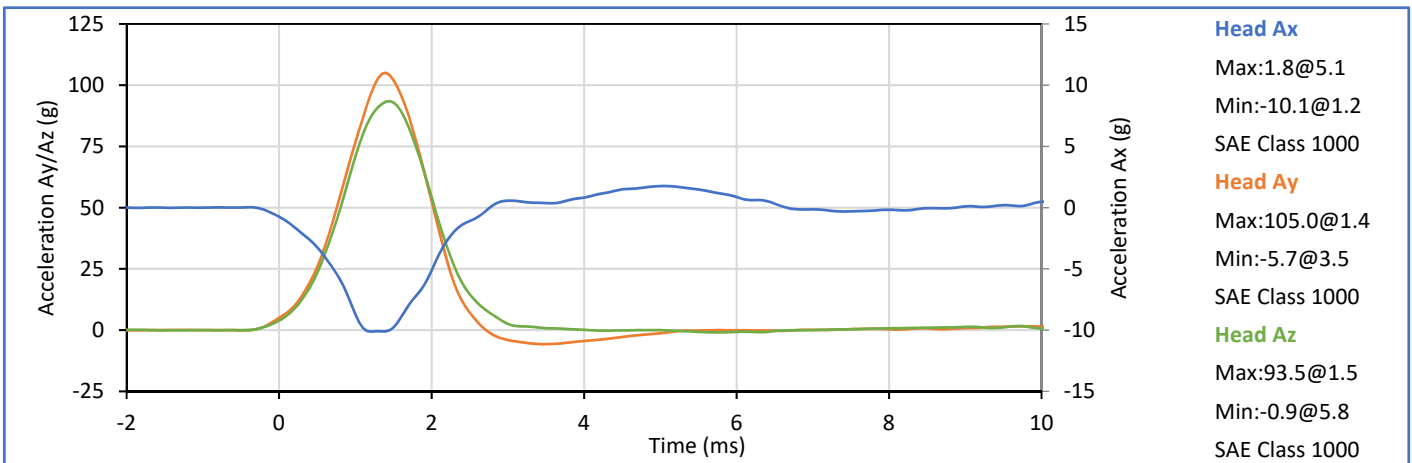
Technician:   
 J. Hernandez

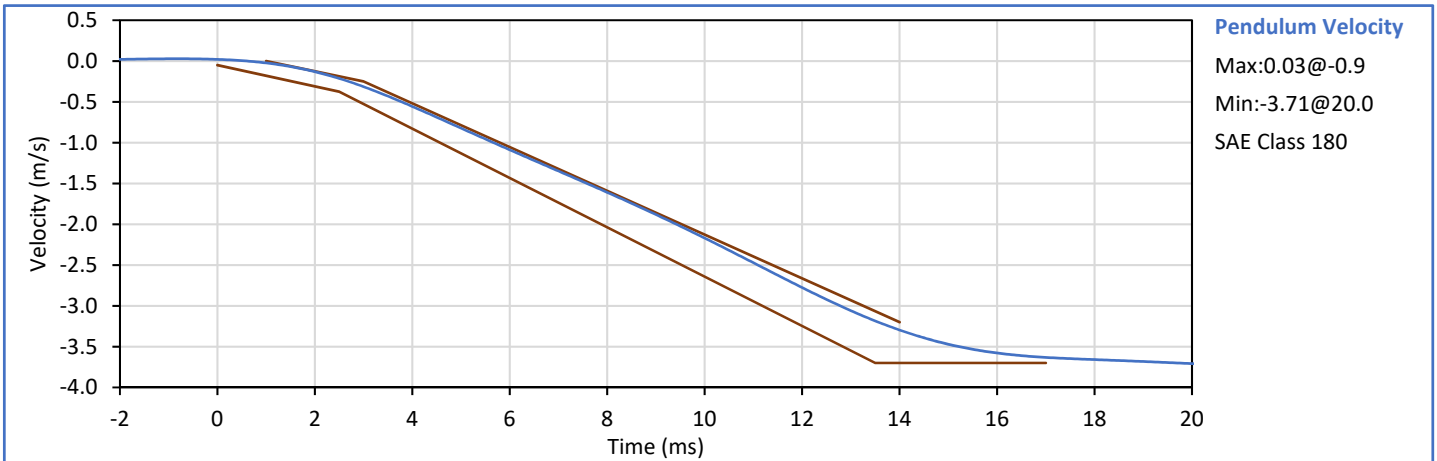
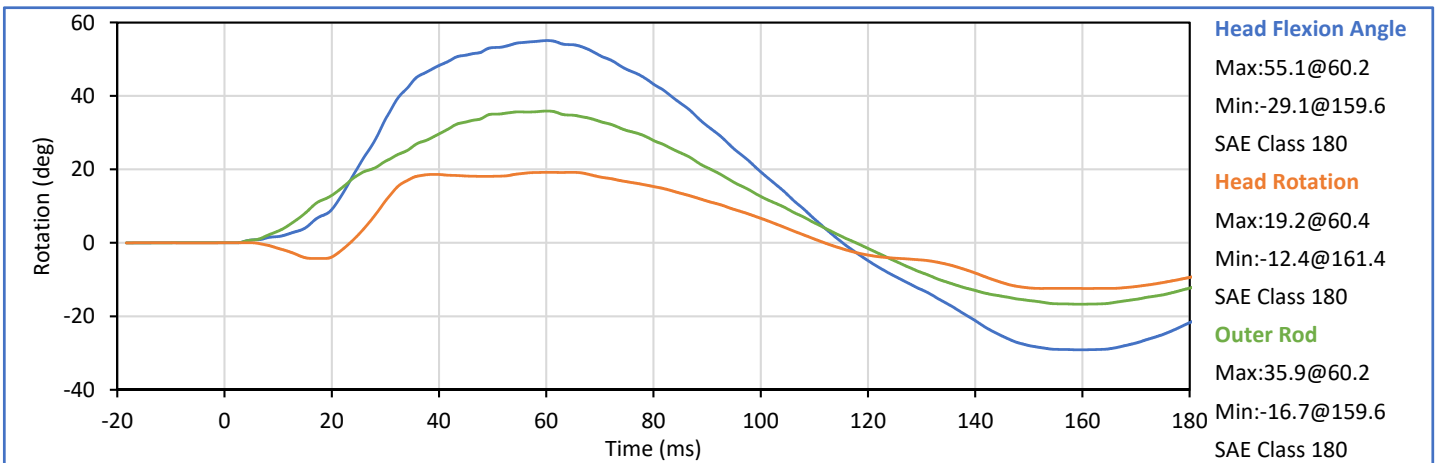
Technician:   
 J. Hernandez

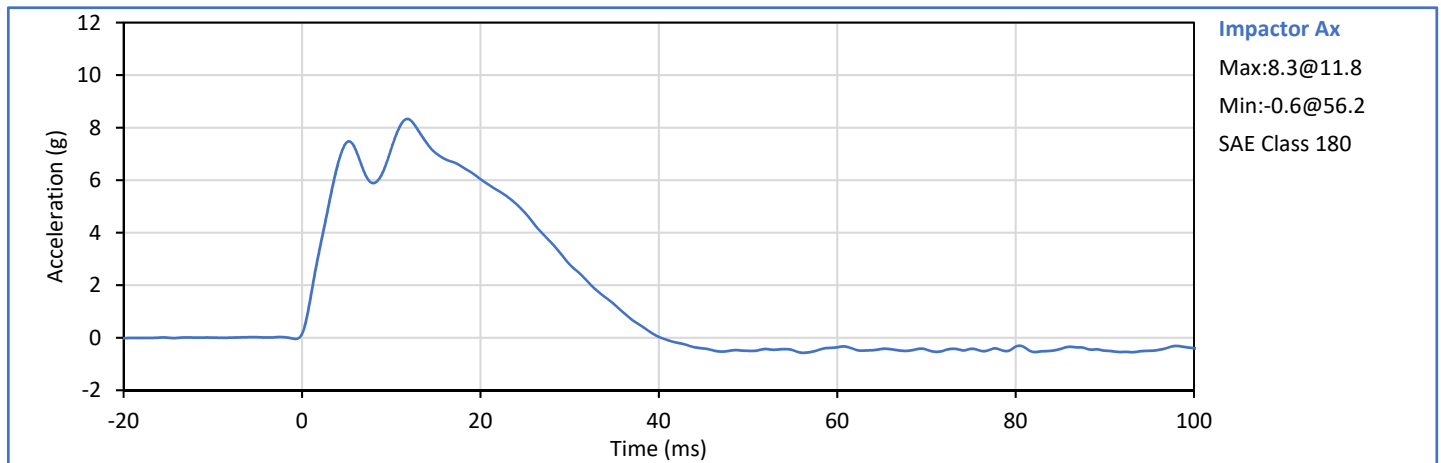
Technician:           *J. Hernandez*            
J. Hernandez

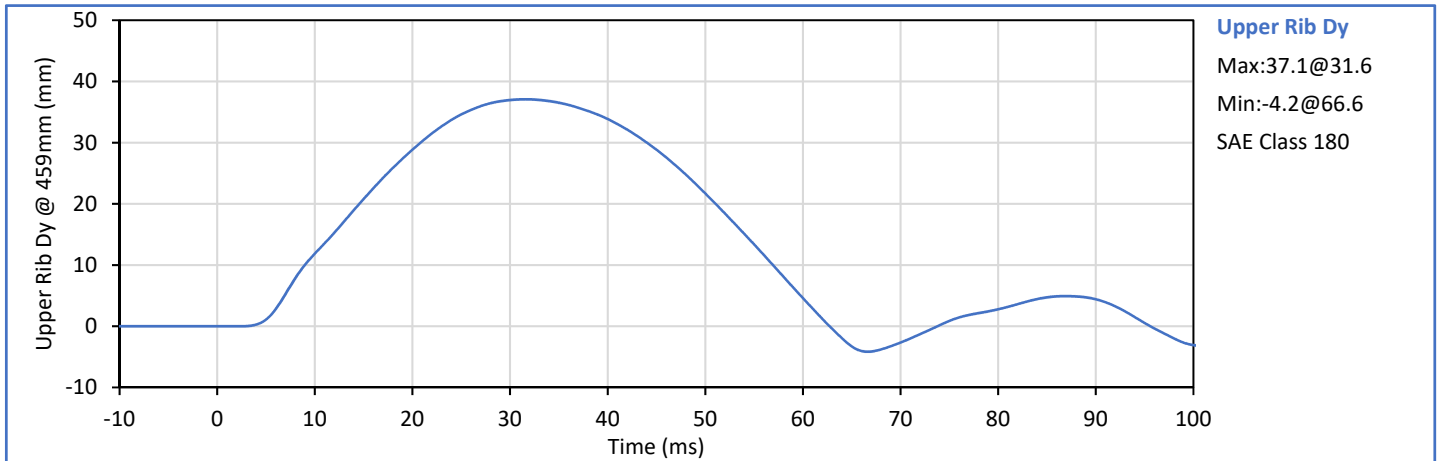
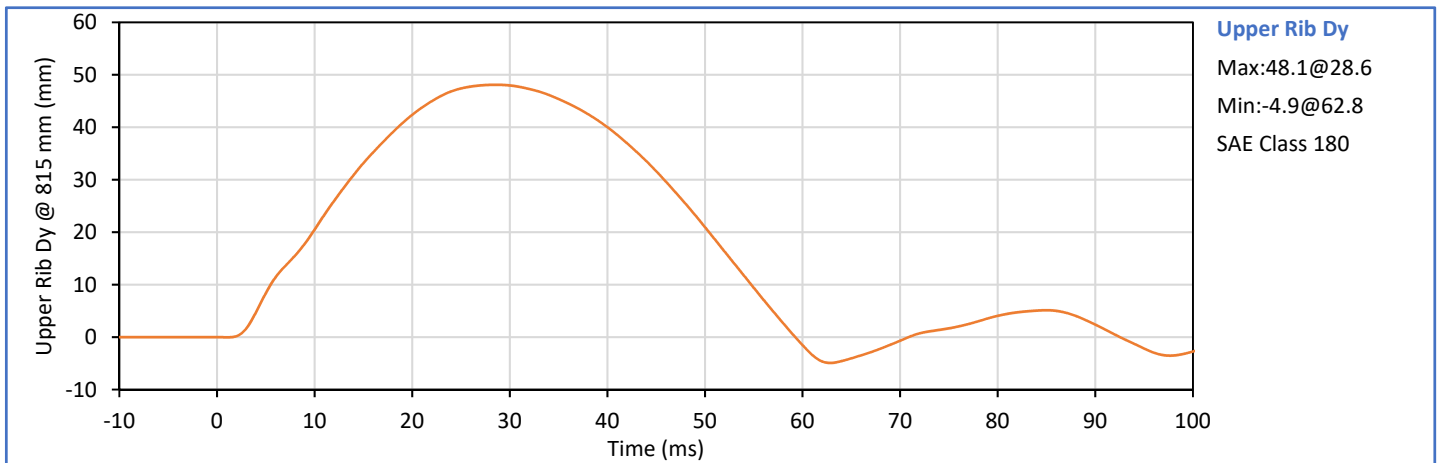
Technician:           *J. Hernandez*            
 J. Hernandez

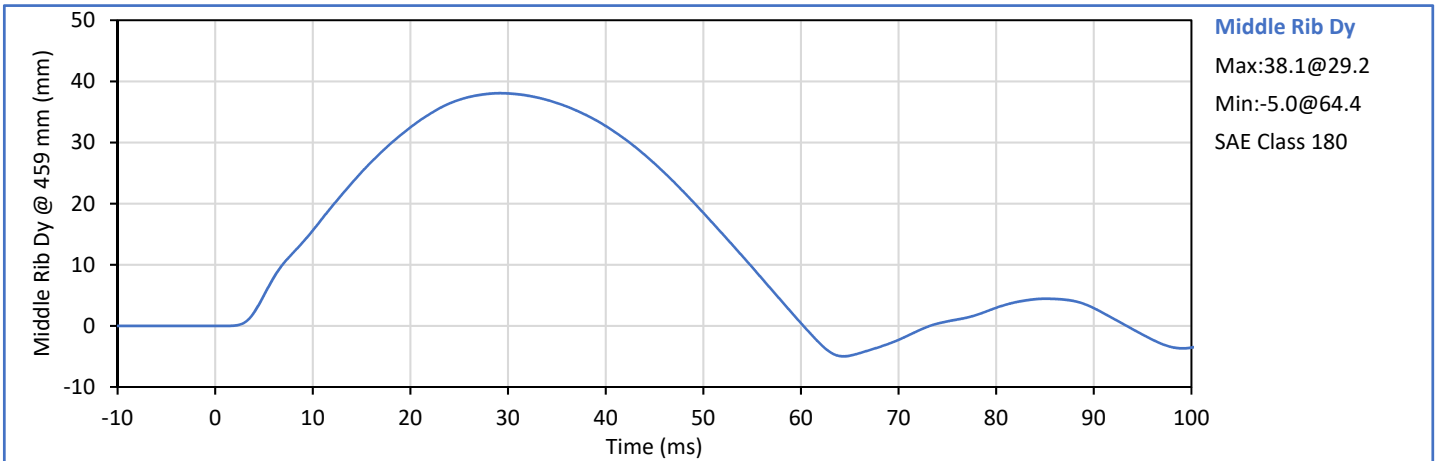
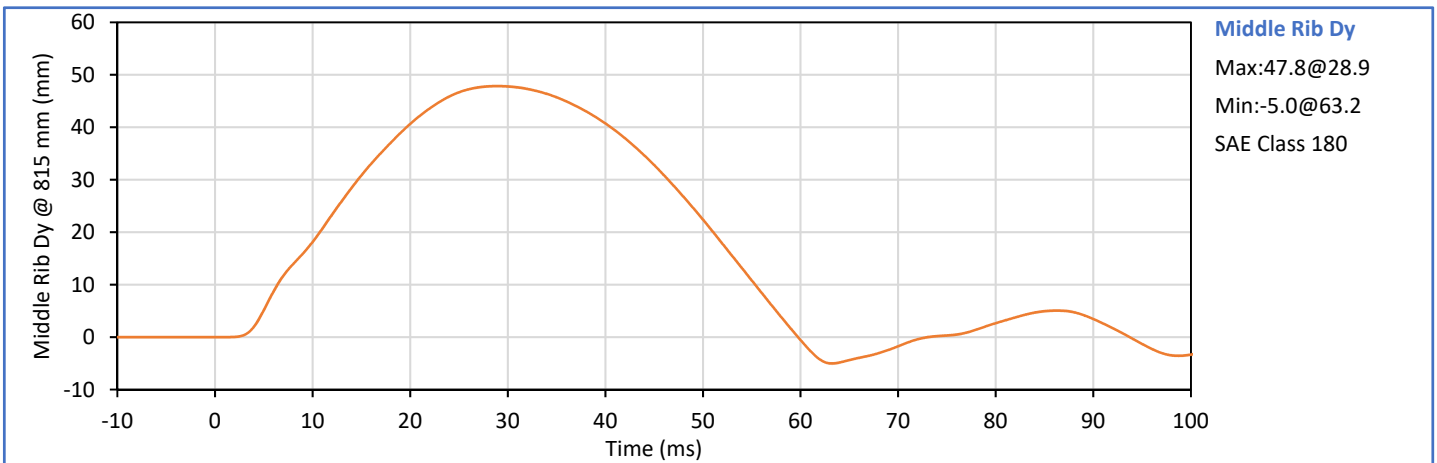
Technician:           *J. Hernandez*            
 J. Hernandez

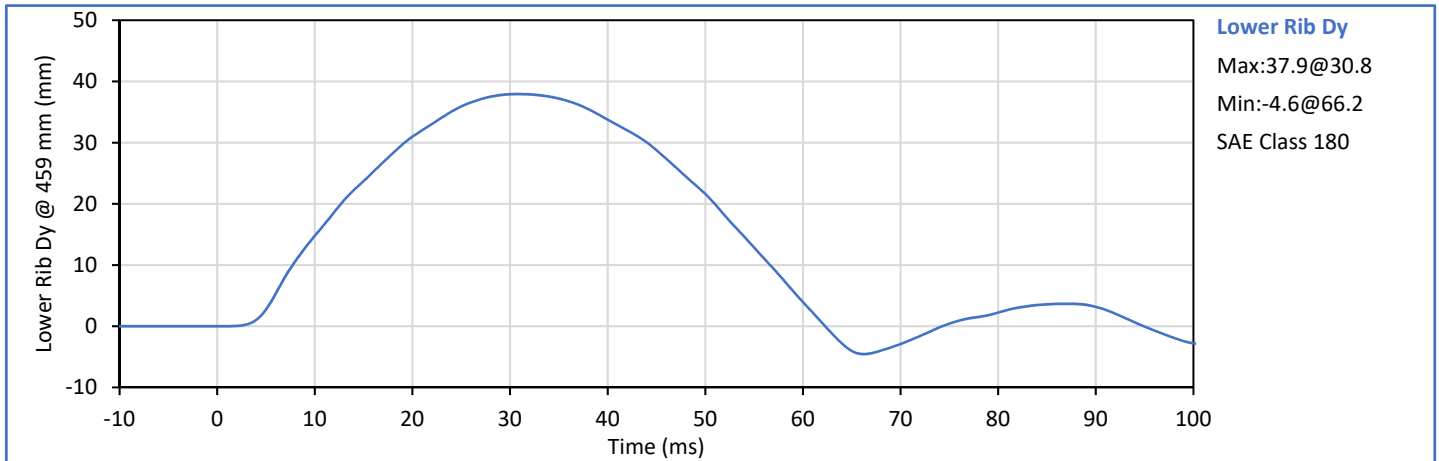
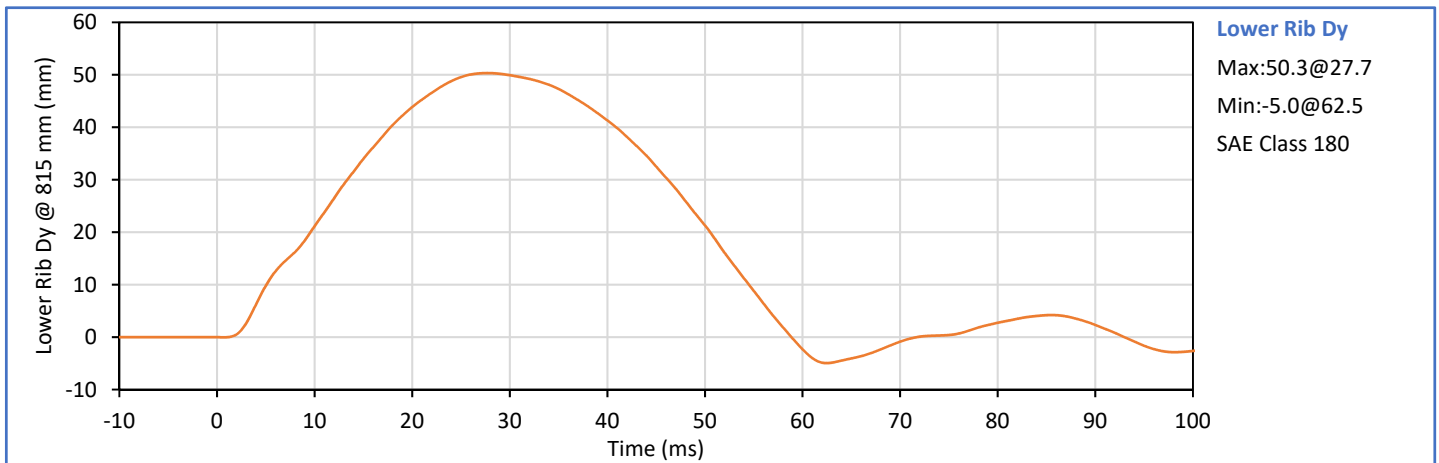
Technician: *J. Hernandez*  
 J. Hernandez

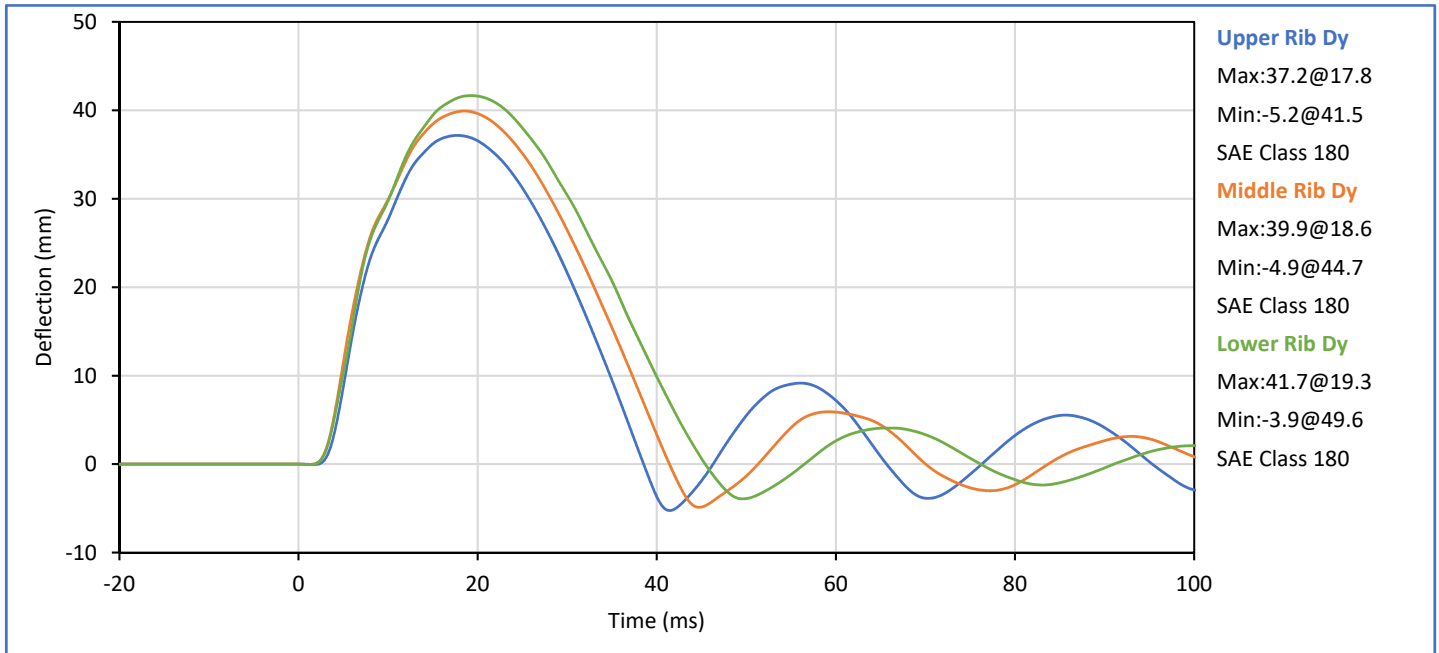
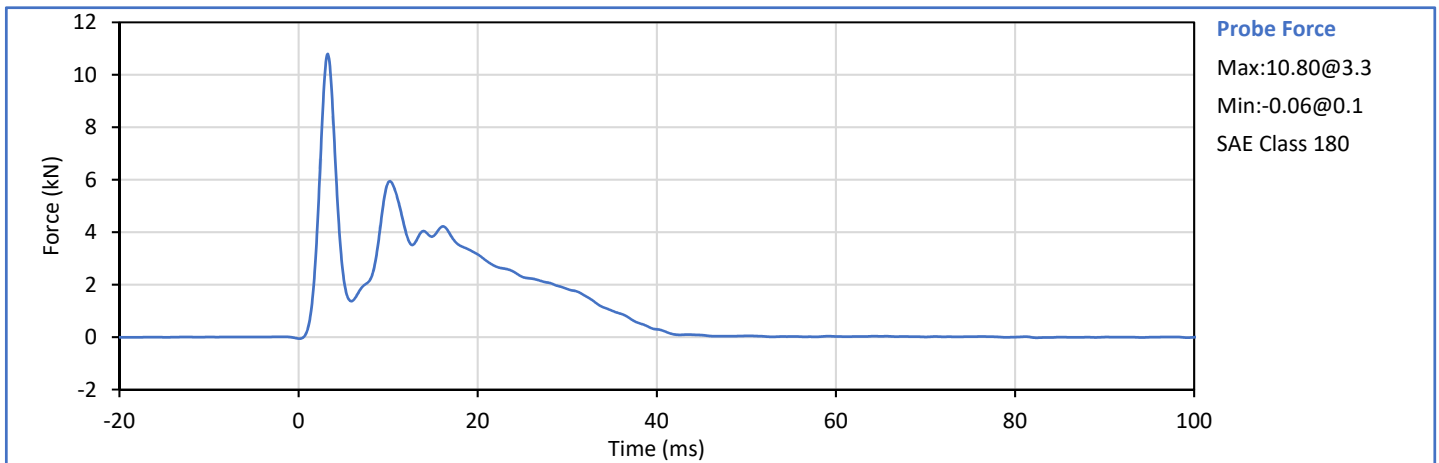
Technician: *J. Hernandez*  
 J. Hernandez

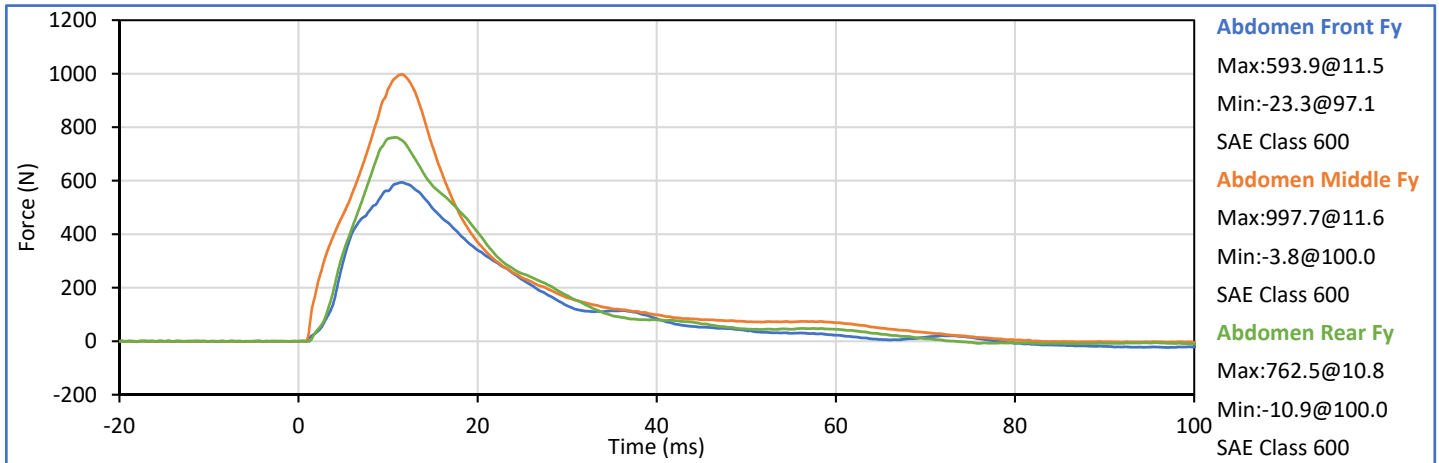
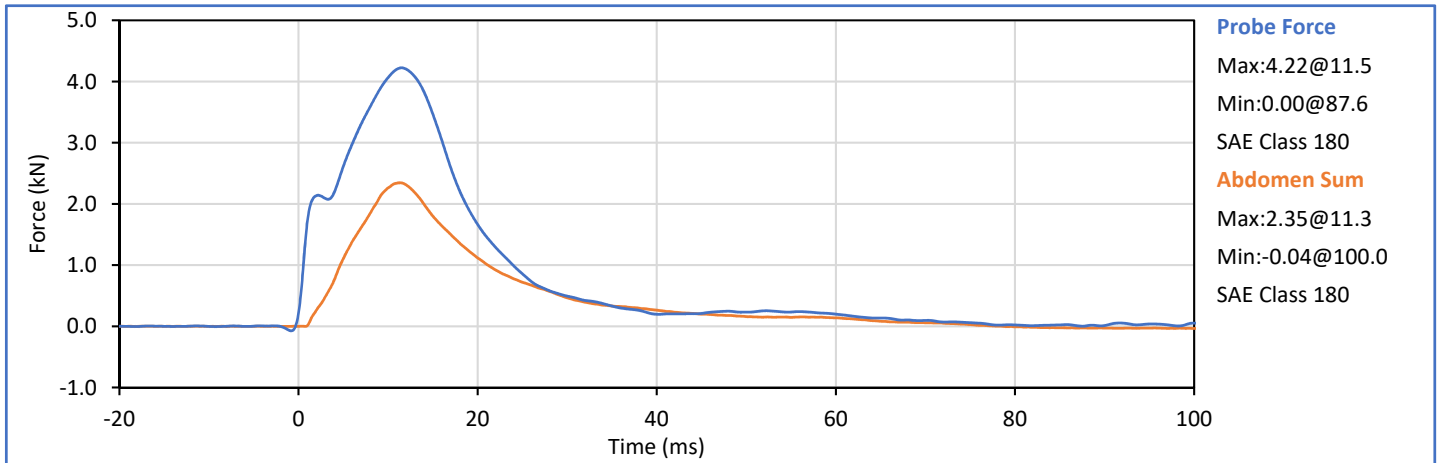
Tested Parameter	Units	Spec. Low	Spec. High	Result	Pass/Fail
Laboratory Temperature	°C	20.6	22.2	21.4	Pass
Laboratory Humidity	%	10	70	41	Pass
Impactor Velocity	m/s	3.90	4.10	4.08	Pass
Peak Impactor Force	kN	4.00	4.80	4.22	Pass
Time of Peak Impactor Force	ms	10.6	13.0	11.5	Pass
Sum of Abdomen Forces	kN	2.20	2.70	2.35	Pass
Time of Peak Sum Abdomen Force	ms	10.0	12.3	11.3	Pass
<b>Overall Test Results</b>					<b>Pass</b>

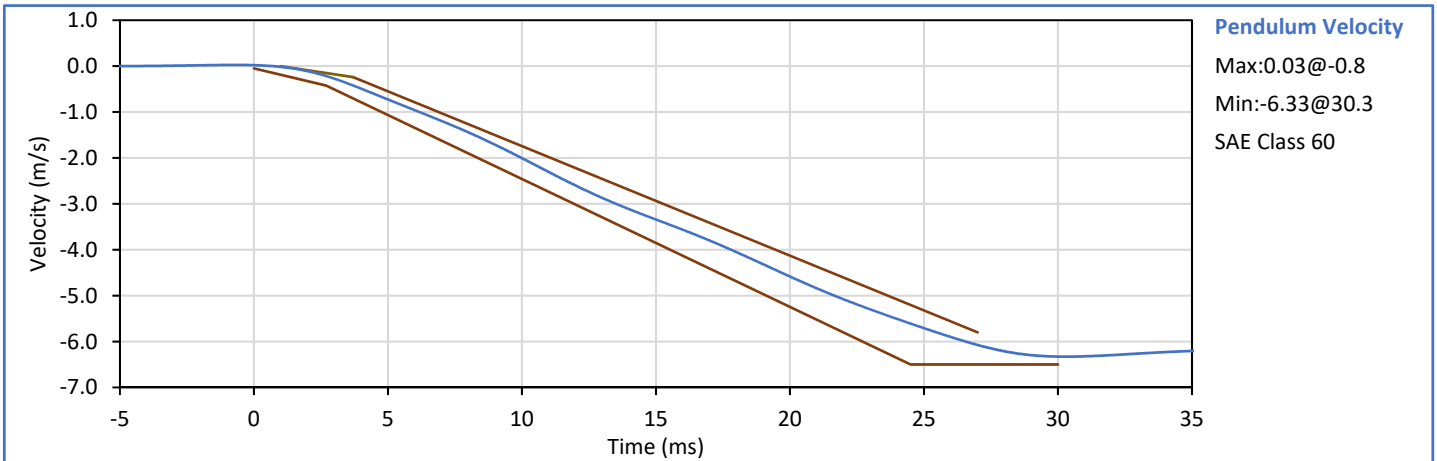
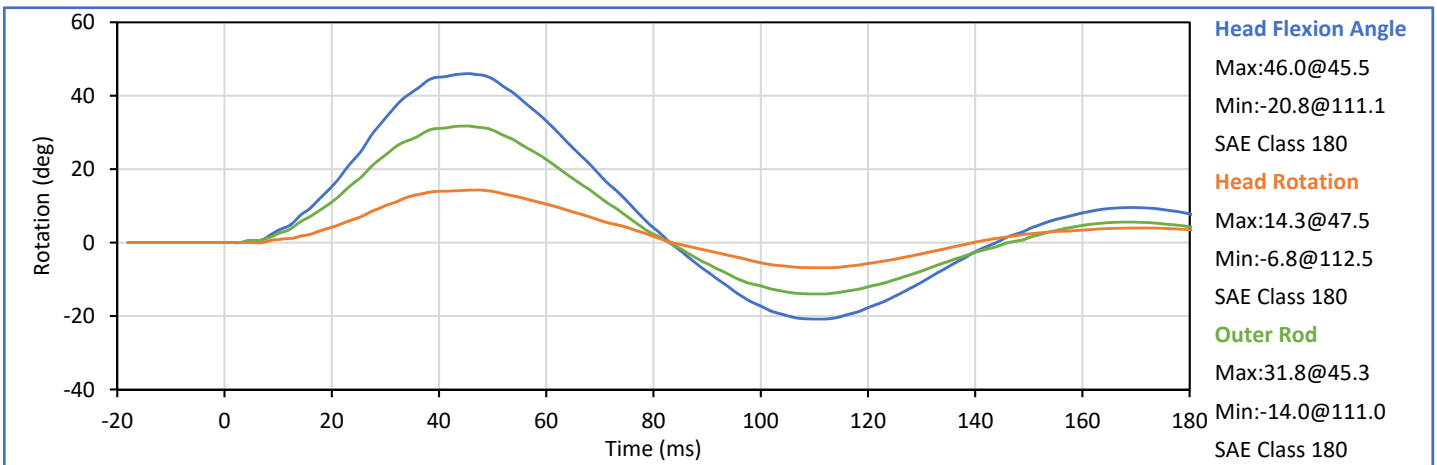
Technician: *J. Hernandez*  
 J. Hernandez

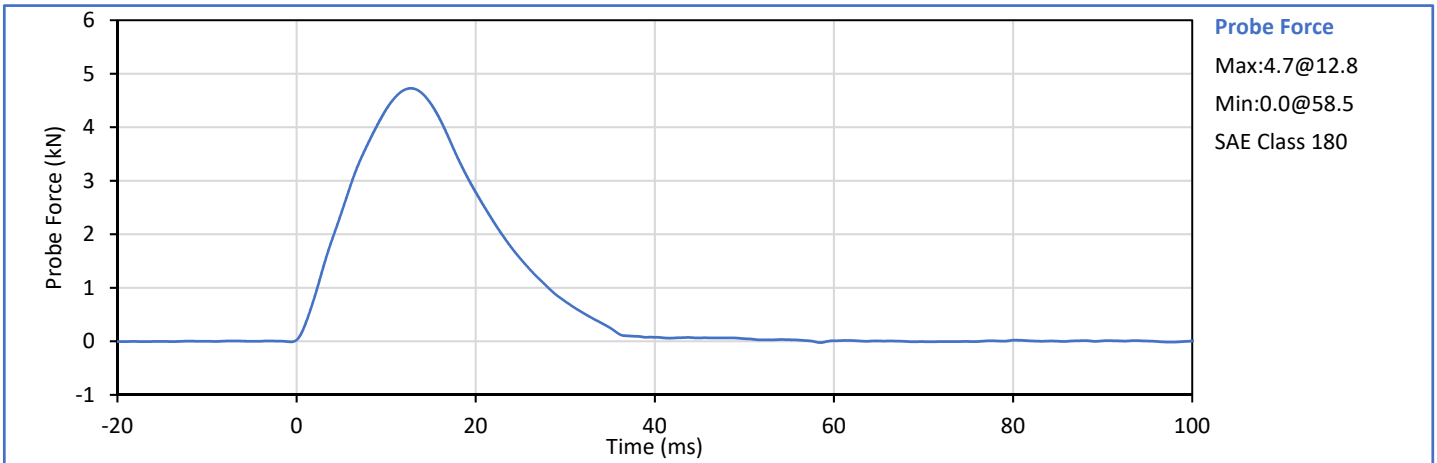
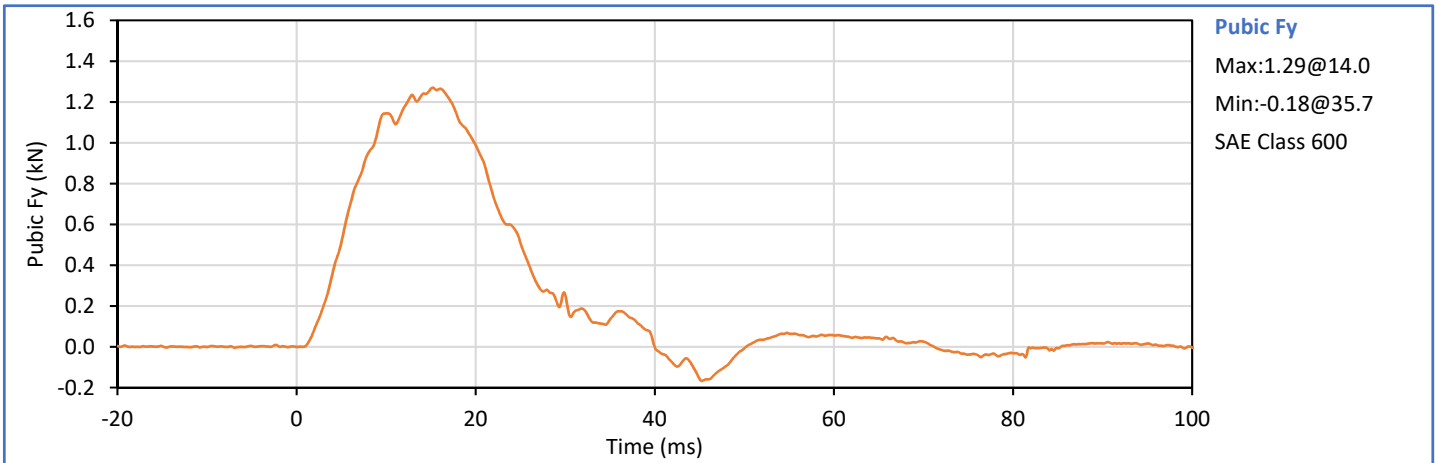
Technician:   
 J. Hernandez

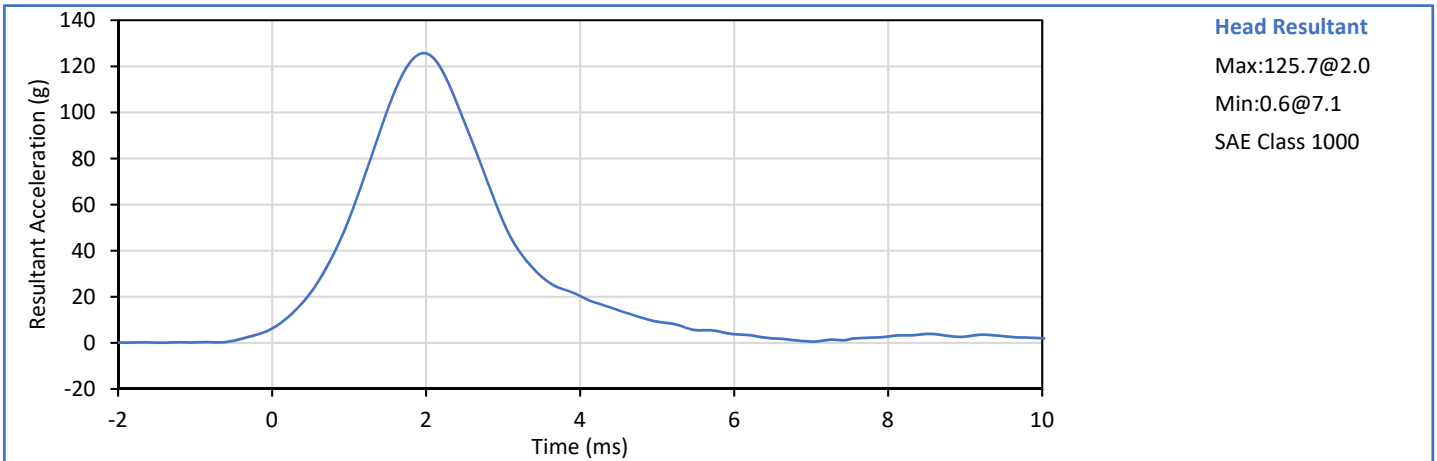
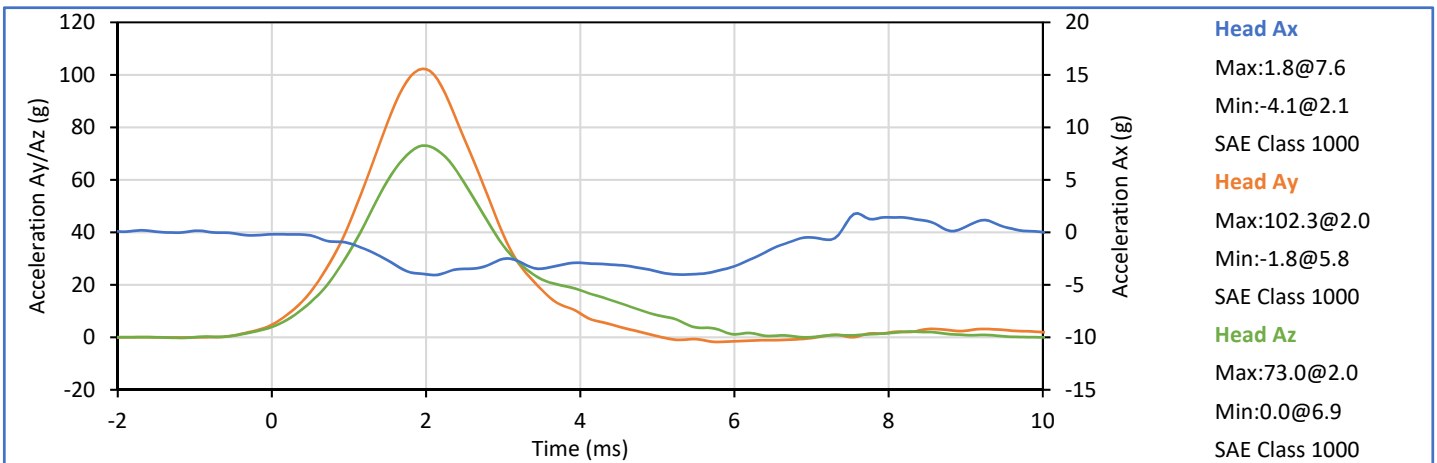
Technician: *J. Hernandez*  
 J. Hernandez

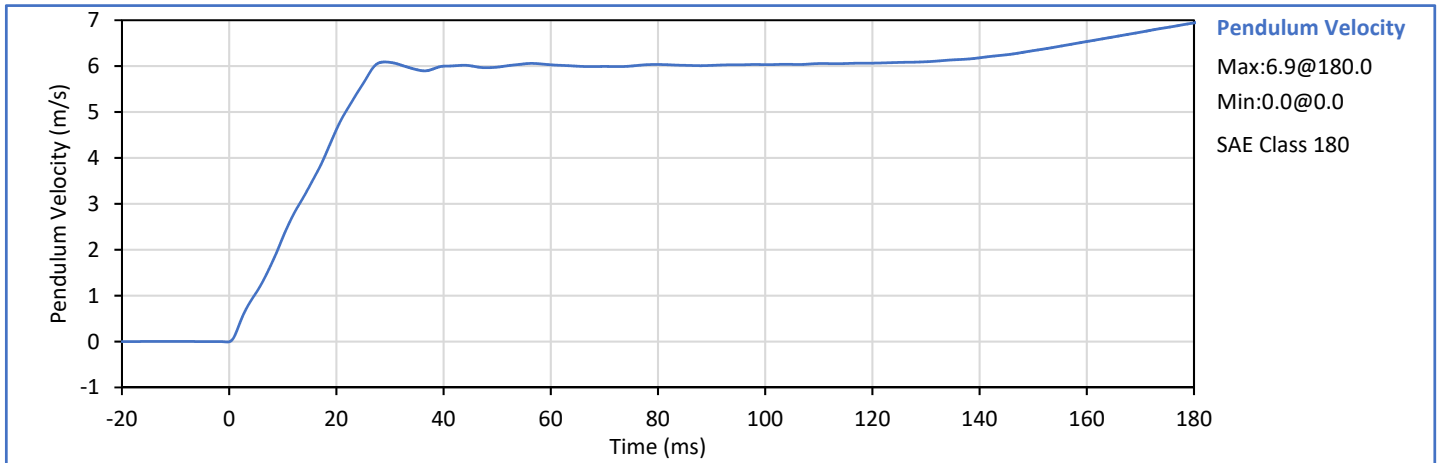
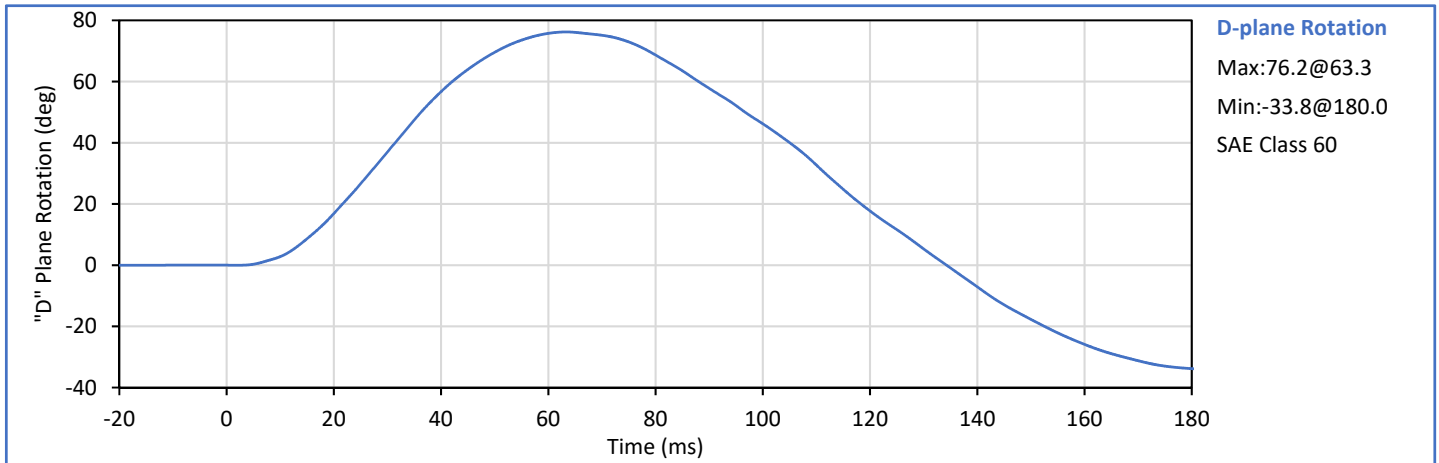
Technician:   
 J. Hernandez

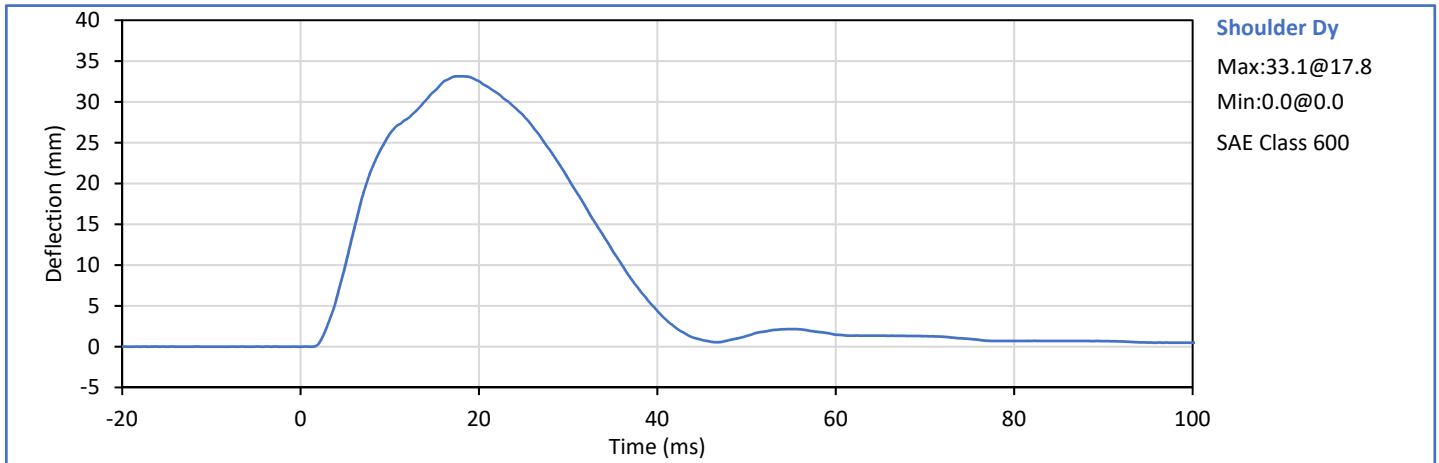
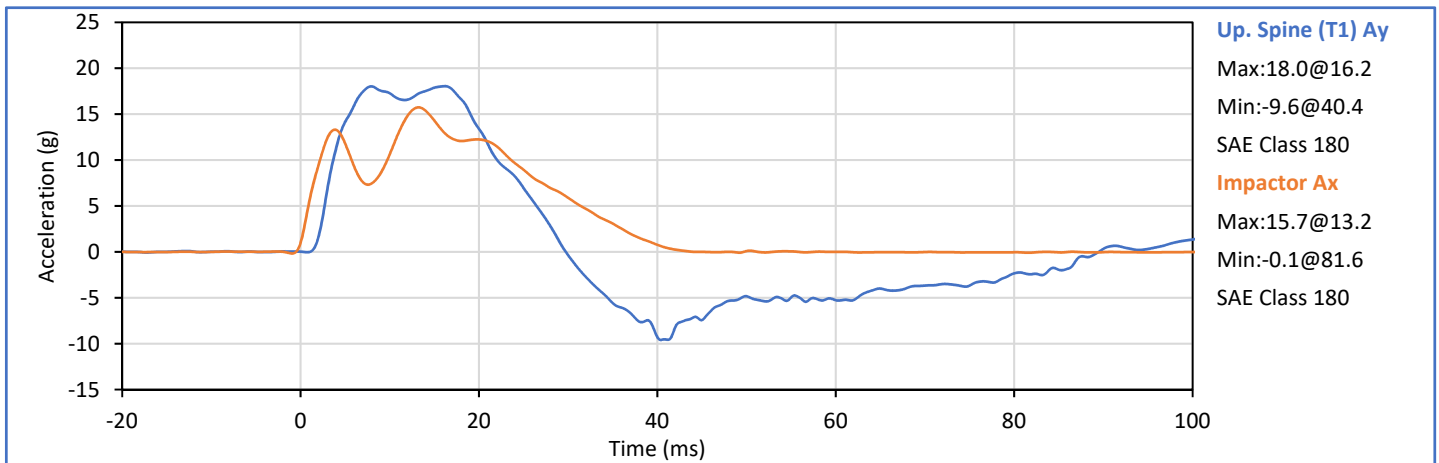
Technician:   
 J. Hernandez

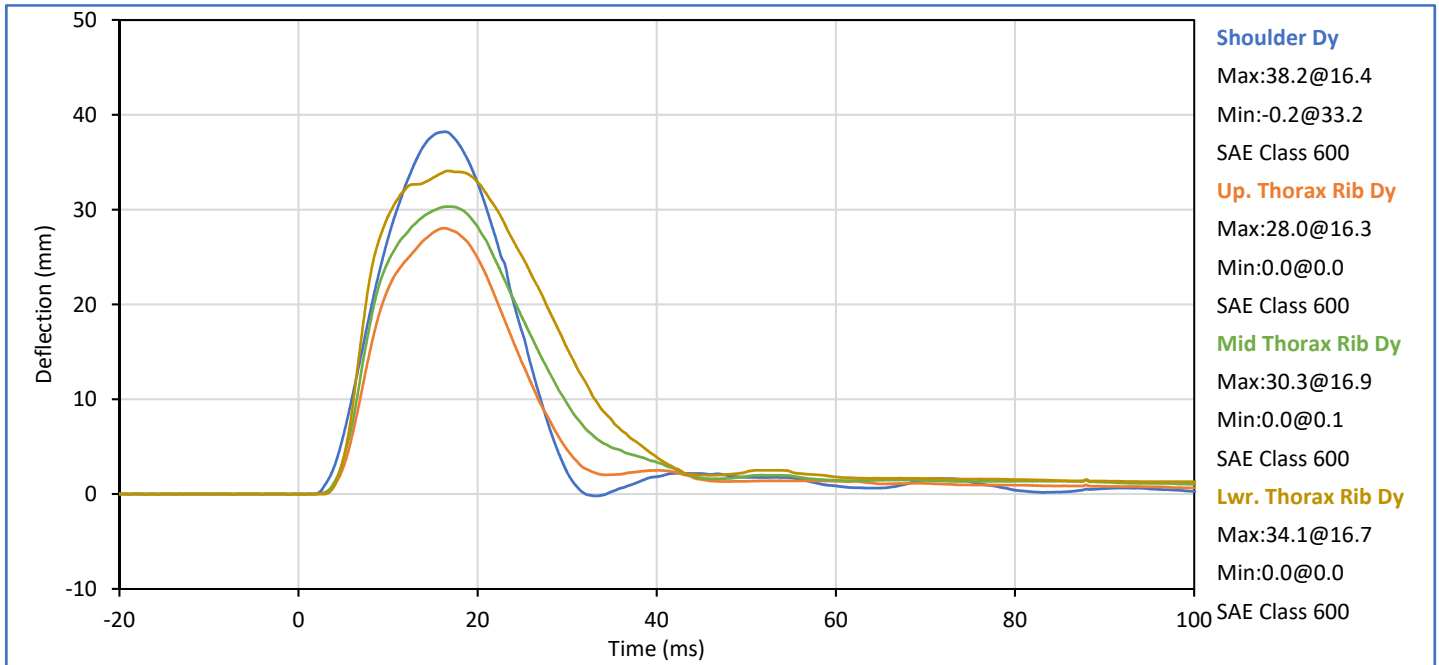
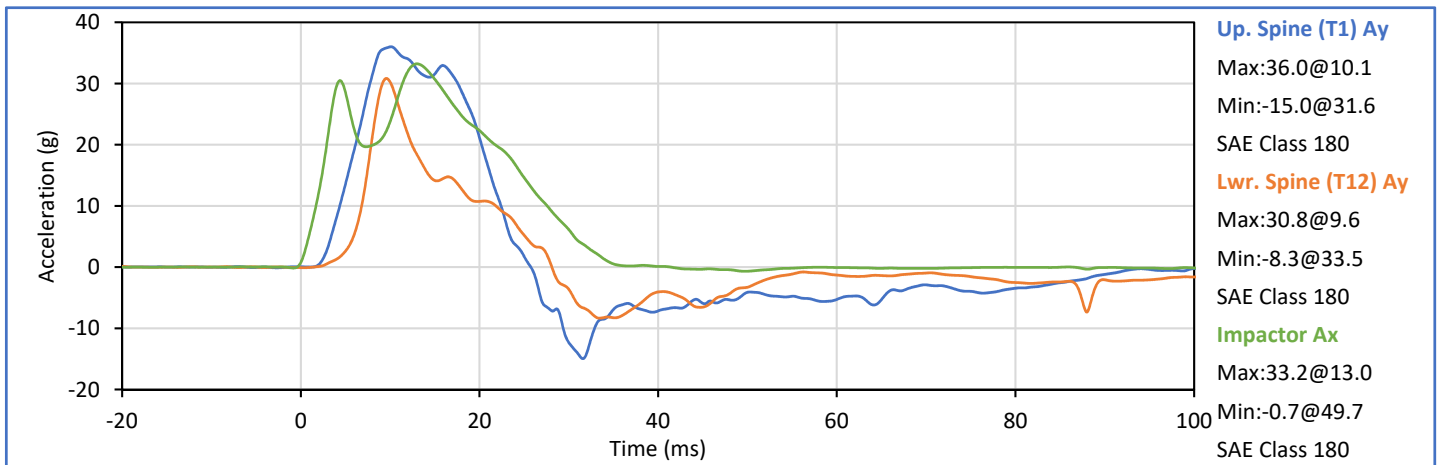
Technician:   
 J. Hernandez

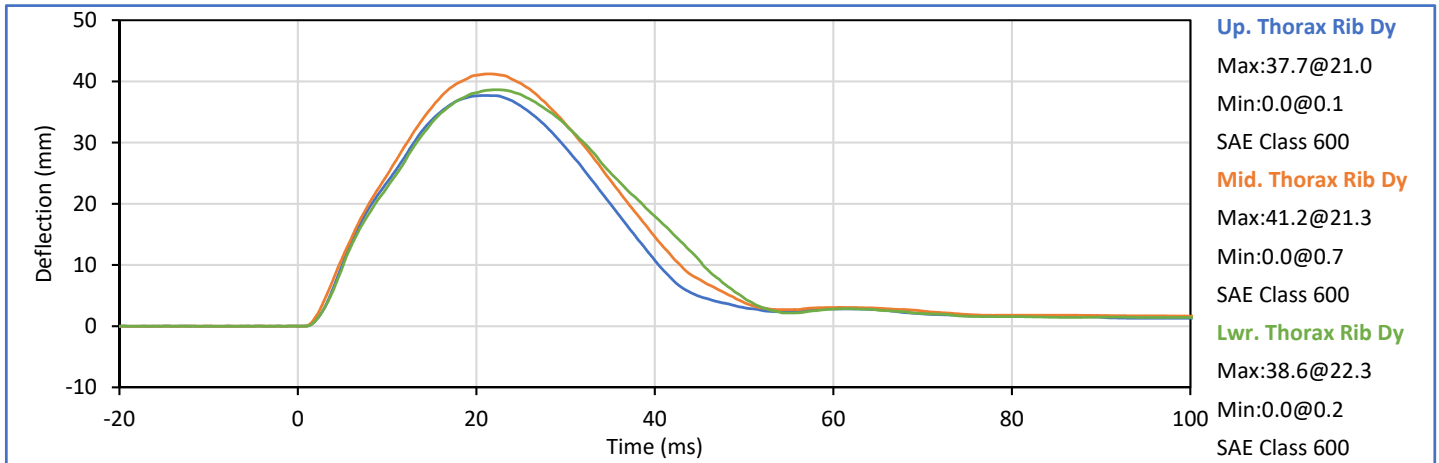
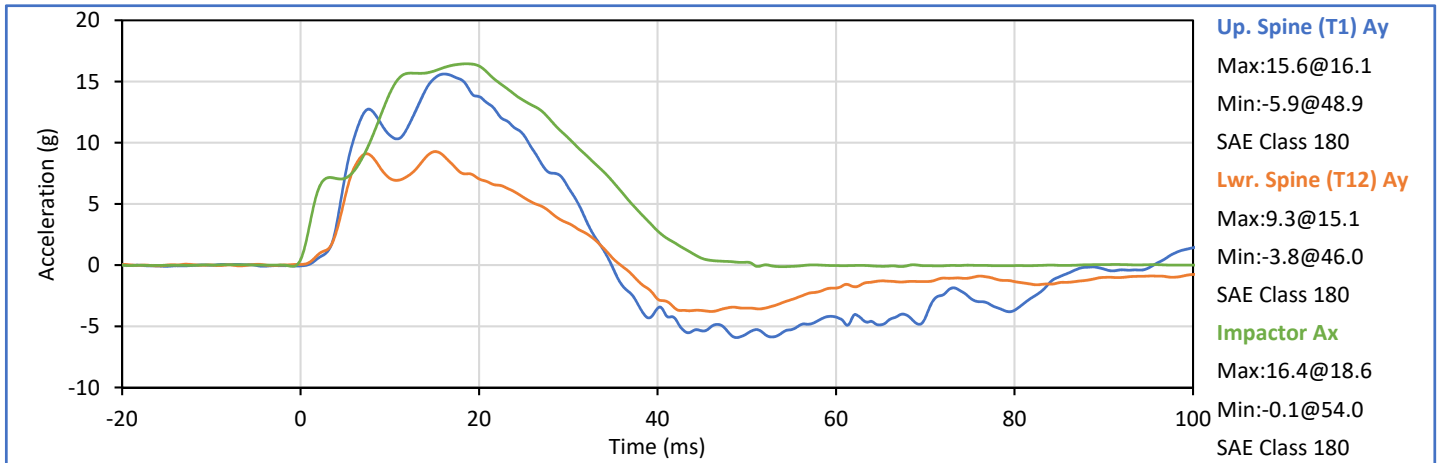
Technician:   
 J. Hernandez

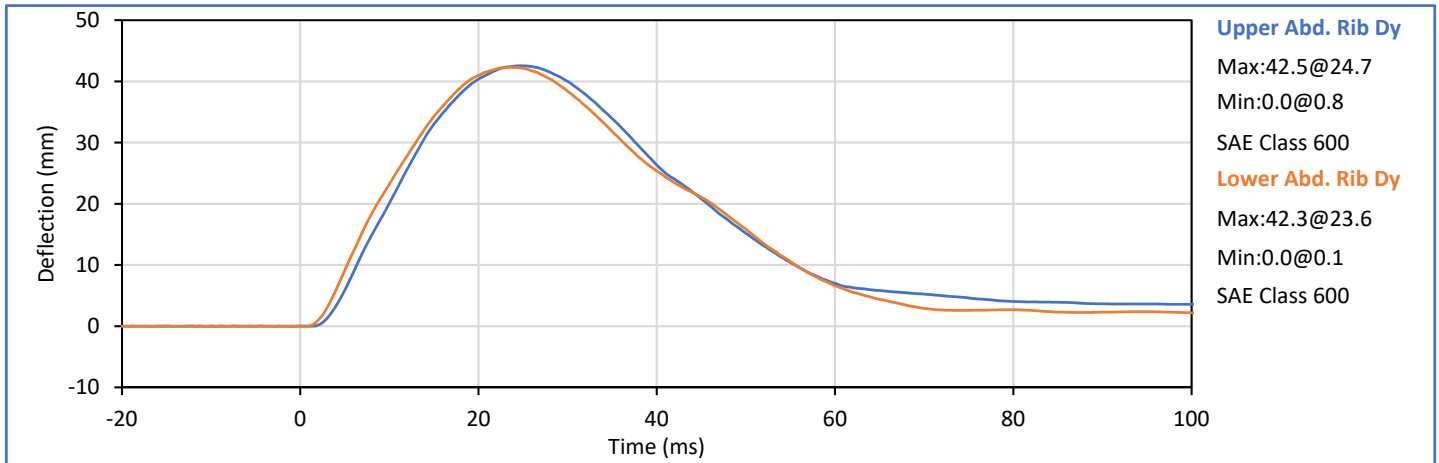
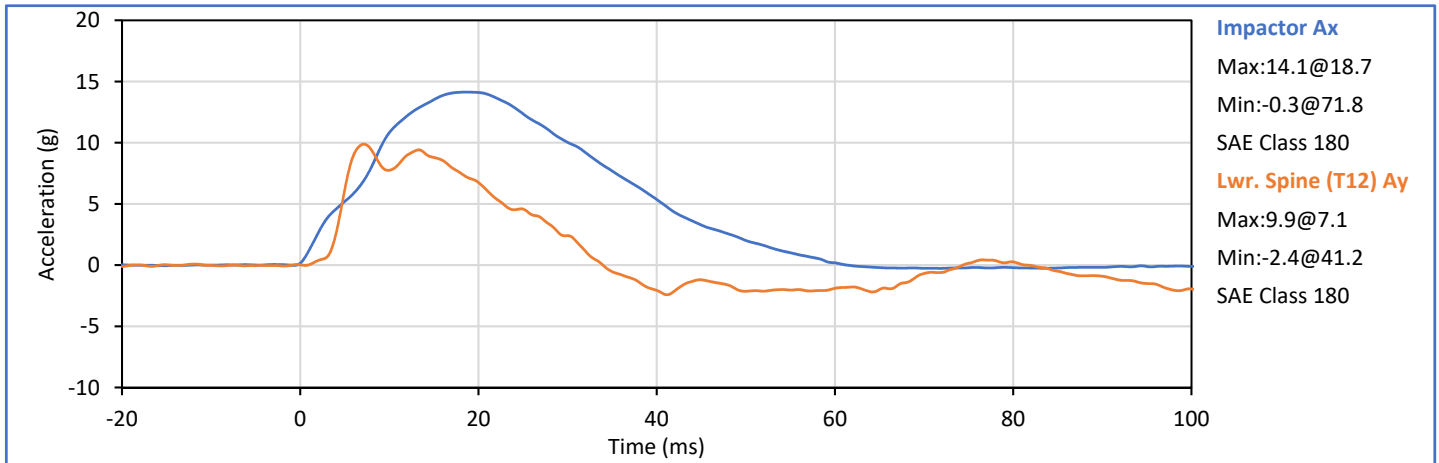
Tested Parameter	Units	Spec. Low	Spec. High	Result	Pass/Fail
Laboratory Temperature	°C	20.6	22.2	20.7	Pass
Laboratory Humidity	%	10	70	38	Pass
Impactor Velocity	m/s	4.20	4.40	4.31	Pass
Peak Upper Abdomen Rib Dy	mm	36.0	47.0	42.5	Pass
Peak Lower Abdomen Rib Dy	mm	33.0	44.0	42.3	Pass
Peak Lower Spine T12 Ay	mm	9.0	14.0	9.9	Pass
Peak Impactor Ax	g	12.0	16.0	14.1	Pass
<b>Overall Test Results</b>					<b>Pass</b>
