**REPORT NUMBER: SINCAP-KAR-19-006**

**NEW CAR ASSESSMENT PROGRAM (NCAP)  
MOVING DEFORMABLE BARRIER SIDE IMPACT TEST**

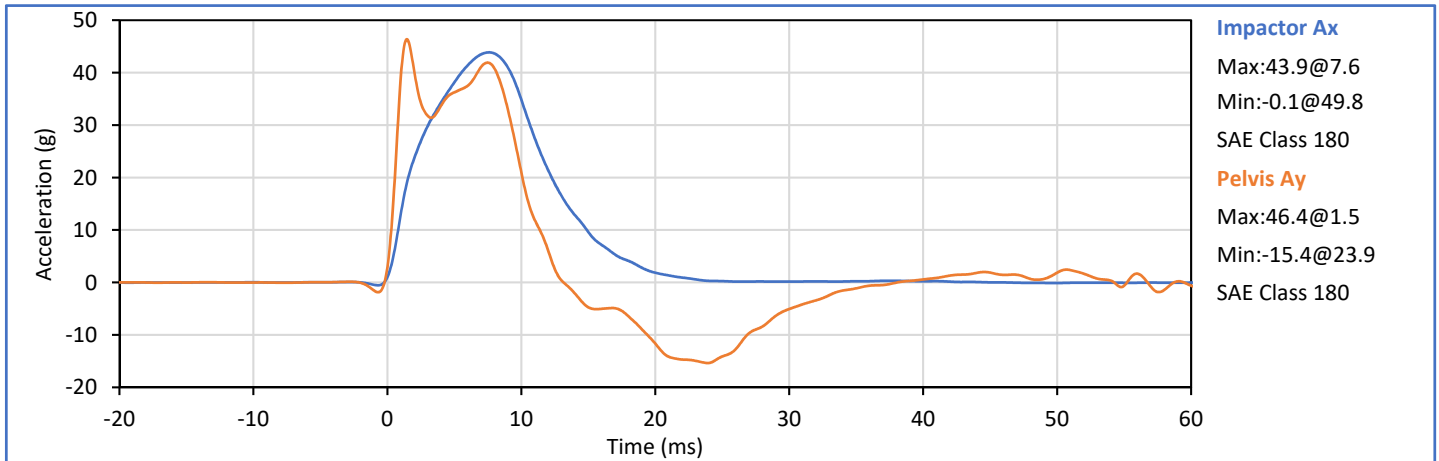
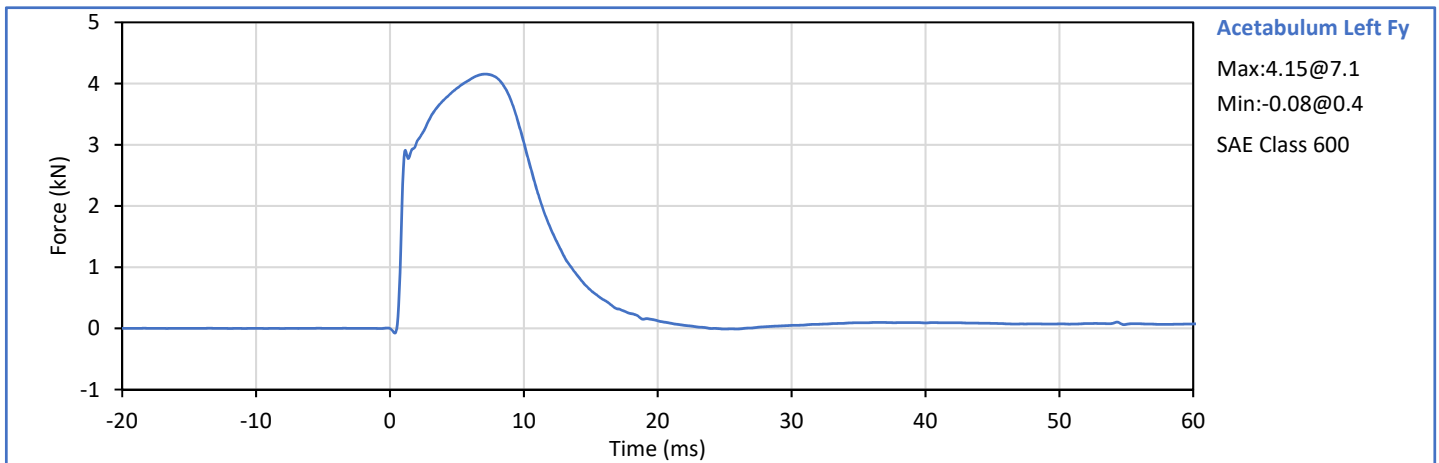
Pelvis Plug S/N: 12246 (SACO)

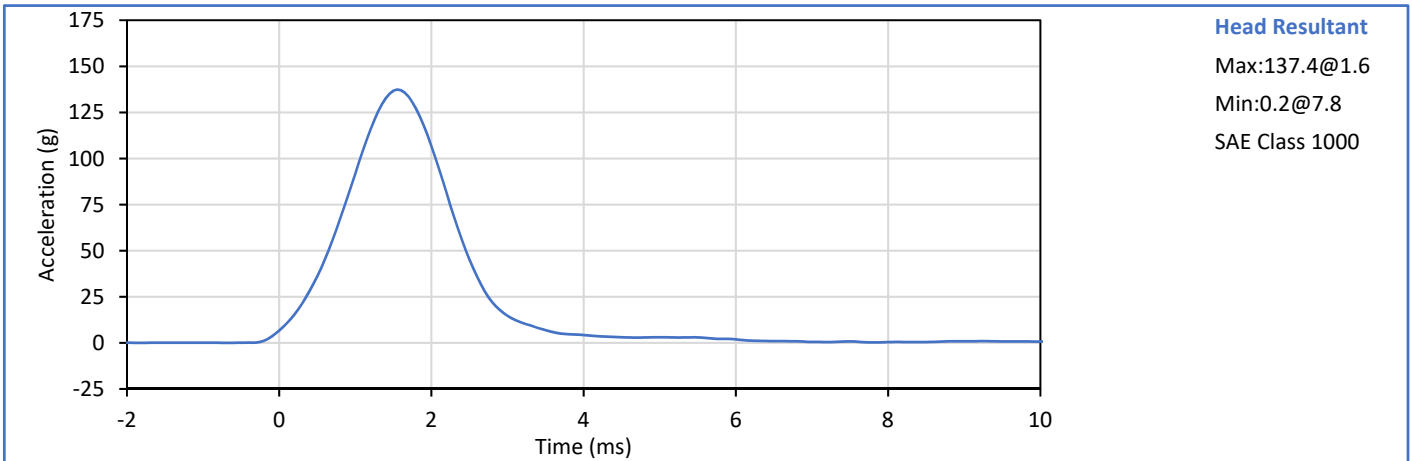
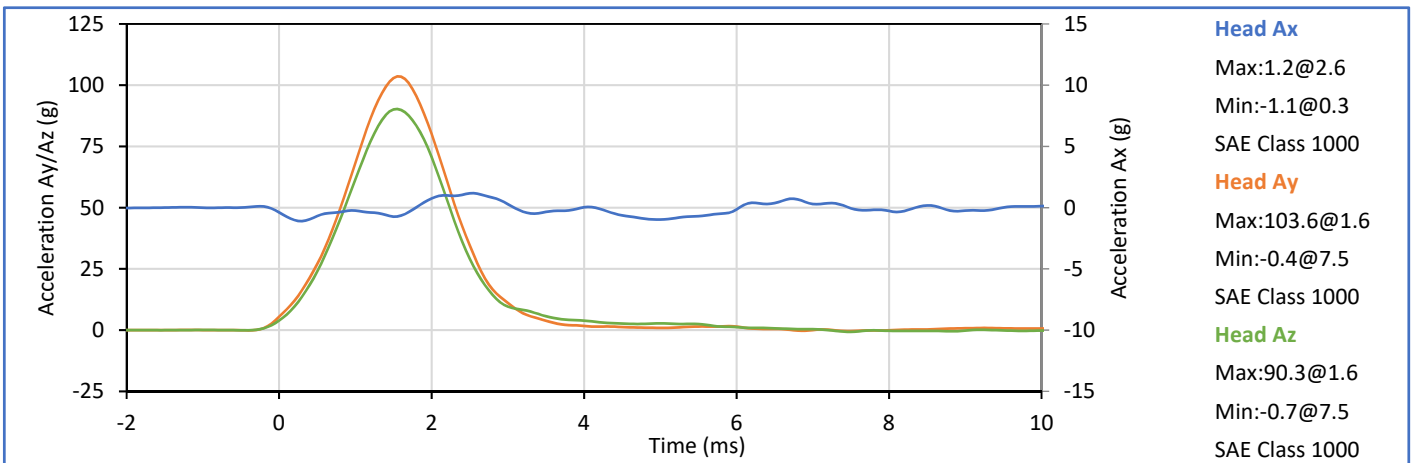
Technician:   
 J. Hernandez

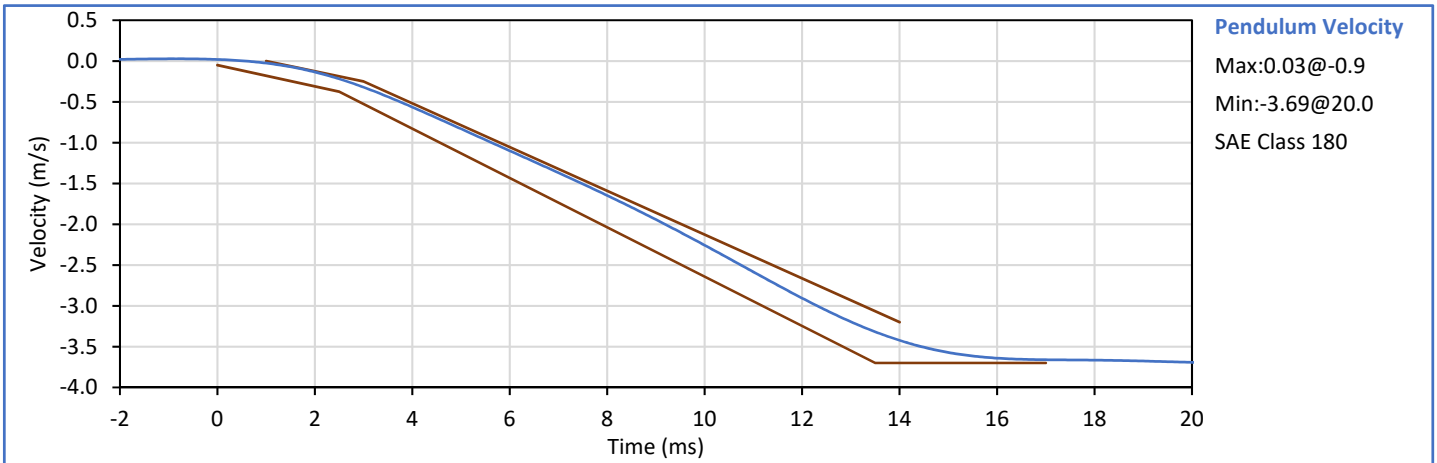
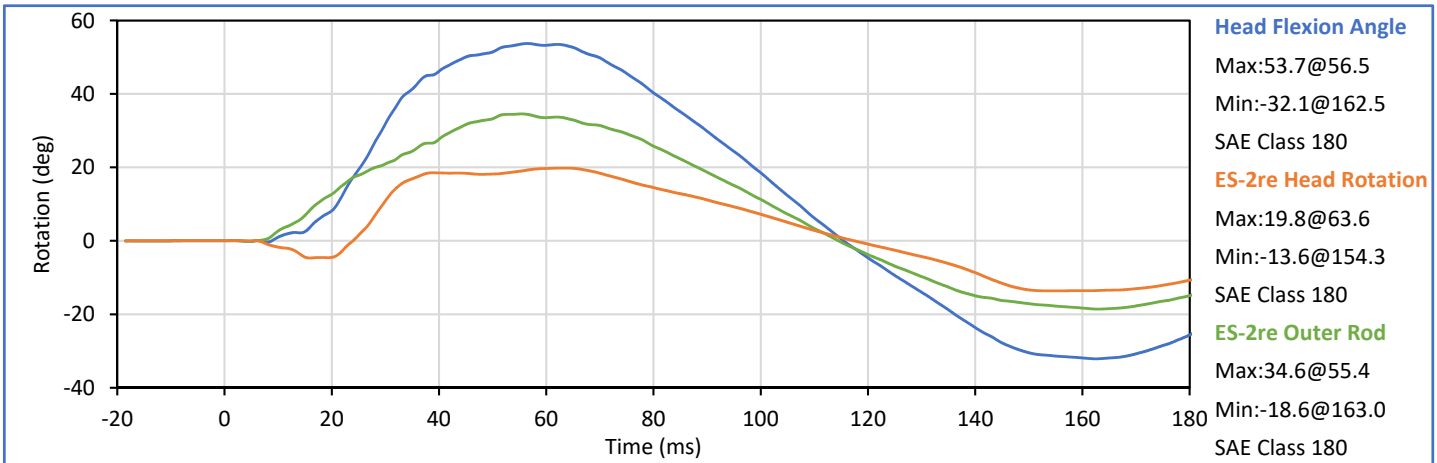
Technician:   
 J. Hernandez

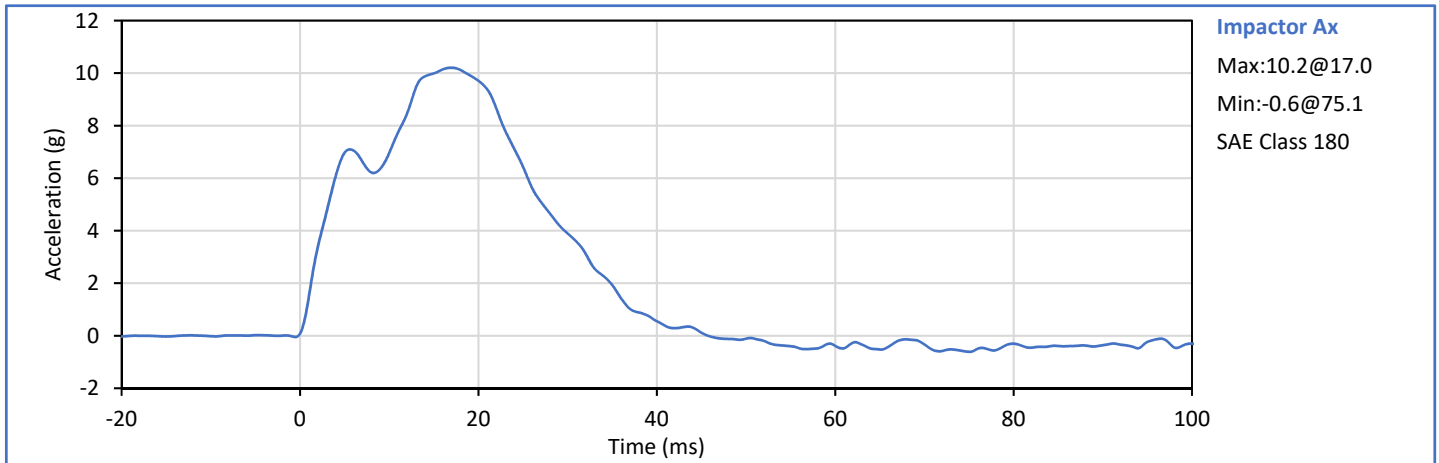
Technician:   
J. Hernandez

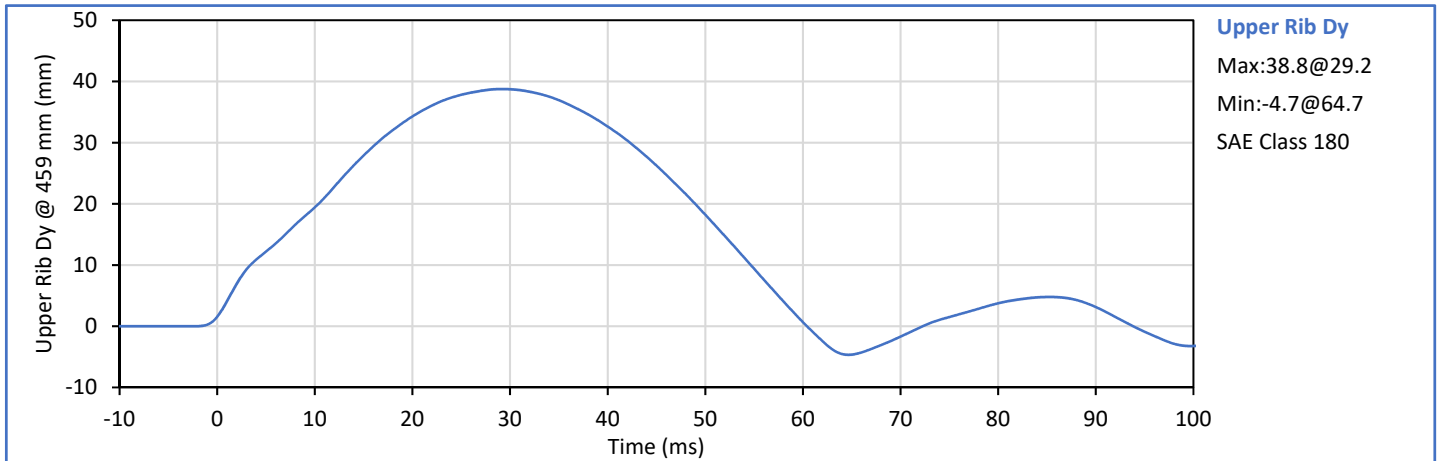
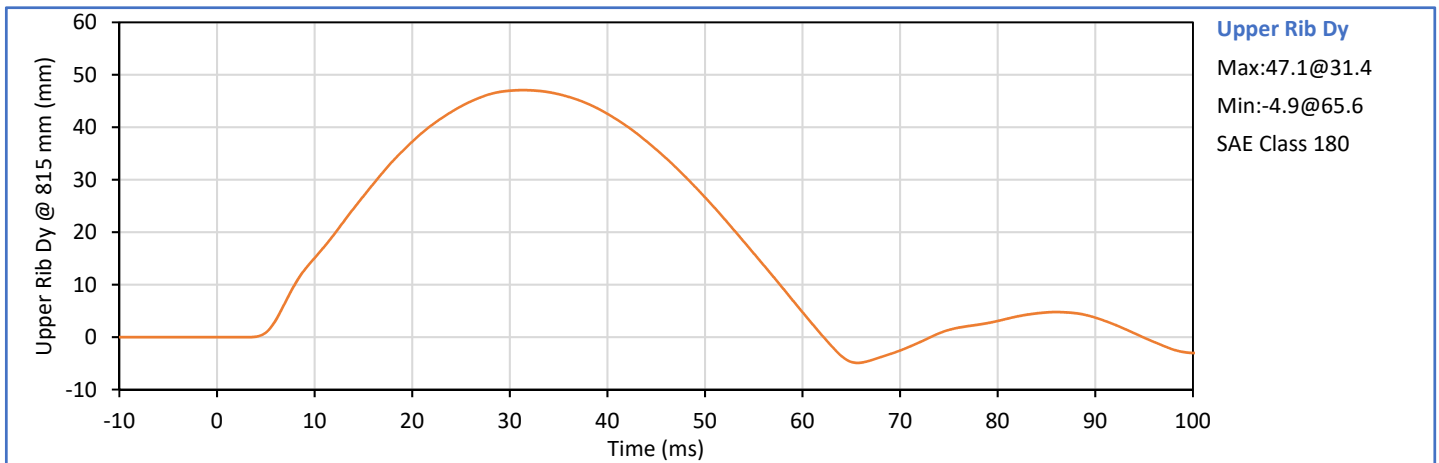
Technician:   
 J. Hernandez

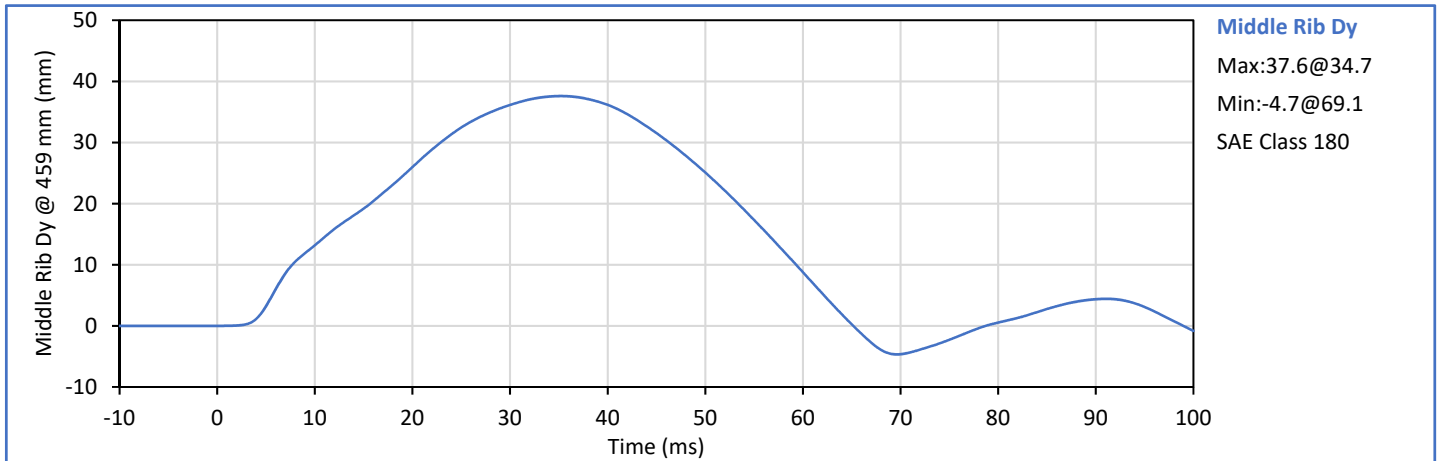
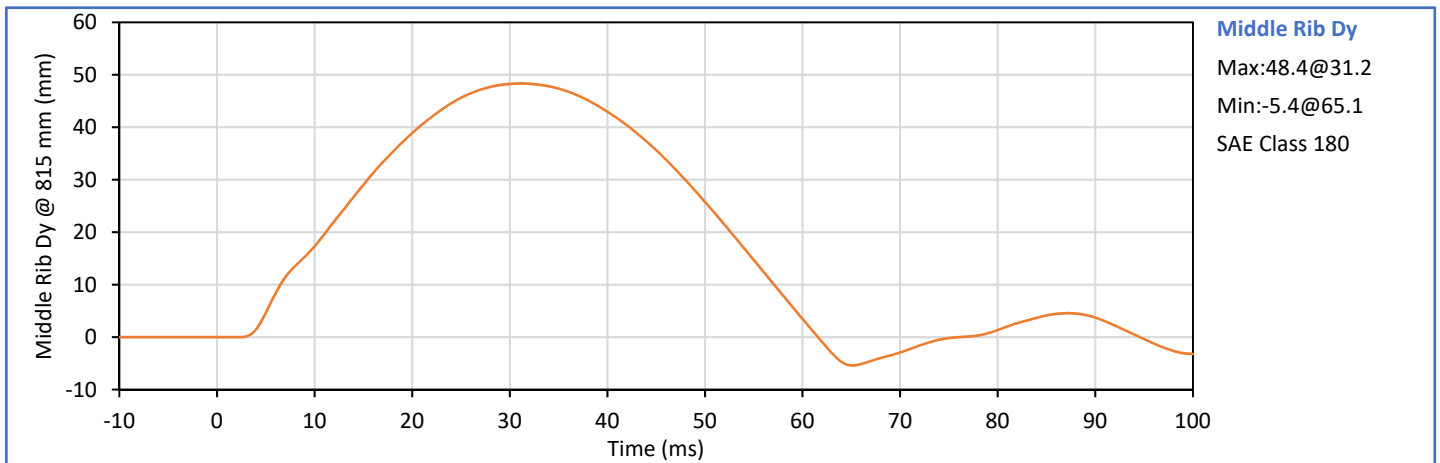
Technician: *J. Hernandez*  
 J. Hernandez

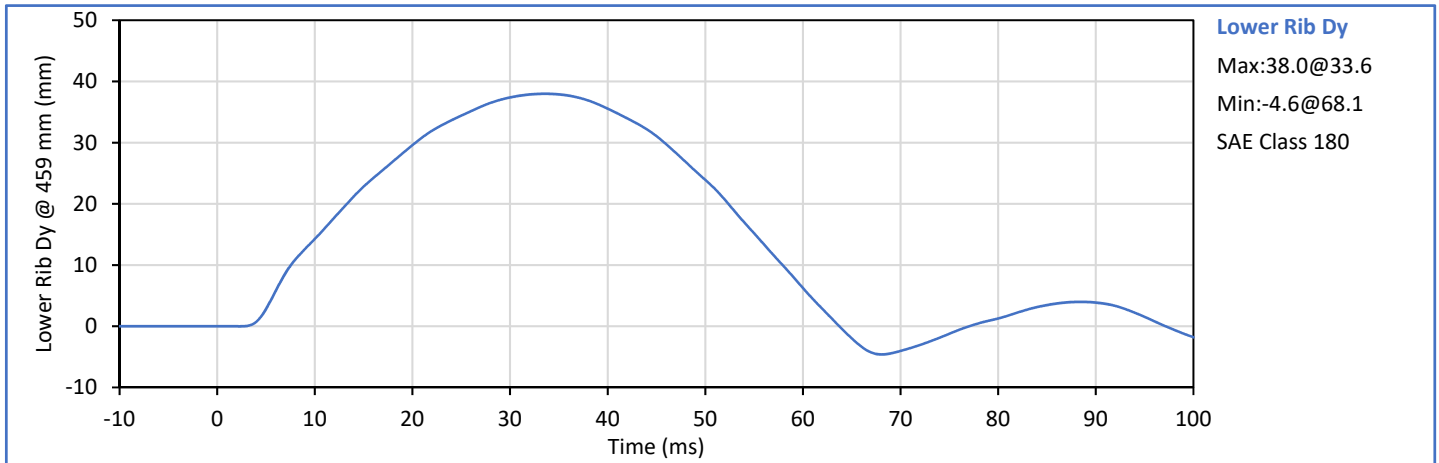
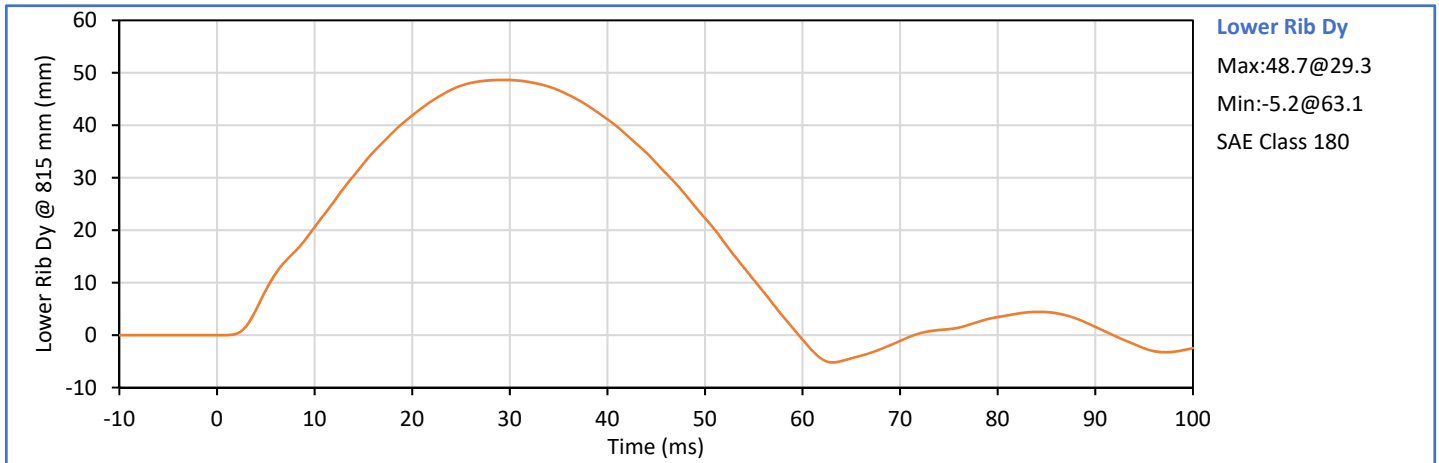
Technician: *J. Hernandez*  
 J. Hernandez

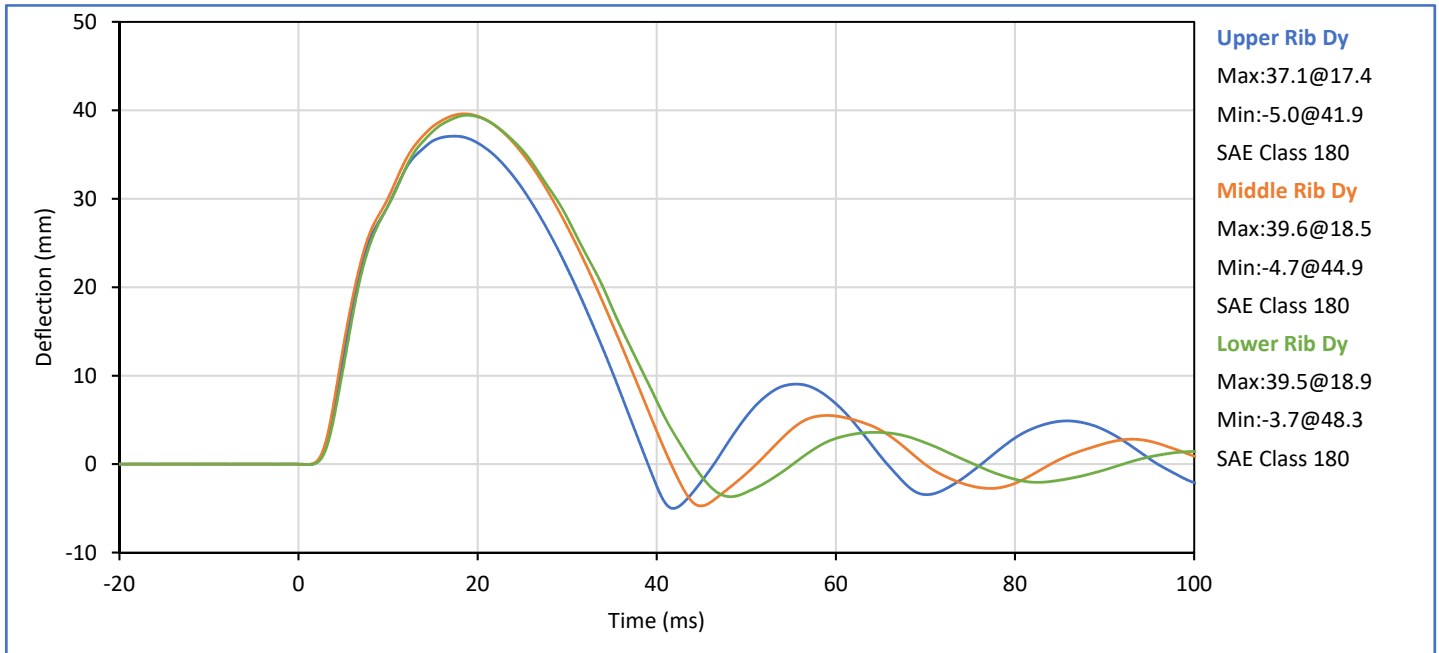
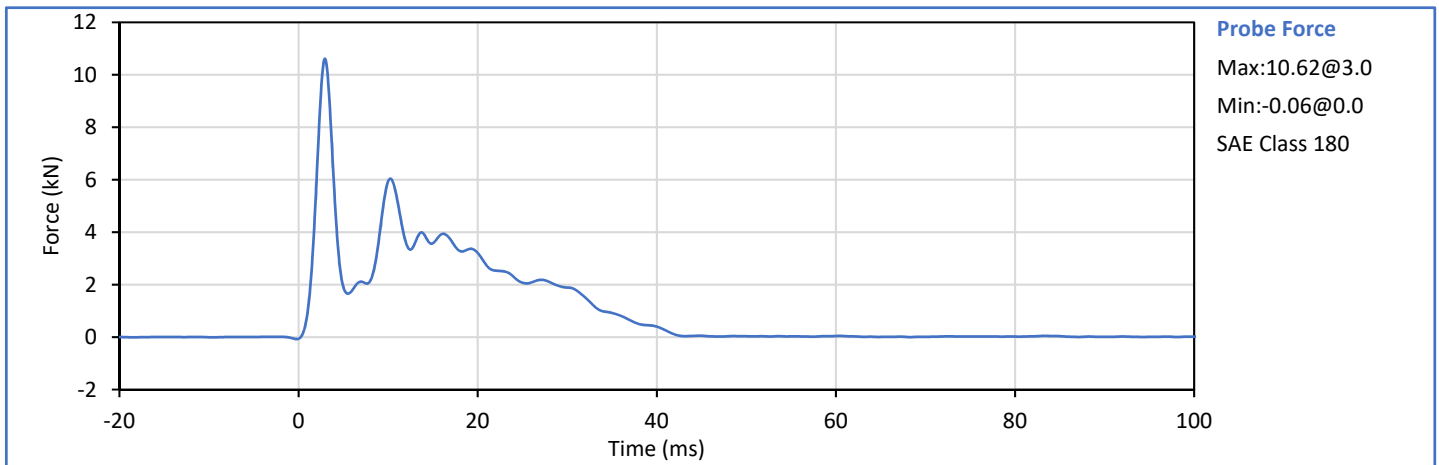
Technician: *J. Hernandez*  
 J. Hernandez

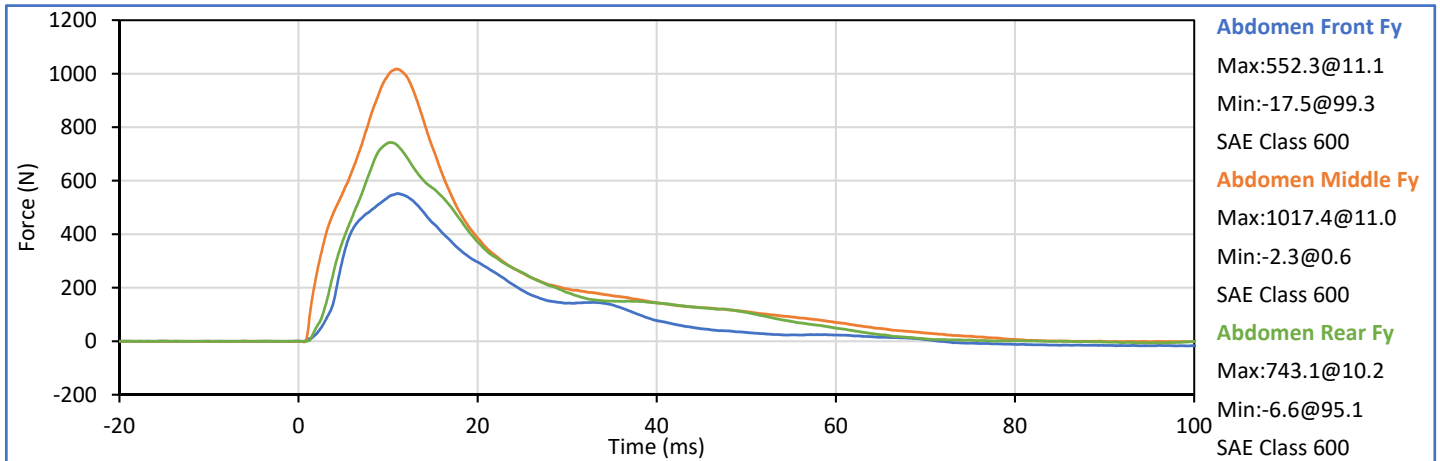
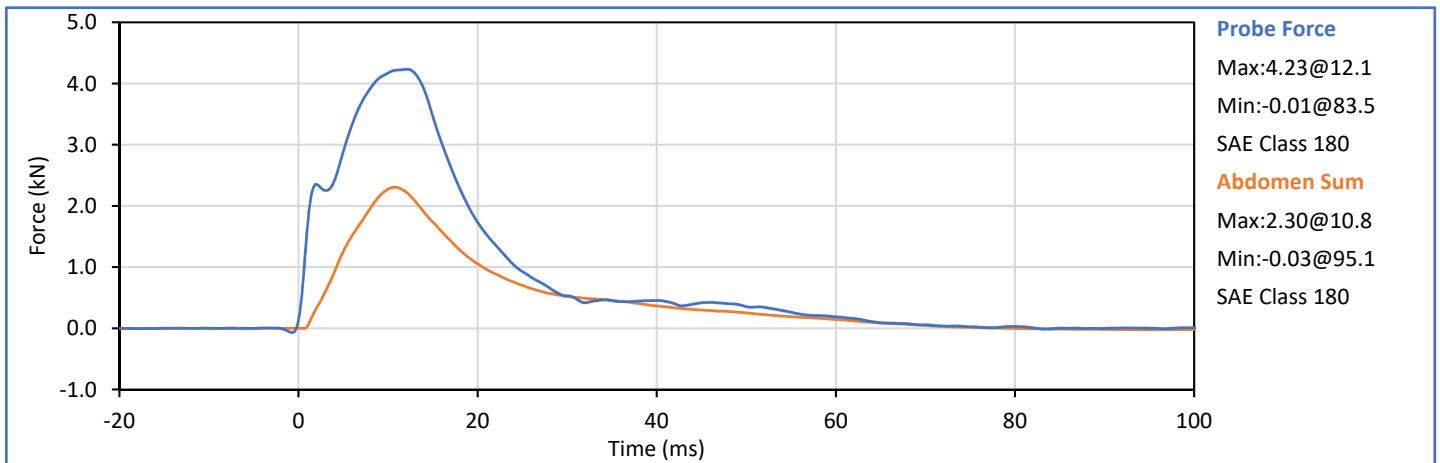
Technician:   
 J. Hernandez

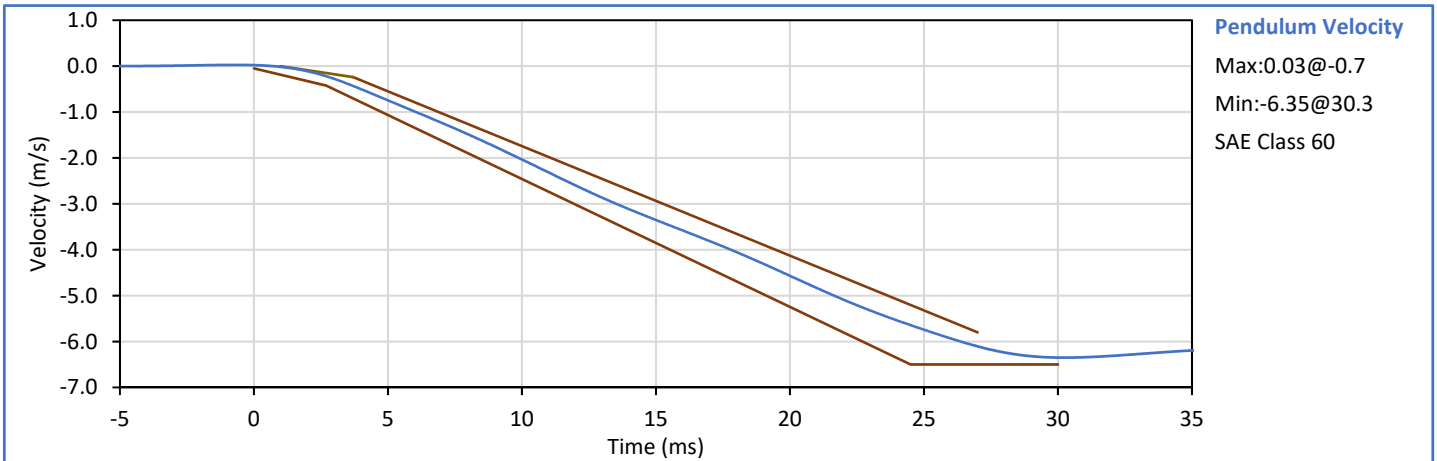
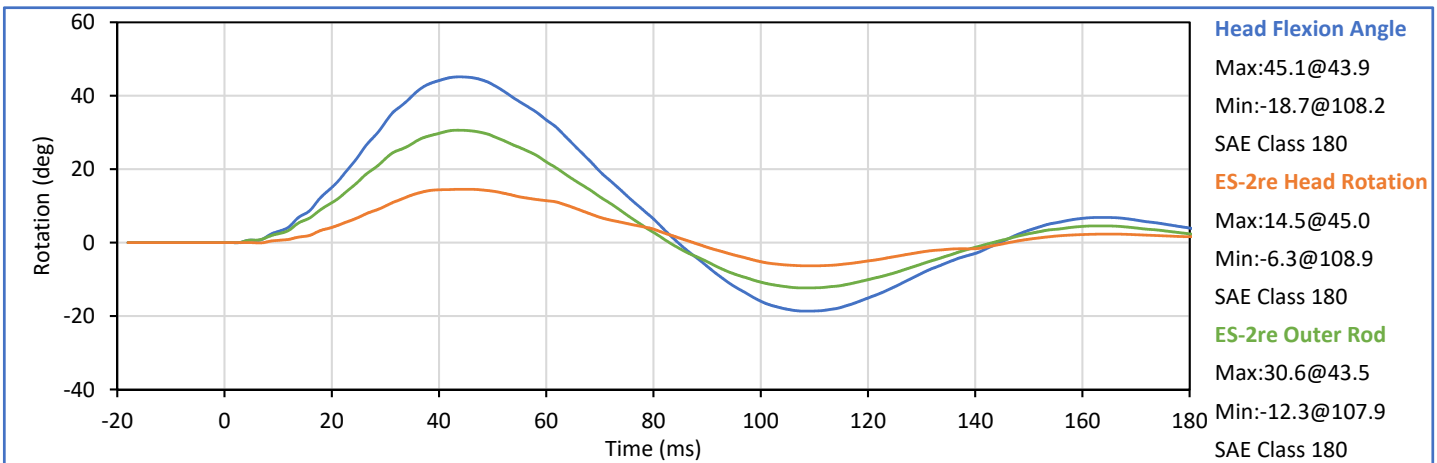
Technician:   
 J. Hernandez

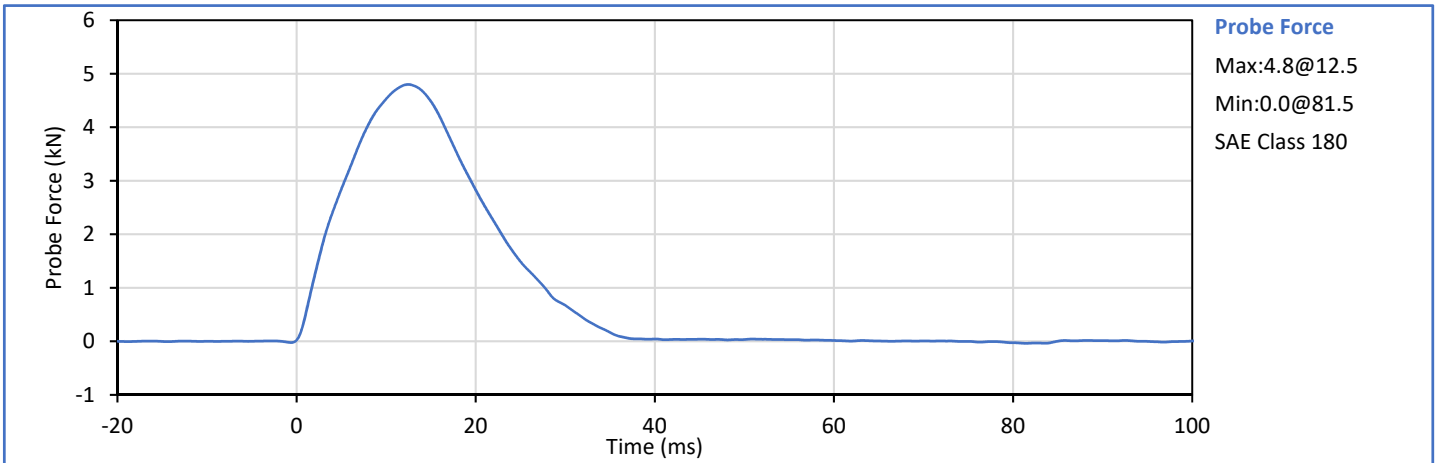
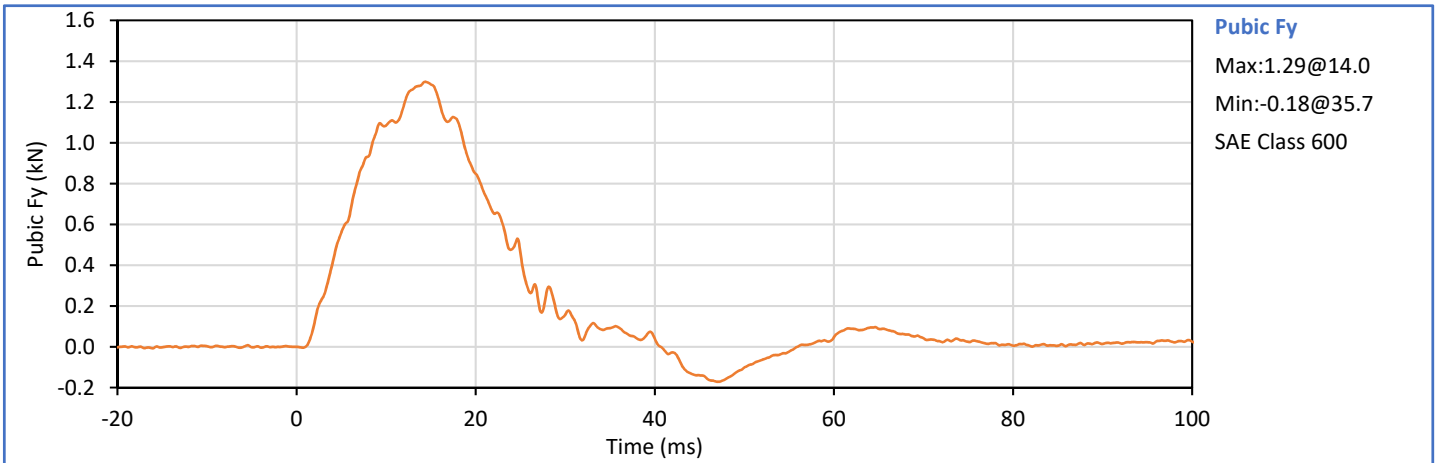
Technician:   
 J. Hernandez

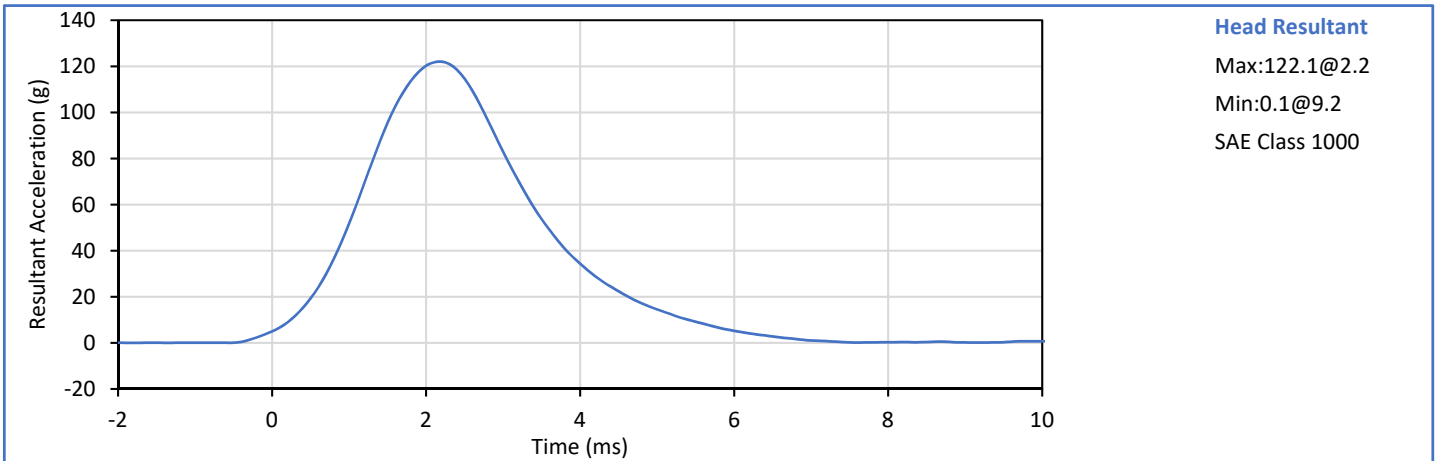
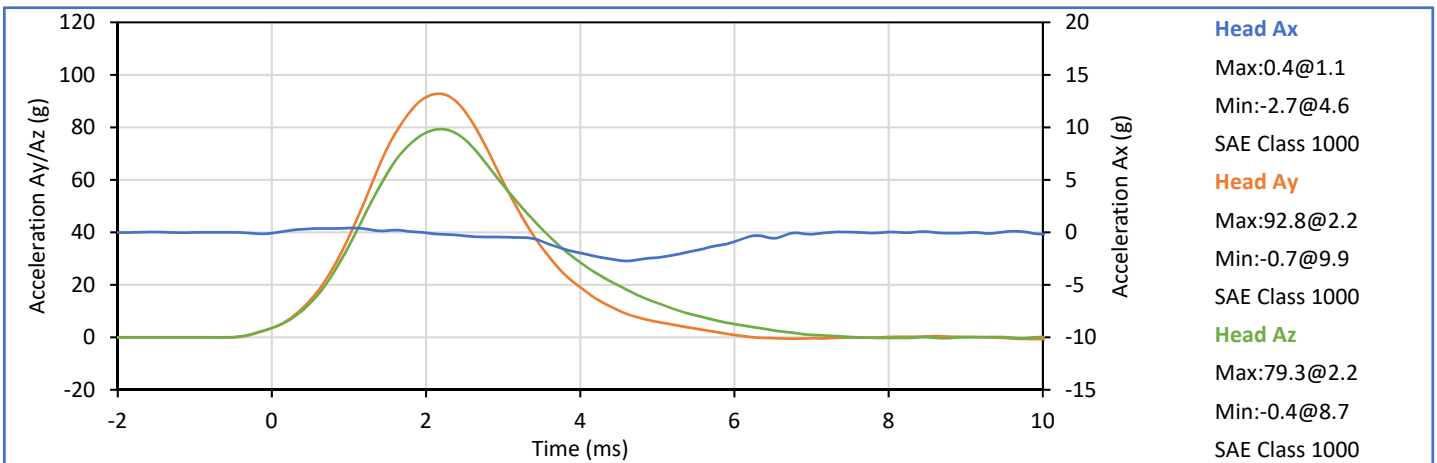
Technician:   
 J. Hernandez

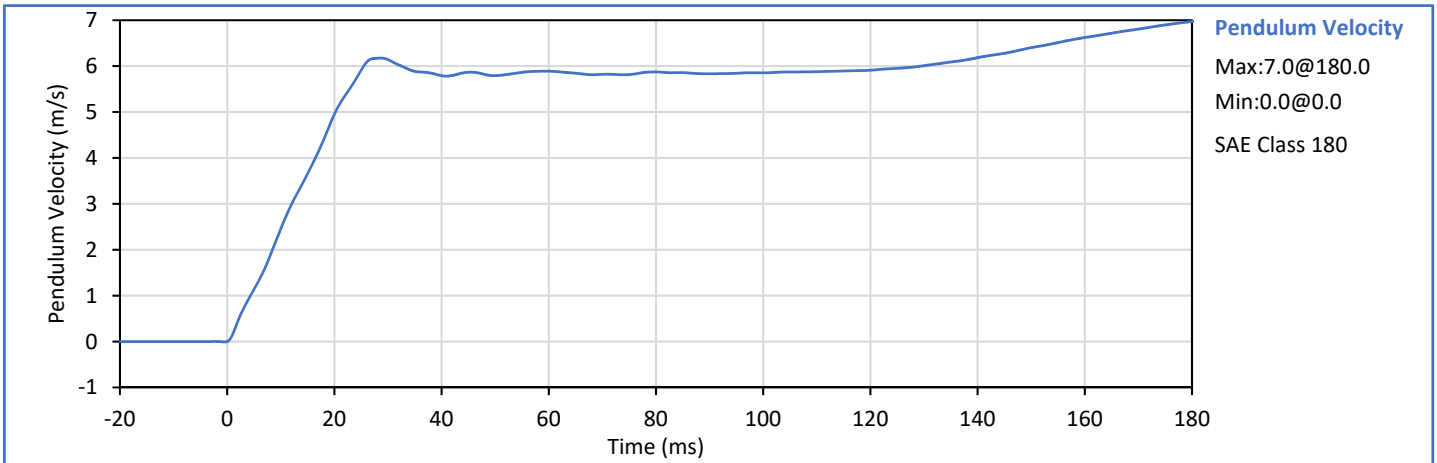
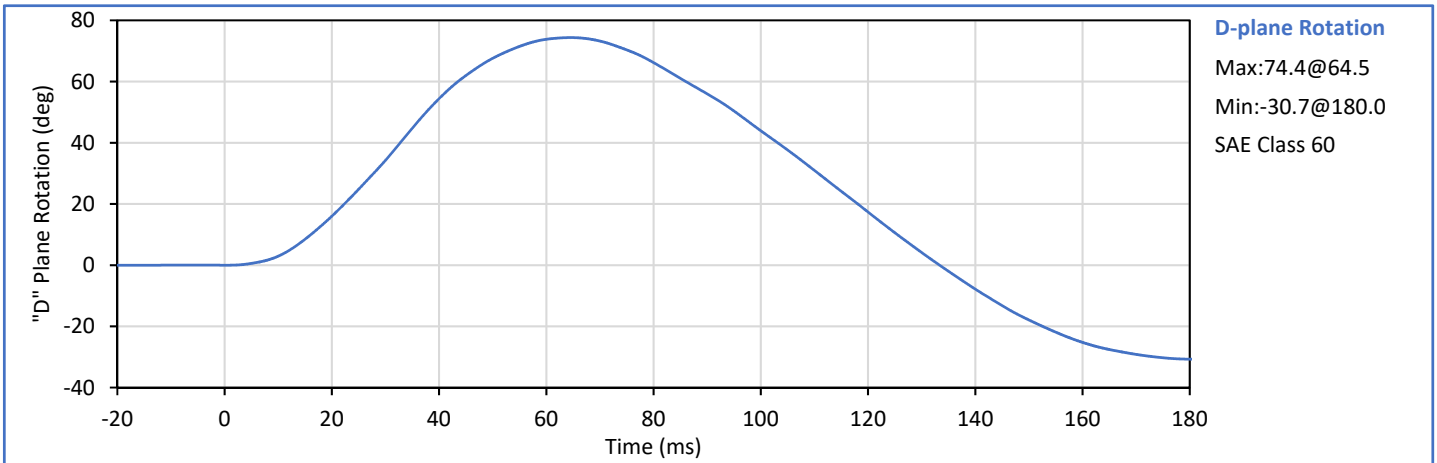
Tested Parameter	Units	Spec. Low	Spec. High	Result	Pass/Fail
Laboratory Temperature	°C	20.6	22.2	21.4	Pass
Laboratory Humidity	%	10	70	30	Pass
Pendulum Velocity	m/s	5.51	5.63	5.61	Pass
Pendulum Decel at 10 ms	m/s	2.20	2.80	2.45	Pass
Pendulum Decel at 15 ms	m/s	3.30	4.10	3.66	Pass
Pendulum Decel at 20 ms	m/s	4.40	5.40	4.95	Pass
Pendulum Decel at 25 ms	m/s	5.40	6.10	5.91	Pass
Pendulum Decel from 25-100 ms	m/s	5.50	6.20	6.18	Pass
Peak "D" Plane Rotation	deg	71.0	81.0	74.4	Pass
Time of Peak "D" Plane Rotation	ms	50.0	70.0	64.5	Pass
Peak Occ. Condyle Moment	Nm	-44.0	-36.0	-41.0	Pass
Time of Moment Decay to 0 Nm	ms	102.0	126.0	116.7	Pass
<b>Overall Test Results</b>					<b>Pass</b>

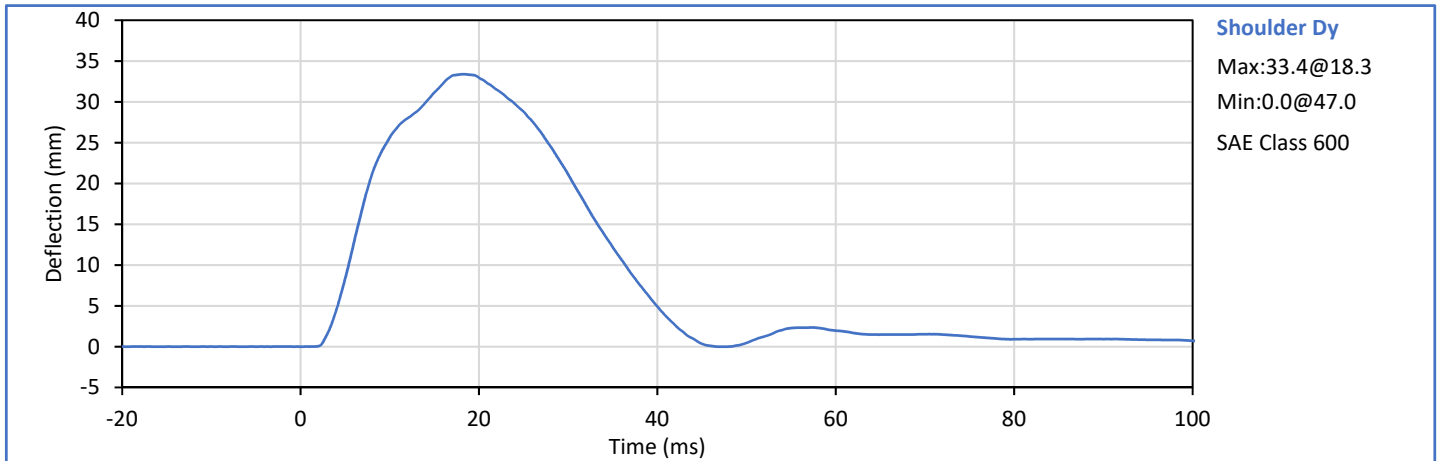
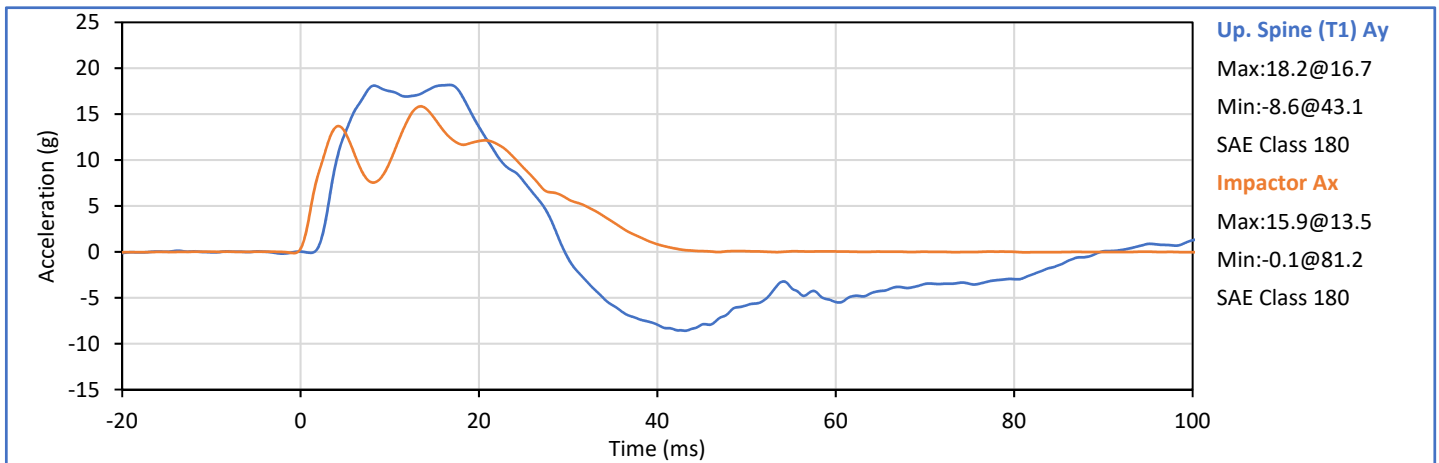
Technician:   
 J. Hernandez

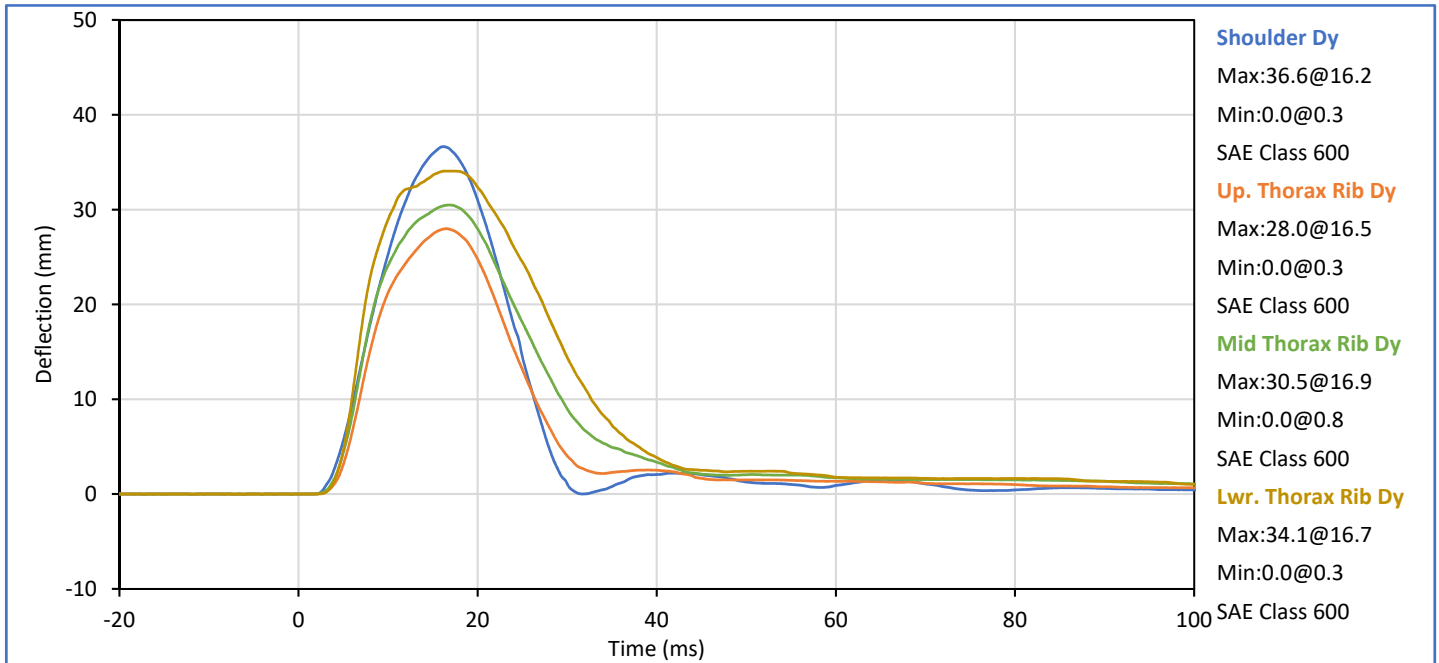
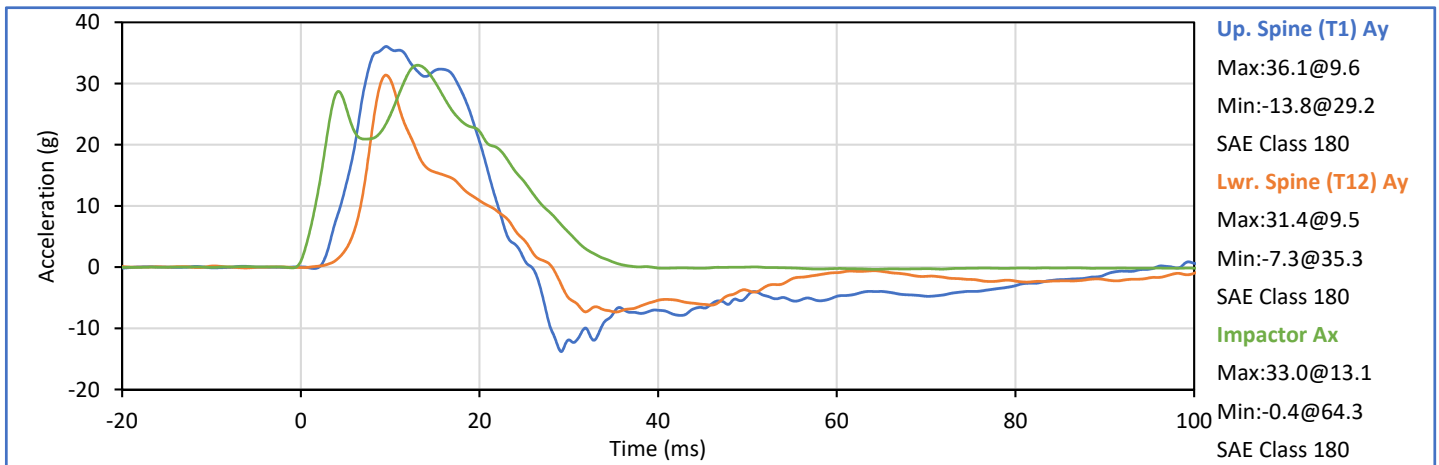
Tested Parameter	Units	Spec. Low	Spec. High	Result	Pass/Fail
Laboratory Temperature	°C	20.6	22.2	21.4	Pass
Laboratory Humidity	%	10	70	30	Pass
Impactor Velocity	m/s	6.60	6.80	6.67	Pass
Peak Shoulder Dy	mm	31.0	40.0	36.6	Pass
Peak Upper Rib Dy	mm	25.0	32.0	28.0	Pass
Peak Middle Rib Dy	mm	30.0	36.0	30.5	Pass
Peak Lower Rib Dy	mm	32.0	38.0	34.1	Pass
Peak Upper Spine (T1) Ay	g	34.0	43.0	36.1	Pass
Peak Lower Spine (T12) Ay	g	29.0	37.0	31.4	Pass
Peak Impactor Ax	g	30.0	36.0	33.0	Pass
<b>Overall Test Results</b>					<b>Pass</b>

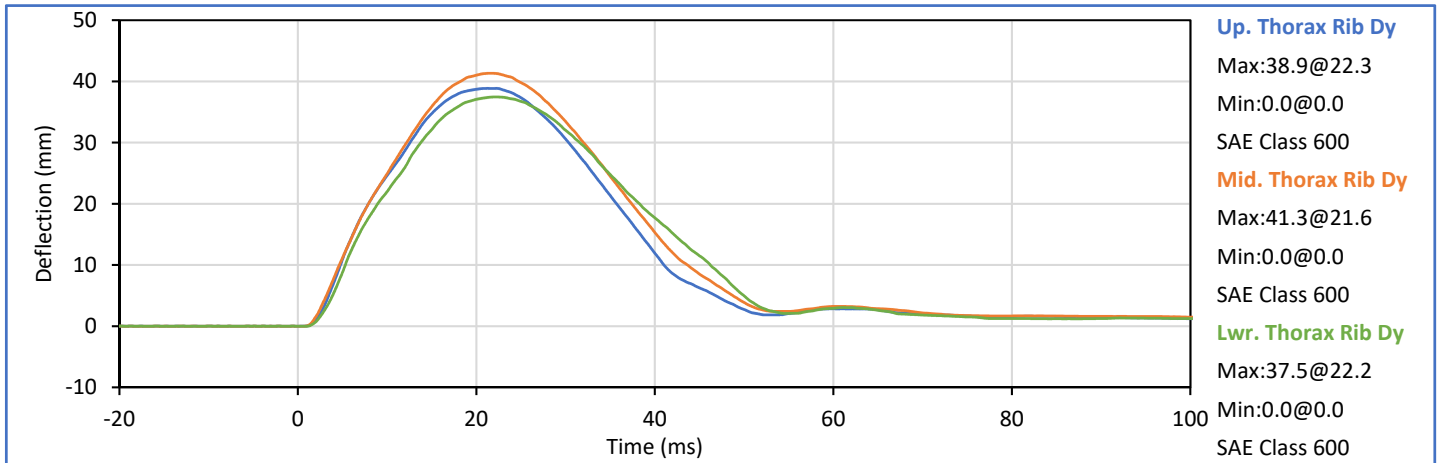
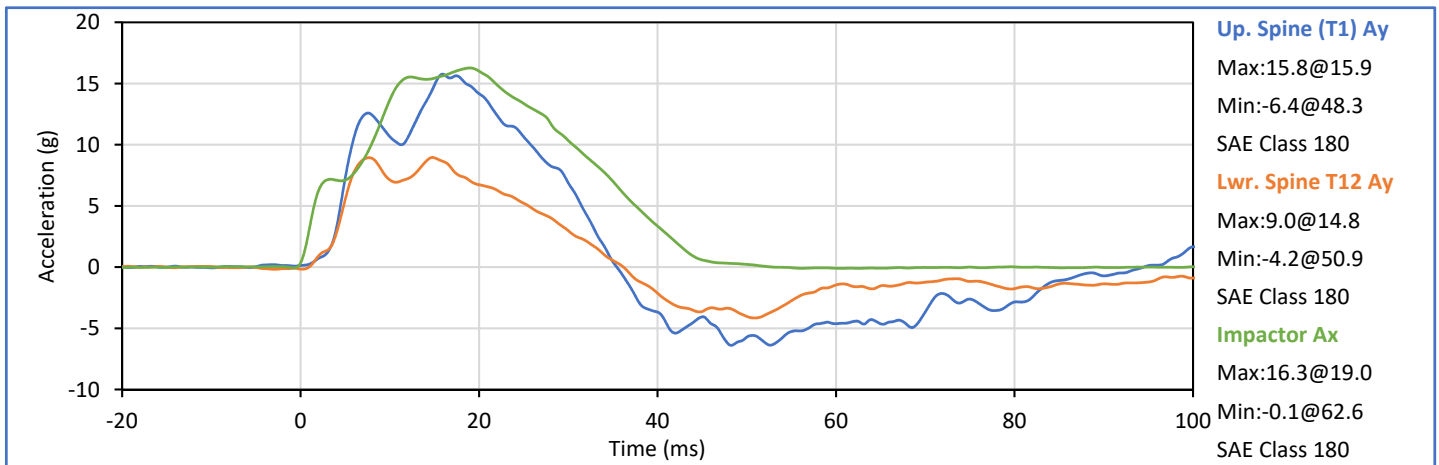
Technician:   
 J. Hernandez

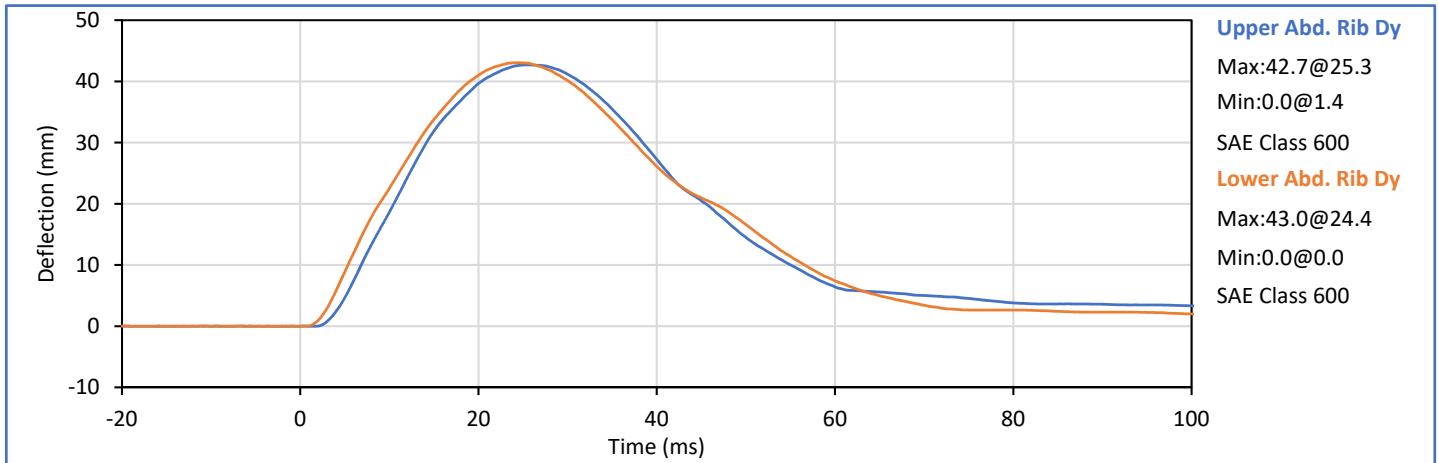
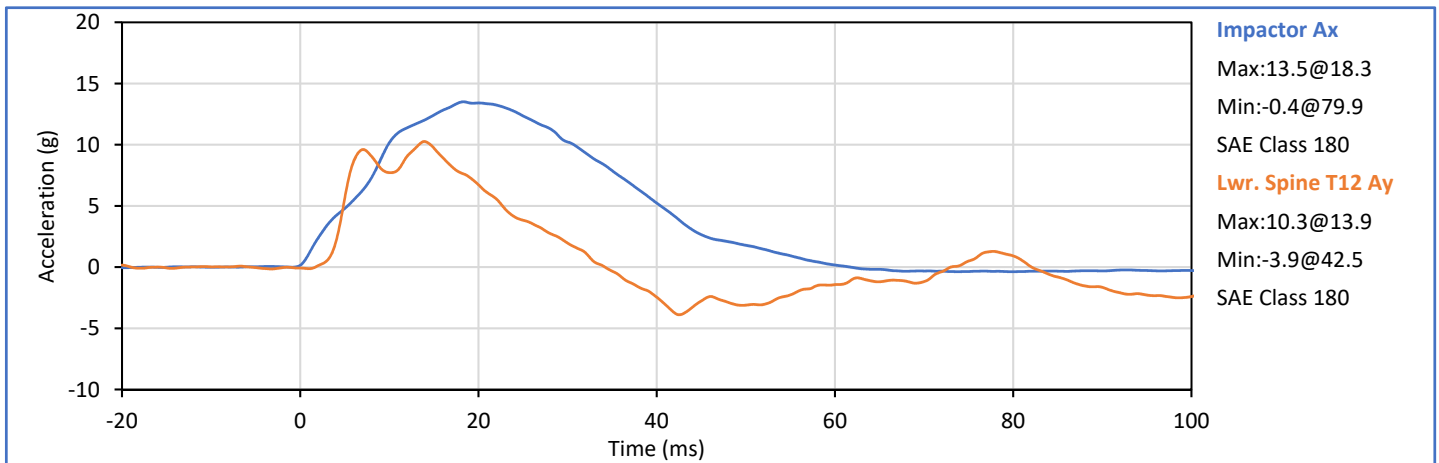
Tested Parameter	Units	Spec. Low	Spec. High	Result	Pass/Fail
Laboratory Temperature	°C	20.6	22.2	21.1	Pass
Laboratory Humidity	%	10	70	30	Pass
Impactor Velocity	m/s	4.20	4.40	4.33	Pass
Peak Upper Abdomen Rib Dy	mm	36.0	47.0	42.7	Pass
Peak Lower Abdomen Rib Dy	mm	33.0	44.0	43.0	Pass
Peak Lower Spine T12 Ay	mm	9.0	14.0	10.3	Pass
Peak Impactor Ax	g	12.0	16.0	13.5	Pass
<b>Overall Test Results</b>					<b>Pass</b>
