**REPORT NUMBER: SINCAP-KAR-19-006**

**NEW CAR ASSESSMENT PROGRAM (NCAP)  
MOVING DEFORMABLE BARRIER SIDE IMPACT TEST**

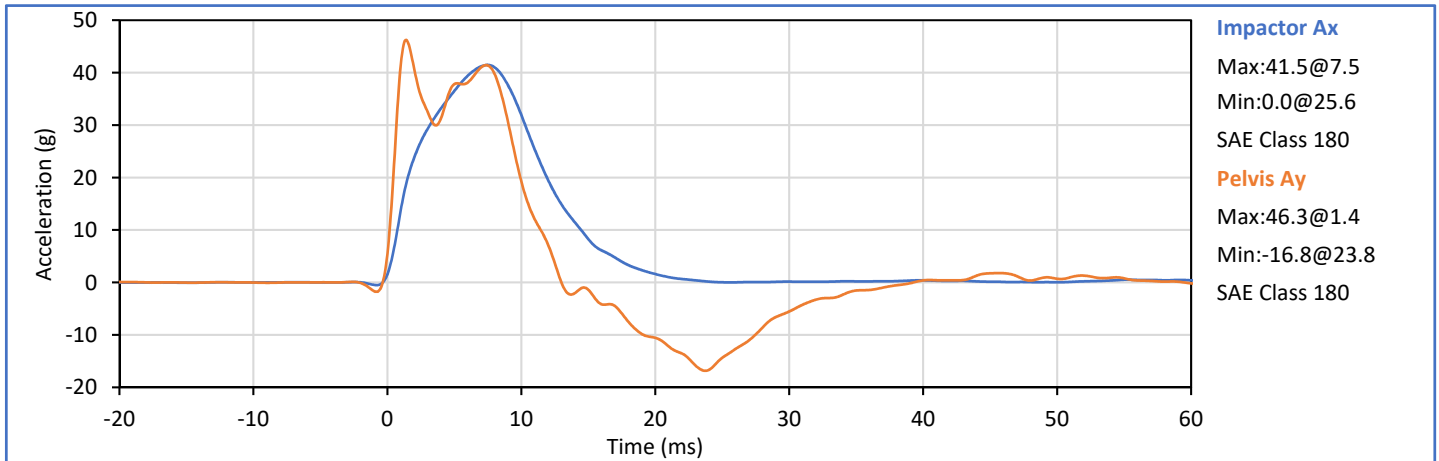
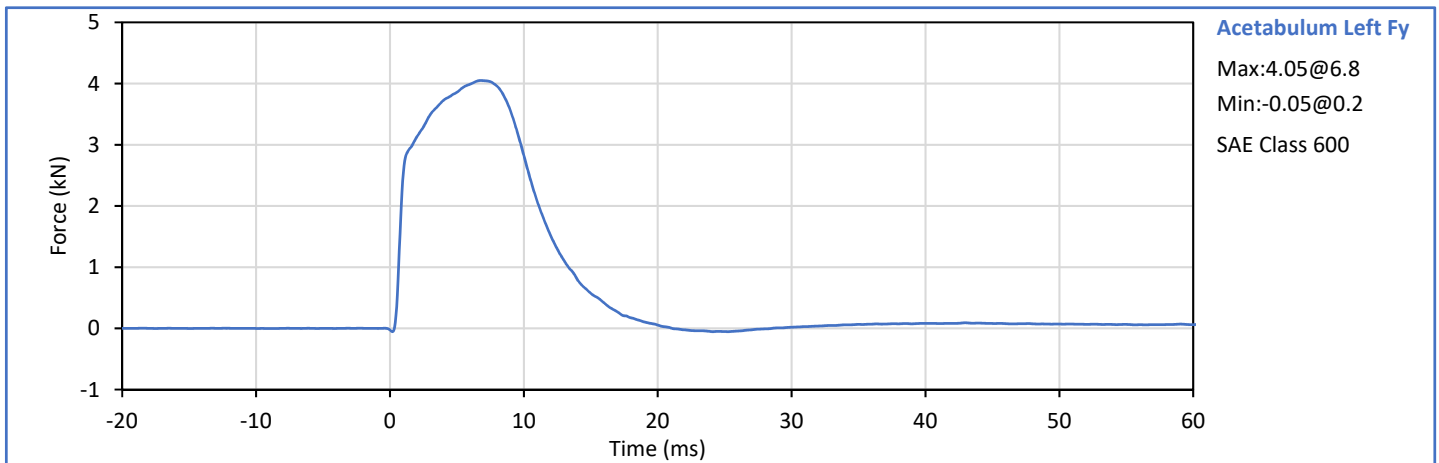
Technician:   
 J. Hernandez
