**REPORT NUMBER: SPNCAP-MGA-2019-010**

**NEW CAR ASSESSMENT PROGRAM (NCAP)  
Side Impact Pole Test**

**FCA US LLC  
2019 Dodge Durango SXT 5-Door SUV  
NHTSA No.: M20190301**

**MGA RESEARCH CORPORATION  
5000 Warren Road  
Burlington, WI 53105**

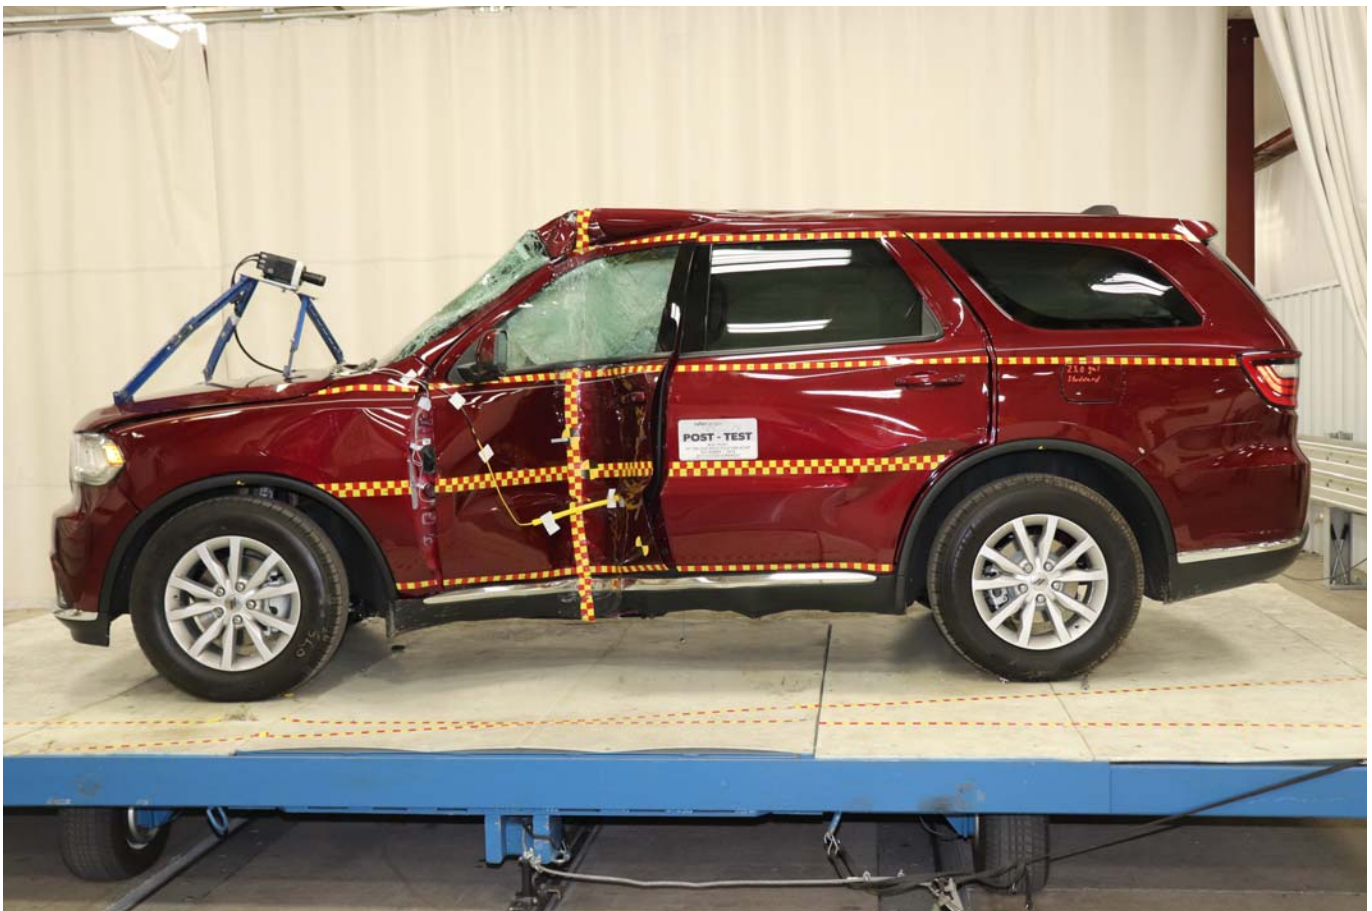
Photo No. 008 - Post-Test Left Side View of Test Vehicle

Critical Areas of Performance	Observations and Conclusions
Pillar Performance	No Separation
Sill Separation	None
Windshield Damage	Cracked
Side Window Damage	Left Front Window Cracked
Other Notable Effects	None

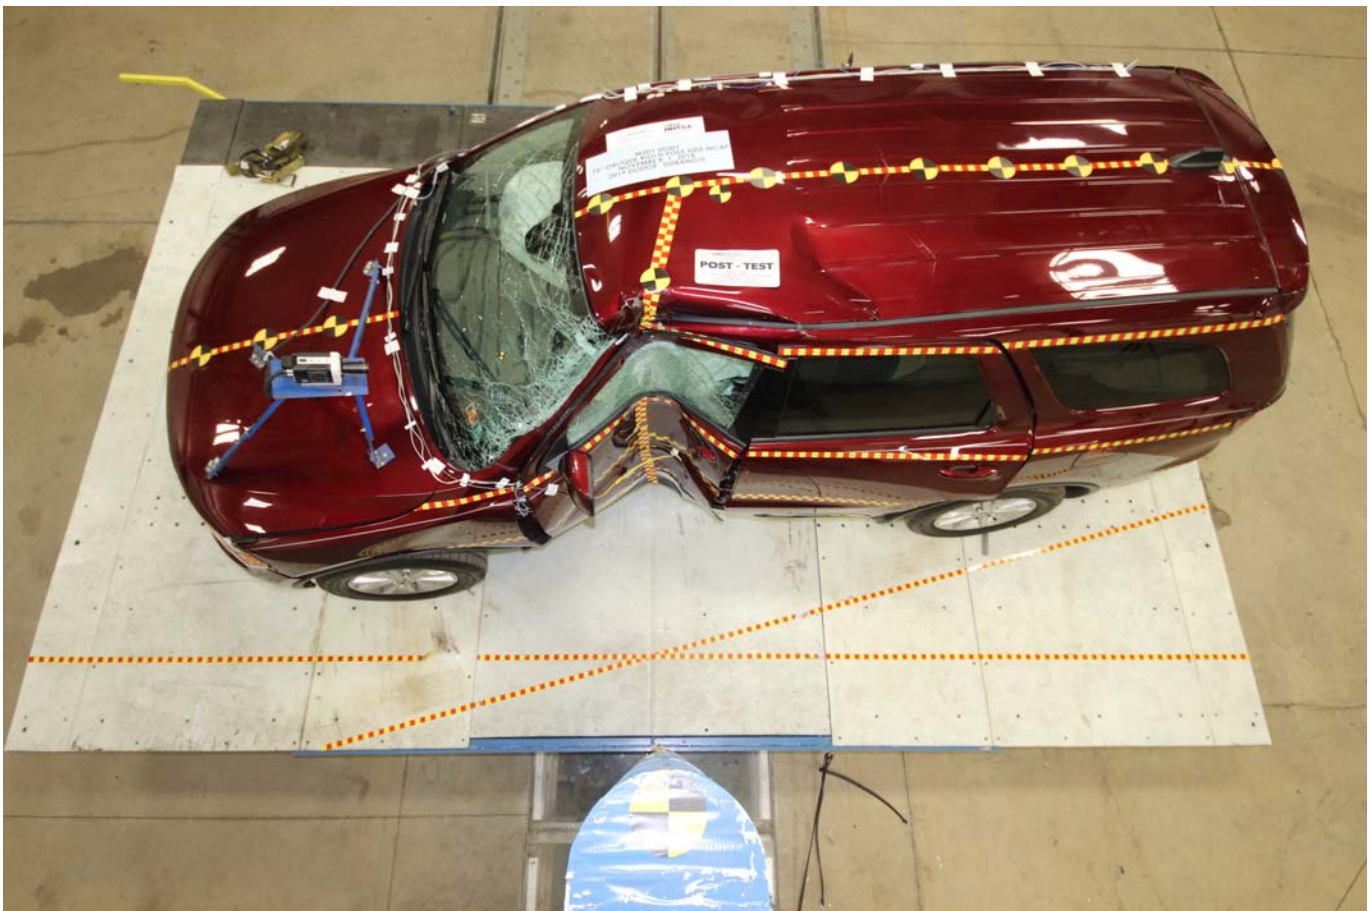
Photo No. 016 - Post-Test Overhead View of Test Area

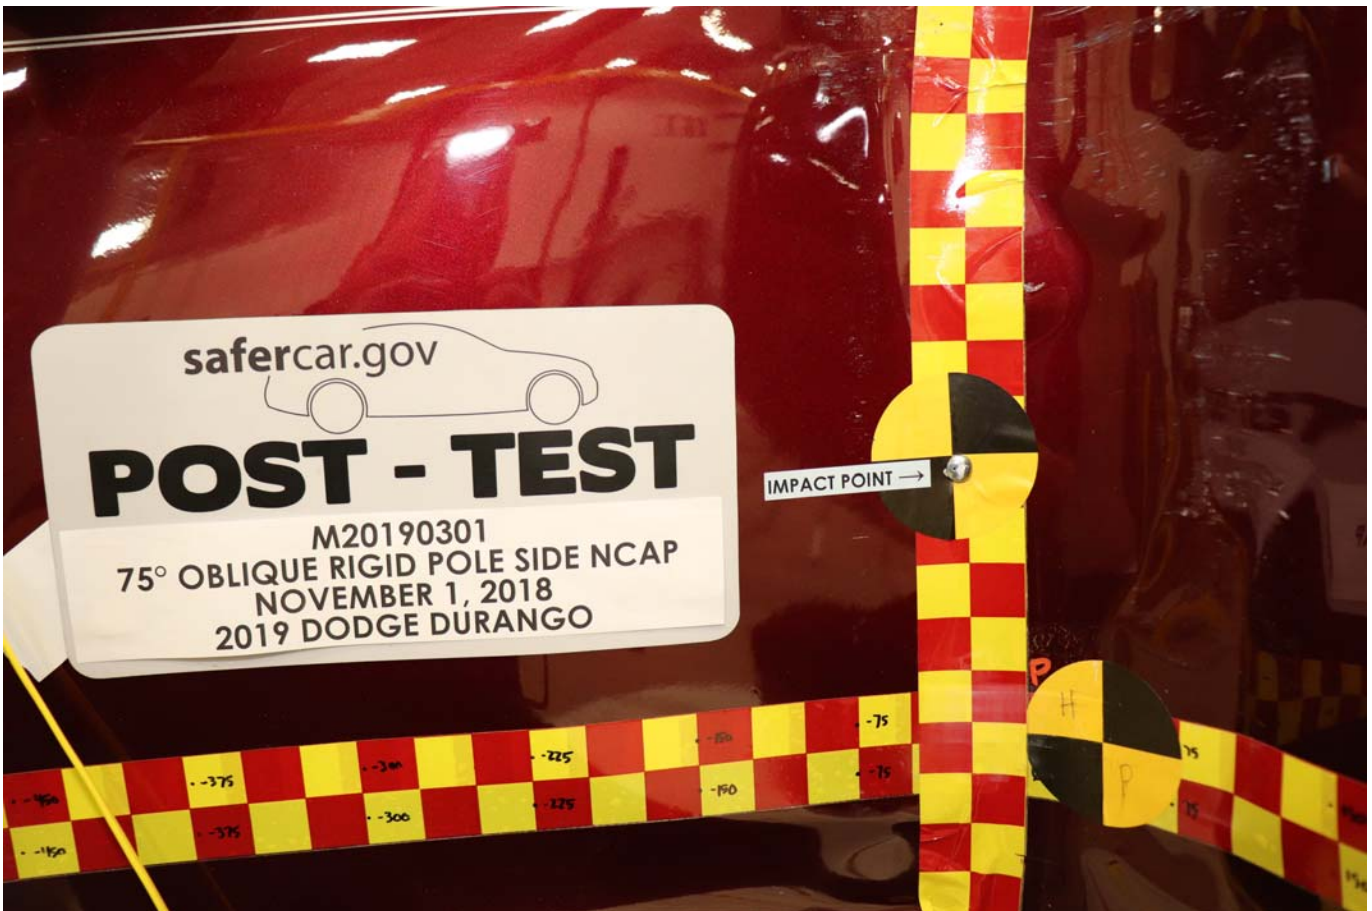
Photo No. 020 - Post-Test Close-Up View of Impact Point Target Showing Impact Location

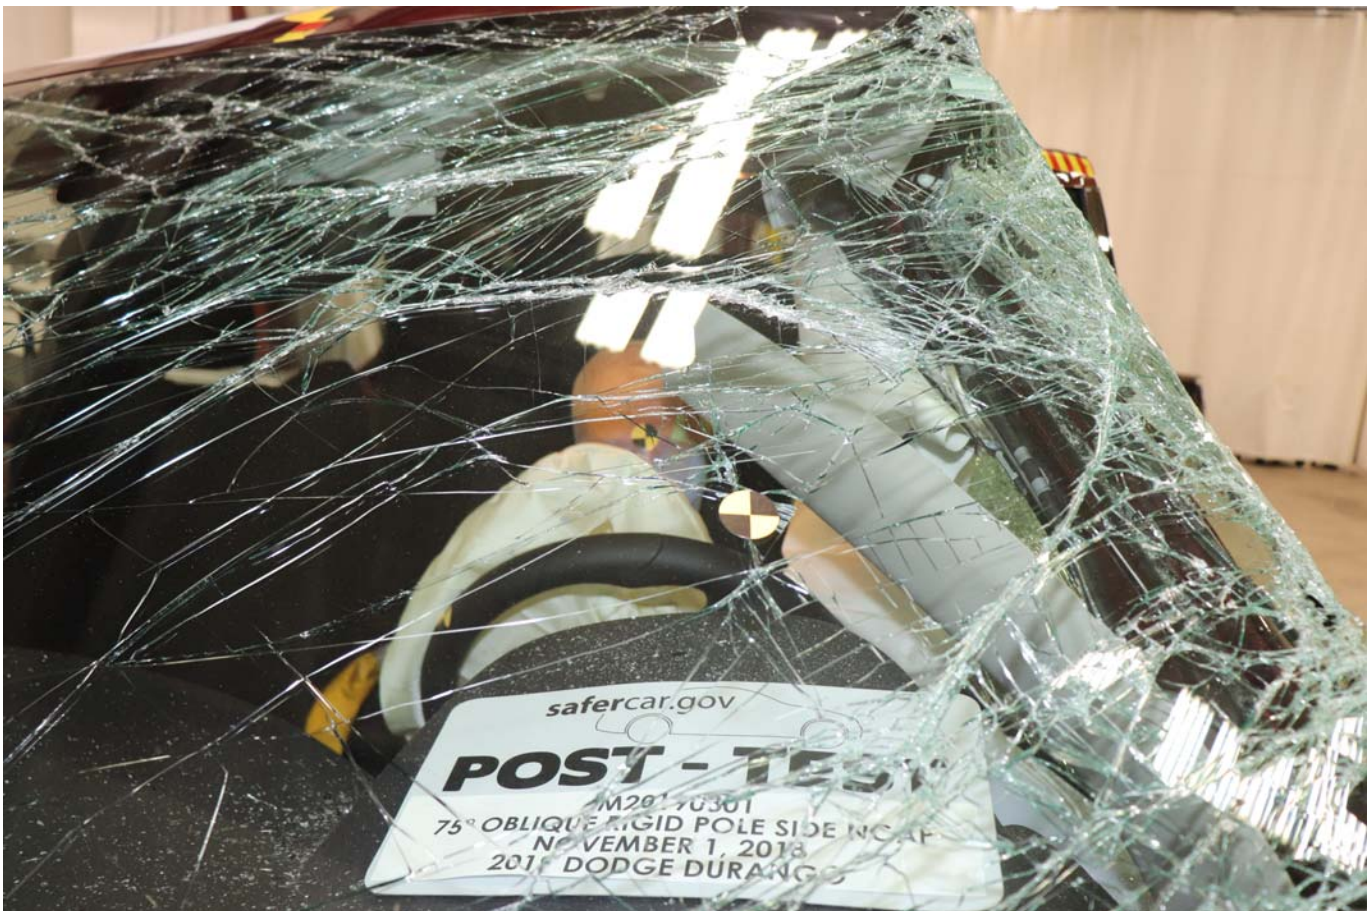
Photo No. 022 - Post-Test Front Close-Up View of Dummy

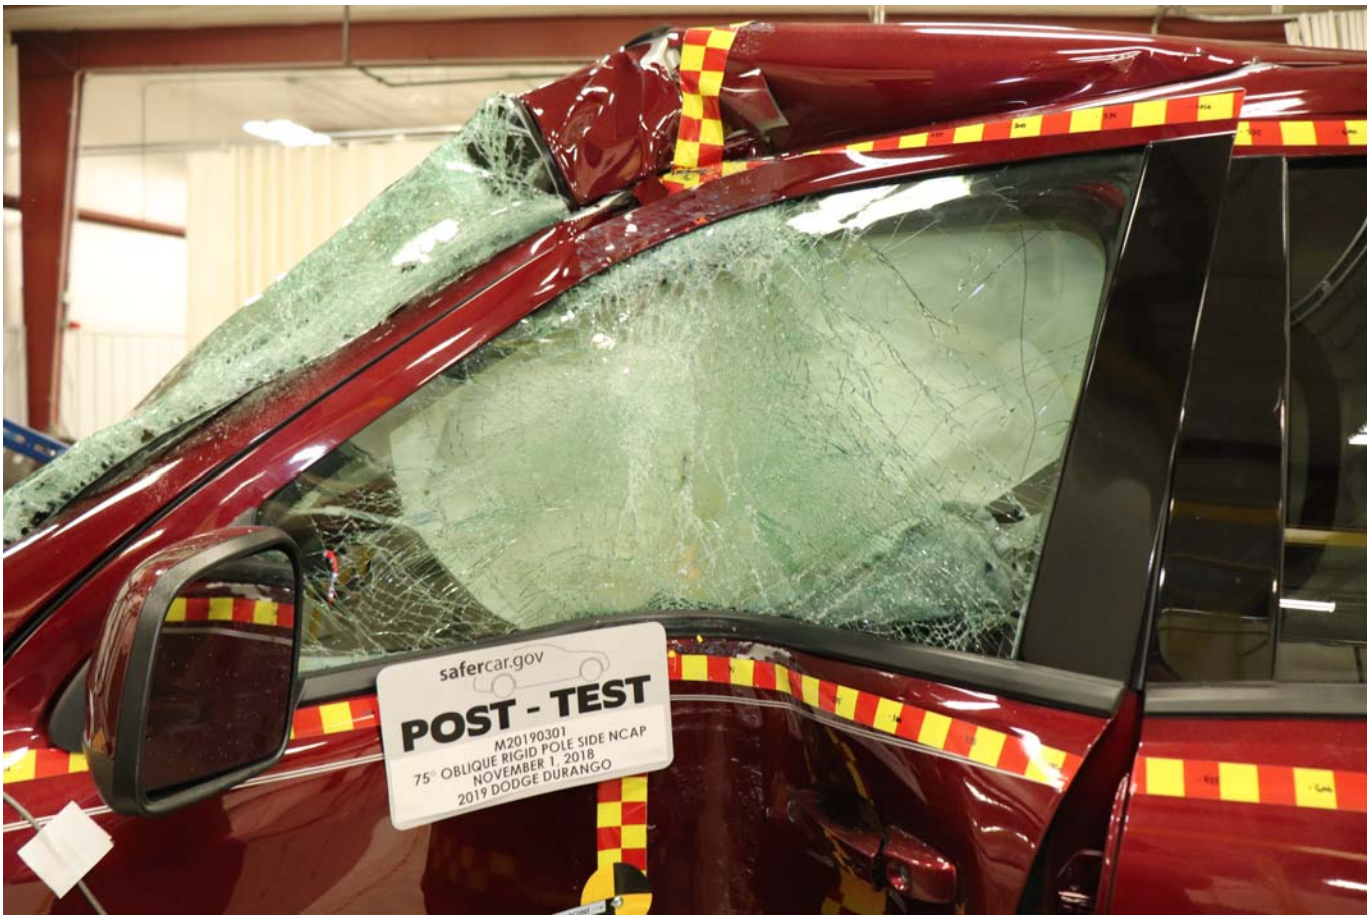
Photo No. 025 - Post-Test Left Side View of Dummy Shoulder and Door Top View

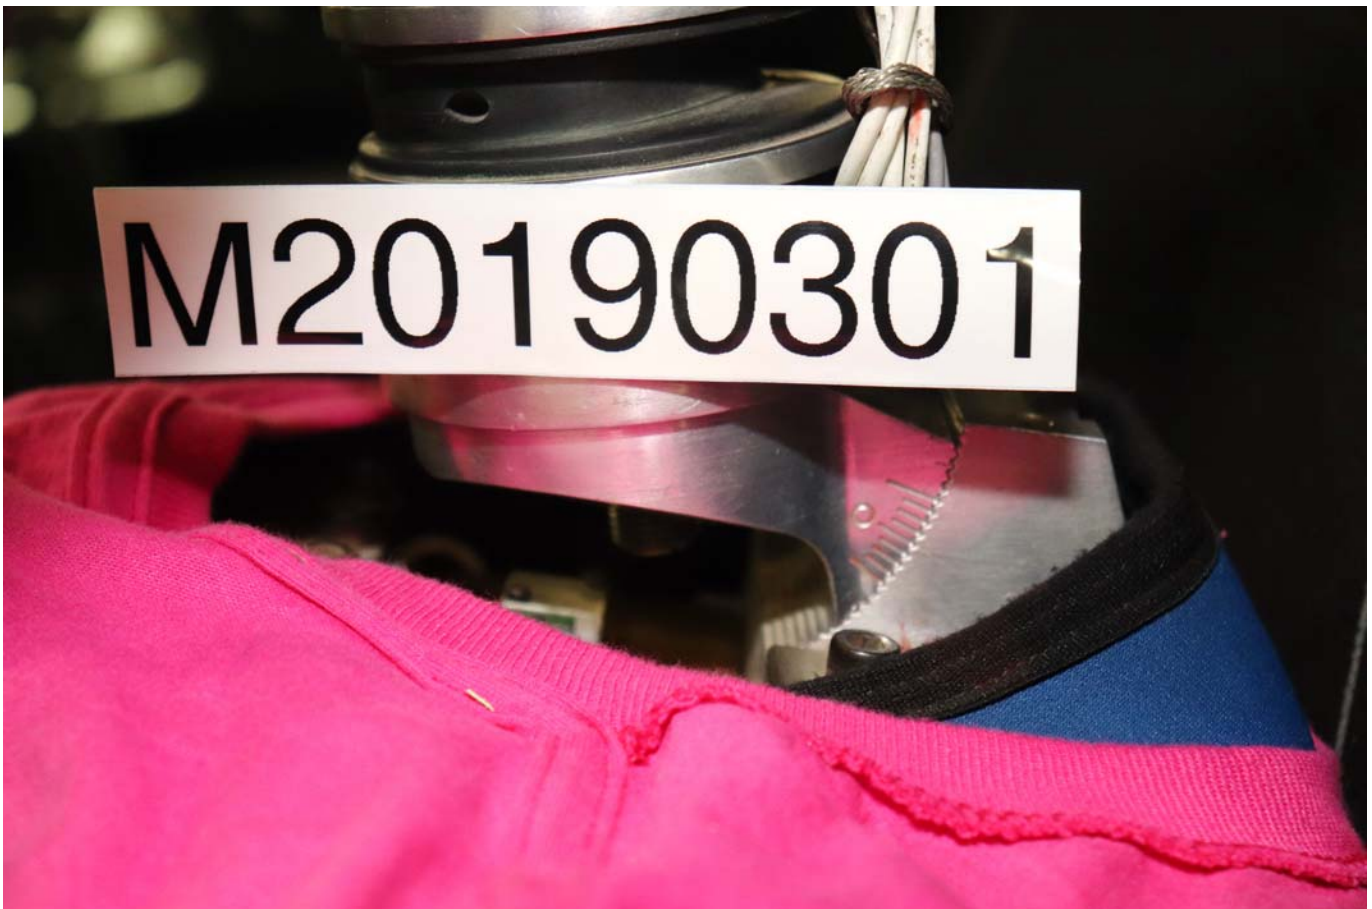
Photo No. 030 - Pre-Test Left Side View of Dummy Neck Showing Position of Adjustable Neck Bracket

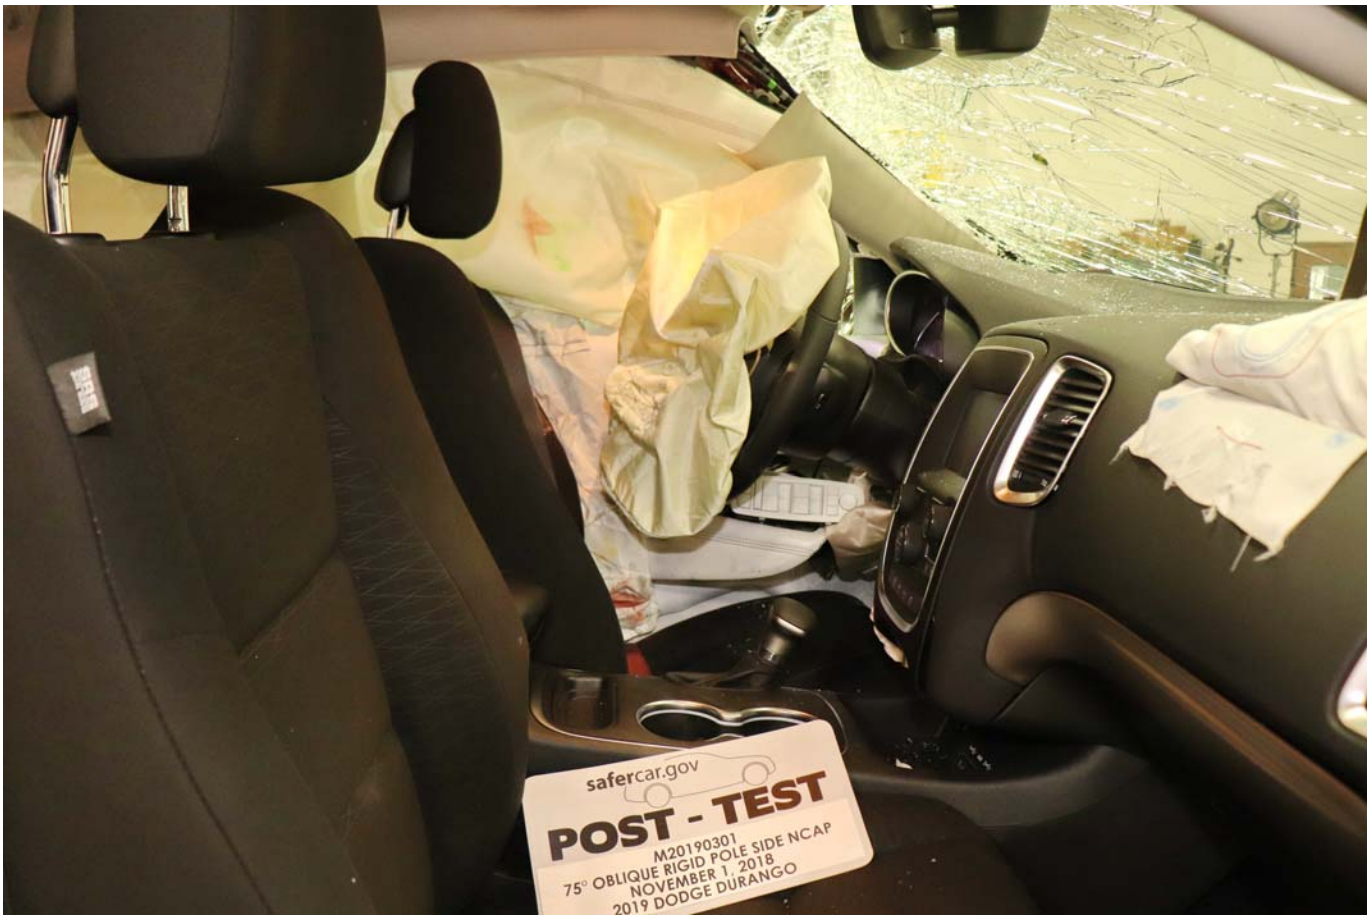
Photo No. 045 - Post-Test Inner Door Panel View Showing Dummy Contact Location

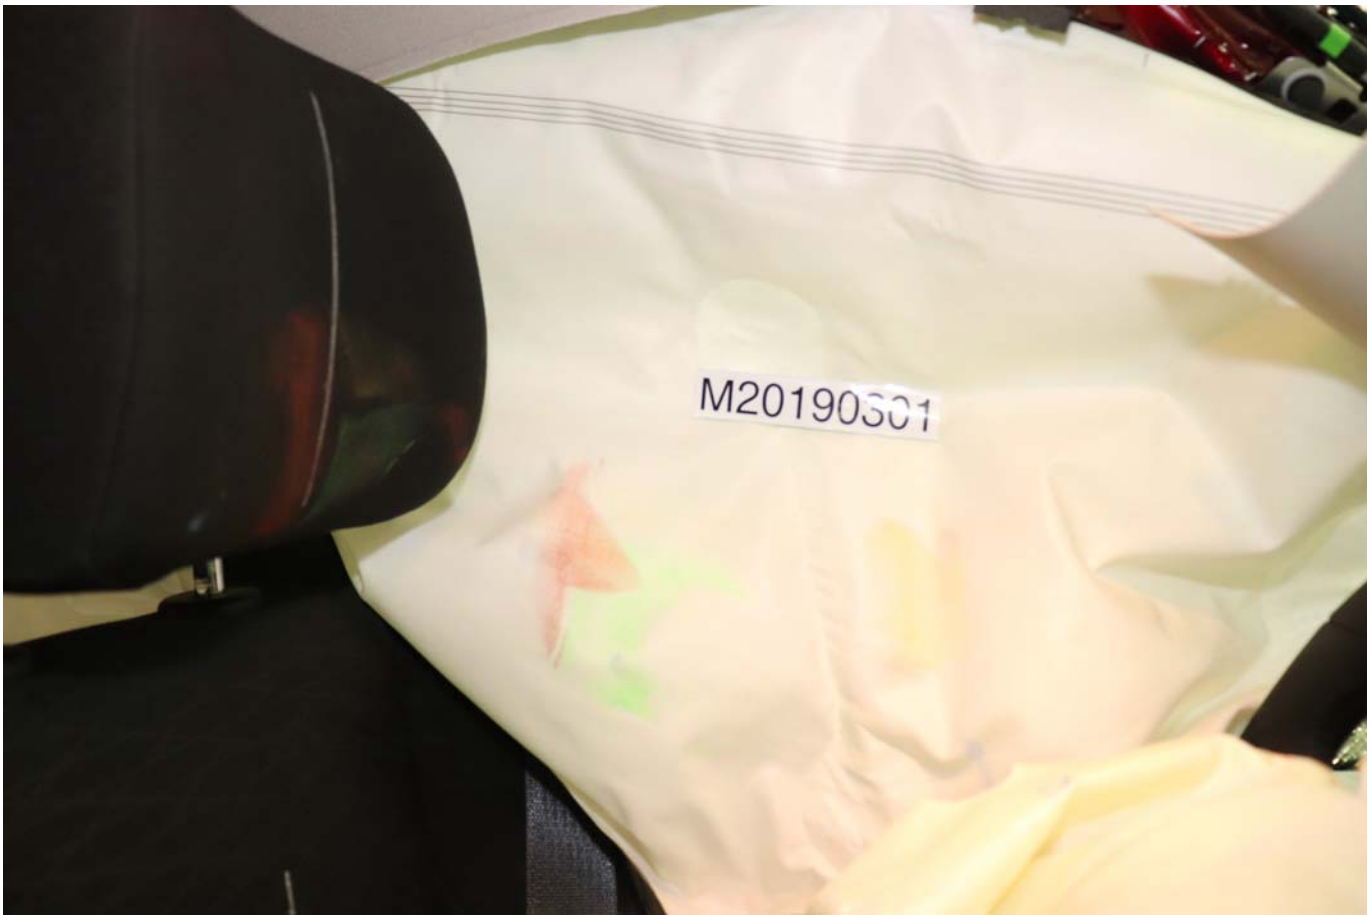
Photo No. 047 - Post-Test Dummy Close-Up Head Contact with Side Air Bag View

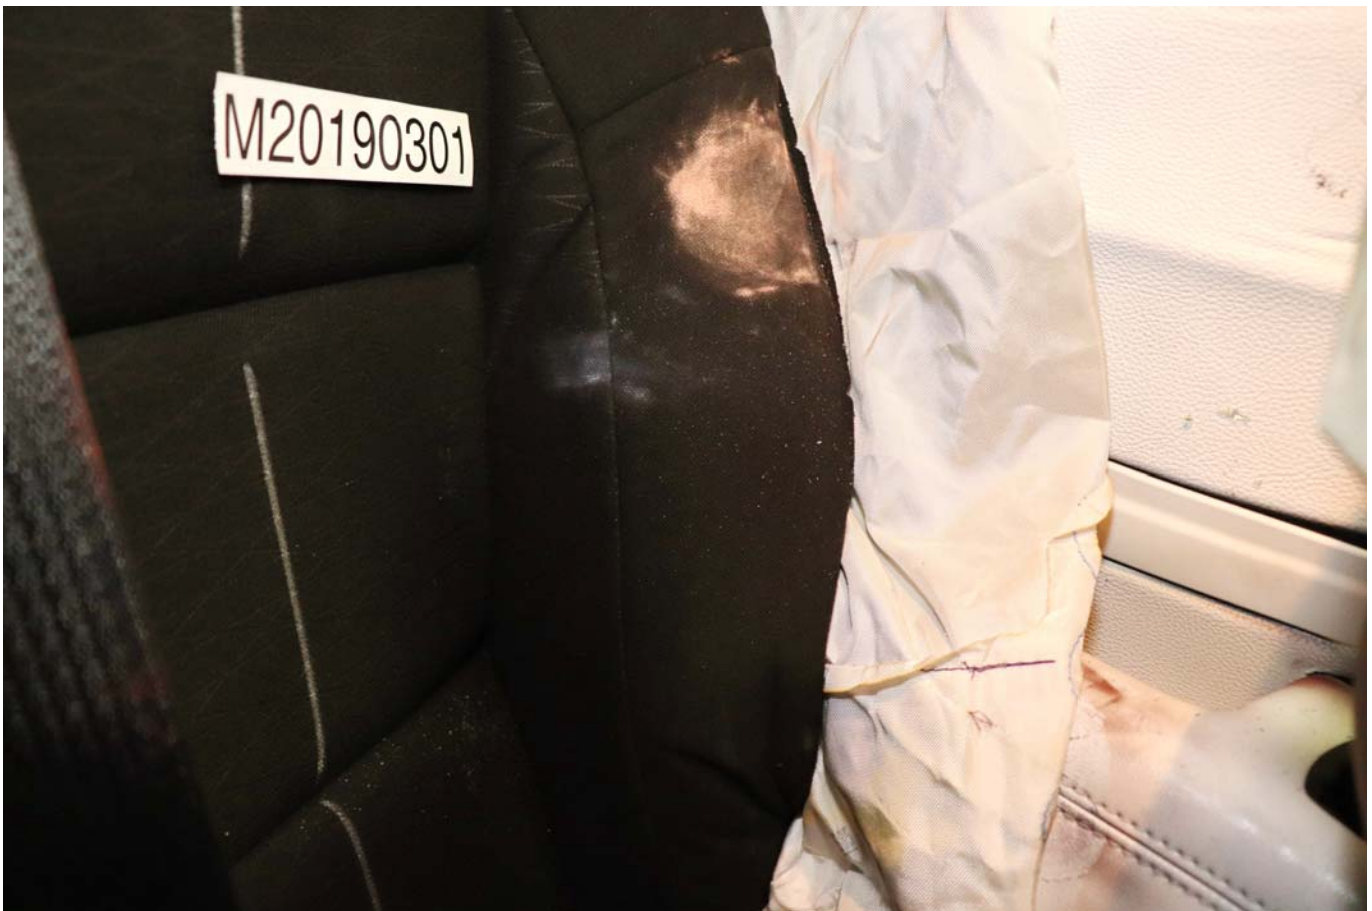
Photo No. 048 - Post-Test Dummy Close-Up Torso Contact with Vehicle Interior View

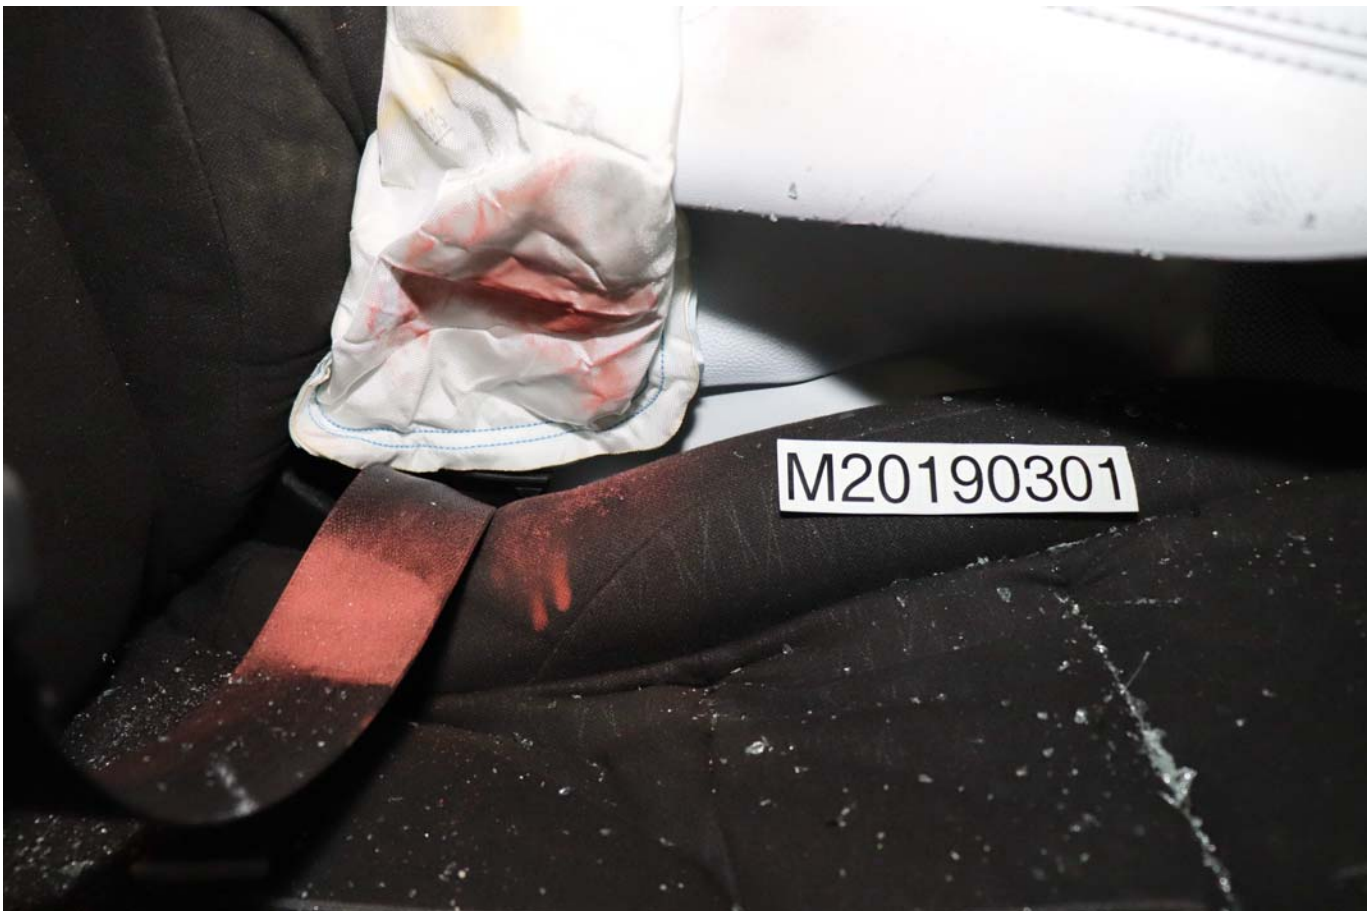
Photo No. 050 - Post-Test Dummy Close-Up Pelvis Contact with Vehicle Interior View

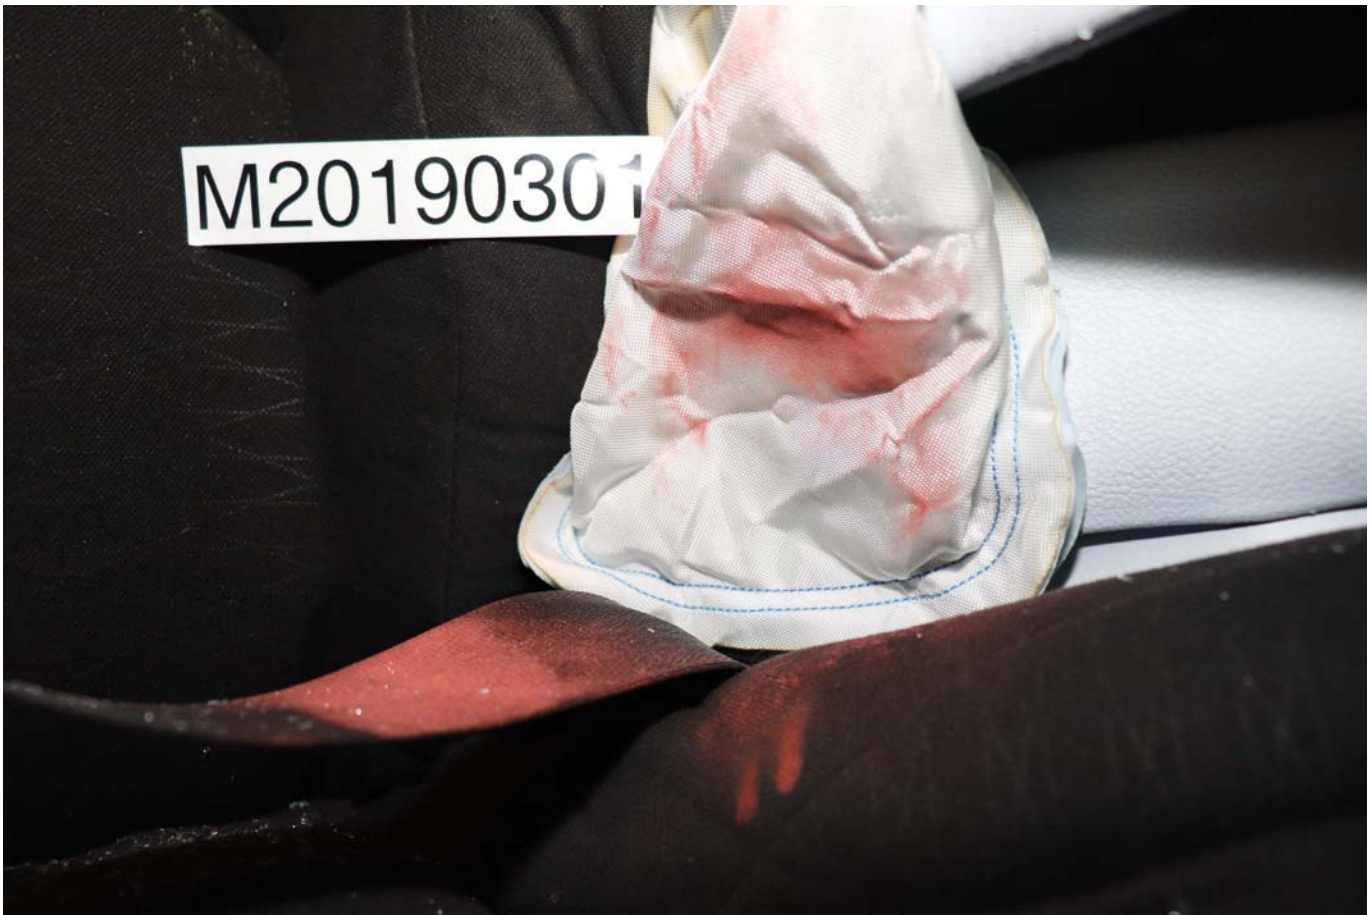
Photo No. 051 - Post-Test Dummy Close-Up Pelvis Contact with Side Air Bag View

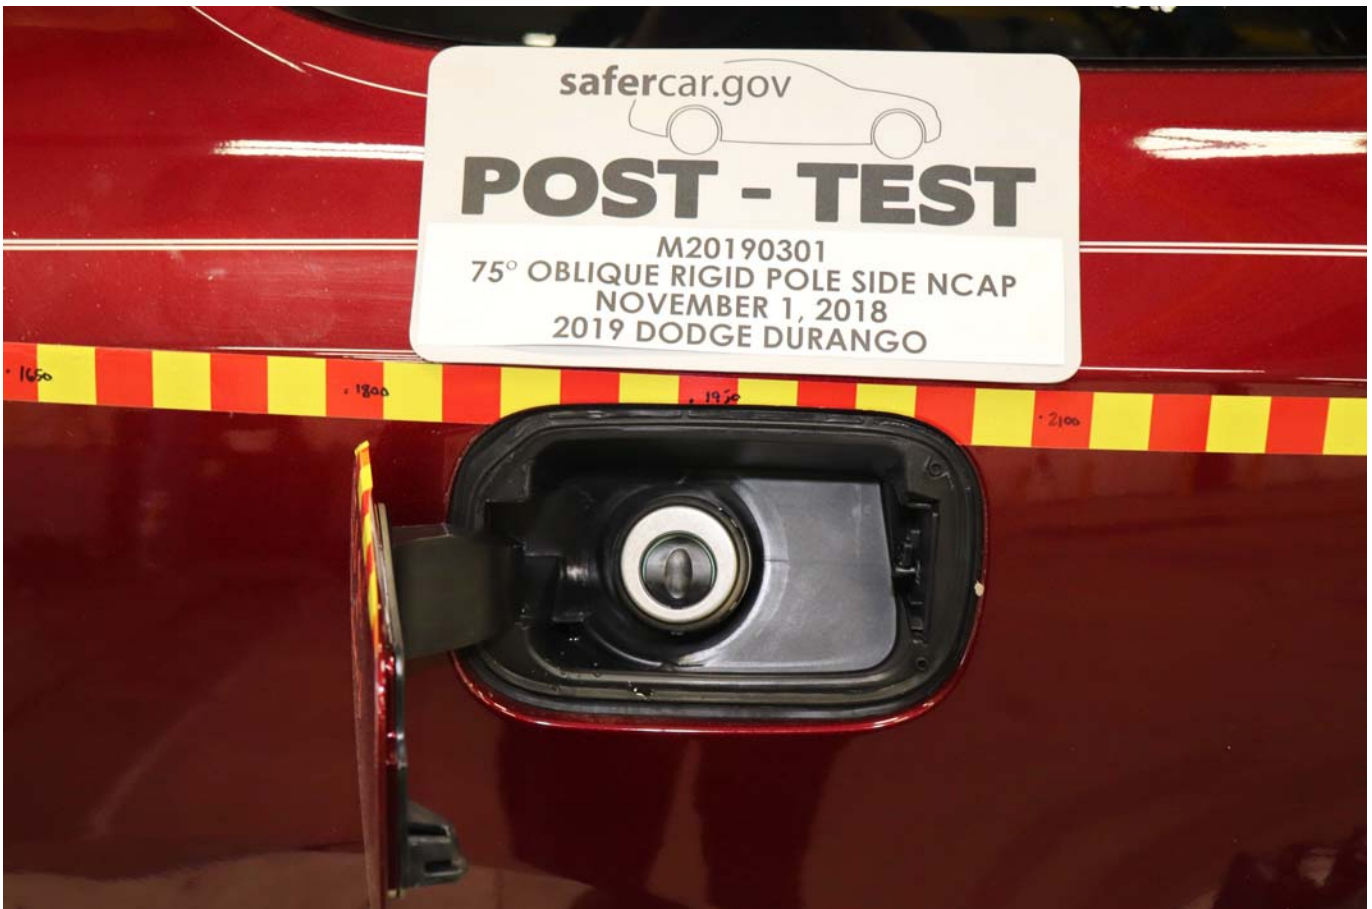
Photo No. 054 - Post-Test View of Fuel Filler Cap or Fuel Filler Neck

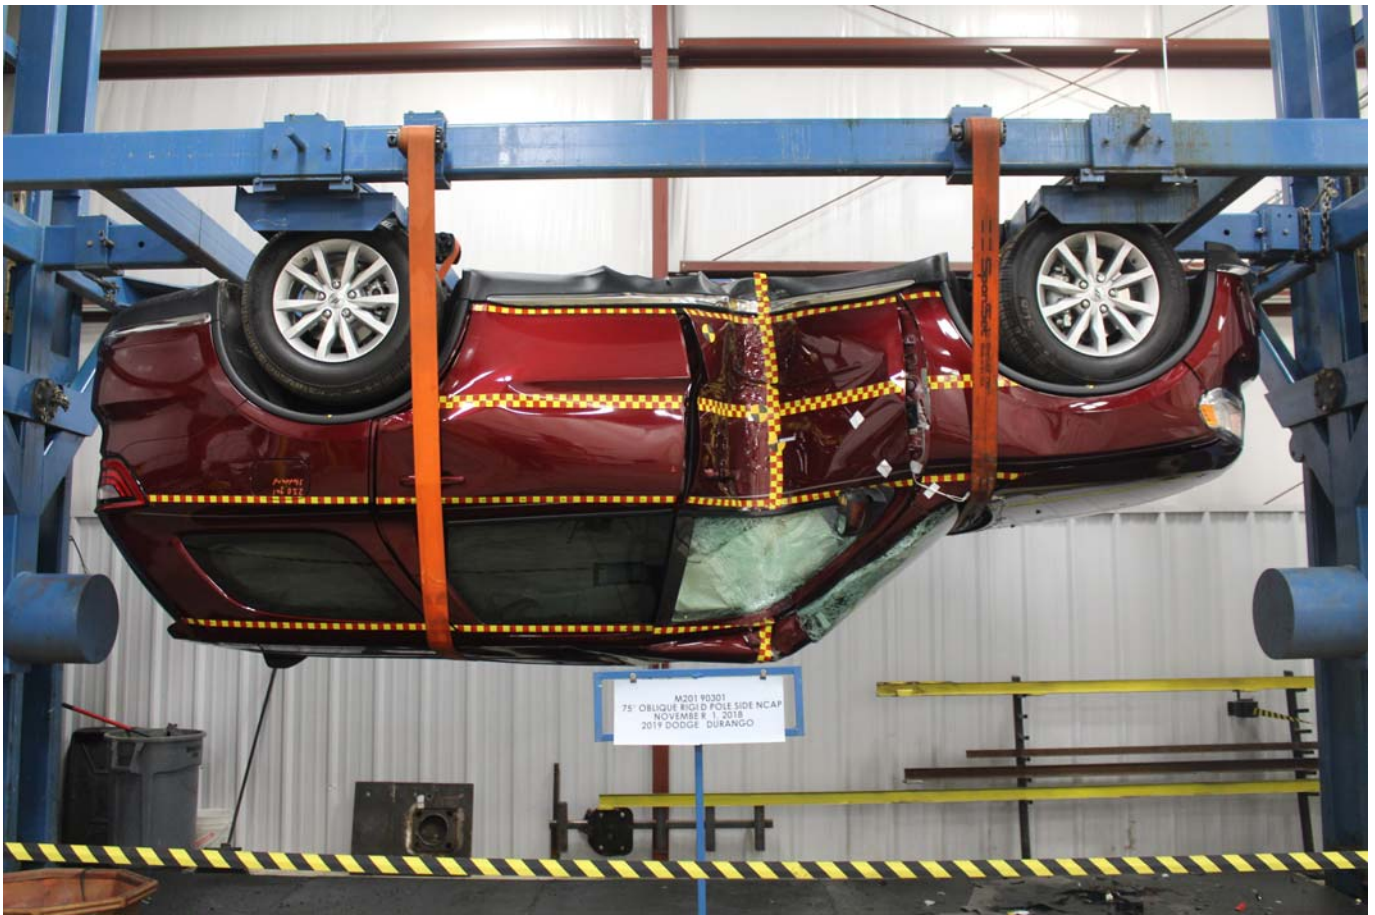
Photo No. 065 - FMVSS Photo No. 301 Static Rollover 180 Degrees

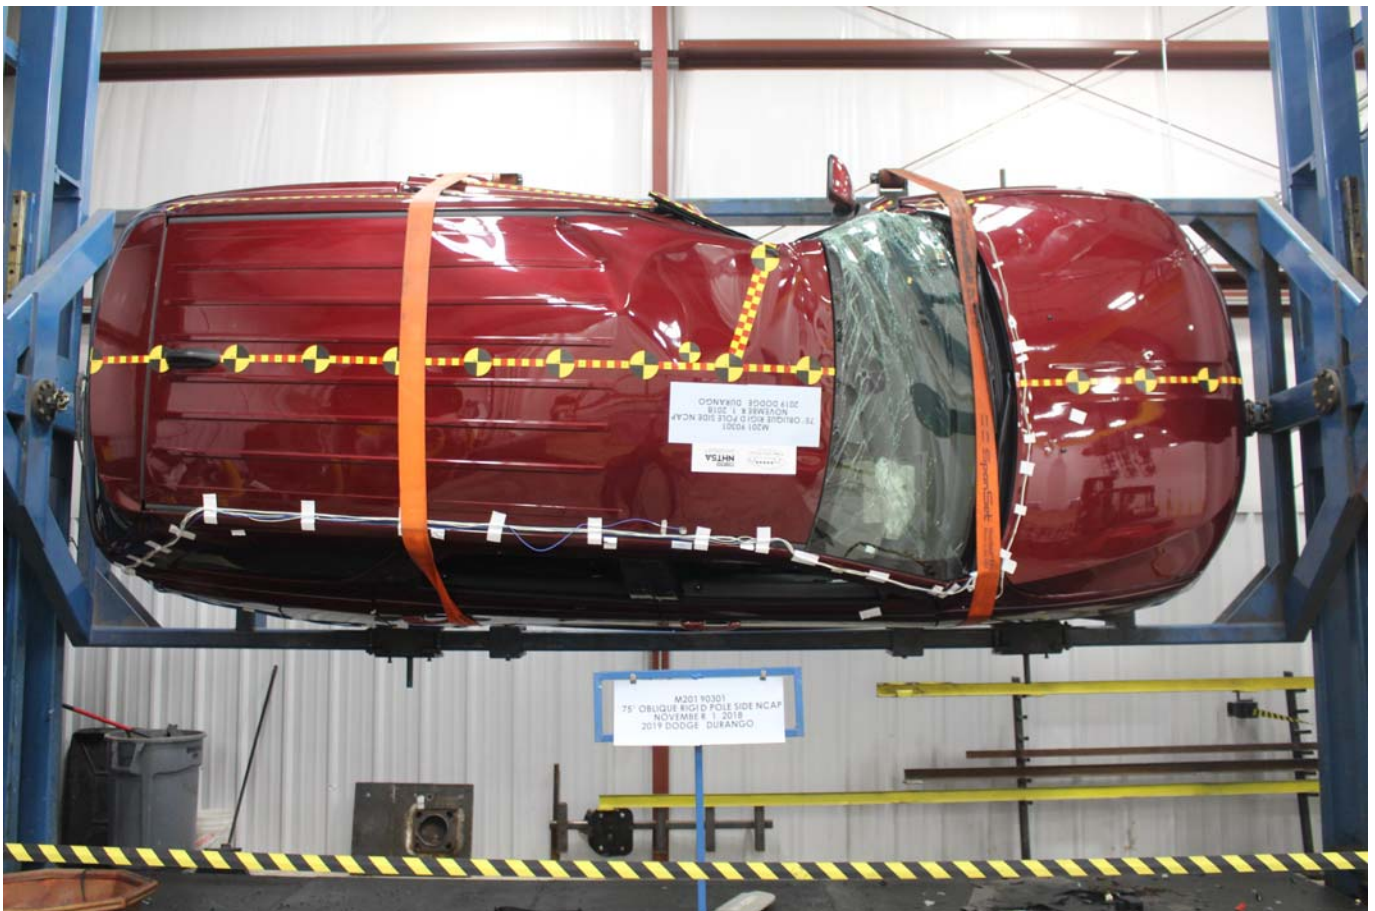
Photo No. 066 - FMVSS Photo No. 301 Static Rollover 270 Degrees
