**REPORT NUMBER: SPNCAP-KAR-19-007  
NEW CAR ASSESSMENT PROGRAM (NCAP)  
SIDE IMPACT POLE TEST**

**NISSAN MOTOR CO. LTD  
2019 NISSAN FRONTIER S CREW CAB 4-DOOR TRUCK**

**NHTSA No: M20195204**

**FINAL REPORT**

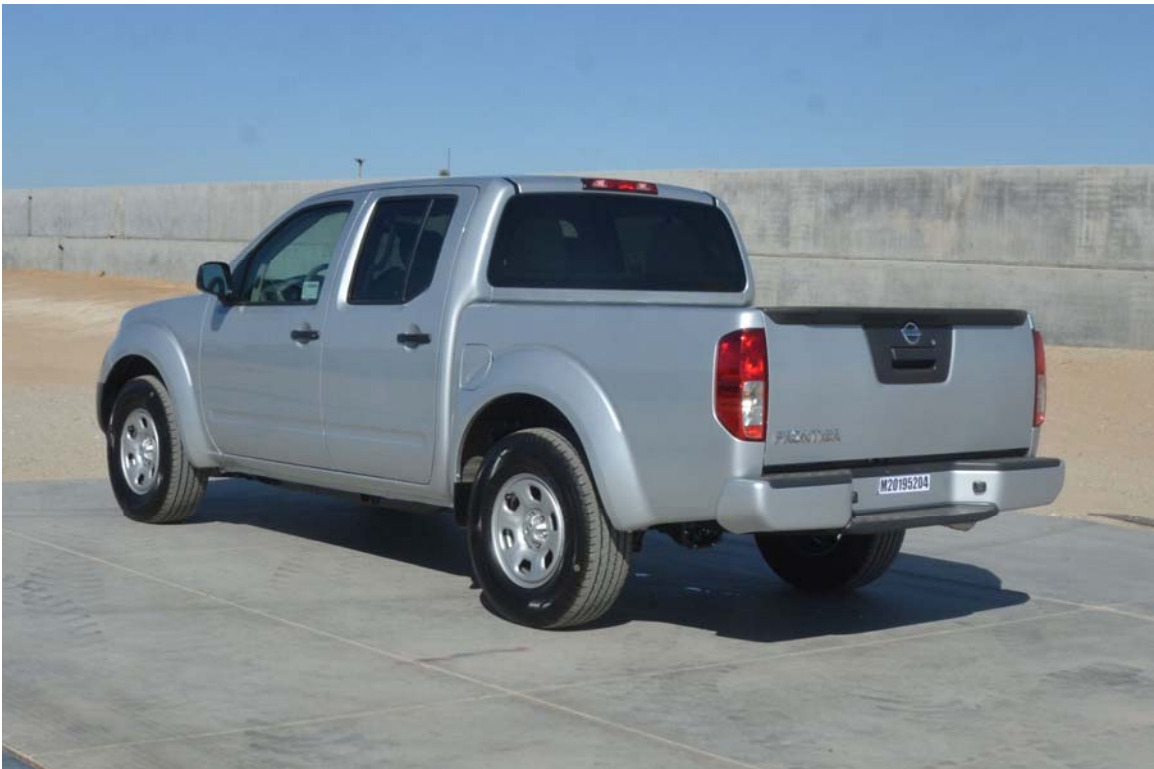
FIGURE 2. As-Delivered Left Rear  $\frac{3}{4}$  View of Test Vehicle

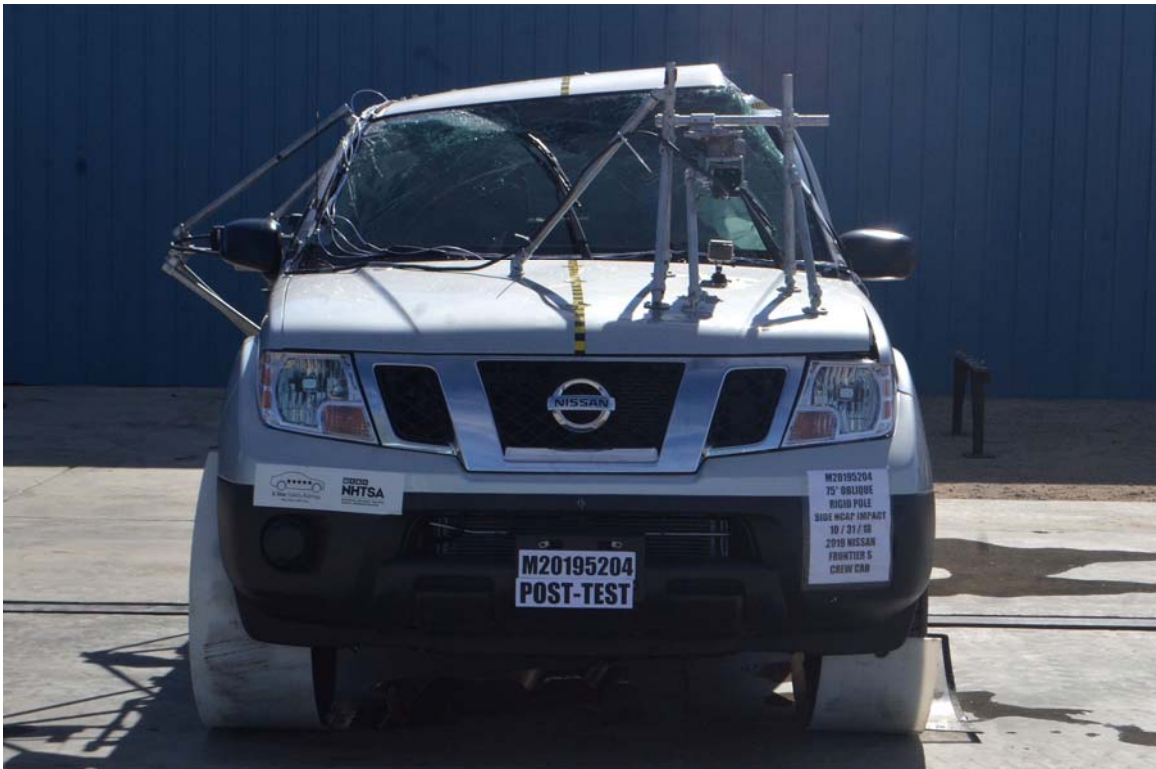
FIGURE 4. Post-Test Frontal View of Test Vehicle

The struck side doors of the vehicle were jammed shut. There was no separation at the hinges or latches. The remaining doors remained closed and latched. There were no ATD values that exceeded limits.

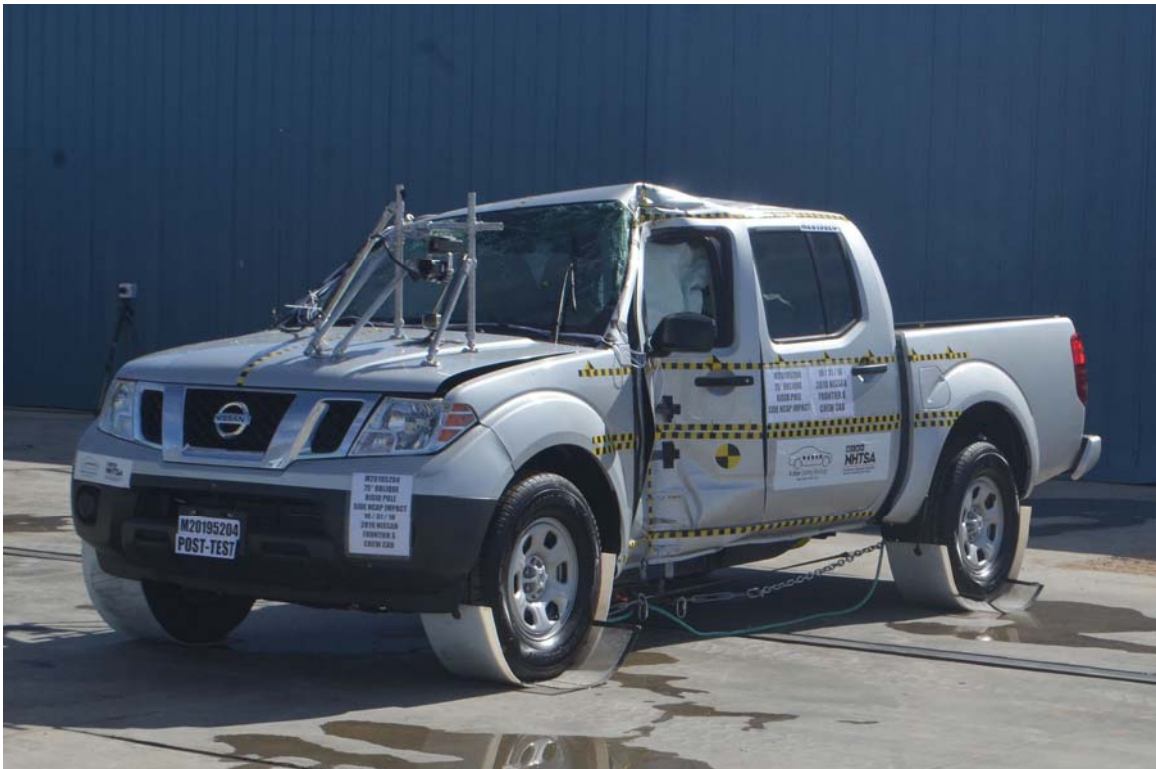
FIGURE 6. Post-Test Left Front  $\frac{3}{4}$  View of Test Vehicle

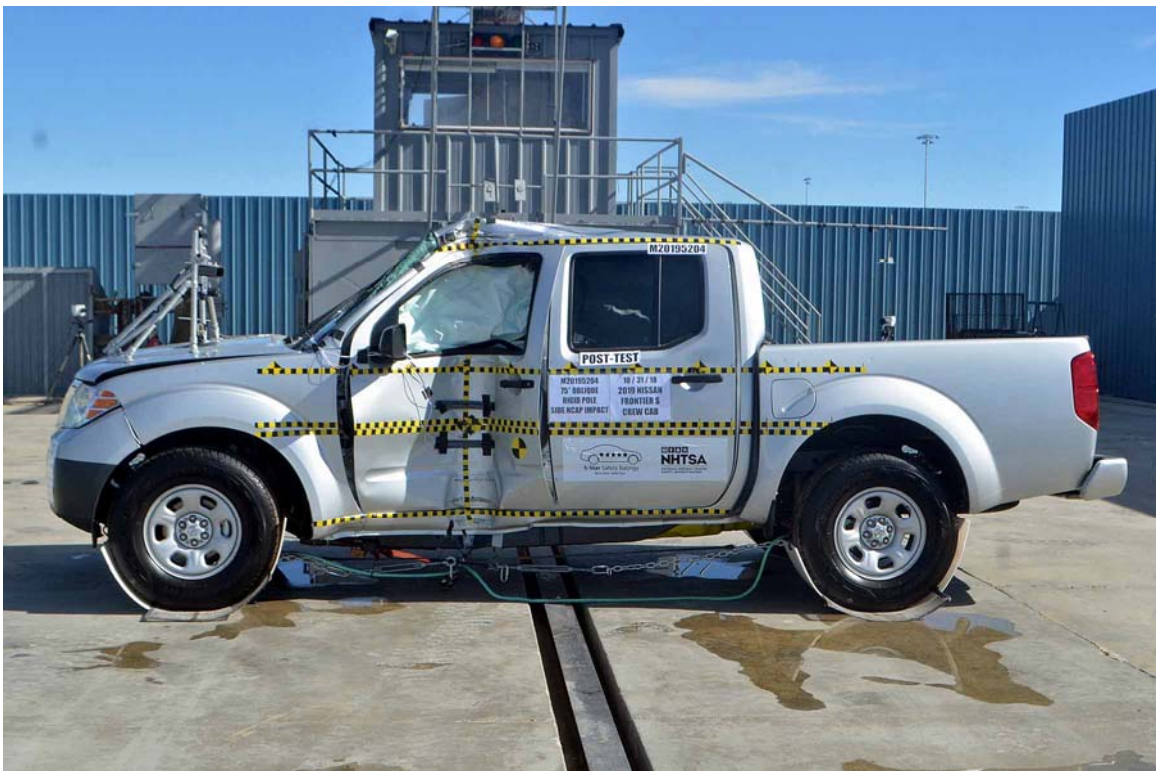
FIGURE 8. Post-Test Left Side View of Test Vehicle

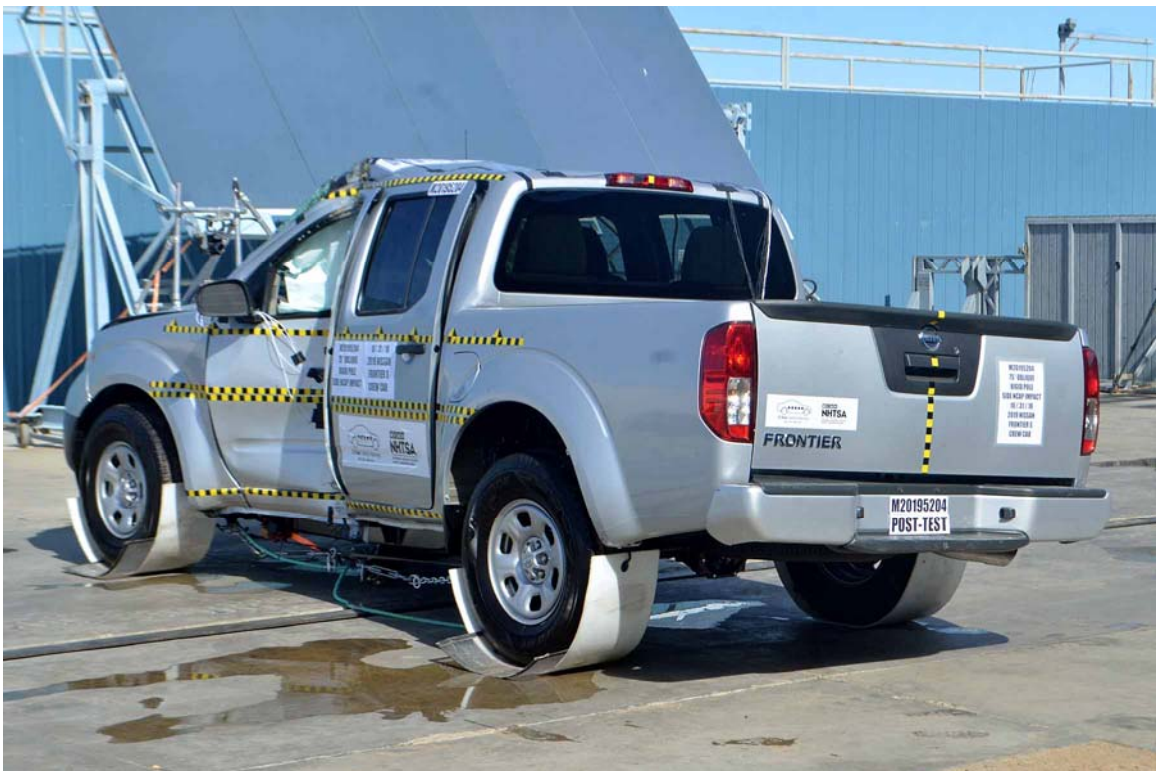
FIGURE 10. Post-Test Left Rear  $\frac{3}{4}$  View of Test Vehicle

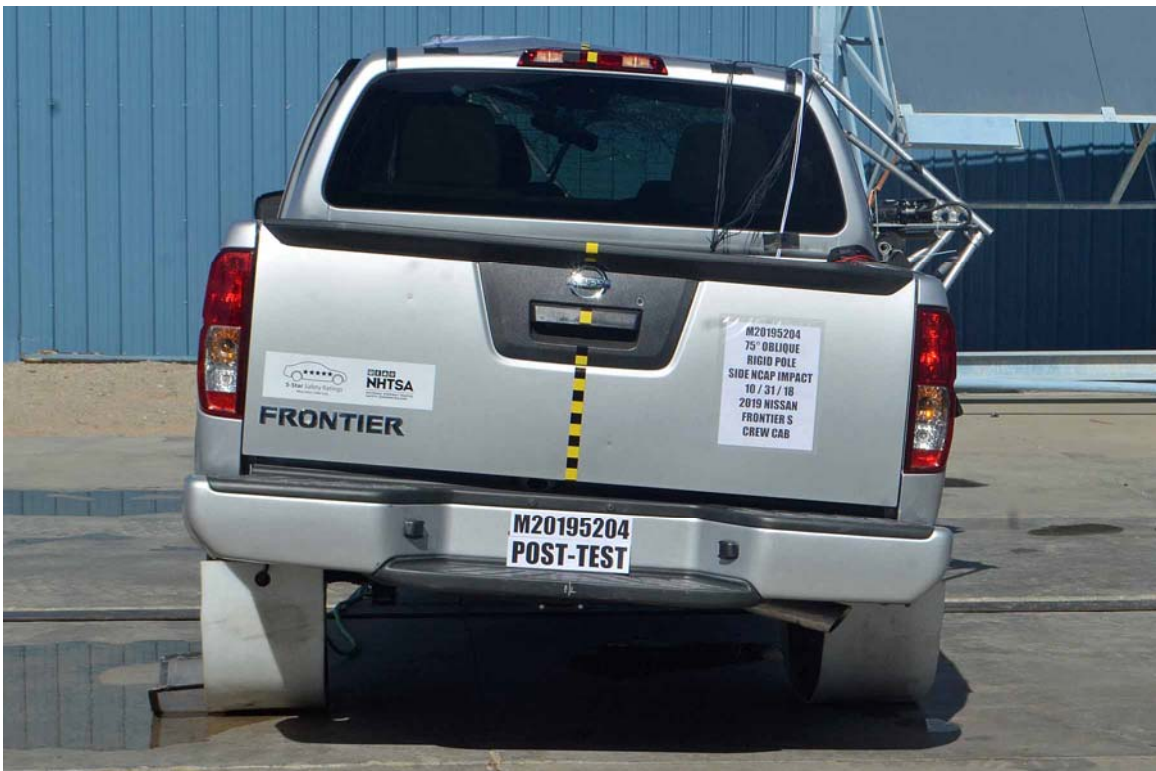
FIGURE 12. Post-Test Rear View of Test Vehicle

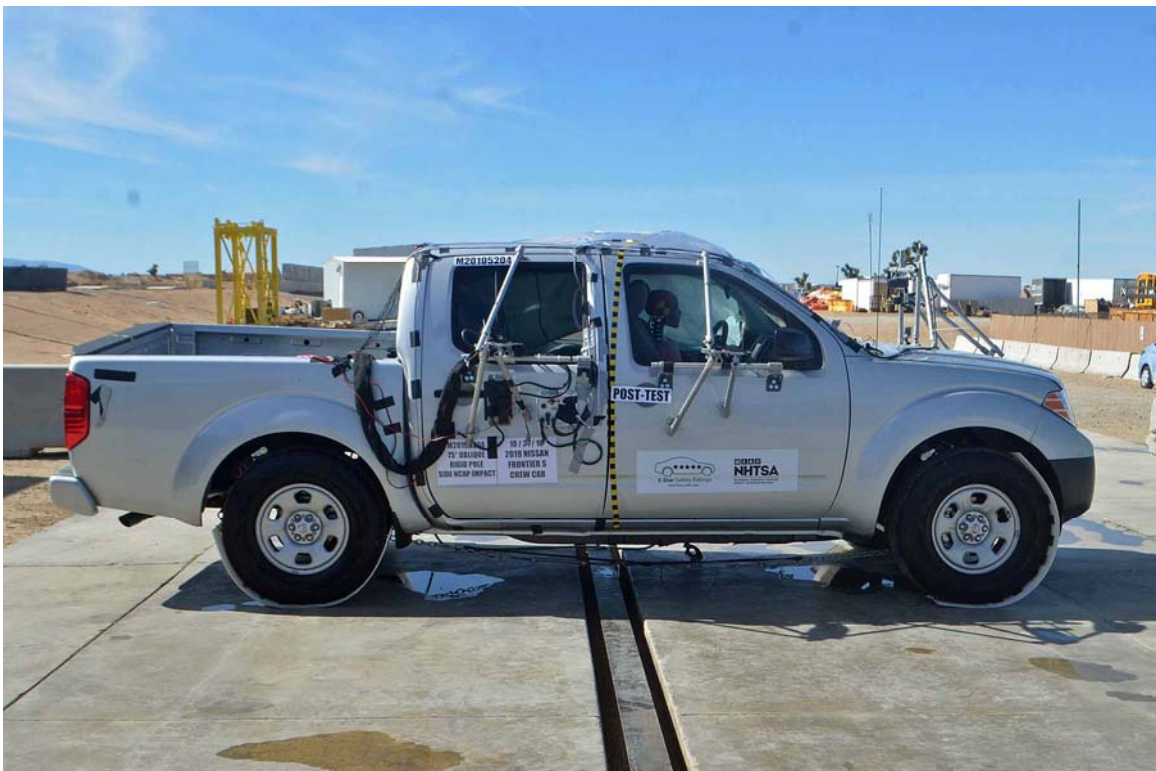
FIGURE 14. Post-Test Right Side View of Test Vehicle

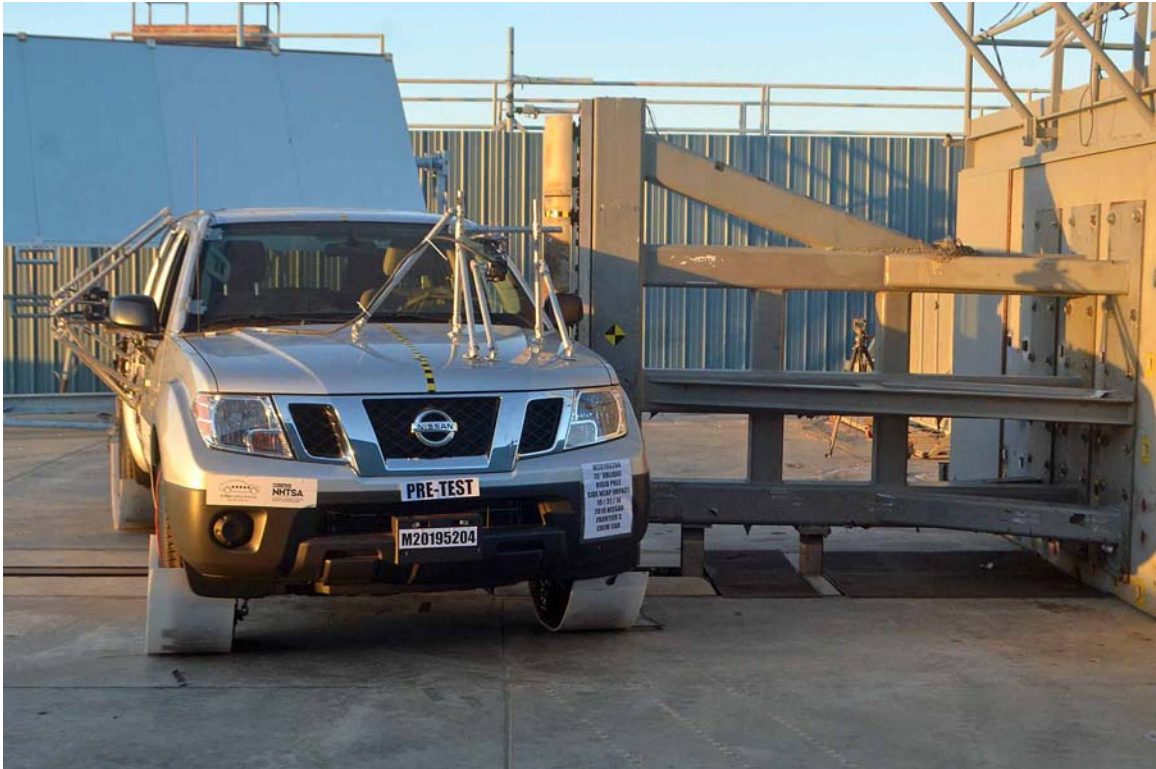
FIGURE 17. Pre-Test Left Side View of Pole Positioned Against Side of Vehicle

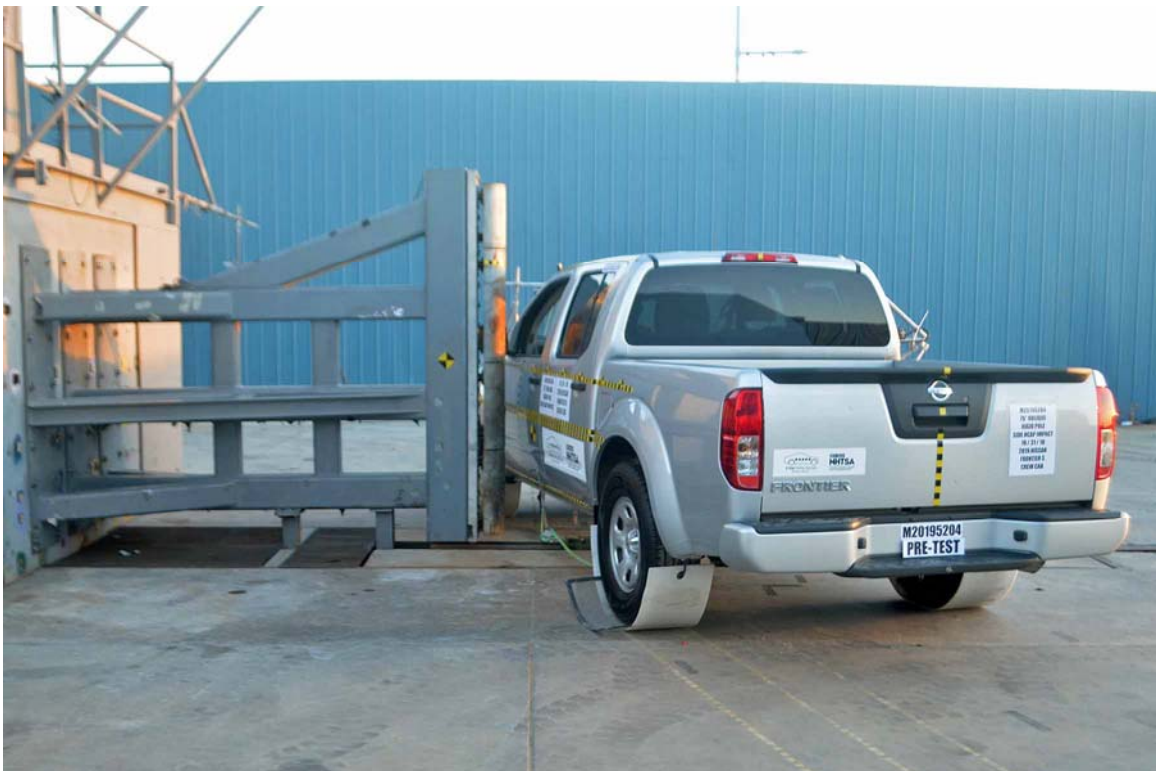
FIGURE 18. Pre-Test Right Side View of Pole Positioned Against Side of Vehicle

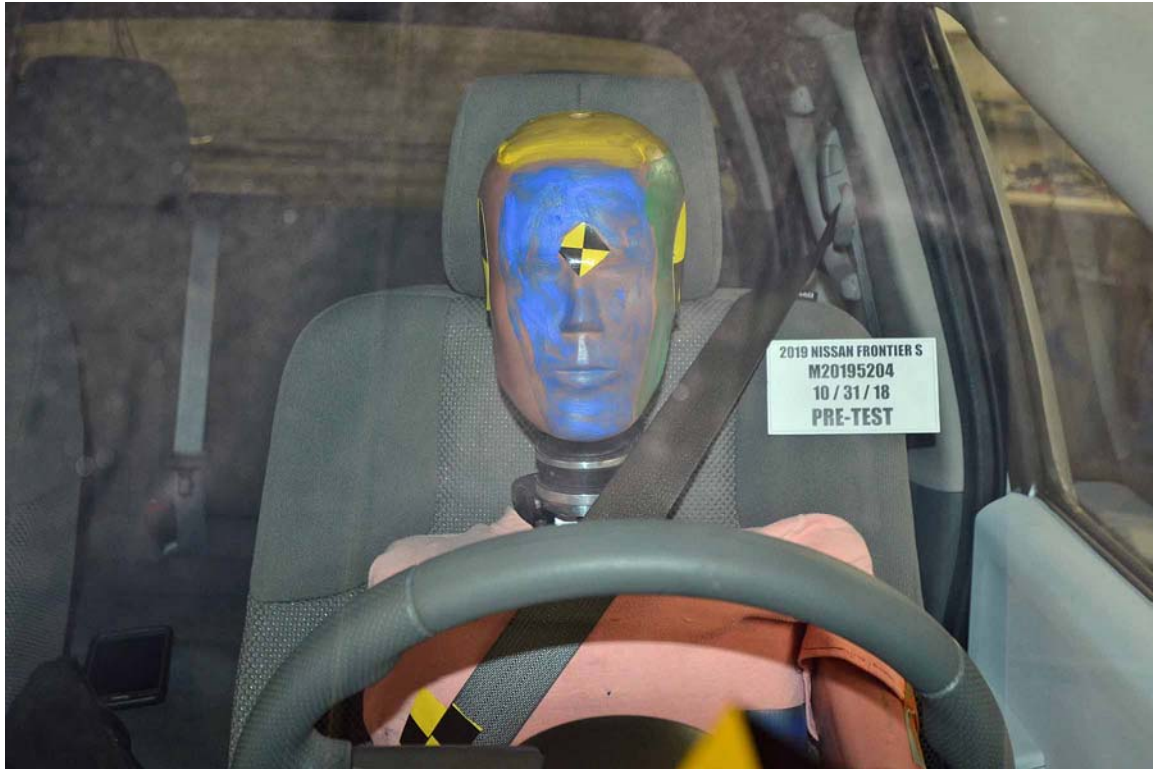
FIGURE 21. Pre-Test Front Close-Up View of Dummy Head and Chest

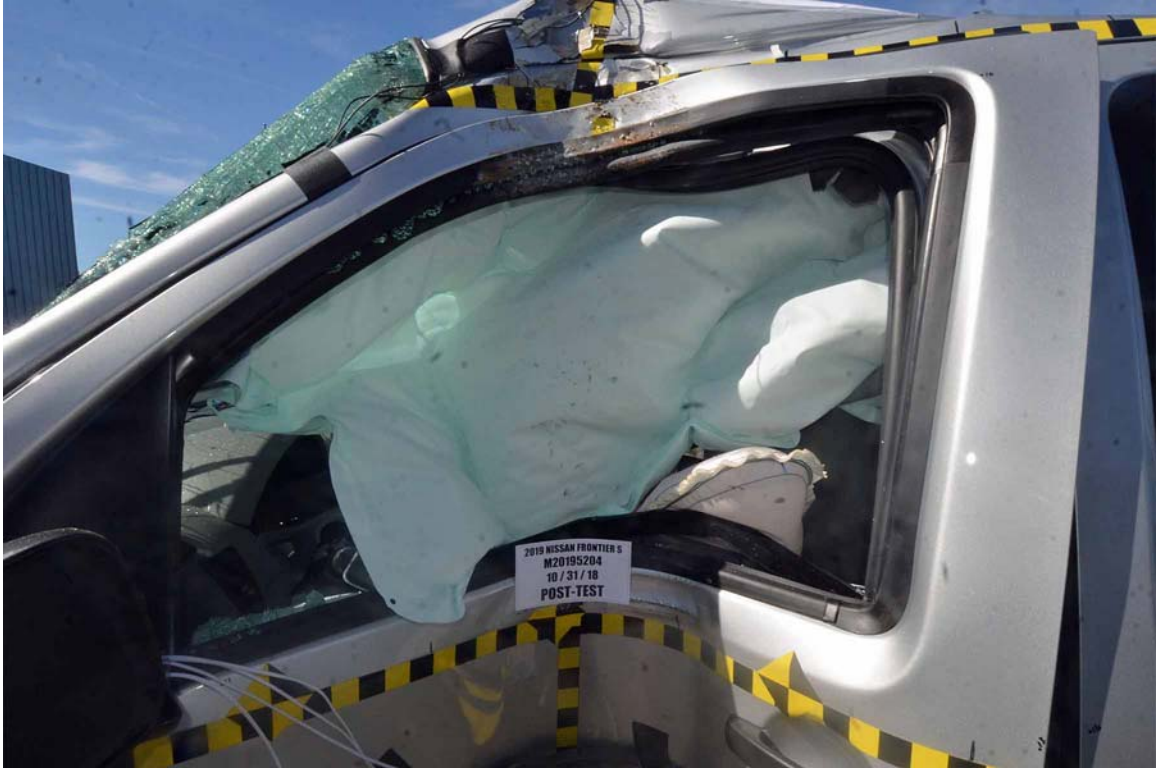
FIGURE 25. Post-Test Left Side View of Dummy Shoulder and Door Top View

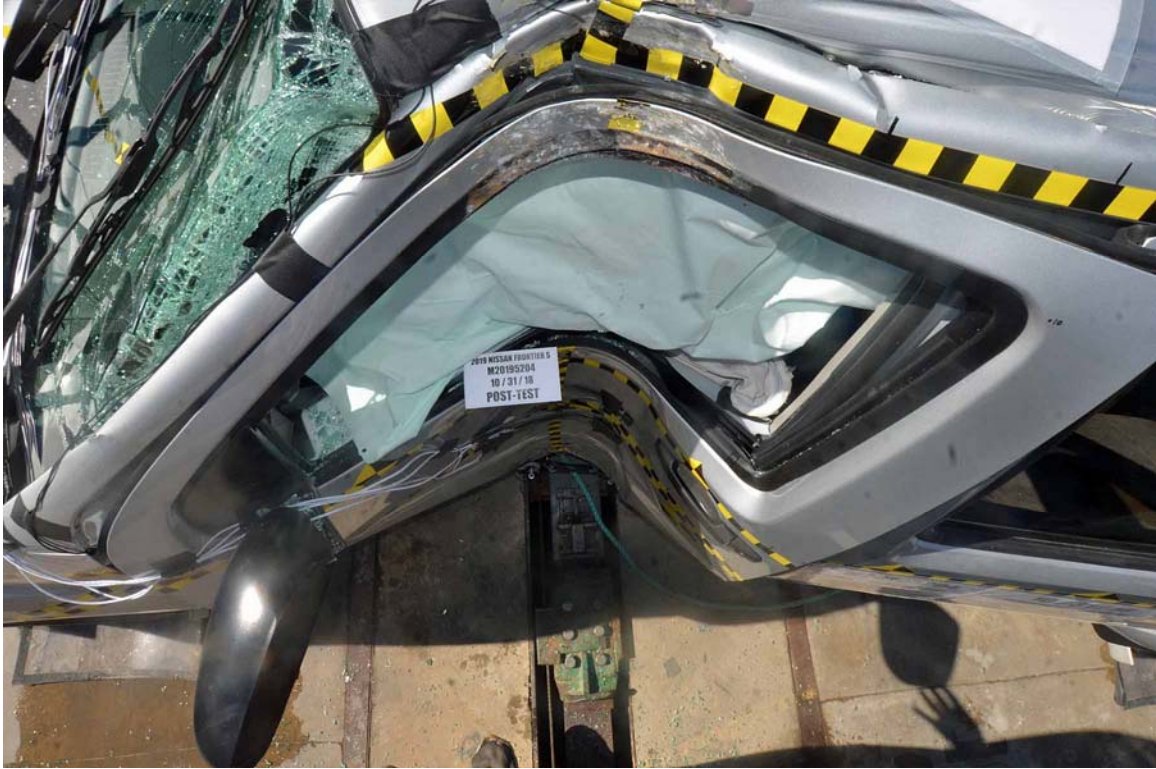
FIGURE 41. Post-Test Dummy and Door Clearance View

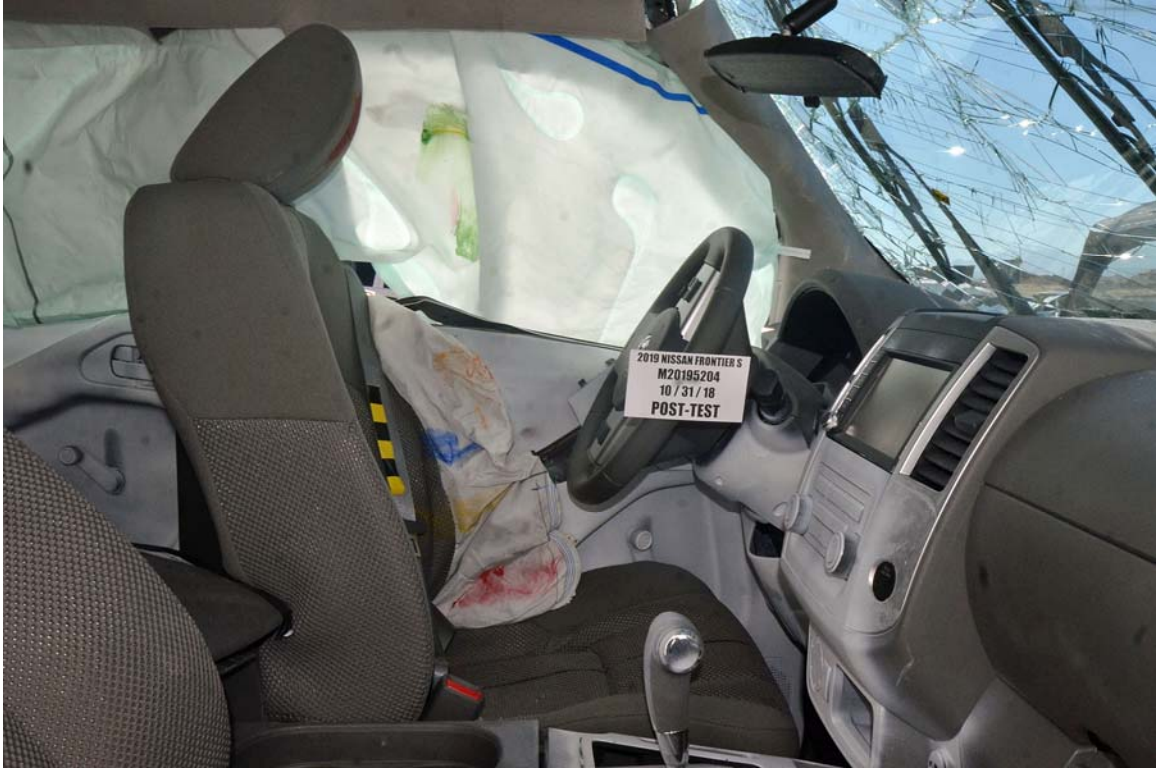
FIGURE 45. Post-Test Inner Door Panel View Showing Dummy Contact Locations

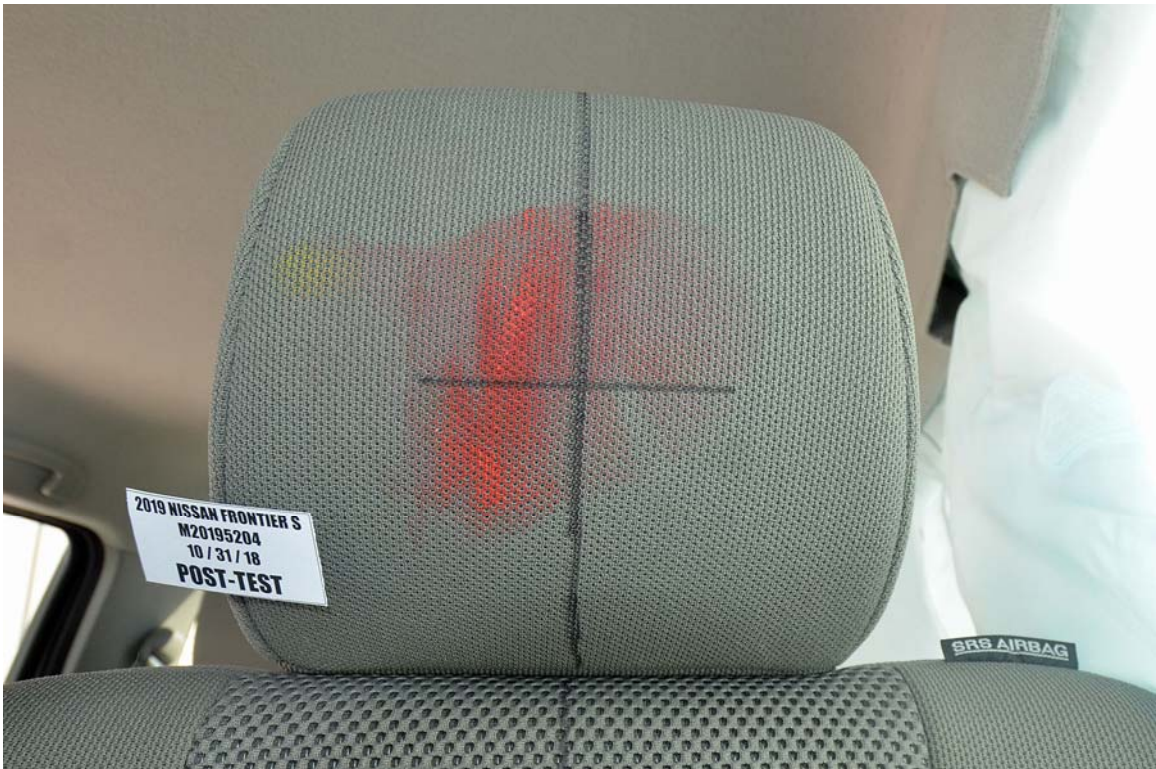
FIGURE 46. Post-Test Dummy Close-Up Head Contact with Vehicle Interior View

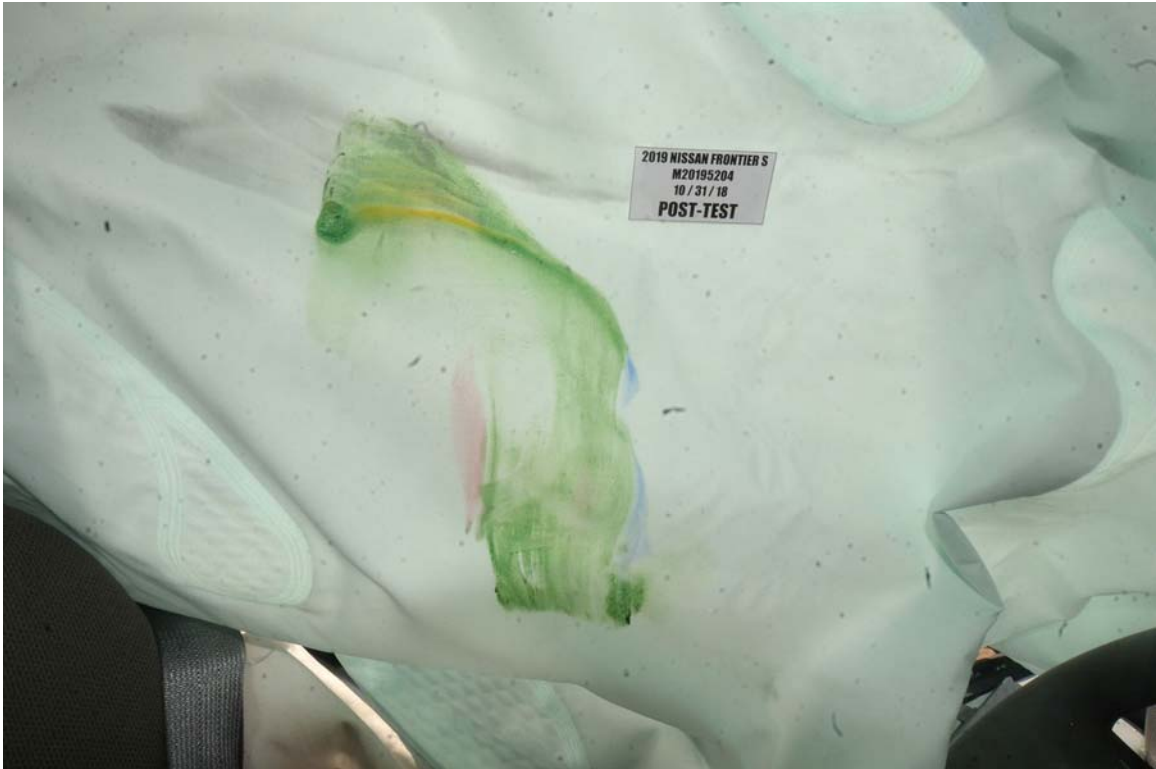
FIGURE 47. Post-Test Dummy Close-Up Head Contact With Side Airbag View

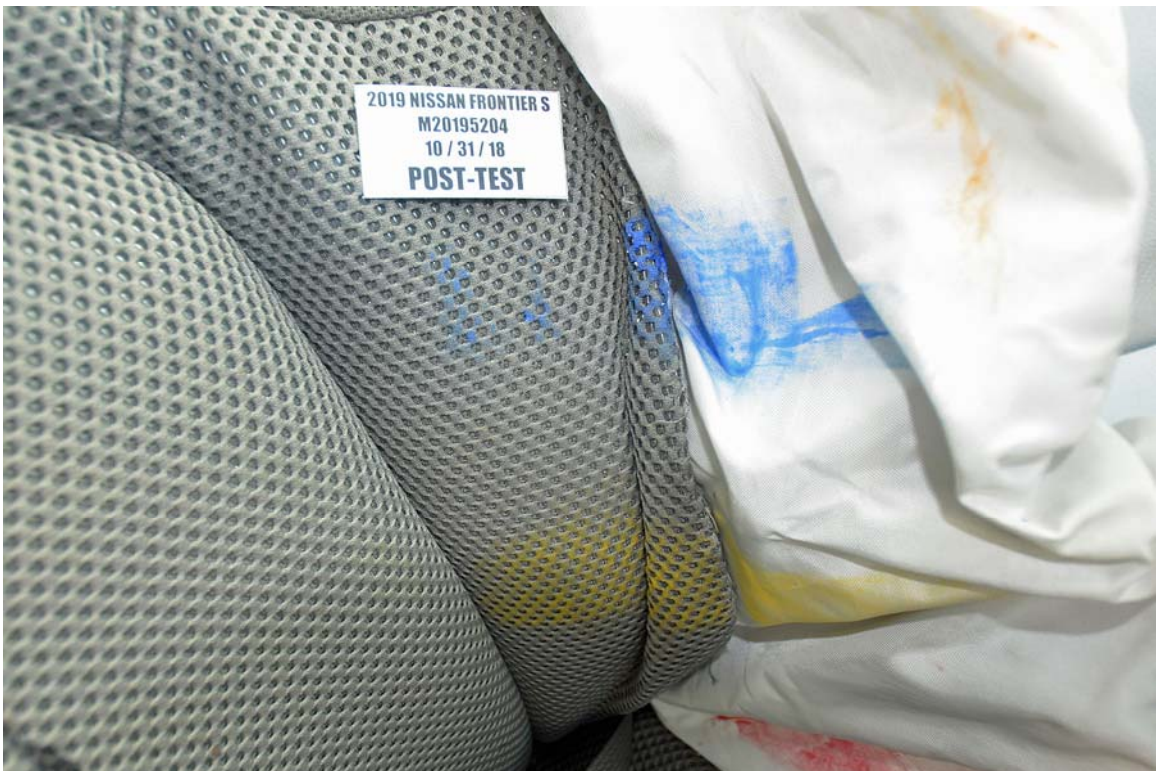
FIGURE 48. Post-Test Dummy Close-Up Torso Contact With Vehicle Interior View

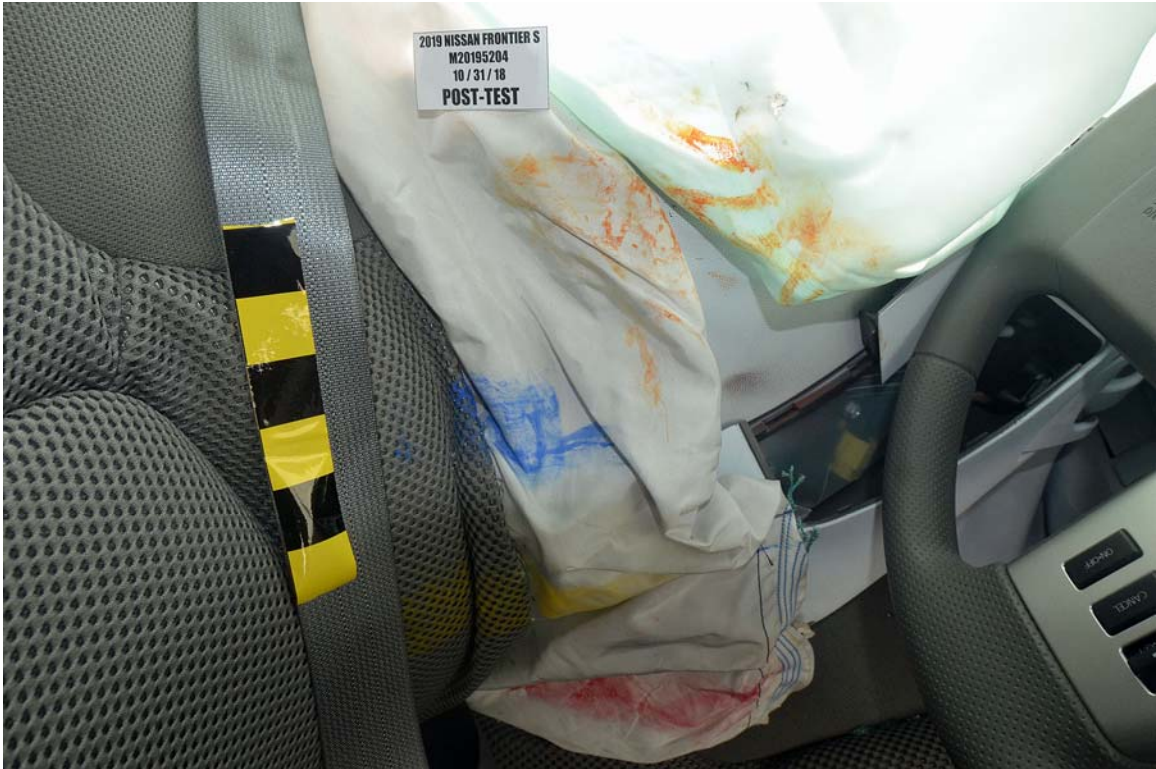
FIGURE 49. Post-Test Dummy Close-Up Torso Contact With Side Airbag View

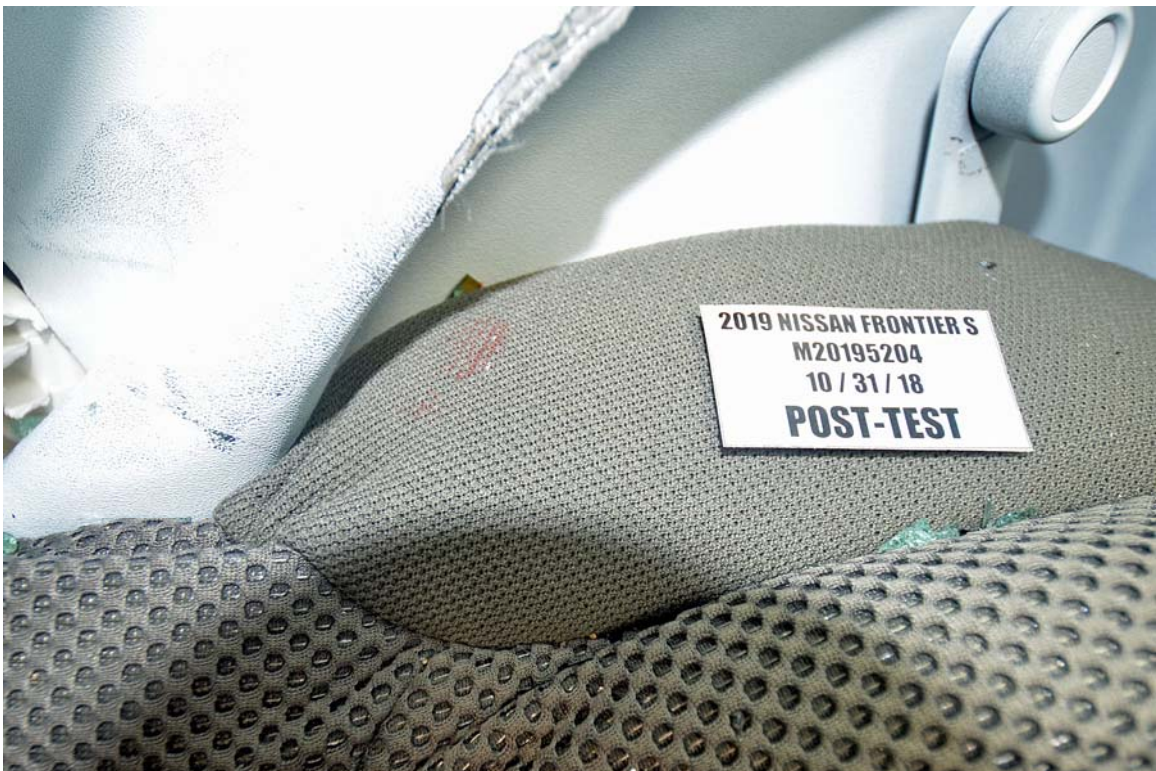
FIGURE 50. Post-Test Dummy Close-Up Pelvis Contact With Vehicle Interior View

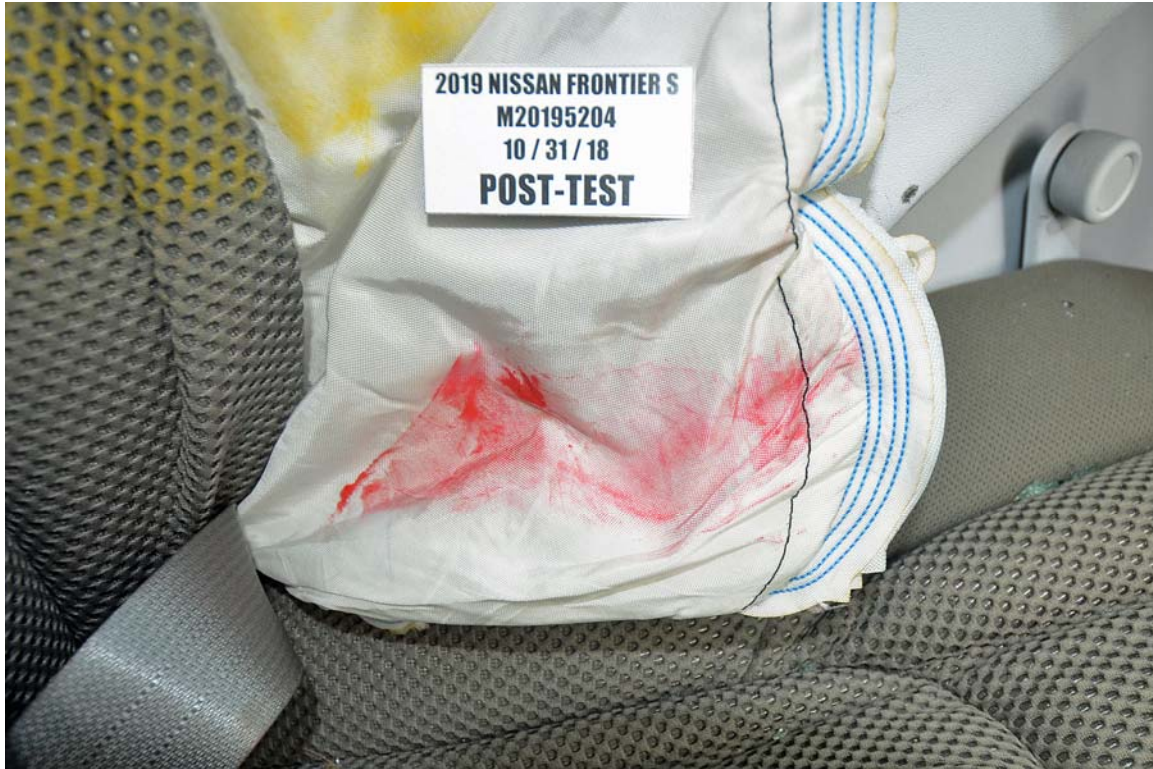
FIGURE 51. Post-Test Dummy Close-Up Pelvis Contact With Side Airbag View

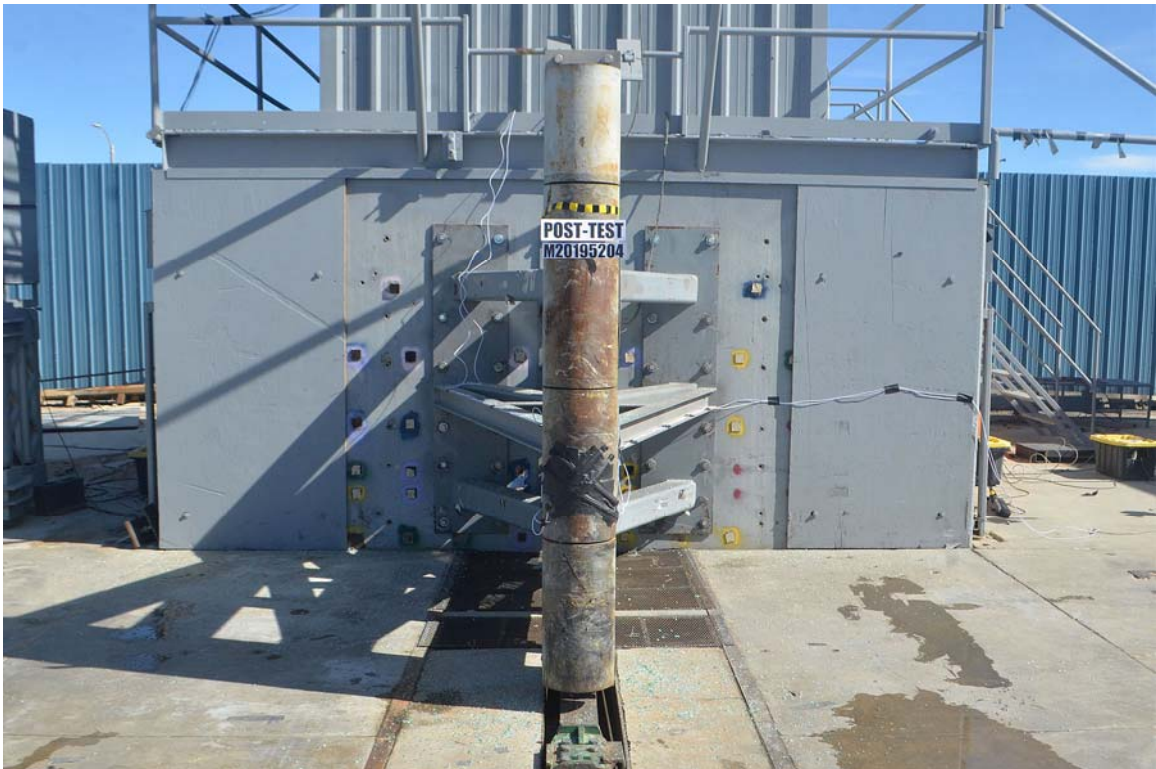
FIGURE 58. Post-Test Pole Barrier Front View

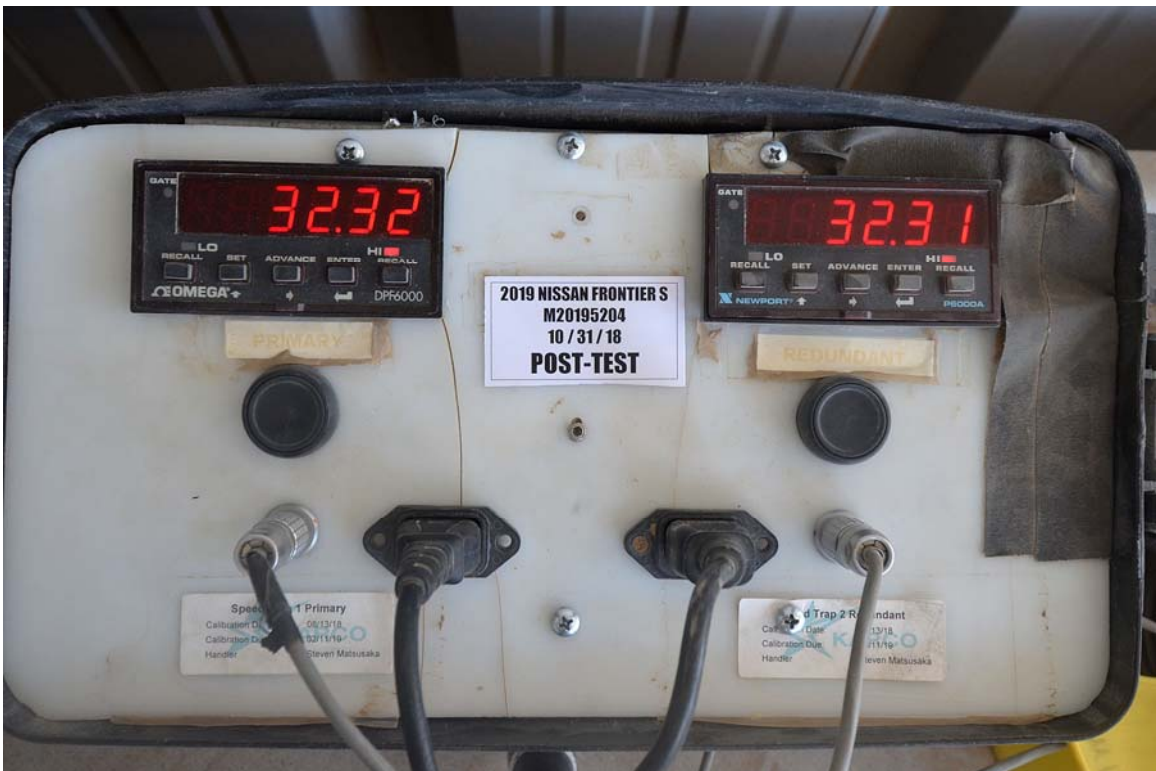
FIGURE 62. Post-Test Primary and Redundant Speed Trap Read-Out
