REPORT NUMBER: TWG-MGA-2018-006

**SIDE AIRBAG OUT-OF-POSITION INJURY
TECHNICAL WORKING GROUP**

**TOYOTA MOTOR CORPORATION
2018 Toyota Camry LE 4-Door Sedan
NHTSA No.: M20185102TWG3**

FINAL REPORT

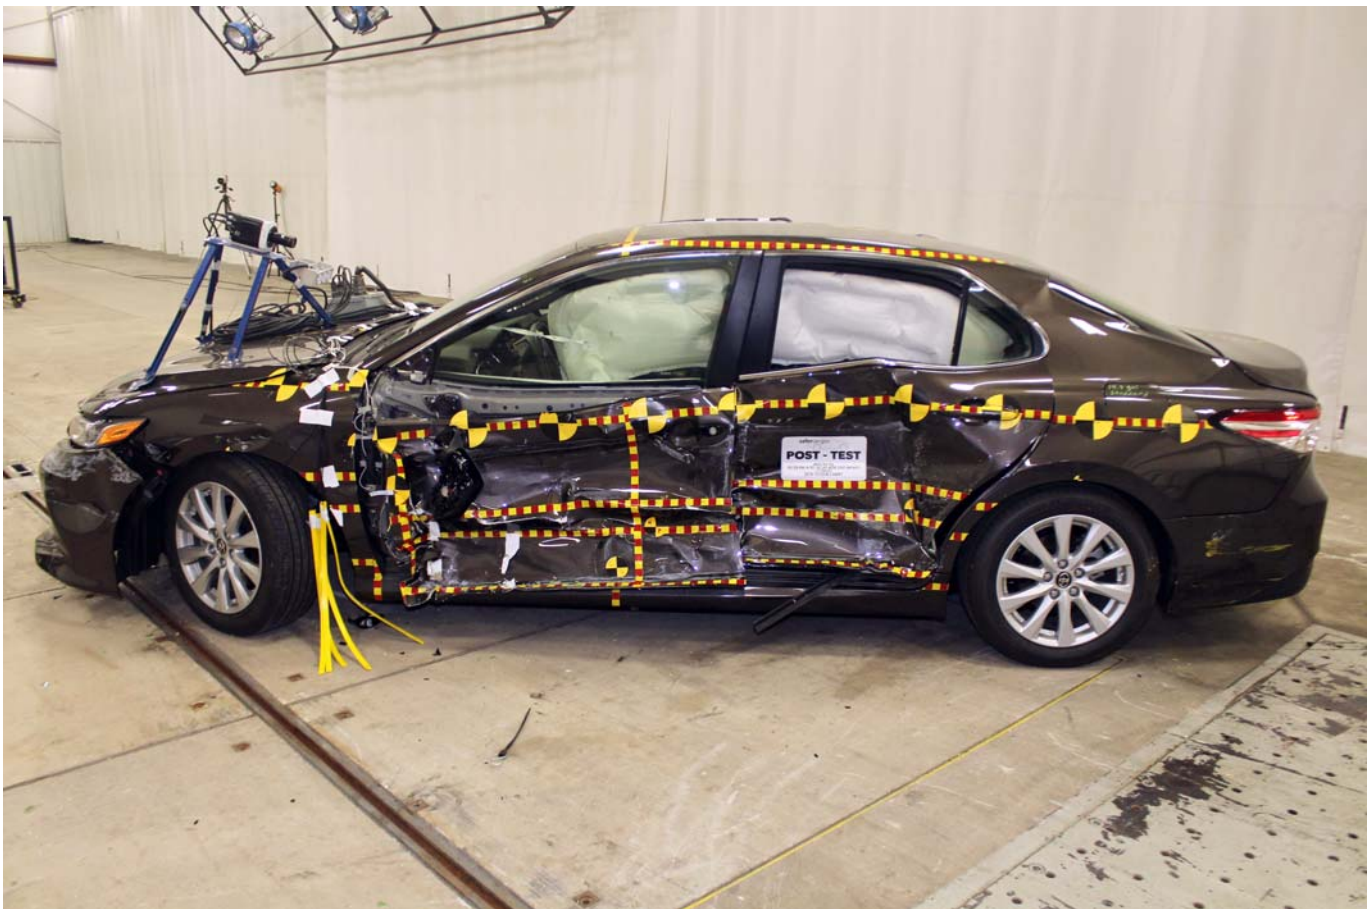
Photo No. 004 - Post-Test Vehicle Left Side View

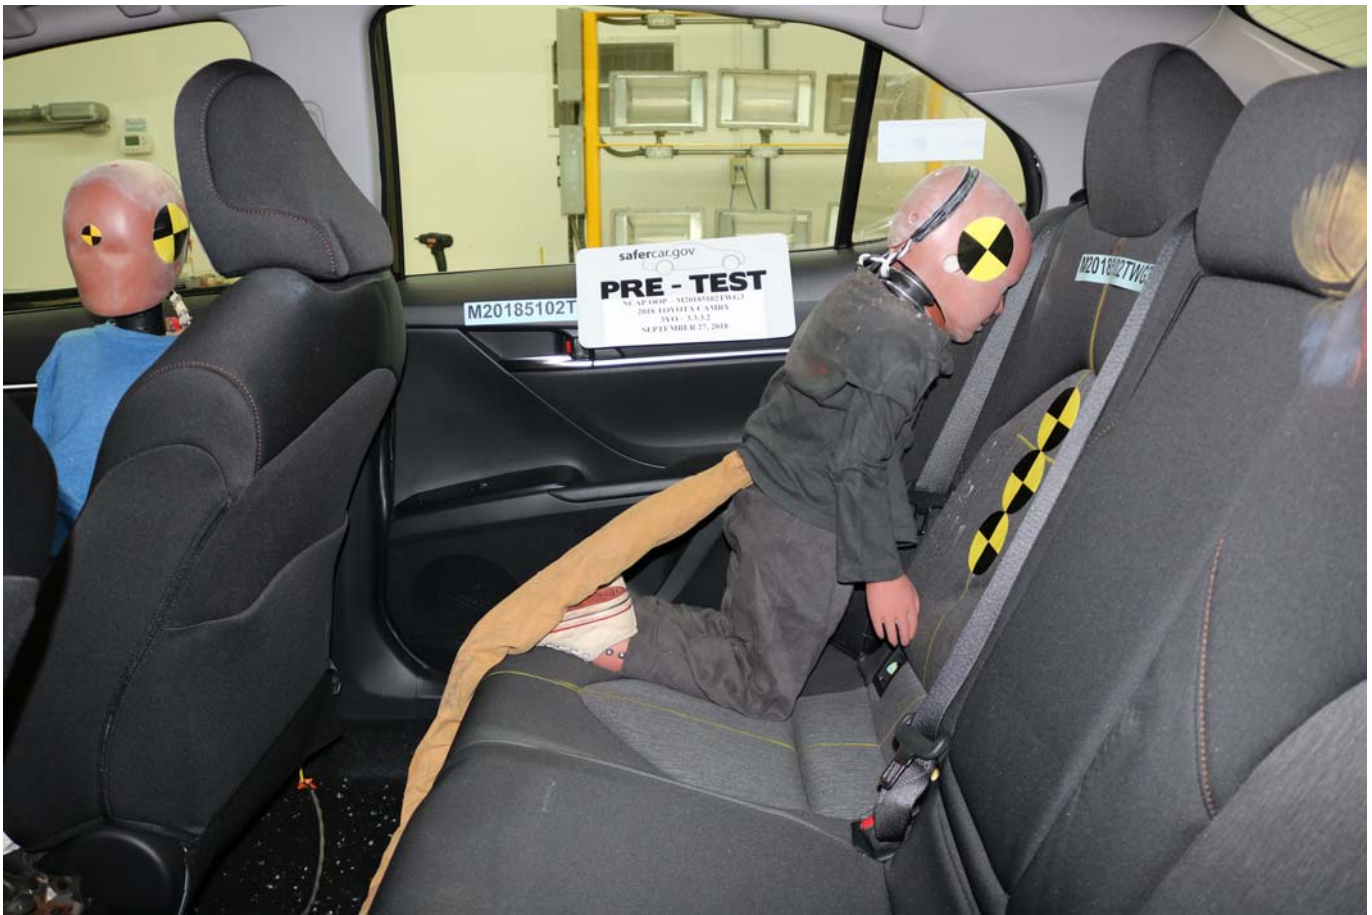
Photo No. 005 - Pre-Test 3-Year-Old Child Dummy Left Side View

The Hybrid III 3-Year-Old child dummy was placed in the right rear passenger seat along the outboard edge of the seat cushion, kneeling and facing rearward. The vertical centerline of the dummy's sternum was aligned as close as possible with the leading edge of the seatback bolster. The sternum contacted with seat. The dummy's head was placed in between the seat bolster and pillar/side trim to maximize contact between the sternum and seatback. The head remained in its neutral orientation. The outboard leg was positioned at the outboard edge of the seat cushion and parallel to the seat centerline and remained on the cushion. The outboard knee and lower leg was slid toward the seatback/seat cushion junction until the top edge of the upper rib was aligned horizontally with the top edge of the airbag module. The inboard leg was aligned parallel to the centerline of the seat cushion. The inboard knee and lower leg was slid toward the seat bight until a line drawn through both shoulder bolts was perpendicular to the vehicle centerline. The inboard arm was rotated towards the seatback until the thumb contacts the seatback. The outboard arm and hand was rotated to hang down as close to vertical as possible.

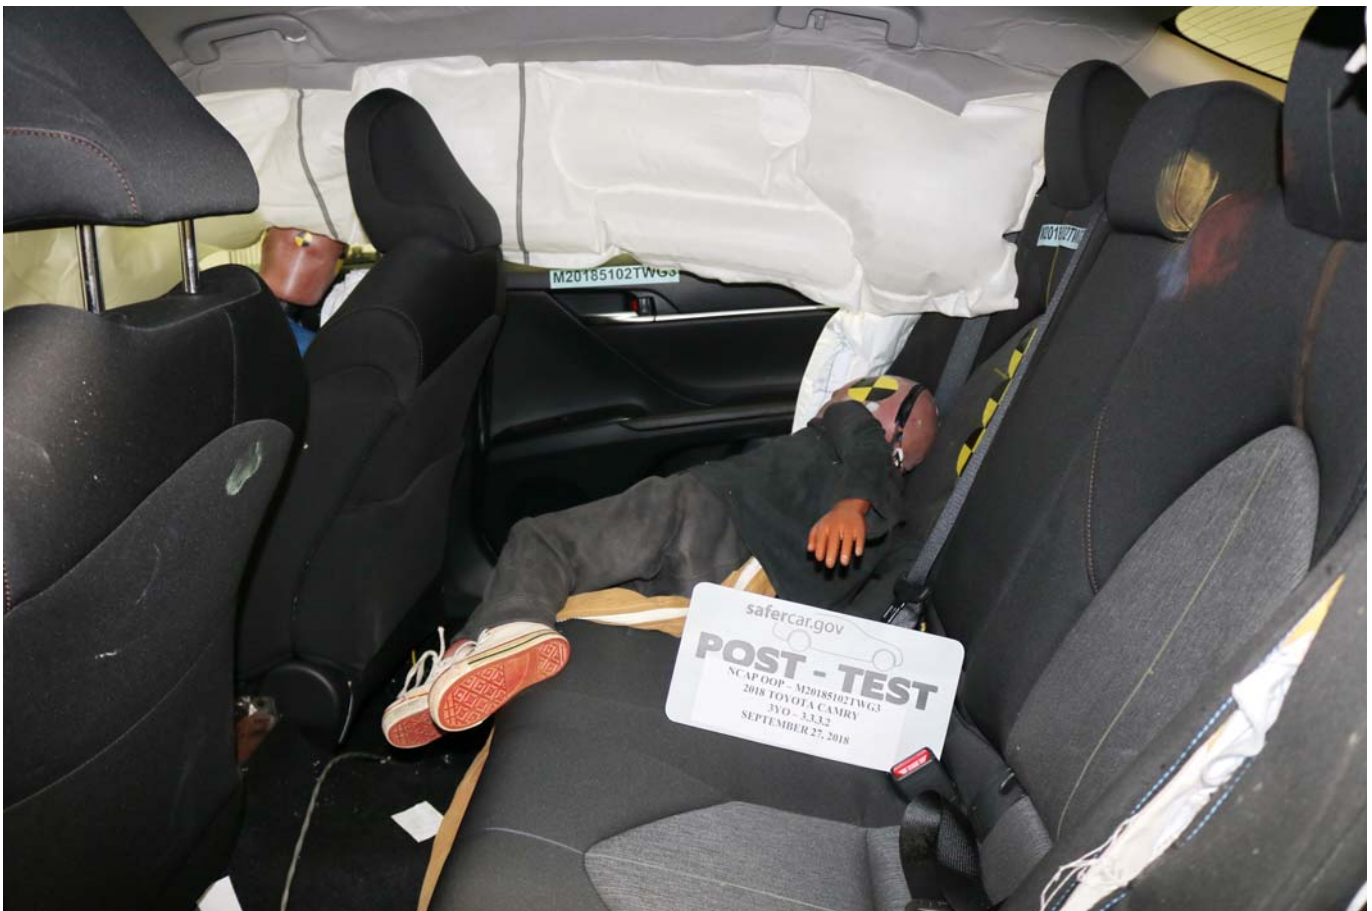
Photo No. 006 - Post-Test 3-Year-Old Child Dummy Left Side View

- Side curtain airbag to back of head and shoulder
- Side torso/pelvis airbag to left side of torso

Visible Dummy Contact Points	
Head Contact	Side curtain airbag to back of head
Left Shoulder Contact	None
Left Torso Contact	Side torso airbag to torso
Left Pelvis Contact	None

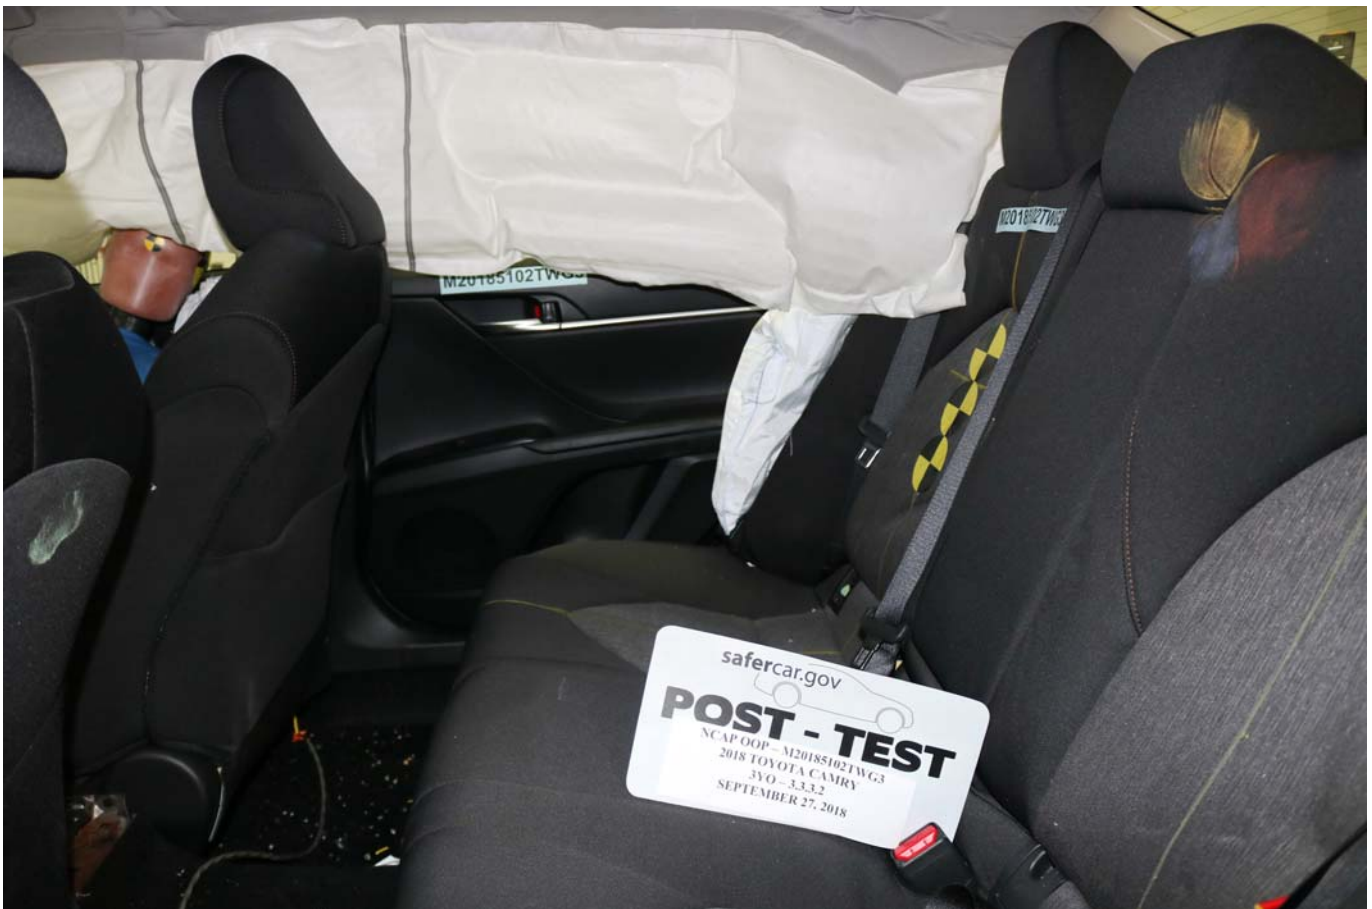
Photo No. 022 - Post-Test Curtain Airbag Left Side View

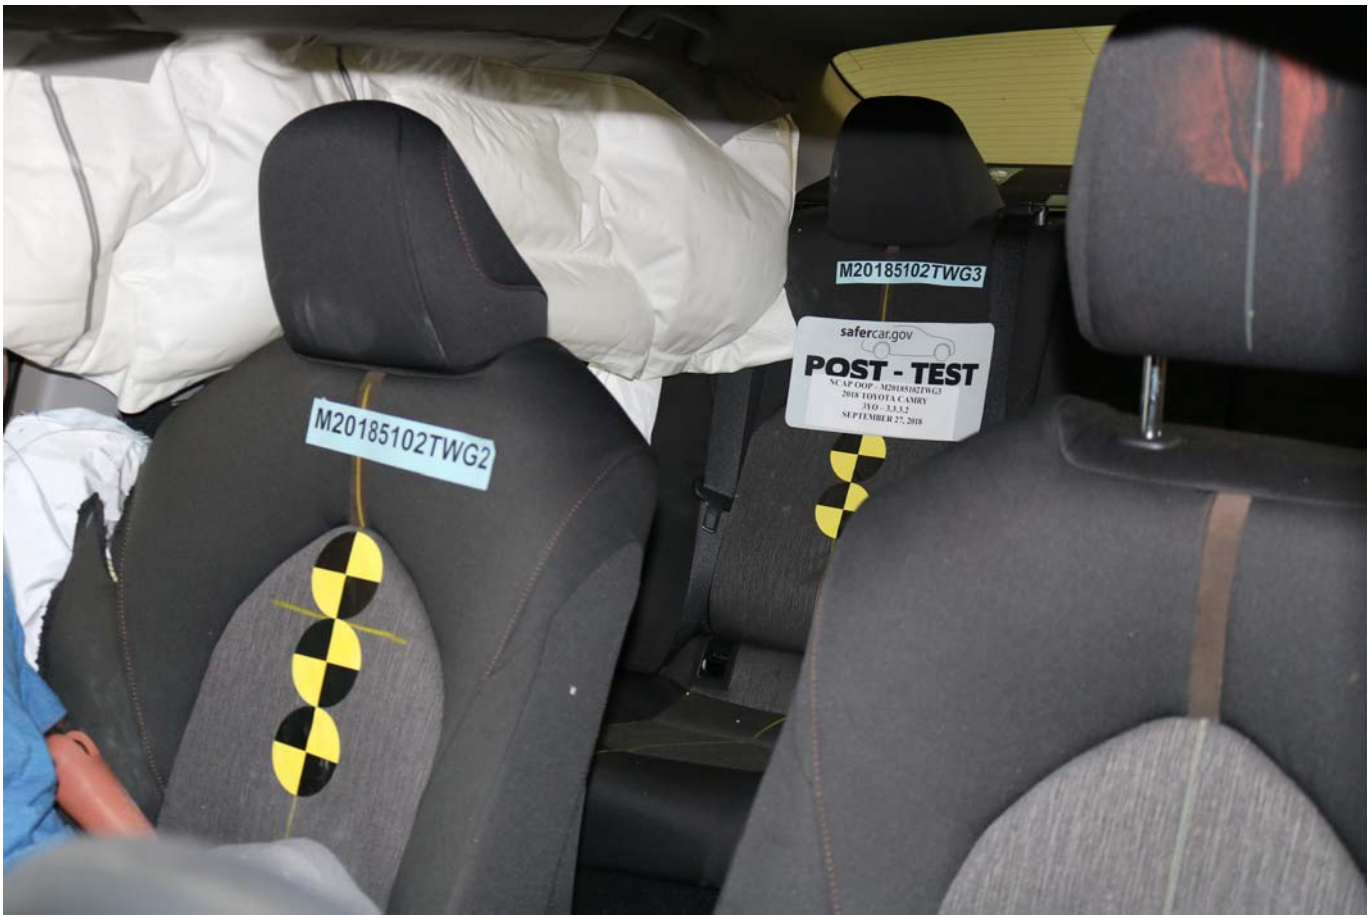
Photo No. 023 - Post-Test Curtain Airbag Left Three-Quarter Front View
