**REPORT NUMBER: SPNCAP-KAR-19-008
NEW CAR ASSESSMENT PROGRAM (NCAP)
SIDE IMPACT POLE TEST**

**SUBARU CORPORATION
2019 SUBARU FORESTER 5-DOOR MPV**

NHTSA No: O20195501

FINAL REPORT

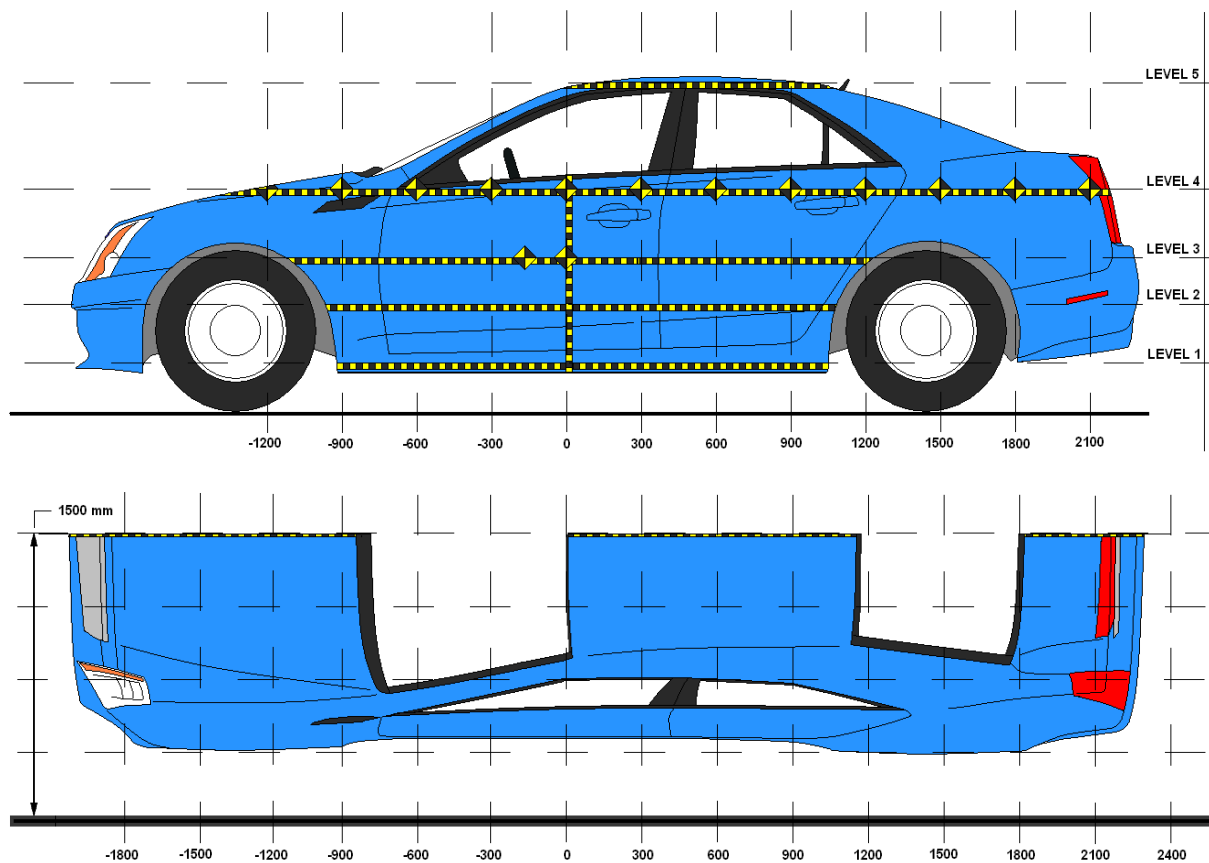
TEST VEHICLE EXTERIOR CRUSH MEASUREMENTS

NOTE: All measurements in mm with tolerance of ± 3 mm

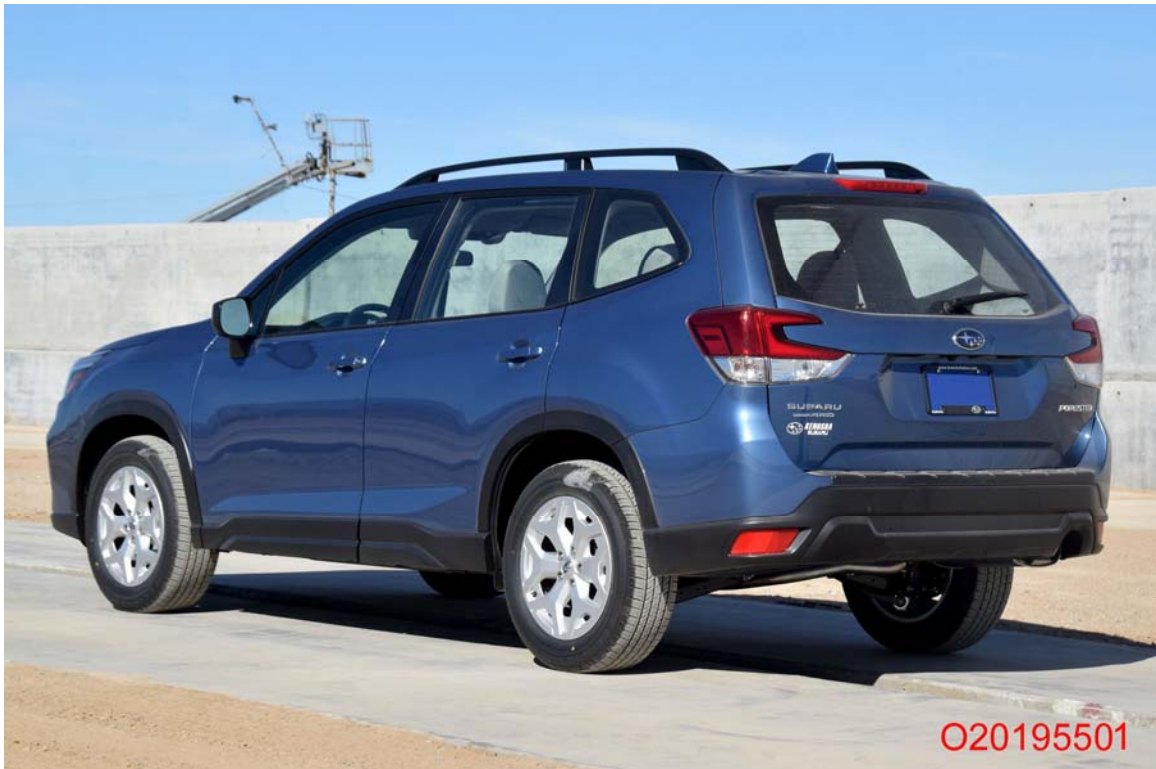
FIGURE 2. As-Delivered Left Rear $\frac{3}{4}$ View of Test Vehicle

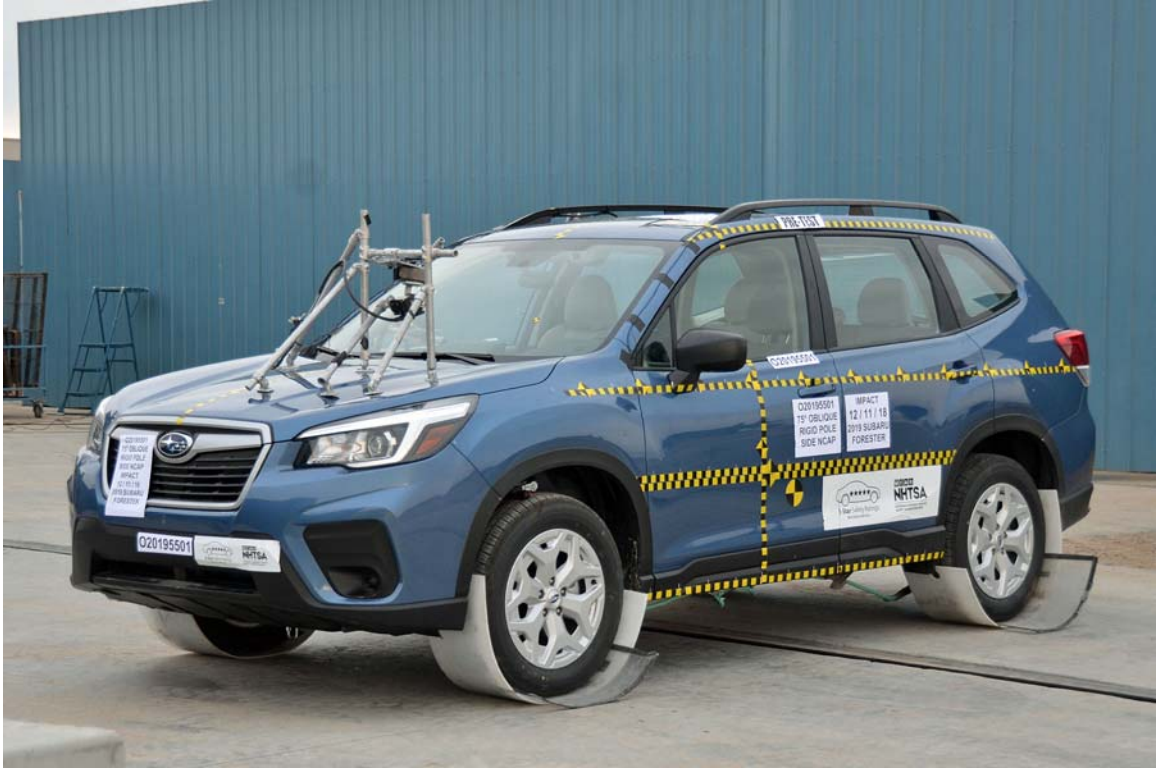
FIGURE 5. Pre-Test Left Front $\frac{3}{4}$ View of Test Vehicle

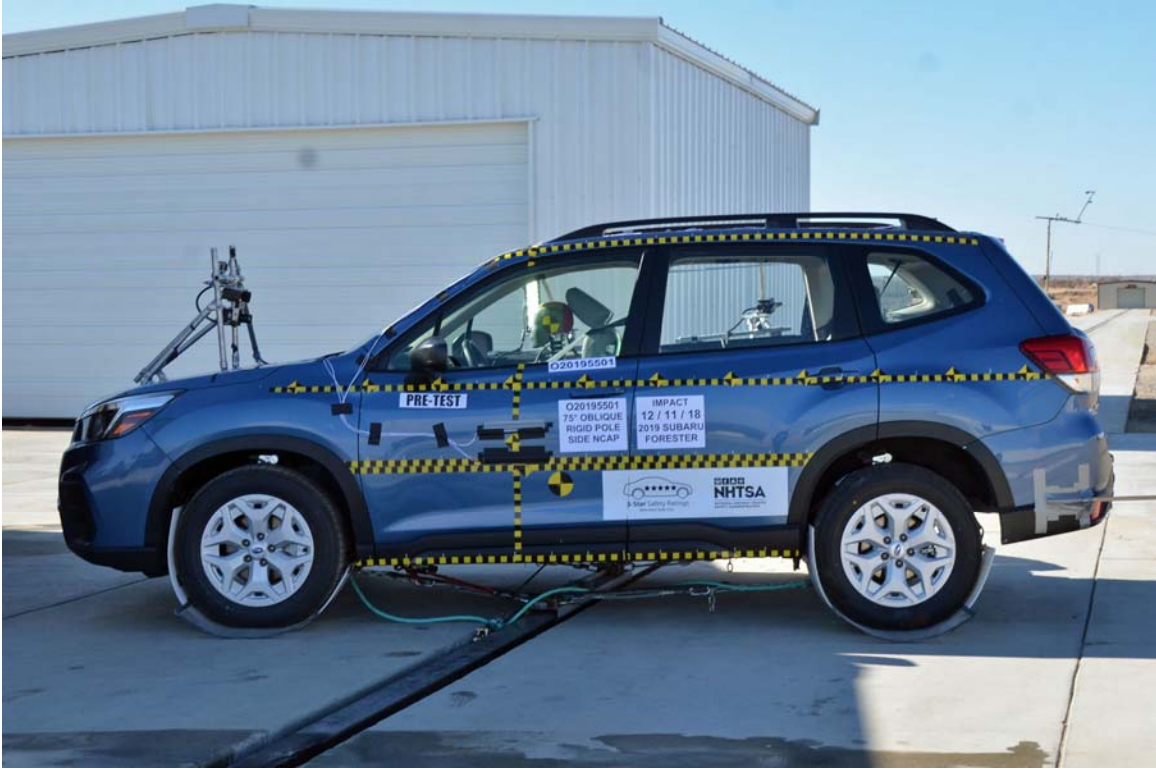
FIGURE 7. Pre-Test Left Side View of Test Vehicle

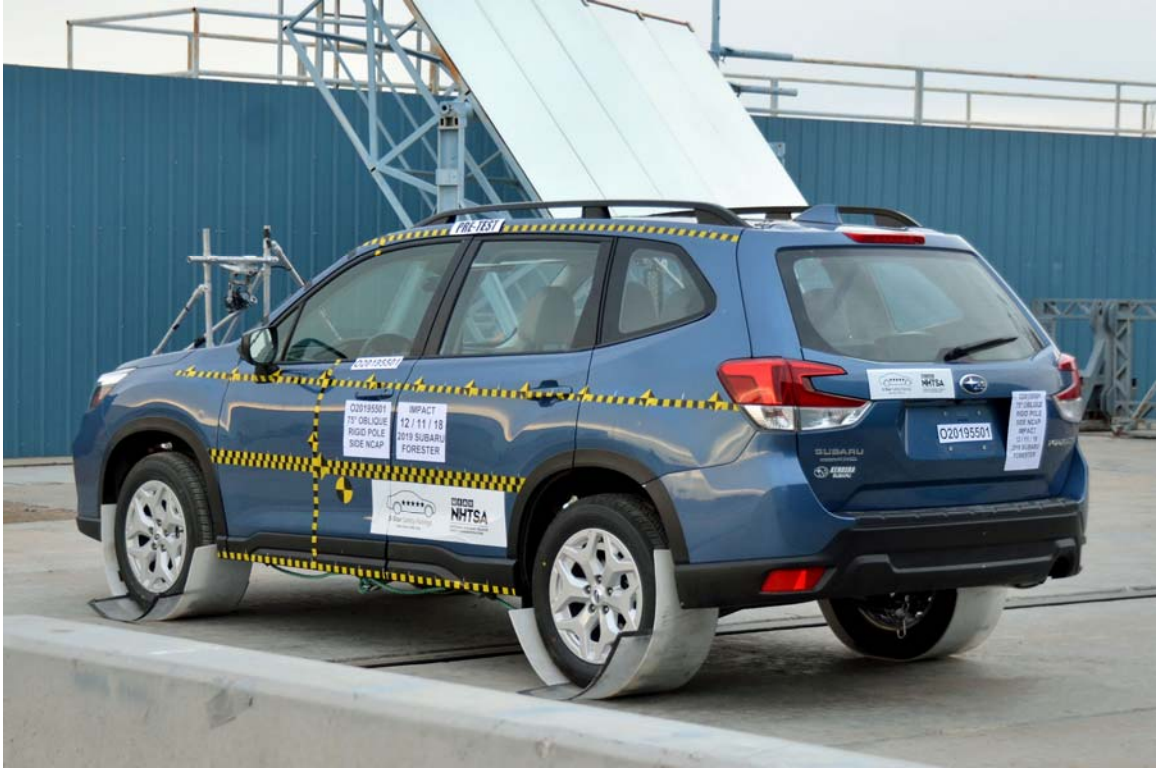
FIGURE 9. Pre-Test Left Rear $\frac{3}{4}$ View of Test Vehicle

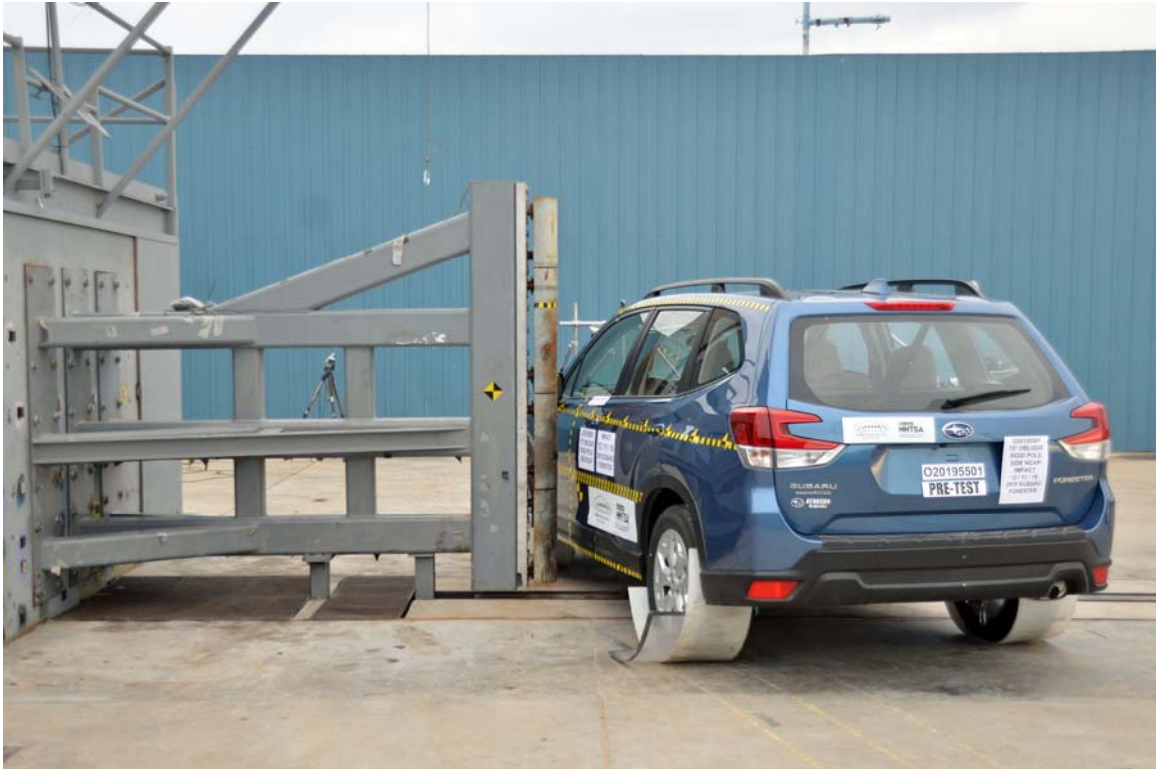
FIGURE 18. Pre-Test Right Side View of Pole Positioned Against Side of Vehicle

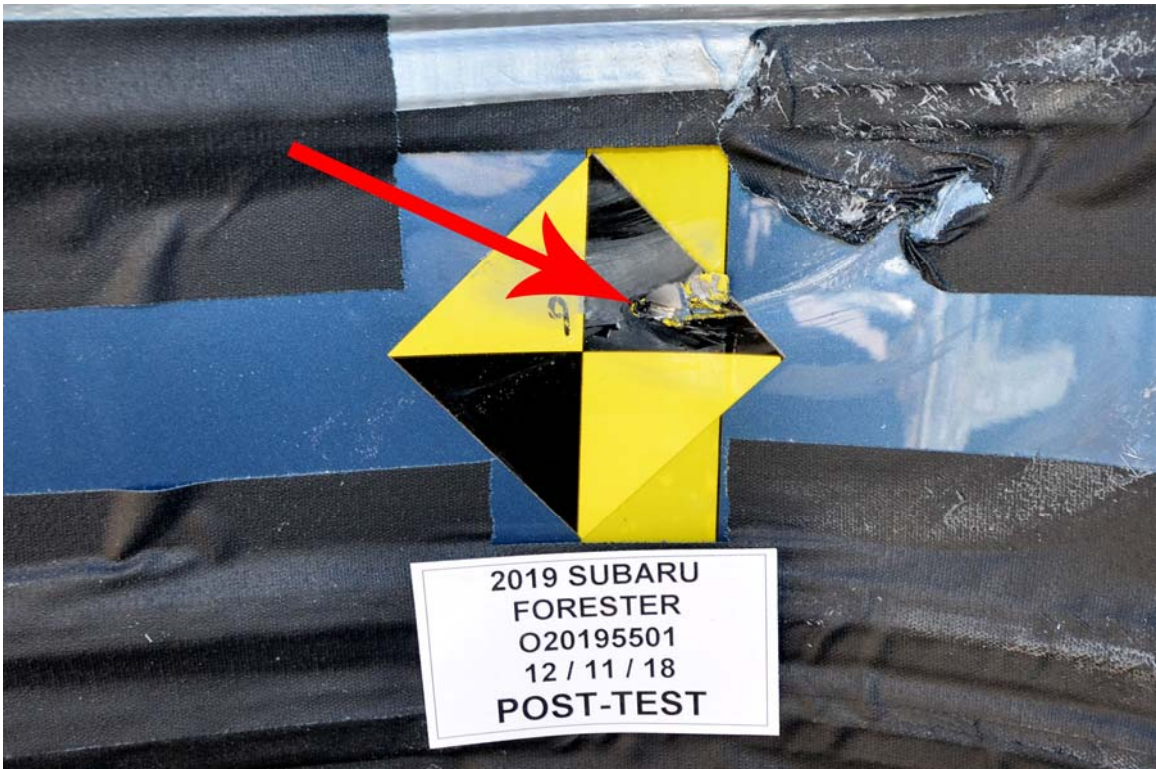
FIGURE 20. Post-Test Close-Up View of Impact Point Target Showing Impact Location

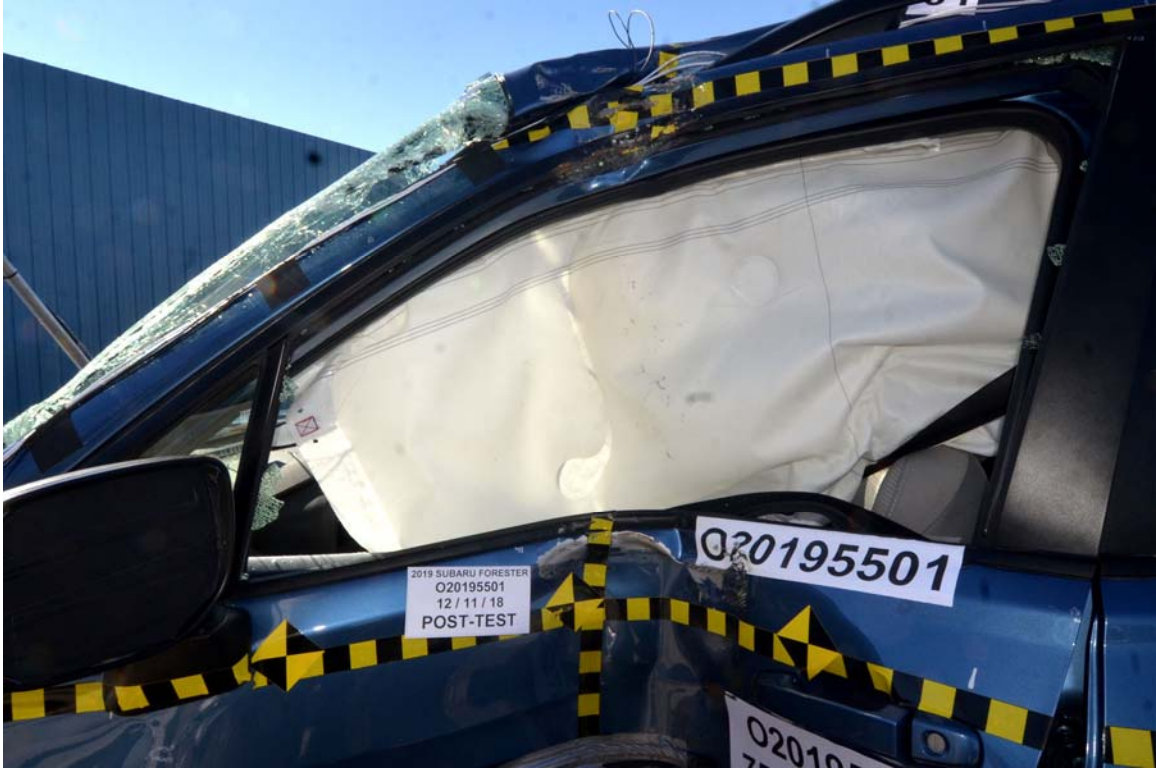
FIGURE 25. Post-Test Left Side View of Dummy Shoulder and Door Top View

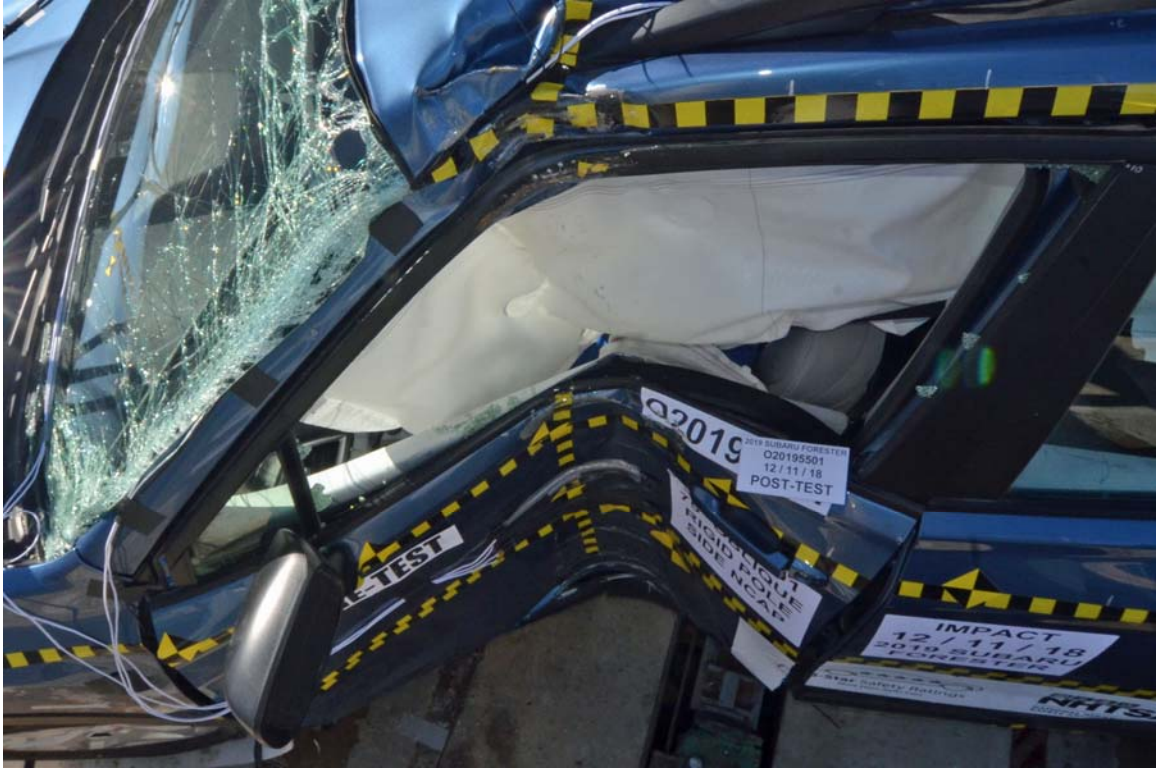
FIGURE 41. Post-Test Dummy and Door Clearance View

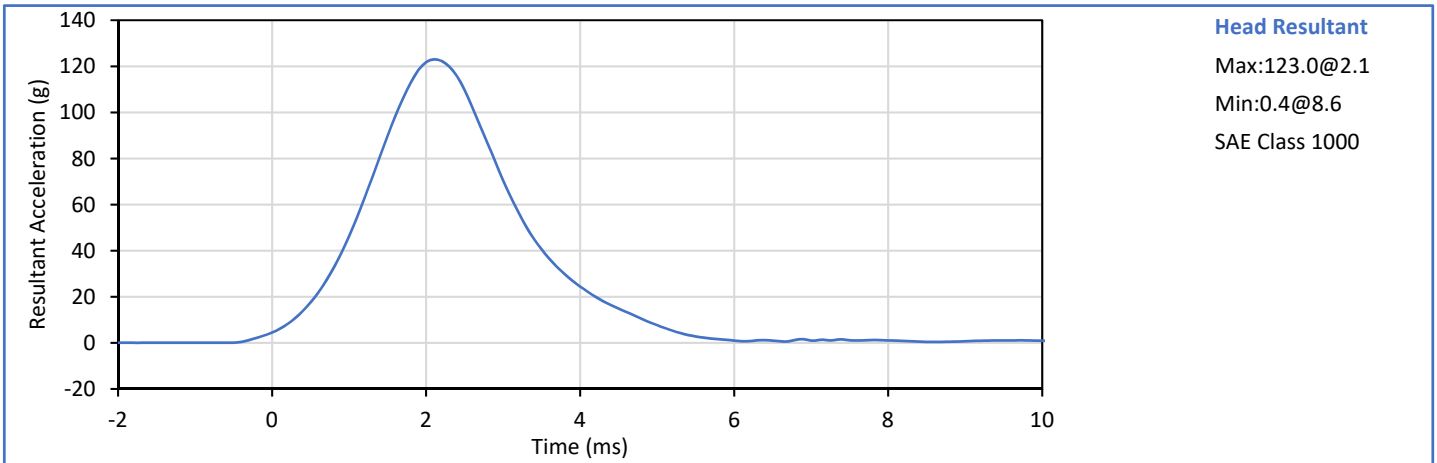
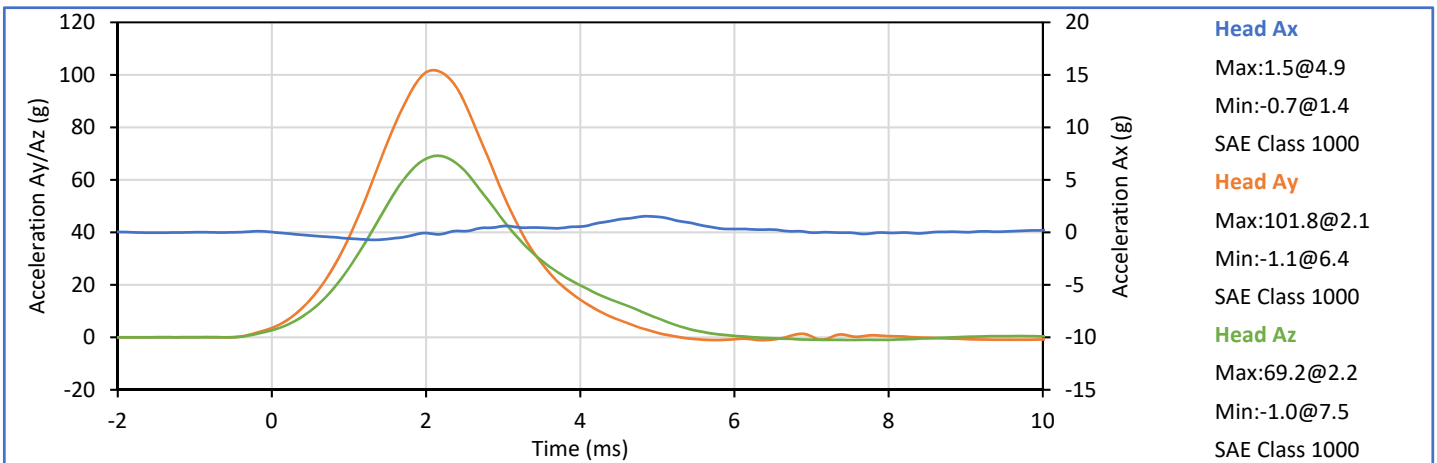
Tested Parameter	Units	Spec. Low	Spec. High	Result	Pass/Fail
Laboratory Temperature	°C	18.9	25.6	21.2	Pass
Laboratory Humidity	%	10	70	22	Pass
Peak Resultant Acceleration	g	115.0	137.0	123.0	Pass
Peak Head Ax	g	-15.0	15.0	-0.9	Pass
Oscillations After Main Pulse	%	0.0	15.0	1.3	Pass
Is Acceleration Unimodal?	Yes/No	Yes		Yes	Pass
Overall Test Results					Pass

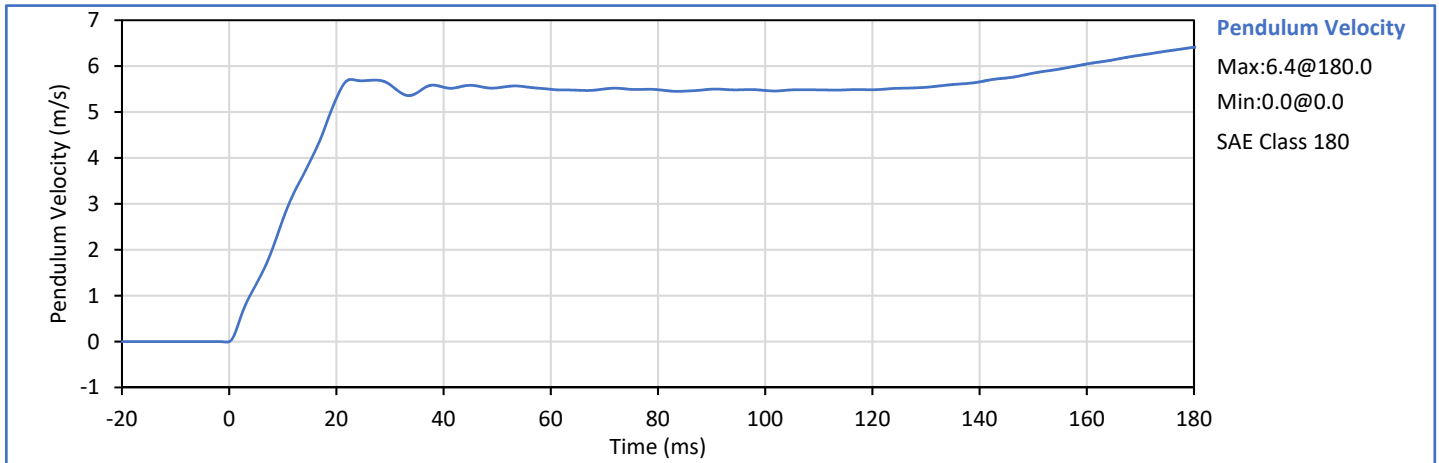
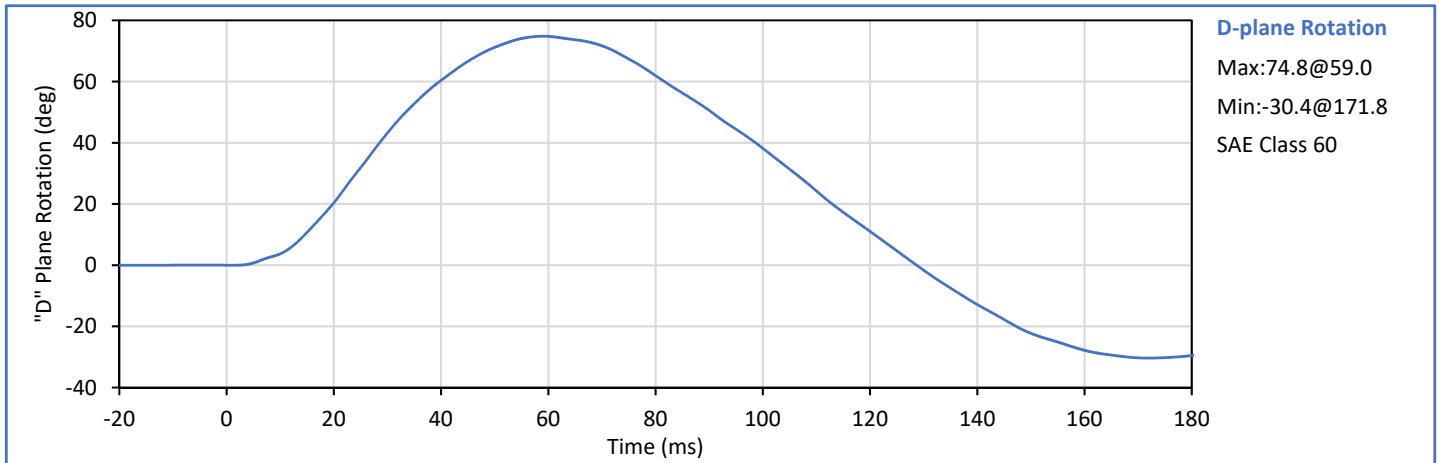
Tested Parameter	Units	Spec. Low	Spec. High	Result	Pass/Fail
Laboratory Temperature	°C	20.6	22.2	21.4	Pass
Laboratory Humidity	%	10	70	25	Pass
Pendulum Velocity	m/s	5.51	5.63	5.58	Pass
Pendulum Decel at 10 ms	m/s	2.20	2.80	2.65	Pass
Pendulum Decel at 15 ms	m/s	3.30	4.10	3.90	Pass
Pendulum Decel at 20 ms	m/s	4.40	5.40	5.30	Pass
Pendulum Decel at 25 ms	m/s	5.40	6.10	5.68	Pass
Pendulum Decel from 25-100 ms	m/s	5.50	6.20	5.70	Pass
Peak "D" Plane Rotation	deg	71.0	81.0	74.8	Pass
Time of Peak "D" Plane Rotation	ms	50.0	70.0	59.0	Pass
Peak Occ. Condyle Moment	Nm	-44.0	-36.0	-43.7	Pass
Time of Moment Decay to 0 Nm	ms	102.0	126.0	110.4	Pass
Overall Test Results					Pass
