REPORT NUMBER: SINCAP-KAR-19-009

**NEW CAR ASSESSMENT PROGRAM (NCAP)
MOVING DEFORMABLE BARRIER SIDE IMPACT TEST**

**SUBARU CORPORATION
2019 SUBARU FORESTER 5-DOOR MPV**

FINAL REPORT

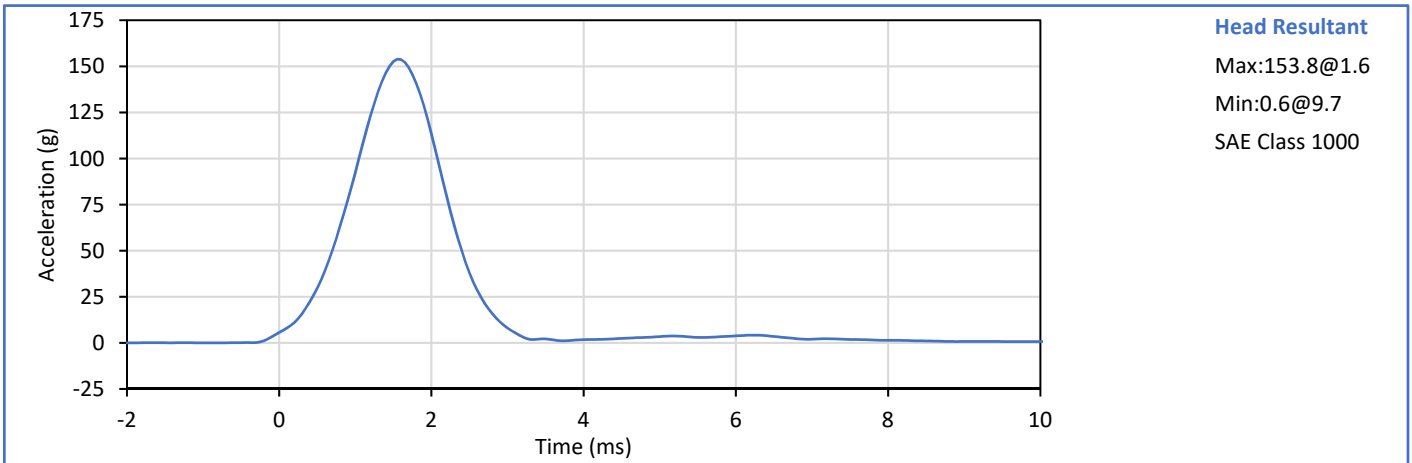
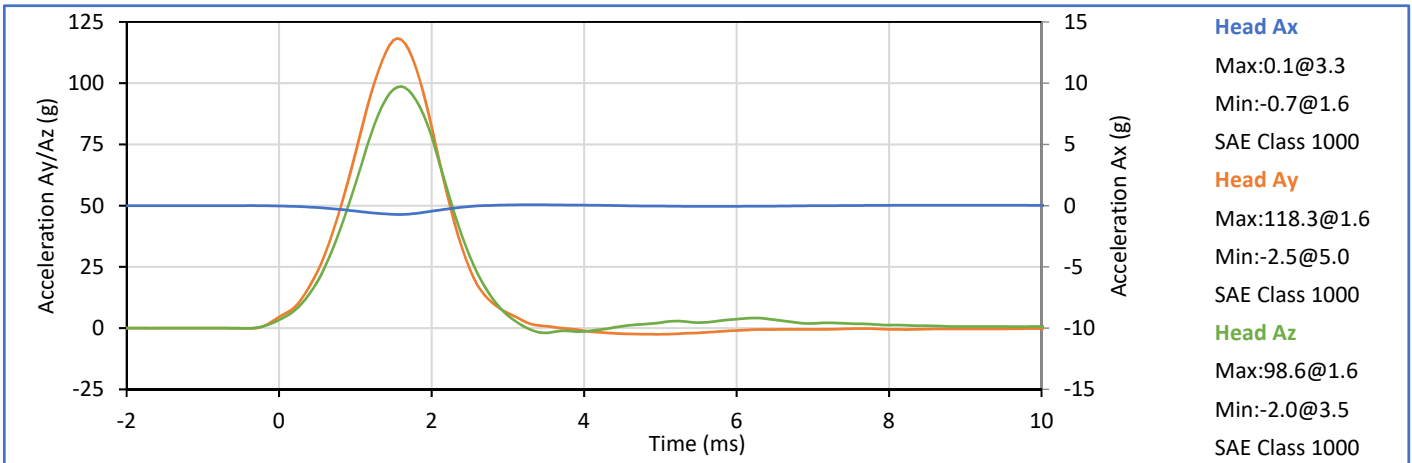
Tested Parameter	Units	Spec. Low	Spec. High	Result	Pass/Fail
Laboratory Temperature	°C	18.9	25.6	21.6	Pass
Laboratory Humidity	%	10	70	22	Pass
Peak Resultant Acceleration	g	125.0	155.0	153.8	Pass
Peak Head Ax	g	-15.0	15.0	0.1	Pass
Oscillations After Main Pulse	%	0.0	15.0	2.7	Pass
Is Acceleration Unimodal?	Yes/No	Yes		Yes	Pass
Overall Test Results					Pass

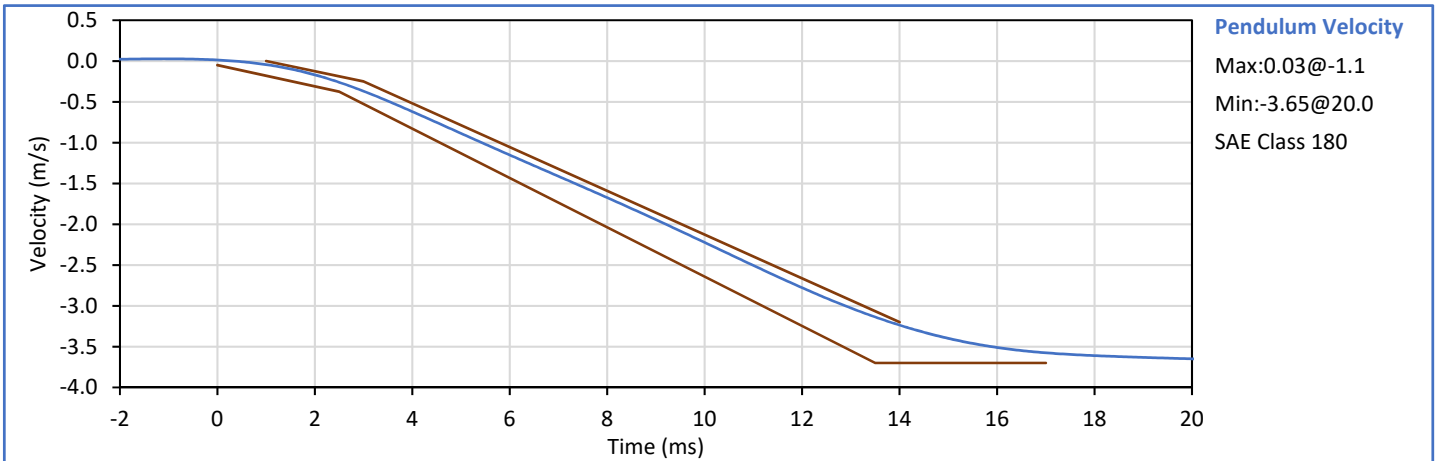
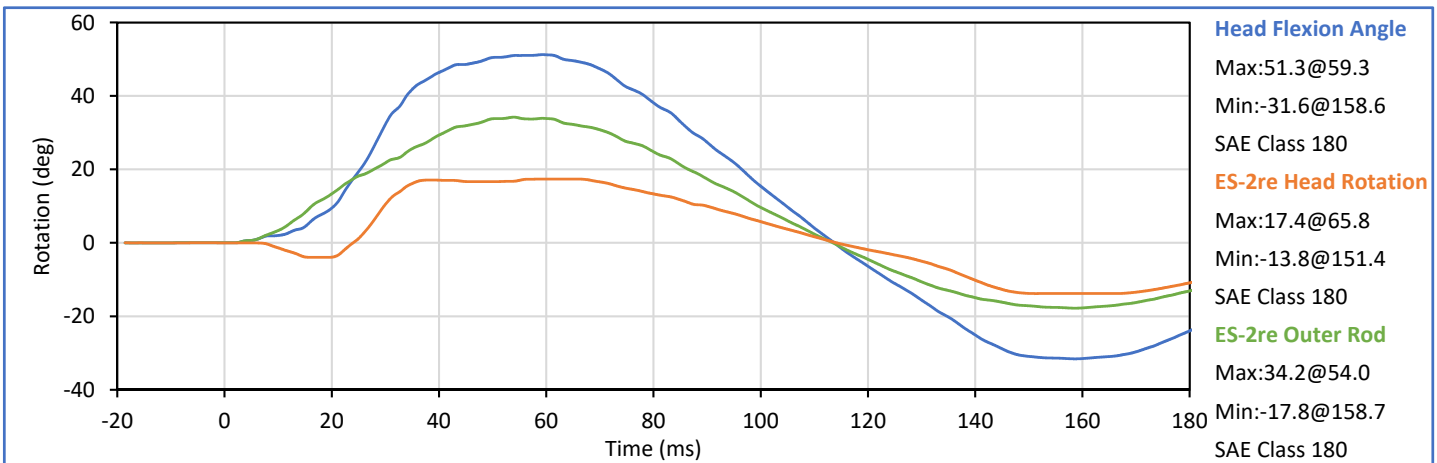
Tested Parameter	Units	Spec. Low	Spec. High	Result	Pass/Fail
Laboratory Temperature	°C	20.6	22.2	21.4	Pass
Laboratory Humidity	%	10	70	22	Pass
Pendulum Velocity	m/s	3.30	3.50	3.48	Pass
Peak Headform Flexion	deg	49.0	59.0	51.3	Pass
Time of Peak Headform Flexion	ms	54.0	66.0	59.3	Pass
Flexion Decay (Peak to zero)	ms	53.0	88.0	54.4	Pass
Overall Test Results					Pass

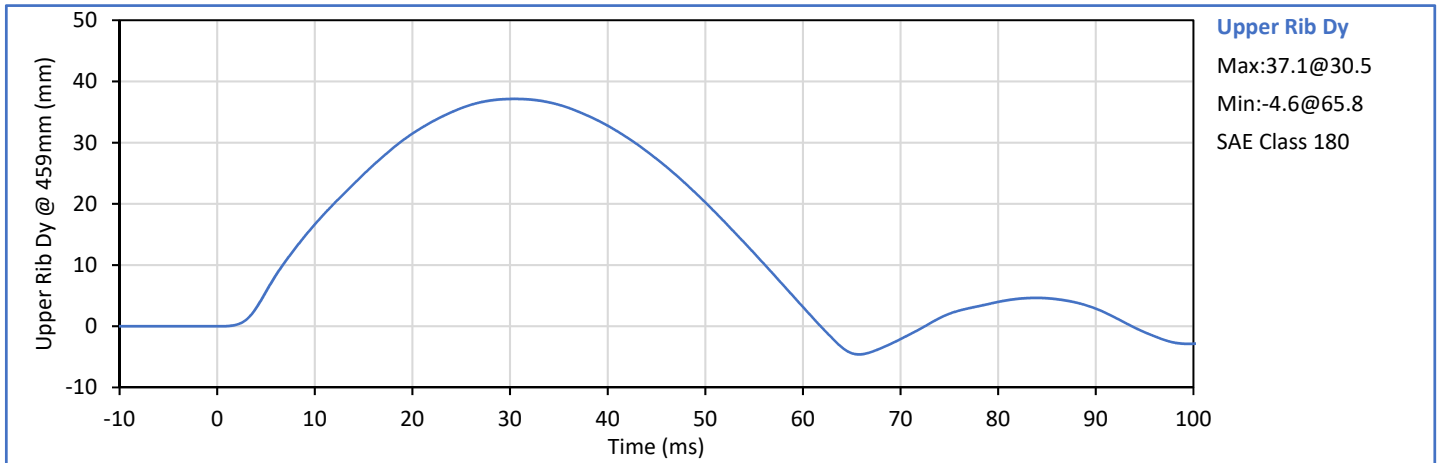
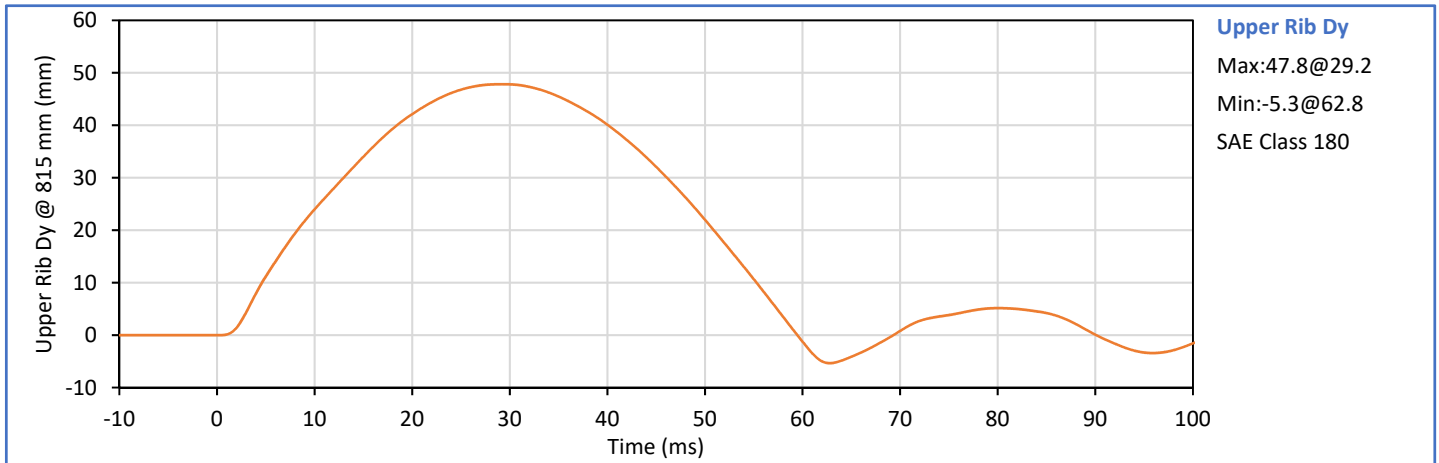
Tested Parameter	Units	Spec. Low	Spec. High	Result	Pass/Fail
Laboratory Temperature	°C	20.6	22.2	21.6	Pass
Laboratory Humidity	%	10	70	22	Pass
Upper Rib Dy @ 459mm	mm	36.0	40.0	37.1	Pass
Upper Rib Dy @ 815mm	mm	46.0	51.0	47.8	Pass
Overall Test Results					Pass

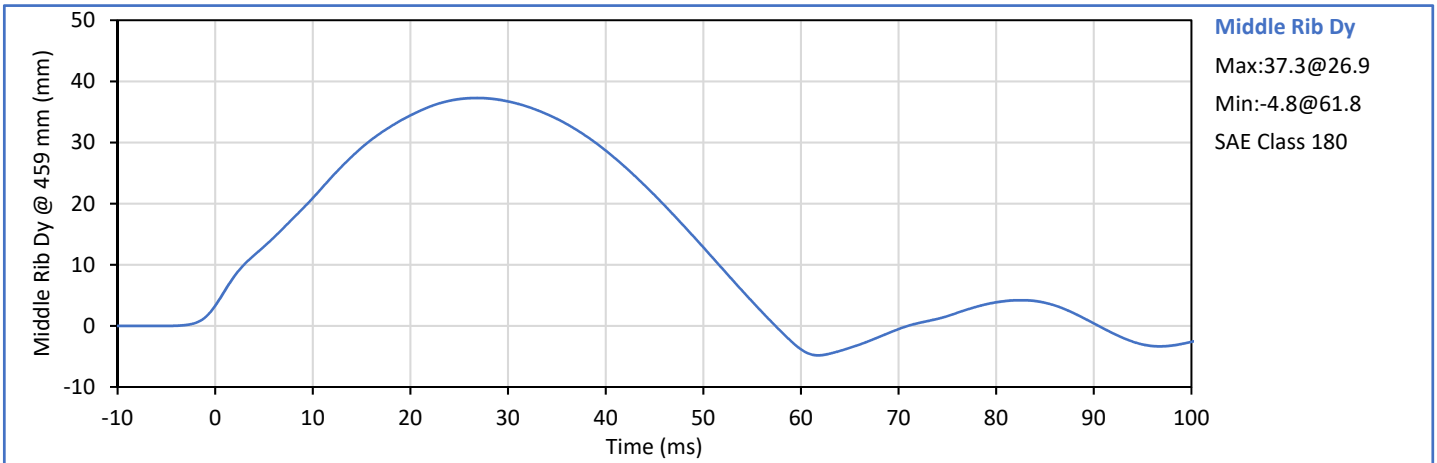
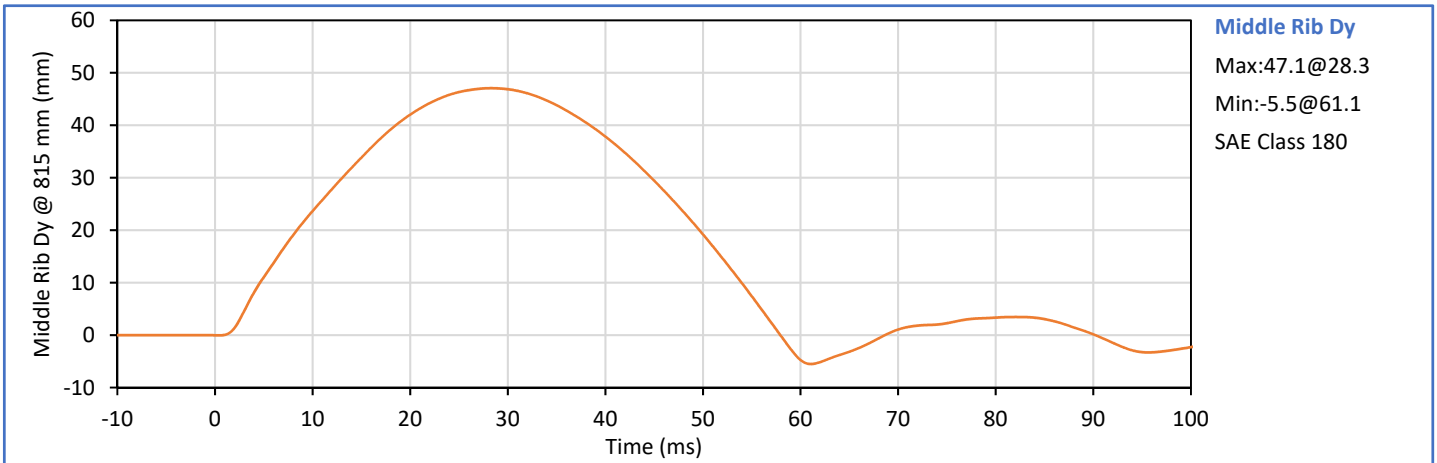
Tested Parameter	Units	Spec. Low	Spec. High	Result	Pass/Fail
Laboratory Temperature	°C	20.6	22.2	21.4	Pass
Laboratory Humidity	%	10	70	22	Pass
Middle Rib Dy @ 459mm	mm	36.0	40.0	37.3	Pass
Middle Rib Dy @ 815mm	mm	46.0	51.0	47.1	Pass
Overall Test Results					Pass

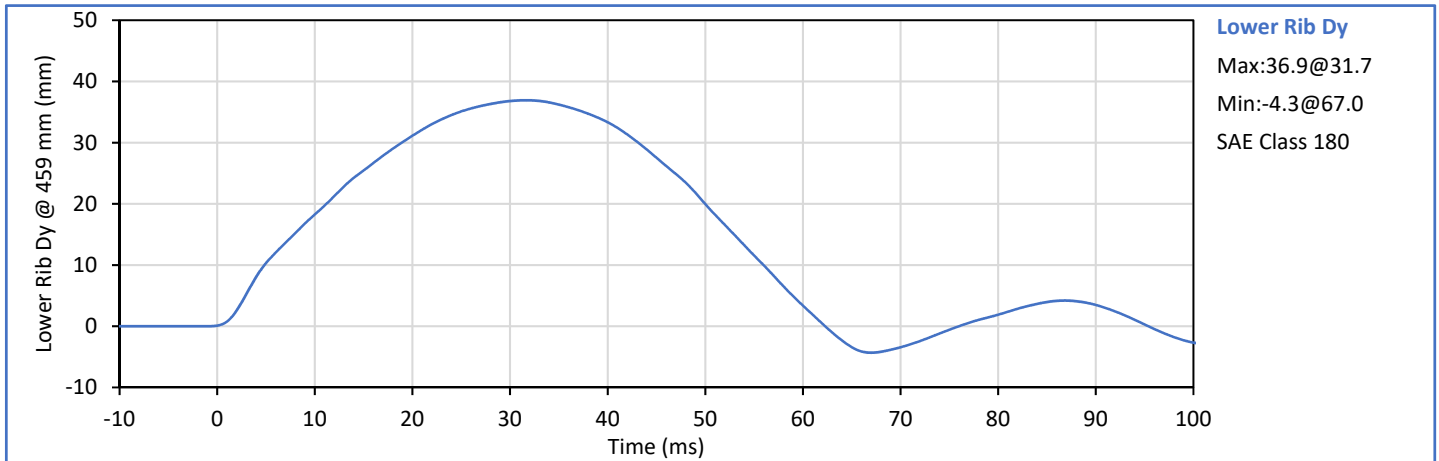
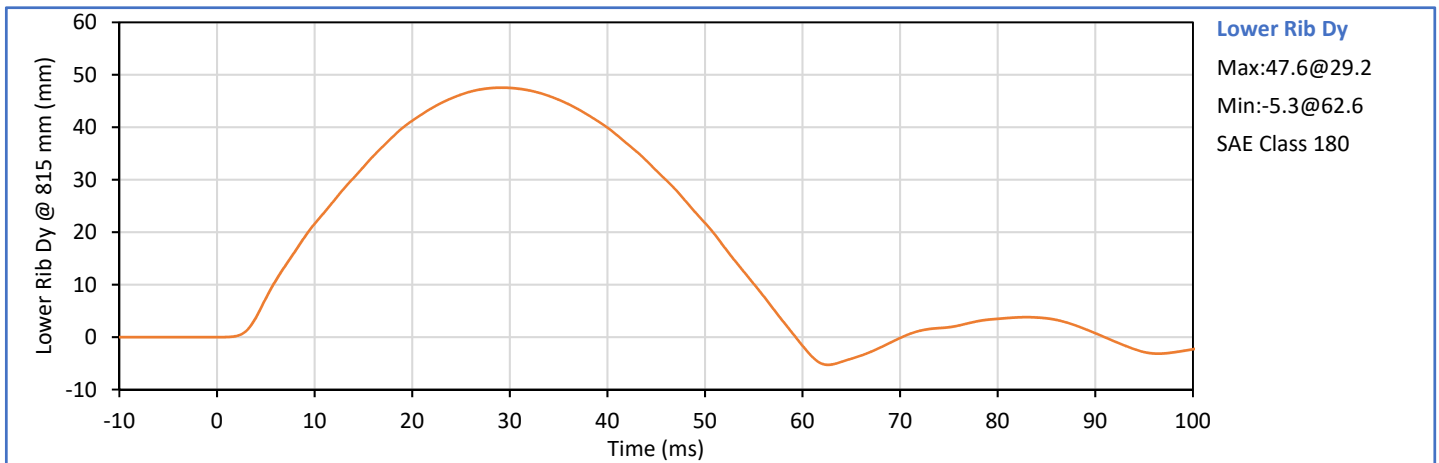
Tested Parameter	Units	Spec. Low	Spec. High	Result	Pass/Fail
Laboratory Temperature	°C	20.6	22.2	21.8	Pass
Laboratory Humidity	%	10	70	34	Pass
Lower Rib Dy @ 459mm	mm	36.0	40.0	36.9	Pass
Lower Rib Dy @ 815mm	mm	46.0	51.0	47.6	Pass
Overall Test Results					Pass

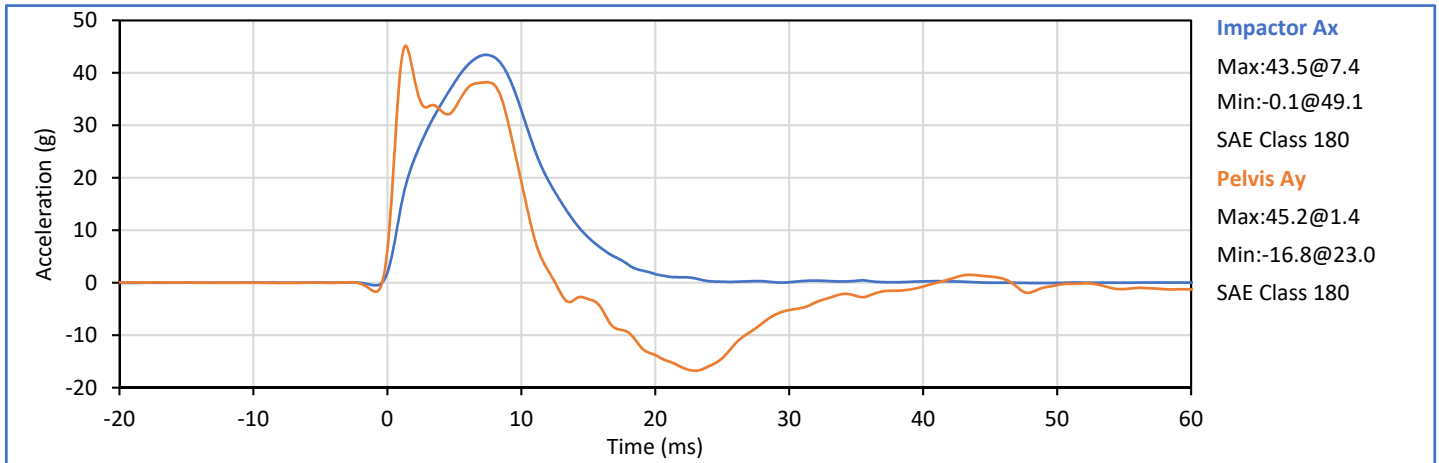
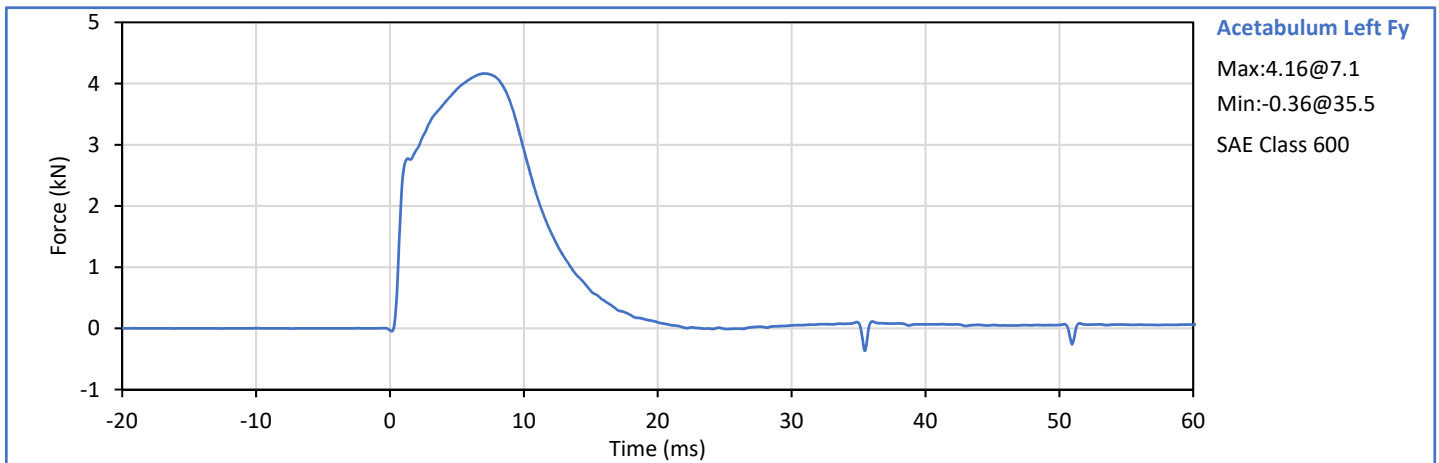
Tested Parameter	Units	Spec. Low	Spec. High	Result	Pass/Fail
Laboratory Temperature	°C	20.6	22.2	21.2	Pass
Laboratory Humidity	%	10	70	20	Pass
Impactor Velocity	m/s	6.60	6.80	6.71	Pass
Peak Acetabulum Fy	kN	3.60	4.30	4.16	Pass
Pelvis Ay after 6ms	g	34.0	42.0	38.2	Pass
Peak Impactor Ax	g	38.0	47.0	43.5	Pass
Overall Test Results					Pass

Pelvis Plug S/N: 12240 (SACO)
