**REPORT NUMBER: SINCAP-MGA-2018-038**

**NEW CAR ASSESSMENT PROGRAM (NCAP)  
Moving Deformable Barrier Side Impact Test**

**MITSUBISHI MOTORS CORPORATION  
2018 Mitsubishi Outlander PHEV SEL S-AWC 5-Door SUV  
NHTSA No.: O20185602**

**MGA RESEARCH CORPORATION  
5000 Warren Road  
Burlington, WI 53105**

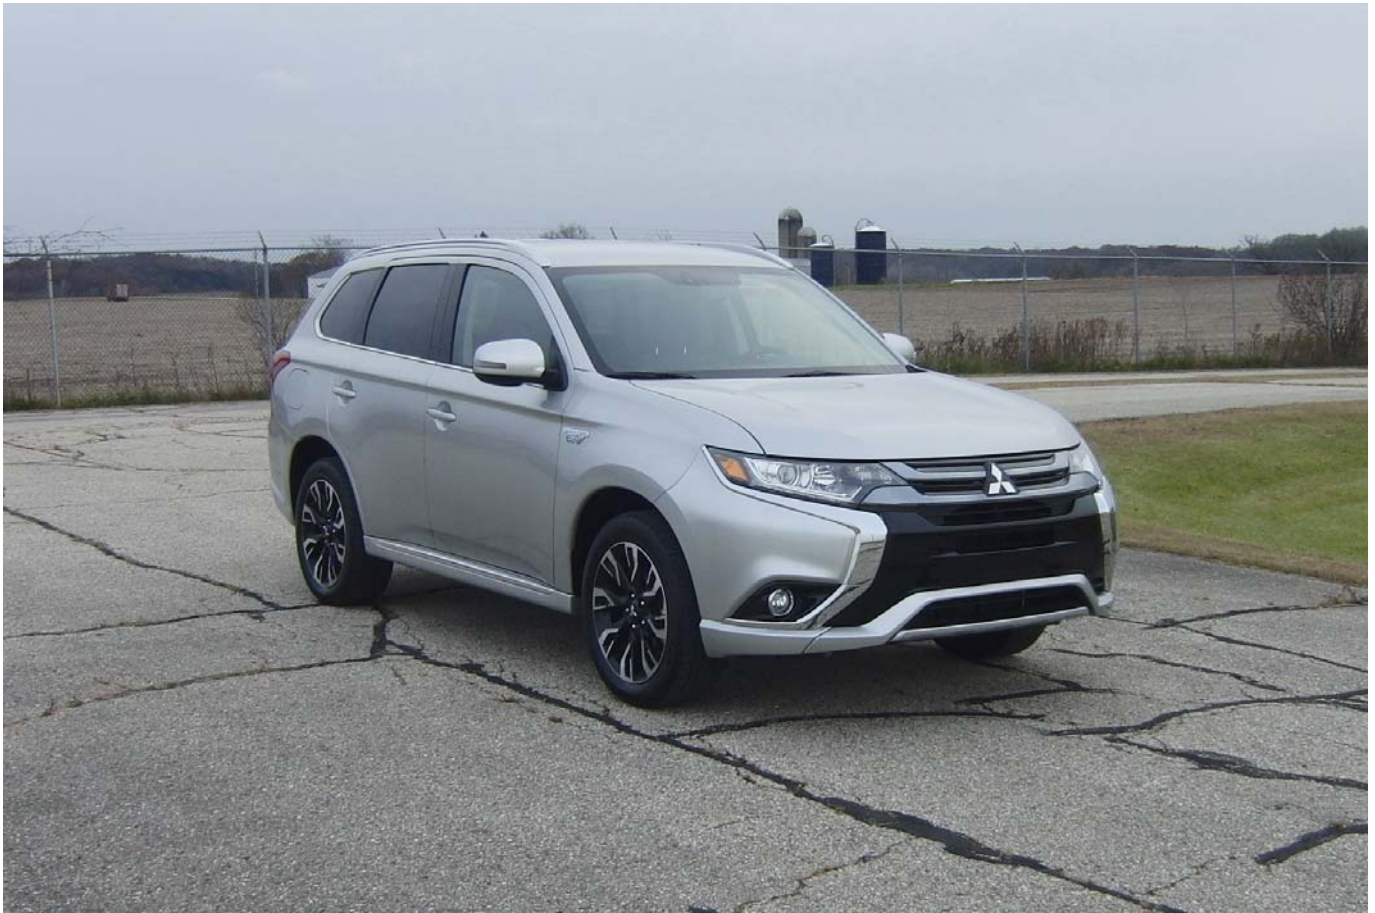
Photo No. 001 - As Delivered Right Front Three-Quarter View of Test Vehicle

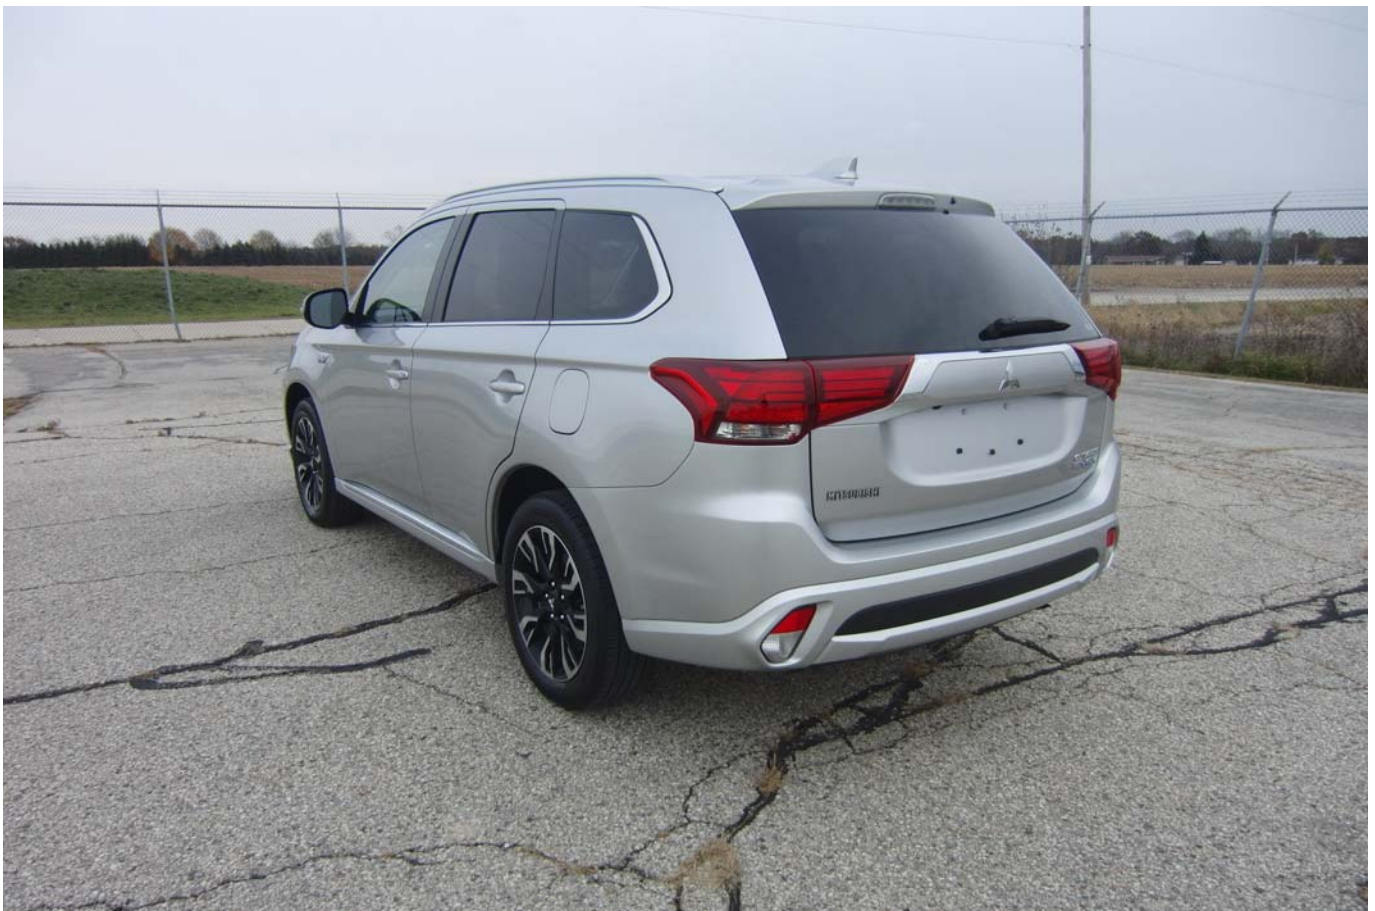
Photo No. 002 - As Delivered Left Rear Three-Quarter View of Test Vehicle

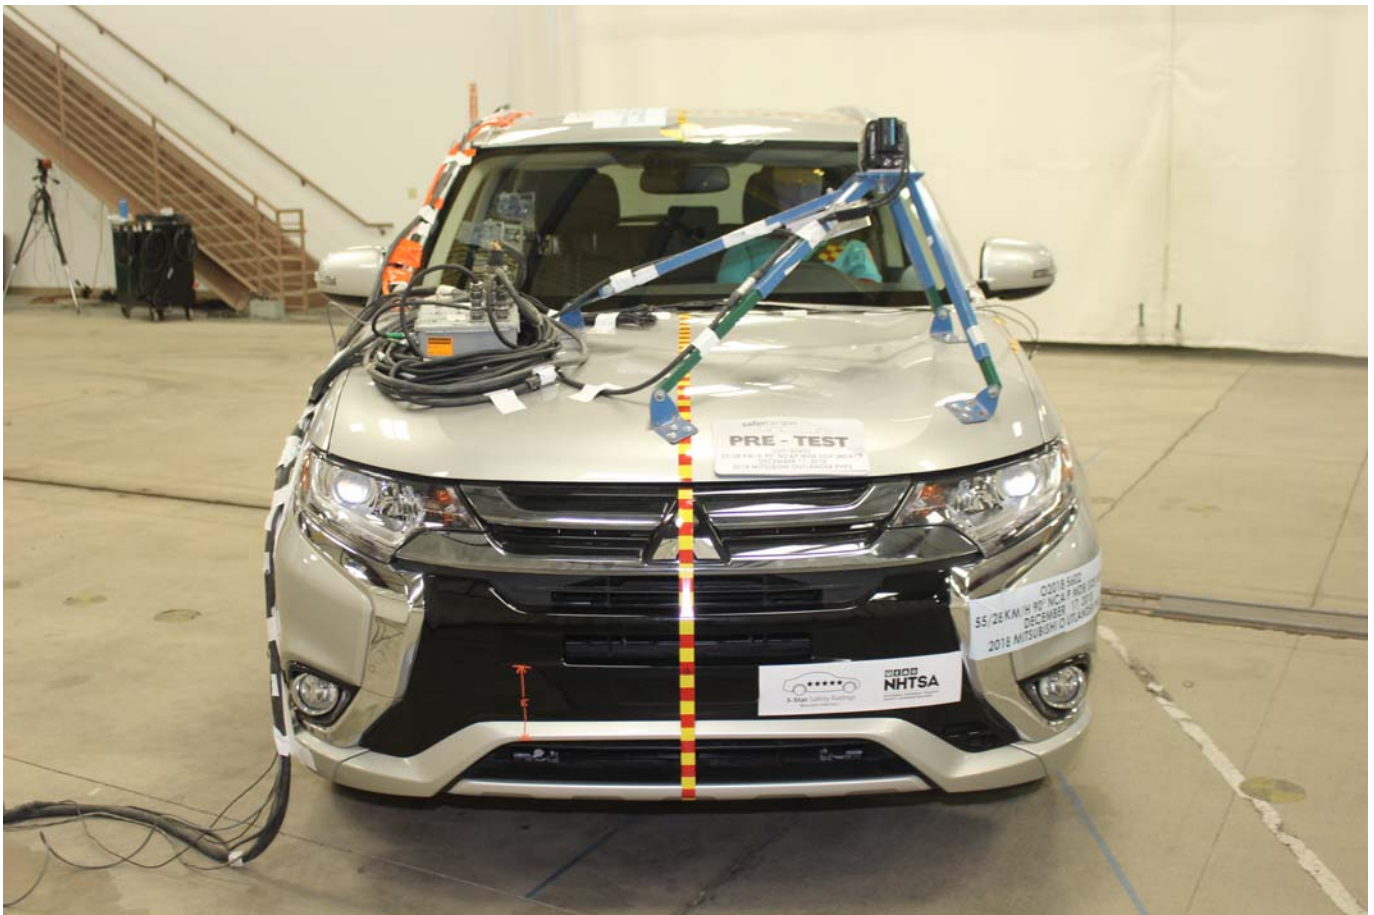
Photo No. 003 - Pre-Test Frontal View of Test Vehicle

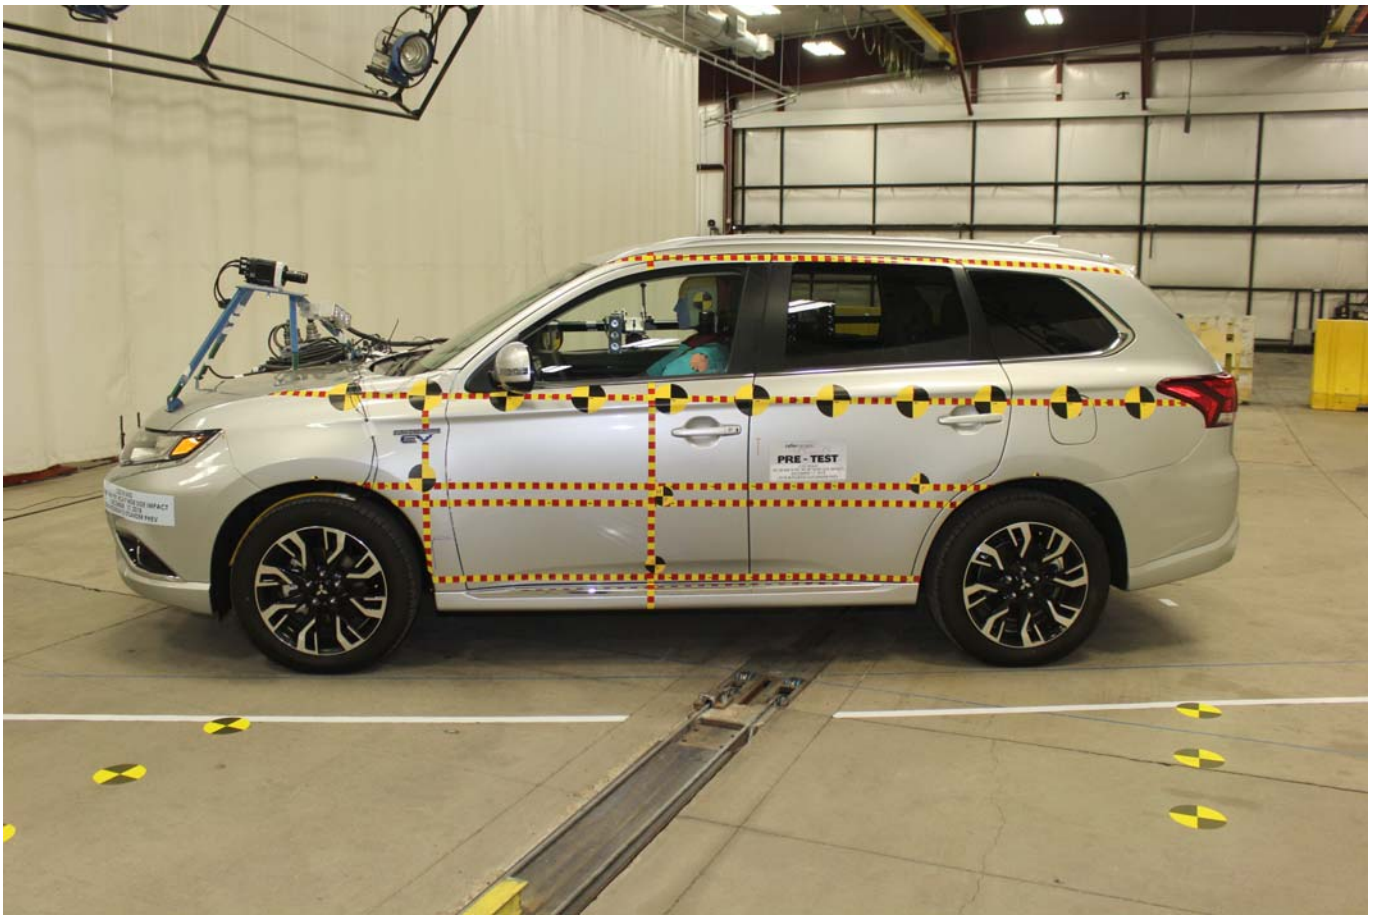
Photo No. 007 - Pre-Test Left Side View of Test Vehicle

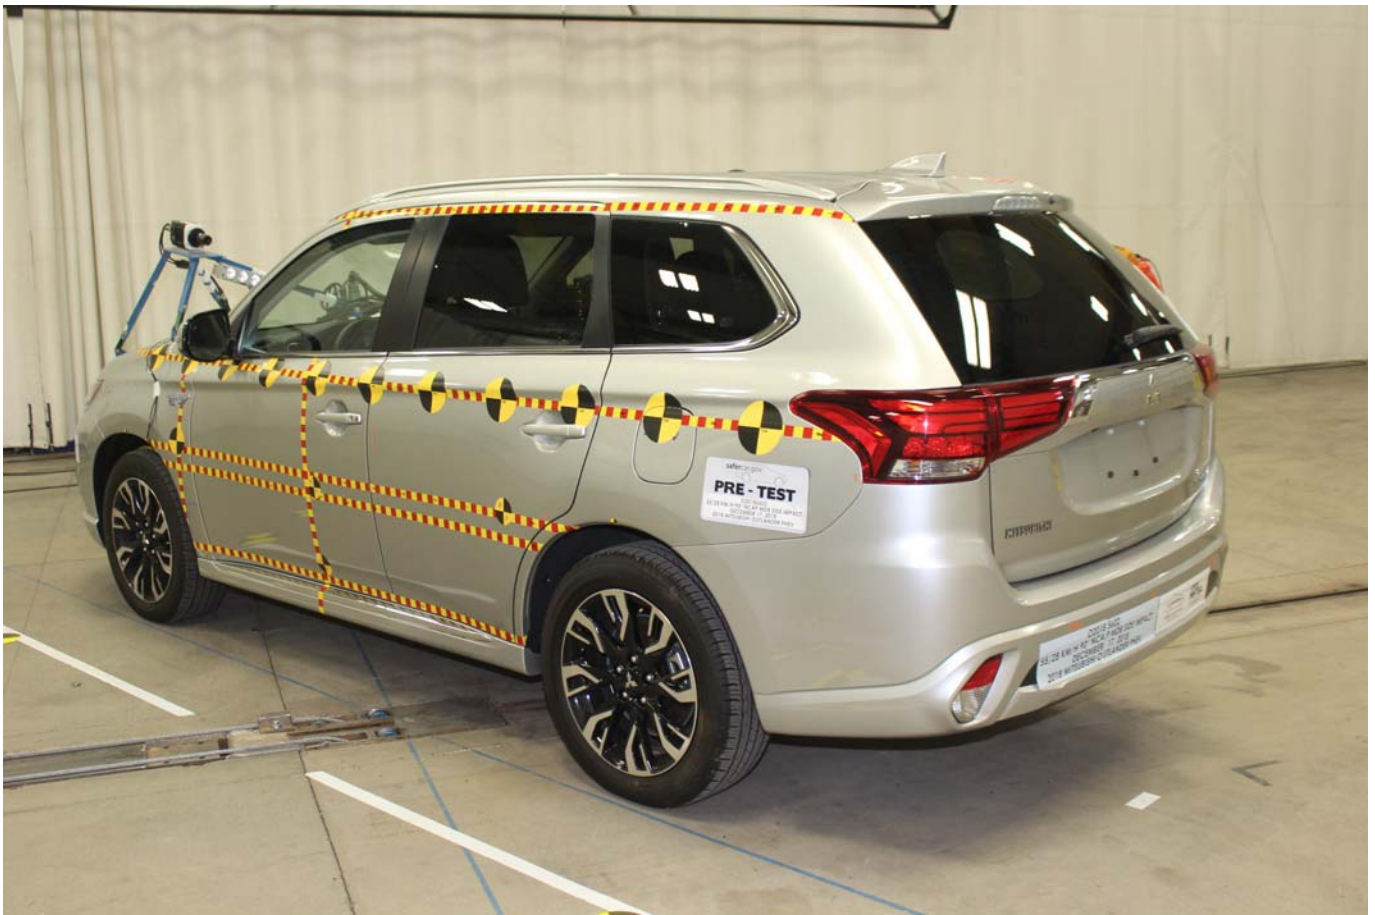
Photo No. 009 - Pre-Test Left Three-Quarter Rear View of Test Vehicle

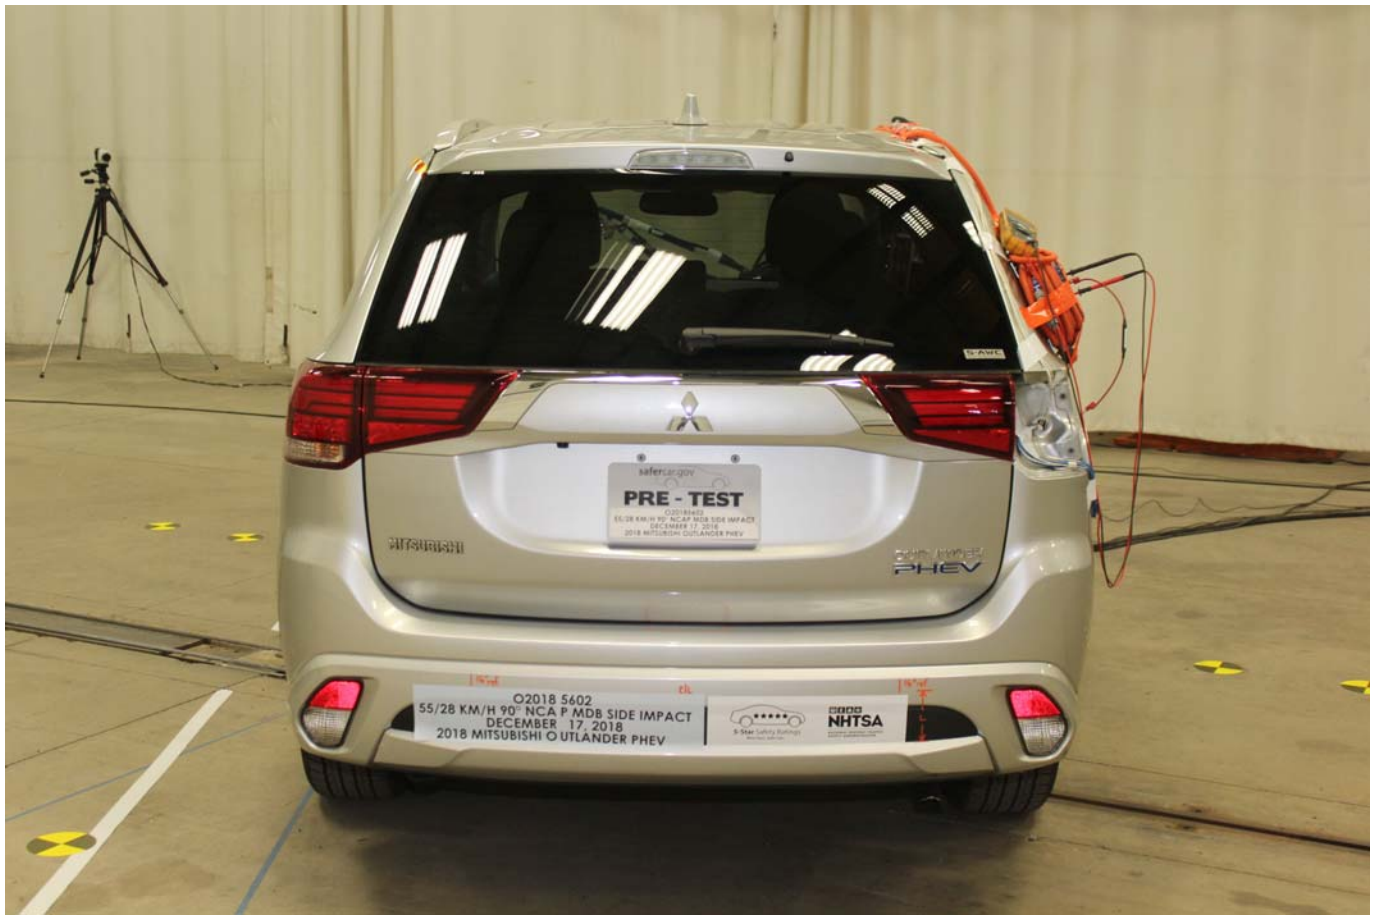
Photo No. 011 - Pre-Test Rear View of Test Vehicle

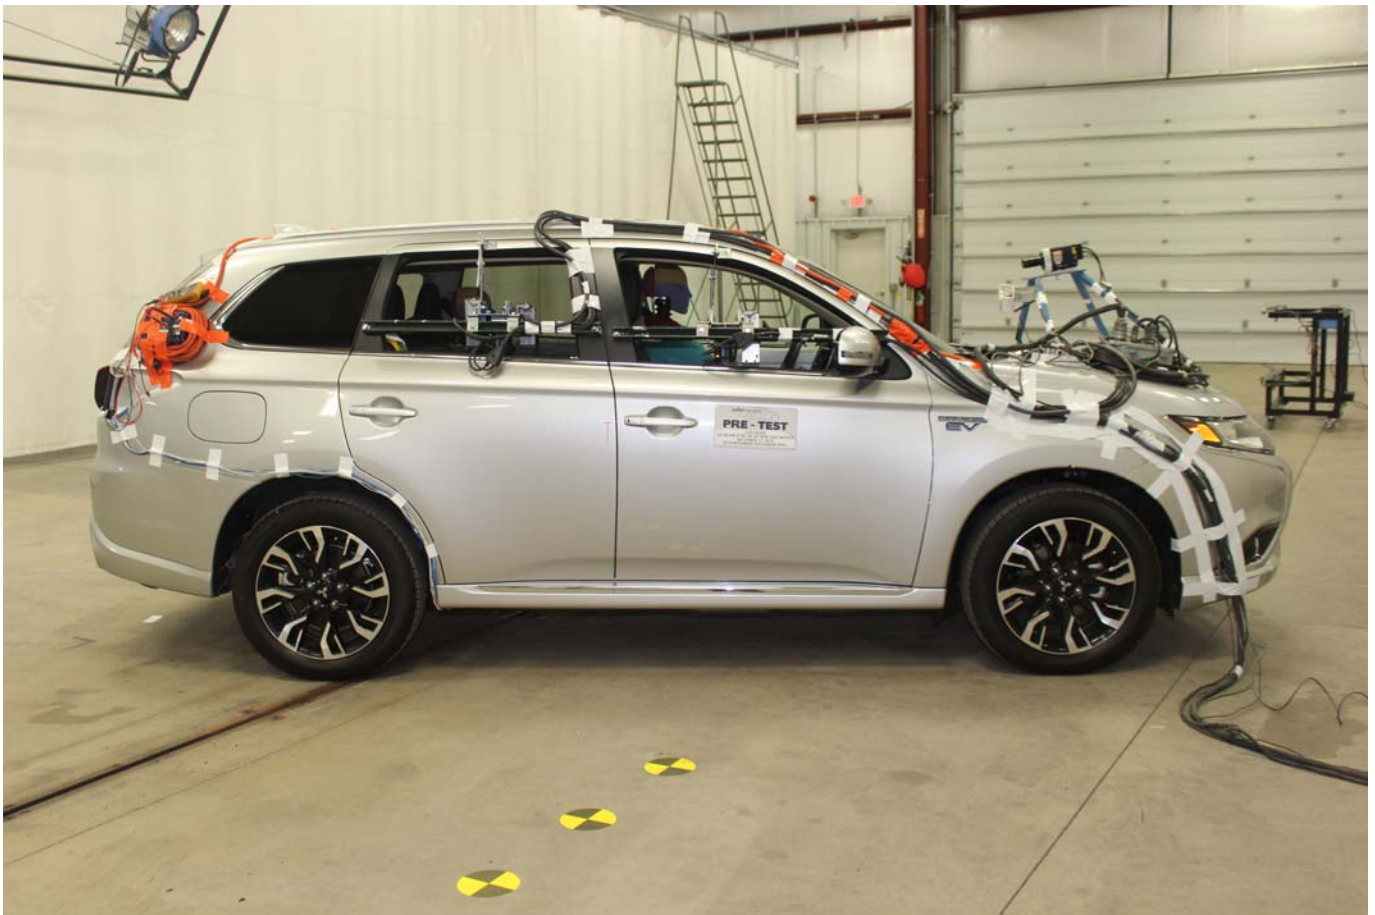
Photo No. 013 - Pre-Test Right Side View of Test Vehicle

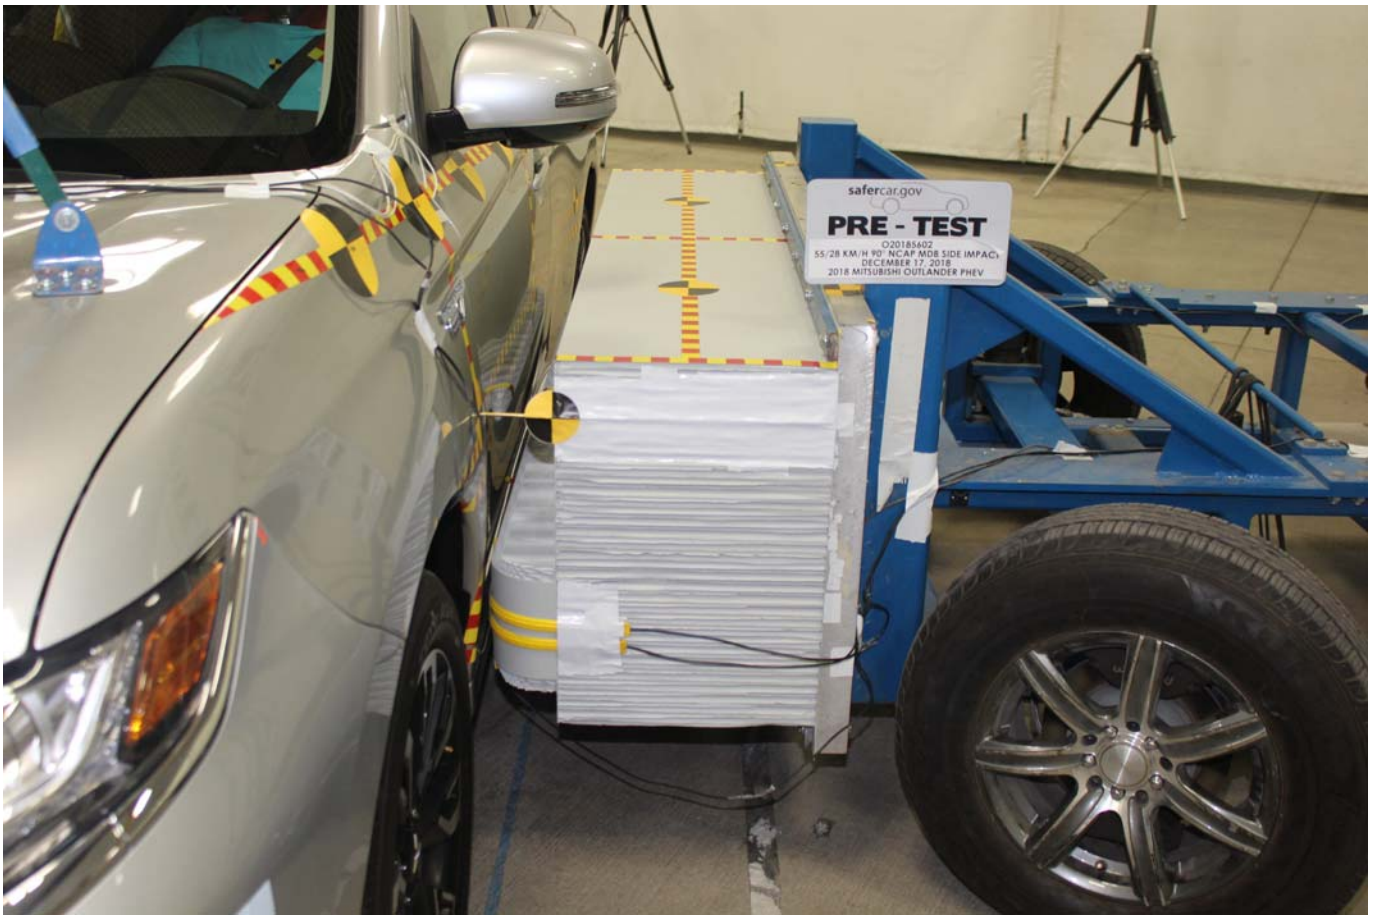
Photo No. 017 - Pre-Test Left Side View of MDB Positioned Against Side of Test Vehicle

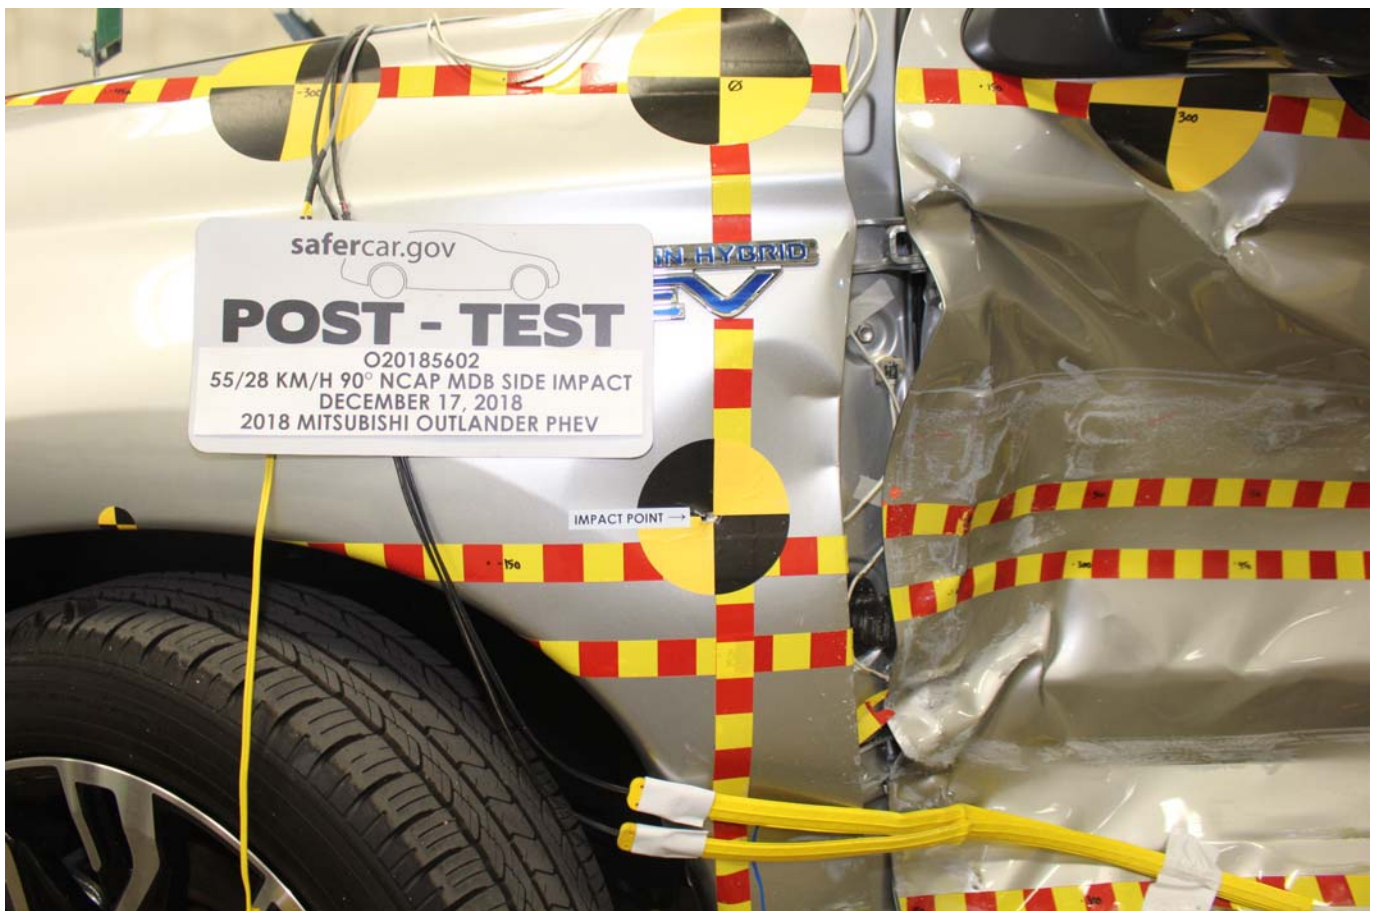
Photo No. 020 - Post-Test Close-Up View of Impact Point Target

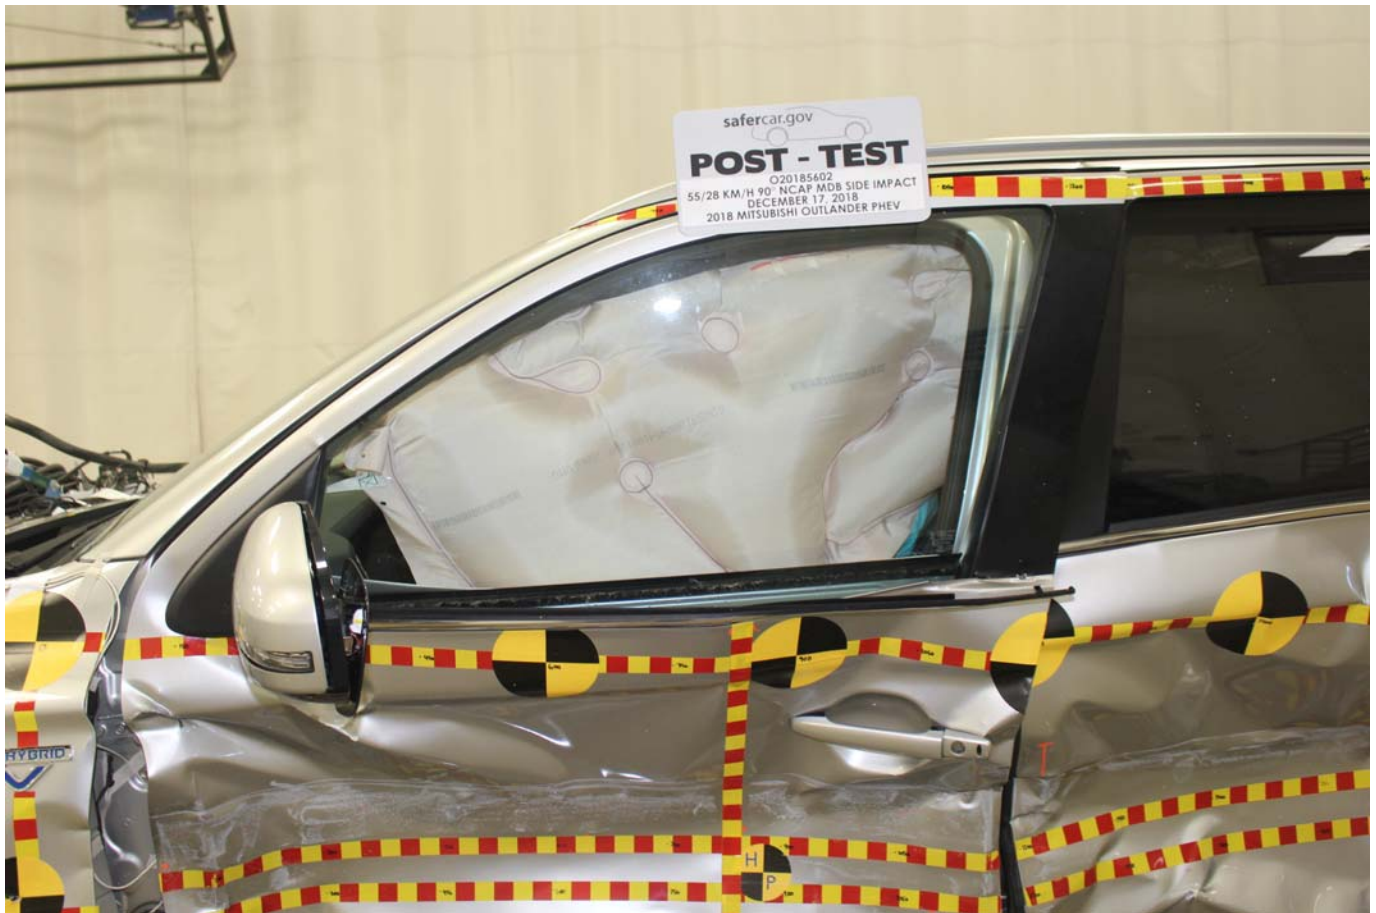
Photo No. 029 - Post-Test Left Side View of Driver Dummy Shoulder and Door Top View

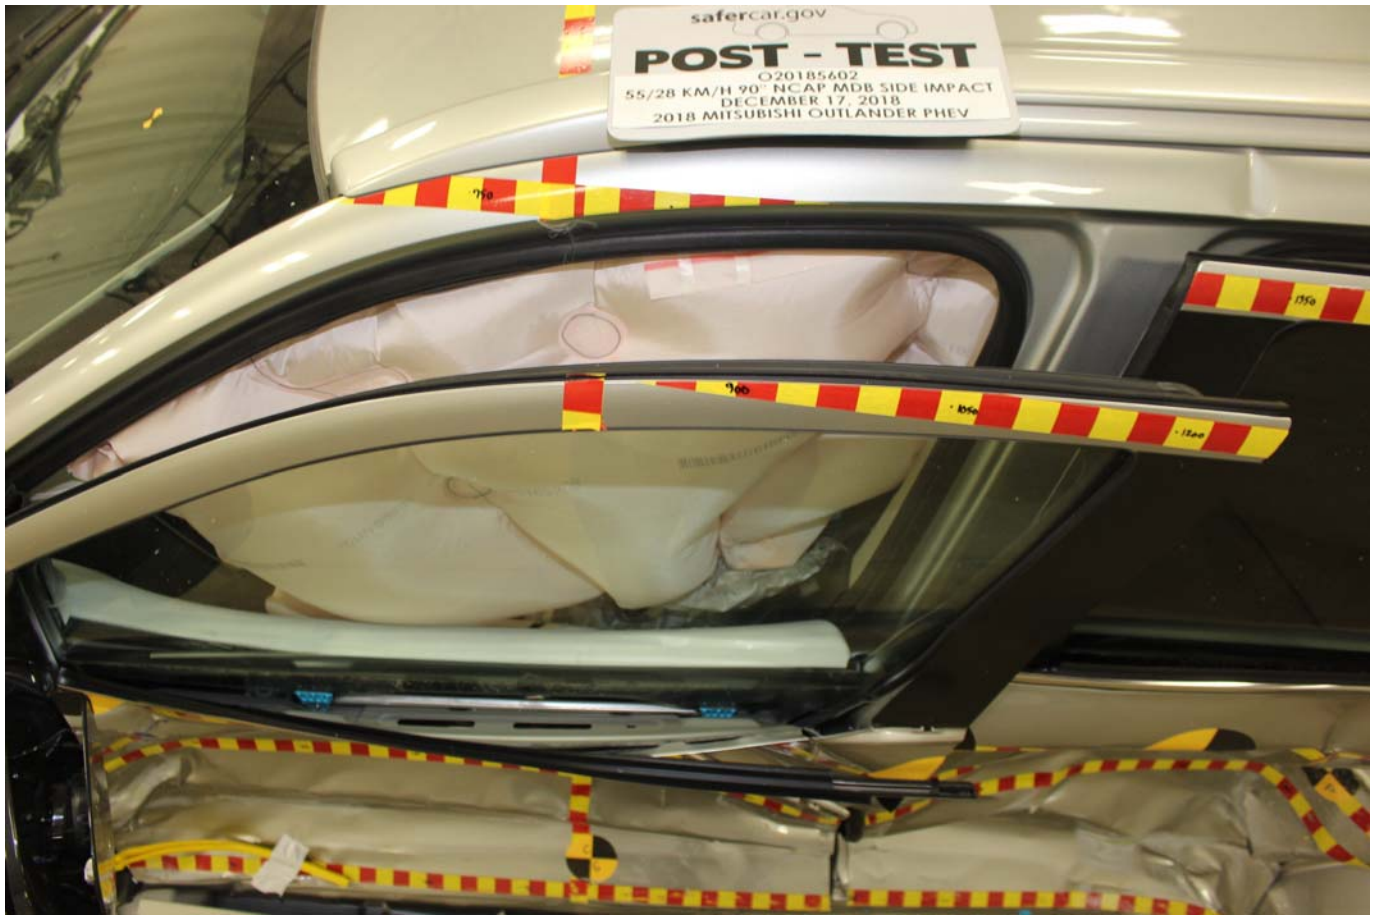
Photo No. 043 - Post-Test Driver Dummy and Door Clearance View

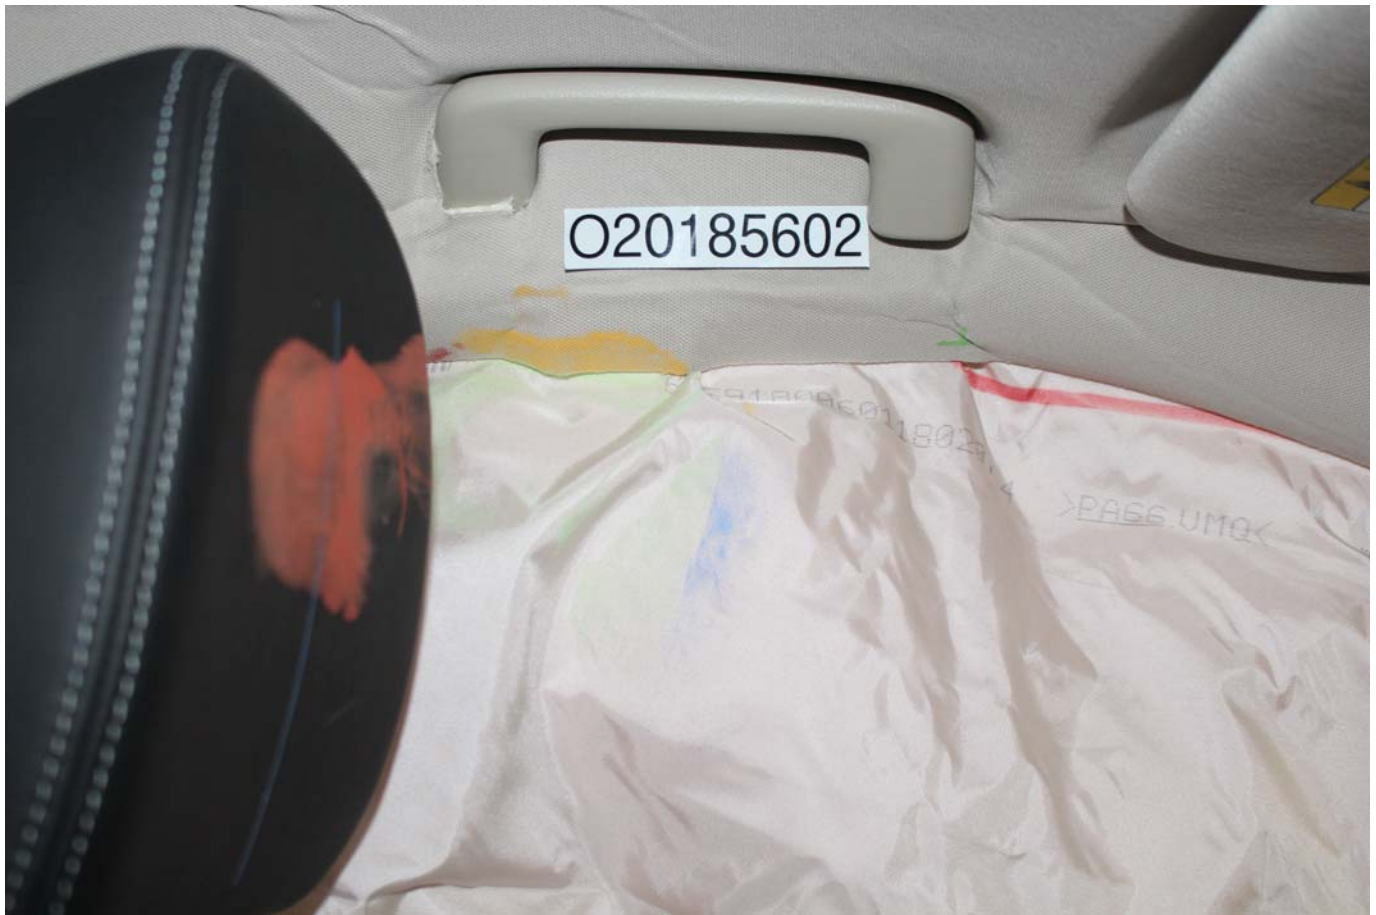
Photo No. 049 - Post-Test Driver Dummy Close-up Head Contact with Side Airbag View

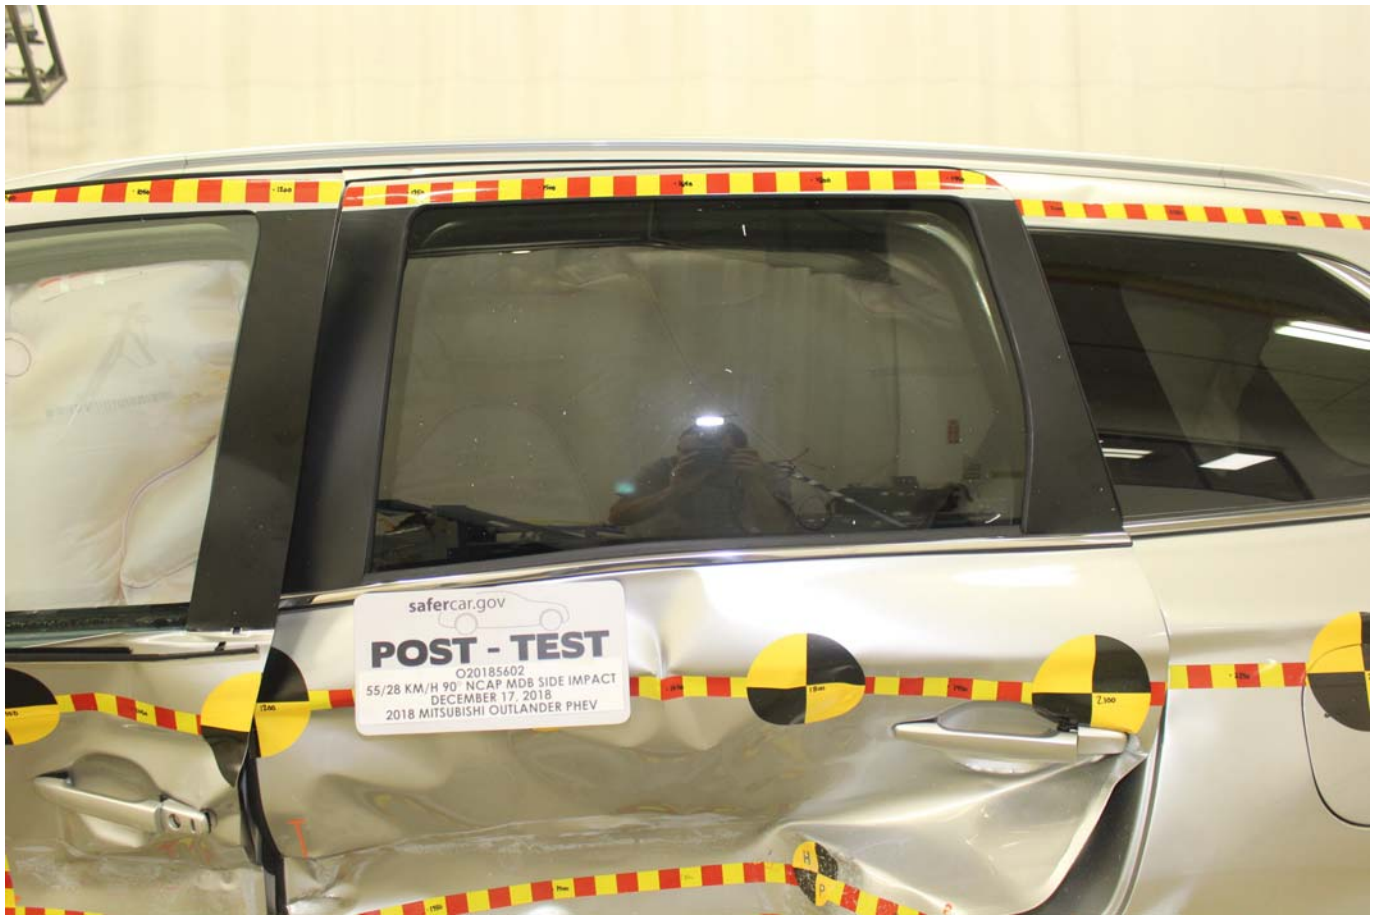
Photo No. 057 - Post-Test Left Side View of Rear Passenger Dummy Shoulder and Door Top View

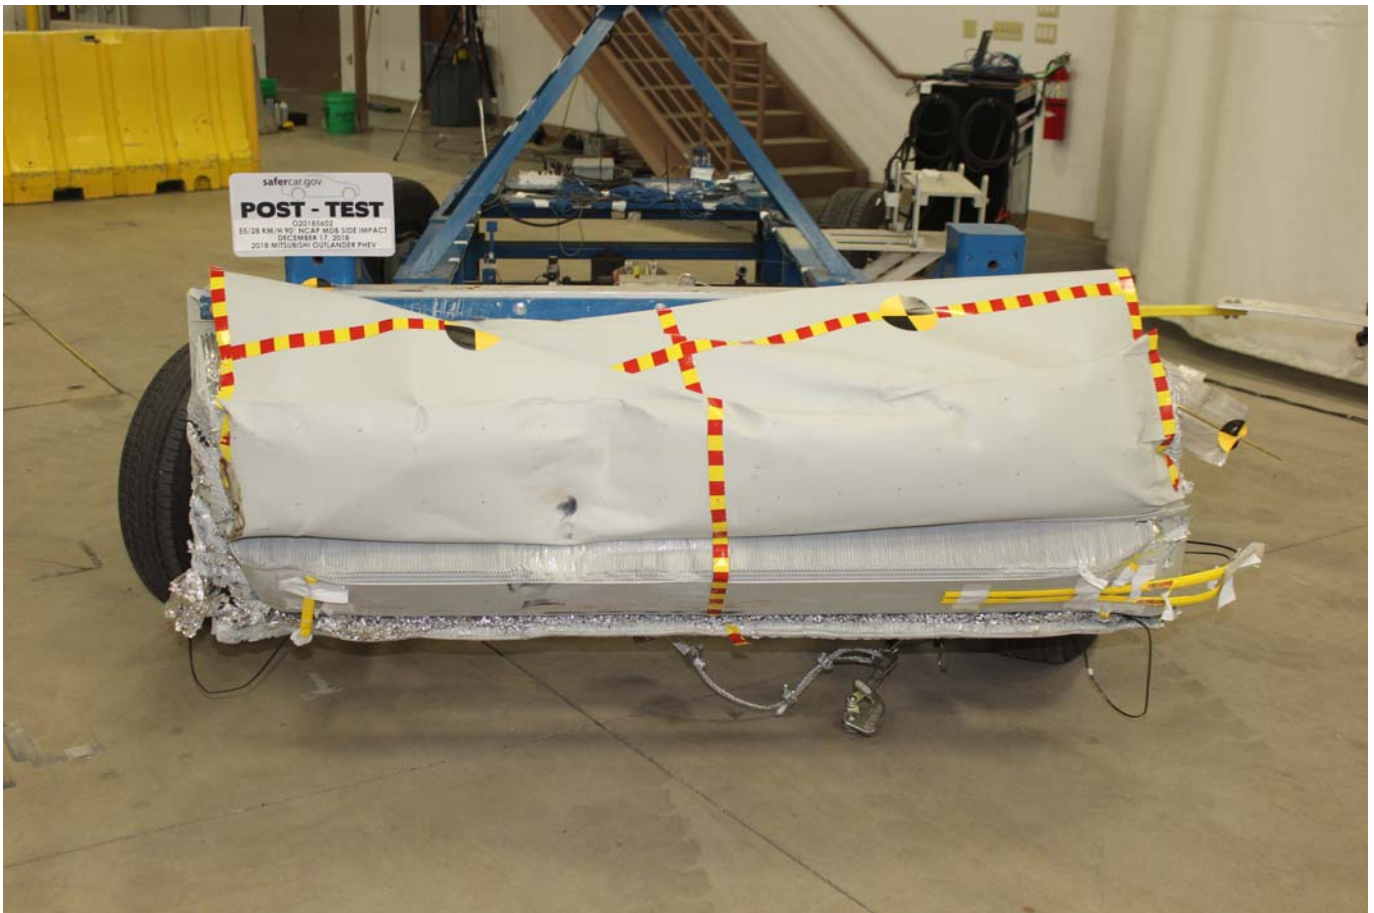
Photo No. 085 - Post-Test Front View of MDB Impactor Face

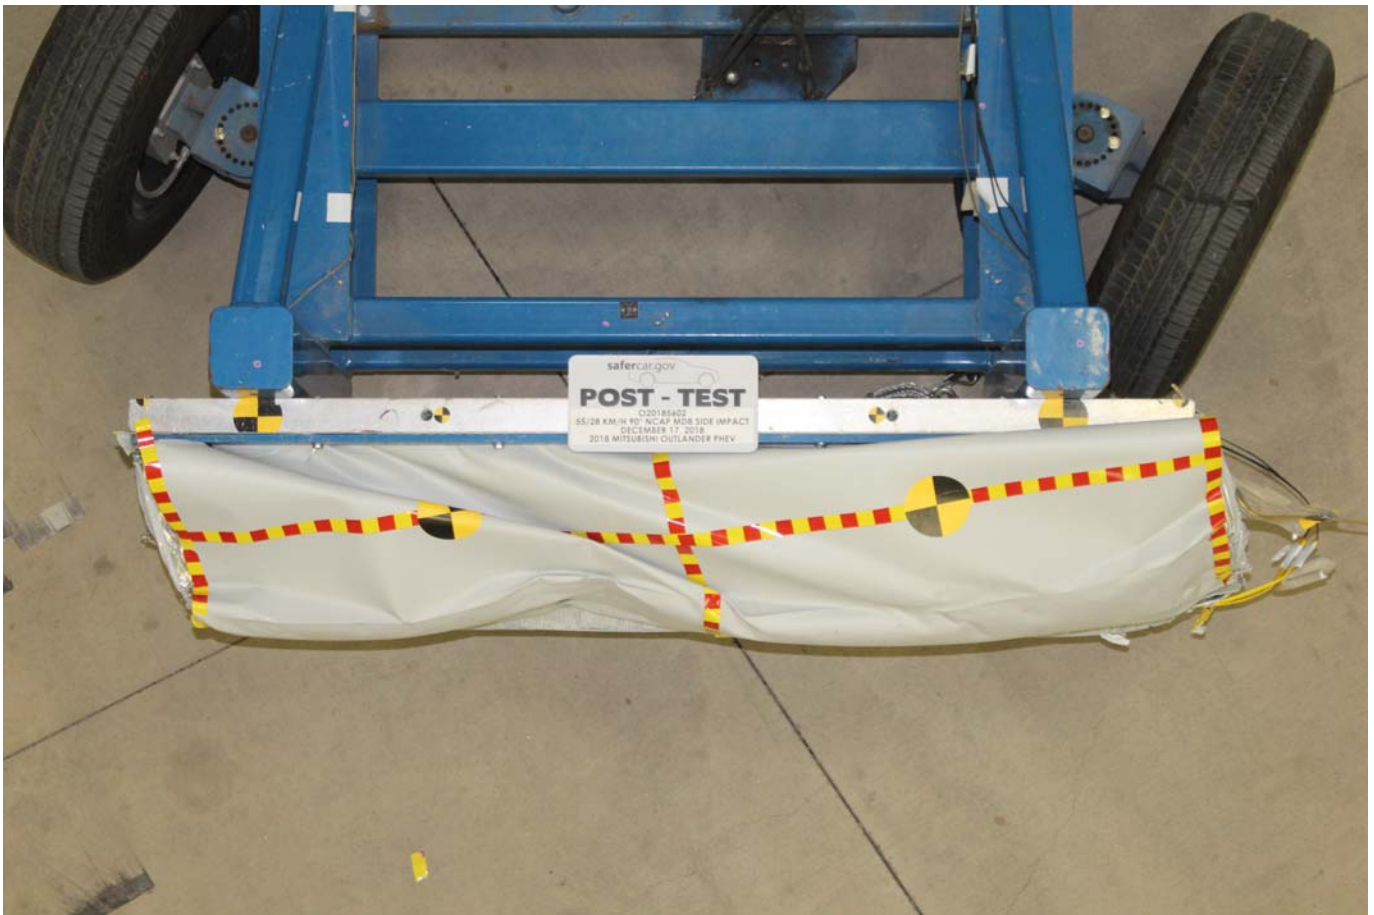
Photo No. 087 - Post-Test Top View of MDB Impactor Face

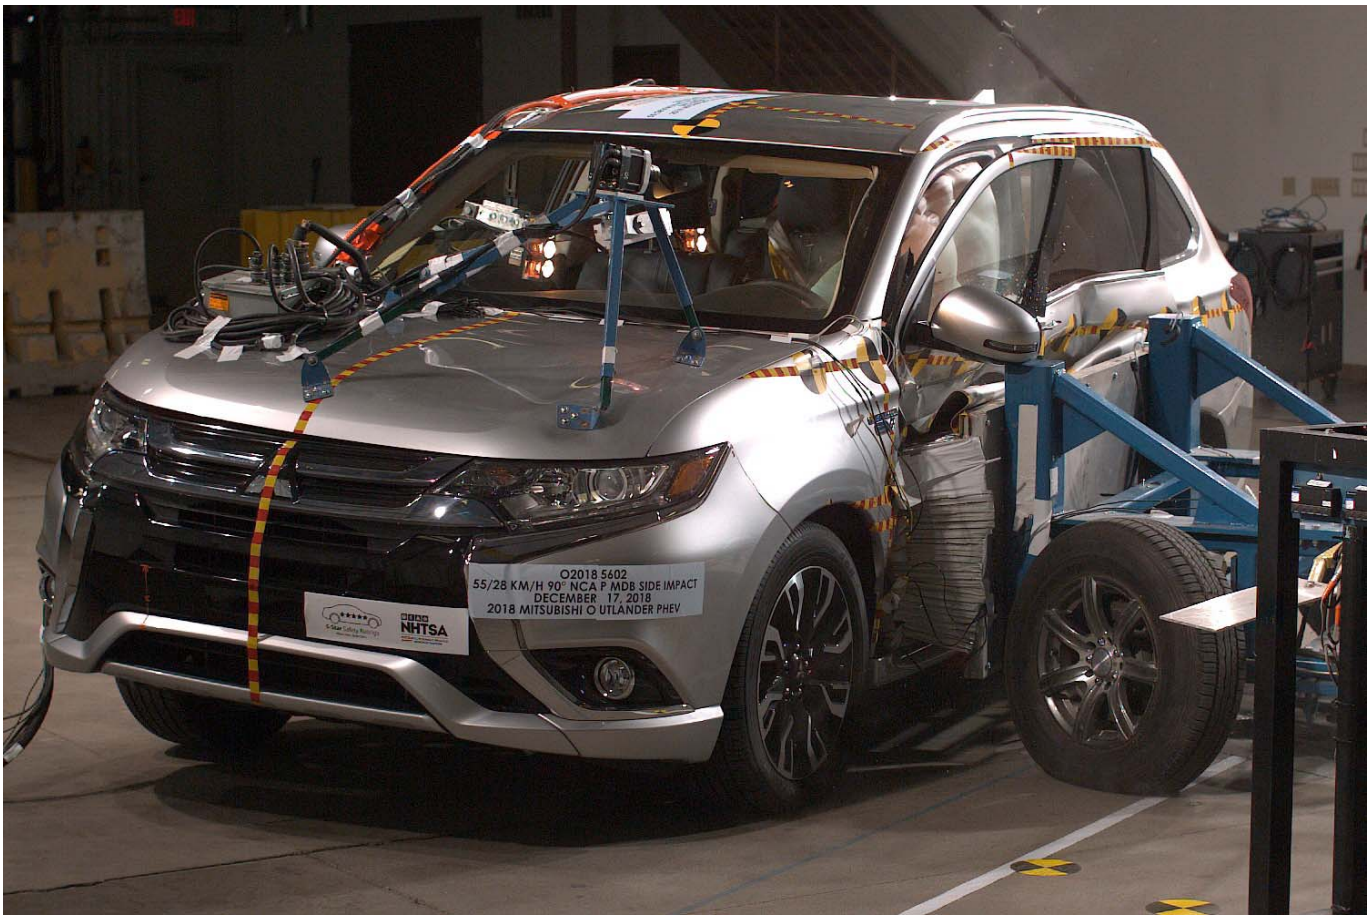
Photo No. 101 - Impact Event
