**REPORT NUMBER: SPNCAP-MGA-2018-040**

**NEW CAR ASSESSMENT PROGRAM (NCAP)  
Side Impact Pole Test**

**MITSUBISHI MOTOR CORPORATION  
2018 Mitsubishi Outlander PHEV SEL S-AWC 5-Door SUV  
NHTSA No.: O20185601**

**FINAL REPORT**

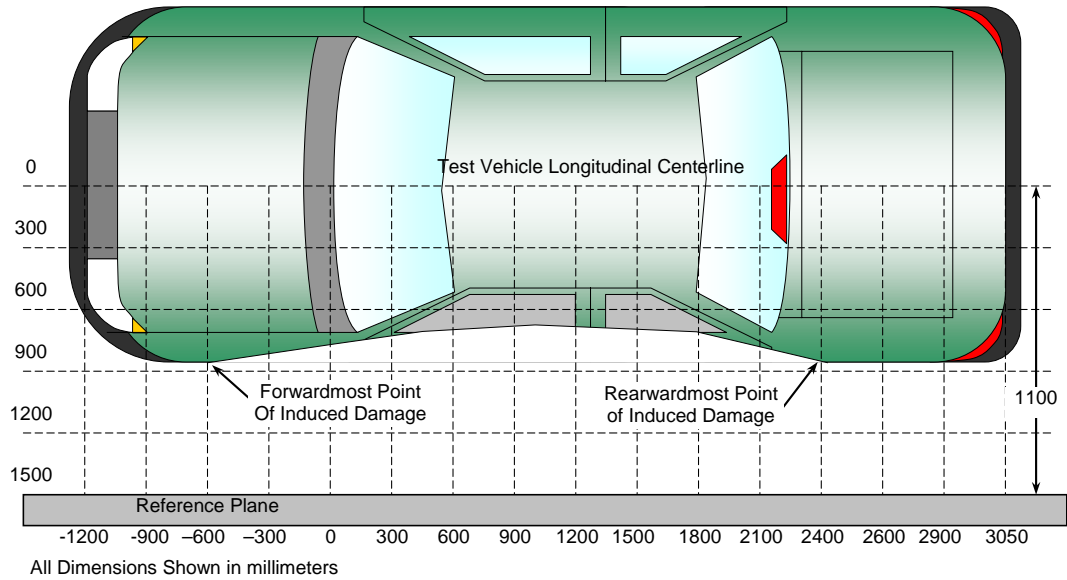
**DATA SHEET NO. 11**  
**VEHICLE DAMAGE PROFILE DISTANCES**

**TOP VIEW**

**DAMAGE PROFILE DISTANCES**

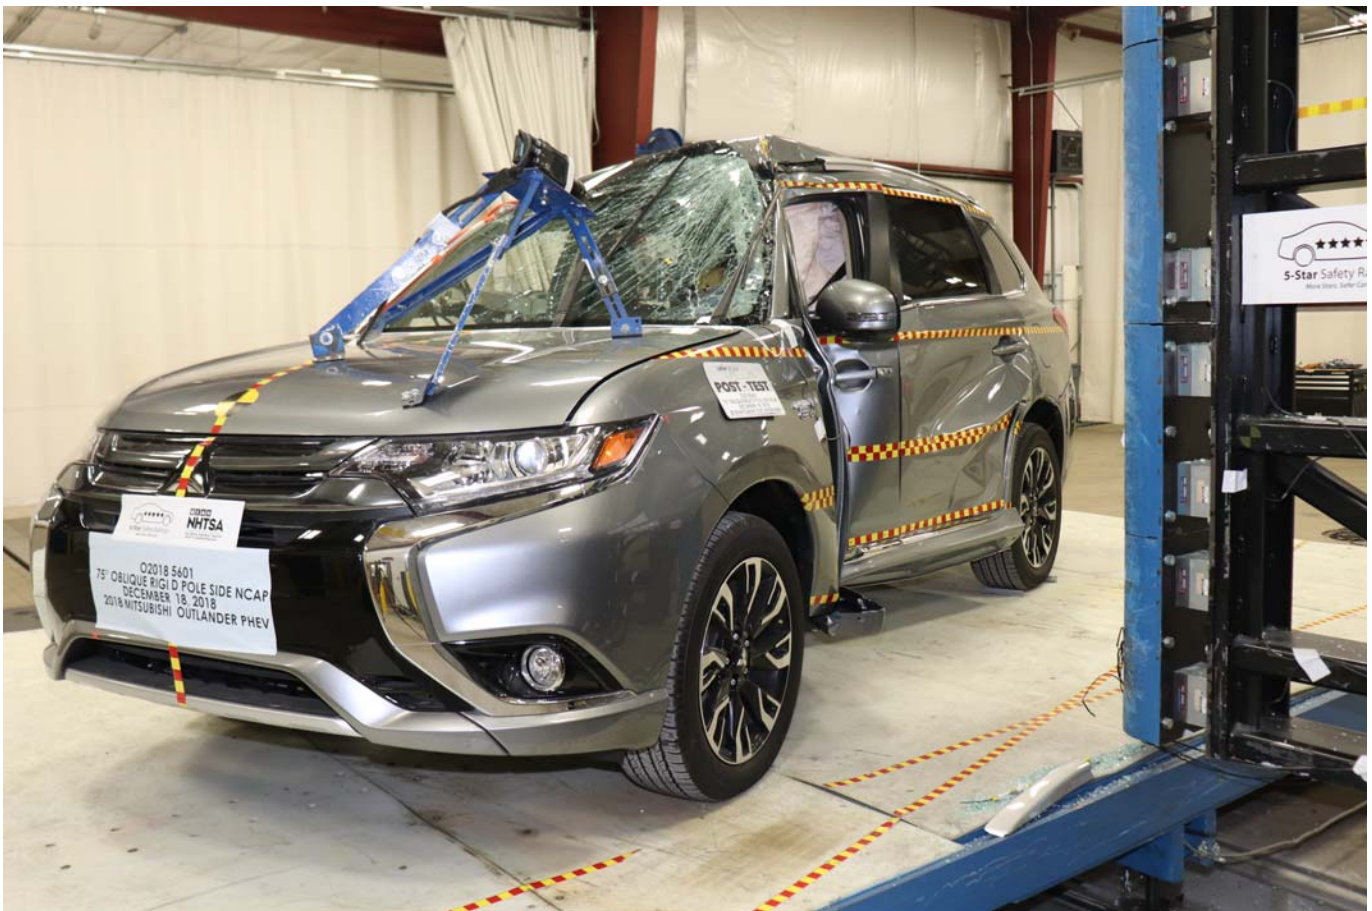
Photo No. 006 - Post-Test Left Front Three-Quarter View of Test Vehicle

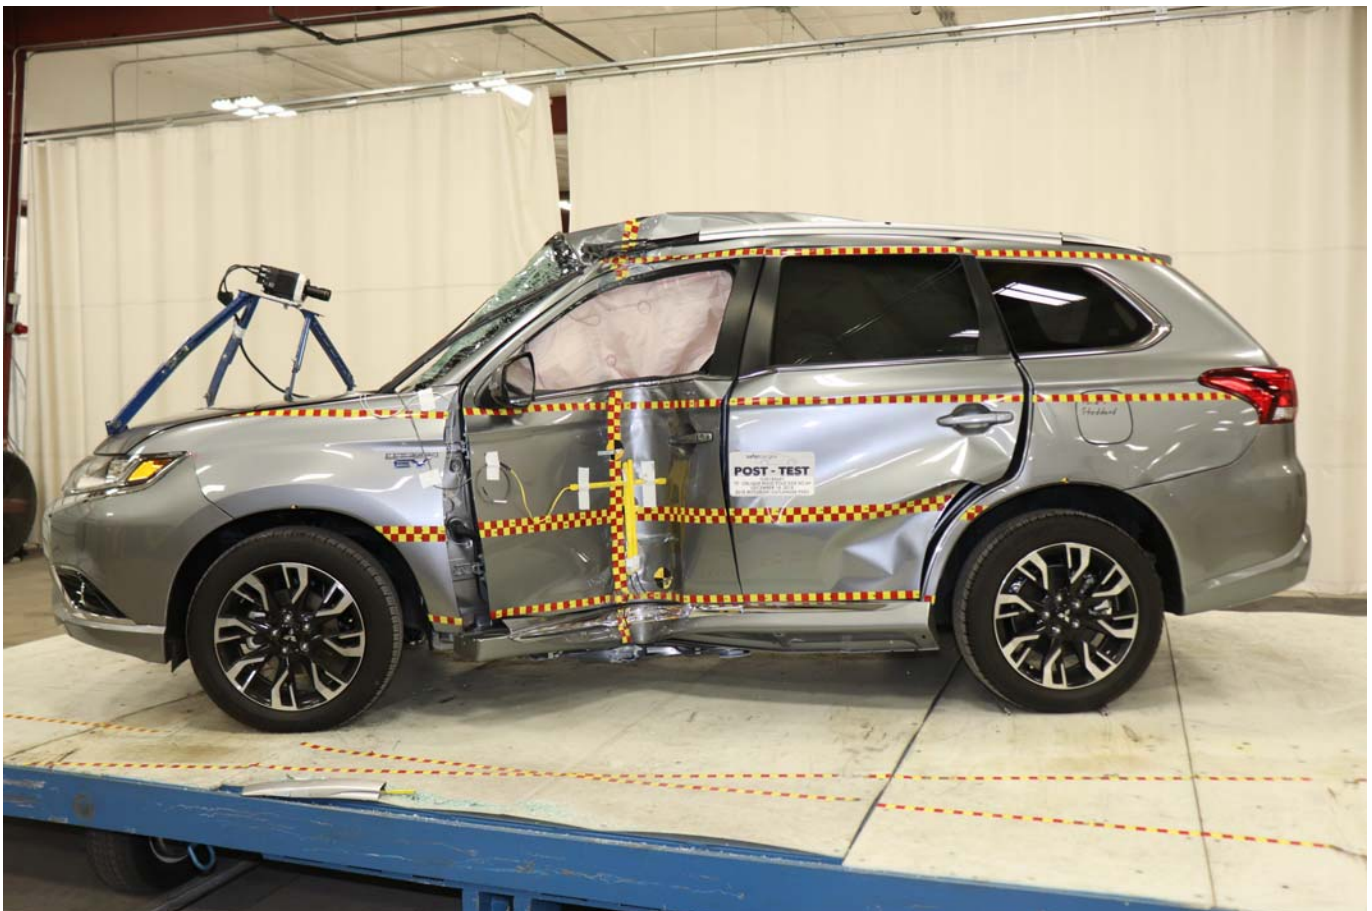
Photo No. 008 - Post-Test Left Side View of Test Vehicle

Critical Areas of Performance	Observations and Conclusions
Pillar Performance	No Separation
Sill Separation	None
Windshield Damage	Cracked
Side Window Damage	Left Front Window Broken
Other Notable Effects	None

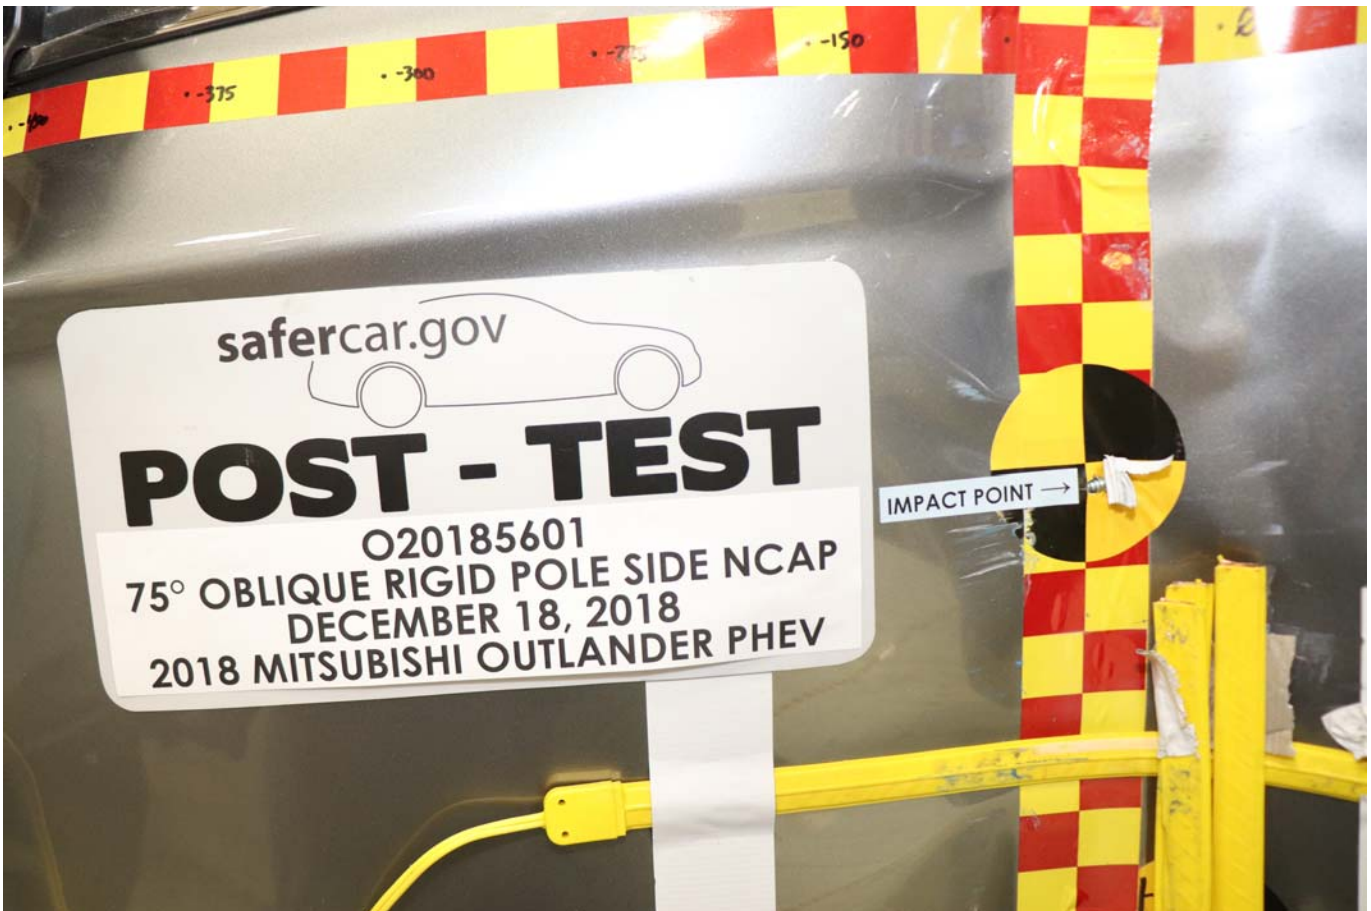
Photo No. 020 - Post-Test Close-Up View of Impact Point Target Showing Impact Location

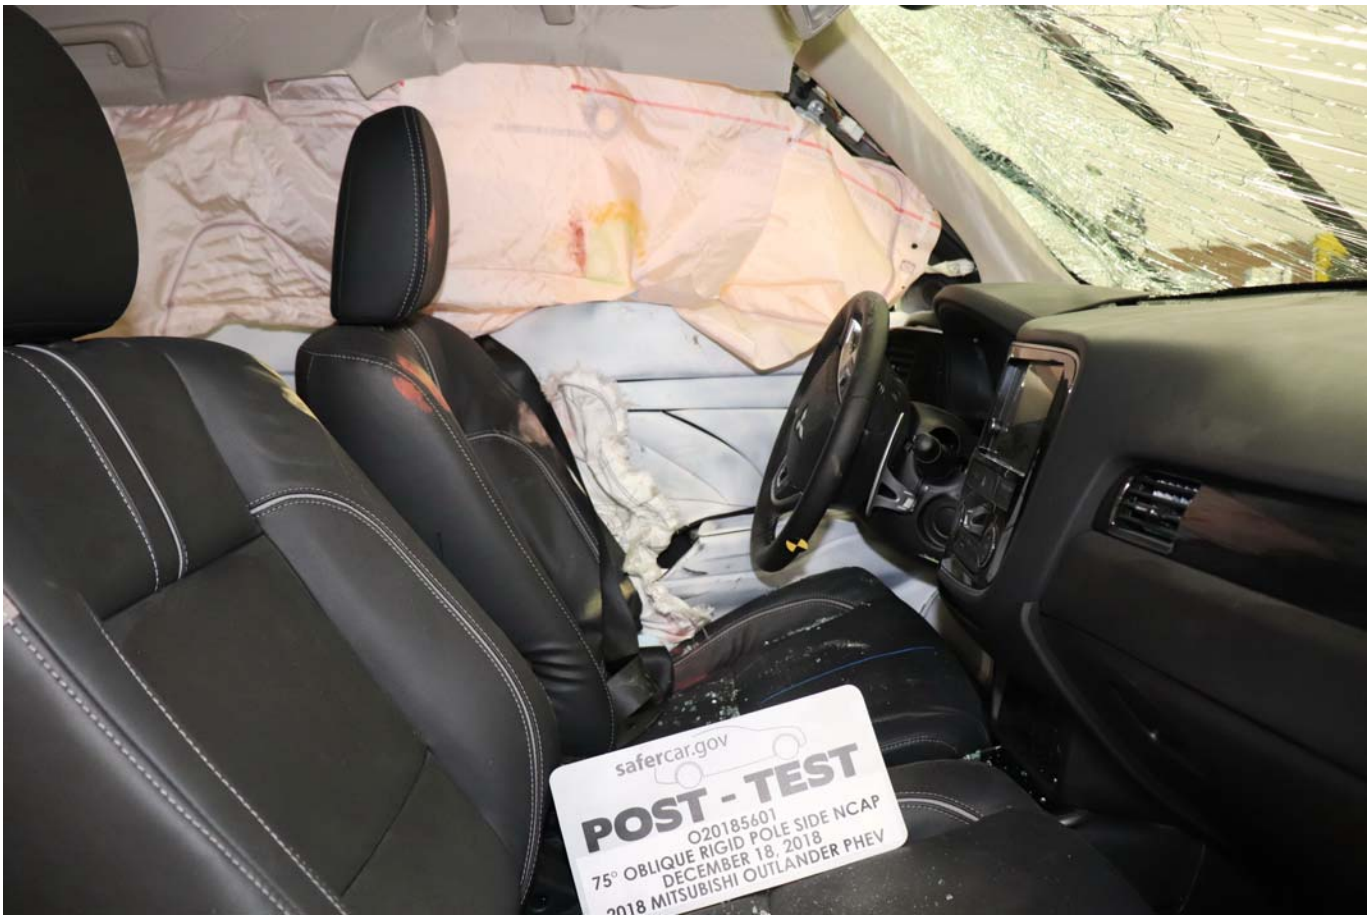
Photo No. 045 - Post-Test Inner Door Panel View Showing Dummy Contact Location

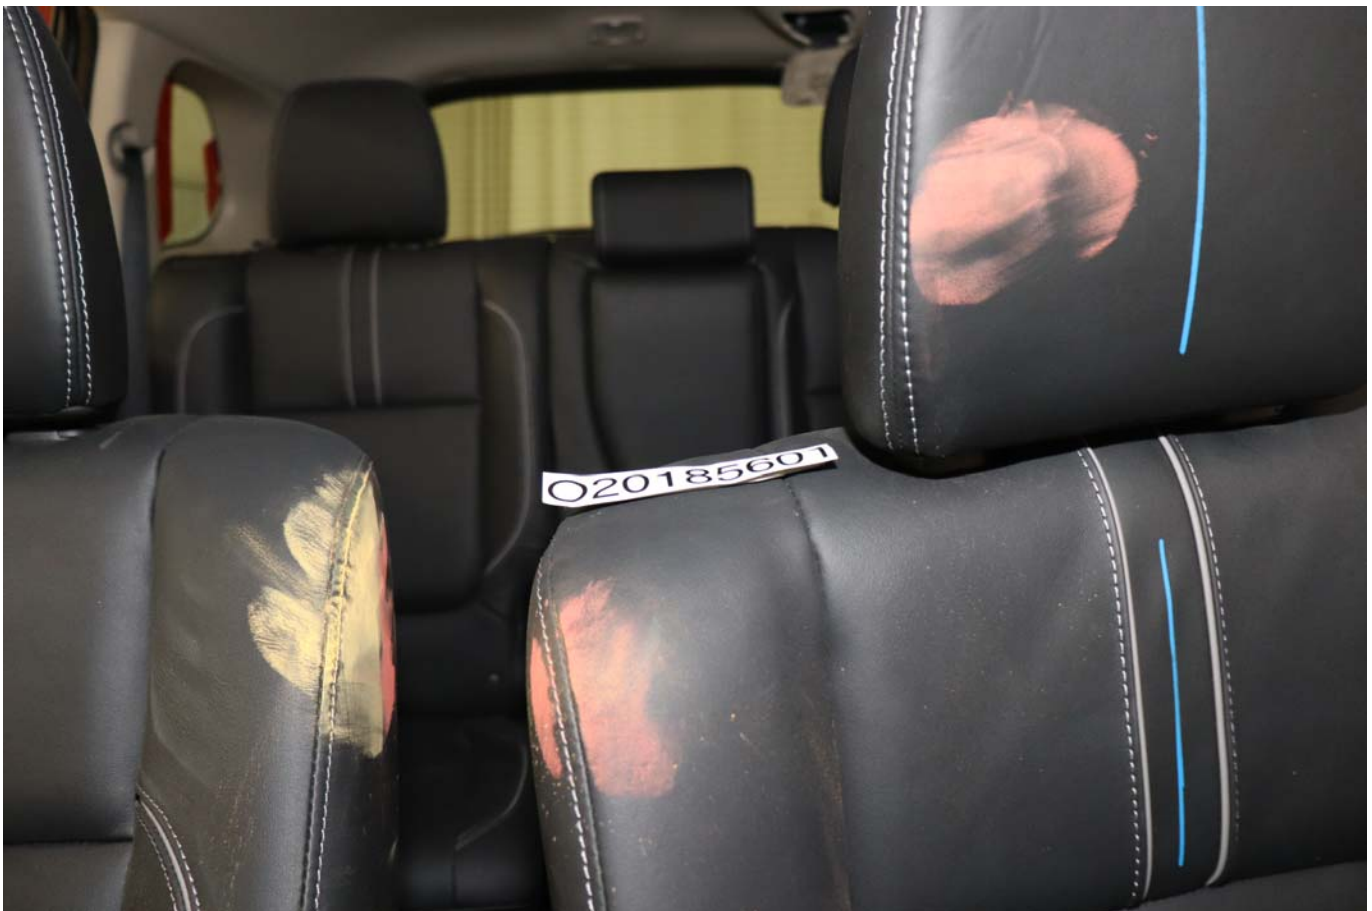
Photo No. 046 - Post-Test Dummy Close-Up Head Contact with Vehicle Interior View

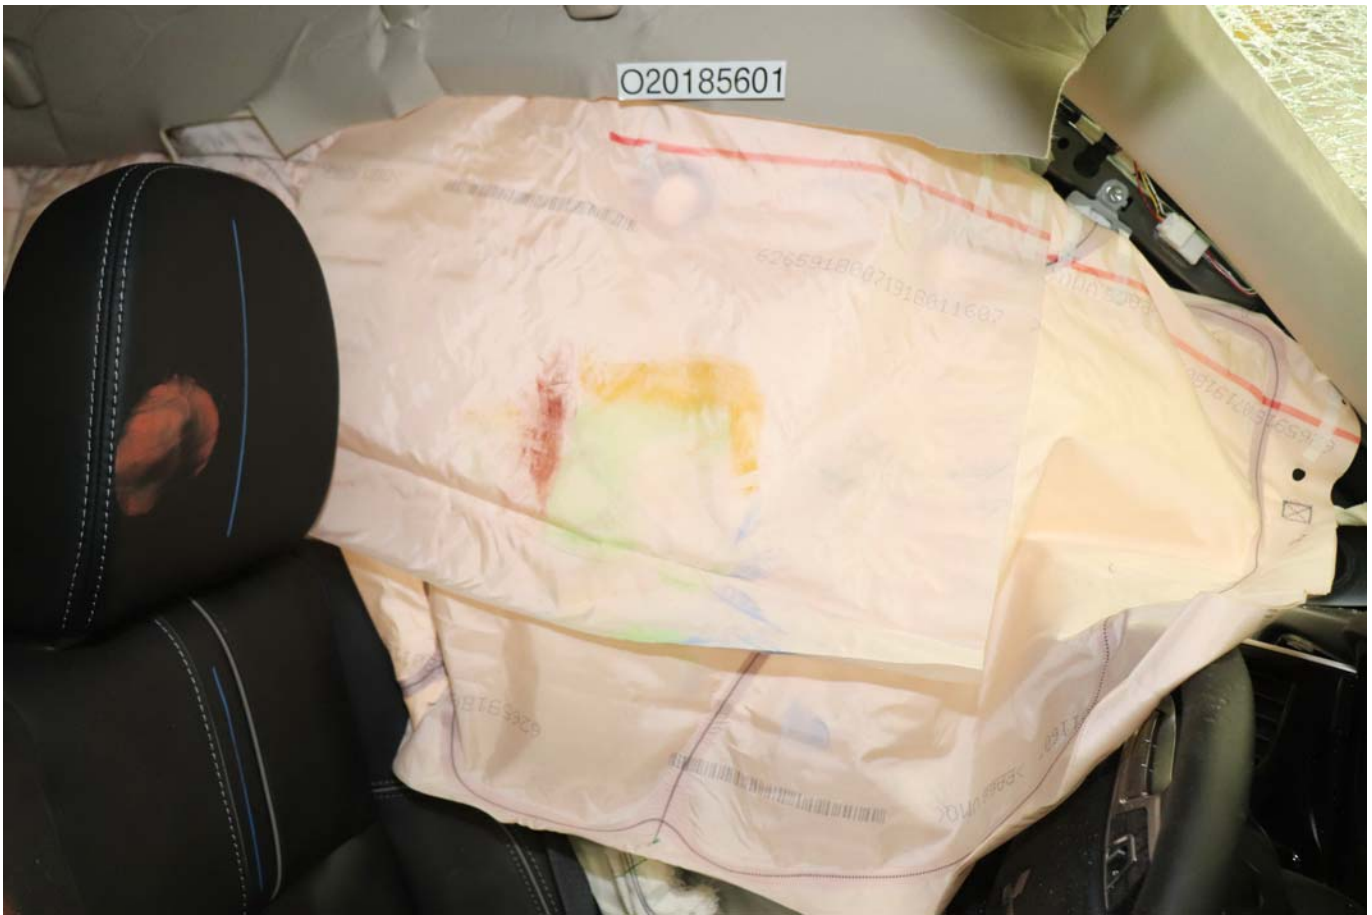
Photo No. 047 - Post-Test Dummy Close-Up Head Contact with Side Air Bag View

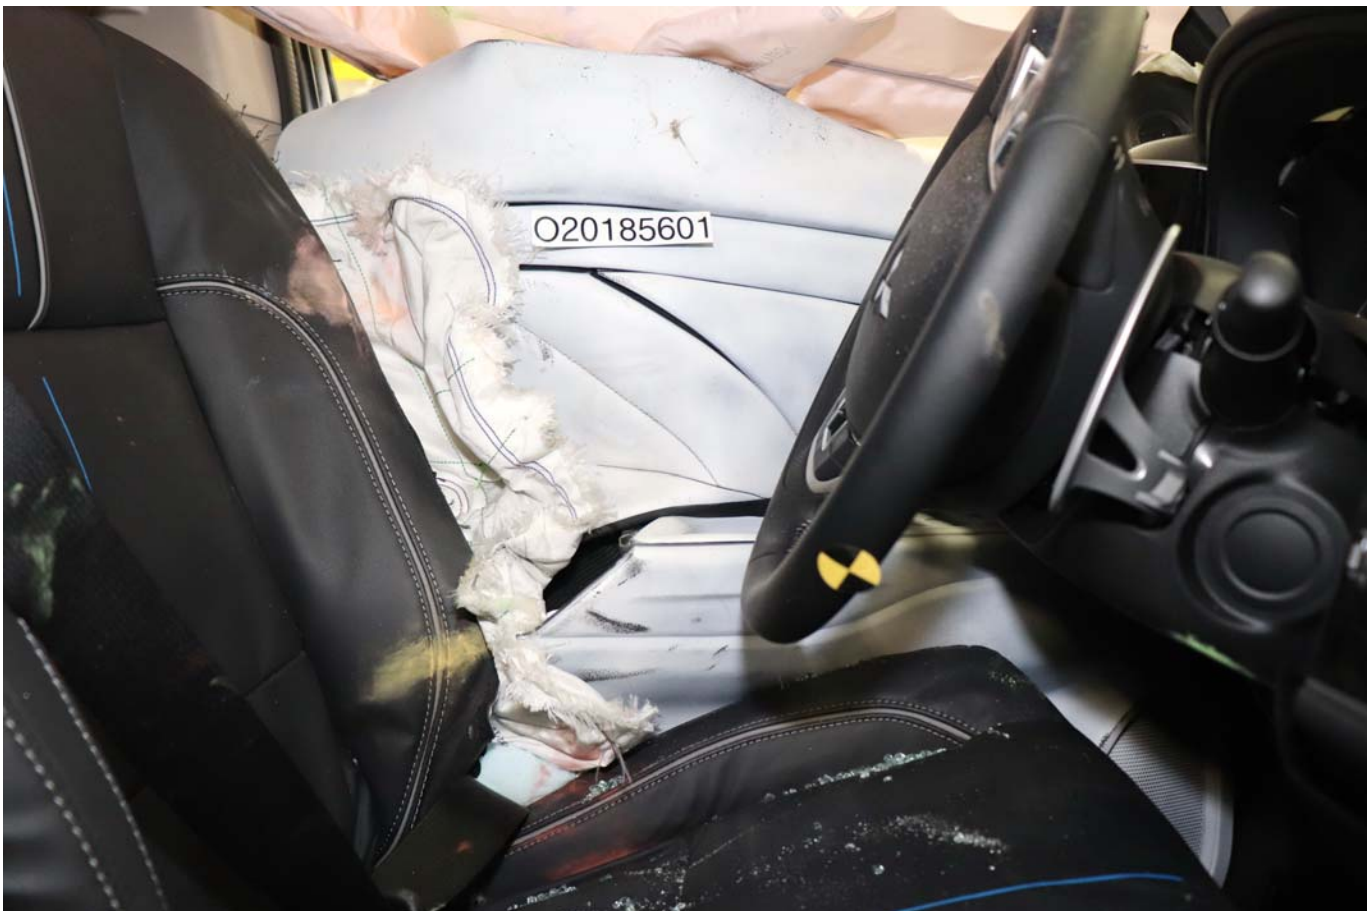
Photo No. 048 - Post-Test Dummy Close-Up Torso Contact with Vehicle Interior View

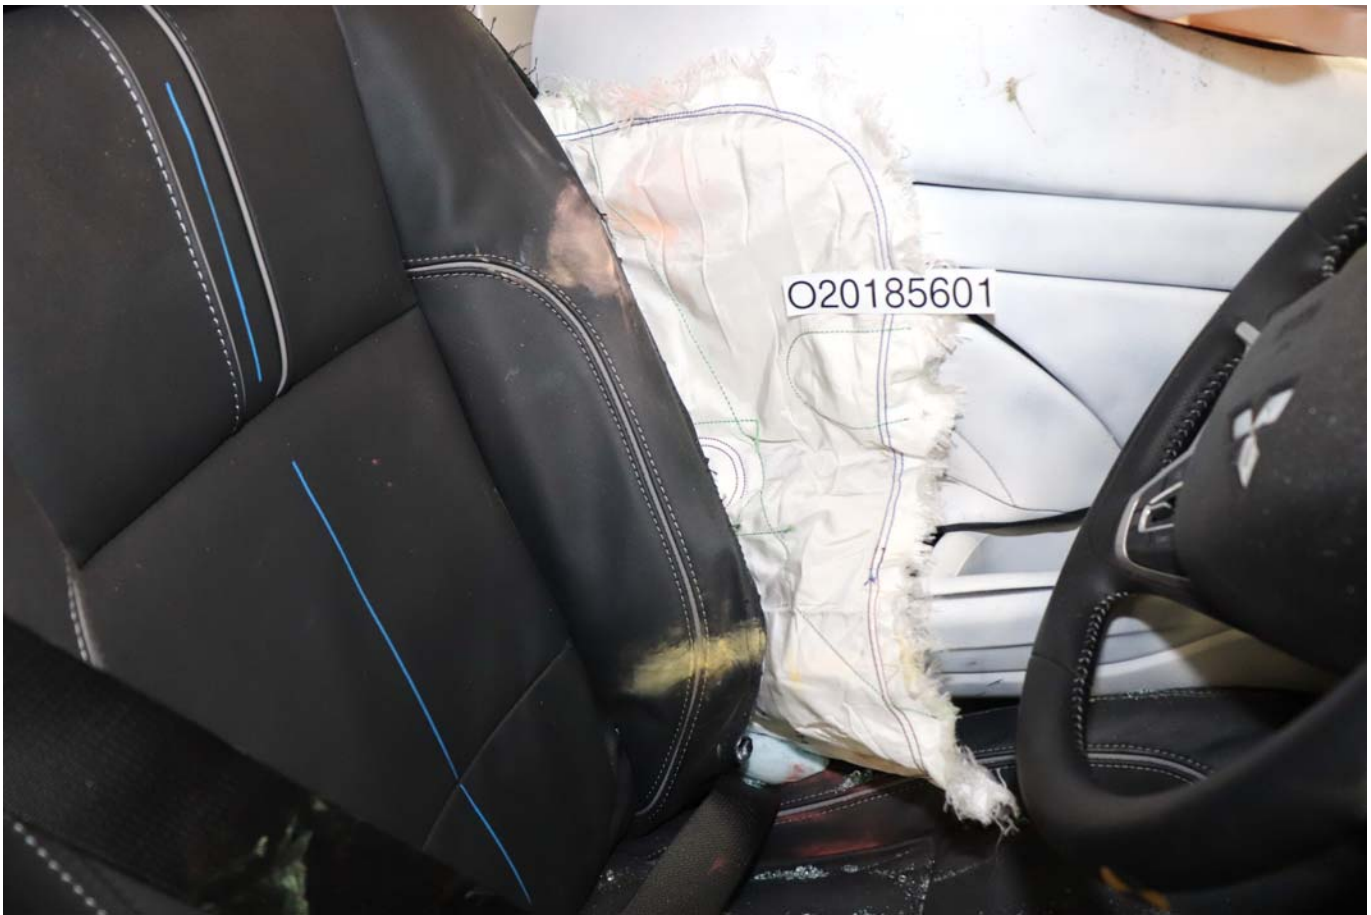
Photo No. 049 - Post-Test Dummy Close-Up Torso Contact with Side Air Bag View

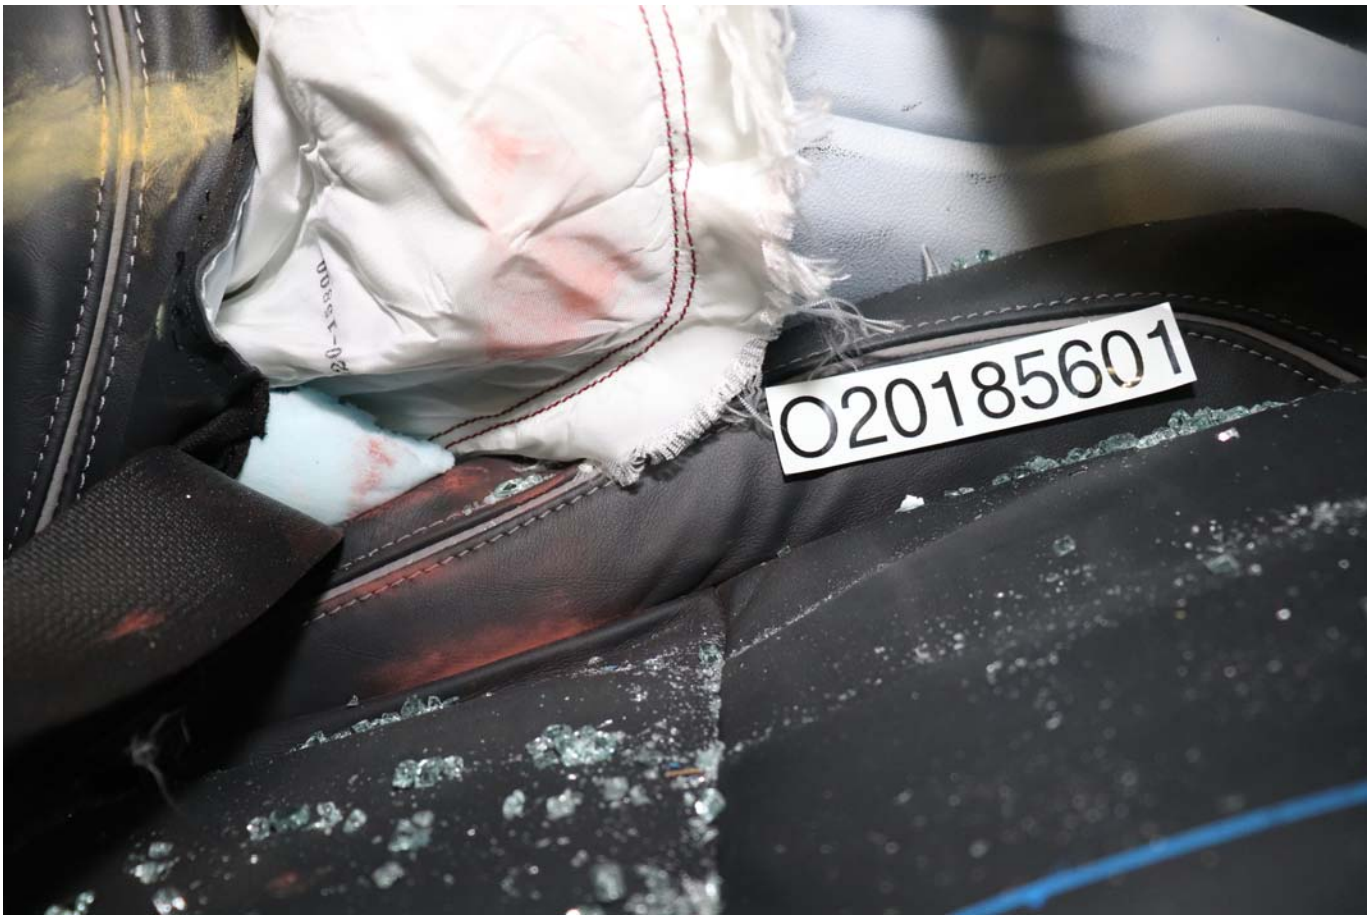
Photo No. 051 - Post-Test Dummy Close-Up Pelvis Contact with Side Air Bag View

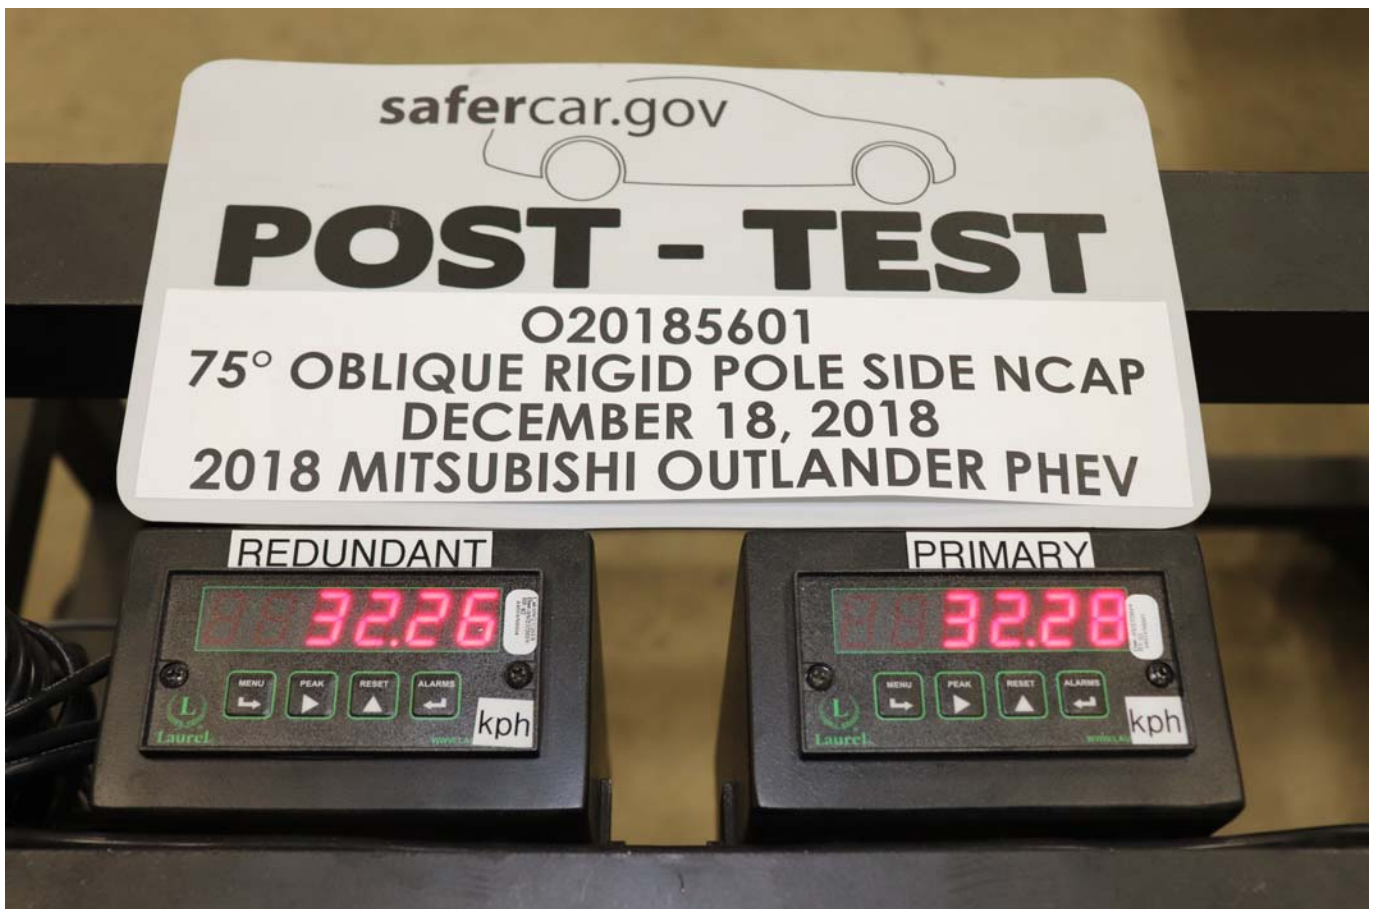
Photo No. 062 - Post-Test Primary and Redundant Speed Trap Read-Out

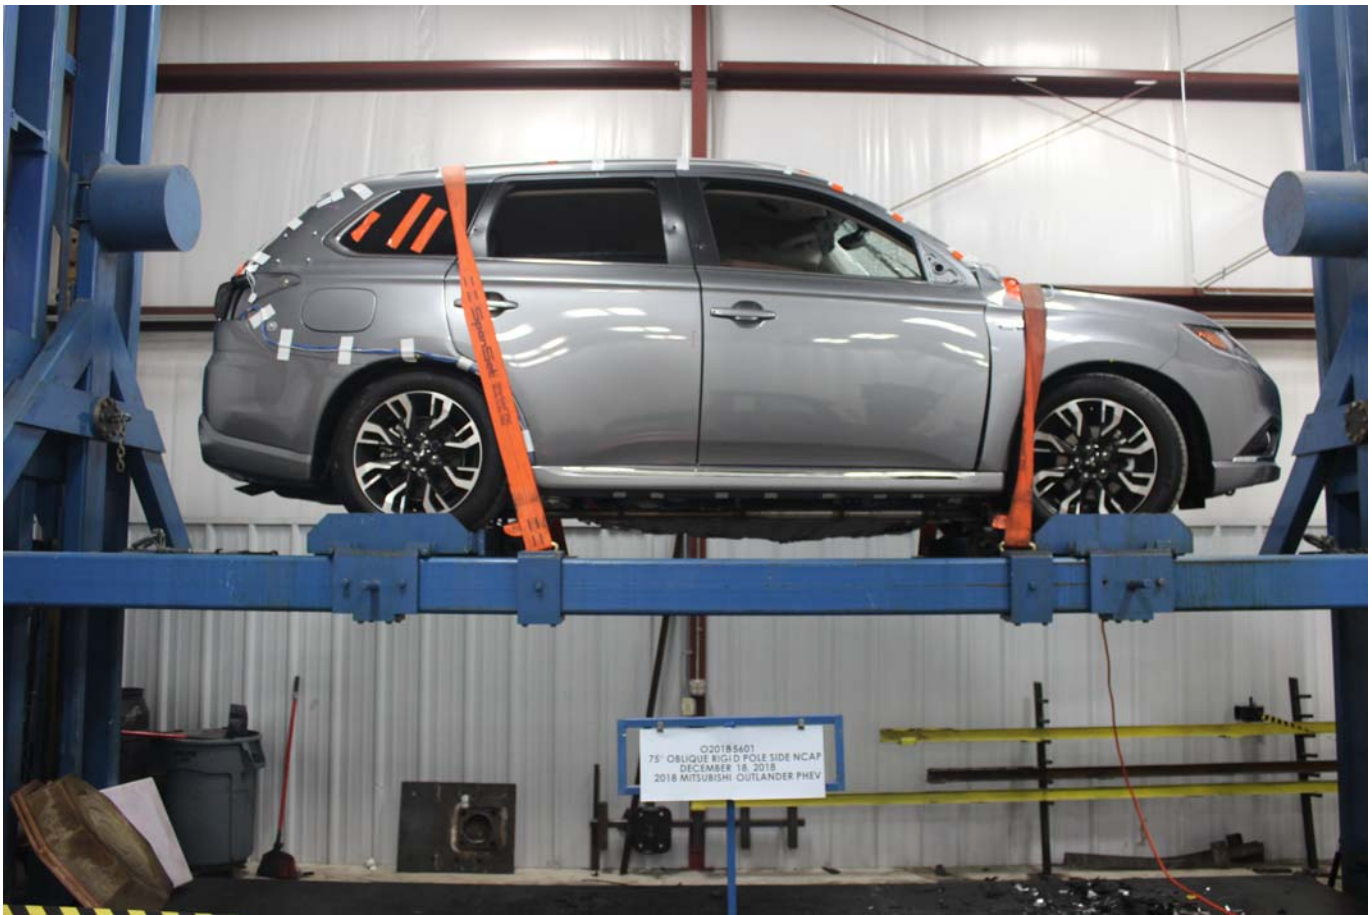
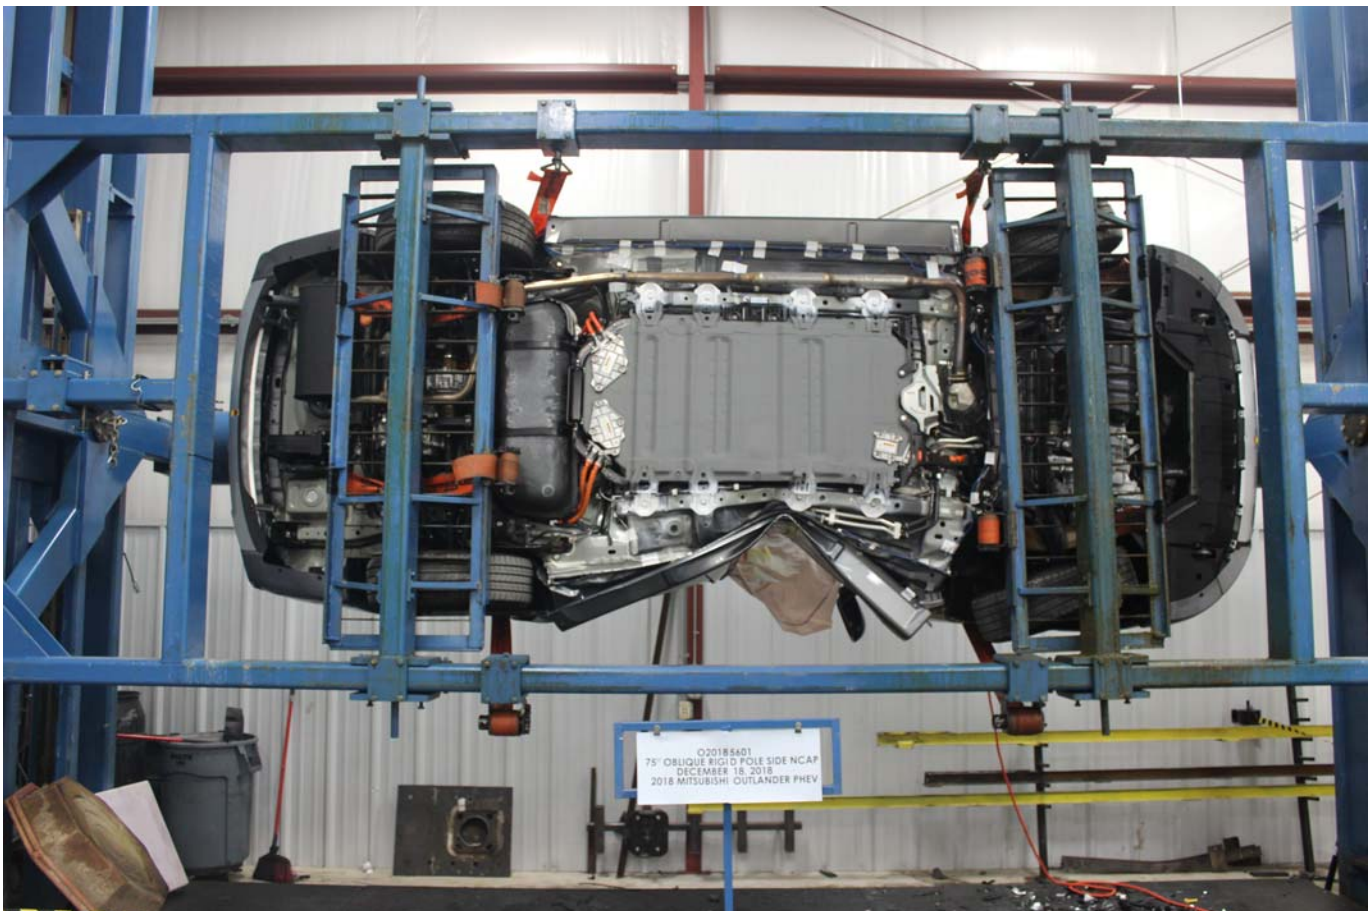
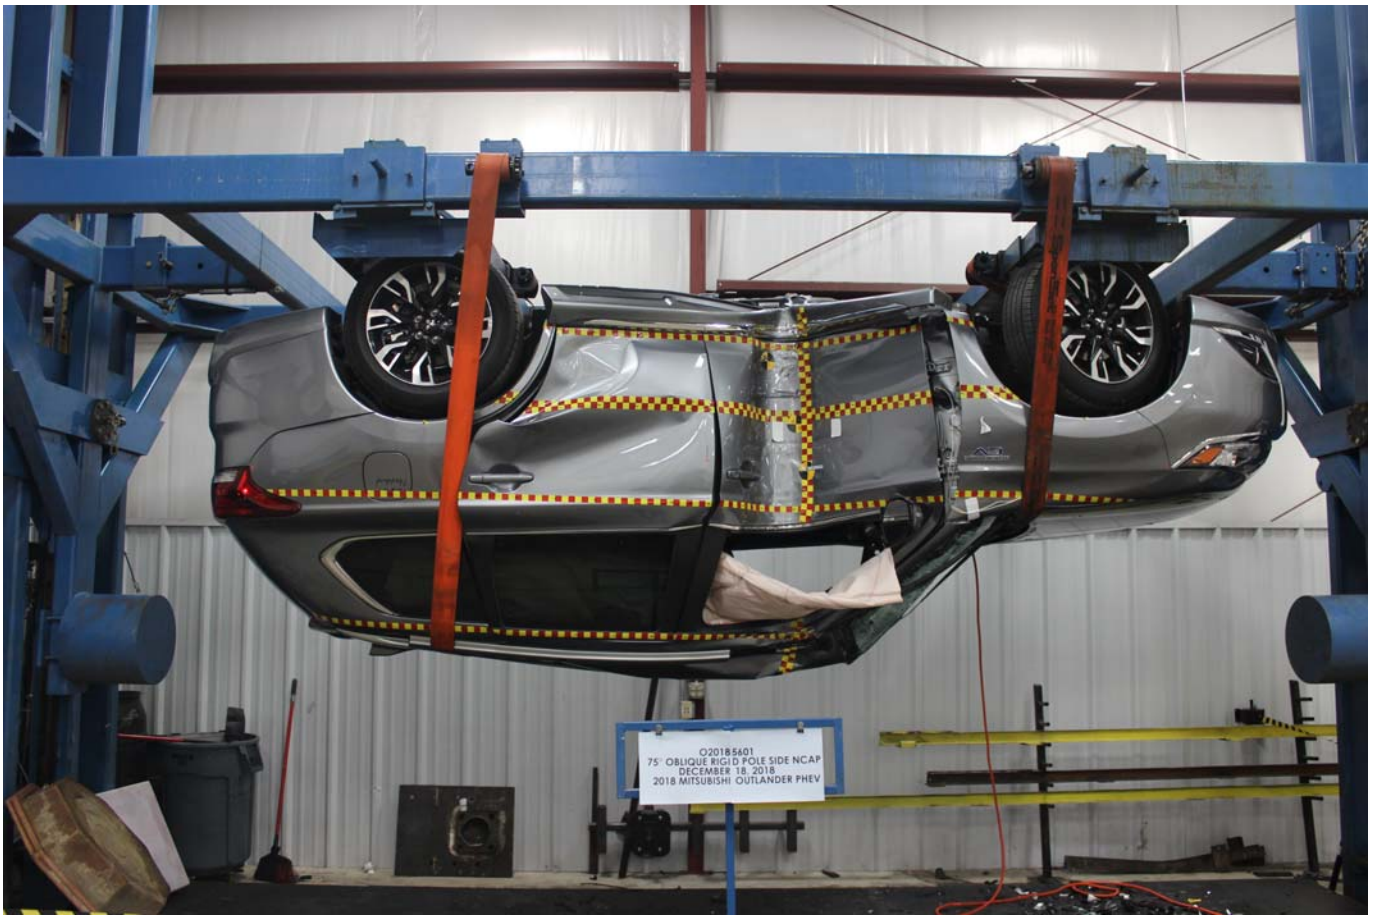
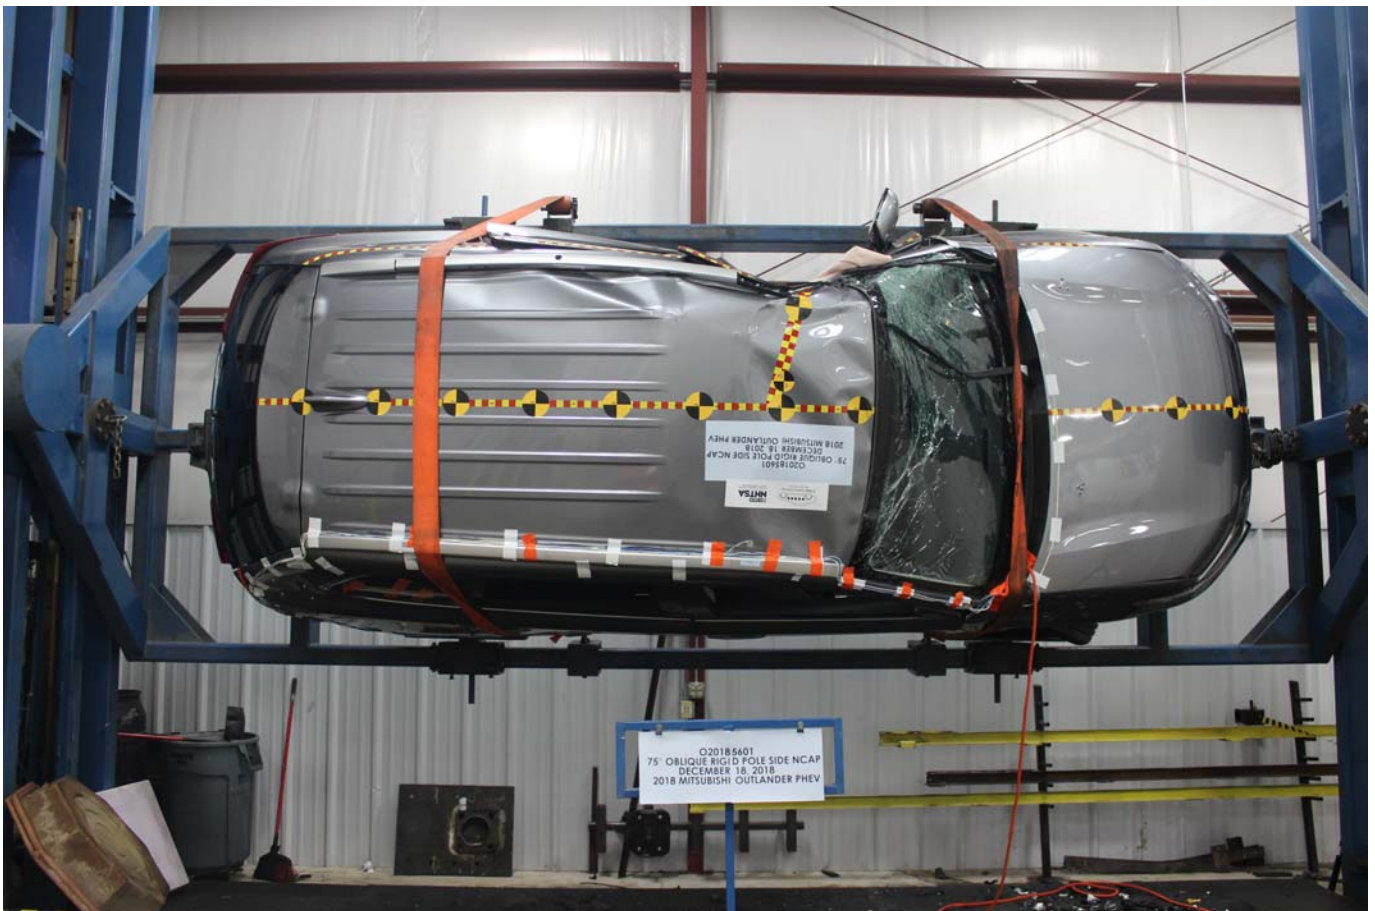
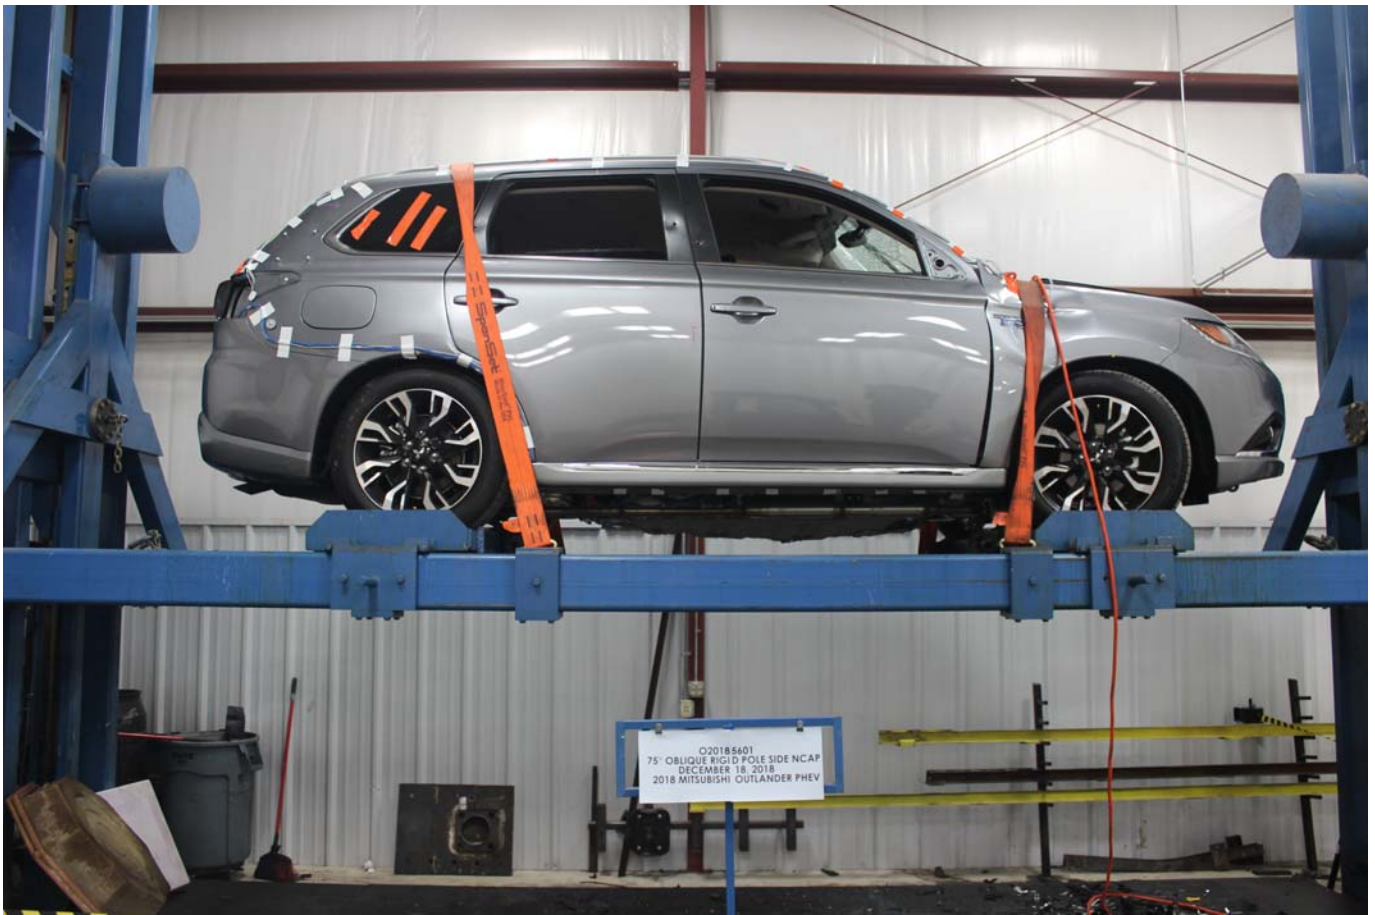
Photo No. 063 - FMVSS Photo No. 301 Static Rollover 0 Degrees

Photo No. 064 - FMVSS Photo No. 301 Static Rollover 90 Degrees

Photo No. 065 - FMVSS Photo No. 301 Static Rollover 180 Degrees

Photo No. 066 - FMVSS Photo No. 301 Static Rollover 270 Degrees

Photo No. 067 - FMVSS Photo No. 301 Static Rollover 360 Degrees

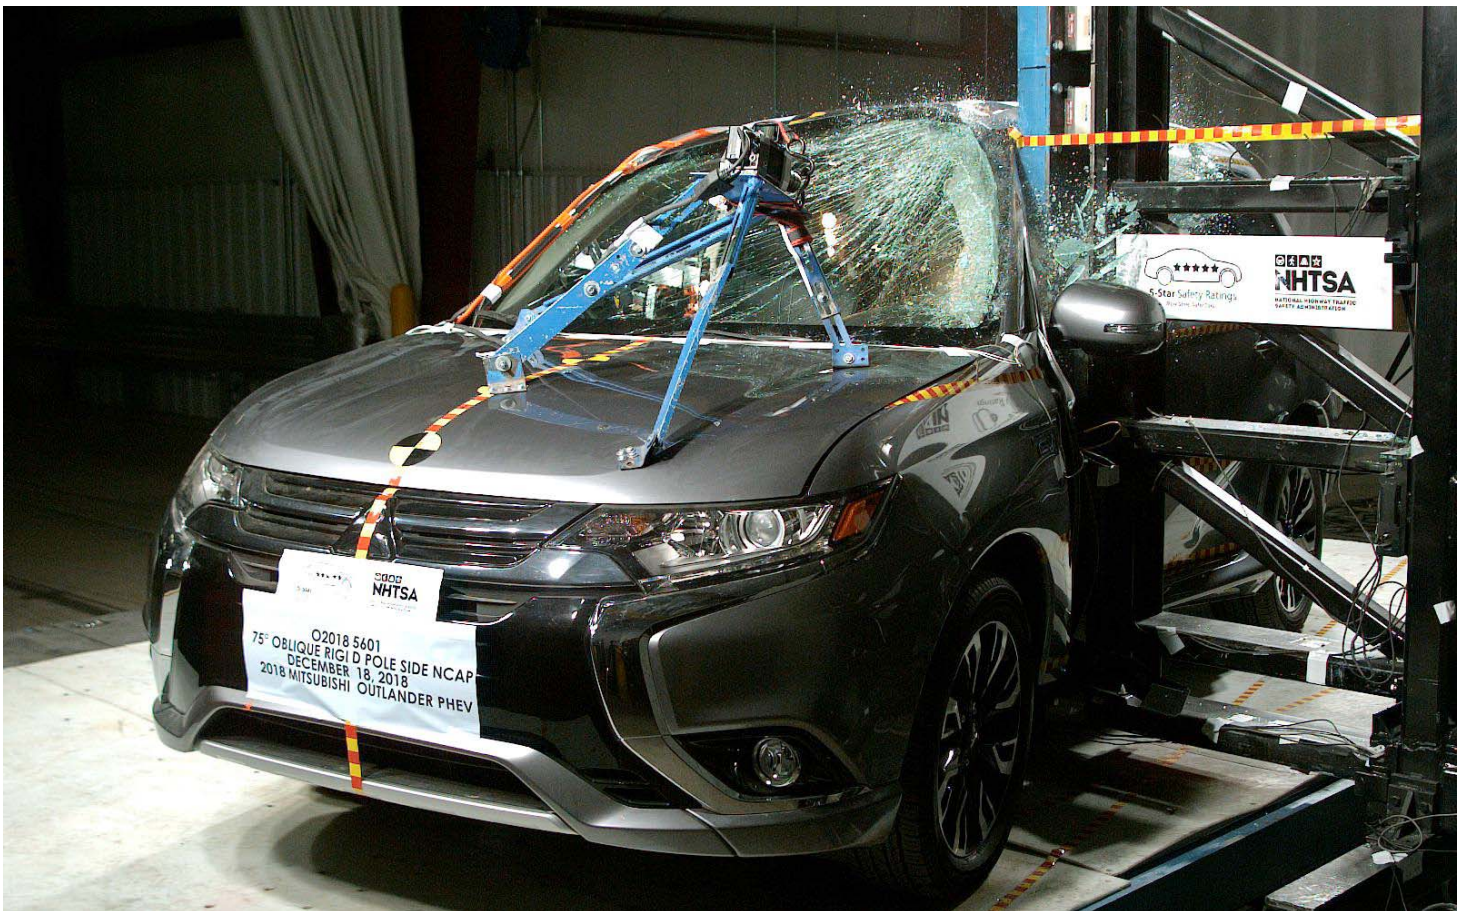
Photo No. 068 - Impact Event

A rigid pole side impact test was conducted on a 2018 Mitsubishi Outlander PHEV SEL S-AWC 5-Door SUV. The subject vehicle was towed into the rigid pole at an angle of 75° and a velocity of 32.28 km/h. The test was conducted by MGA Research Corporation in Burlington, Wisconsin on December 18, 2018. Pre-test and post-test photographs of the test vehicle and side impact dummy (SID-IIs) are included in Appendix A of this report.

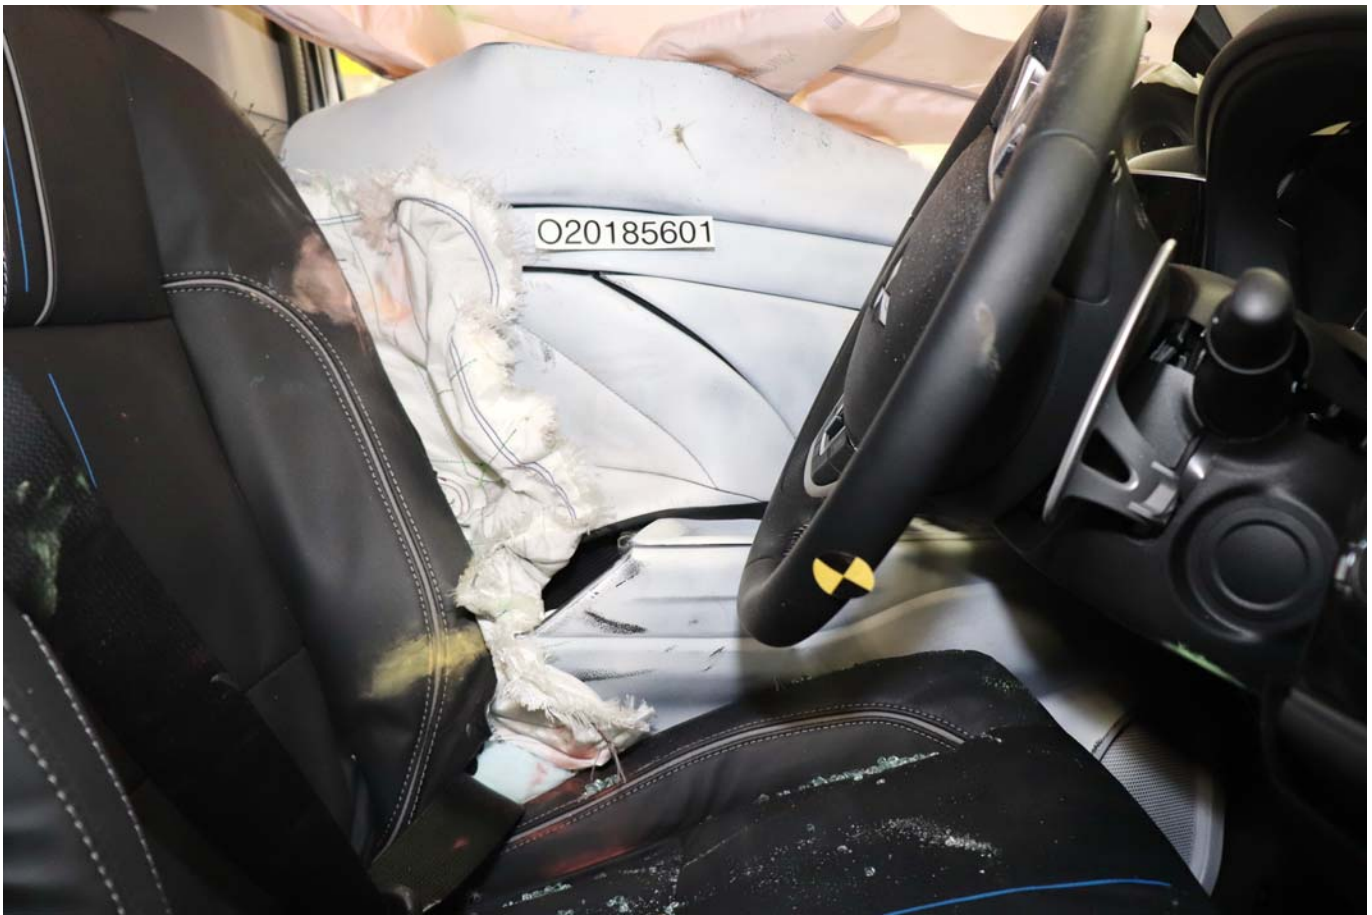
Photo No. 071 - Post-Test View of Shattered Vehicle Inner Door Panel
