**REPORT NUMBER: SPNCAP-KAR-19-011
NEW CAR ASSESSMENT PROGRAM (NCAP)
SIDE IMPACT POLE TEST**

**FCA US LLC
2019 DODGE GRAND CARAVAN SE 5-DOOR MINIVAN**

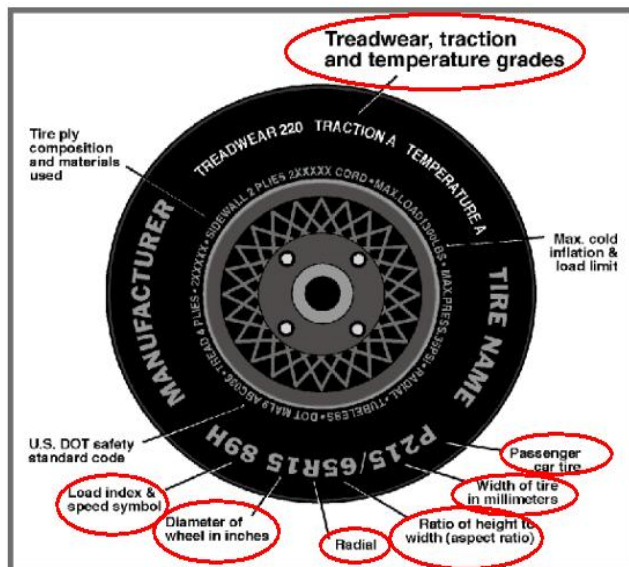
Measured Parameter	Front	Front
Max. Tire Pressure (kPa)	300	300
Cold Pressure (kPa)	250	250
Recommended Tire Size	P225/65R17	P225/65R17
Tire Size on Vehicle	P225/65R17	P225/65R17
Tire Manufacturer	Michelin	Michelin
Tire Model	Energy Saver A/S	Energy Saver A/S
Treadware	480	480
Traction Grade	A	A
Temperature Grade	B	B
Tire Plies Sidewall	1 Polyester	1 Polyester
Tire Plies Body	1 Polyester, 1 Polyamide, 2 Steel	1 Polyester, 1 Polyamide, 2 Steel
Load Index/Speed Symbol	100T	!00T
Tire Material	Polyester, Polyamide, Steel	Polyester, Polyamide, Steel
DOT Safety Code Left	M33T OOKX 3218	M33T OOKX 3218
DOT Safety Code Right	M33T OOKX 3218	M33T OOKX 3218

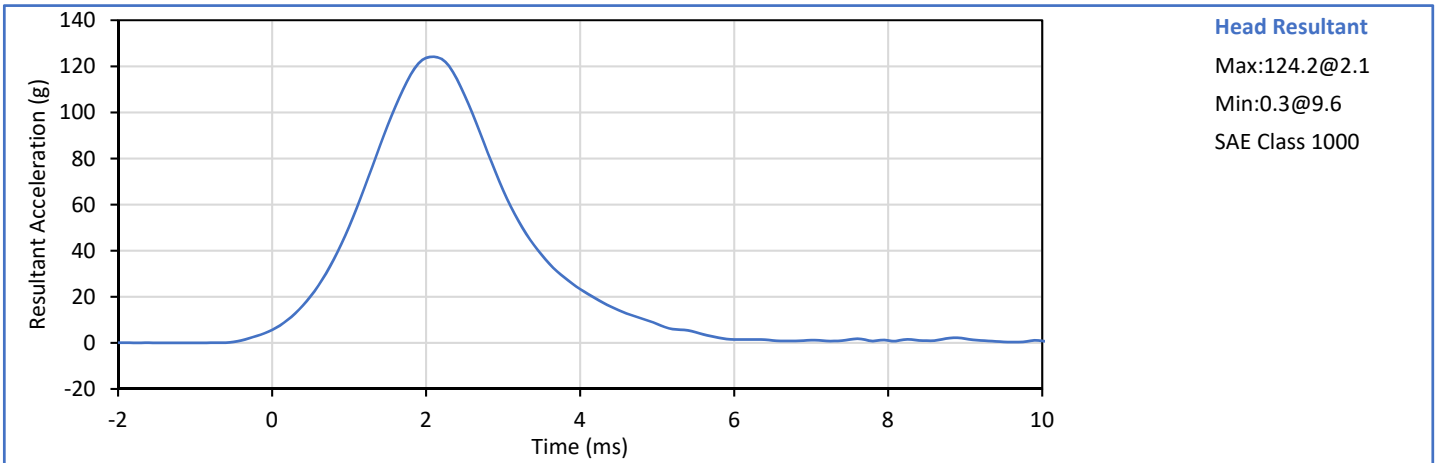
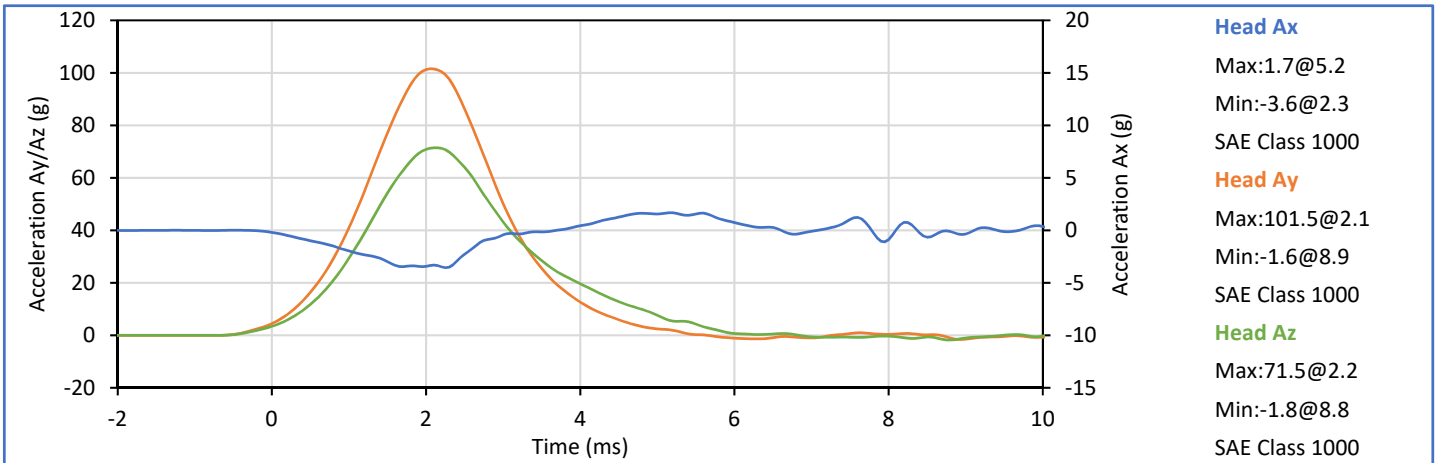
Technician:
 J. Hernandez

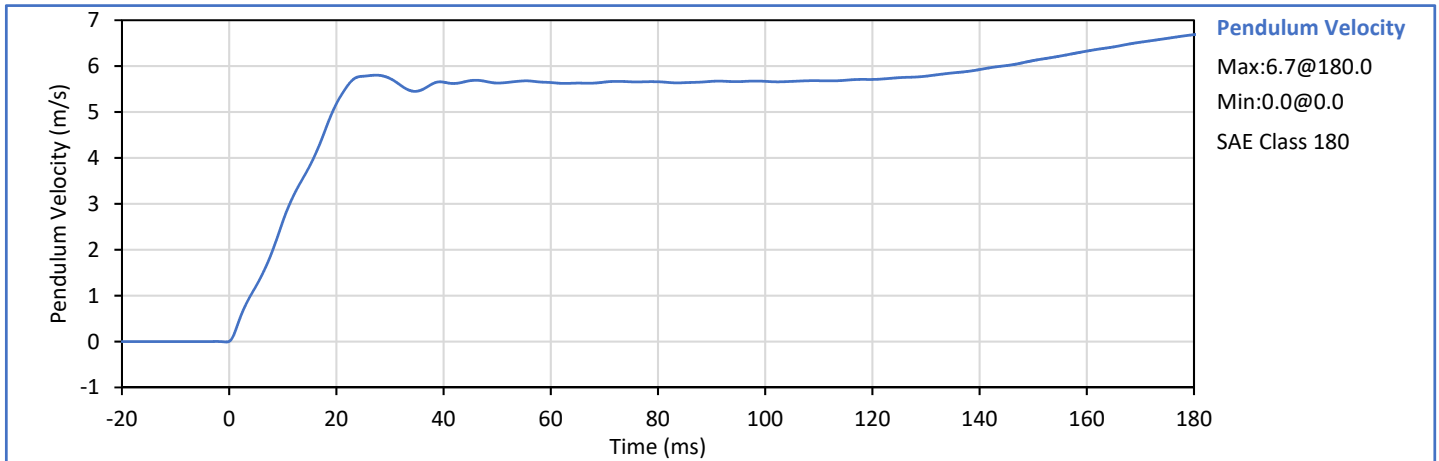
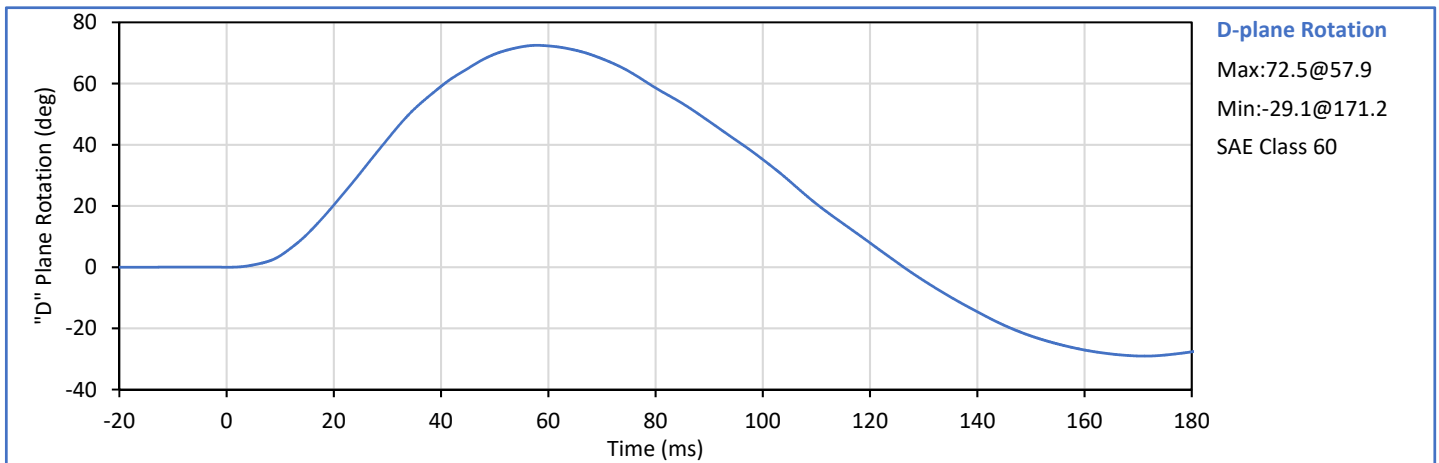
Technician:
 J. Hernandez

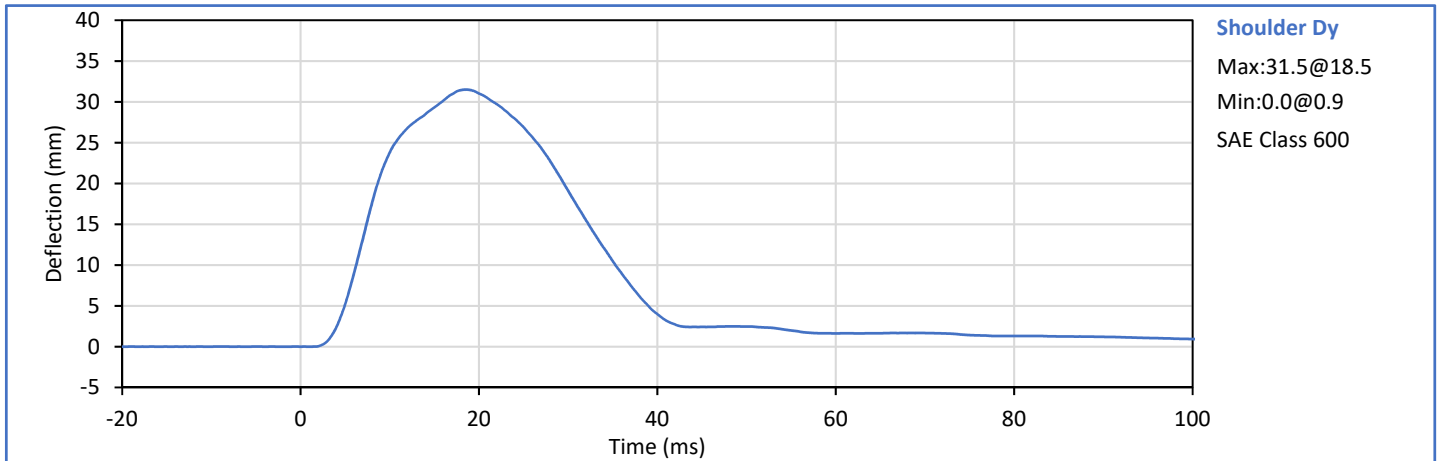
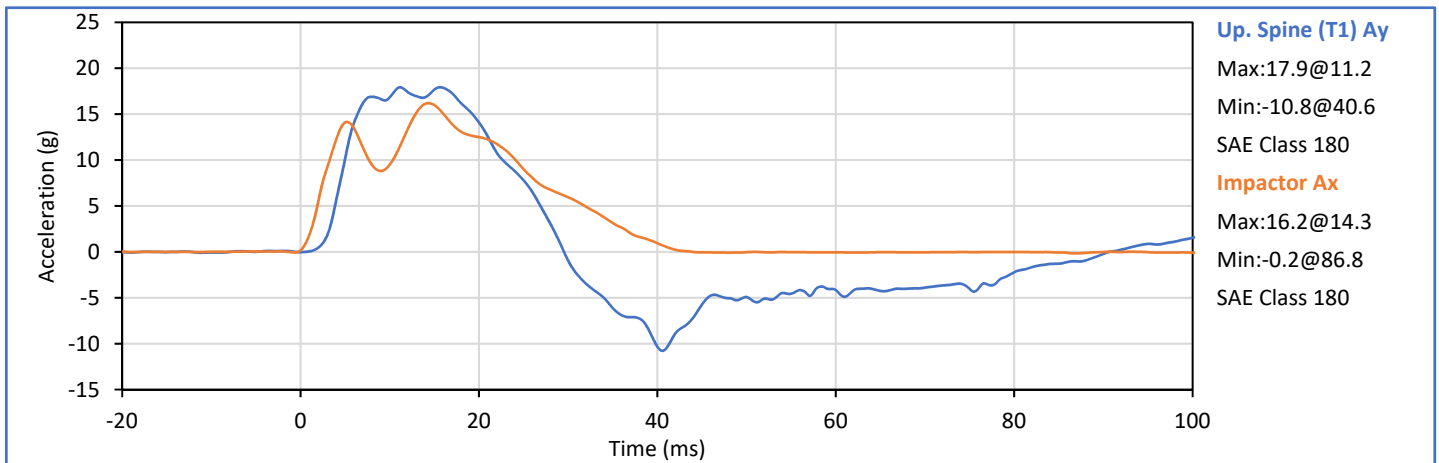
Technician: *J. Hernandez*
 J. Hernandez

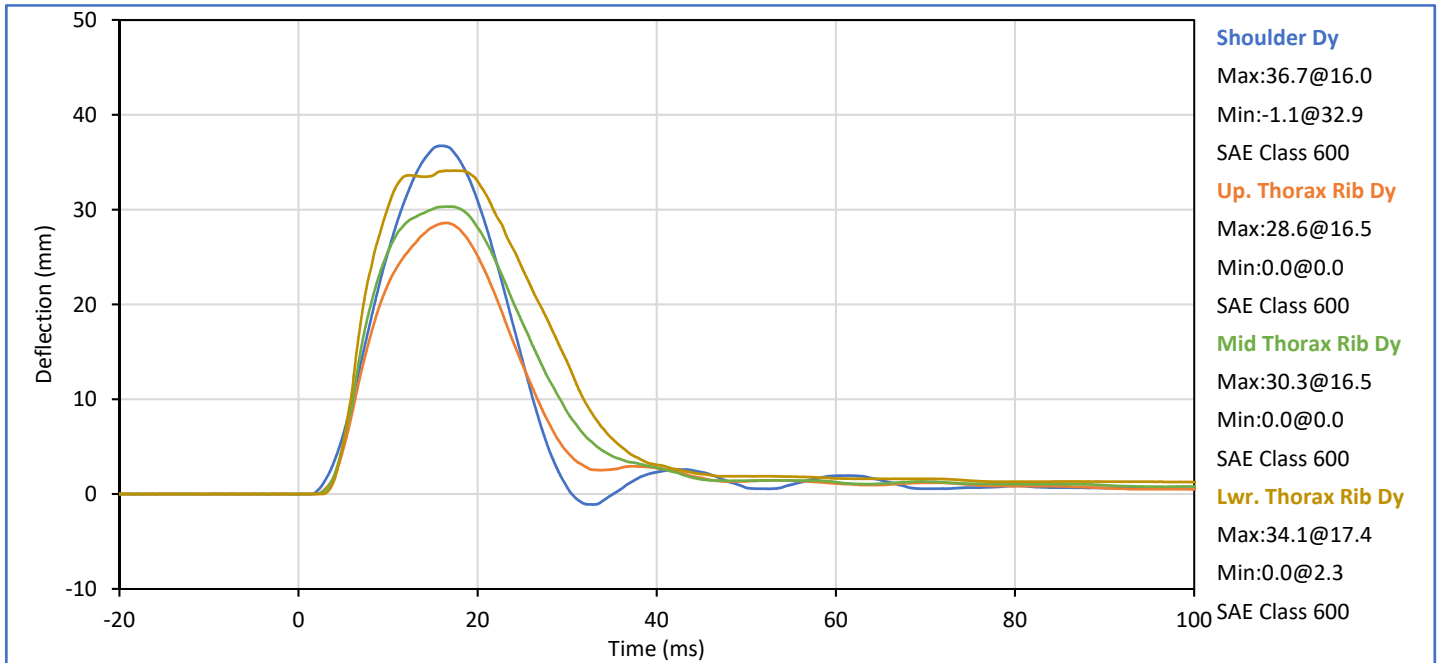
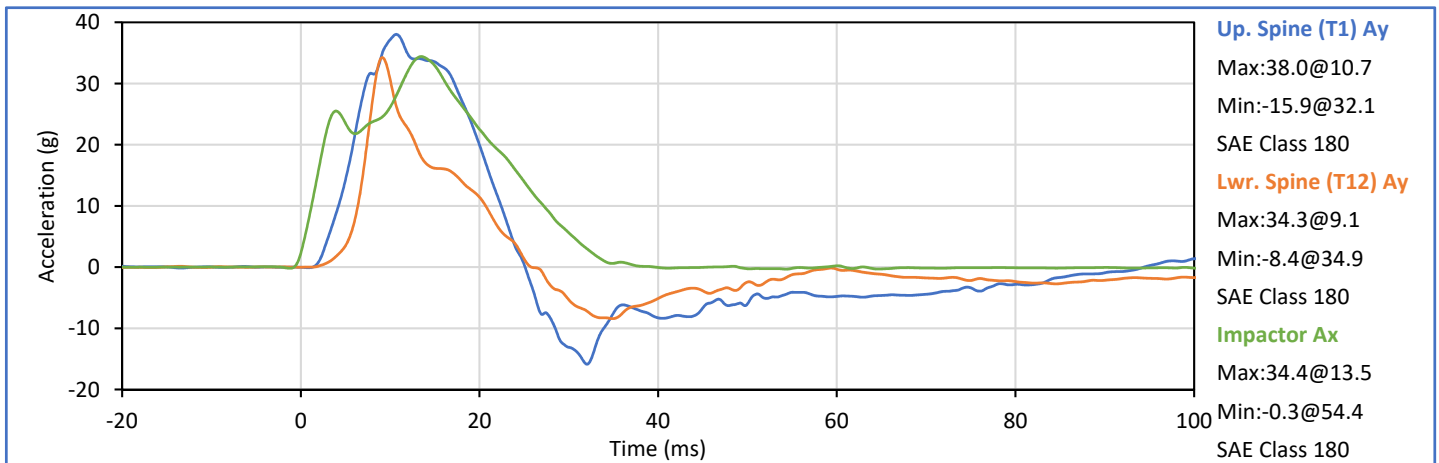
Technician:
 J. Hernandez

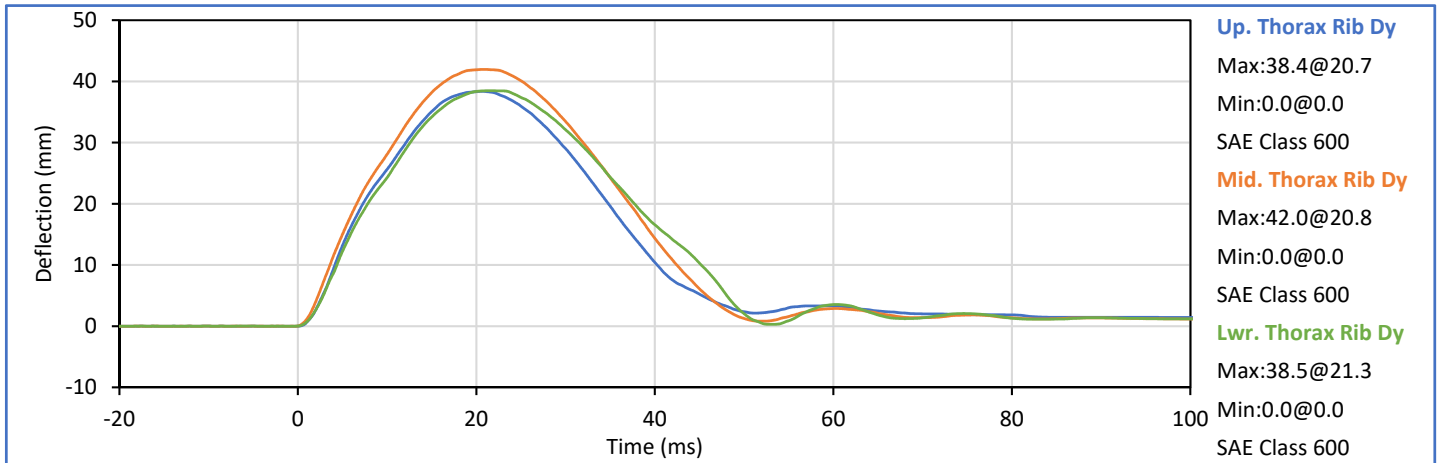
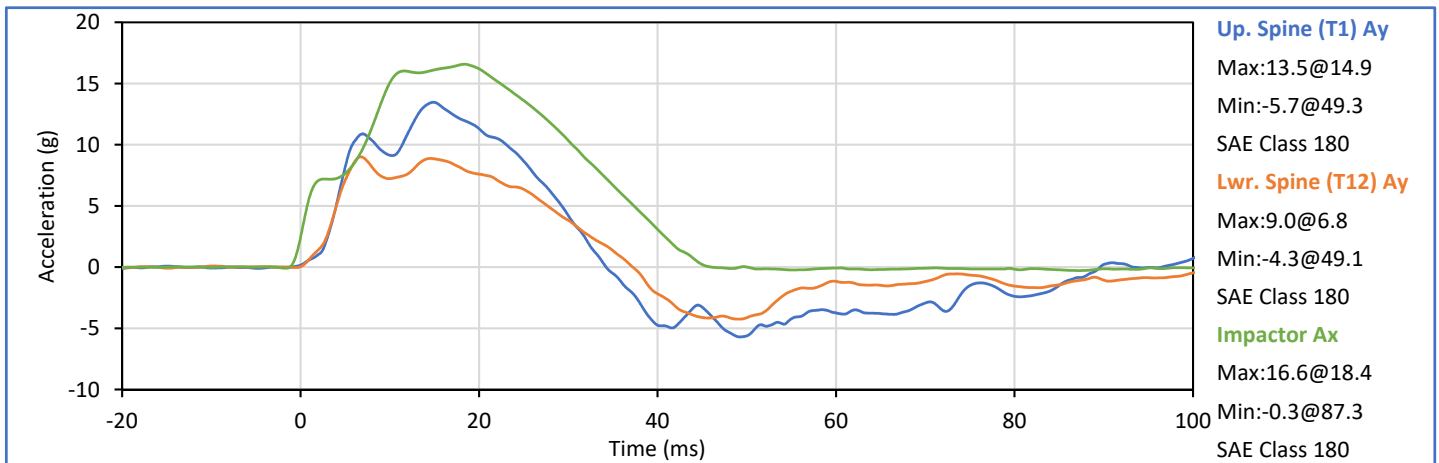
Technician:
 J. Hernandez

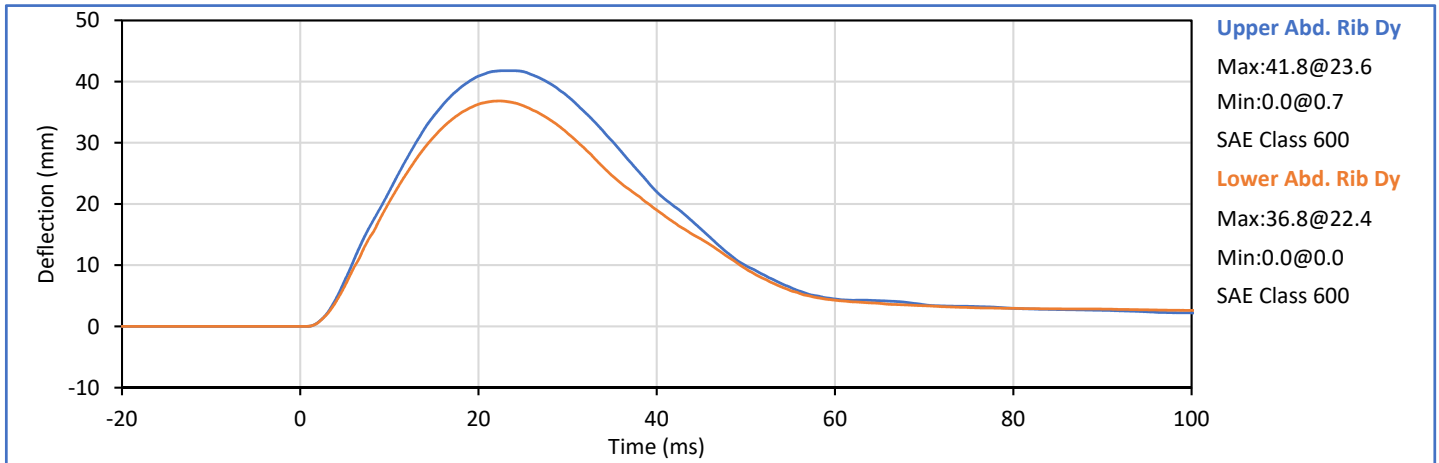
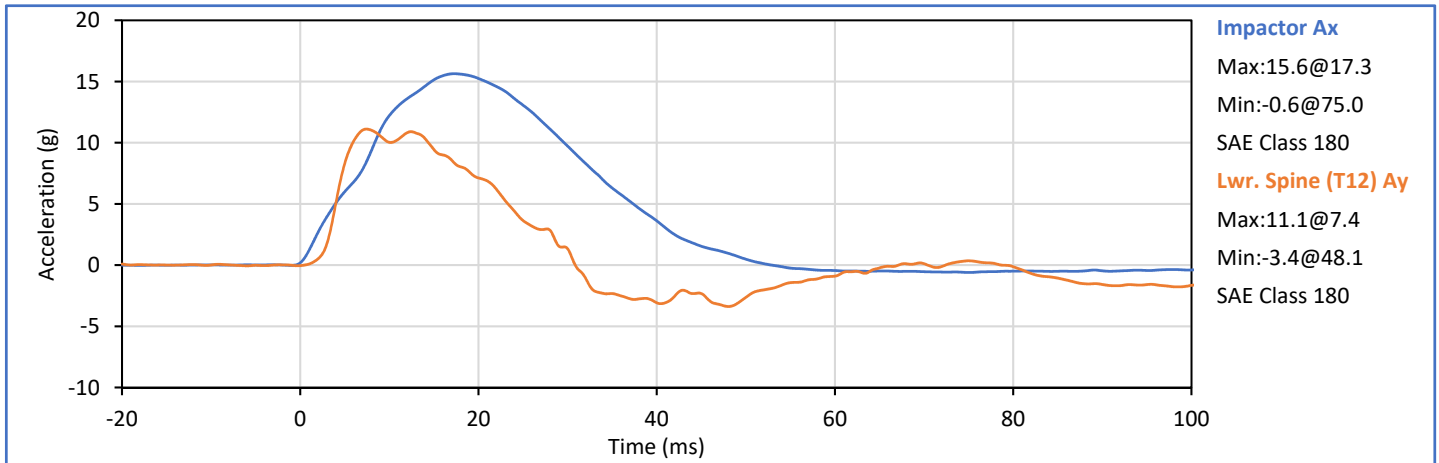
Tested Parameter	Units	Spec. Low	Spec. High	Result	Pass/Fail
Laboratory Temperature	°C	20.6	22.2	21.2	Pass
Laboratory Humidity	%	10	70	30	Pass
Impactor Velocity	m/s	4.20	4.40	4.32	Pass
Peak Upper Abdomen Rib Dy	mm	36.0	47.0	41.8	Pass
Peak Lower Abdomen Rib Dy	mm	33.0	44.0	36.8	Pass
Peak Lower Spine T12 Ay	mm	9.0	14.0	11.1	Pass
Peak Impactor Ax	g	12.0	16.0	15.6	Pass
Overall Test Results					Pass

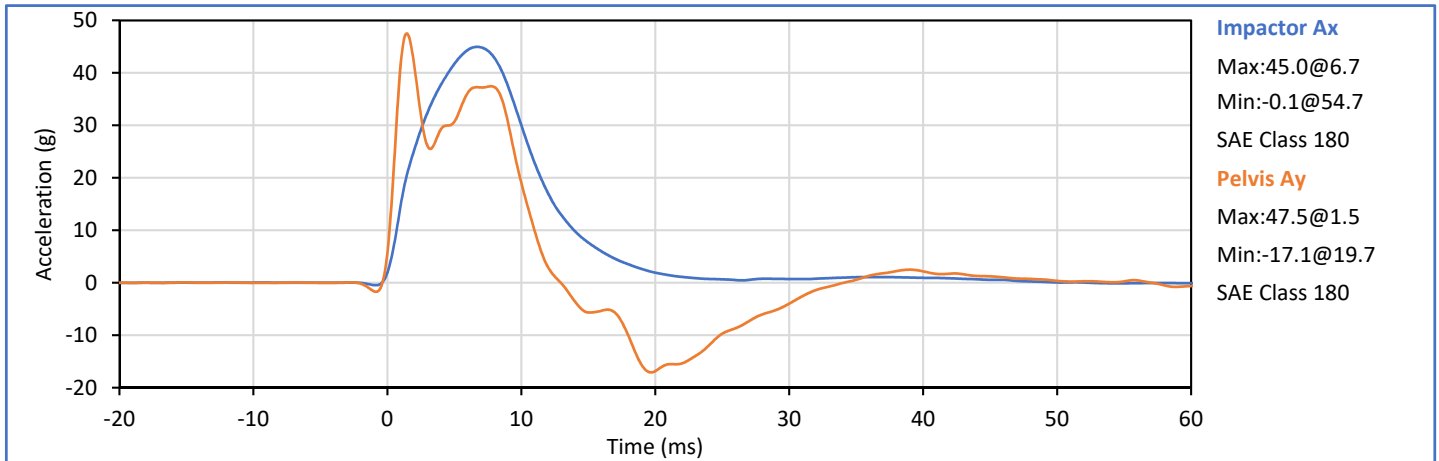
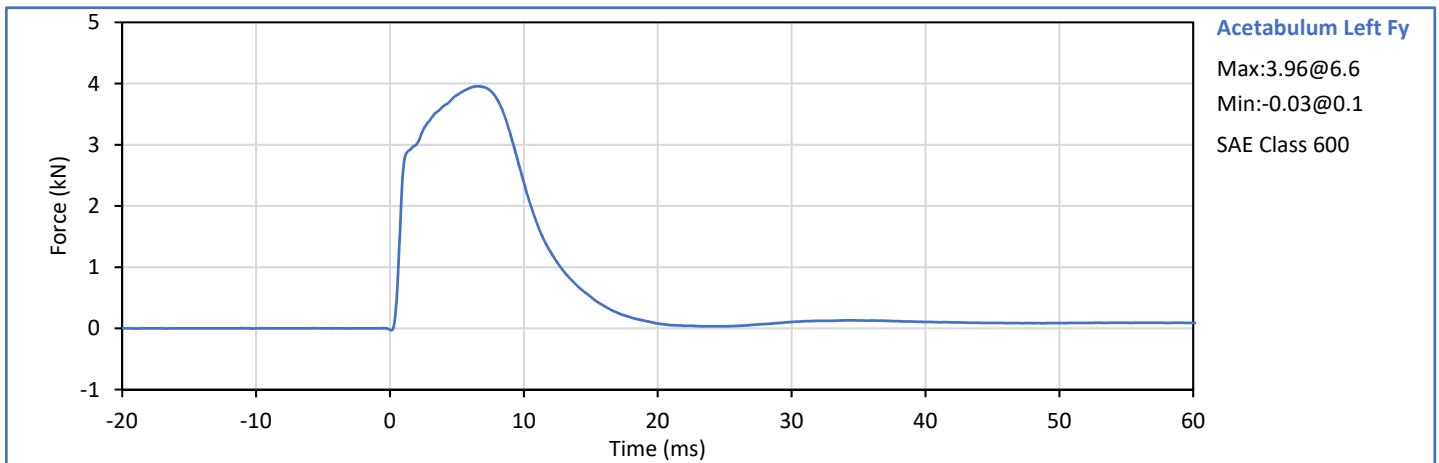
Technician: *J. Hernandez*
 J. Hernandez

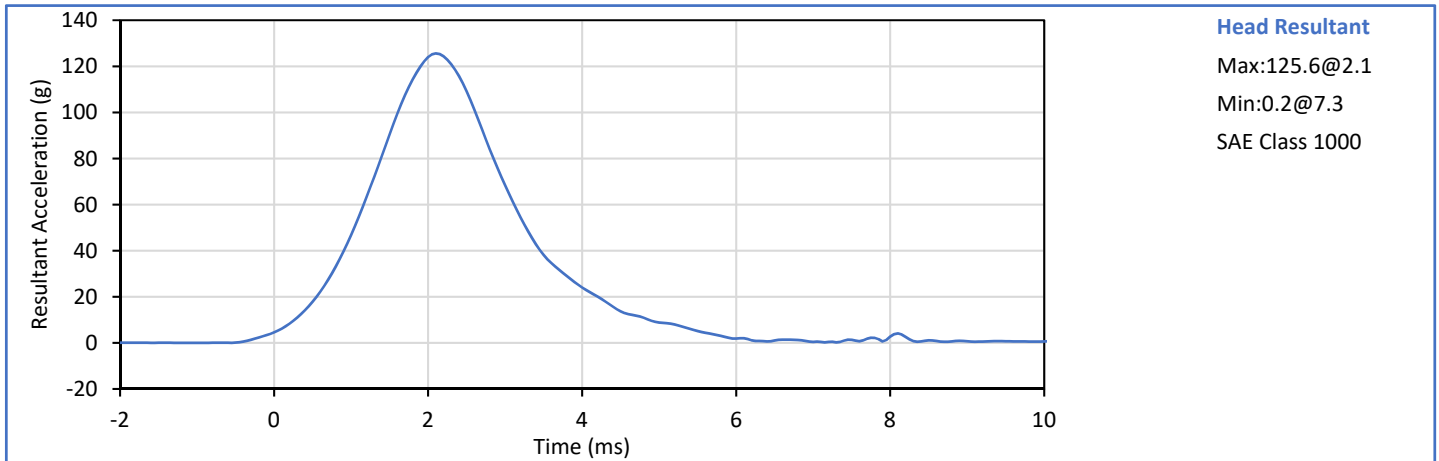
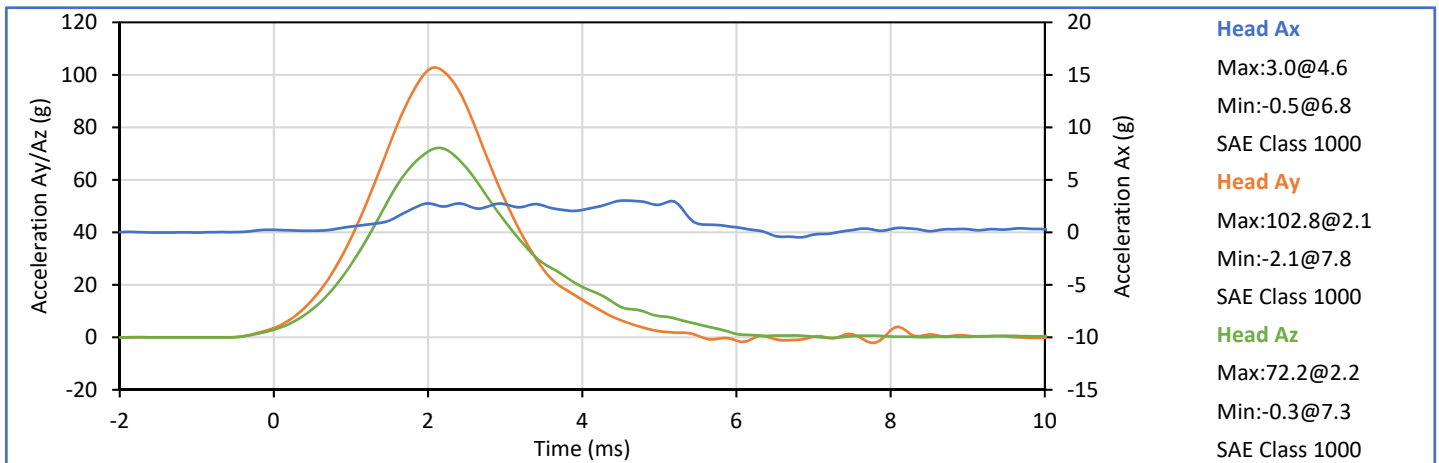
Technician:
 J. Hernandez

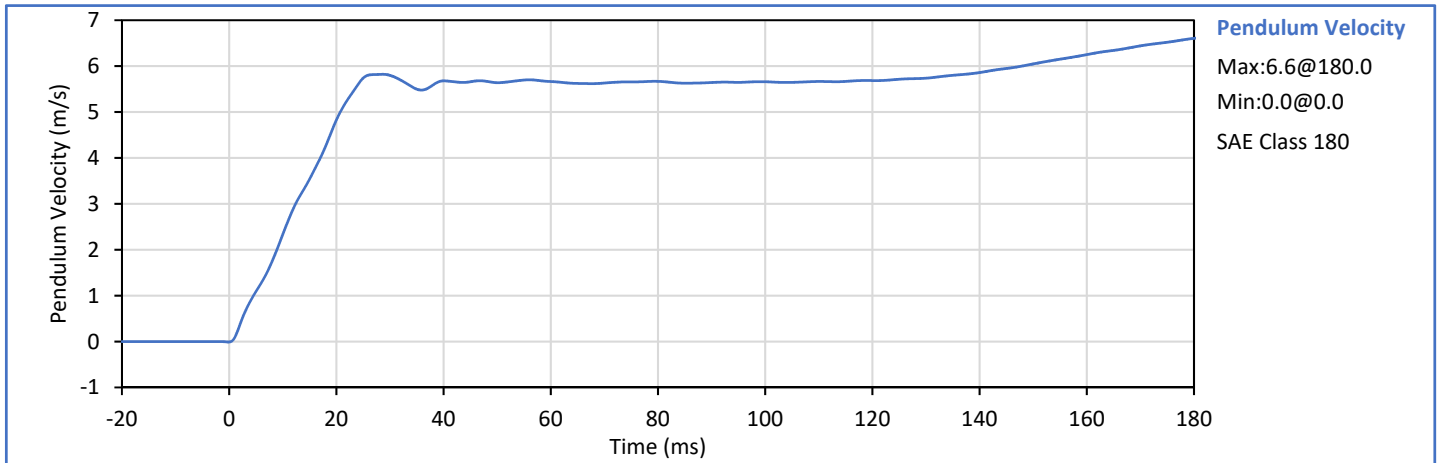
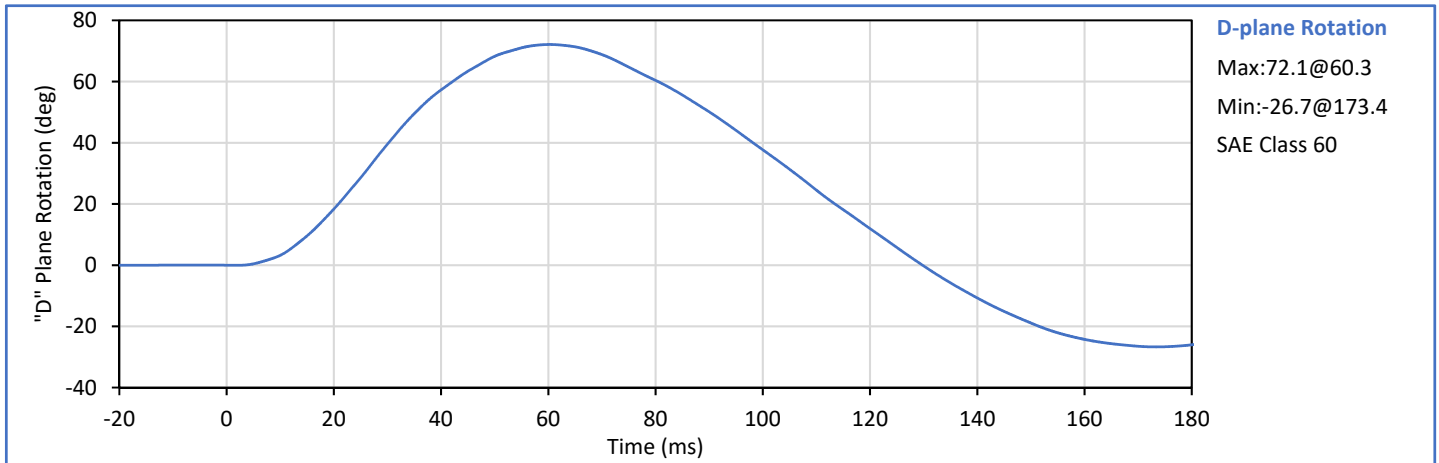
Technician: *J. Hernandez*
 J. Hernandez

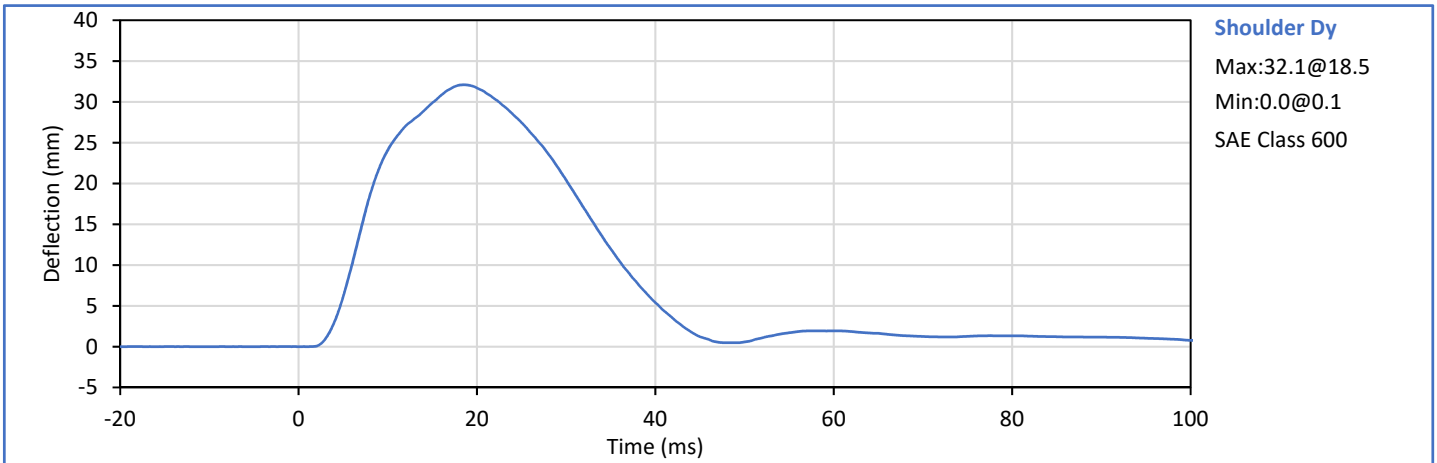
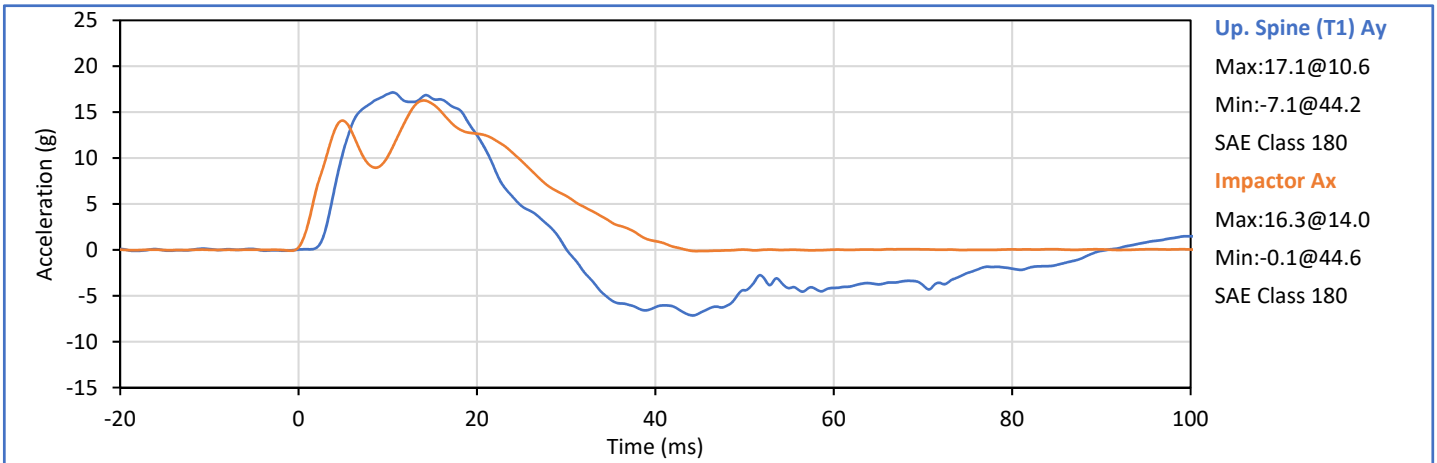
Technician: *J. Hernandez*
 J. Hernandez

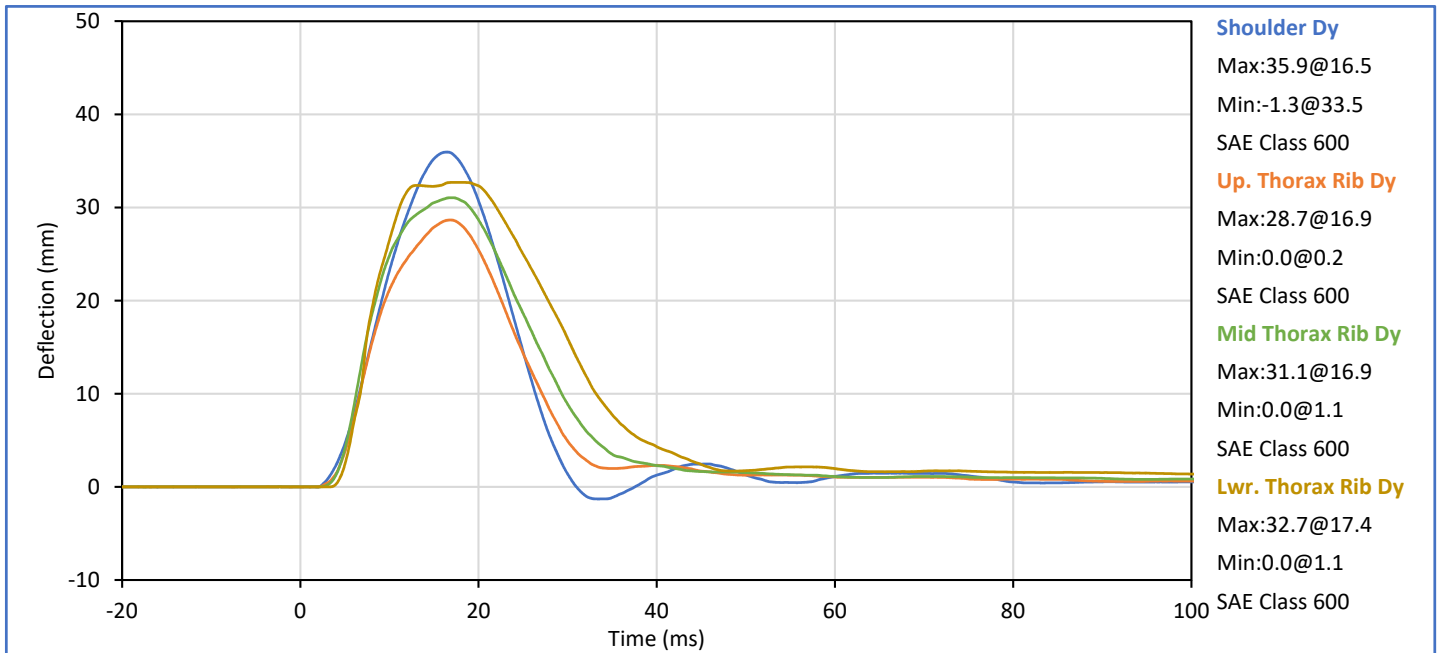
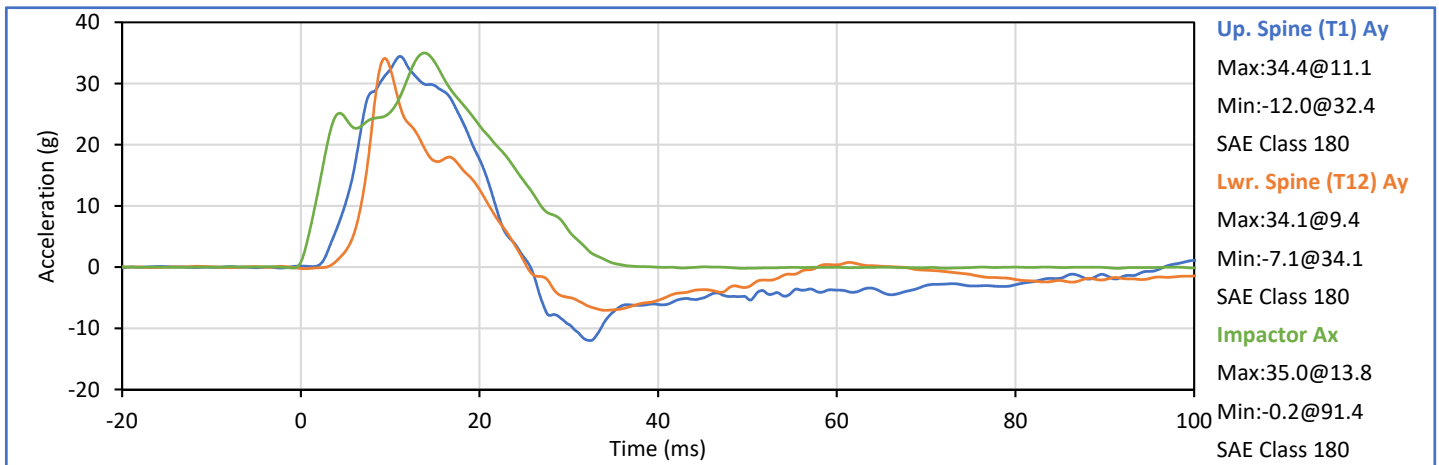
Tested Parameter	Units	Spec. Low	Spec. High	Result	Pass/Fail
Laboratory Temperature	°C	20.6	22.2	20.9	Pass
Laboratory Humidity	%	10	70	22	Pass
Impactor Velocity	m/s	6.60	6.80	6.68	Pass
Peak Shoulder Dy	mm	31.0	40.0	35.9	Pass
Peak Upper Rib Dy	mm	25.0	32.0	28.7	Pass
Peak Middle Rib Dy	mm	30.0	36.0	31.1	Pass
Peak Lower Rib Dy	mm	32.0	38.0	32.7	Pass
Peak Upper Spine (T1) Ay	g	34.0	43.0	34.4	Pass
Peak Lower Spine (T12) Ay	g	29.0	37.0	34.1	Pass
Peak Impactor Ax	g	30.0	36.0	35.0	Pass
Overall Test Results					Pass

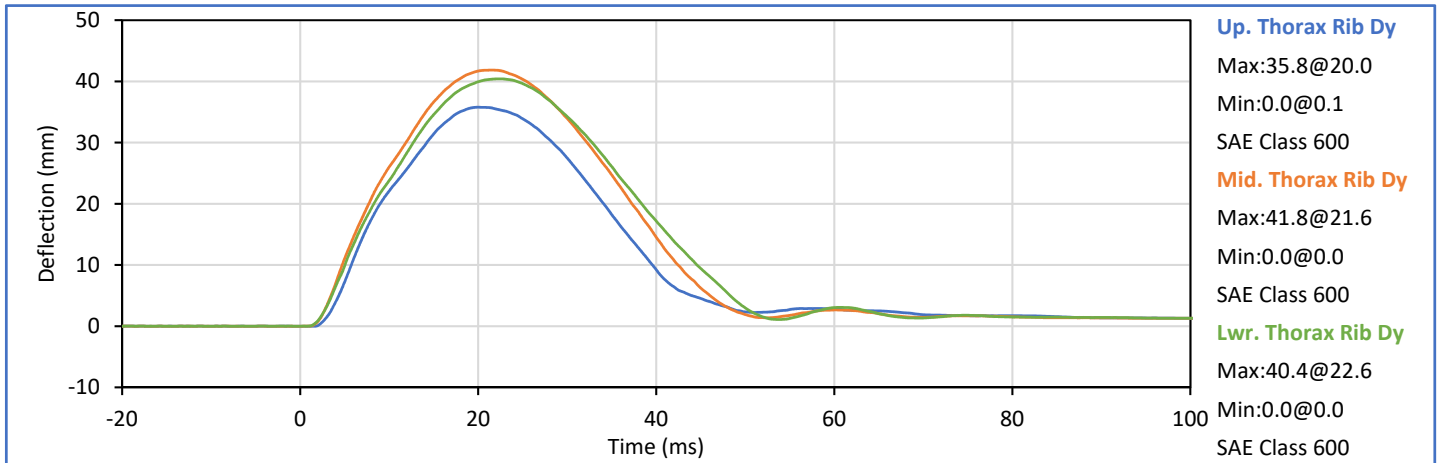
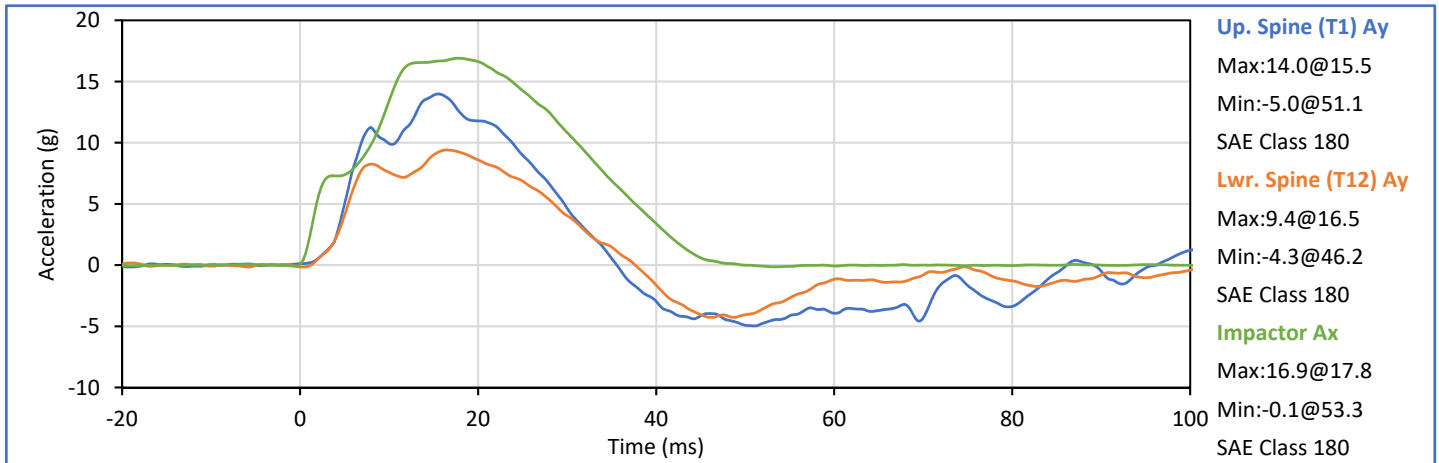
Technician:
 J. Hernandez

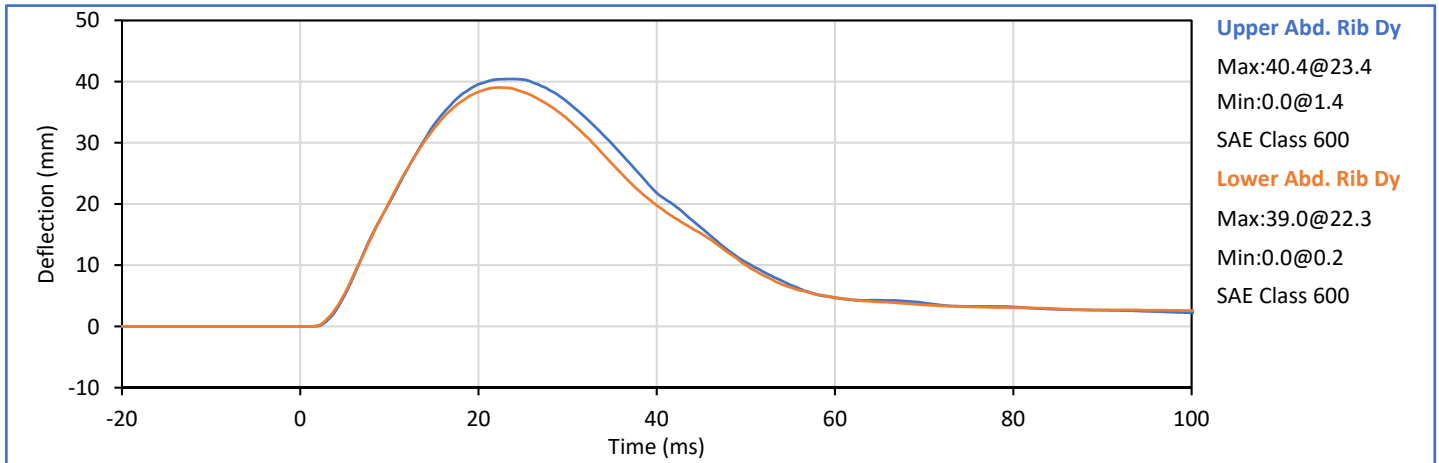
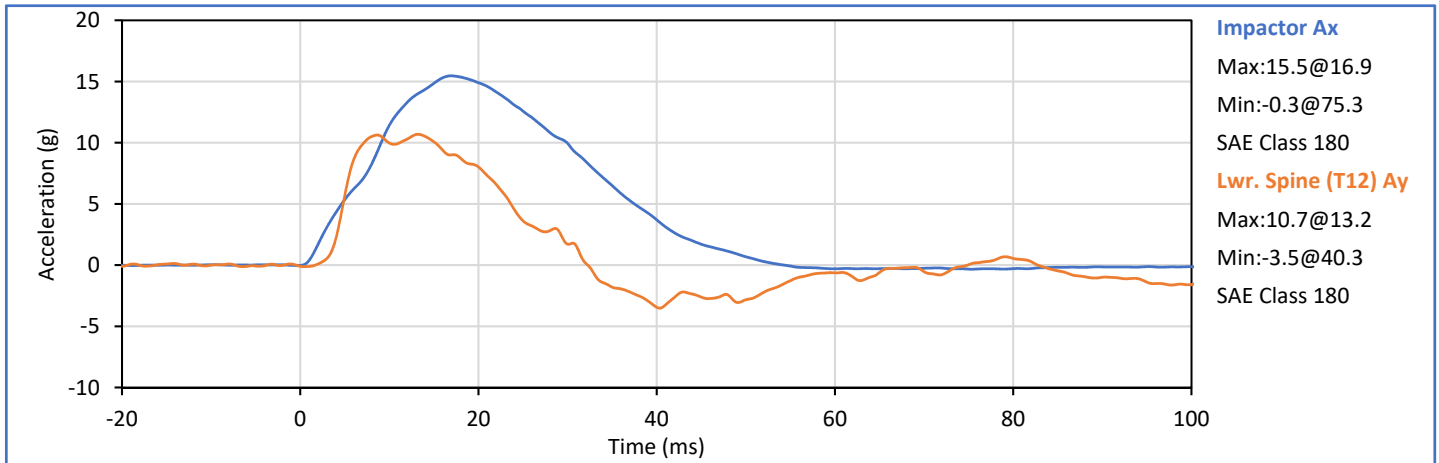
Tested Parameter	Units	Spec. Low	Spec. High	Result	Pass/Fail
Laboratory Temperature	°C	20.6	22.2	20.9	Pass
Laboratory Humidity	%	10	70	22	Pass
Impactor Velocity	m/s	4.20	4.40	4.34	Pass
Peak Upper Abdomen Rib Dy	mm	36.0	47.0	40.4	Pass
Peak Lower Abdomen Rib Dy	mm	33.0	44.0	39.0	Pass
Peak Lower Spine T12 Ay	mm	9.0	14.0	10.7	Pass
Peak Impactor Ax	g	12.0	16.0	15.5	Pass
Overall Test Results					Pass

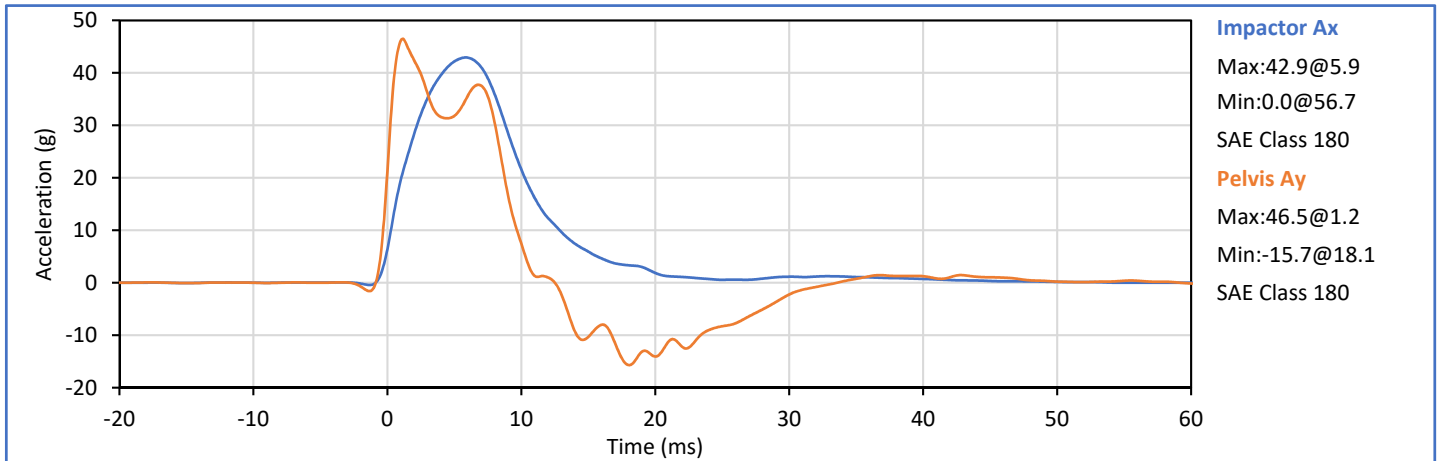
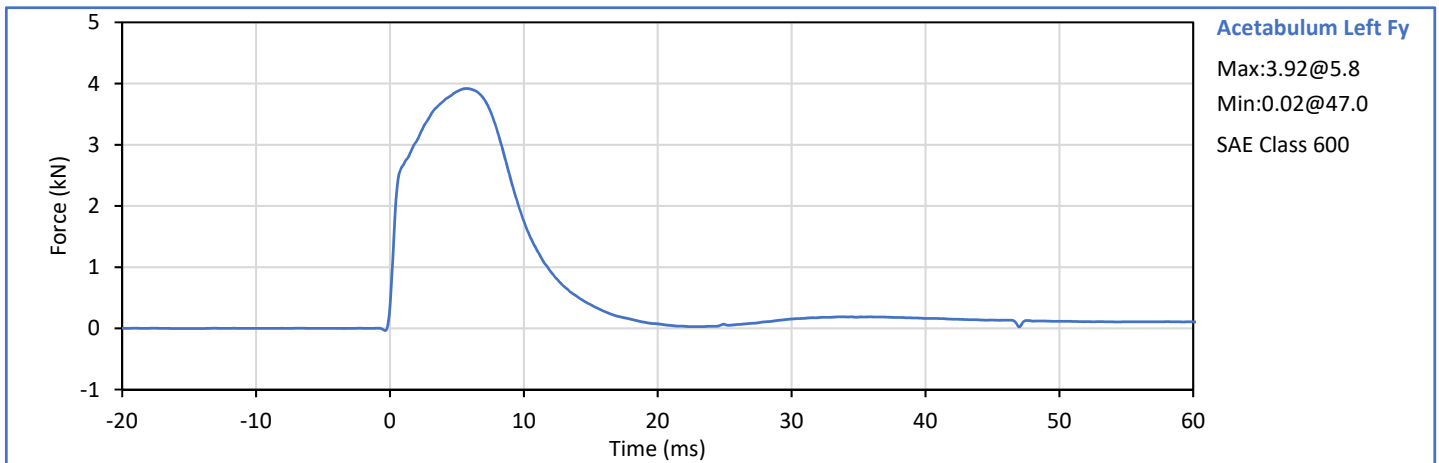
Pelvis Plug S/N: 11821 (SACO)
