**NEW CAR ASSESSMENT PROGRAM (NCAP)
MOVING DEFORMABLE BARRIER SIDE IMPACT TEST**

**FCA US LLC
2019 DODGE GRAND CARAVAN SE 5-DOOR MINIVAN**

NHTSA No: M20190304

FINAL REPORT

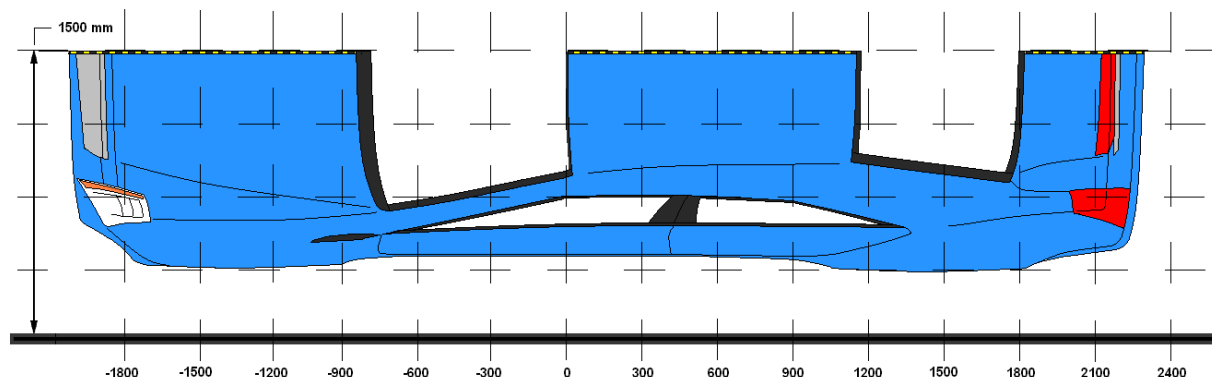
VEHICLE AND MDB DAMAGE PROFILE DISTANCES

VEHICLE DAMAGE PROFILE DISTANCES

DPD	Distance From Impact Point (mm)	Level	Pre-Test (mm)	Post-Test (mm)	Crush (mm)
1	2550	5	788	810	22
2	1950	2	536	674	138
3	1350	2	522	792	270
4	900	2	519	741	222
5	300	2	528	715	187
6	-300	2	531	551	20

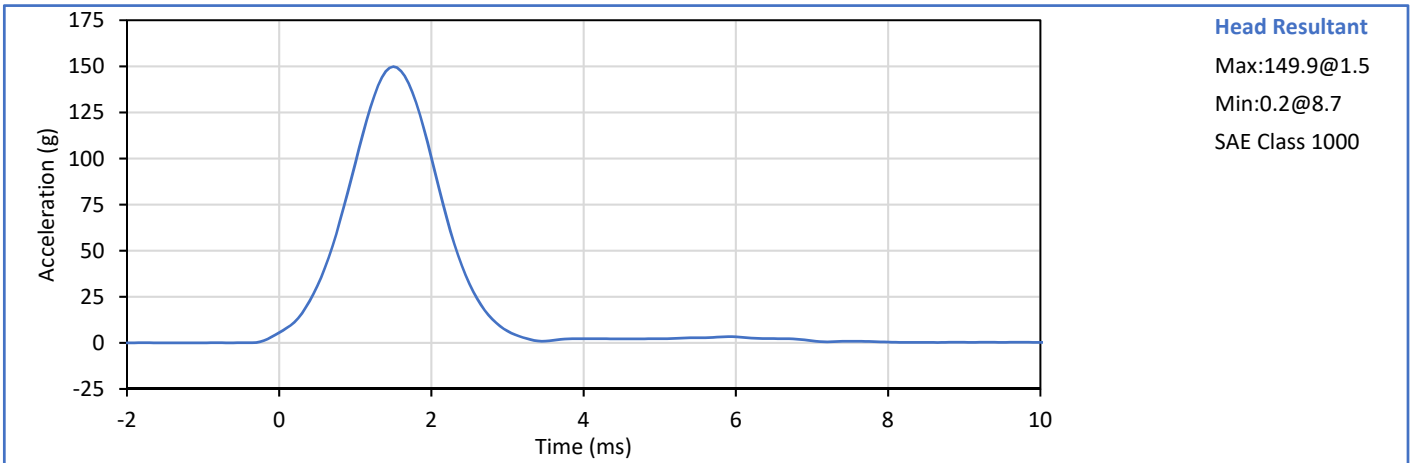
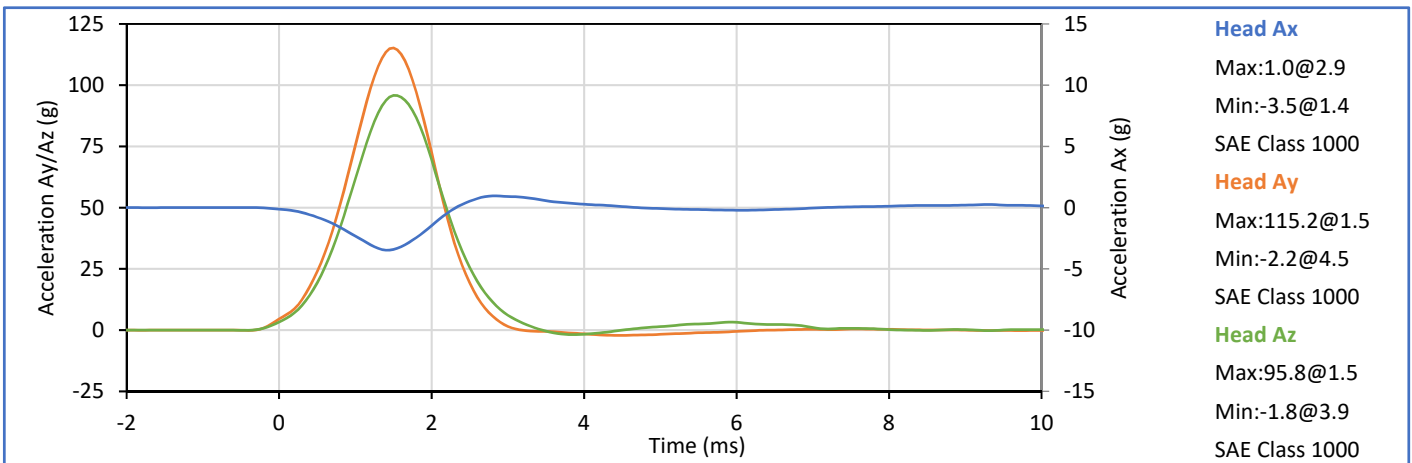
Tested Parameter	Units	Spec. Low	Spec. High	Result	Pass/Fail
Laboratory Temperature	°C	18.9	25.6	21.6	Pass
Laboratory Humidity	%	10	70	30	Pass
Peak Resultant Acceleration	g	125.0	155.0	149.9	Pass
Peak Head Ax	g	-15.0	15.0	1.0	Pass
Oscillations After Main Pulse	%	0.0	15.0	2.2	Pass
Is Acceleration Unimodal?	Yes/No	Yes		Yes	Pass
Overall Test Results					Pass

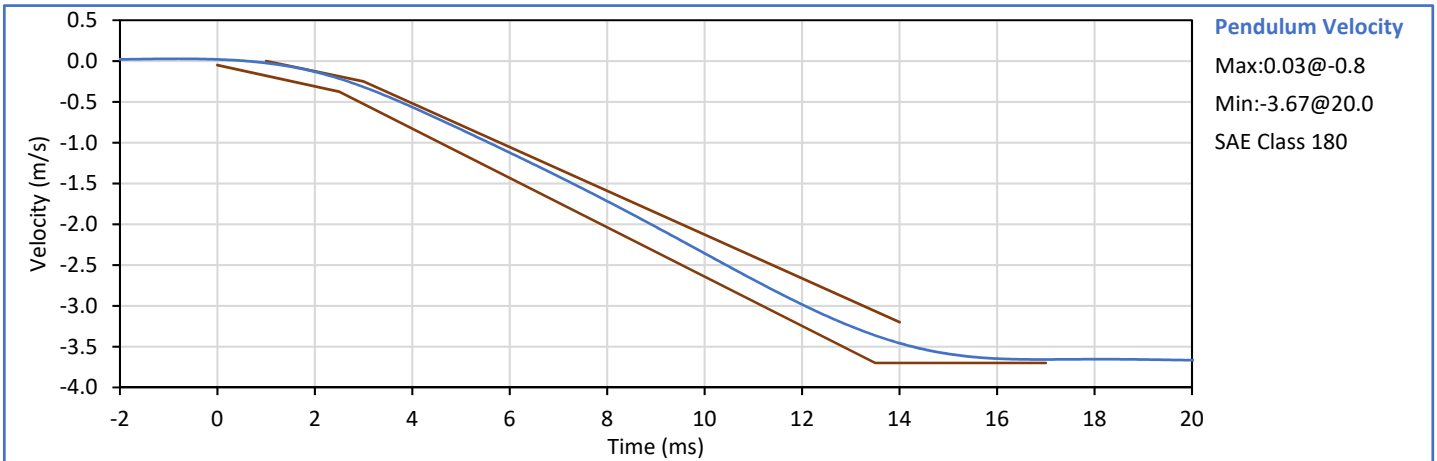
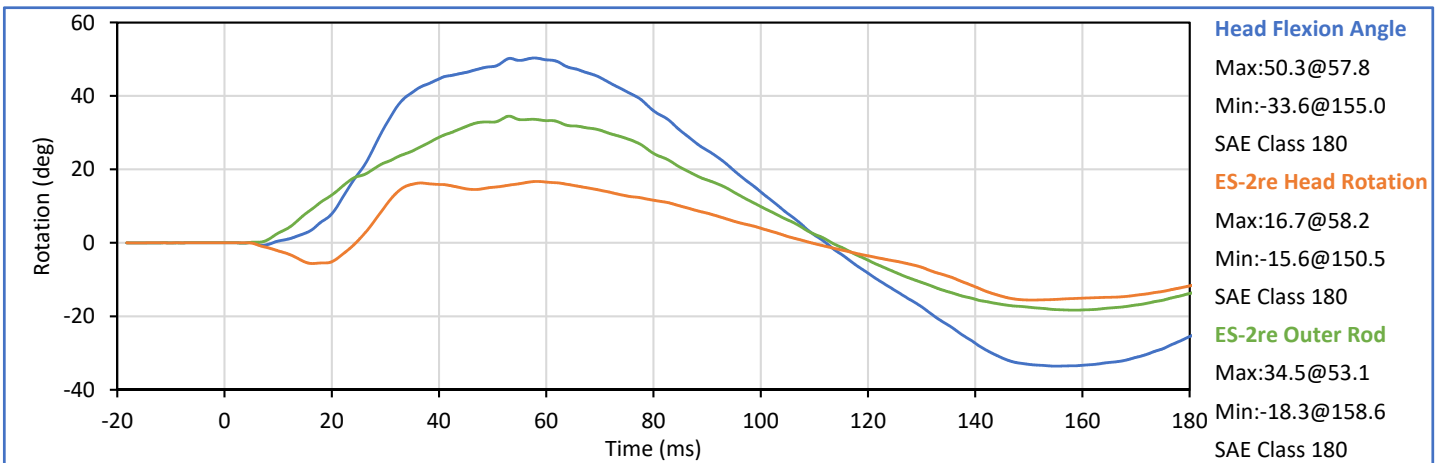
Tested Parameter	Units	Spec. Low	Spec. High	Result	Pass/Fail
Laboratory Temperature	°C	20.6	22.2	21.2	Pass
Laboratory Humidity	%	10	70	25	Pass
Pendulum Velocity	m/s	3.30	3.50	3.46	Pass
Peak Headform Flexion	deg	49.0	59.0	50.3	Pass
Time of Peak Headform Flexion	ms	54.0	66.0	57.8	Pass
Flexion Decay (Peak to zero)	ms	53.0	88.0	54.4	Pass
Overall Test Results					Pass

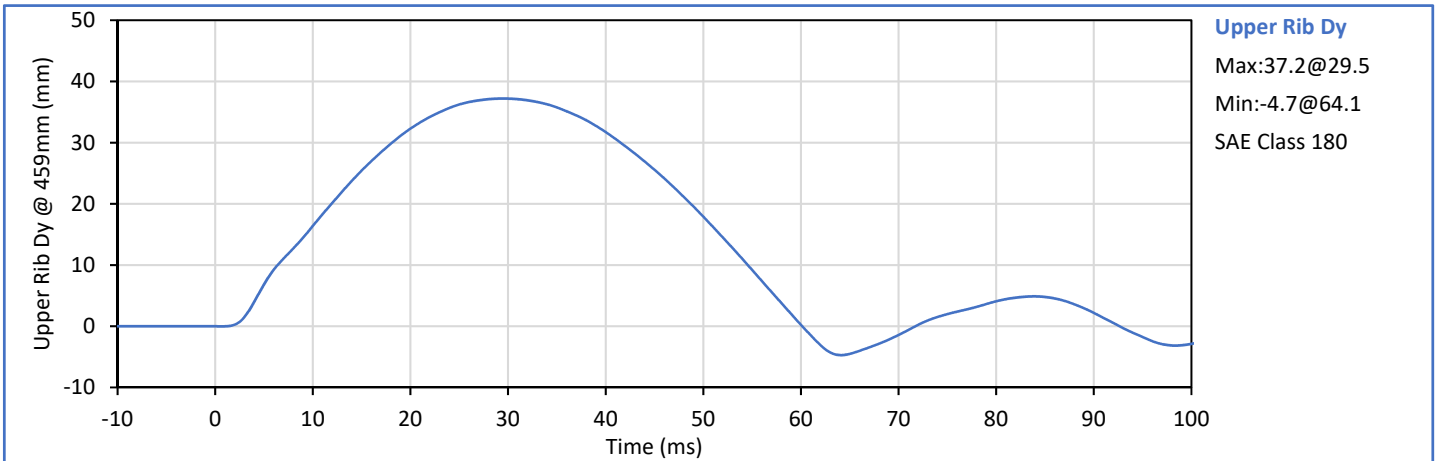
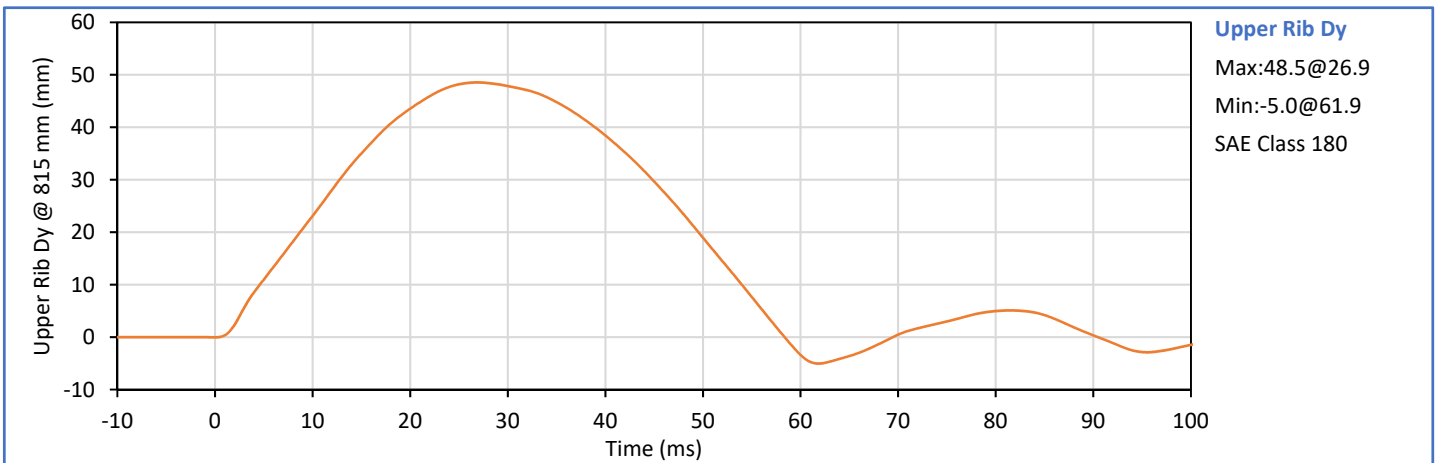
Tested Parameter	Units	Spec. Low	Spec. High	Result	Pass/Fail
Laboratory Temperature	°C	20.6	22.2	21.4	Pass
Laboratory Humidity	%	10	70	30	Pass
Upper Rib Dy @ 459mm	mm	36.0	40.0	37.2	Pass
Upper Rib Dy @ 815mm	mm	46.0	51.0	48.5	Pass
Overall Test Results					Pass

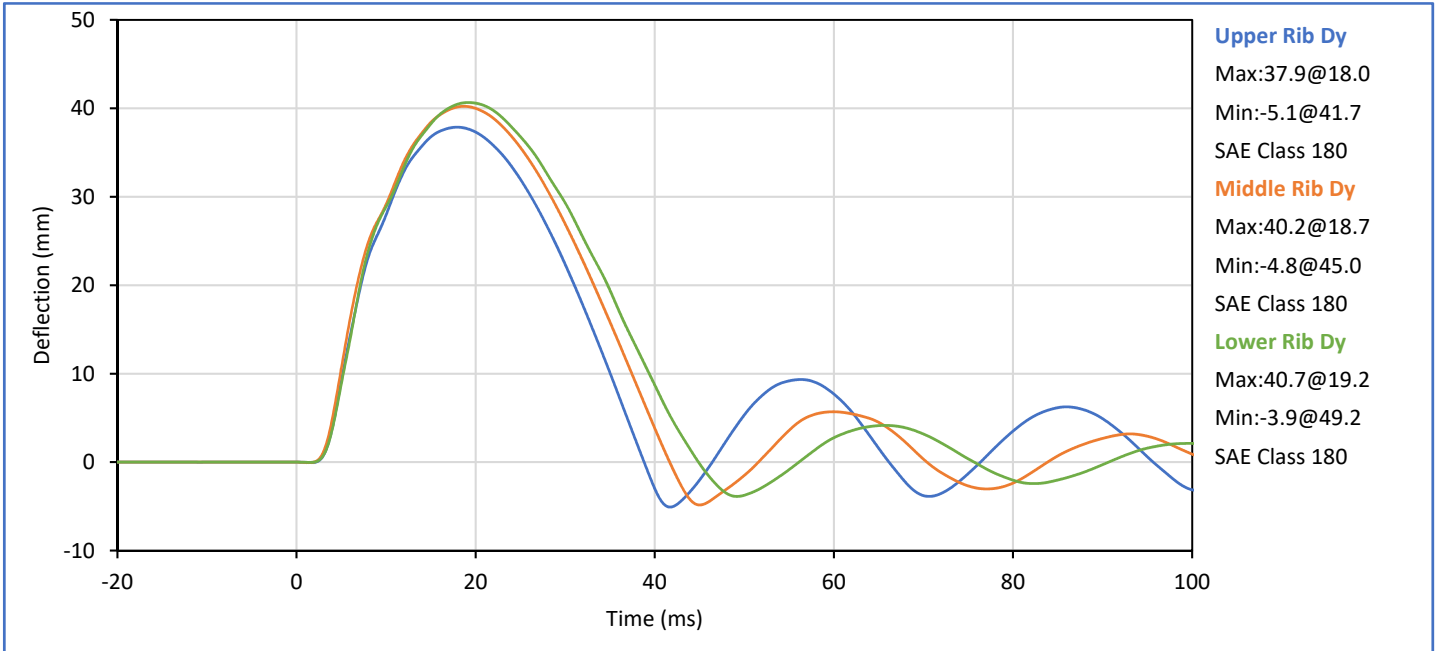
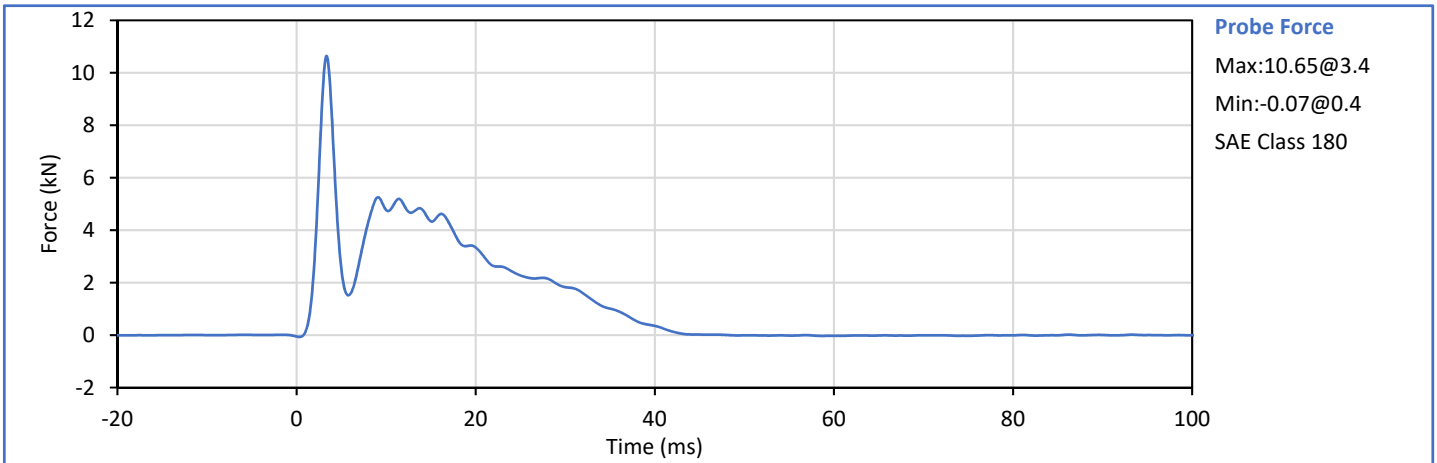
Tested Parameter	Units	Spec. Low	Spec. High	Result	Pass/Fail
Laboratory Temperature	°C	20.6	22.2	21.4	Pass
Laboratory Humidity	%	10	70	30	Pass
Impactor Velocity	m/s	5.40	5.60	5.42	Pass
Peak Upper Rib Dy	mm	34.0	41.0	37.9	Pass
Peak Middle Rib Dy	mm	37.0	45.0	40.2	Pass
Peak Lower Rib Dy	mm	37.0	44.0	40.7	Pass
Peak Impactor Force After 6 ms	kN	5.10	6.20	5.26	Pass
Overall Test Results					Pass

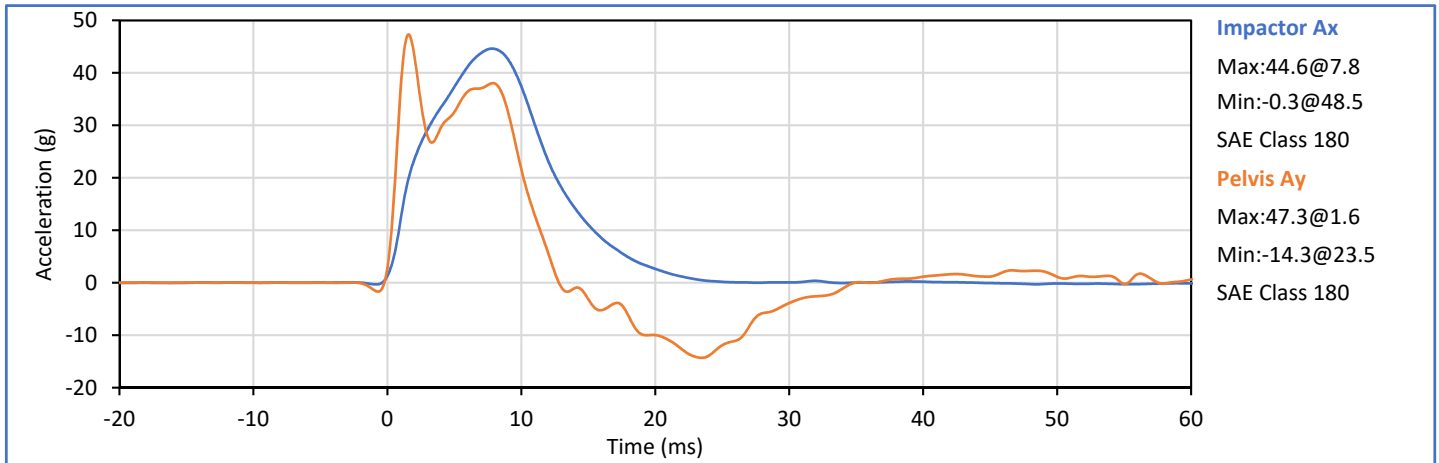
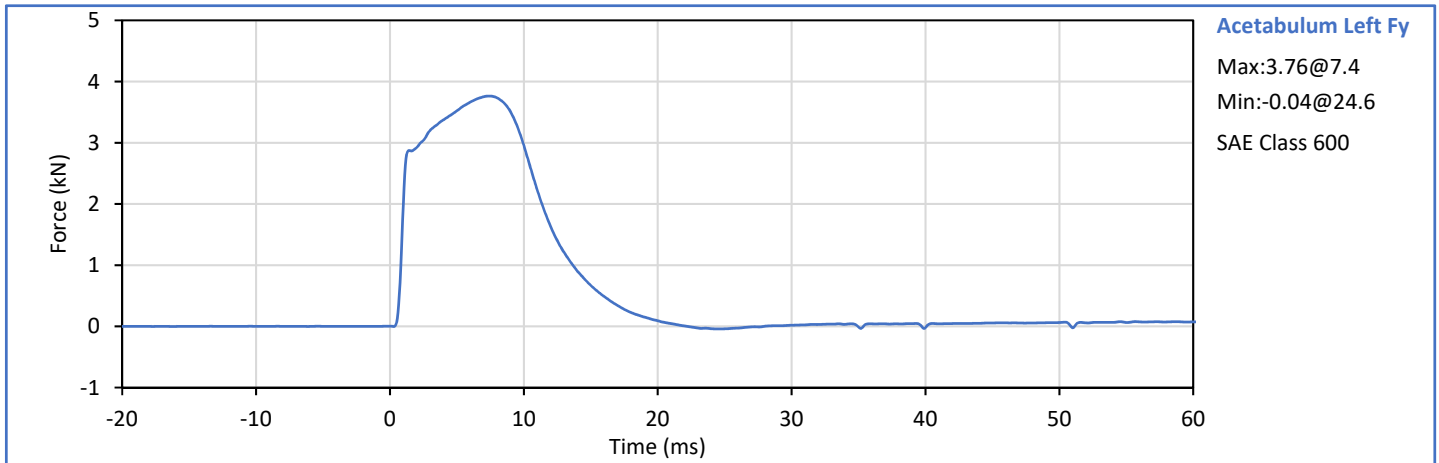
Tested Parameter	Units	Spec. Low	Spec. High	Result	Pass/Fail
Laboratory Temperature	°C	20.6	22.2	21.2	Pass
Laboratory Humidity	%	10	70	42	Pass
Impactor Velocity	m/s	6.60	6.80	6.61	Pass
Peak Acetabulum Fy	kN	3.60	4.30	3.76	Pass
Pelvis Ay after 6ms	g	34.0	42.0	38.1	Pass
Peak Impactor Ax	g	38.0	47.0	44.6	Pass
Overall Test Results					Pass
