Final Report Number: NCAP-TRC-19-003

**New Car Assessment Program (NCAP)
Frontal Barrier Impact Test**

**BAYERISCHE MOTOREN WERKE AG
2019 BMW X5 5-DR SUV
NHTSA Number: M20194103**

**PREPARED BY:
Transportation Research Center Inc.
10820 State Route 347
P. O. Box B-67
East Liberty, OH 43319**

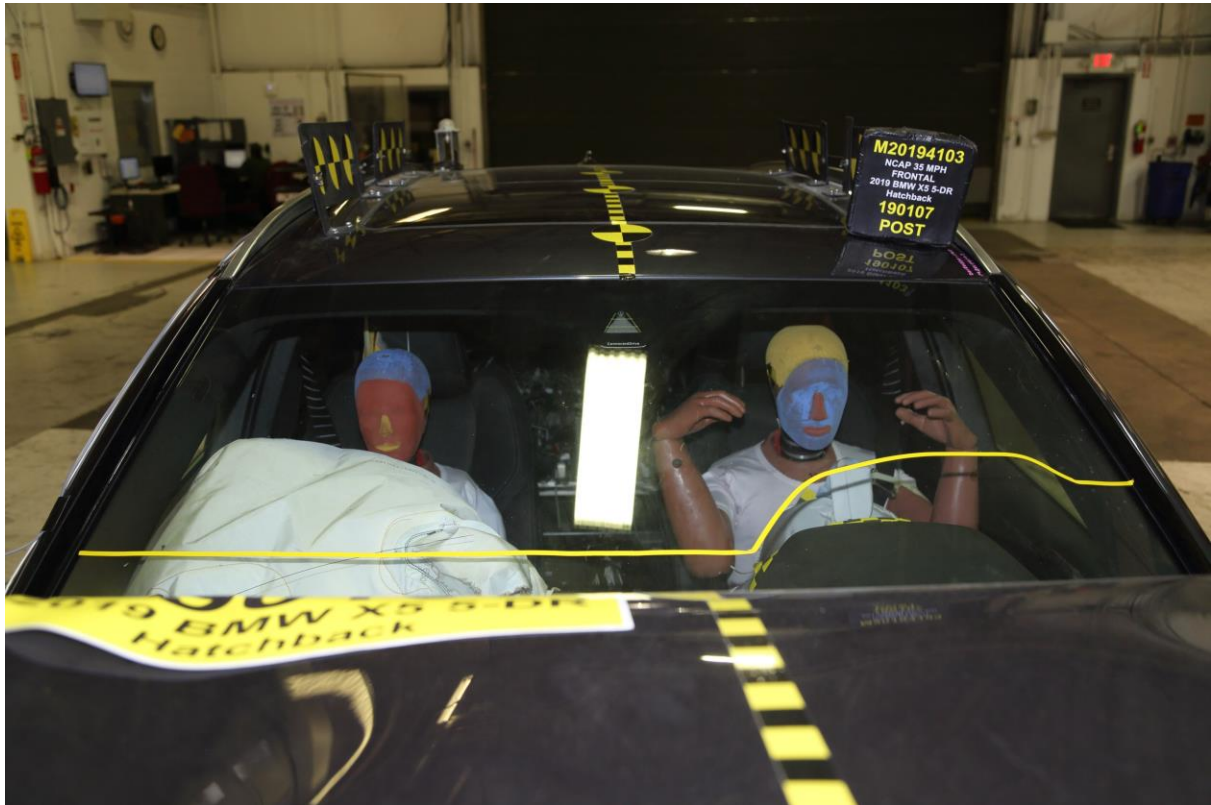
019 Post-Test Windshield View

Critical Areas of Performance	Observations
Windshield Damage	Small crack at lower right corner
Window Damage	None
Other Notable Effects	None

There was 100.0 percent windshield retention and no intrusion into the protected zone of the windshield during the event. There was no Stoddard solvent leakage (or electrolyte spillage) after the event or during any phase of the static rollover.

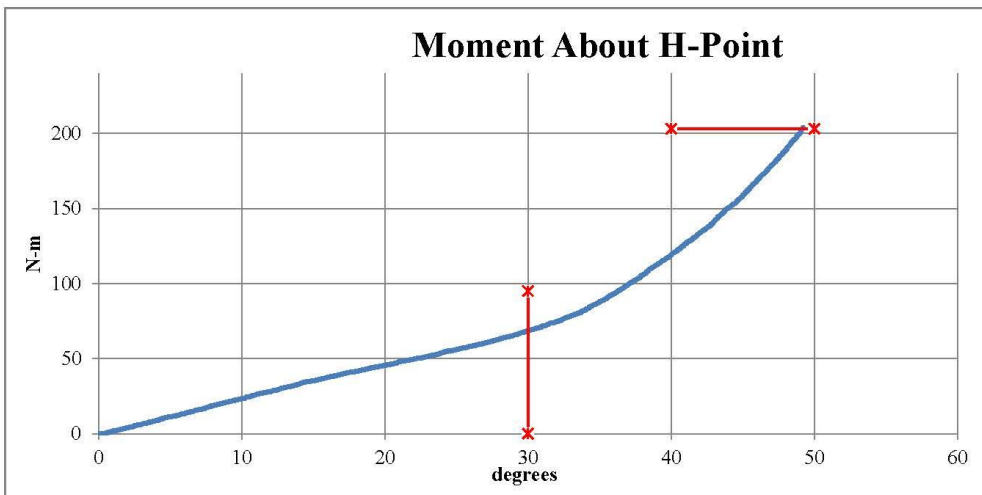
Serial Number: 037 Date: 14-Dec-2018
Side Tested: Left Hip Time: 7:37
Test Number: 1

TEST PARAMETER	SPECIFICATION	TEST RESULTS
Temperature	18.9 - 25.6	21.8 °C Pass
Humidity	10 - 70	41 % Pass
Moment at 30°	0 ≤ 94.9	68.71 N-m Pass
Angle at 203 Nm	40 - 50	49.21 deg Pass
Average Velocity	5 - 10	7.06 deg/sec Pass

Max: 9.54 deg/sec Min: 5.3 deg/sec

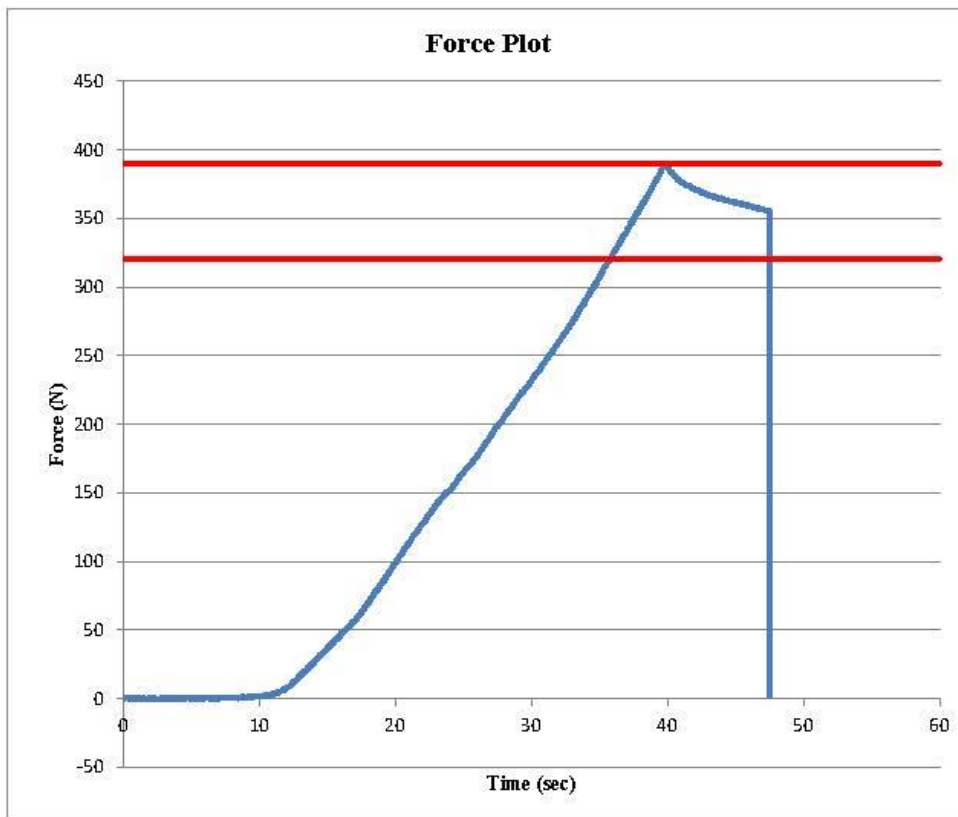
TEST PARAMETER	SPECIFICATION	TEST RESULTS
Temperature	18.9 - 25.6	21.3 °C Pass
Humidity	10 - 70	41 % Pass
Average Angular Velocity	0.5 - 1.5	0.98 deg/sec Pass
Initial Angle	0 - 20	17.16 deg Pass
Peak Force at 45.31°	320 - 390	389.48 N Pass
Final Angle	-8 - 8	5.23 deg Pass

Comments:
Abdomen S/N: 1047
Pelvis S/N: 885
Lumbar S/N: N/A
