**REPORT NUMBER: SINCAP-MGA-2018-015**

**NEW CAR ASSESSMENT PROGRAM (NCAP)  
Moving Deformable Barrier Side Impact Test**

**HYUNDAI MOTOR MANUFACTURING ALABAMA, LLC  
2019 Hyundai Santa Fe SE 5-Door SUV  
NHTSA No.: M20194205**

**FINAL REPORT**

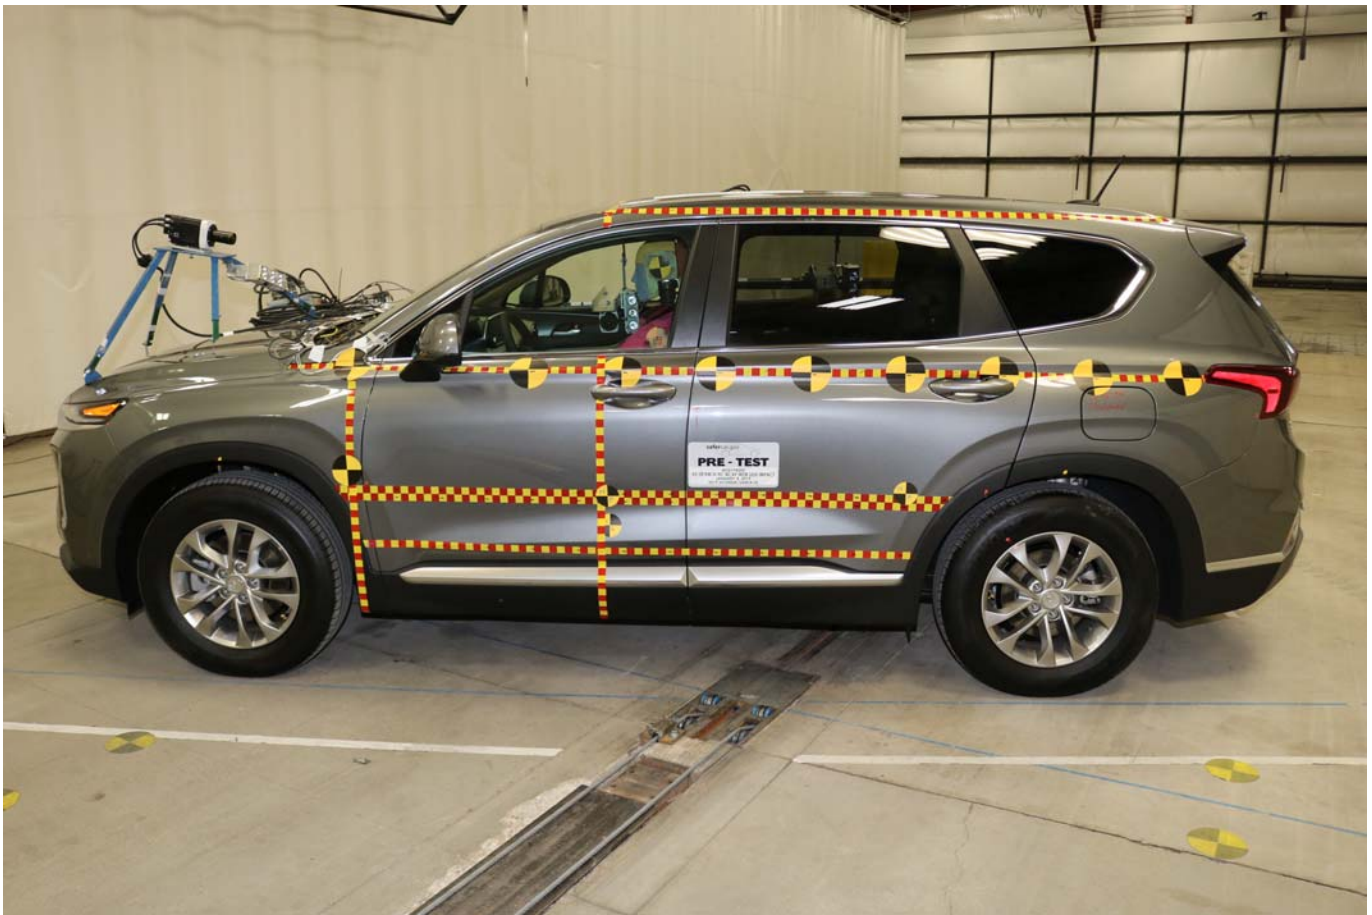
Photo No. 007 - Pre-Test Left Side View of Test Vehicle

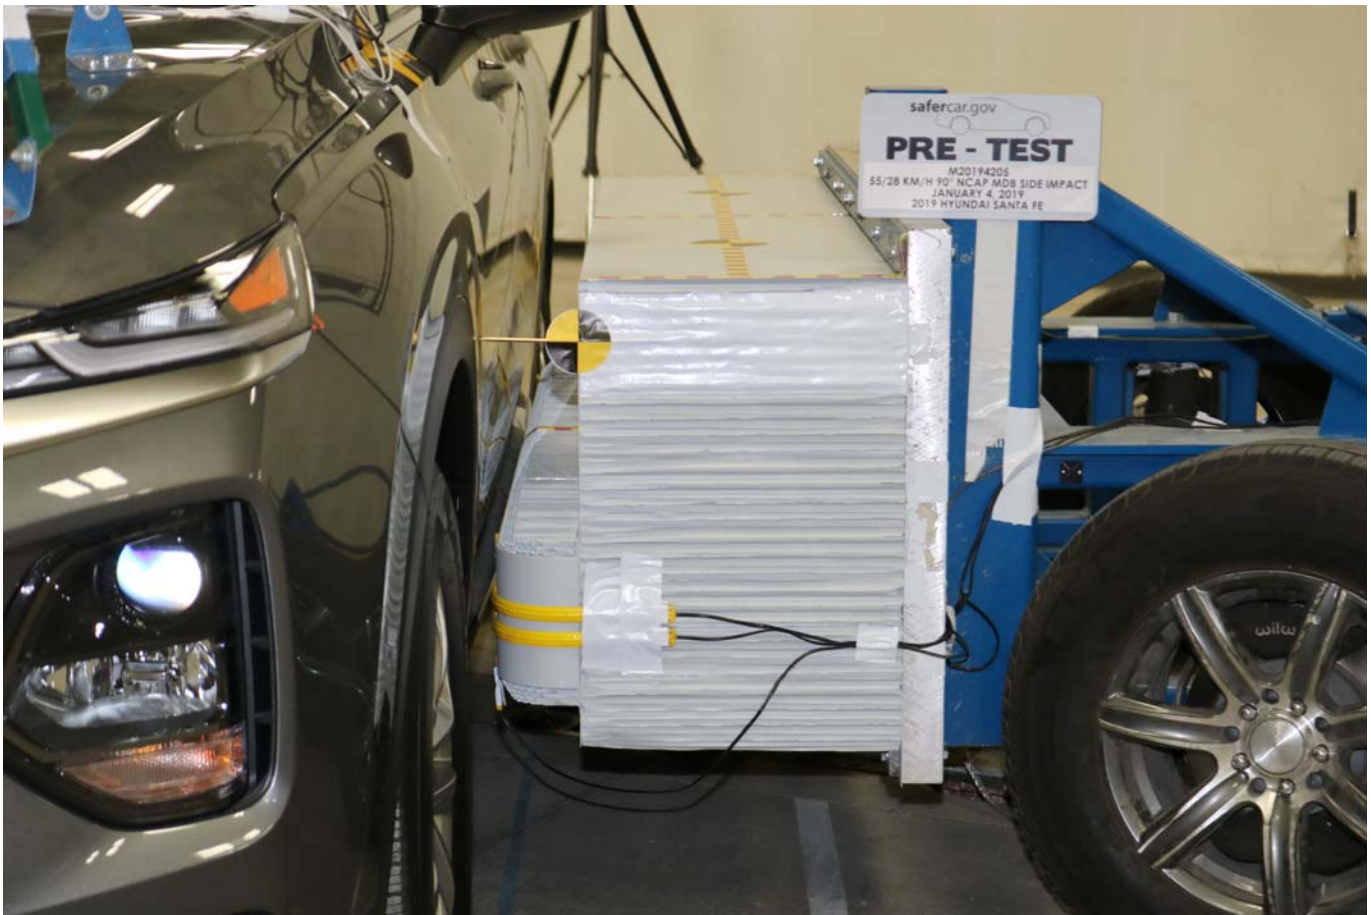
Photo No. 017 - Pre-Test Left Side View of MDB Positioned Against Side of Test Vehicle

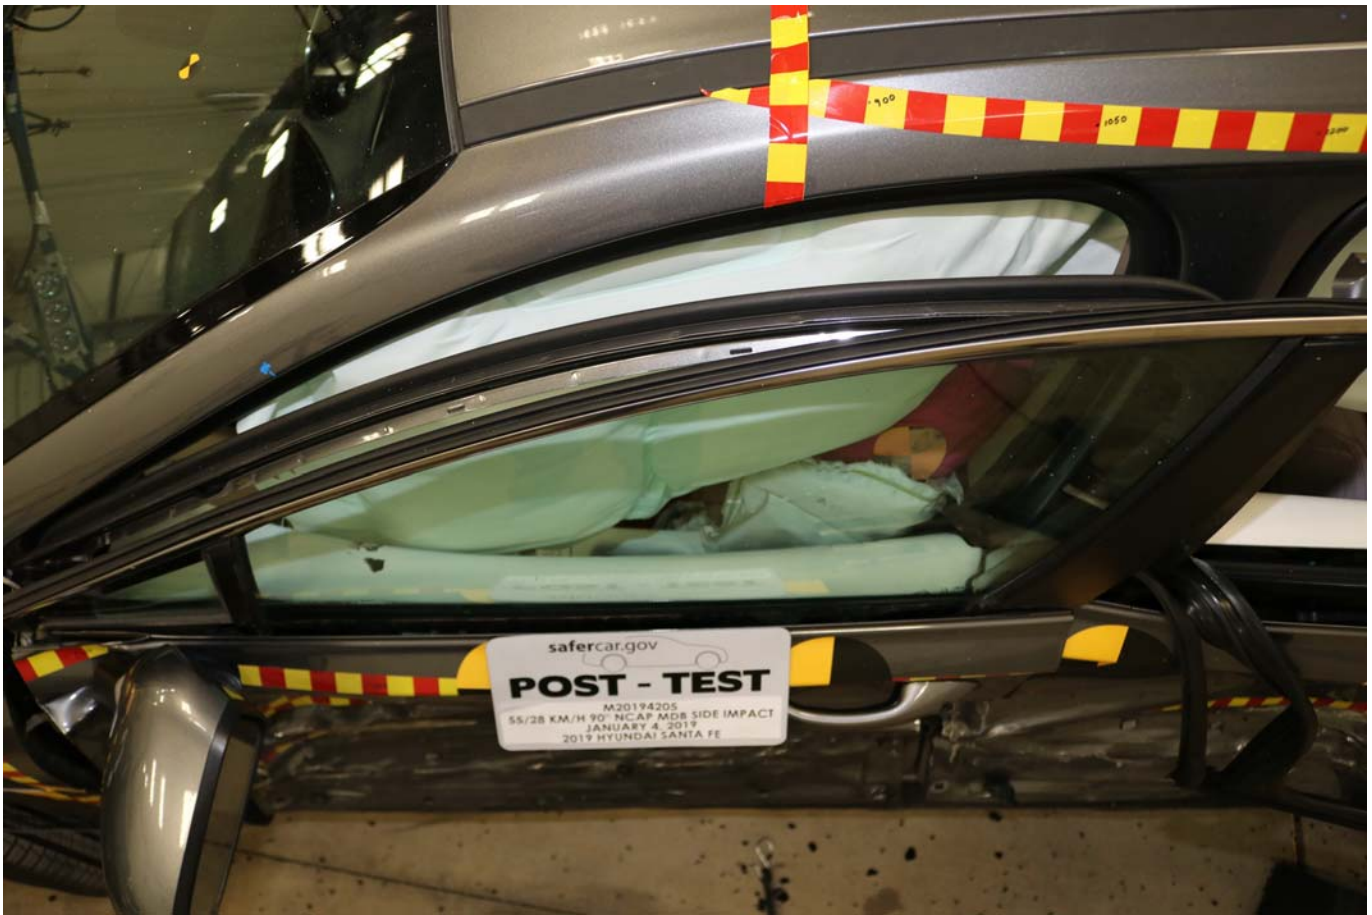
Photo No. 043 - Post-Test Driver Dummy and Door Clearance View

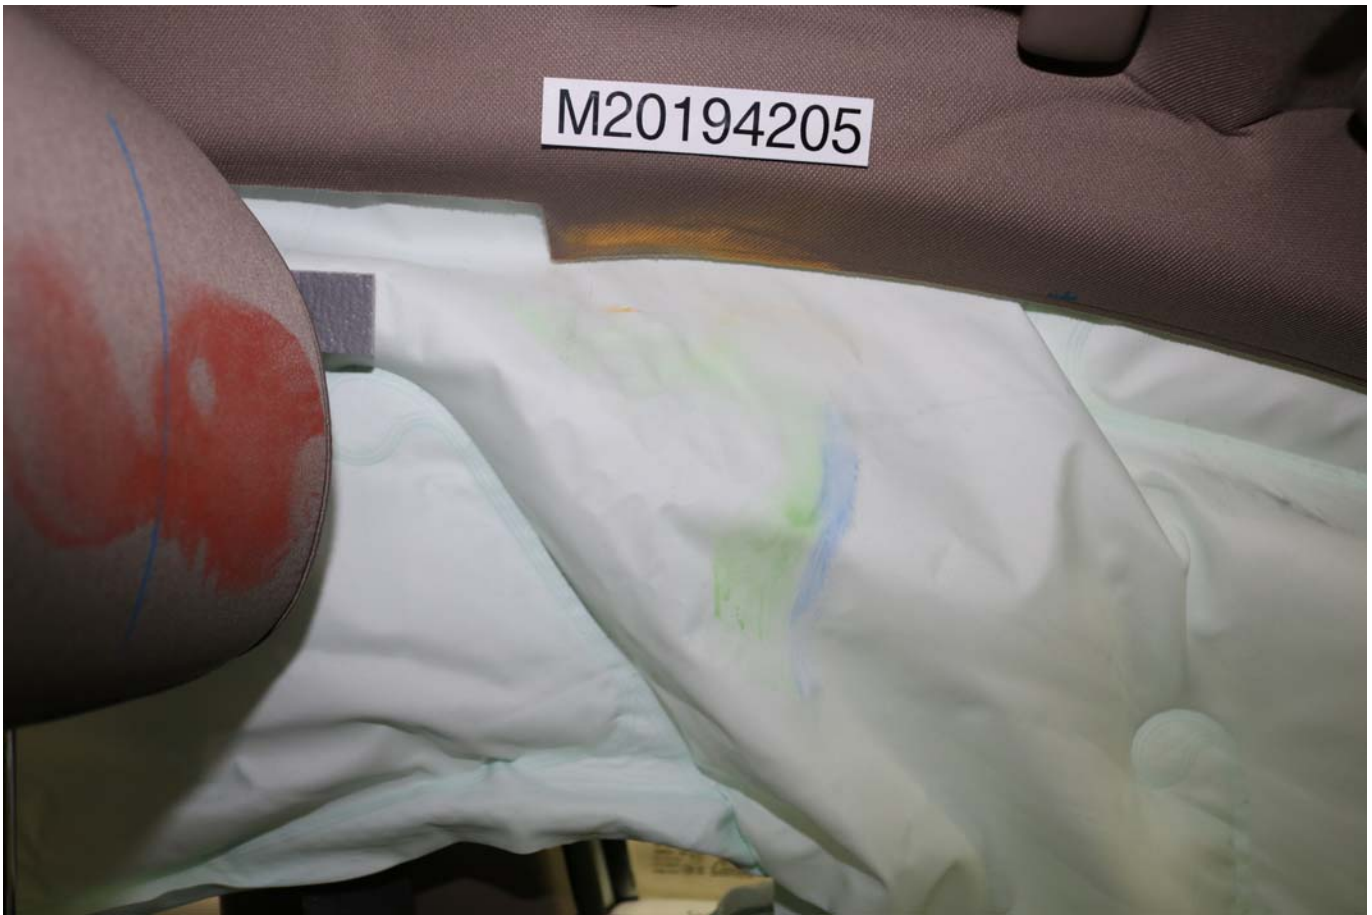
Photo No. 049 - Post-Test Driver Dummy Close-up Head Contact with Side Airbag View

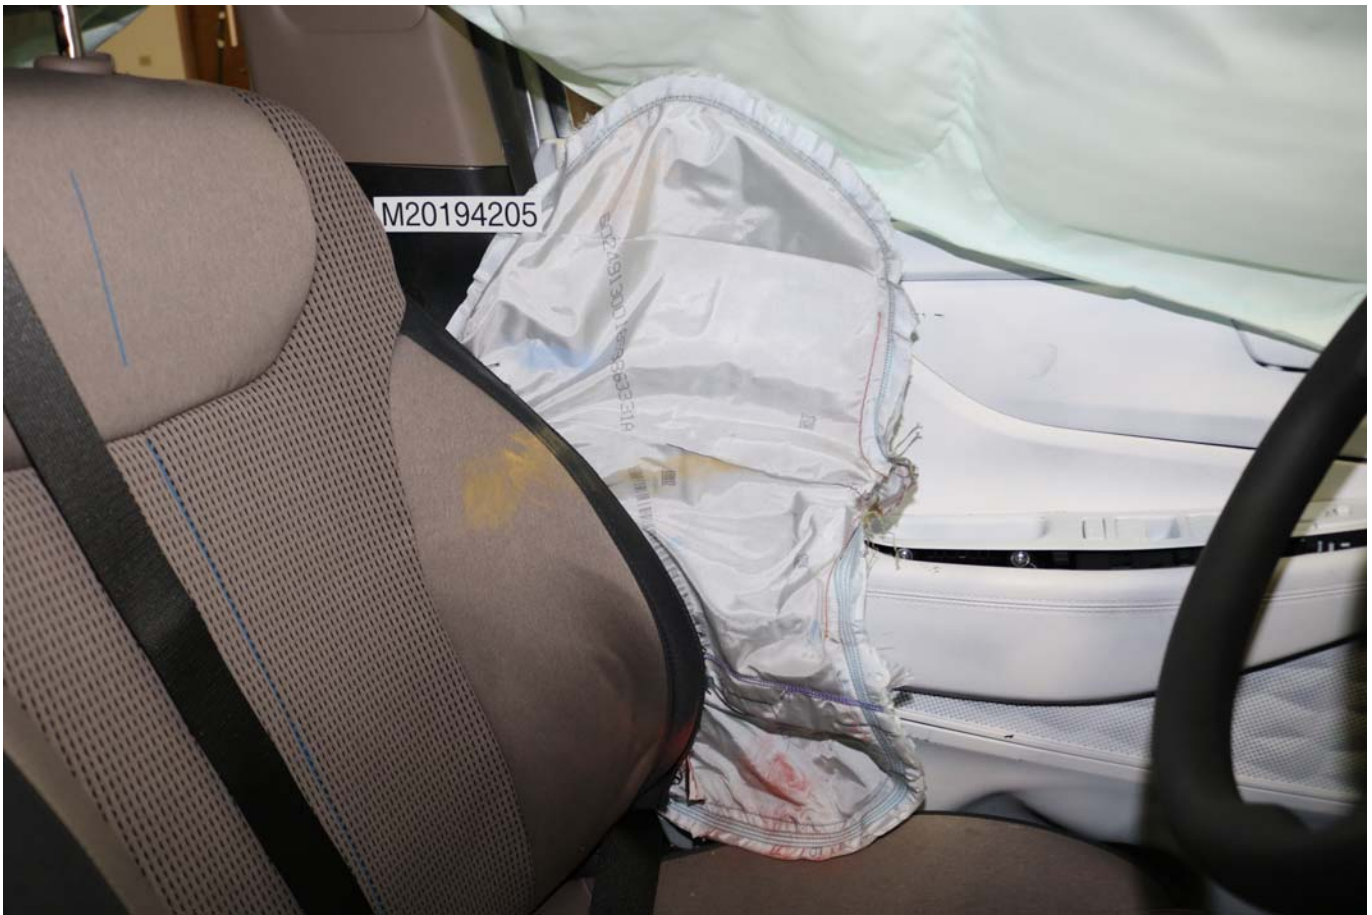
Photo No. 051 - Post-Test Driver Dummy Close-up Torso Contact with Side Airbag View

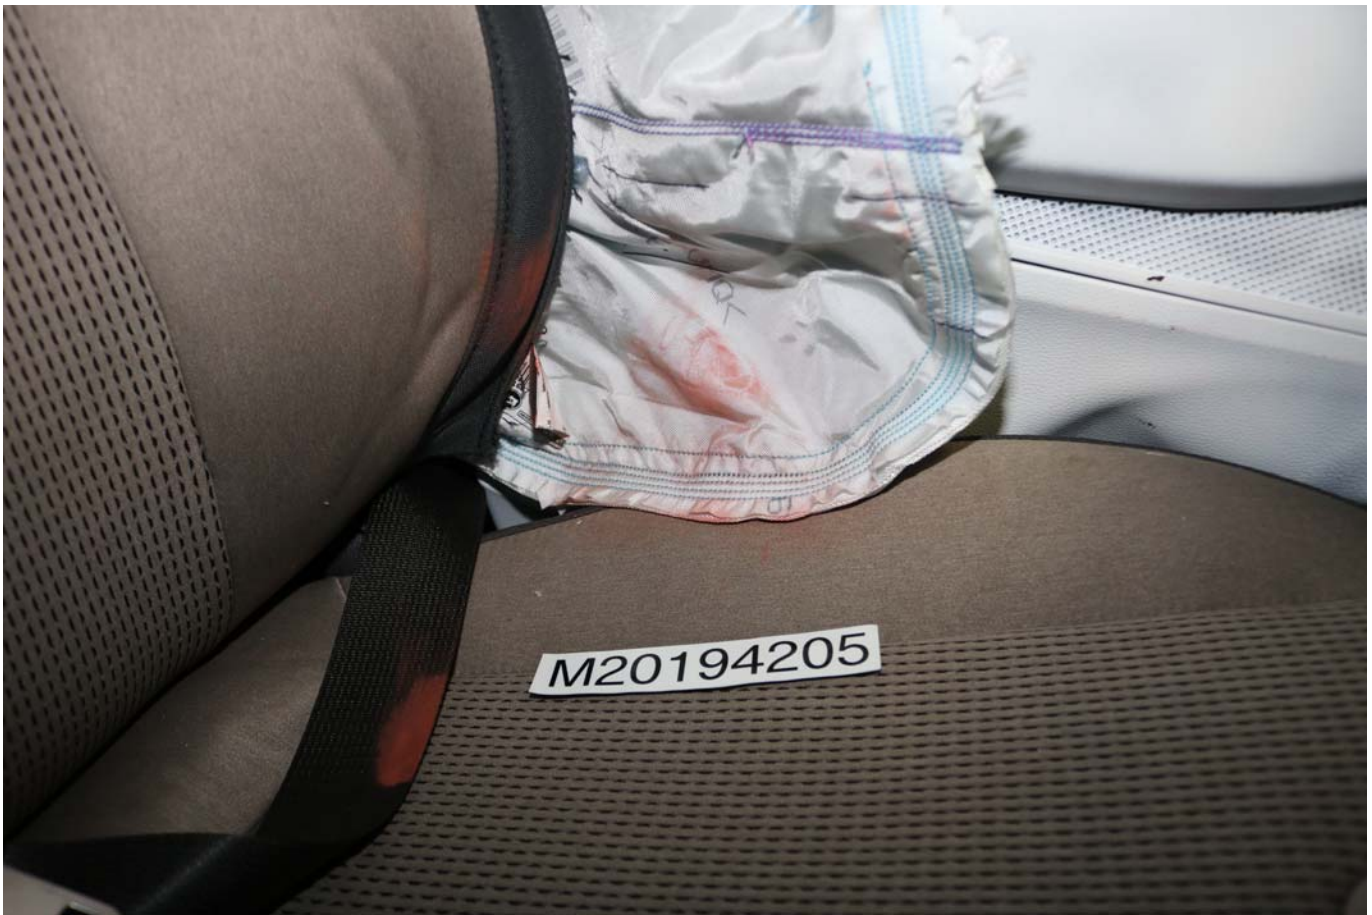
Photo No. 053 - Post-Test Driver Dummy Close-up Pelvis Contact with Side Airbag View

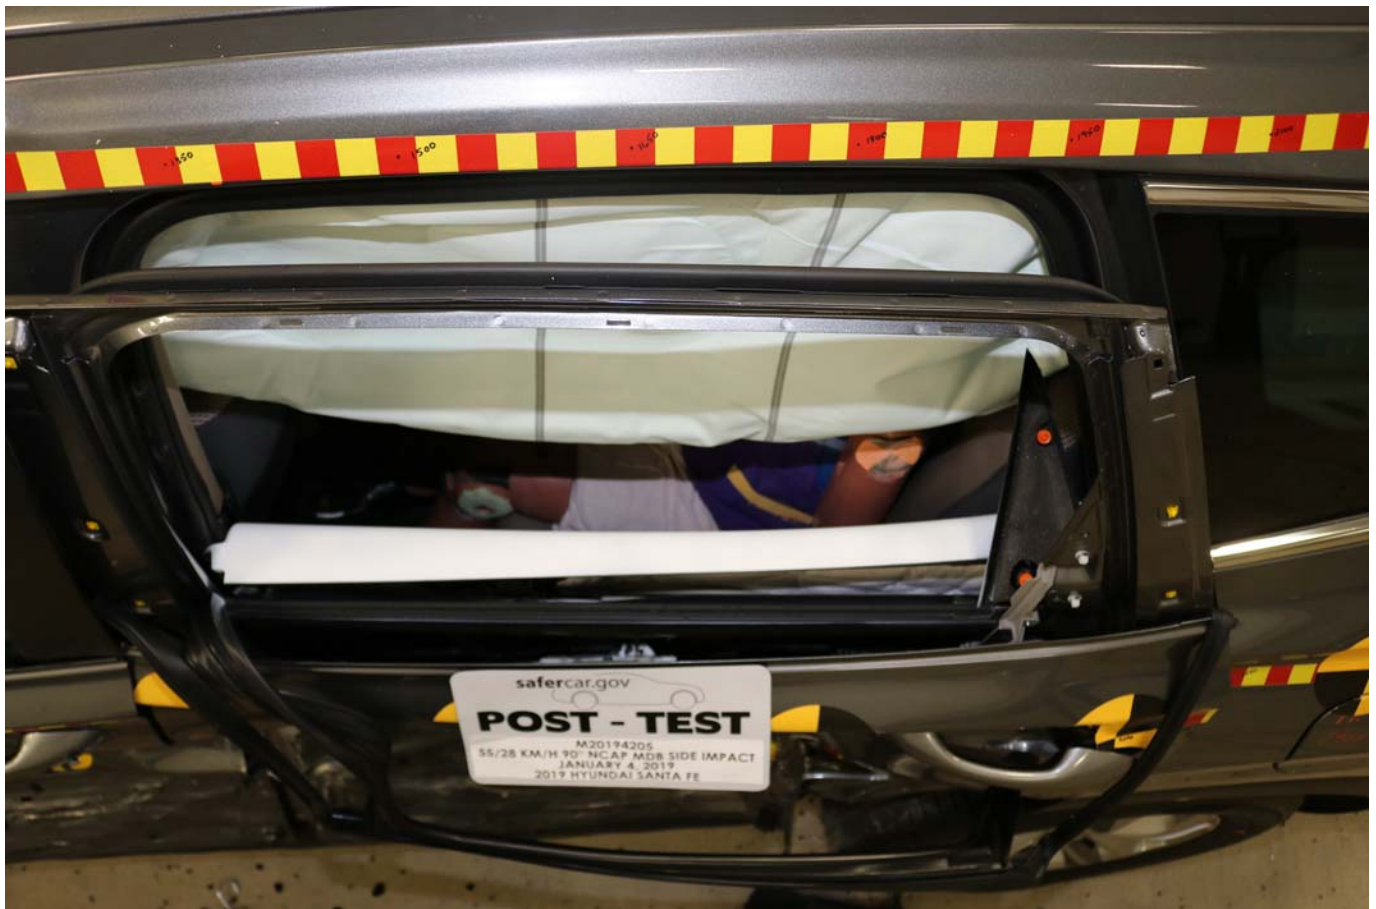
Photo No. 070 - Post-Test Rear Passenger Dummy and Door Clearance View

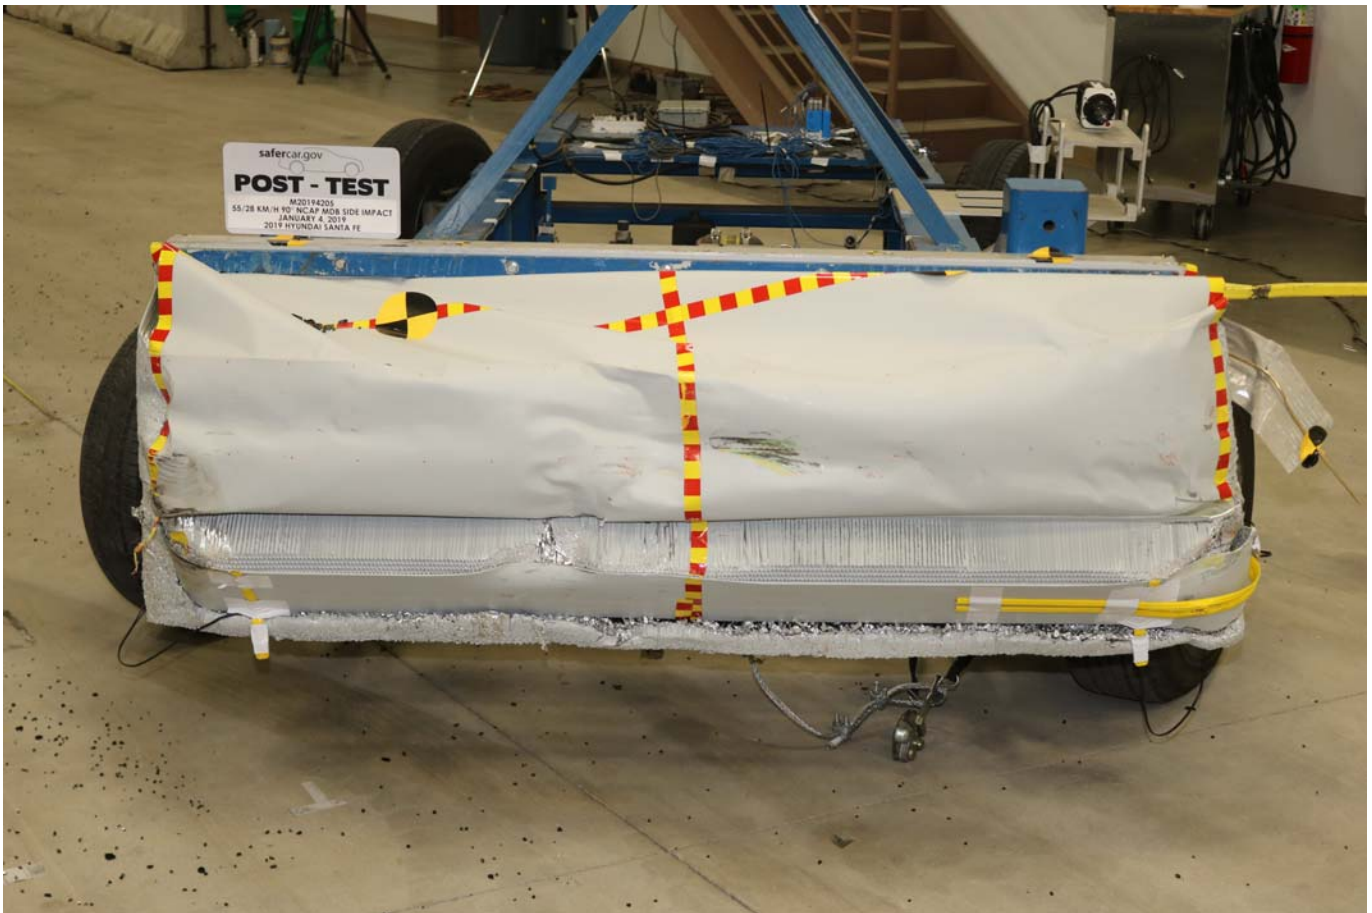
Photo No. 085 - Post-Test Front View of MDB Impactor Face

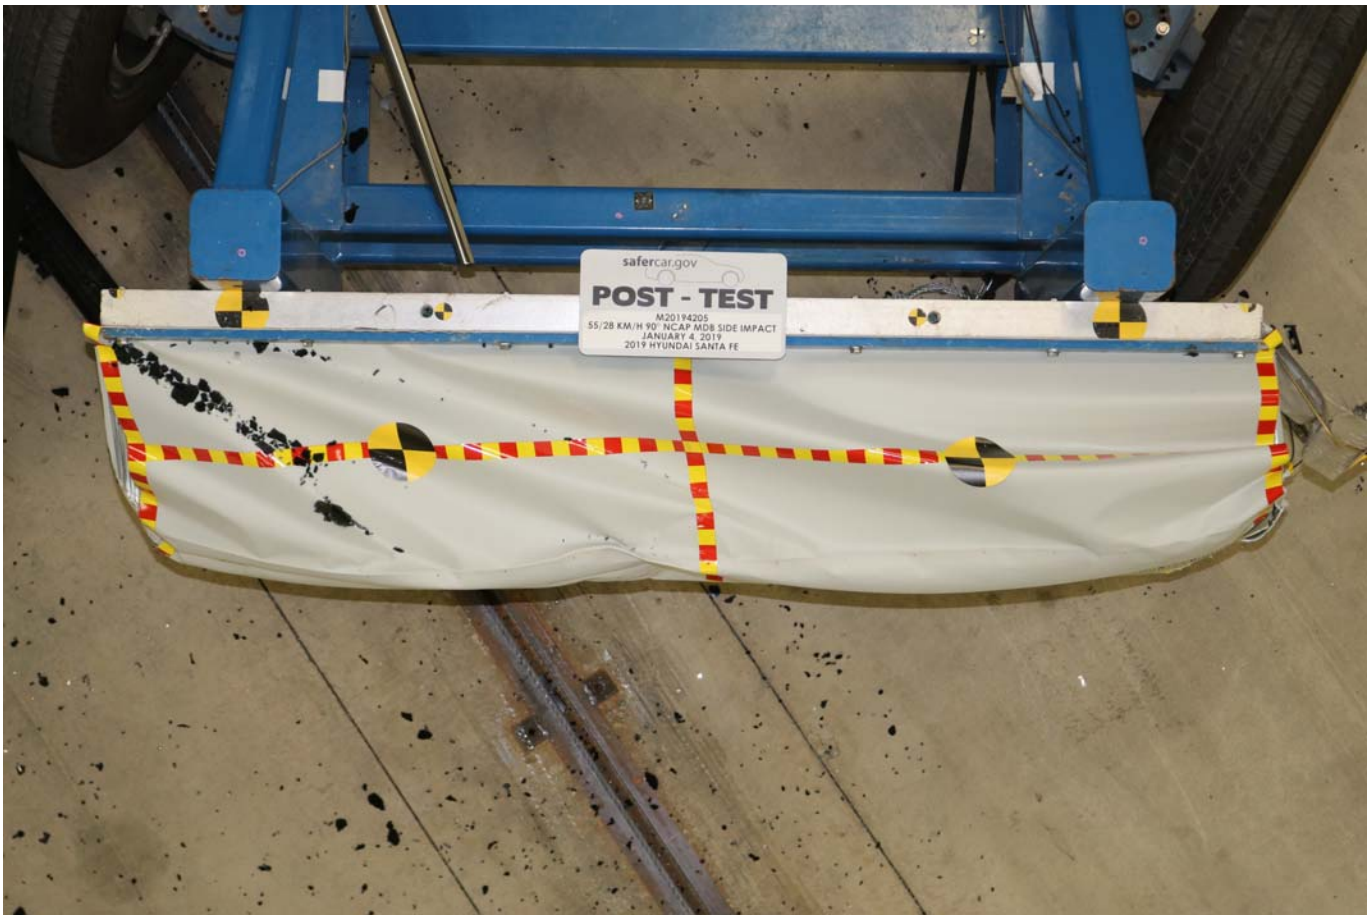
Photo No. 087 - Post-Test Top View of MDB Impactor Face

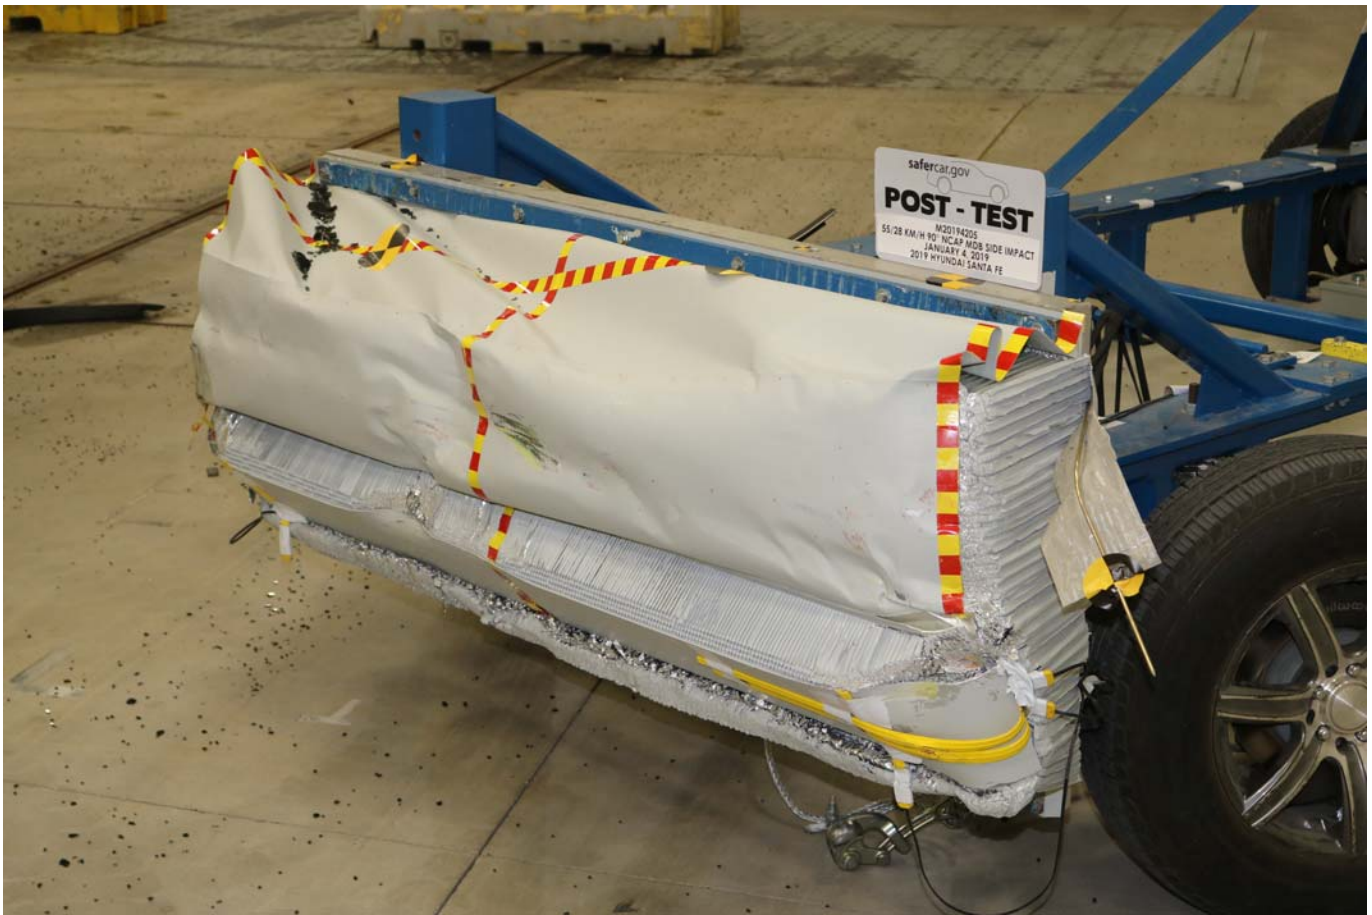
Photo No. 089 - Post-Test Left Side View of MDB Impactor Face

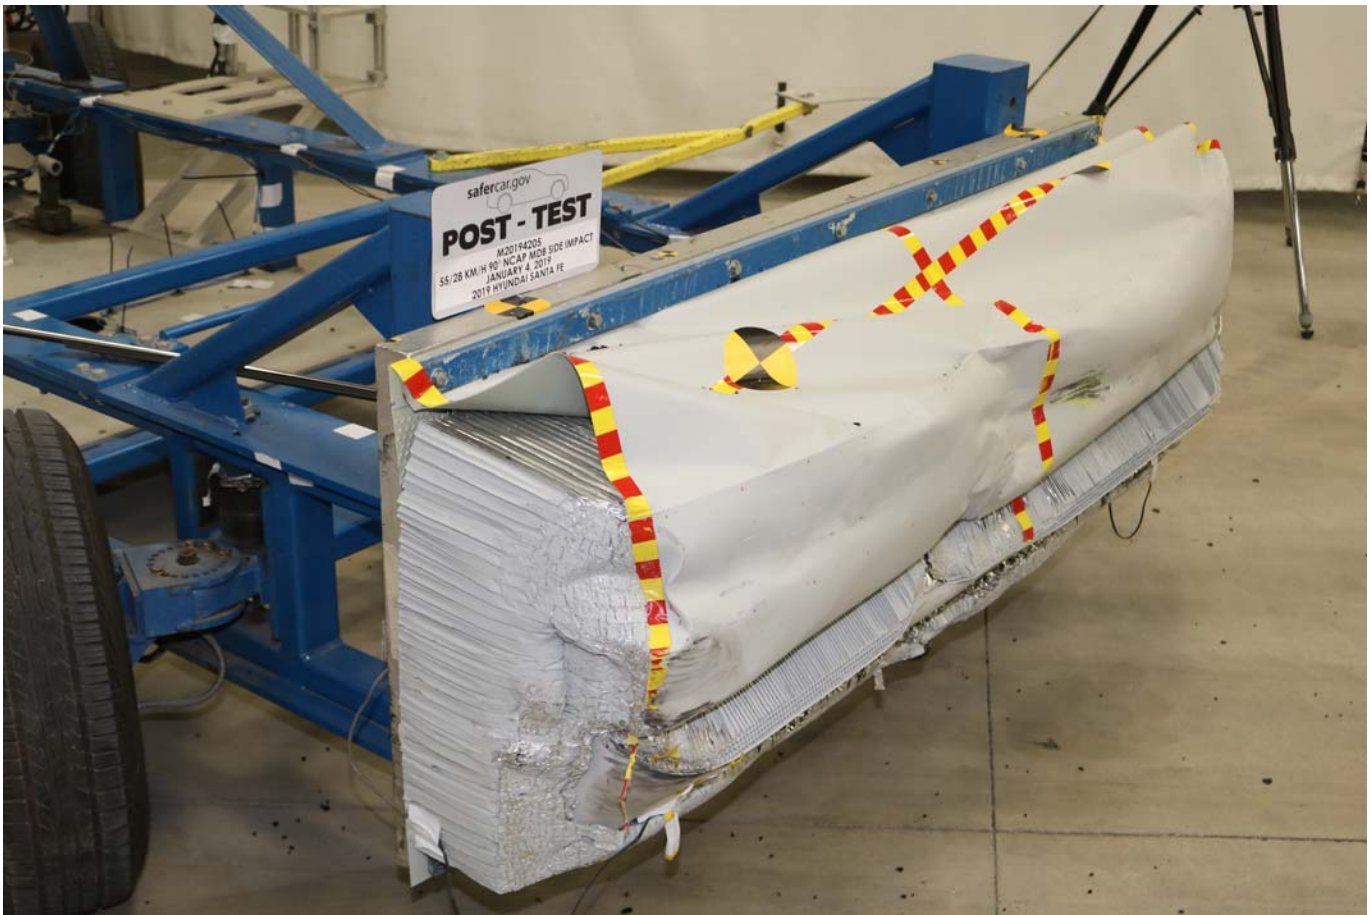
Photo No. 091 - Post-Test Right Side View of MDB Impactor Face

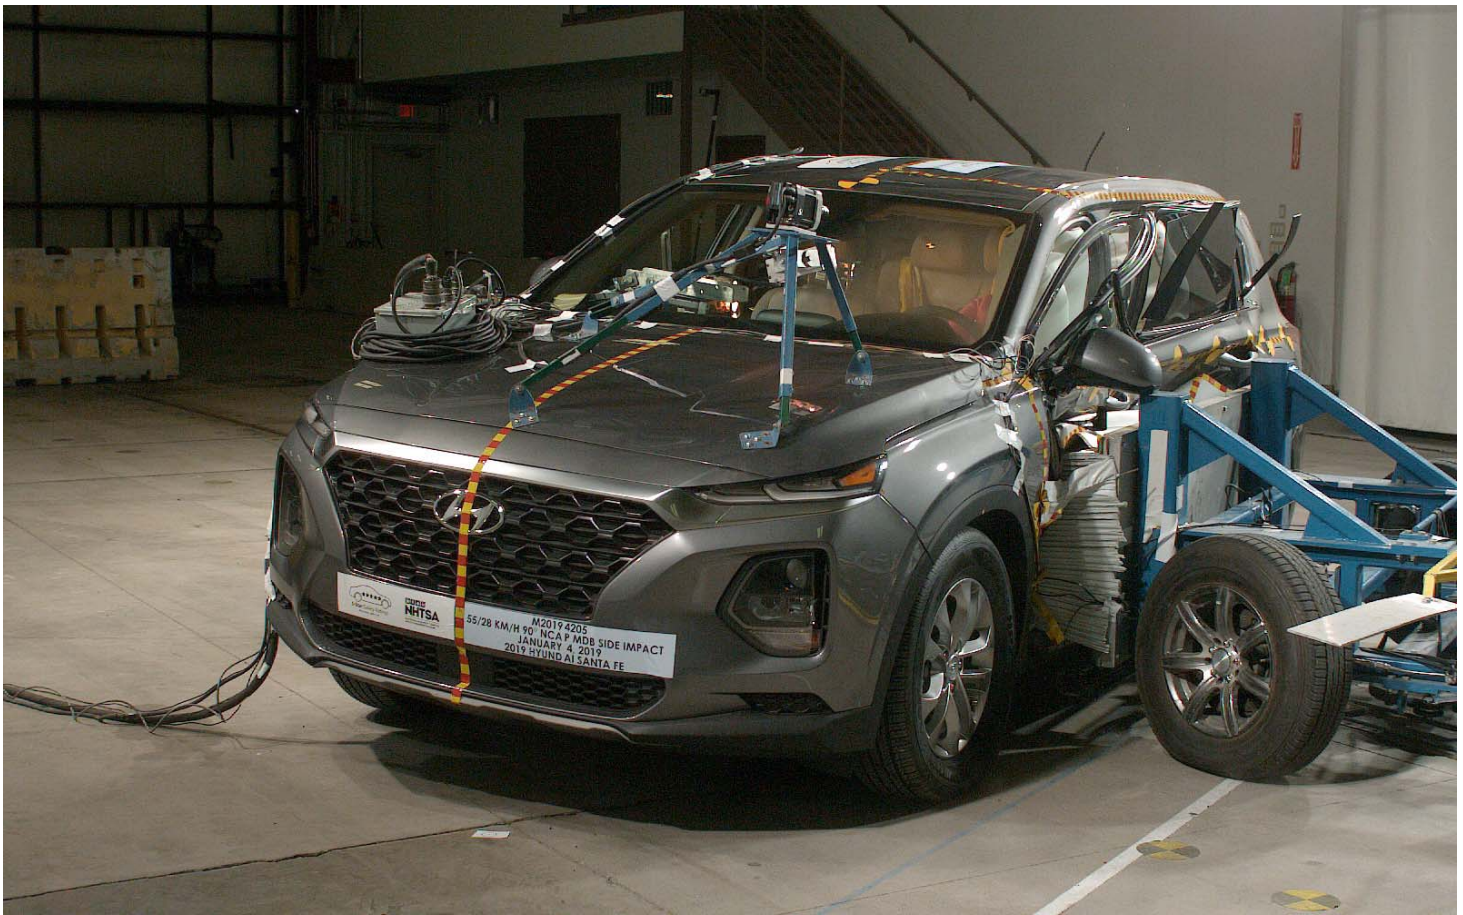
Photo No. 101 - Impact Event
