**REPORT NUMBER: SINCAP-MGA-2019-016**

**NEW CAR ASSESSMENT PROGRAM (NCAP)  
Moving Deformable Barrier Side Impact Test**

**TOYOTA MOTOR CORPORATION  
2019 Toyota Corolla Hatchback SE 5-Door Hatchback  
NHTSA No.: O20195102**

**FINAL REPORT**

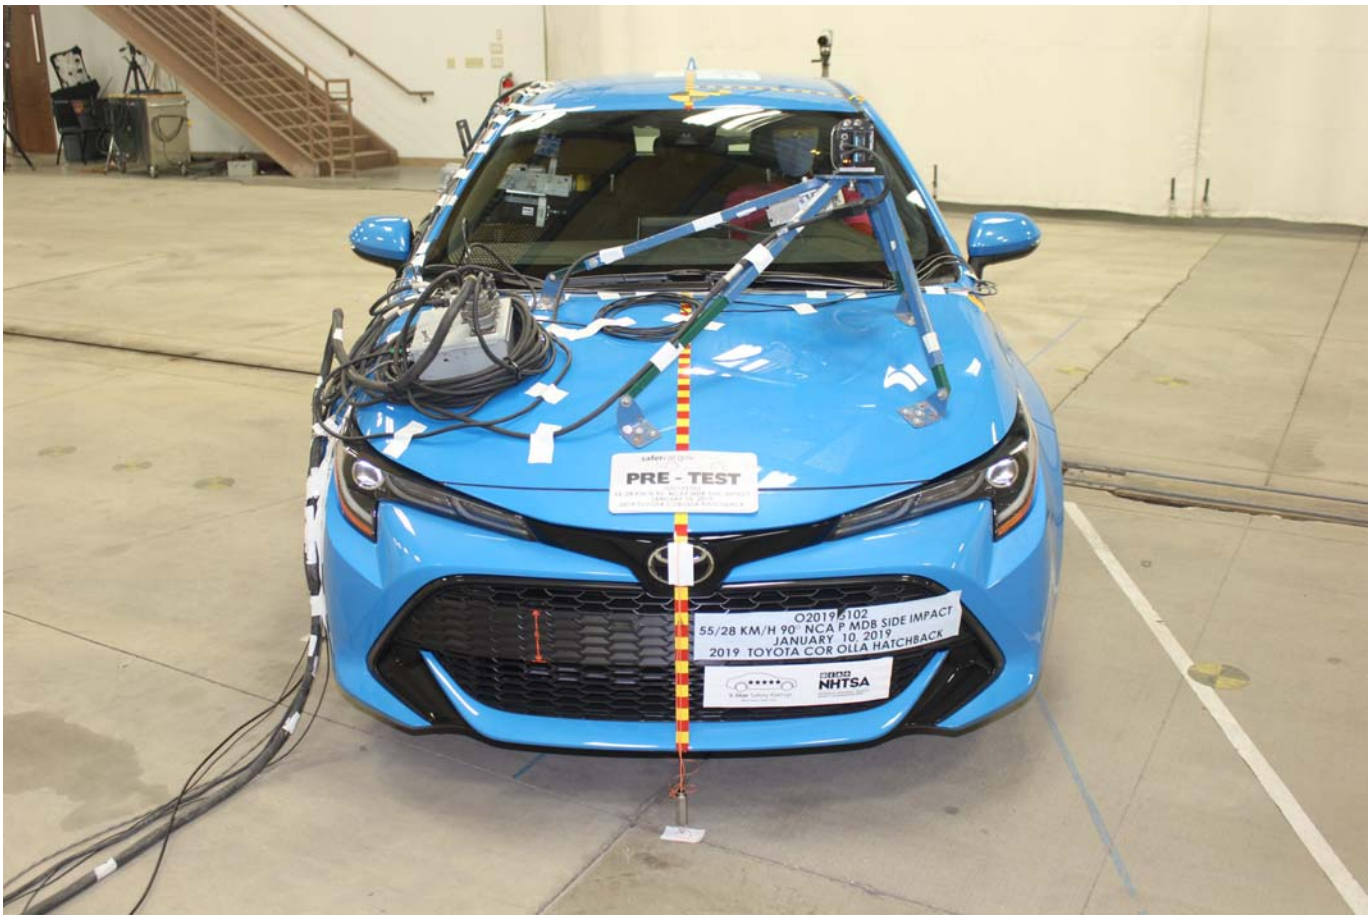
Photo No. 004 - Post-Test Frontal View of Test Vehicle

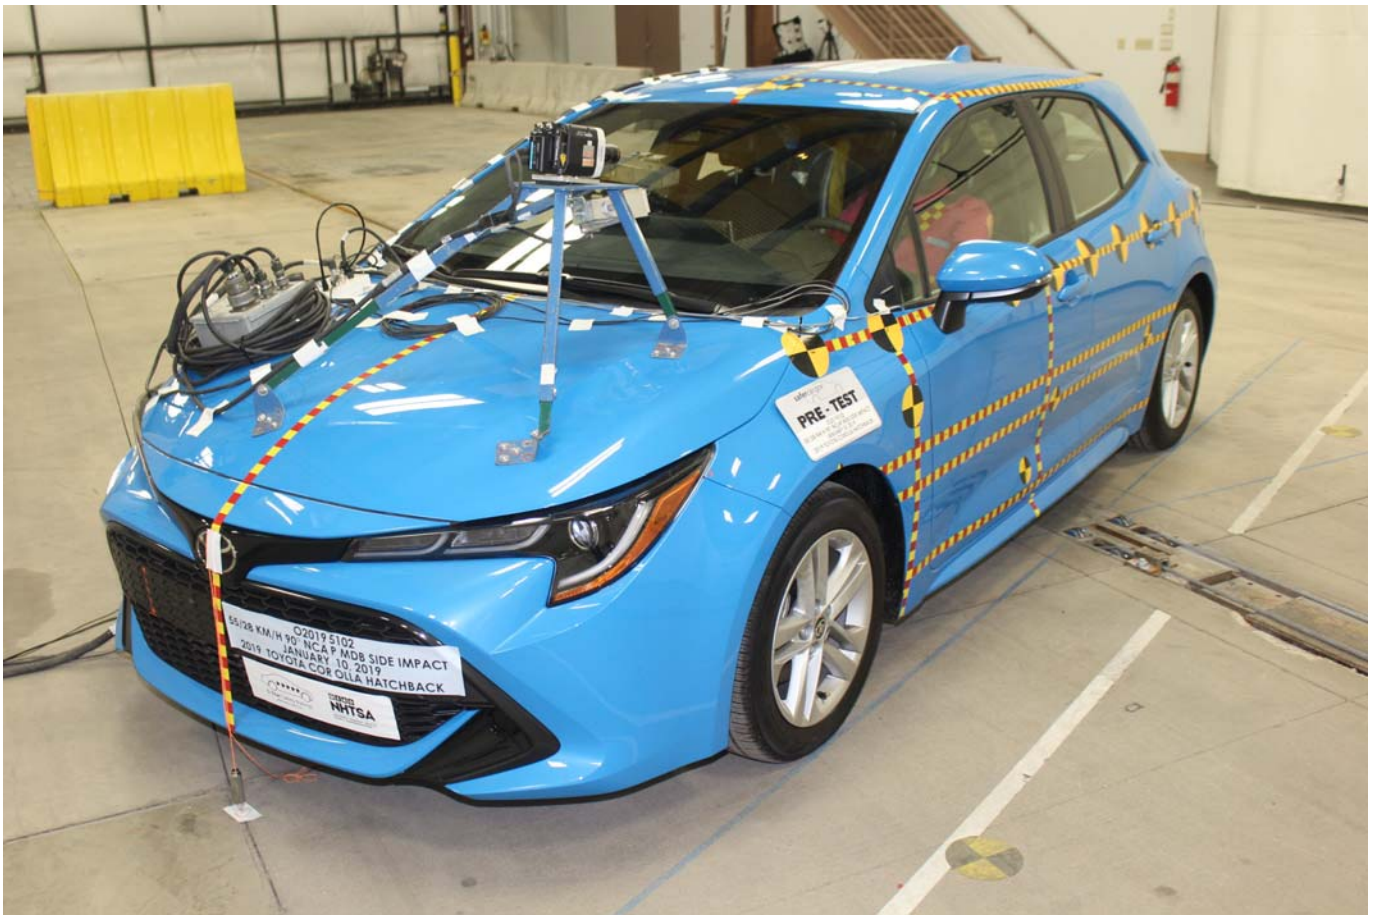
Photo No. 006 - Post-Test Left Front Three-Quarter View of Test Vehicle

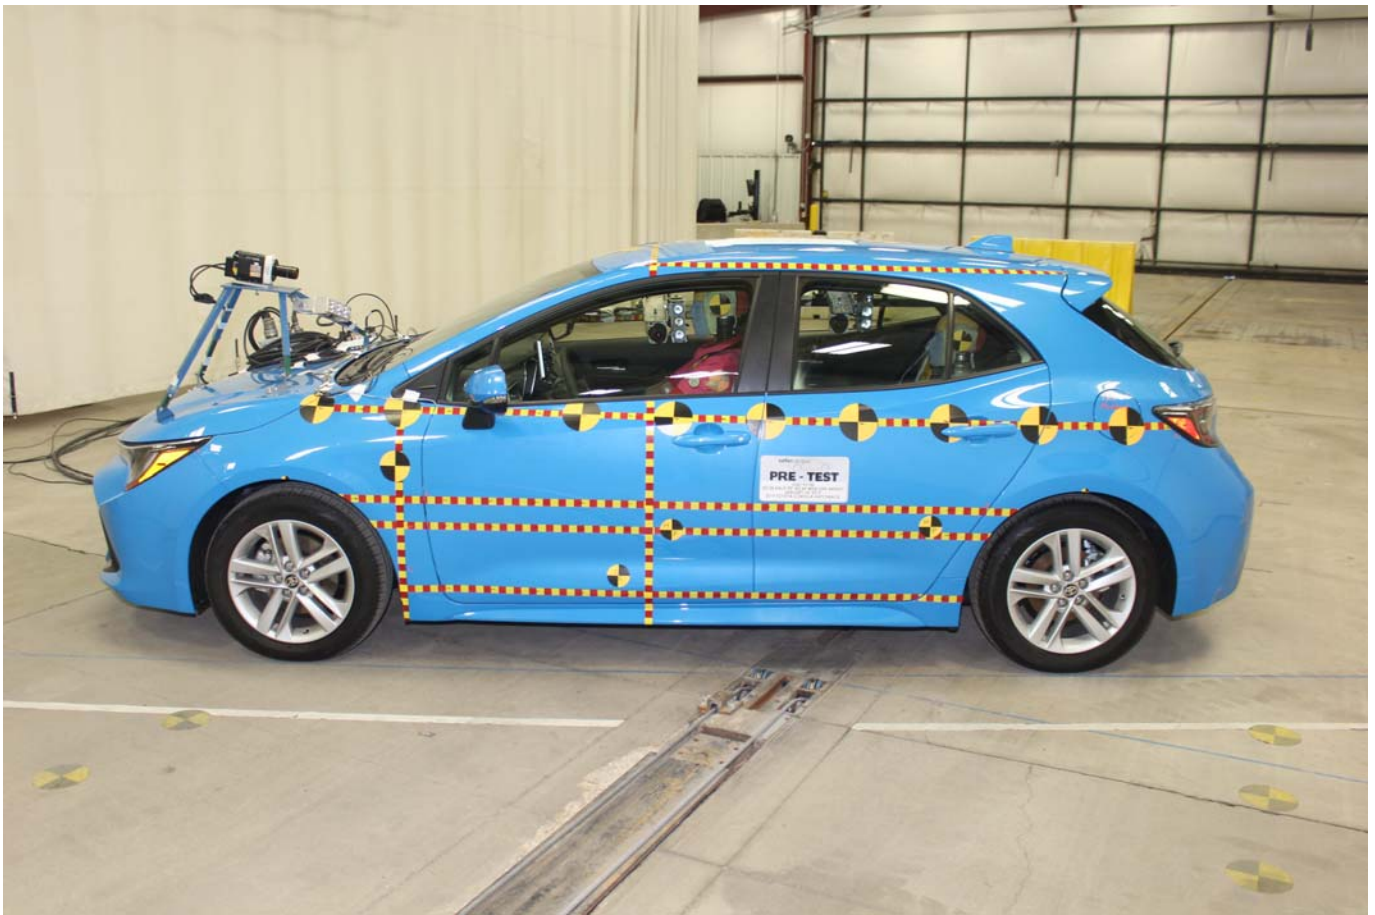
Photo No. 008 - Post-Test Left Side View of Test Vehicle

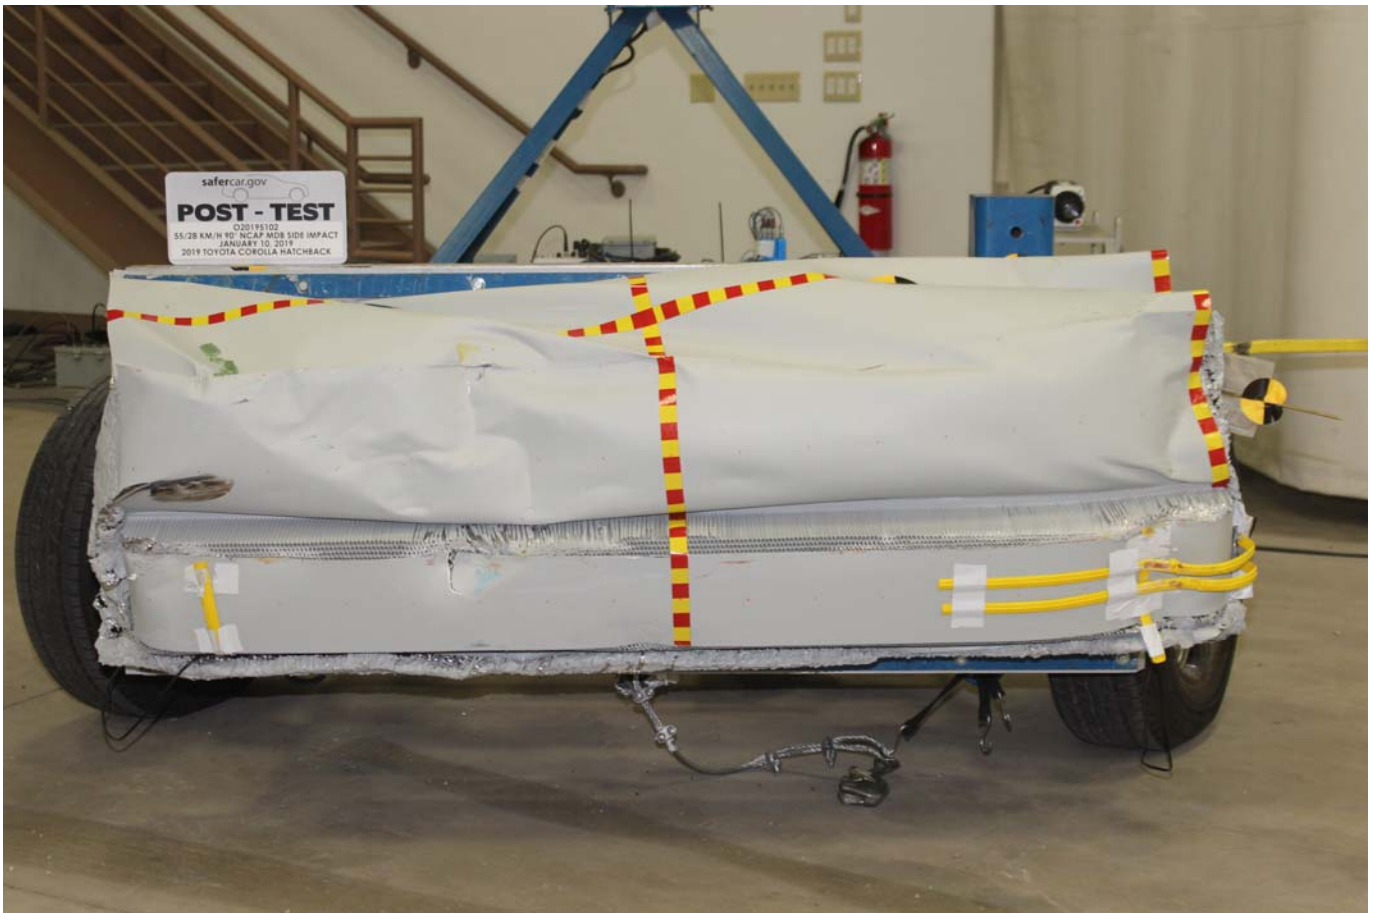
Photo No. 085 - Post-Test Front View of MDB Impactor Face

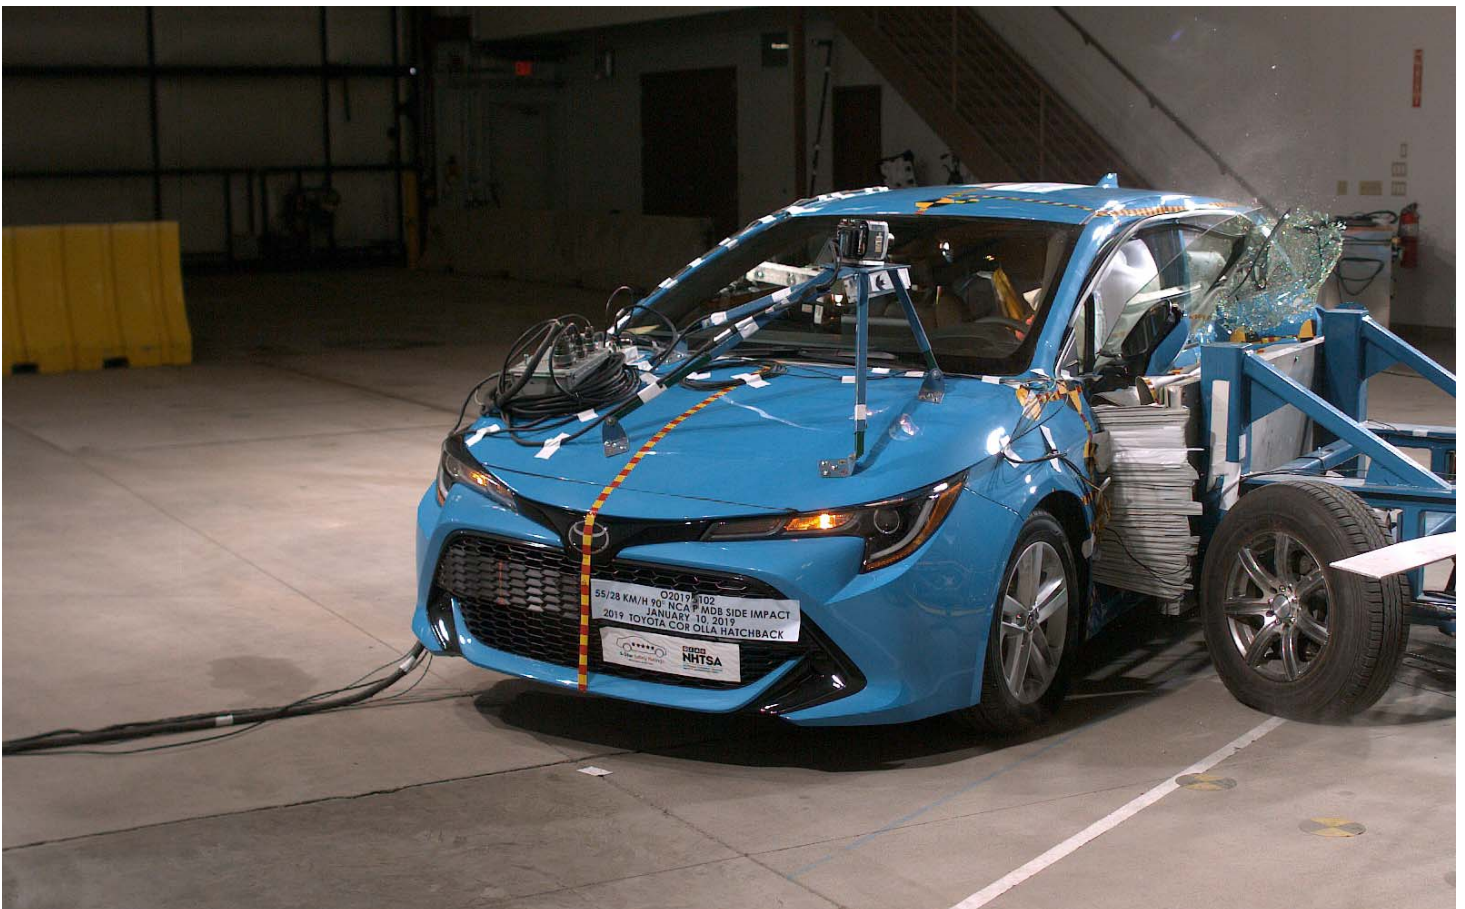
Photo No. 101 - Impact Event
