REPORT NUMBER: SPNCAP-CAL-19-001

**NEW CAR ASSESSMENT PROGRAM (NCAP)
SIDE IMPACT POLE TEST**

**Ford Motor Co.
2019 Ford Edge
SUV**

NHTSA No: M20190201

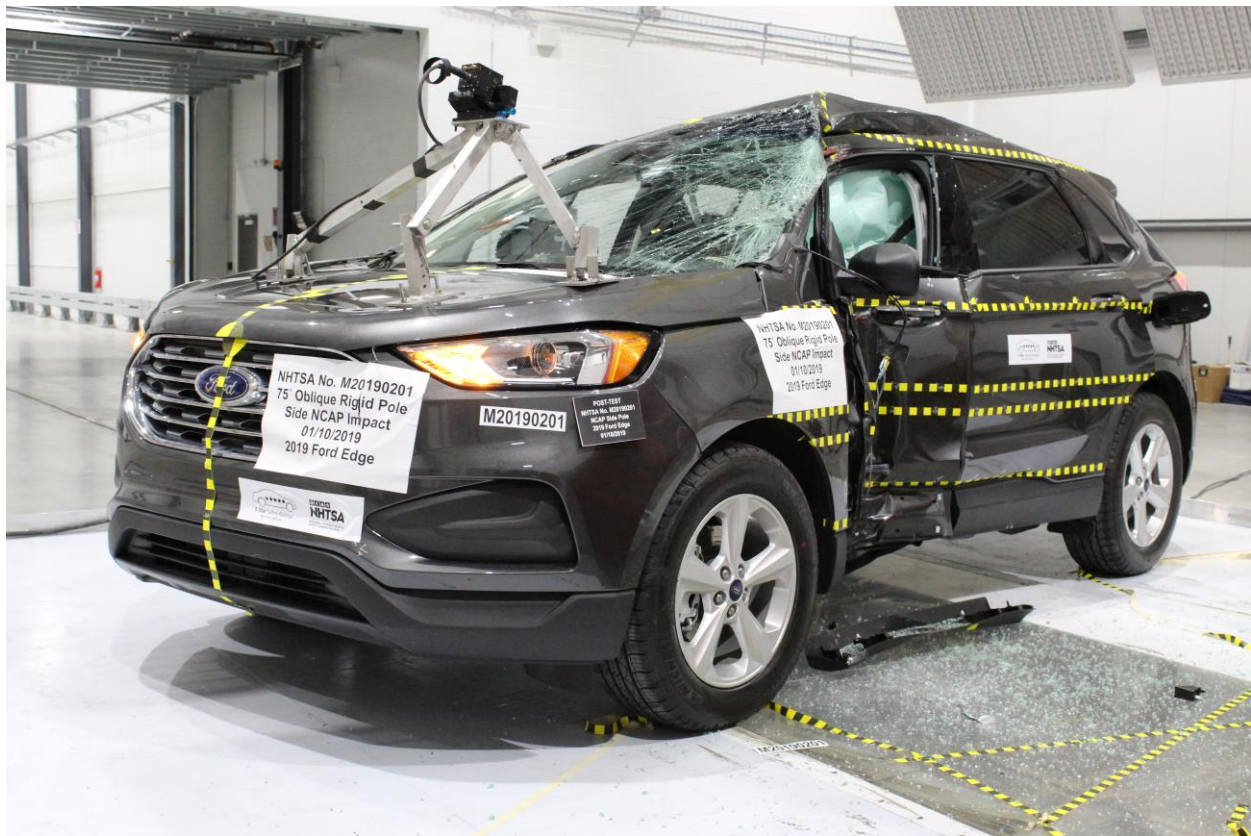
Figure A-6: Post-Test Left Front ¾ View of Test Vehicle

Critical Areas of Performance	Observations and Conclusions
Pillar Performance	A-Pillar Buckled
Sill Separation	None
Windshield Damage	Cracks throughout with separation along Driver A-Pillar
Side Window Damage	Driver window shattered
Other Notable Effects	None

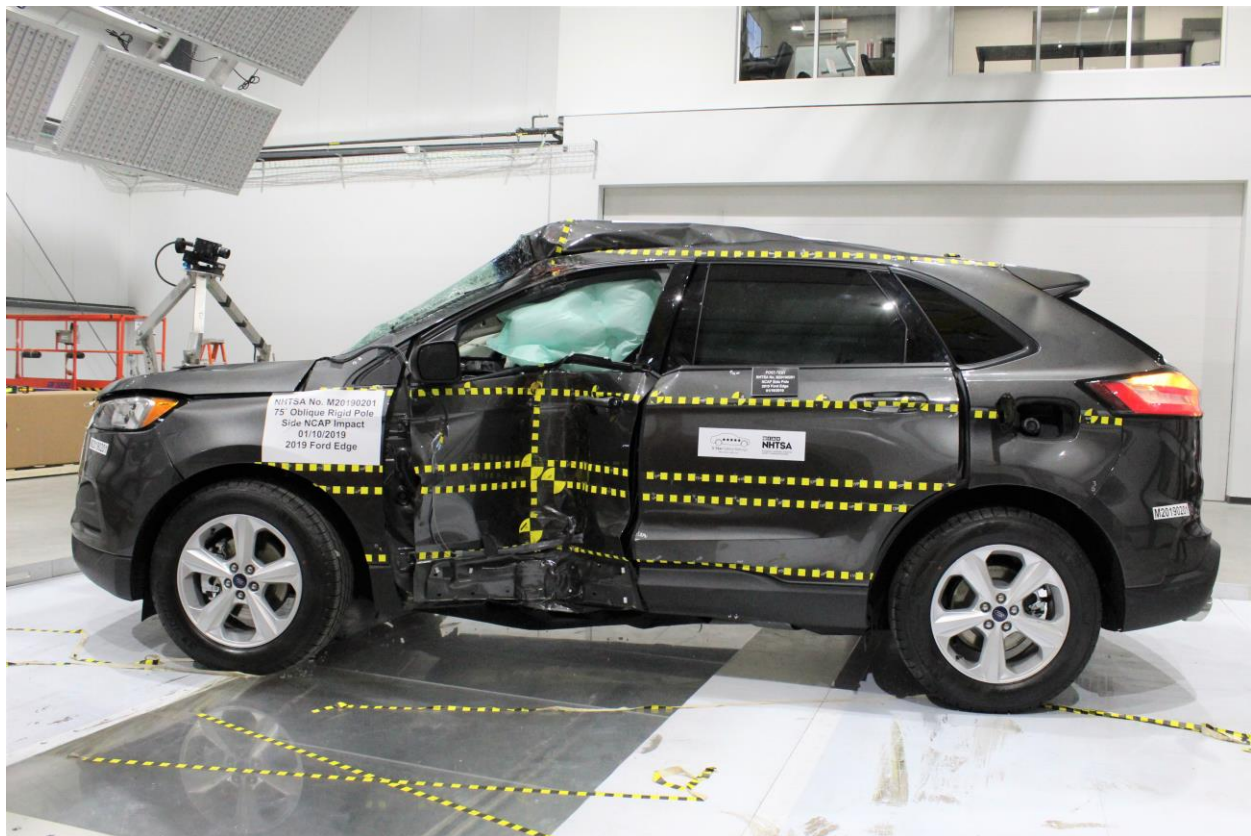
Figure A-8: Post-Test Left Side View of Test Vehicle

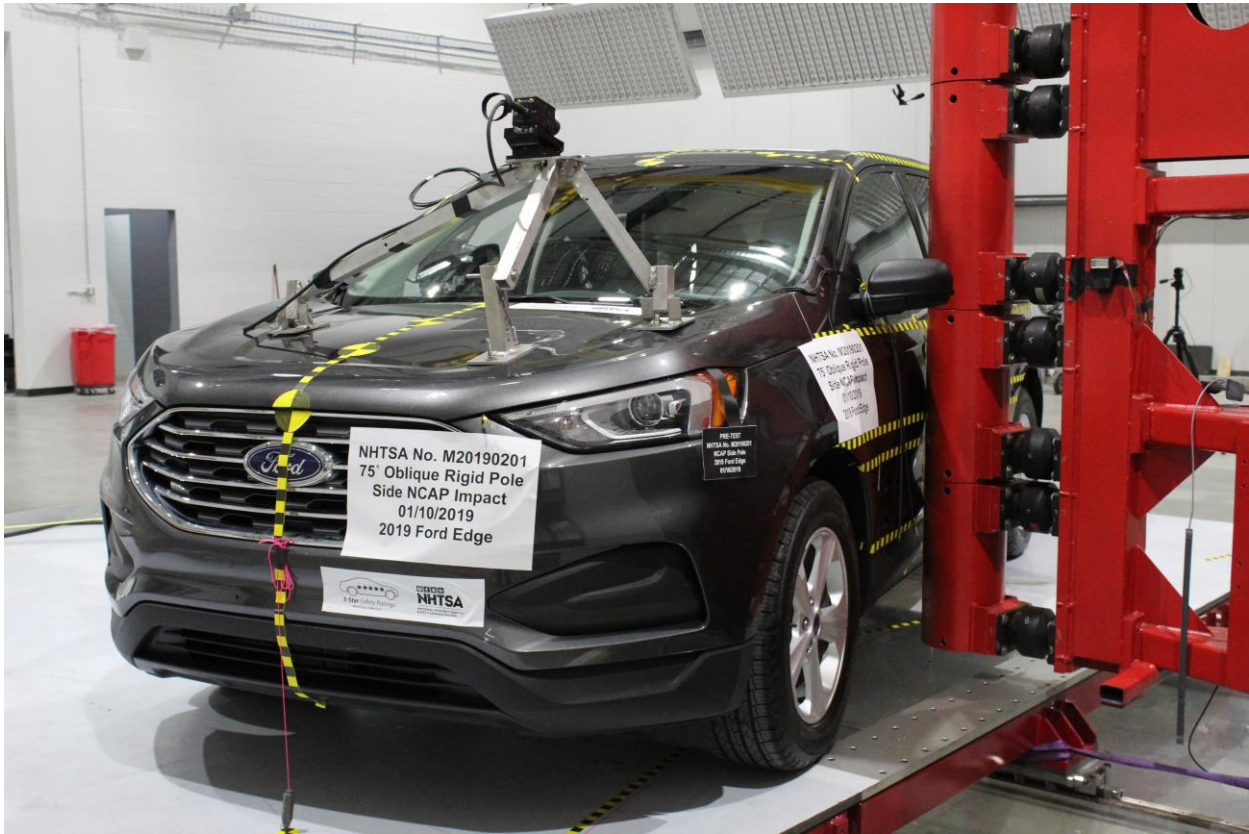
Figure A-17: Pre-Test Left Side View of Pole Positioned Against Side of Vehicle

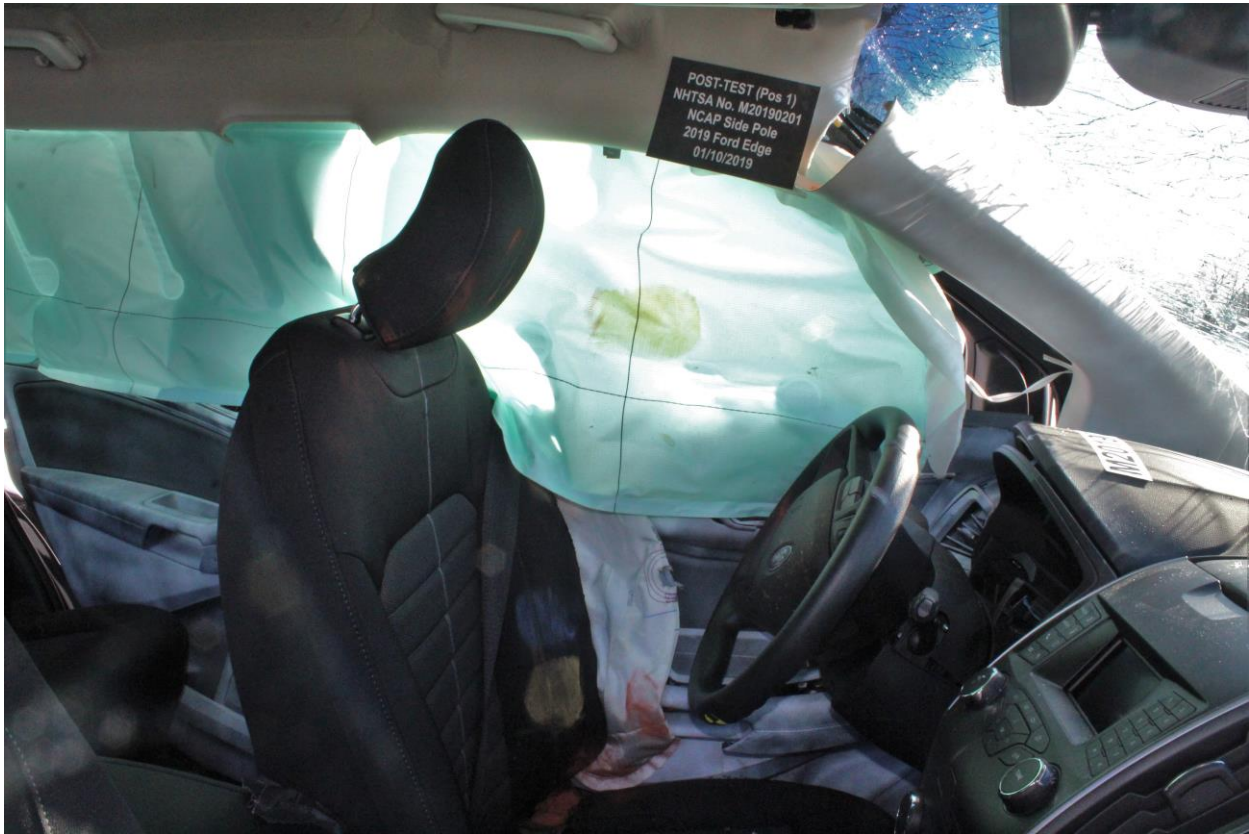
Figure A-45: Post-Test Inner Door Panel View Showing Dummy Contact Location

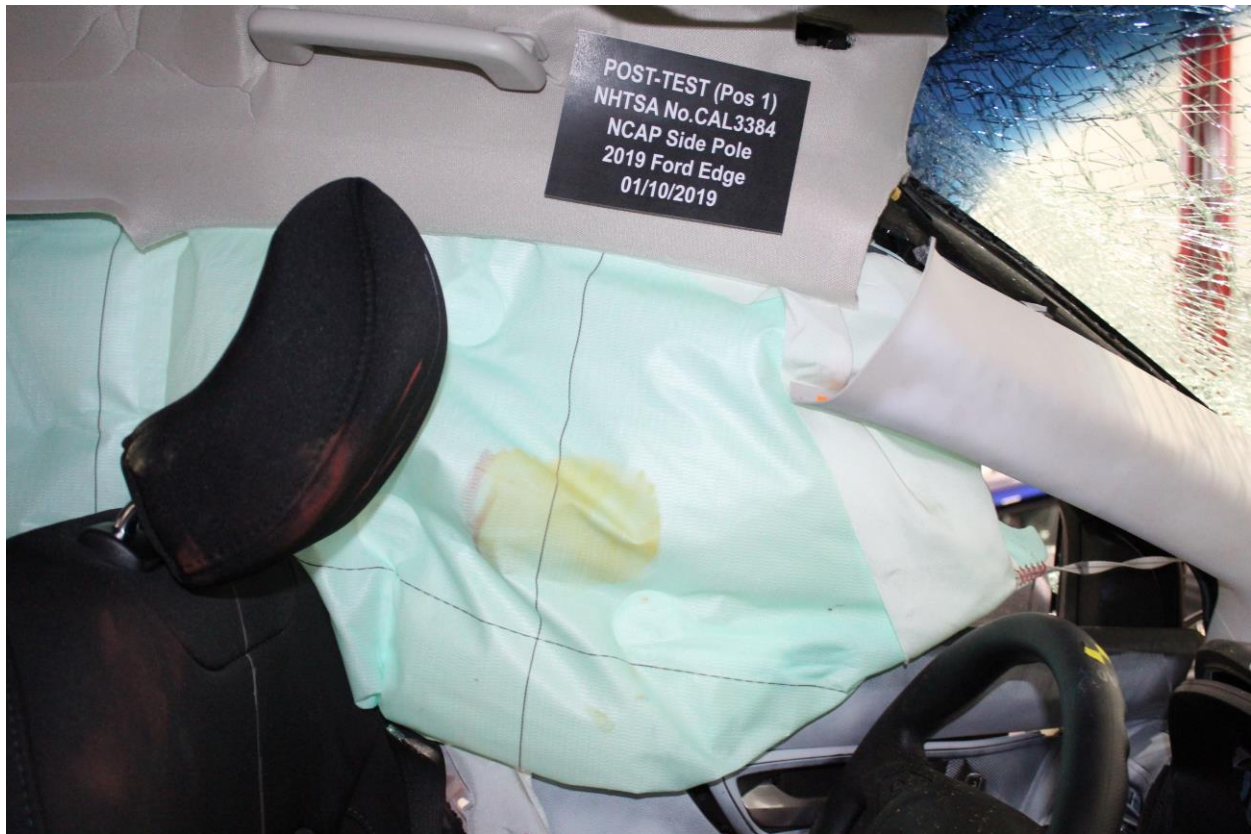
Figure A-47: Post-Test Dummy Close-Up Head Contact with Side Airbag View

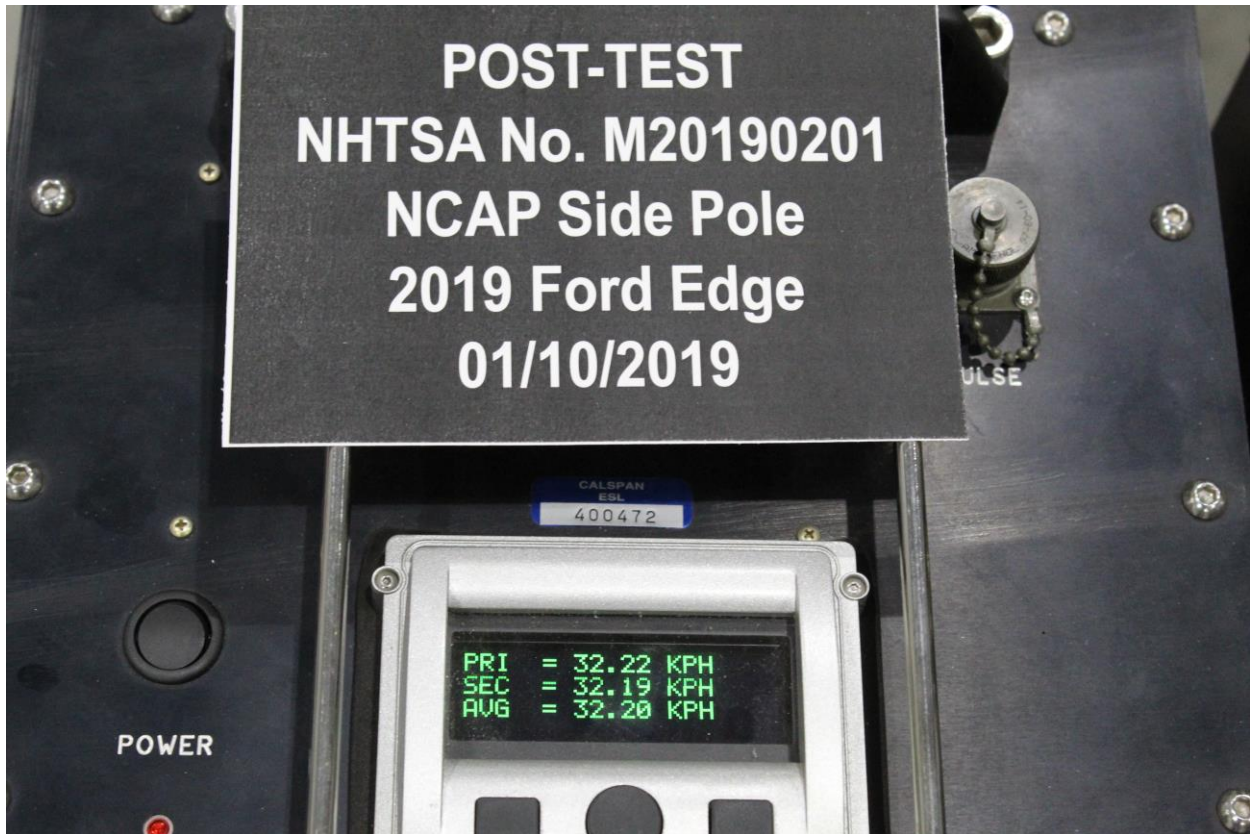
Figure A-62: Post-Test Primary and Redundant Speed Trap Read-Out

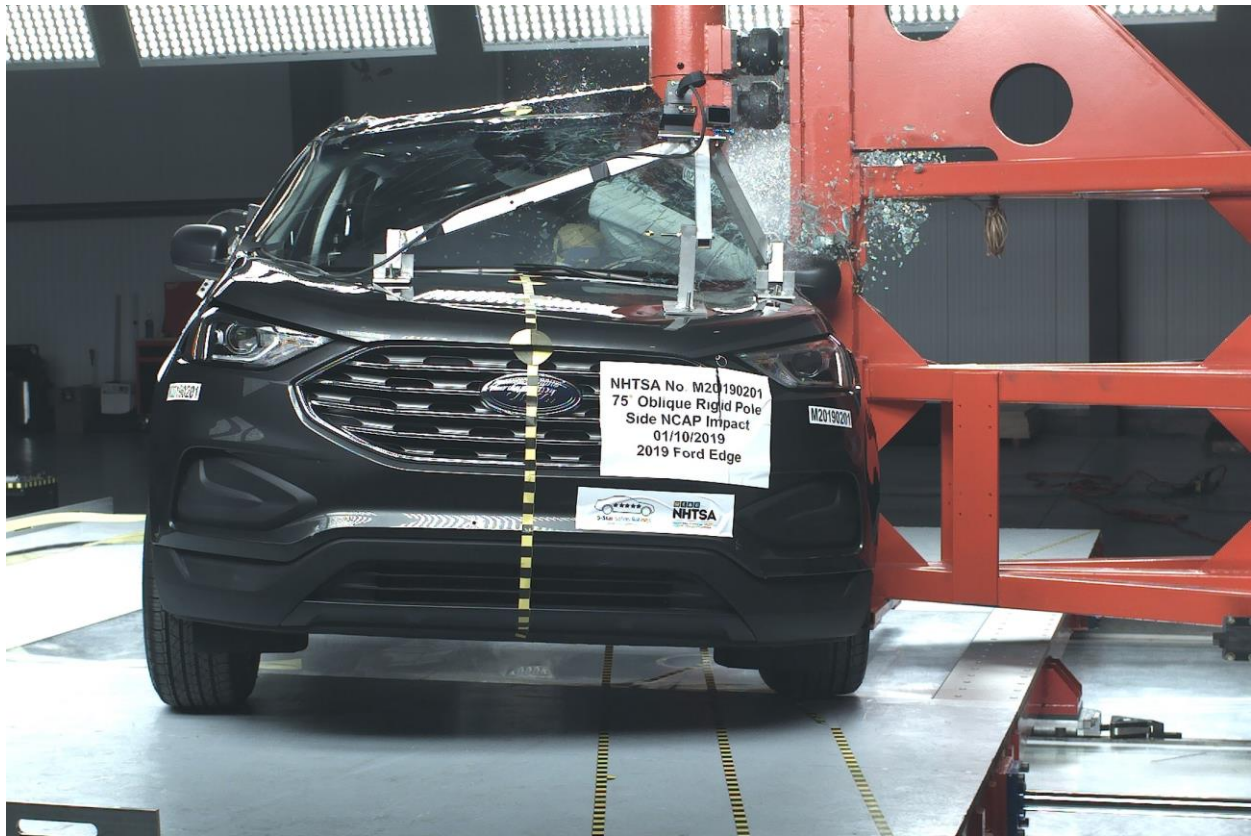
Figure A-68: Impact Event

A rigid pole side impact test was conducted on a 2019 Ford Edge SUV. The subject vehicle was towed into the rigid pole at an angle of 75° and a velocity of 32.22 km/h. The test was conducted by Calspan Corporation's Transportation Test Operations facility in Buffalo, New York on January 10, 2019. Pre-test and post-test photographs of the test vehicle and side impact dummy (SID-IIs) are included in Appendix A of this report.
