**REPORT NUMBER: SINCAP-CAL-19-002**

**NEW CAR ASSESSMENT PROGRAM (NCAP)  
MOVING DEFORMABLE BARRIER SIDE IMPACT TEST**

**Ford Motor Company  
2019 Ford Edge  
Four Door SUV**

**NHTSA No: M20190202**

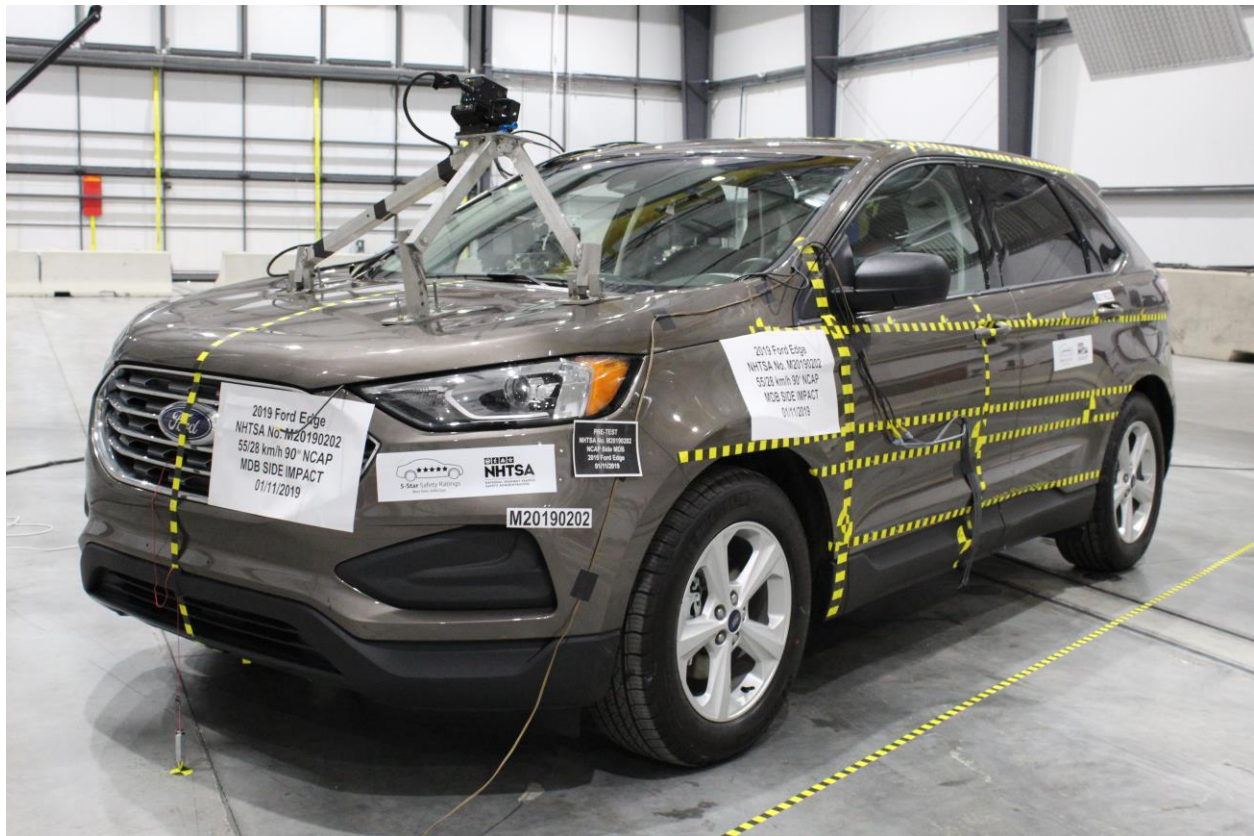
**Figure A-5: Pre-Test Left Front  $\frac{3}{4}$  View of Test Vehicle**

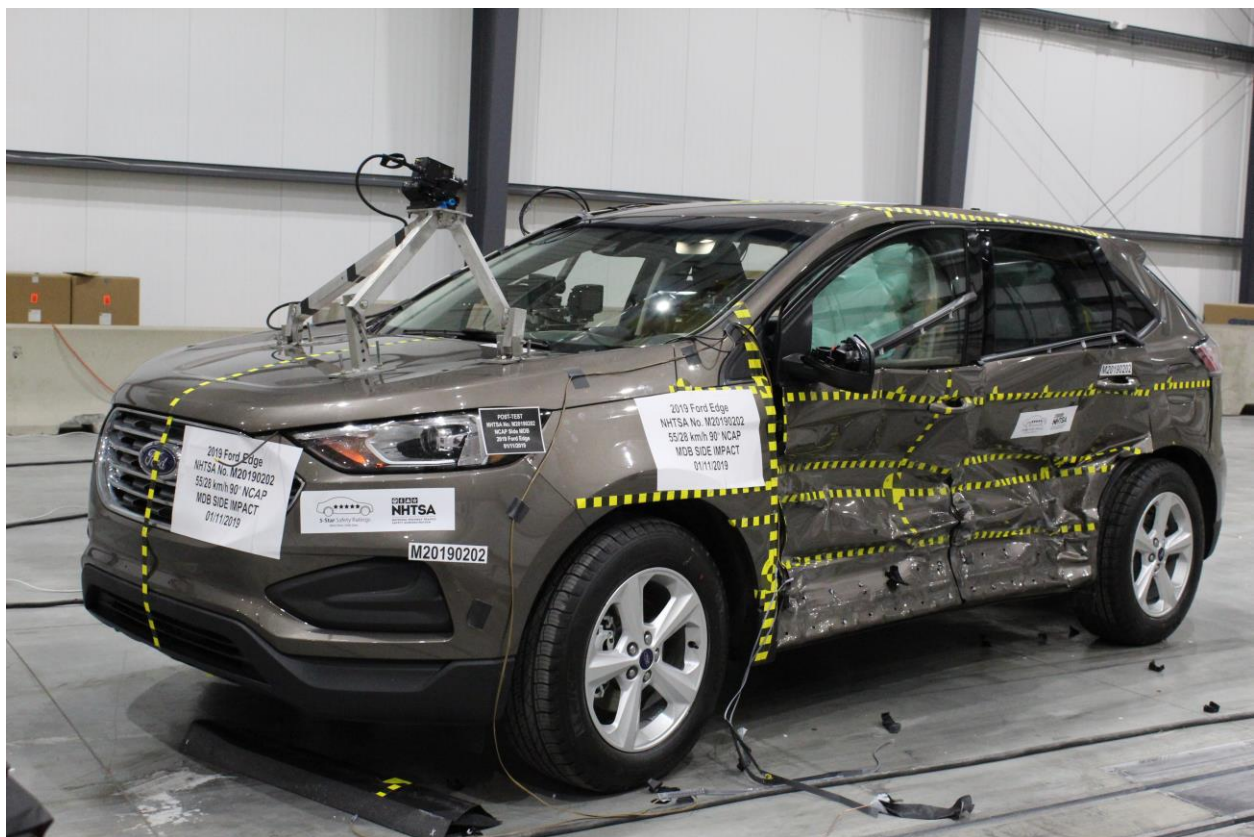
**Figure A-6: Post-Test Left Front  $\frac{3}{4}$  View of Test Vehicle**

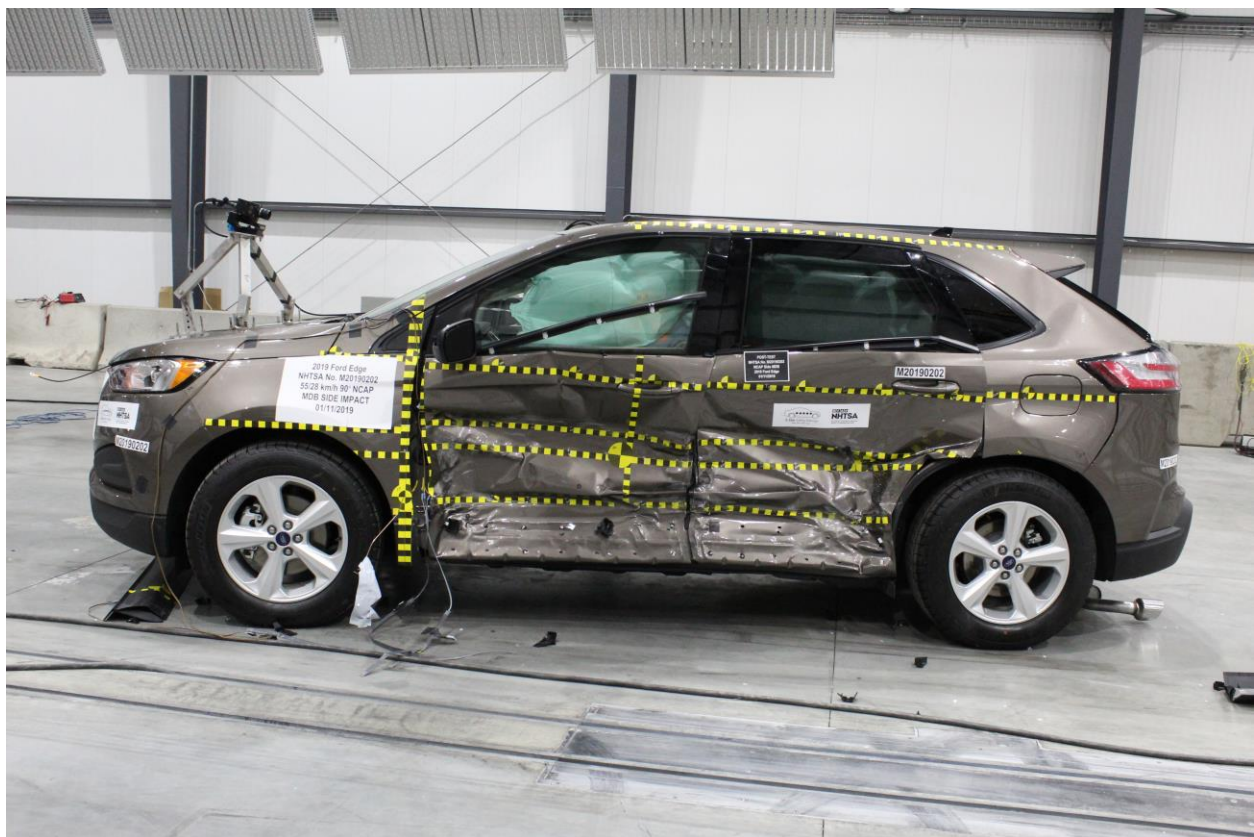
**Figure A-8: Post-Test Left Side View of Test Vehicle**

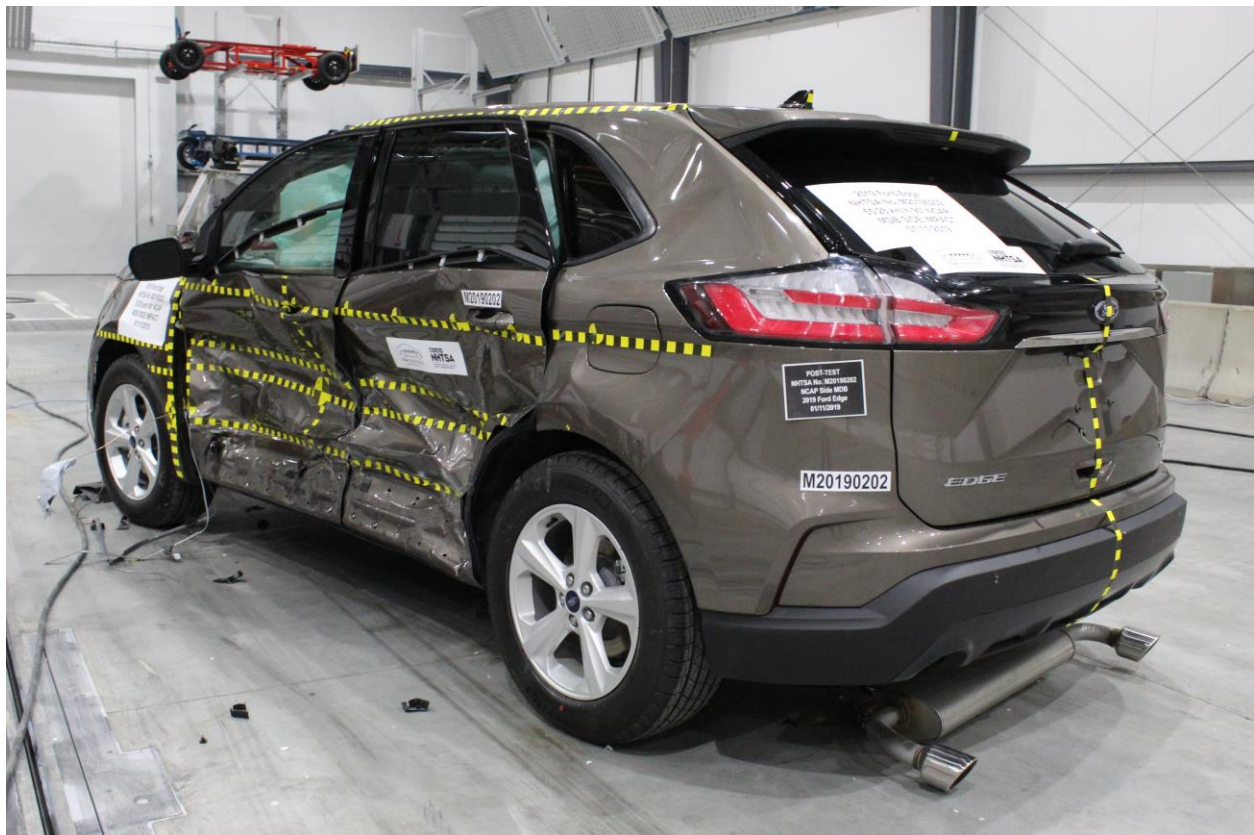
**Figure A-10: Post-Test Left Rear  $\frac{3}{4}$  View of Test Vehicle**

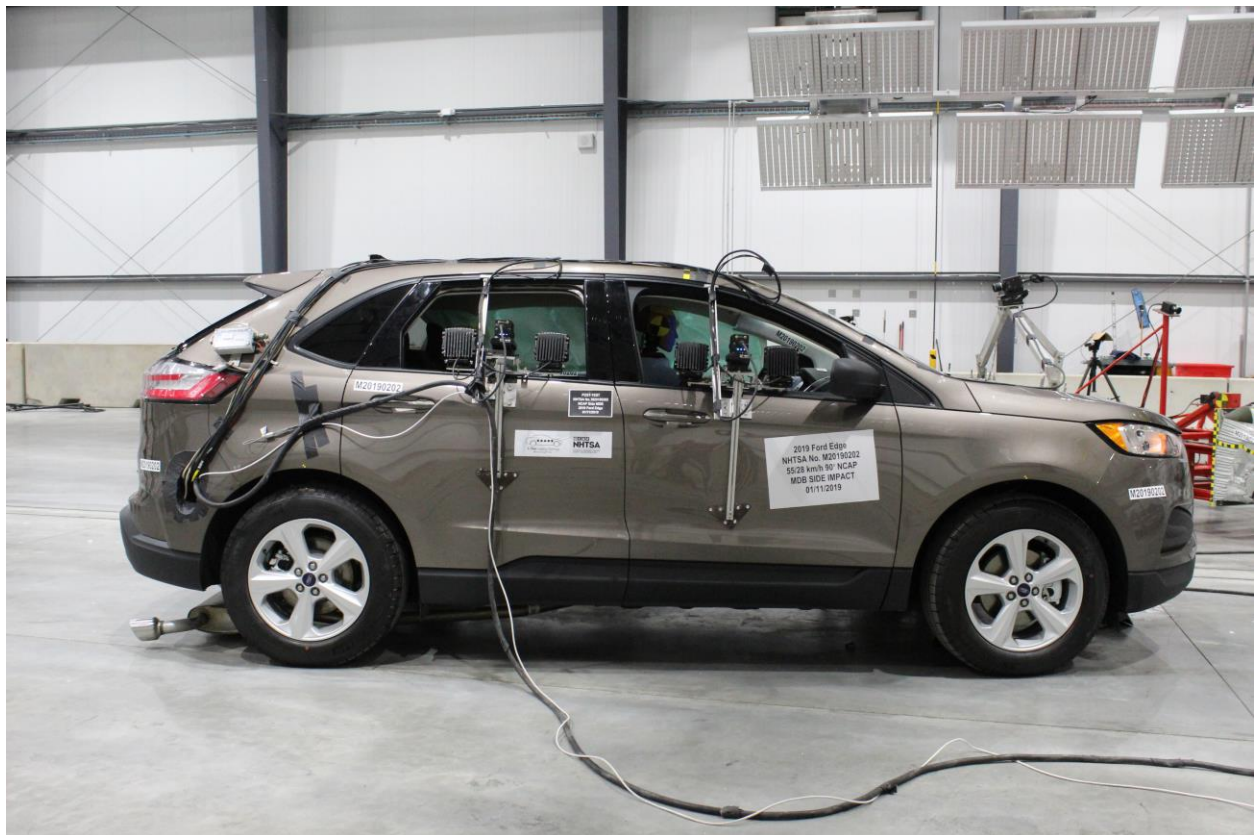
**Figure A-14: Post-Test Right Side View of Test Vehicle**

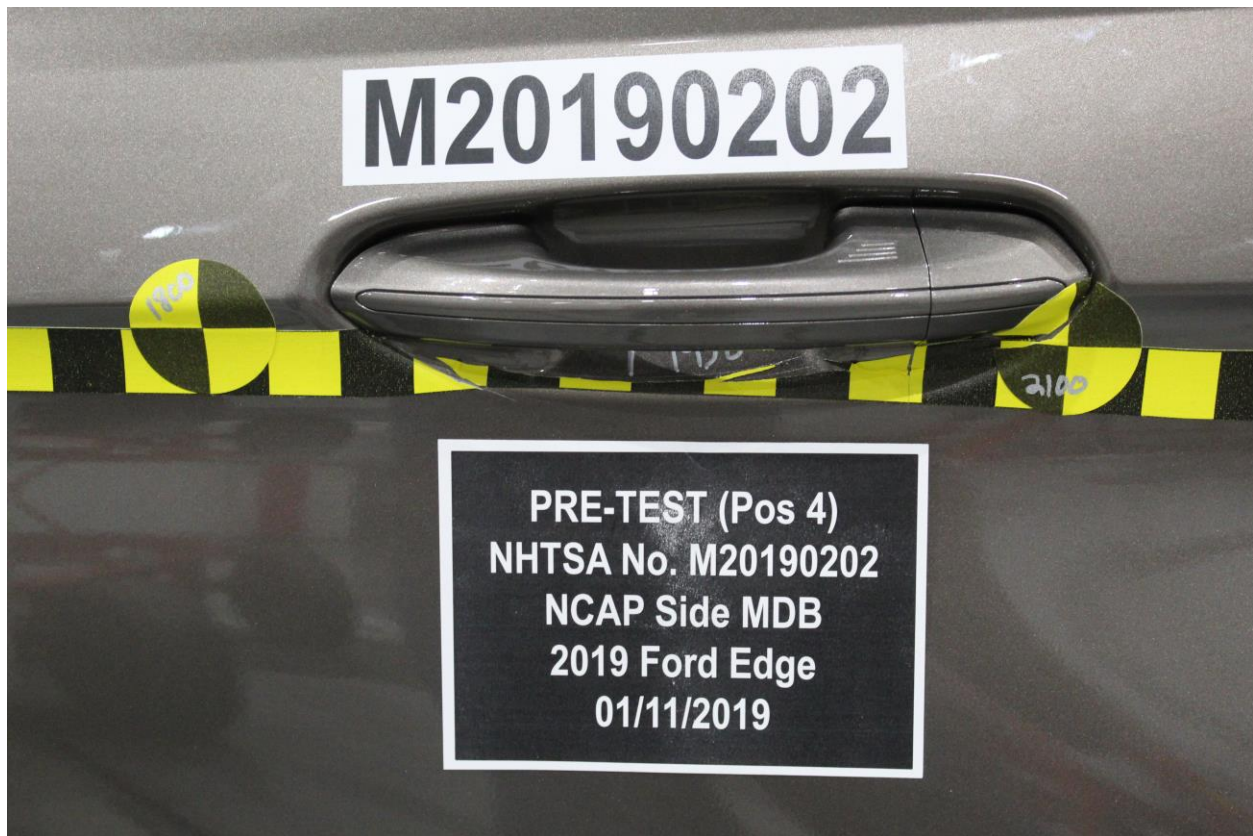
Figure A-23: Pre-Test Left Rear Door Latch Close-Up

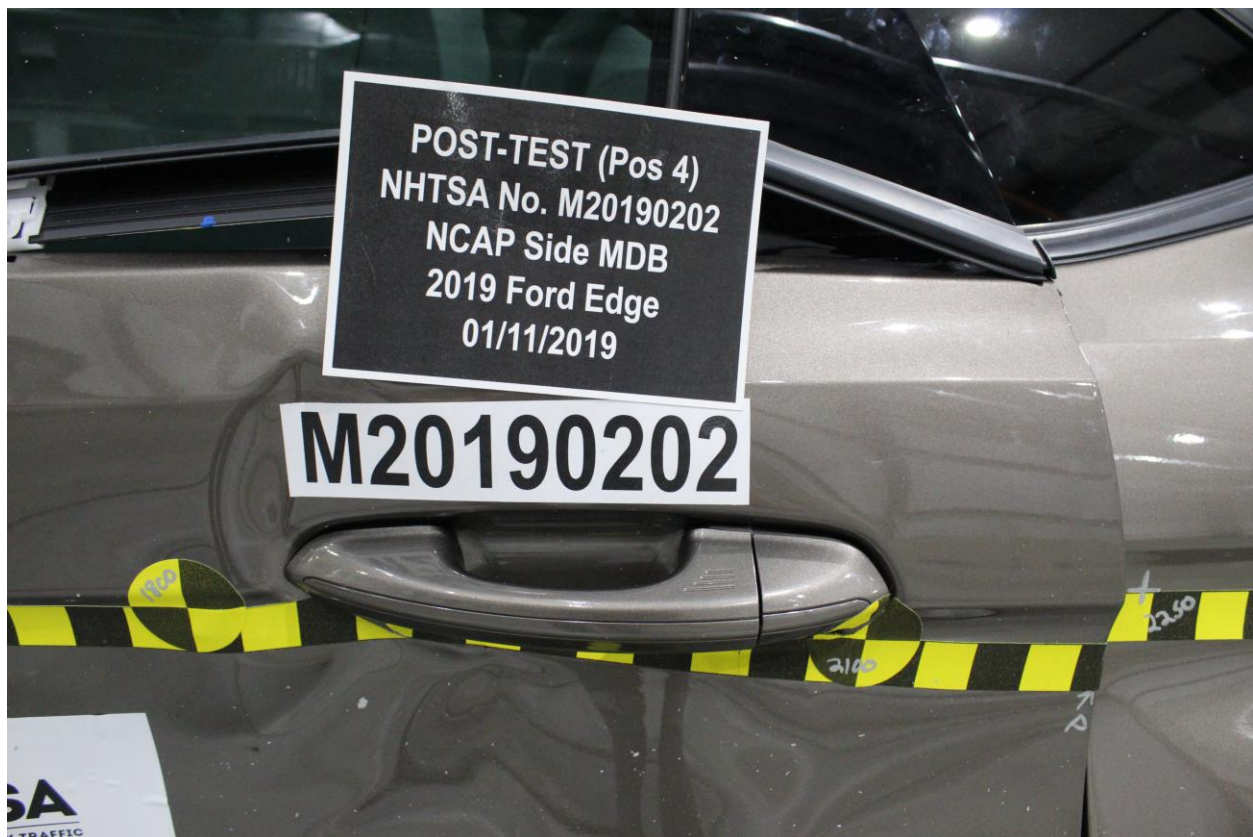
Figure A-24: Post-Test Left Rear Door Latch Close-Up

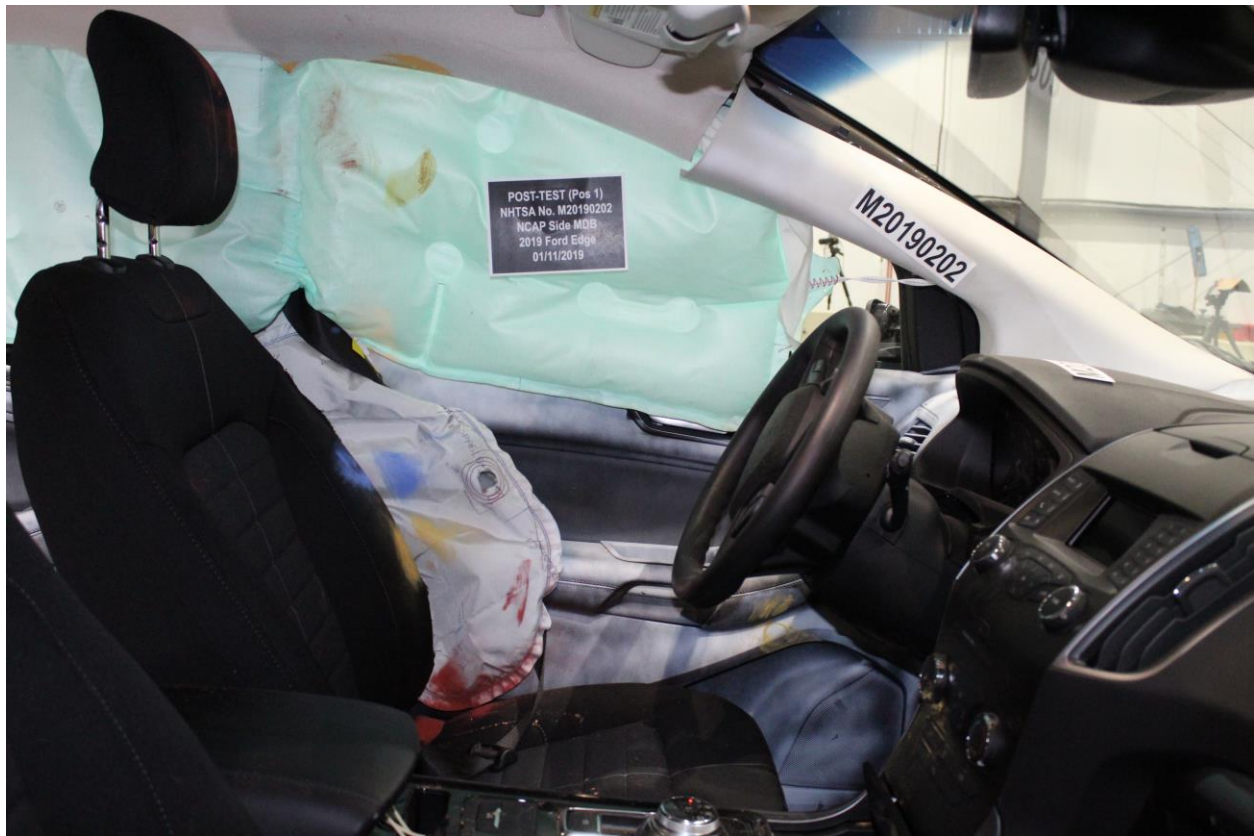
**Figure A-47: Post-Test Driver Inner Door Panel View Showing Driver Dummy Contact Locations**

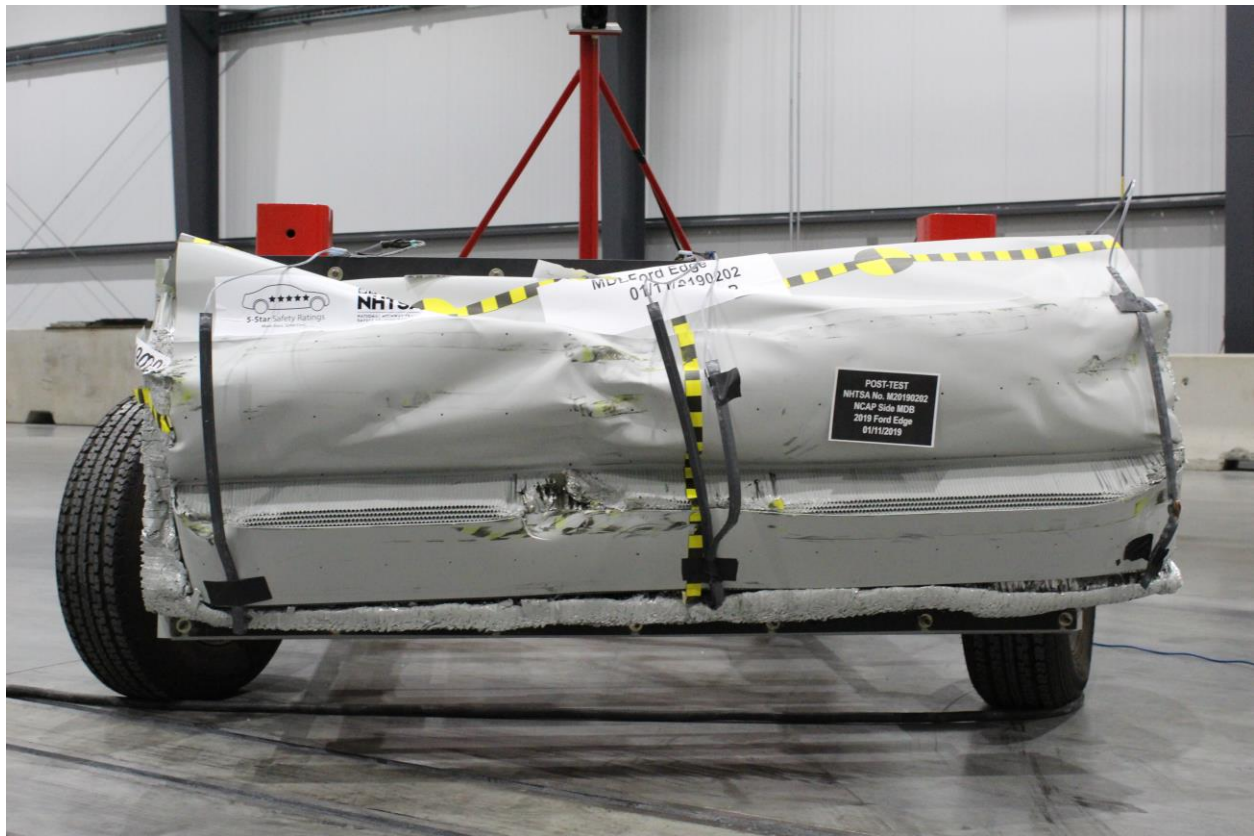
**Figure A-85: Post-Test Front View of MDB Impactor Face**

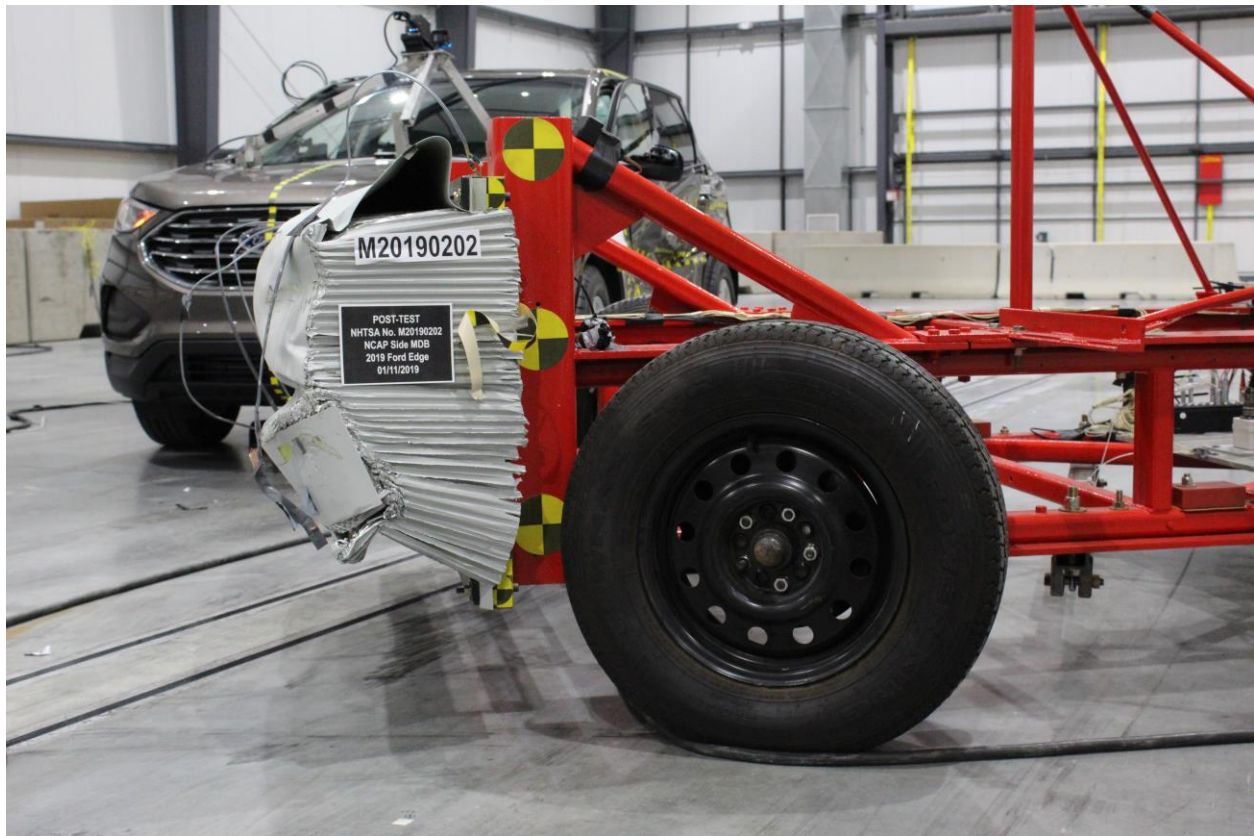
**Figure A-89: Post-Test Left Side View of MDB Impactor Face**
